Your Ref: Porsche Taycan
(chassis number WP0ZZZY1ZMSA28493)
Our Ref : CI/TP22010943/D

04 November 2022

INSPECTION REPORT OF AN UNREGISTERED PORSCHE TAYCAN MOTOR CAR WITH CHASSIS NUMBER WP0ZZZY1ZMSA28493

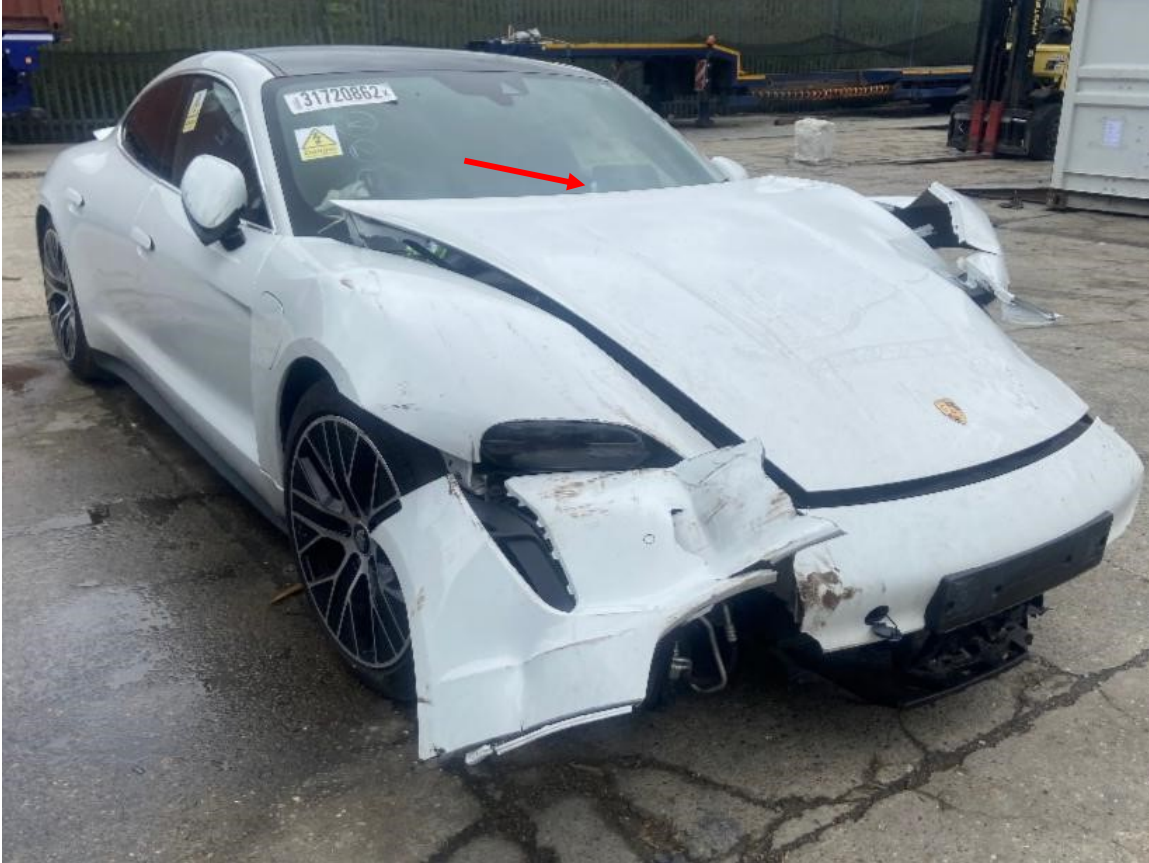
3. The photographs provided to me had showed damage to the frontal portion of the Motor Car. Body parts damaged include the front bumper, front bumper lower lip, front bumper centre frame, front bumper right air guide, front bumper left air guide, front bumper right lower grille, front bumper left lower grille, front bumper sensors, front bonnet, front bonnet hinges, front right headlamp, front right signal lamp, front right fender, front left headlamp, front left signal lamp, front left fender, front left fender inner shield, front left radiator, left side high voltage charging port cover and left side rocker garnish amongst others.

Photo 1 shows the front right body of the Motor Car (photograph provided to me). The Motor Car was observed to have sustained damage at its frontal portion. The front bumper, front bumper lower lip, front bumper right air guide, front bumper right lower grille, front bumper sensors, front bonnet, front bonnet right hinge, front right headlamp, front right signal lamp and front right fender were amongst the body parts that were observed to have been damaged. The front left passenger airbag was deployed (arrowed).

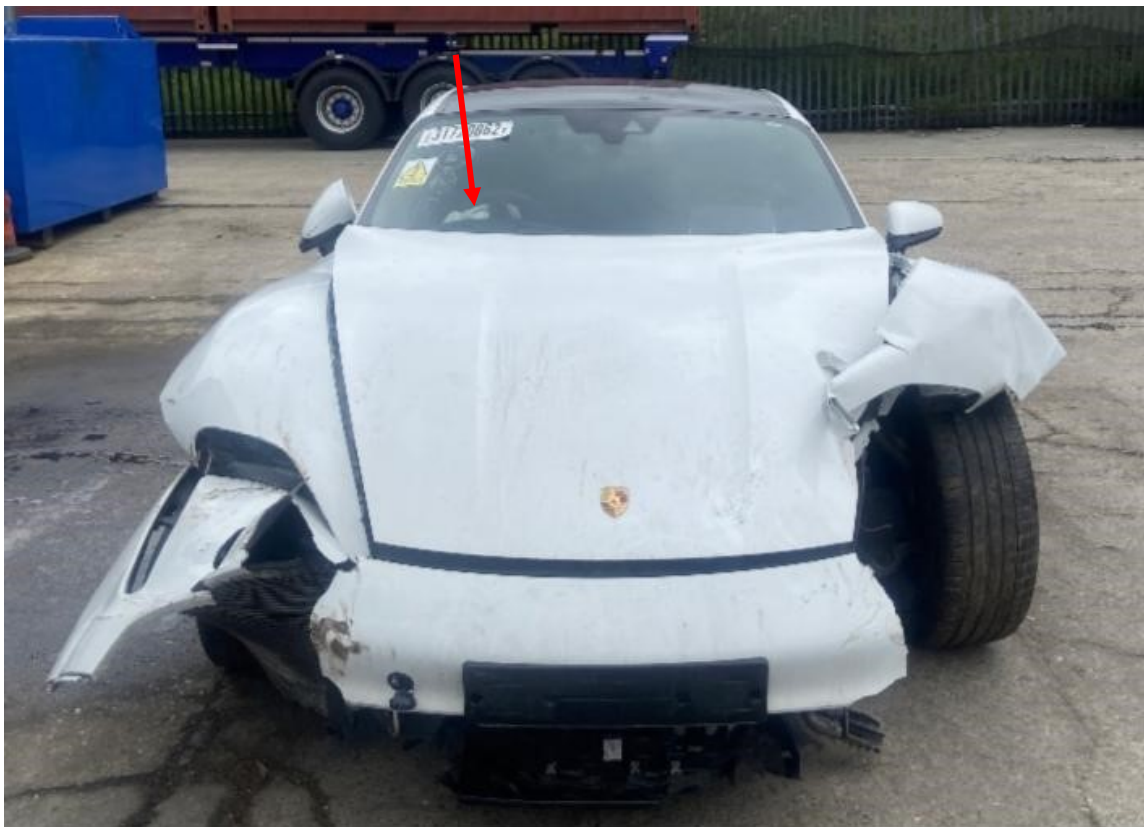
Photo 2 shows the frontal body of the Motor Car (photograph provided to me). The Motor Car was observed to have sustained damage at its frontal portion. The front bumper, front bumper lower lip, front bumper centre frame, front bumper right air guide, front bumper left air guide, front bumper right lower grille, front bumper left lower grille, front bumper sensors, front bonnet, front right headlamp and front left headlamp were amongst the body parts that were observed to have been damaged. The driver's airbag was deployed (arrowed).

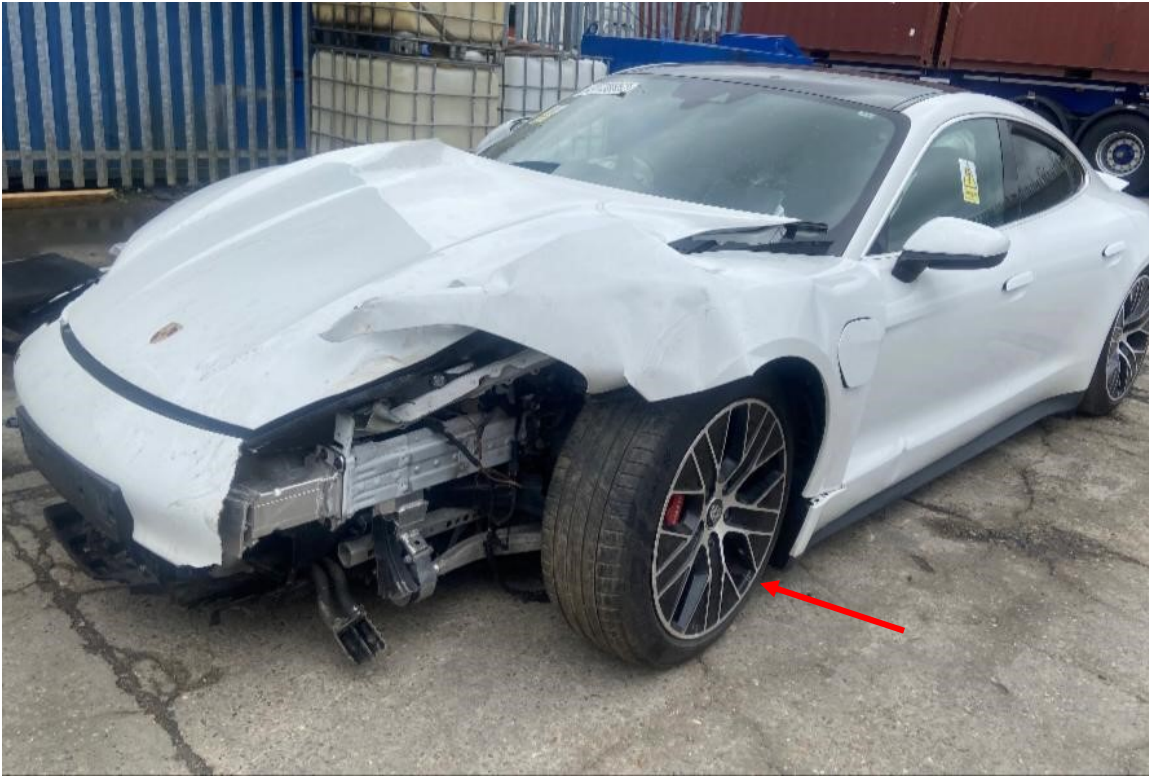
4. The front left wheel was observed to be orientated more towards the left as compared to the front right wheel, which would suggest damage to the undercarriage parts at the front left wheel of the Motor Car. Undercarriage parts that may possibly be damaged include the front left lower arm, front left knuckle arm and front left shock absorber amongst others.

Photo 3 shows the front left body of the Motor Car (photograph provided to me). The Motor Car was observed to have sustained damage at its frontal portion. The front bumper, front bumper lower lip, front bumper left air guide, front left headlamp, front left signal lamp, front left fender, front left fender inner shield, front left radiator, left side high voltage charging port cover and left side rocker garnish were amongst the body parts that were observed to have been damaged. The front left wheel (arrowed) was observed to be orientated more towards the left as compared to the front right wheel (refer to photograph 1 above). This suggests damage to the undercarriage parts at the front left wheel of the Motor Car. Undercarriage parts that may possibly be damaged include the front left lower arm, front left knuckle arm and front left shock absorber amongst others.

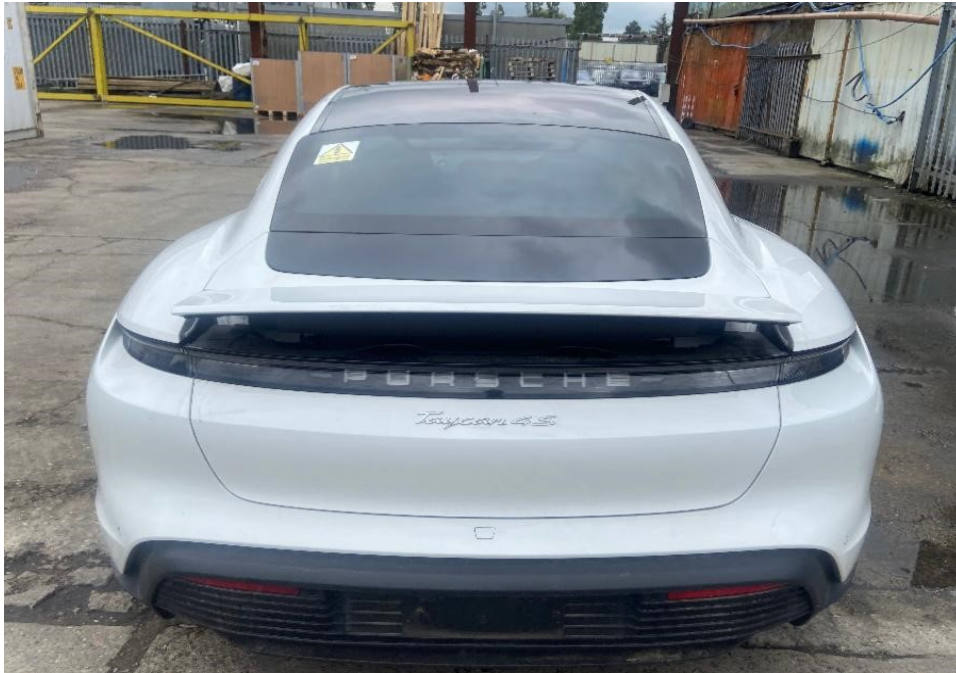
Photo 4 shows the rear body of the Motor Car (photograph provided to me). Apart for the frontal portion, there was no physical damage observed to other areas of the Motor Car.

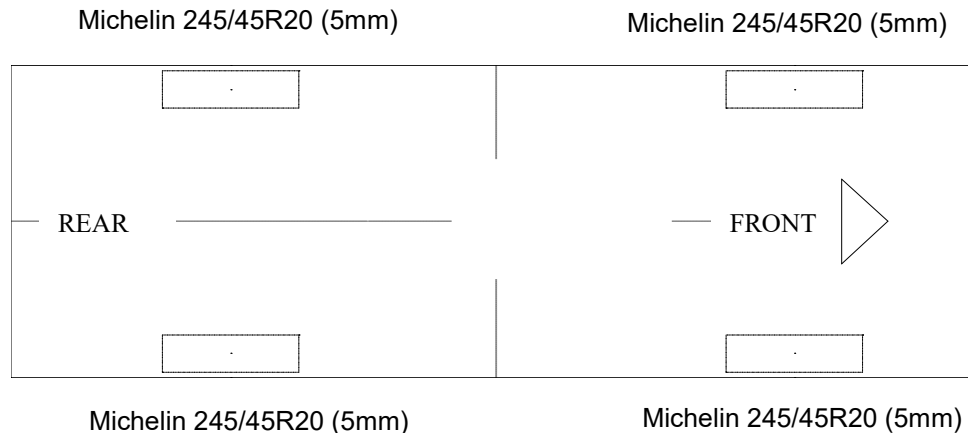
10. The Motor Car was fitted with 20inch sport wheel rims that were wrapped with tyres that were observed to be of serviceable condition. The tyres were also sufficiently inflated for vehicular operation. The tyre brand, tyre size and approximate remaining tread depth of the 4 tyres of the Motor Car were recorded as follows: -

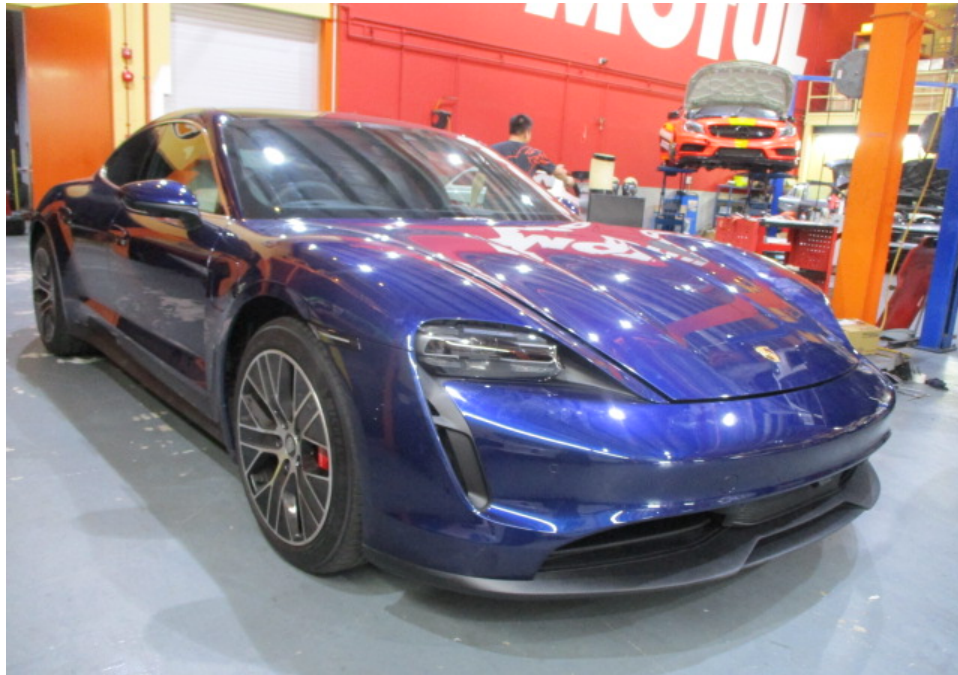
Photo 5 shows a general view of the front right body of the Motor Car at the time of my inspection. The Motor Car was observed to be in a relatively good general condition with no loose exterior fittings observed. The body parts at the frontal portion of the Motor Car were visually examined and it was observed that the repair/restoration works carried out to the damaged area of the Motor Car (refer to photograph 1 - 3 above) were reasonably adequate and in order.

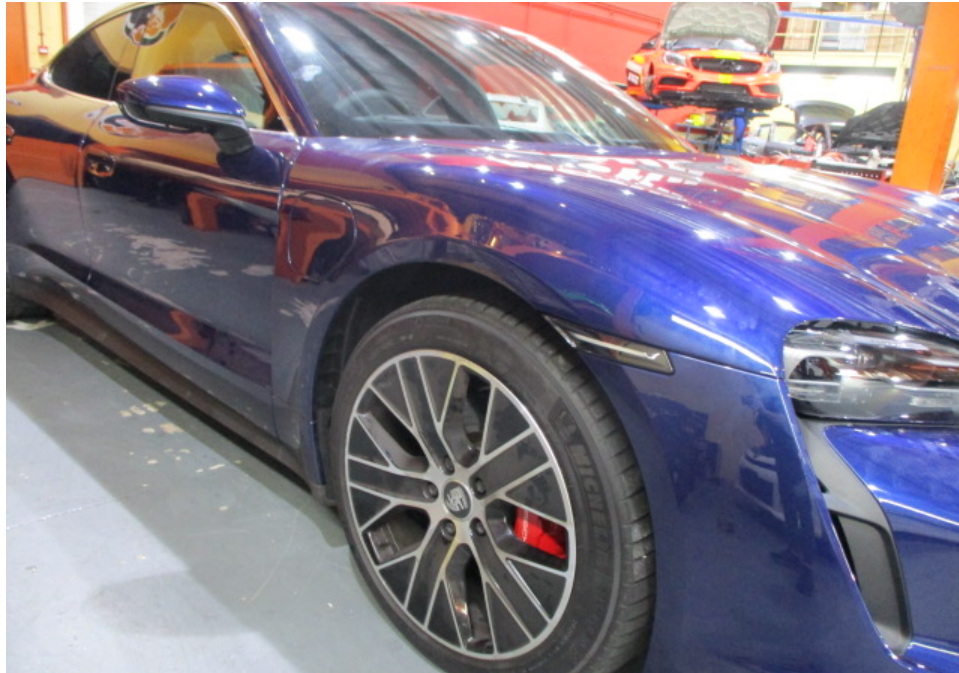
Photo 6 shows a closer view of the Motor Car's front bonnet, front right signal lamp, front right fender and front right wheel rim. The body parts at the frontal portion of the Motor Car were visually examined and it was observed that the repair/restoration works carried out to the damaged area of the Motor Car (refer to photograph 1 - 3 above) were reasonably adequate and in order.

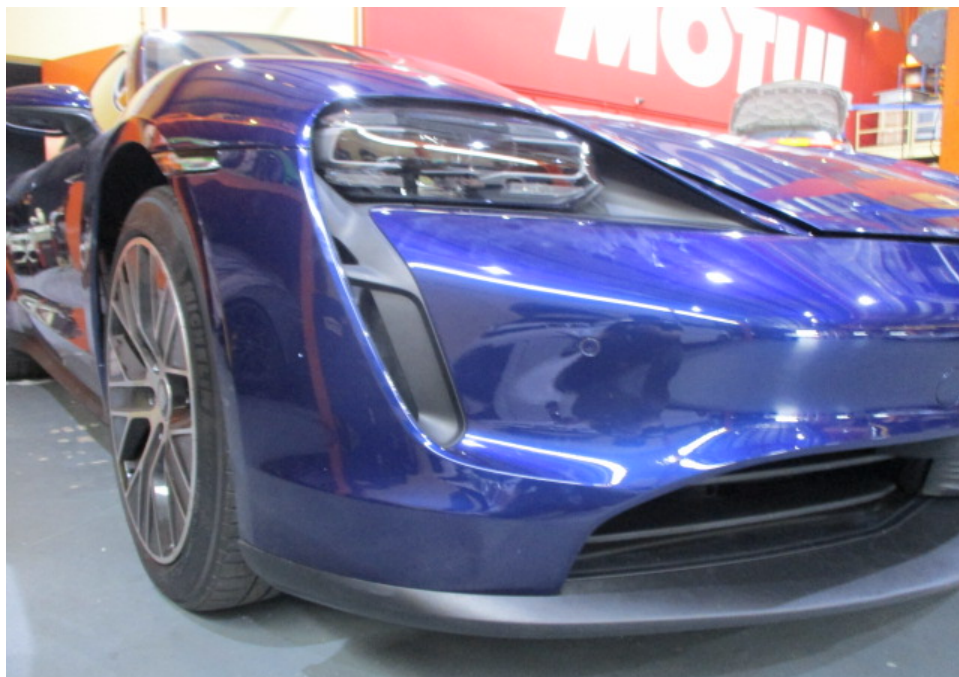
Photo 7 shows a closer view of the Motor Car's front bumper, front bumper lower lip, front bumper right air guide, front bumper right lower grille and front right headlamp. The body parts at the frontal portion of the Motor Car were visually examined and it was observed that the repair/restoration works carried out to the damaged area of the Motor Car (refer to photograph 1 - 3 above) were reasonably adequate and in order.

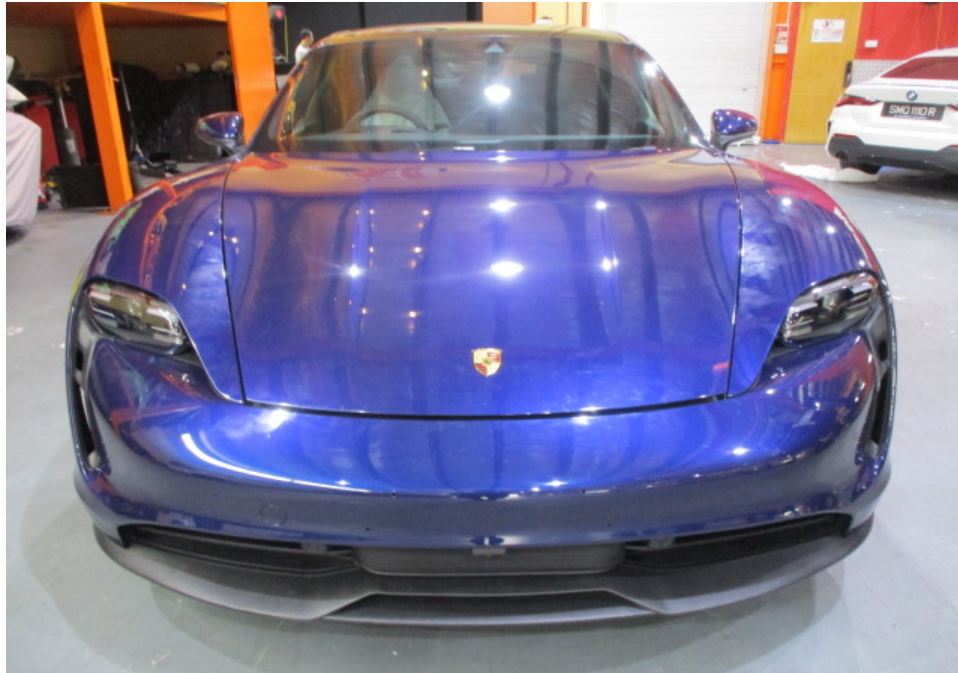
Photo 8 shows a general view of the Motor Car's frontal portion at the time of my inspection. The body parts at the frontal portion of the Motor Car were visually examined and it was observed that the repair/restoration works carried out to the damaged area of the Motor Car (refer to photograph 1 - 3 above) were reasonably adequate and in order.

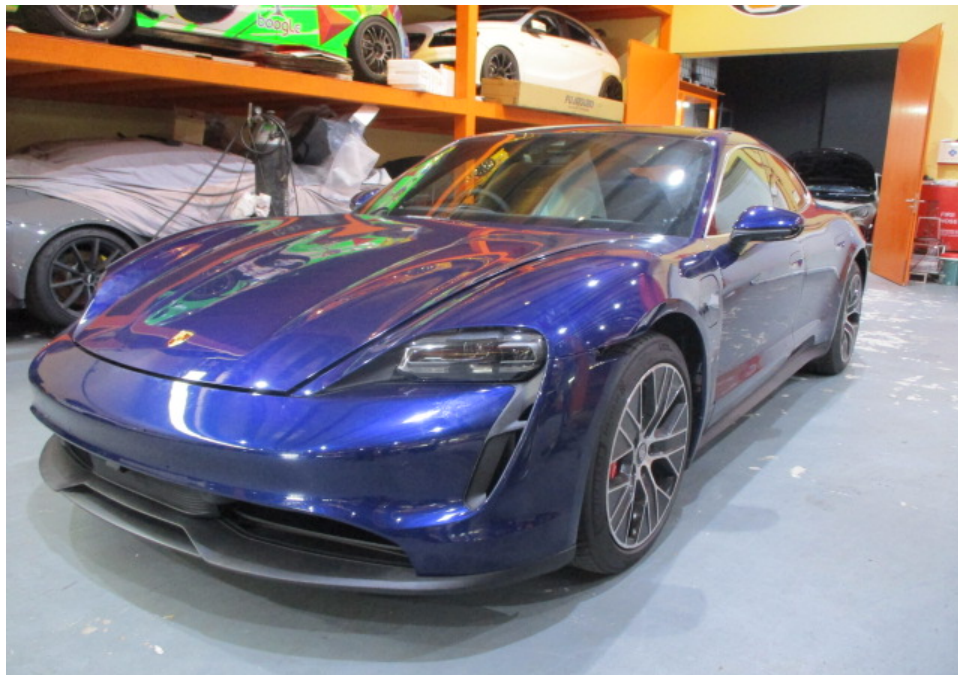
Photo 9 shows a general view of the front left body of the Motor Car at the time of my inspection. The Motor Car was observed to be in a relatively good general condition with no loose exterior fittings observed. The body parts at the frontal portion of the Motor Car were visually examined and it was observed that the repair/restoration works carried out to the damaged area of the Motor Car (refer to photograph 1 - 3 above) were reasonably adequate and in order.

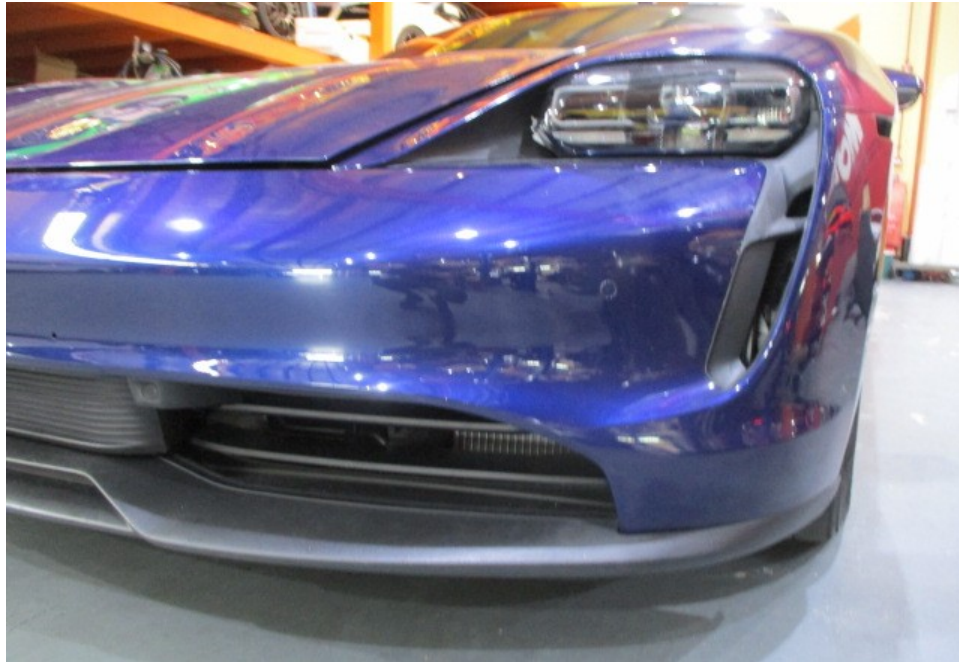
Photo 10 shows a closer view of the Motor Car's front bumper, front bumper lower lip, front bumper left air guide, front bumper left lower grille and front left headlamp. The body parts at the frontal portion of the Motor Car were visually examined and it was observed that the repair/restoration works carried out to the damaged area of the Motor Car (refer to photograph 1 - 3 above) were reasonably adequate and in order.

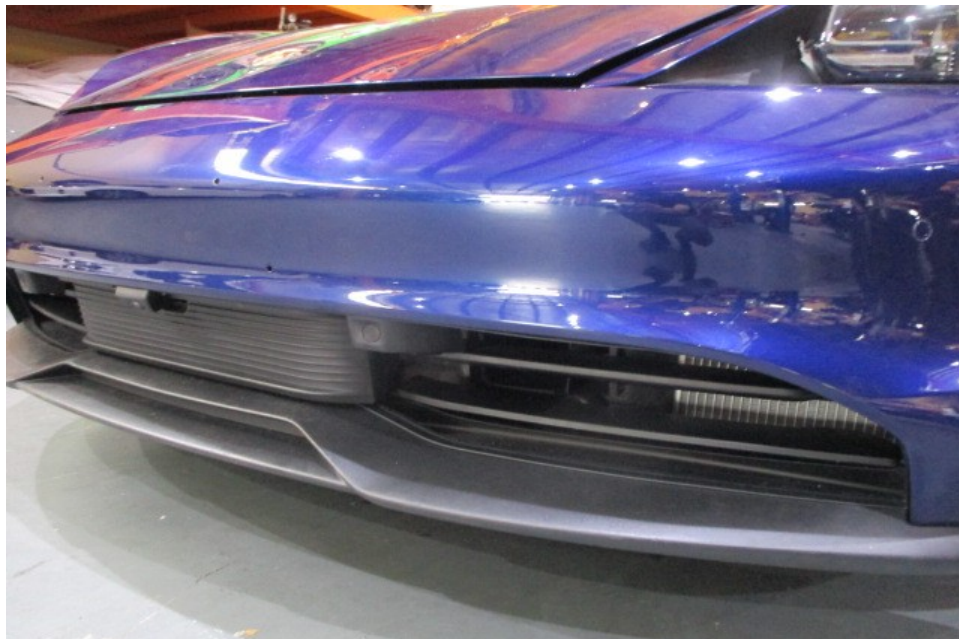
Photo 11 shows a closer view of the Motor Car's front bumper, front bumper lower lip, front bumper left lower grille, front bumper sensors, front bumper centre frame and front left radiator. The body parts at the frontal portion of the Motor Car were visually examined and it was observed that the repair/restoration works carried out to the damaged area of the Motor Car (refer to photograph 1 - 3 above) were reasonably adequate and in order.

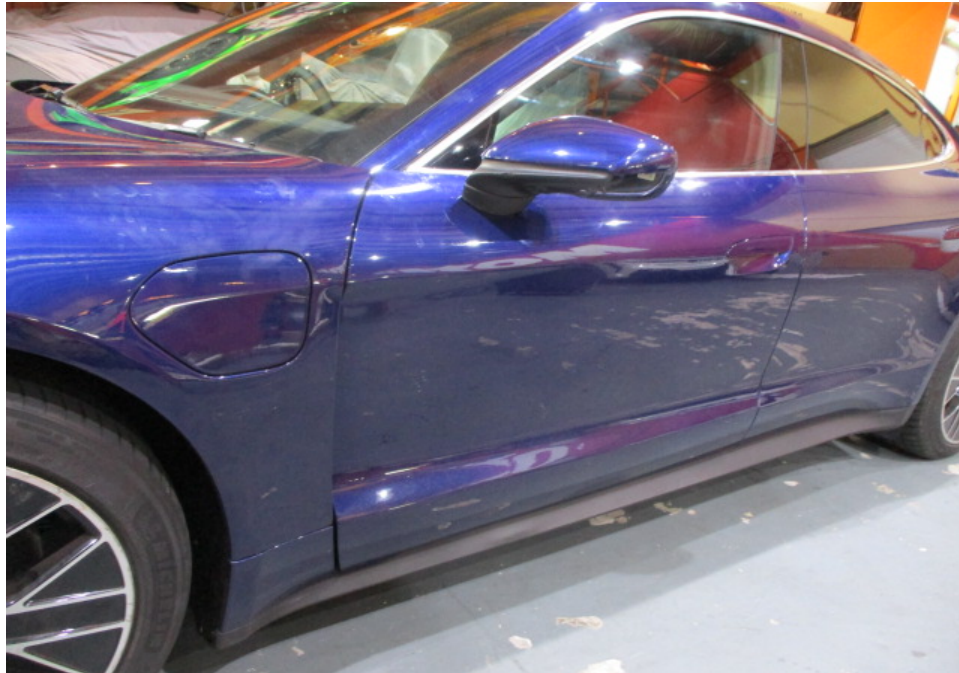
Photo 12 shows a closer view of the Motor Car's left side high voltage charging port cover, front left door, left side wing mirror and left side rocker panel garnish. The body parts at the frontal portion of the Motor Car were visually examined and it was observed that the repair/restoration works carried out to the damaged area of the Motor Car (refer to photograph 1 - 3 above) were reasonably adequate and in order.

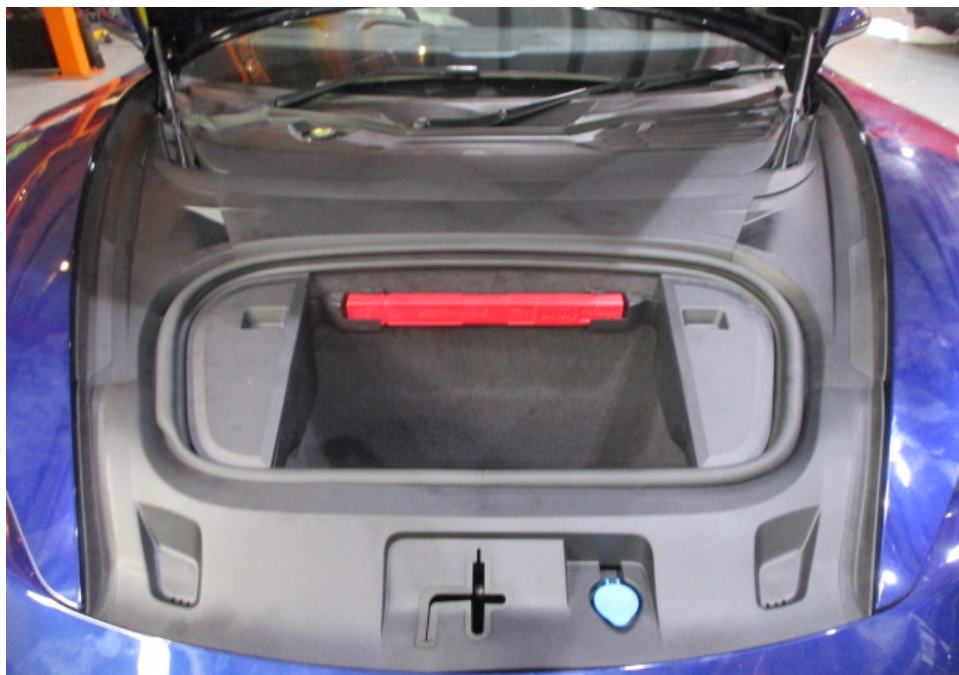
Photo 13 shows a general view of the Motor Car's front bonnet compartment at the time of my inspection. All inner trims, garnishes and upholstery etc were observed to be properly fitted.

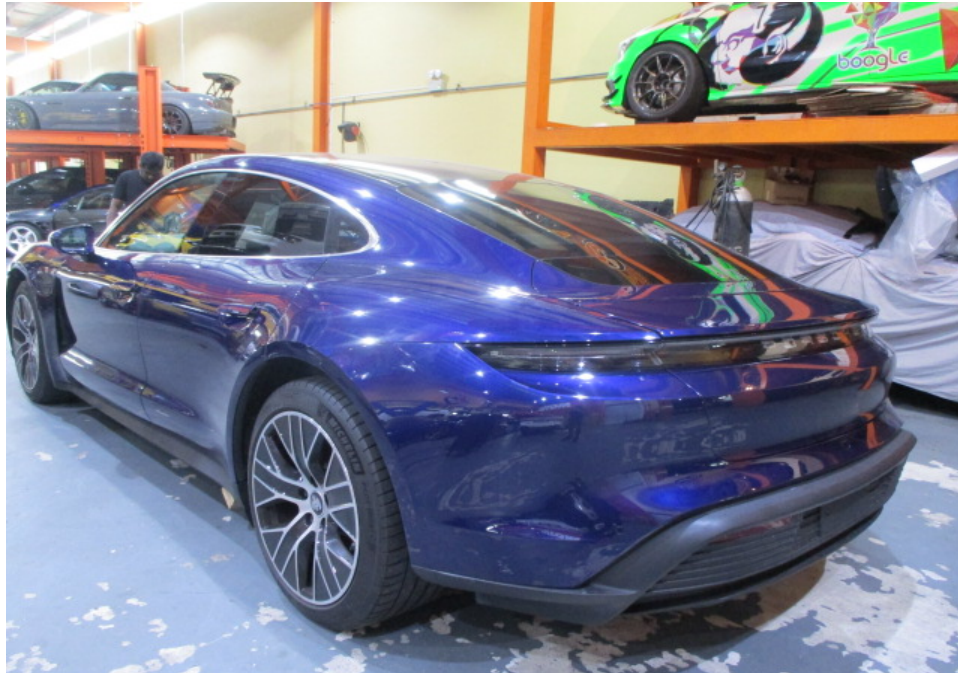
Photo 14 shows a general view of the rear left body of the Motor Car at the time of my inspection. The Motor Car was observed to be in a relatively good general condition with no loose exterior fittings observed. The mileage of the Motor Car recorded at the time of my inspection was 18,435km.

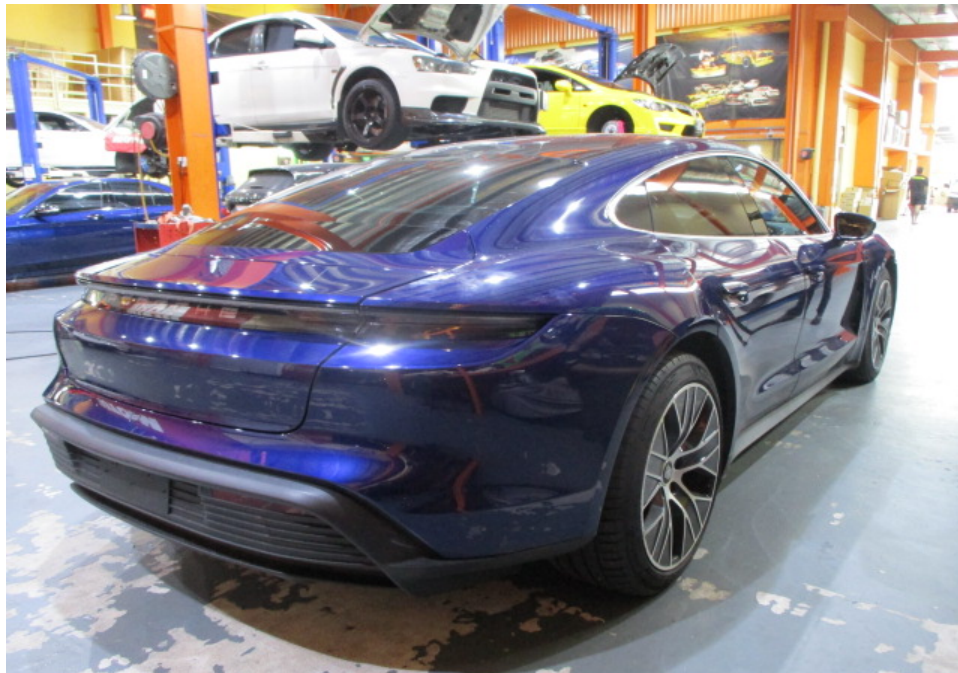
Photo 15 shows a general view of the rear right body of the Motor Car at the time of my inspection. The Motor Car was observed to be in a relatively good general condition with no loose exterior fittings observed. The mileage of the Motor Car recorded at the time of my inspection was 18,435km.

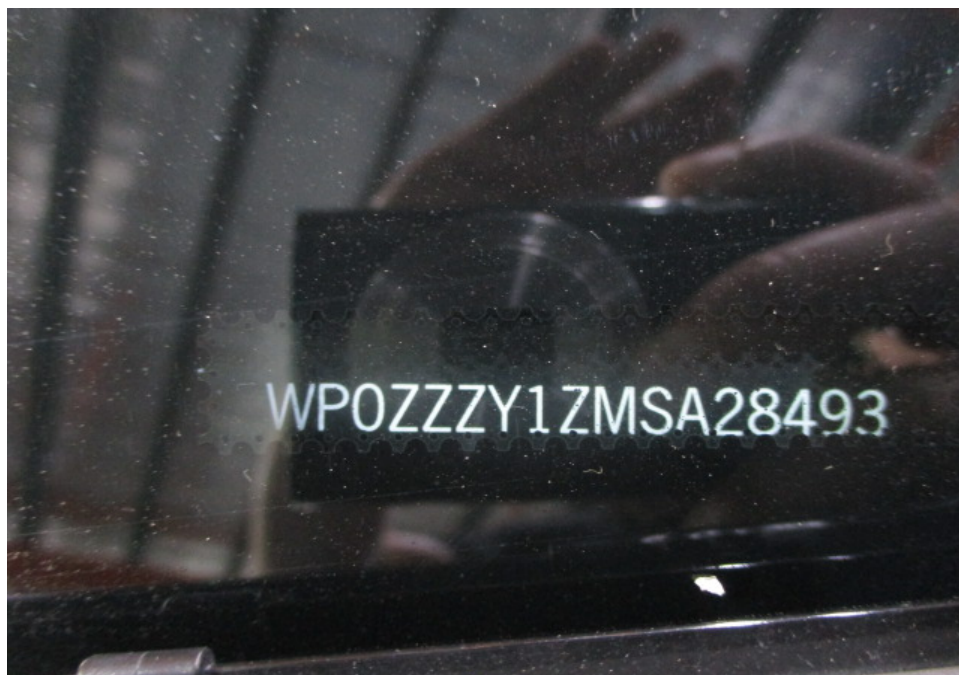
Photo 16 shows the chassis number of the Motor Car. The chassis number recorded was WP0ZZZY1ZMSA28493.

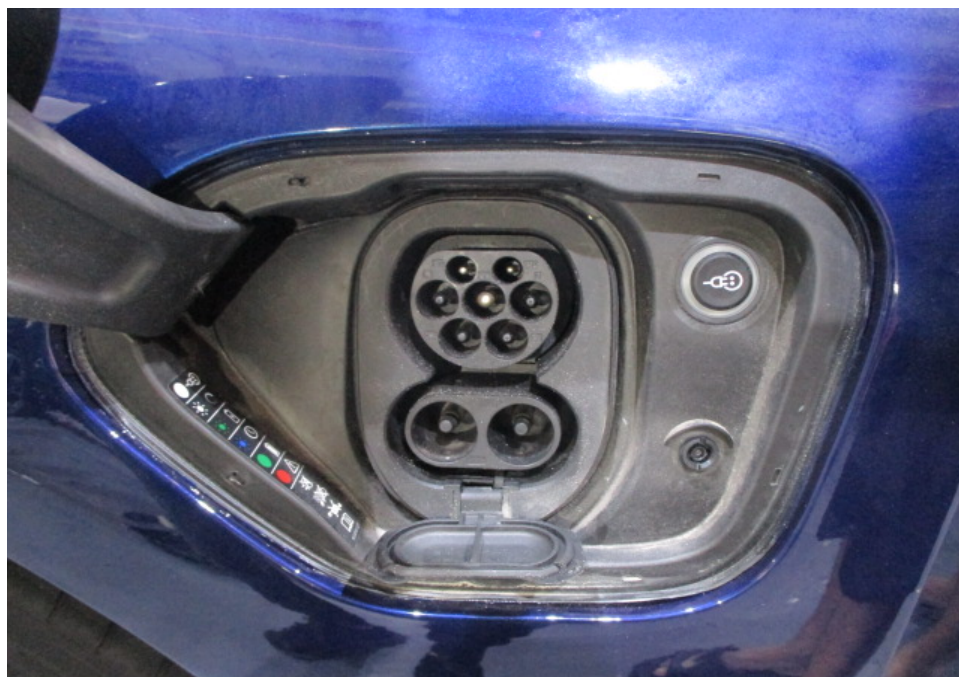
Photo 17 shows the high voltage charging port located at the front left fender of the Motor Car at the time of my inspection. A Combined Charging Standard 2 (CCS 2) for direct current (DC) charging was fitted on the front left fender of the Motor Car. No physical damage was observed to the charging head.

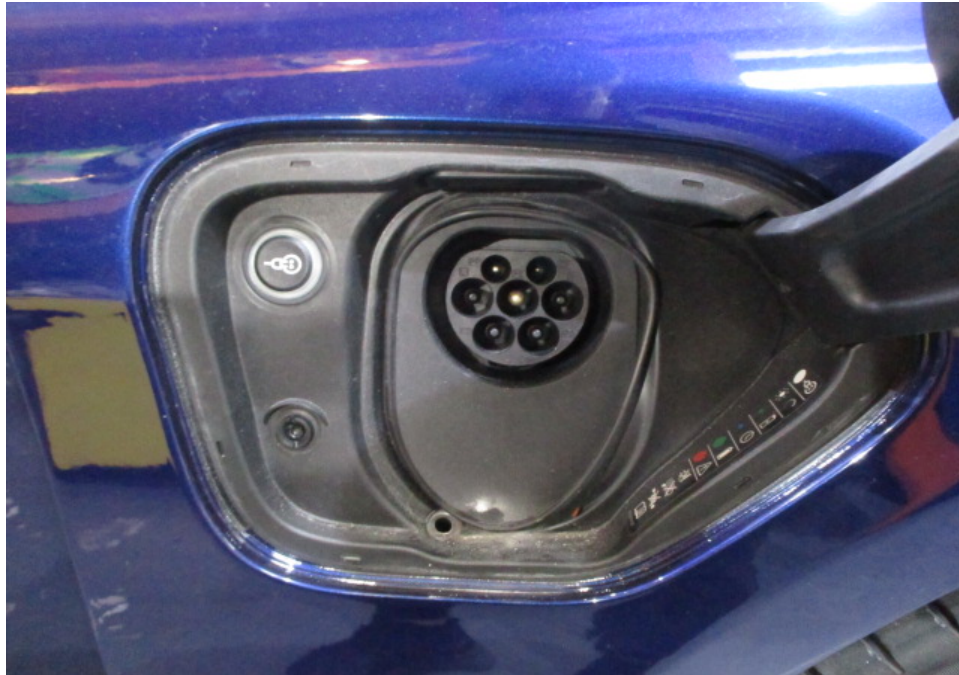
Photo 18 shows the high voltage charging port located at the front right fender of the Motor Car at the time of my inspection. A JS 1772 (Type 2) for alternating current (AC) charging was fitted on the front right fender of the Motor Car. No physical damage was observed to the charging head.

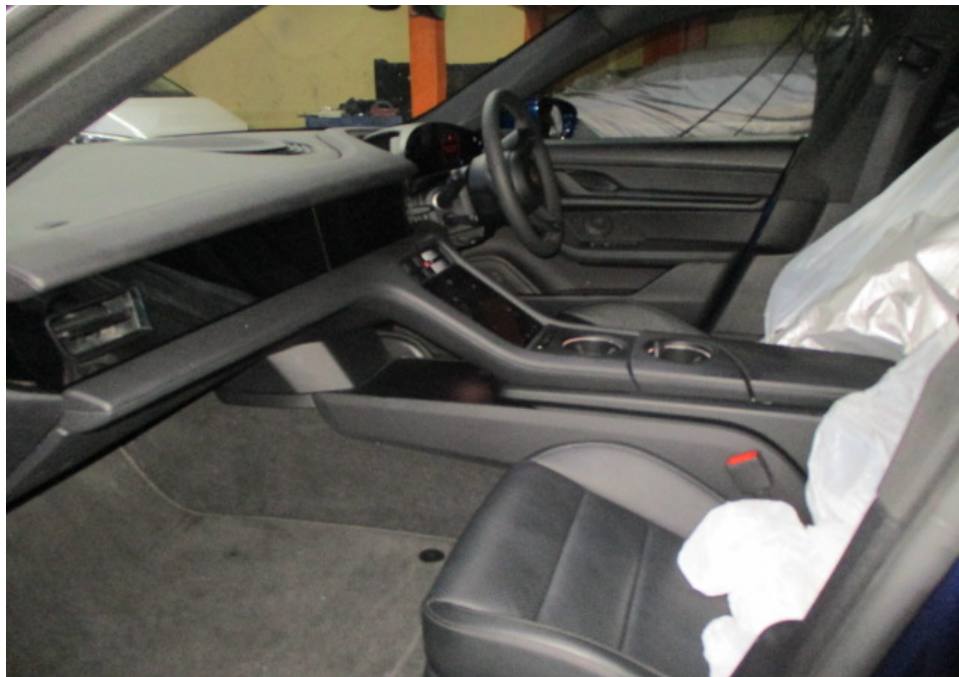
Photo 19 shows the interior compartment of the Motor Car at the time of my inspection. The various parts and components, trims, carpet, and upholstery inside the interior compartment were all observed to be intact and properly fitted.

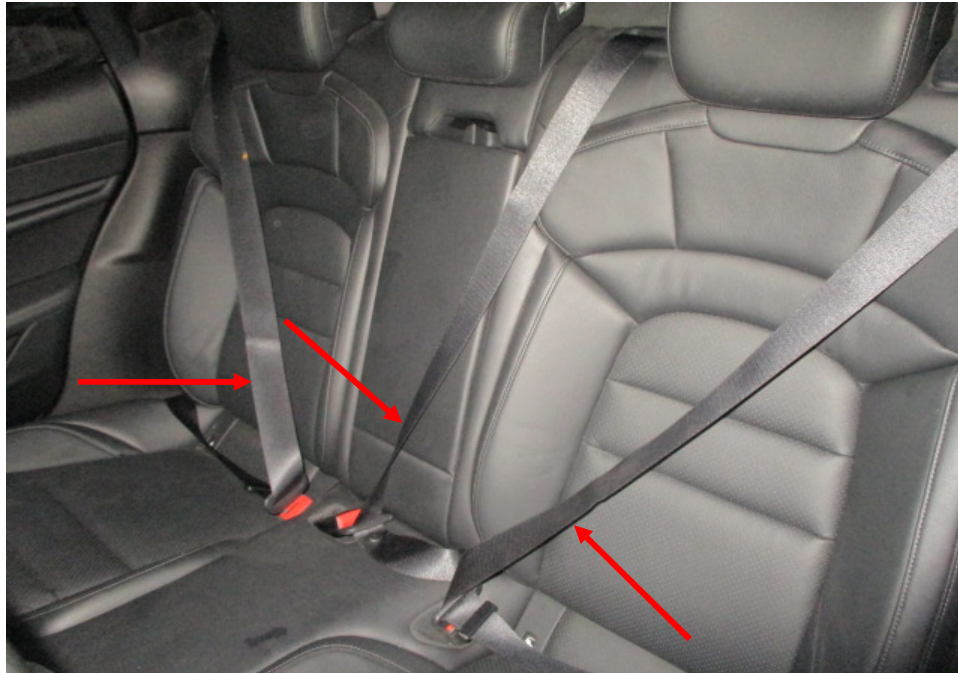
Photo 20 shows the rear seats of the Motor Car. All the seats of the Motor Car were secured via seat rails to the floorboard. They were also fitted with a retractable seat belt reel and a pre-tensioner. The seat belts (arrowed) were tested and were able to be fastened into the respective pre-tensions that were fitted on the side of each individual seat.

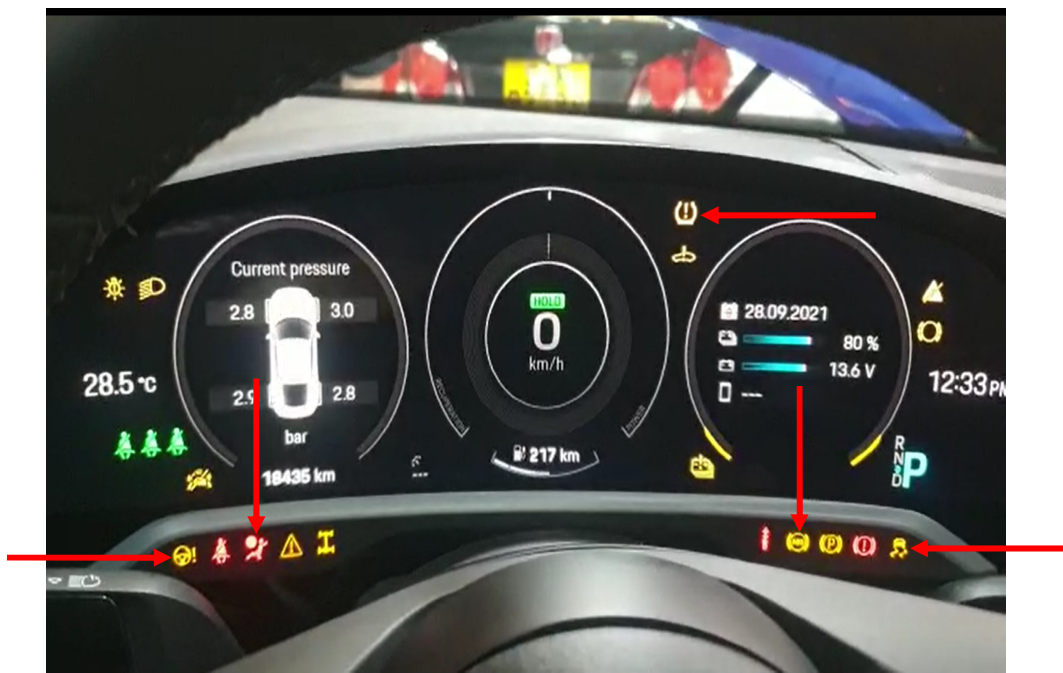
Photo 21 shows the warning lights for the various electronic safety features appearing on the instrument panel of the Motor Car during its self-test when the engine is cranked, in particular the ABS, SRS, EPS, TPM and SCS lights (arrowed).

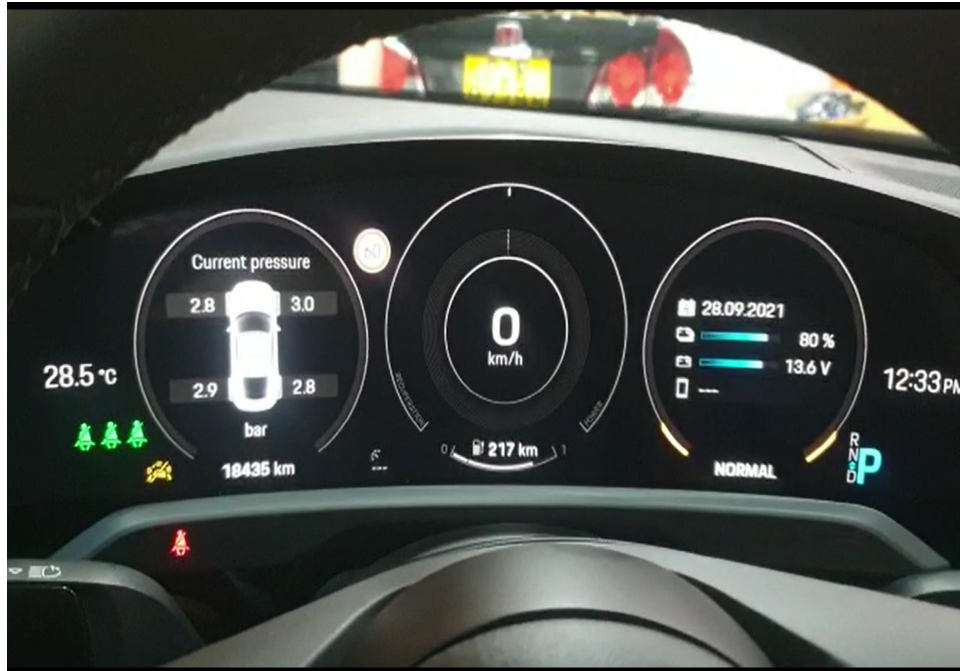
Photo 22 shows the respective warning lights no longer illuminated, indicating that there is no fault detected to the ABS, SRS, EPS, TPM and SCS systems of the Motor Car during the self-test. These electronic systems were hence in working condition at the time of my inspection.

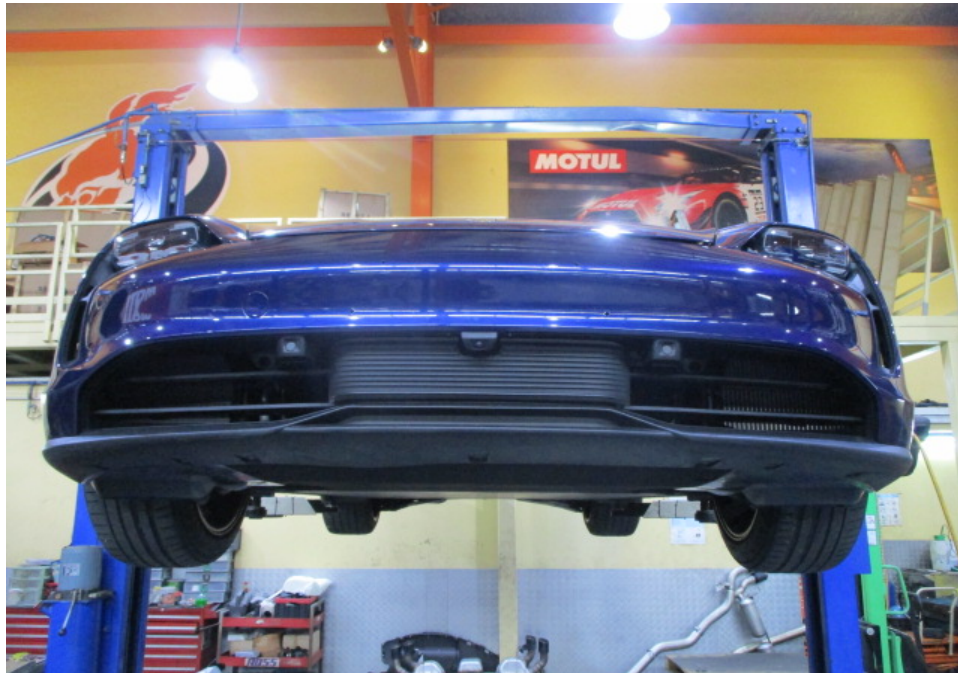
Photo 23 shows the Motor Car hoisted up for checks on its undercarriage. There was no sign(s) or indication(s) of fluid leakage and/or fluid stain(s) on the underside of the Motor Car. The undercarriage components of the Motor Car were also all observed to be intact and secured in an appropriate manner.

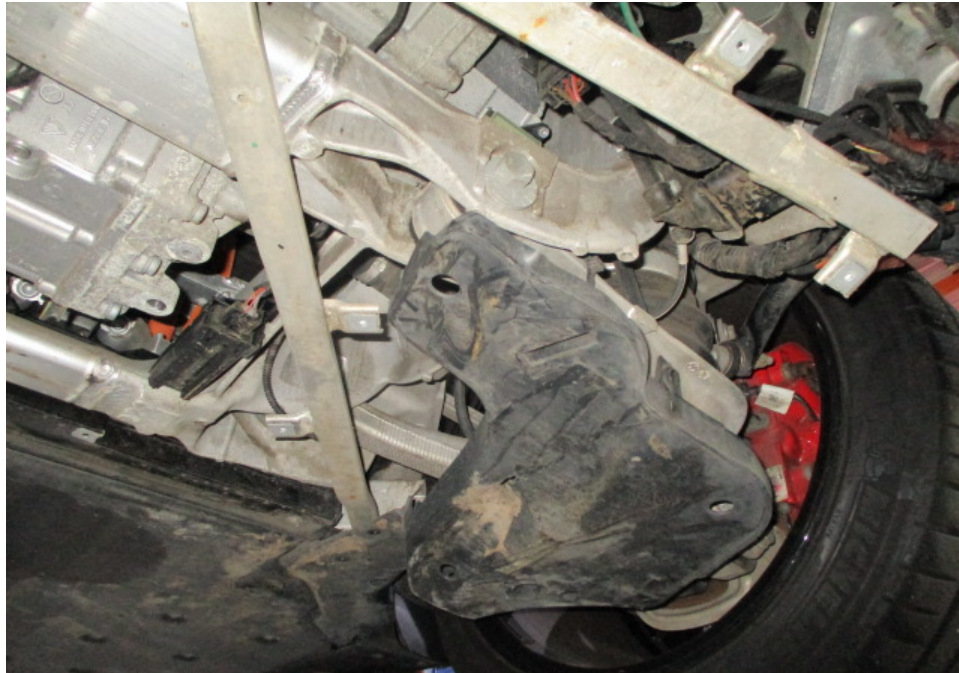
Photo 24 shows a general view of the control arms and linkages at the rear right wheel of the Motor Car. I did not observe any fluid leak and/or fluid stain on the underside of the Motor Car. All of the Motor Car's undercarriage components were observed to be intact and secured in an appropriate manner.

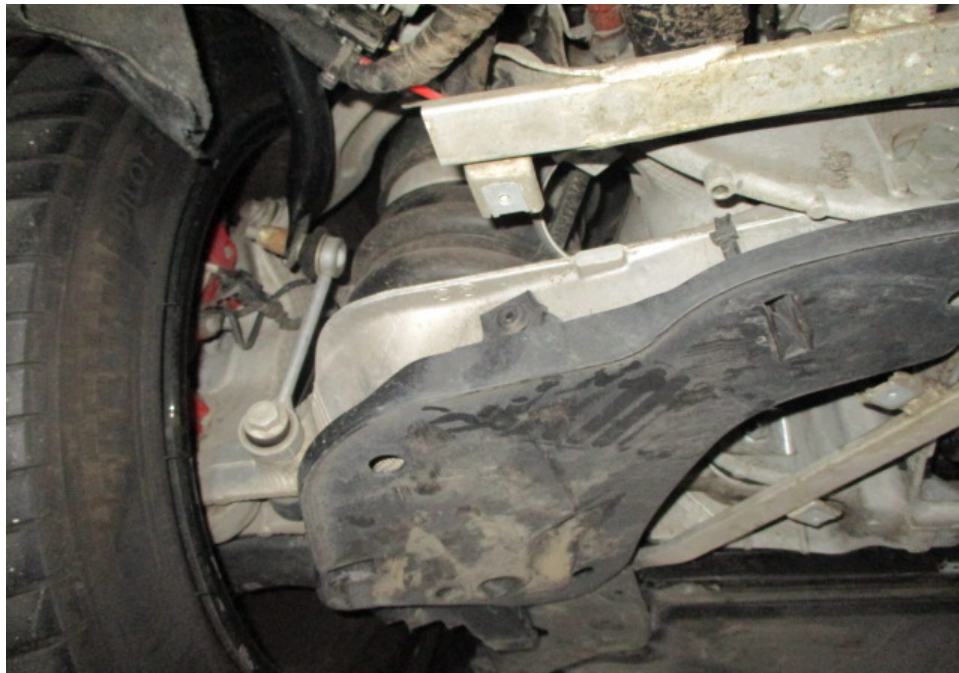
Photo 25 shows a general view of the control arms and linkages at the rear left wheel of the Motor Car. I did not observe any fluid leak and/or fluid stain on the underside of the Motor Car. All of the Motor Car's undercarriage components were observed to be intact and secured in an appropriate manner.

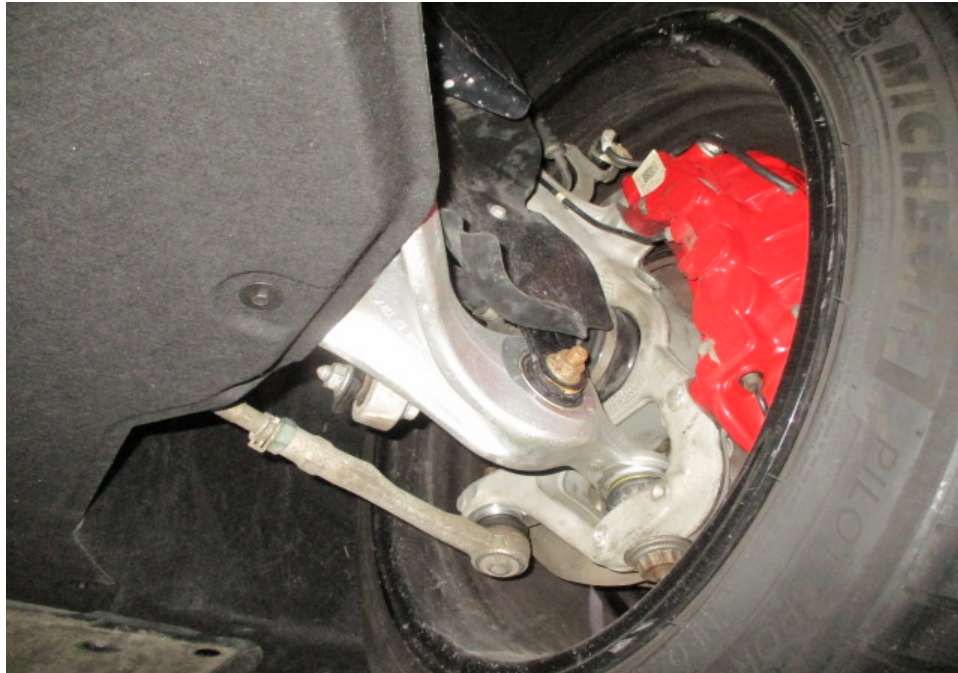
Photo 26 shows the various undercarriage components at the front left wheel of the Motor Car. The mechanical components, control arms and linkages were all found to be intact and secured in an appropriate manner.

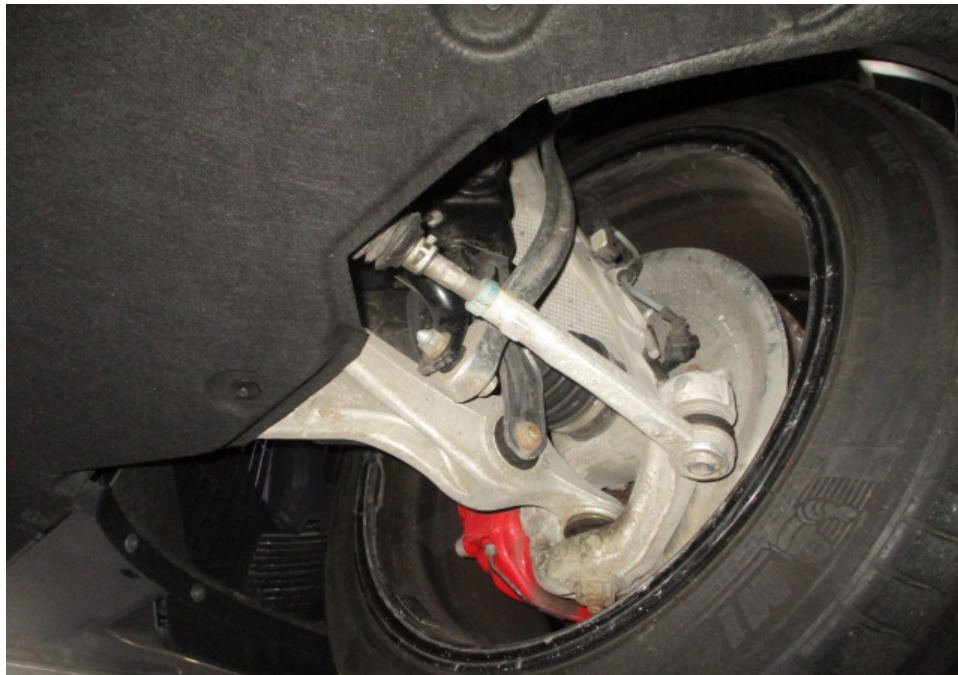
Photo 27 shows the various undercarriage components at the front right wheel of the Motor Car. The mechanical components, control arms and linkages were all found to be intact and secured in an appropriate manner. I also did not observe any fluid leak and/or fluid stain on the underside of the Motor Car.

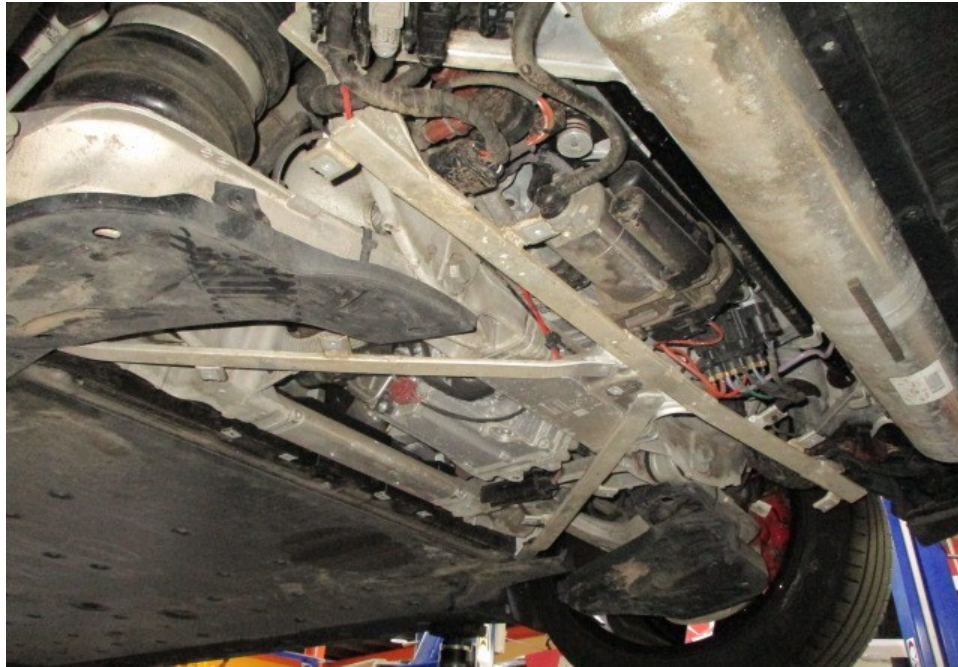
Photo 28 shows the underside rear of the Motor Car, at the location where the rear electric motor is fitted. The high voltage system of the Motor Car was visually checked, and it was observed that the various high voltage parts and components like the high voltage battery, inverter unit, converter unit, high voltage cables, electric motors and electric aircon compressor amongst others, were properly secured and without any physical damage..
