Your Ref: Porsche Taycan
(chassis number WP0ZZZY1ZMSA28493)
Our Ref : CI/TP22010943/D

04 November 2022

INSPECTION REPORT OF AN UNREGISTERED PORSCHE TAYCAN MOTOR CAR WITH CHASSIS NUMBER WP0ZZZY1ZMSA28493

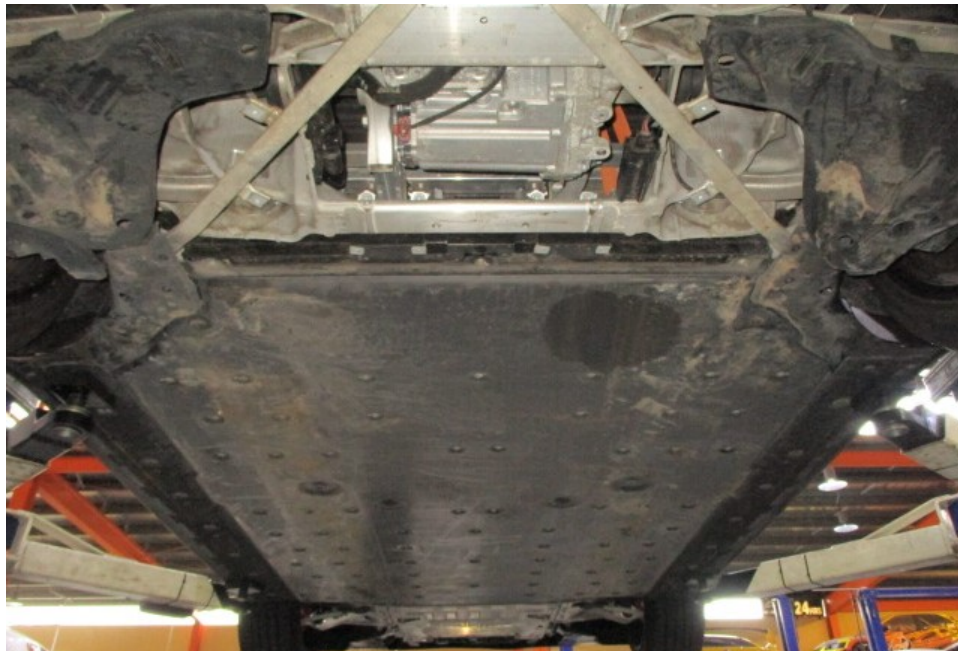
Photo 29 shows the underside centre of the Motor Car, at the location where the high voltage battery is fitted. The high voltage system of the Motor Car was visually checked, and it was observed that the various high voltage parts and components like the high voltage battery, inverter unit, converter unit, high voltage cables, electric motors and electric aircon compressor amongst others, were properly secured and without any physical damage.

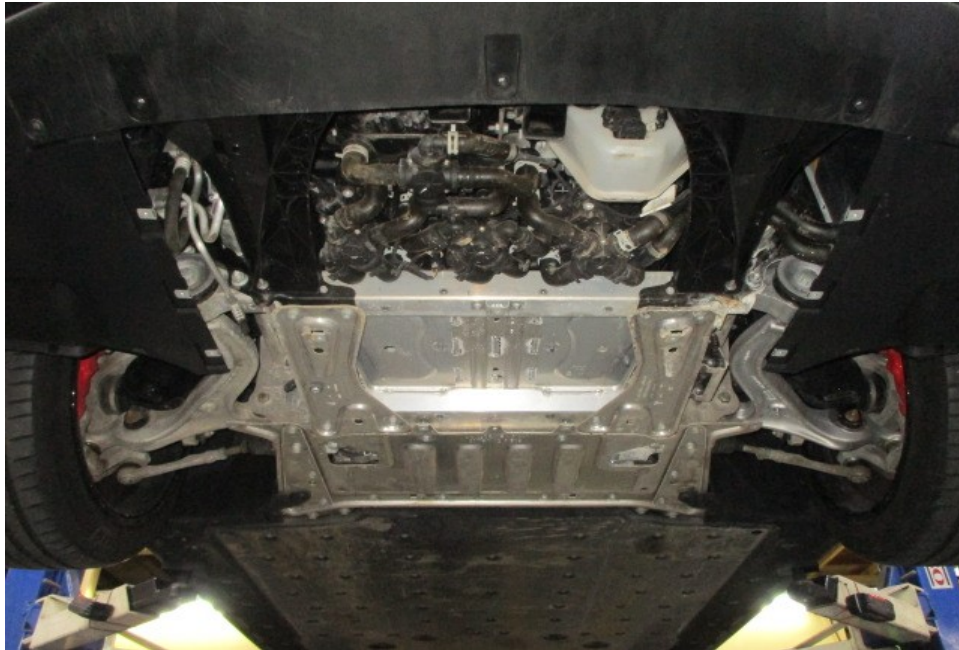
Photo 30 shows the underside front of the Motor Car, at the location where the front electric motor, is fitted. The high voltage system of the Motor Car was visually checked, and it was observed that the various high voltage parts and components like the high voltage battery, inverter unit, converter unit, high voltage cables, electric motors and electric aircon compressor amongst others, were properly secured and without any physical damage.

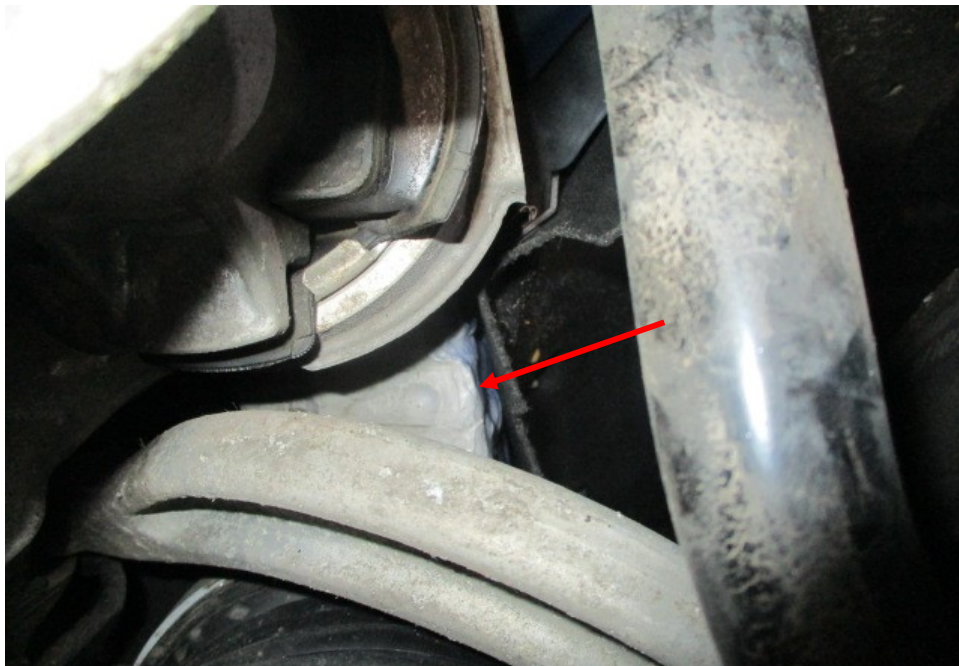
Photo 31 shows the chassis/structural body at the underside rear right of the Motor Car. I did not find any weld marks other than original spot weld marks on the chassis/structural body of the Motor Car. The original factory sealant (arrowed) at the joints along the chassis/structural body was untouched, indicating no work was done on the chassis/structural body of the Motor Car and that the chassis/structural body was originally fitted.

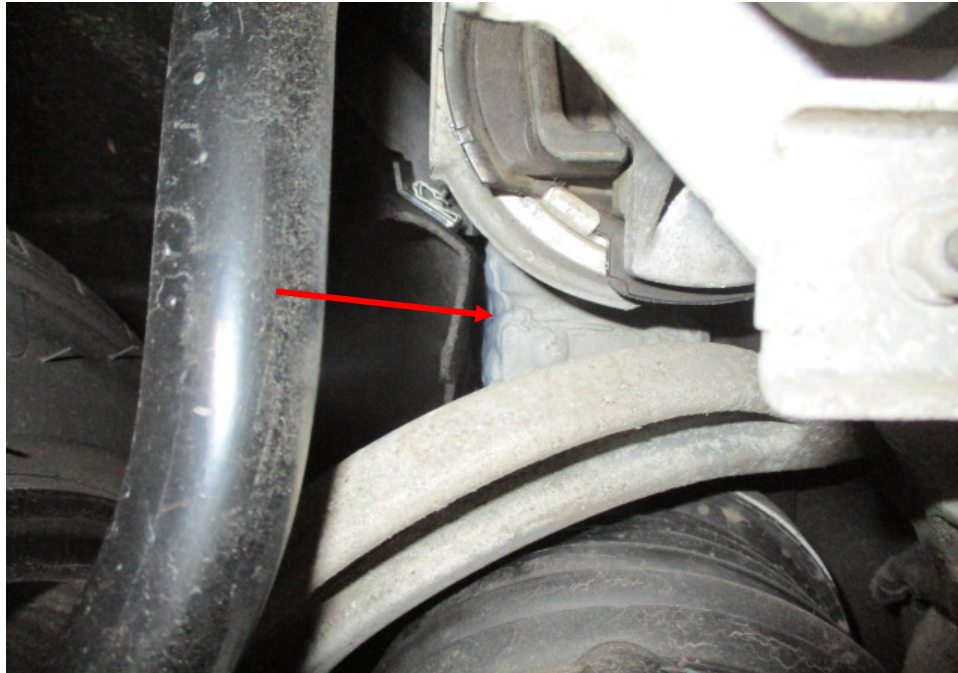
Photo 32 shows the chassis/structural body at the underside rear left of the Motor Car. The original factory sealant (arrowed) at the joints along the chassis/structural body was observed to be untouched. In general, I had found no work was carried out on the chassis/structural body of the Motor Car. The chassis/structural body of the Motor Car was originally fitted.

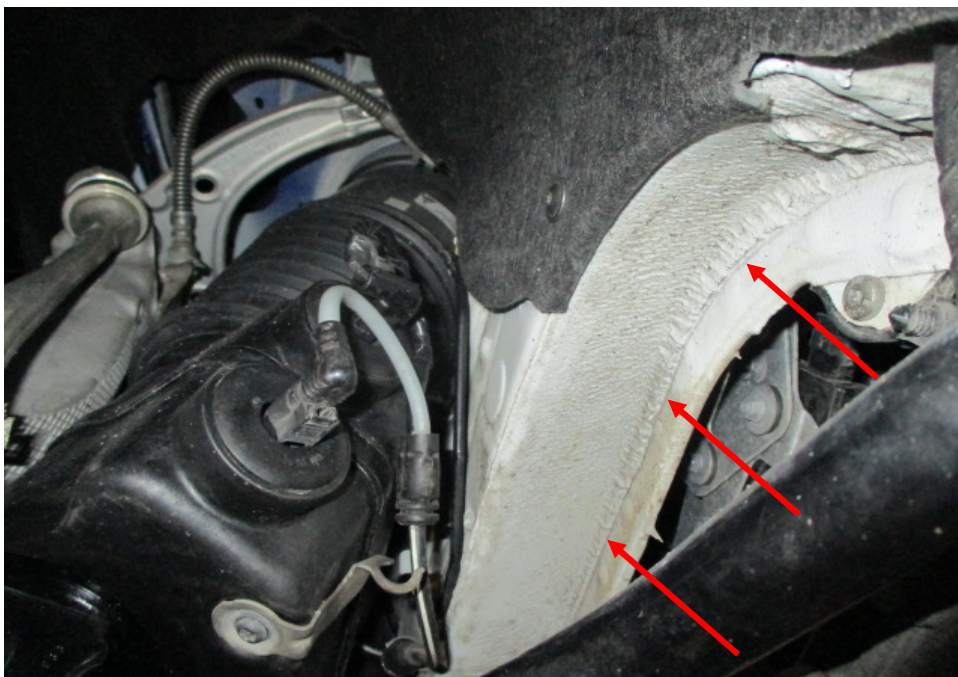
Photo 33 shows the chassis/structural body at the underside front left of the Motor Car. I did not find any weld marks other than original spot weld marks on the chassis/structural body of the Motor Car. The original factory sealant (arrowed) at the joints along the chassis/structural body was untouched, indicating no work was done on the chassis/structural body of the Motor Car and that the chassis/structural body was originally fitted.

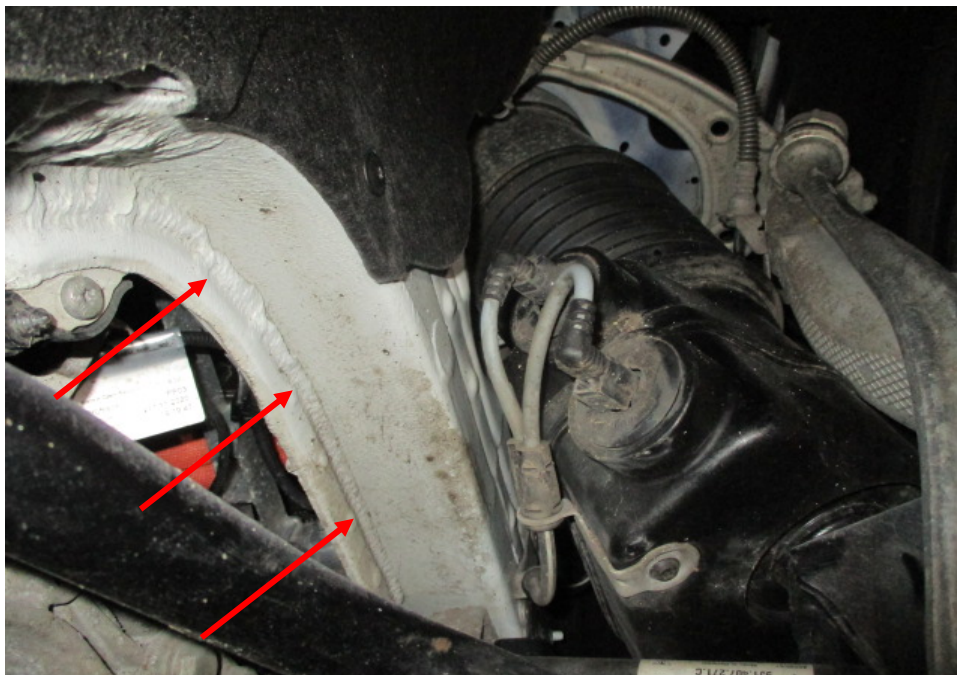
Photo 34 shows the chassis/structural body at the underside front right of the Motor Car. The original factory sealant (arrowed) at the joints along the chassis/structural body was observed to be untouched. In general, I had found no work was carried out on the chassis/structural body of the Motor Car. The chassis/structural body of the Motor Car was originally fitted.
