Your Ref :1202200044463  
Our Ref : CS4/FWD22010948/N

18 November 2022

**TECHNICAL INVESTIGATION REPORT OF FIRE INCIDENT INVOLVING THE INSURED MOTORCYCLE FBB 7707P ON 21 OCTOBER 2022**

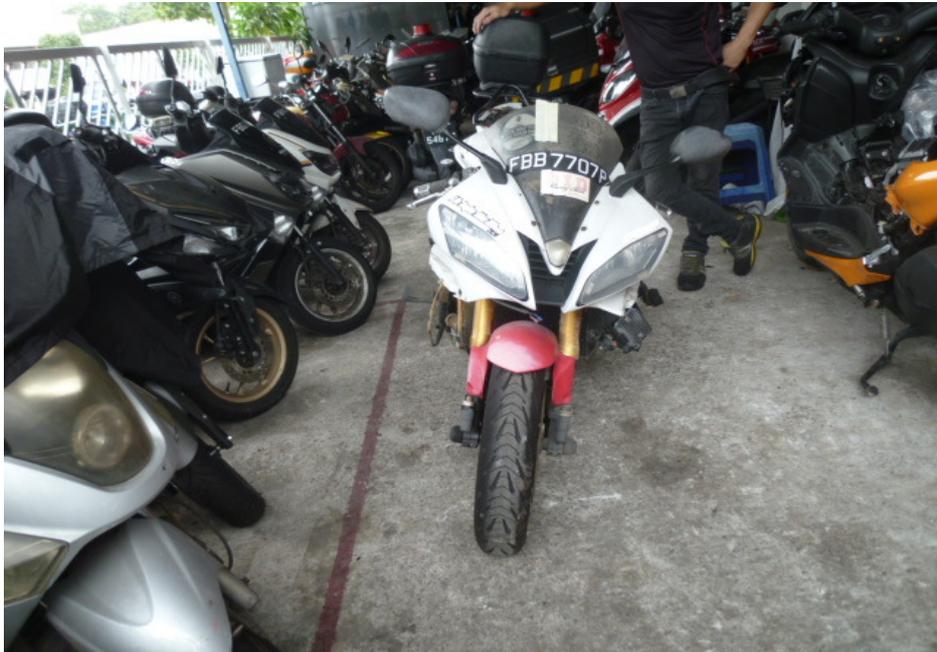
**Photo 1** shows the general view of the frontal portion of the Insured Motorcycle at the time of our inspection. The fire damage to the Insured Motorcycle was confined mainly to its left body and right body.

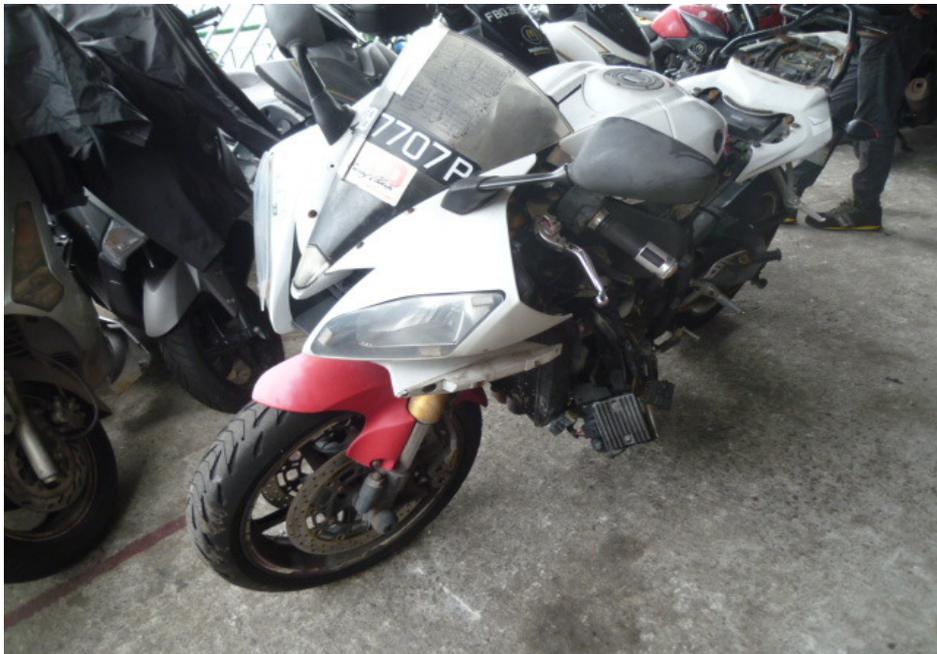
**Photo 2** shows the general view of the left frontal portion of the Insured Motorcycle at the time of inspection. The fire damage to the Insured Motorcycle was confined mainly to its left body and right body.

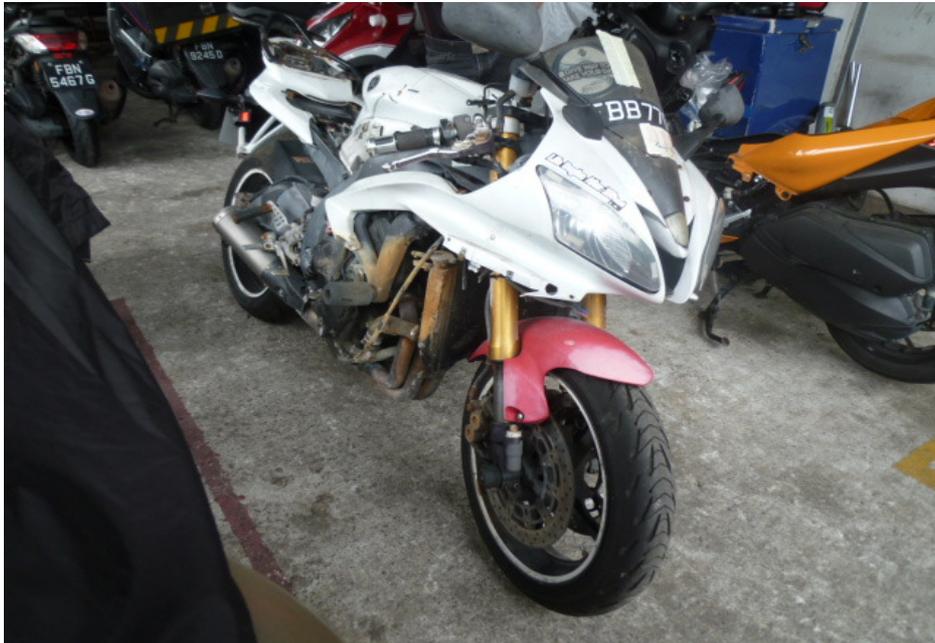
**Photo 3** shows the general view of the right frontal portion of the Insured Motorcycle at the time of inspection. The fire damage to the Insured Motorcycle was confined mainly to its left body and right body. Its side fairings, radiator, radiator hoses, left horn, rectifier, exhaust headers, crankcase covers and oil pan were amongst the body parts that were found to have been affected as a result of the fire.

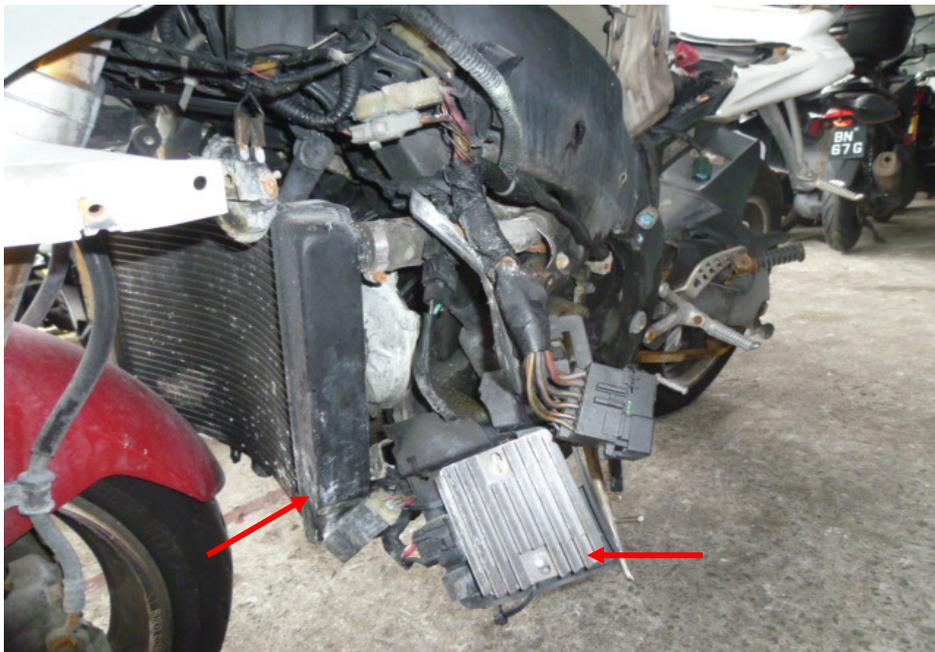
**Photo 4** shows the radiator and rectifier of the Insured Motorcycle which had been partially burnt and/or melted as a result of the fire (arrowed).

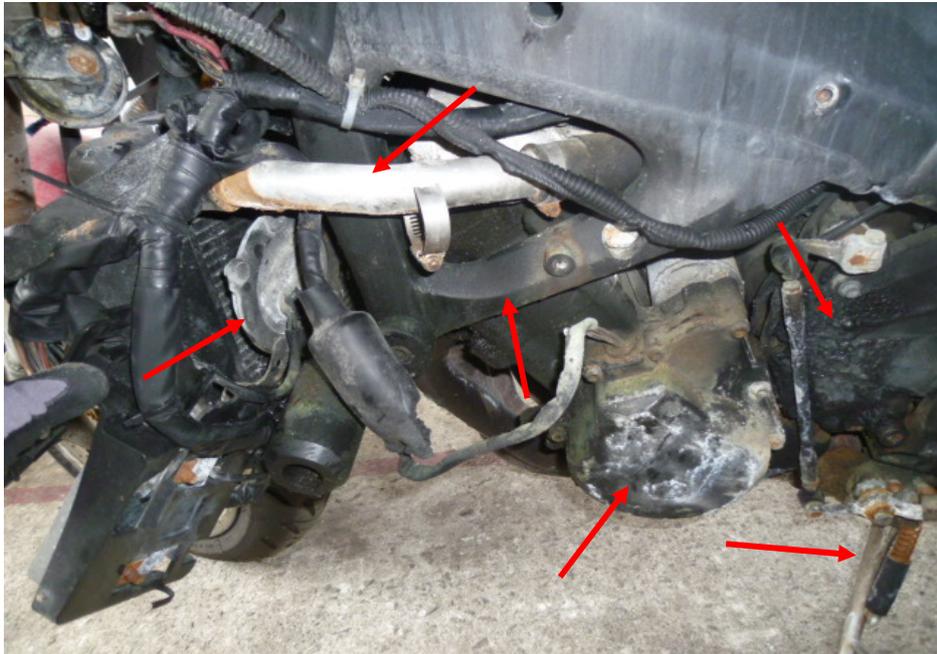
**Photo 5** shows the radiator fan, radiator hose, left crankcase, front sprocket cover, side stand and left subframe of the Insured Motorcycle which had been partially burnt and/or melted as a result of the fire (arrowed).

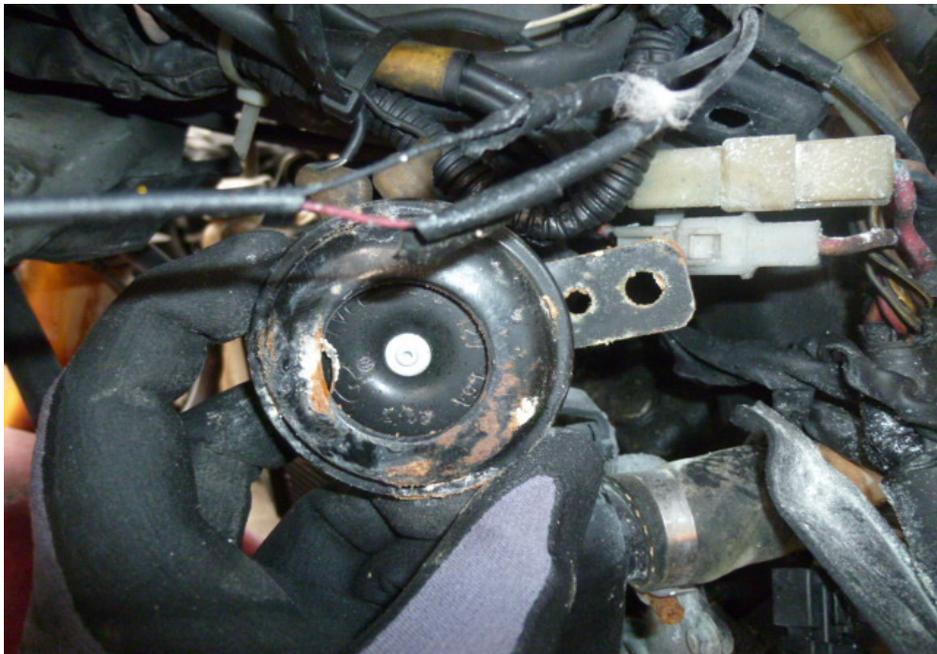
**Photo 6** shows the left horn of the Insured Motorcycle which had been partially burnt and/or melted as a result of the fire.

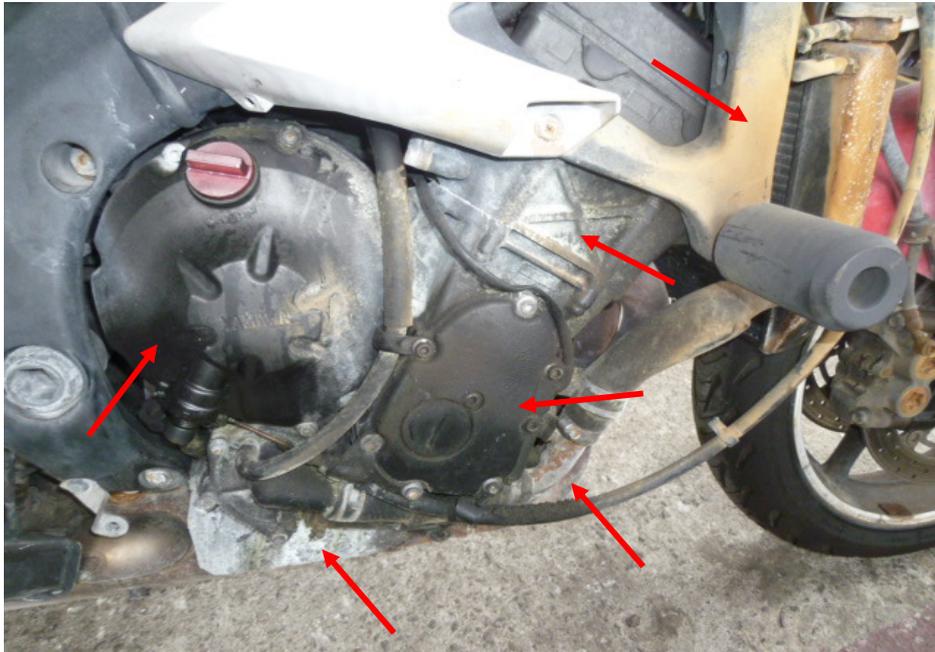
**Photo 7** shows the engine cylinder, clutch crankcase, oil pump cover, exhaust headers, oil pan and right subframe of the Insured Motorcycle which had been partially burnt and/or melted as a result of the fire (arrowed).

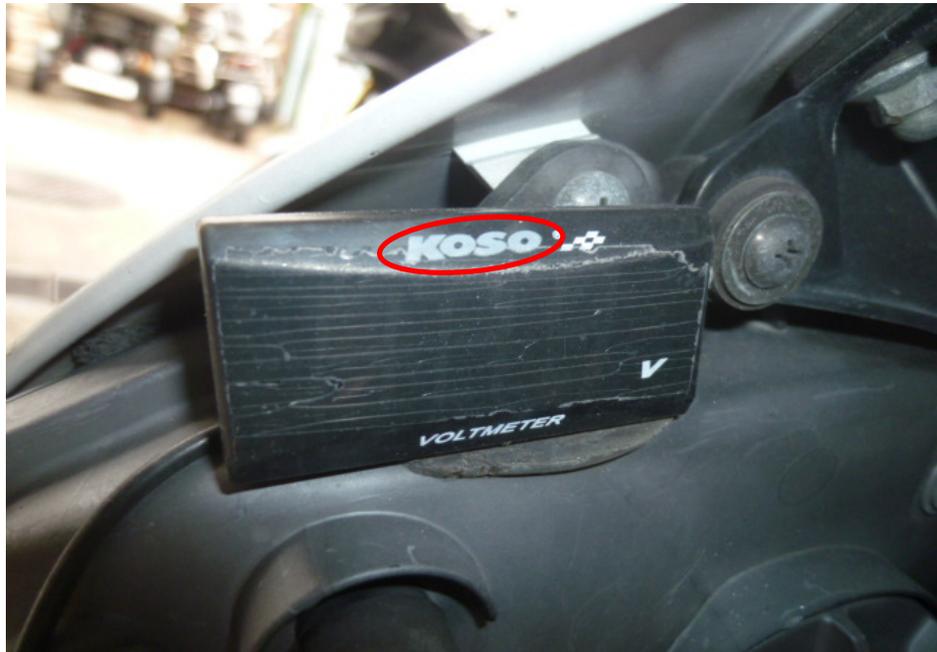
6. At the time of physical inspection of the Insured Motorcycle, we had found an additionally fitted electronic and/or electrical component(s) on the Insured Motorcycle. It was a voltmeter. This fitted component was not the standard type for the Insured Motorcycle. See photo 8 below.

**Photo 8** shows the voltmeter found fitted on the Insured Motorcycle. The brand of the voltmeter was 'KOSO' (circled).

24. We found the Insured Motorcycle to be fitted with a voltmeter. The abovementioned electrical/electronic component does not require prior approval from LTA.
25. Although the voltmeter fitted on the Insured Motorcycle was not the standard type for the Insured Motorcycle, we are of the view that this part did not cause and/or contribute to the fire incident.
26. Our investigations had also revealed that at the time of writing this report, there is no manufacturer recall of electrical nature to similar make and model motorcycle as the Insured Motorcycle that may possibly be related to this incident.

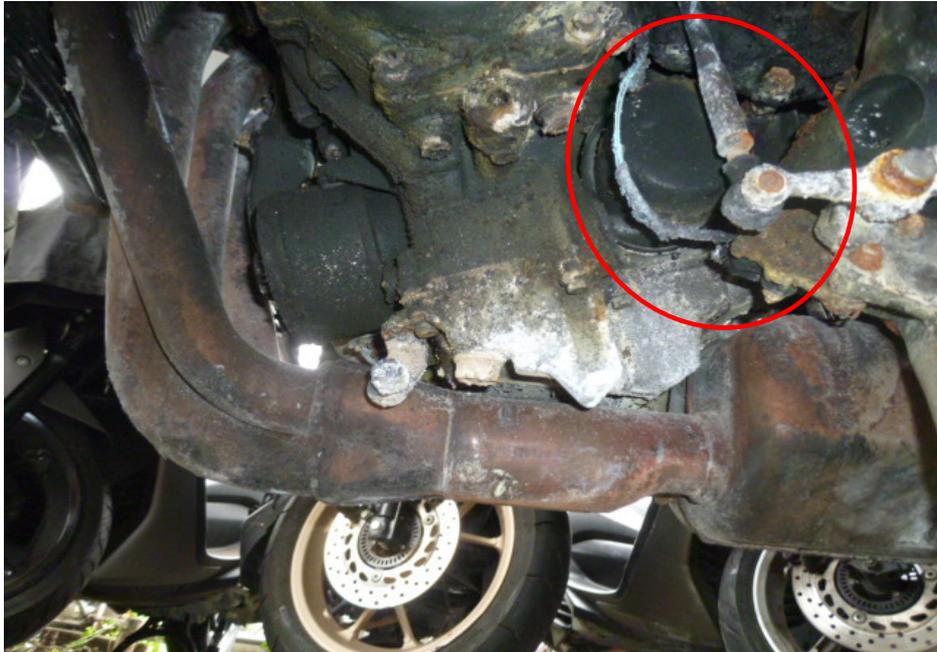
7. For this particular case, based on the nature of fire damage, the fire seemed to have started from the left lower centre portion of the Insured Motorcycle.
8. Upon closer examination of the left lower centre portion of the Insured Motorcycle where the fire had likely started, we had found several stretches of wirings with greenish residue. These wirings were original factory fitted wirings leading from the side stand sensor of the Insured Vehicle. The presence of greenish residue indicates internal heating of copper wires, a sign of an electrical short circuit occurring. The greenish residue is normally left behind from oxidation as a result of chemical reaction involving the copper wires. This physical evidence would appear to suggest that the cause of fire to the Insured Motorcycle could have possibly been due to electrical in nature. See photos 9 – 14 below.

**Photo 9** shows a view of the left lower centre portion of the Insured Motorcycle. Upon closer examination of the left lower centre portion of the Insured Motorcycle which was where the fire had likely started, we had found several stretches of wirings with greenish residue (circled). These wirings were original factory fitted wirings leading from the side stand sensor of the Insured Motorcycle. The presence of such greenish residue suggests occurrence of an electrical short circuit.

22. Having investigated and technically analysed the damages of burnt nature to the Insured Motorcycle, we are of the view that the cause of fire to the Insured Motorcycle was of electrical in nature. For this particular case, the fire had originated along the wirings at the left lower centre portion of the Insured Motorcycle. The wirings were original factory wirings leading from the side stand sensor of the Insured Motorcycle.

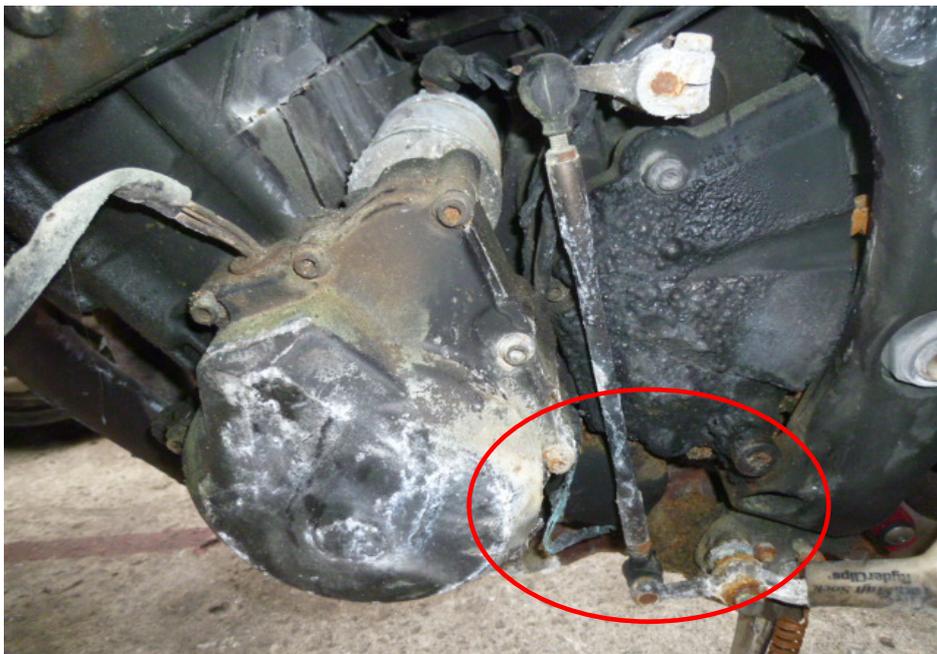
**Photo 10** shows a closer view of the left lower centre portion of the Insured Motorcycle which was where the fire had likely started. We had found several stretches of wirings with greenish residue (circled).

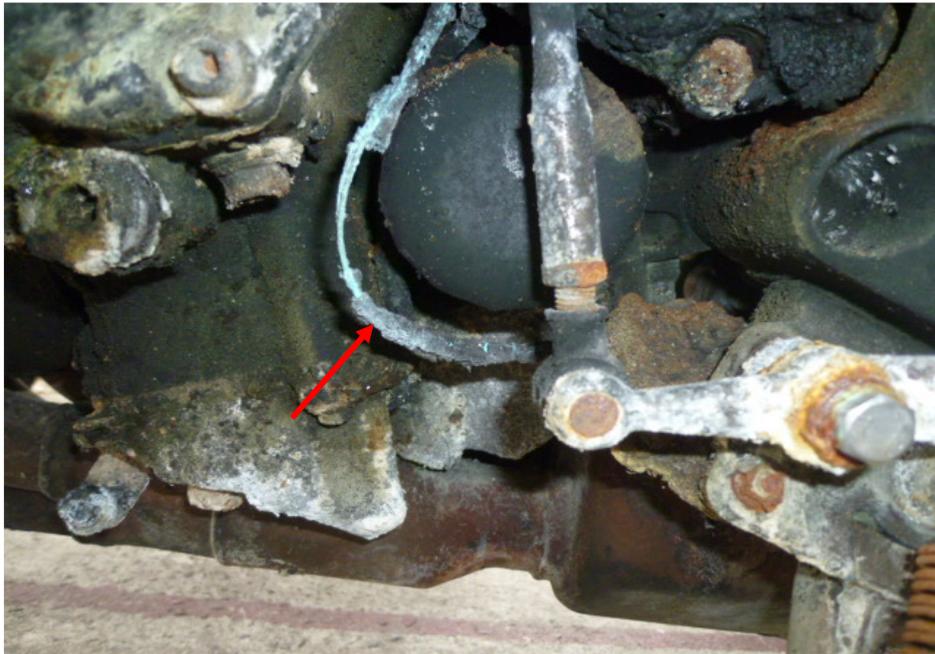
**Photo 11** shows a closer view of the wirings with greenish residue (arrowed). The presence of greenish residue indicates internal heating of copper wires, a sign of an electrical short circuit occurring. The greenish residue is normally left behind from oxidation as a result of chemical reaction involving the copper wires.

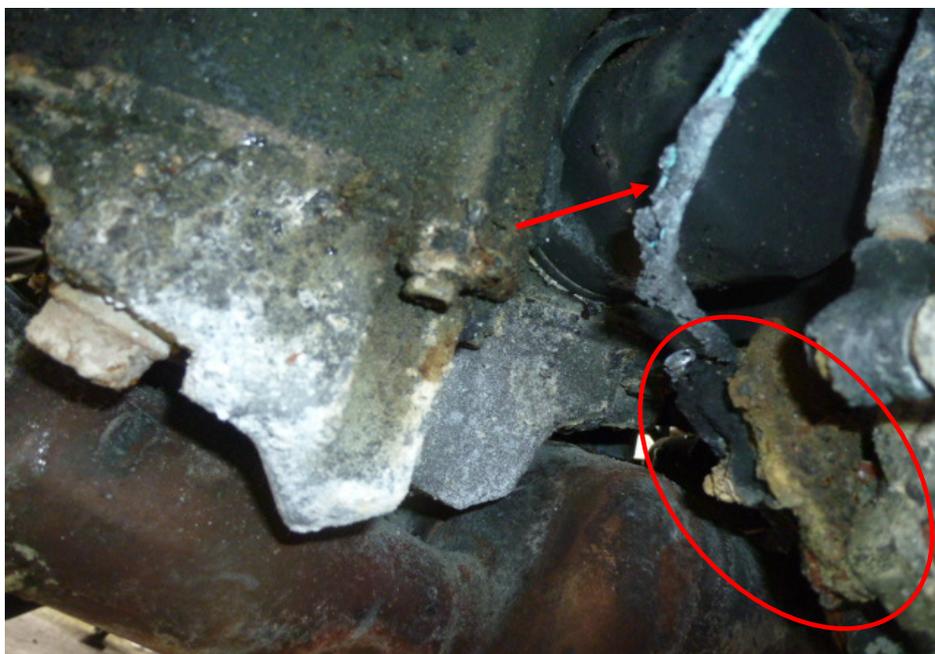
**Photo 12** shows a closer view of the wirings with greenish residue (arrowed) leading from the side stand sensor (circled) of the Insured Vehicle. The presence of greenish residue indicates internal heating of copper wires, a sign of an electrical short circuit occurring.

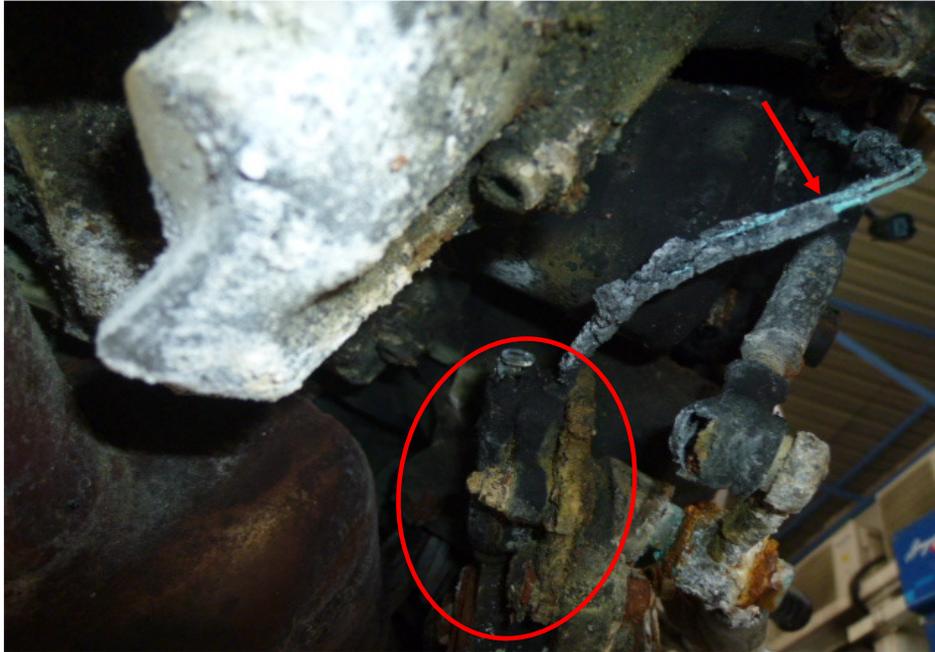
**Photo 13** shows a close up view of the wirings with greenish residue (arrowed) leading from the side stand sensor (circled) of the Insured Vehicle. The presence of greenish residue indicates internal heating of copper wires, a sign of an electrical short circuit occurring.

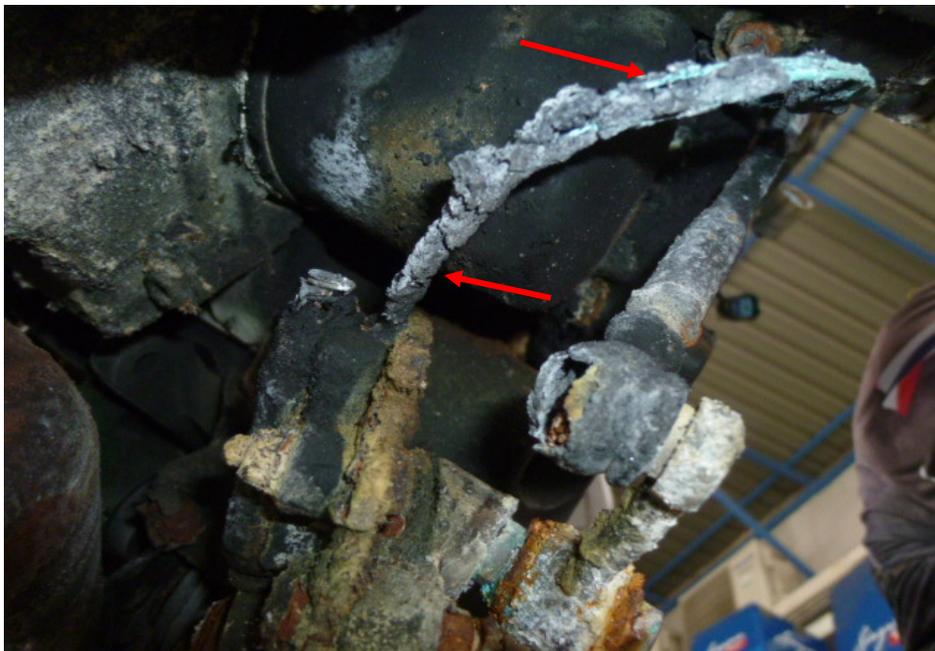
**Photo 14** shows a close up view of the wirings with greenish residue (red arrows). The presence of greenish residue indicates internal heating of copper wires, a sign of an electrical short circuit occurring.
