Your Ref: MCM220045
Our Ref : CI/III22011028/P

**TECHNICAL INVESTIGATION REPORT OF WARRANTY CLAIM INVOLVING
THE INSURED VEHICLE SMQ 2943Y ON 14th October 2022**

Vehicle Registration No.	: SMQ 2943Y
Make / Model	: HONDA FREED HYBIRD
Chassis No	: GB7-1100367
Year of Registration	: NIL
Mileage	: 37,029KM

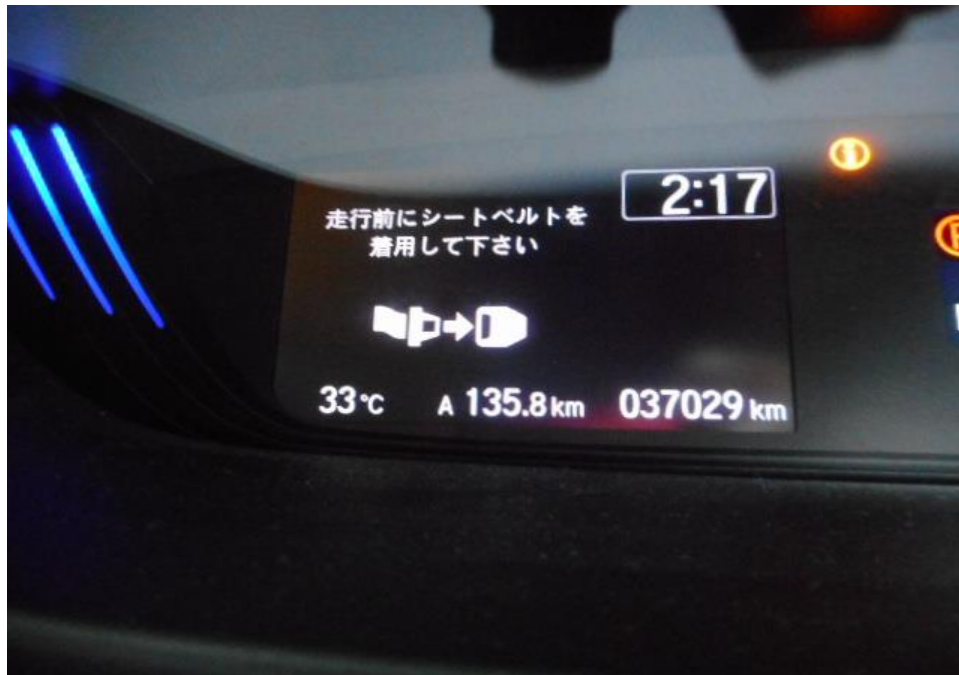
Photo 1 shows the mileage of the Insured Vehicle recorded at the time inspection at 37,029KM

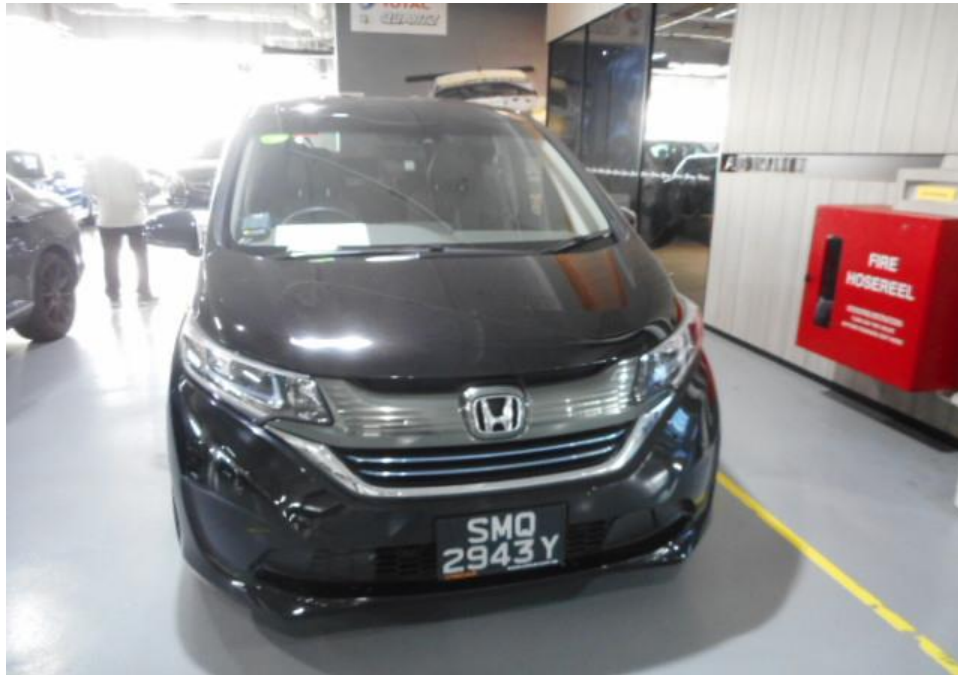
Photo 2 shows the general view of the front portion of the Insured Vehicle at the time of our inspection. The Insured Vehicle is observed to be unaffected by any signs of accident.

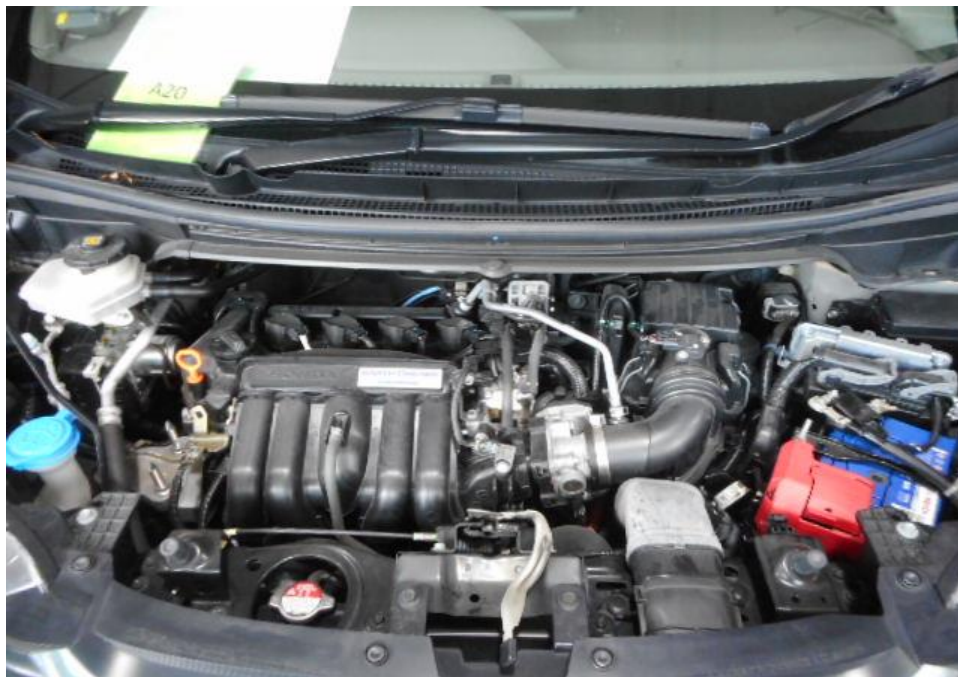
Photo 3 shows the general view of the engine portion of the Insured Vehicle at the time of our inspection. The engine compartment is observed to be unaffected by any signs of accident.

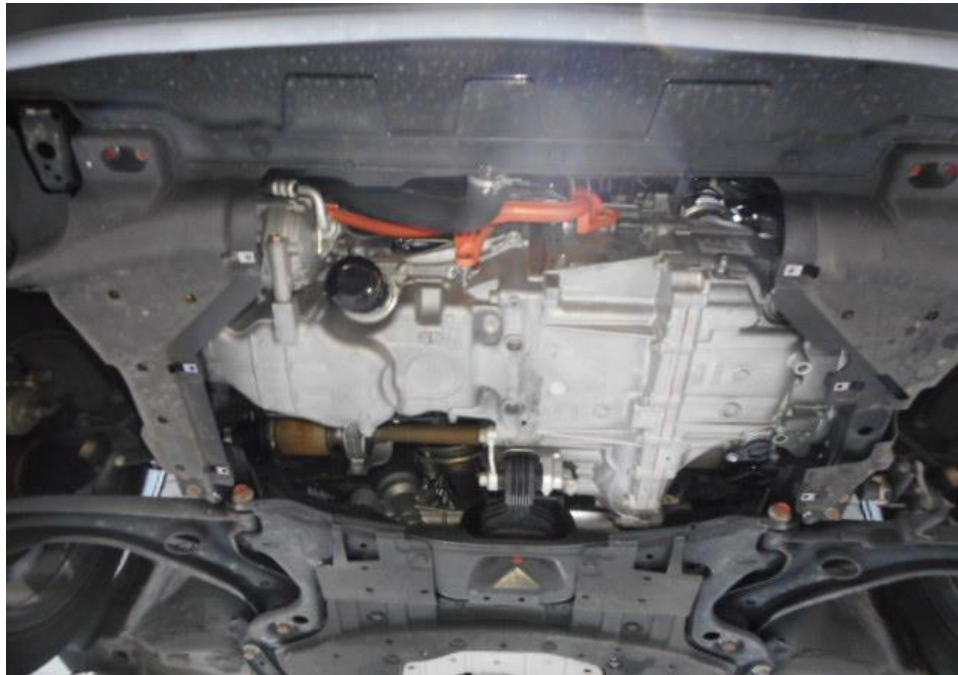
Photo 4 shows the general view of the undercarriage portion of the Insured Vehicle at the time of our inspection. The undercarriage compartment is observed to be unaffected by any signs of accident.

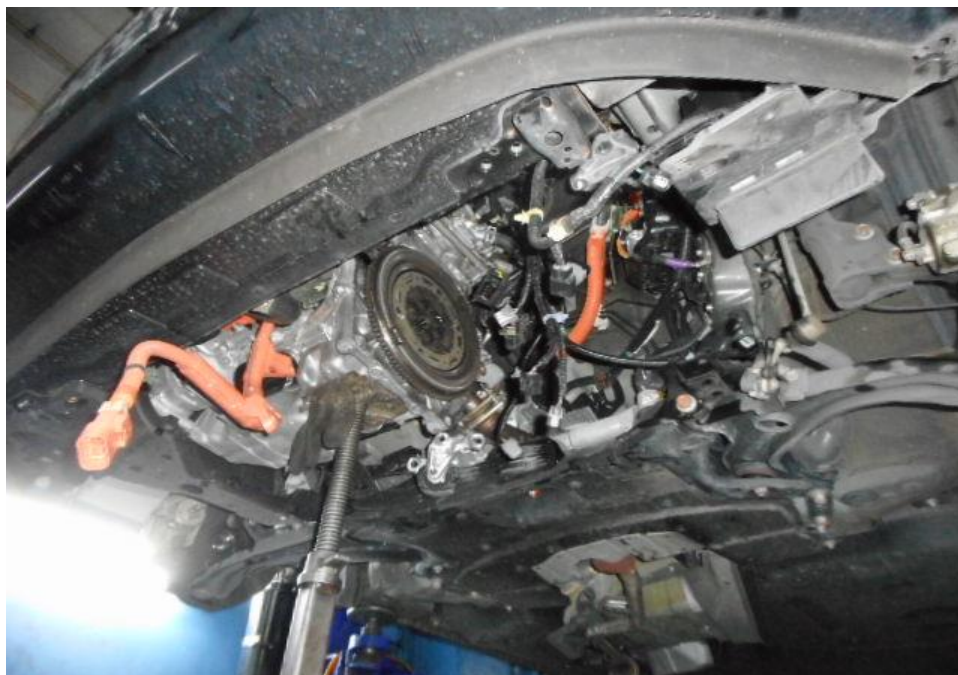
Photo 5 shows the general view of the gearbox underside portion of the Insured Vehicle at the time of our inspection. The gearbox underside compartment is observed to be unaffected and by any signs of accident.

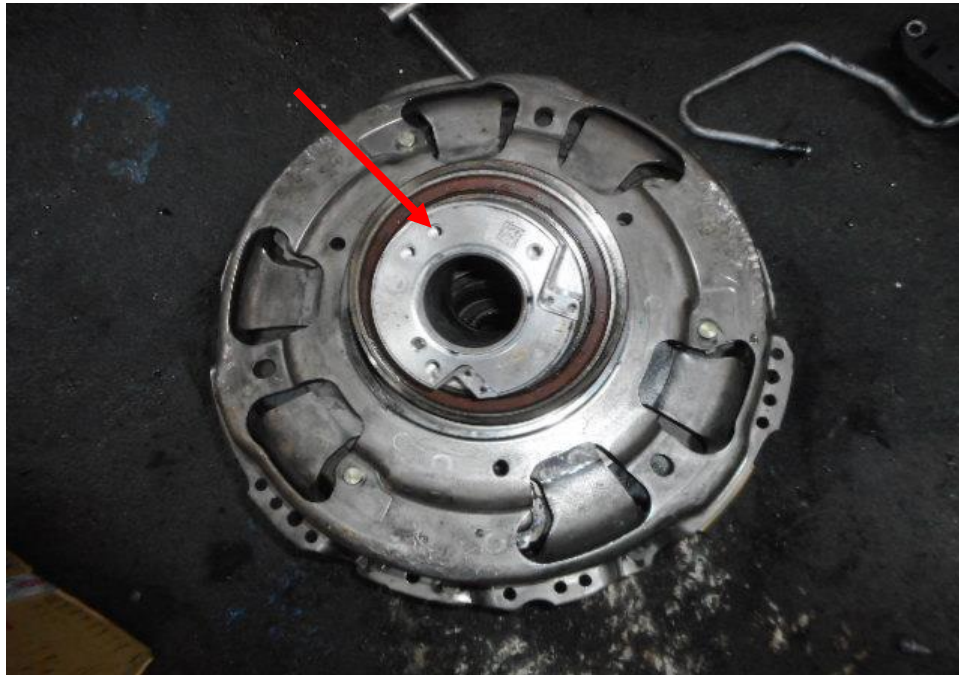
Photo 6 shows the general view of clutch unit of the gearbox unit of the Insured Vehicle at the time of our inspection. The clutch bearing (arrowed) component in the gearbox unit is observed to be unaffected and by any signs of accident. However, whining and grinding sound was heard when the clutch bearing was turned and upon closer inspection there was grease leaking out from the clutch bearing.

7. We did not find any evidence which had suggested that the cause of abnormalities to the Insured Vehicle was due to poor maintenance and/or recurring problem.
8. The recommendation to replace the clutch of the gearbox unit at \$4,772.20 as stated in the quotation is justifiable as all the relevant checks has been conducted to the Insured Vehicle.

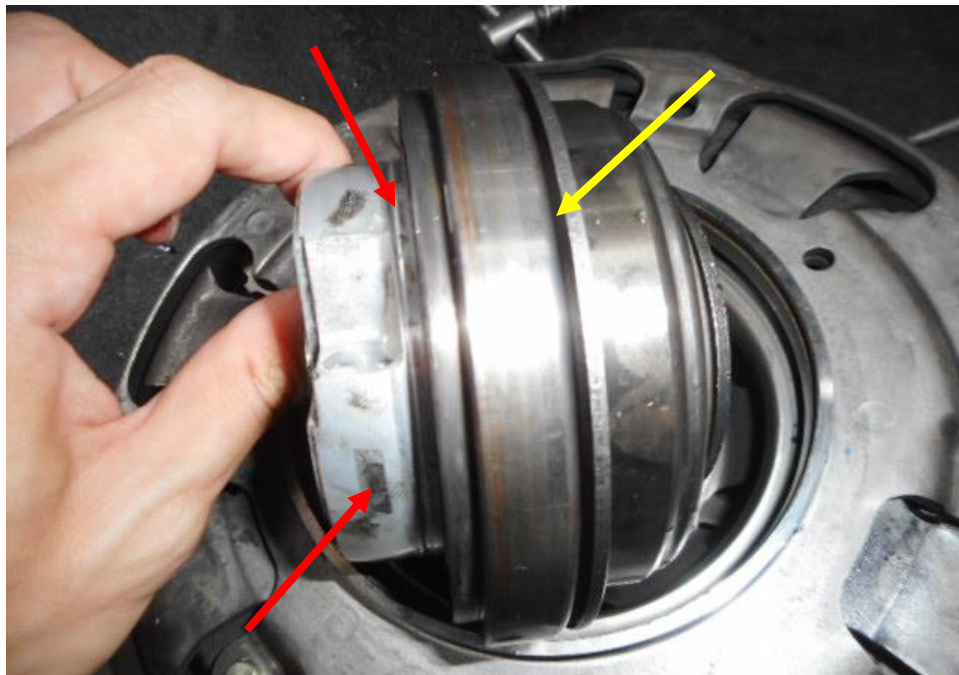
Photo 7 shows the close up view of inside clutch unit of the gearbox unit of the Insured Vehicle at the time of our inspection. The clutch bearing (yellow arrow) component in the gearbox unit is observed to be unaffected and by any signs of accident. However, whining and grinding sound was heard when the clutch bearing was turned and upon closer inspection there was grease leaking (red arrow) out from the clutch bearing.

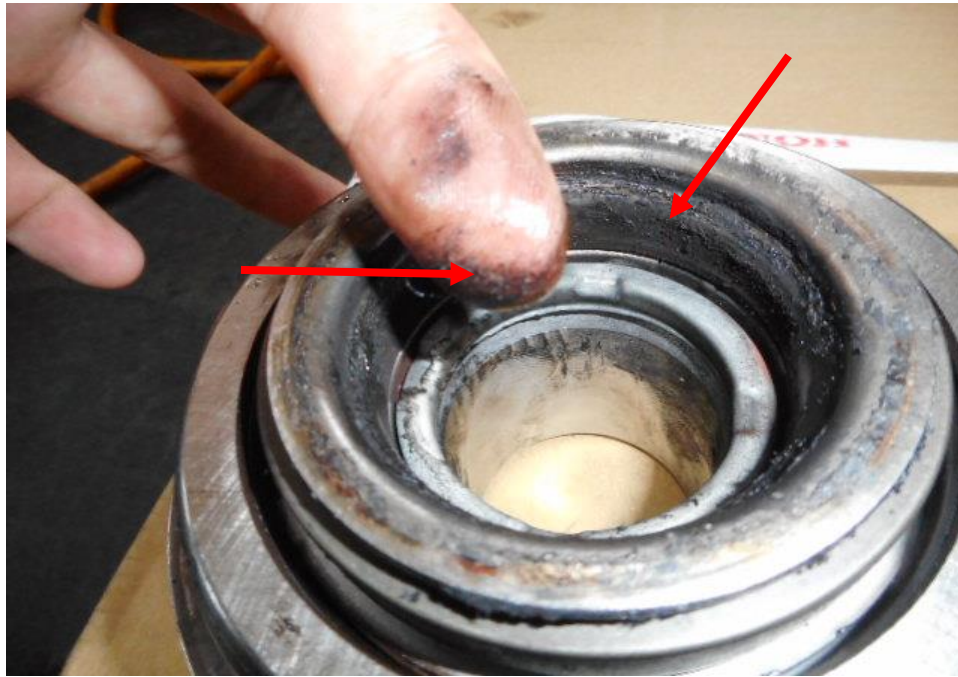
Photo 8 shows the close up view of clutch bearing of the clutch of the gearbox unit of the Insured Vehicle at the time of our inspection. The clutch bearing (yellow arrow) component in the gearbox unit is observed to be unaffected and by any signs of accident. However, whining and grinding sound was heard when the clutch bearing was turned and upon closer inspection there was grease leaking (red arrow) out from the clutch bearing.
