Your Ref: xsjqbaucrZ  
Our Ref : CI/III22011065/P

**M/s India International Insurance Pte. Ltd.**

**TECHNICAL INVESTIGATION REPORT OF WARRANTY CLAIM INVOLVING  
THE INSURED VEHICLE SMX 2594J ON 17<sup>th</sup> October 2022**

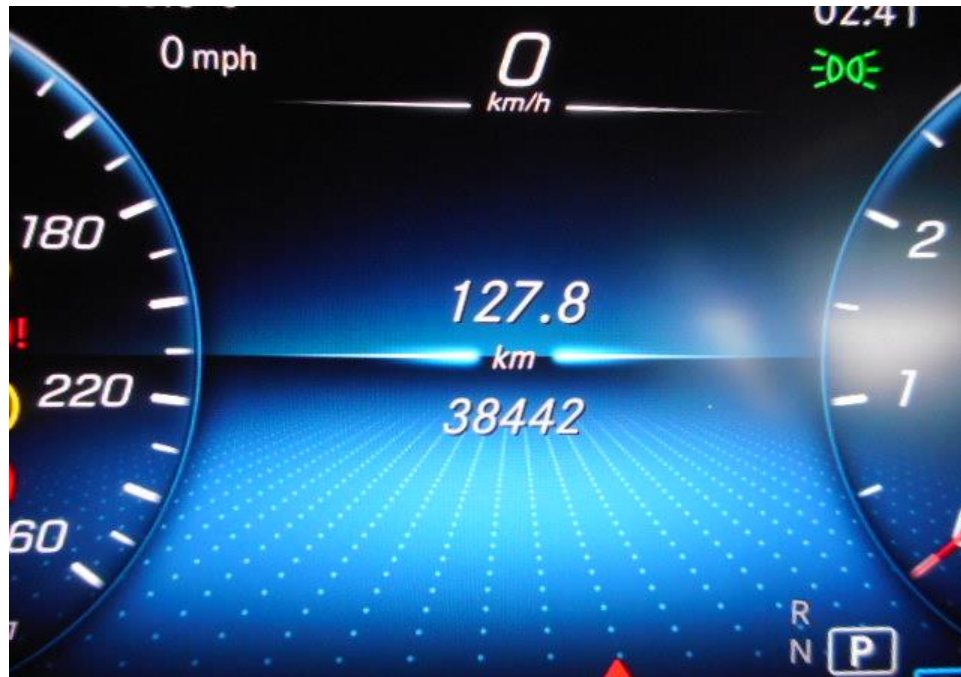
**Photo 1** shows the mileage of the Insured Vehicle recorded at the time inspection at 38,442KM

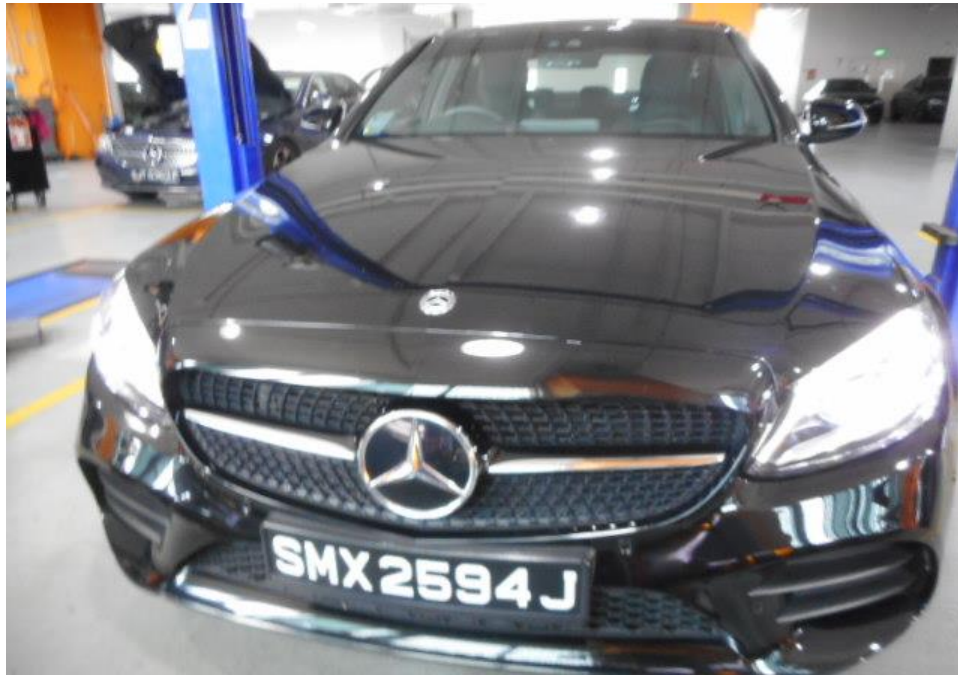
**Photo 2** shows the general view of the front portion of the Insured Vehicle at the time of our inspection. The Insured Vehicle is observed to be unaffected by any signs of accident.

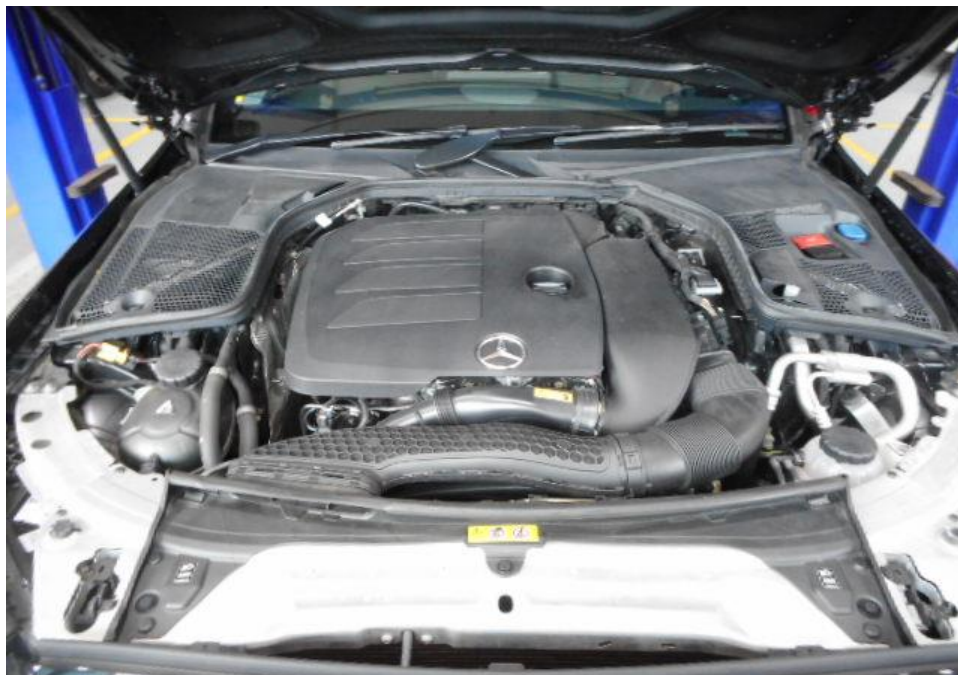
**Photo 3** shows the general view of the engine portion of the Insured Vehicle at the time of our inspection. The engine compartment is observed to be unaffected by any signs of accident.

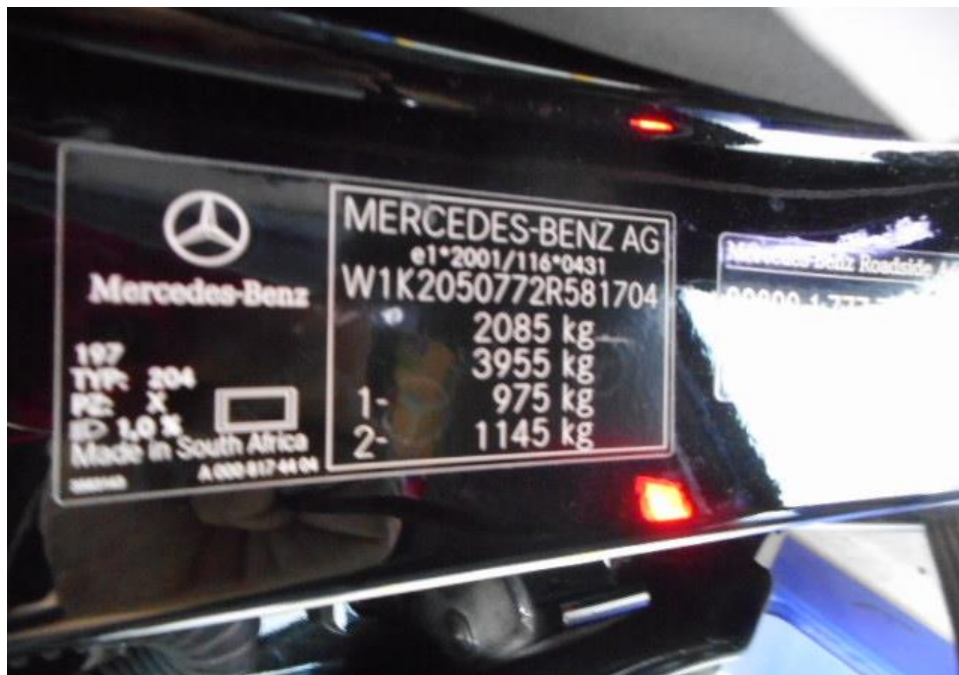
**Photo 4** shows the chassis number of the Insured Vehicle at the time of our inspection.

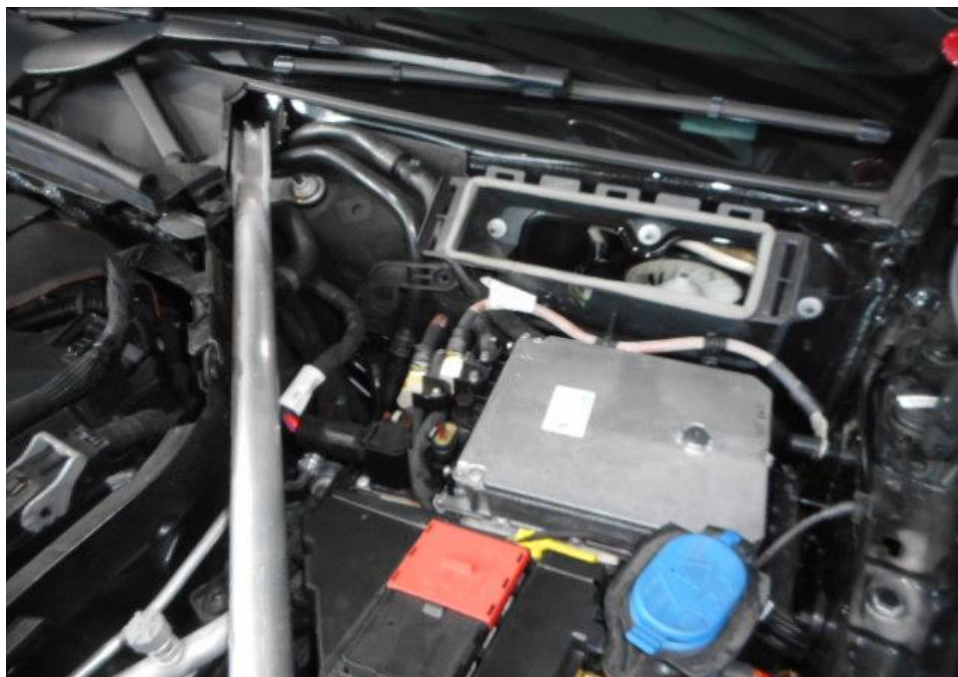
**Photo 5** shows the general view of the 48v battery and its components in the engine compartment portion of the Insured Vehicle at the time of our inspection. The 48v battery and its components is observed to be unaffected and by any signs of accident.

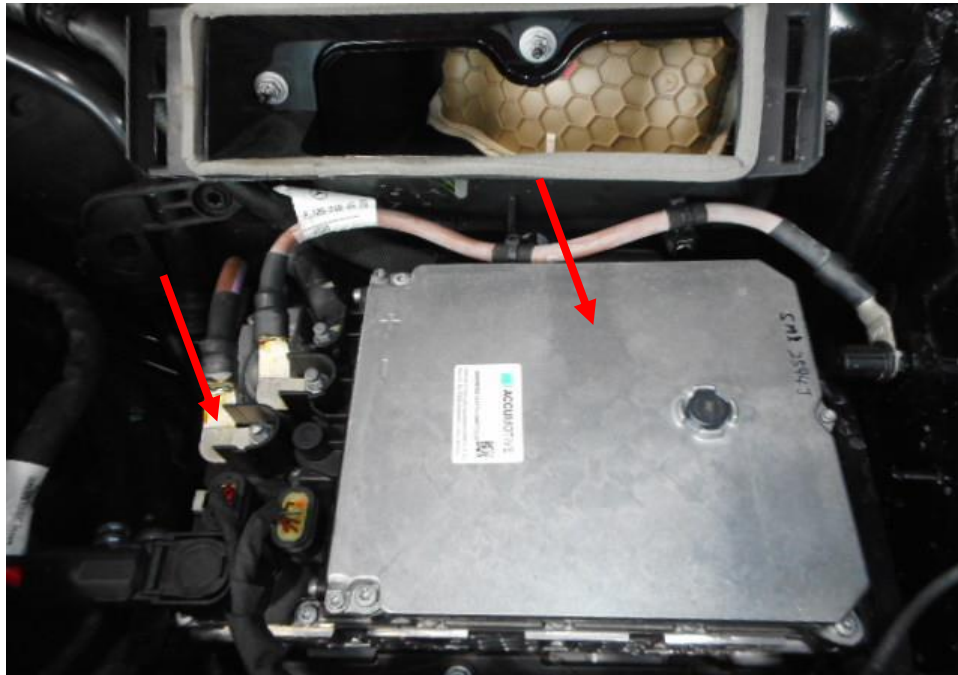
**Photo 6** shows the close up view of the 48v battery and its components (arrowed) in the engine compartment portion of the Insured Vehicle at the time of our inspection. The 48v battery and its components is observed to be unaffected and by any signs of accident.

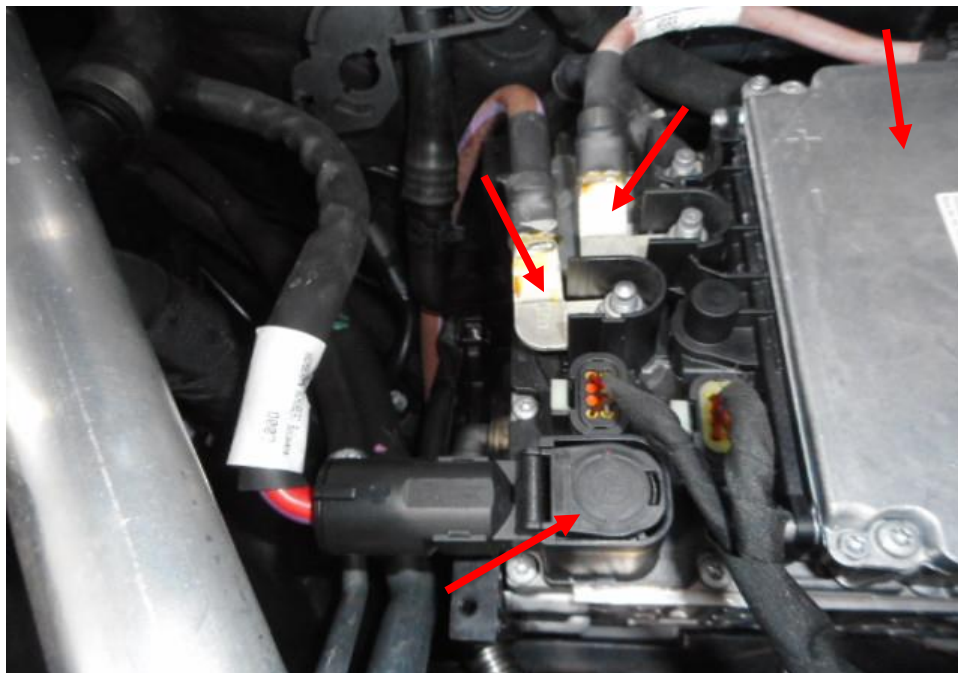
**Photo 7** shows the close up view of the 48v battery and its components (arrowed) in the engine compartment portion of the Insured Vehicle at the time of our inspection. The 48v battery and its components is observed to be unaffected and by any signs of accident.

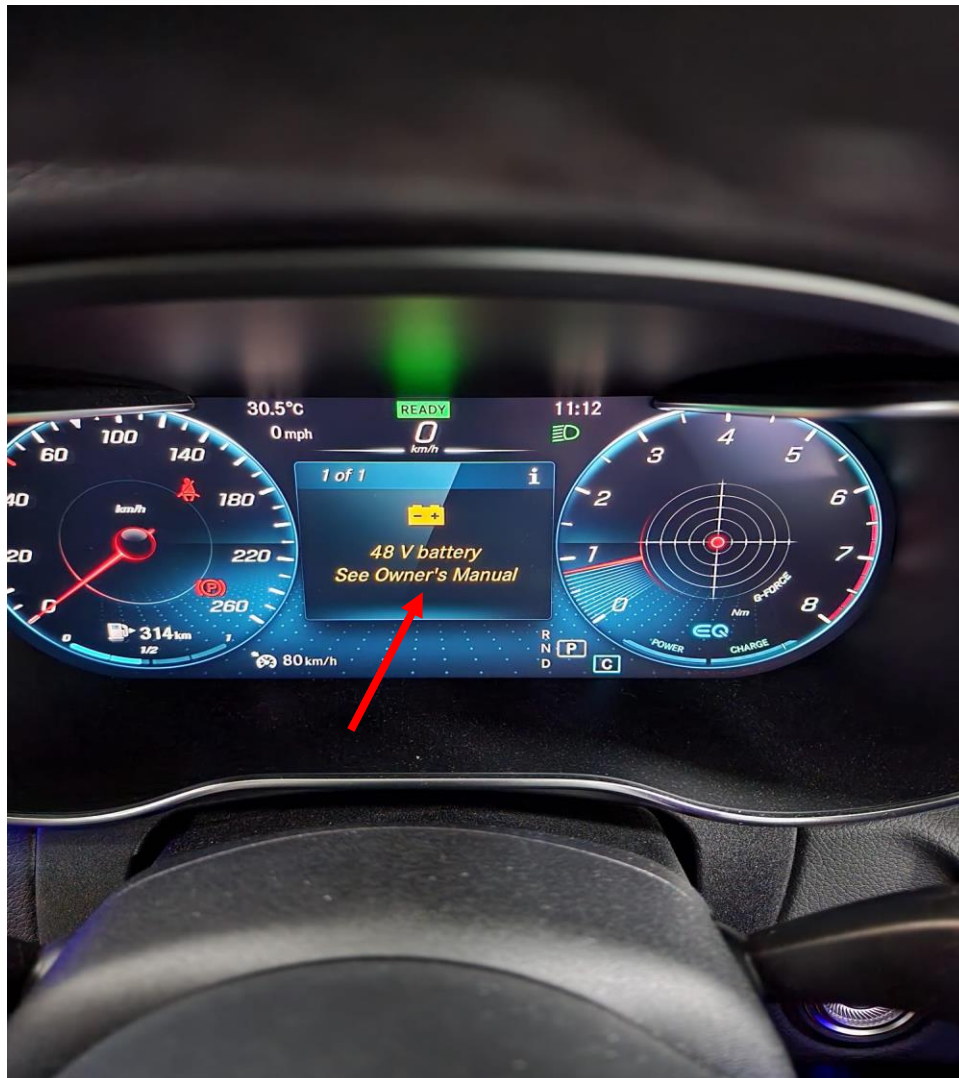
5. The complaint on the Insured Vehicle was noted be an error and warning message light regarding the electronic 48V battery Systems (ISG) for the integrated starter generator system and there is difficulty in starting up the engine of the Insured Vehicle. There is a recommendation by the workshop to replace 48V battery and its electric DC converter unit. The vehicle was observed to be unaffected by any signs of accident.

**Photo 8** shows the conducted ECU diagnosis of the Insured Vehicle at the time of our inspection. There was an electronic error (arrowed) on the 48v battery integrated starter system (ISG) of the Insured Vehicle.

8. We did not find any evidence which had suggested that the cause of abnormalities to the Insured Vehicle was due to poor maintenance and/or recurring problem.
9. The recommendation to replace the 48V battery and DC convertor unit at \$5,098.55 is justifiable as all the relevant checks has been conducted.
