LKK Auto Consultants
#01-25 Paya Ubi Industrial Park, 51
Ubi Avenue 1
408933

Insurer Reference: SML4035G
Repairer Reference: M6697/SML4035G
Date calculated: 21/12/2022 5:55 PM

Full Report
Registration: SML4035G
Printed: 21/12/2022 5:55 PM

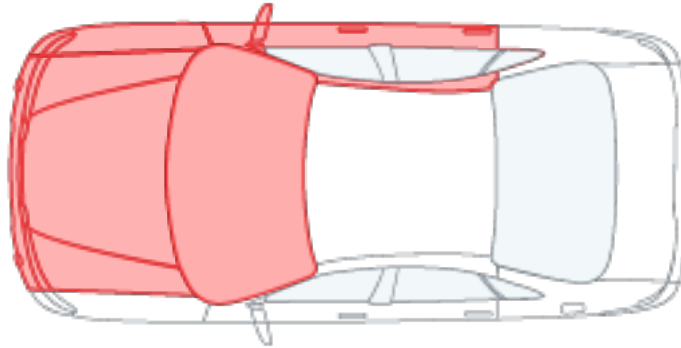
Damage Areas

| Code | Description | Time Base 10 WU/h | Price = 42.00 SGD/h | |
|---|--|---|---|---|
| 820120) | RENEW R/DOOR MIRROR (REMOVED) | | 3.0 | 12.60 |
| NO NUMBER | R + R WINDSCREEN | | 28.0 | 117.60 |
| 0283 | FRONT BUMPER REPAIR | | 10.0* | 42.00 |
| 0742 | R/F WING REPAIR | | 10.0* | 42.00 |
| 1482 | RIGHT FRONT DOOR REPAIR | | 10.0* | 42.00 |
| 2092 | RIGHT A-PILLAR REPAIR | | 5.0* | 21.00 |
