Your Ref: BMW M4 Coupe  
(chassis number WBS32AZ070CG97273)  
Our Ref : CI/TP22011132/D

08 November 2022

**INSPECTION REPORT OF AN UNREGISTERED BMW M4 COUPE MOTOR CAR WITH CHASSIS NUMBER WBS32AZ070CG97273**

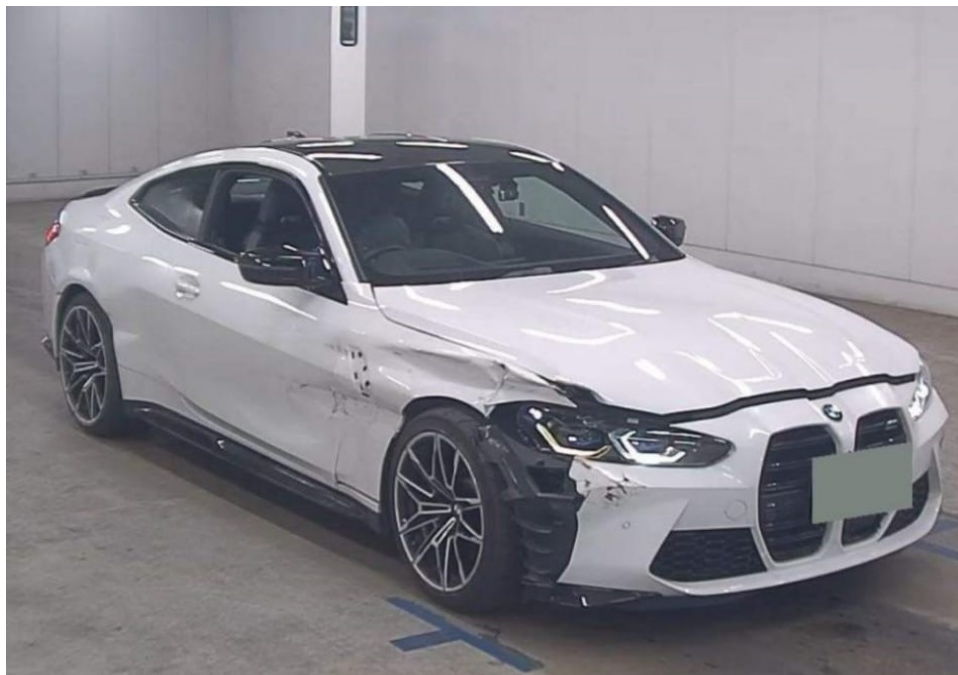
3. The photographs provided to me had showed damage to the right front portion of the Motor Car. Body parts damaged include the front bumper, front bumper right bracket, front bumper right lower garnish, front bumper right air guide, front bumper right sensor, front bonnet, front right headlamp, front right fender and front right door amongst others.
4. Apart for the right front portion, there was no physical damage observed to other areas of the Motor Car except for the front left fender, which was observed to be dented. The airbag(s) of the Motor Car was not deployed as seen from the photographs that were provided to me. See photo 1 – 4 below.

**Photo 1** shows the front right body of the Motor Car (photograph provided to me). The Motor Car was observed to have sustained damage at its right front portion. The front bumper, front bumper right bracket, front bumper right lower garnish, front bumper right air guide, front bumper right sensor, front bonnet, front right headlamp, front right fender and front right door were amongst the body parts that were observed to have been damaged.

22. The body parts at the right front portion of the Motor Car were visually examined, and it was noted that the repair/restoration works carried out to the damaged area of the Motor Car (refer to photograph 1 above) were reasonably adequate and in order.

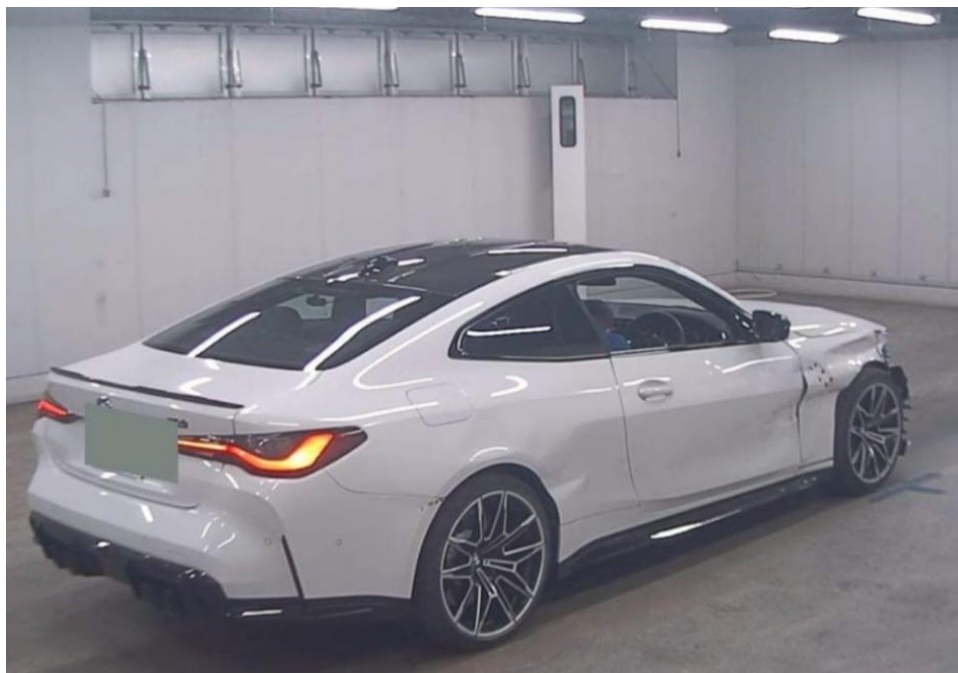
**Photo 2** shows the rear right body of the Motor Car (photograph provided to me). No physical damage was observed to the rear right portion of the Motor Car. The Motor Car's airbag(s) was not deployed as seen from the photographs that were provided to me.

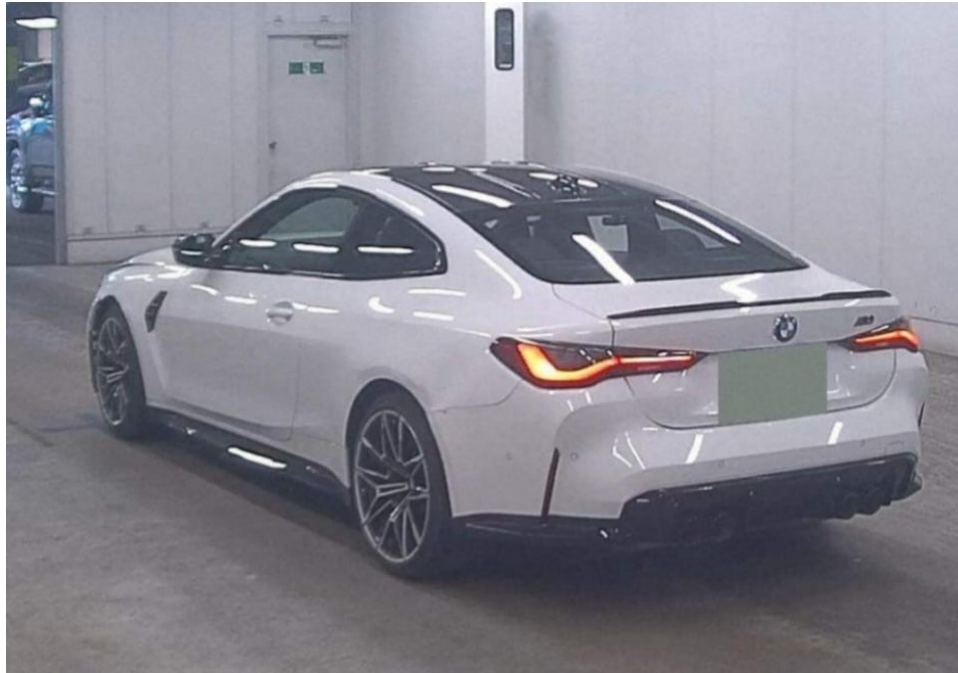
**Photo 3** shows the rear left body of the Motor Car (photograph provided to me). No physical damage was observed to the rear left portion of the Motor Car. The Motor Car's airbag(s) was not deployed as seen from the photographs that were provided to me.

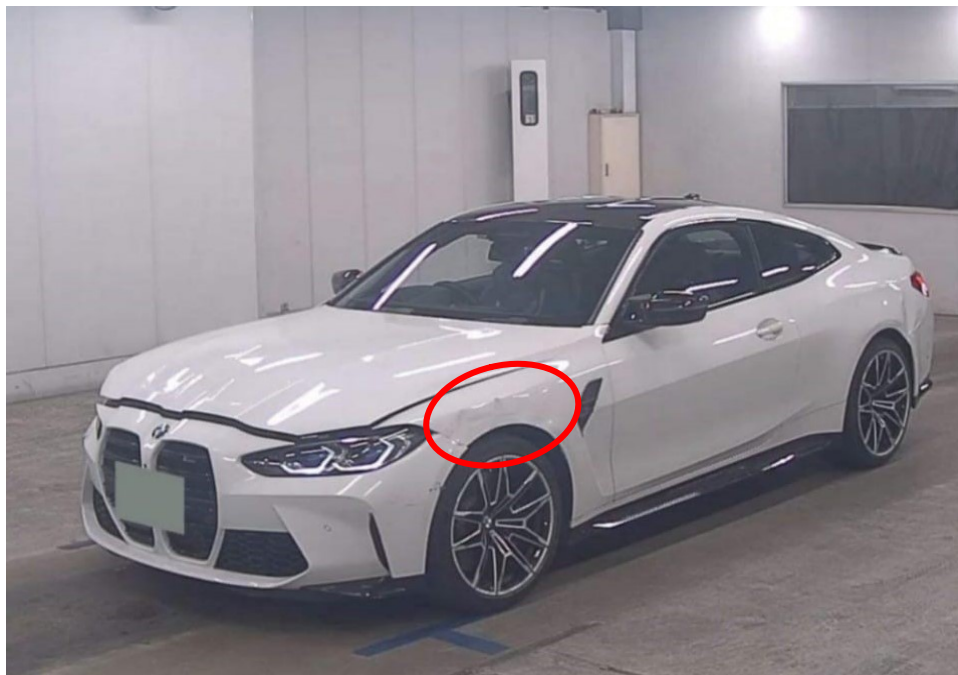
**Photo 4** shows the front left body of the Motor Car (photograph provided to me). No physical damage was observed to the front left portion of the Motor Car except for the front left fender, which was observed to be dented (circled). The airbag(s) of the Motor Car was not deployed as seen from the photographs that were provided to me.

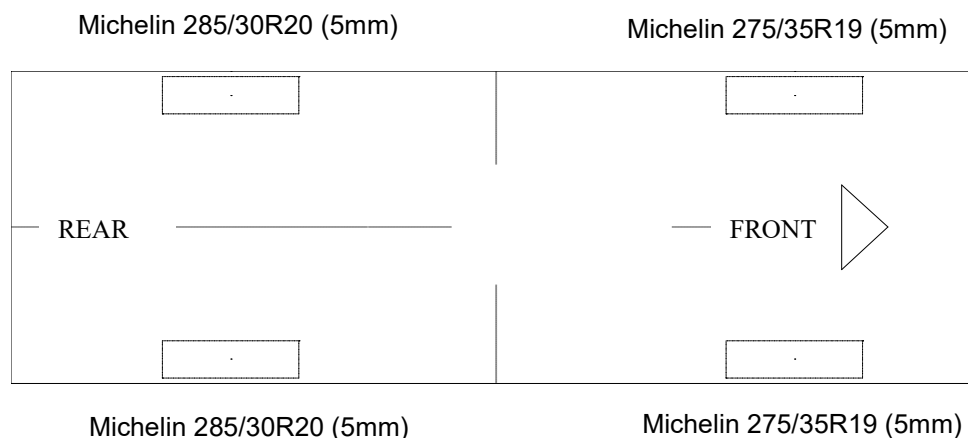
8. It was fitted with 19inch (front) and 20inch (rear) sport wheel rims that were wrapped with tyres that were observed to be of serviceable condition. The tyres were also sufficiently inflated for vehicular operation. The tyre brand, tyre size and approximate remaining tread depth of the 4 tyres of the Motor Car were recorded as follows: -

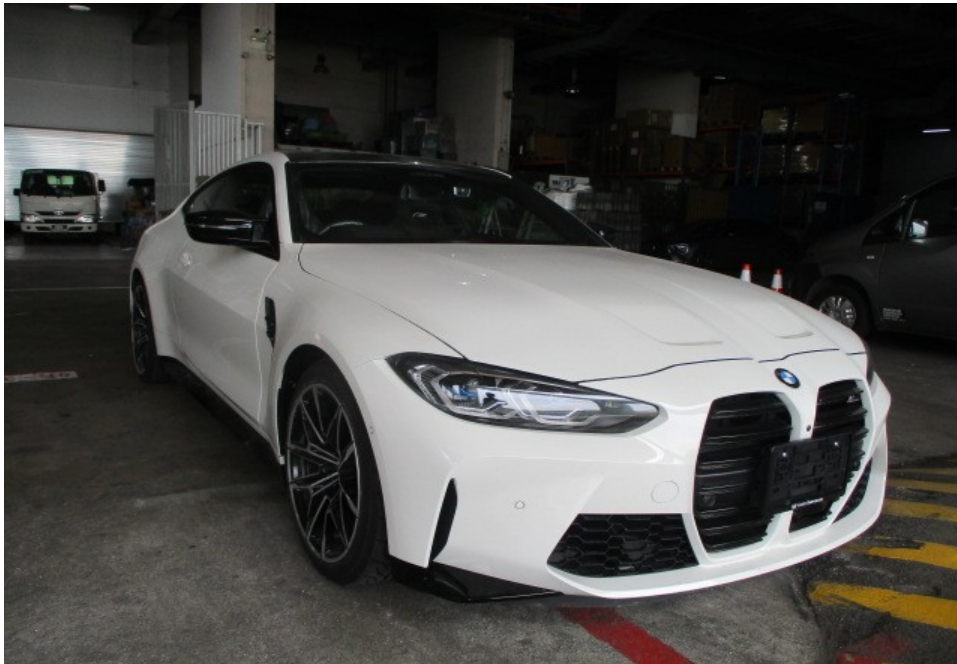
**Photo 5** shows a general view of the front right body of the Motor Car at the time of my inspection. The Motor Car was observed to be in a relatively good general condition with no loose exterior fittings observed. The body parts at the right front portion of the Motor Car were visually examined and it was observed that the repair/restoration works carried out to the damaged area of the Motor Car (refer to photograph 1 above) were reasonably adequate and in order.

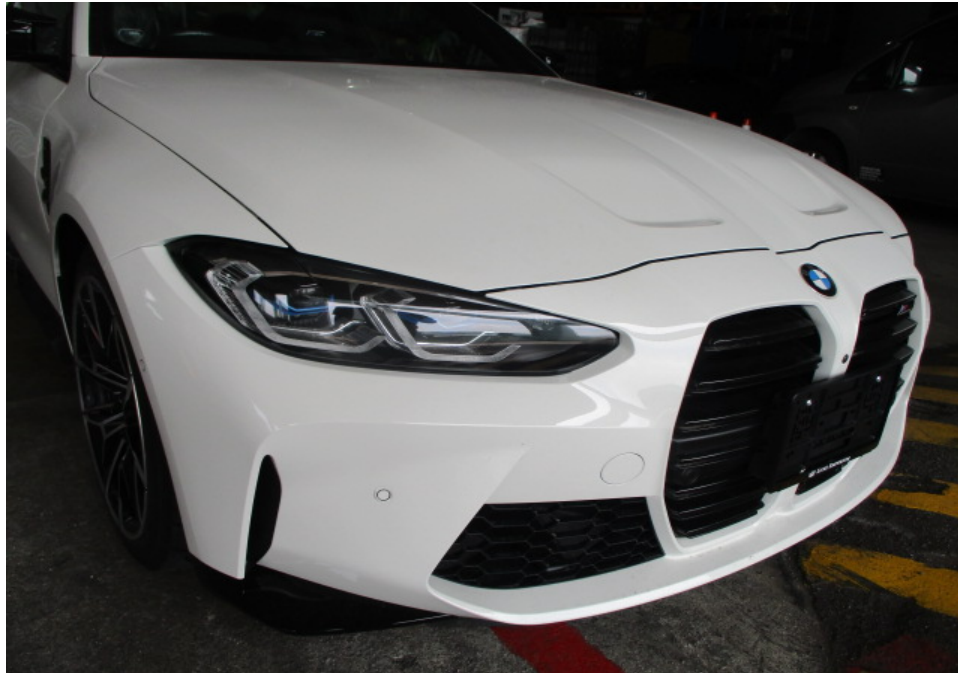
**Photo 6** shows a closer view of the Motor Car's front bumper, front bumper right sensor, front right headlamp and front bonnet. The body parts at the right front portion of the Motor Car were visually examined and it was observed that the repair/restoration works carried out to the damaged area of the Motor Car (refer to photograph 1 above) were reasonably adequate and in order.

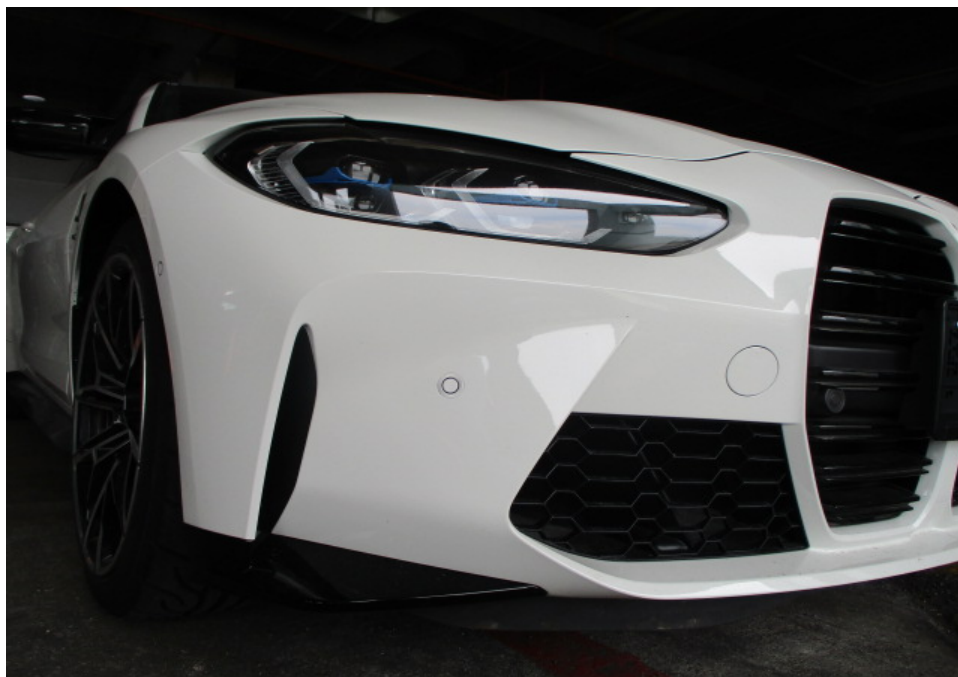
**Photo 7** shows a closer view of the Motor Car's front bumper, front bumper right sensor, front bumper right lower grille, front bumper right lower garnish and front bumper right air guide. The body parts at the right front portion of the Motor Car were visually examined and it was observed that the repair/restoration works carried out to the damaged area of the Motor Car (refer to photograph 1 above) were reasonably adequate and in order.

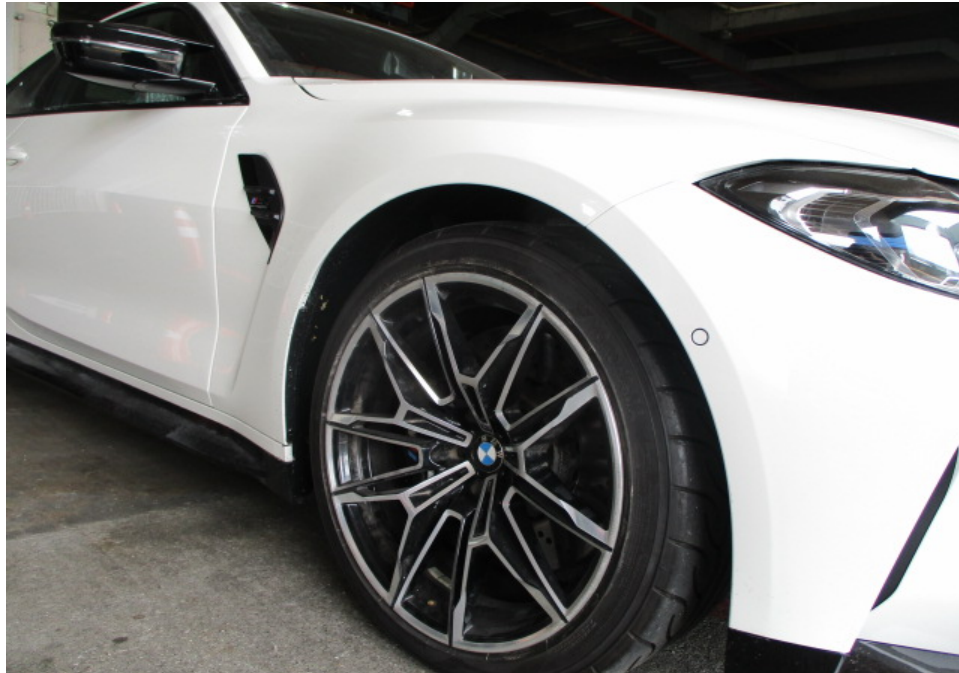
**Photo 8** shows a closer view of the Motor Car's front bumper, front bumper right sensor, front right fender, front right wheel rim and front right door. The body parts at the right front portion of the Motor Car were visually examined and it was observed that the repair/restoration works carried out to the damaged area of the Motor Car (refer to photograph 1 above) were reasonably adequate and in order.

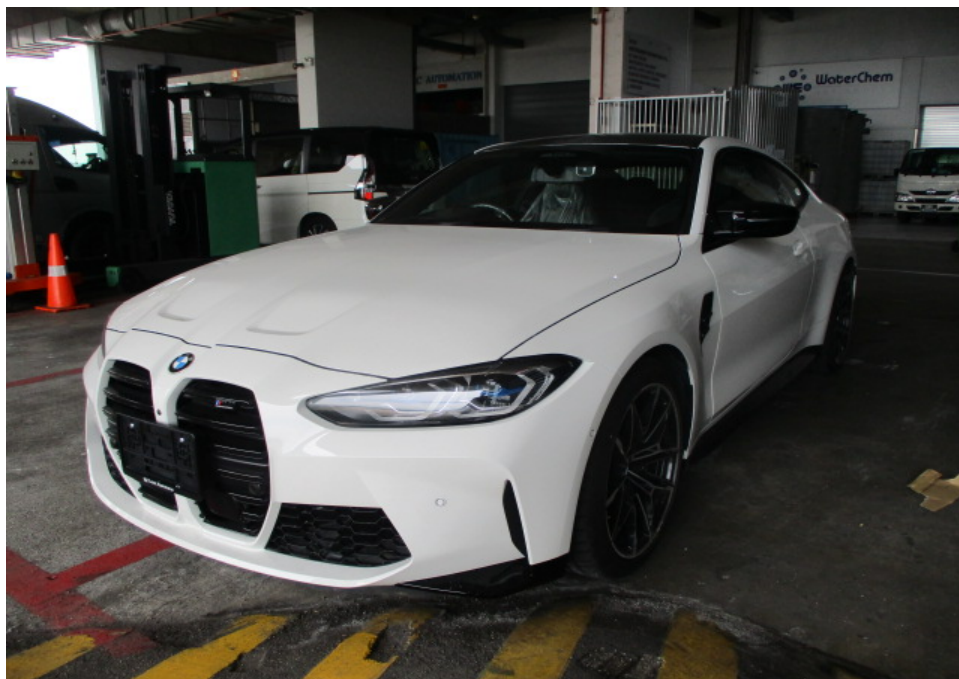
**Photo 9** shows a general view of the front left body of the Motor Car at the time of my inspection. The Motor Car was observed to be in a relatively good general condition with no loose exterior fittings observed. The body parts at the front left portion of the Motor Car were visually examined and it was observed that the repair/restoration works carried out to the damaged area of the Motor Car (refer to photograph 4 above) were reasonably adequate and in order.

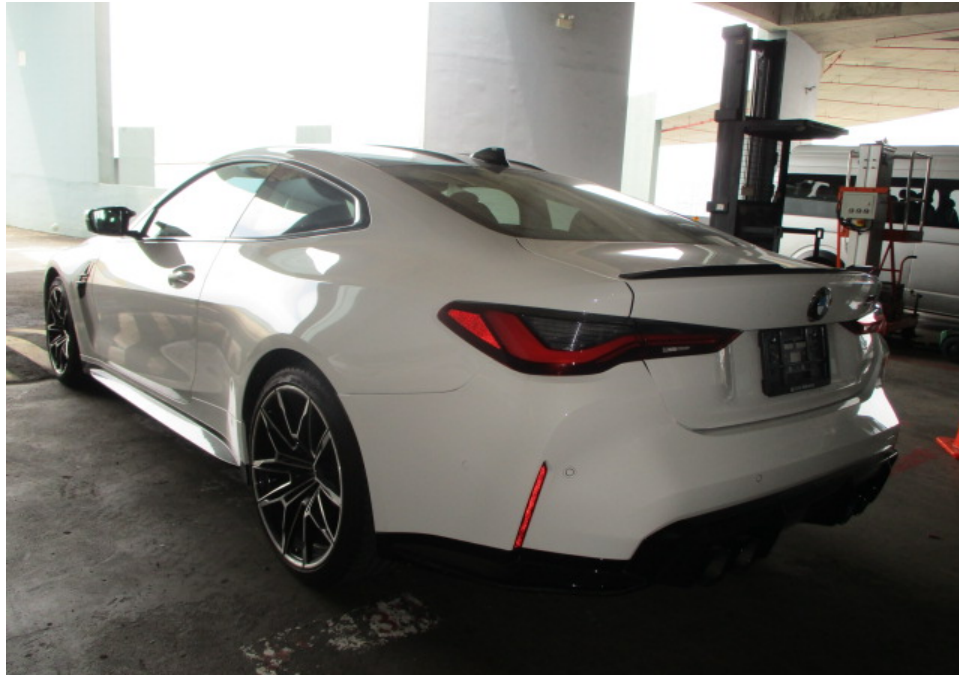
**Photo 10** shows a general view of the rear left body of the Motor Car at the time of my inspection. The Motor Car was observed to be in a relatively good general condition with no loose exterior fittings observed. The mileage of the Motor Car recorded at the time of my inspection was 21,181km.

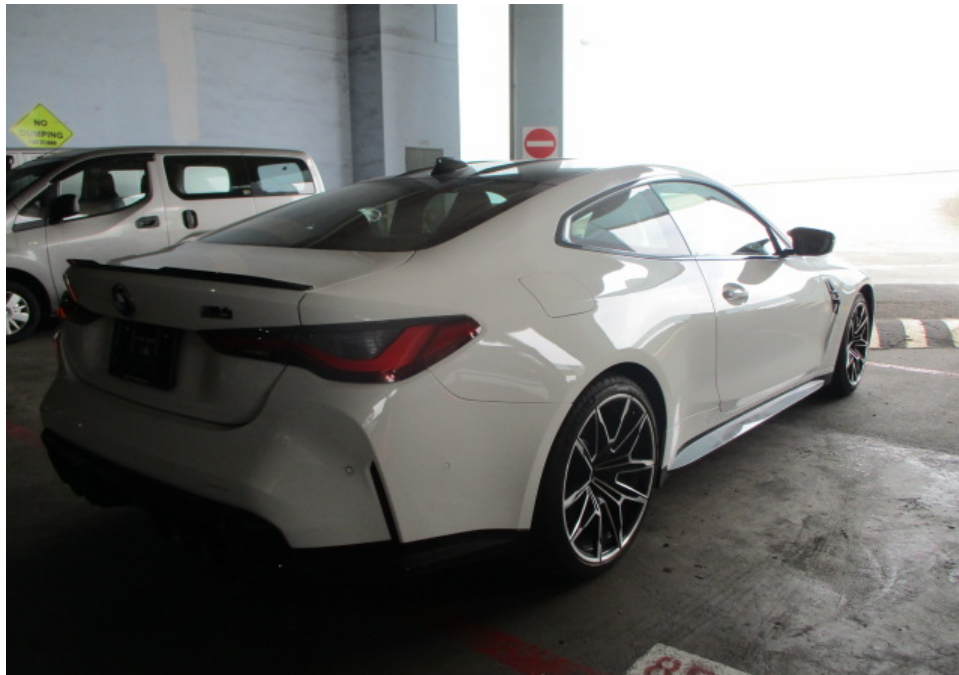
**Photo 11** shows a general view of the rear right body of the Motor Car at the time of my inspection. The Motor Car was observed to be in a relatively good general condition with no loose exterior fittings observed. The mileage of the Motor Car recorded at the time of my inspection was 21,181km.

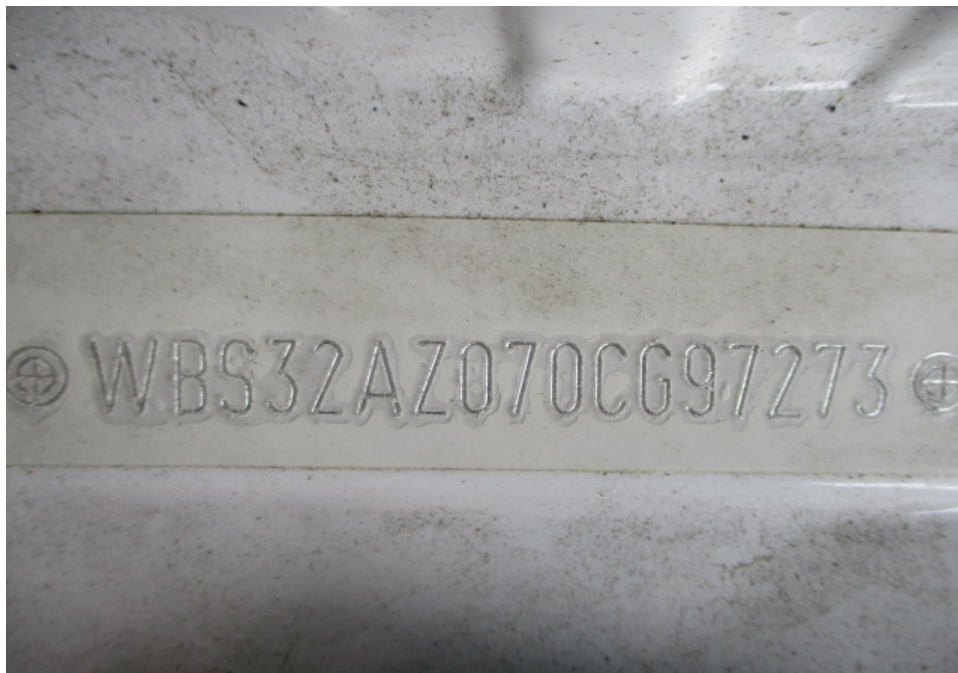
**Photo 12** shows the chassis number of the Motor Car. The chassis number recorded was WBS32AZ070CG97273.

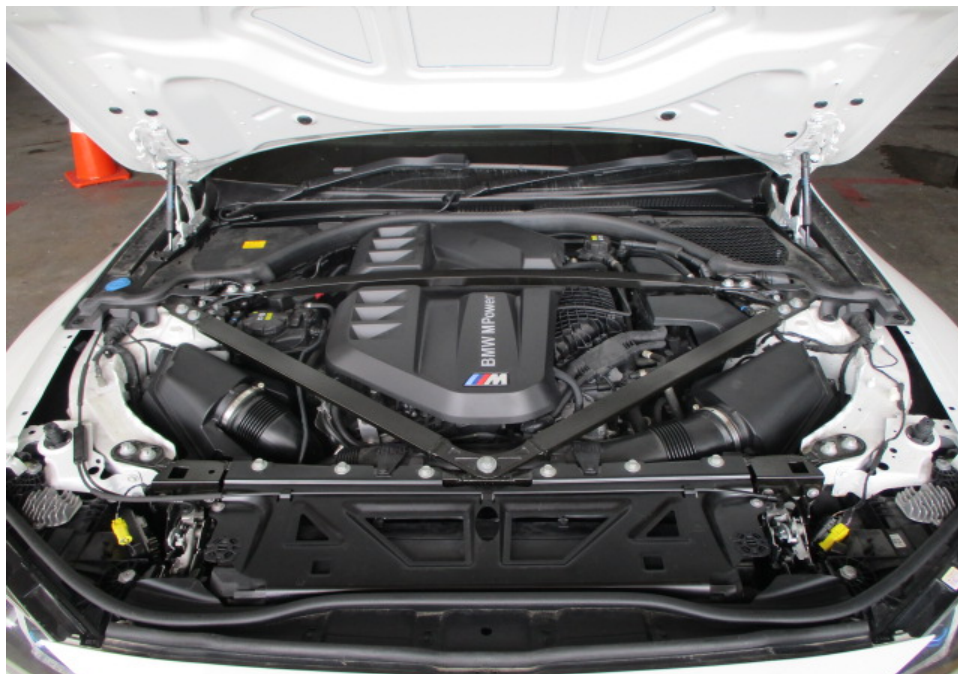
**Photo 13** shows a general view of the engine compartment of the Motor Car at the time of my inspection. The various parts and components inside the engine compartment were all observed to be intact and properly fitted. There was also no sign(s) or indication(s) of fluid leak and/or fluid stain found inside the engine compartment.

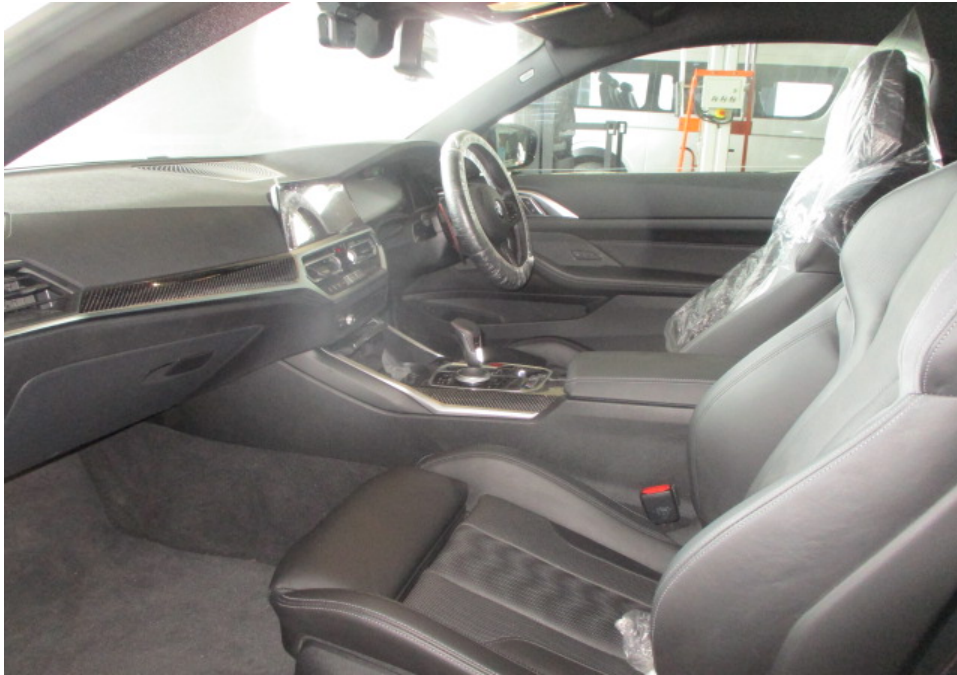
**Photo 14** shows the interior compartment of the Motor Car at the time of my inspection. The various parts and components, trims, carpet, and upholstery inside the interior compartment were all observed to be intact and properly fitted.

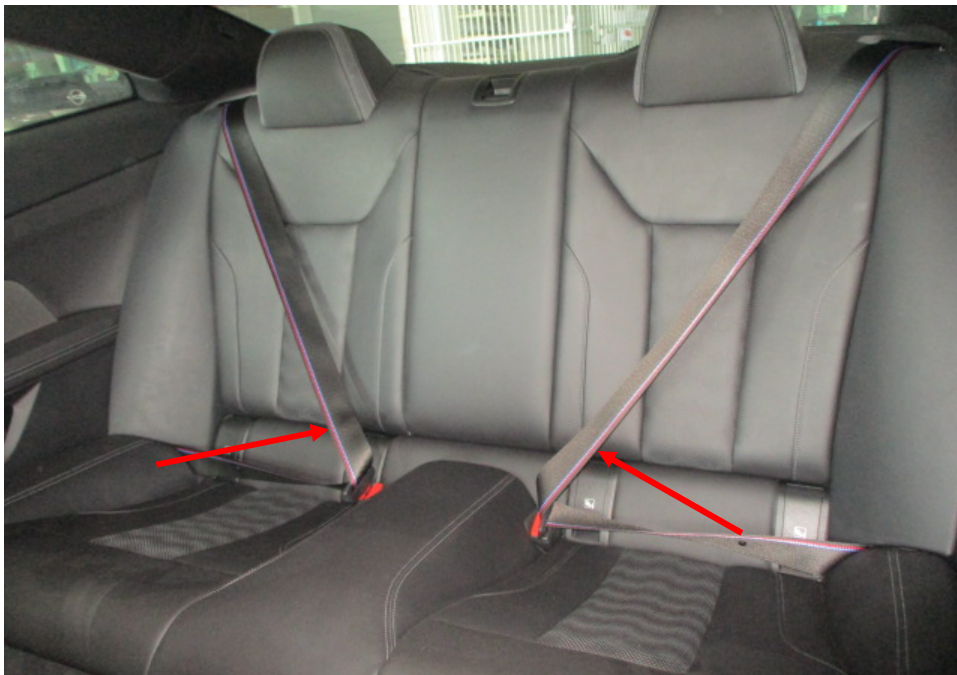
**Photo 15** shows the rear seats of the Motor Car. All the seats of the Motor Car were secured via seat rails to the floorboard. They were also fitted with a retractable seat belt reel and a pre-tensioner. The seat belts (arrowed) were tested and were able to be fastened into the respective pre-tensions that were fitted on the side of each individual seat.

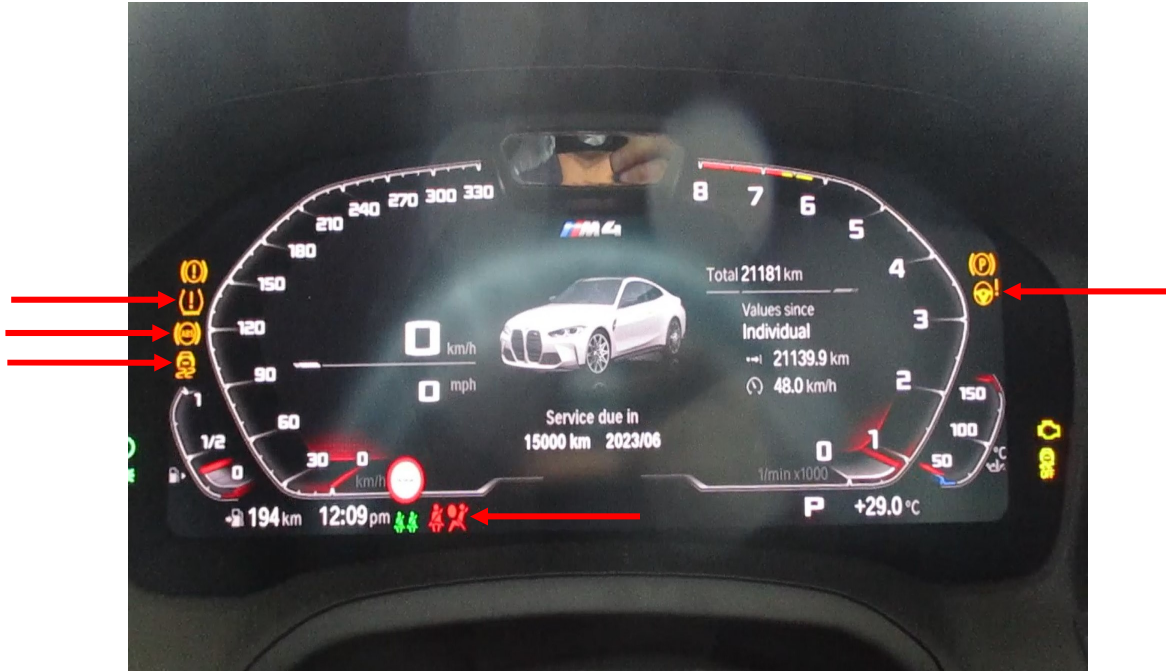
**Photo 16** shows the warning lights for the various electronic safety features appearing on the instrument panel of the Motor Car during its self-test when the engine is cranked, in particular the ABS, SRS, IAS, TPM and DSC lights (arrowed).

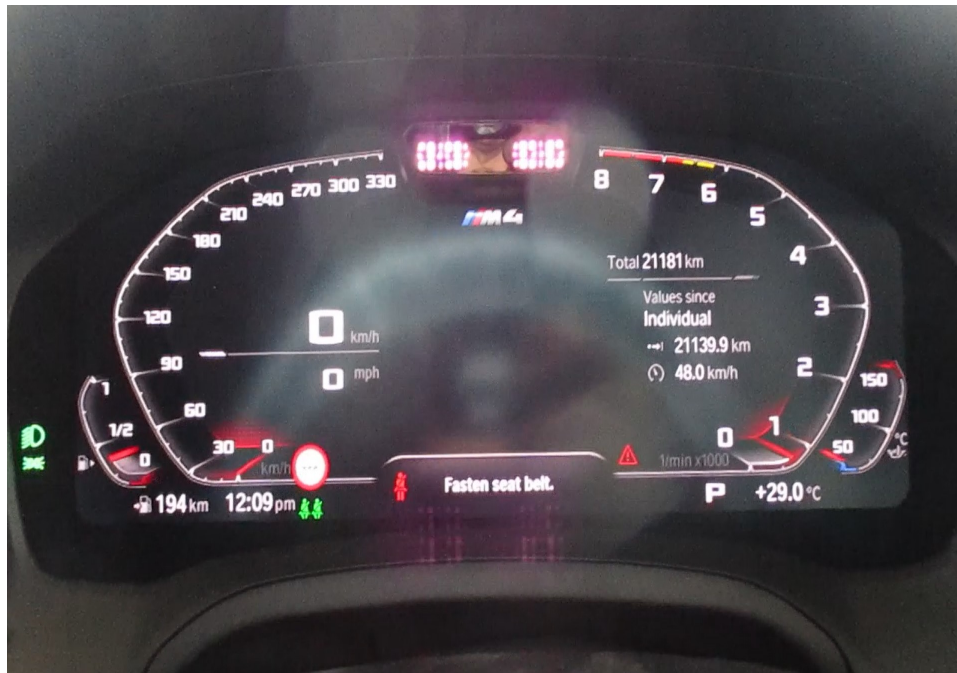
**Photo 17** shows the respective warning lights no longer illuminated, indicating that there is no fault detected to the ABS, SRS, IAS, TPM and DSC systems of the Motor Car during the self-test. These electronic systems were hence in working condition at the time of my inspection.

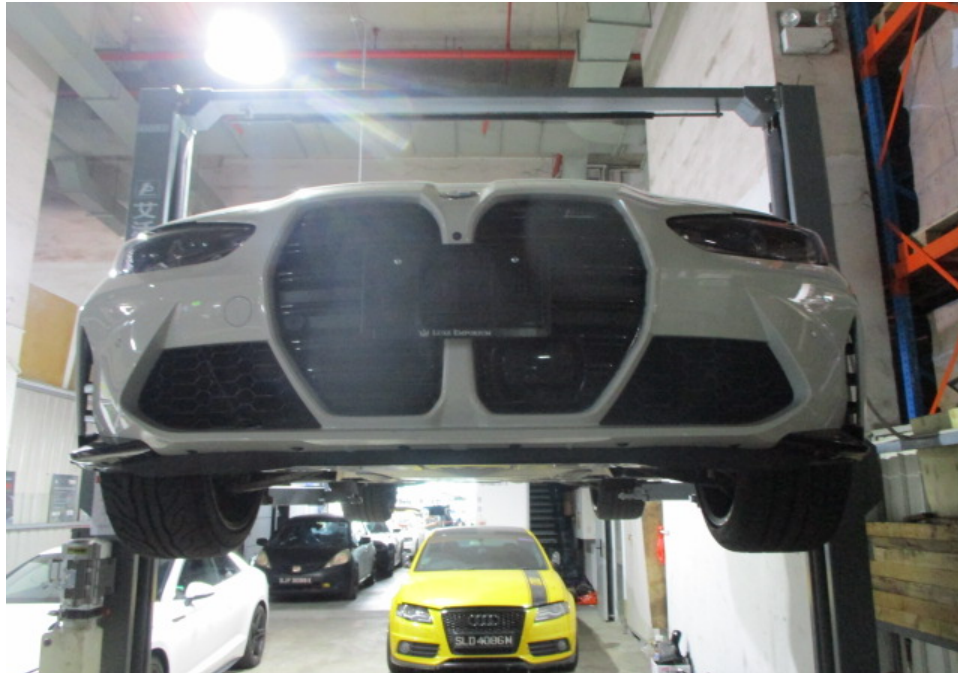
**Photo 18** shows the Motor Car hoisted up for checks on its undercarriage. There was no sign(s) or indication(s) of fluid leakage and/or fluid stain(s) on the underside of the Motor Car. The undercarriage components of the Motor Car were also all observed to be intact and secured in an appropriate manner.

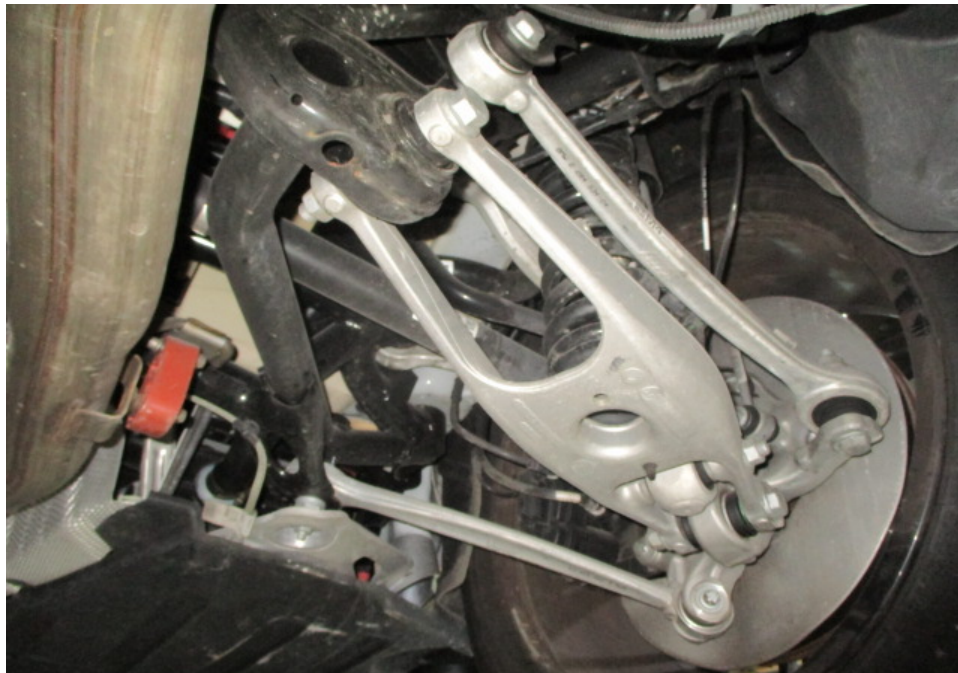
**Photo 19** shows a general view of the control arms and linkages at the rear right wheel of the Motor Car. I did not observe any fluid leak and/or fluid stain on the underside of the Motor Car. All of the Motor Car's undercarriage components were observed to be intact and secured in an appropriate manner.

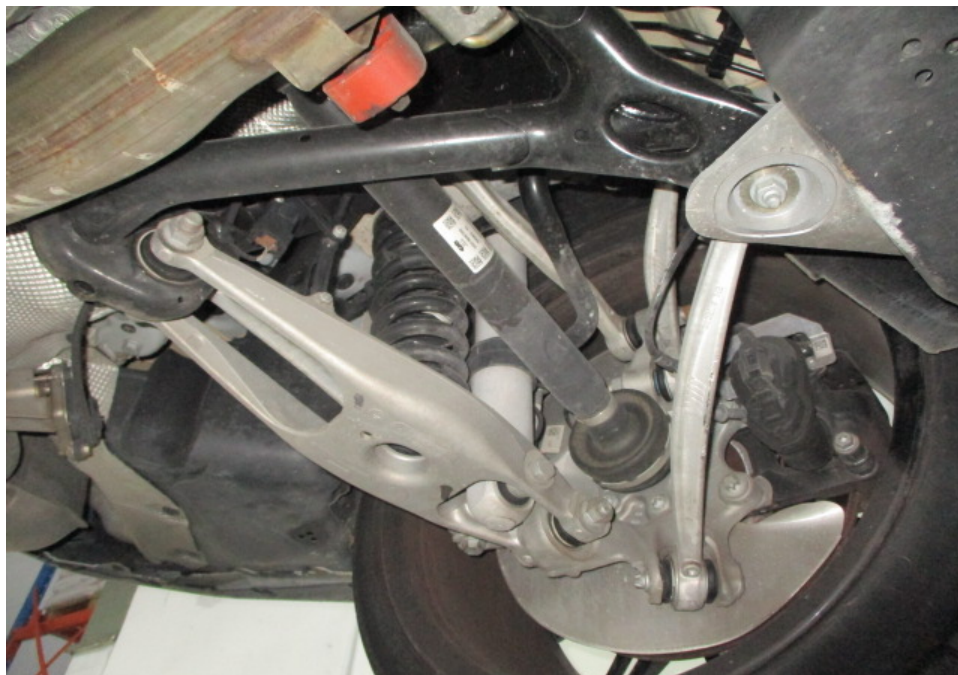
**Photo 20** shows a general view of the control arms and linkages at the rear left wheel of the Motor Car. I did not observe any fluid leak and/or fluid stain on the underside of the Motor Car. All of the Motor Car's undercarriage components were observed to be intact and secured in an appropriate manner.

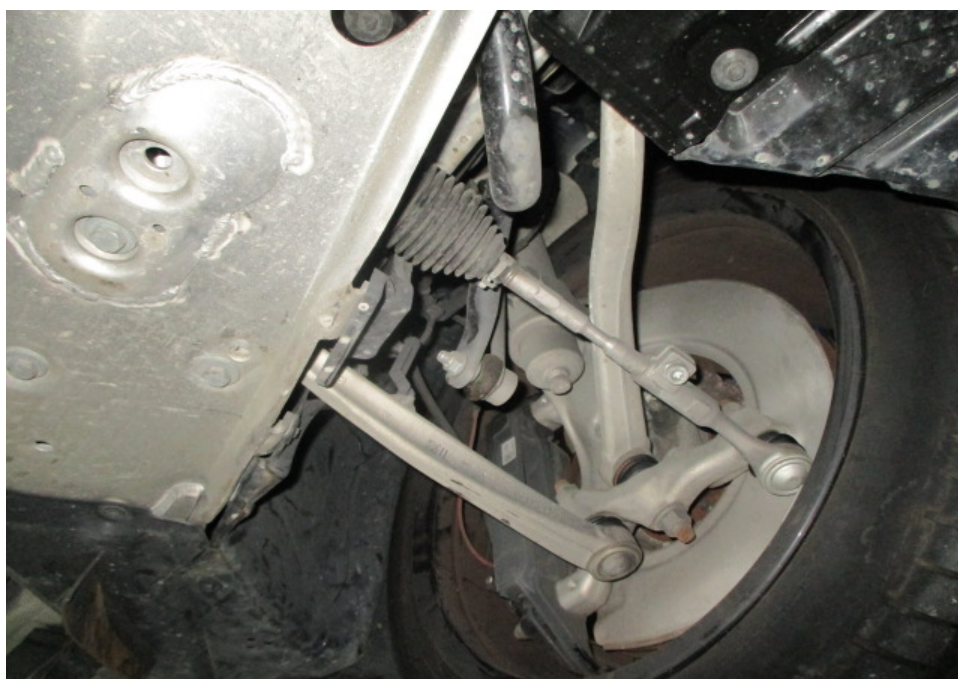
**Photo 21** shows the various undercarriage components at the front left wheel of the Motor Car. The mechanical components, control arms and linkages were all found to be intact and secured in an appropriate manner.

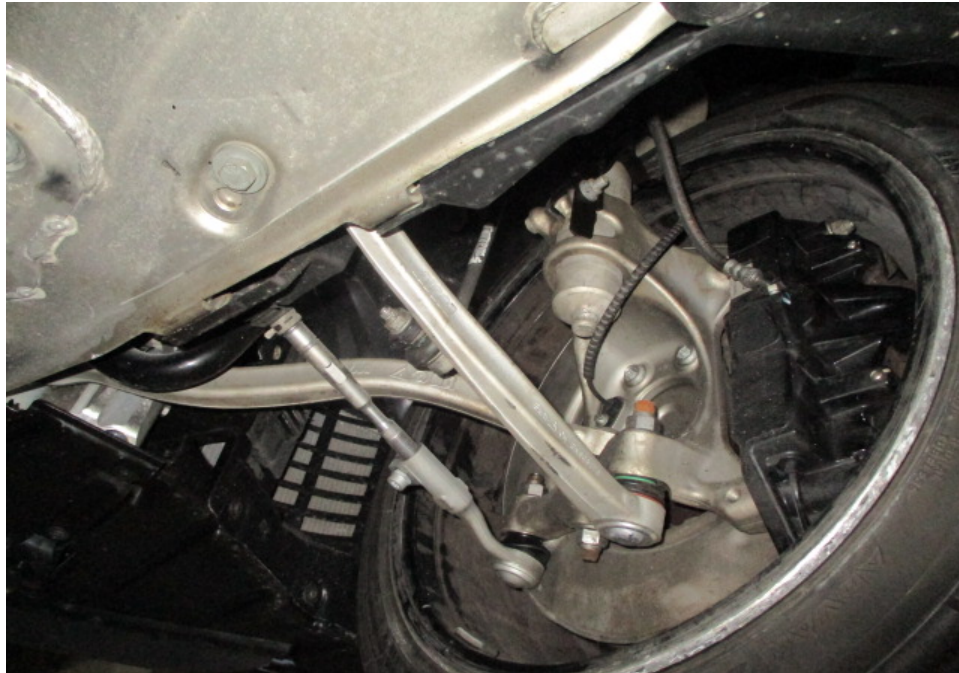
**Photo 22** shows the various undercarriage components at the front right wheel of the Motor Car. The mechanical components, control arms and linkages were all found to be intact and secured in an appropriate manner. I also did not observe any fluid leak and/or fluid stain on the underside of the Motor Car.

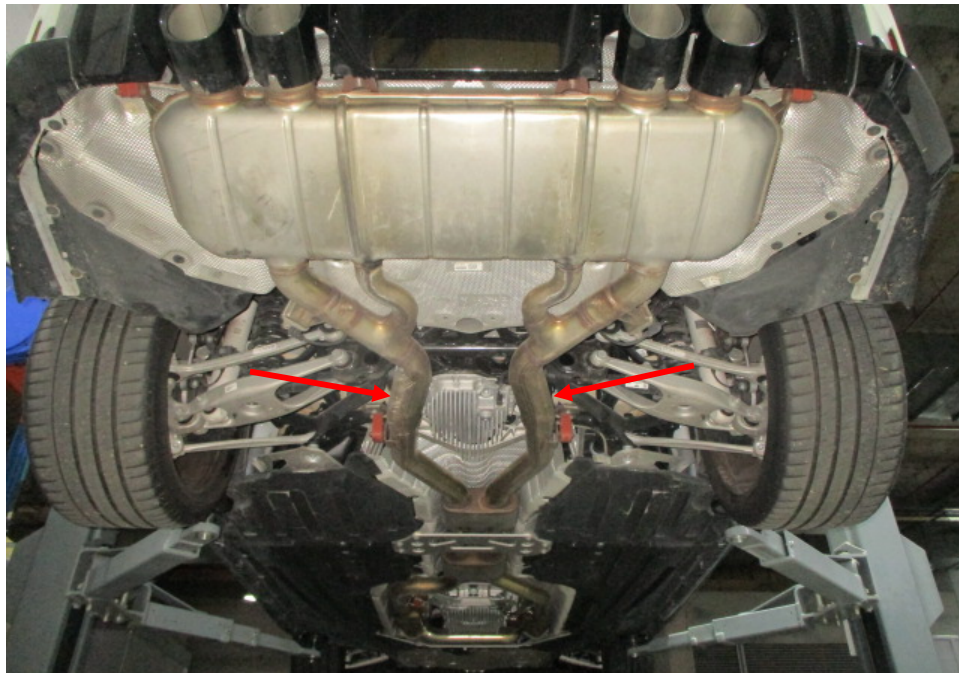
**Photo 23** shows the rear section of the Motor Car's exhaust system. My examination of the Motor Car's exhaust system revealed no sign(s) or indication(s) of any cut or weld marks along its exhaust pipes (arrowed), on its rear muffler, on its centre resonator boxes and on its catalytic converters.

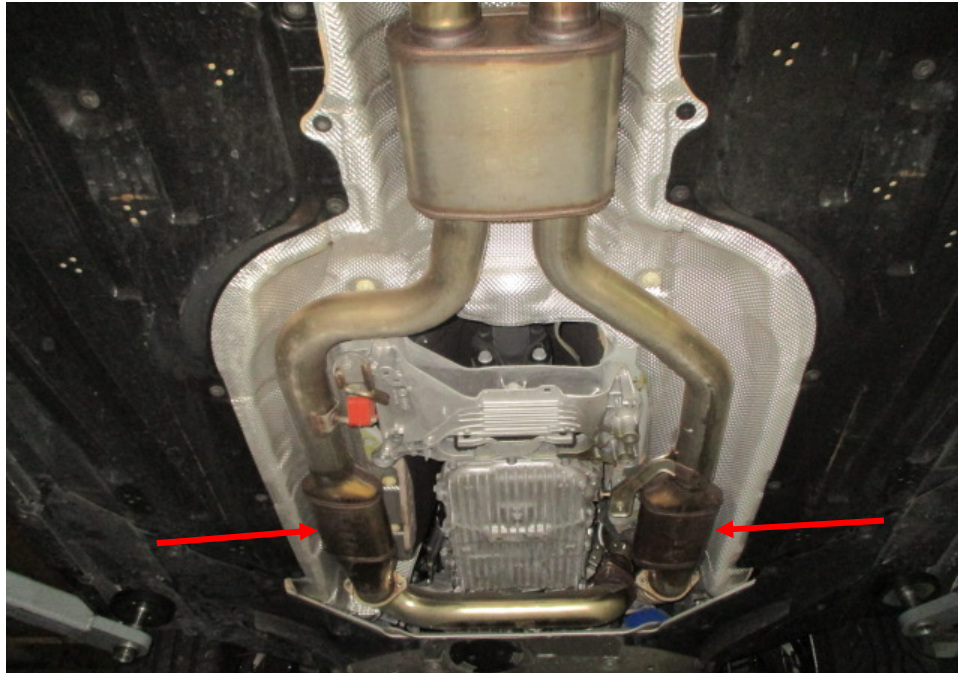
**Photo 24** shows the front section of the Motor Car's exhaust system. My examination of the Motor Car's exhaust system revealed no sign(s) or indication(s) of any cut or weld marks along its exhaust pipes, on its rear muffler, on its centre resonator boxes (arrowed) and on its catalytic converters.

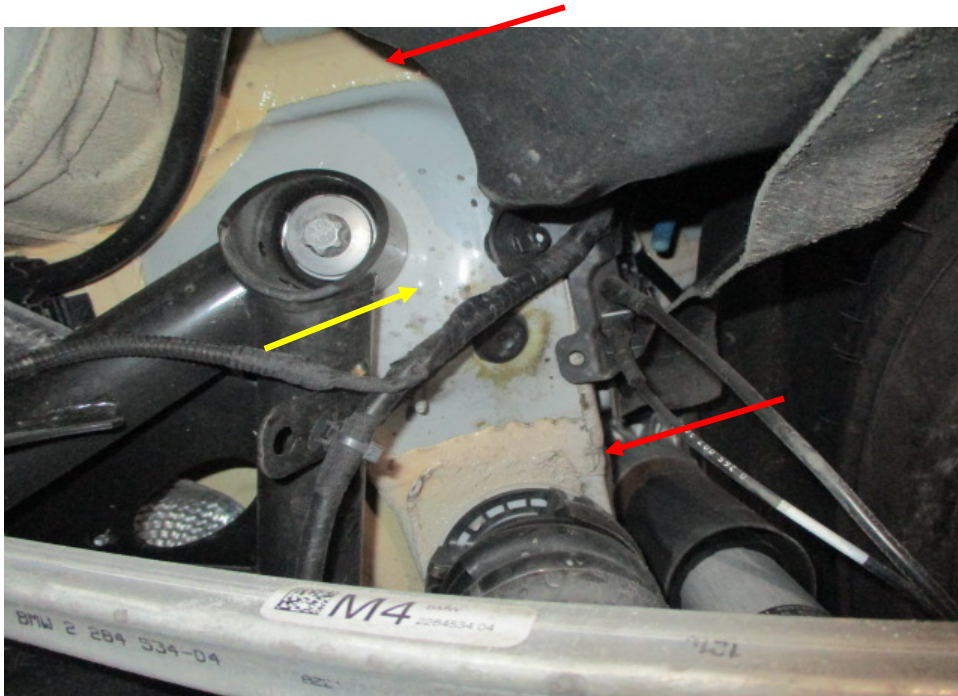
**Photo 25** shows the chassis/structural body at the underside rear right of the Motor Car. I did not find any weld marks other than original spot weld marks (yellow arrow) on the chassis/structural body of the Motor Car. The original factory sealant (red arrow) at the joints along the chassis/structural body was untouched, indicating no work was done on the chassis/structural body of the Motor Car and that the chassis/structural body was originally fitted.

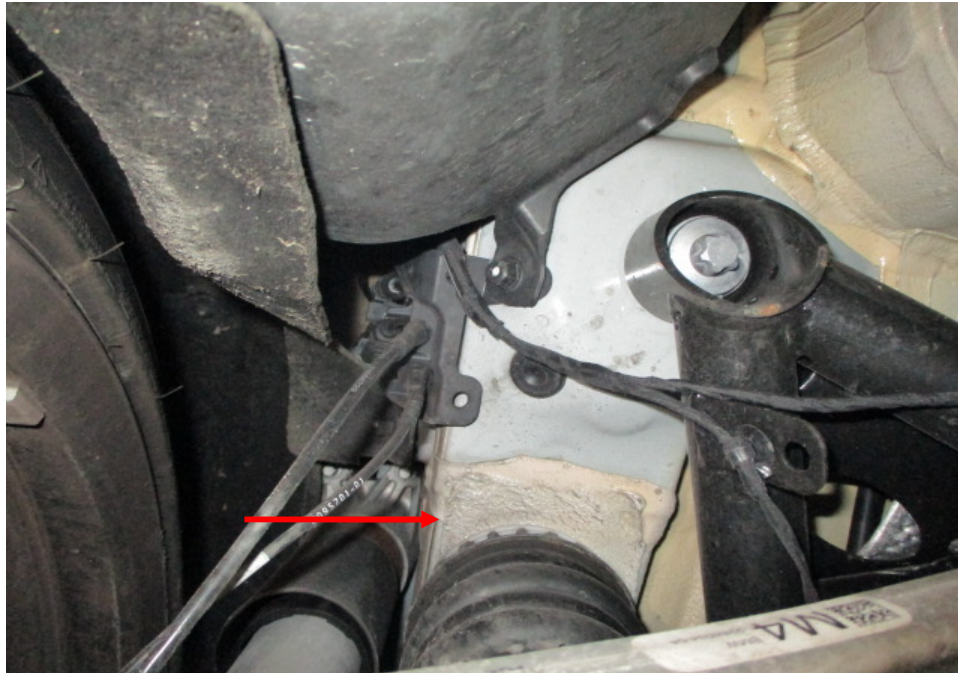
**Photo 26** shows the chassis/structural body at the underside rear left of the Motor Car. The original factory sealant (arrowed) at the joints along the chassis/structural body was observed to be untouched. In general, I had found no work was carried out on the chassis/structural body of the Motor Car. The chassis/structural body of the Motor Car was originally fitted.

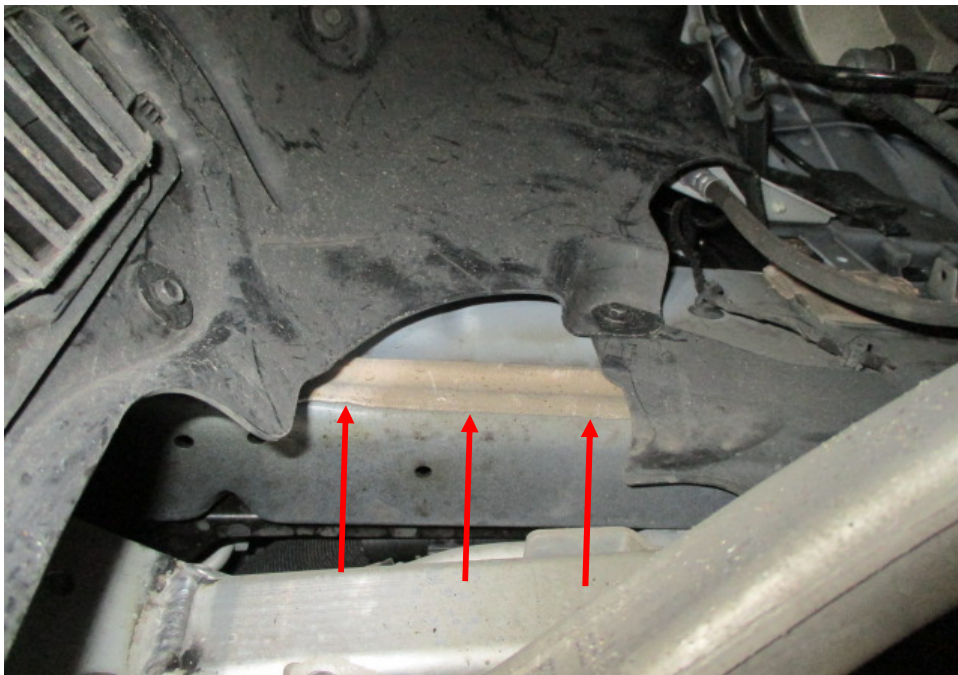
**Photo 27** shows the chassis/structural body at the underside front left of the Motor Car. The original factory sealant (arrowed) at the joints along the chassis/structural body was observed to be untouched. In general, I had found no work was carried out on the chassis/structural body of the Motor Car. The chassis/structural body of the Motor Car was originally fitted.

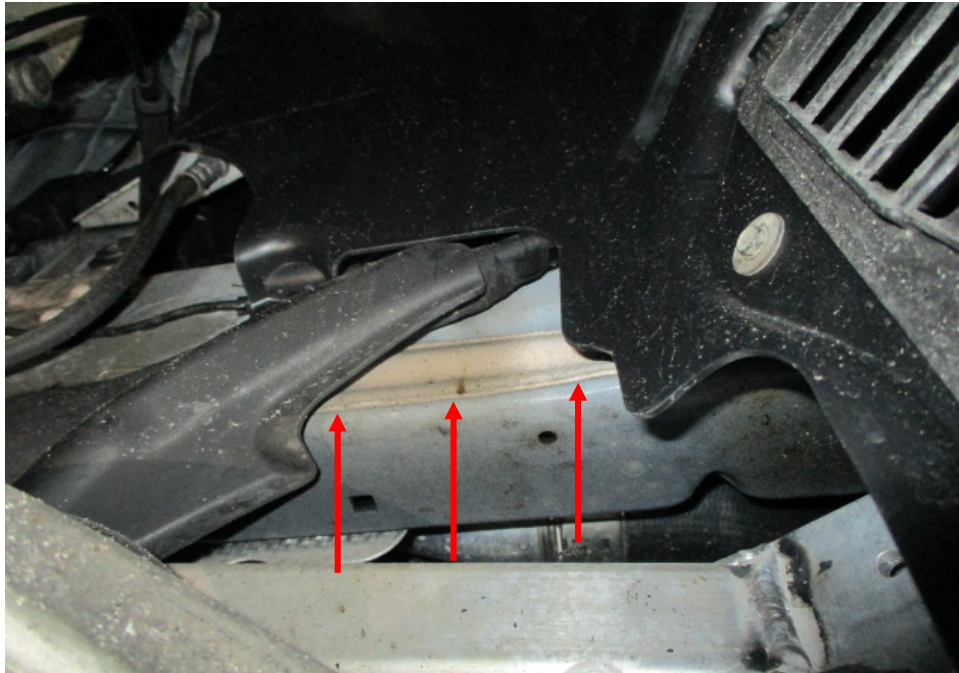
**Photo 28** shows the chassis/structural body at the underside front right of the Motor Car. I did not find any weld marks other than original spot weld marks on the chassis/structural body of the Motor Car. The original factory sealant (arrowed) at the joints along the chassis/structural body was untouched, indicating no work was done on the chassis/structural body of the Motor Car and that the chassis/structural body was originally fitted.

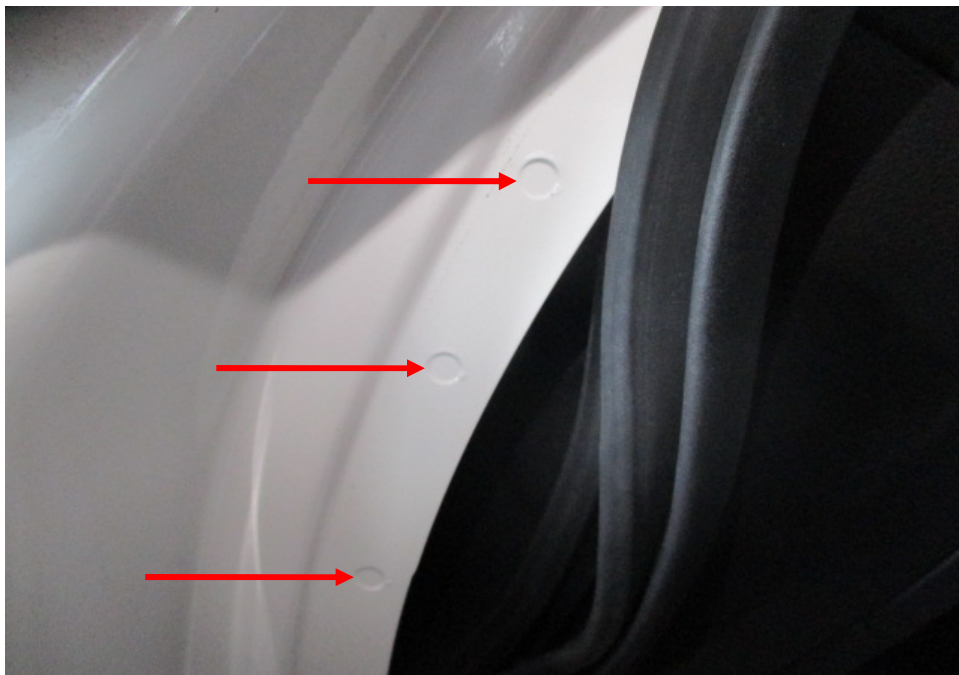
**Photo 29** shows the left side "A" pillar of the Motor Car. I did not find any weld marks other than original spot weld marks (arrowed) on the left side "A" pillar of the Motor Car which, indicates that there was no re-welding works carried out. In general, I had found all the non-detachable body panels of the Motor Car to be originally fitted at the time of my inspection.
