Your Ref: BMW M4 Coupe  
(chassis number WBS32AZ070CG97273)  
Our Ref : CI/TP22011132/D

08 November 2022

**INSPECTION REPORT OF AN UNREGISTERED BMW M4 COUPE MOTOR CAR WITH CHASSIS NUMBER WBS32AZ070CG97273**

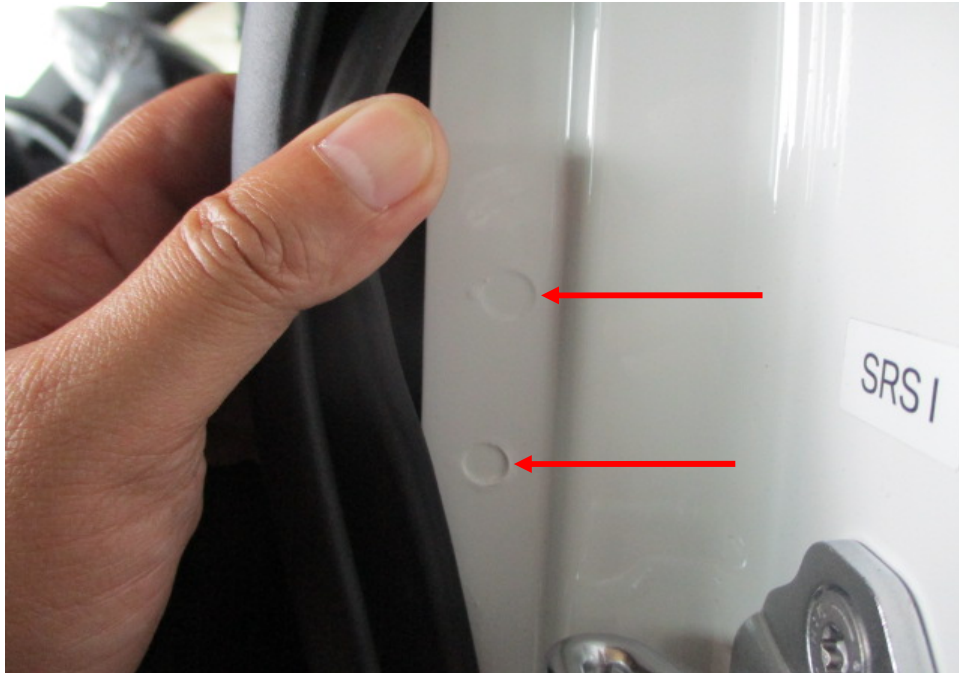
**Photo 30** shows the left side rear body panel of the Motor Car. I did not find any weld marks other than original spot weld marks (arrowed) on the left side rear body panel of the Motor Car, which indicates that there was no re-welding works carried out. In general, I had found all the non-detachable body panels of the Motor Car to be originally fitted at the time of my inspection.

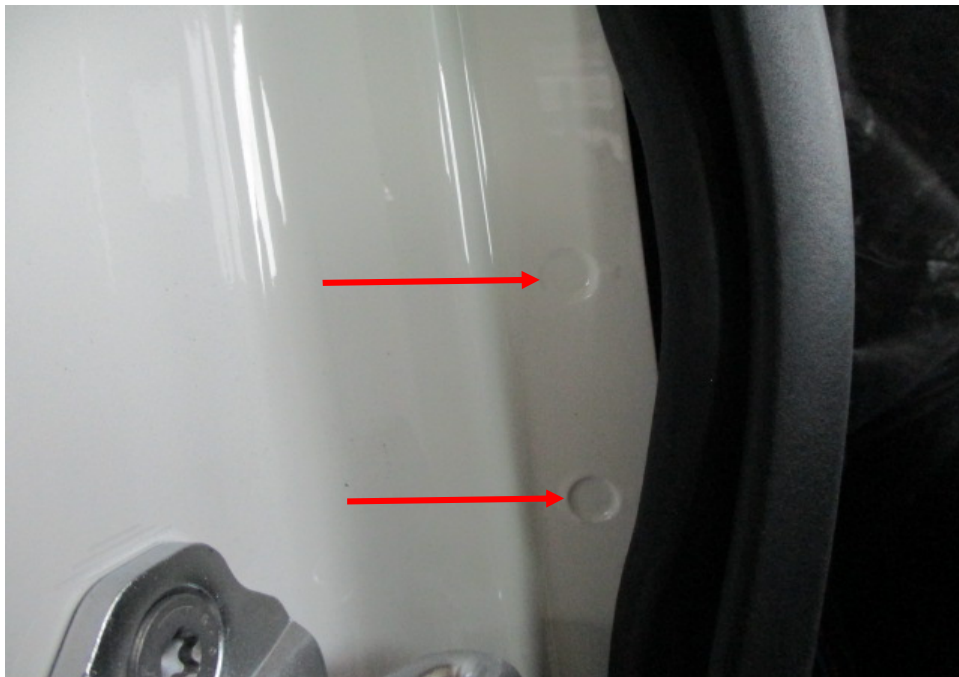
**Photo 31** shows the right side rear body panel of the Motor Car. I did not find any weld marks other than original spot weld marks (arrowed) on the right side rear body panel of the Motor Car, which indicates that there was no re-welding works carried out. In general, I had found all the non-detachable body panels of the Motor Car to be originally fitted at the time of my inspection.

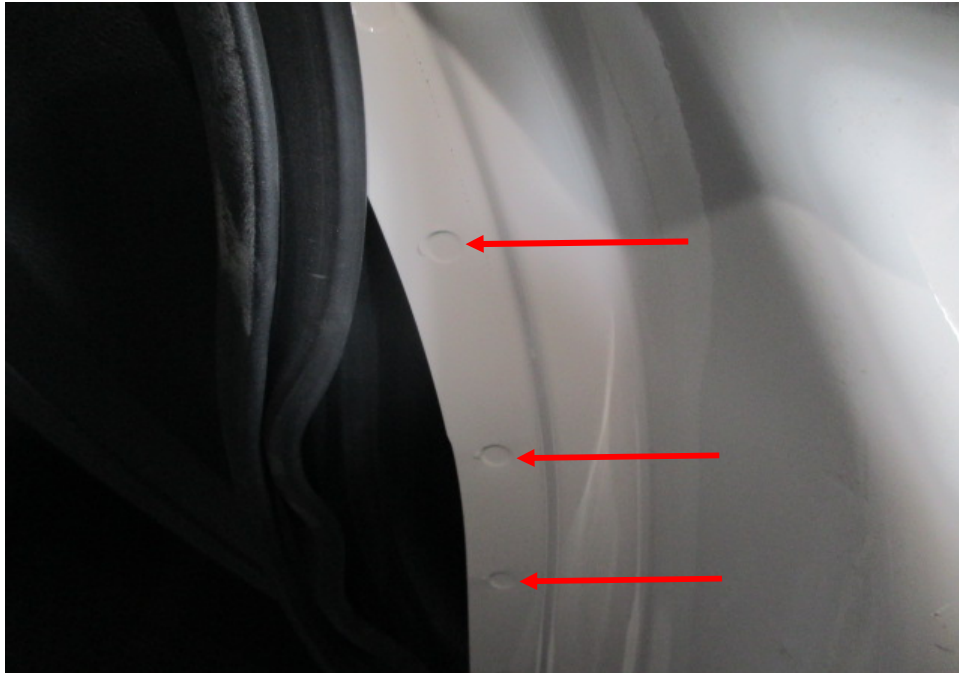
**Photo 32** shows the right side "A" pillar of the Motor Car. I did not find any weld marks other than original spot weld marks (arrowed) on the right side "A" pillar of the Motor Car, which indicates that there was no re-welding works carried out. In general, I had found all the non-detachable body panels of the Motor Car to be originally fitted at the time of my inspection.
