Your Ref: Porsche Cayenne
(chassis number WP1ZZZ9YZMDA14714)
Our Ref : CI/TP22011148/D

**INSPECTION REPORT OF AN UNREGISTERED PORSCHE CAYENNE
MOTOR CAR WITH CHASSIS NUMBER WP1ZZZ9YZMDA14714**

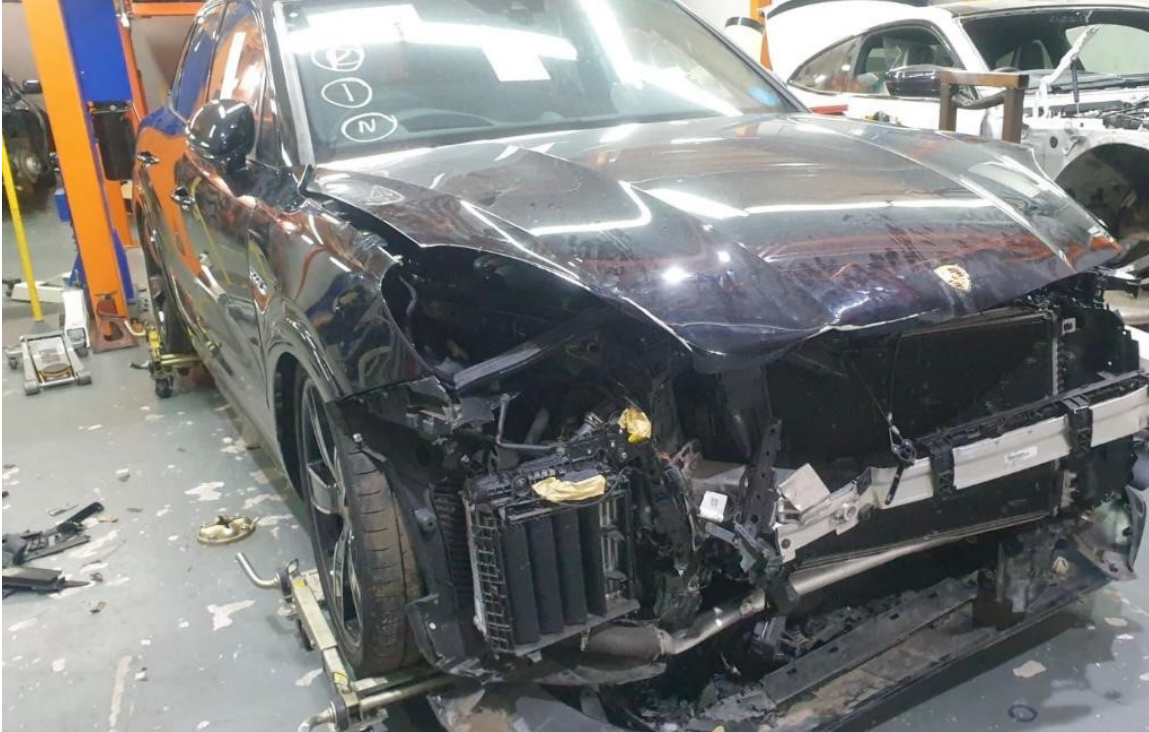
Photo 1 shows the front right body of the Motor Car (photograph provided to me). The Motor Car was observed to have sustained damage at its frontal portion. The front bumper reinforcement, front right fender, front right fender wheel arc garnish, front bonnet, front bonnet locks and front bonnet hinges were amongst the body parts that were observed to have been damaged. The front right headlamp, front bumper and all its related parts and attachments like the front bumper lower cover, front bumper sensors, front bumper centre grille, front bumper right grille, front right day light and front radar unit amongst others were observed to be damaged/dislodged/missing.

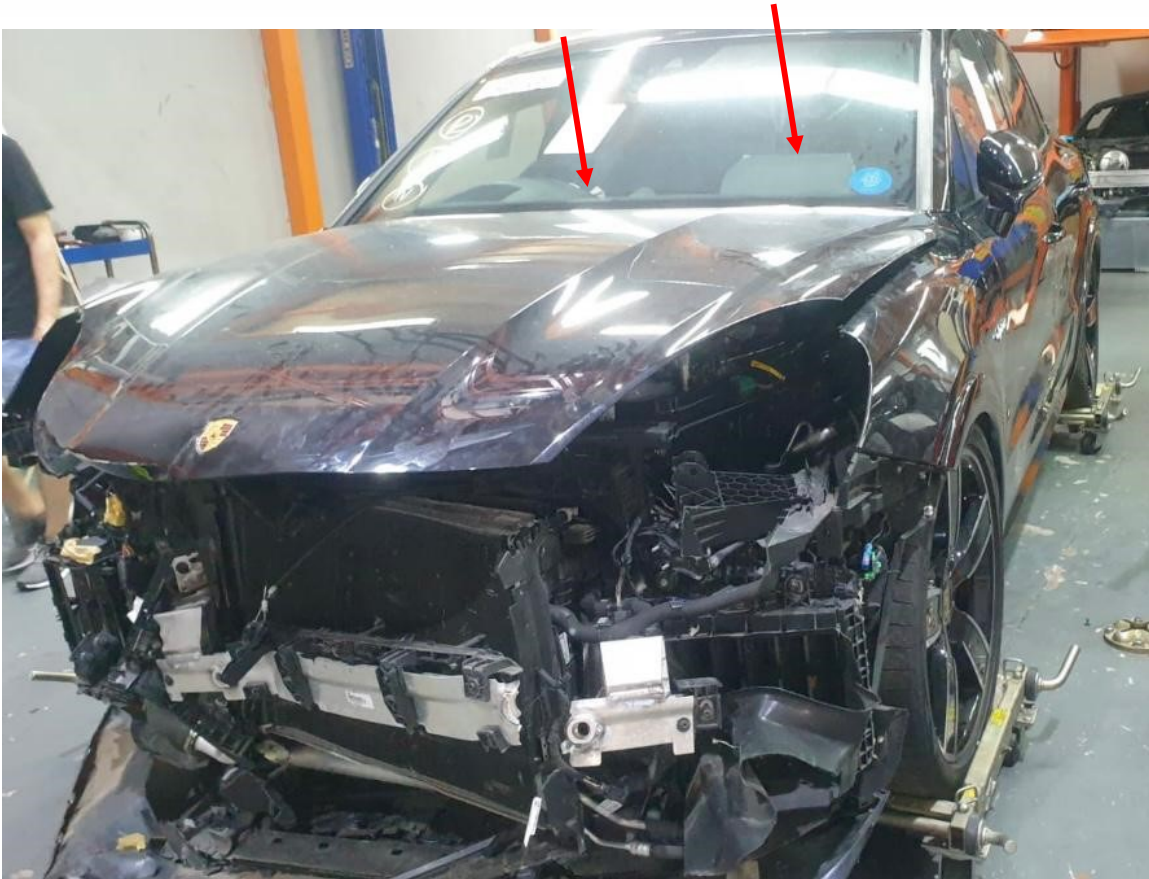
Photo 2 shows the front left body of the Motor Car (photograph provided to me). The Motor Car was observed to have sustained damage at its frontal portion. The front bumper reinforcement, front under cover, front left fender, front left fender wheel arc garnish, front left inner air guide, front centre inner air guide, front support panel, front support panel top cover, front bonnet, front bonnet locks, front bonnet hinges, aircon condenser and radiator were amongst the body parts that were observed to have been damaged. The front left headlamp, front bumper and all its related parts and attachments like the front bumper lower cover, front bumper sensors, front bumper centre grille, front bumper left grille, front left day light and front radar unit amongst others were observed to be damaged/dislodged/missing. The driver's airbag and front left passenger airbag were deployed (arrowed).

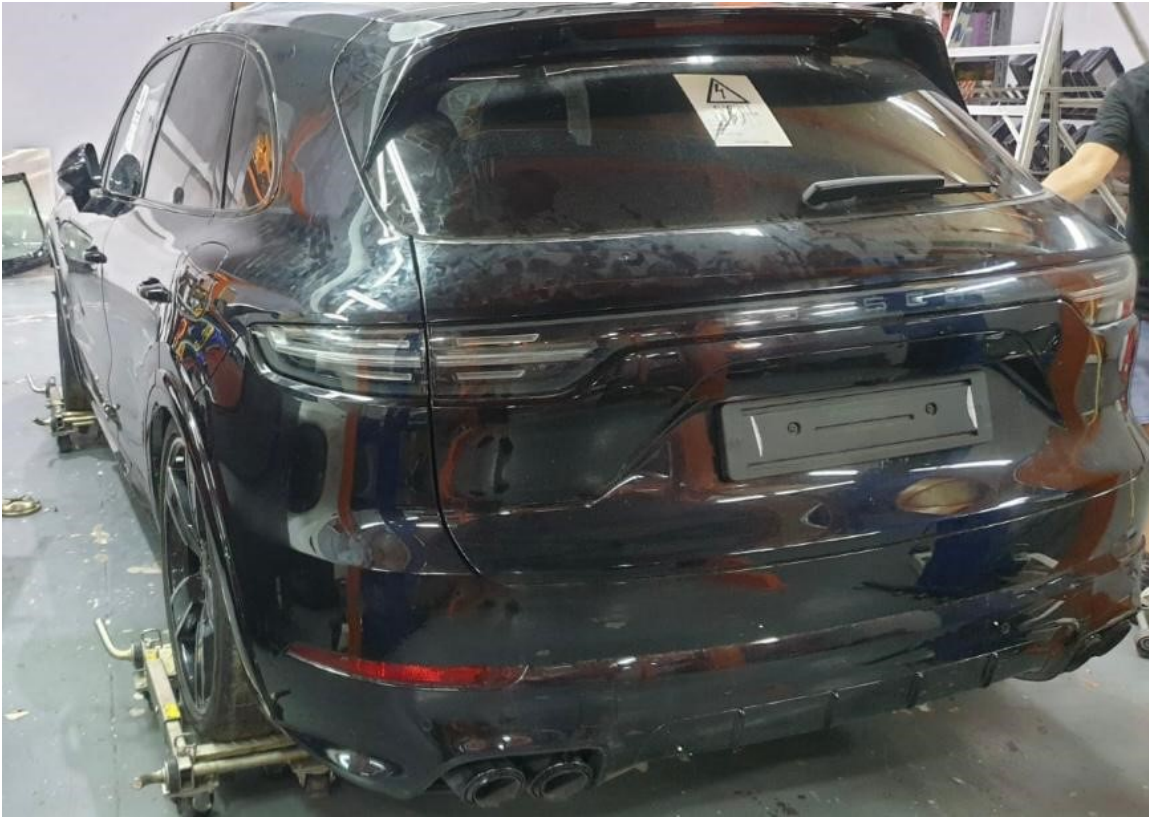
Photo 3 shows the rear left body of the Motor Car (photograph provided to me). Apart for the frontal portion, there was no physical damage observed to other areas of the Motor Car.

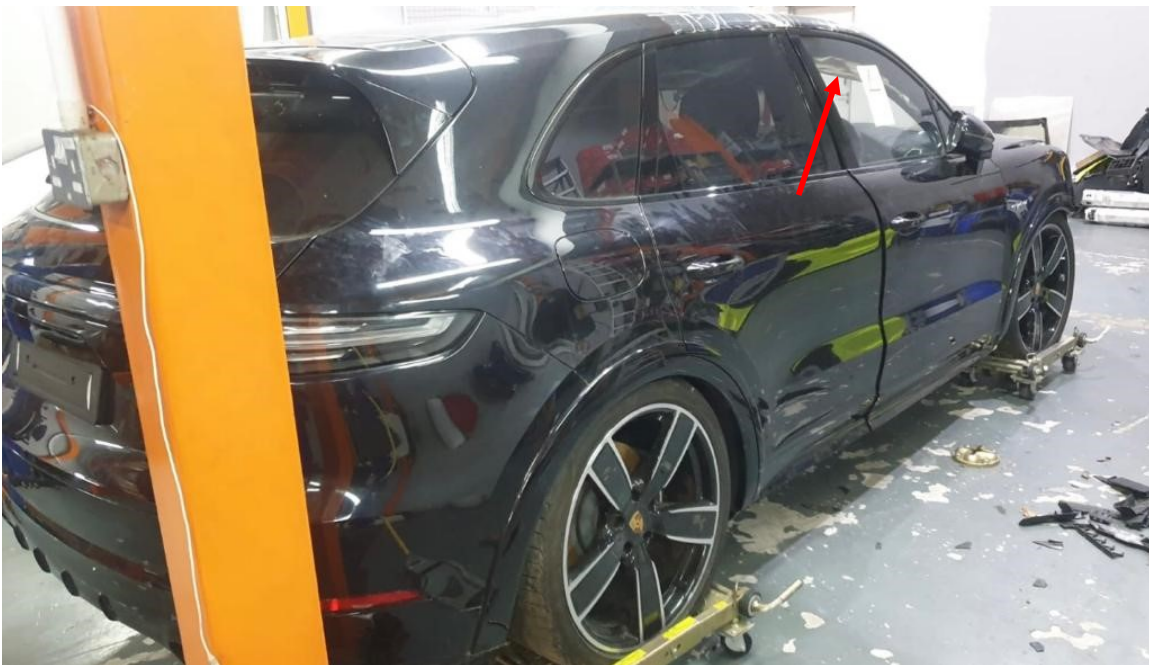
Photo 4 shows the rear right body of the Motor Car (photograph provided to me). Apart for the frontal portion, there was no physical damage observed to other areas of the Motor Car. The right curtain airbag was deployed (arrowed).

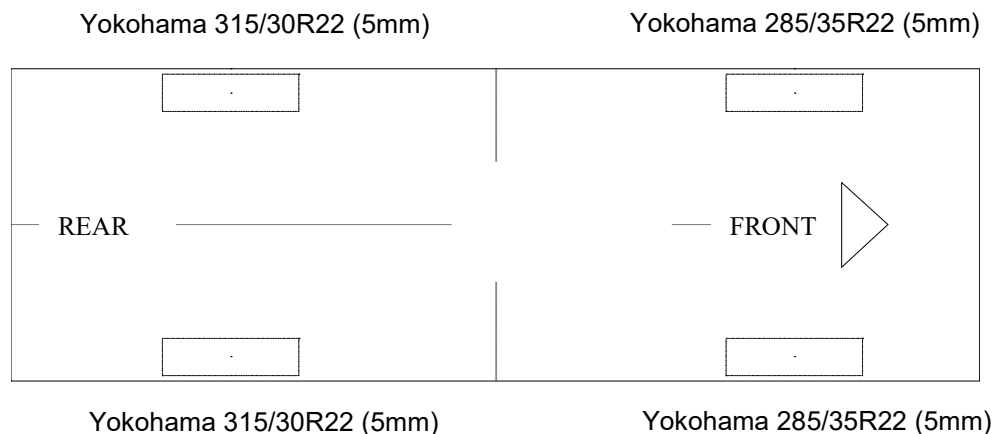
9. It was fitted with 22inch sport wheel rims that were wrapped with tyres that were observed to be of serviceable condition. The tyres were also sufficiently inflated for vehicular operation. The tyre brand, tyre size and approximate remaining tread depth of the 4 tyres of the Motor Car were recorded as follows: -

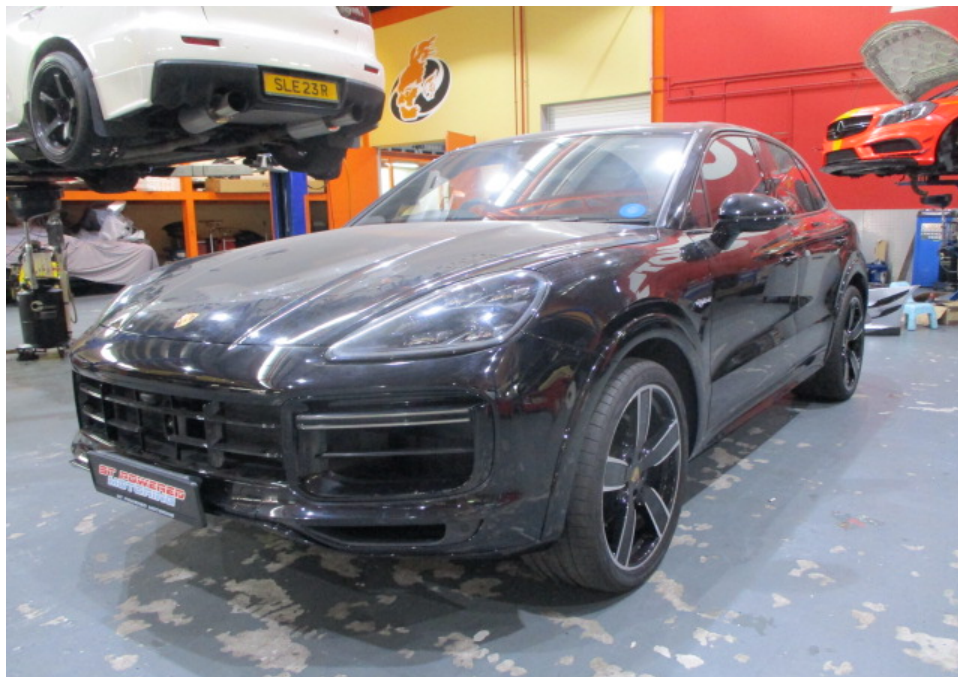
Photo 5 shows a general view of the front left body of the Motor Car at the time of my inspection. The Motor Car was observed to be in a relatively good general condition with no loose exterior fittings observed. The body parts at the frontal portion of the Motor Car were visually examined and it was observed that the repair/restoration works carried out to the damaged area of the Motor Car (refer to photograph 1 & 2 above) were reasonably adequate and in order.

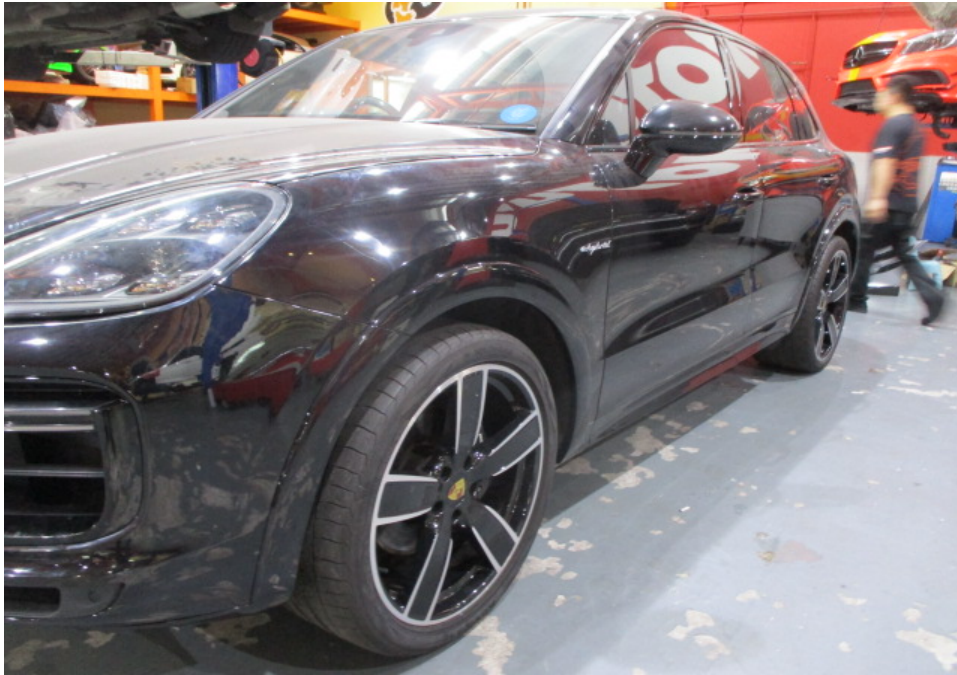
Photo 6 shows a closer view of the Motor Car's front bonnet, front left headlamp, front left wheel rim, front left fender and front left fender wheel arc garnish. The body parts at the frontal portion of the Motor Car were visually examined and it was observed that the repair/restoration works carried out to the damaged area of the Motor Car (refer to photograph 1 & 2 above) were reasonably adequate and in order.

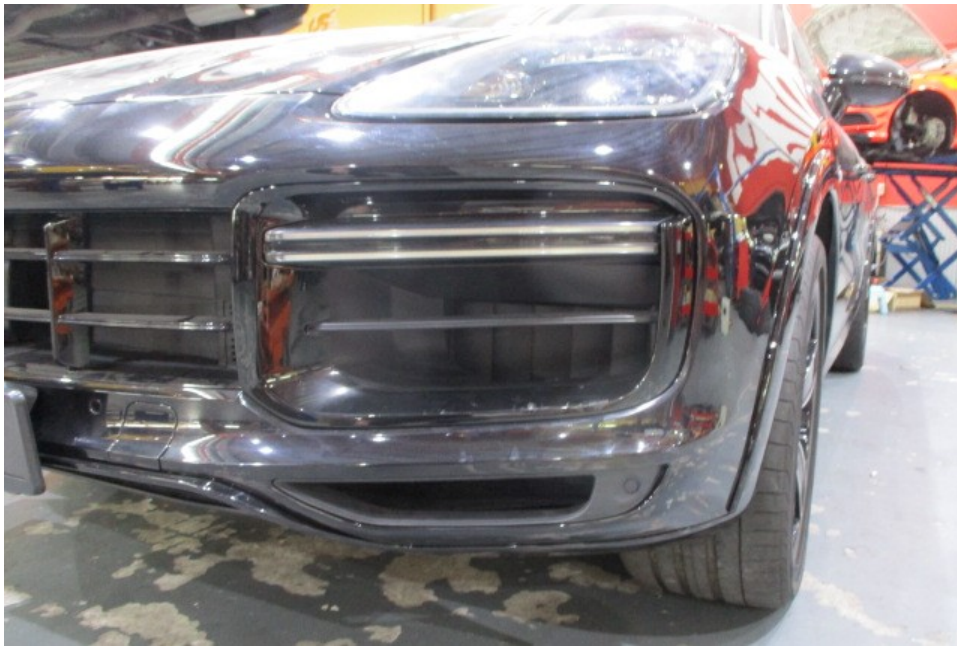
Photo 7 shows a closer view of the Motor Car's front bumper, front bumper lower cover, front bumper left grille, front left headlamp and front left day light. The body parts at the frontal portion of the Motor Car were visually examined and it was observed that the repair/restoration works carried out to the damaged area of the Motor Car (refer to photograph 1 & 2 above) were reasonably adequate and in order.

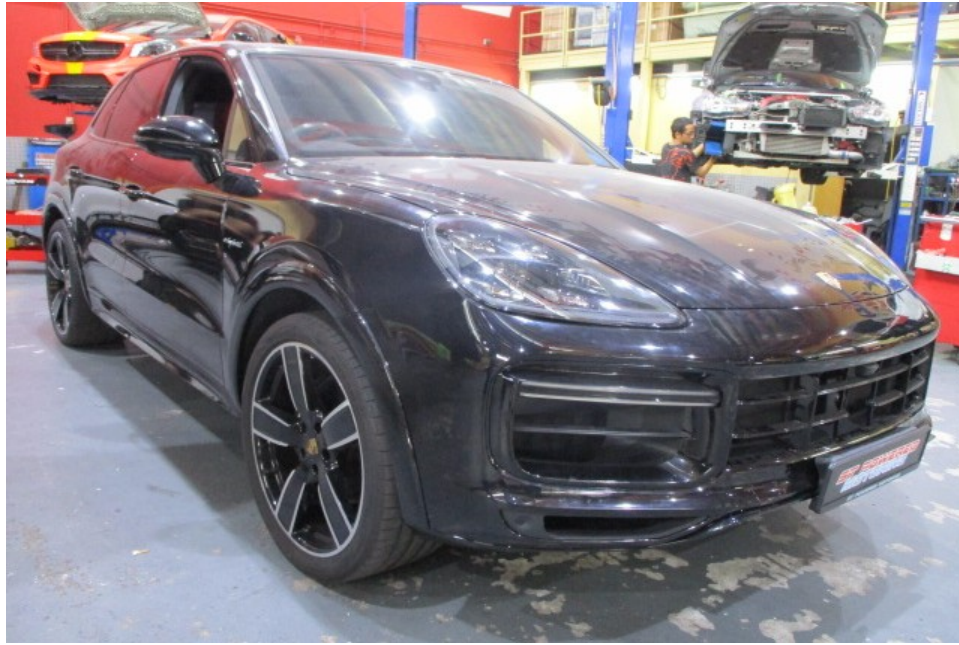
Photo 8 shows a general view of the front right body of the Motor Car at the time of my inspection. The Motor Car was observed to be in a relatively good general condition with no loose exterior fittings observed. The body parts at the frontal portion of the Motor Car were visually examined and it was observed that the repair/restoration works carried out to the damaged area of the Motor Car (refer to photograph 1 & 2 above) were reasonably adequate and in order.

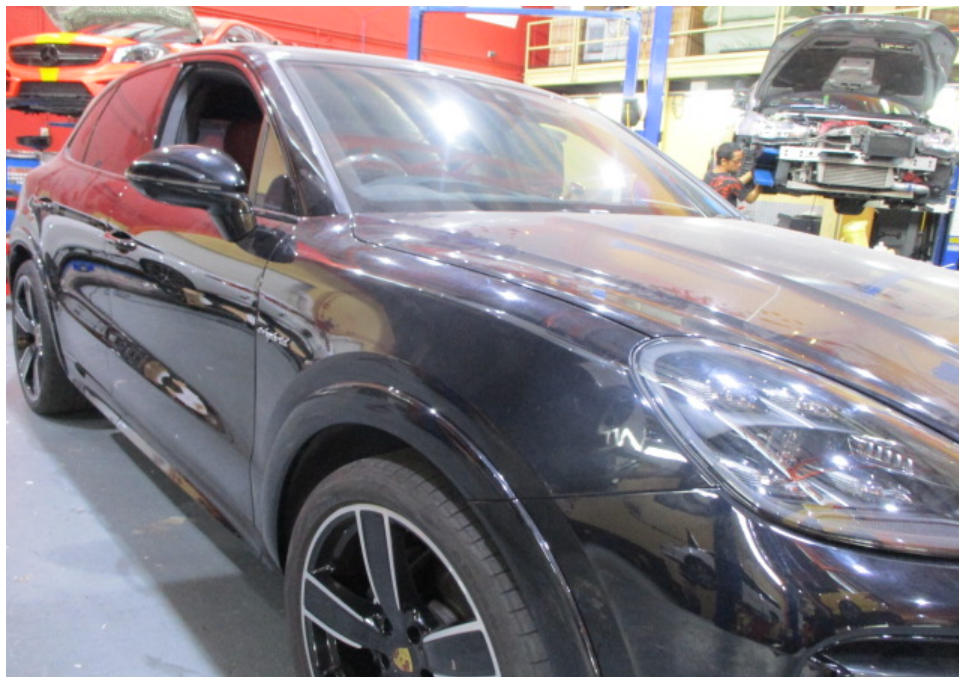
Photo 9 shows a closer view of the Motor Car's front bonnet, front right headlamp, front right wheel rim, front right fender and front right fender wheel arc garnish. The body parts at the frontal portion of the Motor Car were visually examined and it was observed that the repair/restoration works carried out to the damaged area of the Motor Car (refer to photograph 1 & 2 above) were reasonably adequate and in order.

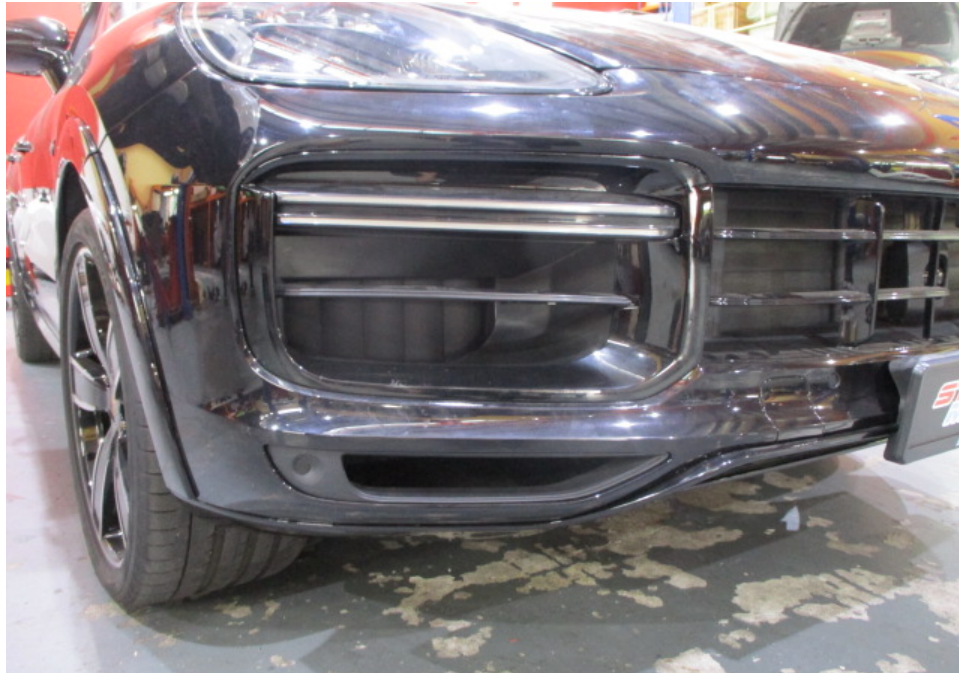
Photo 10 shows a closer view of the Motor Car's front bumper, front bumper right grille, front right day light and front right headlamp. The body parts at the frontal portion of the Motor Car were visually examined and it was observed that the repair/restoration works carried out to the damaged area of the Motor Car (refer to photograph 1 & 2 above) were reasonably adequate and in order.

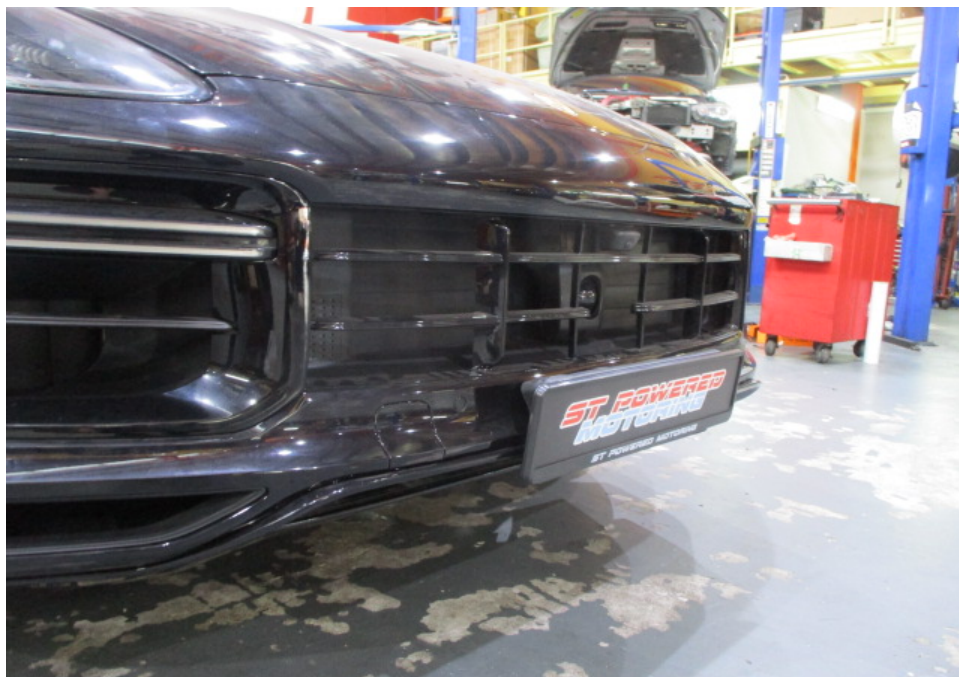
Photo 11 shows a closer view of the Motor Car's front bumper, front bumper lower cover, front bumper centre grille and front radar unit. The body parts at the frontal portion of the Motor Car were visually examined and it was observed that the repair/restoration works carried out to the damaged area of the Motor Car (refer to photograph 1 & 2 above) were reasonably adequate and in order.

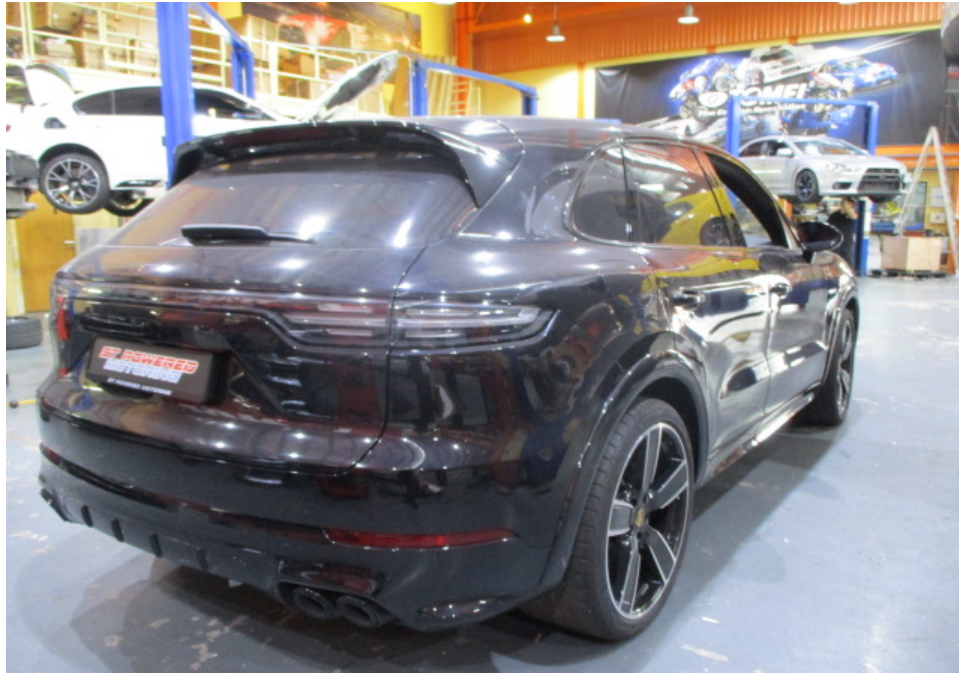
Photo 12 shows a general view of the rear right body of the Motor Car at the time of my inspection. The Motor Car was observed to be in a relatively good general condition with no loose exterior fittings observed. The mileage of the Motor Car recorded at the time of my inspection was 7,897km.

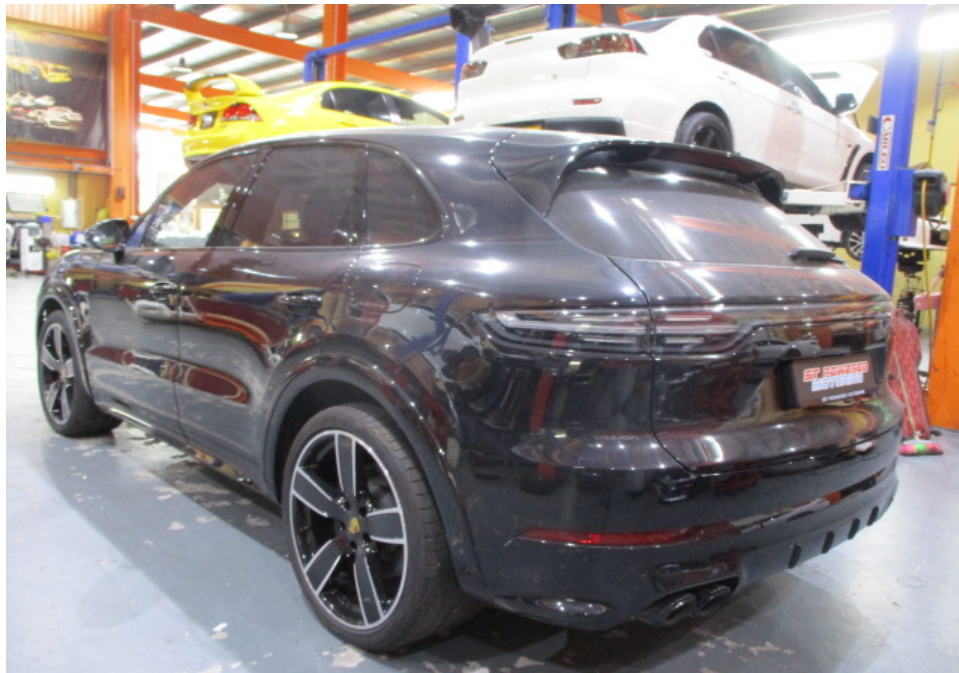
Photo 13 shows a general view of the rear left body of the Motor Car at the time of my inspection. The Motor Car was observed to be in a relatively good general condition with no loose exterior fittings observed. The mileage of the Motor Car recorded at the time of my inspection was 7,897km.

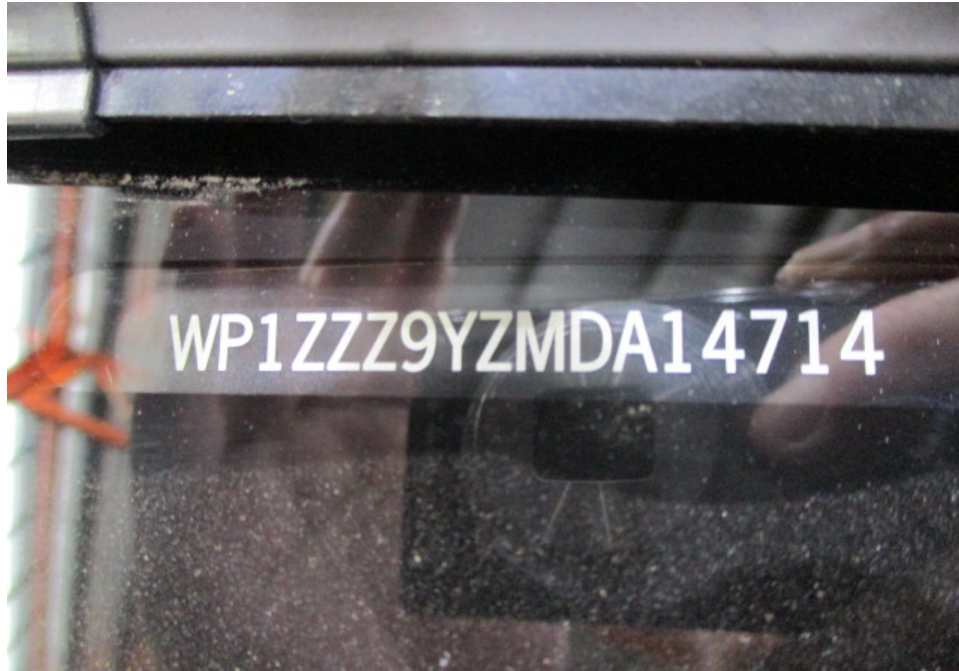
Photo 14 shows the chassis number of the Motor Car. The chassis number recorded was WP1ZZZ9YZMDA14714.

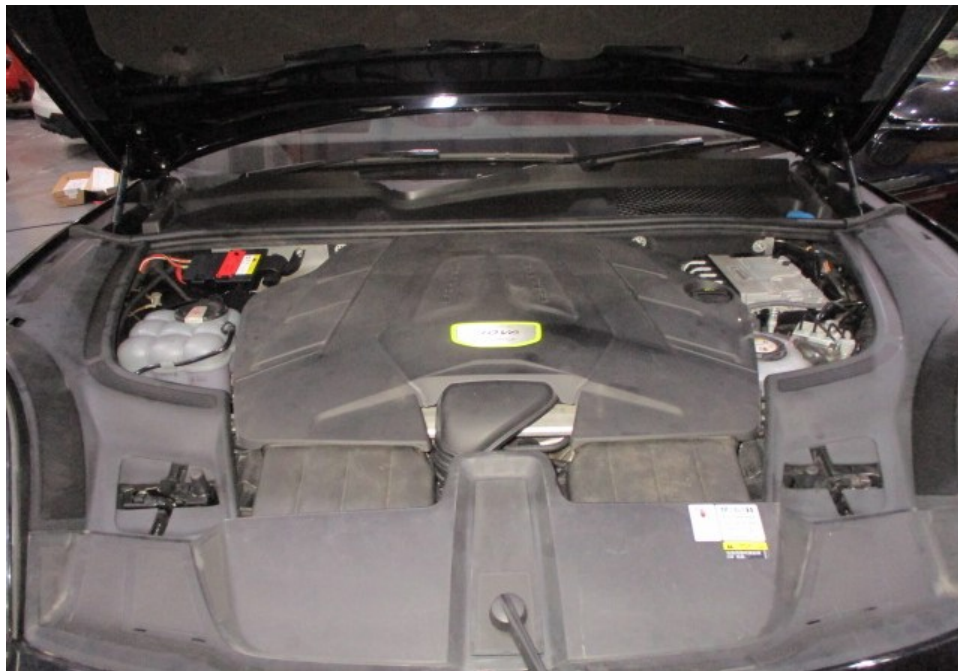
Photo 15 shows a general view of the engine compartment of the Motor Car at the time of my inspection. The various parts and components inside the engine compartment were all observed to be intact and properly fitted. There was also no sign(s) or indication(s) of fluid leak and/or fluid stain found inside the engine compartment. The repair/restoration works carried out to the various parts within the engine compartment like the front bonnet locks, front support panel, front support panel top garnish, aircon condenser and radiator amongst others were reasonably adequate and in order.

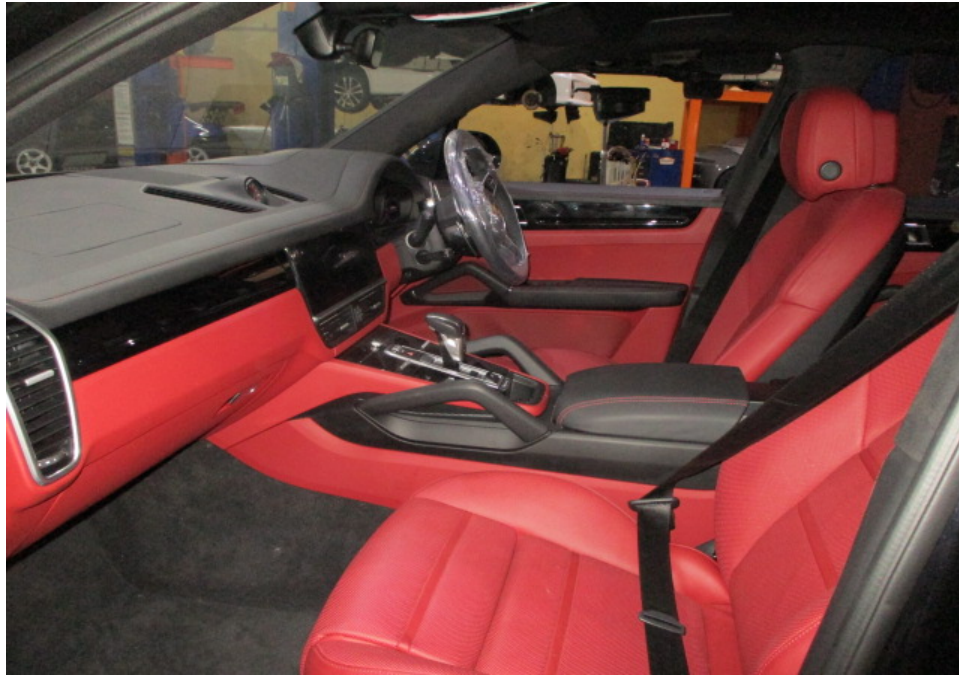
Photo 16 shows the interior compartment of the Motor Car. The front dashboard, steering wheel, seats, upholstery and trims etc were all observed to be intact and properly fitted.

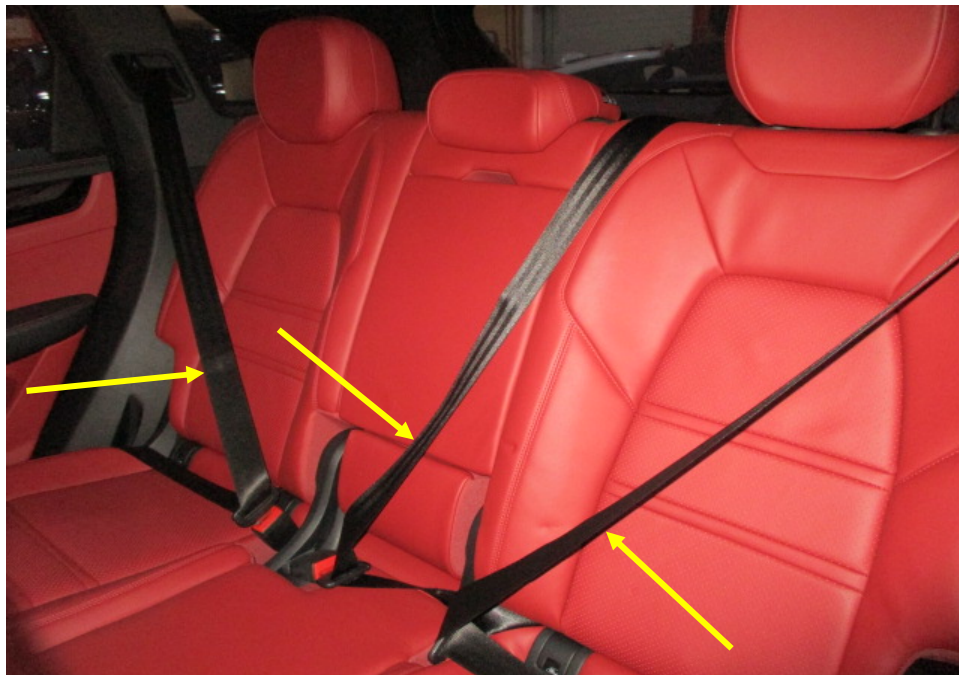
Photo 17 shows the rear seats of the Motor Car. All the seats of the Motor Car were secured via seat rails to the floorboard. They were also fitted with a retractable seat belt reel and a pre-tensioner. The seat belts (arrowed) were tested and were able to be fastened into the respective pre-tensions that were fitted on the side of each individual seat.

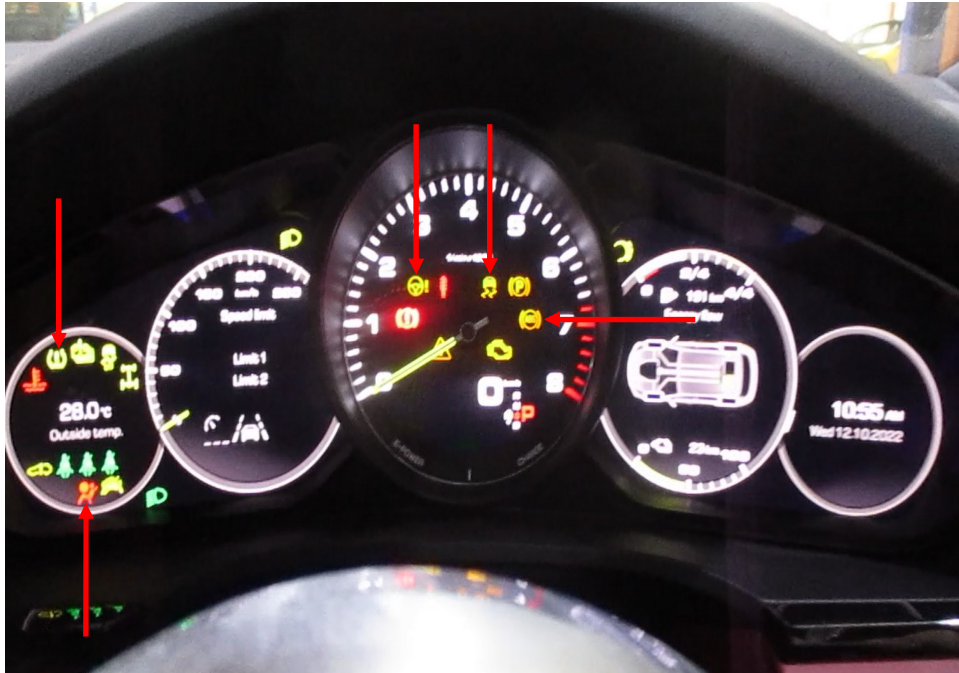
Photo 18 shows the warning lights for the various electronic safety features appearing on the instrument panel of the Motor Car during its self-test when the engine is cranked, in particular the ABS, SRS, TPM, EPS and TCS lights (arrowed).

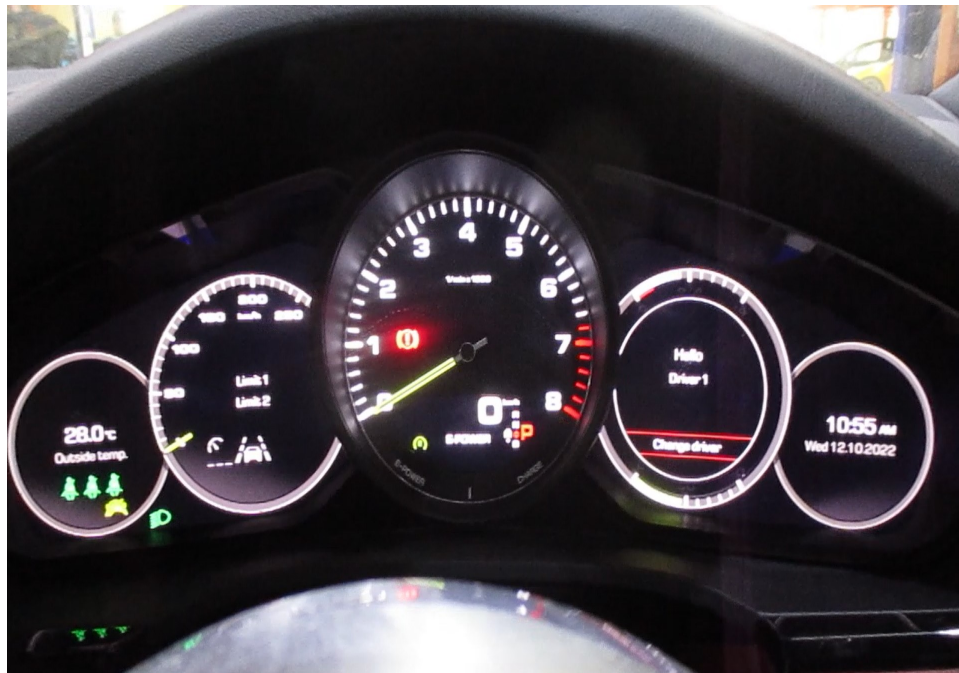
Photo 19 shows the respective warning lights no longer illuminated, indicating that there is no fault detected to the ABS, SRS, TPM, EPS and TCS systems of the Motor Car during the self-test. These electronic systems were hence in working condition at the time of my inspection.

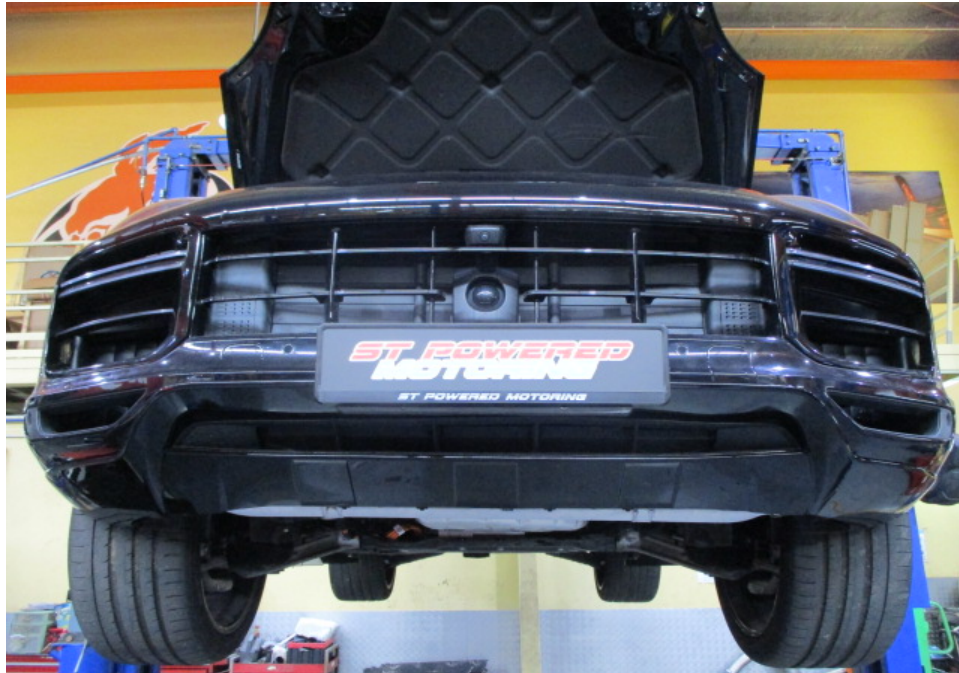
Photo 20 shows the Motor Car hoisted up for checks on its undercarriage. There was no sign(s) or indication(s) of fluid leakage and/or fluid stain(s) on the underside of the Motor Car. The undercarriage components of the Motor Car were also all observed to be intact and secured in an appropriate manner.

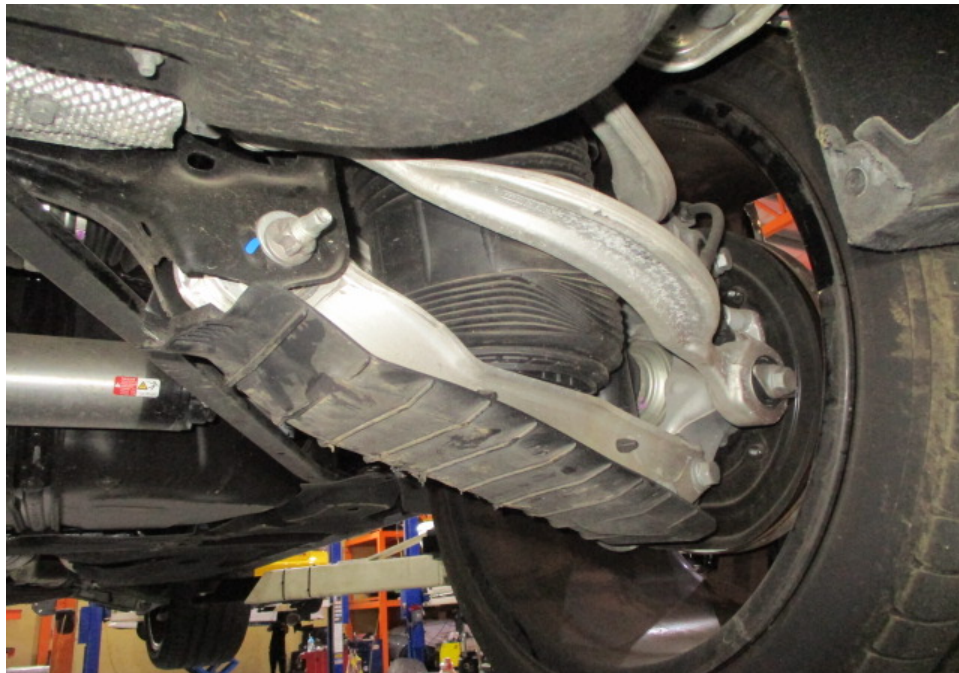
Photo 21 shows a general view of the control arms and linkages at the rear right wheel of the Motor Car. I did not observe any fluid leak and/or fluid stain on the underside of the Motor Car. All of the Motor Car's undercarriage components were observed to be intact and secured in an appropriate manner.

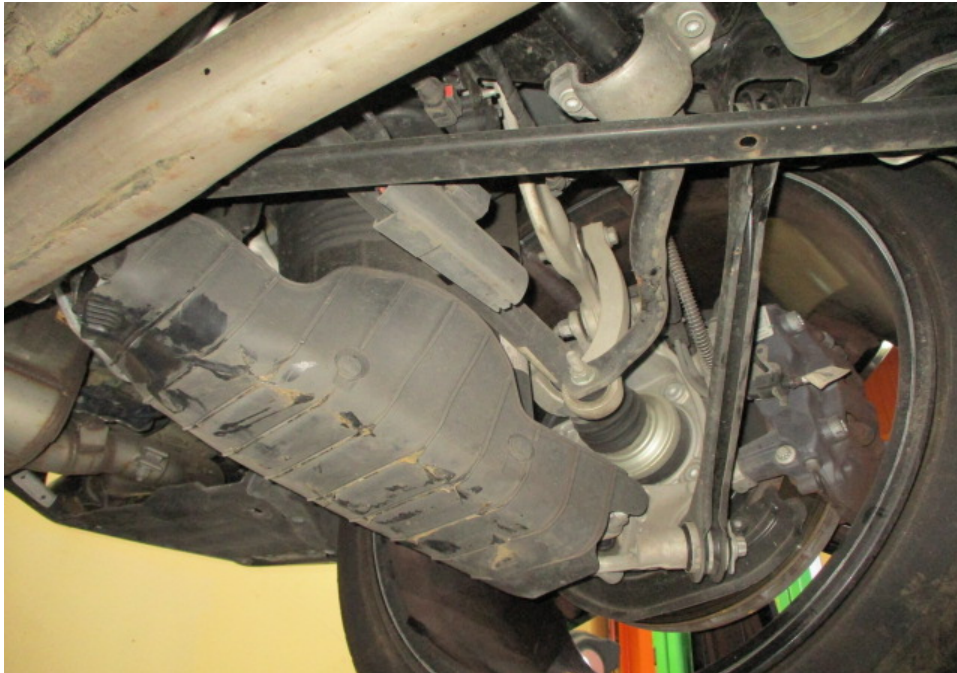
Photo 22 shows a general view of the control arms and linkages at the rear left wheel of the Motor Car. I did not observe any fluid leak and/or fluid stain on the underside of the Motor Car. All of the Motor Car's undercarriage components were observed to be intact and secured in an appropriate manner.

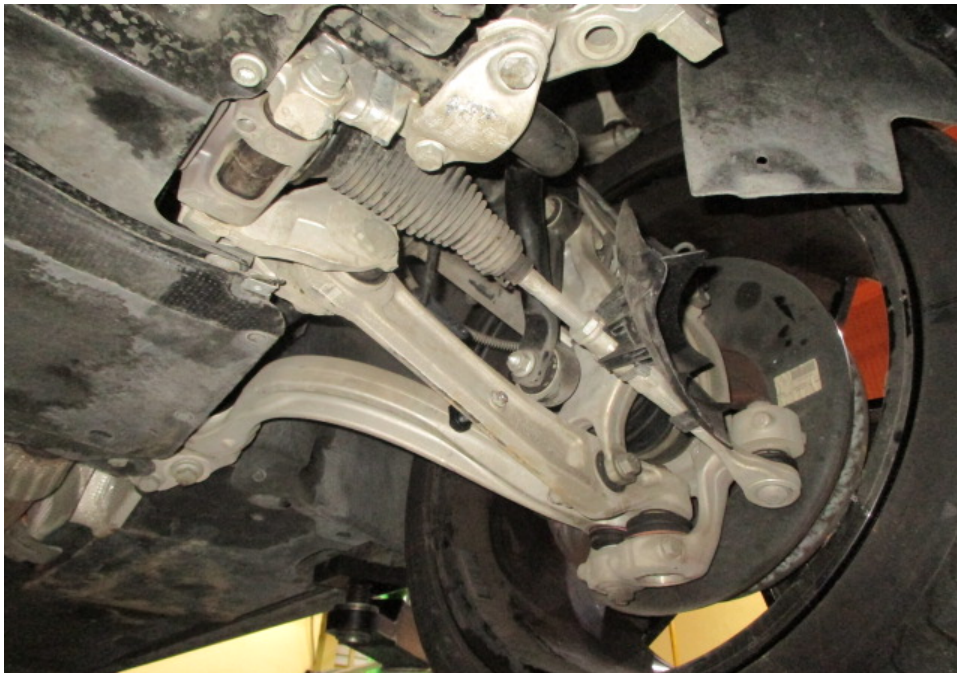
Photo 23 shows a general view of the control arms and linkages at the front left wheel of the Motor Car. I did not observe any fluid leak and/or fluid stain on the underside of the Motor Car. All of the Motor Car's undercarriage components were observed to be intact and secured in an appropriate manner.

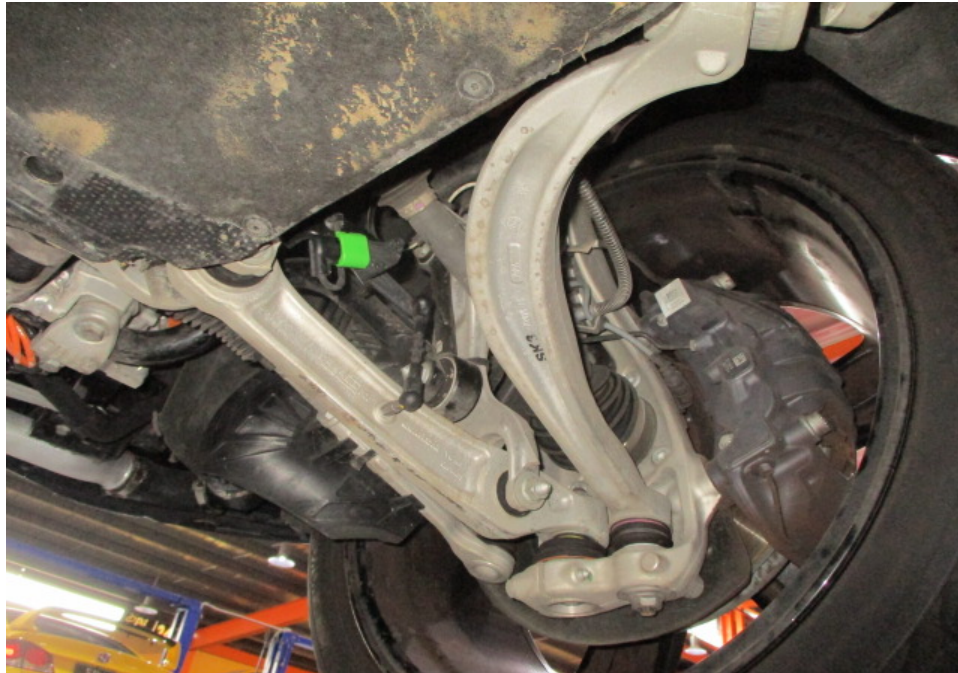
Photo 24 shows the various undercarriage components at the front right wheel of the Motor Car. The mechanical components, control arms and linkages were all found to be intact and secured in an appropriate manner. I also did not observe any fluid leak and/or fluid stain on the underside of the Motor Car.

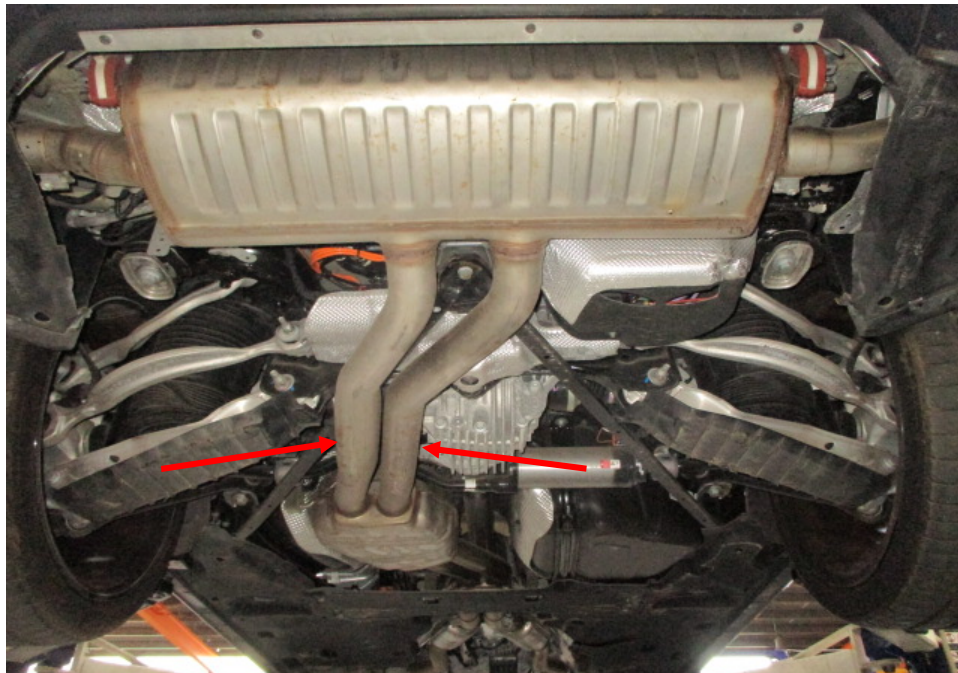
Photo 25 shows the rear section of the Motor Car's exhaust system. My examination of the Motor Car's exhaust system revealed no sign(s) or indication(s) of any cut or weld marks along its exhaust pipes (arrowed), on its rear muffler, on its centre resonator boxes and on its catalytic converters.

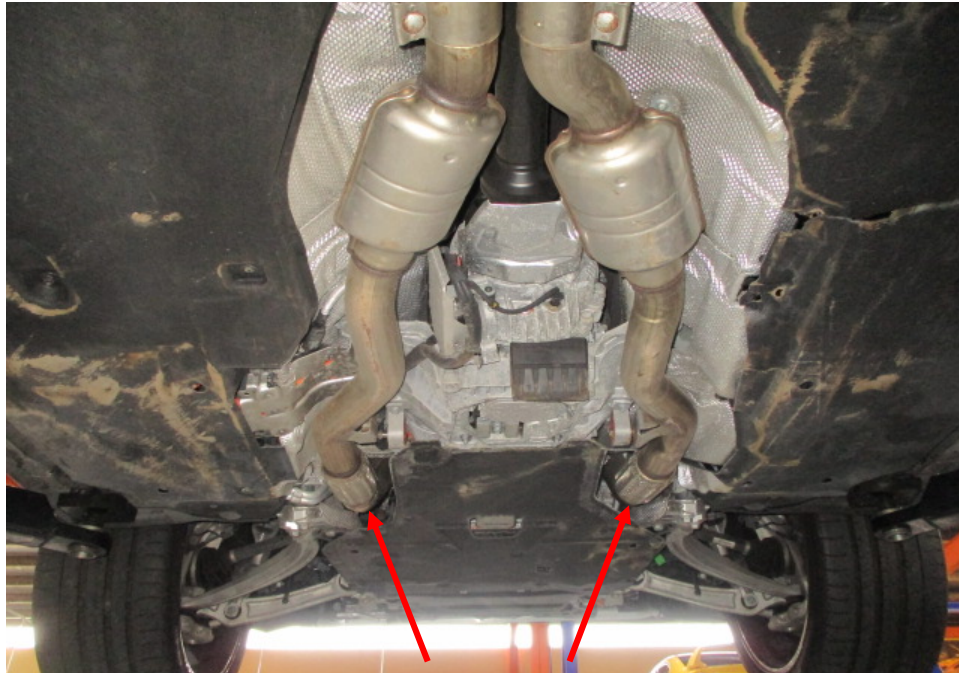
Photo 26 shows the front section of the Motor Car's exhaust system. My examination of the Motor Car's exhaust system revealed no sign(s) or indication(s) of any cut or weld marks along its exhaust pipes, on its rear muffler, on its centre resonator boxes and on its catalytic converters (arrowed).

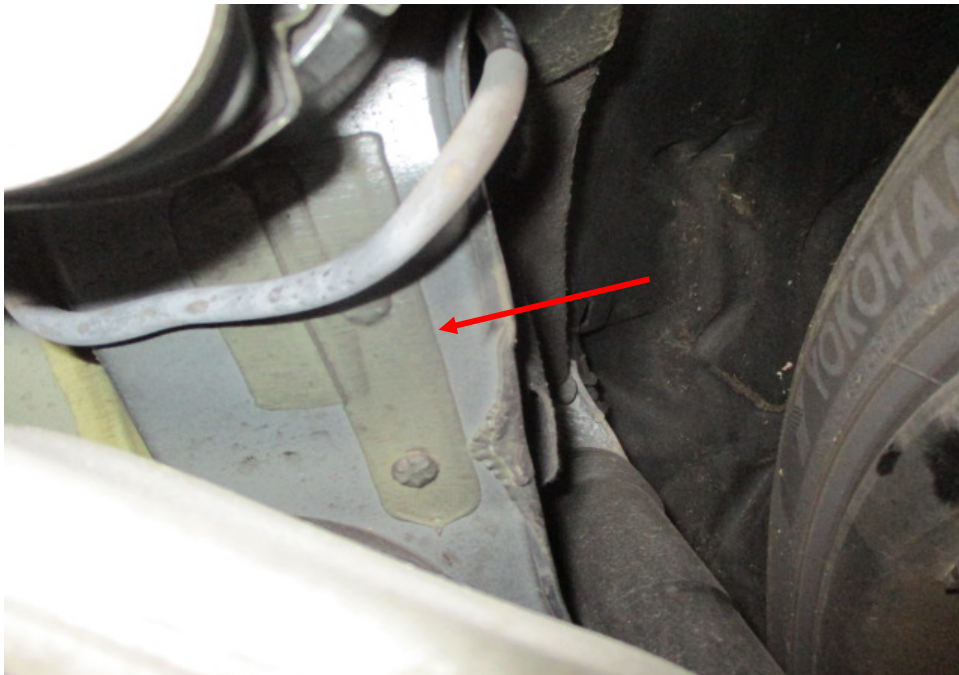
Photo 27 shows the chassis/structural body at the underside rear right of the Motor Car. I did not find any weld marks other than original spot weld marks on the chassis/structural body of the Motor Car. The original factory sealant (arrowed) at the joints along the chassis/structural body was untouched, indicating no work was done on the chassis/structural body of the Motor Car and that the chassis/structural body was originally fitted.

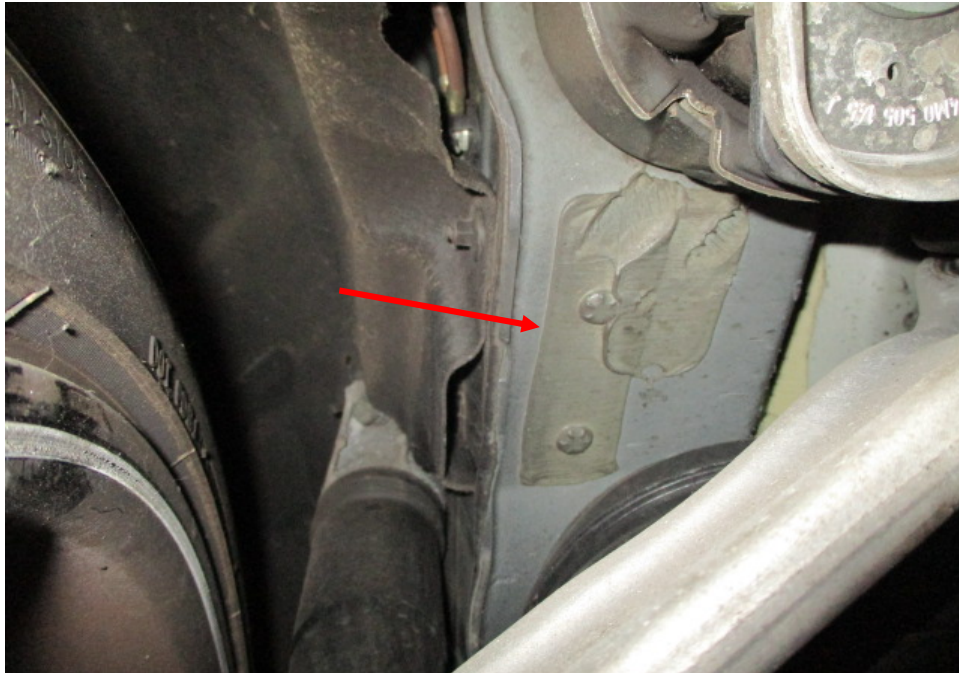
Photo 28 shows the chassis/structural body at the underside rear left of the Motor Car. The original factory sealant (arrowed) at the joints along the chassis/structural body was observed to be untouched. In general, I had found no work was carried out on the chassis/structural body of the Motor Car. The chassis/structural body of the Motor Car was originally fitted.
