Your Ref: Porsche Cayenne
(chassis number WP1ZZZ9YZMDA14714)
Our Ref : CI/TP22011148/D

**INSPECTION REPORT OF AN UNREGISTERED PORSCHE CAYENNE
MOTOR CAR WITH CHASSIS NUMBER WP1ZZZ9YZMDA14714**

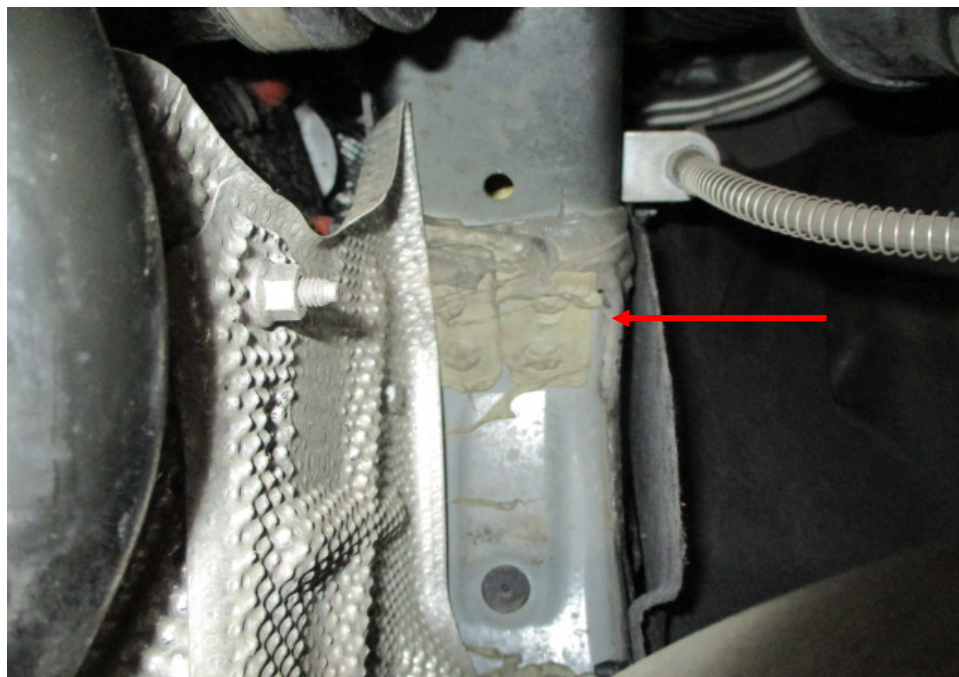
Photo 29 shows the chassis/structural body at the underside front left of the Motor Car. I did not find any weld marks other than original spot weld marks on the chassis/structural body of the Motor Car. The original factory sealant (arrowed) at the joints along the chassis/structural body was untouched, indicating no work was done on the chassis/structural body of the Motor Car and that the chassis/structural body was originally fitted.

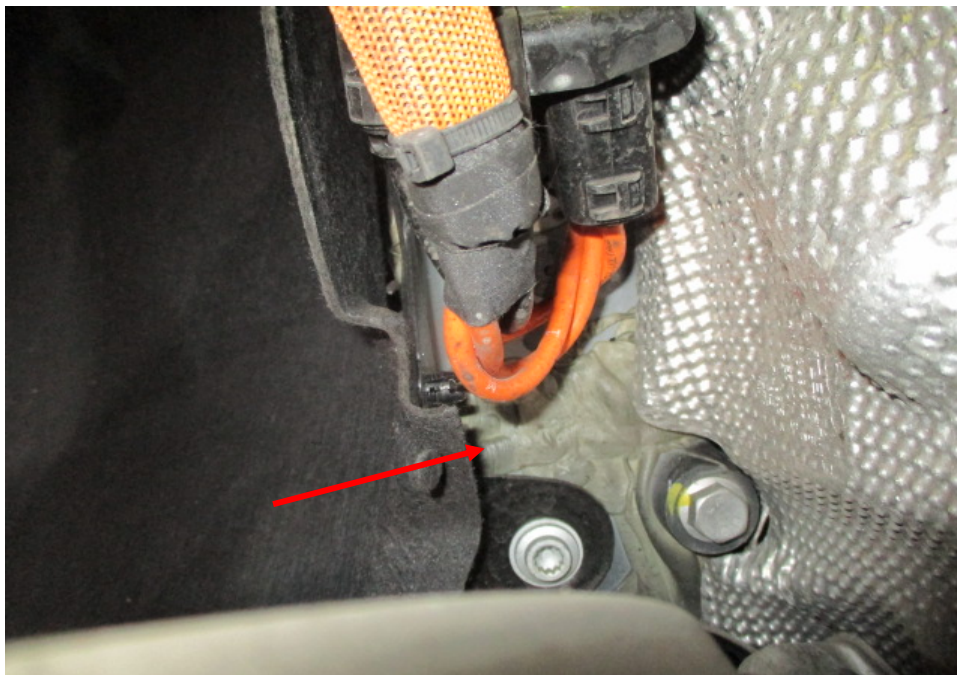
Photo 30 shows the chassis/structural body at the underside front right of the Motor Car. The original factory sealant (arrowed) at the joints along the chassis/structural body was observed to be untouched. In general, I had found no work was carried out on the chassis/structural body of the Motor Car. The chassis/structural body of the Motor Car was originally fitted.
