Your Ref: GBJ 391U
Our Ref : CI/TP22011381/D

14 November 2022

MECHANICAL INSPECTION REPORT OF MOTOR LORRY GBJ 391U

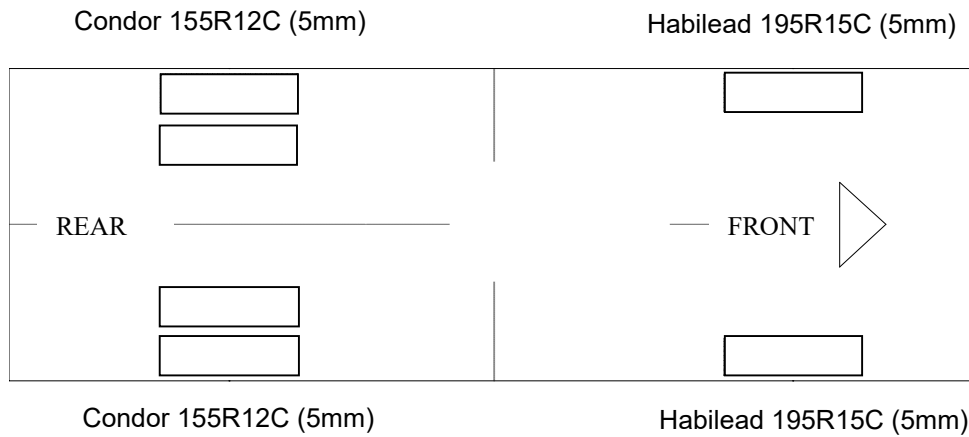
6. The 2 front tyres and 4 rear tyres of the Motor Lorry were observed to be in serviceable condition ie tread pattern clearly visible and sufficiently inflated for vehicular operation. I did not find any tear, cut or burst mark(s) on the outer and the inner sidewalls as well as across the tread of the 6 tyres. The tyre brand, tyre size and remaining tread depth of the 6 tyres of the Motor Lorry were recorded as follows: -

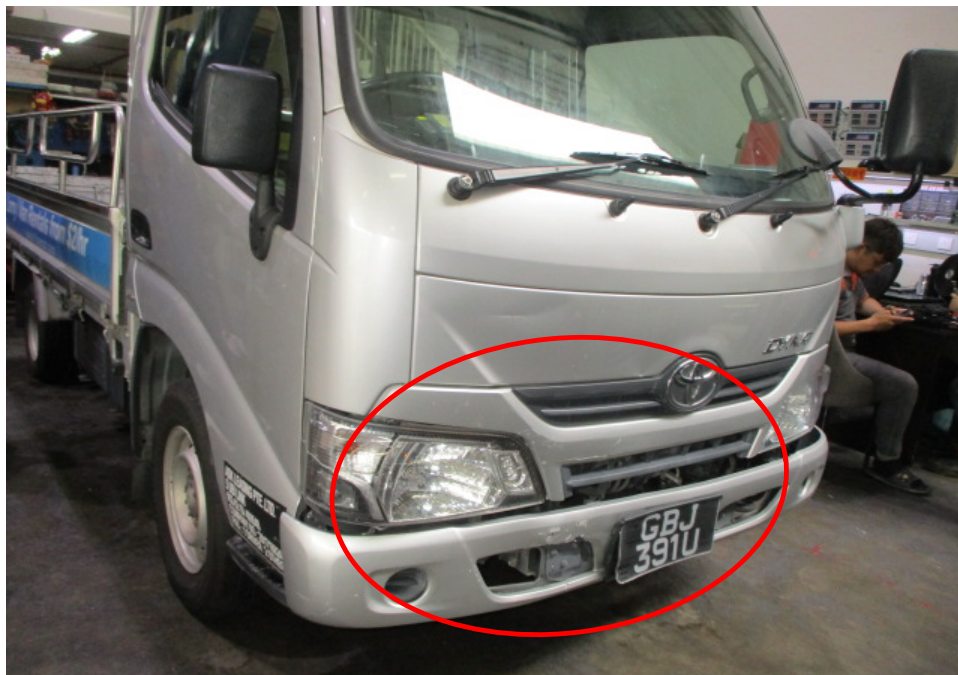
4. The mileage of the Motor Lorry recorded at the time of my inspection was 122,417km.
5. The Motor Lorry was observed to have sustained relatively minor impact damage at its frontal portion. Body parts damaged include the front bumper, front number plate, front grille, front centre panel and front right headlamp amongst others.

Photo 1 shows a general view of the front right body of the Motor Lorry at the time of my inspection. The Motor Lorry was observed to have sustained relatively minor impact damage at its frontal portion (circled). Body parts damaged include the front bumper, front number plate, front grille, front centre panel and front right headlamp amongst others

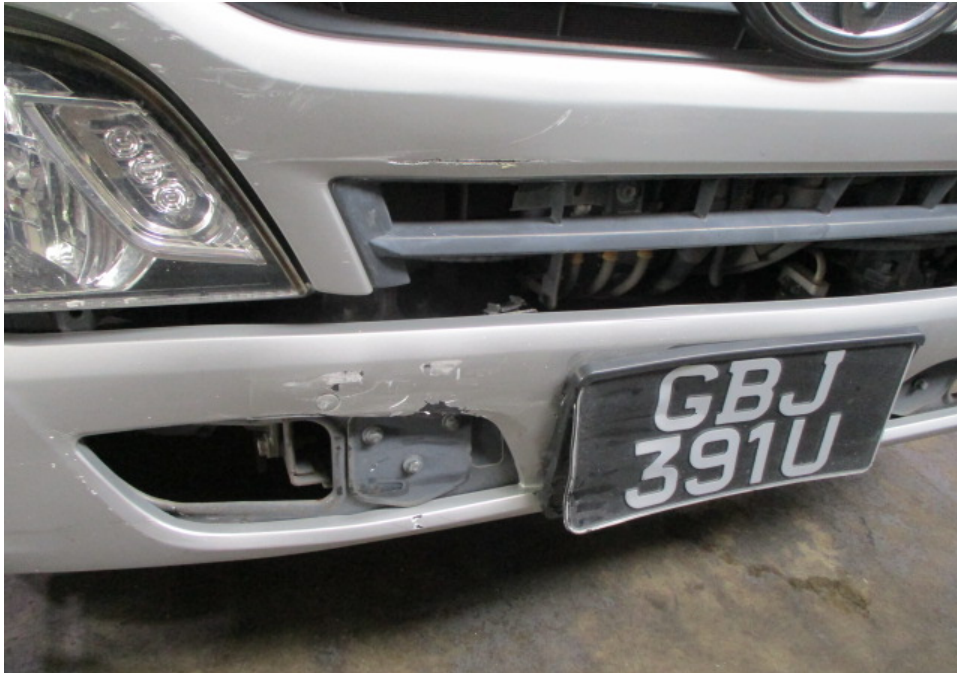
Photo 2 shows a closer view of the damaged front bumper, front number plate and front grille of the Motor Lorry.

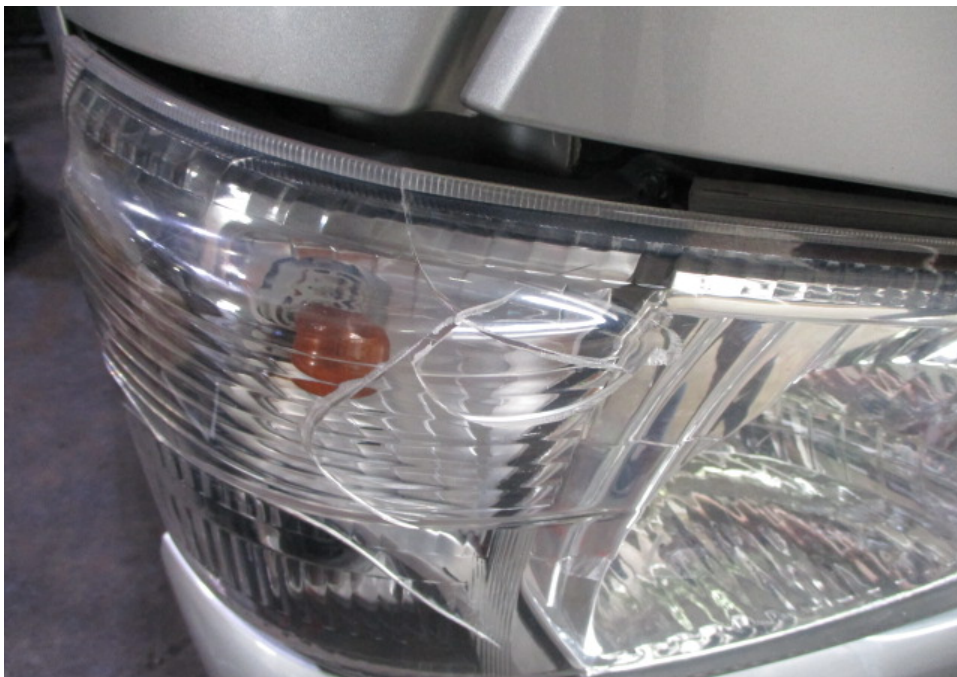
Photo 3 shows a closer view of the damaged front right headlamp of the Motor Lorry.

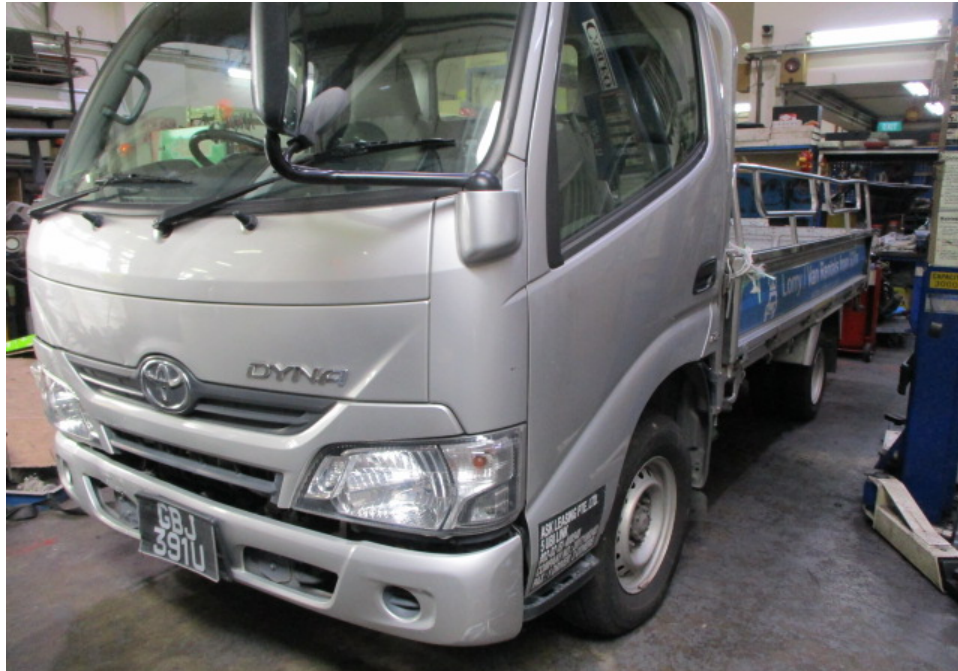
Photo 4 shows a general view of the front left body of the Motor Lorry at the time of my inspection. The Motor Lorry was observed to be in good general condition. Some relatively minor impact damage was observed at its frontal portion. The mileage of the Motor Lorry at the time of my inspection was 122,417km.

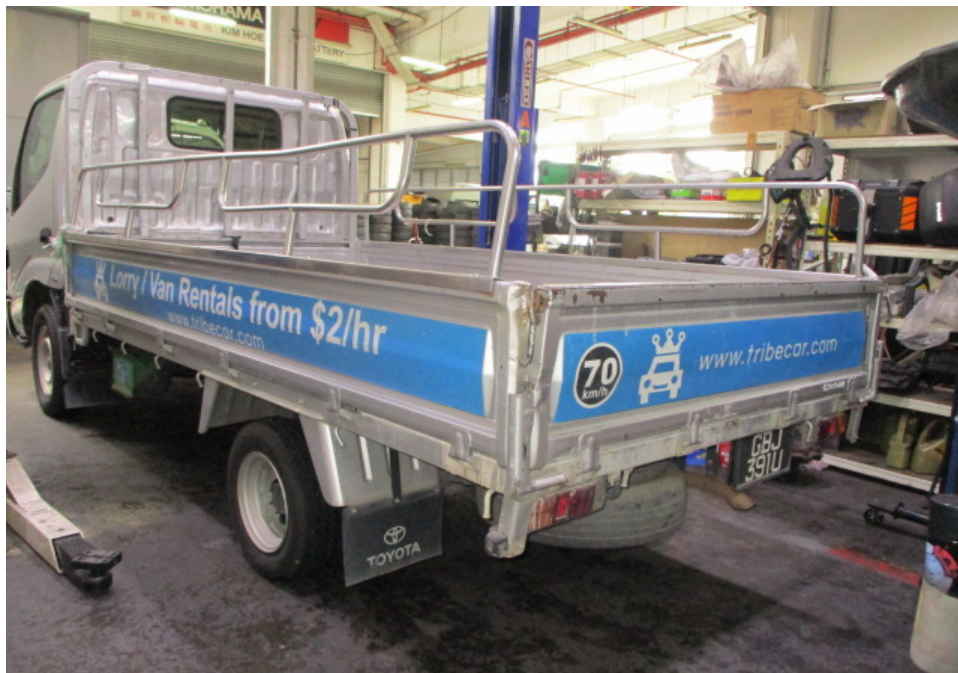
Photo 5 shows a general view of the Motor Lorry's rear left body at the time of my inspection. There was no damage observed to the rear portion of the Motor Lorry. The mileage of the Motor Lorry at the time of my inspection was 122,417km.

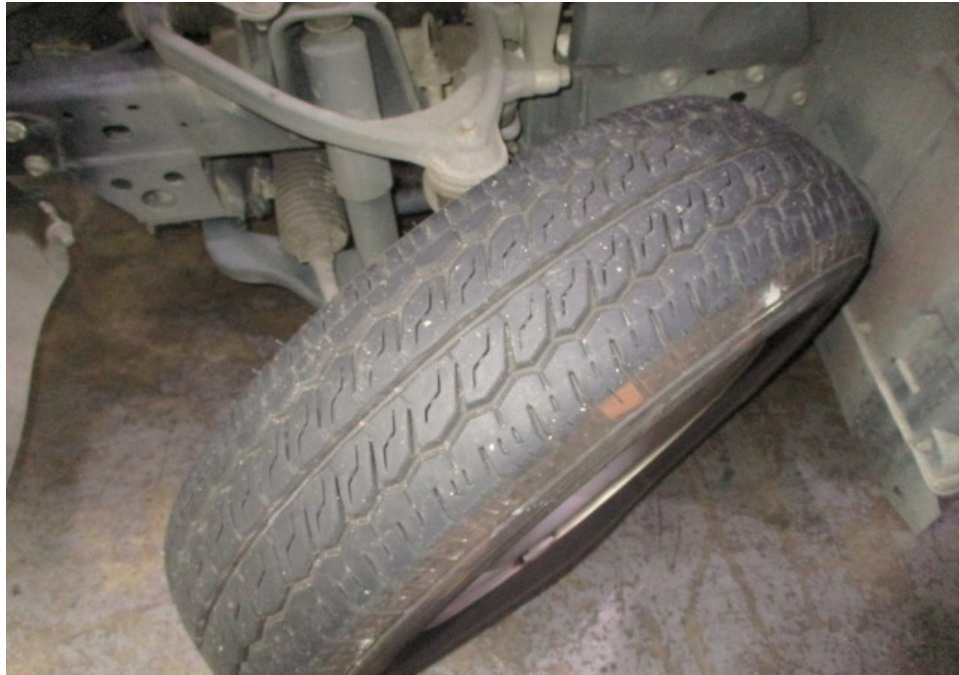
Photo 6 shows the front left tyre of the Motor Lorry, which was observed to be in serviceable condition with remaining tread depth of approximately 5mm. The tyre, which was wrapped around standard alloy wheel rim, was also observed to be sufficiently inflated for vehicular operation. Overall, there was no tear, cut or burst mark(s) on the outer and the inner sidewalls as well as across the tread of the 6 tyres that were fitted on the Motor Lorry.

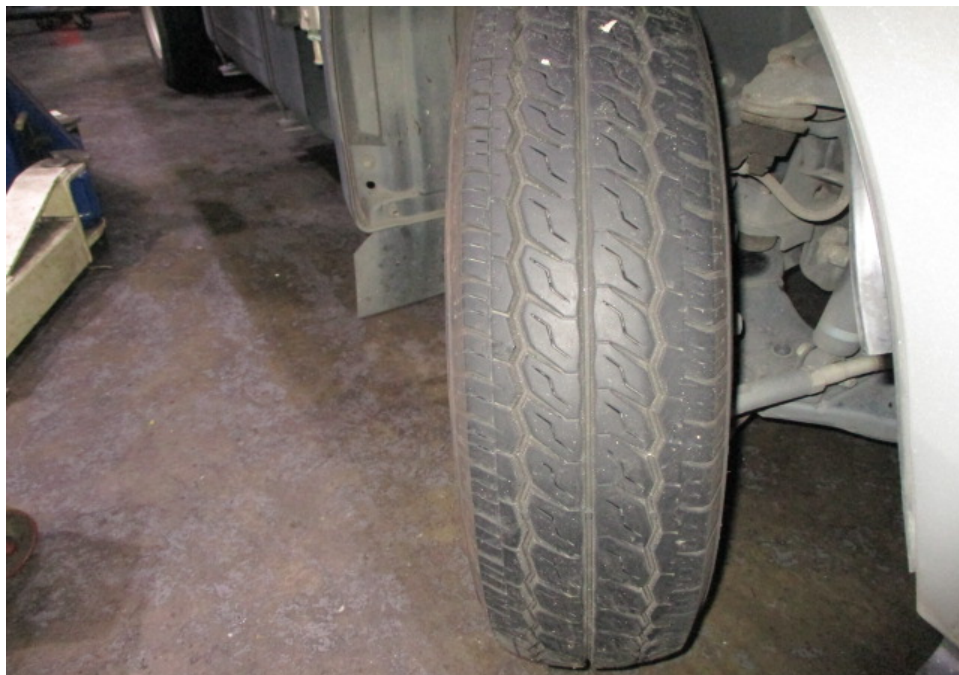
Photo 7 shows the front right tyre of the Motor Lorry, which was observed to be in serviceable condition with remaining tread depth of approximately 5mm. The tyre, which was wrapped around standard alloy wheel rim, was also observed to be sufficiently inflated for vehicular operation.

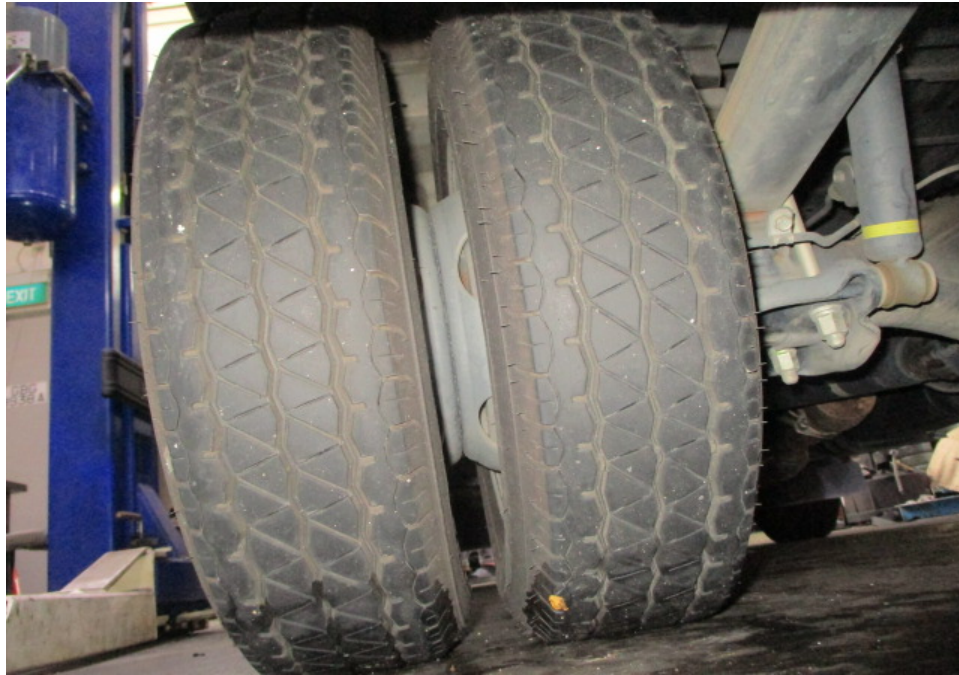
Photo 8 shows the rear left tyres of the Motor Lorry, which was observed to be in serviceable condition with remaining tread depth of approximately 5mm. The tyres, which were wrapped around standard alloy wheel rim, were also observed to be sufficiently inflated for vehicular operation. Overall, there was also no damage found on all 6 alloy wheel rims of the Motor Lorry.

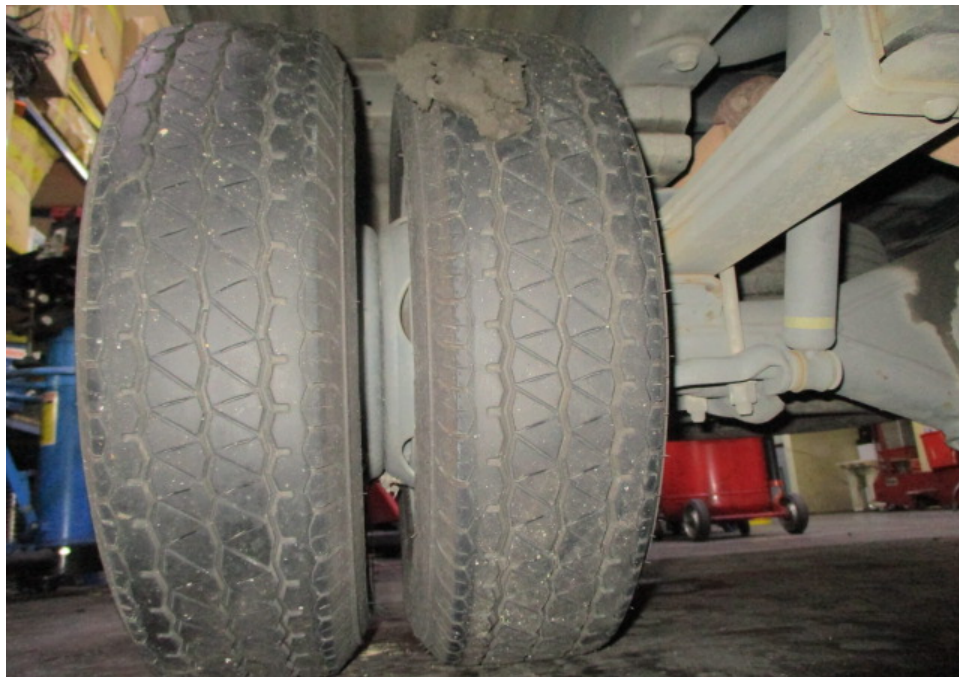
Photo 9 shows the rear right tyres of the Motor Lorry, which were observed to be in serviceable condition with remaining tread depth of approximately 5mm. Overall, there was no tear, cut or burst mark(s) on the outer and the inner sidewalls as well as across the tread of the 6 tyres that were fitted on the Motor Lorry.

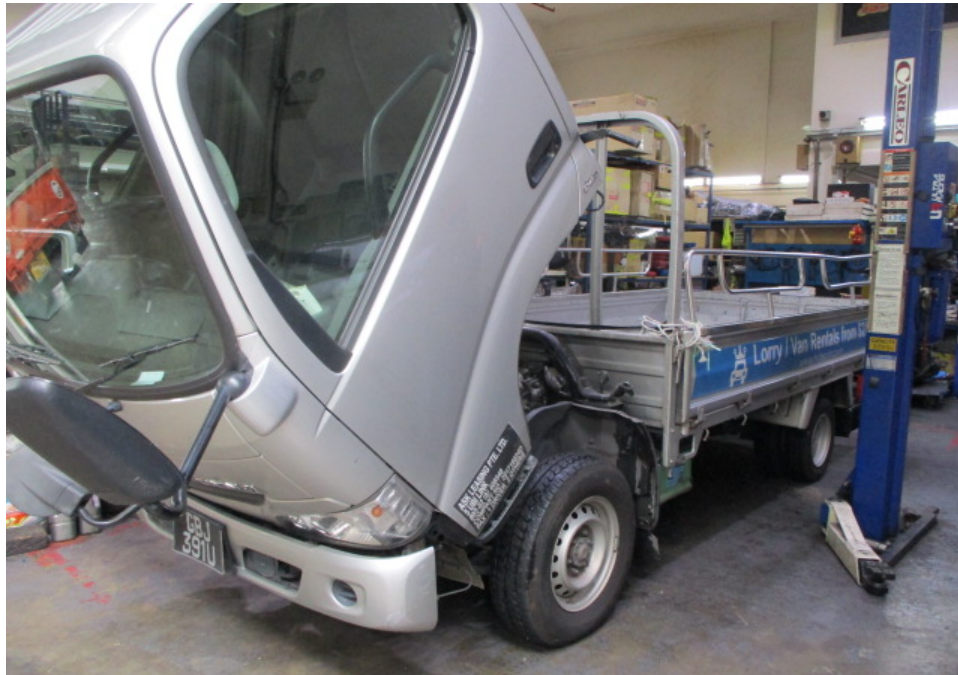
Photo 10 shows the Motor Lorry with its front cabin lifted to facilitate my checks of its engine compartment. Overall, I had found the various parts and components inside the engine compartment to be intact and unaffected by the accident. There was also no sign(s) or indication(s) of fluid leakage and/or fluid stain within the engine compartment. The various operating fluids like the brake fluid, engine oil and engine coolant were all found to be of sufficient level for operating purposes. Visually, there was also no contamination found to these fluids.

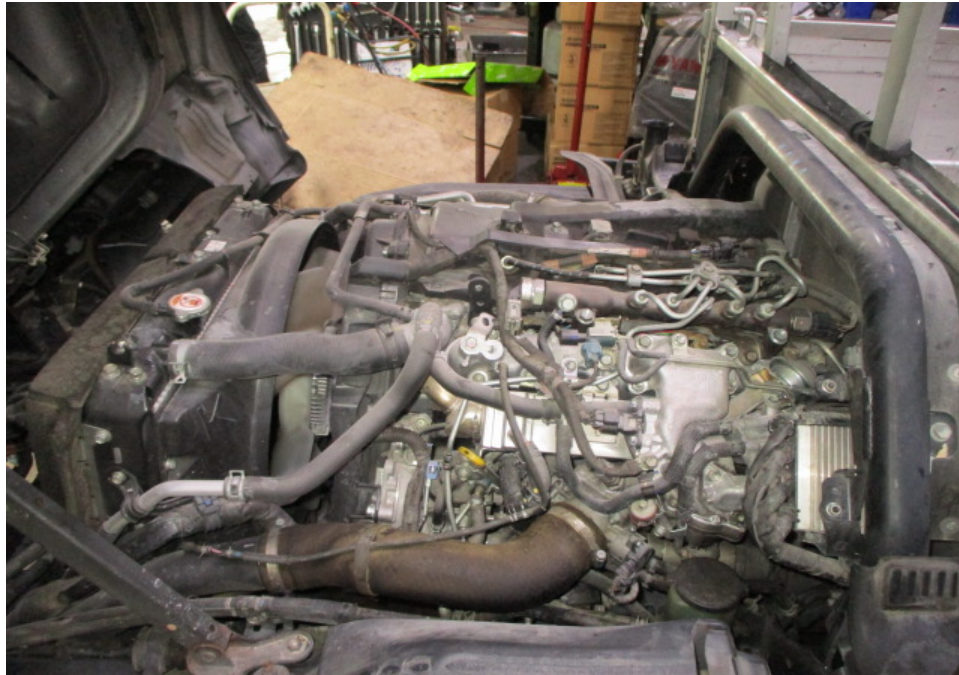
Photo 11 shows a general view of the Motor Lorry's engine compartment. The various parts and components inside the engine compartment were unaffected by the accident. There was also no sign(s) or indication(s) of fluid leakage and/or fluid stain within the engine compartment (photograph shows the engine compartment as viewed from the left front side of the Motor Lorry).

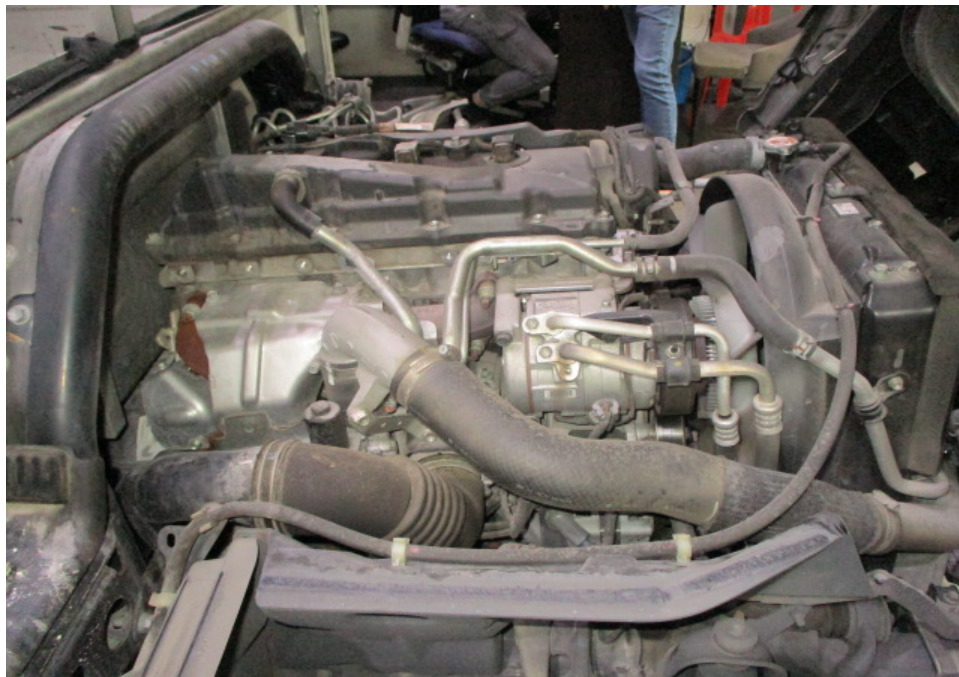
Photo 12 shows another view of the Motor Lorry's engine compartment. The various parts and components inside the engine compartment were unaffected by the accident. There was also no sign(s) or indication(s) of fluid leakage and/or fluid stain within the engine compartment (photograph shows the engine compartment as viewed from the right front side of the Motor Lorry).

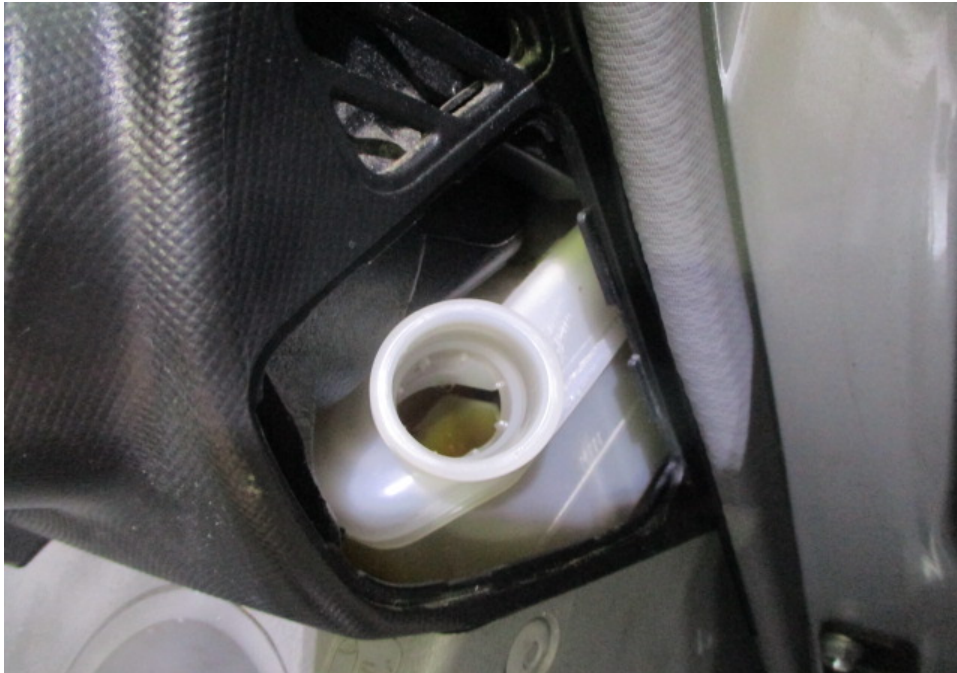
Photo 13 shows the brake fluid reservoir of the Motor Lorry at the time of my inspection. The brake fluid was observed to be of sufficient level and without any visible contamination.

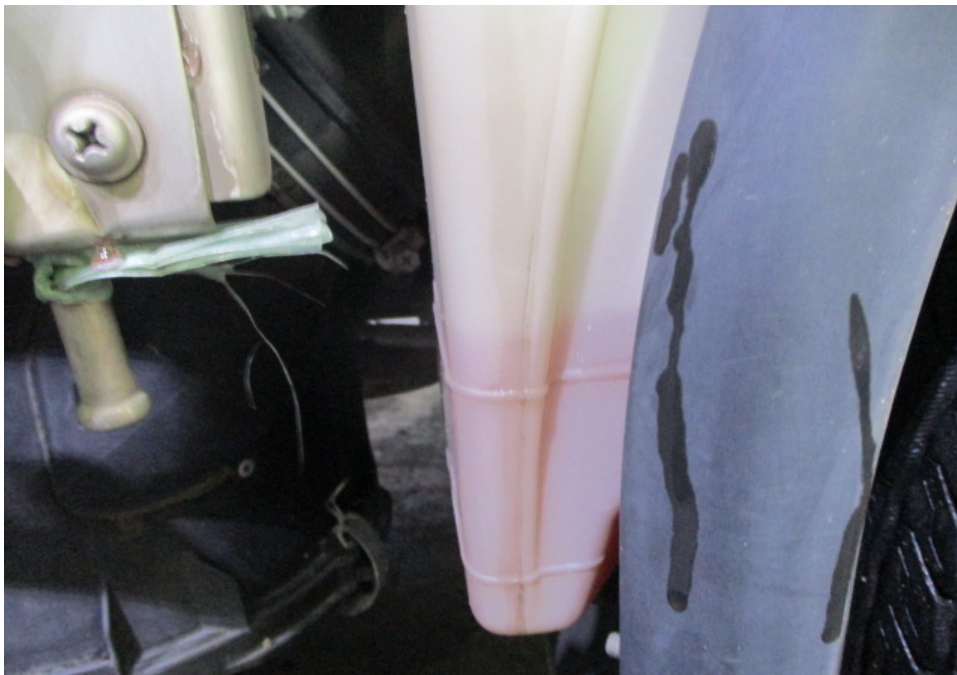
Photo 14 shows the engine coolant reservoir of the Motor Lorry at the time of my inspection. The engine coolant was observed to be of sufficient level and without any visible contamination.

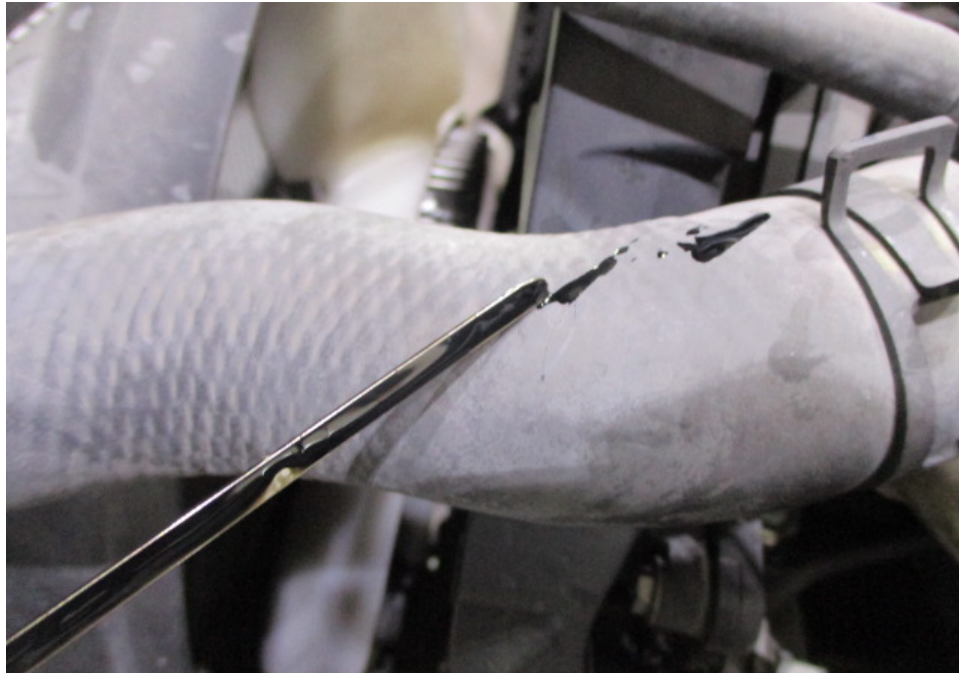
Photo 15 shows the engine dip stick of the Motor Lorry at the time of my inspection. The engine oil was observed to be of sufficient level and without any visible contamination.

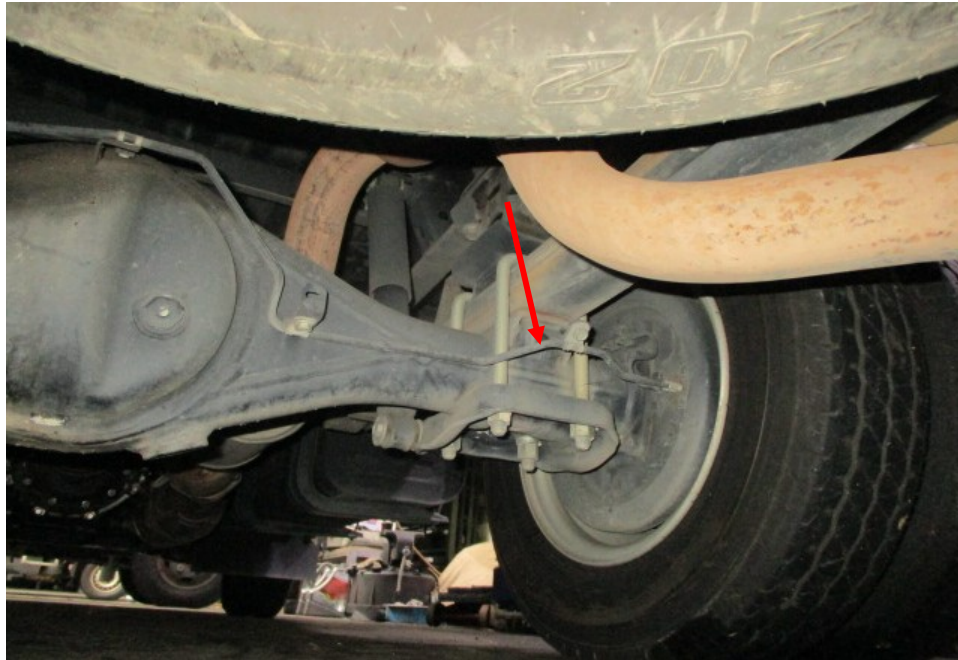
Photo 16 shows the brake fluid pipe (arrowed) at the rear right wheel of the Motor Lorry. I did not observe any leakage of brake fluid at the time of my inspection of the Motor Lorry. My static tests of the Motor Lorry's braking system, along with my visual examination of the various mechanical components in the braking system, had indicated that there was no internal leakage of pressure/vacuum. The braking system of the Motor Lorry was likely to be in serviceable condition at the material time of accident.

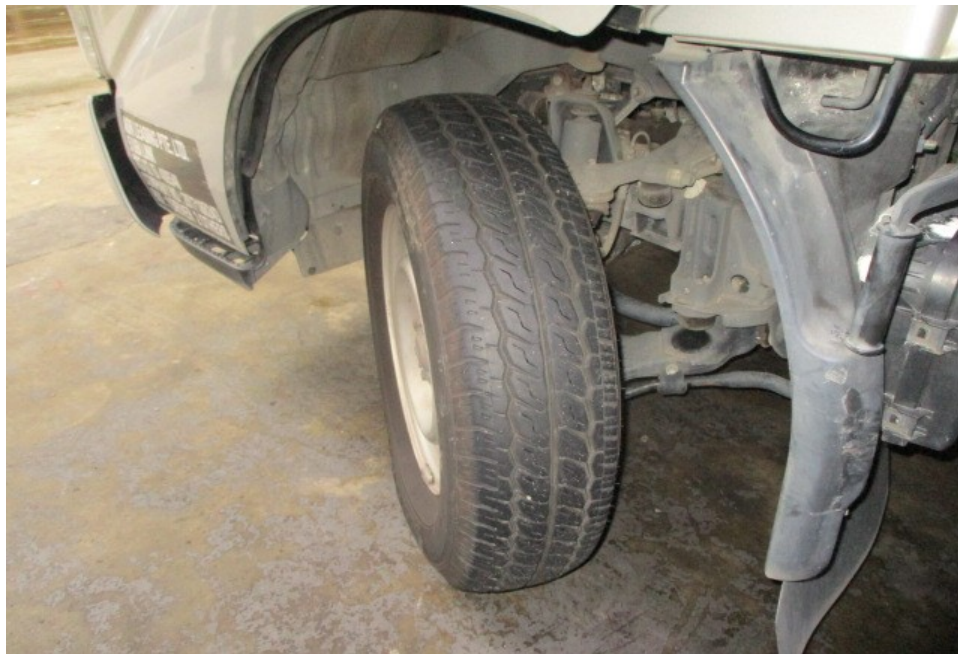
Photo 17 shows the front left wheel of the Motor Lorry turned to its full right. During my steering system test, I did not experience any abnormal free play and/or resistance when I had turned the steering wheel towards full left and full right. This would indicate that the steering system of the Motor Lorry was likely to be in serviceable condition at the material time of accident.

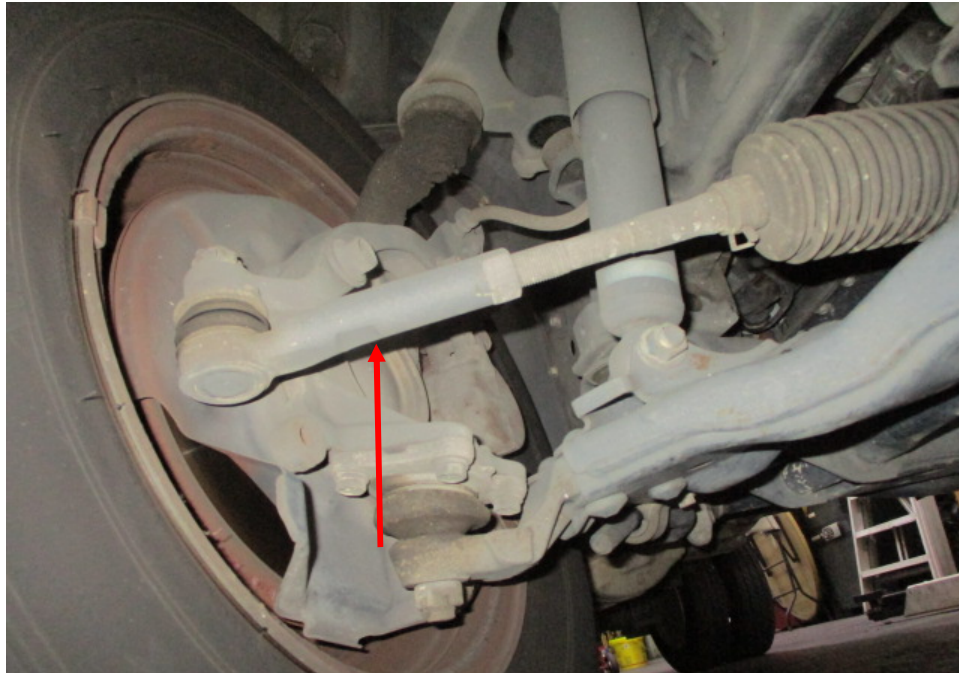
Photo 18 shows the various undercarriage components at the front right wheel of the Motor Lorry, in particular the steering tie rod end (arrowed). The various steering components were all found to be intact, indicating that the steering system of the Motor Lorry was likely to be in serviceable condition at the material time of accident. There was also no sign of fluid stain(s) observed on the various undercarriage components.

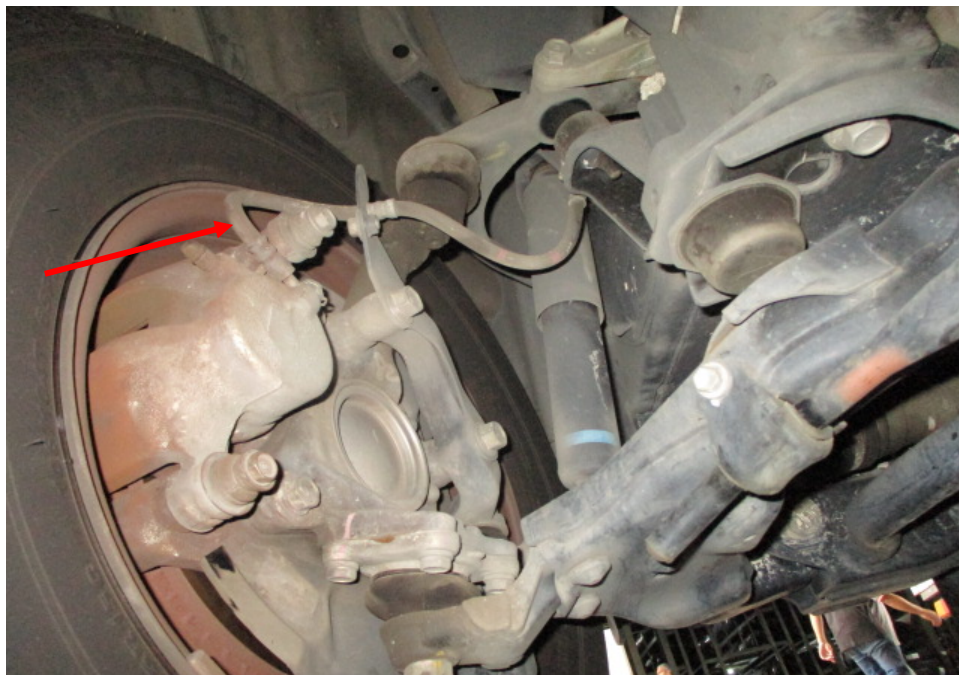
Photo 19 shows the various undercarriage components at the front left wheel of the Motor Lorry, in particular the brake fluid hose (arrowed). I did not observe any leakage of brake fluid at the time of my inspection of the Motor Lorry. My static tests of the Motor Lorry's braking system had indicated that its braking system was likely to be in serviceable condition at the material time of accident.

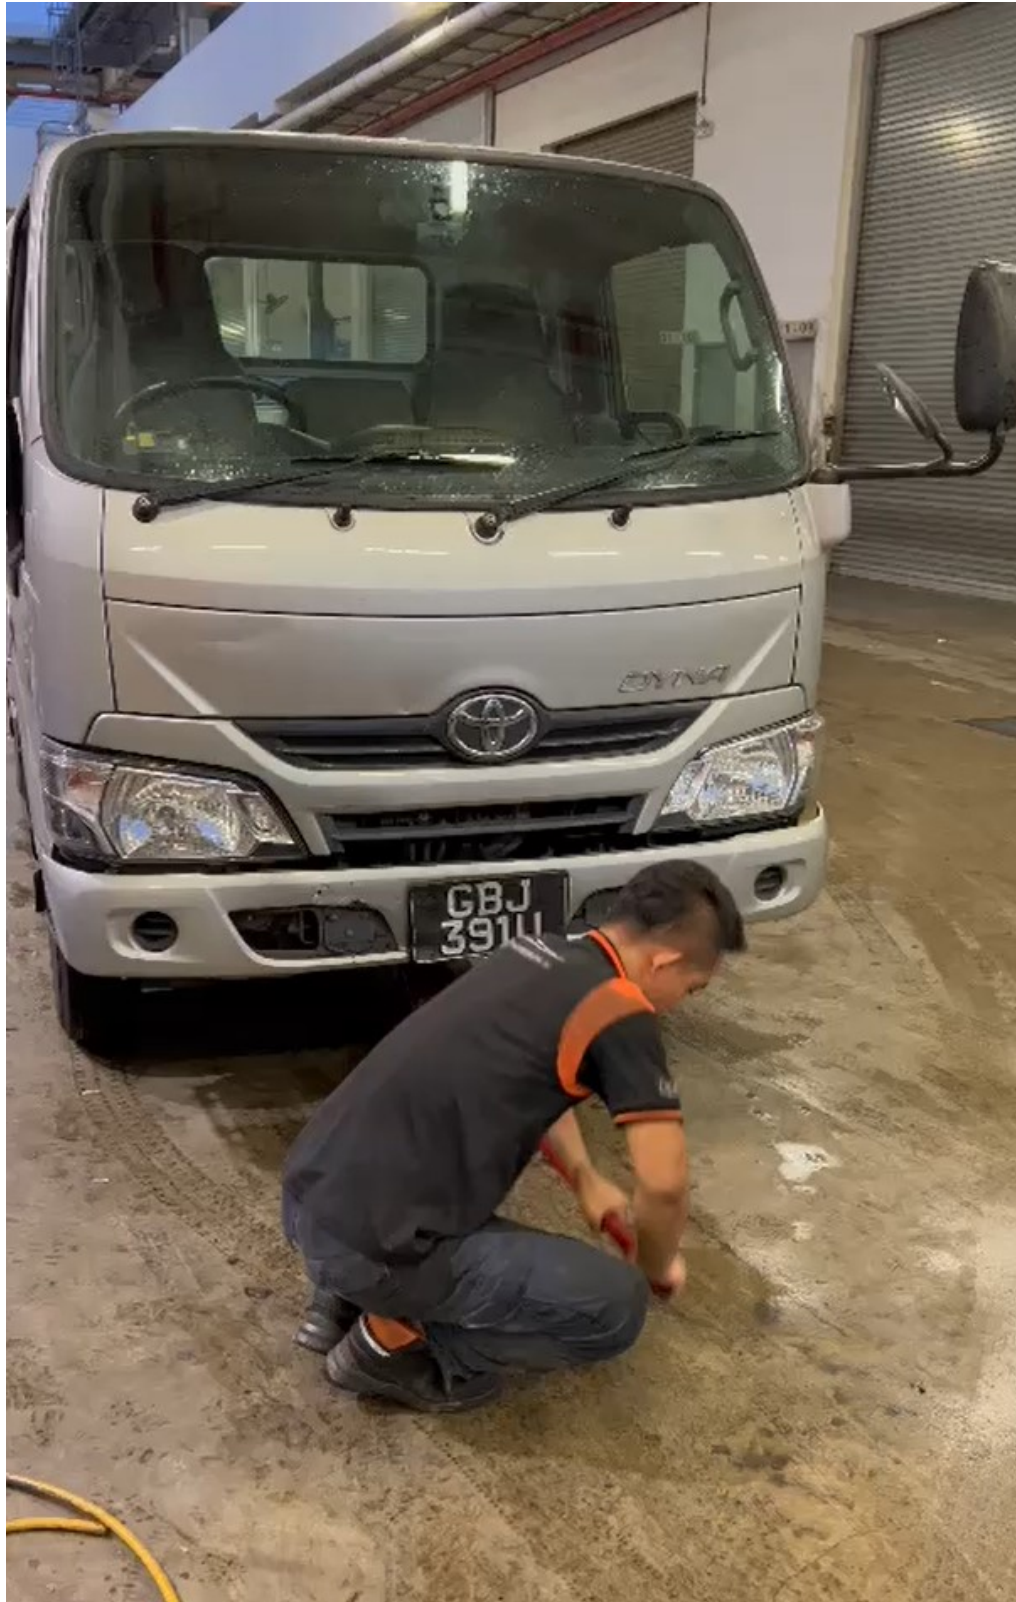
Photo 20 shows the Motor Lorry being jacked up at its frontal portion for removal and checks of its front brake pads.

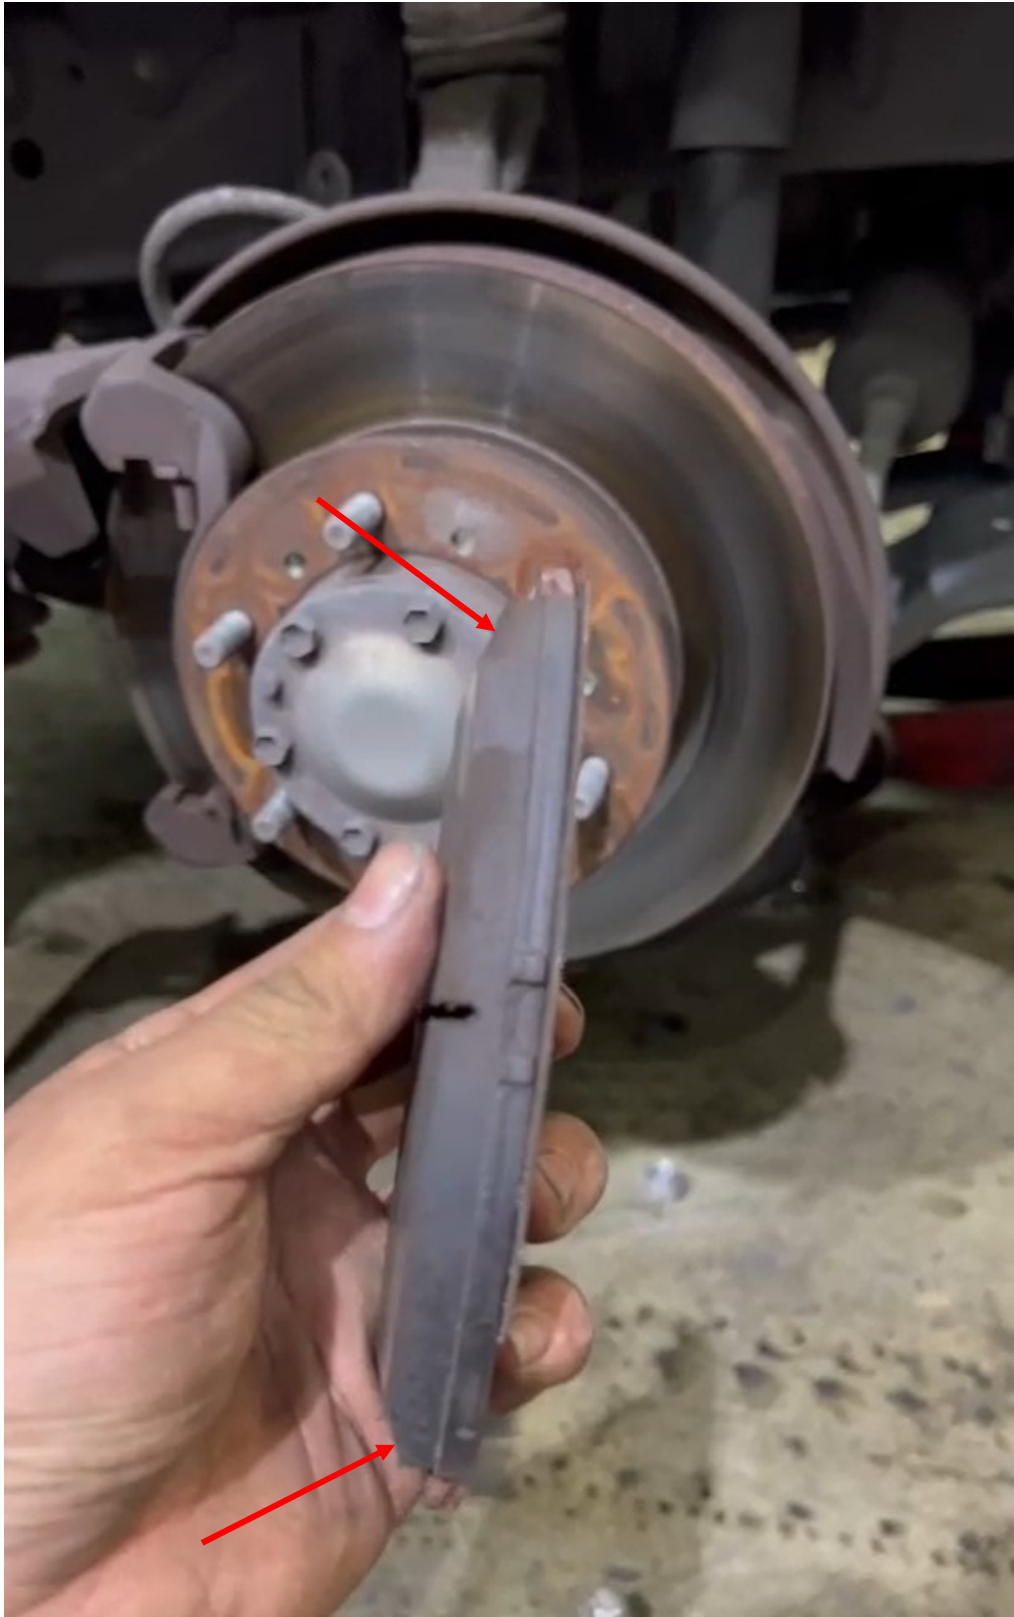
Photo 21 shows the Motor Lorry's front right brake pad after it was removed. The front right brake pad was found to be with sufficient frictional material (arrowed) for operational purposes.

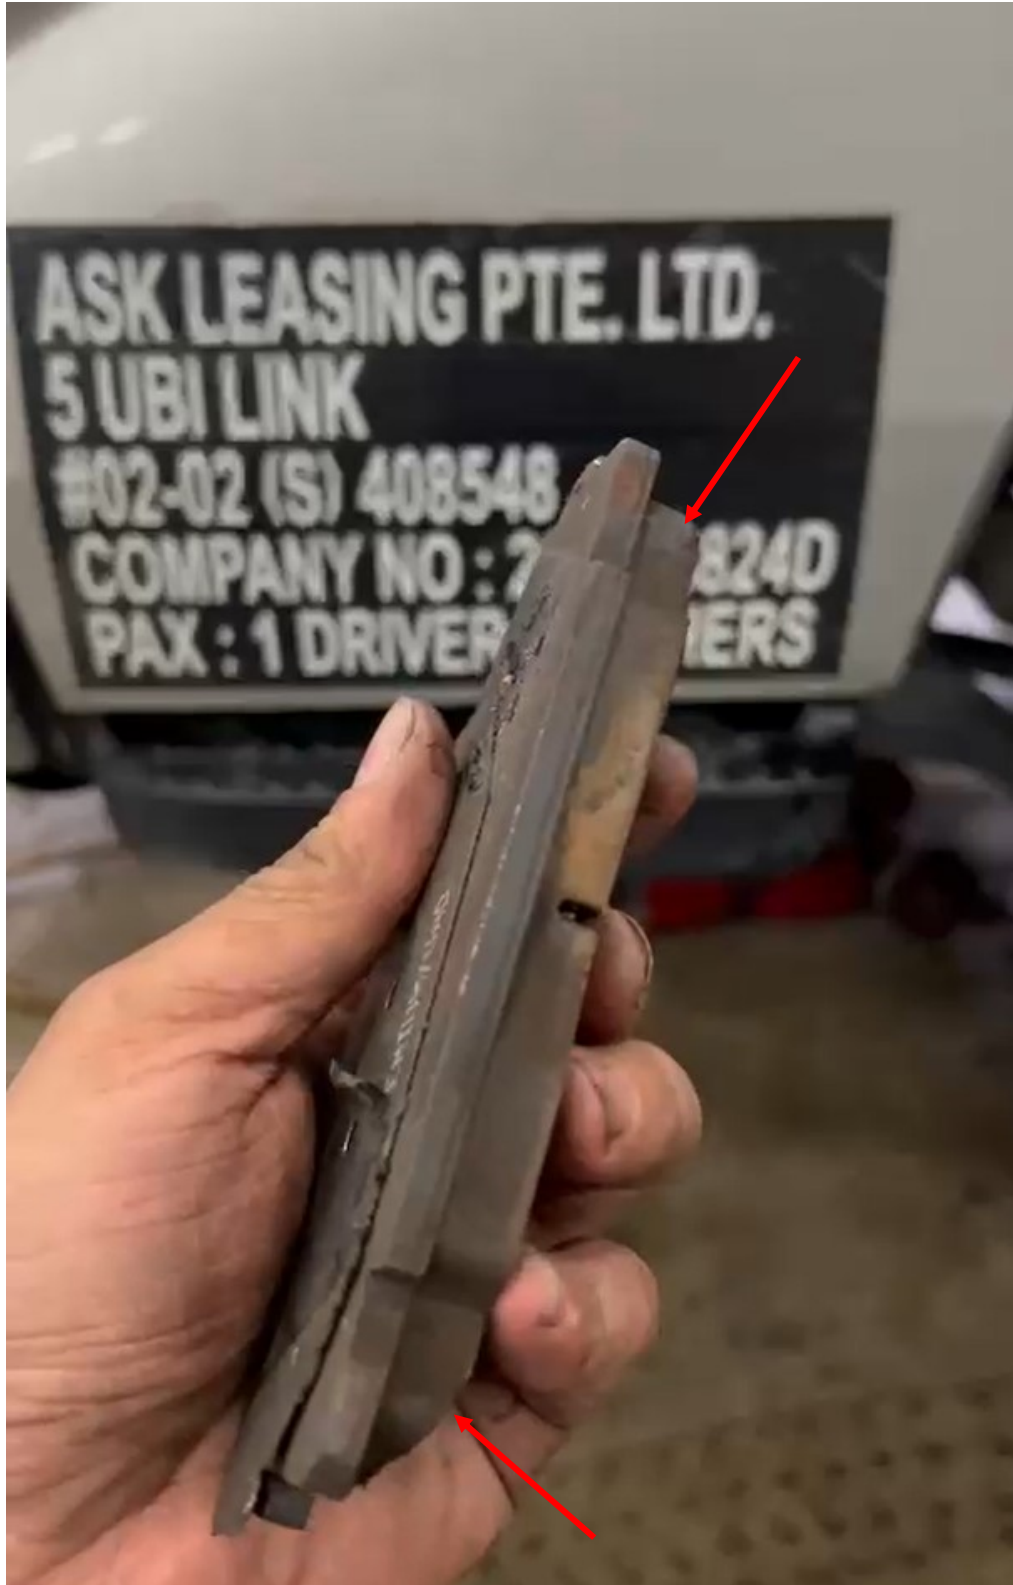
Photo 22 shows the Motor Lorry's front left brake pad after it was removed. The front left brake pad was found to be with sufficient frictional material (arrowed) for operational purposes

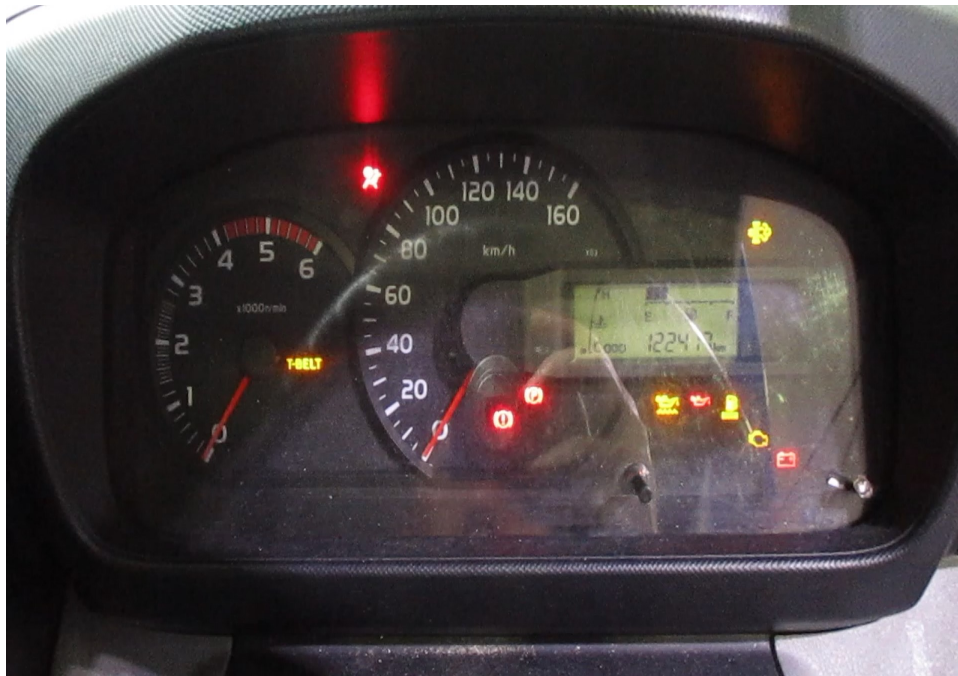
Photo 23 shows the warning lights for the various electronic safety features and warning features like the Supplemental Restraint System (SRS), warning lights for engine oil level and engine oil pressure, charging system, check engine light etc appearing on the instrument panel of the Motor Lorry during its self-test when the engine is cranked.

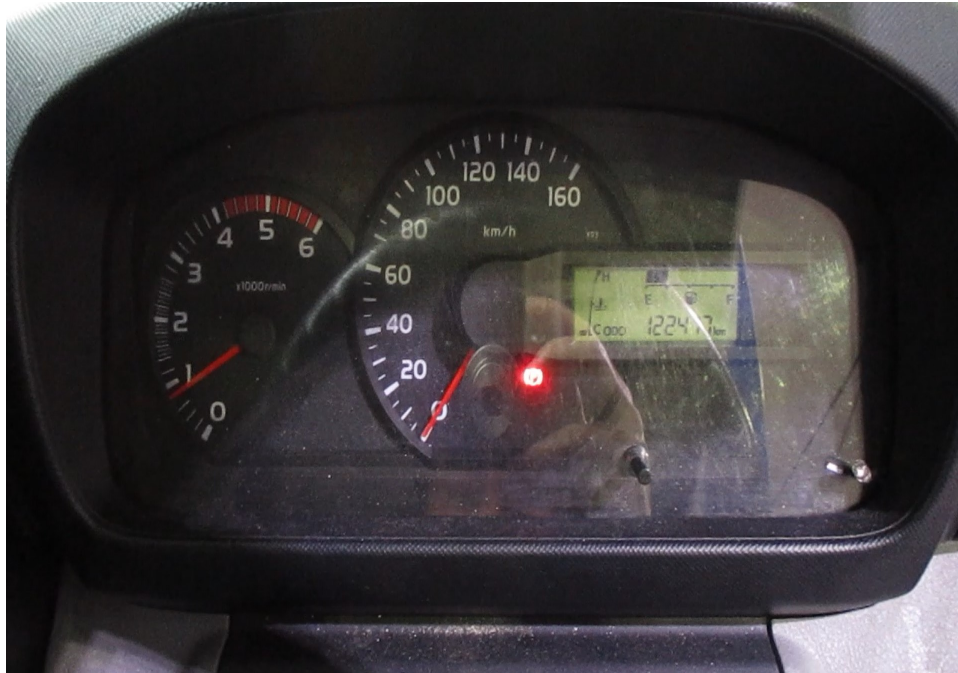
Photo 24 shows the warning lights no longer illuminated, indicating that there is no fault detected to the electronic safety features and warning features of the Motor Lorry during the self-test. These electronic safety systems and warning features of the Motor Lorry like the Supplemental Restraint System (SRS), warning lights for engine oil level and engine oil pressure, charging system, check engine light etc were all hence in working condition.
