Your Ref: TP/IP/24910/2022
Our Ref : CI/TPD22011546/N

13 January 2023

INSPECTION REPORT OF MOTORCYCLE VBM 4278

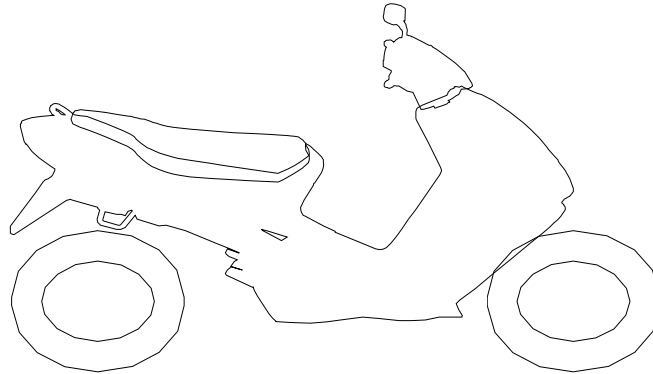
7. The tread pattern of the front tyre was clearly visible. However the rear tyre was observed to be bald. The tyre brand, tyre size and remaining tread depth of the 2 tyres were recorded as follows:-

Maxxis 70/80 - 17 (0mm)

Maxxis 70/80 - 17 (2mm)

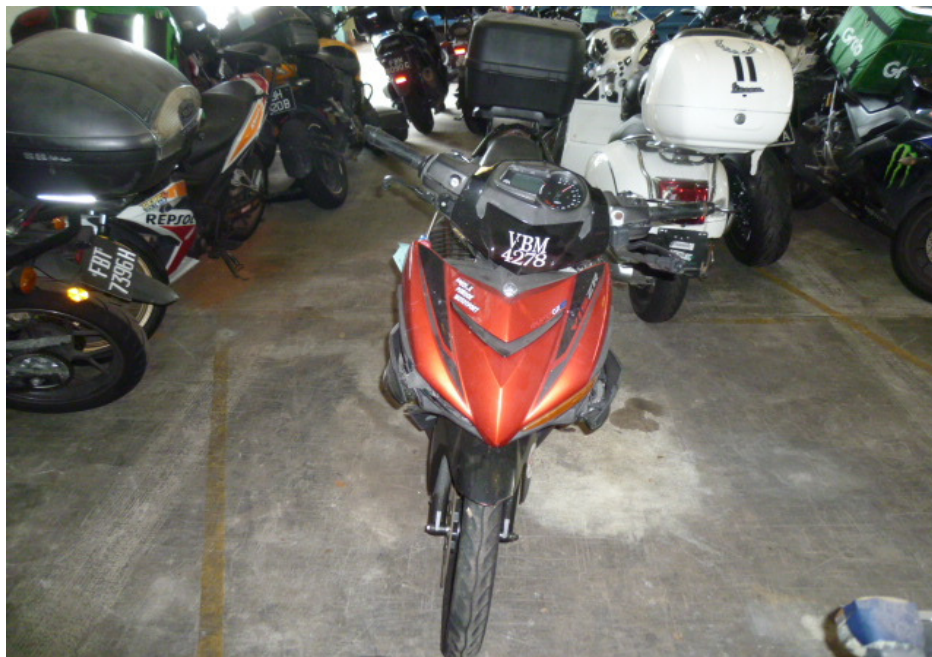
Photo 1 shows a general view of the frontal portion of the Motorcycle at the time of our inspection. The Motorcycle was observed to have sustained damages all around.

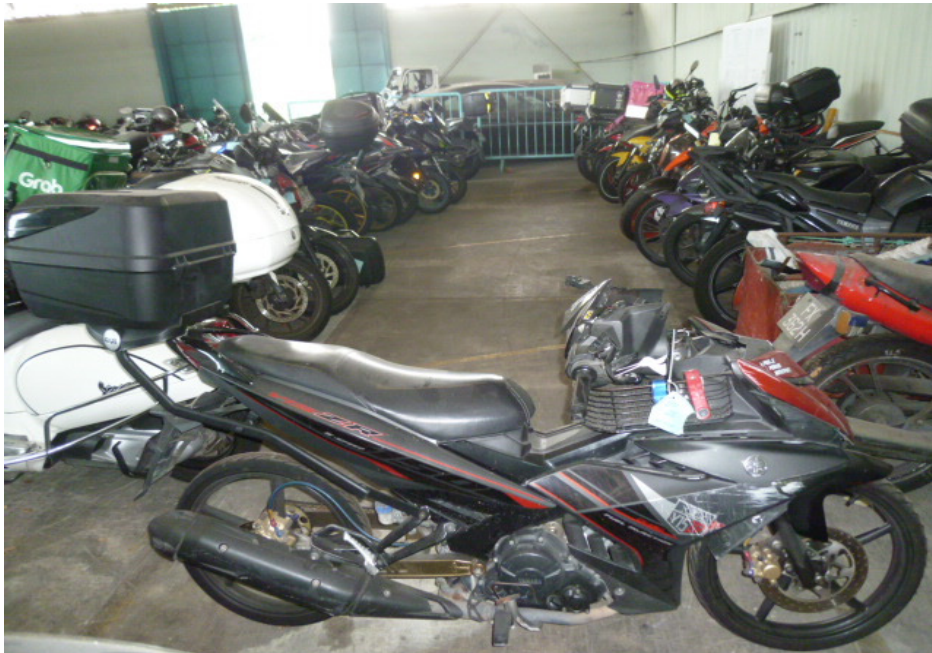
Photo 2 shows a general view of the right body of the Motorcycle at the time of our inspection. The Motorcycle was observed to have sustained damages all around. The mileage of the Motorcycle could not be recorded at the time of our inspection due to unavailability of the ignition key.

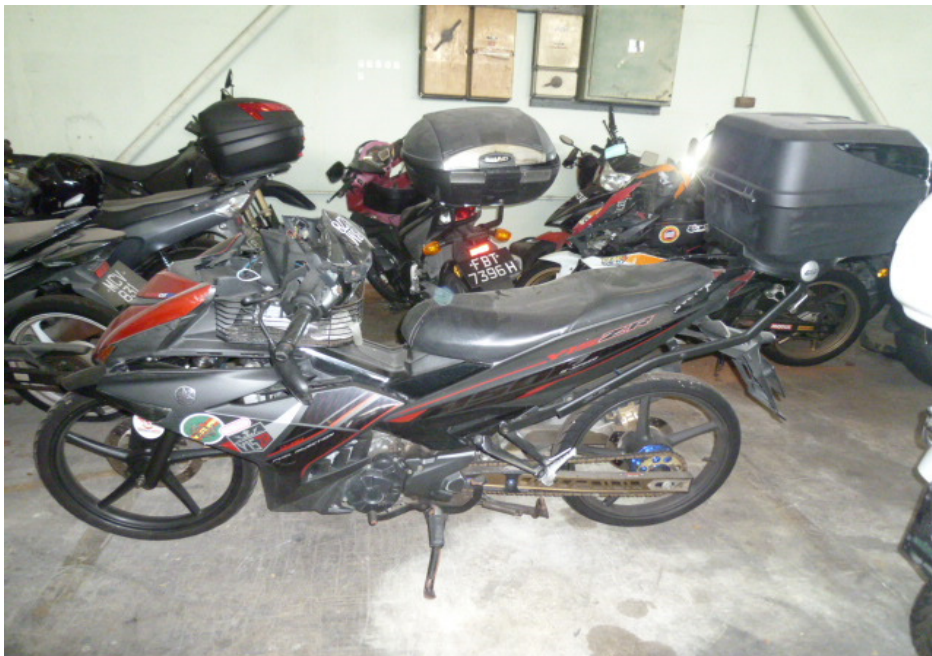
Photo 3 shows a general view of the left body of the Motorcycle at the time of our inspection. The Motorcycle was observed to have sustained damages all around.

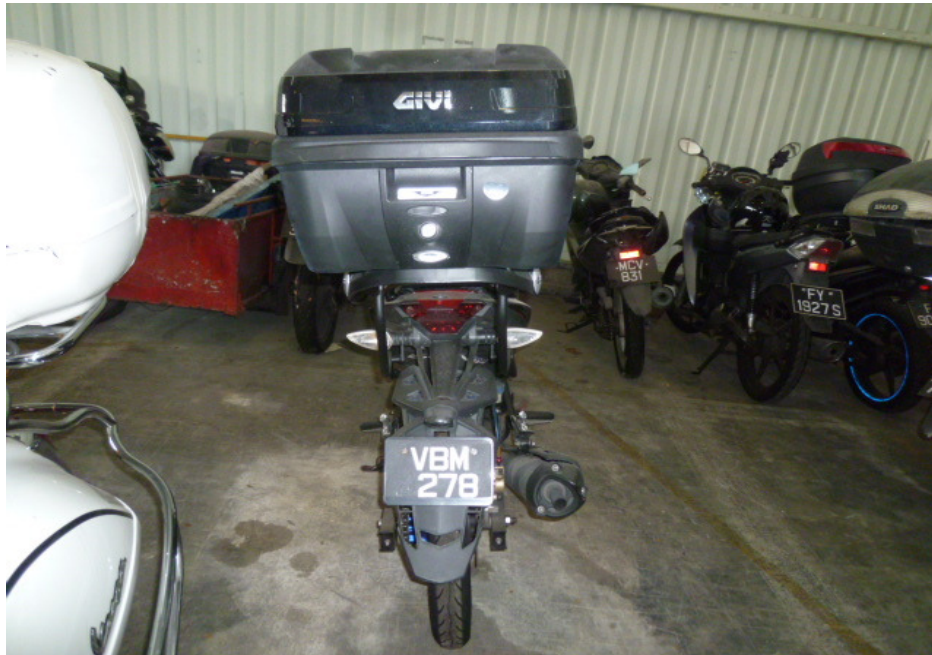
4. The mileage of the Motorcycle could not be recorded at the time of our inspection due to unavailability of the ignition key.
5. The Motorcycle was observed to have sustained damages all around. The body parts that were found to have been damaged include its steering stem, headlight assembly, front cowling, front mudguard, side cowlings, left side mirrors, front brake lever and left rear side cover, amongst others.

Photo 4 shows a general view of the rear portion of the Motorcycle at the time of our inspection. The Motorcycle was observed to have sustained damages all around. The body parts that were found to have been damaged include its steering stem, headlight assembly, front cowling, front mudguard, side cowlings, left side mirrors, front brake lever and left rear side cover, amongst others.

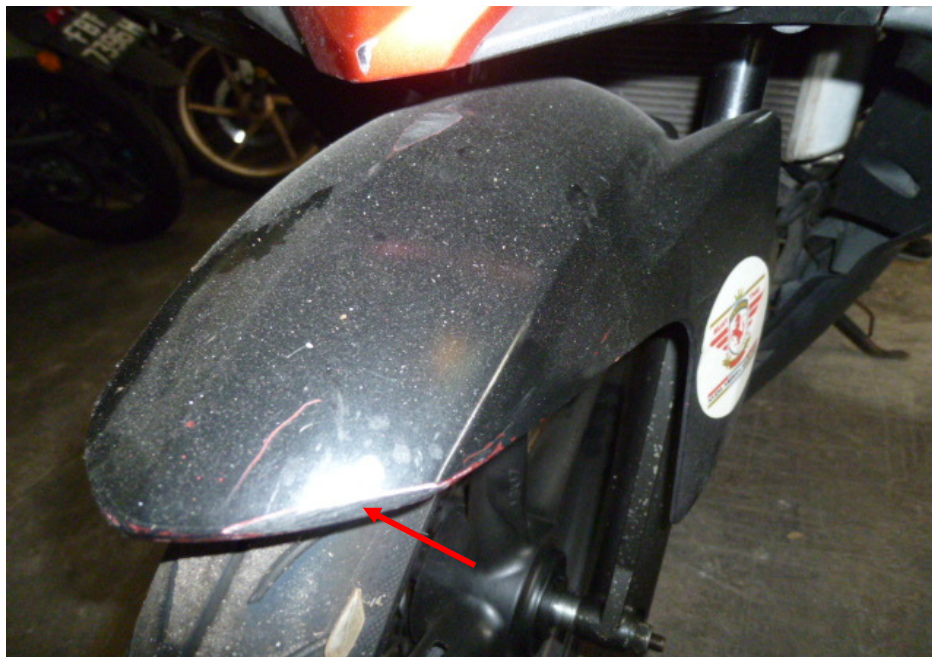
Photo 5 shows a closer view of the grazed front mudguard of the Motorcycle that as a result of the accident (arrowed).

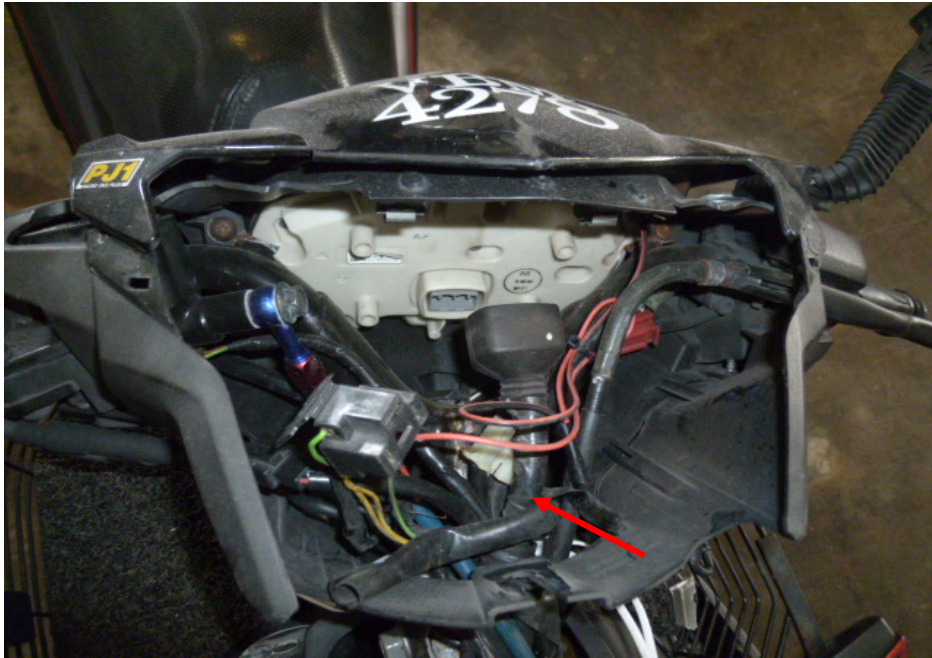
Photo 6 shows the missing headlight assembly (arrowed) of the Motorcycle as a result of the accident.

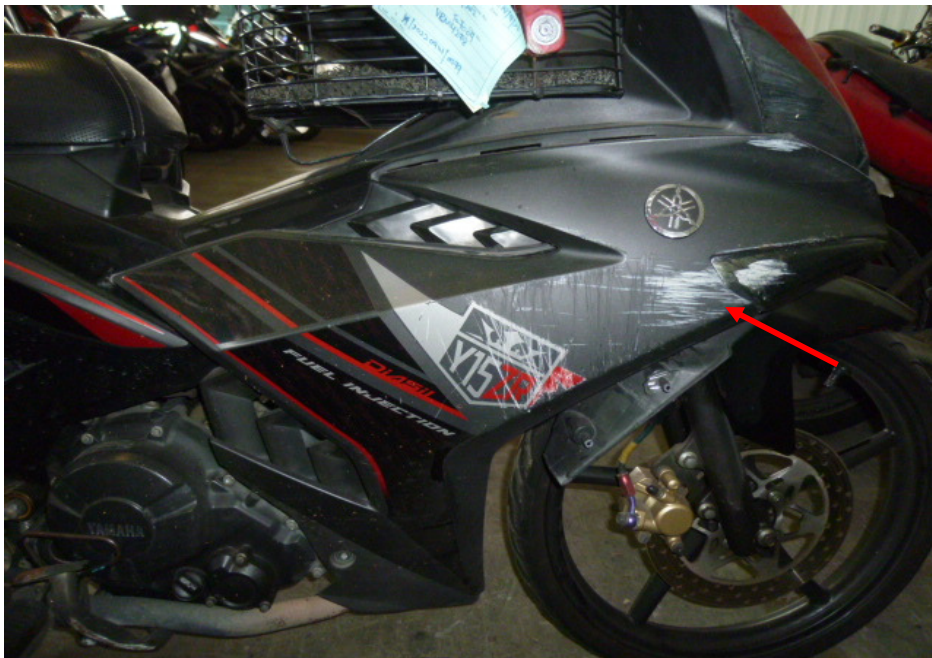
Photo 7 shows a closer view of the grazed right cowling of the Motorcycle as a result of the accident.

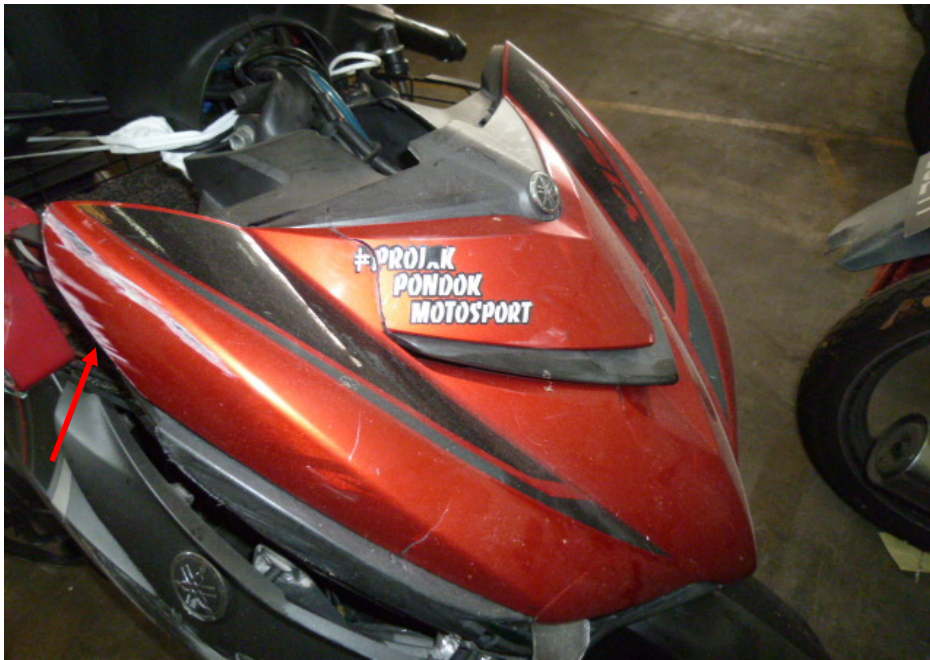
Photo 8 shows a closer view of the grazed front cowling of the Motorcycle as a result of the accident (arrowed).

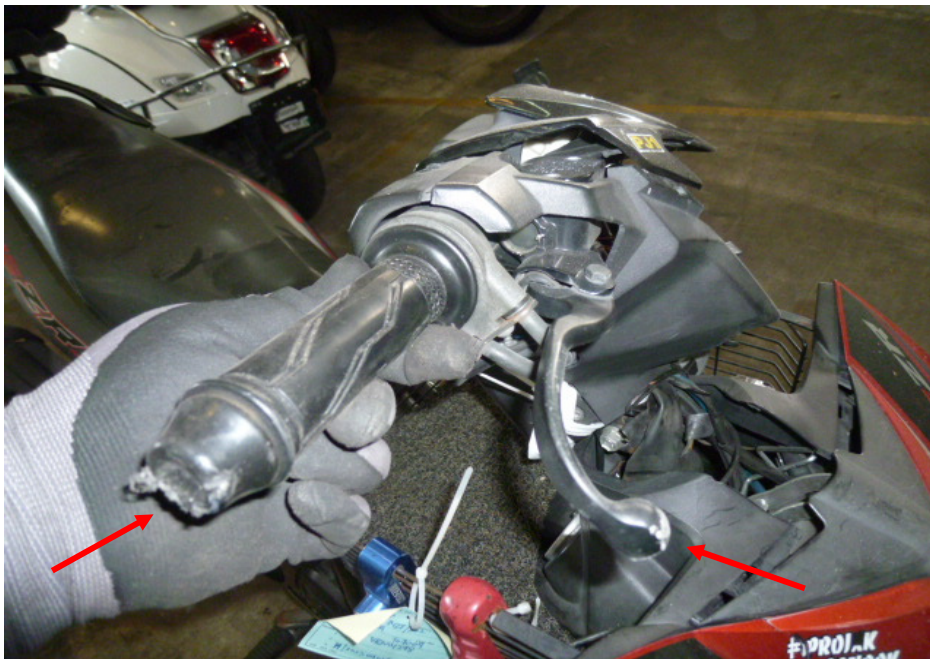
Photo 9 shows the right handlebar end and front brake lever (arrowed), which were amongst the body parts of the Motorcycle that had sustained damage as a result of the accident.

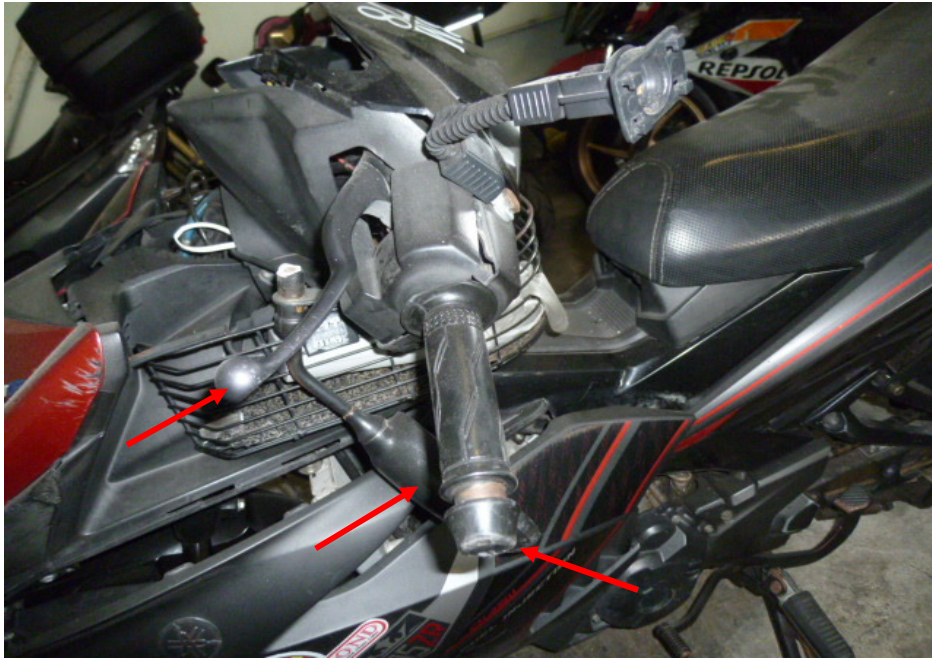
Photo 10 shows the left handlebar end, clutch brake lever and left side mirror (arrowed), which were amongst the body parts of the Motorcycle that had sustained damage as a result of the accident.

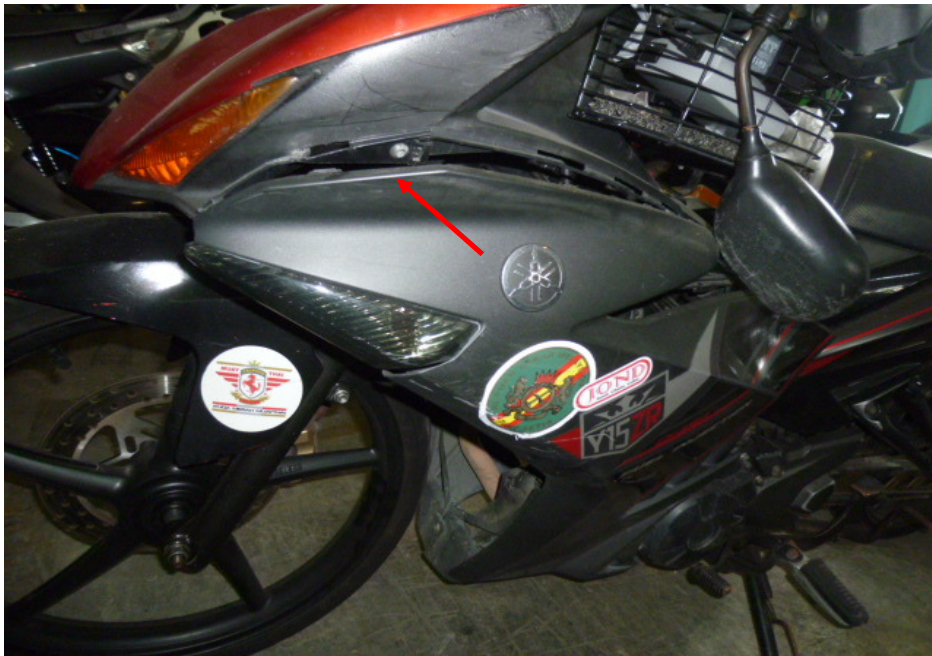
Photo 11 shows a closer view of the cracked left cowling of the Motorcycle as a result of the accident (arrowed).

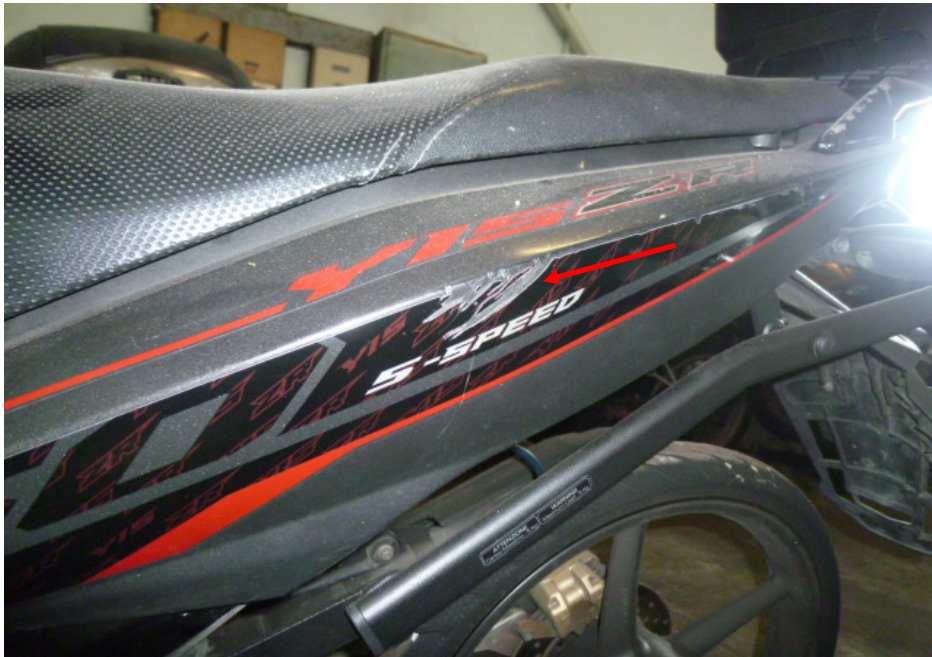
Photo 12 shows a closer view of the grazed left rear side cover of the Motorcycle as a result of the accident (arrowed).

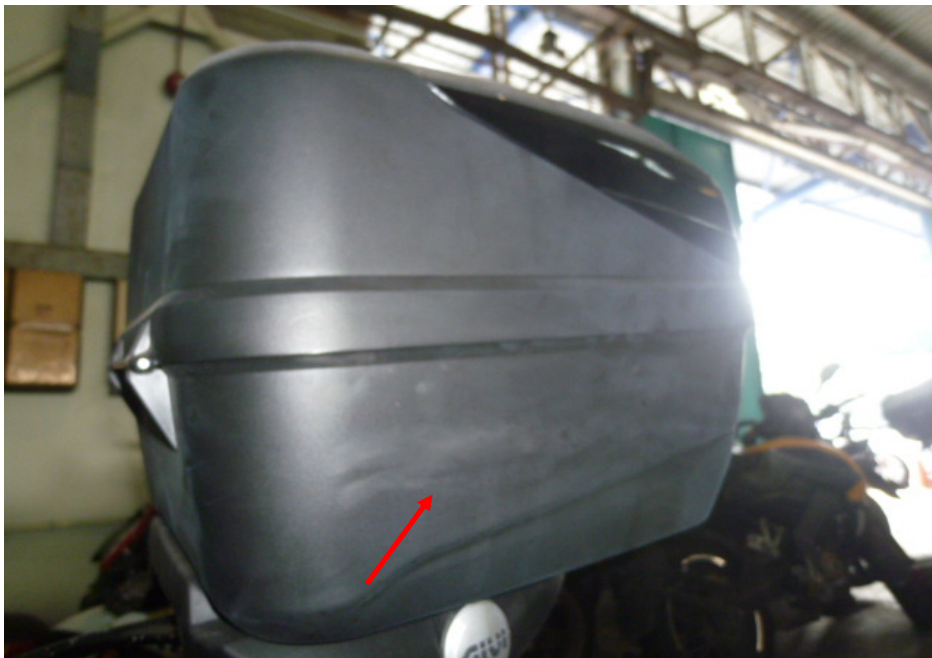
Photo 13 shows grazed top box (arrowed) of the Motorcycle a result of the accident.

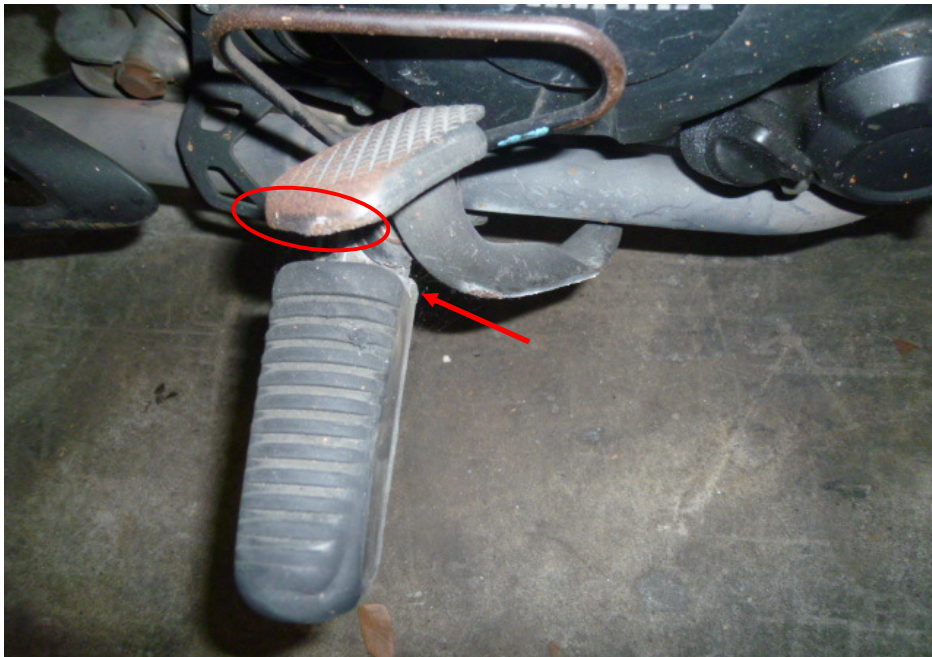
Photo 14 shows the rear brake pedal (circled) and right front footrest (arrowed) of the Motorcycle that had sustained damage as a result of the accident.

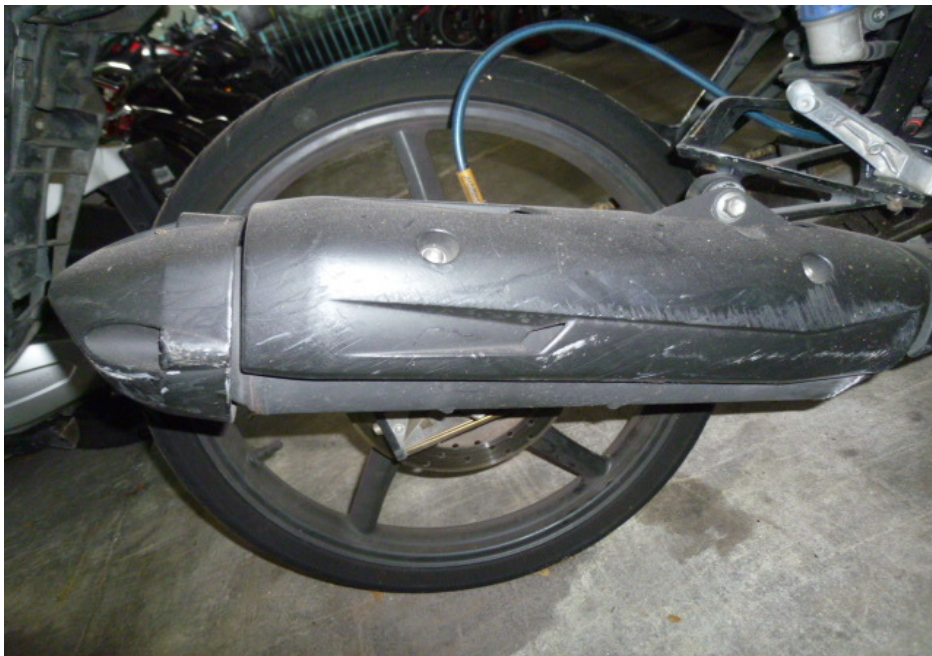
Photo 15 shows the grazed exhaust muffler heat shield of the Motorcycle as a result of the accident.

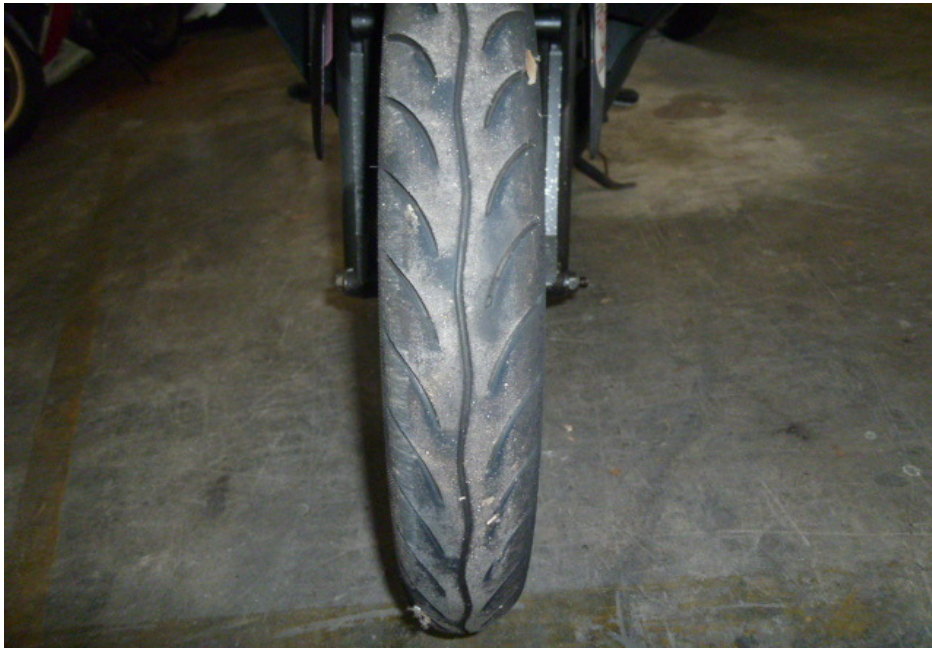
Photo 16 shows the condition of the Motorcycle's front tyre. The front tyre was observed to be in serviceable condition with remaining tread depth of approximately 2mm. The tyre was also observed to be sufficiently inflated for vehicular operation. We did not observe any tear, burst mark(s) and/or punctured hole(s) on the sidewalls as well as across the tread of the front tyre.

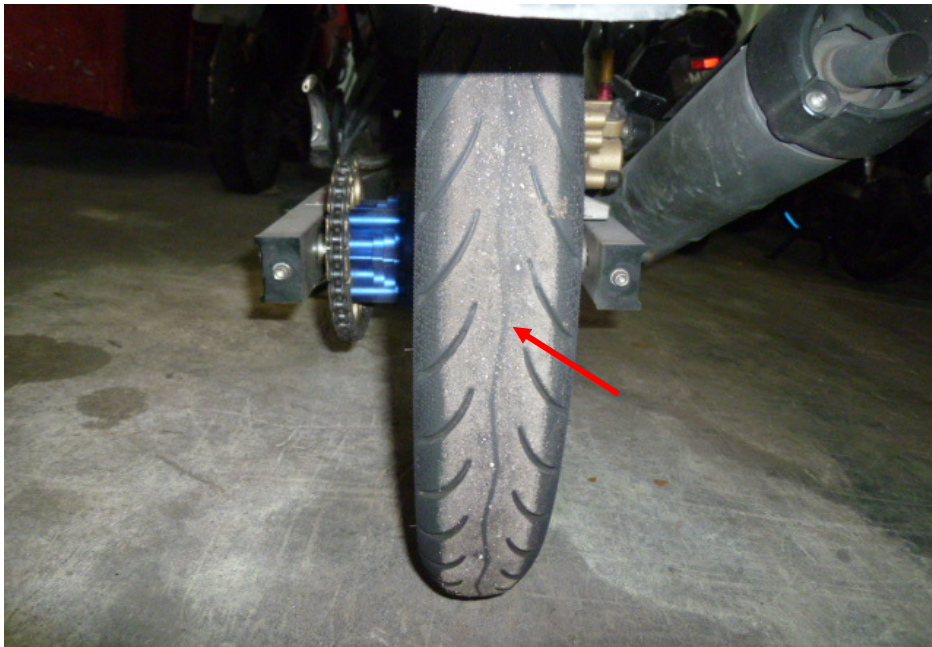
Photo 17 shows the condition of the Motorcycle's rear tyre. There was no tear, burst mark(s) and/or punctured hole(s) on the sidewalls as well as across the tread of the rear tyre. The front tyre was also observed to be sufficiently inflated for vehicular operation. However the rear tyre was observed to be bald (arrowed).

20. The front tyre of the Motorcycle was found to be in a serviceable condition. There was no tear, cut or burst mark(s) on the outer and the inner sidewalls as well as across the tread of the tyres. The front tyre was sufficiently inflated for vehicular operation with remaining tread depth of approximately 2mm. The rear tyre was sufficiently inflated for vehicular operation. However the rear tyre was observed to be bald.

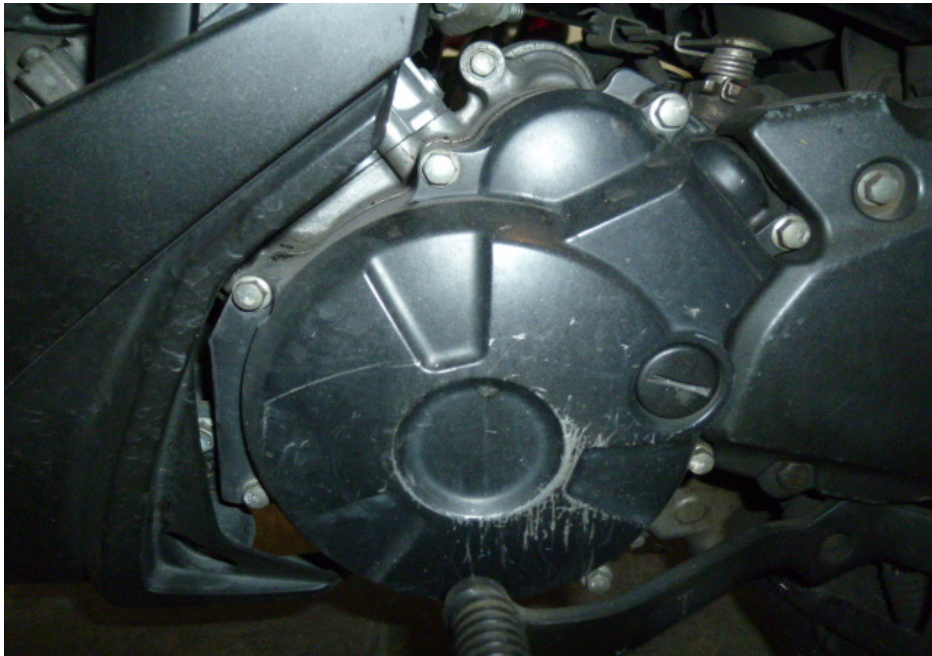
Photo 18 shows the left side of the engine of the Motorcycle at the time of our inspection. The various engine related parts and components were found to be intact with no visible damage. There was also no sign(s) or indication(s) of fluid leak observed around the left engine area of the Motorcycle.

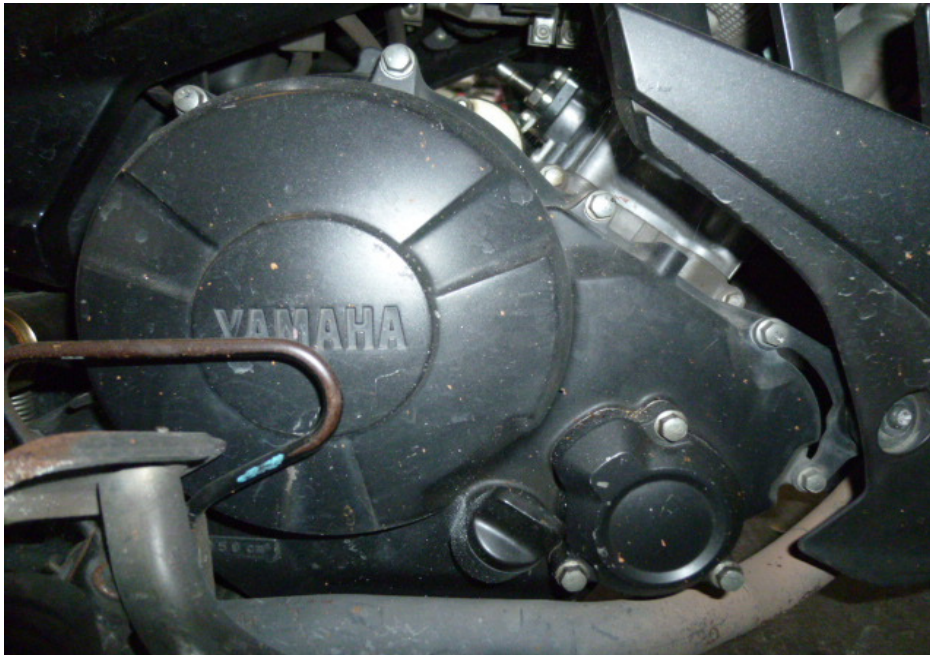
Photo 19 shows the right side of the engine of the Motorcycle at the time of our inspection. The various engine related parts and components were found to be intact with no visible damage. There was also no sign(s) or indication(s) of fluid leak observed around the right engine area of the Motorcycle.

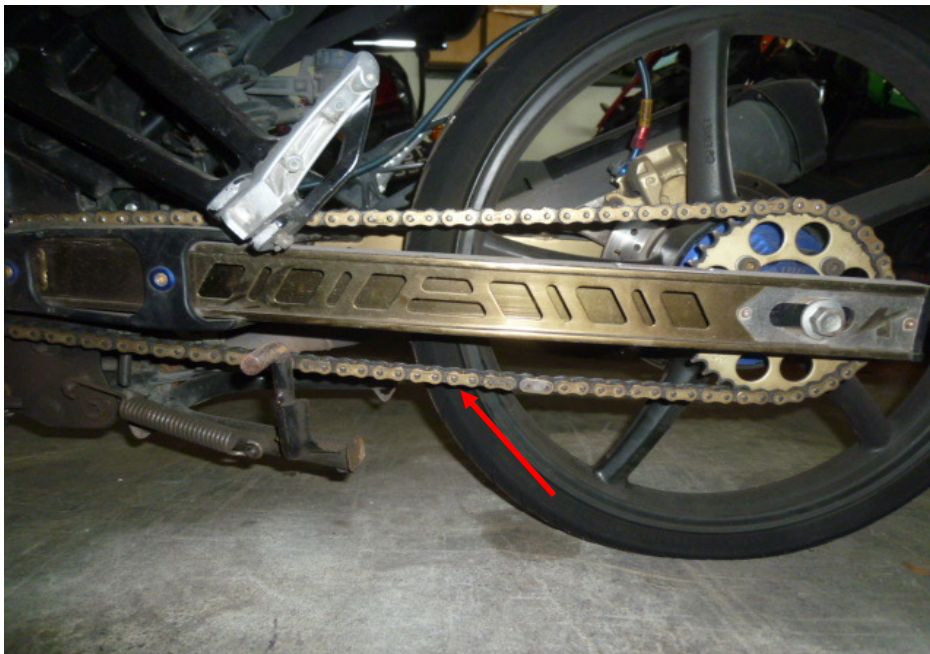
Photo 20 shows the general view of the gear train (arrowed) of the Motorcycle, which was observed to be intact with no misalignment. It was also adequately lubricated for operating purposes.

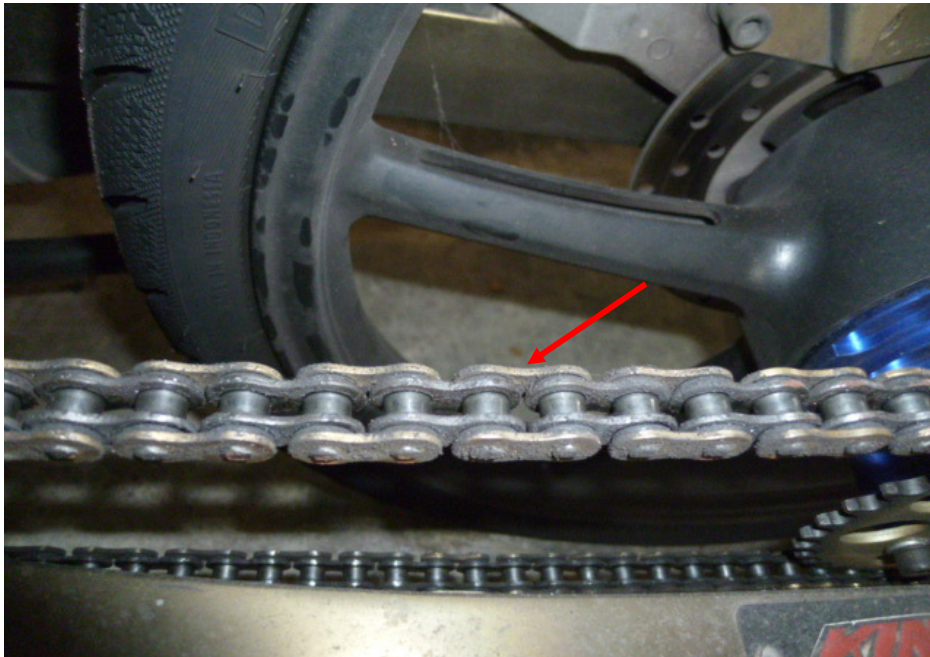
Photo 21 shows a closer view of the gear train (arrowed) of the Motorcycle, which was observed to be intact with no misalignment. It was also adequately lubricated for operating purposes.

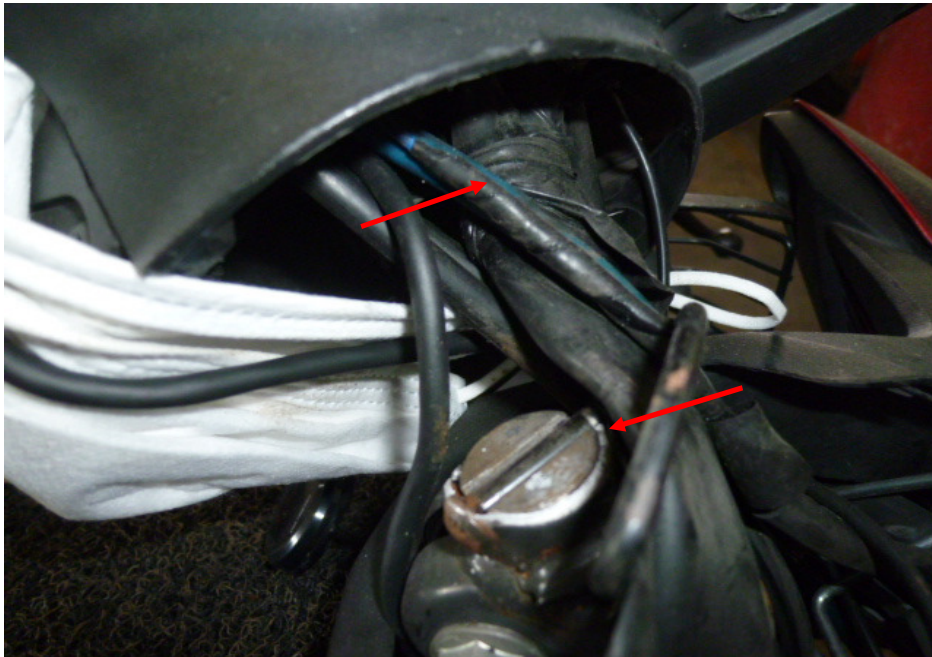
11. For this case, we were not able to conduct any test(s) on the steering system of the Motorcycle due to the damage to its steering stem. The steering stem was observed to be broken as a result of the accident.

Photo 22 shows a close up view of the steering stem of the Motorcycle. The steering stem was observed to be broken as a result of the accident (arrowed). We were hence not able to conduct any tests on the steering system of the Motorcycle.

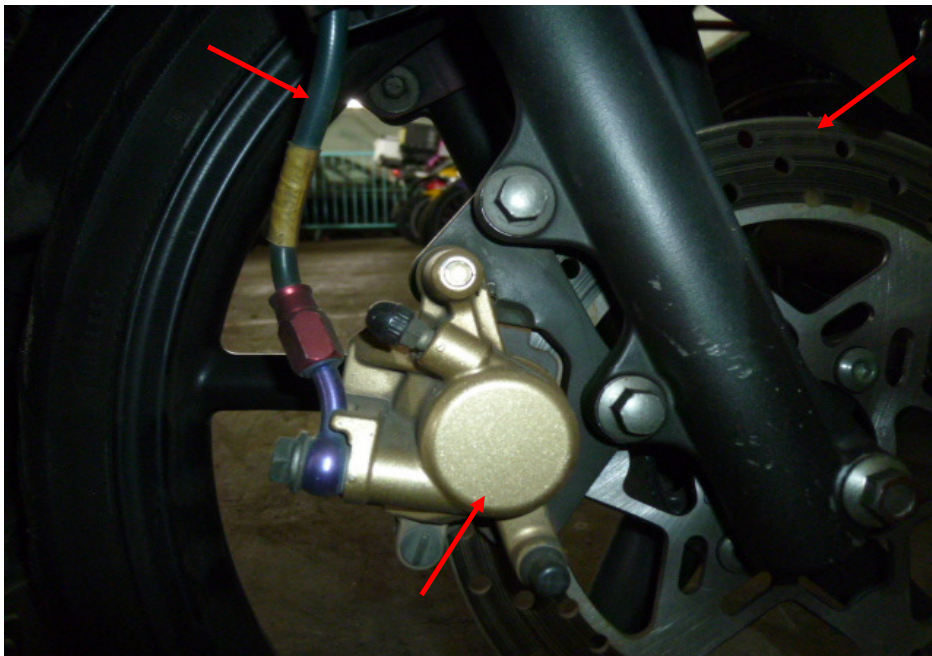
Photo 23 shows a close up view of the front brake caliper, front brake disc and front brake hose (arrowed) of the Motorcycle, which are all part of the components in the hydraulic front brake system of the Motorcycle. Our visual checks of these various components had revealed all to be intact with no visible damage. No leakage of brake fluid was also observed.

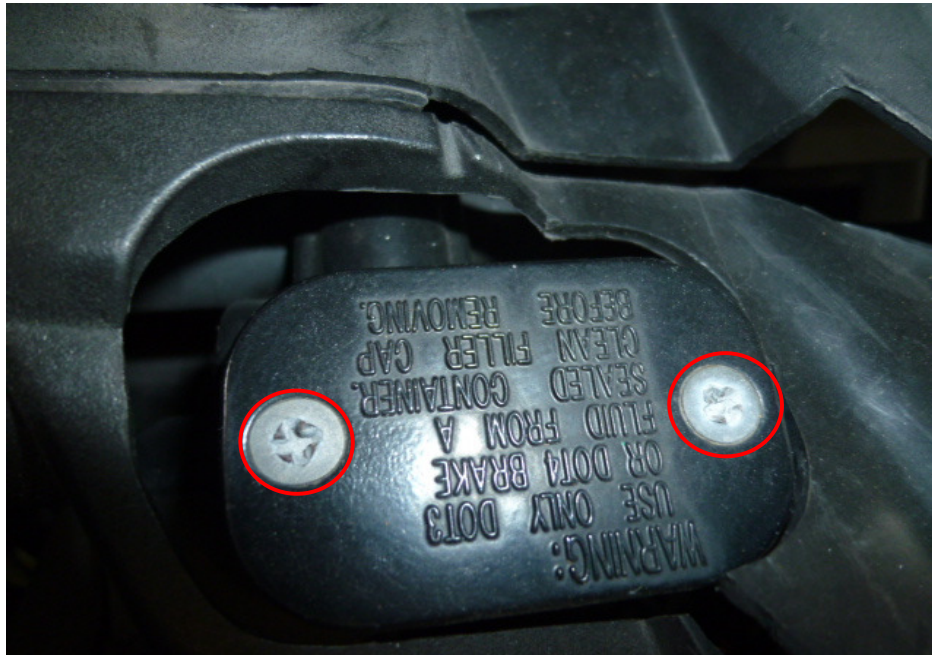
14. We were unable remove the front brake reservoir cover to examine whether the front brake fluid was without contamination due to worn out screws. However the front brake fluid was observed to be of sufficient level for operational purposes.

Photo 24 shows the brake fluid reservoir cover for the front brake of the Motorcycle. We were unable to examine whether the front brake fluid was without contamination due to the worn out screws (circled).

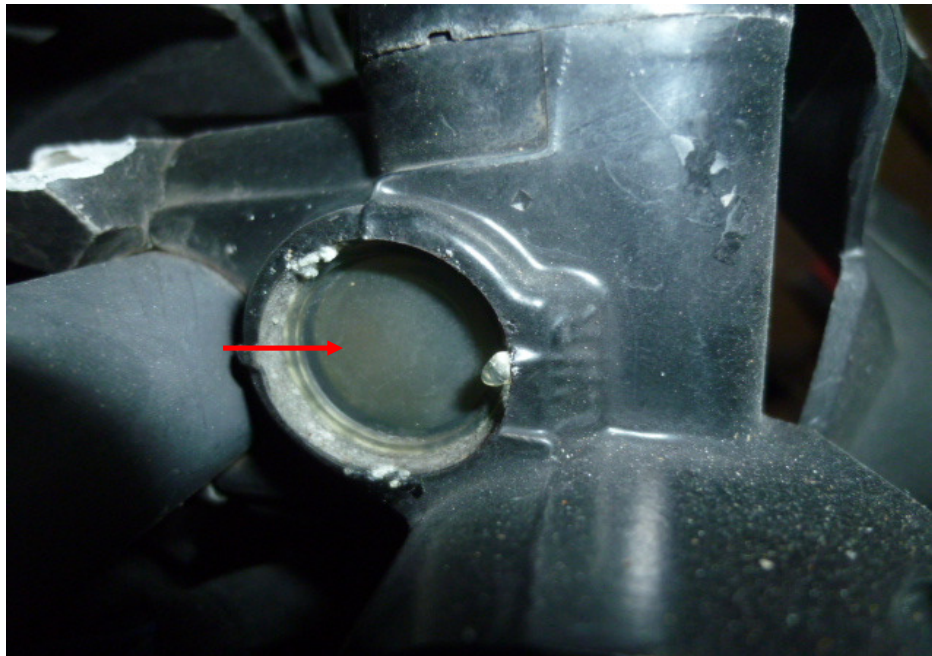
Photo 25 shows a close up view of the brake fluid reservoir for the front brake of the Motorcycle. The brake fluid was observed to be of sufficient level for operational purposes (arrowed).

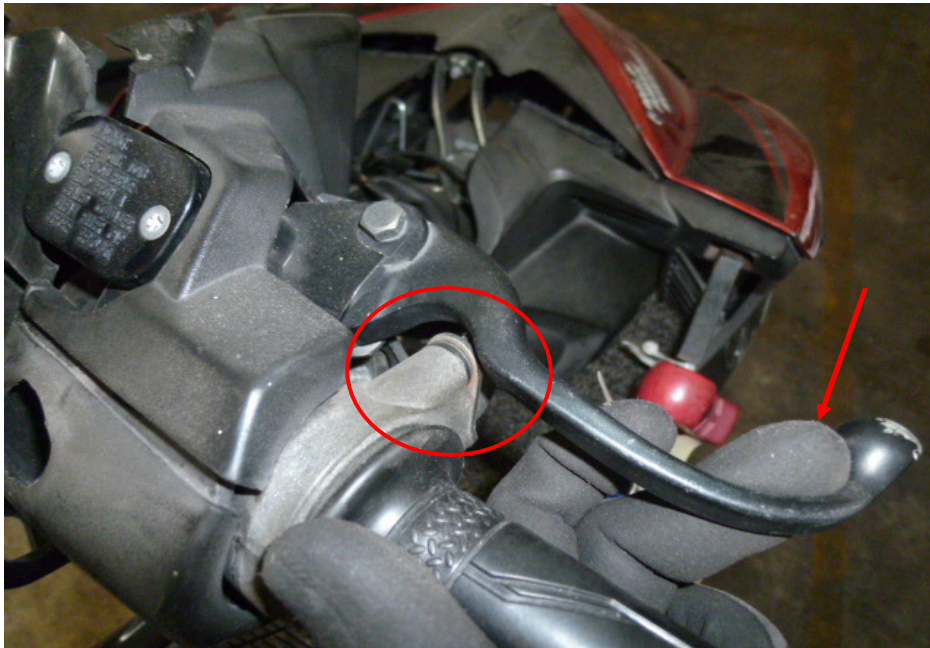
17. For this case, we were not able to determine whether the front braking system of the Motorcycle was in serviceable condition. There was some resistance felt (spongy like feel) upon pressing the front brake lever. However the accident had caused the throttle cable housing of the Motorcycle to rotate. Hence we were unable to fully depress the front brake lever to determine if there is a leakage of pressure/vacuum in the front brake system.

Photo 26 shows the front brake lever being depressed. There was some resistance felt (spongy like feel) upon pressing the front brake lever (arrowed). However the accident had caused the throttle cable housing of the Motorcycle to rotate (circled). Hence we were unable to fully depress the front brake lever to determine if there is a leakage of pressure/vacuum in the front brake system.

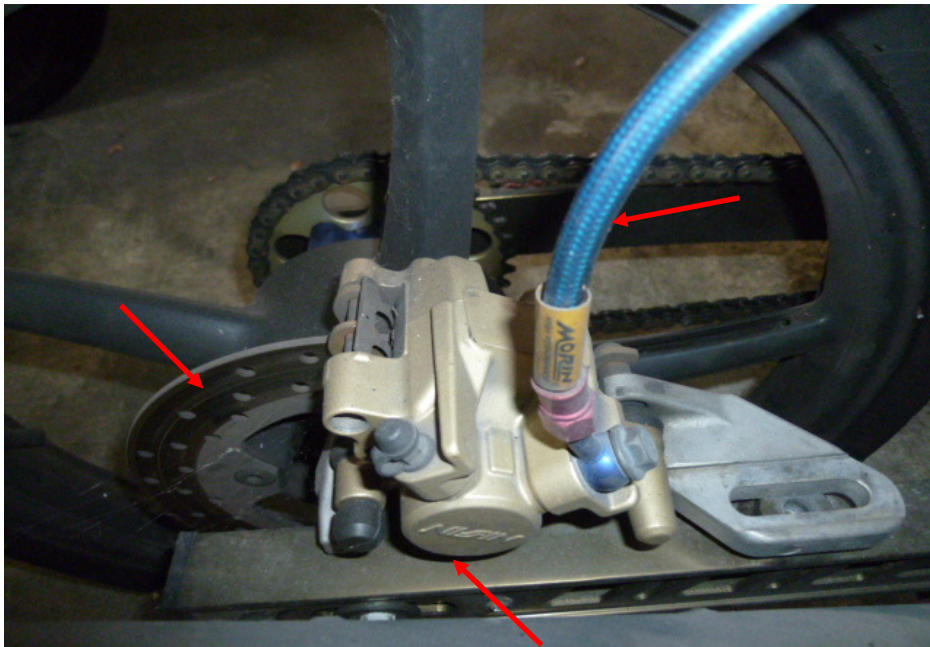
Photo 27 shows a close up view of the rear brake caliper, rear brake disc and rear brake hose (arrowed) of the Motorcycle, which are all part of the components in the hydraulic rear brake system of the Motorcycle. Our visual checks of these various components had revealed all to be intact with no visible damage. No leakage of brake fluid was also observed.

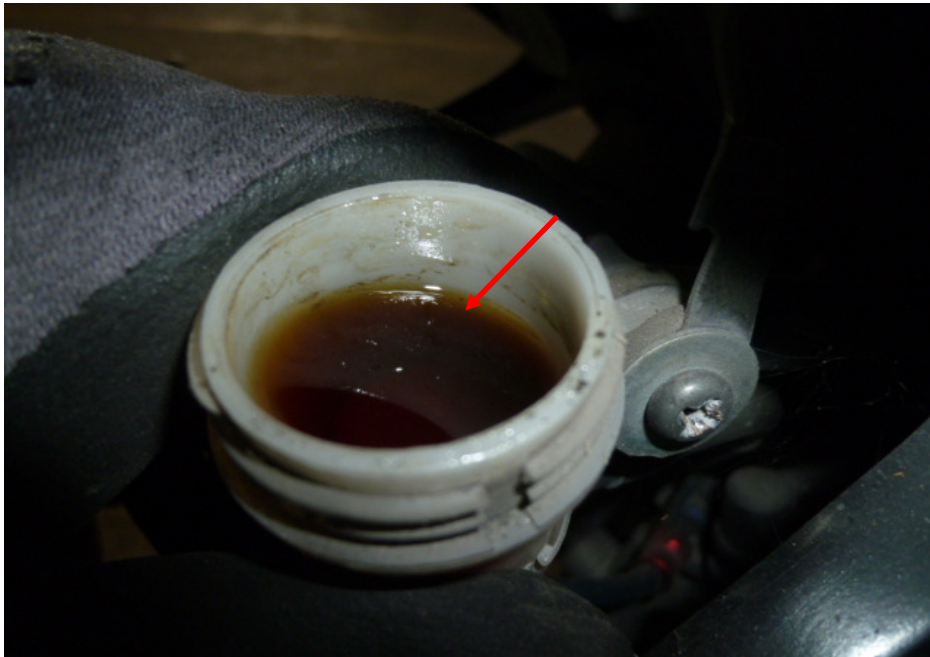
15. The brake fluid for the rear brake was observed to be of sufficient level for operating purposes. However it was found to be slightly contaminated.

Photo 28 shows the brake fluid reservoir for the rear brake of the Motorcycle. The brake fluid was observed to be of sufficient level for operating purposes. However it was found to be slightly contaminated (arrowed).
