Your Ref: TP/IP/26786/2022
Our Ref : CI/TPD22011547/N

17 January 2023

MECHANICAL INSPECTION REPORT OF MOTORCYCLE FBE 5809B

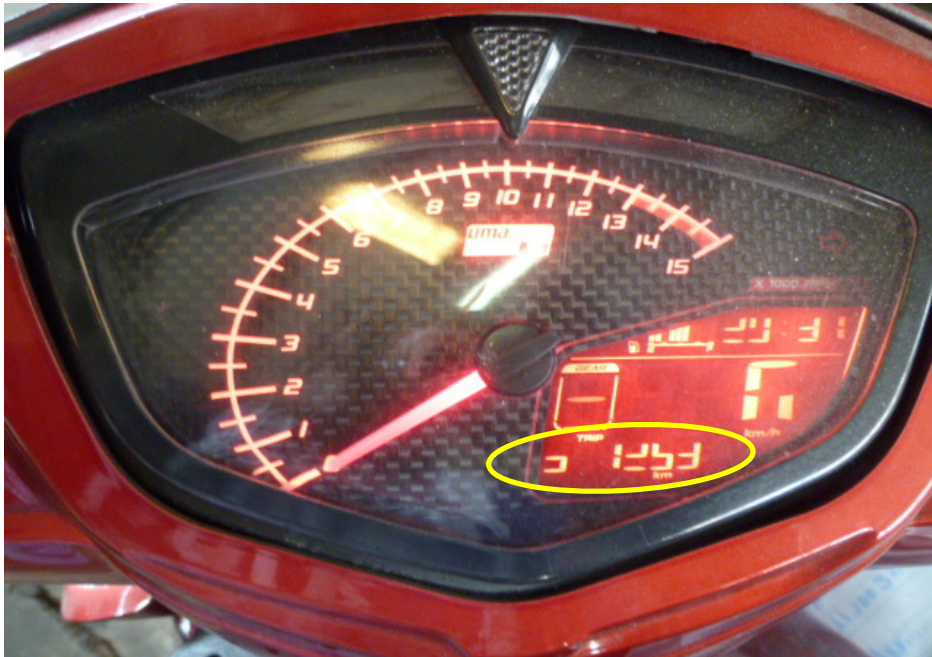
4. The mileage of the Motorcycle could not be recorded at the time of our inspection due to damages sustained to the speedometer gauge.
5. The Motorcycle had sustained damages all around. Body parts that were found to have been damaged include its head cowl, headlight assembly, speedometer gauge, front fork assembly, front mudguard, handlebar ends, right side mirror, clutch lever, front brake lever, side cowlings, gear shift pedal, left front footrest, left pillion foot peg, top box rack, top box and rear number plate, amongst others.

Photo 1 shows the speedometer gauge of the Motorcycle. The mileage of the Motorcycle could not be recorded at the time of our inspection due to a damaged display screen (circled).

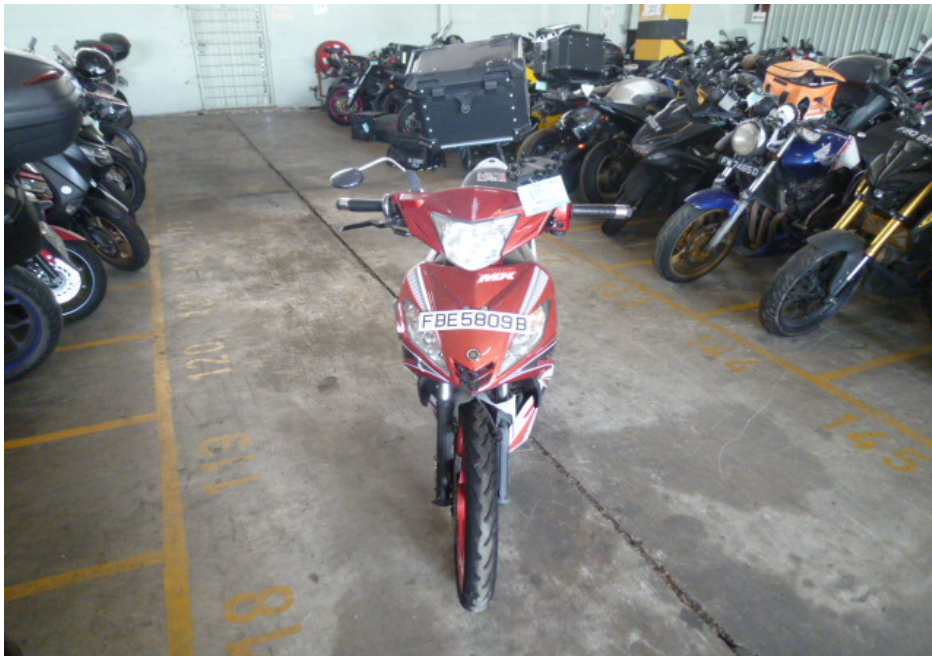
Photo 2 shows a general view of the frontal portion of the Motorcycle at the time of our inspection. The Motorcycle had sustained damages all around.

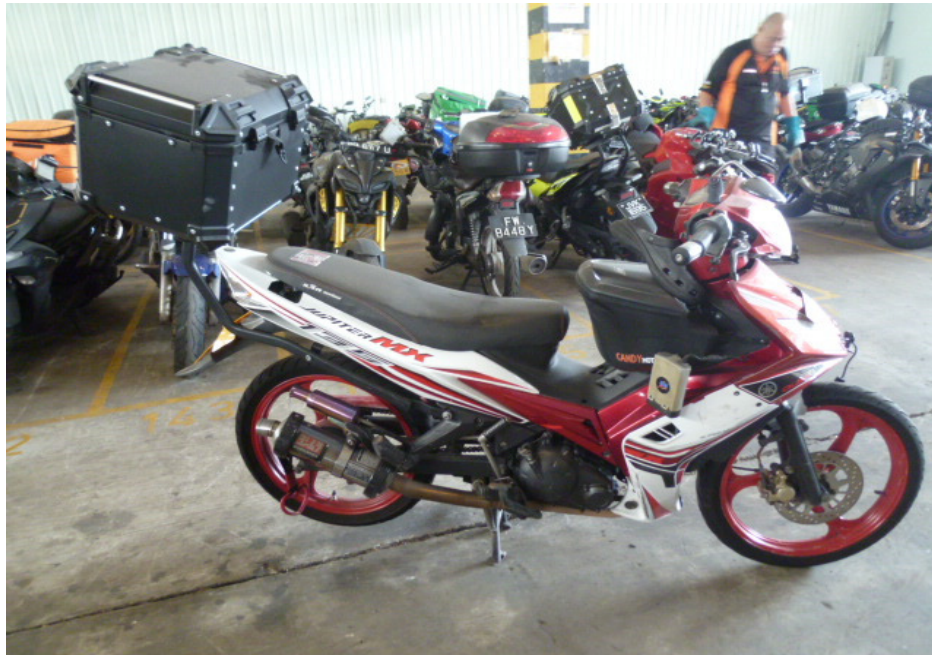
Photo 3 shows a general view of the right body of the Motorcycle at the time of our inspection. The Motorcycle had sustained damages all around.

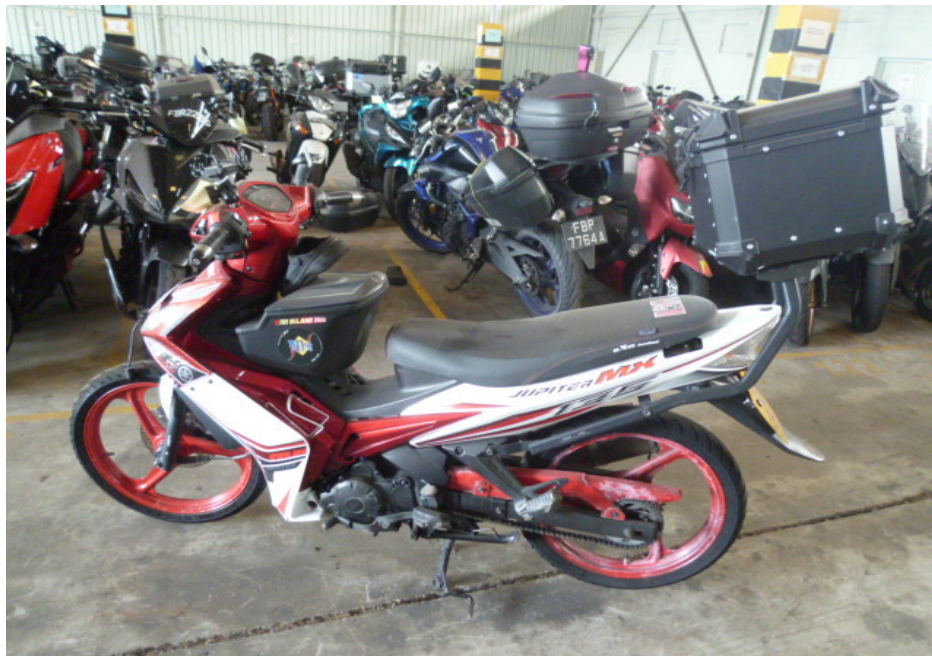
Photo 4 shows a general view of the left body of the Motorcycle at the time of our inspection. The Motorcycle had sustained damages all around. Body parts that were found to have been damaged include its head cowl, headlight assembly, speedometer gauge, front fork assembly, front mudguard, handlebar ends, right side mirror, clutch lever, front brake lever, side cowlings, gear shift pedal, left front footrest, left pillion foot peg, top box rack, top box and rear number plate, amongst others.

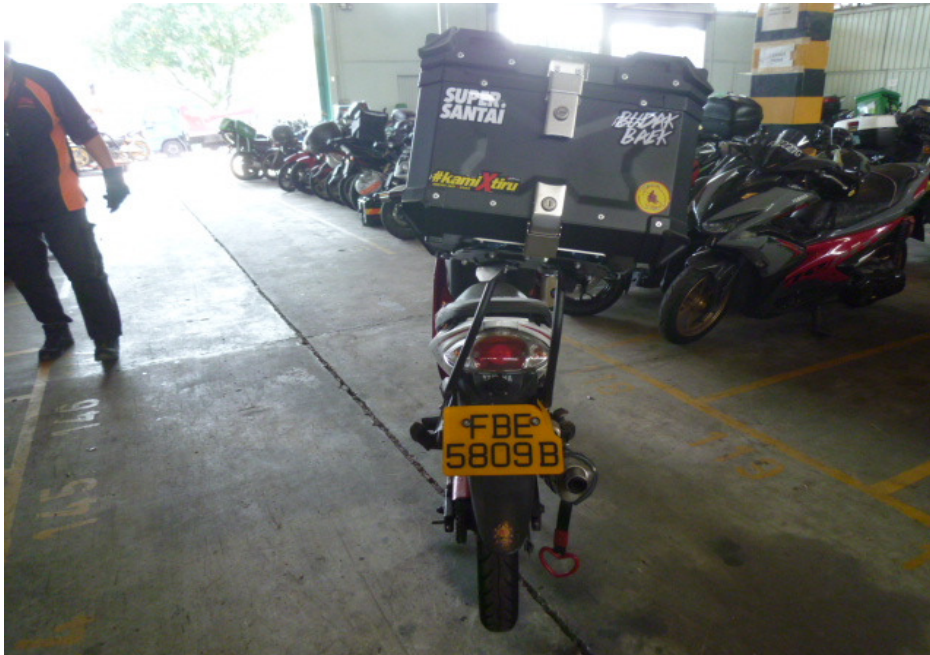
Photo 5 shows a general view of the rear portion of the Motorcycle at the time of our inspection. The Motorcycle had sustained damages all around.

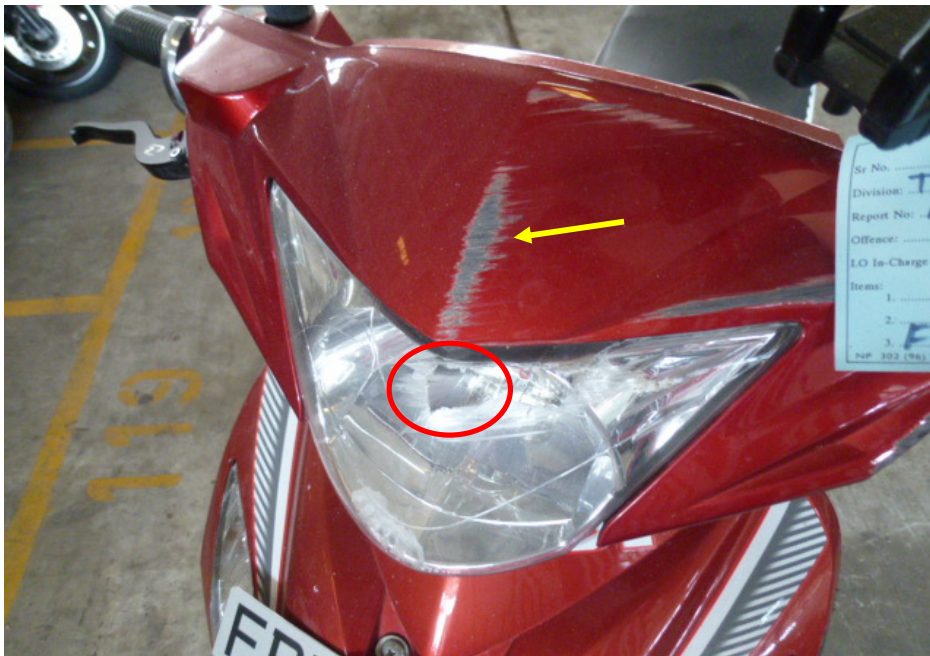
Photo 6 shows a closer view of the cracked headlight assembly (circled) and grazed head cowl (arrowed) of the Motorcycle as a result of the accident.

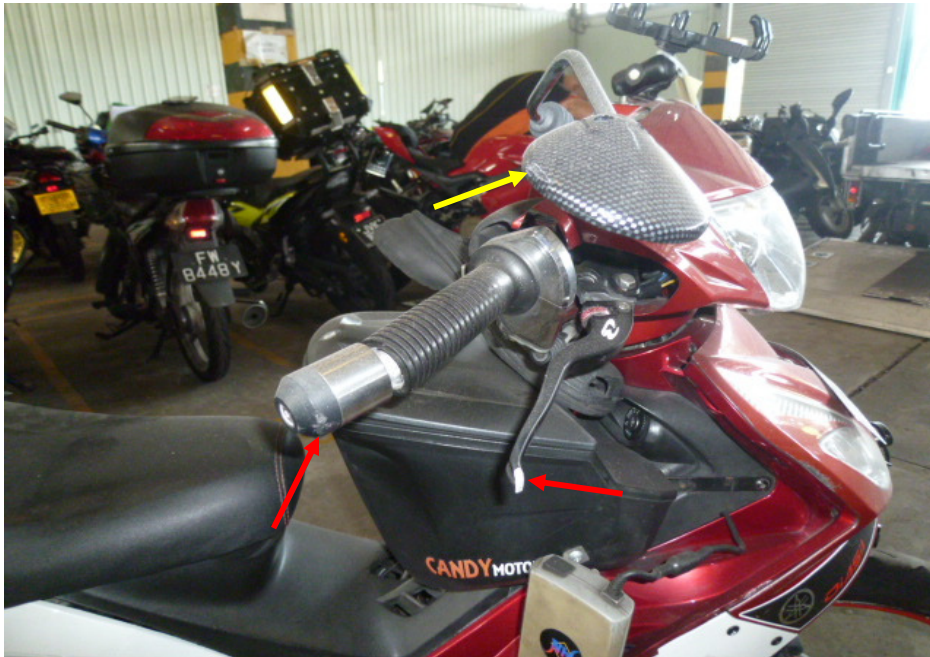
Photo 7 shows a closer view of the right side mirror, front brake lever and right handlebar end of the Motorcycle (arrowed). These parts were amongst the body parts of the Motorcycle which were damaged as a result of the accident.

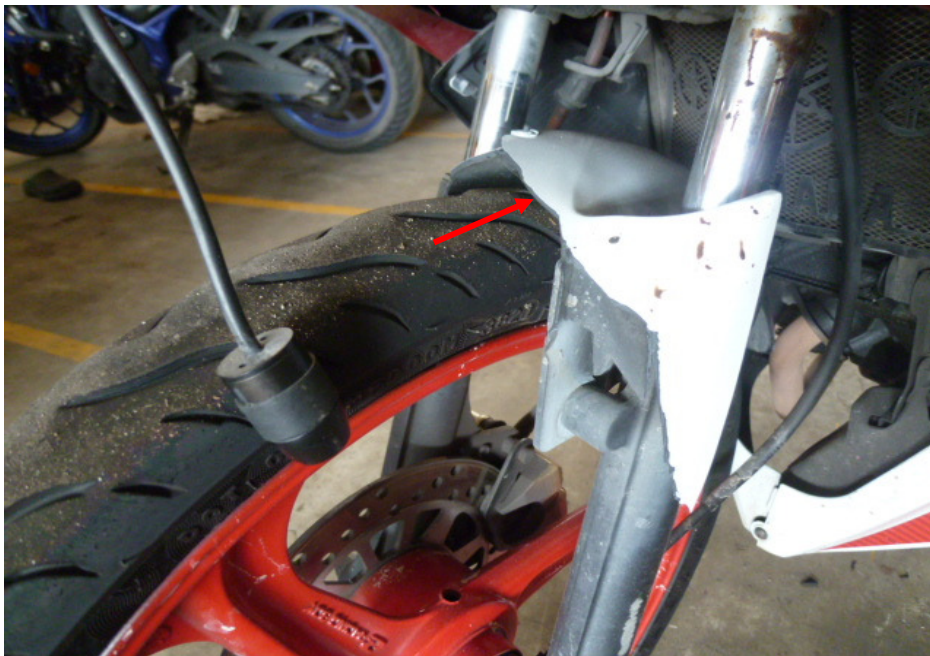
Photo 8 shows a closer view of the front mudguard which was amongst the body parts at the front body of the Motorcycle that had sustained damage as a result of the accident (arrowed).

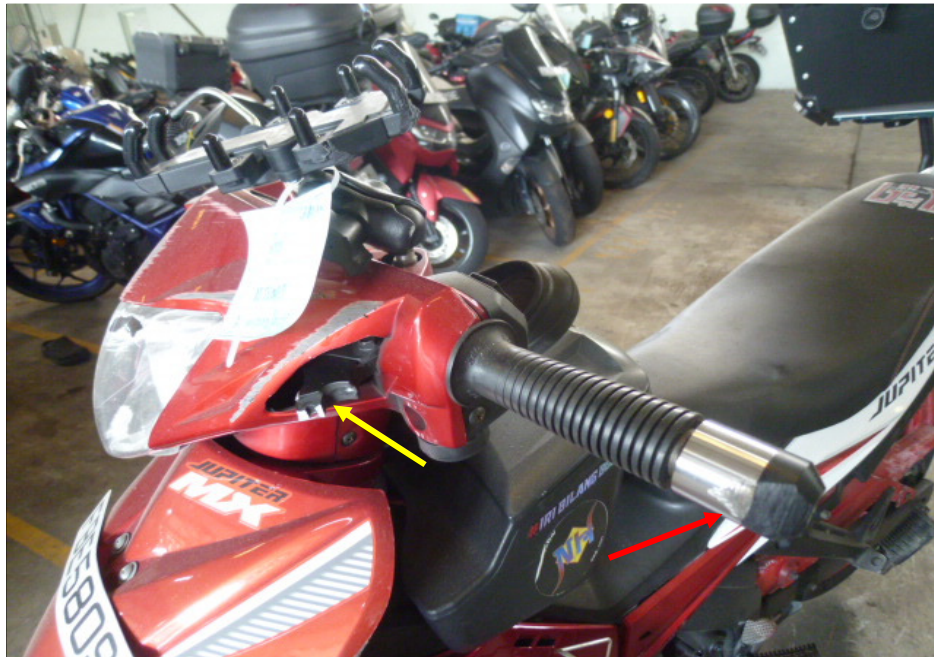
Photo 9 shows a closer view of the clutch lever and left handlebar end of the Motorcycle (arrowed). These parts were amongst the body parts of the Motorcycle which were damaged as a result of the accident.

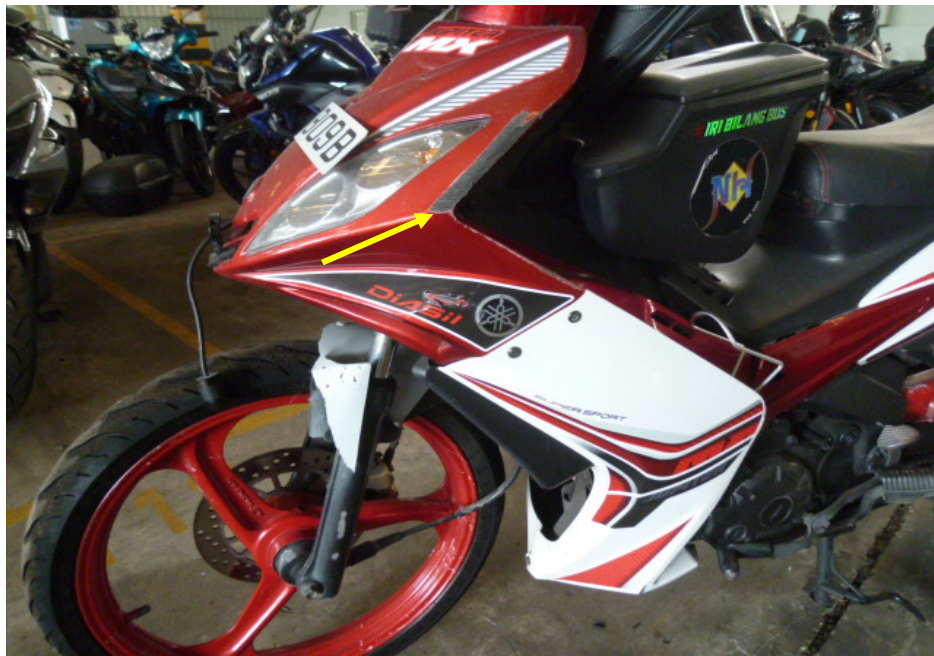
Photo 10 shows a closer view of the grazed left cowling of the Motorcycle as a result of the accident (arrowed).

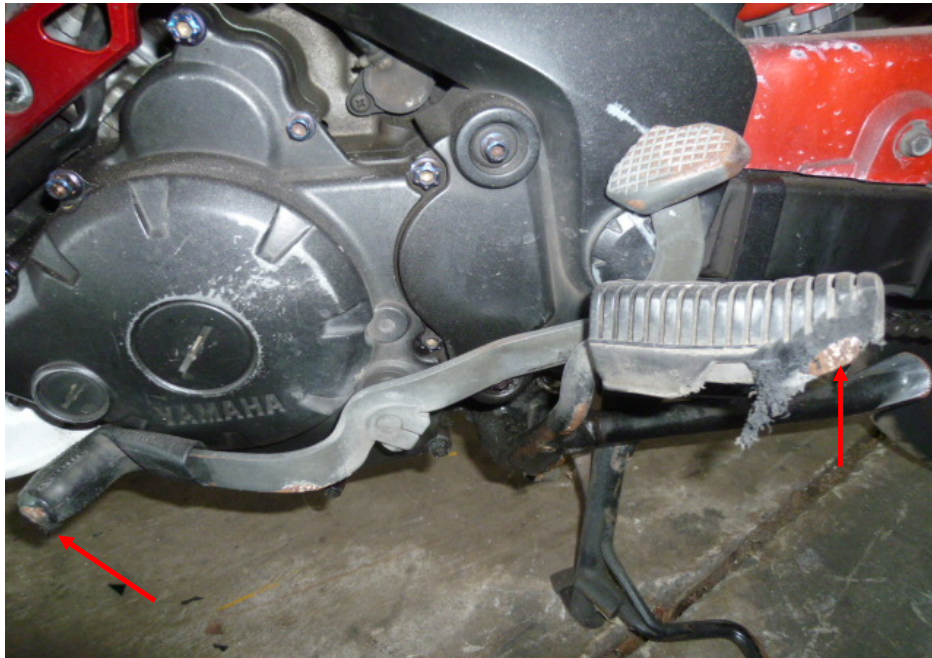
Photo 11 shows the gear shift pedal and left front footrest of the Motorcycle which had sustained damage as a result of the accident (arrowed).

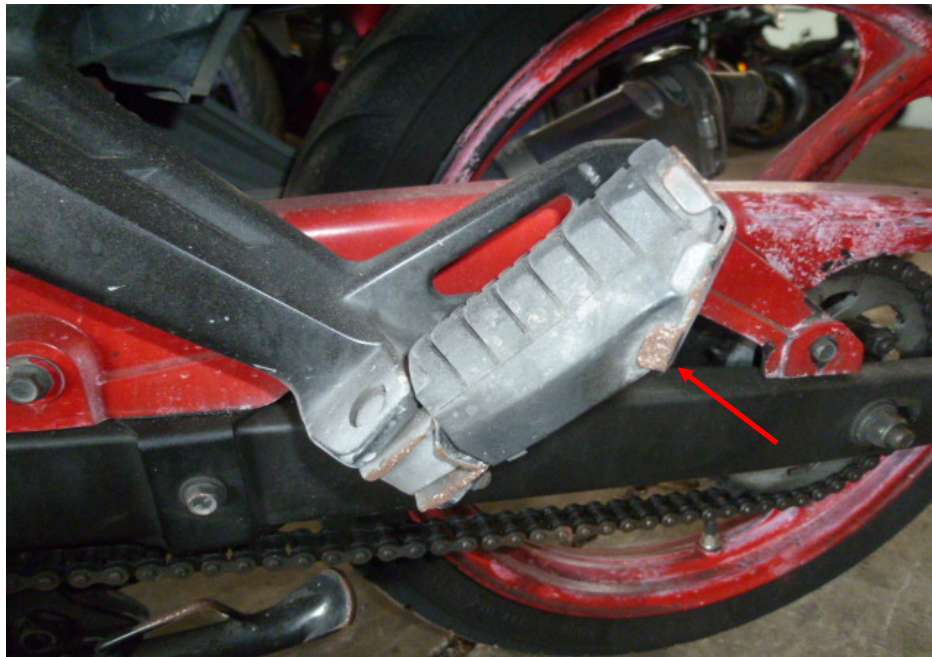
Photo 12 shows a closer view of the left pillion foot peg which was amongst the body parts of the Motorcycle that had sustained damage as a result of the accident (arrowed).

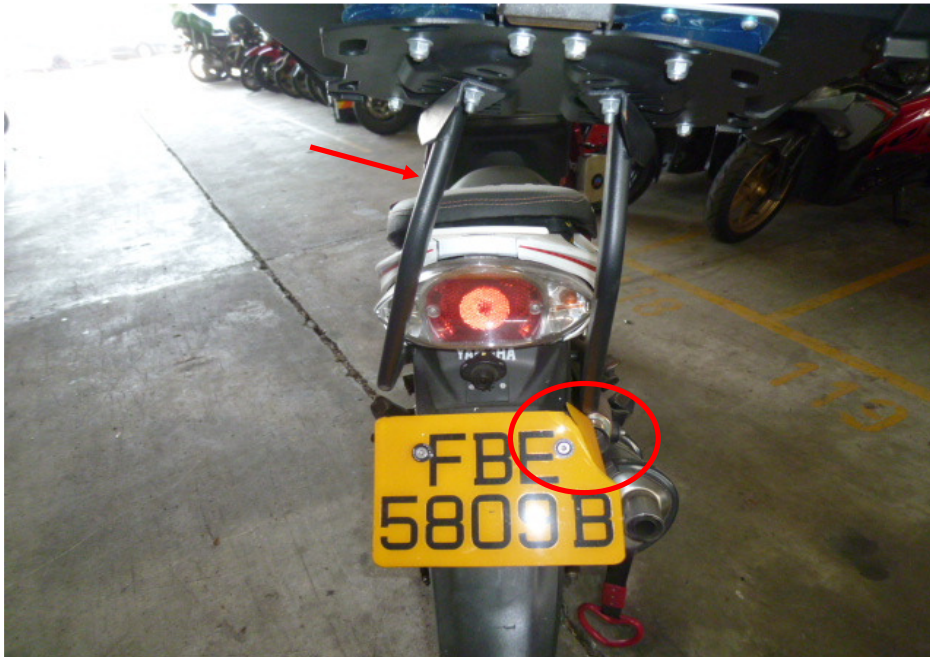
Photo 13 shows the cracked rear number plate (circled) and bent top box rack (arrowed) of the Motorcycle as a result of the accident.

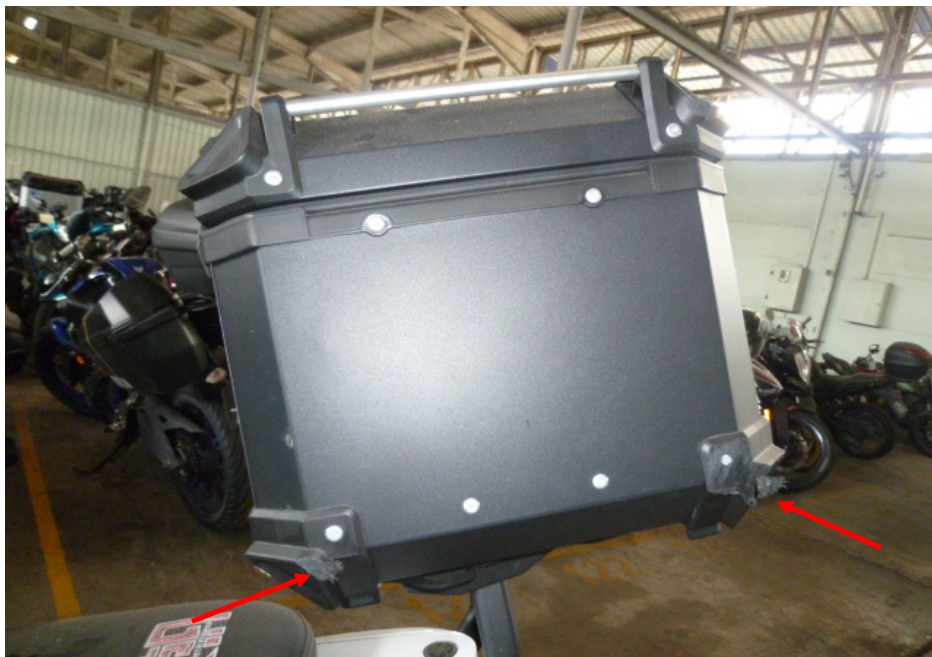
Photo 14 shows the top box of the Motorcycle which had sustained damage as a result of the accident (arrowed).

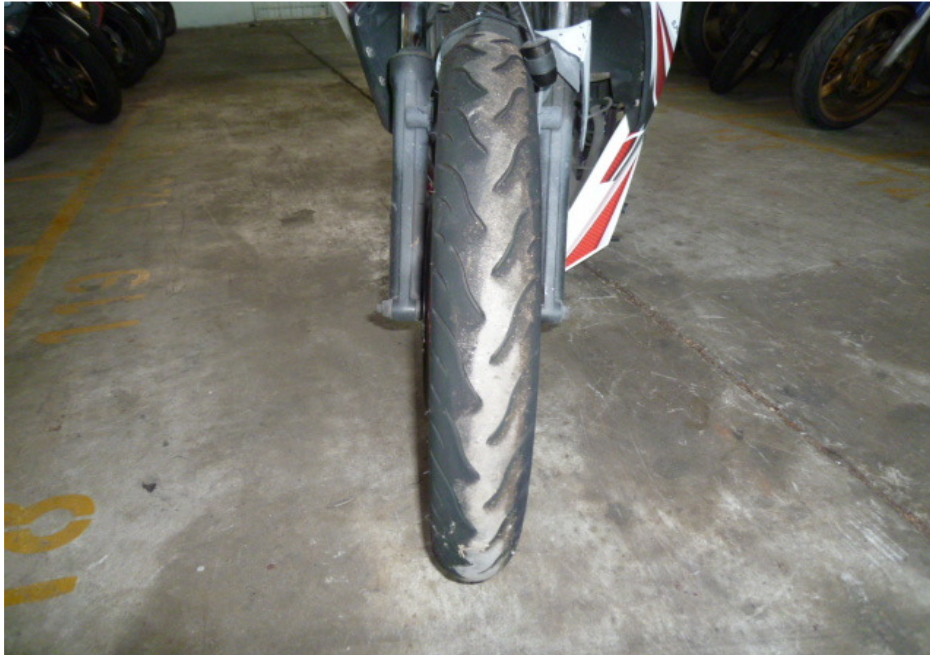
Photo 15 shows the condition of the Motorcycle's front tyre. The front tyre was observed to be in serviceable condition with remaining tread depth of approximately 3mm. There was no tear, burst mark(s) and/or punctured hole(s) on the sidewalls as well as across the tread of the front tyre.

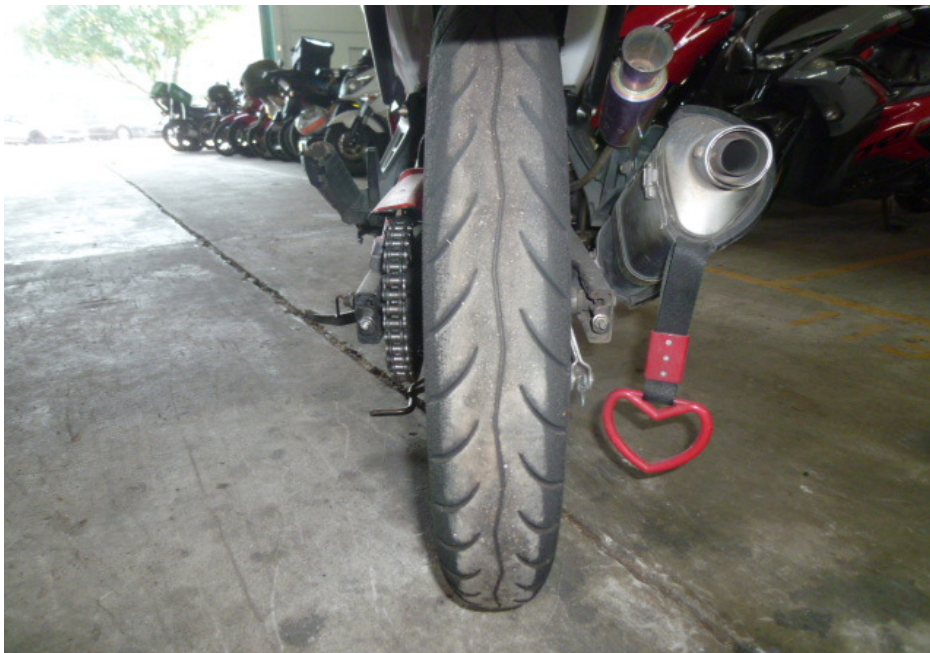
Photo 16 shows the condition of the Motorcycle's rear tyre. The pattern of the tread was clearly visible with remaining tread depth of approximately 1mm. We did not observe any tear, burst mark(s) and/or punctured hole(s) on the sidewalls as well as across the tread of the rear tyre.

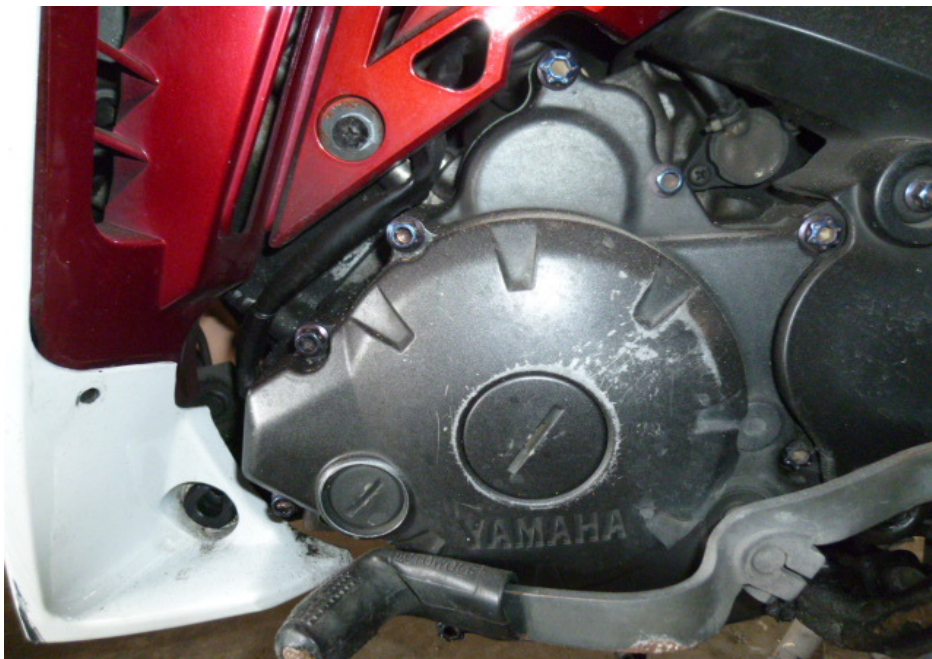
Photo 17 shows the left side of the engine of the Motorcycle at the time of our inspection. The various engine related parts and components were found to be intact with no visible damage. There was also no sign(s) or indication(s) of fluid leak observed around the left engine area of the Motorcycle.

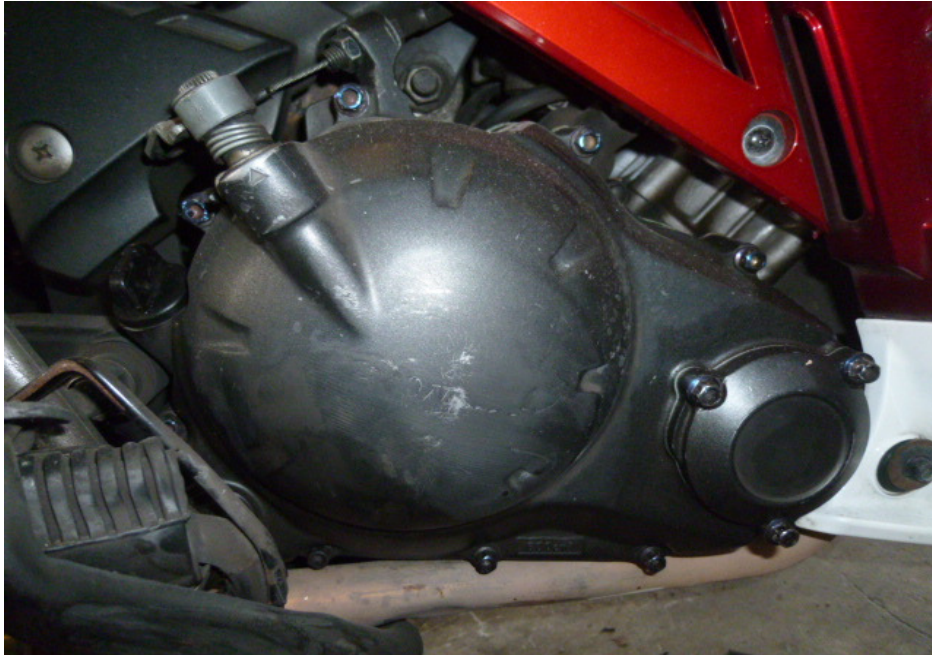
Photo 18 shows the right side of the engine of the Motorcycle at the time of our inspection. The various engine related parts and components were found to be intact with no visible damage. There was also no sign(s) or indication(s) of fluid leak observed around the right engine area of the Motorcycle.

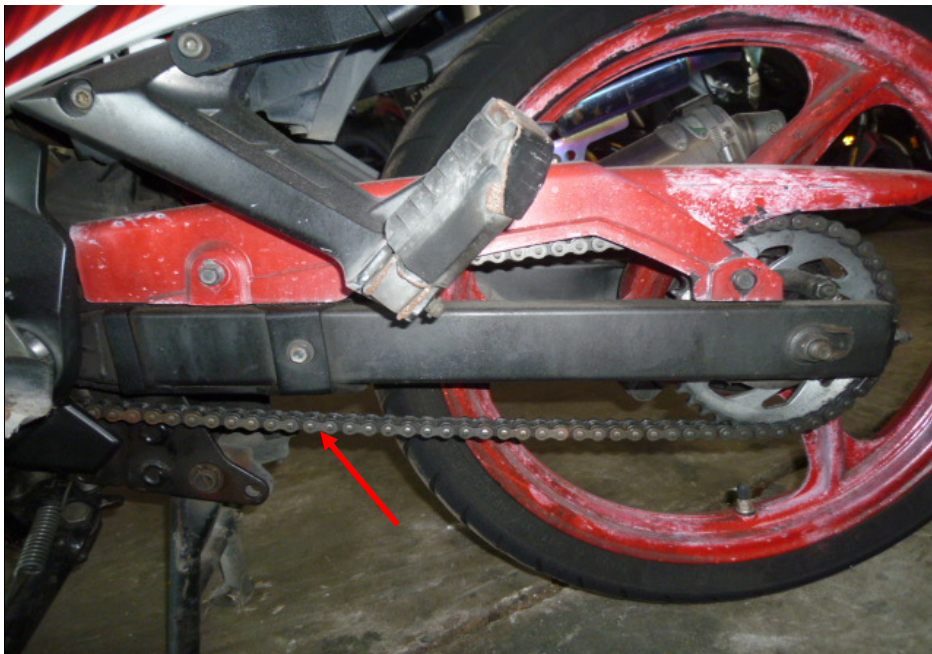
Photo 19 shows the gear train (arrowed) of the Motorcycle, which was observed to be intact with no misalignment. It was also adequately lubricated for operating purposes. The gear train rotates the rear wheel of the Motorcycle.

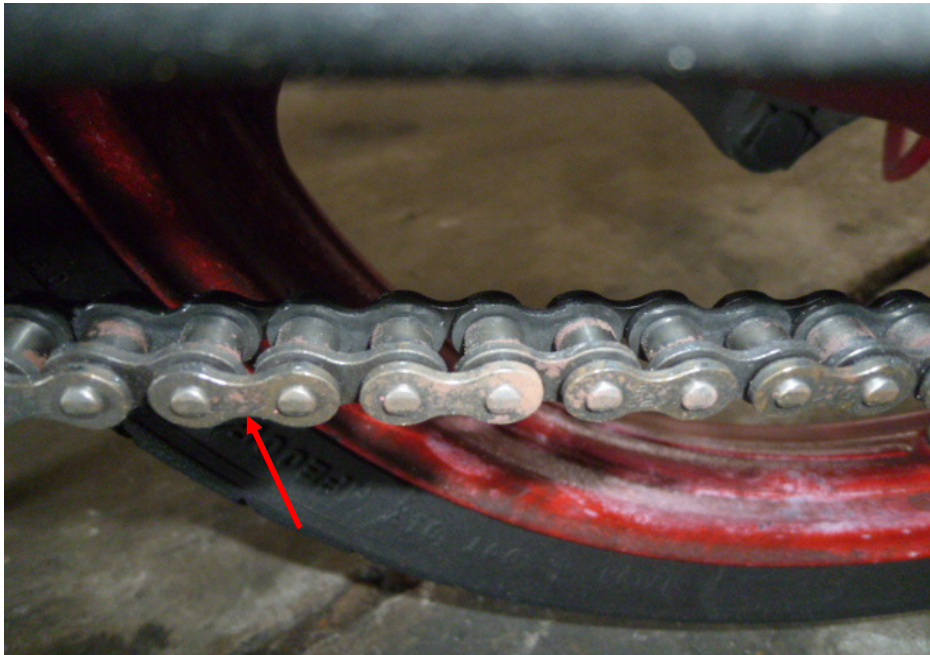
Photo 20 shows the closer view of the gear train (arrowed) of the Motorcycle, which was observed to be intact with no misalignment. It was also adequately lubricated for operating purposes.

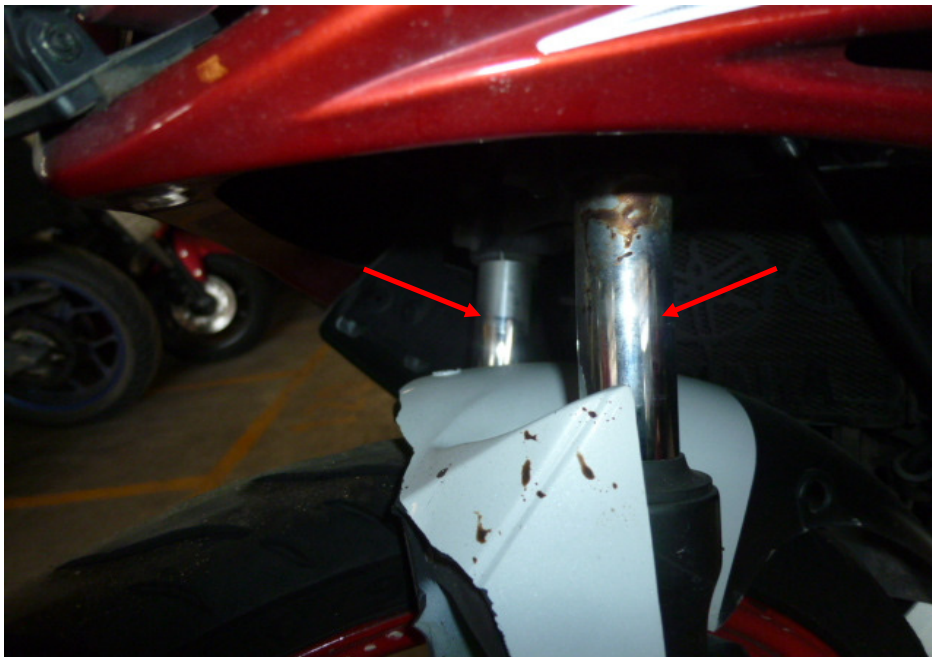
11. For this case, we were not able to conduct any test(s) on the steering system of the Motorcycle due to the damage of its fork assembly. The front forks were found to be bent inwards as a result of the accident.

Photo 21 shows the front forks of the Motorcycle. The front forks were observed to be bent inwards as a result of the accident (arrowed). We were hence not able to conduct any tests on the steering system of the Motorcycle.

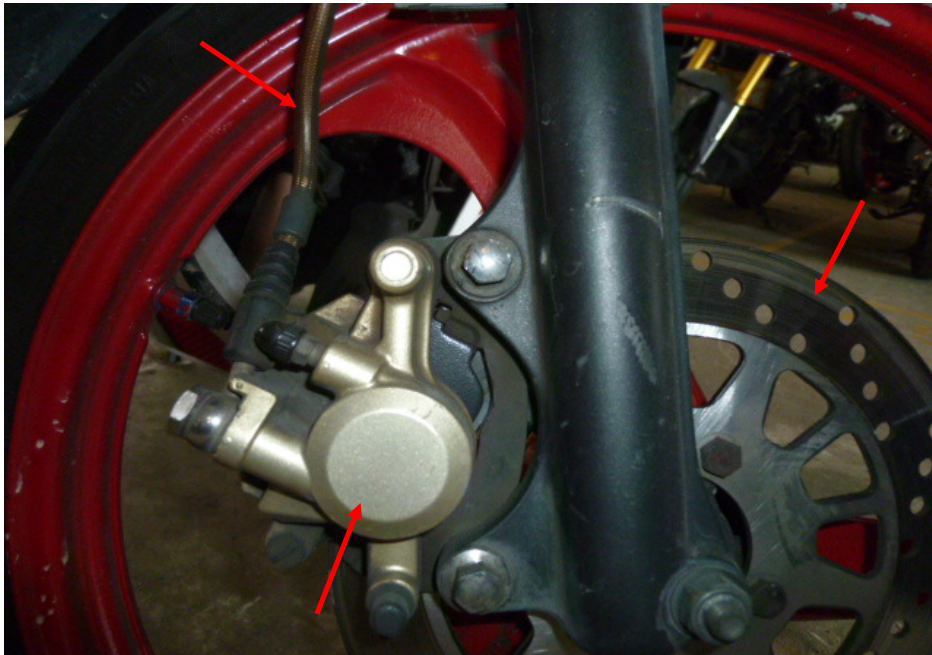
Photo 22 shows a close up view of the front brake caliper, front brake disc and front brake hose (arrowed) of the Motorcycle, which are all part of the components in the hydraulic front brake system of the Motorcycle. Our visual checks of these various components had revealed all to be intact with no visible damage. No leakage of brake fluid was also observed.

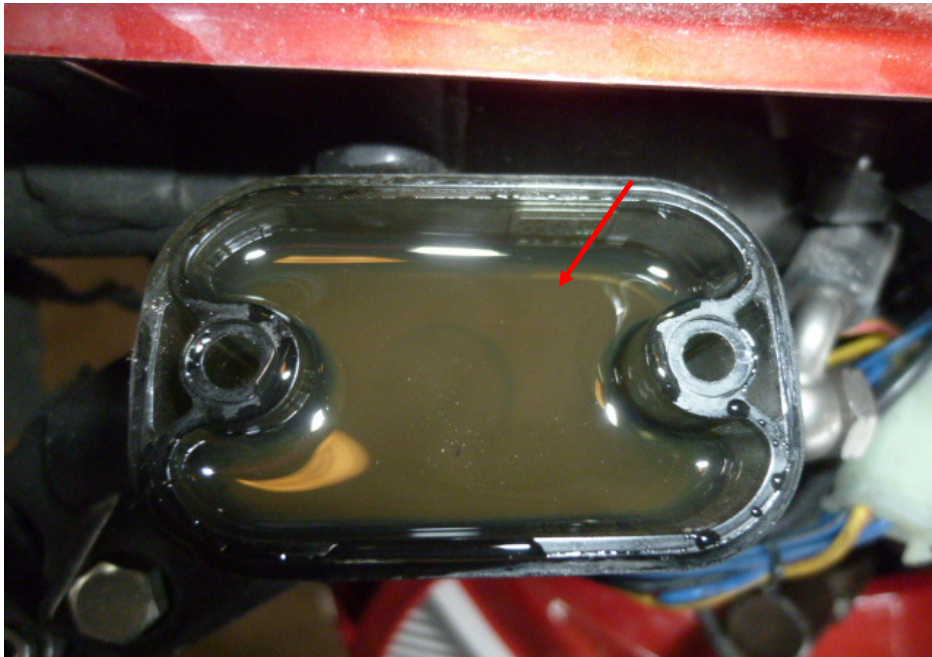
Photo 23 shows the brake fluid reservoir for the front brake of the Motorcycle. The brake fluid was found to be of sufficient level for operating purposes. However the brake fluid was found to be contaminated (arrowed).

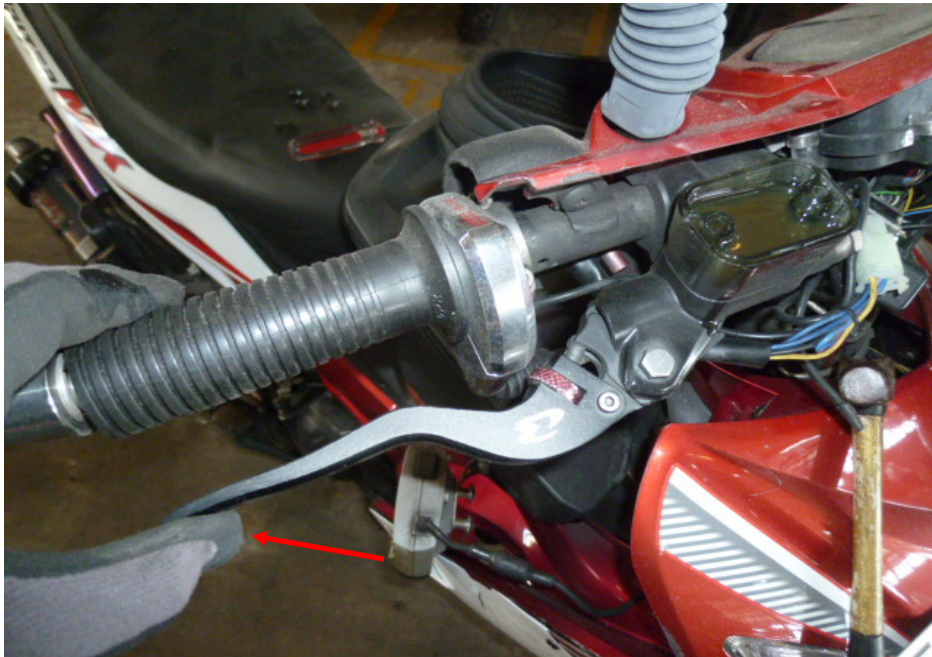
13. Static brake tests conducted on the Motorcycle had appeared to indicate that the front brake system of the Motorcycle was in serviceable condition. There was some resistance felt (spongy like feel) upon pressing the front brake lever. This would indicate that there's no leakage of pressure/vacuum in the front brake system.
14. For this case, we were not able to carry out any operational tests to the steering system and braking system of the Motorcycle due to the damage of its front forks, which had rendered the Motorcycle immobile for the operational tests. We were not able to push the Motorcycle manually forward and backward, simulating movement of the Motorcycle, for the operational tests. See photos 21 – 25 below.

Photo 24 shows the front brake lever being depressed. There was some resistance felt (spongy like feel) upon pressing the front brake lever (arrowed). This would indicate that there is no leakage of pressure/vacuum in the front brake system.

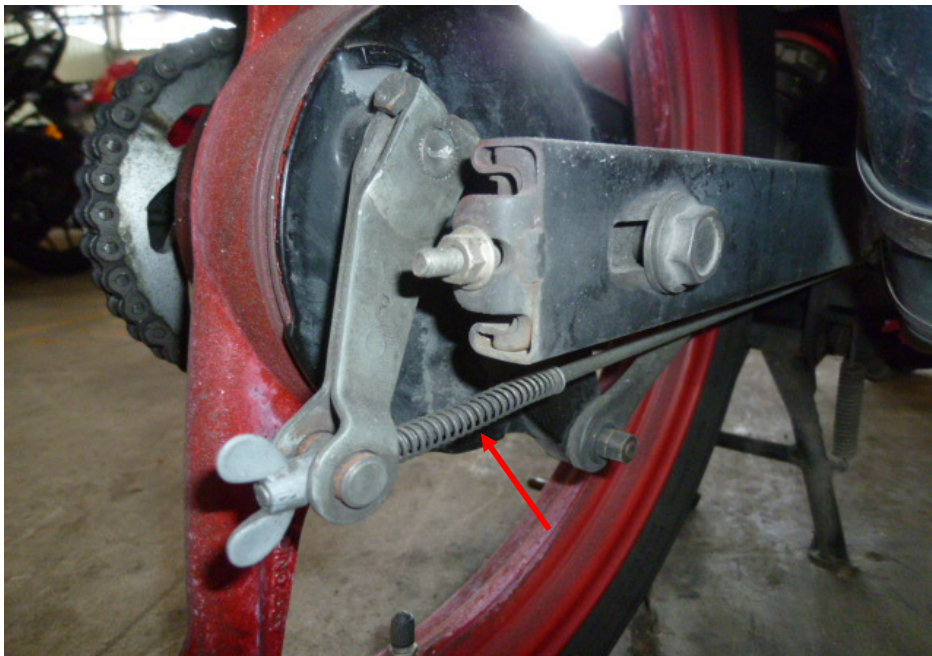
Photo 25 shows the rear wheel of the Motorcycle. The type of brake system for the rear wheel was of a mechanical type, controlled by the brake foot pedal of the Motorcycle. Our checks of the cable (arrowed), spring and drum which are all part of the components in the rear brake system of the Motorcycle reveal all to be intact and without damage.
