Your Ref: TP/IP/22475/2022
Our Ref : CI/TPD22011550/N

Fatal Accident Investigation Team

INSPECTION REPORT OF MOTORCYCLE FBM 9526Z

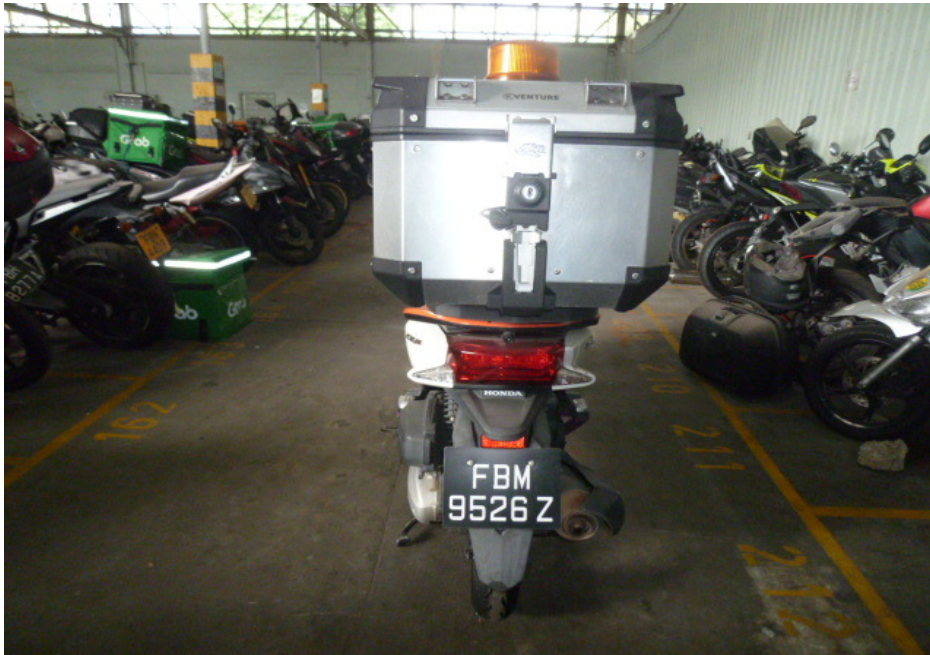
Photo 1 shows a general view of the rear portion of the Motorcycle at the time of our inspection. The Motorcycle was observed to have sustained minor damages at the frontal portion and left body.

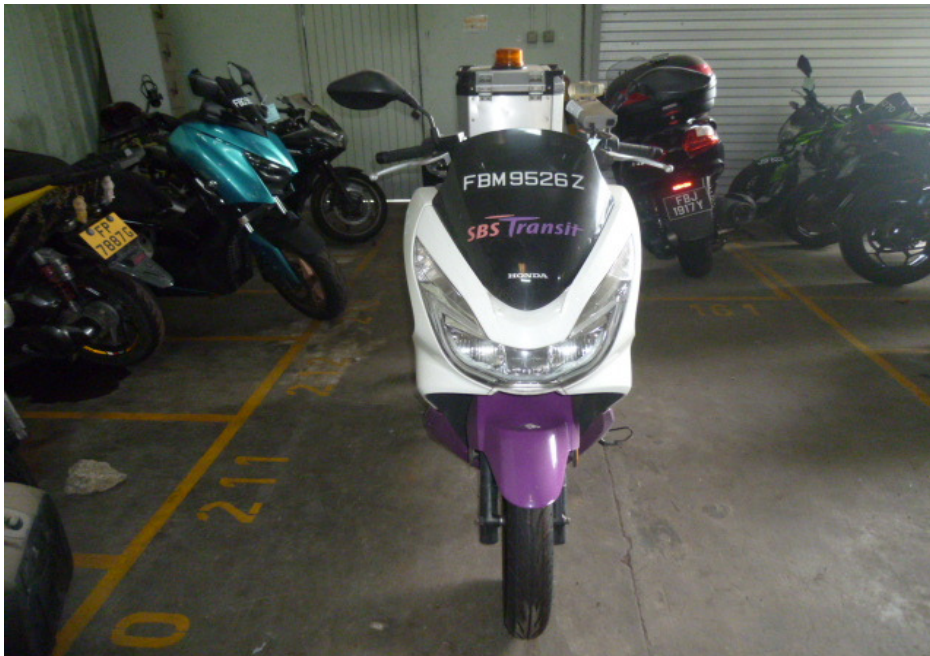
Photo 2 shows a general view of the frontal portion of the Motorcycle at the time of our inspection. The Motorcycle was observed to have sustained minor damages at the frontal portion and left body.

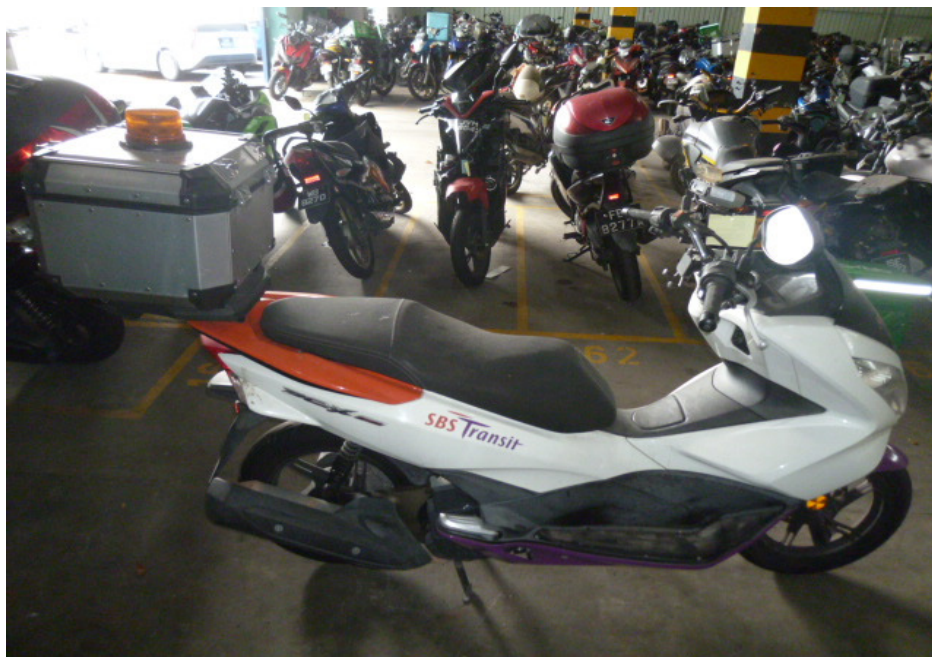
Photo 3 shows a general view of the right body of the Motorcycle at the time of our inspection. The Motorcycle was observed to have sustained minor damages at the frontal portion and left body.

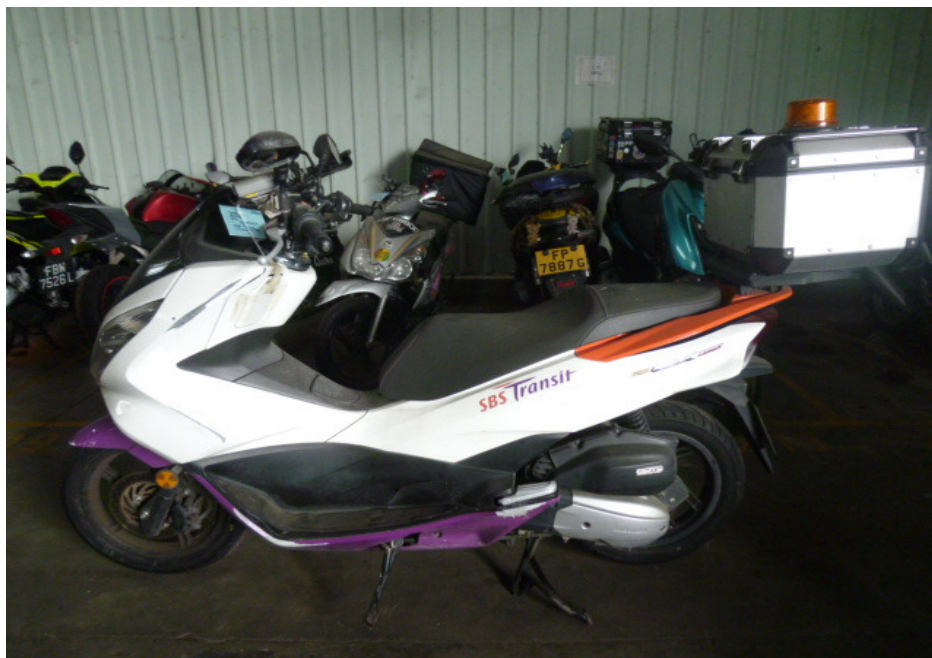
Photo 4 shows a general view of the left body of the Motorcycle at the time of our inspection. The body parts that were found to have been damaged include its front mudguard, rear brake lever, left side mirror, left handlebar end, left side cowl, left rear bottom cowl, main stand, left pillion footpeg and top box, amongst others as a result of the accident.

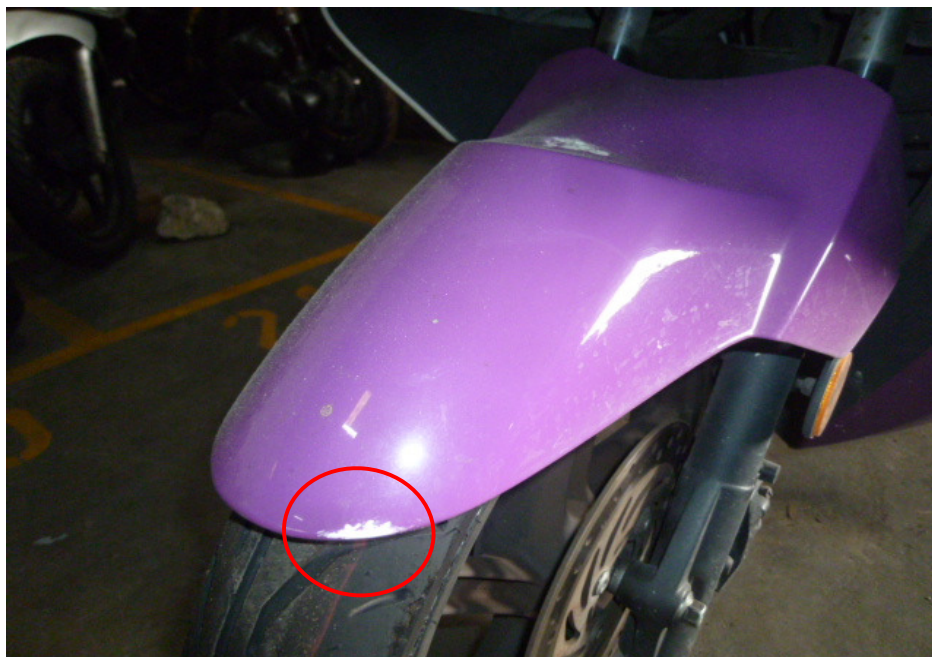
Photo 5 shows a closer view of the front mudguard which was amongst the body parts at the front body of the Motorcycle that had sustained damage as a result of the accident (circled).

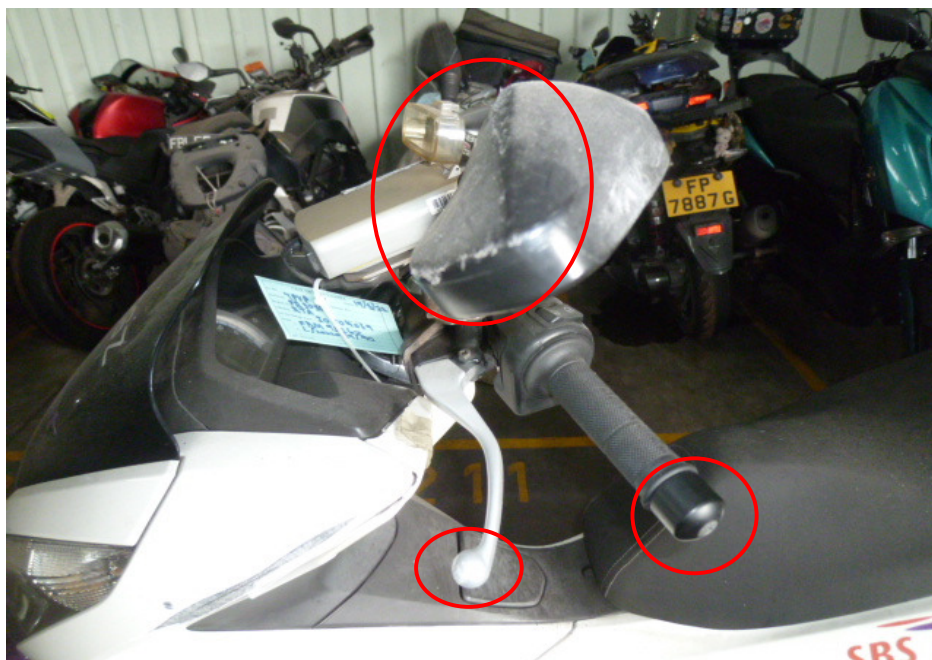
Photo 6 shows a closer view of the left side mirror, left handlebar end and rear brake lever of the Motorcycle which were observed to be damaged due to the accident (circled).

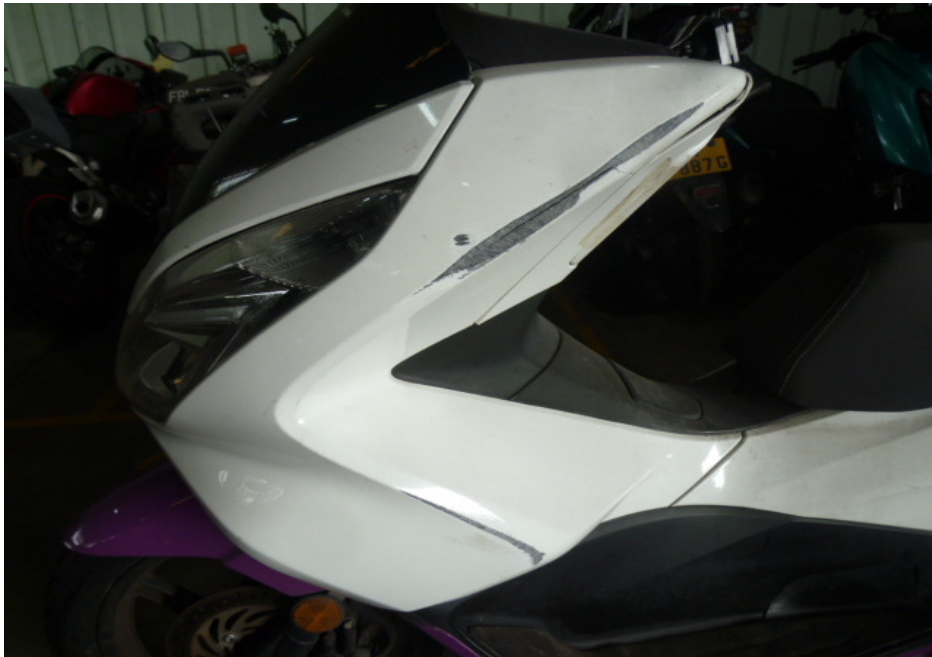
Photo 7 shows the damaged left side cowling of the Motorcycle. The damage sustained was mainly of grazing nature.

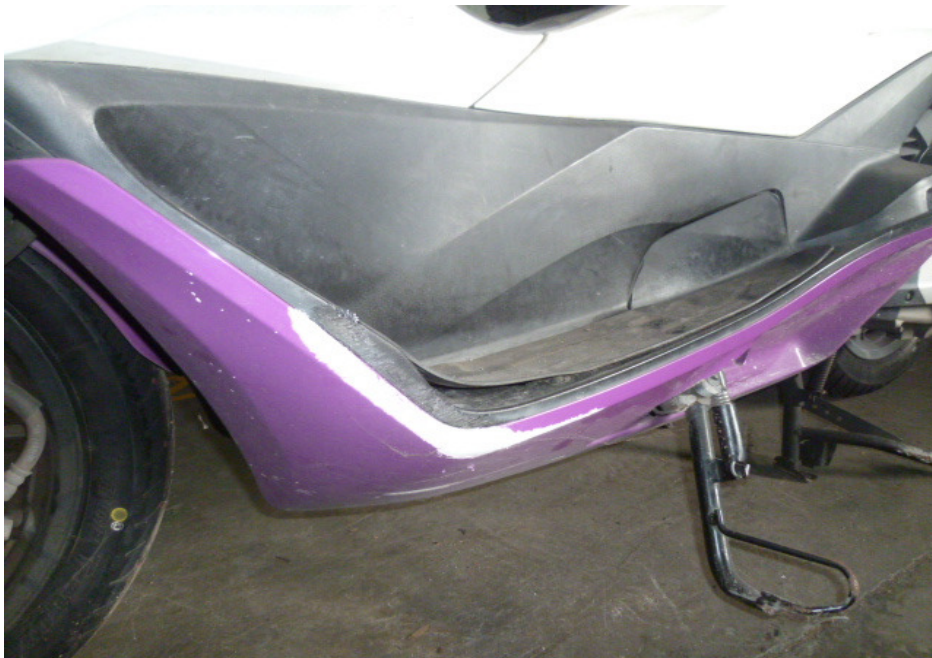
Photo 8 shows a close-up view of the left lower side cowling of the Motorcycle at the time of our inspection. The damage sustained was mainly of grazing nature.

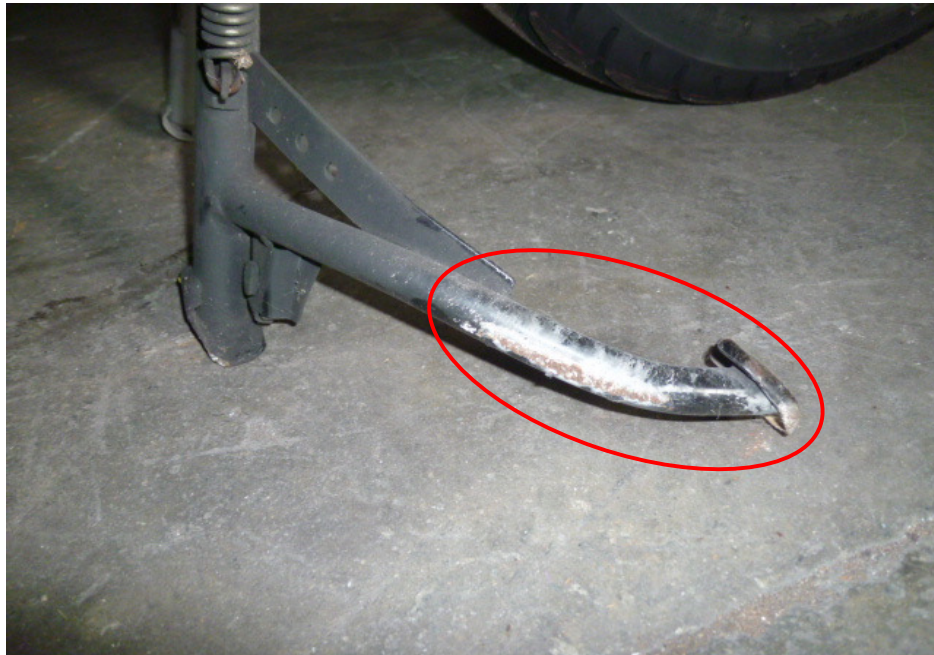
Photo 9 shows a closer view of the grazed main stand of the Motorcycle at the time of our inspection (circled).

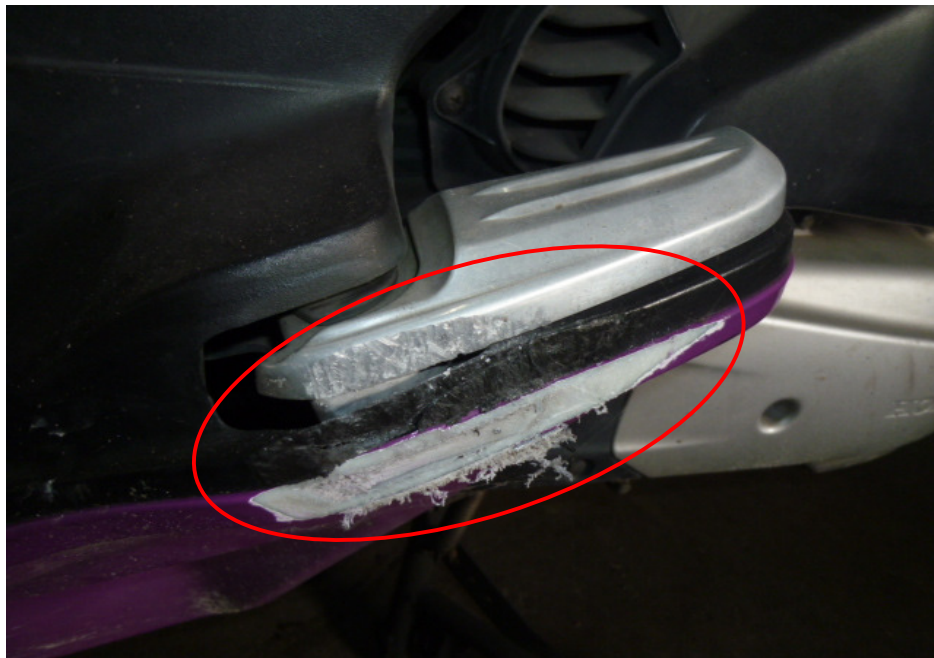
Photo 10 shows a closer view of the damaged left pillion footpeg and left rear bottom cowling of the Motorcycle at the time of our inspection (circled).

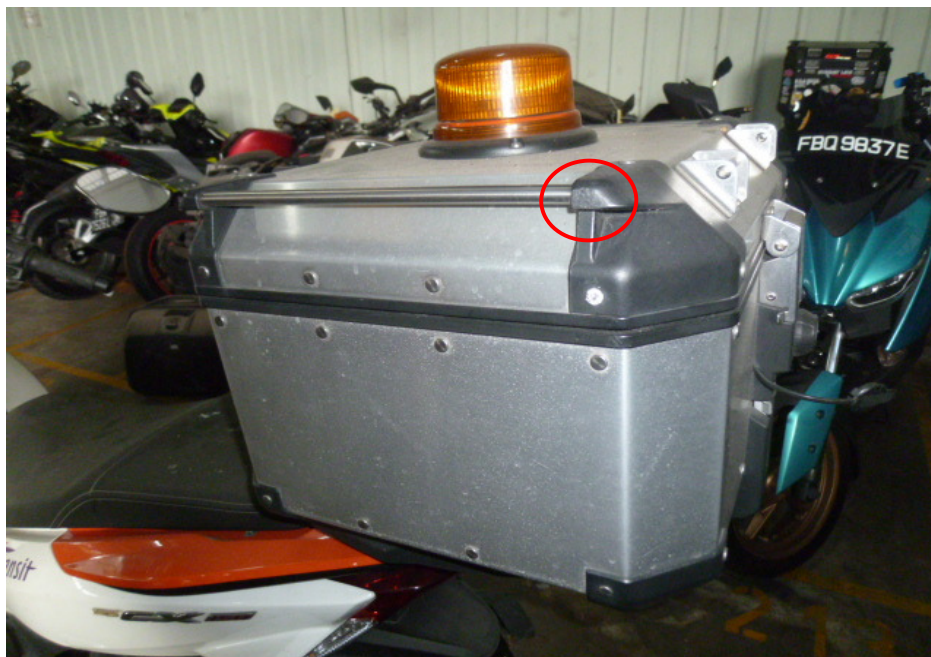
Photo 11 shows a closer view of the top box of the Motorcycle which had sustained damages of grazing nature due to the accident (circled).

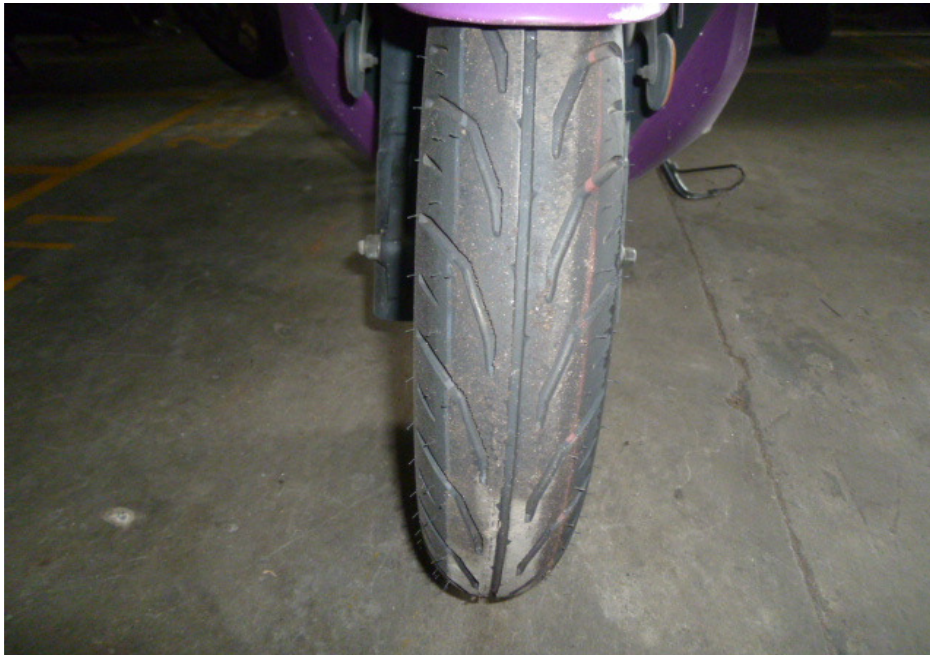
Photo 12 shows the condition of the Motorcycle's front tyre. The front tyre was observed to be in serviceable condition with remaining tread depth of approximately 3mm. There was no tear, burst mark(s) and/or punctured hole(s) on the sidewalls as well as across the tread of the front tyre.

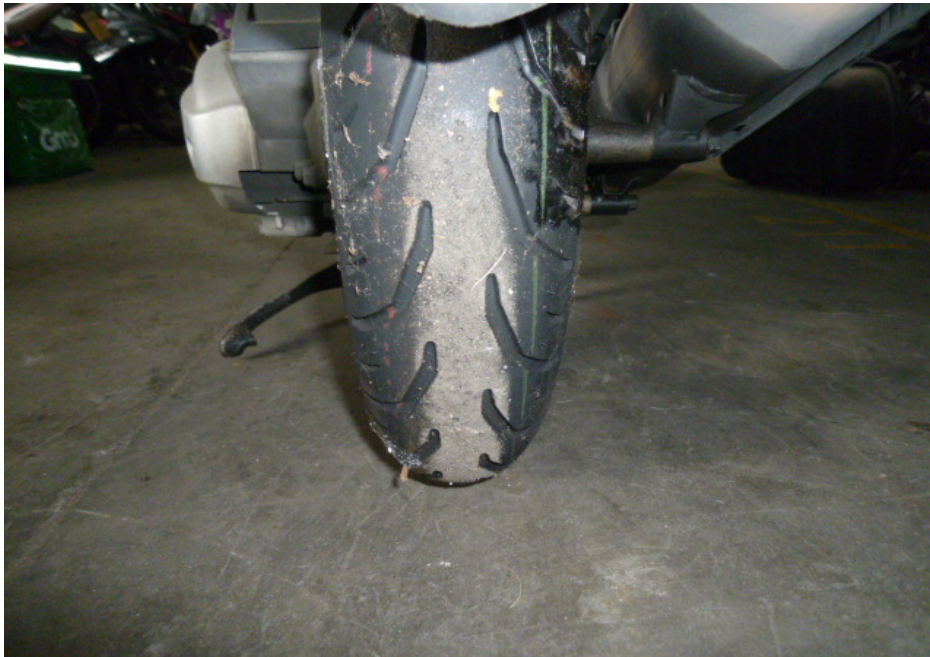
Photo 13 shows the condition of the Motorcycle's rear tyre. The rear tyre was observed to be in serviceable condition with remaining tread depth of approximately 5mm. The tyre was also observed to be sufficiently inflated for vehicular operation. We did not observe any tear, burst mark(s) and/or punctured hole(s) on the sidewalls as well as across the tread of the rear tyre.

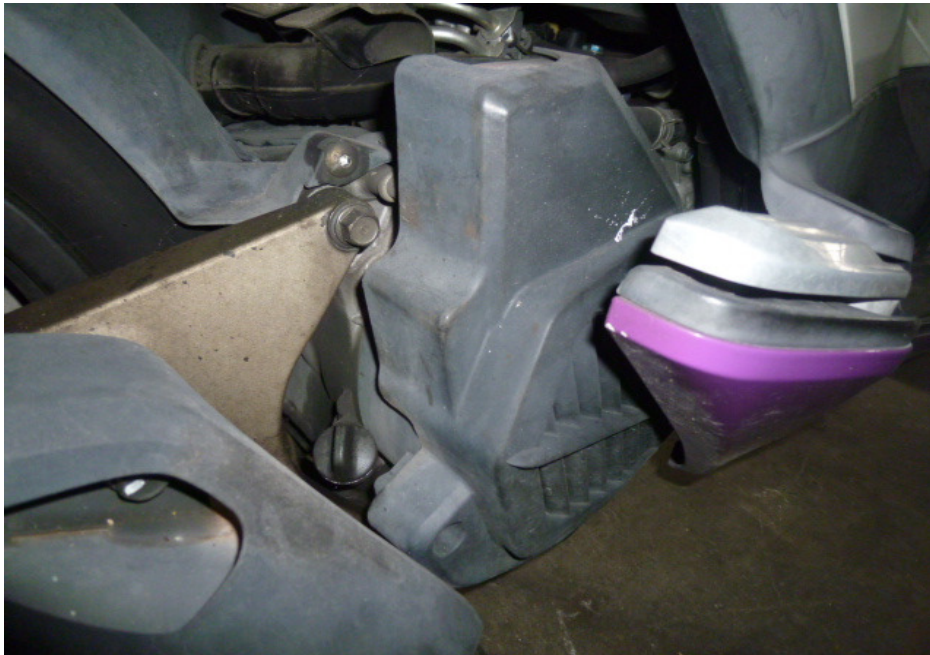
Photo 14 shows the radiator of the Motorcycle at the time of our inspection. The radiator was found to be intact with no visible damage. There was also no sign(s) or indication(s) of fluid leak observed around the radiator of the Motorcycle.

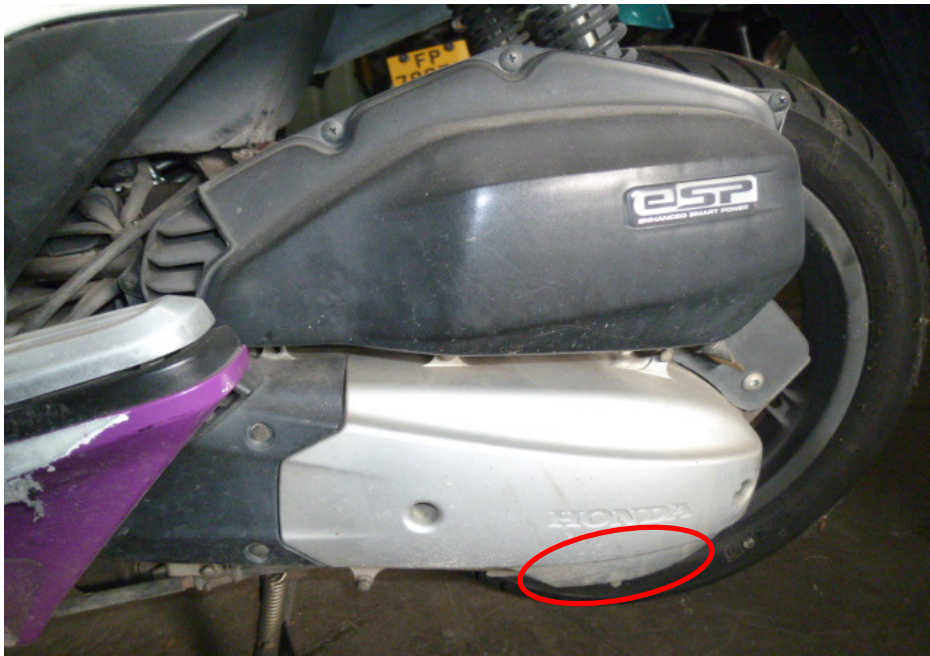
Photo 15 shows the drive train of the Motorcycle which was found to be intact without any misalignment. However the drive train cover had sustained damages of grazing nature as a result of the accident (circled). Upon examination of the Motorcycle's engine area, we had observed that the various engine related parts and components were intact with no visible damage. There was also no sign(s) or indication(s) of fluid leak observed around the engine area of the Motorcycle.

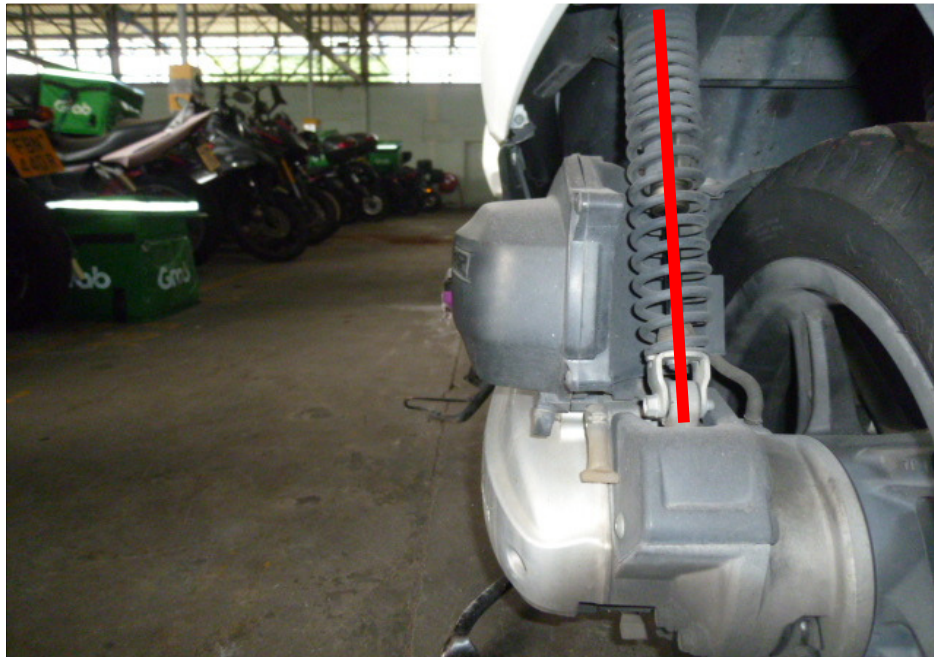
Photo 16 shows the left shock absorber of the Motorcycle which was found to be intact without any misalignment.

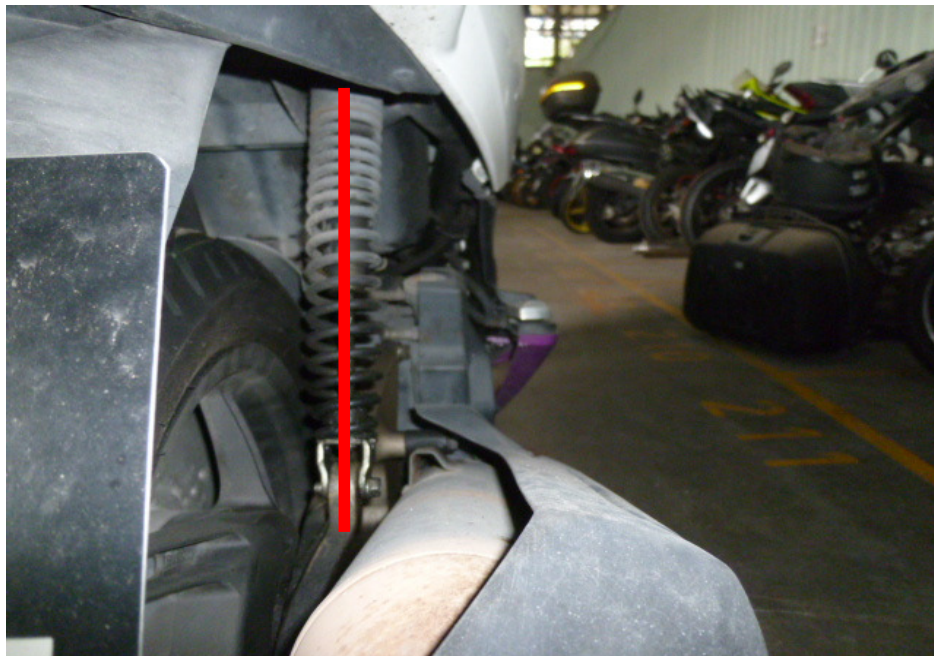
Photo 17 shows the right shock absorber of the Motorcycle which was found to be intact without any misalignment.

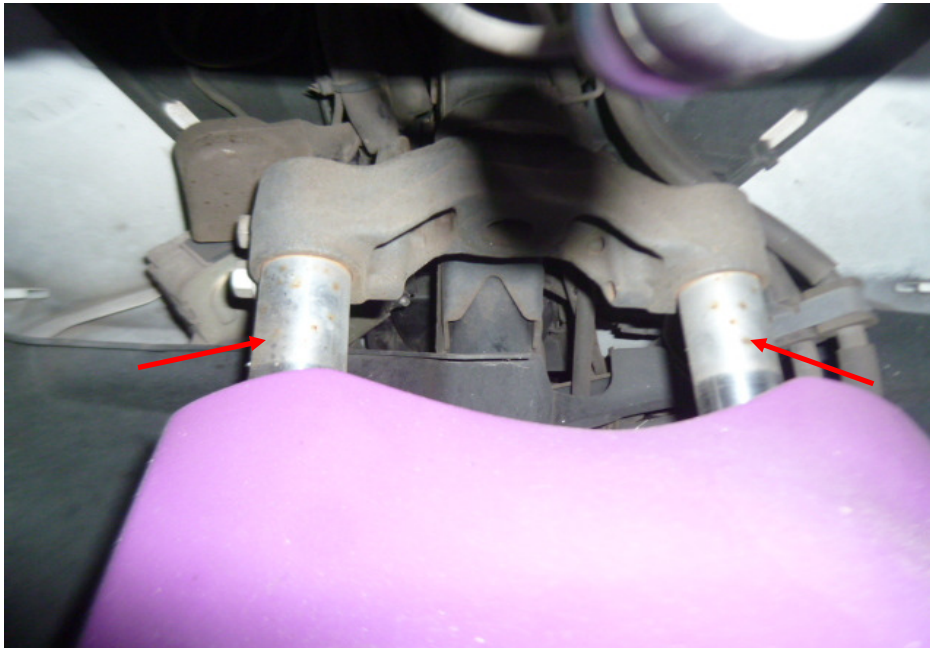
Photo 18 shows the front forks (arrowed) of the Motorcycle. The front forks and fork brackets of the Motorcycle were both found to be intact and undamaged. Turning the Motorcycle's handle bar towards the left and right did not produce any abnormal free play and/or resistance. The steering system of the Motorcycle was in serviceable condition at the time of our inspection.

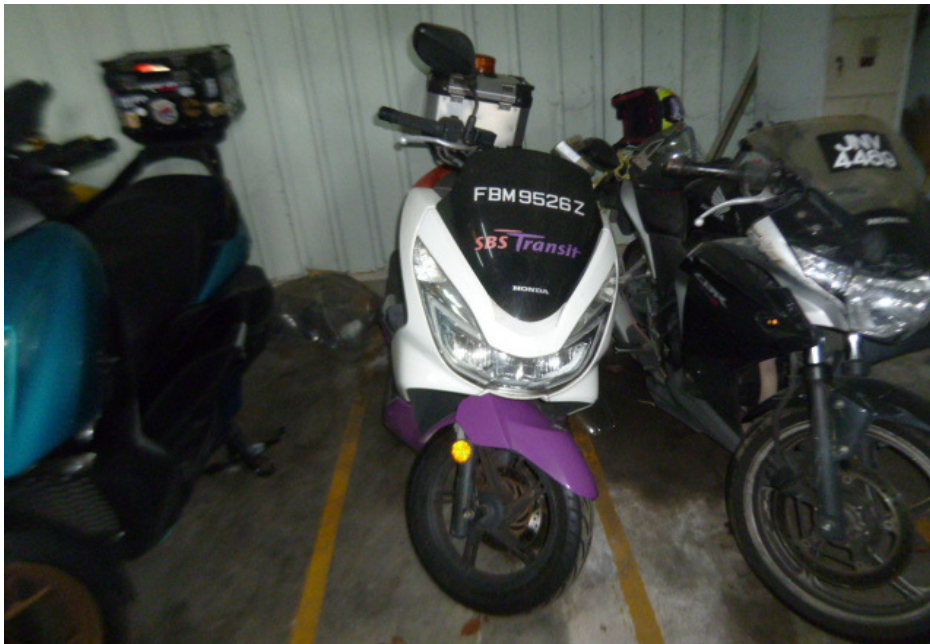
Photo 19 shows the front wheel of the Motorcycle turned towards its full left. Turning the Motorcycle's handle bar towards the left and right did not produce any abnormal free play and/or resistance. This would indicate that the steering system of the Motorcycle was in serviceable condition at the time of our inspection.

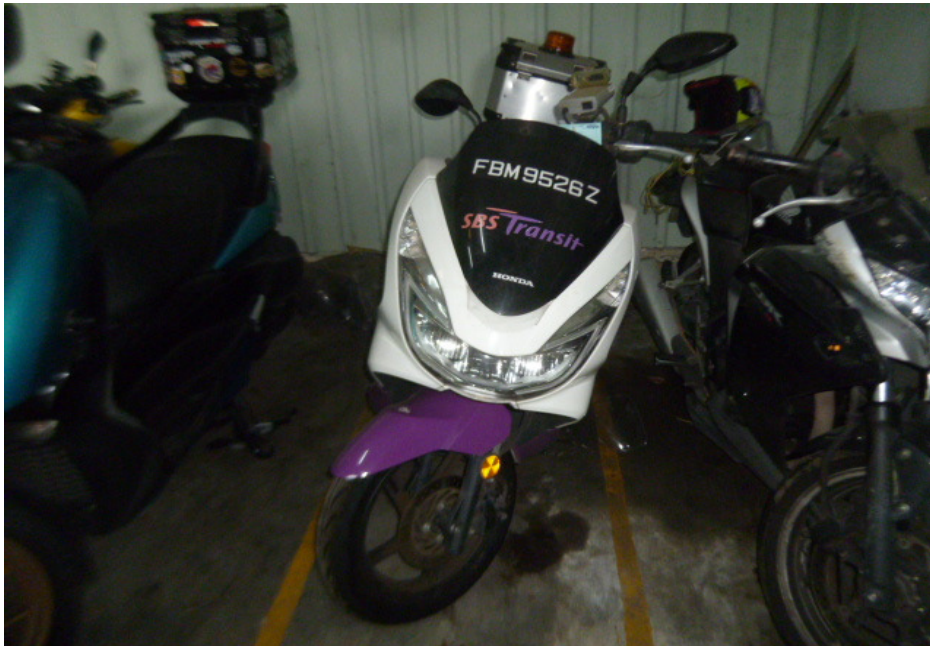
Photo 20 shows the front wheel of the Motorcycle turned towards its full right. Turning the Motorcycle's handle bar towards the left and right did not produce any abnormal free play and/or resistance. This would indicate that the steering system of the Motorcycle was in serviceable condition at the time of our inspection.

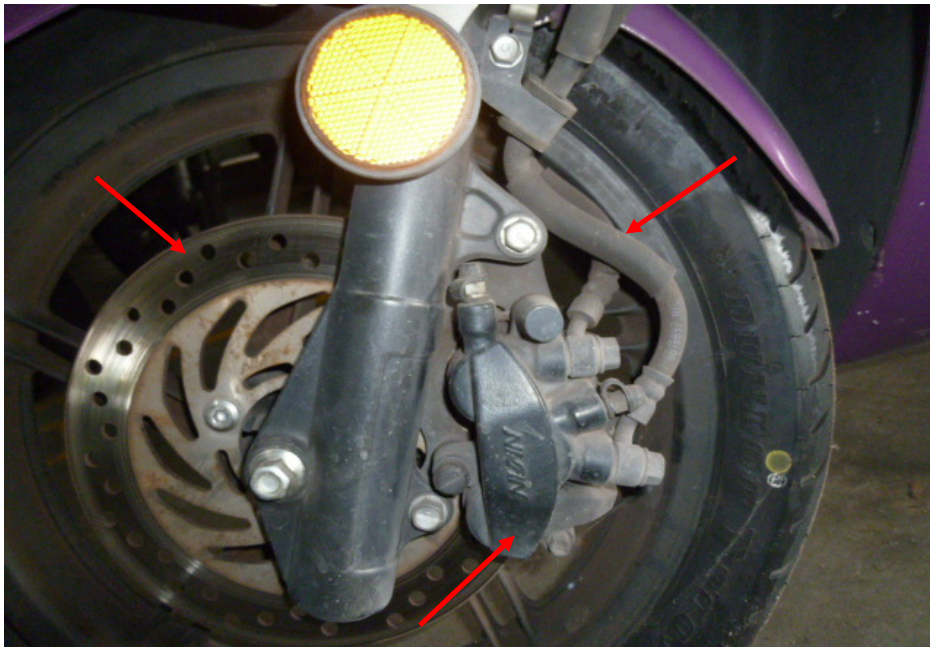
Photo 21 shows a close up view of the front brake caliper, front brake disc and front brake hose (arrowed) of the Motorcycle, which are all part of the components in the hydraulic front brake system of the Motorcycle. Our visual checks of these various components had revealed all to be intact with no visible damage. No leakage of brake fluid was also observed.

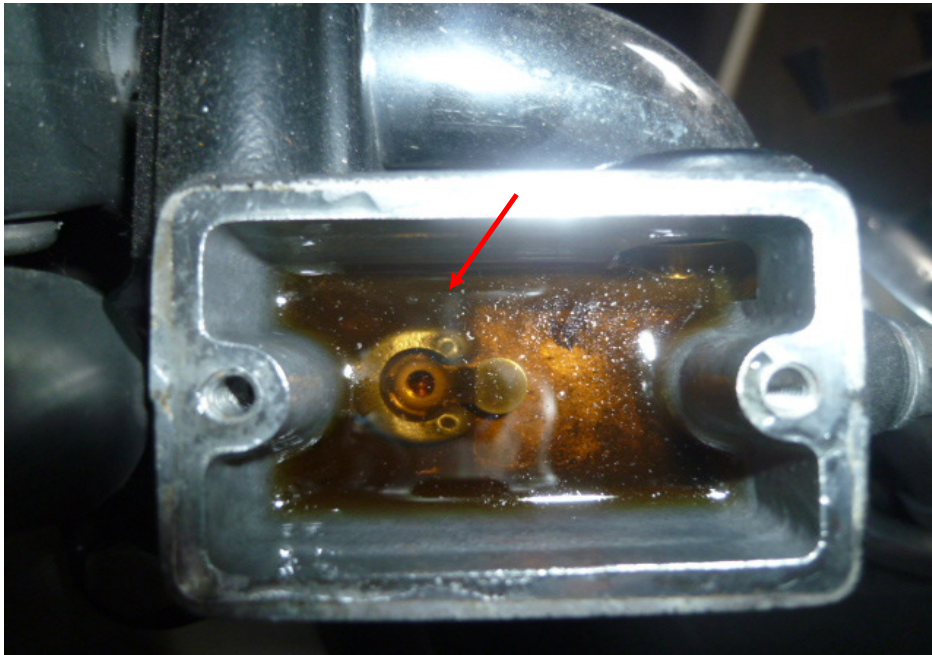
11. The brake system of the Motorcycle was of a semi-hydraulic type, where hydraulic (brake fluid) pressure controls the brake for the front wheel while the brake for the rear wheel is controlled by mechanical means (cables and springs). Our visual examination of the various components in the brake system, like the brake disc, brake caliper, drum, brake lever and brake foot pedal, revealed all to be intact and without damage. There was also no visible tear or cut observed on the connecting hoses and cables. Our checks on the brake fluid had also indicated that the front brake fluid was of sufficient level for operational purposes. However it was found to be slightly contaminated.

Photo 22 shows the brake fluid reservoir for the front brake of the Motorcycle. The brake fluid was observed to be of sufficient level for operational purposes. However it was found to be slightly contaminated (arrowed).

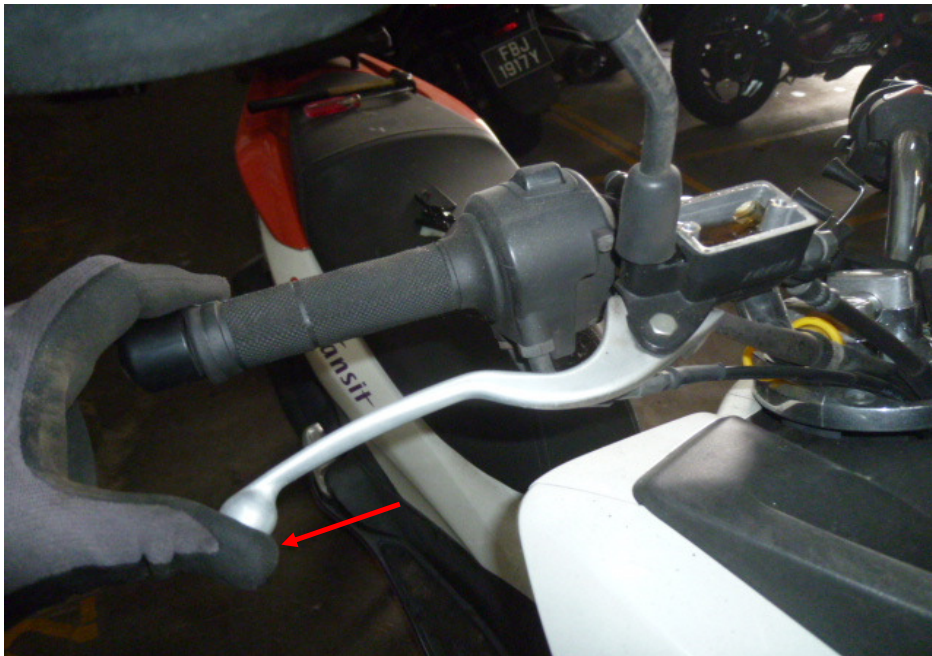
12. Static brake tests conducted on the Motorcycle had appeared to indicate that the brake system of the Motorcycle was in serviceable condition. There was some resistance felt (spongy like feel) upon pressing the front brake lever. This would indicate that there's no leakage of pressure/vacuum in the front brake system.

Photo 23 shows the front brake lever being depressed. There was some resistance felt (spongy like feel) upon pressing the front brake lever (arrowed). This would indicate that there is no leakage of pressure/vacuum in the front brake system.

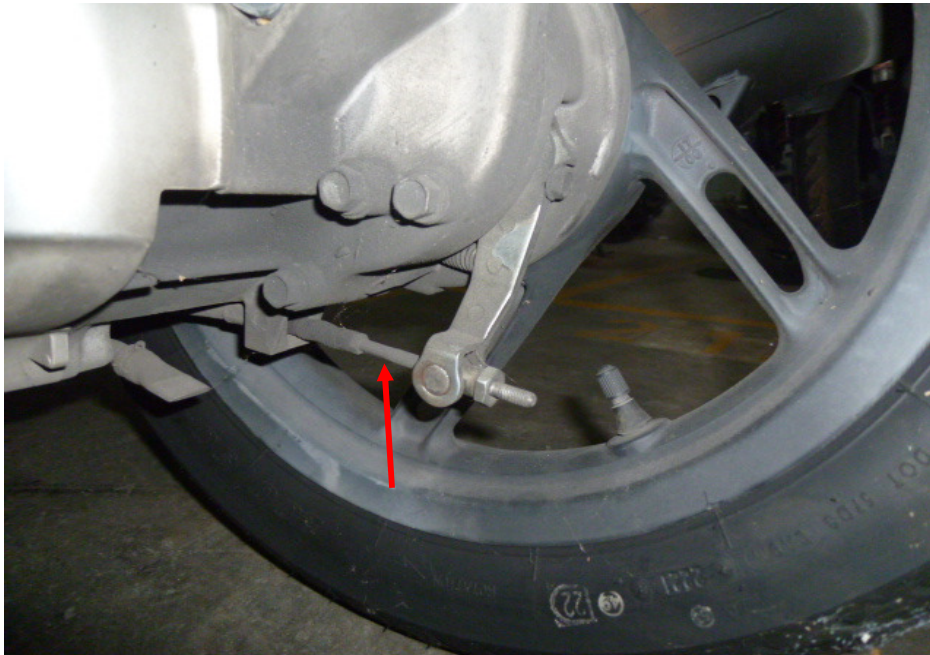
Photo 24 shows the rear wheel of the Motorcycle. The type of brake system for the rear wheel was of a mechanical type, controlled by the brake foot pedal of the Motorcycle. Our checks of the cable (arrowed), spring and drum which are all part of the components in the rear brake system of the Motorcycle reveal all to be intact and without damage.
