Your Ref: TP/IP/26022/2022  
Our Ref : CI/TPD22011553/N

17 November 2022

**Fatal Accident Investigation Team**

**INSPECTION REPORT OF MOTORCYCLE JNV 4469**

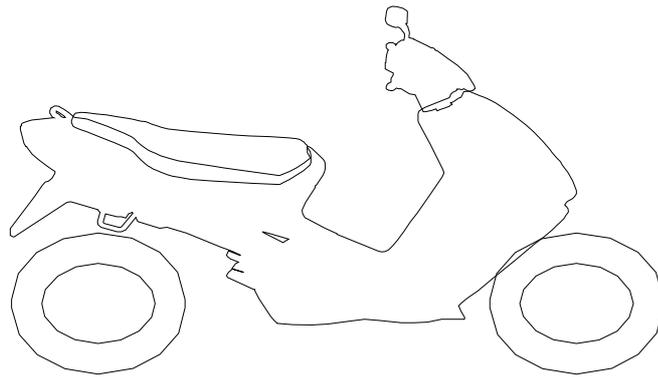
7. The front tyre was both observed to be sufficiently inflated for vehicular operation. However the rear tyre was observed to be deflated. The tyre brand, tyre size and remaining tread depth of the 2 tyres were recorded as follows:-

Pirelli 150/60 - 17 (3mm)  
(Deflated)

Pirelli 110/70 - 17 (3mm)

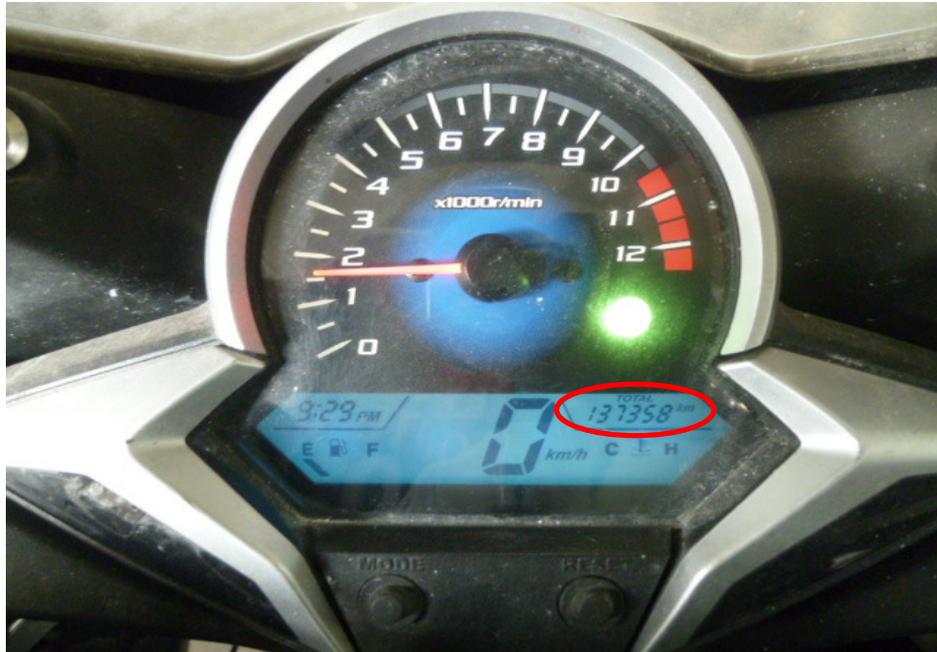
**Photo 1** shows the speedometer gauge of the Motorcycle. The mileage of the Motorcycle at the time of our inspection was 137, 358km (circled).

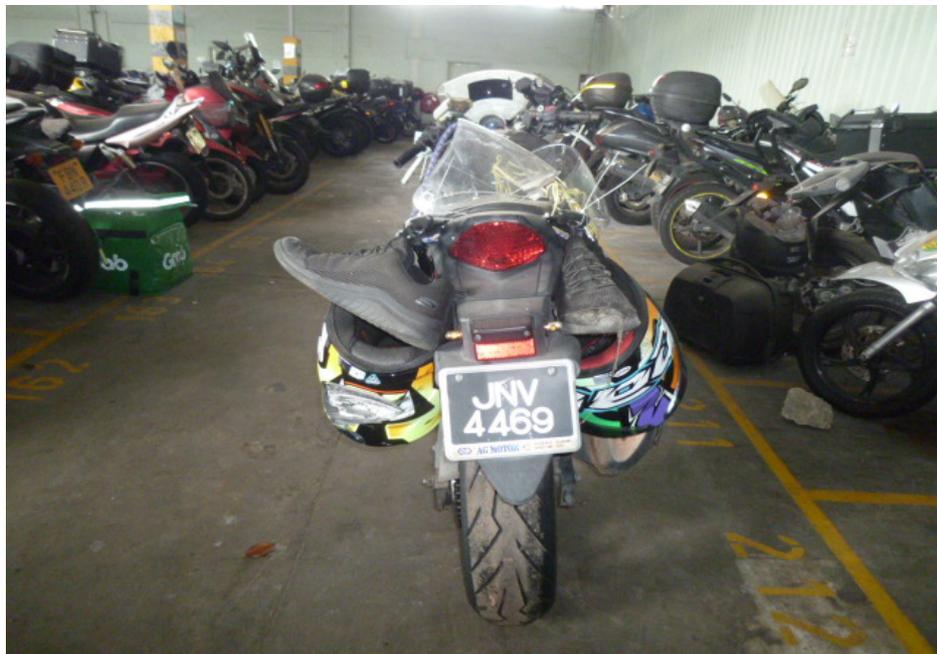
**Photo 2** shows a general view of the rear portion of the Motorcycle at the time of our inspection. The Motorcycle was observed to have sustained damages all around.

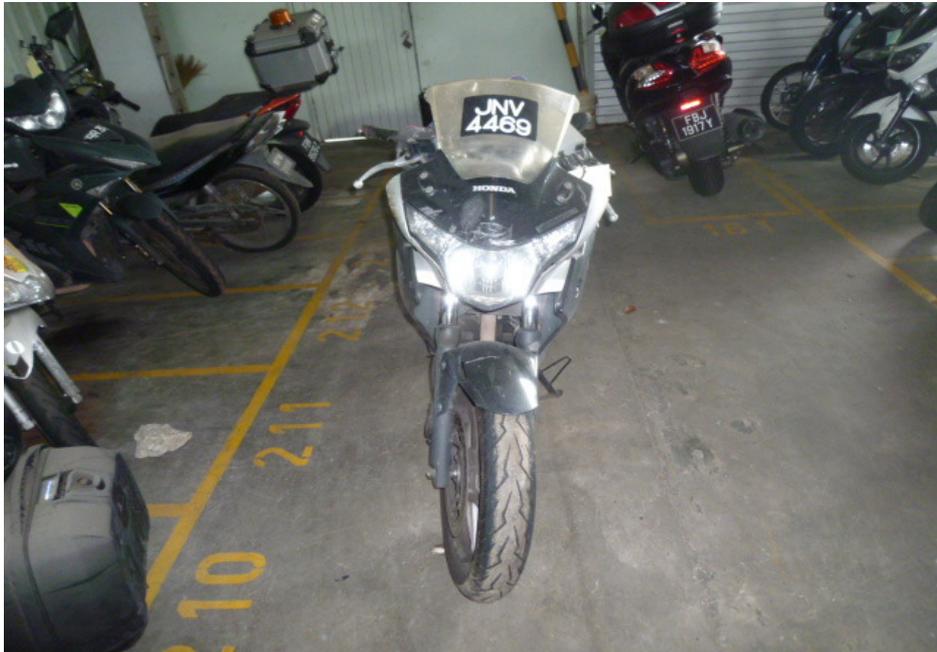
**Photo 3** shows a general view of the frontal portion of the Motorcycle at the time of our inspection. The Motorcycle was observed to have sustained damages all around.

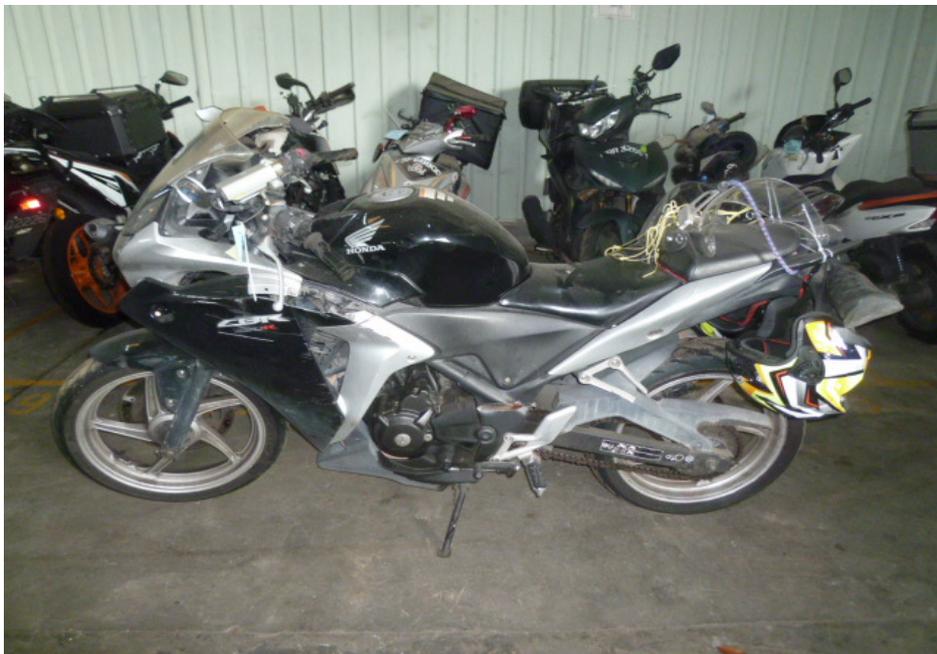
**Photo 4** shows a general view of the left body of the Motorcycle at the time of our inspection. The Motorcycle was observed to have sustained damages all around. The body parts that were found to have been damaged include its head cowling, front mudguard, side cowlings, right handlebar end, front brake lever, petrol tank, left subframe, rear brake pedal, right front footrest, right rear side cover and exhaust muffler heat shield, amongst others.

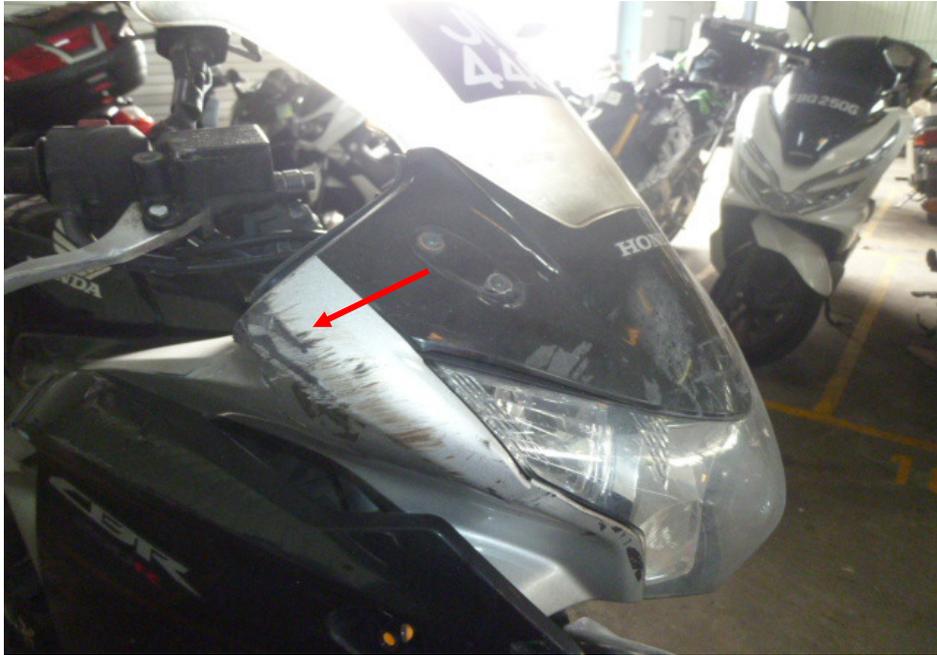
**Photo 5** shows the grazed head cowl (arrowed) of the Motorcycle as a result of the accident.

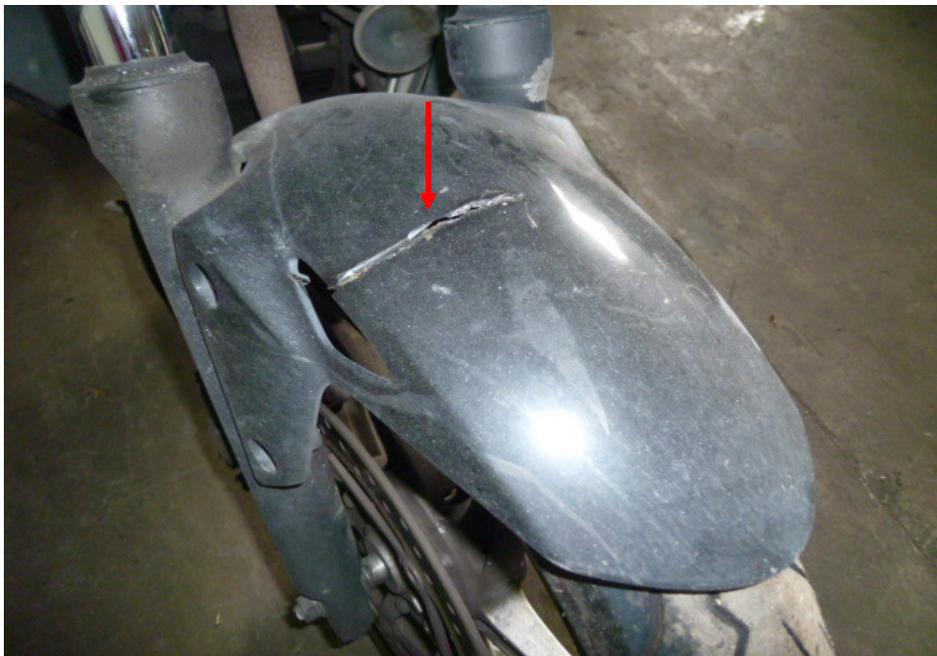
**Photo 6** shows a closer view of the front mudguard (arrowed) which was amongst the body parts of the Motorcycle that had sustained damage as a result of the accident.

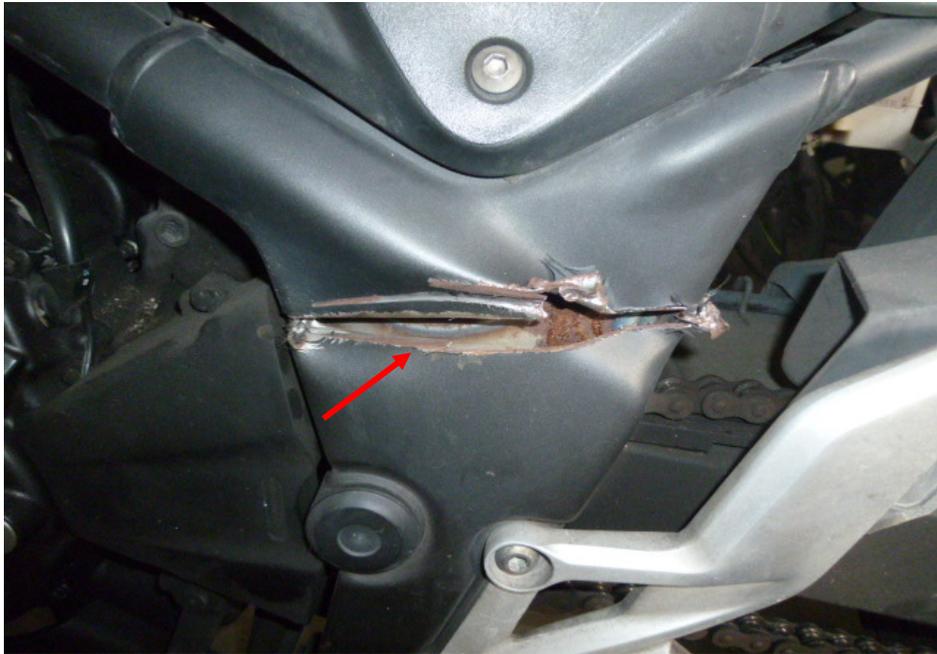
**Photo 7** shows a closer view of the deformed left subframe (arrowed) of the Motorcycle as a result of the accident.

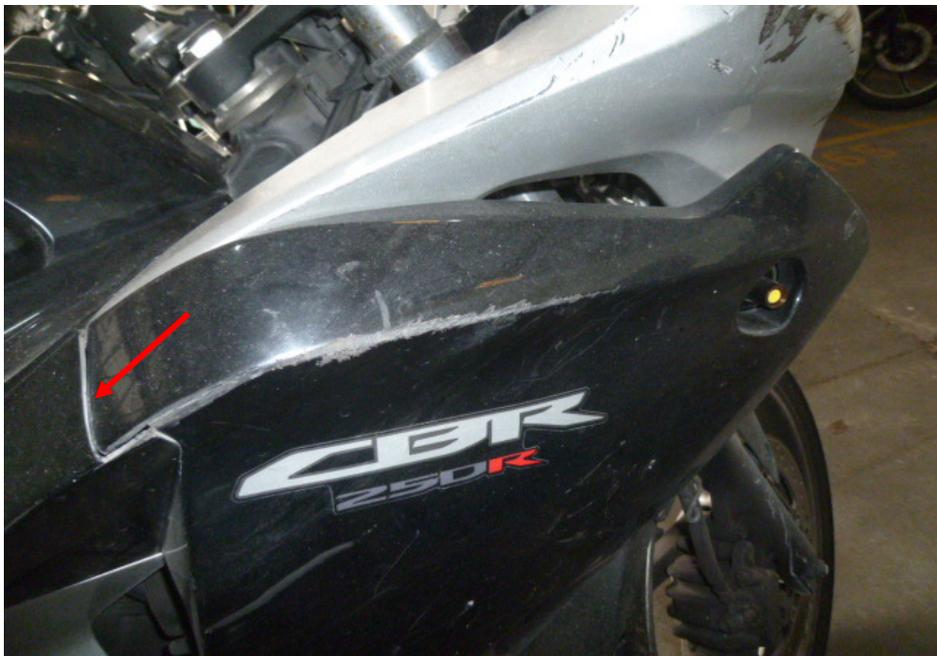
**Photo 8** shows a closer view of the cracked right cowling of the Motorcycle as a result of the accident (arrowed).

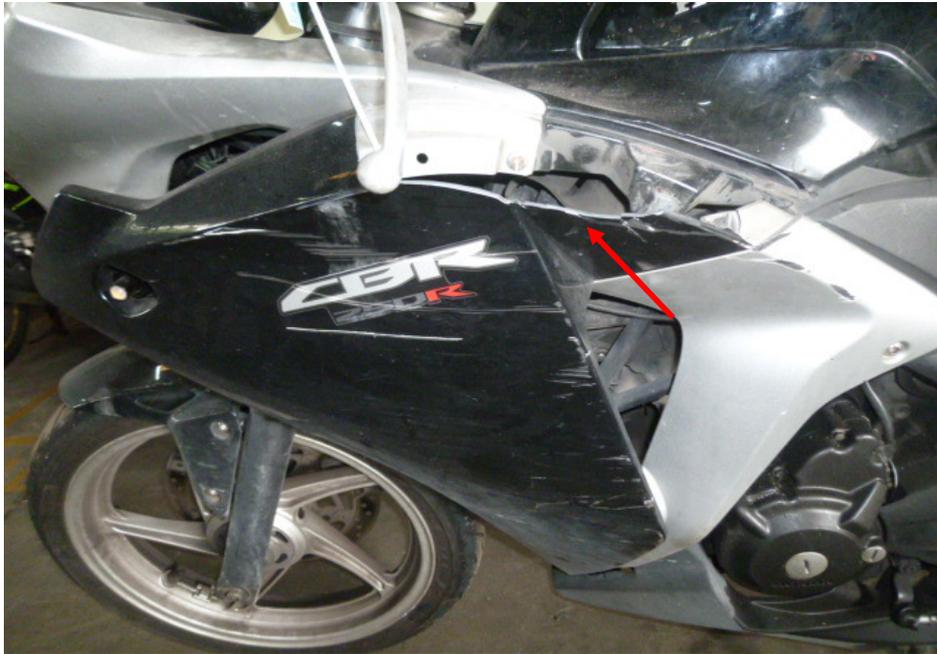
**Photo 9** shows a closer view of the cracked left cowling of the Motorcycle as a result of the accident (arrowed).

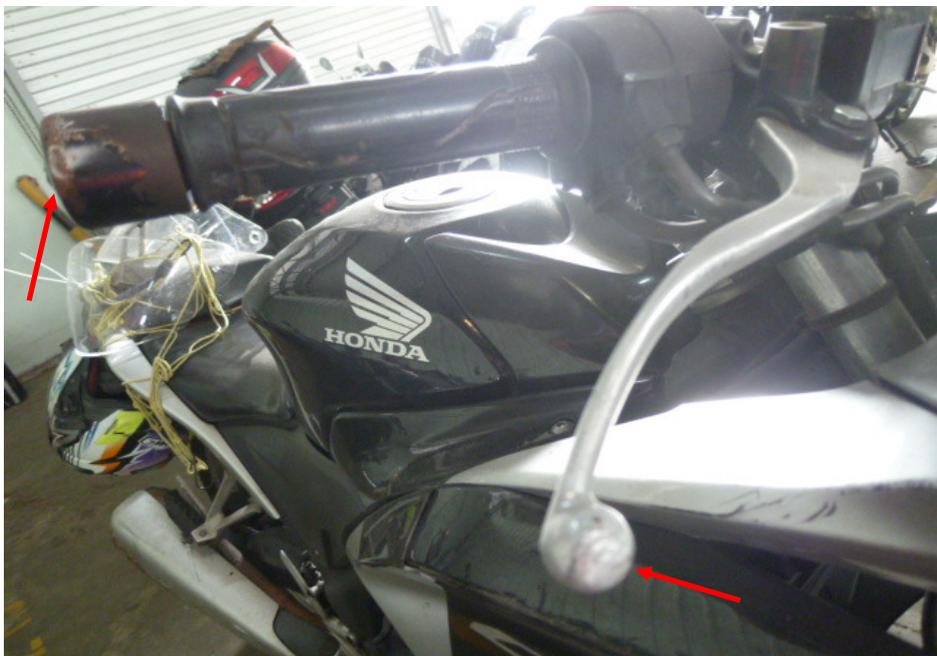
**Photo 10** shows the right handlebar end and front brake lever (arrowed), which were amongst the body parts of the Motorcycle that had sustained damage as a result of the accident.

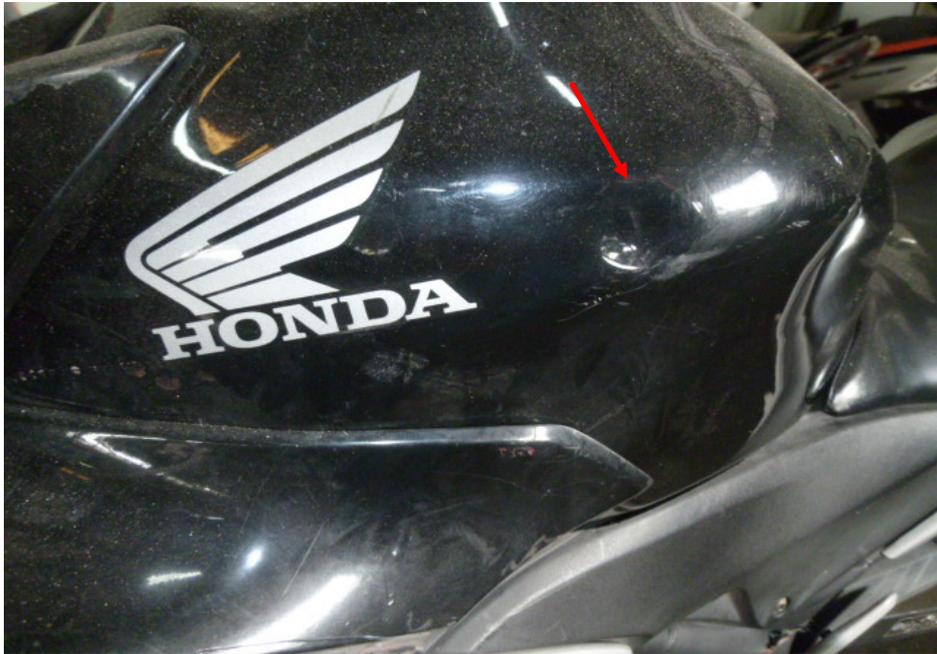
**Photo 11** shows a closer view of the dented petrol tank of the Motorcycle as a result of the accident (arrowed).

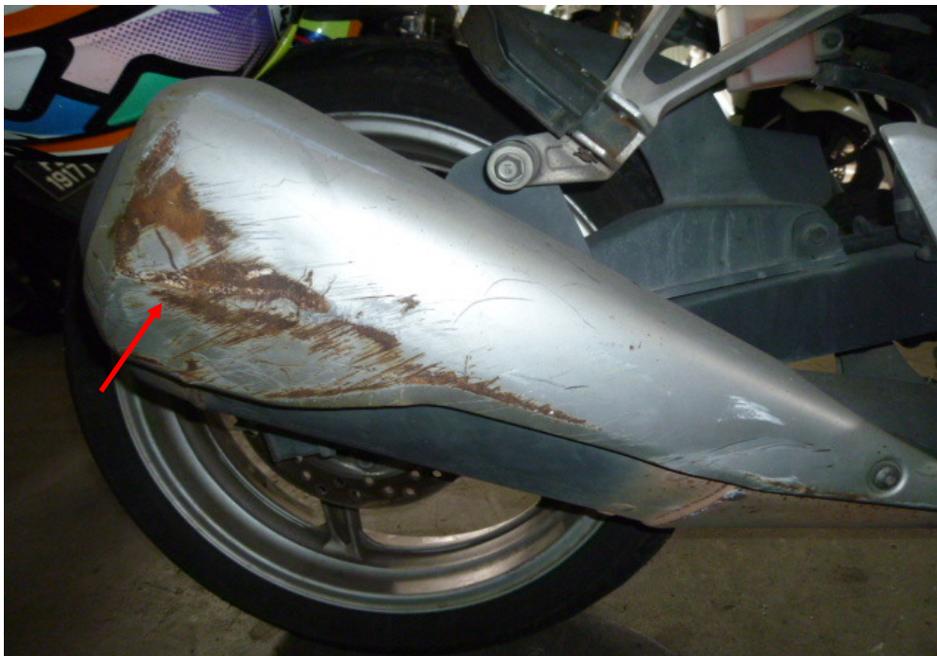
**Photo 12** shows a closer view of the grazed exhaust muffler heat shield (arrowed) of the Motorcycle as a result of the accident.

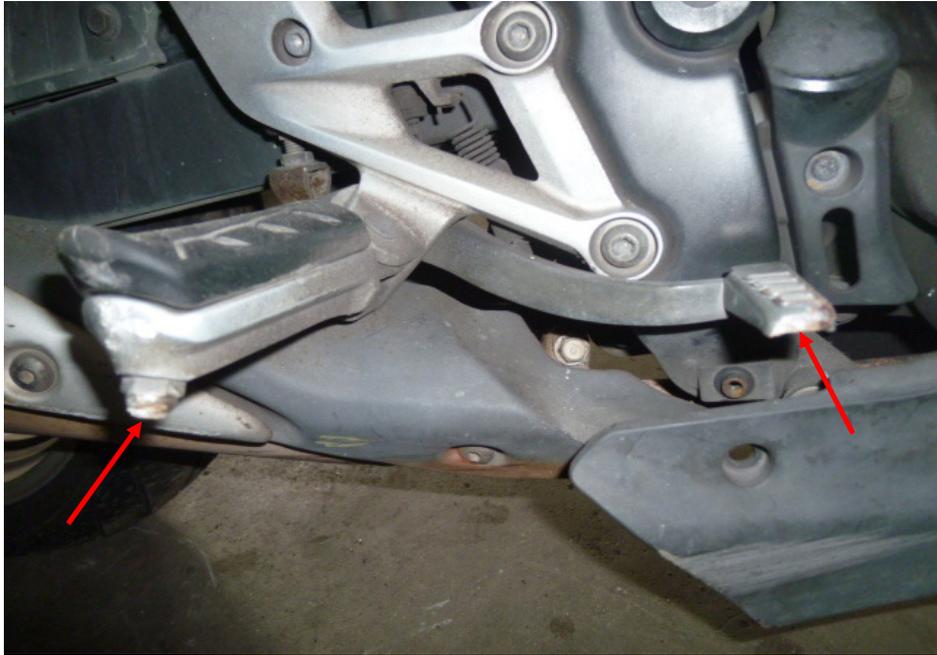
**Photo 13** shows the rear brake pedal and right front footrest of the Motorcycle that had sustained damage as a result of the accident (arrowed).

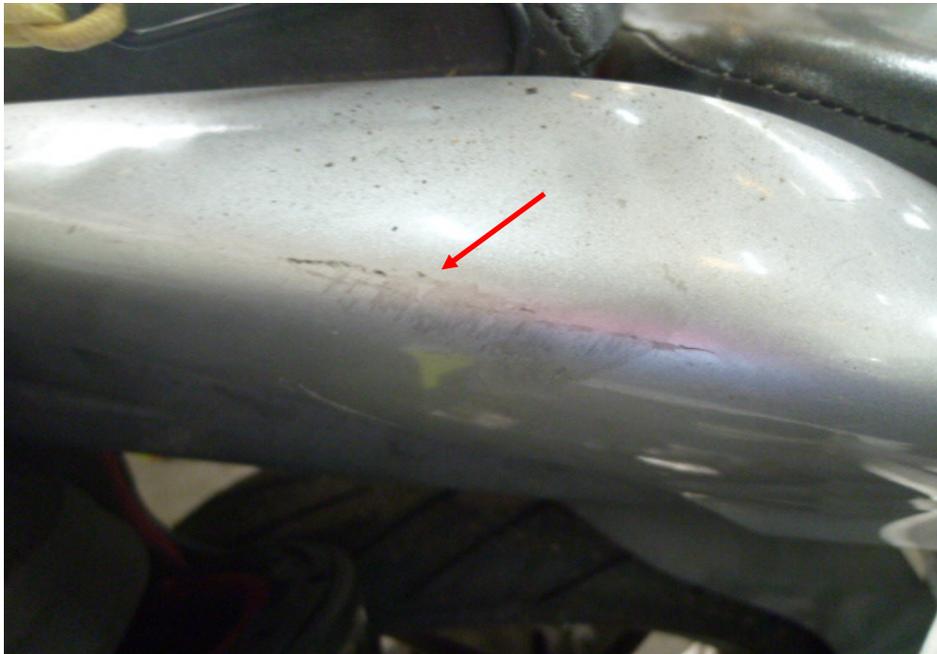
**Photo 14** shows a closer view of the grazed right rear side cover of the Motorcycle as a result of the accident (arrowed).

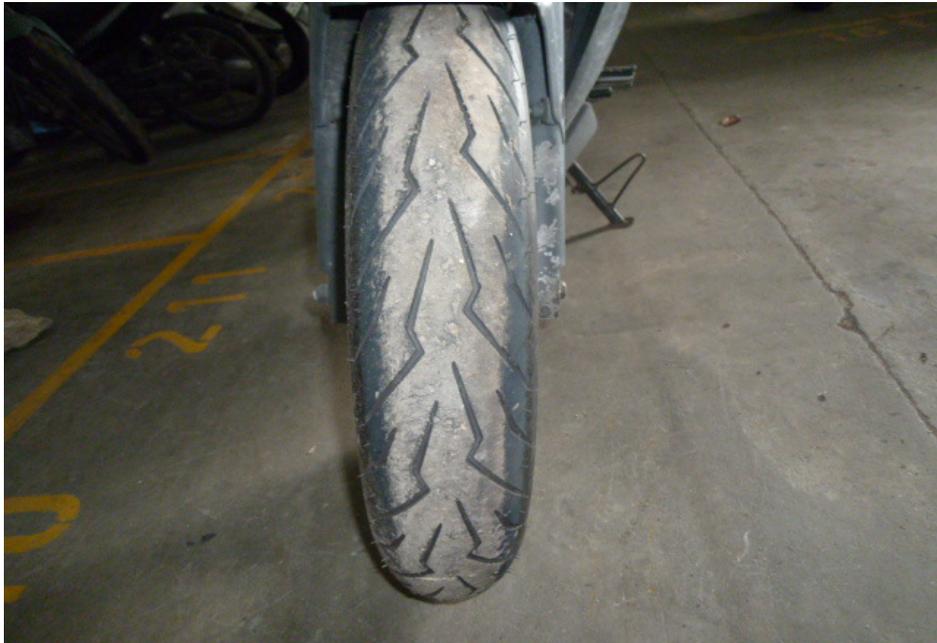
**Photo 15** shows the condition of the Motorcycle's front tyre. The front tyre was observed to be in serviceable condition with remaining tread depth of approximately 3mm. There was no tear, burst mark(s) and/or punctured hole(s) on the sidewalls as well as across the tread of the front tyre. The front tyre was also observed to be sufficiently inflated for vehicular operation.

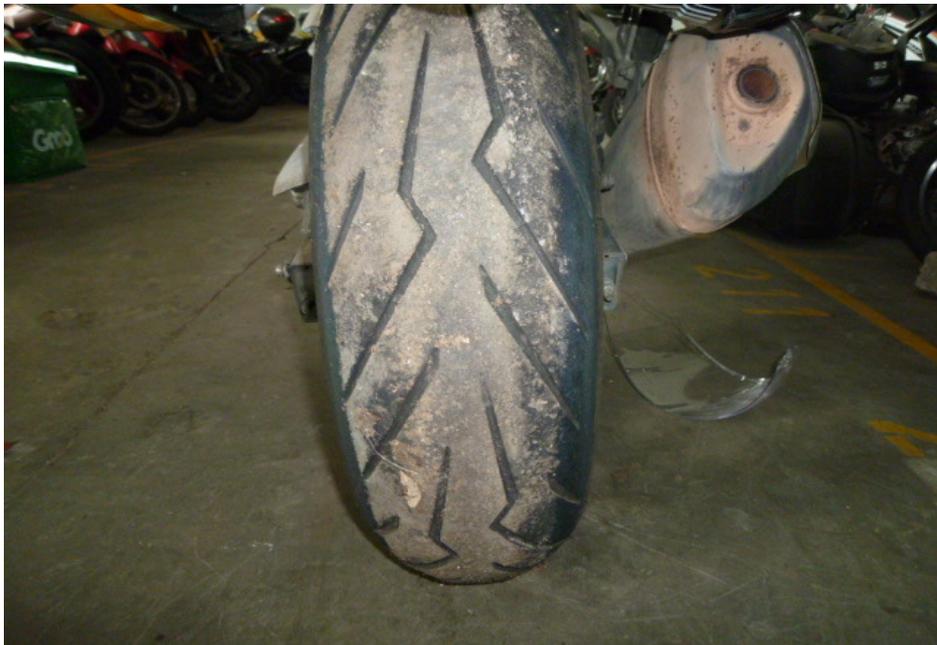
**Photo 16** shows the condition of the Motorcycle's rear tyre. The rear tyre was observed to be in serviceable condition with remaining tread depth of approximately 3mm. We did not observe any tear, burst mark(s) and/or punctured hole(s) on the sidewalls as well as across the tread of the rear tyre. However the front tyre was observed to be deflated.

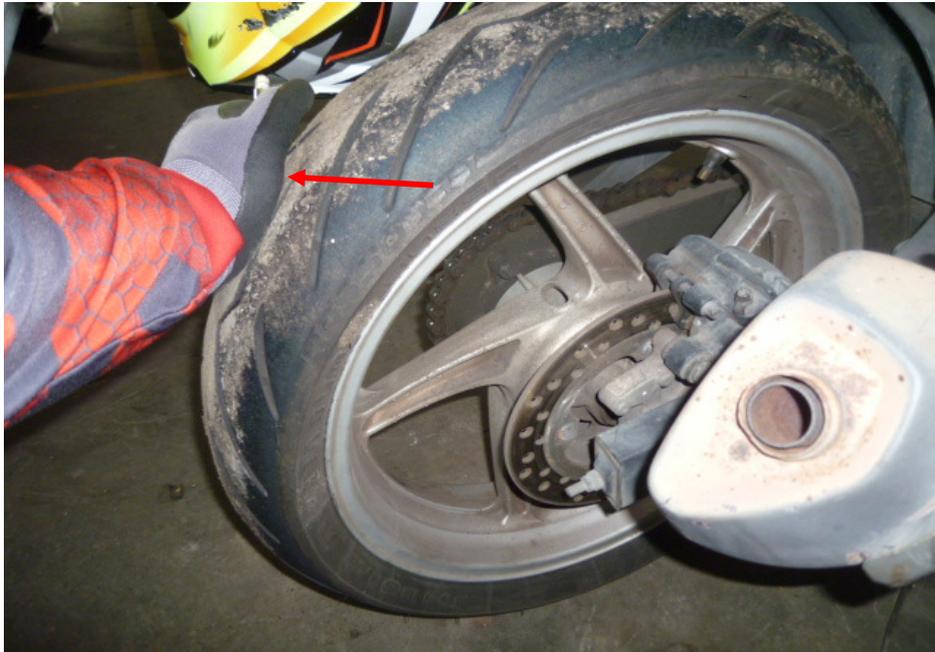
**Photo 17** shows the deflated rear tyre (arrowed) of the Motorcycle at the time of our inspection.

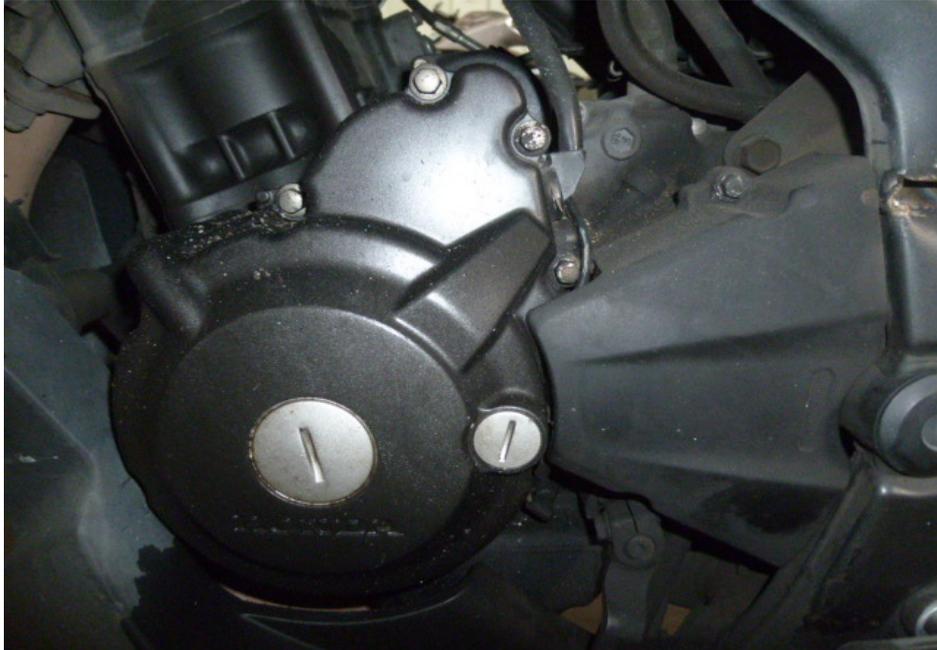
**Photo 18** shows the left side of the engine of the Motorcycle at the time of our inspection. The various engine related parts and components were found to be intact with no visible damage. There was also no sign(s) or indication(s) of fluid leak observed around the left engine area of the Motorcycle.

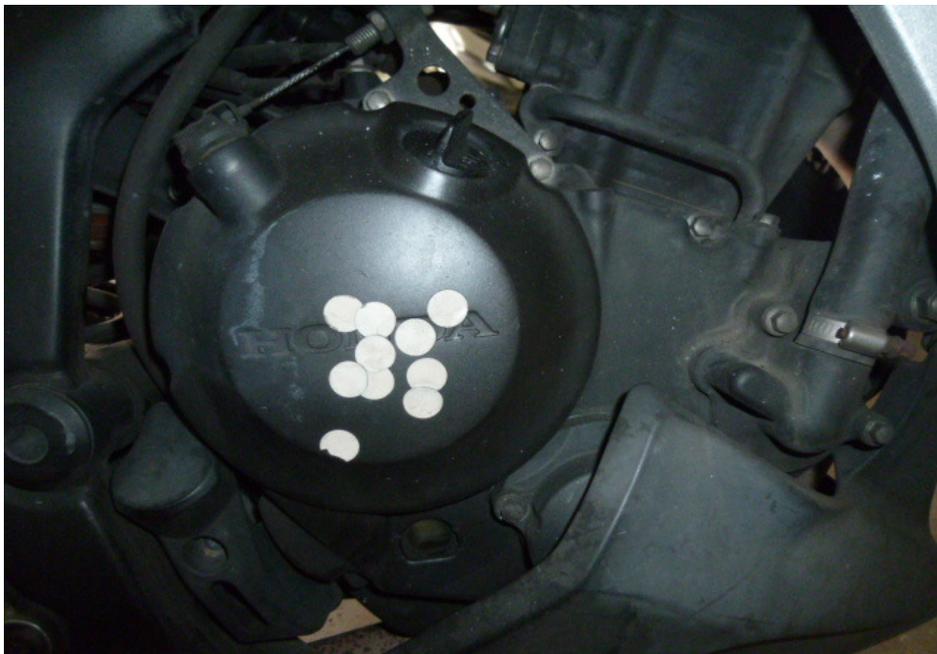
**Photo 19** shows the right side of the engine of the Motorcycle at the time of our inspection. The various engine related parts and components were found to be intact with no visible damage. There was also no sign(s) or indication(s) of fluid leak observed around the right engine area of the Motorcycle.

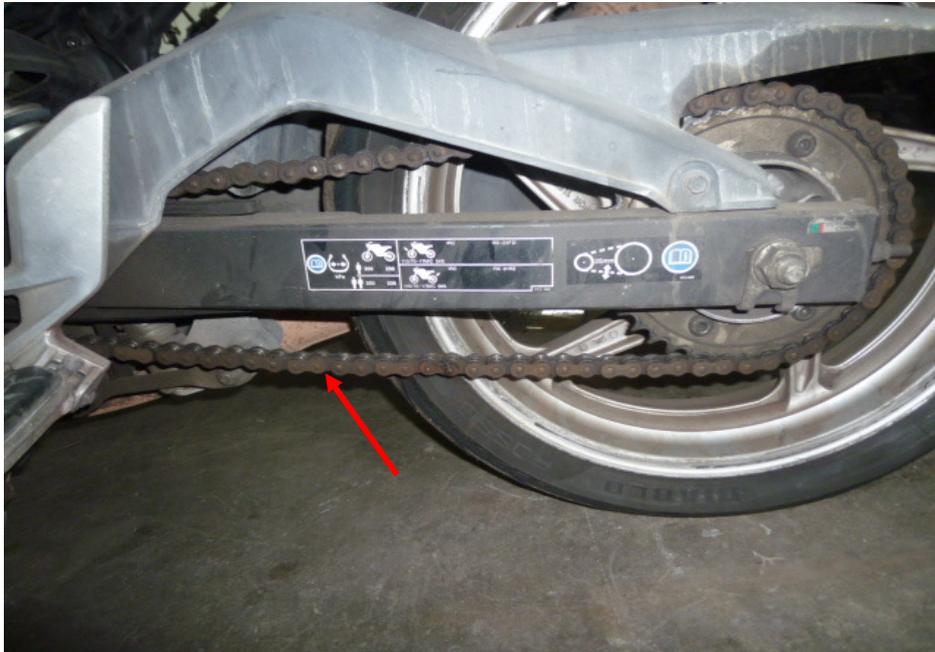
**Photo 20** shows the general view of the gear train (arrowed) of the Motorcycle, which was observed to be intact with no misalignment. It was also adequately lubricated for operating purposes.

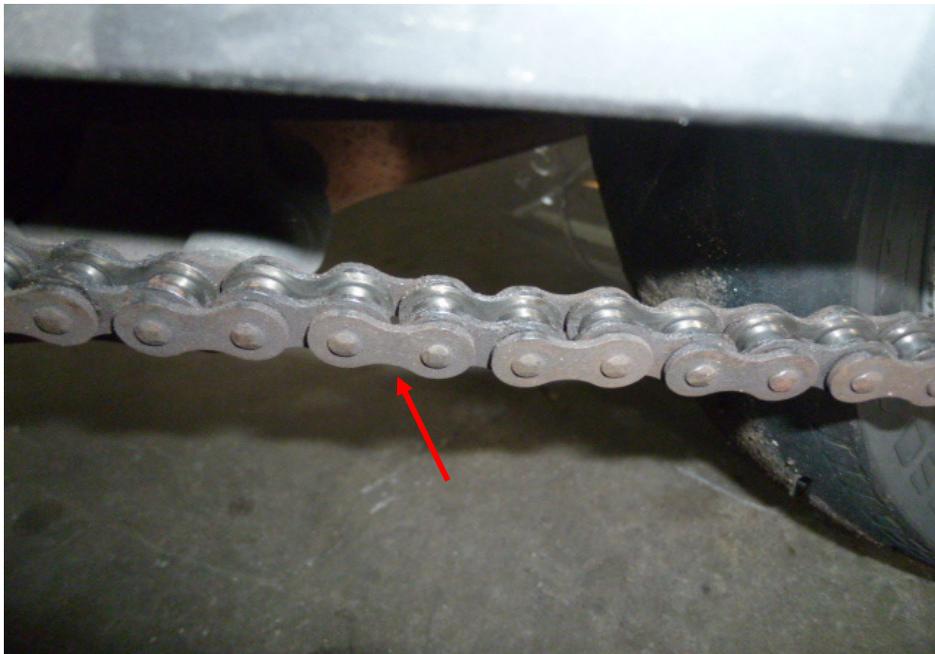
**Photo 21** shows a closer view of the gear train (arrowed) of the Motorcycle, which was observed to be intact with no misalignment. It was also adequately lubricated for operating purposes.

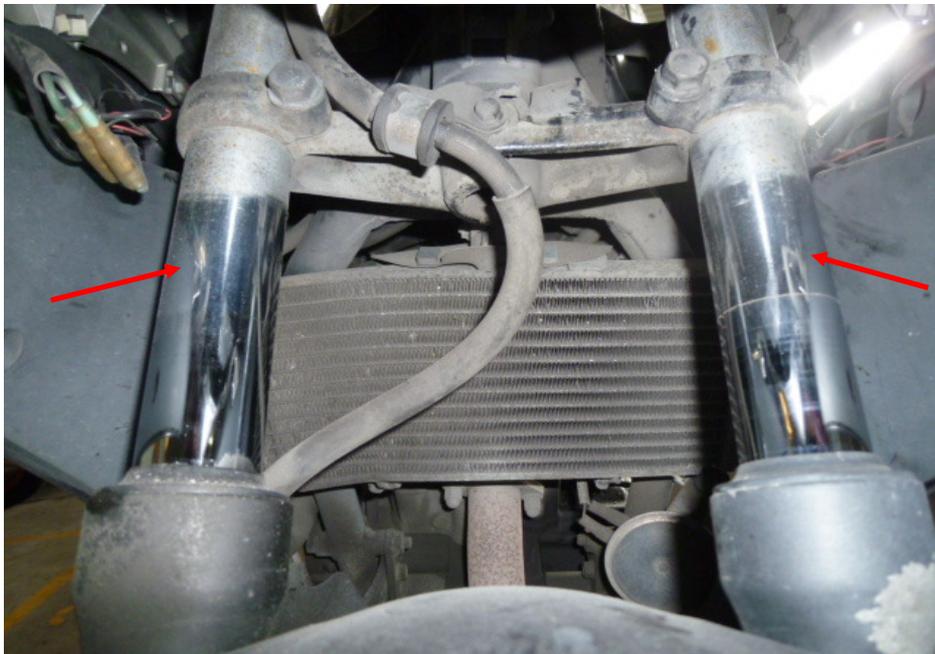
**Photo 21** shows the front forks (arrowed) of the Motorcycle. The front forks and fork bracket of the Motorcycle were both found to be intact and undamaged. Turning the Motorcycle's handle bar towards the left and right did not produce any abnormal free play. The steering system of the Motorcycle was in serviceable condition at the time of our inspection.

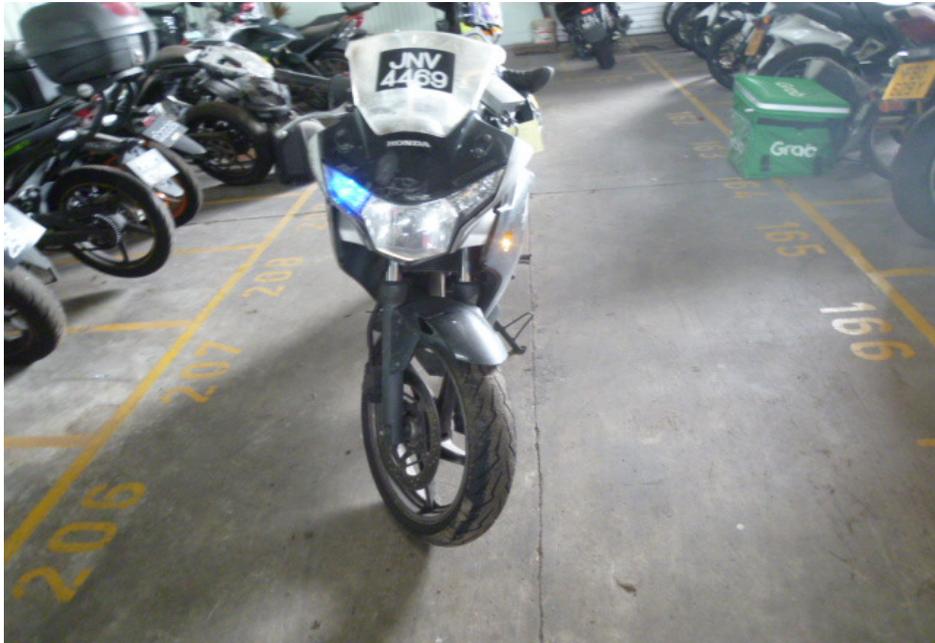
**Photo 22** shows the front wheel of the Motorcycle turned towards its full left. Turning the Motorcycle's handle bar towards the left did not produce any abnormal free play and/or resistance. This would indicate that the steering system of the Motorcycle was in serviceable condition at the time of our inspection.

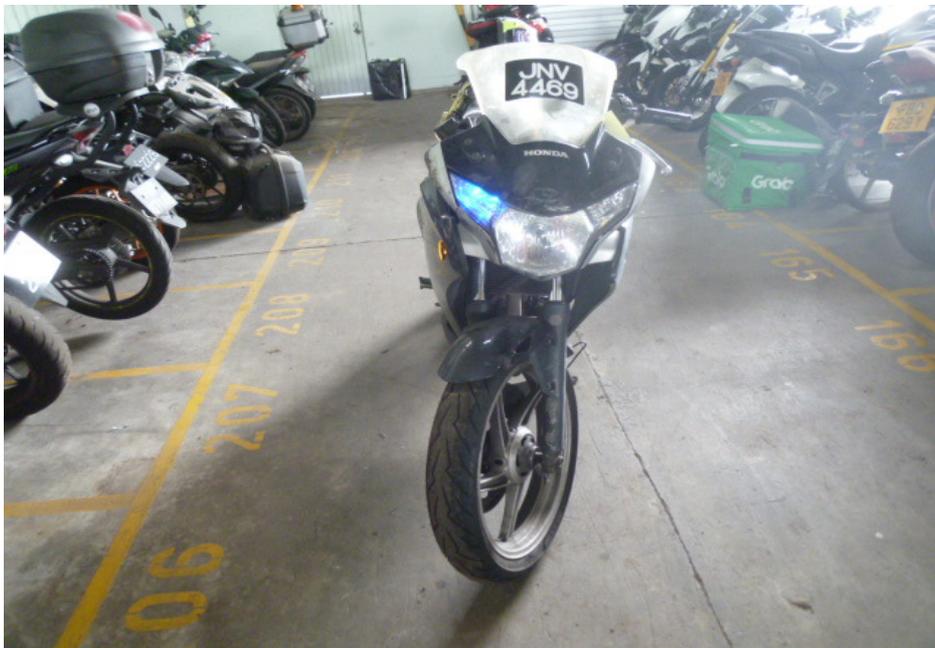
**Photo 23** shows the front wheel of the Motorcycle turned towards its full right. Turning the Motorcycle's handle bar towards the right did not produce any abnormal free play and/or resistance. This would indicate that the steering system of the Motorcycle was in serviceable condition at the time of our inspection.

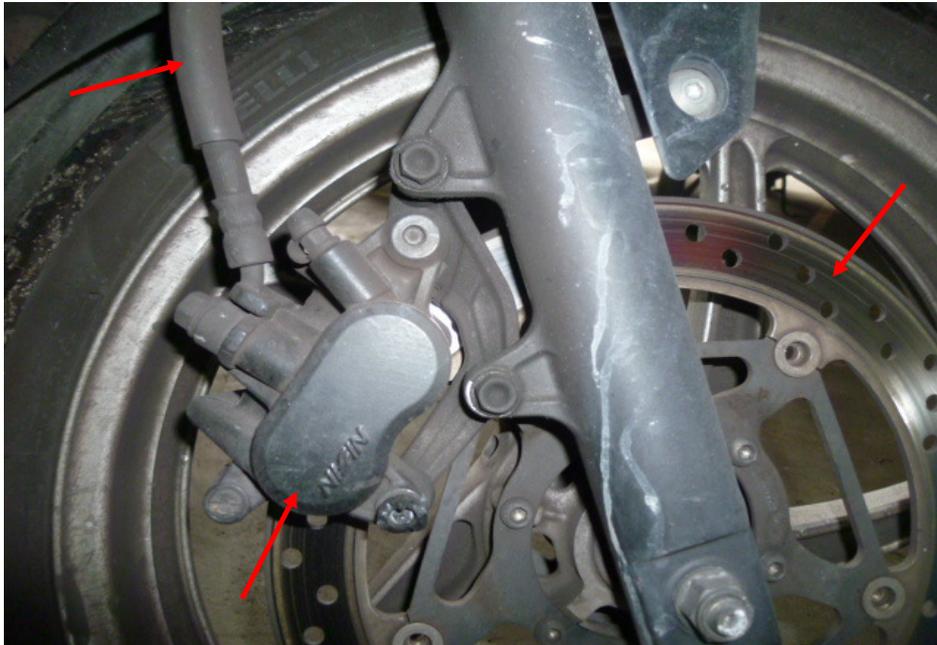
**Photo 24** shows a close up view of the front brake caliper, front brake disc and front brake hose (arrowed) of the Motorcycle, which are all part of the components in the hydraulic front brake system of the Motorcycle. Our visual checks of these various components had revealed all to be intact with no visible damage. No leakage of brake fluid was also observed.

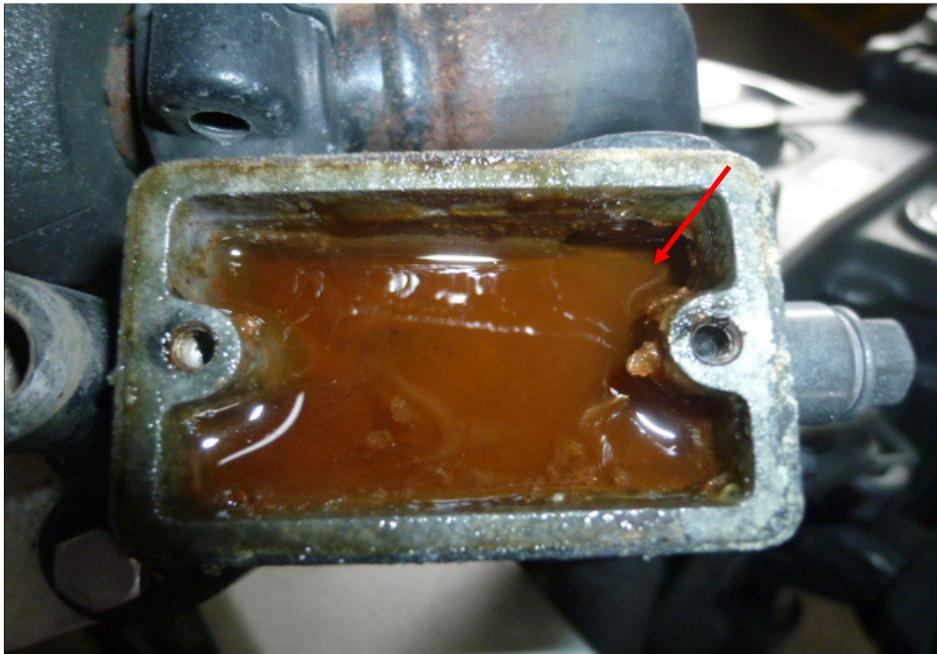
14. The brake fluid for the front brake was found to be of sufficient level for operational purposes. However it was found to be contaminated. We were unable remove the rear brake reservoir cover to examine whether the rear brake fluid was without contamination due to a worn out screw. However the rear brake fluid was observed to be of sufficient level for operational purposes.

**Photo 25** shows the brake fluid reservoir for the front brake of the Motorcycle. The brake fluid was observed to be of sufficient level for operational purposes. However it was found to be contaminated (arrowed).

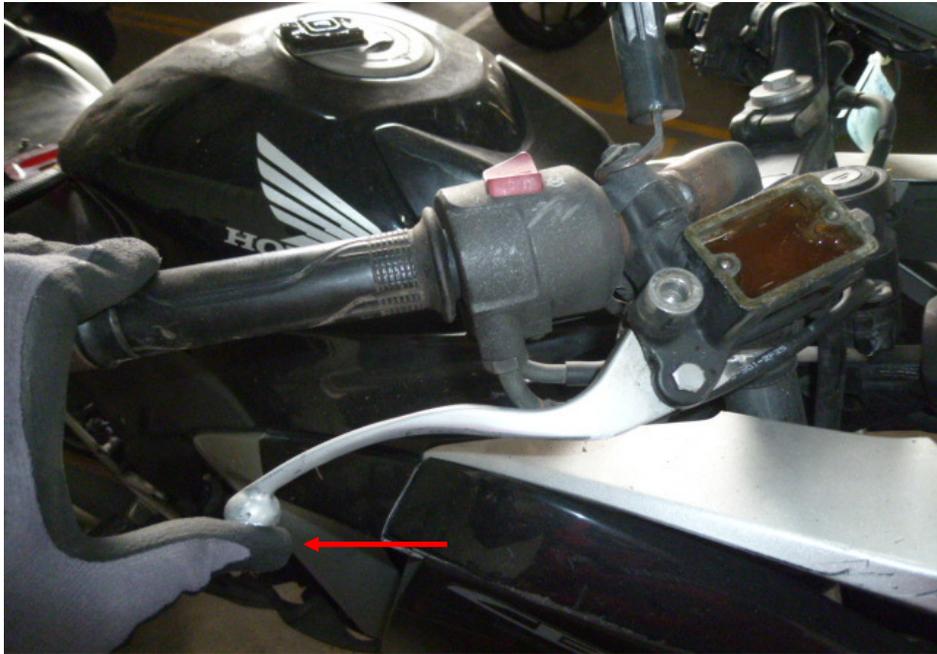
15. Static brake tests conducted on the Motorcycle had appear to indicate that the braking system of the Motorcycle was in serviceable condition. There was some resistance felt (spongy like feel) upon pressing the brake lever and upon stepping on the brake pedal. This would indicate that there was no leakage of pressure/vacuum in the brake system.

**Photo 26** shows the front brake lever being depressed. There was some resistance felt (spongy like feel) upon pressing the front brake lever (arrowed). This would indicate that there is no leakage of pressure/vacuum in the front brake system.

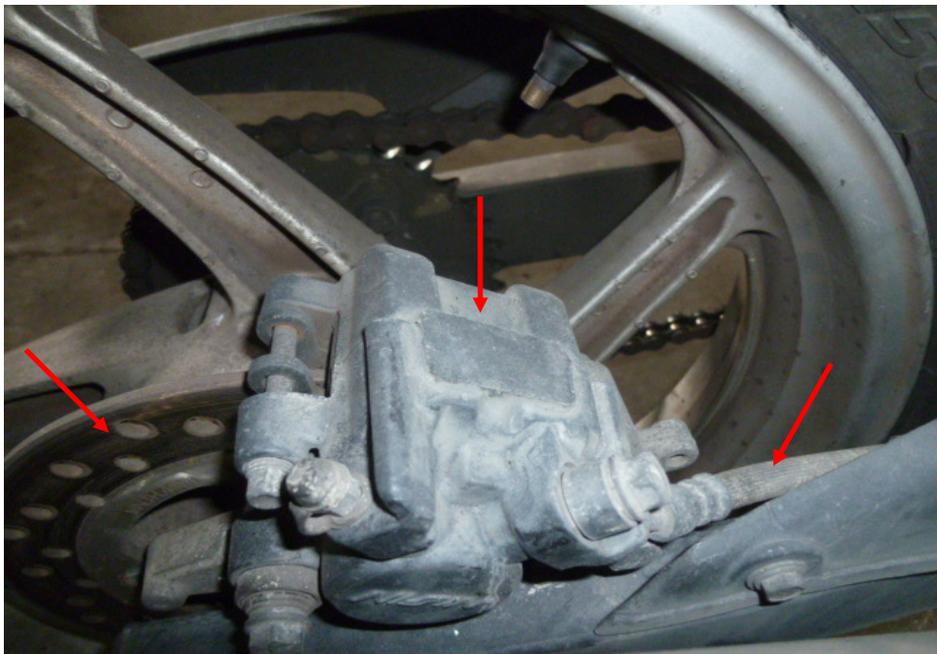
**Photo 27** shows a close up view of the rear brake caliper, rear brake disc and rear brake hose (arrowed) of the Motorcycle, which are all part of the components in the hydraulic rear brake system of the Motorcycle. Our visual checks of these various components had revealed all to be intact with no visible damage. No leakage of brake fluid was also observed.

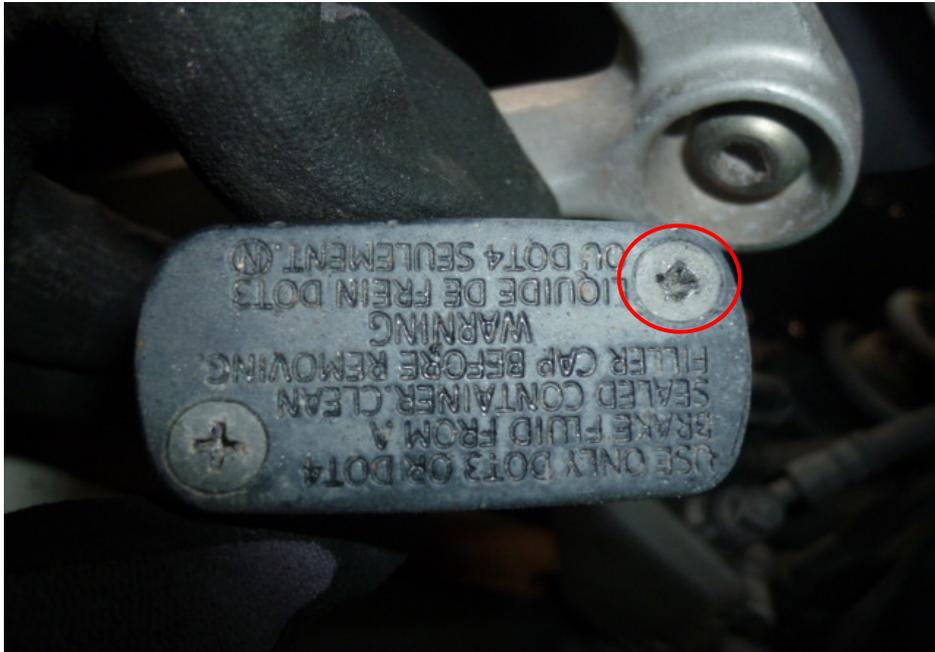
**Photo 28** shows the brake fluid reservoir cover for the rear brake of the Motorcycle. We were unable to examine whether the rear brake fluid was without contamination due to the worn out screw (circled).

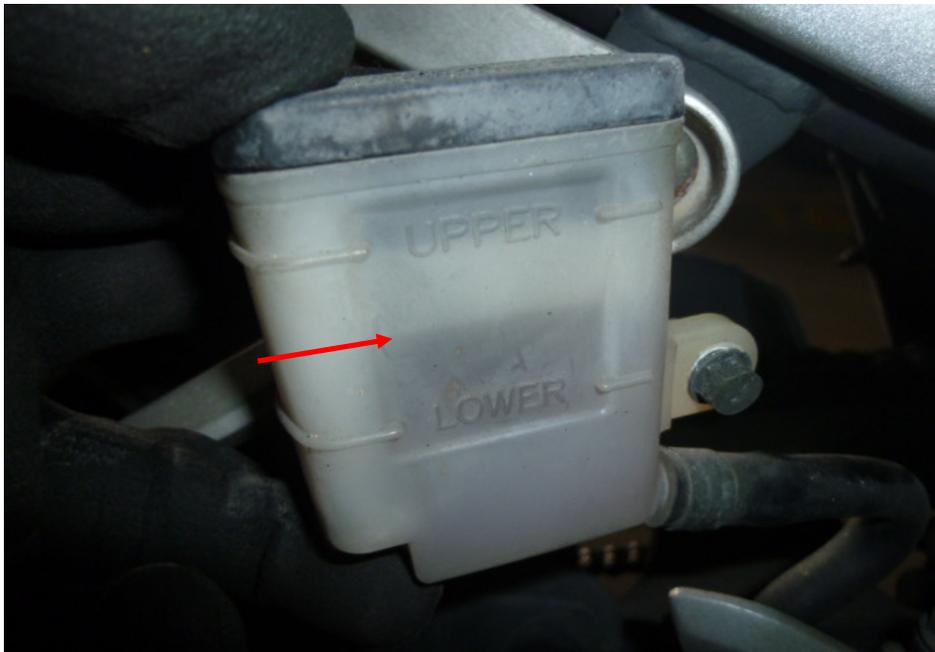
**Photo 29** shows a close up view of the brake fluid reservoir for the rear brake of the Motorcycle. The brake fluid was observed to be of sufficient level for operational purposes (arrowed).
