Your Ref: TP/IP/27029/2022  
Our Ref : CI/TPD22011555/N

**Fatal Accident Investigation Team**

**INSPECTION REPORT OF MOTORCYCLE FBK 6865A**

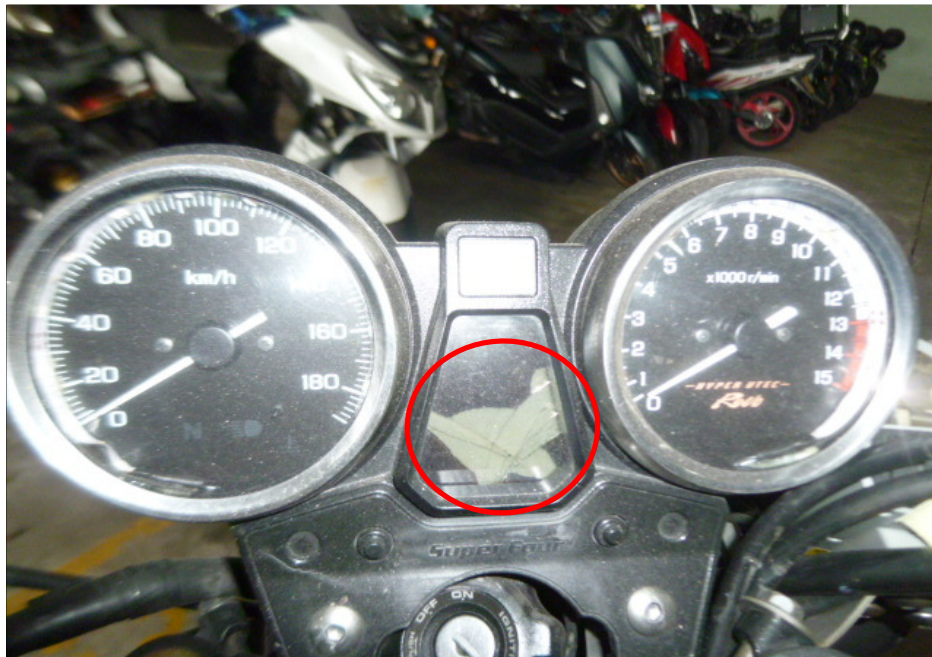
4. The mileage of the Motorcycle could not be recorded at the time of our inspection due to damages sustained to the speedometer gauge.
5. The Motorcycle was observed to have sustained damages at its frontal portion and left body. The body parts that were found to have been damaged include its headlight cover, handlebar and gear shift pedal, amongst others.

**Photo 1** shows the damaged speedometer gauge as a result of the accident (circled). Hence the mileage of the Motorcycle could not be recorded at the time of our inspection.

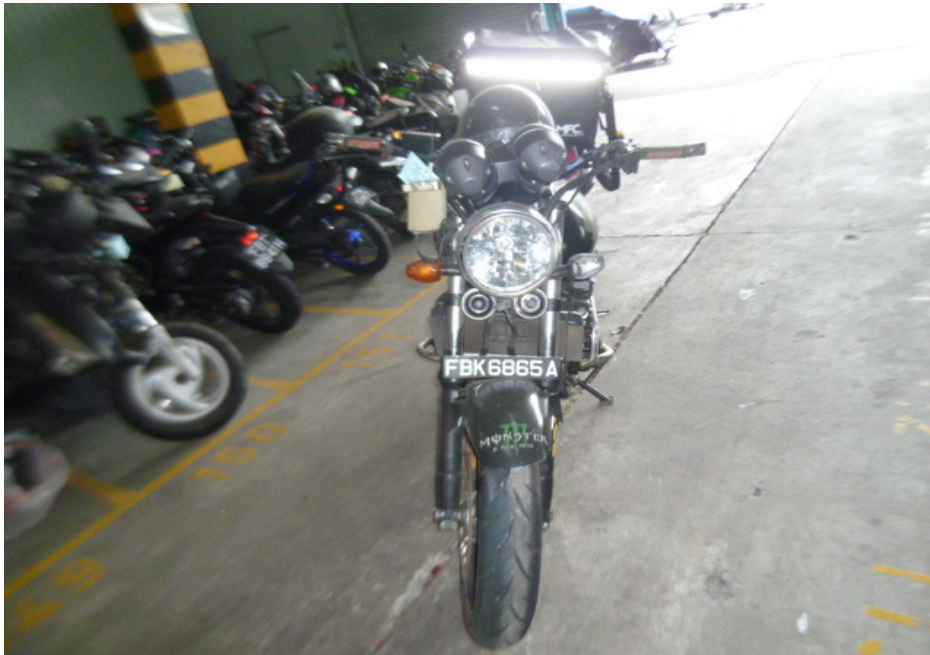
**Photo 2** shows a general view of the frontal portion of the Motorcycle at the time of our inspection. The Motorcycle was observed to have sustained damages at its frontal portion and left body.

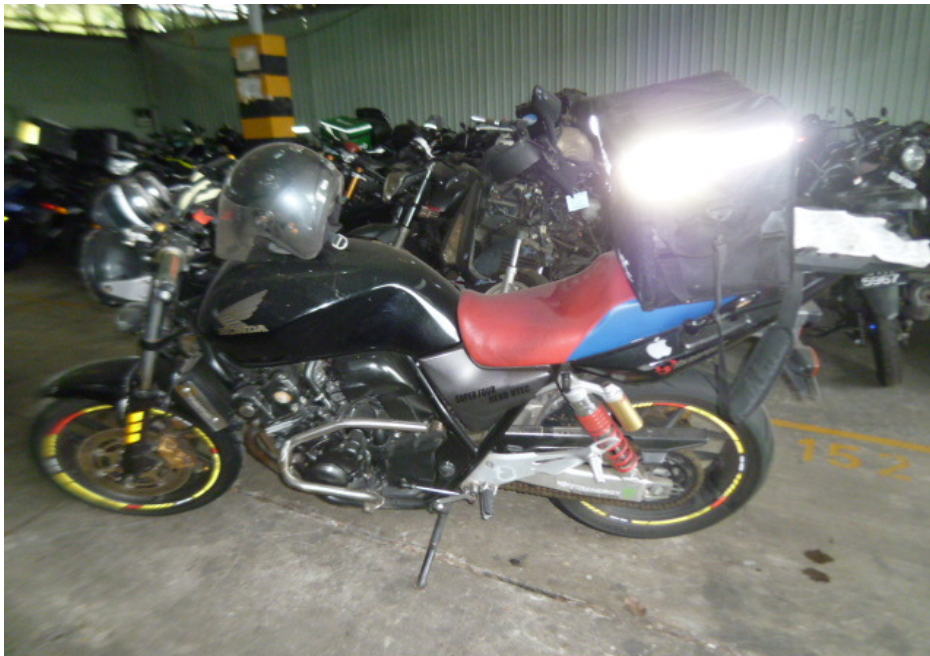
**Photo 3** shows a general view of the left body of the Motorcycle at the time of our inspection. The Motorcycle was observed to have sustained damages at its frontal portion and left body. The body parts that were found to have been damaged include its headlight cover, handlebar and gear shift pedal, amongst others.

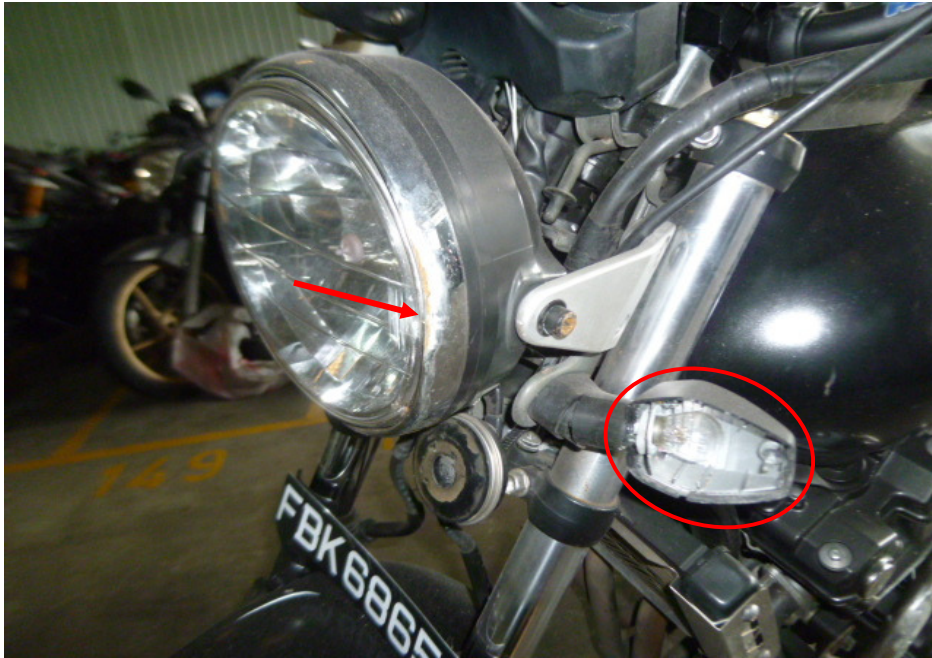
**Photo 4** shows a closer view of the grazed headlight cover (arrowed) and broken left front signal lamp (circled) of the Motorcycle as a result of the accident.

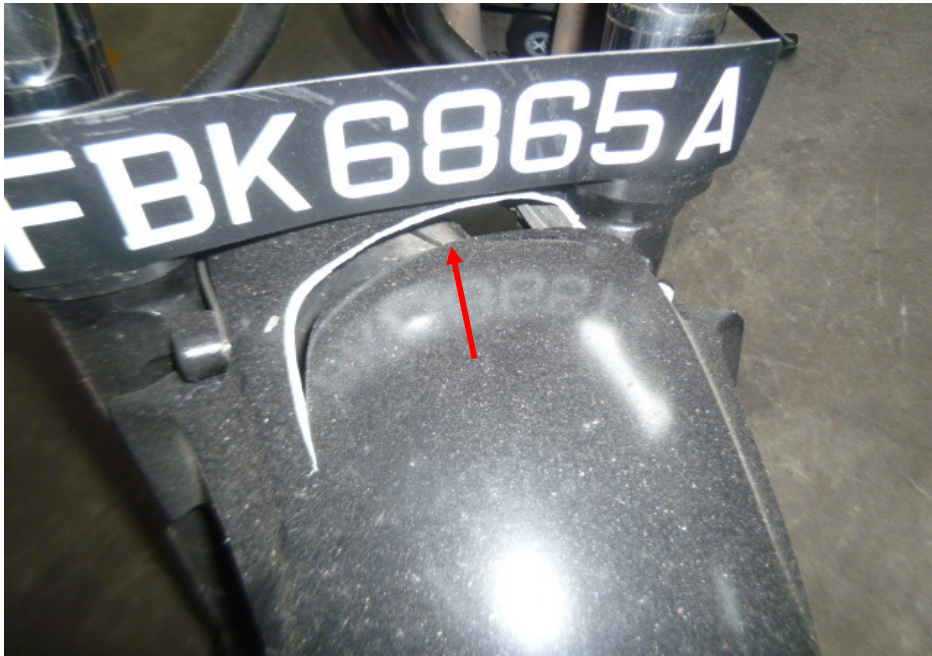
**Photo 5** shows a closer view of the front mudguard which was amongst the body parts at the front body of the Motorcycle that had sustained damage as a result of the accident (arrowed).

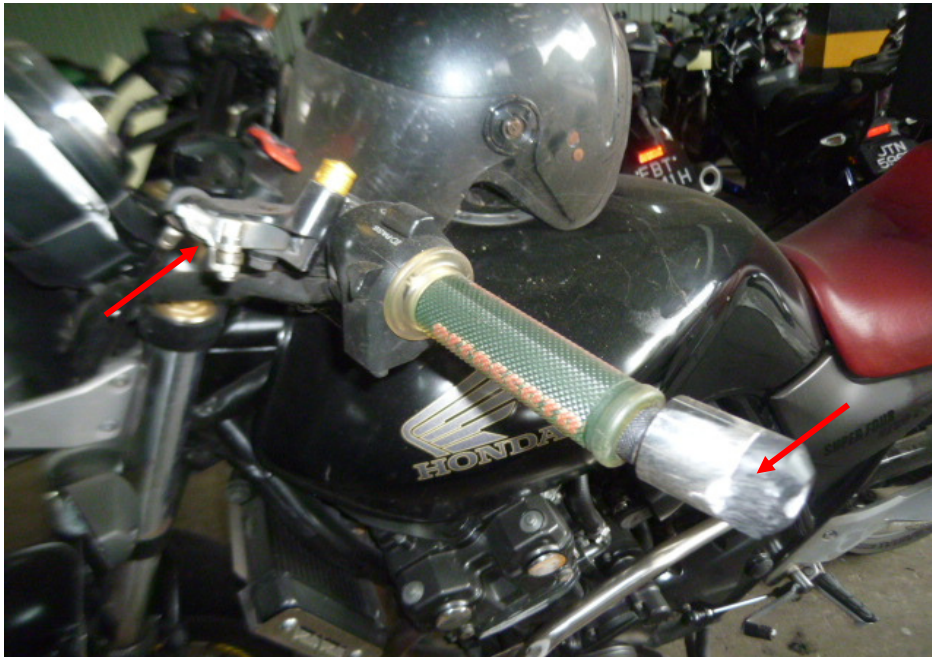
**Photo 6** shows a closer view of the clutch lever and left handlebar end (arrowed) which were amongst the body parts at the front body of the Motorcycle that had sustained damage as a result of the accident.

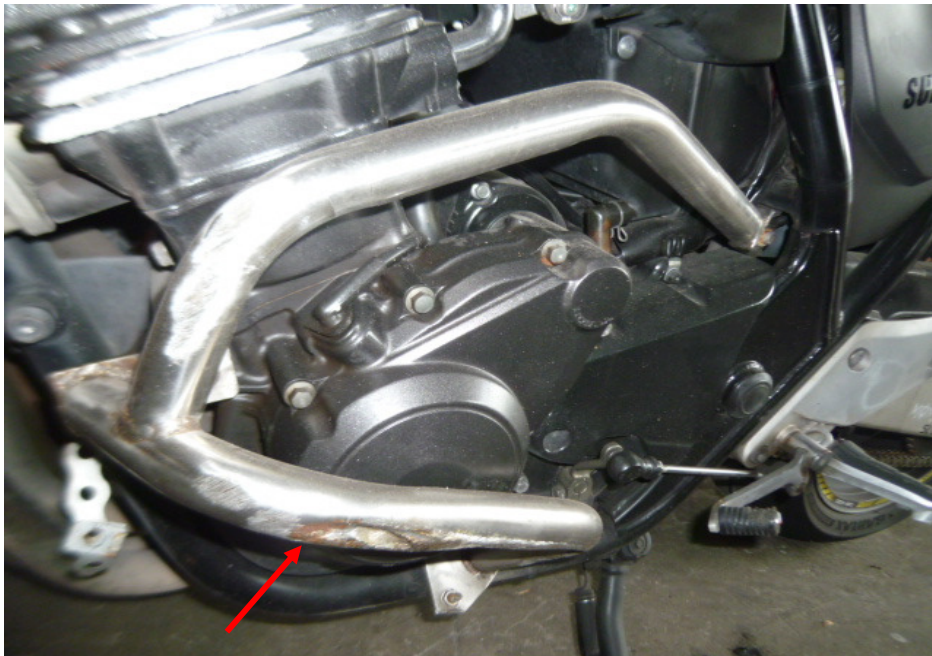
**Photo 7** shows the grazed left engine crashbar of the Motorcycle as a result of the accident (arrowed).

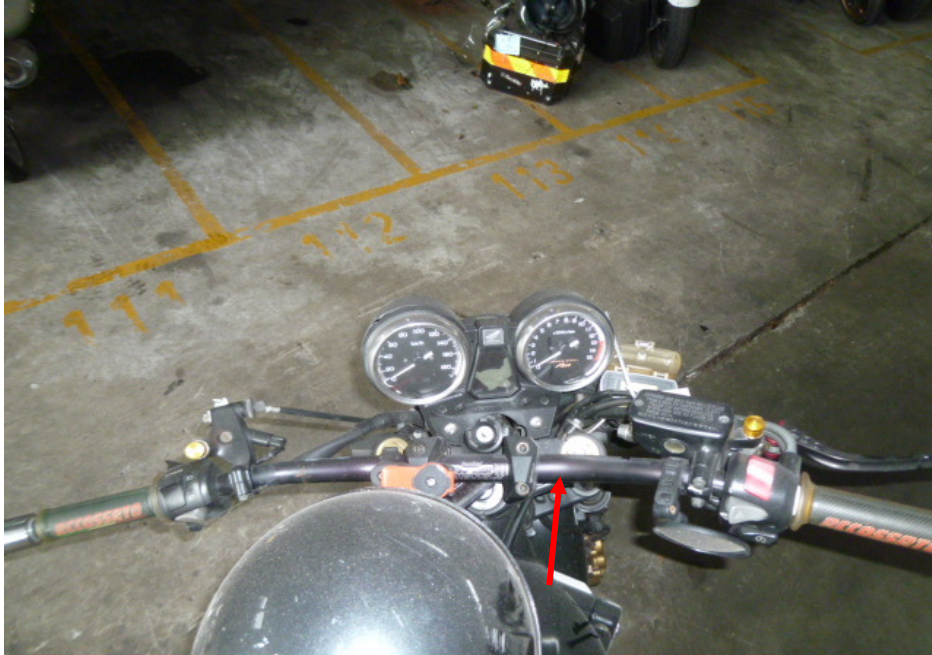
**Photo 8** shows the bent handlebar of the Motorcycle as a result of the accident (arrowed).

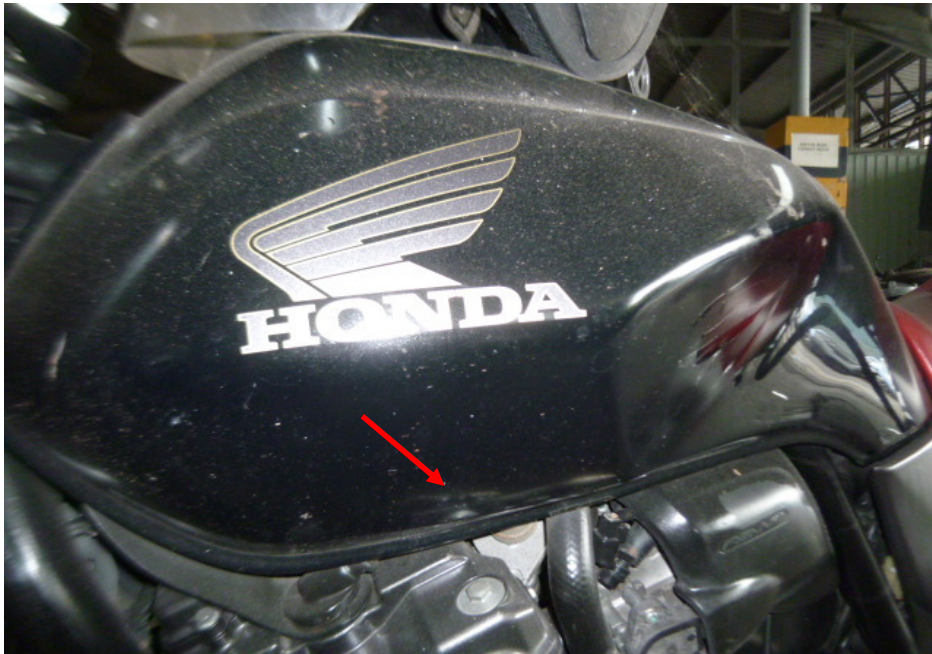
**Photo 9** shows the grazed petrol tank of the Motorcycle as a result of the accident (arrowed).

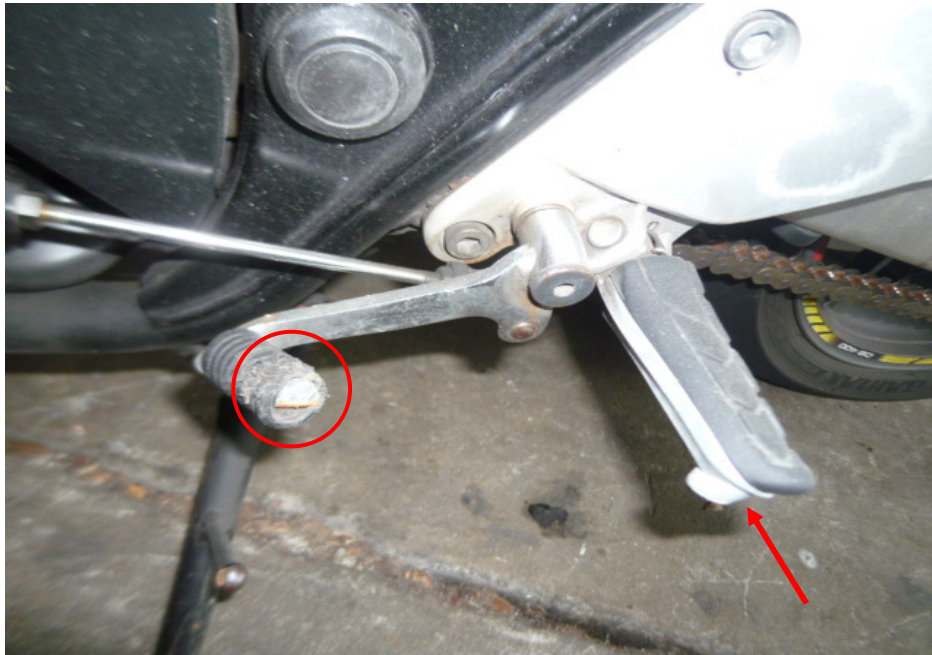
**Photo 10** shows a closer view of the left front footrest (arrowed) and gear shift pedal (circled) which were amongst the body parts of the Motorcycle that had sustained damage as a result of the accident.

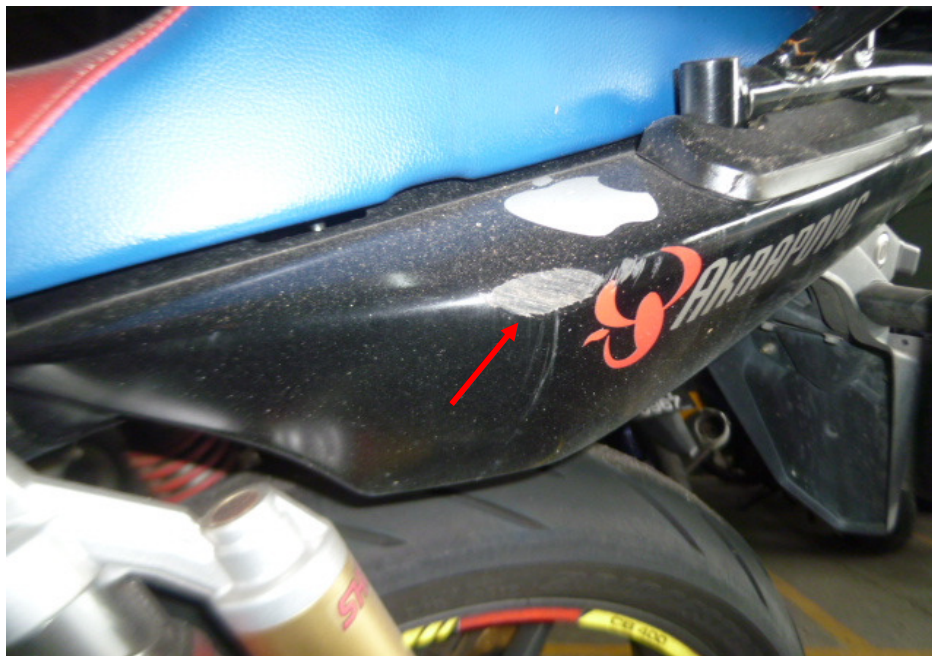
**Photo 11** shows the grazed left rear side cover (arrowed) of the Motorcycle as a result of the accident.

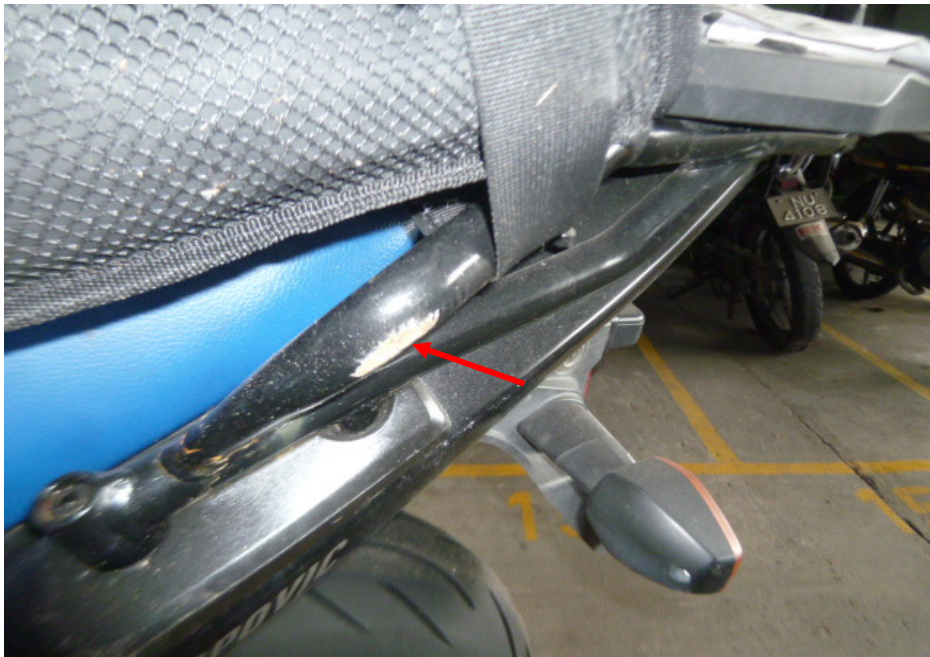
**Photo 12** shows a closer view of the left pillion grab rail (arrowed) which was amongst the body parts at the rear body of the Motorcycle that had sustained damage as a result of the accident.

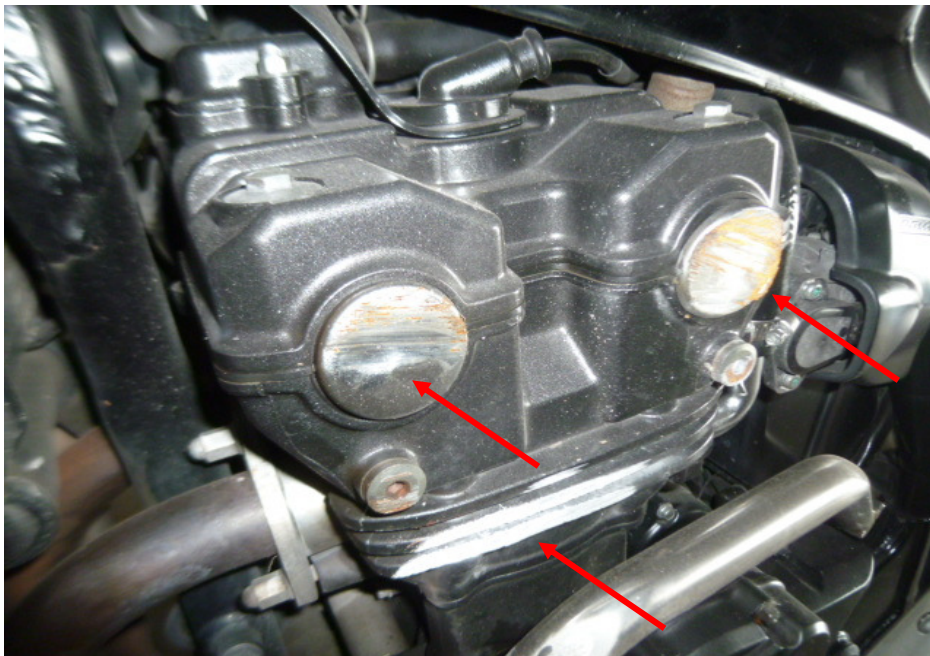
**Photo 13** shows a closer view of the grazed left engine cover (arrowed) the Motorcycle as a result of the accident.

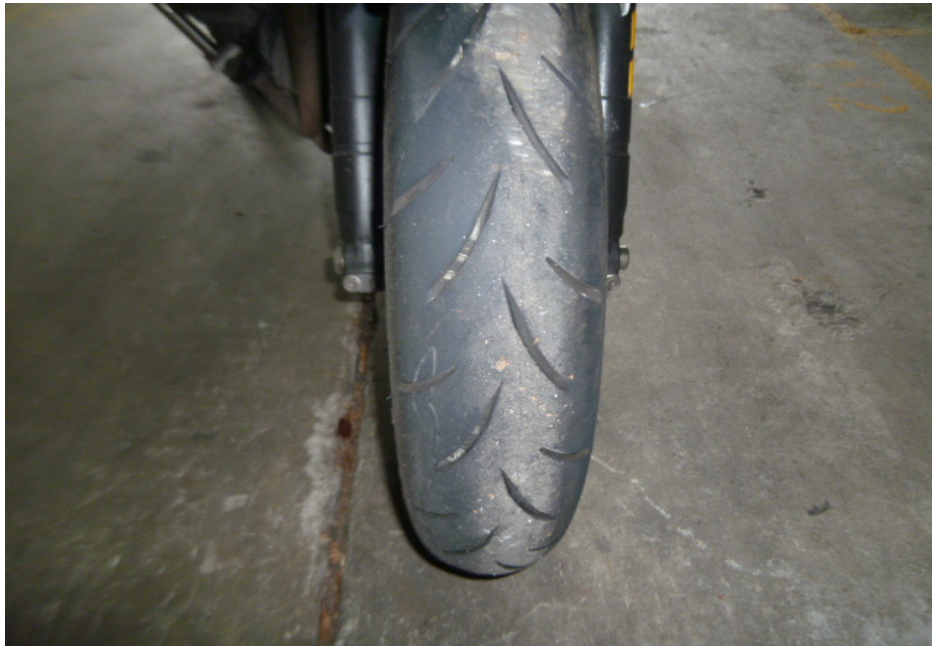
**Photo 14** shows the front tyre of the Motorcycle at the time of our inspection. The front tyre was observed to be in serviceable condition with remaining tread depth of approximately 3mm. The pattern of the tread was also clearly visible. There was no tear, burst mark(s) and/or punctured hole(s) on the sidewalls as well as across the tread of the front tyre.

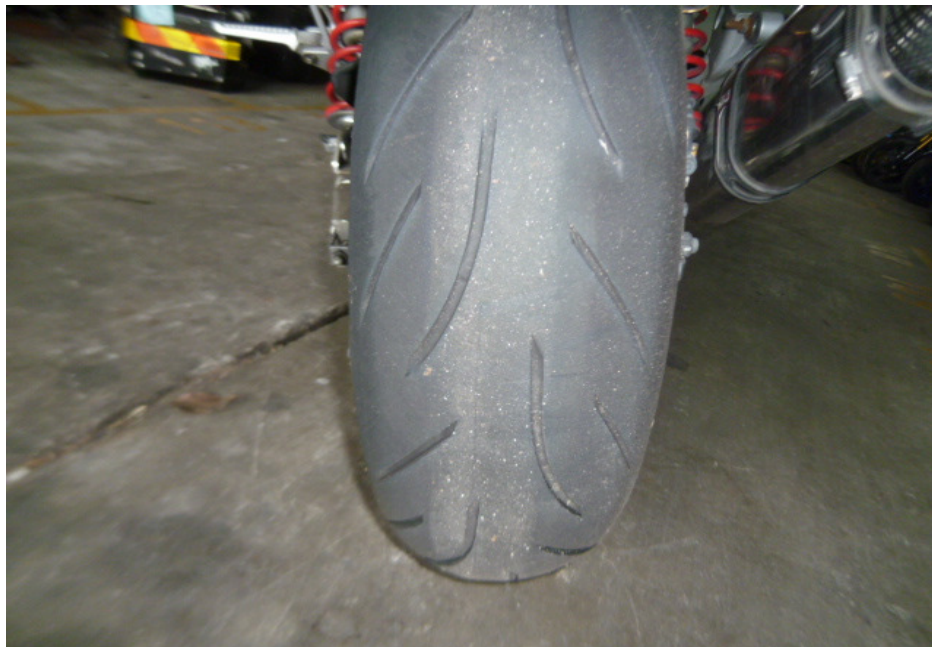
**Photo 15** shows the condition of the Motorcycle's rear tyre. The rear tyre was observed to be in serviceable condition with remaining tread depth of approximately 3mm. The tyre was also observed to be sufficiently inflated for vehicular operation. We did not observe any tear, burst mark(s) and/or punctured hole(s) on the sidewalls as well as across the tread of the rear tyre.

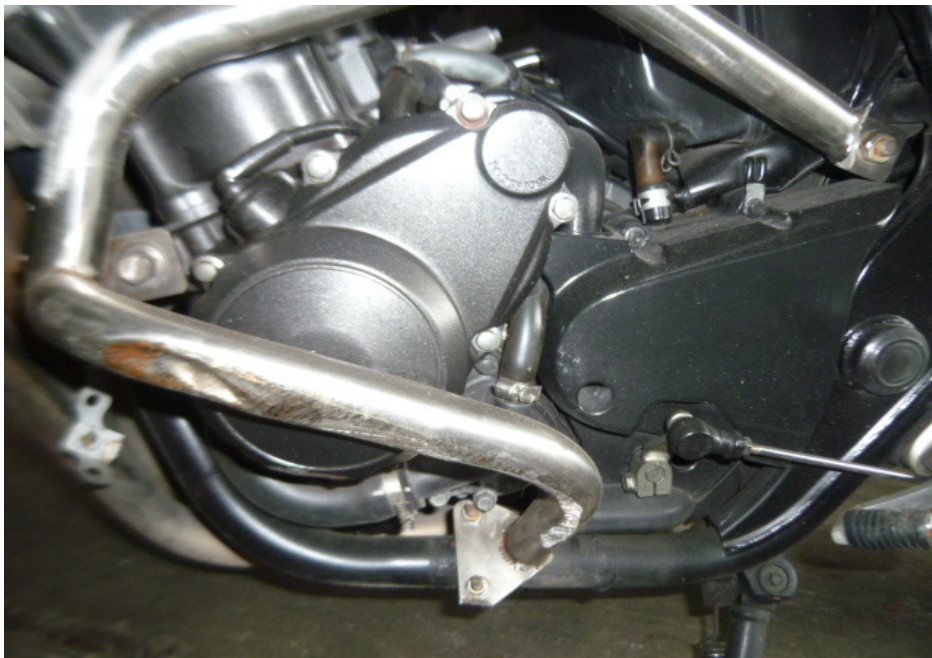
**Photo 16** shows the left side of the engine of the Motorcycle at the time of our inspection. The various engine related parts and components were found to be intact with no visible damage. There was also no sign(s) or indication(s) of fluid leak observed around the left engine area of the Motorcycle.

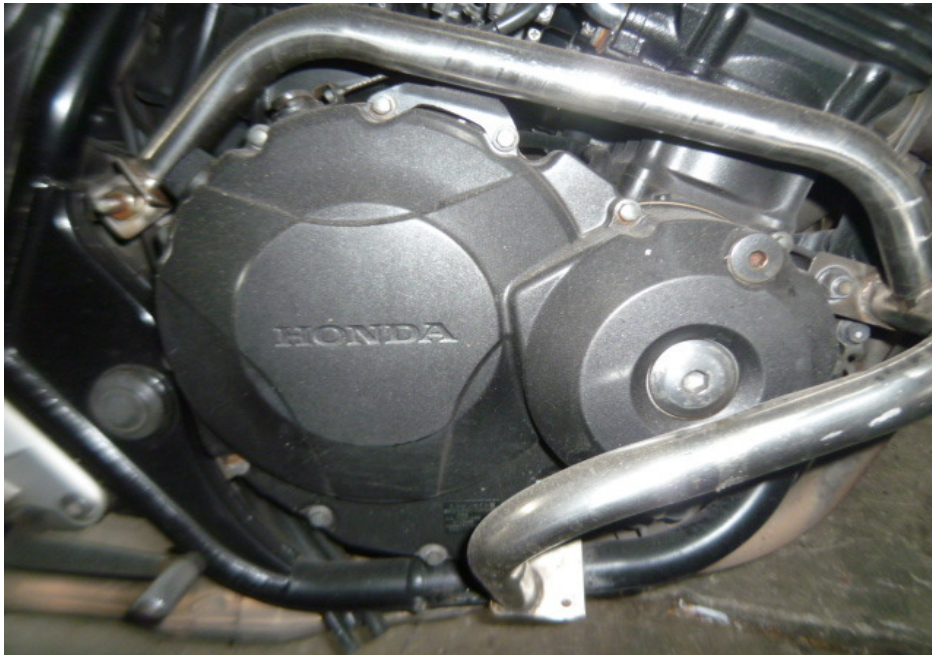
**Photo 17** shows the right side of the engine of the Motorcycle at the time of our inspection. The various engine related parts and components were found to be intact with no visible damage. There was also no sign(s) or indication(s) of fluid leak observed around the right engine area of the Motorcycle.

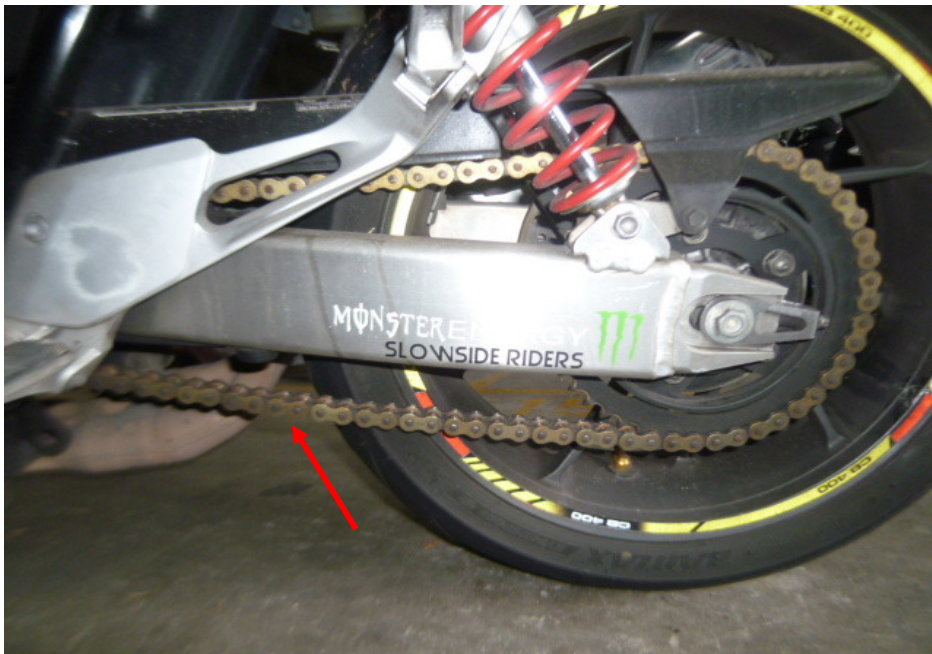
**Photo 18** shows the general view of the gear train (arrowed) of the Motorcycle, which was observed to be intact with no misalignment. It was also adequately lubricated for operating purposes.

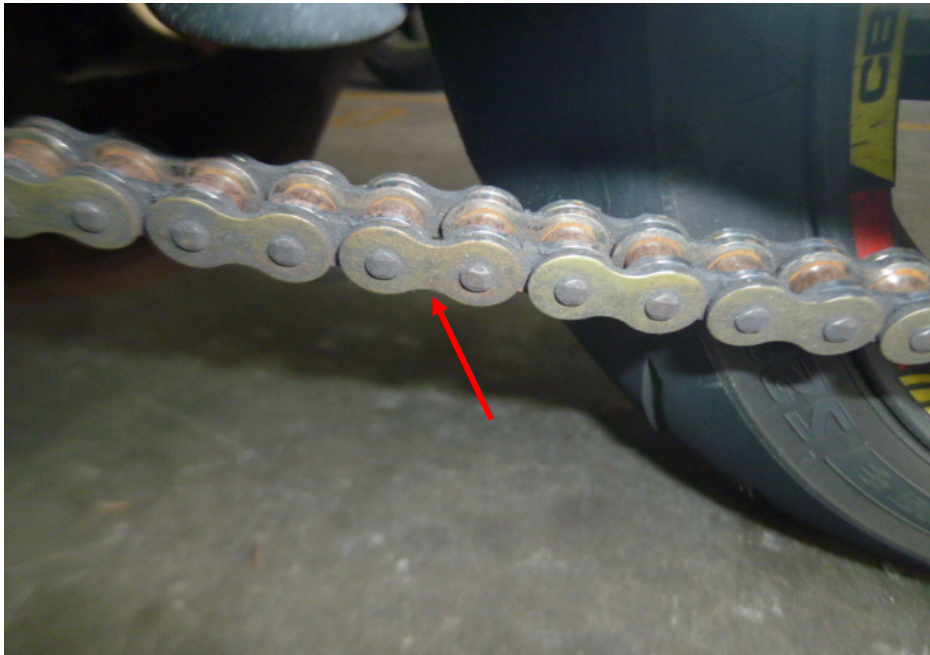
**Photo 19** shows a closer view of the gear train (arrowed) of the Motorcycle, which was observed to be intact with no misalignment. It was also adequately lubricated for operating purposes.

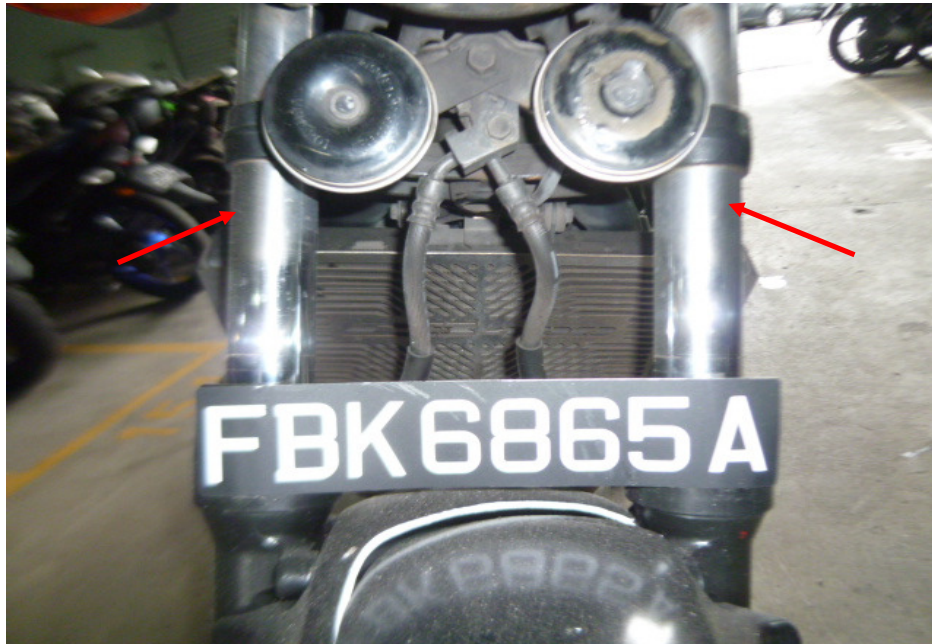
**Photo 20** shows the front forks (arrowed) of the Motorcycle. The front forks and fork bracket of the Motorcycle were both found to be intact and undamaged. Turning the Motorcycle's handle bar towards the left and right did not produce any abnormal free play and/or resistance. The steering system of the Motorcycle was in serviceable condition at the time of our inspection.

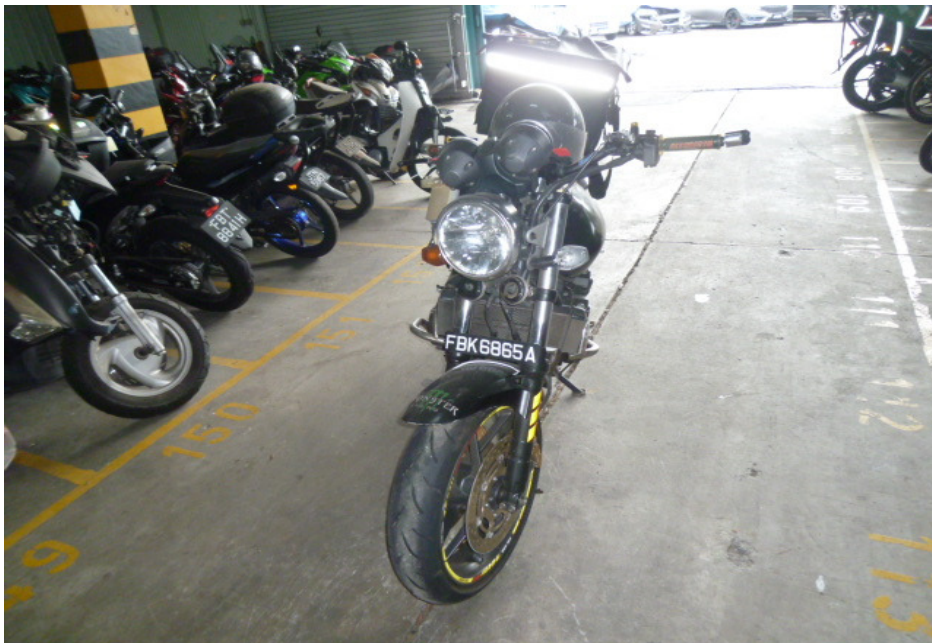
**Photo 21** shows the front wheel of the Motorcycle turned towards its full right. Turning the Motorcycle's handle bar towards the left and right did not produce any abnormal free play and/or resistance. This would indicate that the steering system of the Motorcycle was in serviceable condition at the time of our inspection.

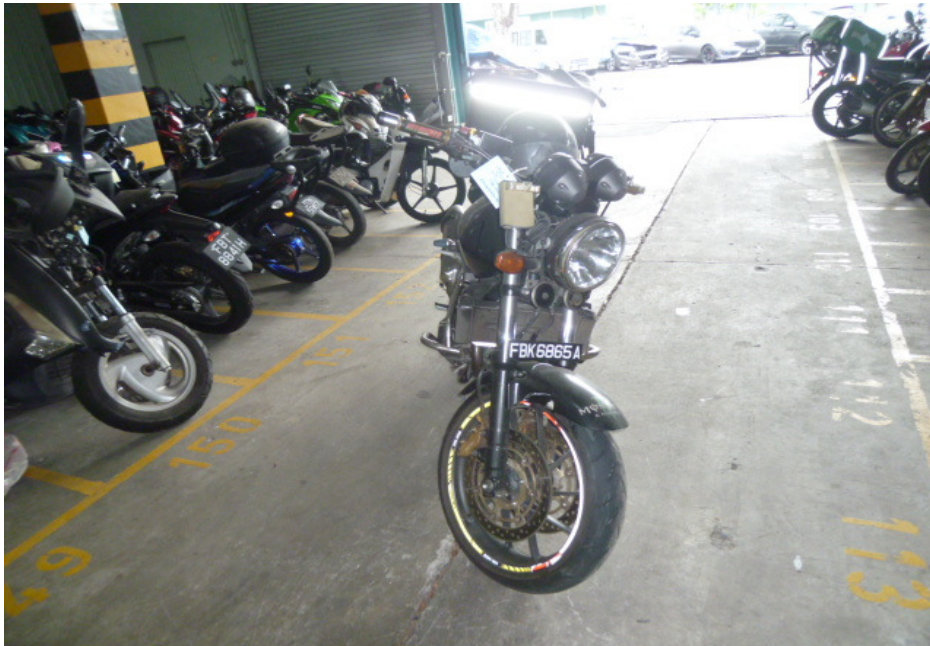
**Photo 22** shows the front wheel of the Motorcycle turned towards its full left. Turning the Motorcycle's handle bar towards the left and right did not produce any abnormal free play and/or resistance. This would indicate that the steering system of the Motorcycle was in serviceable condition at the time of our inspection.

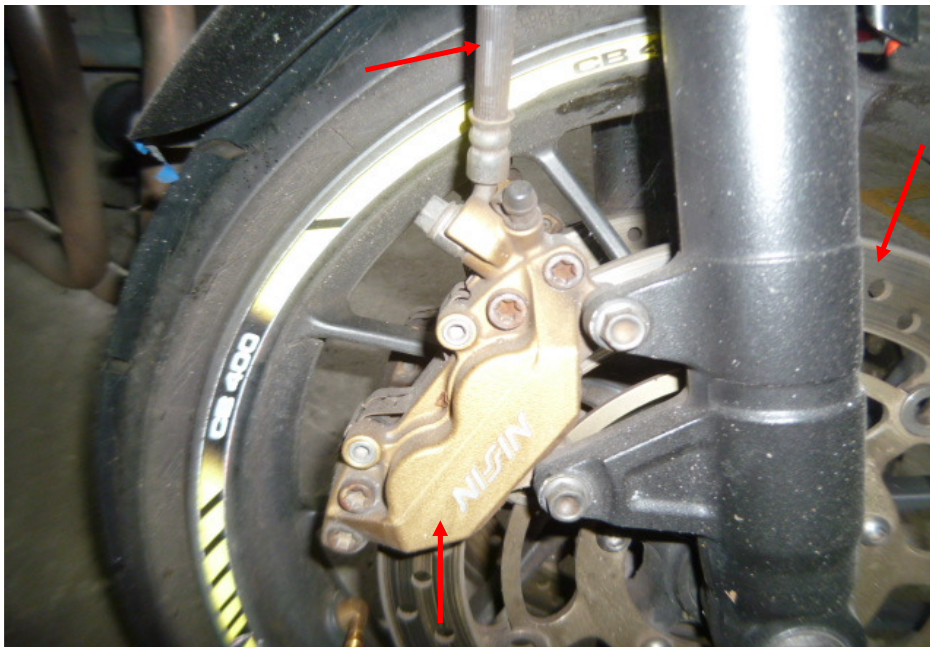
**Photo 23** shows a close up view of the front brake caliper, front brake disc and front brake hose (arrowed) at the right side of the Motorcycle's front wheel, which are all part of the components in the hydraulic front brake system of the Motorcycle. Our visual checks of these various components had revealed all to be intact with no visible damage. No leakage of brake fluid was also observed.

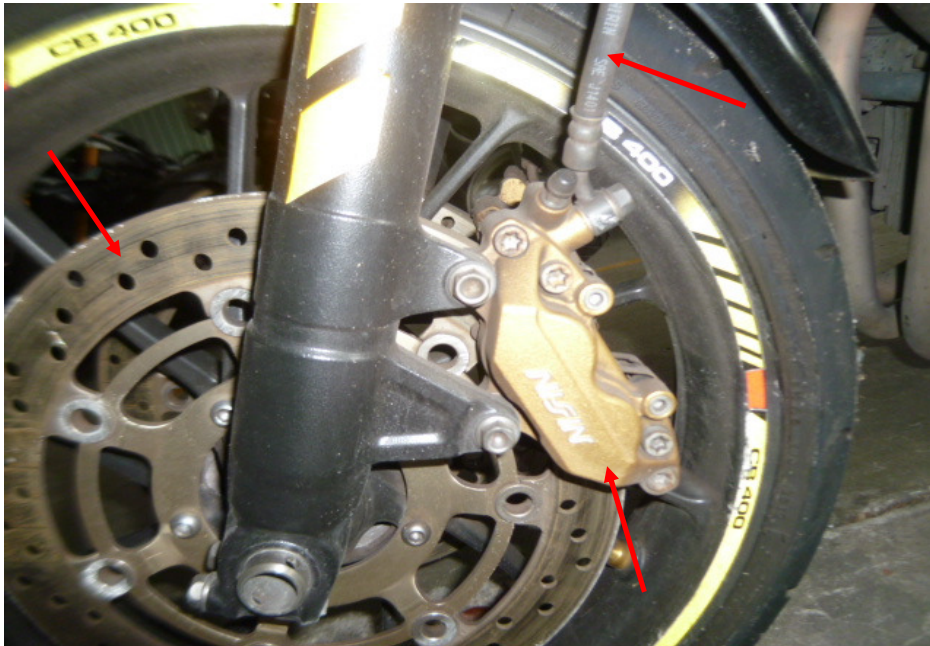
**Photo 24** shows a close up view of the front brake caliper, front brake disc and front brake hose (arrowed) at the left side of the Motorcycle's front wheel, which are all part of the components in the hydraulic front brake system of the Motorcycle. Our visual checks of these various components had revealed all to be intact with no visible damage. No leakage of brake fluid was also observed.

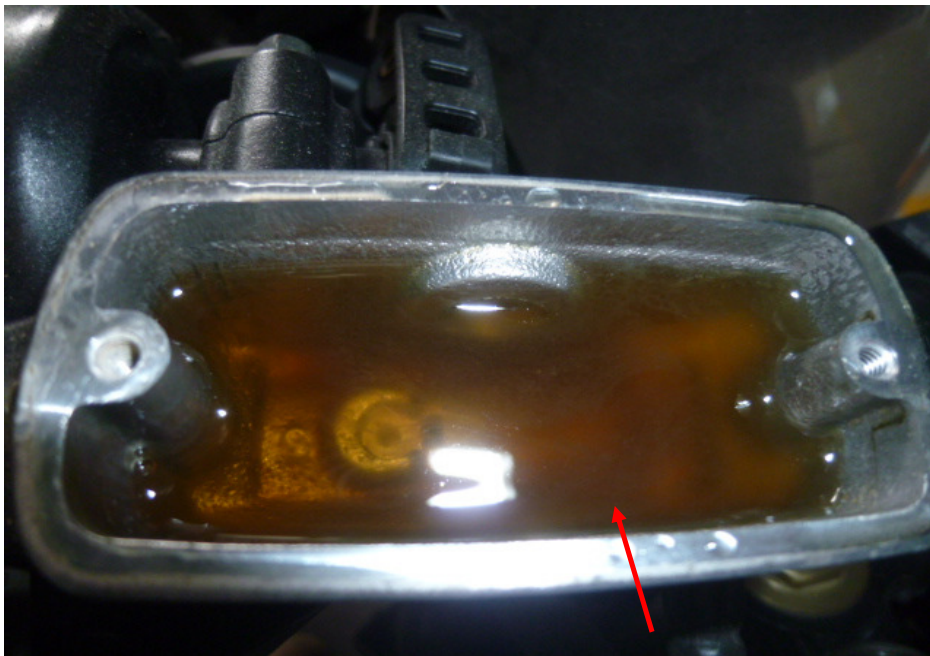
14. The brake fluid for the front brake was found to be of sufficient level for operational purposes. However it was found to be slightly contaminated. The brake fluid for the rear brake was found to be of sufficient level for operational purposes and without any contamination.

**Photo 25** shows the brake fluid reservoir for the front brake of the Motorcycle. The brake fluid was observed to be of sufficient level for operational purposes. However it was found to be slightly contaminated (arrowed).

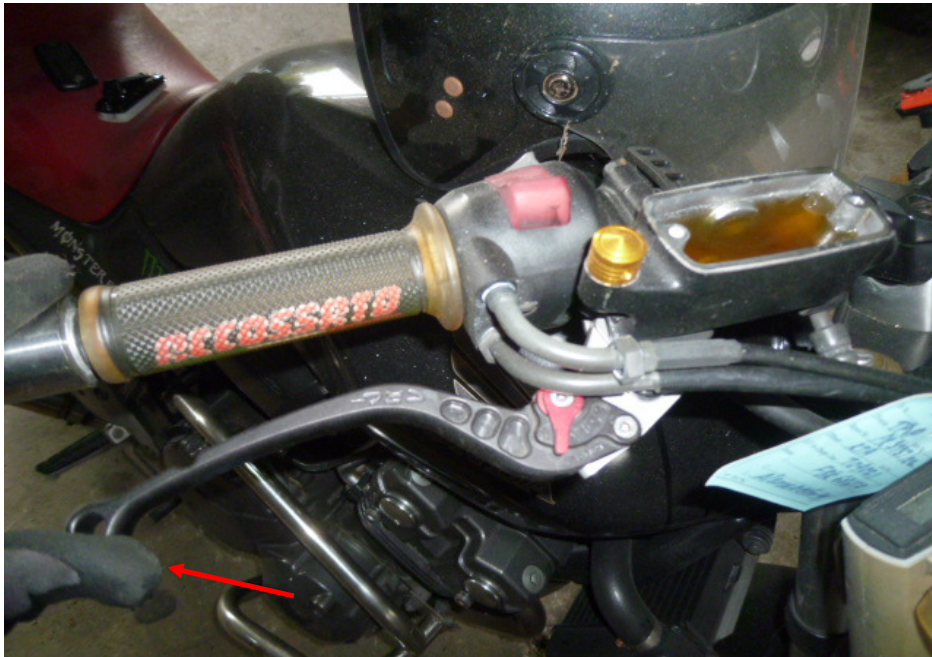
15. Static brake tests conducted on the Motorcycle had appear to indicate that the braking system of the Motorcycle was in serviceable condition. There was some resistance felt (spongy like feel) upon pressing the brake lever and upon stepping on the brake pedal. This would indicate that there was no leakage of pressure/vacuum in the brake system.

**Photo 26** shows the front brake lever being depressed. There was some resistance felt (spongy like feel) upon pressing the front brake lever (arrowed). This would indicate that there is no leakage of pressure/vacuum in the front brake system.

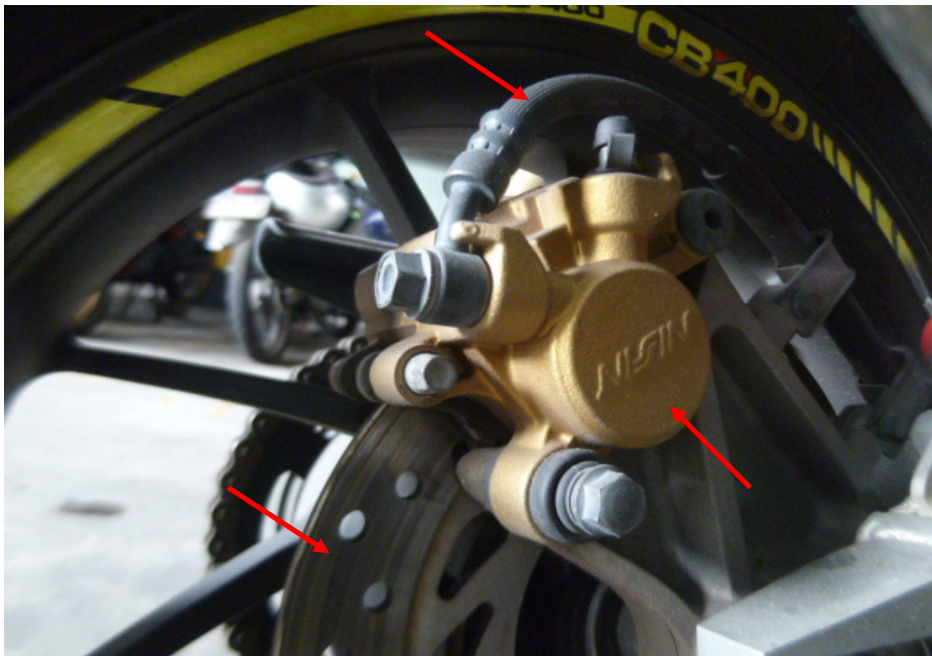
**Photo 27** shows a close up view of the rear brake caliper, rear brake disc and rear brake hose (arrowed) of the Motorcycle, which are all part of the components in the hydraulic rear brake system of the Motorcycle. Our visual checks of these various components had revealed all to be intact with no visible damage. No leakage of brake fluid was also observed.

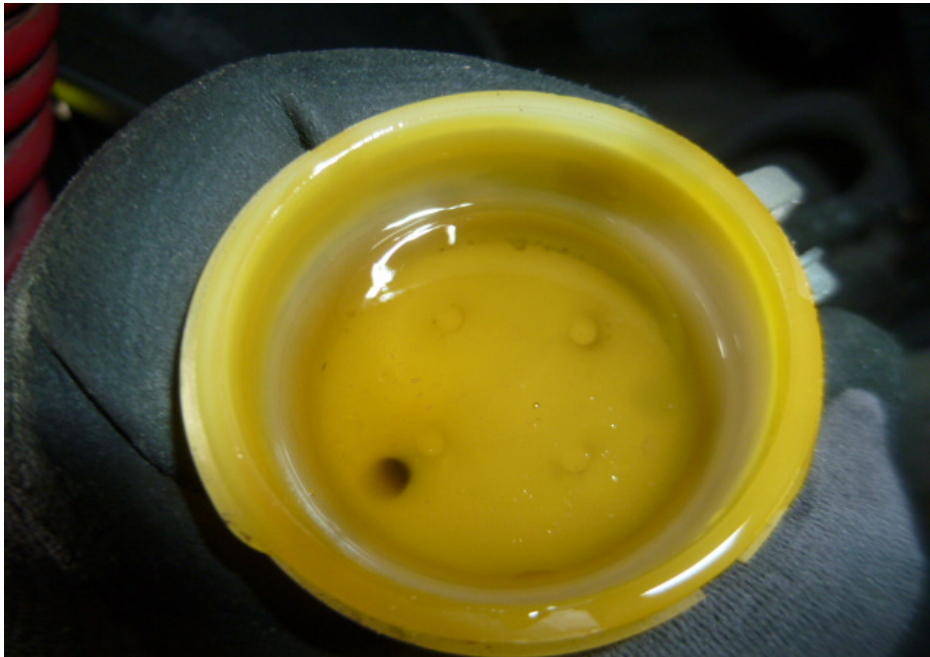
**Photo 28** shows the brake fluid reservoir for the rear brake of the Motorcycle. The brake fluid was observed to be of sufficient level for operational purposes and without any contamination.
