Your Ref: TP/IP/27931/2022
Our Ref : CI/TPD22011558/N

Fatal Accident Investigation Team

Traffic Police Department
Singapore Police Force
10 Ubi Avenue 3
Singapore 408865

INSPECTION REPORT OF MOTORCYCLE FBR 5802B

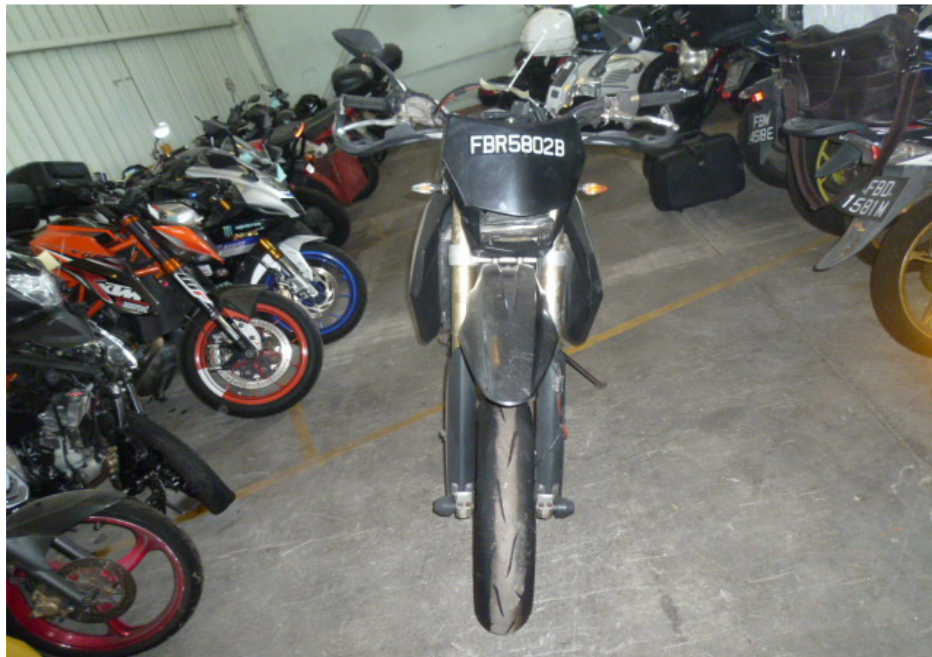
Photo 1 shows a general view of the frontal portion of the Motorcycle at the time of our inspection. The Motorcycle was observed to have sustained damages along its frontal portion and right body.

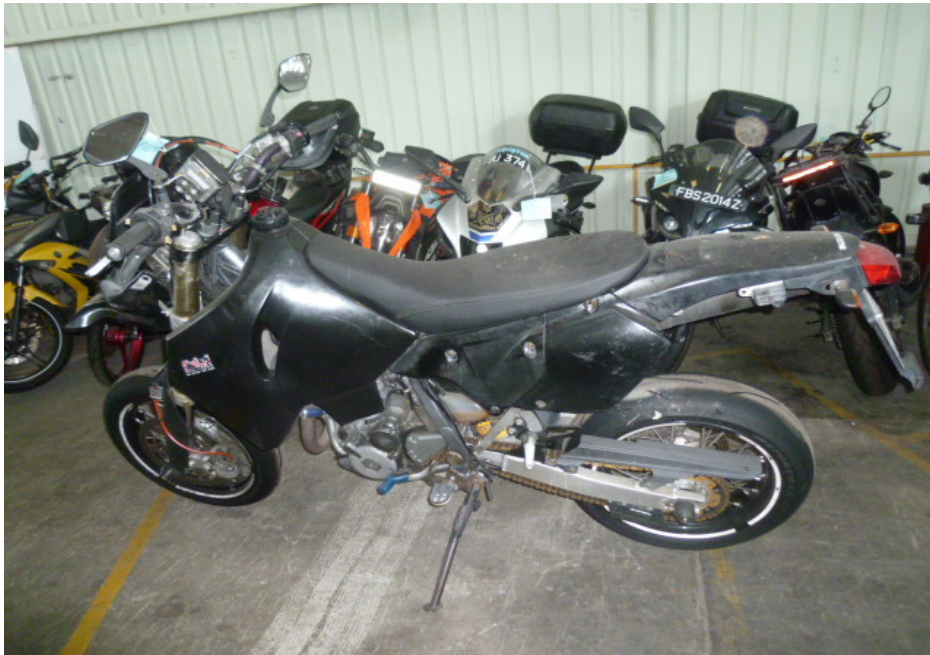
Photo 2 shows a general view of the left body of the Motorcycle at the time of our inspection. The Motorcycle was observed to have sustained damages along its frontal portion and right body.

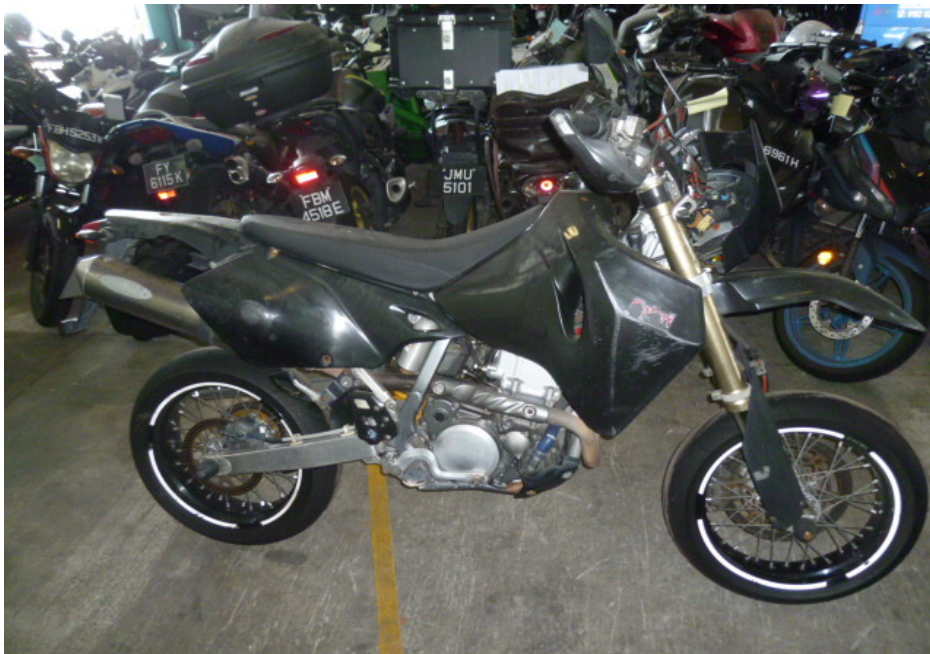
Photo 3 shows a general view of the right body of the Motorcycle at the time of our inspection. The Motorcycle was observed to have sustained damages along its frontal portion and right body.

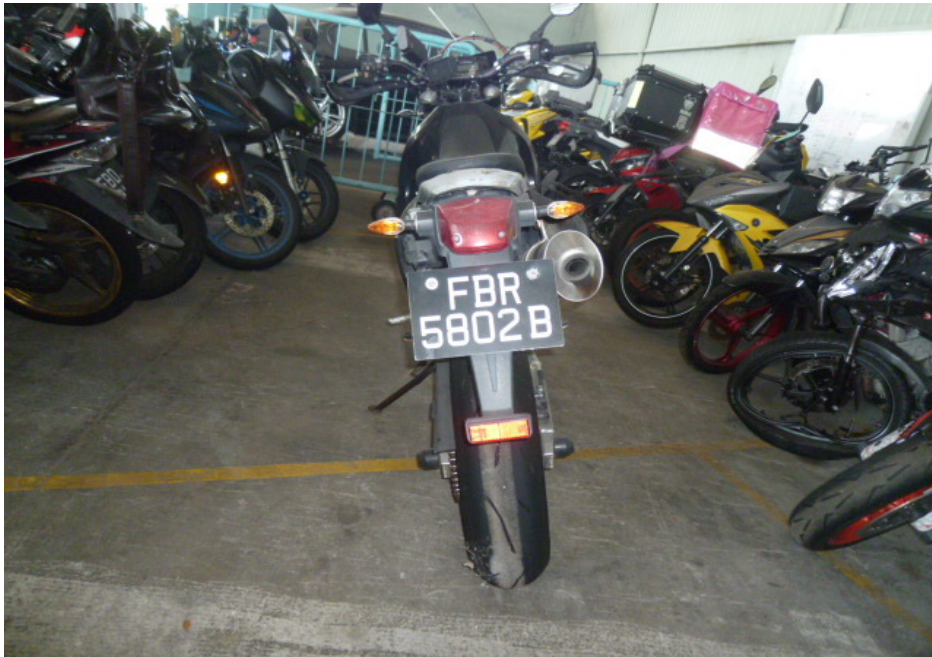
Photo 4 shows a general view of the rear portion of the Motorcycle at the time of our inspection. The Motorcycle was observed to have sustained damages along its frontal portion and right body. Amongst the body parts that were found to have been damaged include its headlight assembly, front mudguard, right cowling, front brake lever guard, rear brake pedal and right front footrest, amongst others.

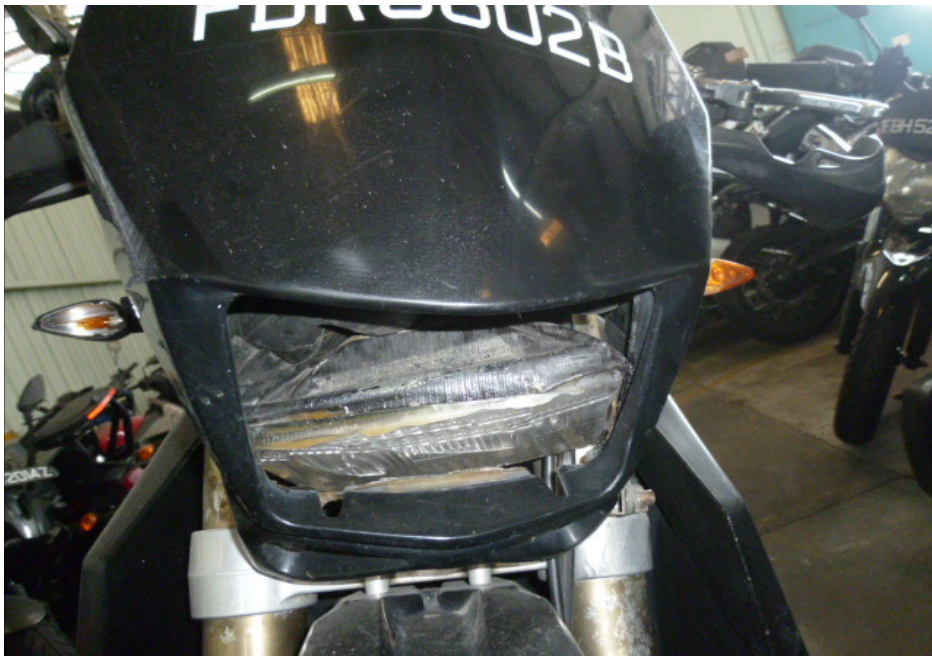
Photo 5 shows a close up view of the headlight assembly which was amongst the body parts of the Motorcycle that had sustained damage as a result of the accident.

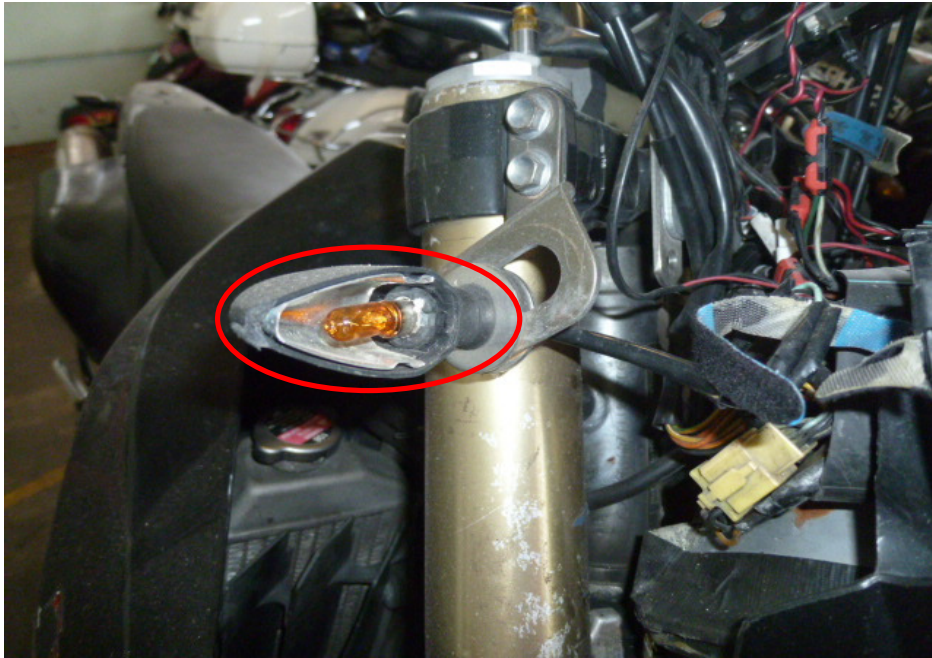
Photo 6 shows the broken left front signal lamp (circled) of the Motorcycle as a result of the accident.

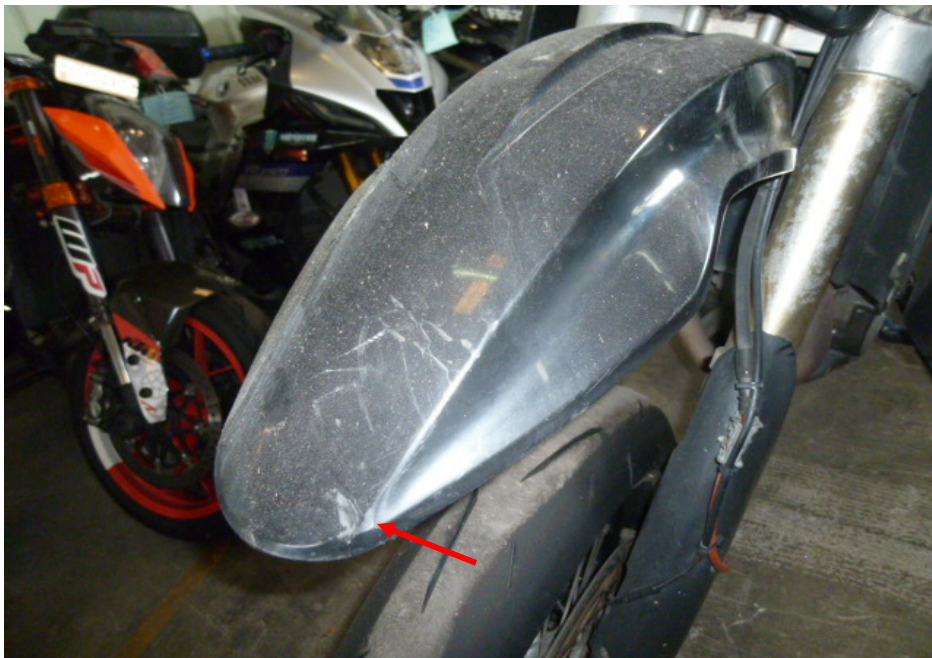
Photo 7 shows a closer view of the front mudguard (arrowed) which was amongst the body parts at the front body of the Motorcycle that had sustained damage as a result of the accident.

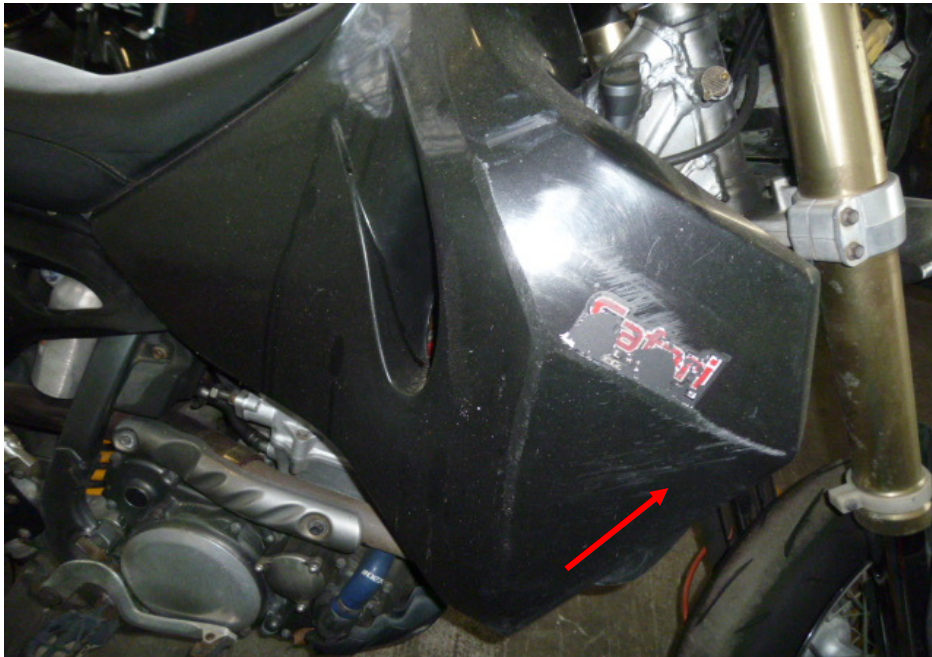
Photo 8 shows a closer view of the right cowling (arrowed) which was amongst the body parts of the Motorcycle that had sustained damage as a result of the accident.

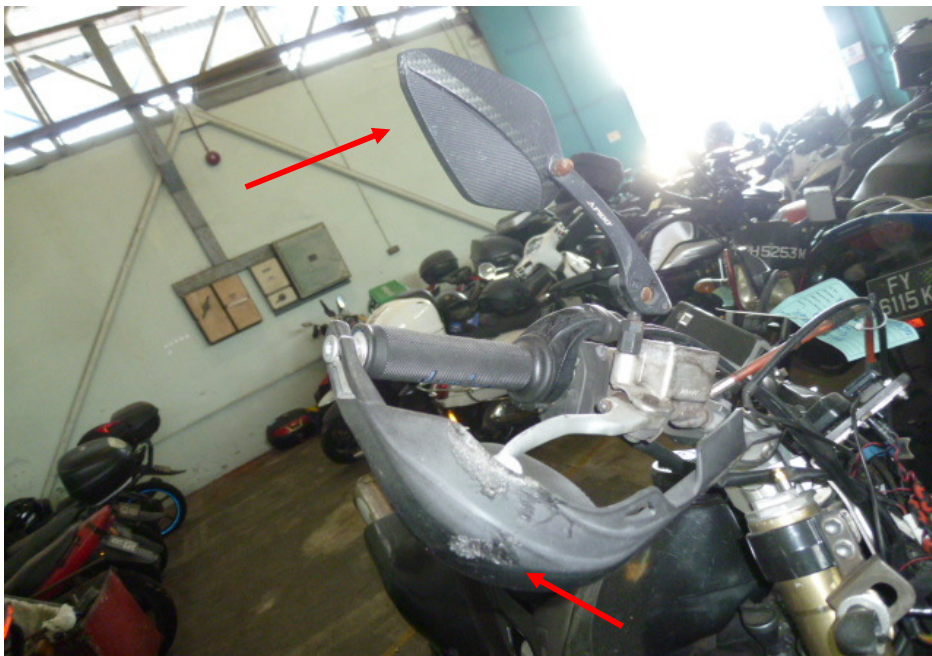
Photo 9 shows the right side mirror and front brake lever guard (arrowed), which were amongst the body parts of the Motorcycle that had sustained damage as a result of the accident.

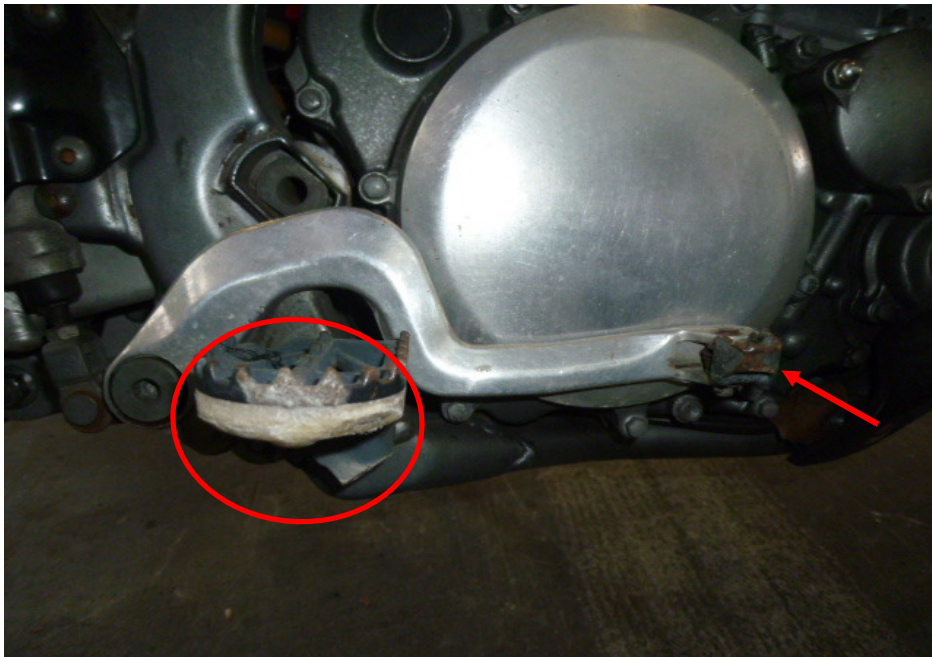
Photo 10 shows a closer view of the rear brake pedal (circled) and right front footrest (arrowed) which were amongst the body parts of the Motorcycle that had sustained damage as a result of the accident.

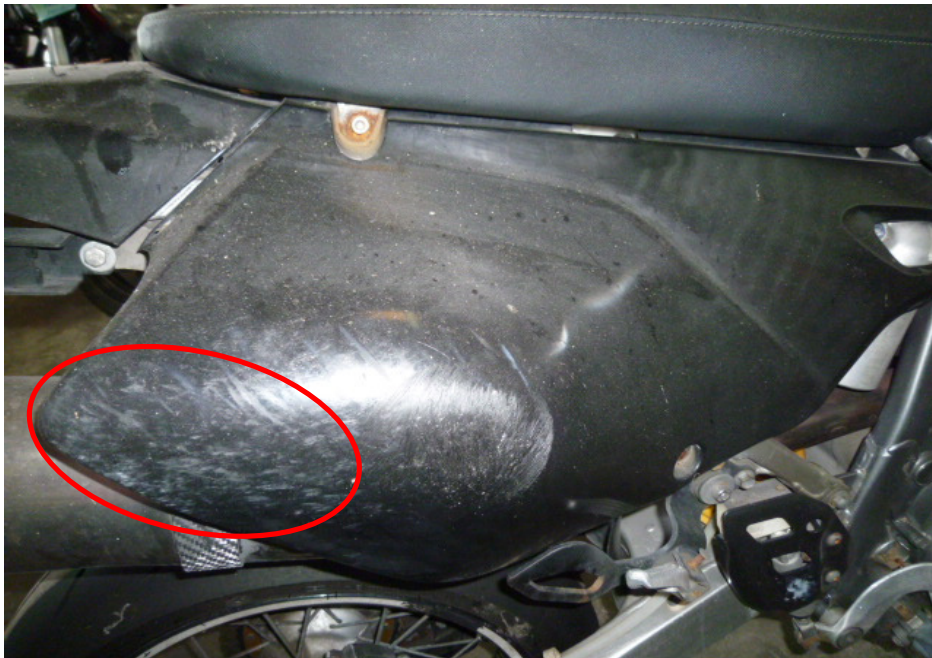
Photo 11 shows a closer view of the right rear side cover which was amongst the body parts of the Motorcycle that had sustained damages of grazing nature as a result of the accident (circled).

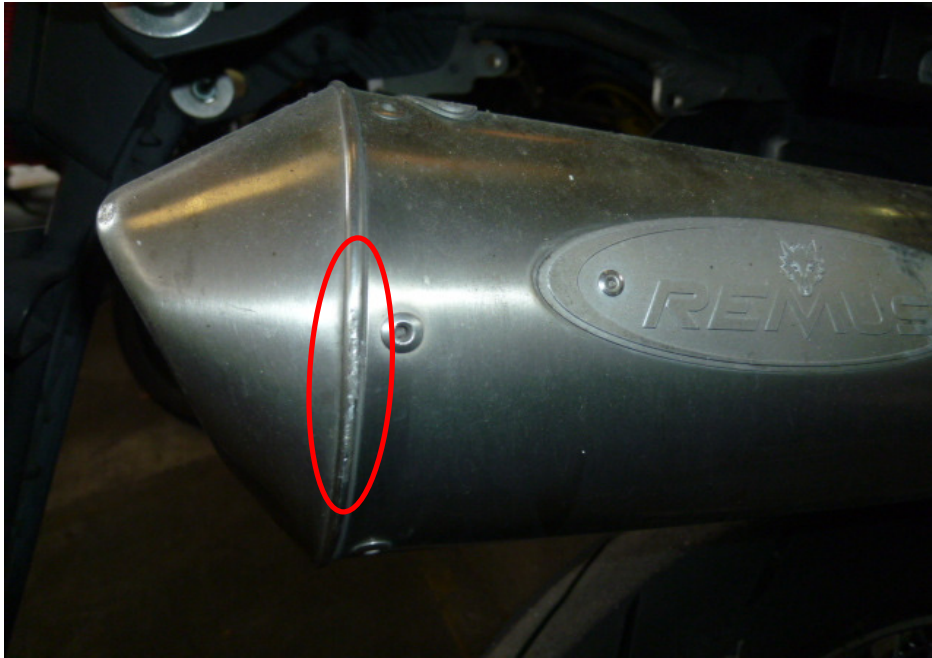
Photo 12 shows the exhaust muffler which was amongst the body parts of the Motorcycle that had sustained damage as a result of the accident (circled).

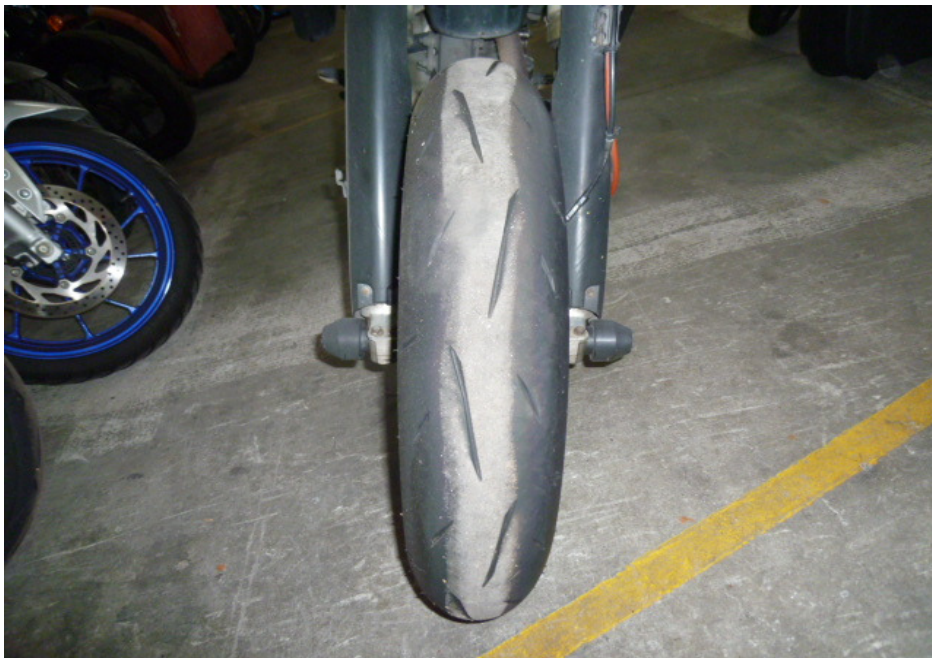
Photo 13 shows the front tyre of the Motorcycle at the time of our inspection. The front tyre was observed to be in serviceable condition with remaining tread depth of approximately 3mm. The pattern of the tread was also clearly visible. There was no tear, burst mark(s) and/or punctured hole(s) on the sidewalls as well as across the tread of the front tyre.

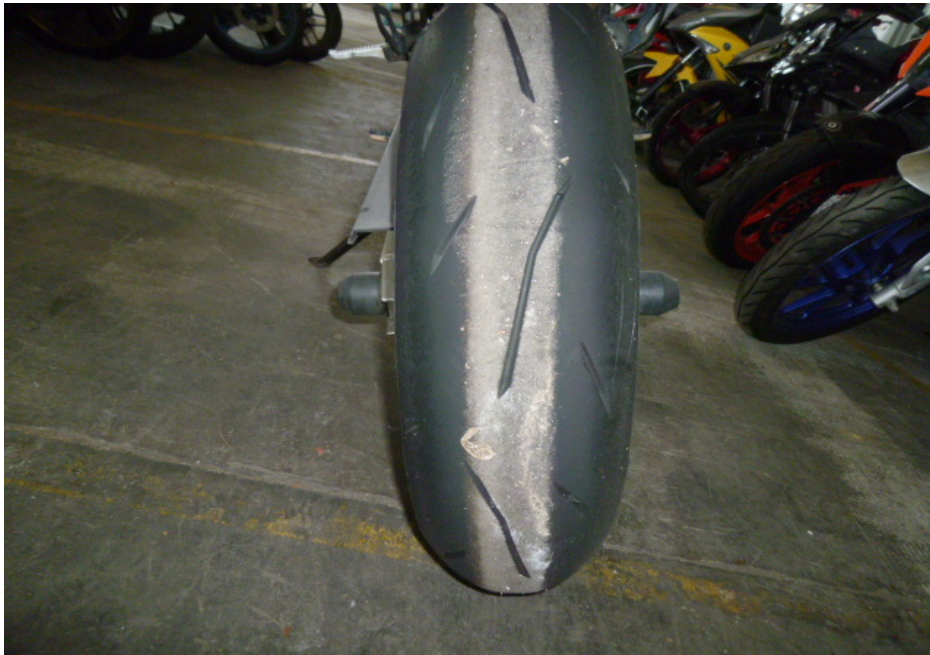
Photo 14 shows the condition of the Motorcycle's rear tyre. The rear tyre was observed to be in serviceable condition with remaining tread depth of approximately 5mm. The tyre was also observed to be sufficiently inflated for vehicular operation. We did not observe any tear, burst mark(s) and/or punctured hole(s) on the sidewalls as well as across the tread of the rear tyre.

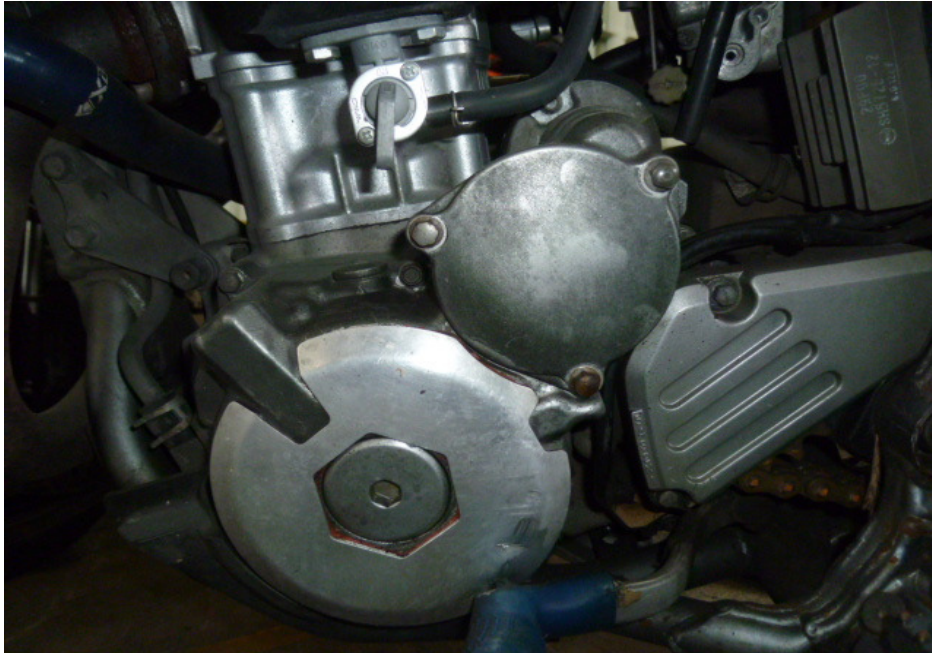
Photo 15 shows the left side of the engine of the Motorcycle at the time of our inspection. The various engine related parts and components were found to be intact with no visible damage. There was also no sign(s) or indication(s) of fluid leak observed around the left engine area of the Motorcycle.

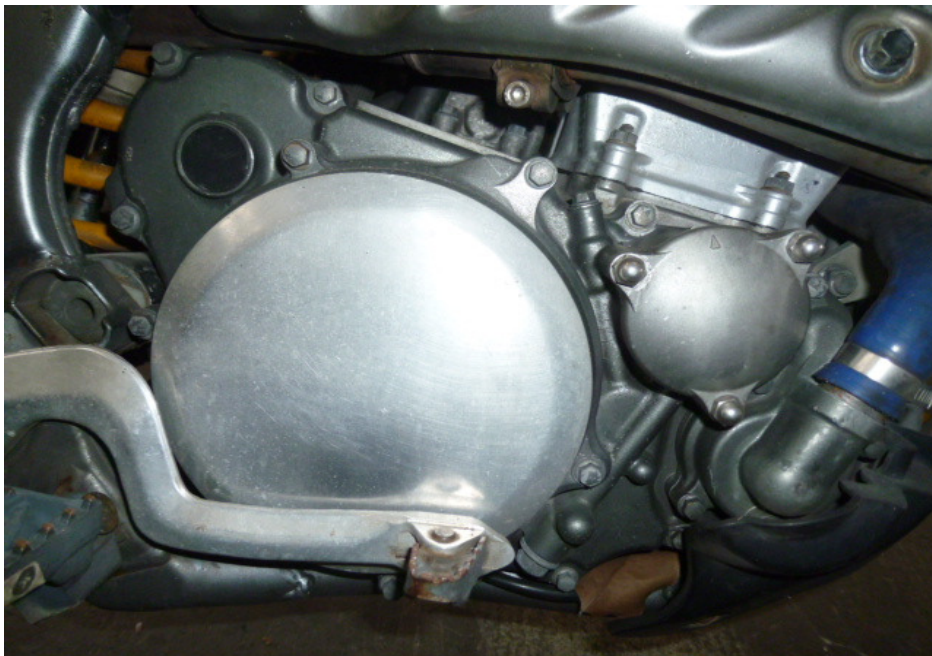
Photo 16 shows the right side of the engine of the Motorcycle at the time of our inspection. The various engine related parts and components were found to be intact with no visible damage. There was also no sign(s) or indication(s) of fluid leak observed around the right engine area of the Motorcycle.

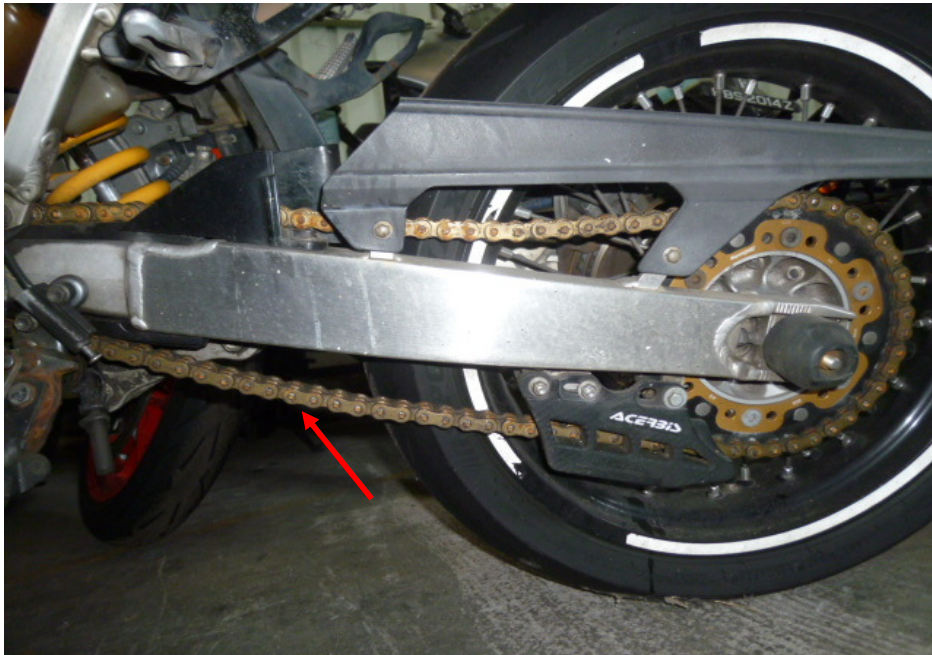
Photo 17 shows the general view of the gear train (arrowed) of the Motorcycle, which was observed to be intact with no misalignment. It was also adequately lubricated for operating purposes.

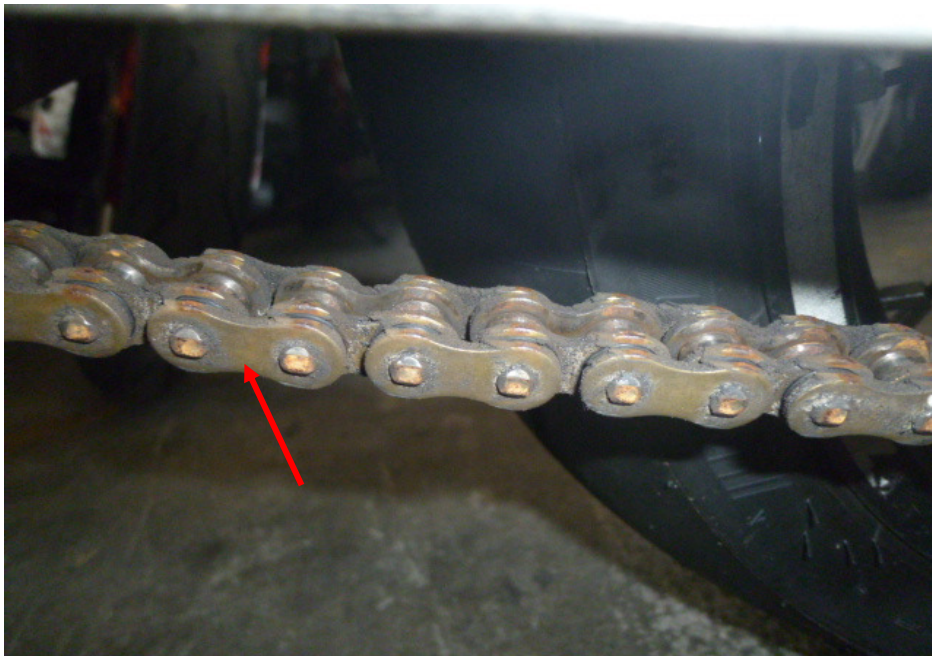
Photo 18 shows a closer view of the gear train (arrowed) of the Motorcycle, which was observed to be intact with no misalignment. It was also adequately lubricated for operating purposes.

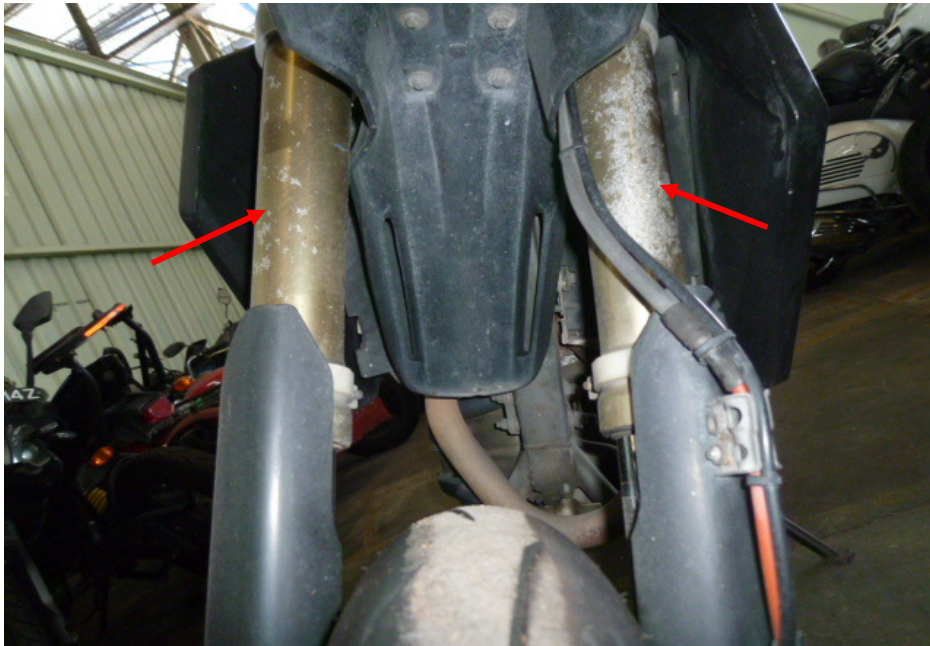
Photo 19 shows the front forks (arrowed) of the Motorcycle. The front forks and fork bracket of the Motorcycle were both found to be intact and undamaged. Turning the Motorcycle's handle bar towards the left and right did not produce any abnormal free play. The steering system of the Motorcycle was in serviceable condition at the time of our inspection.

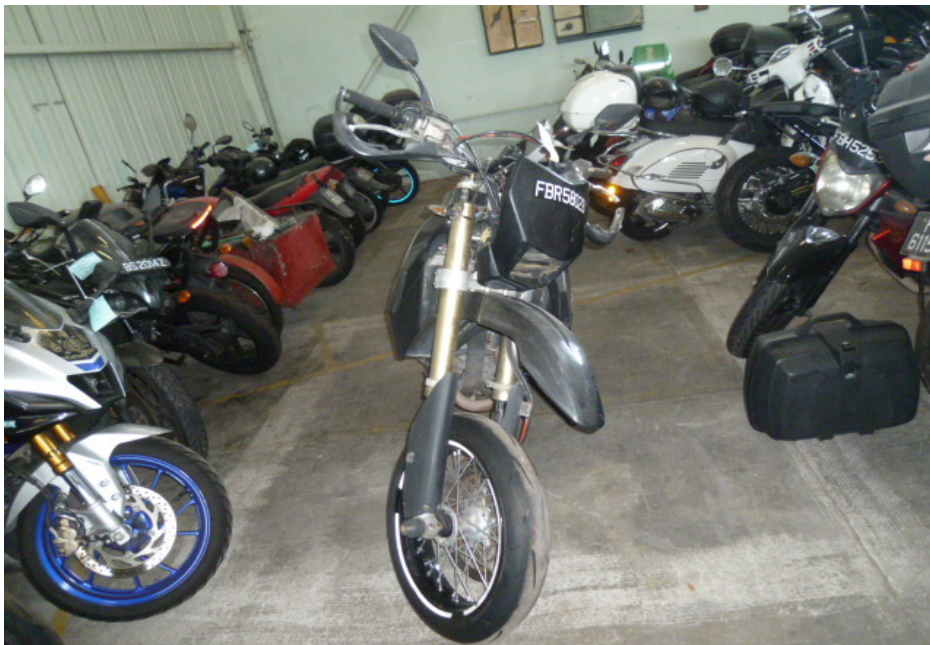
Photo 20 shows the front wheel of the Motorcycle turned towards its full left. Turning the Motorcycle's handle bar towards the left did not produce any abnormal free play and/or resistance. This would indicate that the steering system of the Motorcycle was in serviceable condition at the time of our inspection.

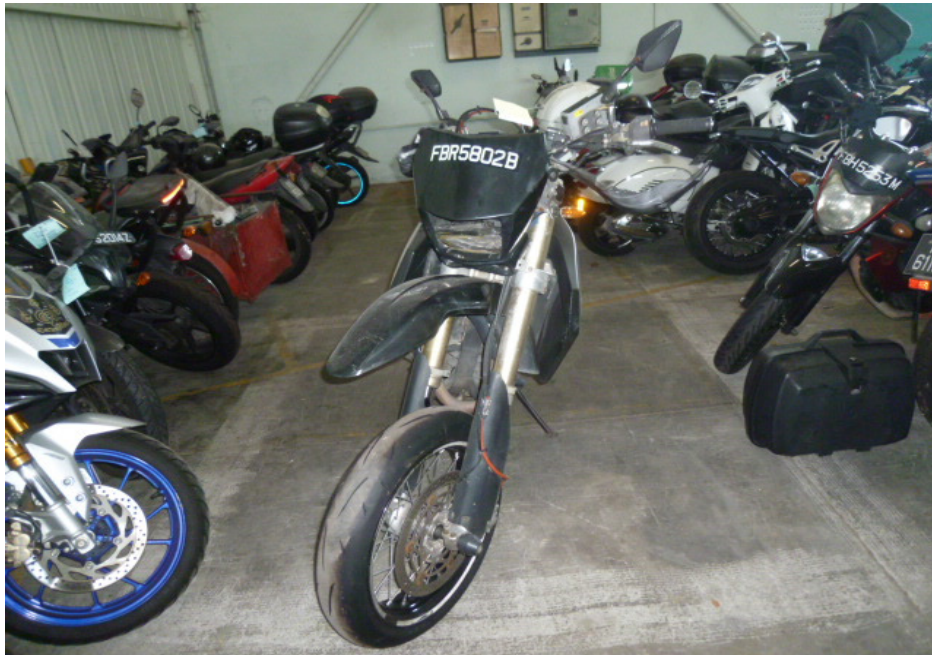
Photo 21 shows the front wheel of the Motorcycle turned towards its full right. Turning the Motorcycle's handle bar towards the right did not produce any abnormal free play and/or resistance. This would indicate that the steering system of the Motorcycle was in serviceable condition at the time of our inspection.

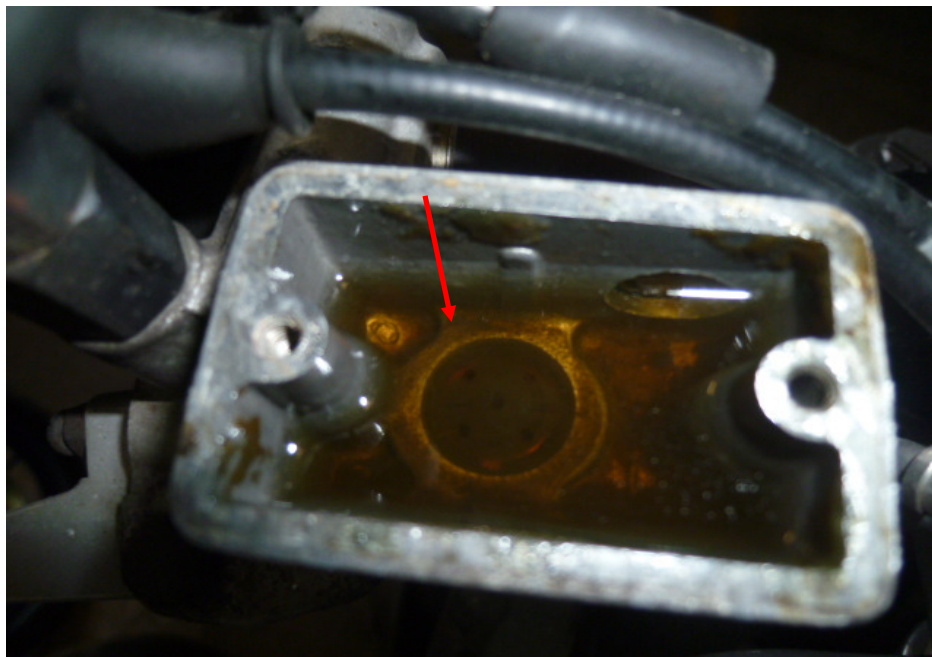
14. The brake fluid for the front brake was observed to be of sufficient level for operational purposes. However the brake fluid for the front brake was found to be slightly contaminated. We were unable remove the right heel guard to examine whether the rear brake fluid was of sufficient level and without contamination for operational purposes due to a worn out screw.

Photo 22 shows a close up view of the brake fluid reservoir for the front brake of the Motorcycle. The front brake fluid was observed to be of sufficient level for operational purposes. However it was found to be slightly contaminated (arrowed).

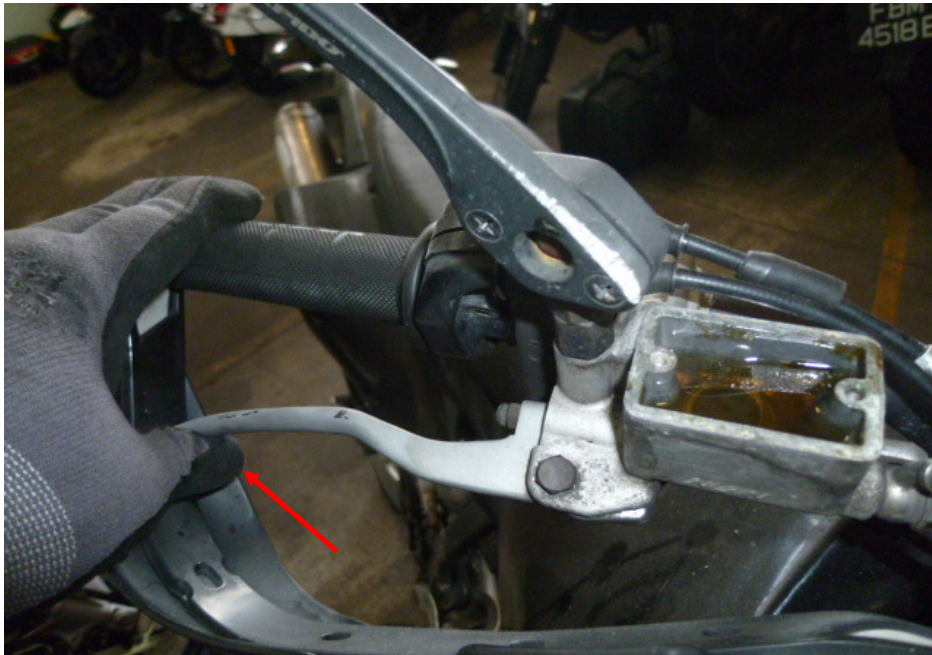
15. Static brake tests conducted on the Motorcycle had appear to indicate that the braking system of the Motorcycle were in serviceable condition. There was some resistance felt (spongy like feel) upon pressing the brake lever and upon stepping on the brake pedal. This would indicate that there was no leakage of pressure/vacuum in the braking system.

Photo 23 shows the front brake lever being depressed. There was some resistance felt (spongy like feel) upon pressing the front brake lever (arrowed). This would indicate that there is no leakage of pressure/vacuum in the front brake system.

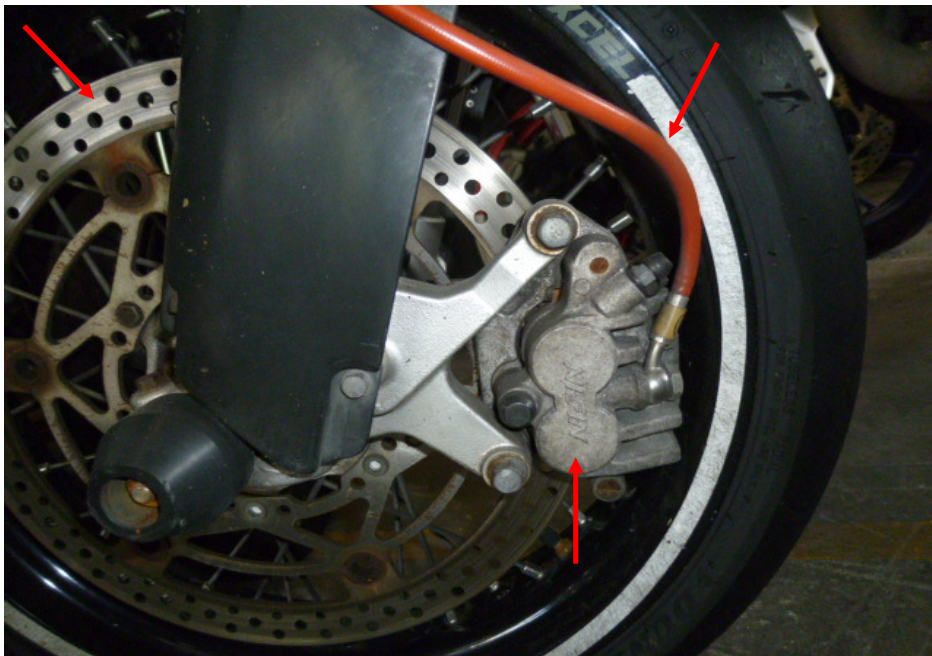
Photo 24 shows a close up view of the front brake caliper, front brake disc and front brake hose (arrowed) of the Motorcycle, which are all part of the components in the hydraulic front brake system of the Motorcycle. Our visual checks of these various components had revealed all to be intact with no visible damage.

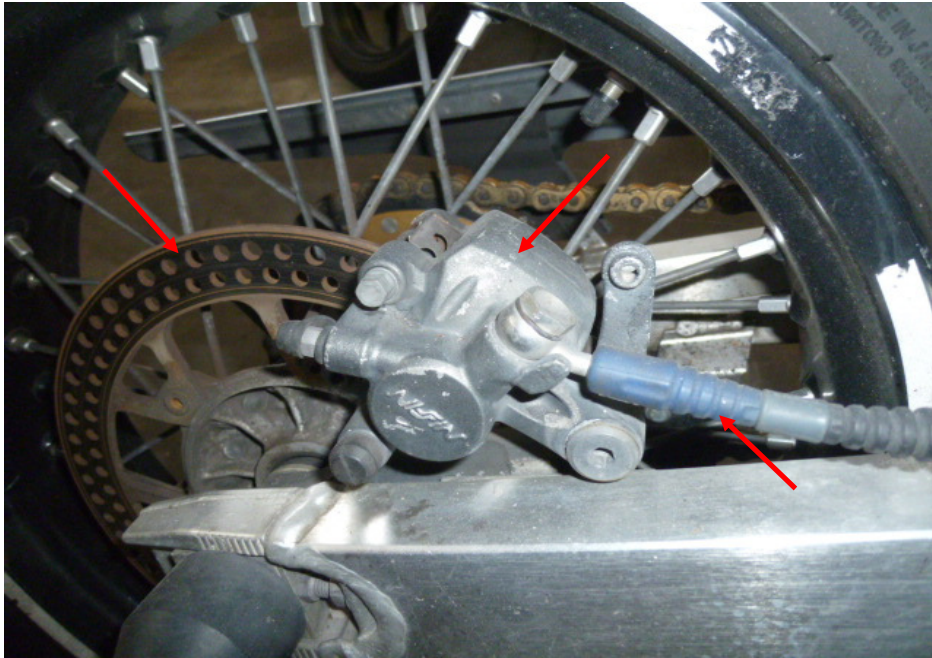
Photo 25 shows a close up view of the rear brake caliper, rear brake disc and rear brake hose (arrowed) of the Motorcycle, which are all part of the components in the hydraulic rear brake system of the Motorcycle. Our visual checks of these various components had revealed all to be intact with no visible damage. No leakage of brake fluid was also observed.

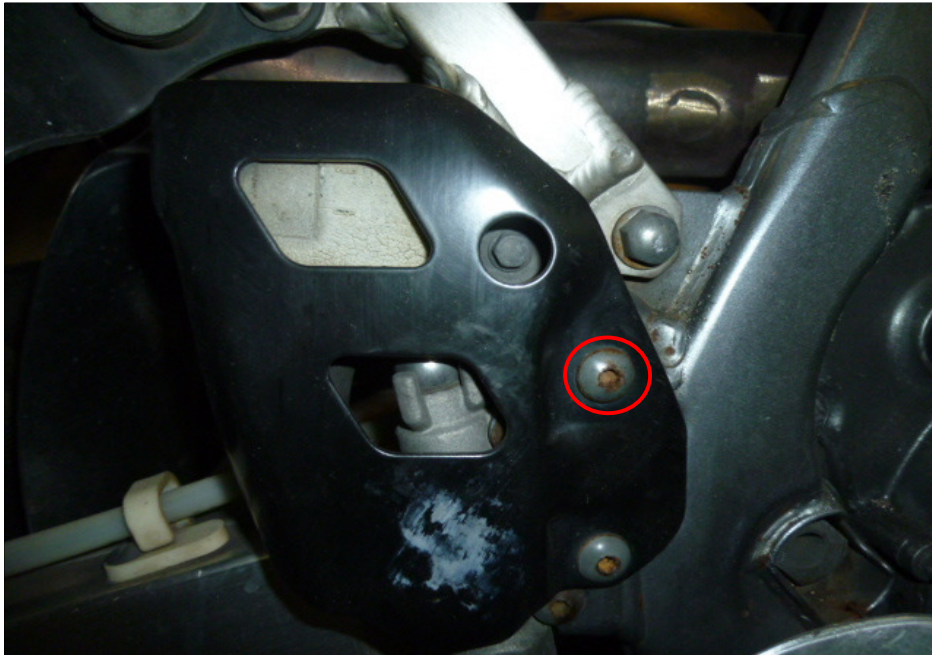
Photo 26 shows the brake fluid reservoir cover for the rear brake of the Motorcycle. We were unable to remove the right heel guard to examine whether the rear brake fluid was of sufficient level for operational purposes and without contamination due to a worn out screw (circled).
