Your Ref: TP/IP/27929/2022
Our Ref : CI/TPD22011559/N

17 January 2023

INSPECTION REPORT OF MOTORCYCLE JVQ 9740

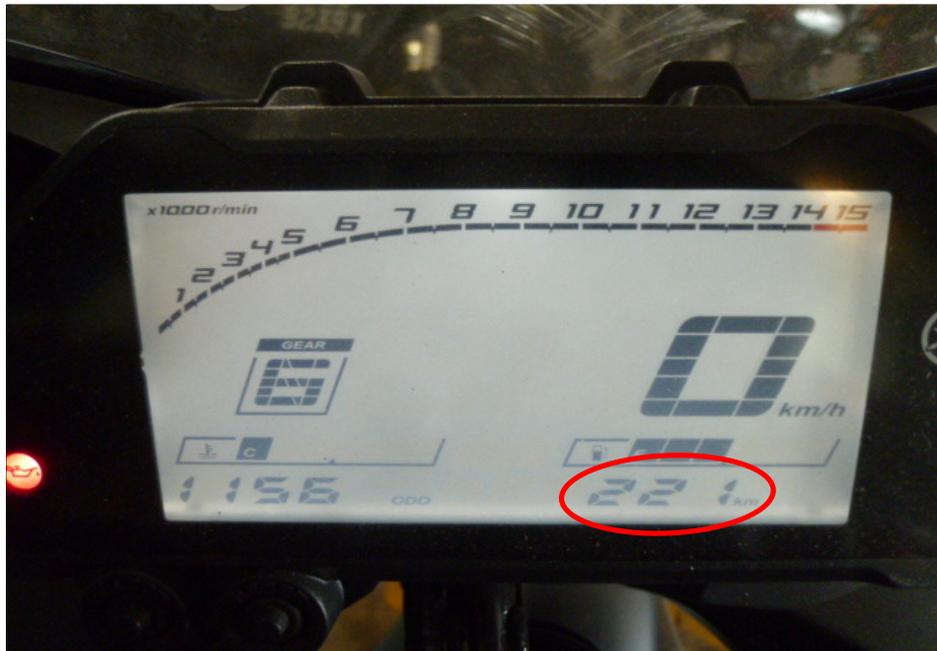
Photo 1 shows the speedometer gauge of the Motorcycle. The mileage of the Motorcycle at the time of our inspection was 221km (circled).

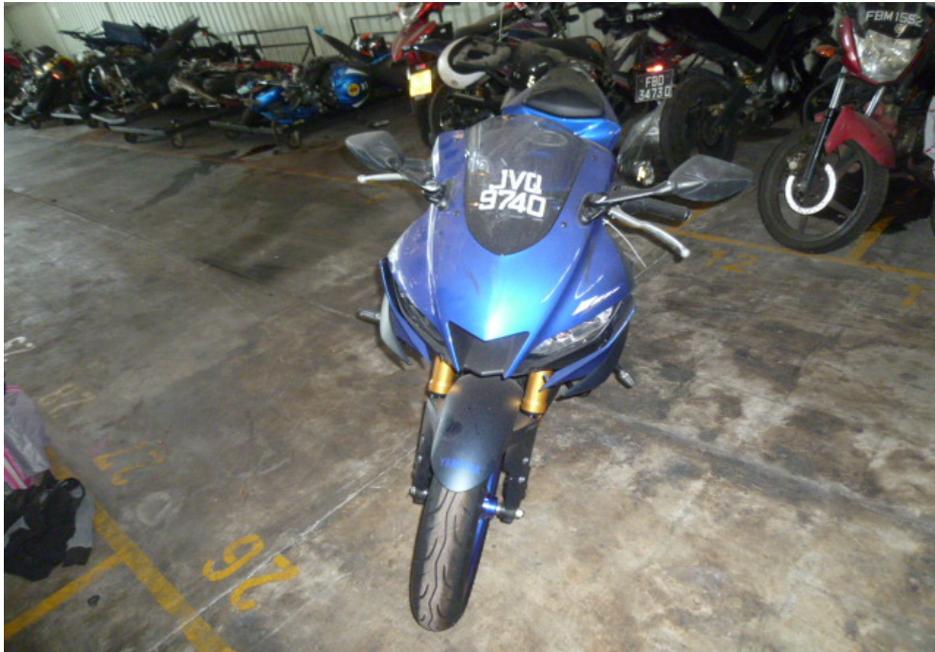
Photo 2 shows a general view of the frontal portion of the Motorcycle at the time of our inspection. The Motorcycle was observed to have sustained damages all around.

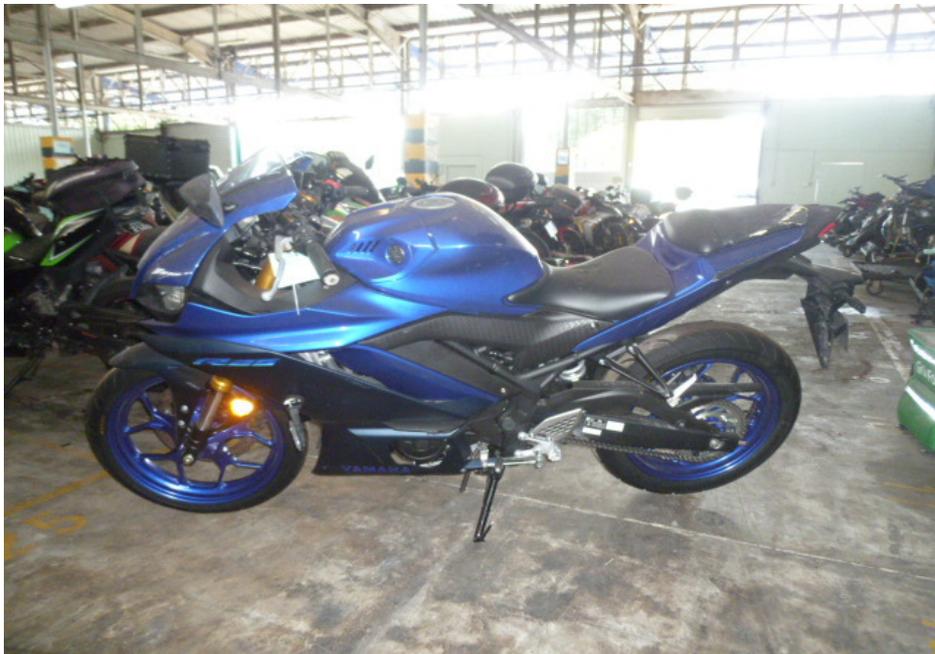
Photo 3 shows a general view of the left body of the Motorcycle at the time of our inspection. The Motorcycle was observed to have sustained damages all around.

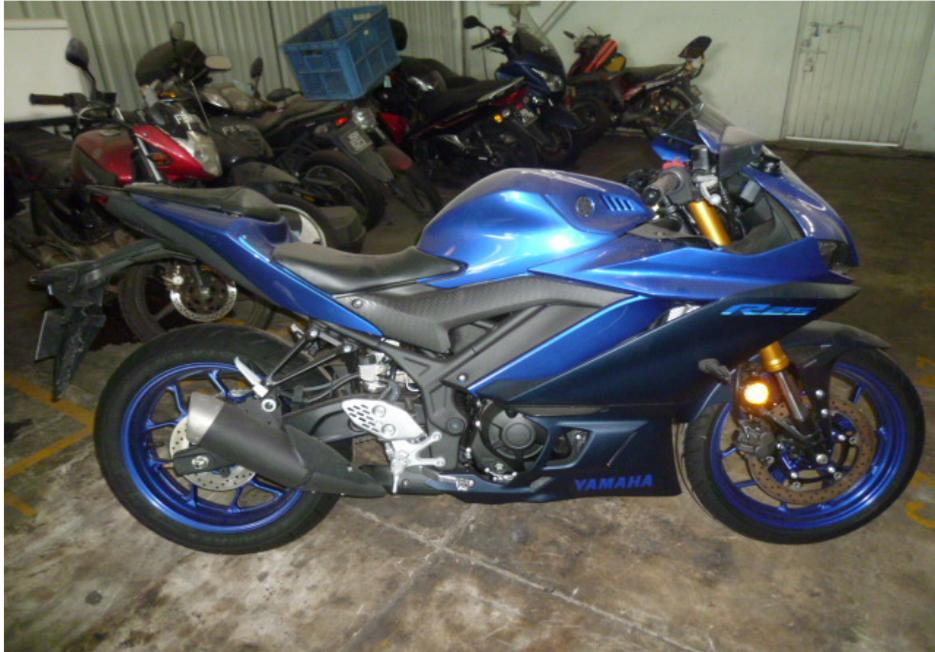
Photo 4 shows a general view of the right body of the Motorcycle at the time of our inspection. The Motorcycle was observed to have sustained damages all around. The body parts that were found to have been damaged include its windshield, left side cowling, left front signal lamp, left side mirror, clutch lever, left handlebar end, gear shift pedal, left front footrest, left rear side cover, rear seat, tail lamp cover and tail lamp, amongst others.

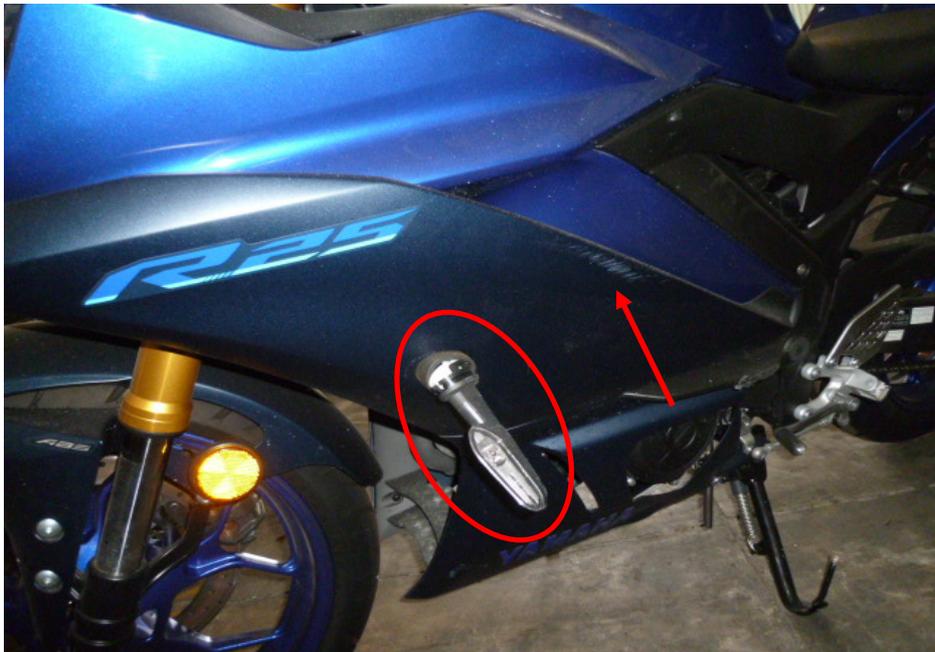
Photo 5 shows a closer view of the left front signal lamp (circled) and grazed left cowling of the Motorcycle as a result of the accident.

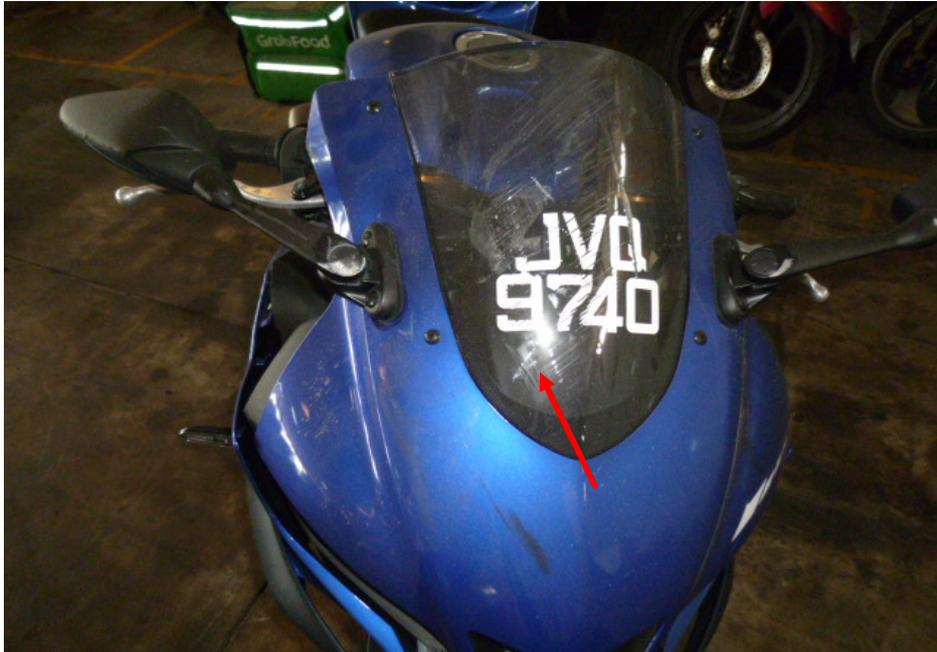
Photo 6 shows the windshield (arrowed), which was amongst the body parts of the Motorcycle that had sustained damage as a result of the accident.

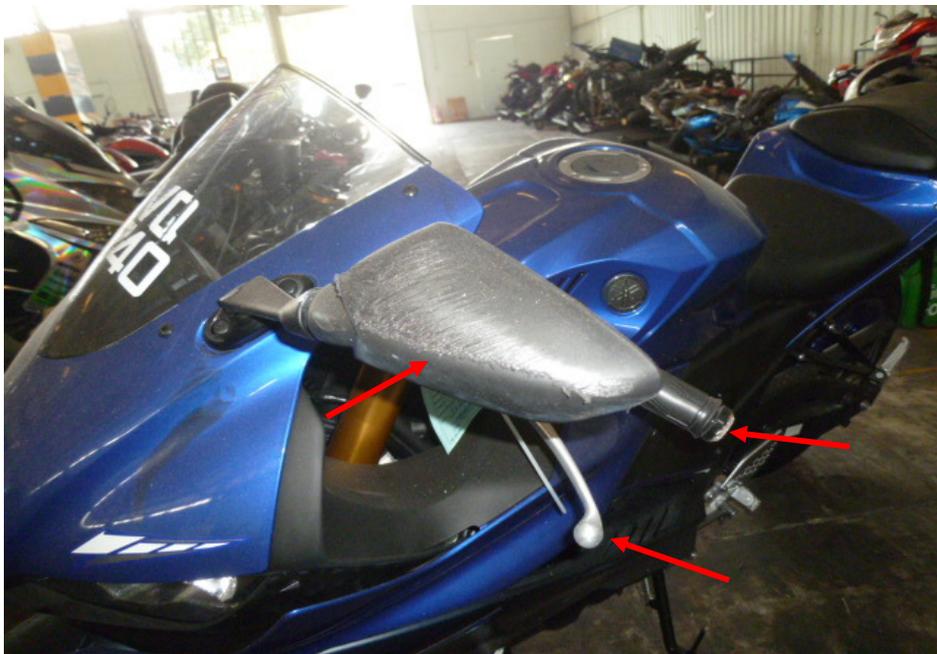
Photo 7 shows the left handlebar end, clutch lever and left side mirror (arrowed), which were amongst the body parts of the Motorcycle that had sustained damage as a result of the accident.

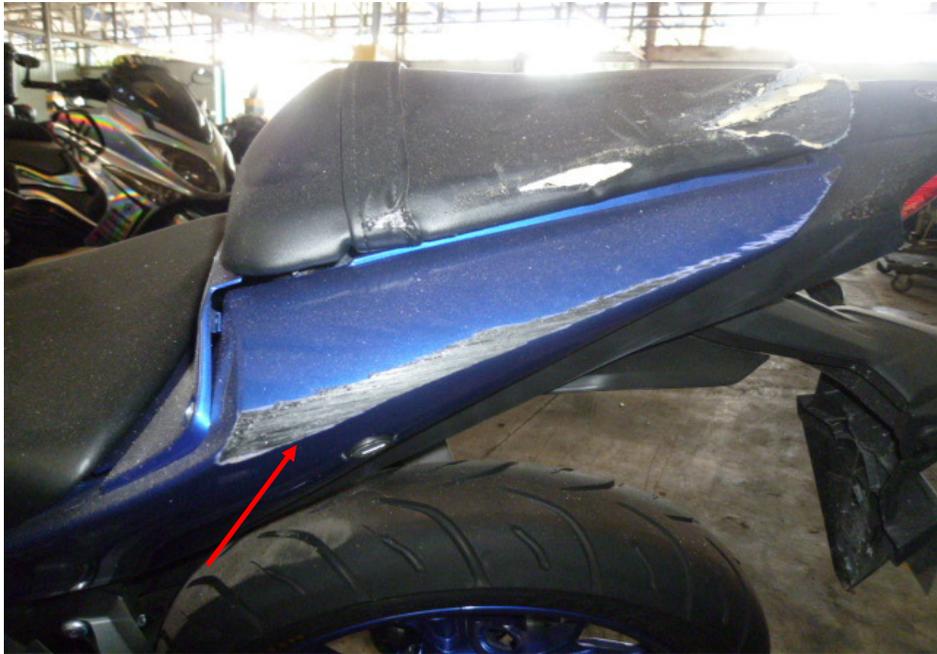
Photo 8 shows a closer view of the grazed left rear side cover of the Motorcycle as a result of the accident (arrowed).

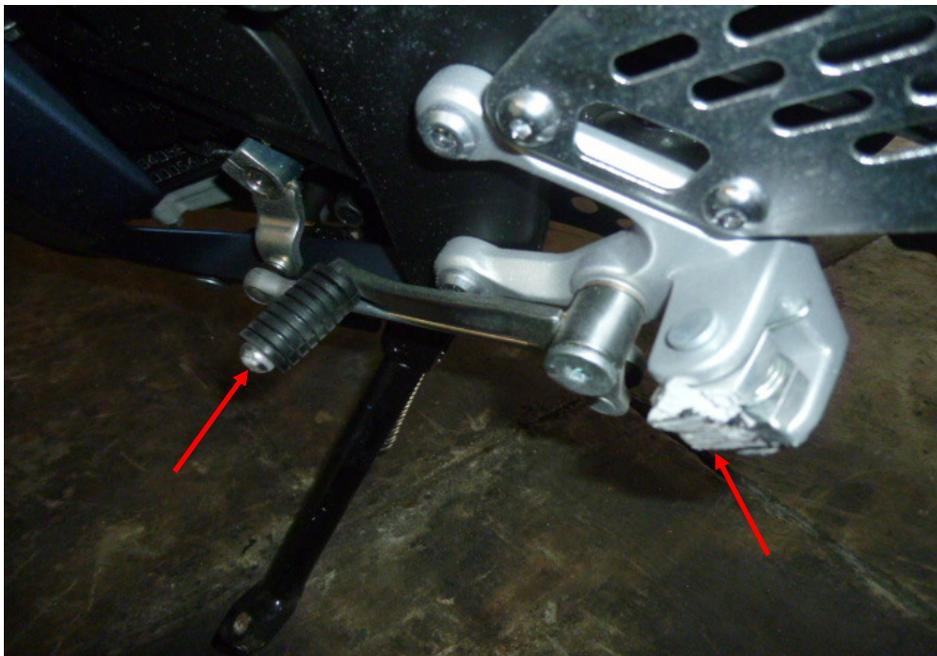
Photo 9 shows the gear shift pedal and left front footrest of the Motorcycle that had sustained damage as a result of the accident (arrowed).

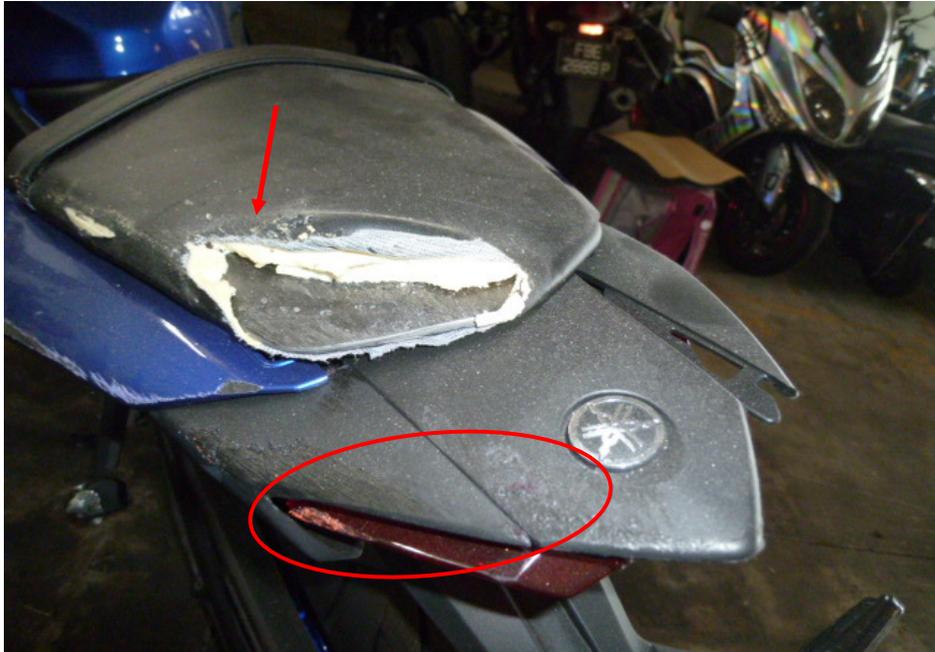
Photo 10 shows a closer view of the torn rear seat (arrowed) and grazed tail lamp as well as tail lamp cover (circled) of the Motorcycle as a result of the accident.

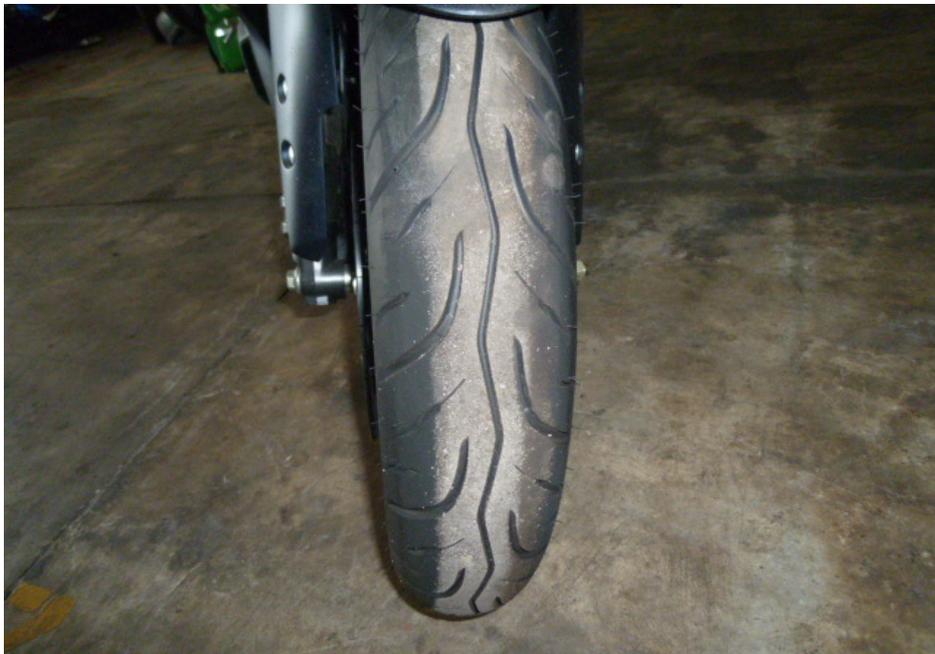
Photo 11 shows the front tyre of the Motorcycle at the time of our inspection. The front tyre was observed to be in serviceable condition with remaining tread depth of approximately 5mm. The pattern of the tread was also clearly visible. There was no tear, burst mark(s) and/or punctured hole(s) on the sidewalls as well as across the tread of the front tyre.

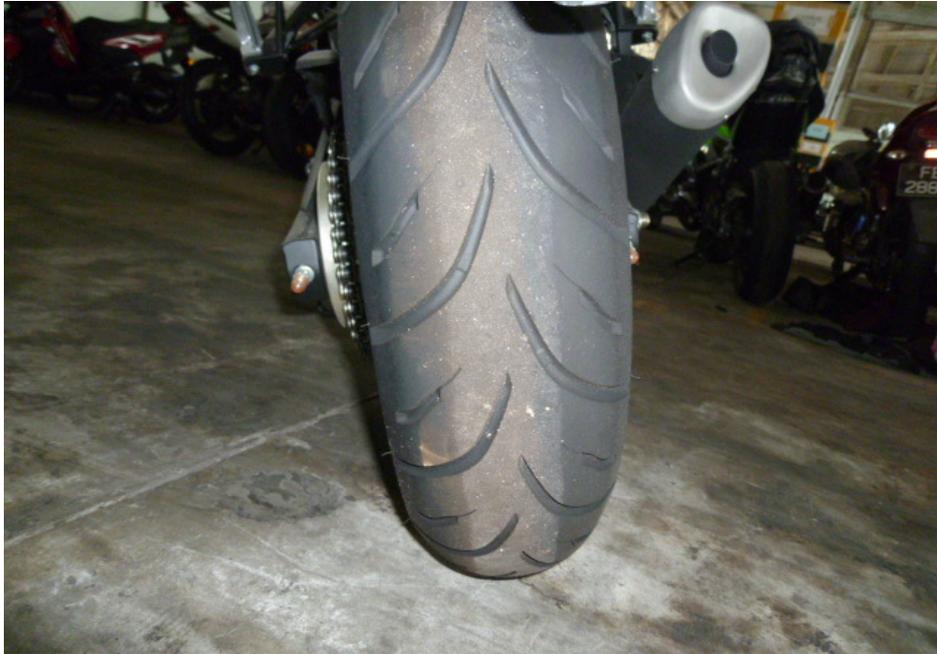
Photo 12 shows the condition of the Motorcycle's rear tyre. The rear tyre was observed to be in serviceable condition with remaining tread depth of approximately 6mm. The tyre was also observed to be sufficiently inflated for vehicular operation. We did not observe any tear, burst mark(s) and/or punctured hole(s) on the sidewalls as well as across the tread of the rear tyre.

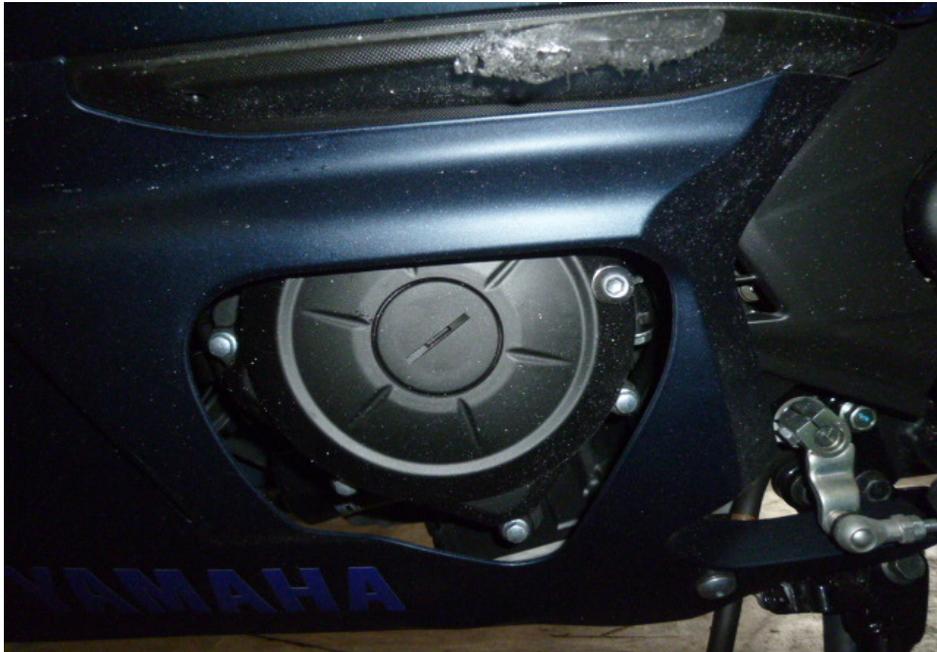
Photo 13 shows the left side of the engine of the Motorcycle at the time of our inspection. The various engine related parts and components were found to be intact with no visible damage. There was also no sign(s) or indication(s) of fluid leak observed around the left engine area of the Motorcycle.

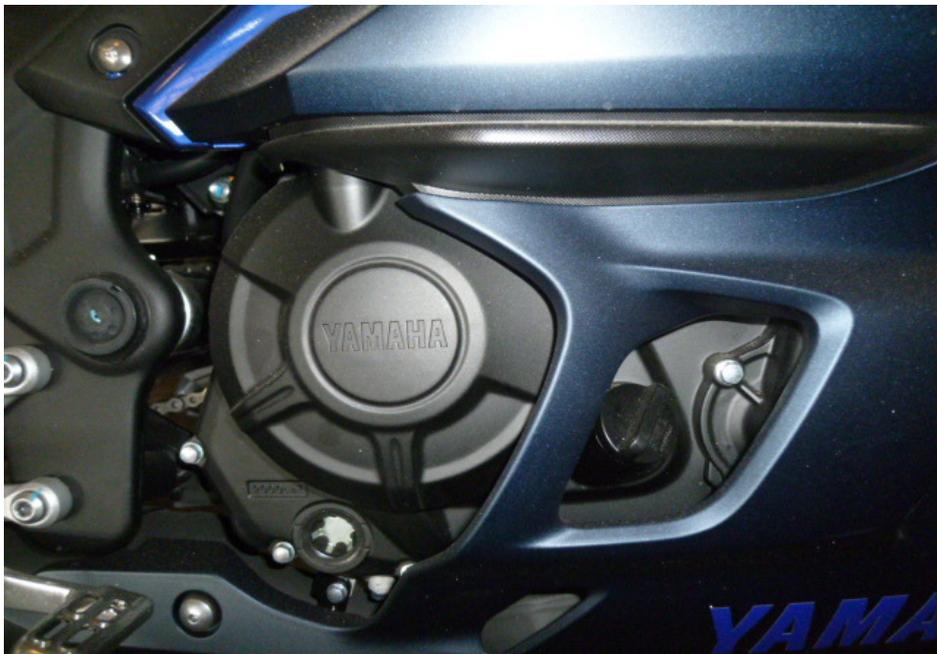
Photo 14 shows the right side of the engine of the Motorcycle at the time of our inspection. The various engine related parts and components were found to be intact with no visible damage. There was also no sign(s) or indication(s) of fluid leak observed around the right engine area of the Motorcycle.

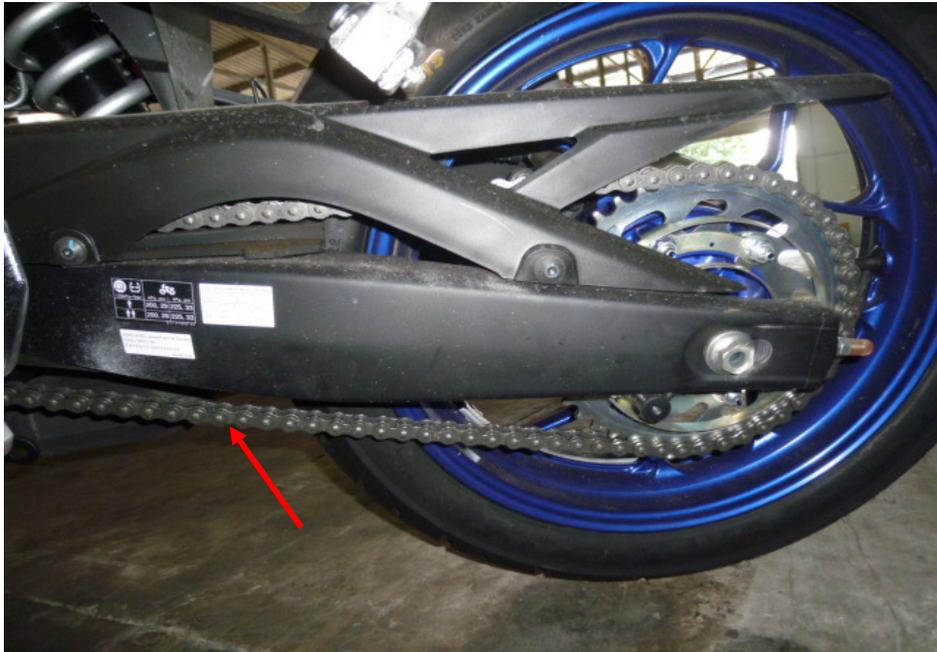
Photo 15 shows the general view of the gear train (arrowed) of the Motorcycle, which was observed to be intact with no misalignment. It was also adequately lubricated for operating purposes.

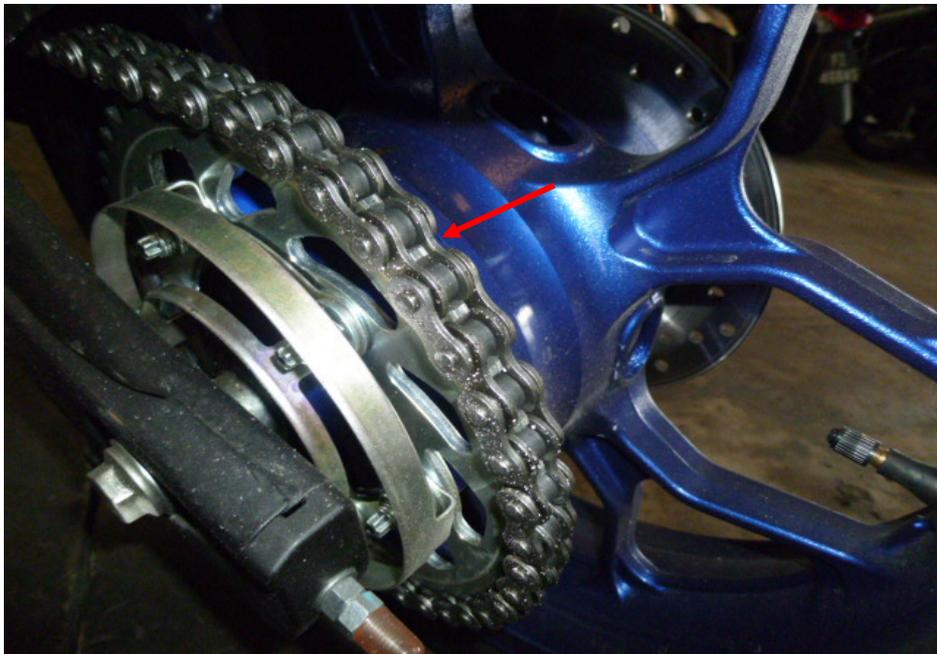
Photo 16 shows a closer view of the gear train (arrowed) of the Motorcycle, which was observed to be intact with no misalignment. It was also adequately lubricated for operating purposes.

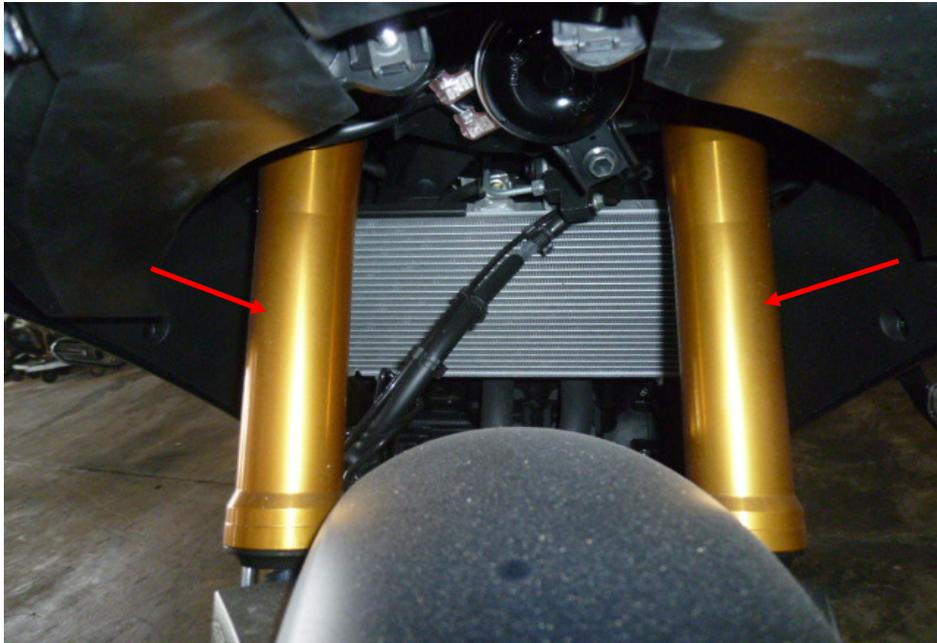
Photo 17 shows the front forks (arrowed) of the Motorcycle. The front forks and fork bracket of the Motorcycle were both found to be intact and undamaged. Turning the Motorcycle's handle bar towards the left and right did not produce any abnormal free play. The steering system of the Motorcycle was in serviceable condition at the time of our inspection.

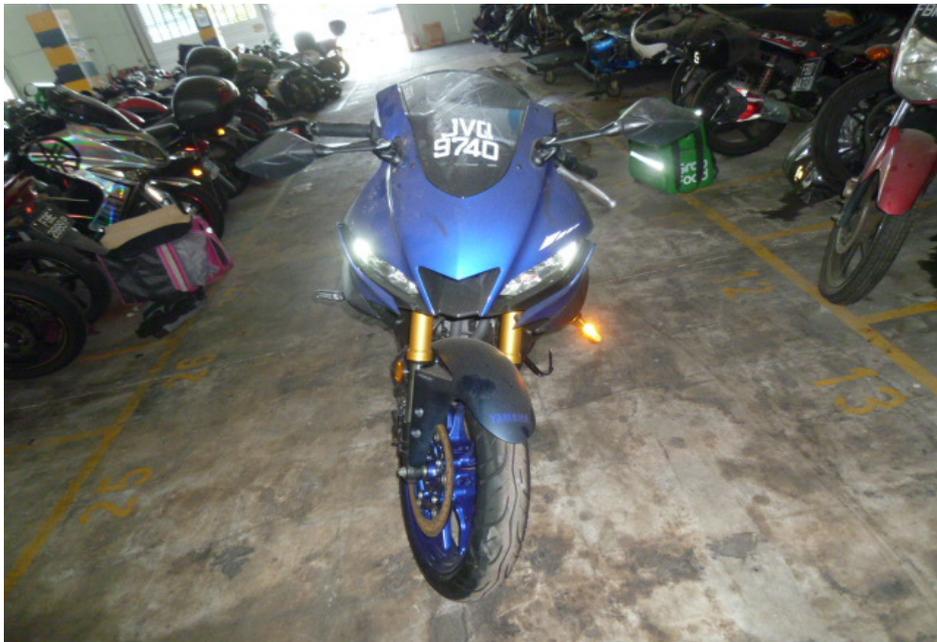
Photo 18 shows the front wheel of the Motorcycle turned towards its full left. Turning the Motorcycle's handle bar towards the left did not produce any abnormal free play and/or resistance. This would indicate that the steering system of the Motorcycle was in serviceable condition at the time of our inspection.

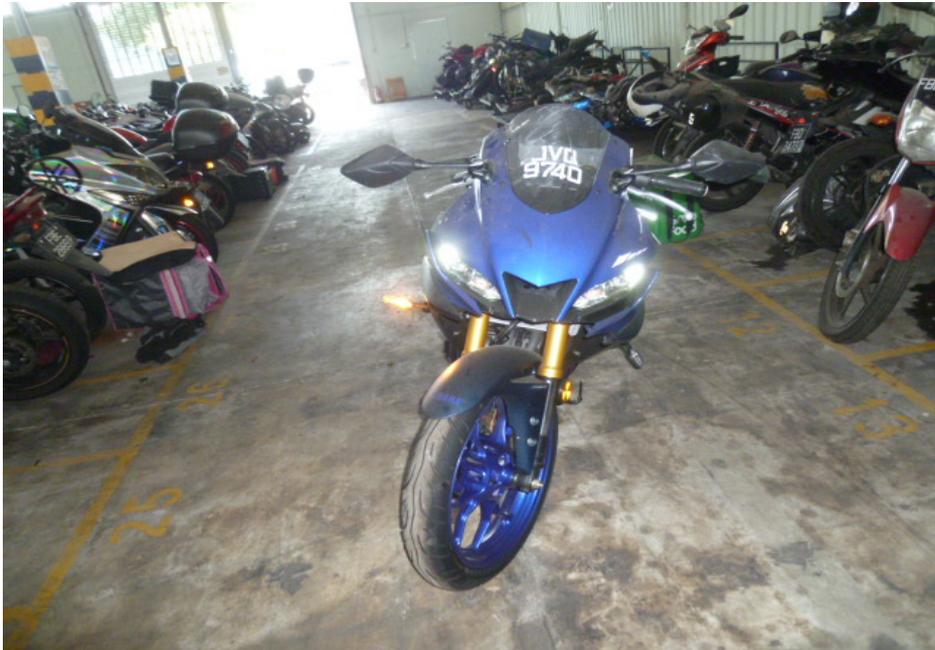
Photo 19 shows the front wheel of the Motorcycle turned towards its full right. Turning the Motorcycle's handle bar towards the right did not produce any abnormal free play and/or resistance. This would indicate that the steering system of the Motorcycle was in serviceable condition at the time of our inspection.

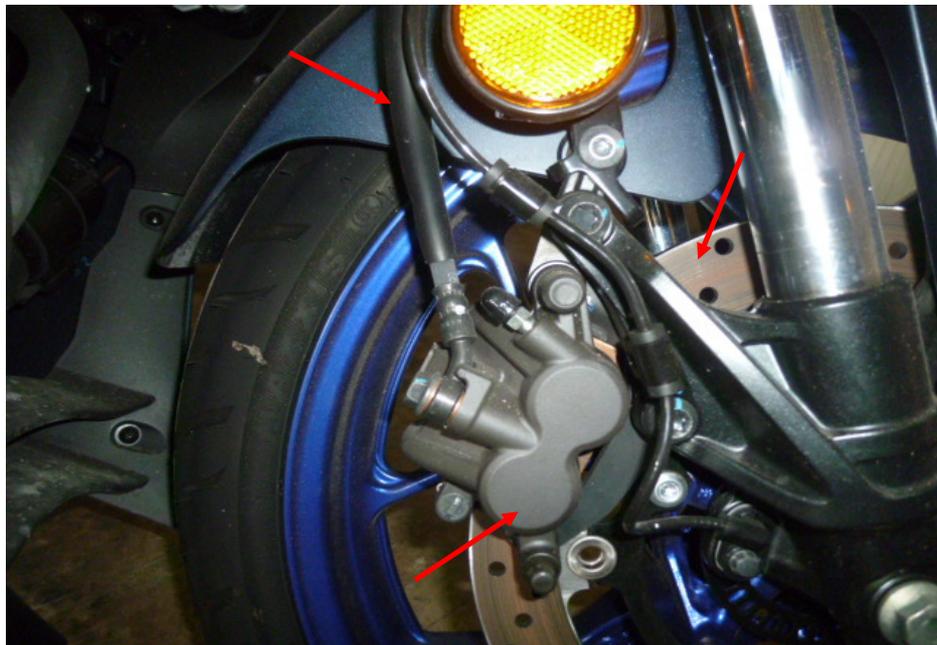
Photo 20 shows a close up view of the front brake caliper, front brake disc and front brake hose (arrowed) of the Motorcycle, which are all part of the components in the hydraulic front brake system of the Motorcycle. Our visual checks of these various components had revealed all to be intact with no visible damage. No leakage of brake fluid was also observed.

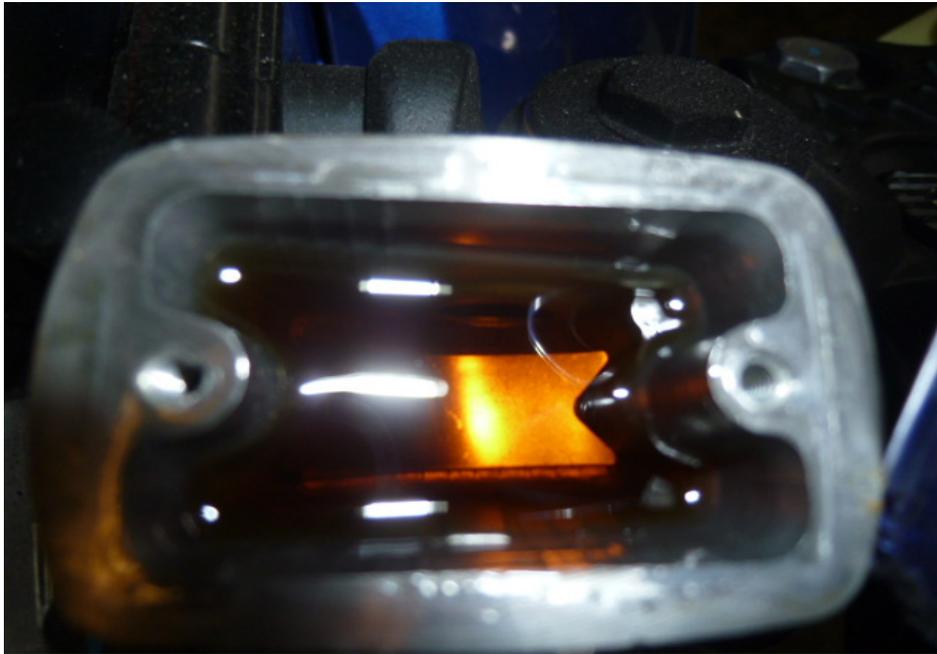
Photo 21 shows the brake fluid reservoir for the front brake of the Motorcycle. The brake fluid was observed to be of sufficient level for operational purposes and without any contamination.

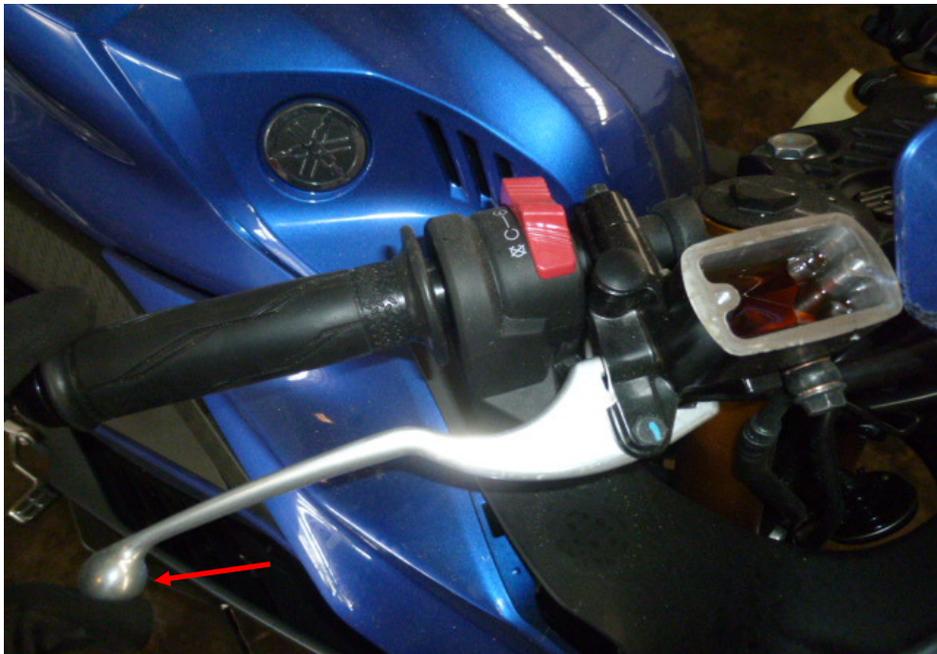
Photo 22 shows the front brake lever being depressed. There was some resistance felt (spongy like feel) upon pressing the front brake lever (arrowed). This would indicate that there is no leakage of pressure/vacuum in the front brake system.

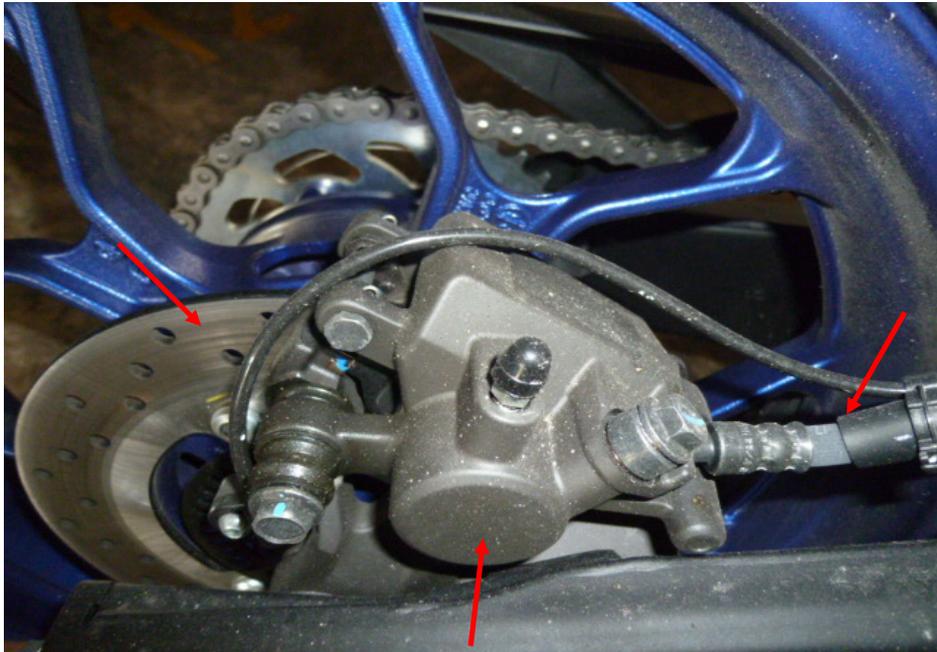
Photo 23 shows a close up view of the rear brake caliper, rear brake disc and rear brake hose (arrowed) of the Motorcycle, which are all part of the components in the hydraulic rear brake system of the Motorcycle. Our visual checks of these various components had revealed all to be intact with no visible damage. No leakage of brake fluid was also observed.

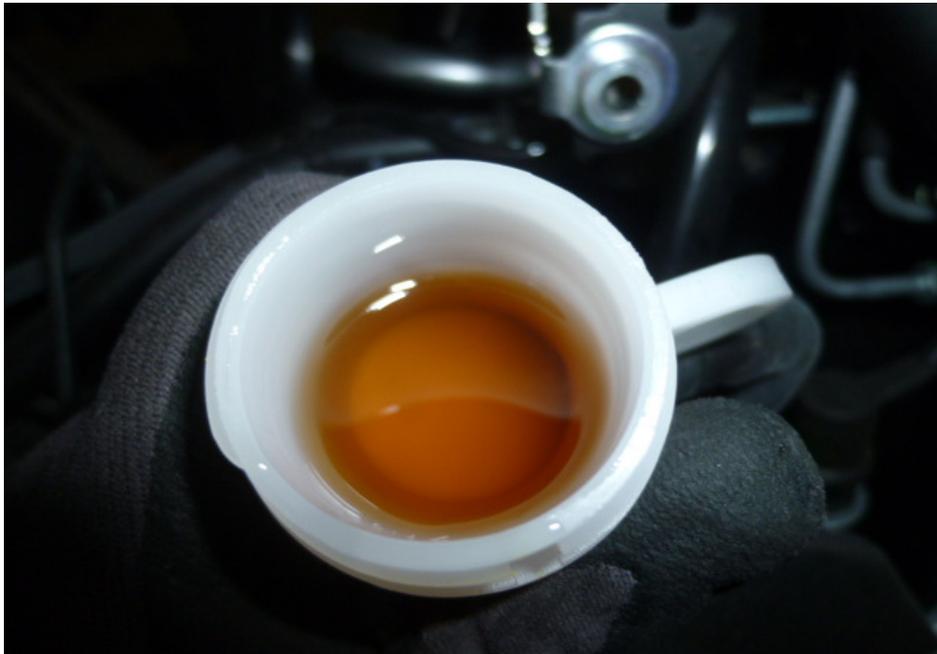
Photo 24 shows the brake fluid reservoir for the rear brake of the Motorcycle. The brake fluid was observed to be of sufficient level for operational purposes and without any contamination.
