Your Ref: TP/IP/27929/2022
Our Ref : CI/TPD22011561/N

Fatal Accident Investigation Team

INSPECTION REPORT OF MOTORCYCLE FBB 2710L

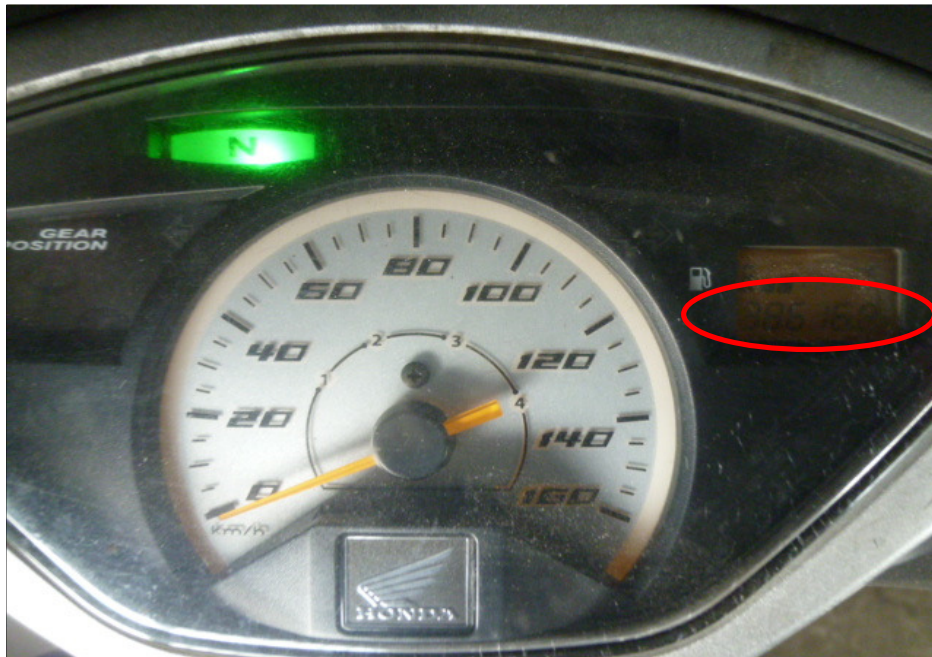
Photo 1 shows the speedometer gauge of the Motorcycle. The mileage of the Motorcycle at the time of our inspection was 38, 616km (circled).

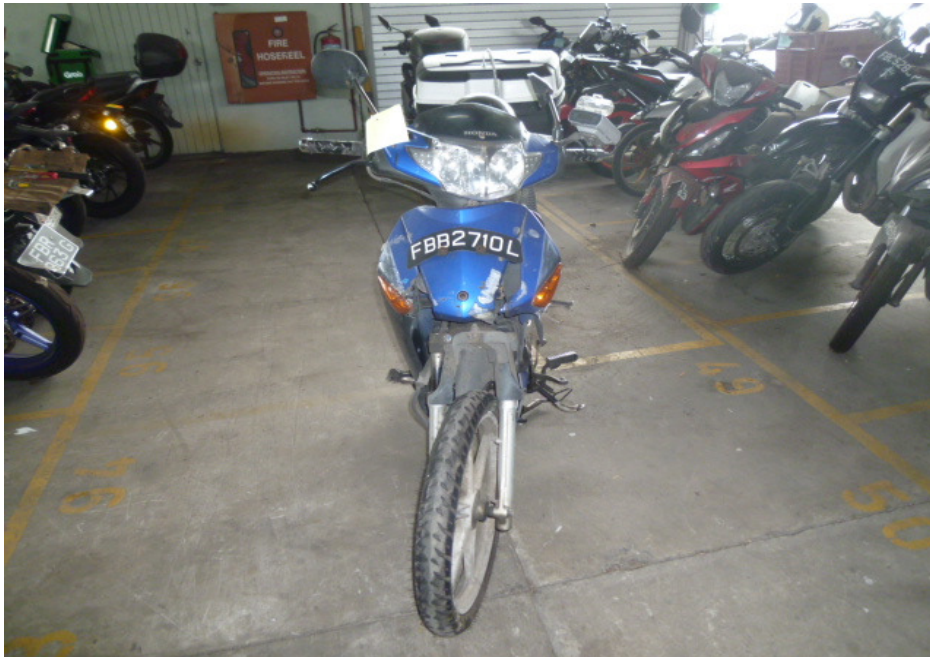
Photo 2 shows a general view of the frontal portion of the Motorcycle at the time of our inspection. The Motorcycle was observed to have sustained damages all around.

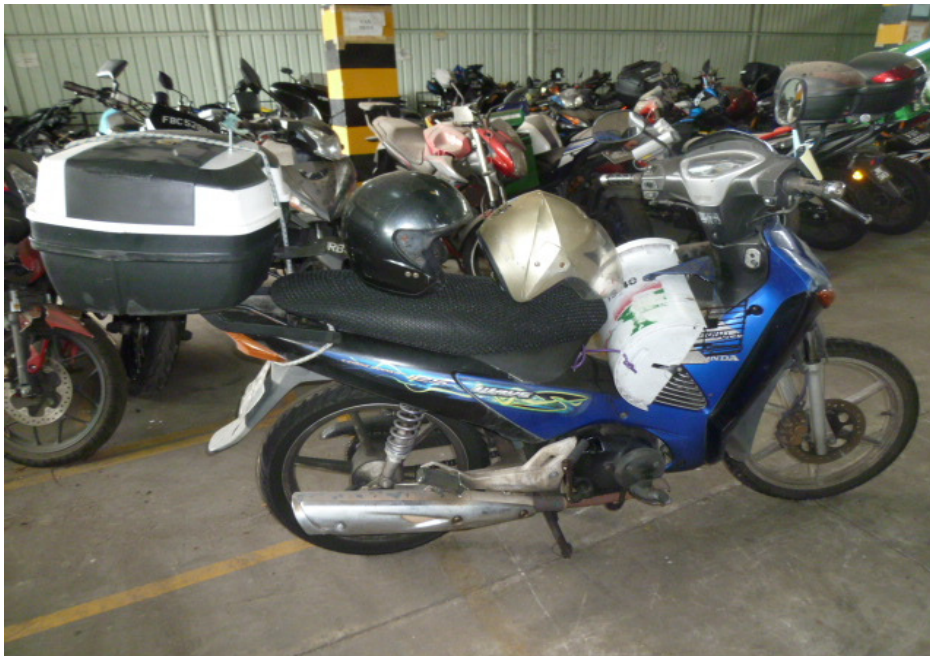
4. The mileage of the Motorcycle at the time of our inspection was 38, 616km.
5. The Motorcycle was observed to have sustained damages all around. The body parts that were found to have been damaged include its headlight, head cowl, front cowl, side cowlings, right side mirror, right handlebar end, front brake lever, left front footrest and top box, amongst others.

Photo 3 shows a general view of the right body of the Motorcycle at the time of our inspection. The Motorcycle was observed to have sustained damages all around. The body parts that were found to have been damaged include its headlight, head cowl, front cowl, side cowlings, right side mirror, right handlebar end, front brake lever, left front footrest and top box, amongst others.

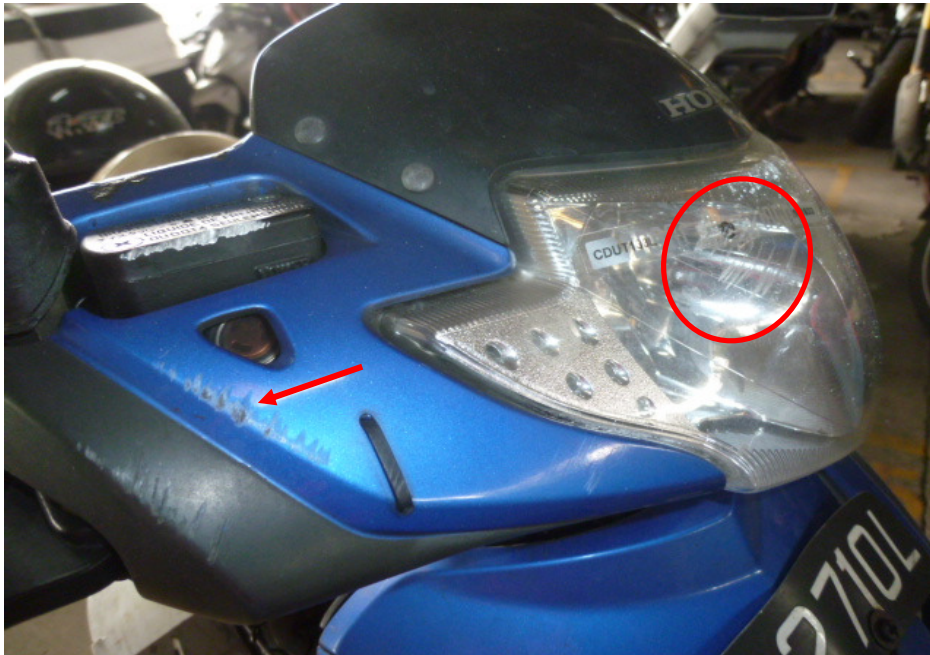
Photo 4 shows a closer view of headlight (circled) and head cowl (arrowed) which were amongst the body parts of the Motorcycle that had sustained damages of grazing nature as a result of the accident (circled).

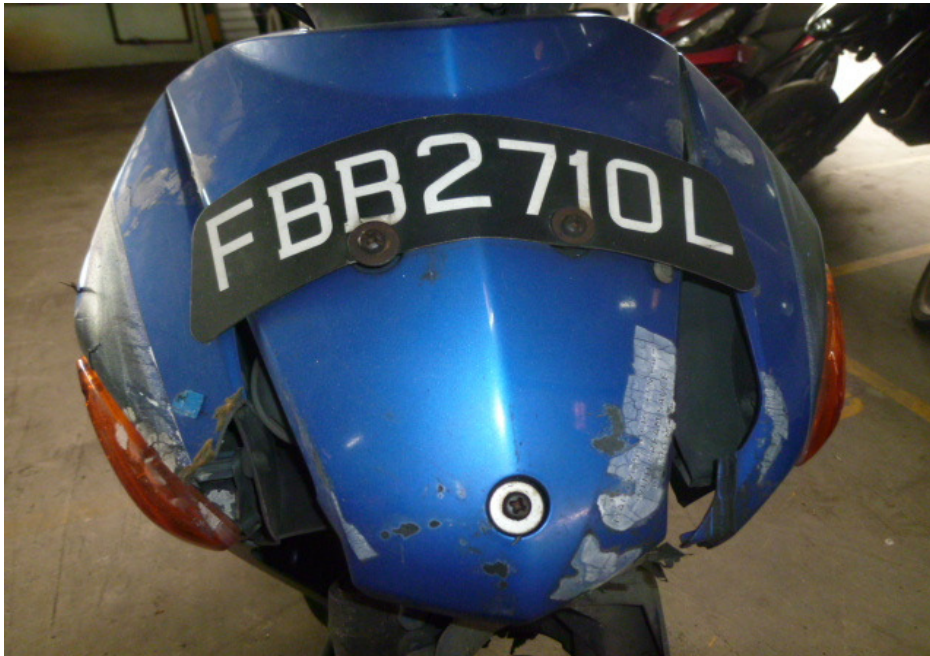
Photo 5 shows a closer view of the front cowl which was amongst the body parts of the Motorcycle that had sustained damage as a result of the accident.

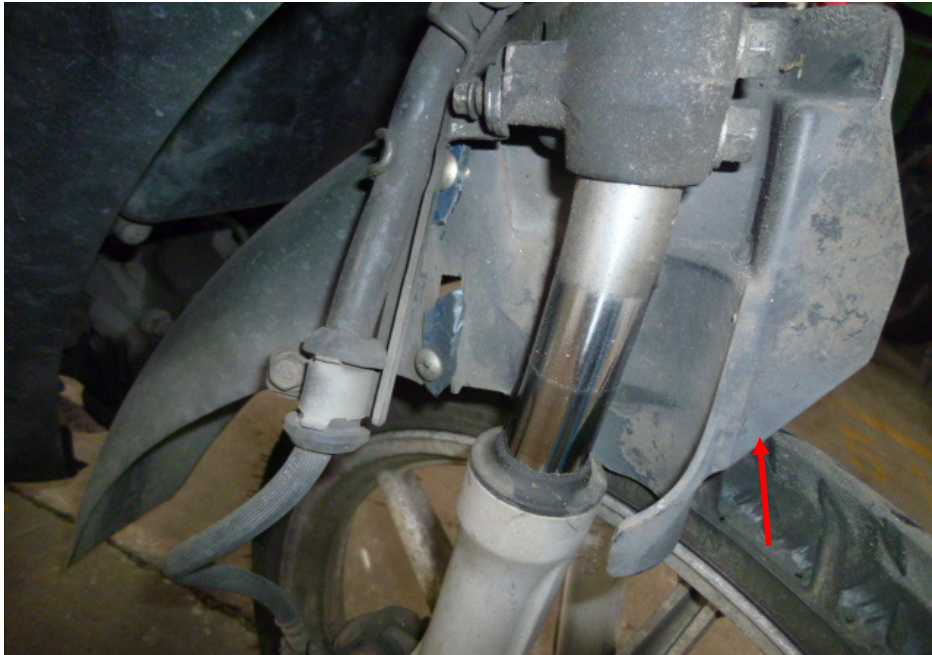
Photo 6 shows the cracked front mudguard (arrowed) of the Motorcycle as a result of the accident.

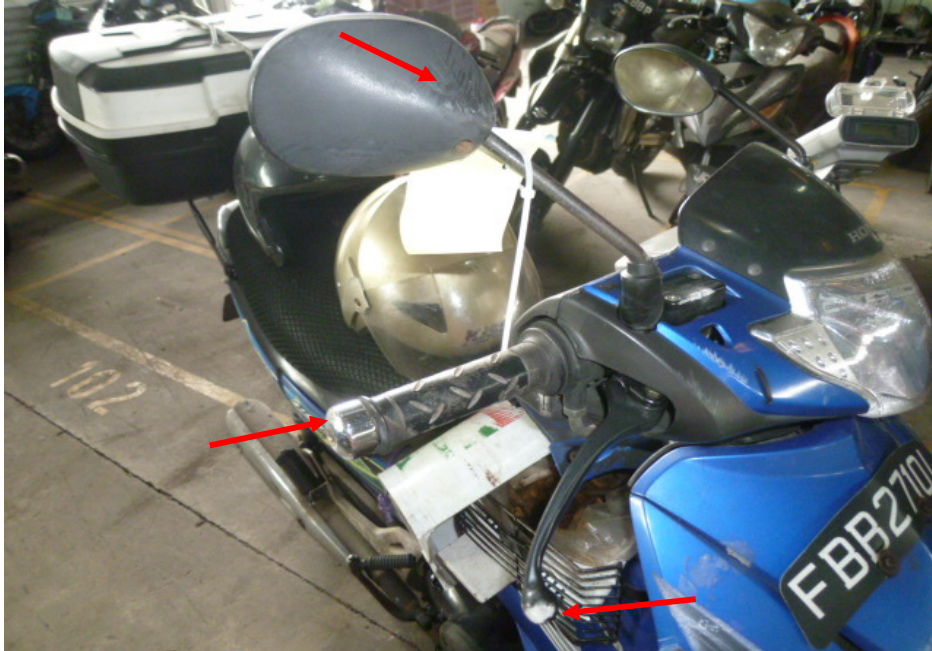
Photo 7 shows the right handlebar end, front brake lever and right side mirror (arrowed), which were amongst the body parts of the Motorcycle that had sustained damage as a result of the accident.

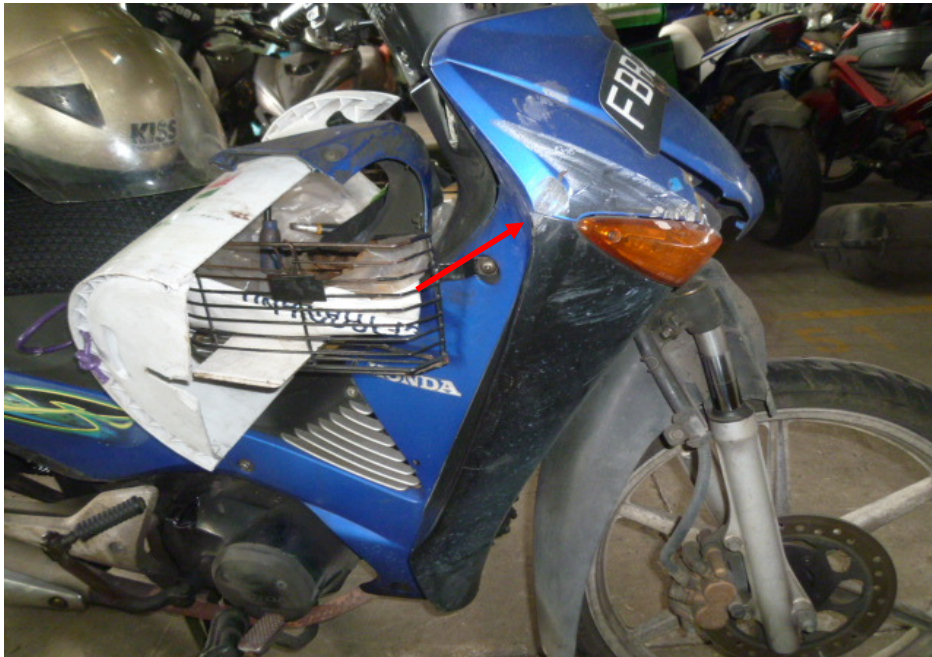
Photo 8 shows a closer view of the right cowling (arrowed) which was amongst the body parts of the Motorcycle that had sustained damage as a result of the accident.

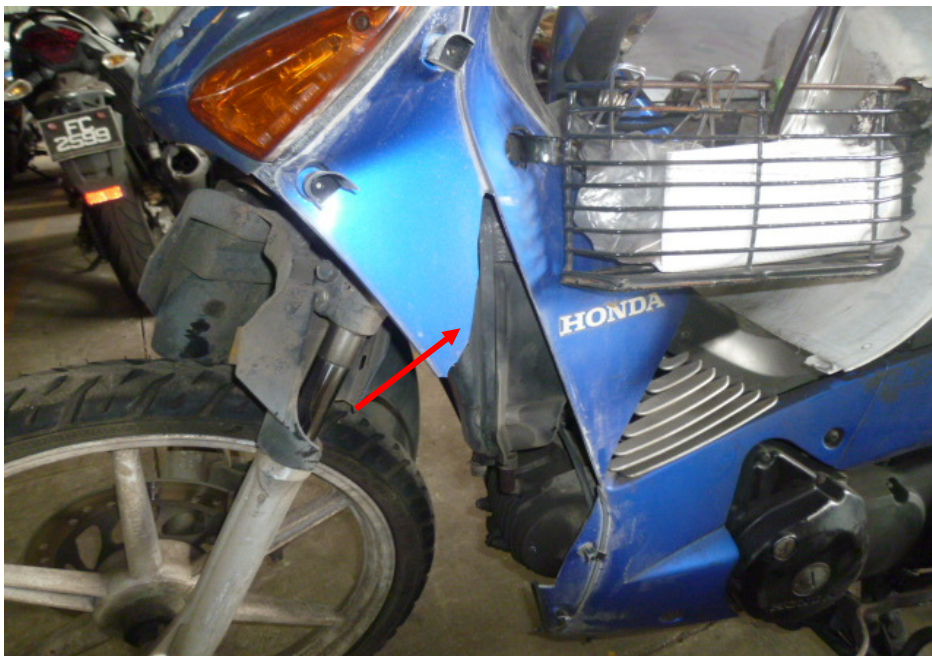
Photo 9 shows the left cowling (arrowed), which were amongst the body parts of the Motorcycle that had sustained damage as a result of the accident.

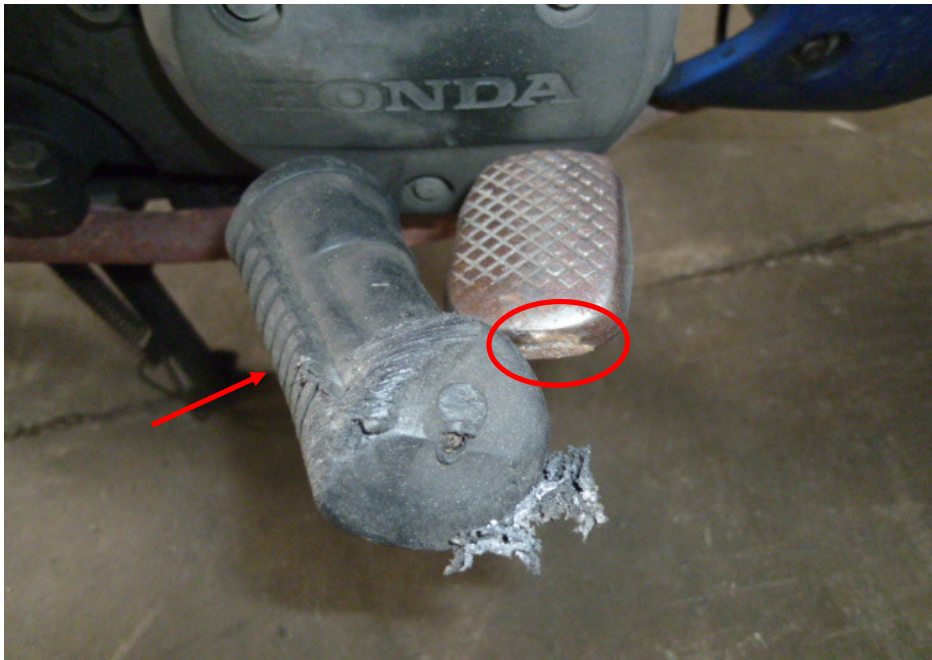
Photo 10 shows the grazed rear brake pedal (circled) and bent left front footrest (arrowed) of the Motorcycle as a result of the accident

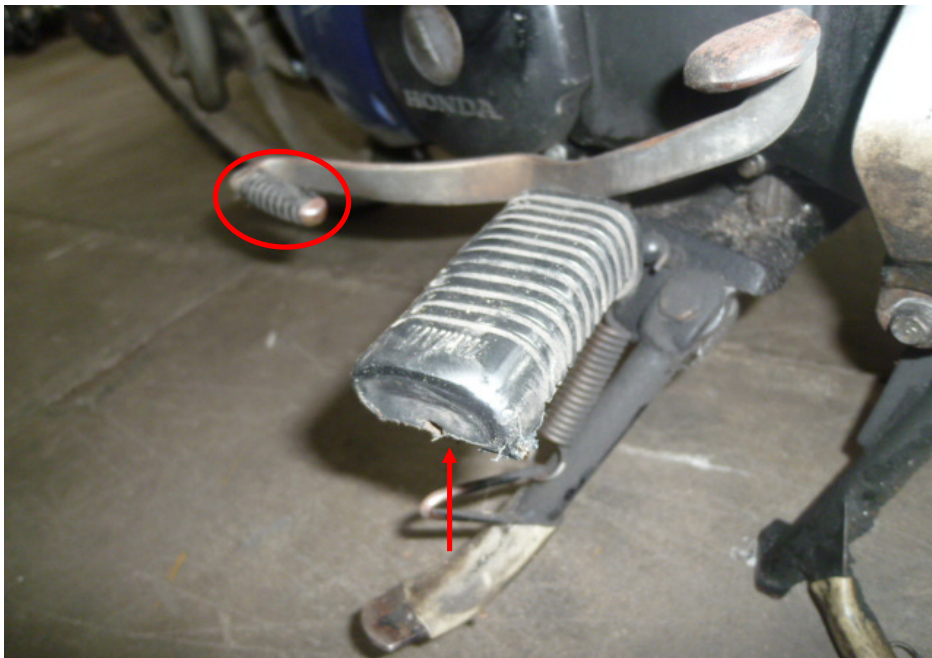
Photo 11 shows the grazed left front footrest (arrowed) and bent gear shift pedal (circled) of the Motorcycle as a result of the accident

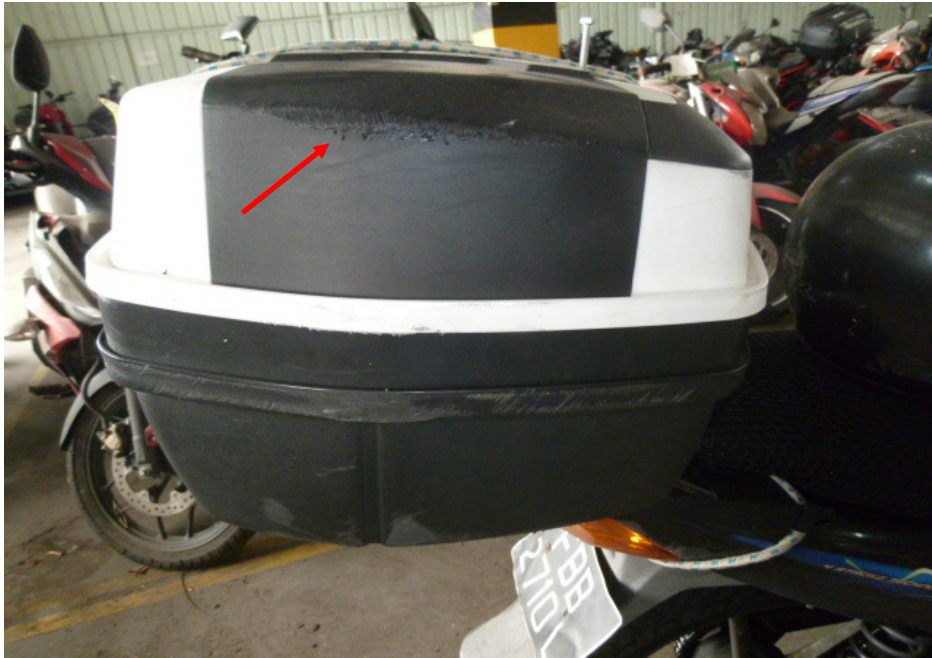
Photo 12 shows the top box of the Motorcycle that had sustained damage as a result of the accident (arrowed).

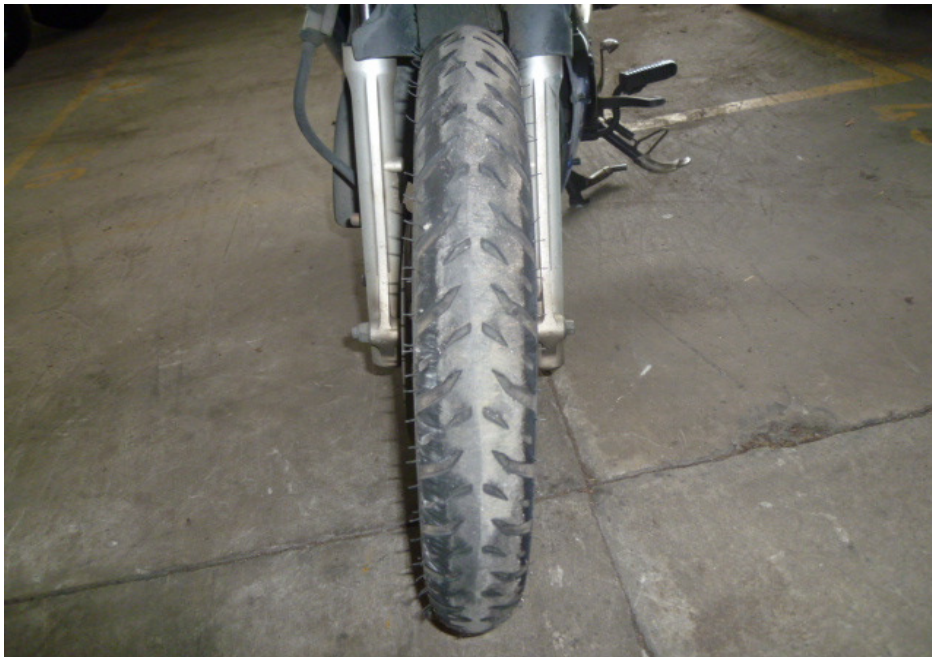
Photo 13 shows the front tyre of the Motorcycle at the time of our inspection. The front tyre was observed to be in serviceable condition with remaining tread depth of approximately 3mm. The pattern of the tread was also clearly visible. There was no tear, burst mark(s) and/or punctured hole(s) on the sidewalls as well as across the tread of the front tyre.

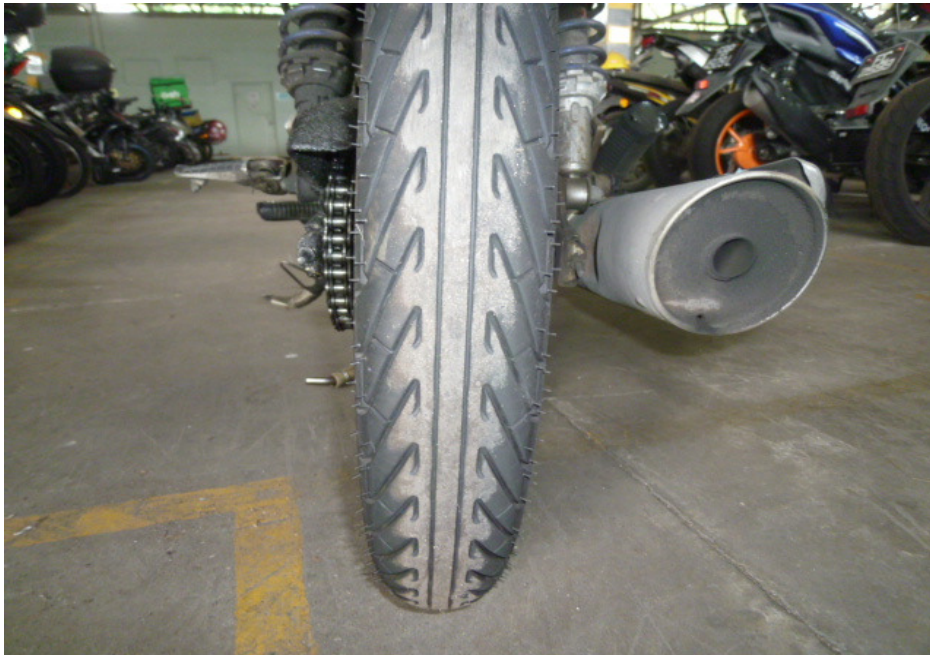
Photo 14 shows the condition of the Motorcycle's rear tyre. The rear tyre was observed to be in serviceable condition with remaining tread depth of approximately 2mm. The tyre was also observed to be sufficiently inflated for vehicular operation. We did not observe any tear, burst mark(s) and/or punctured hole(s) on the sidewalls as well as across the tread of the rear tyre.

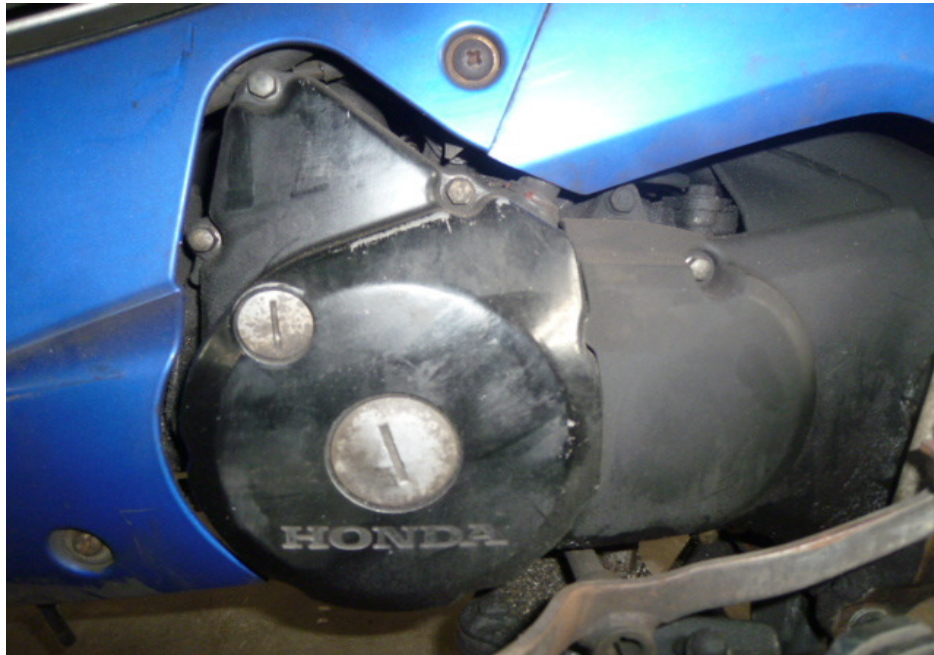
Photo 15 shows the left side of the engine of the Motorcycle at the time of our inspection. The various engine related parts and components were found to be intact with no visible damage. There was also no sign(s) or indication(s) of fluid leak observed around the left engine area of the Motorcycle.

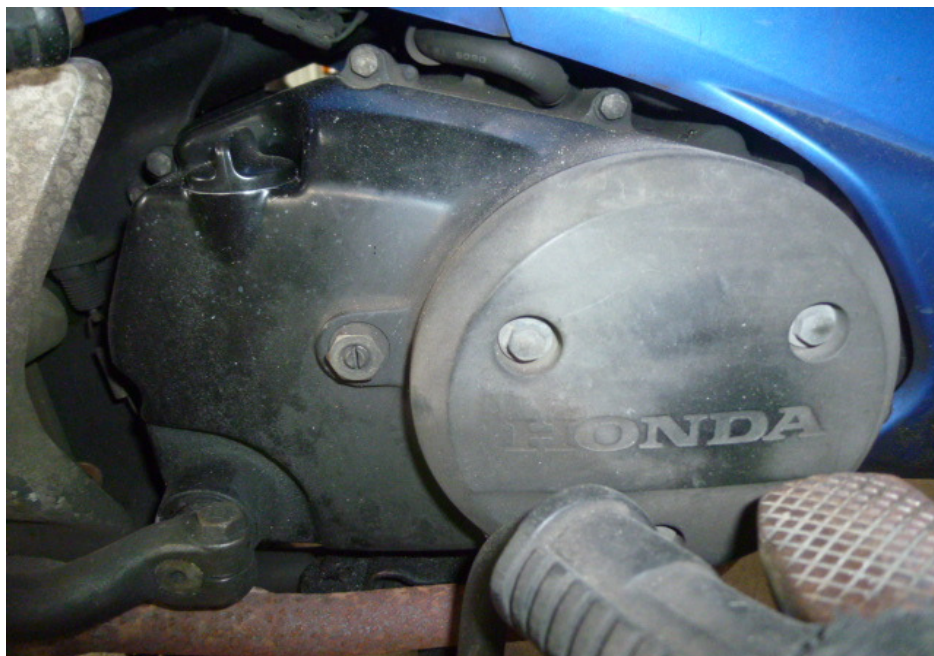
Photo 16 shows the right side of the engine of the Motorcycle at the time of our inspection. The various engine related parts and components were found to be intact with no visible damage. There was also no sign(s) or indication(s) of fluid leak observed around the right engine area of the Motorcycle.

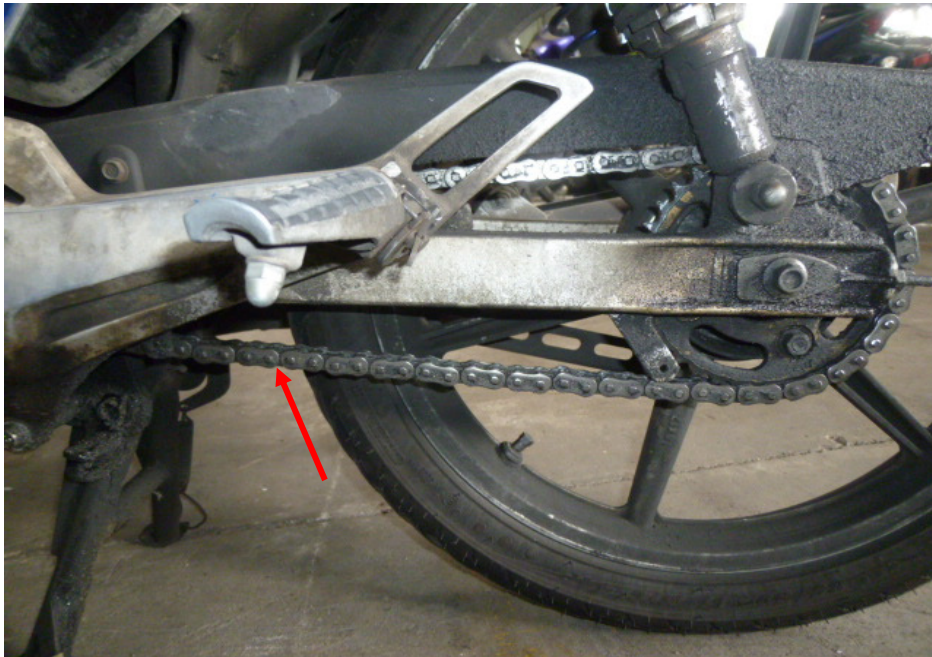
Photo 17 shows the general view of the gear train (arrowed) of the Motorcycle, which was observed to be intact with no misalignment. It was also adequately lubricated for operating purposes.

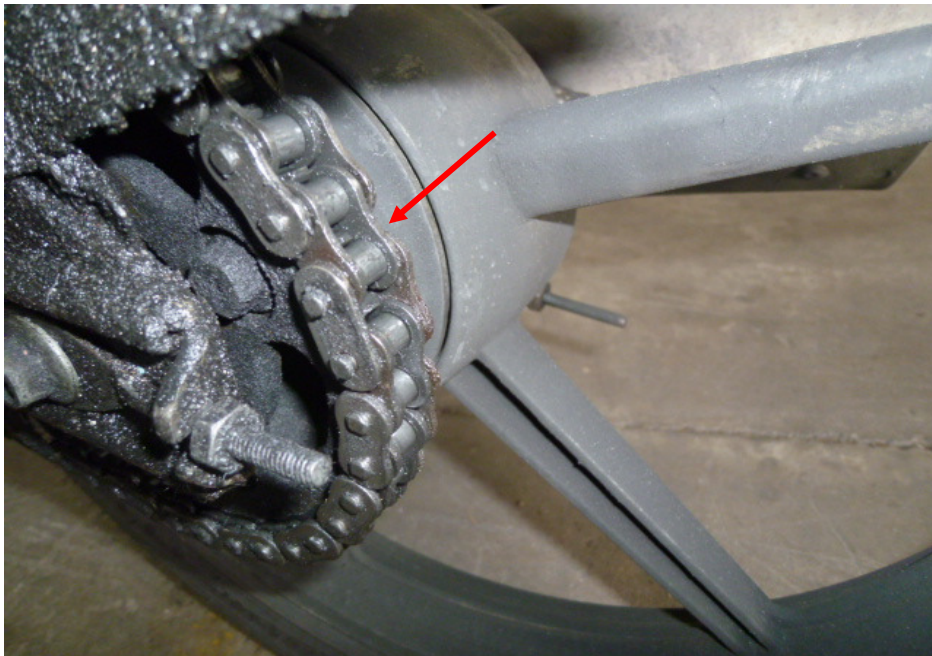
Photo 18 shows a closer view of the gear train (arrowed) of the Motorcycle, which was observed to be intact with no misalignment. It was also adequately lubricated for operating purposes.

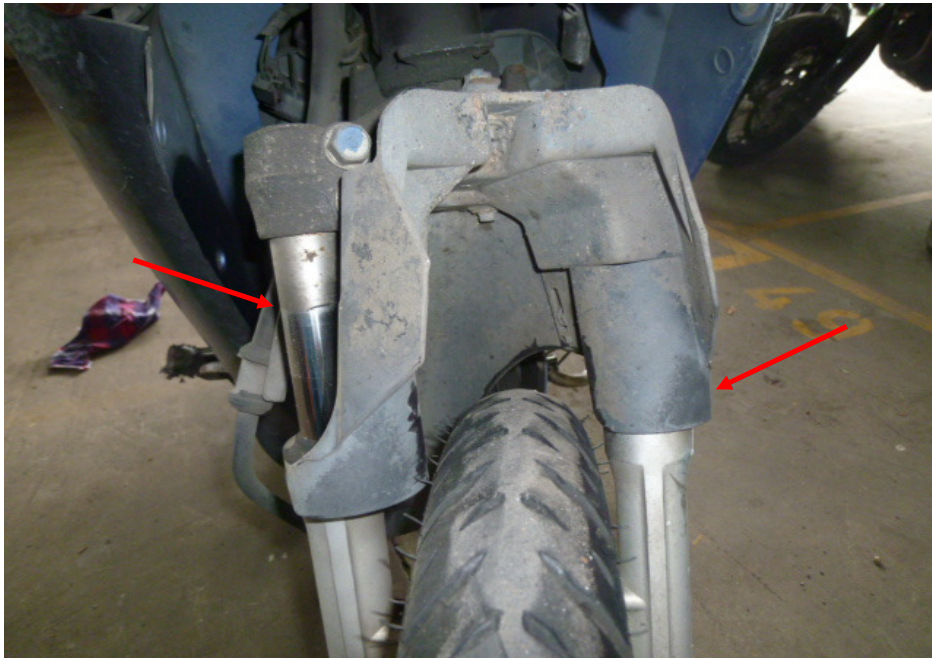
11. For this case, we were not able to conduct any test(s) on the steering system of the Motorcycle due to the damage of its front fork assembly. The front forks and steering stem were found to be bent as a result of the accident.

Photo 19 shows the front fork assembly of the Motorcycle. The front forks were observed to be bent (arrowed) as a result of the accident. We were hence not able to conduct any tests on the steering system of the Motorcycle.

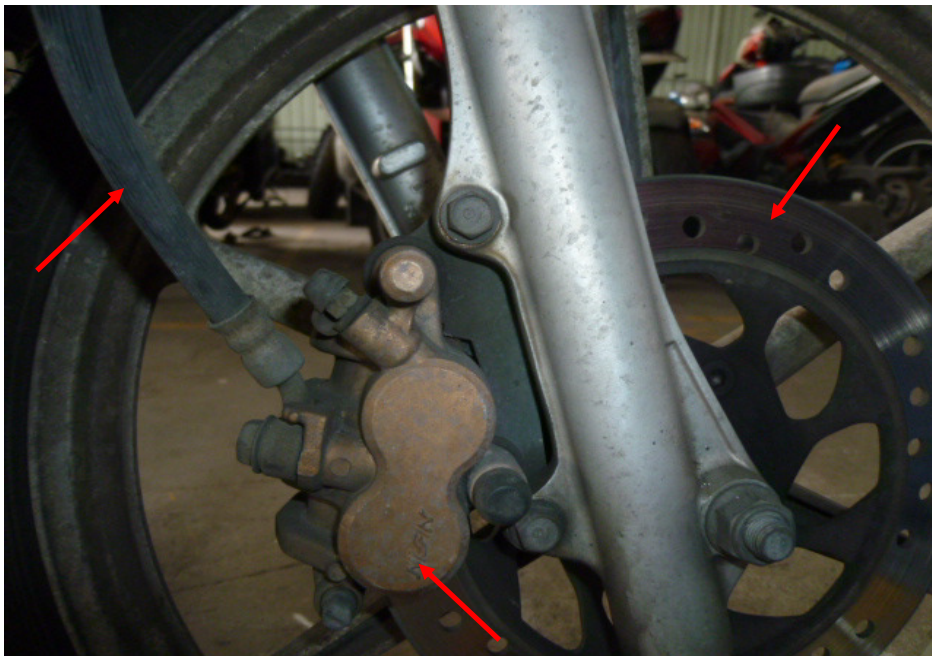
Photo 20 shows a close up view of the front brake caliper, front brake disc and front brake hose (arrowed) of the Motorcycle, which are all part of the components in the hydraulic front brake system of the Motorcycle. Our visual checks of these various components had revealed all to be intact with no visible damage. No leakage of brake fluid was also observed.

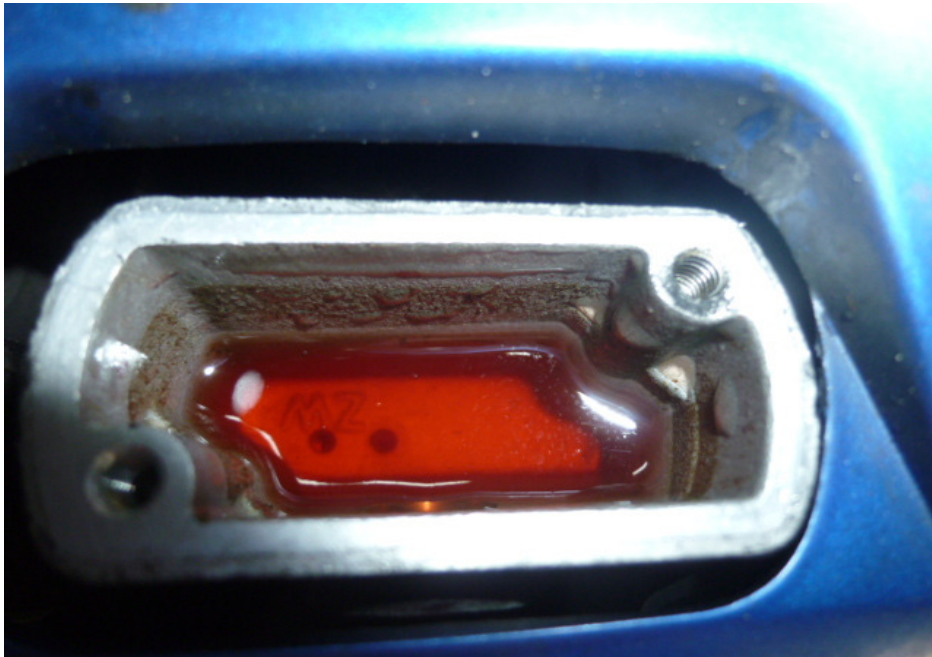
Photo 21 shows the brake fluid reservoir for the front brake of the Motorcycle. The brake fluid was observed to be of sufficient level for operational purposes and without any contamination.

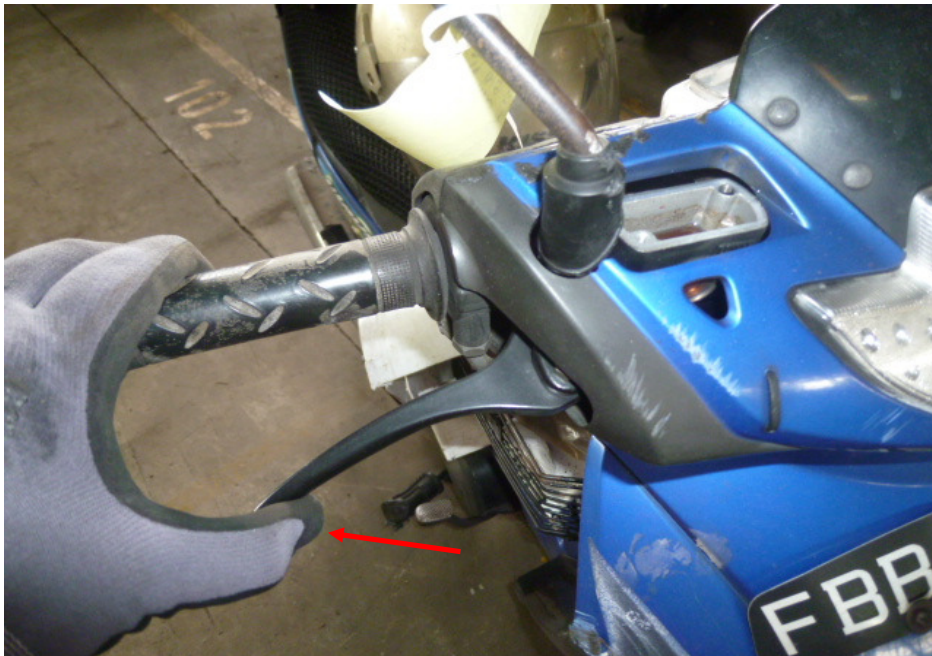
13. Static brake tests conducted on the Motorcycle had appeared to indicate that the brake system of the Motorcycle was in serviceable condition. There was some resistance felt (spongy like feel) upon pressing the front brake lever. This would indicate that there's no leakage of pressure/vacuum in the front brake system.

Photo 22 shows the front brake lever being depressed. There was some resistance felt (spongy like feel) upon pressing the front brake lever (arrowed). This would indicate that there is no leakage of pressure/vacuum in the front brake system.

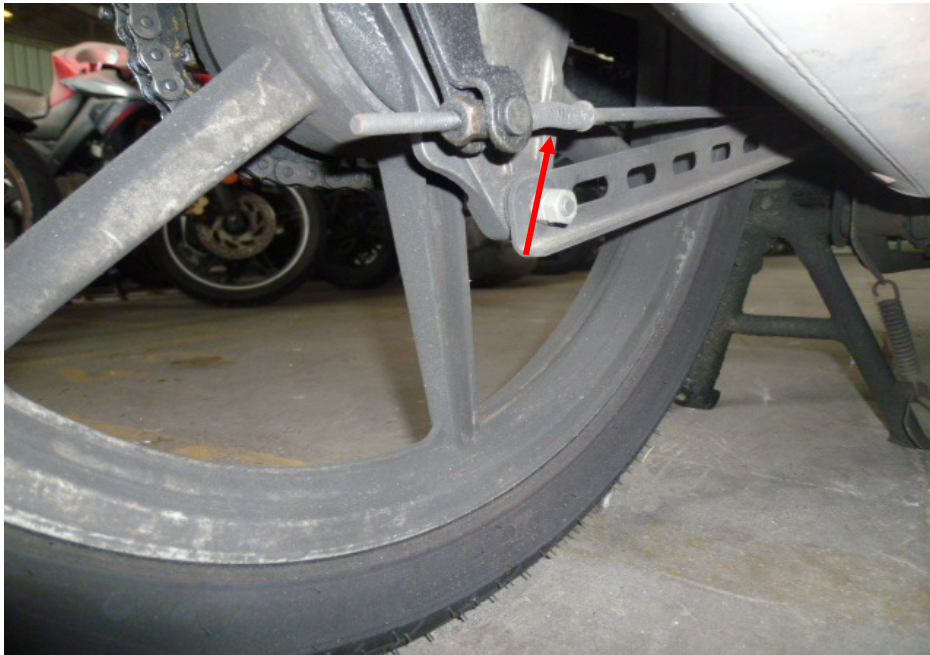
Photo 23 shows the rear wheel of the Motorcycle. The type of brake system for the rear wheel was of a mechanical type, controlled by the brake foot pedal of the Motorcycle. Our checks of the cable (arrowed), spring and drum which are all part of the components in the rear brake system of the Motorcycle reveal all to be intact and without damage.
