Your Ref: TP/IP/27089/2022  
Our Ref : CI/TPD22011565/N

**Fatal Accident Investigation Team**

**INSPECTION REPORT OF MOTORCYCLE FZ 9569J**

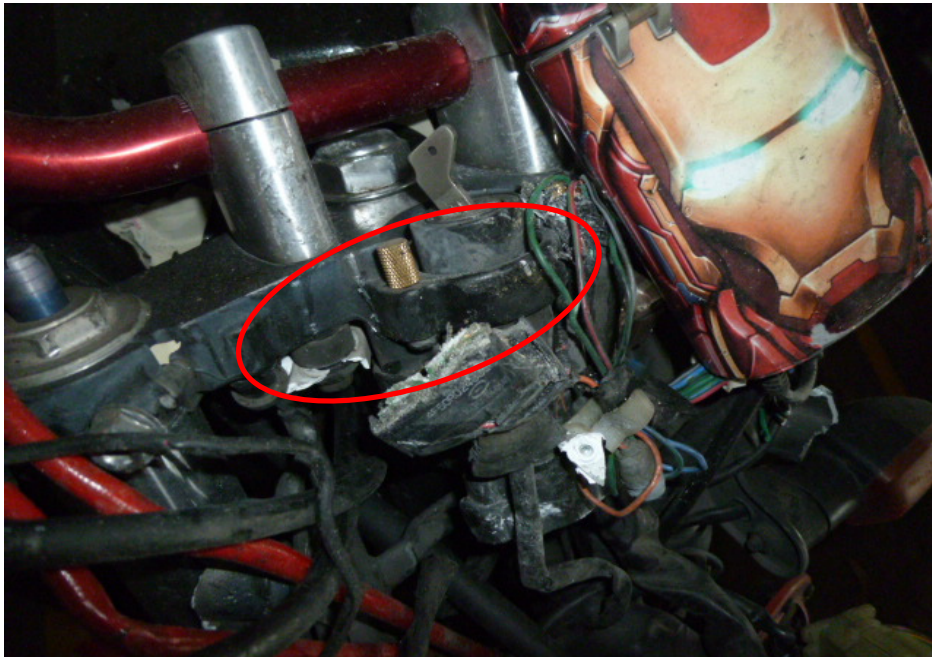
4. The mileage of the Motorcycle was not recorded at the time of our inspection due to a missing speedometer gauge as a result of the accident.
5. The Motorcycle was observed to have sustained damages all around. The body parts that were found to have been damaged include its speedometer gauge, headlight assembly, front forks, front mudguard, handlebar, radiator covers, petrol tank, top box rack, rear number plate and exhaust muffler, amongst others.

**Photo 1** shows the mileage of the Motorcycle could not be recorded at the time of our inspection due to a missing speedometer gauge as a result of the accident (circled).

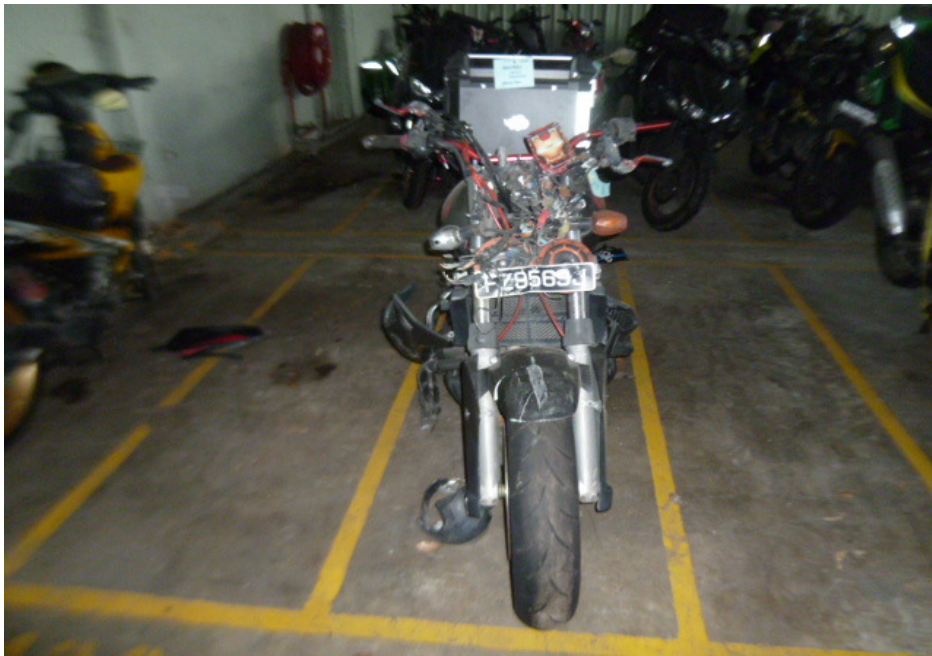
**Photo 2** shows a general view of the frontal portion of the Motorcycle at the time of our inspection. The Motorcycle was observed to have sustained damages all around.

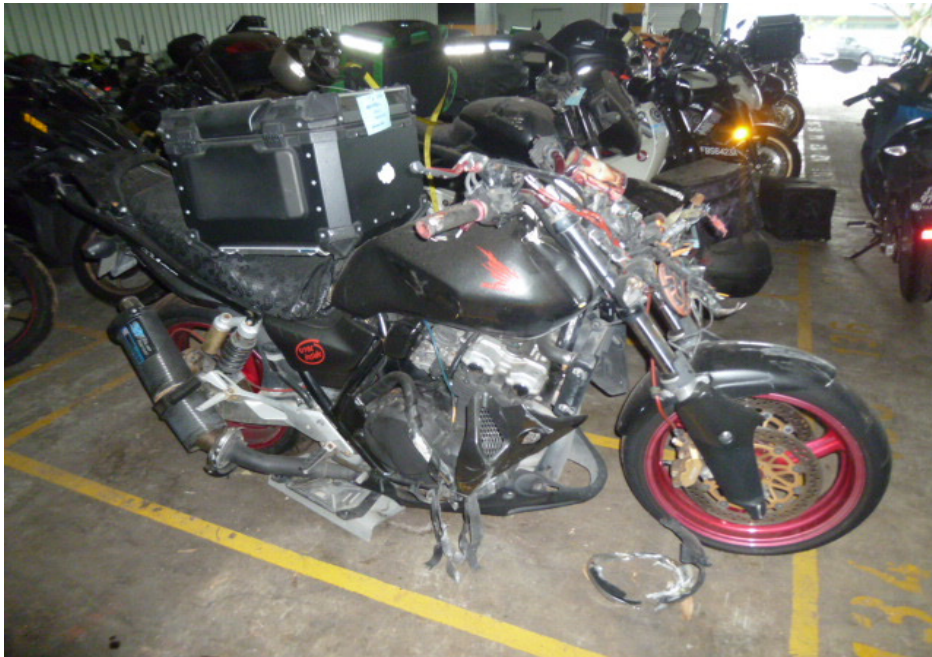
**Photo 3** shows a general view of the right body of the Motorcycle at the time of our inspection. The Motorcycle was observed to have sustained damages all around. The body parts that were found to have been damaged include its speedometer gauge, headlight assembly, front forks, front mudguard, handlebar, radiator covers, petrol tank, top box rack, rear number plate and exhaust muffler, amongst others.

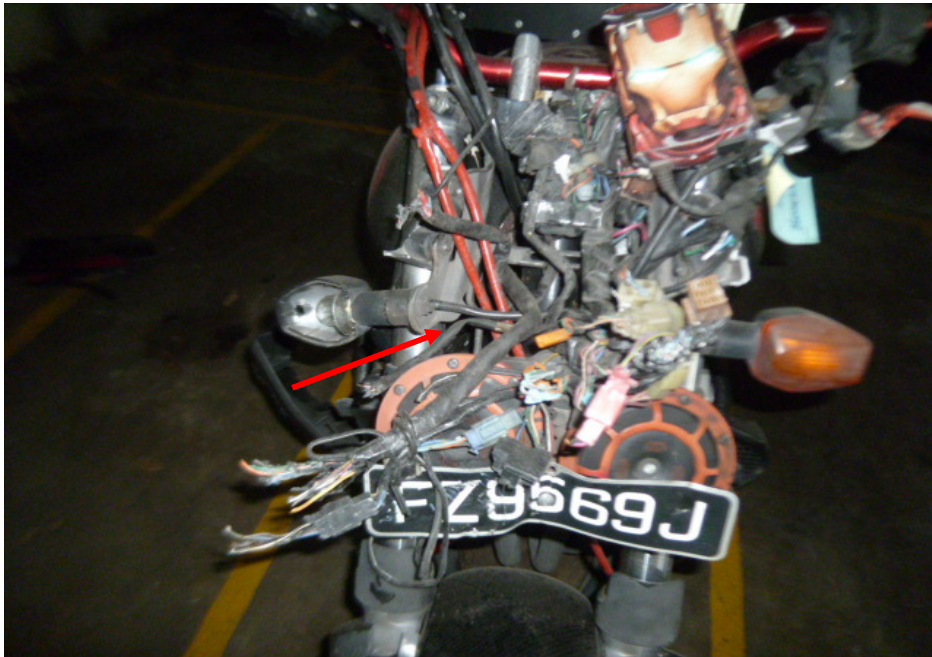
**Photo 4** shows a closer view of the missing headlight assembly (arrowed) of the Motorcycle as a result of the accident.

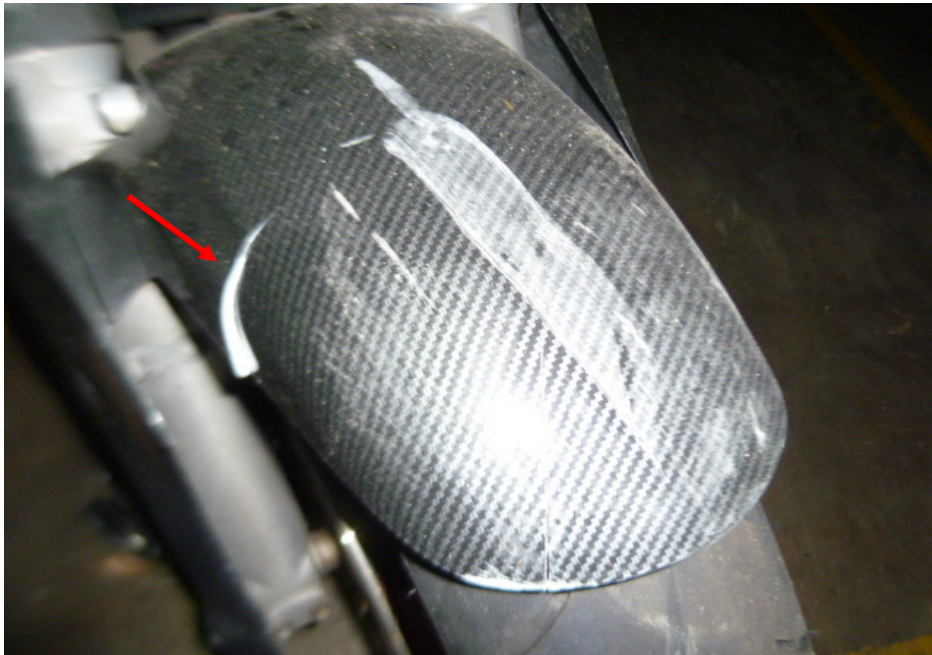
**Photo 5** shows a closer view of the front mudguard which was amongst the body parts at the front body of the Motorcycle that had sustained damage as a result of the accident (arrowed).

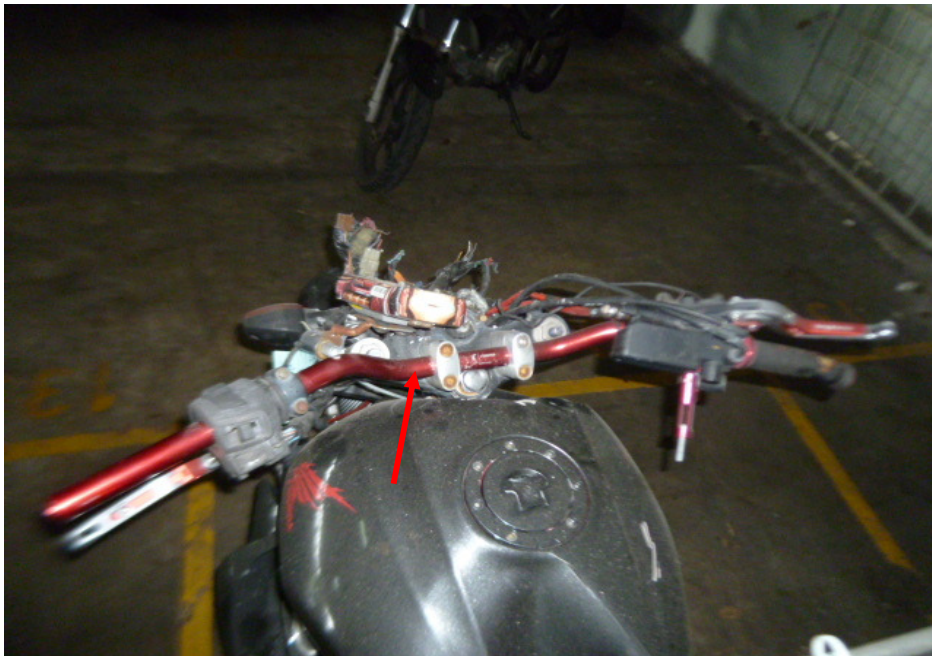
**Photo 6** shows a closer view of the bent handlebar (arrowed) which was amongst the body parts at the front body of the Motorcycle that had sustained damage as a result of the accident.

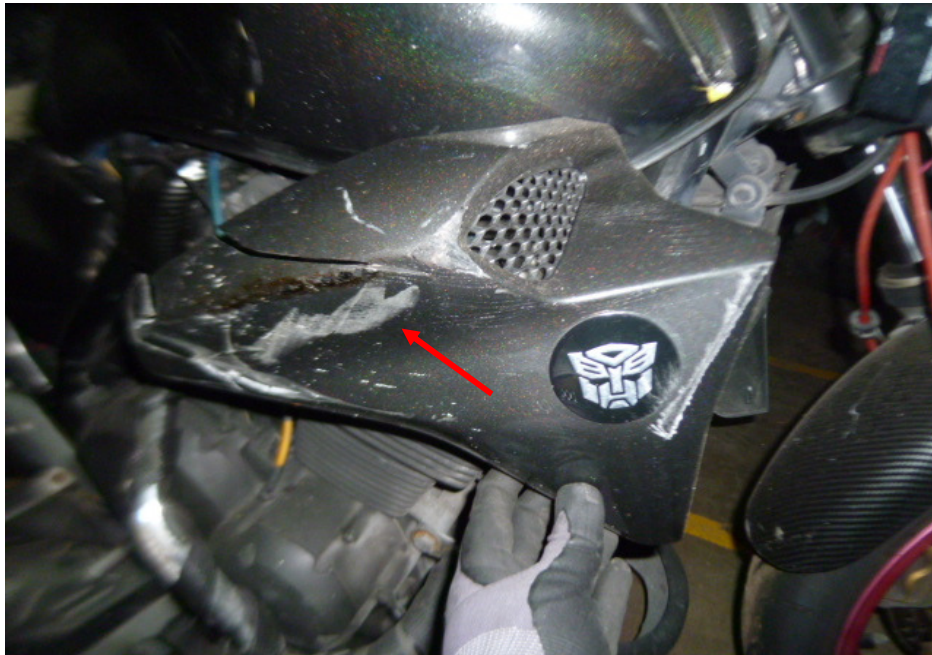
**Photo 7** shows the right radiator cover of the Motorcycle that had sustained damages of grazing nature as a result of the accident (arrowed).

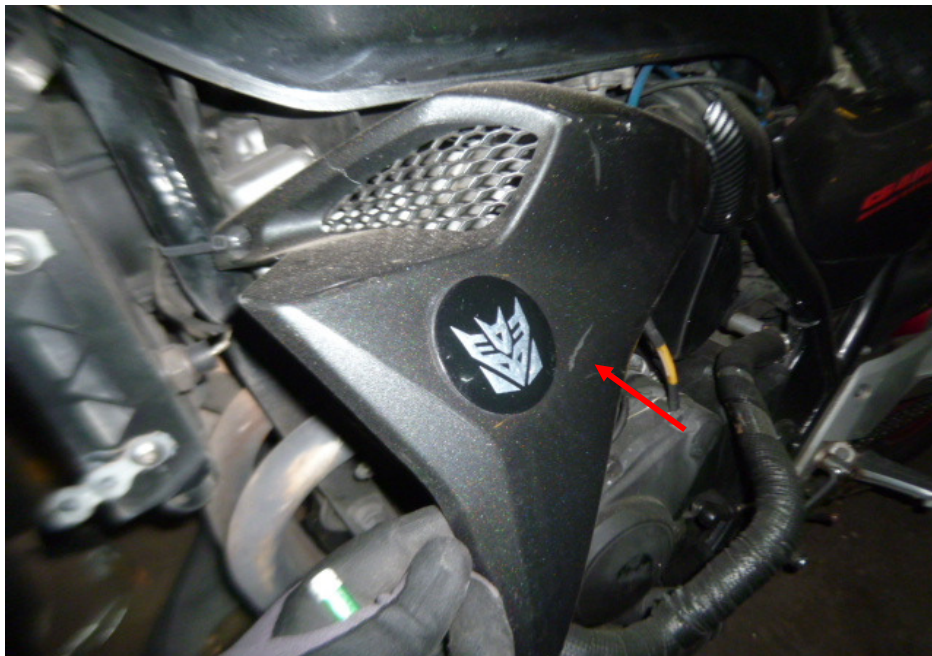
**Photo 8** shows the left radiator cover of the Motorcycle that had sustained damages of grazing nature as a result of the accident (arrowed).

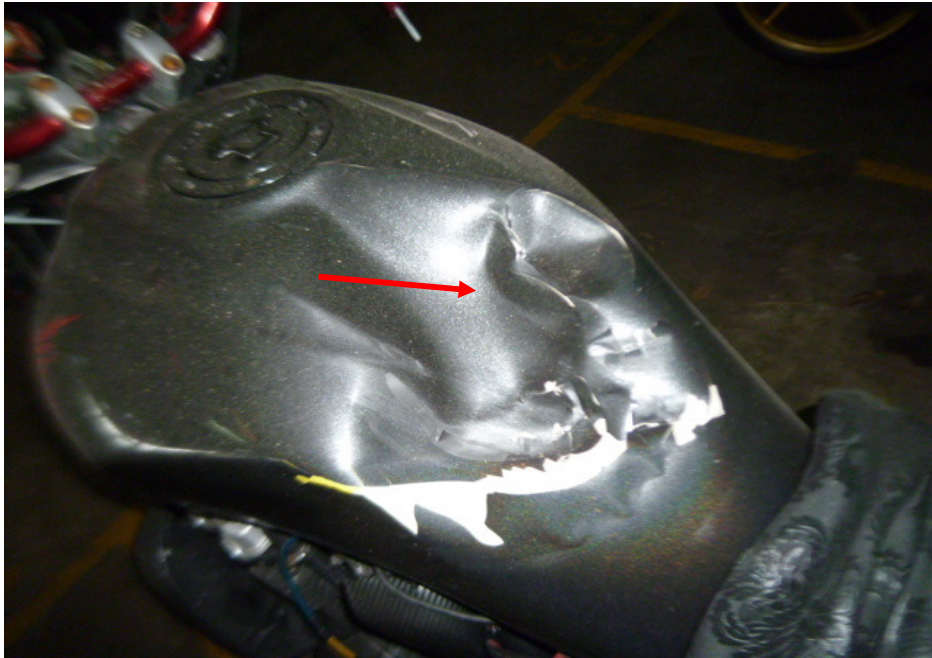
**Photo 9** shows a closer view of the petrol tank, which was amongst the body parts of the Motorcycle that had sustained damage as a result of the accident (arrowed).

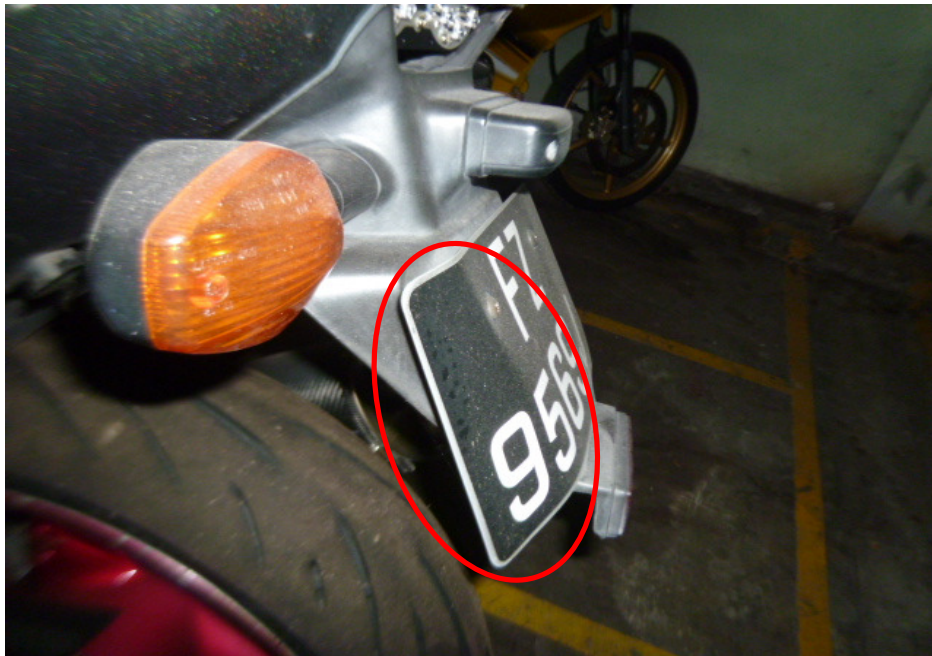
**Photo 10** shows a closer view of the rear number plate (circled) which was amongst the body parts of the Motorcycle that had sustained damage as a result of the accident.

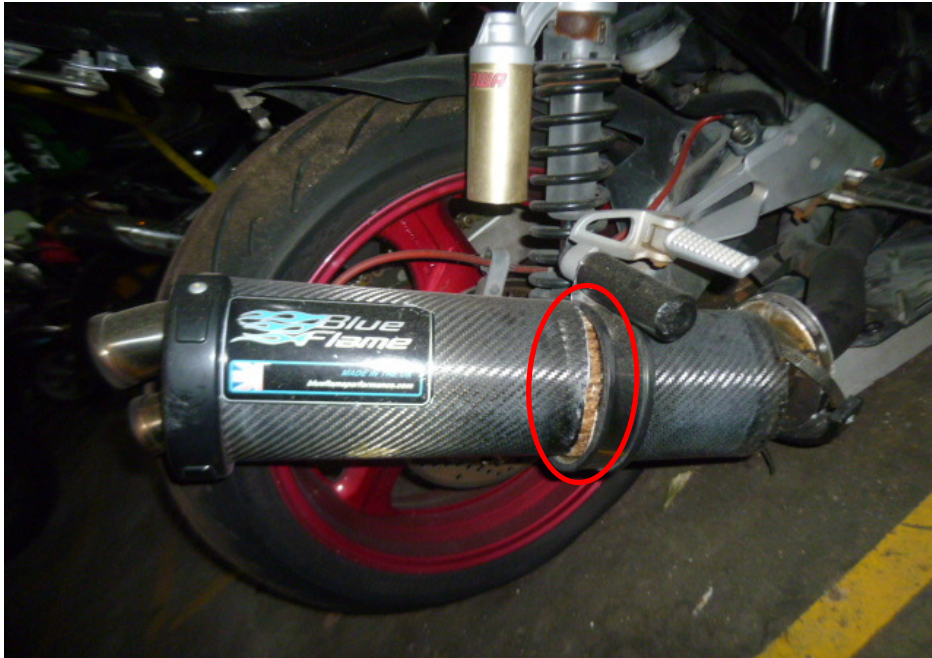
**Photo 11** shows the exhaust muffler (circled) which was amongst the body parts of the Motorcycle that had sustained damage as a result of the accident.

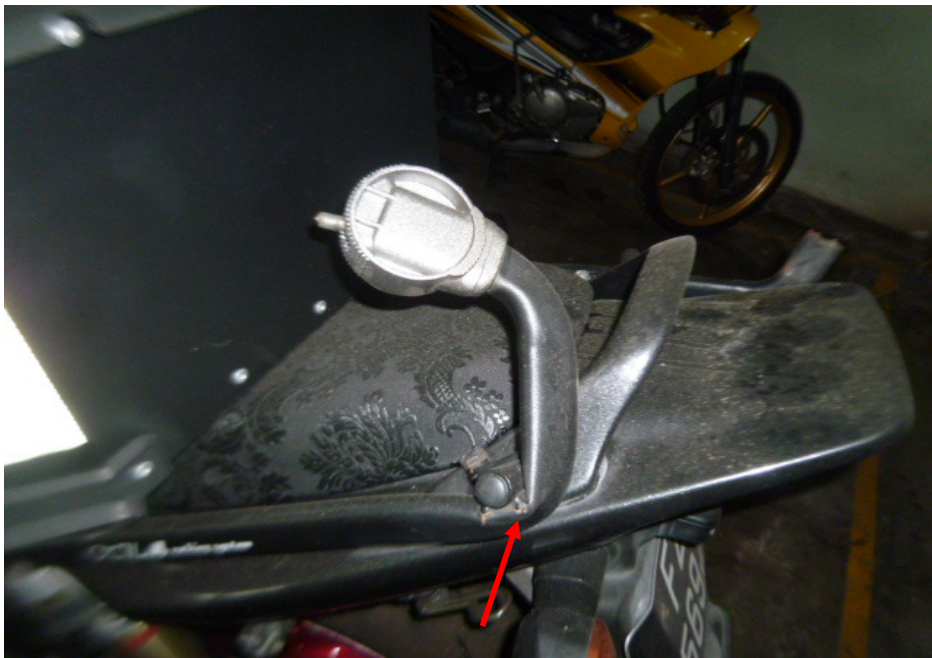
**Photo 12** shows a closer view of the top box rack (arrowed) which was amongst the body parts at the rear body of the Motorcycle that had sustained damage as a result of the accident.

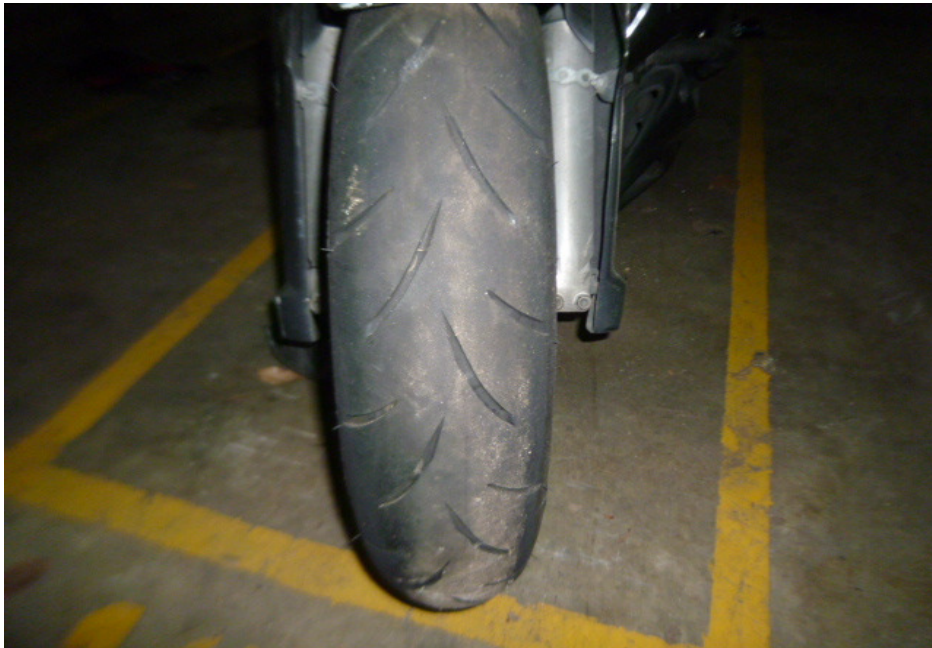
**Photo 13** shows the front tyre of the Motorcycle at the time of our inspection. The front tyre was observed to be in serviceable condition with remaining tread depth of approximately 3mm. The pattern of the tread was also clearly visible. There was no tear, burst mark(s) and/or punctured hole(s) on the sidewalls as well as across the tread of the front tyre.

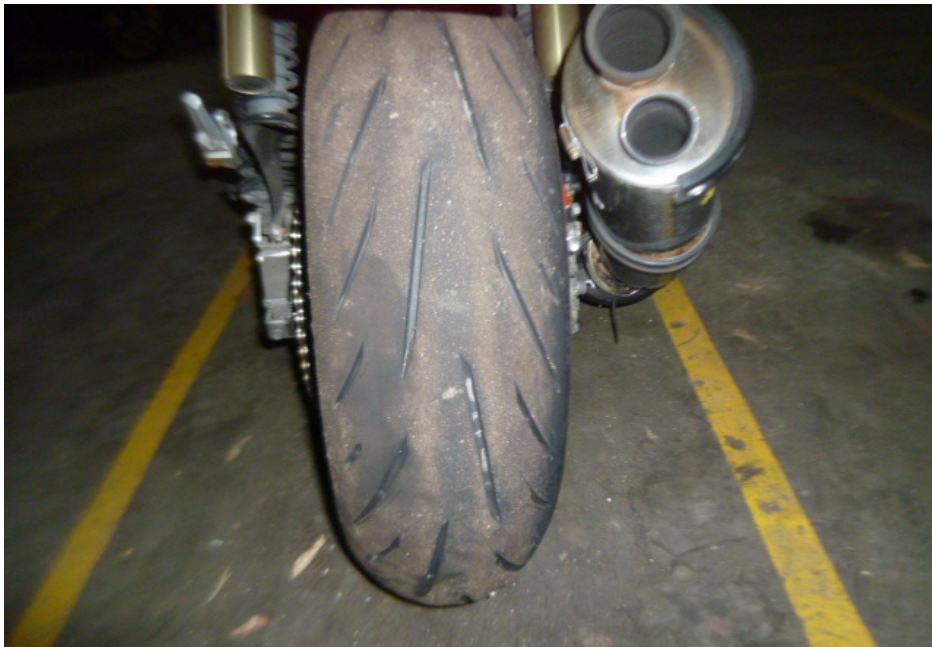
**Photo 14** shows the condition of the Motorcycle's rear tyre. The rear tyre was observed to be in serviceable condition with remaining tread depth of approximately 6mm. We did not observe any tear, burst mark(s) and/or punctured hole(s) on the sidewalls as well as across the tread of the rear tyre. However the rear tyre was also observed to be deflated.

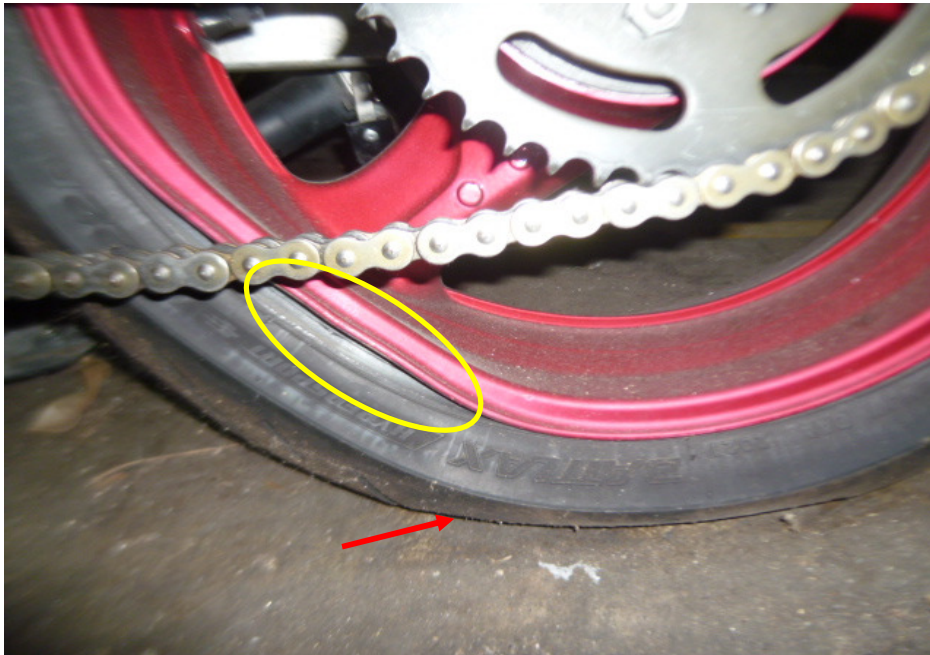
9. The 2 tyres were wrapped around alloy wheel rims. At the time of our inspection, we did not observe any visible damage on the front wheel rim of the Motorcycle. However we did observe that the rear wheel rim was bent as a result of the accident. See photos 1 – 15 below.

**Photo 15** shows the deflated rear tyre (arrowed) and bent rear wheel rim (circled) of the Motorcycle as a result of the accident at the time of our inspection.

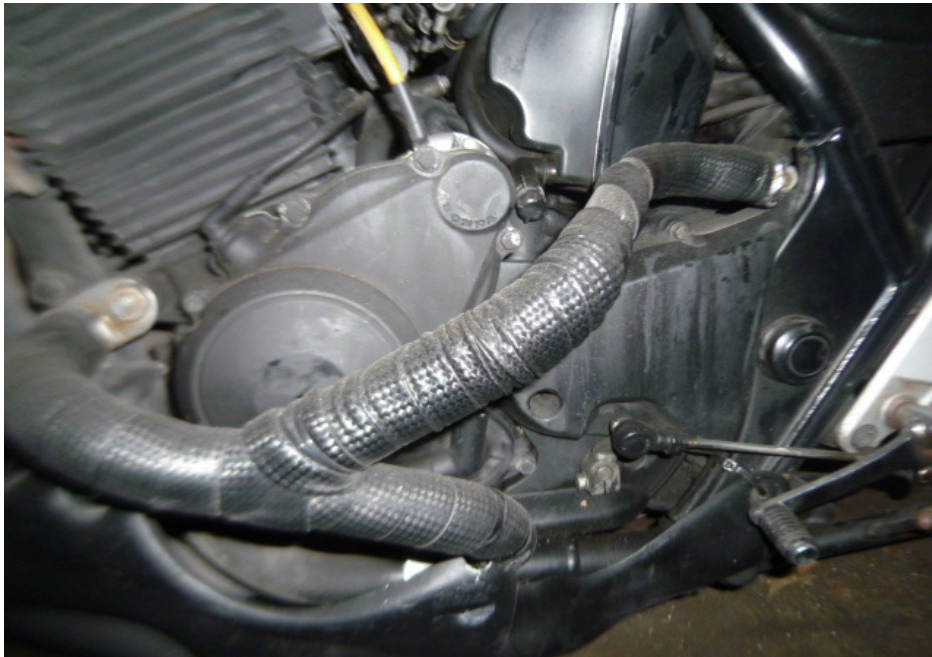
**Photo 16** shows the left side of the engine of the Motorcycle at the time of our inspection. The various engine related parts and components were found to be intact with no visible damage. There was also no sign(s) or indication(s) of fluid leak observed around the left engine area of the Motorcycle.

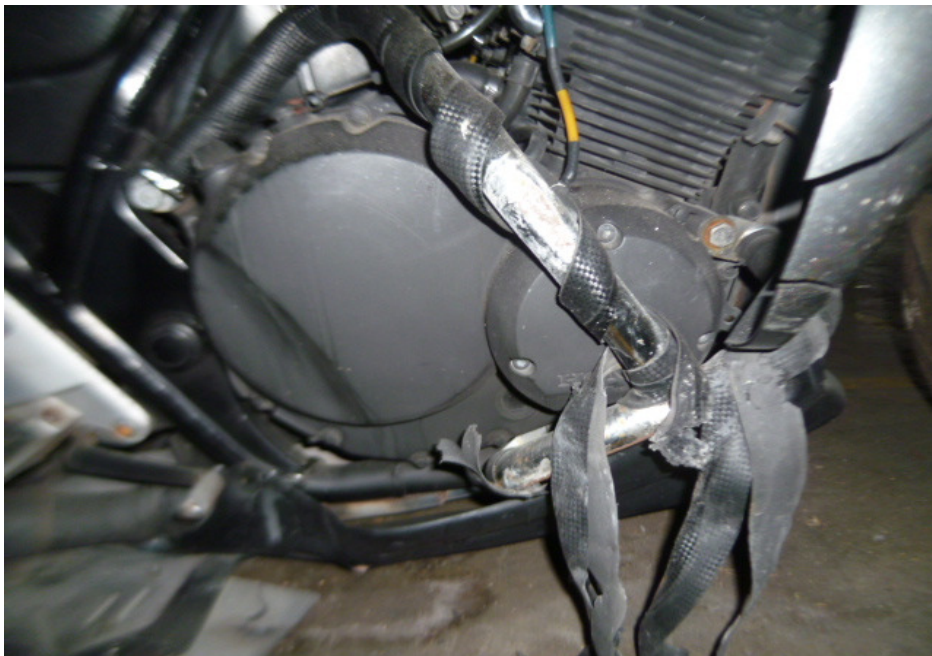
**Photo 17** shows the right side of the engine of the Motorcycle at the time of our inspection. The various engine related parts and components were found to be intact with no visible damage. There was also no sign(s) or indication(s) of fluid leak observed around the right engine area of the Motorcycle.

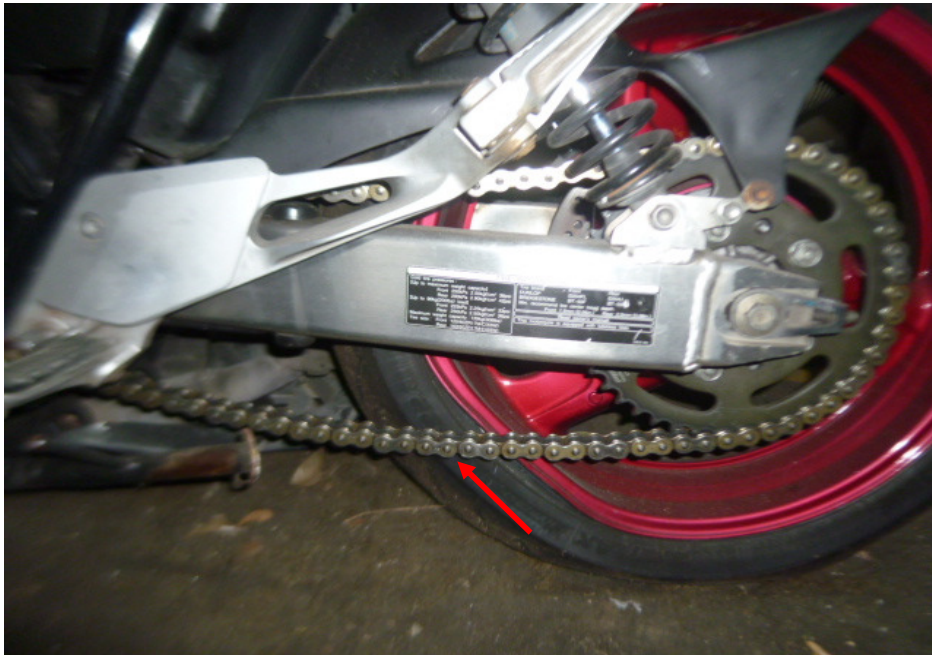
**Photo 18** shows the general view of the gear train (arrowed) of the Motorcycle, which was observed to be intact with no misalignment. It was also adequately lubricated for operating purposes.

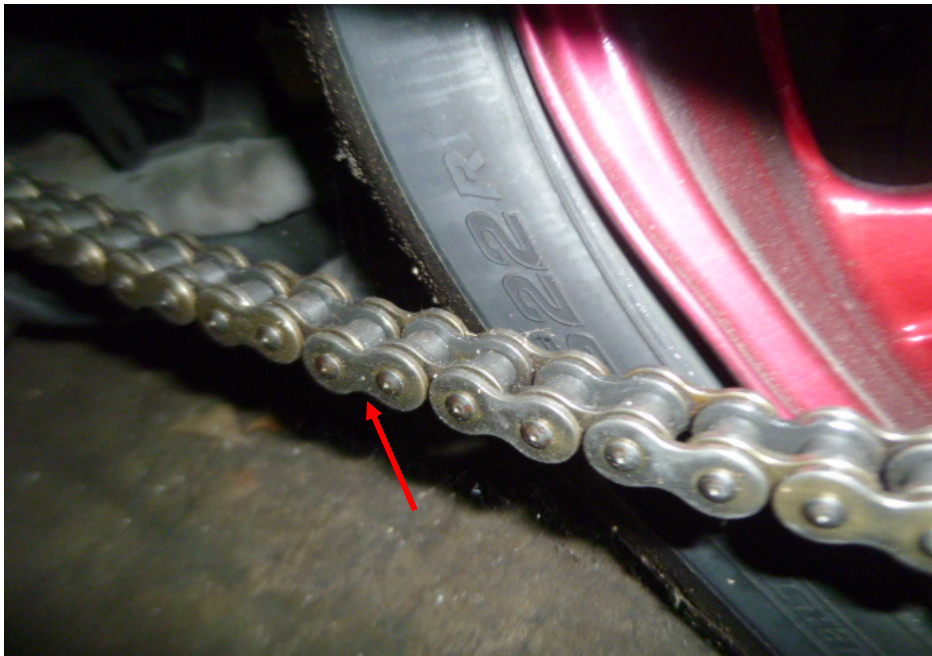
**Photo 19** shows a closer view of the gear train (arrowed) of the Motorcycle, which was observed to be intact with no misalignment. It was also adequately lubricated for operating purposes.

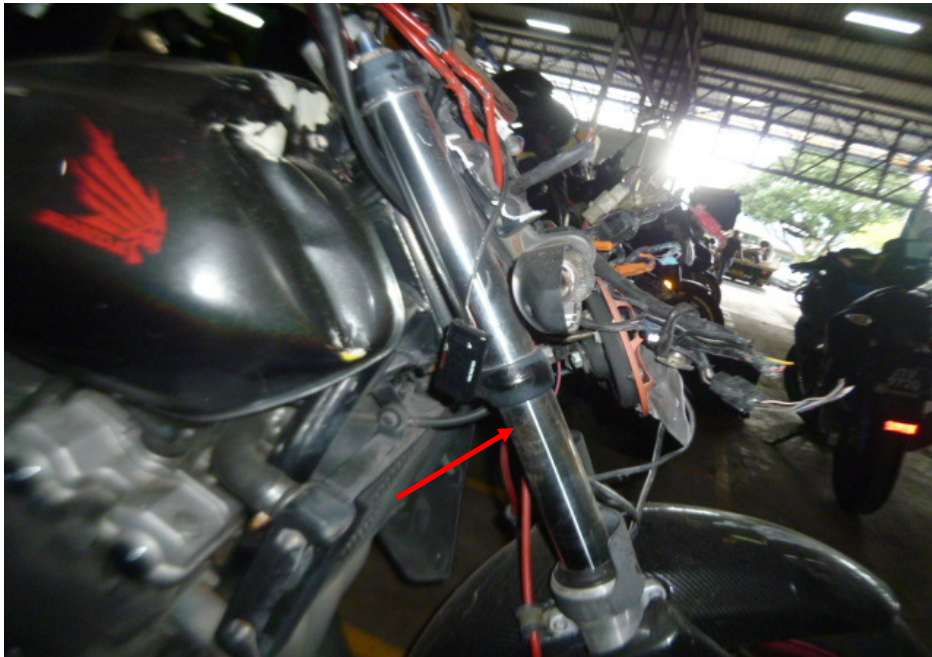
12. For this case, we were not able to conduct any test(s) on the steering system of the Motorcycle due to the damage of its front forks. The right front fork was found to be bent as a result of the accident which had rendered the Motorcycle immobile.

**Photo 20** shows the front forks of the Motorcycle. The right front fork was observed to be bent as a result of the accident (arrowed). We were hence not able to conduct any tests on the steering system of the Motorcycle.

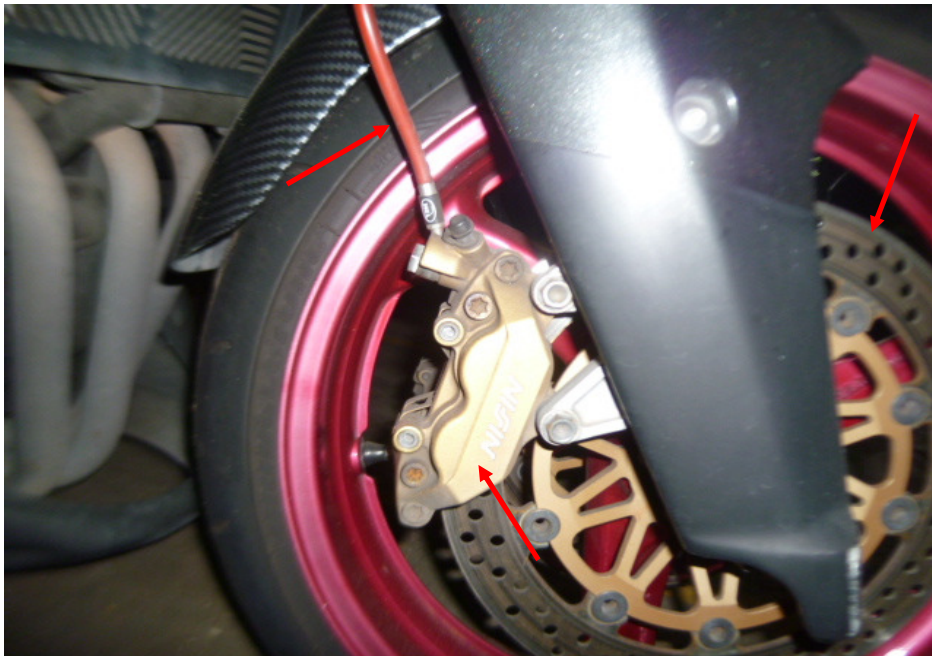
**Photo 21** shows a close up view of the front brake caliper, front brake disc and front brake hose (arrowed) at the right side of the Motorcycle's front wheel, which are all part of the components in the hydraulic front brake system of the Motorcycle. Our visual checks of these various components had revealed all to be intact with no visible damage. No leakage of brake fluid was also observed.

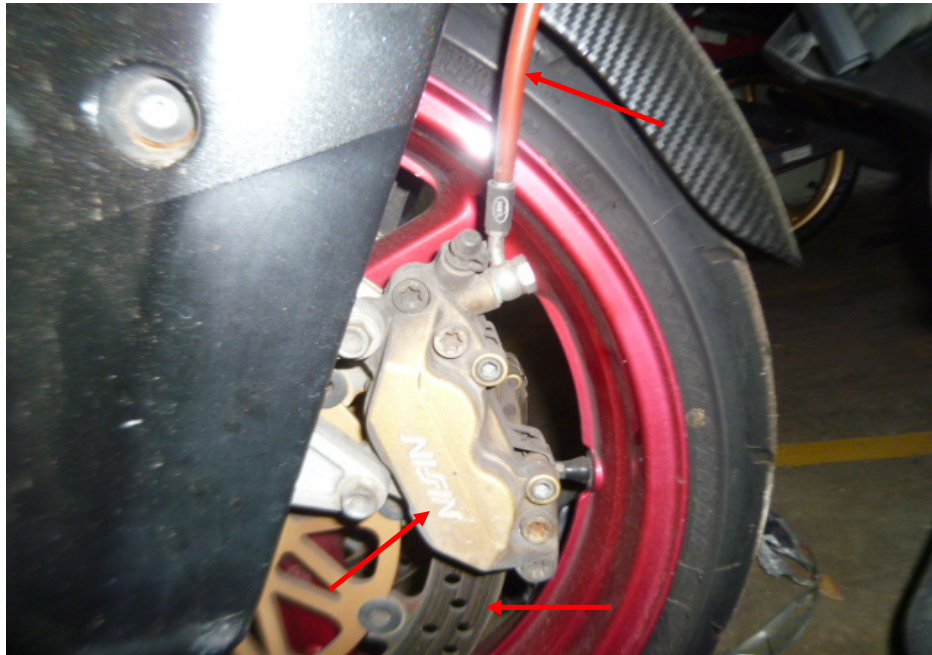
**Photo 22** shows a close up view of the front brake caliper, front brake disc and front brake hose (arrowed) at the left side of the Motorcycle's front wheel, which are all part of the components in the hydraulic front brake system of the Motorcycle. Our visual checks of these various components had revealed all to be intact with no visible damage. No leakage of brake fluid was also observed.

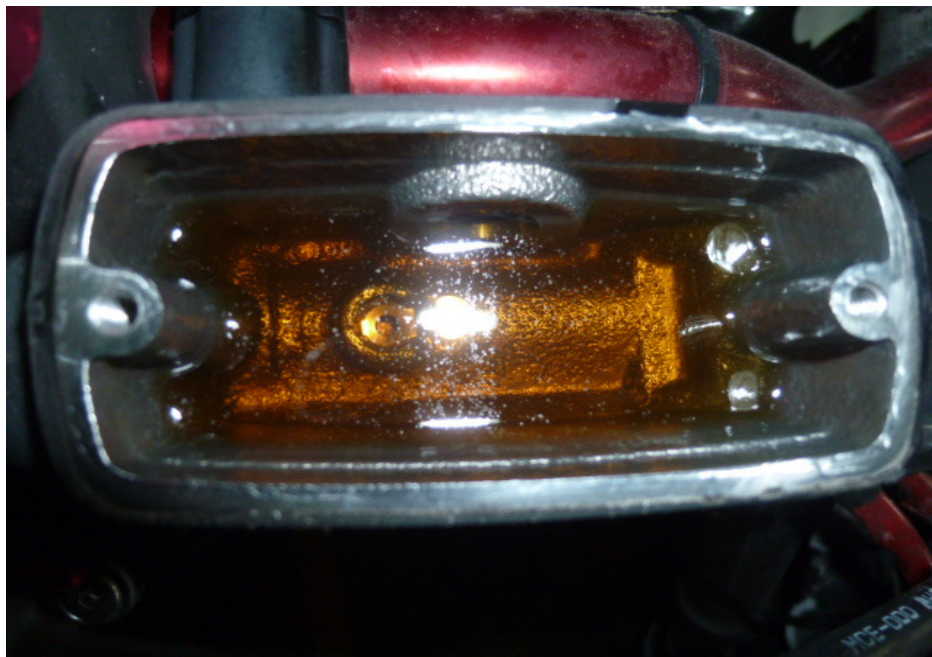
**Photo 23** shows the brake fluid reservoir for the front brake of the Motorcycle. The brake fluid was observed to be of sufficient level for operational purposes and without contamination.

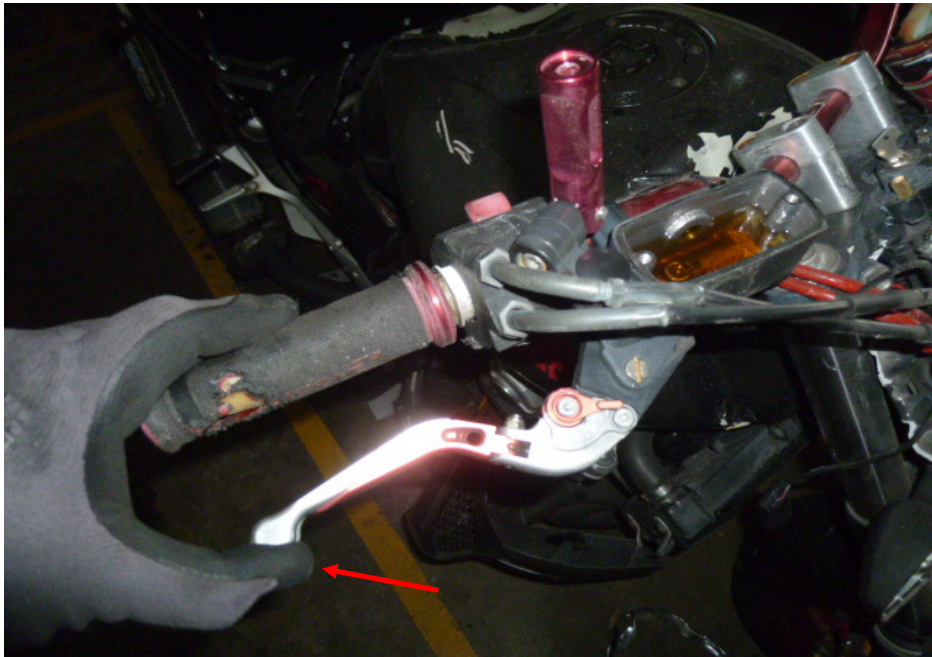
**Photo 24** shows the front brake lever being depressed. There was some resistance felt (spongy like feel) upon pressing the front brake lever (arrowed). This would indicate that there is no leakage of pressure/vacuum in the front brake system.

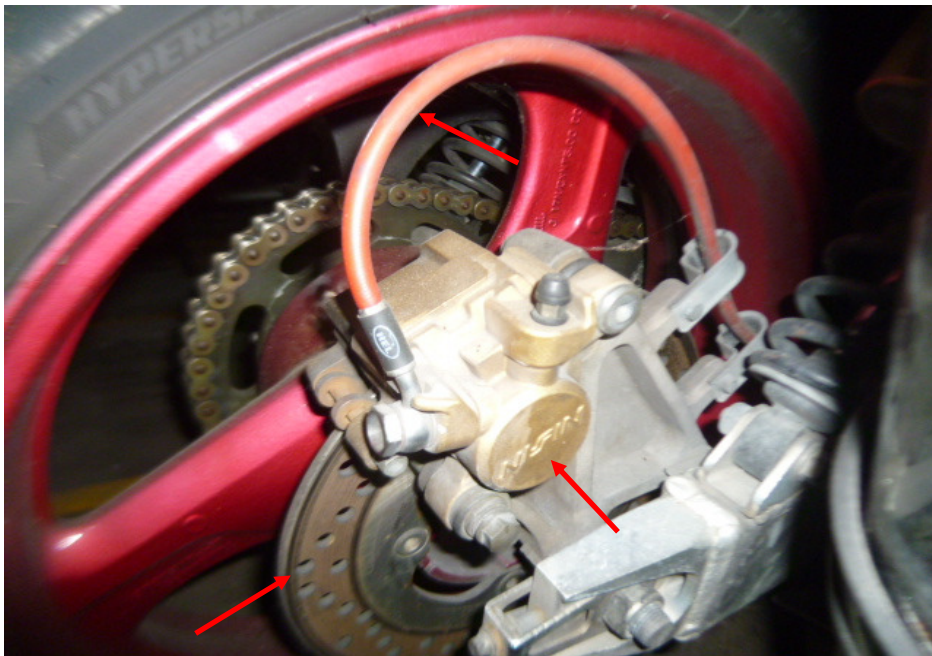
**Photo 25** shows a close up view of the rear brake caliper, rear brake disc and rear brake hose (arrowed) of the Motorcycle, which are all part of the components in the hydraulic rear brake system of the Motorcycle. Our visual checks of these various components had revealed all to be intact with no visible damage. No leakage of brake fluid was also observed.

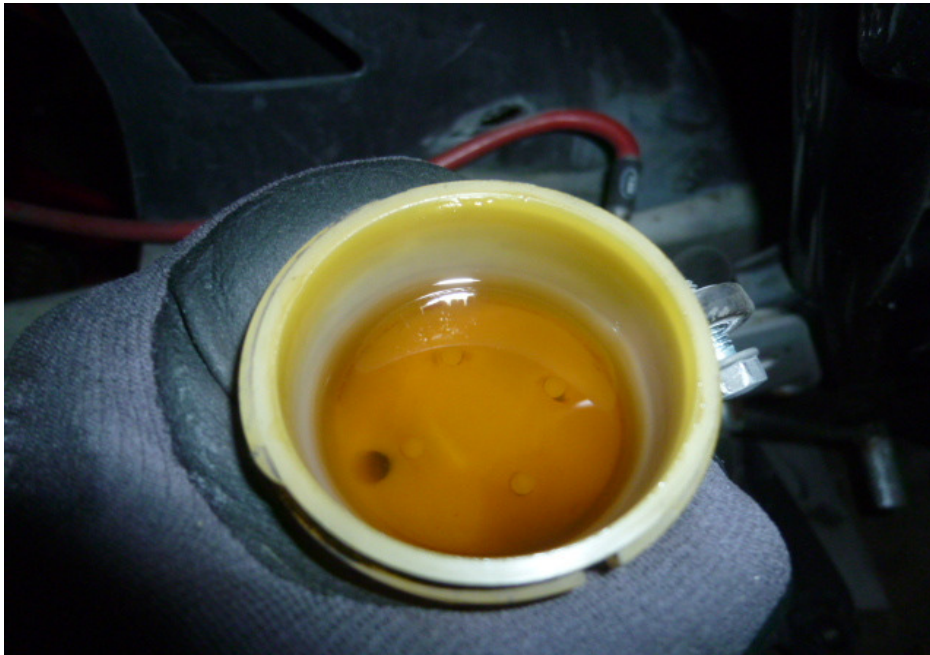
**Photo 26** shows the brake fluid reservoir for the rear brake of the Motorcycle. The brake fluid was observed to be of sufficient level for operational purposes and without any contamination.
