Your Ref: TP/IP/27581/2022
Our Ref : CI/TPD22011566/N

Fatal Accident Investigation Team

INSPECTION REPORT OF MOTORCYCLE FBQ 1383A

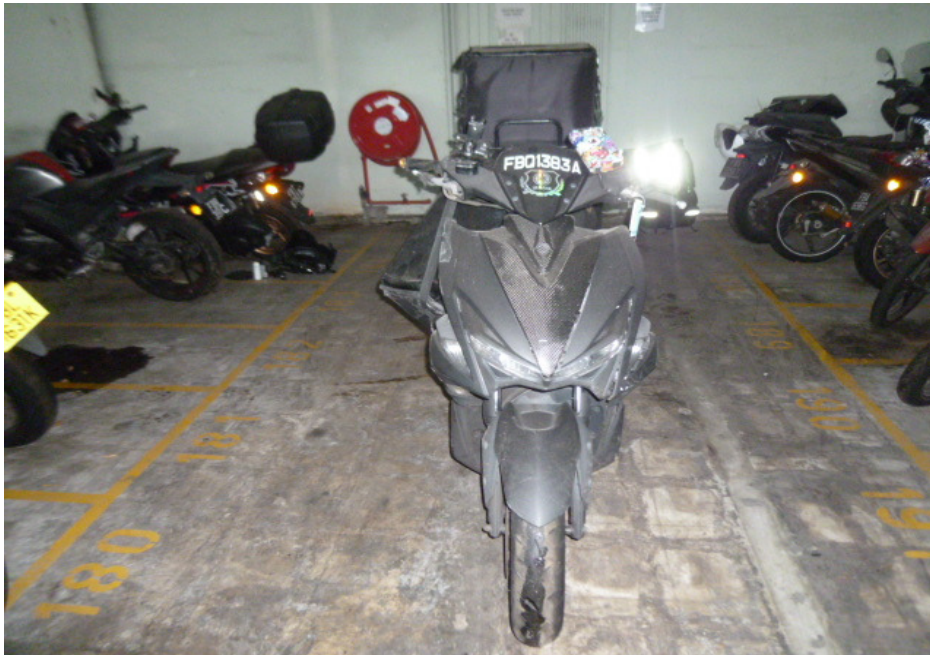
Photo 1 shows a general view of the frontal portion of the Motorcycle at the time of our inspection. The Motorcycle was observed to have sustained damages all around. We were unable to record the mileage of the Motorcycle due to unavailability of the ignition key.

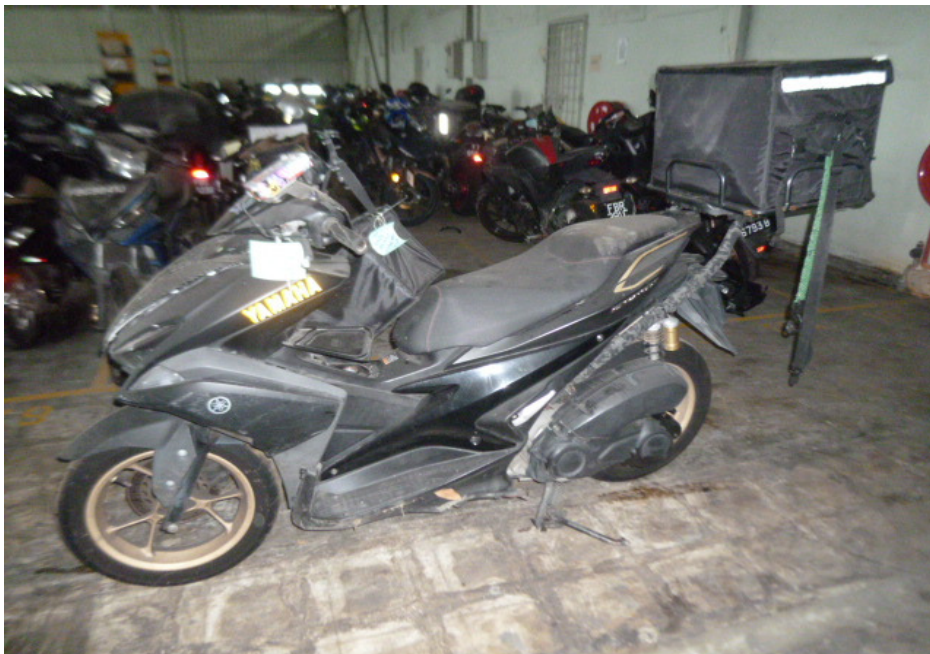
Photo 2 shows a general view of the left body of the Motorcycle at the time of our inspection. The Motorcycle was observed to have sustained damages all around.

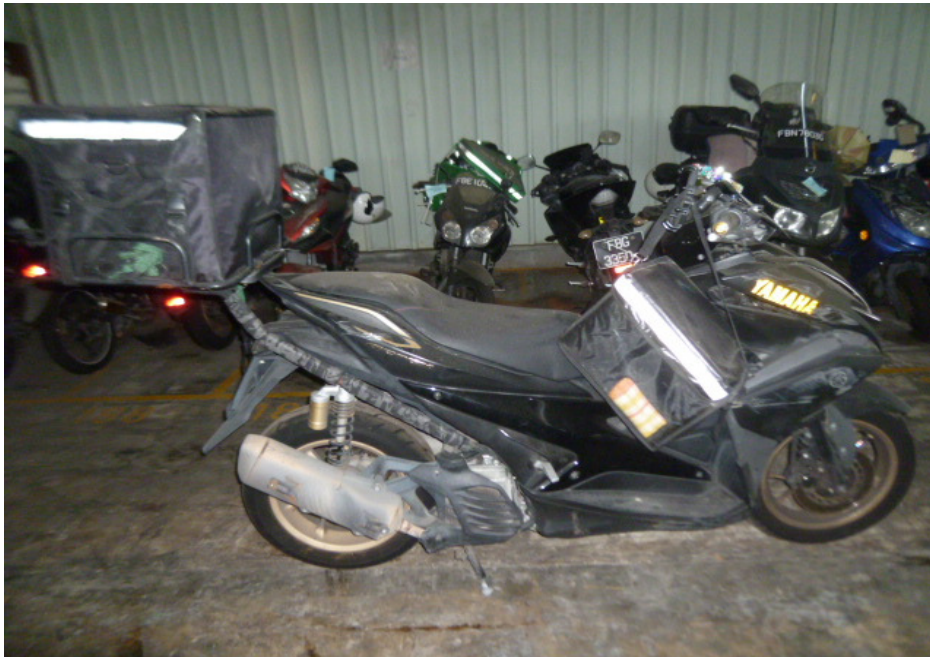
Photo 3 shows a general view of the right body of the Motorcycle at the time of our inspection. The Motorcycle was observed to have sustained damages all around.

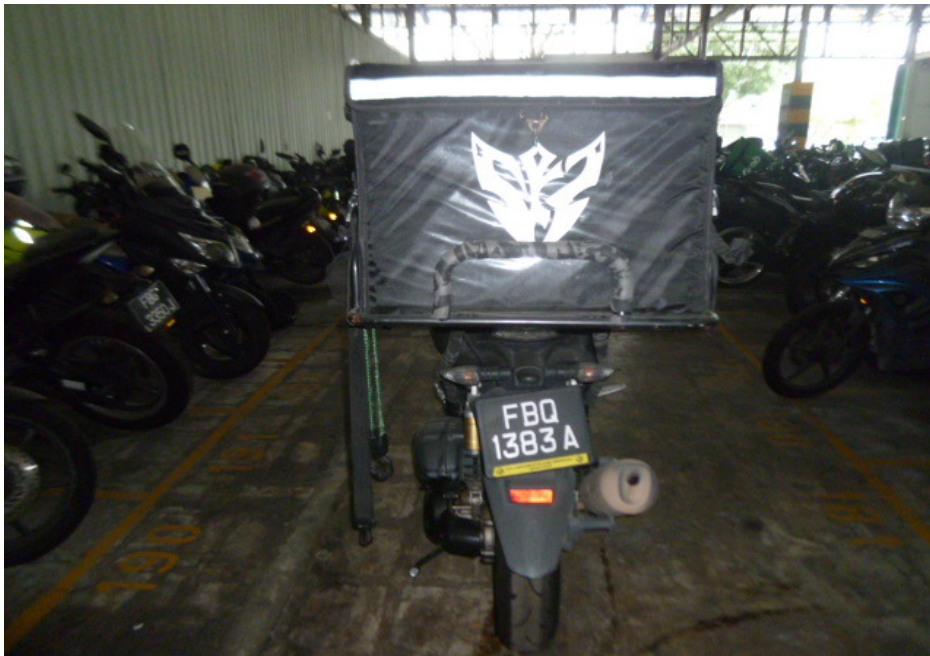
Photo 4 shows a general view of the rear portion of the Motorcycle at the time of our inspection. The Motorcycle was observed to have sustained damages all around. The body parts that were found to have been damaged include its front cowlings, front mudguard, front brake lever, right handlebar end, left side mirror, side cowlings, bottom cowlings, right rear side cover, right pillion foot peg, top box rack and exhaust muffler, amongst others as a result of the accident.

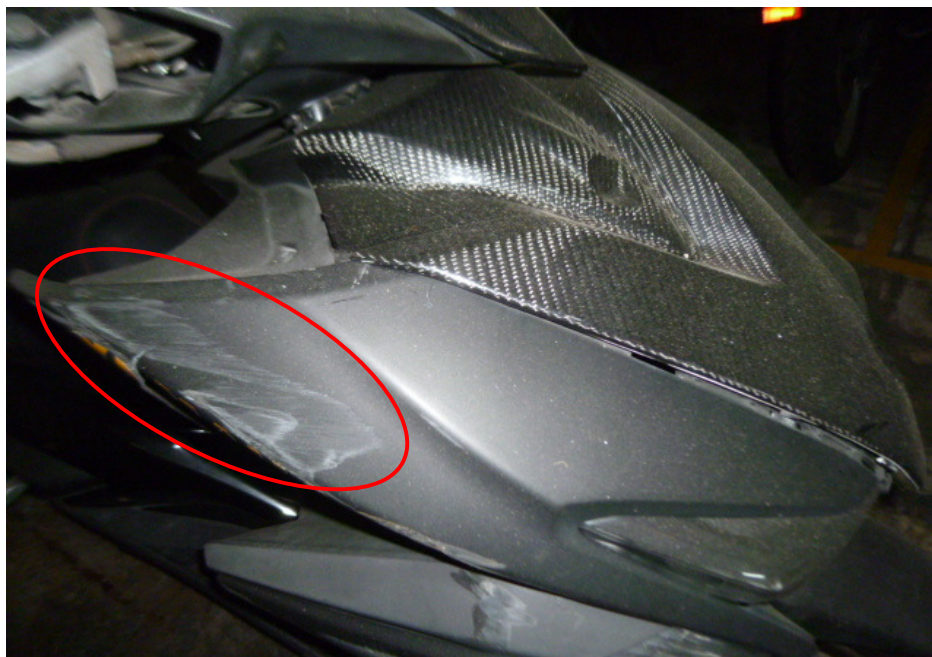
Photo 5 shows the grazed front cowling of the Motorcycle as a result of the accident (circled).

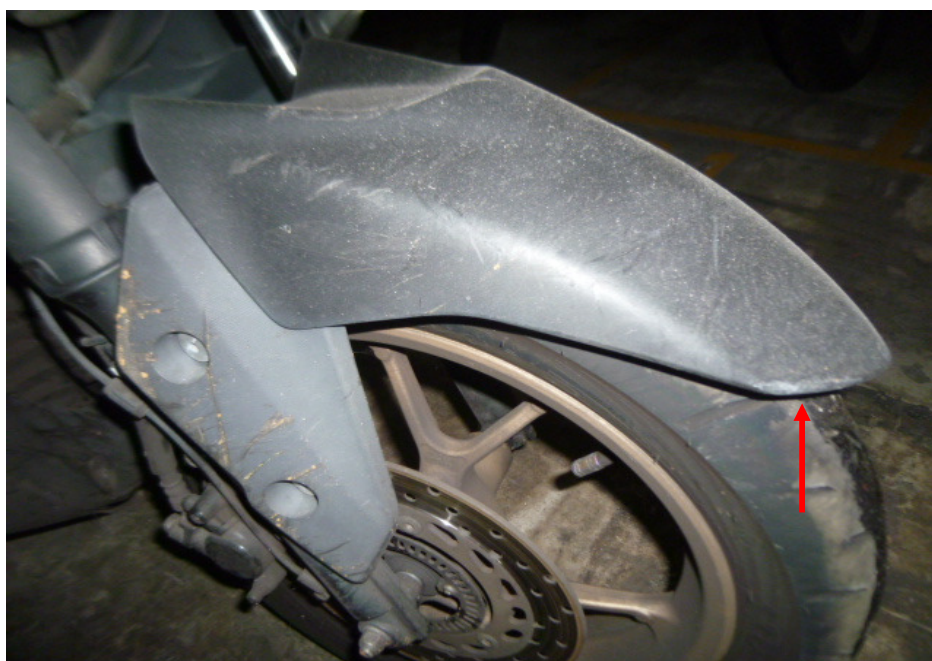
Photo 6 shows a closer view of the grazed front mudguard which was amongst the body parts at the front body of the Motorcycle that had sustained damage as a result of the accident (arrowed).

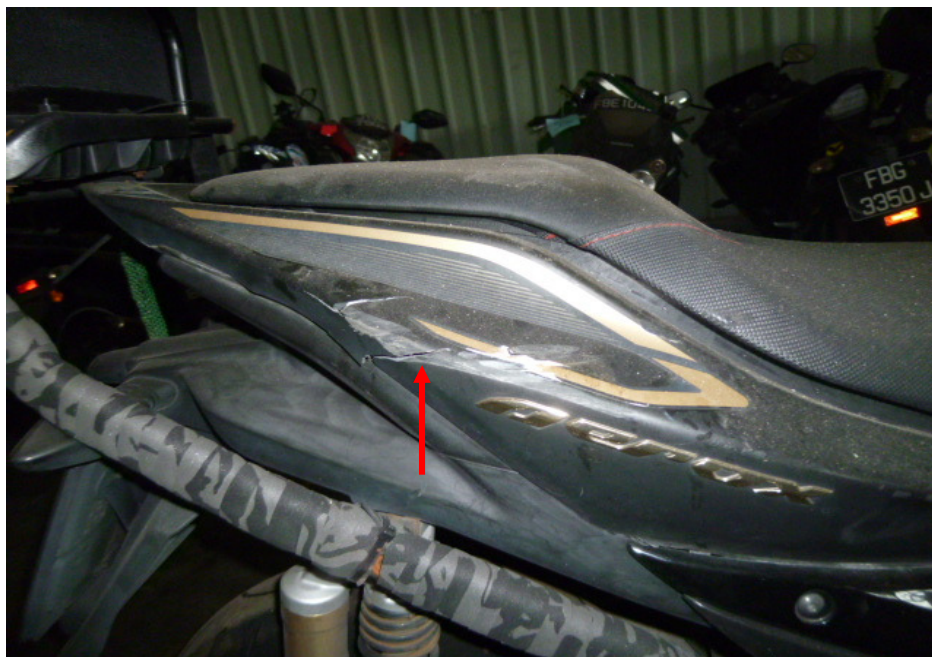
Photo 7 shows a closer view of the cracked right rear side cover of the Motorcycle as a result of the accident (arrowed).

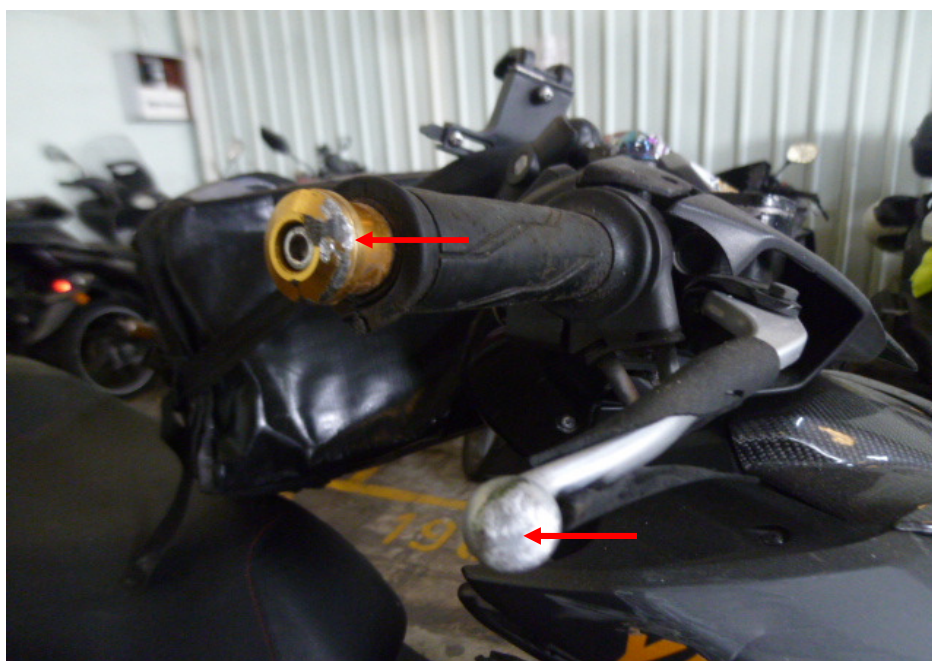
Photo 8 shows a closer view of the right handlebar end and front brake lever of the Motorcycle which were observed to be damaged due to the accident (arrowed).

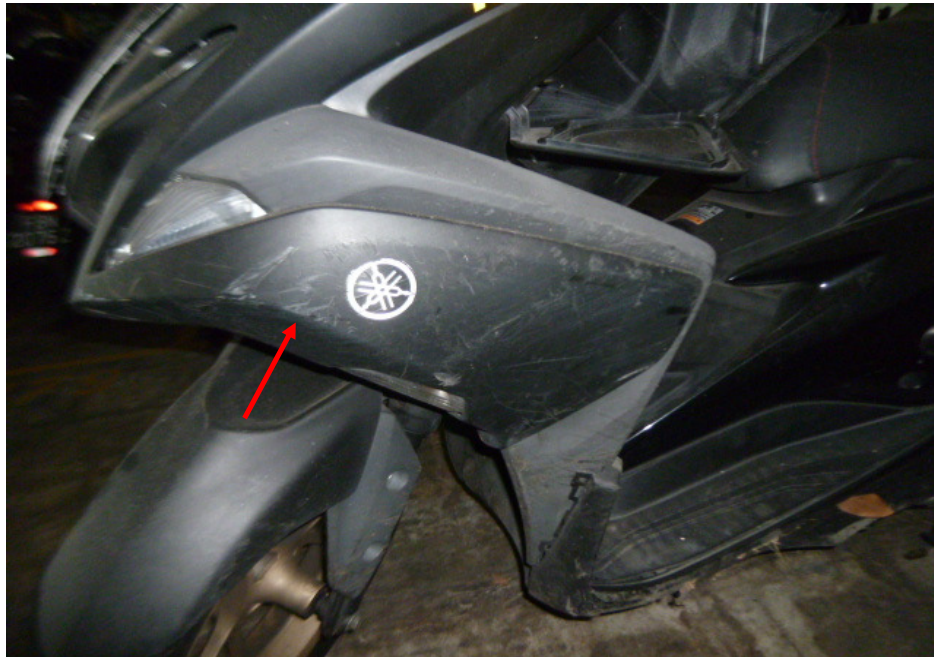
Photo 9 shows the grazed left cowling of the Motorcycle as a result of the accident (arrowed).

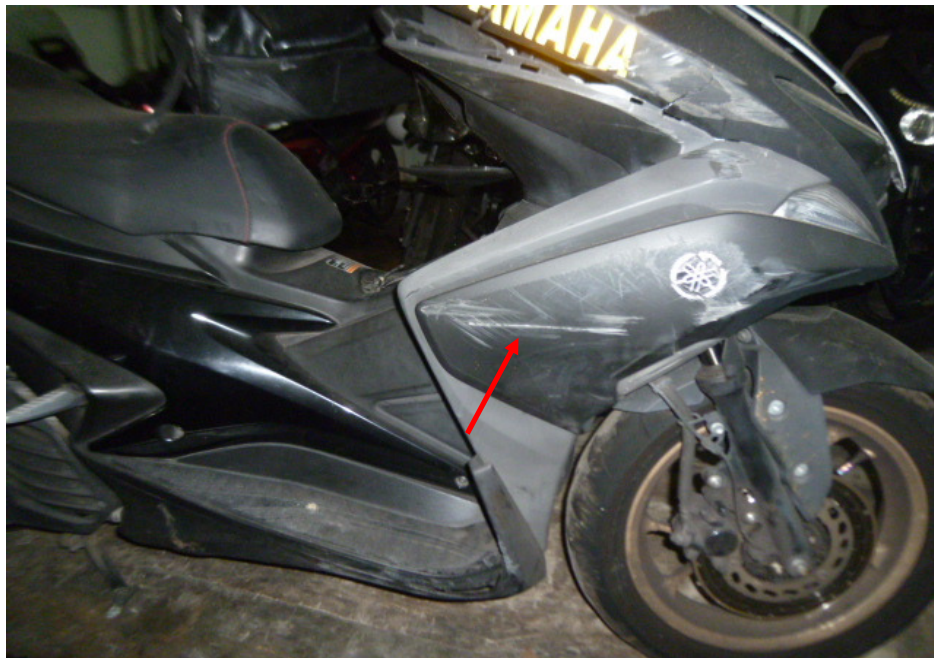
Photo 10 shows the grazed right cowling of the Motorcycle as a result of the accident (arrowed).

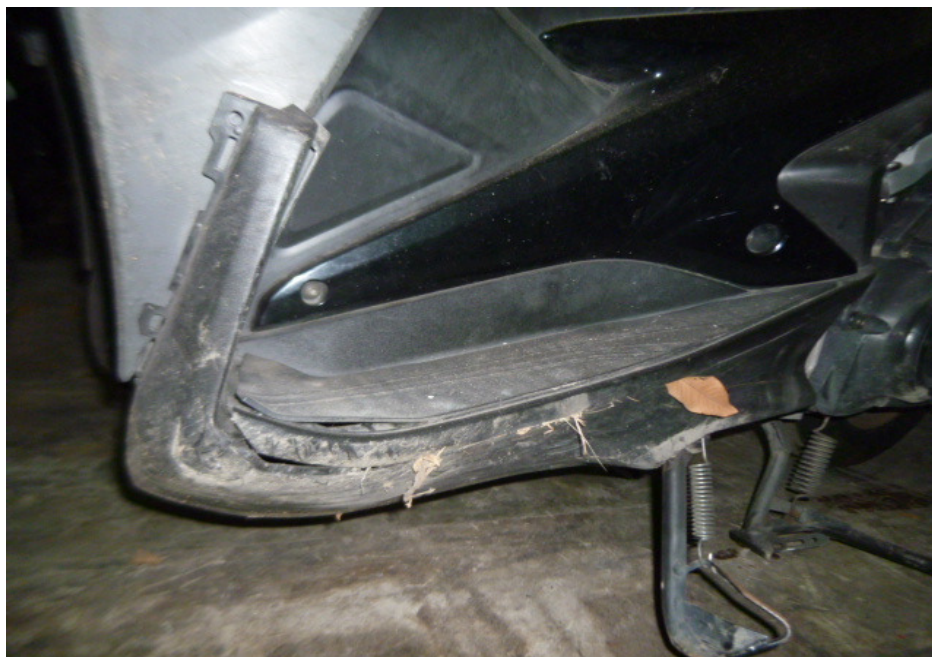
Photo 11 shows a close-up view of the cracked left bottom cowling of the Motorcycle as a result of the accident.

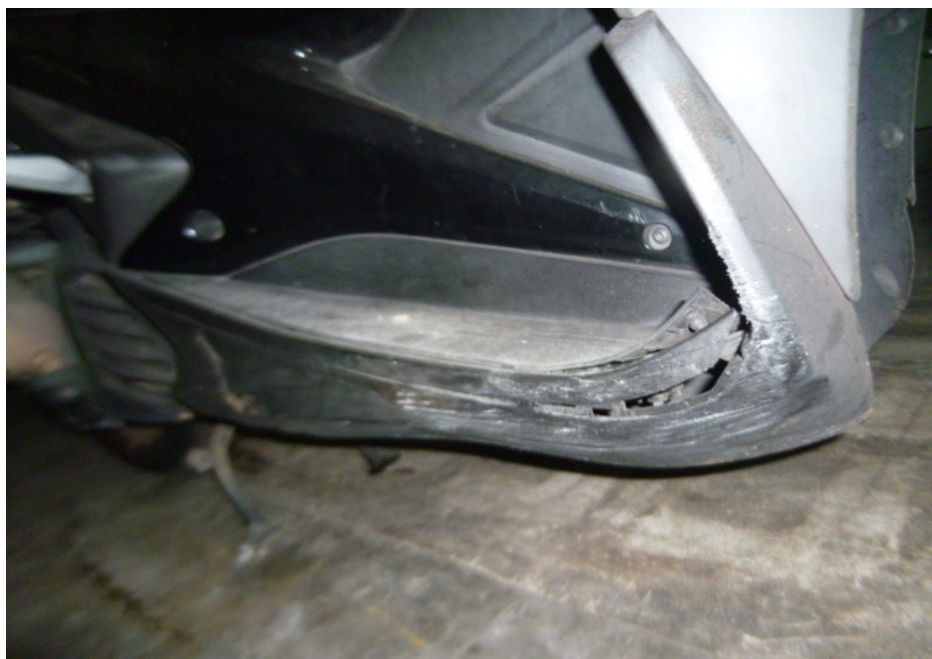
Photo 12 shows a close-up view of the cracked right bottom cowling of the Motorcycle as a result of the accident.

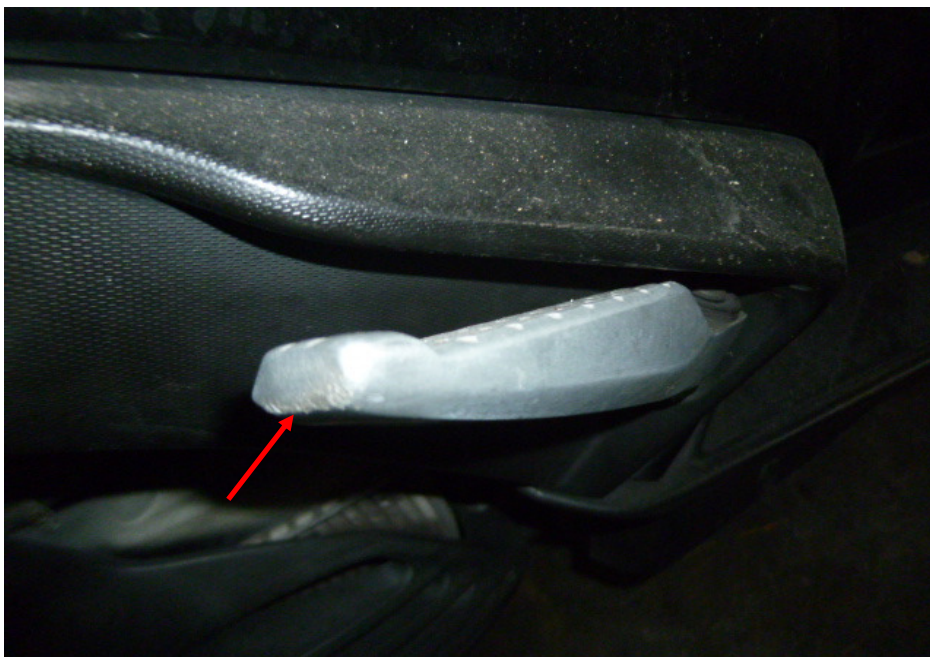
Photo 13 shows a general view of the grazed right pillion foot peg of the Motorcycle as a result of the accident (arrowed).

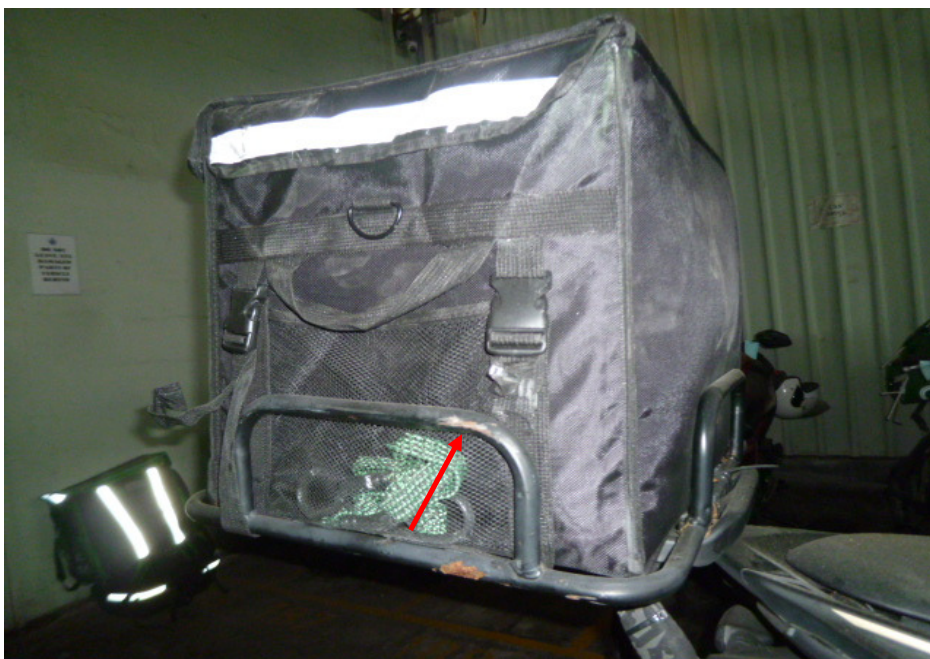
Photo 14 shows the grazed top box rack of the Motorcycle as a result of the accident (arrowed).

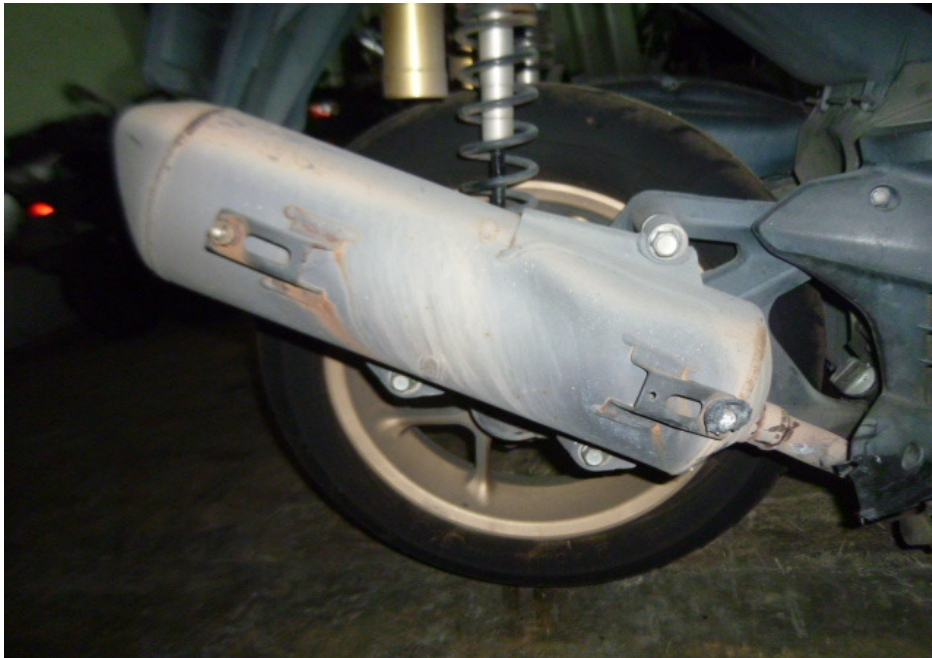
Photo 15 shows a closer view of the deformed exhaust muffler of the Motorcycle as a result of the accident.

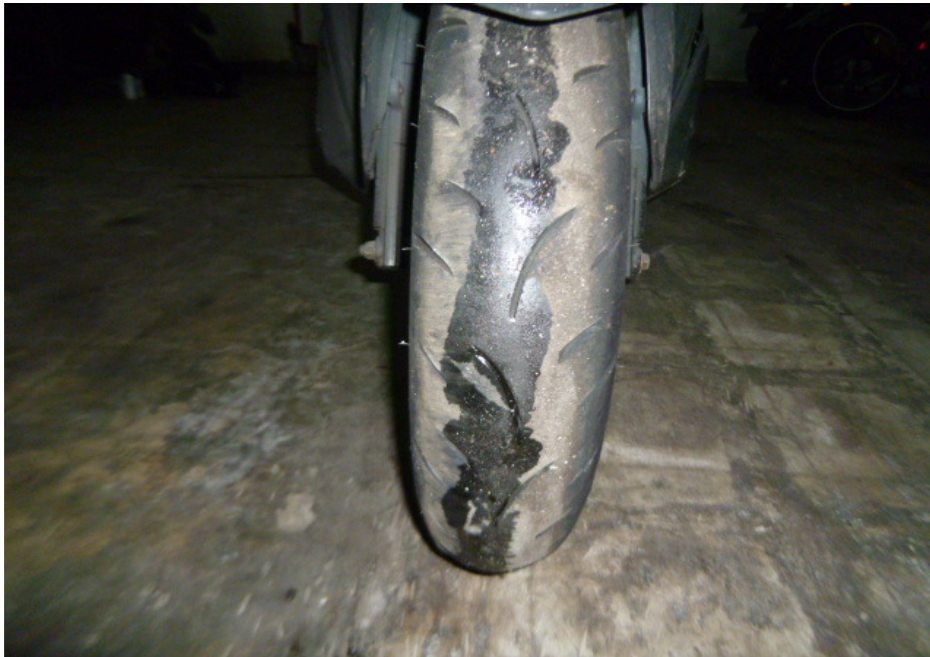
Photo 16 shows the condition of the Motorcycle's front tyre. The front tyre was observed to be in serviceable condition with remaining tread depth of approximately 3mm. There was no tear, burst mark(s) and/or punctured hole(s) on the sidewalls as well as across the tread of the front tyre. The tyre was also observed to be sufficiently inflated for vehicular operation.

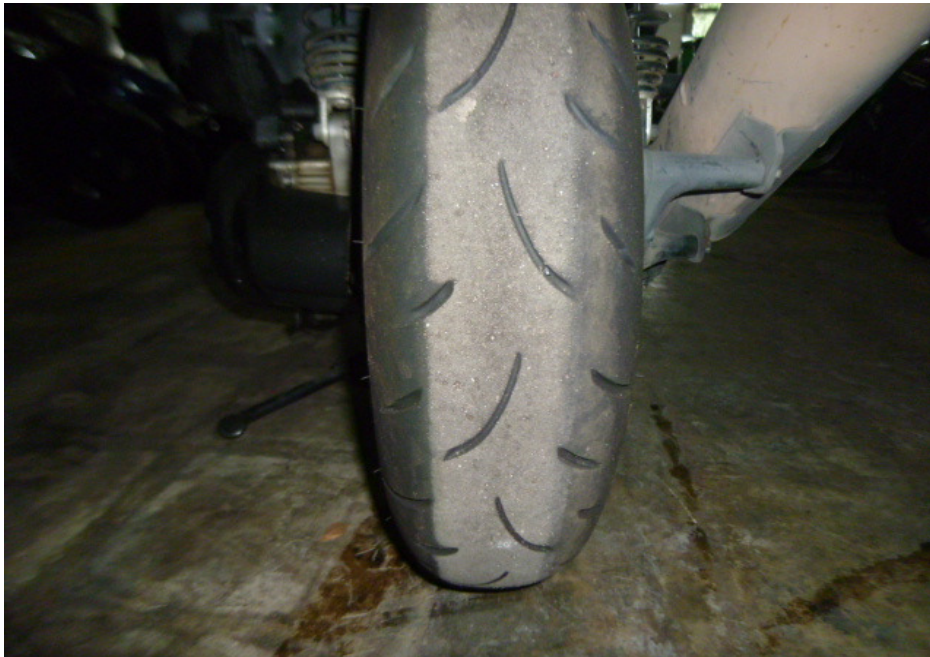
Photo 17 shows the condition of the Motorcycle's rear tyre. The rear tyre was observed to be in serviceable condition with remaining tread depth of approximately 2mm. The tyre was also observed to be sufficiently inflated for vehicular operation. We did not observe any tear, burst mark(s) and/or punctured hole(s) on the sidewalls as well as across the tread of the rear tyre.

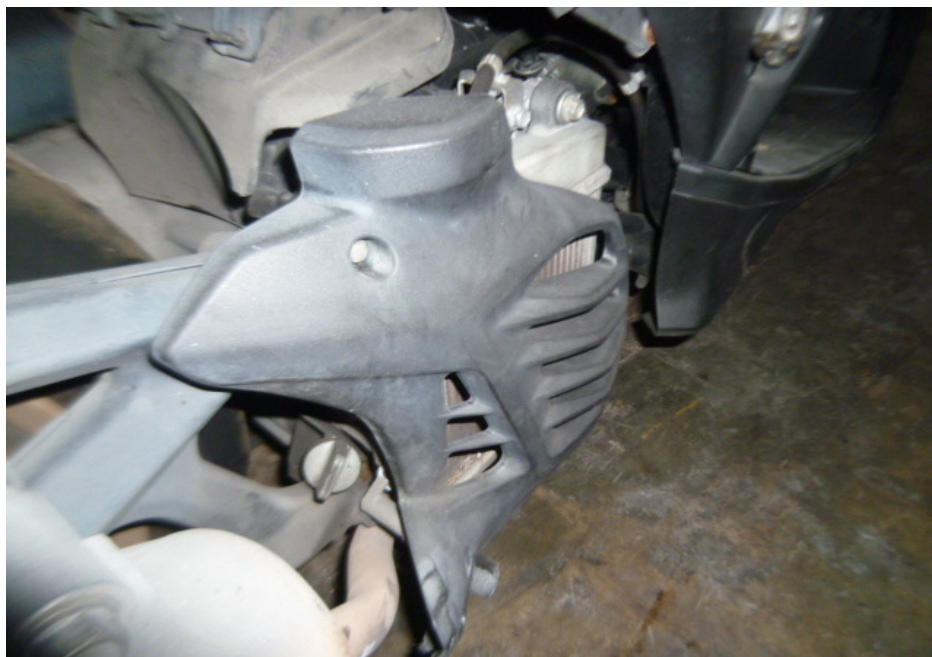
Photo 18 shows the right side of the engine of the Motorcycle at the time of our inspection. The various engine related parts and components were found to be intact with no visible damage. There was also no sign(s) or indication(s) of fluid leak observed around the right engine area of the Motorcycle.

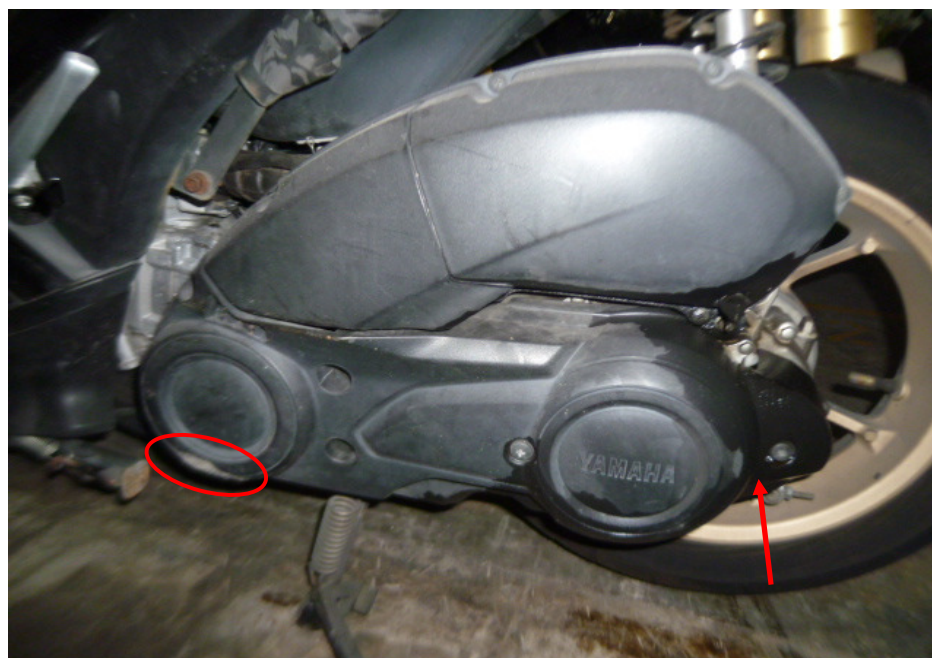
8. Upon examination of the Motorcycle's engine area, we had observed fluid leak around the left engine area of the Motorcycle.
9. The drive train of the Motorcycle was found to be intact without any misalignment. However the drive train cover had sustained damages of grazing nature as a result of the accident. There was no visible tear or cut observed on the connecting hoses and cables. The shock absorbers of the Motorcycle were also found to be intact without any misalignment. See photos 18 - 22 below.

Photo 19 shows the drive train of the Motorcycle which was found to be intact without any misalignment. However the drive train cover had sustained damages of grazing nature as a result of the accident (circled). Upon closer examination of the Motorcycle's left engine area, we had observed fluid leak around the left engine area of the Motorcycle (arrowed).

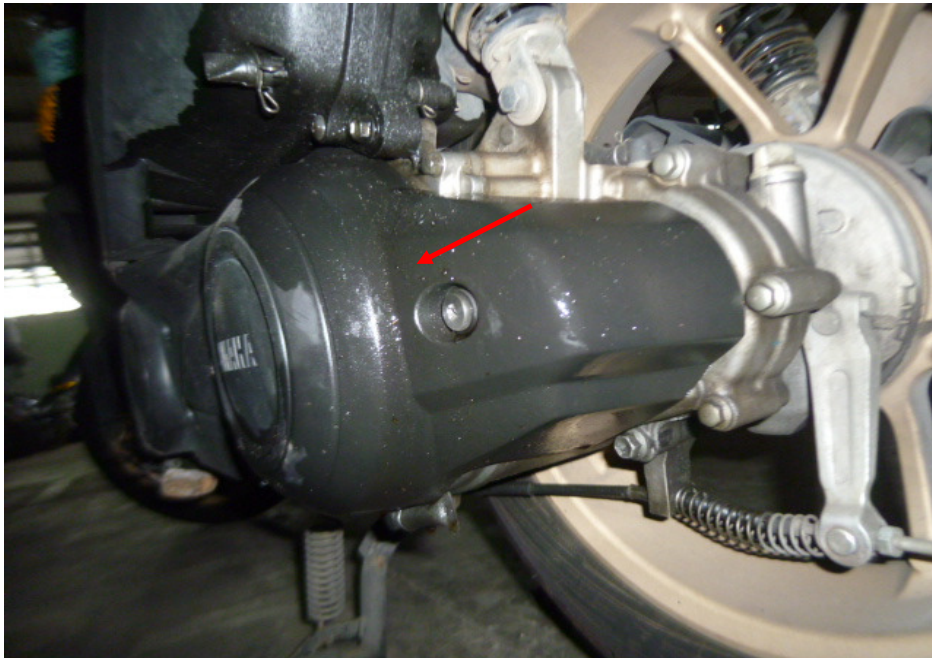
Photo 20 shows the fluid leak observed around the left engine area of the Motorcycle (arrowed).

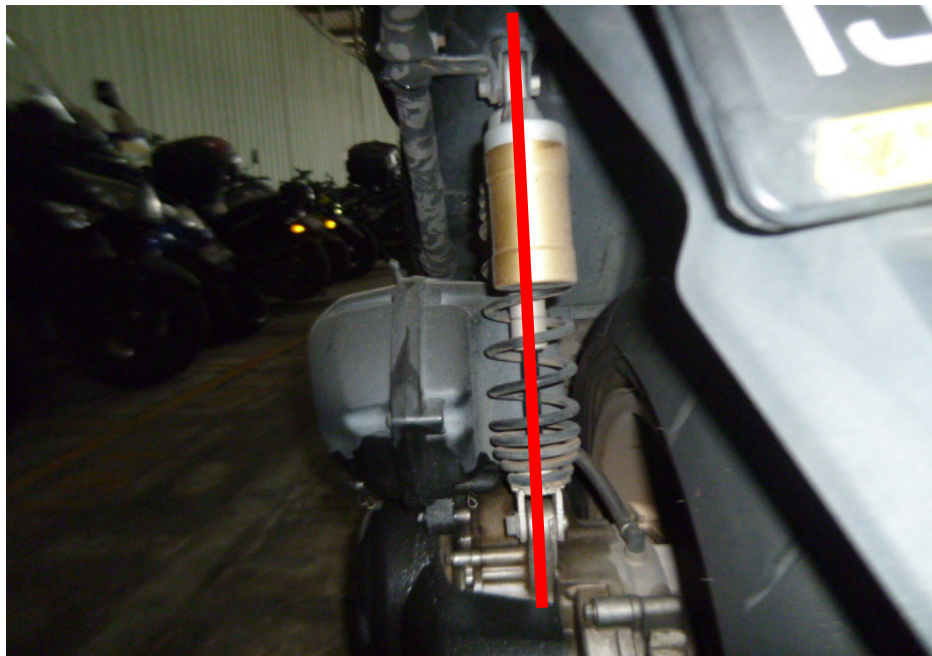
Photo 21 shows the left shock absorber of the Motorcycle which was found to be intact without any misalignment.

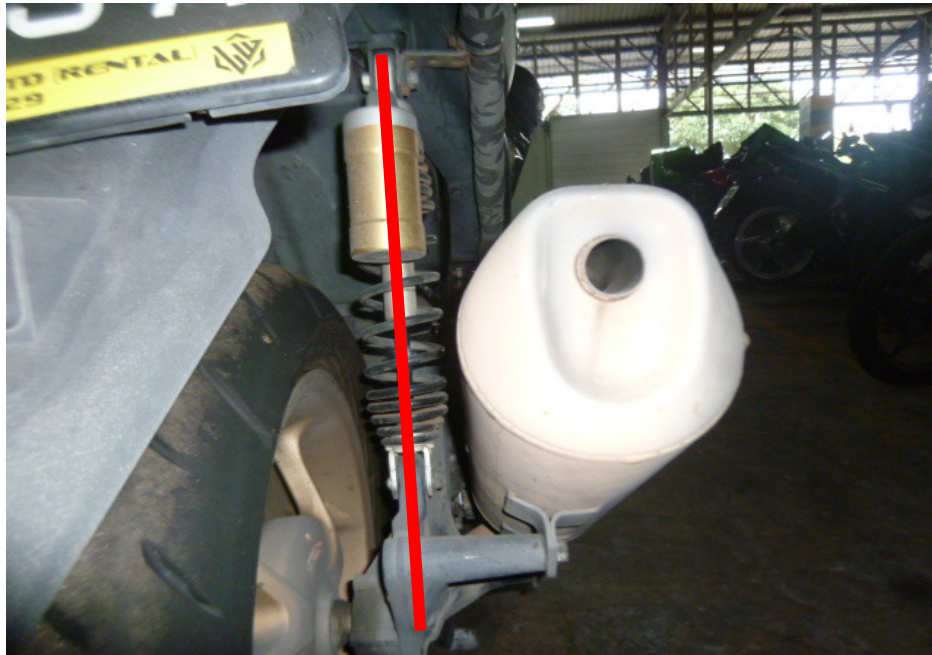
Photo 22 shows the right shock absorber of the Motorcycle which was found to be intact without any misalignment.

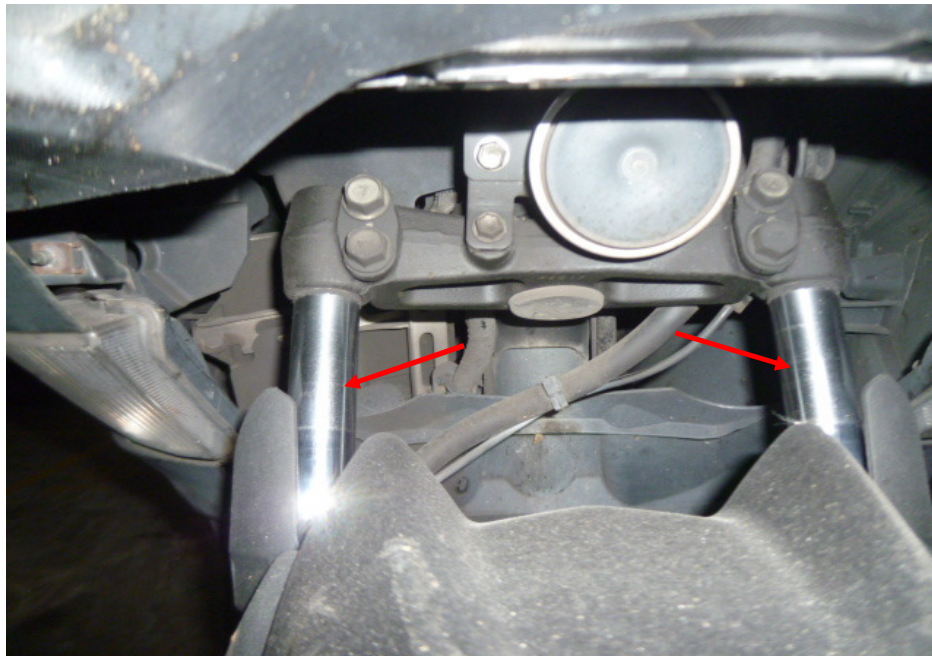
Photo 23 shows the front forks (arrowed) of the Motorcycle. The front forks and fork brackets of the Motorcycle were both found to be intact and undamaged. Turning the Motorcycle's handle bar towards the left and right did not produce any abnormal free play and/or resistance. The steering system of the Motorcycle was in serviceable condition at the time of our inspection.

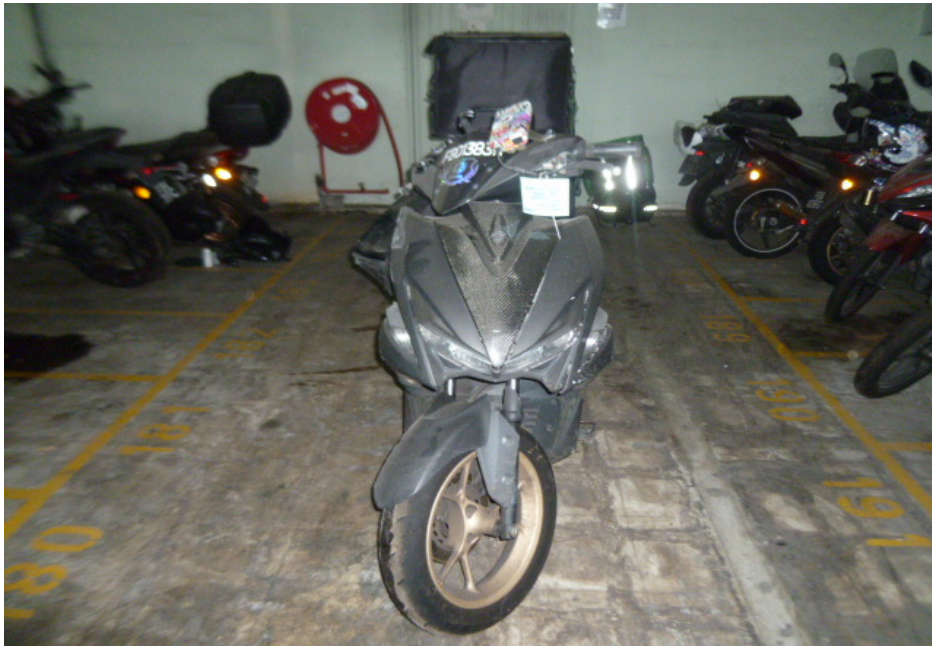
Photo 24 shows the front wheel of the Motorcycle turned towards its full right. Turning the Motorcycle's handle bar towards the left and right did not produce any abnormal free play and/or resistance. This would indicate that the steering system of the Motorcycle was in serviceable condition at the time of our inspection.

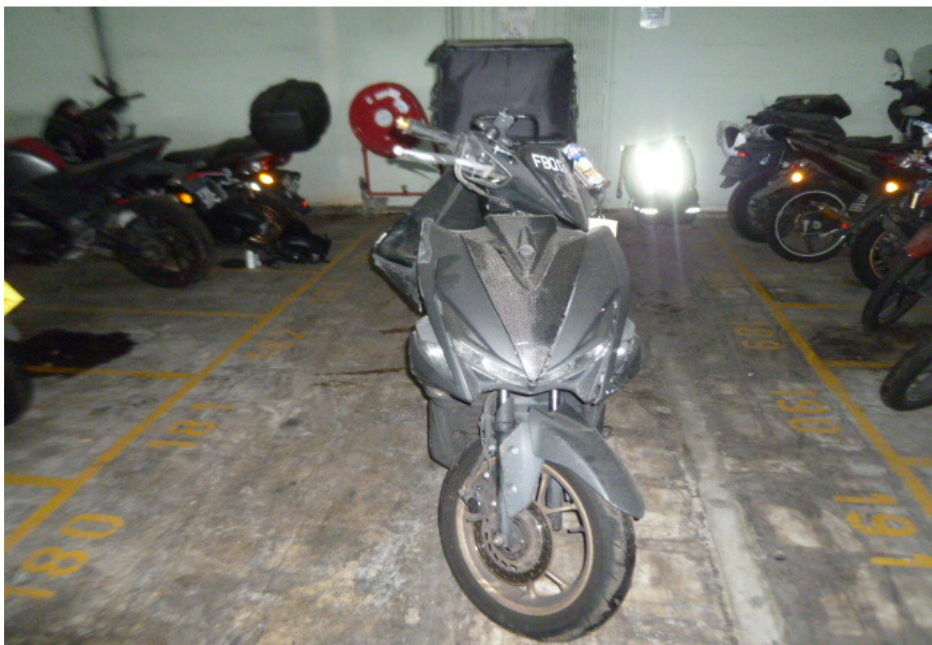
Photo 25 shows the front wheel of the Motorcycle turned towards its full left. Turning the Motorcycle's handle bar towards the left and right did not produce any abnormal free play and/or resistance. This would indicate that the steering system of the Motorcycle was in serviceable condition at the time of our inspection.

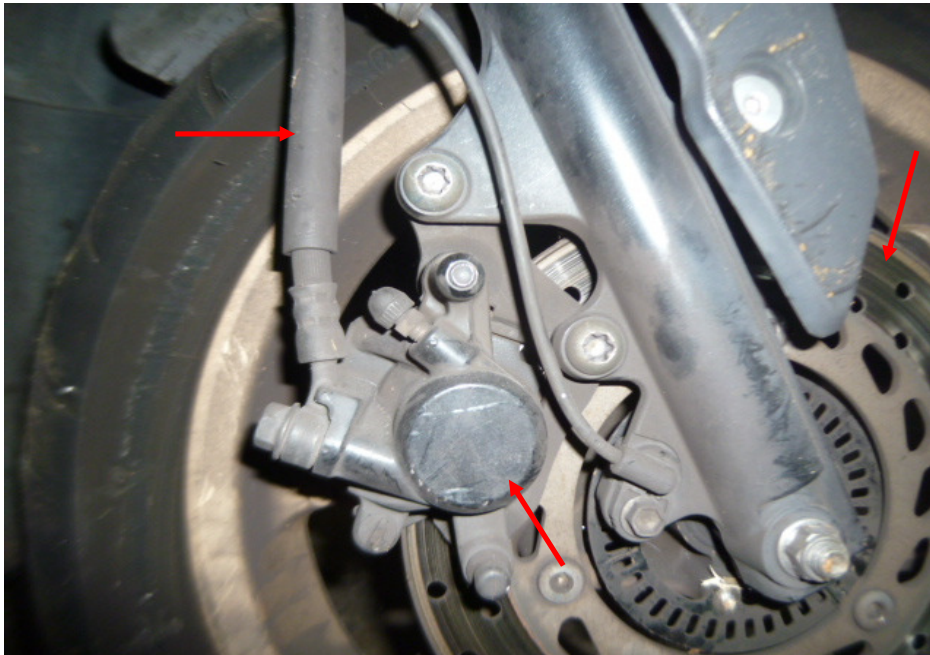
Photo 26 shows a close up view of the front brake caliper, front brake disc and front brake hose (arrowed) of the Motorcycle, which are all part of the components in the hydraulic front brake system of the Motorcycle. Our visual checks of these various components had revealed all to be intact with no visible damage. No leakage of brake fluid was also observed.

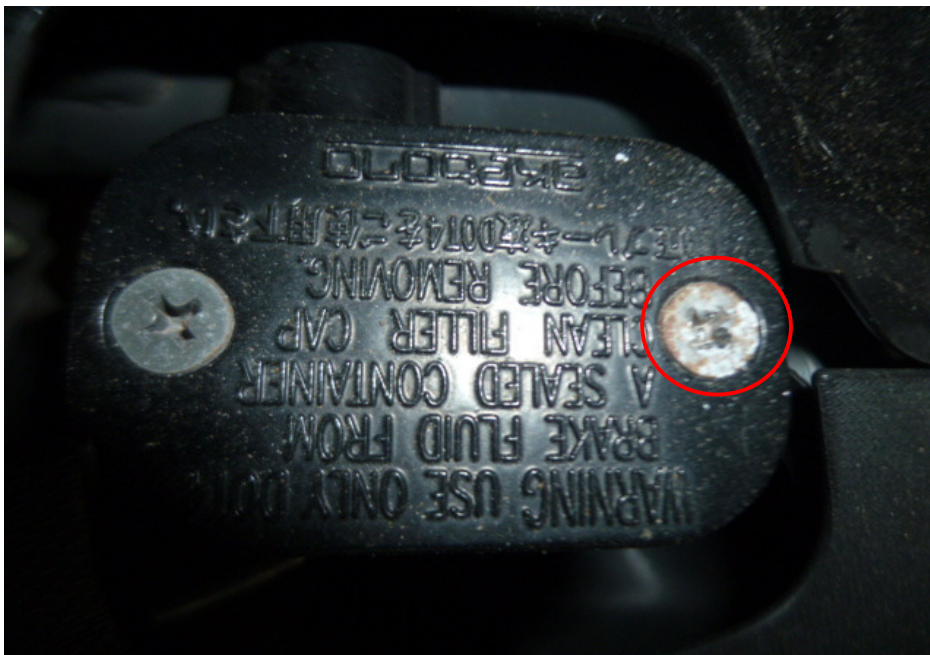
Photo 27 shows the brake fluid reservoir cover for the front brake of the Motorcycle. We were unable to examine whether the front brake fluid was without contamination due to a worn out screw (circled).

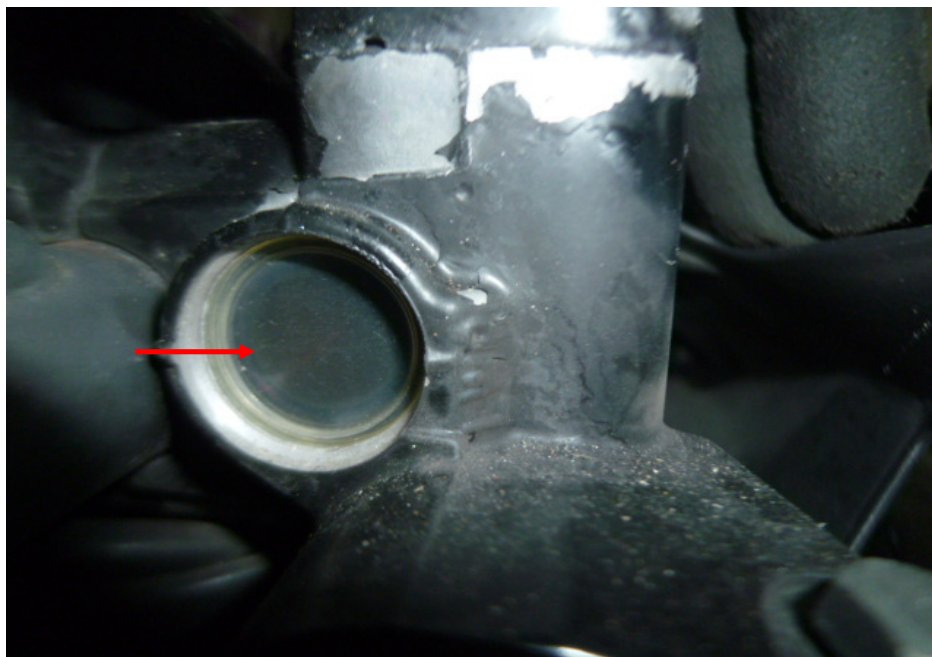
Photo 28 shows a close up view of the brake fluid reservoir for the front brake of the Motorcycle. The brake fluid was observed to be of sufficient level for operational purposes (arrowed).

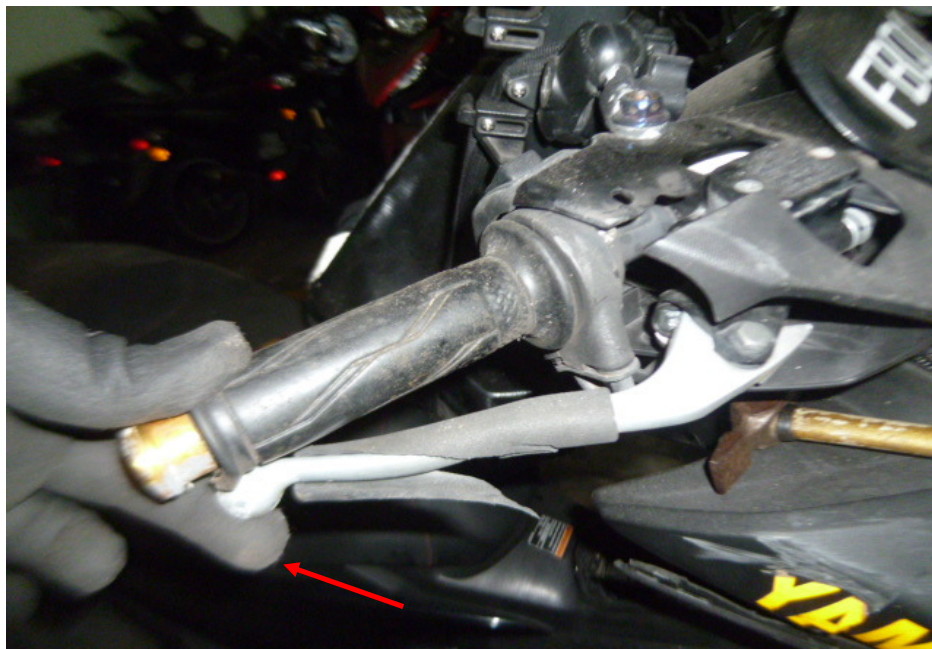
12. We were unable to conduct static brake tests on the front braking system of the Motorcycle due to the broken right hand lever. Hence we were unable to indicate if there was any leakage of pressure/vacuum in the front brake system.

13. We subsequently carried out an operational test of the Motorcycle's braking system. This was done by manually pushing the Motorcycle forward and backward, simulating the Motorcycle in motion, and thereafter engaging the front brake and rear brake of the Motorcycle. At the end of the short operational test, we did not observe any abnormal behaviour of the Motorcycle's rear braking system. The rear wheel of the Motorcycle was able to stop rotating immediately upon depressing the left hand brake lever. However the front wheel of the Motorcycle was unable to stop rotating immediately upon depressing the right hand brake lever.

Photo 29 shows the broken right hand brake lever as a result of the accident (arrowed). We were unable to conduct static brake tests on the front braking system of the Motorcycle due to the broken right hand lever. Hence we were unable to indicate if there was any leakage of pressure/vacuum in the front brake system.

15. Basing on our physical inspection of the Motorcycle, it appears that the steering system and rear braking system of the Motorcycle were all in serviceable condition. However the front braking system of the Motorcycle was damaged as a result of the accident.

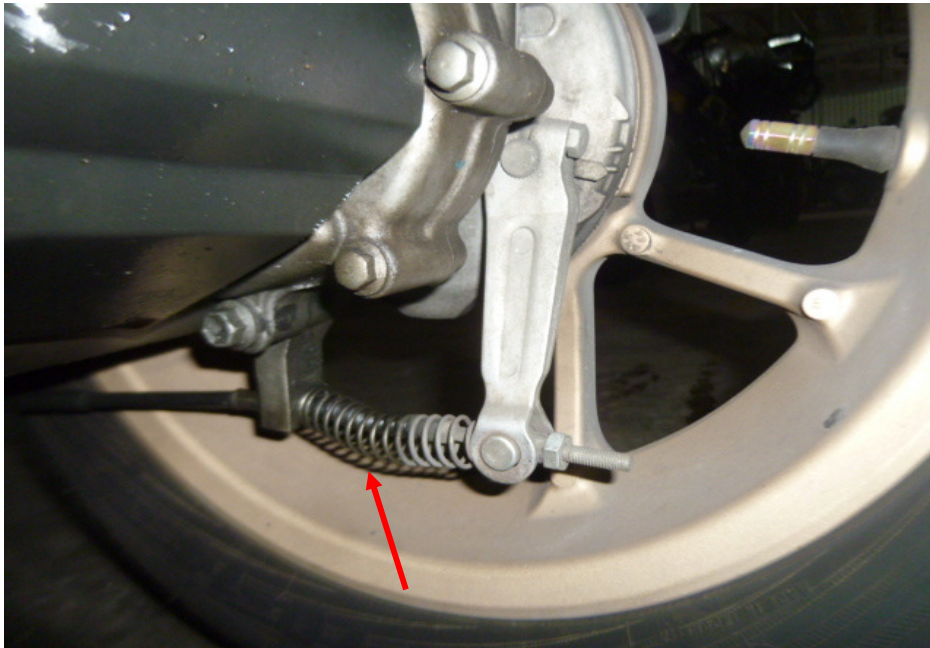
Photo 30 shows the rear wheel of the Motorcycle. The type of brake system for the rear wheel was of a mechanical type, controlled by the brake foot pedal of the Motorcycle. Our checks of the cable (arrowed), spring and drum which are all part of the components in the rear brake system of the Motorcycle reveal all to be intact and without damage.
