# ALLIED AUTO APPRAISAL

Our Ref: Allied/TP/22-07008

Veh No : SMN 3560 C  
: 17-Sep-22  
: 22-Jul-22  
: 23-Jul-22

| Make & Model | : Toyota Prius Plus | Date of Registration | : 02-Aug-19 |

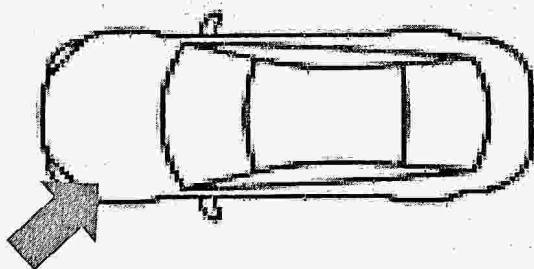
The inspected vehicle sustained damage at the FRONT LEFT SIDE portion.

During visual inspection, our surveyor noted that the front bumper, front left fender, front bonnet and among other parts were affected.
