# ALLIED AUTO APPRAISAL

Our Ref: Allied/TP/22-07008

Veh No : SMN 3560 C  
17-Sep-22  
22-Jul-22  
23-Jul-22

| Make & Model | : Toyota Prius Plus | Date of Registration | : 02-Aug-19 |

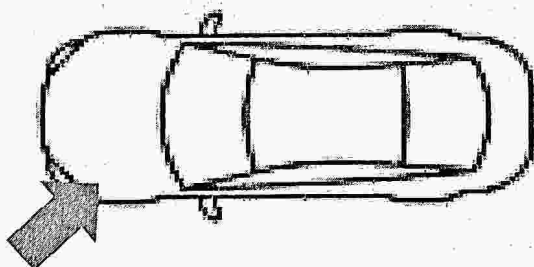
The inspected vehicle sustained damage at the FRONT LEFT SIDE portion.

During visual inspection, our surveyor noted that the front bumper, front left fender, front bonnet and among other parts were affected.

The repairer agree to repair the vehicle on a Lump Sum Basis with our recommendation of SGD 10,050.00 (SGD Ten Thousand and Fifty only) and we are in the opinion the repairer would need about a 7.0 working day period to repair the vehicle.
