Fire Assessment/Investigation**Date of report: 17-Aug-21****Vehicle No.: YM9835J****Claim No.: AVS21/1720 (CMPO)****Description of the loss – Driver story**

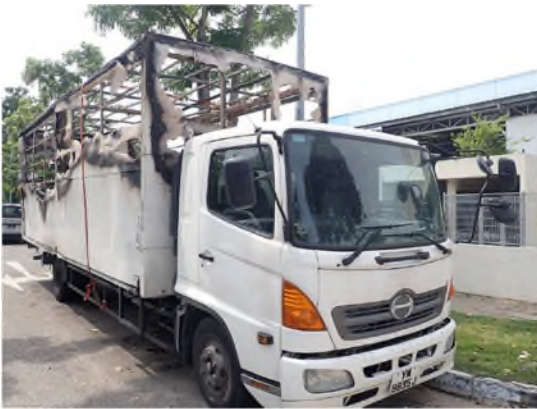
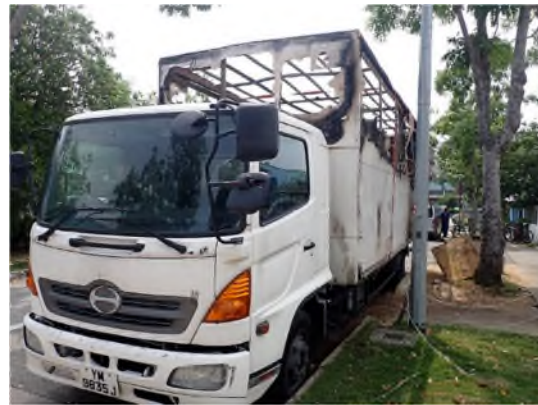
On a first look it can be seen the severe damages caused by the fire prominently in the cargo area (Box).

The following are some photos that illustrate my 1st survey on the front view:

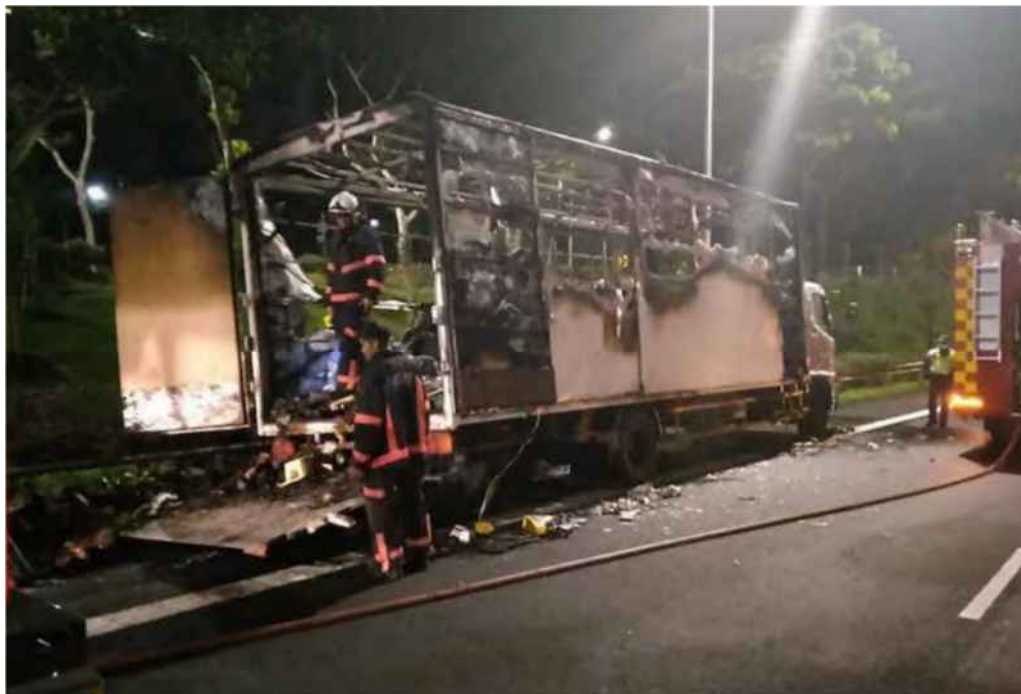
- The fire is more prominent in the lower zone of the left side of the truck.
- There are big flames in the cabin box, supporting the driver story.

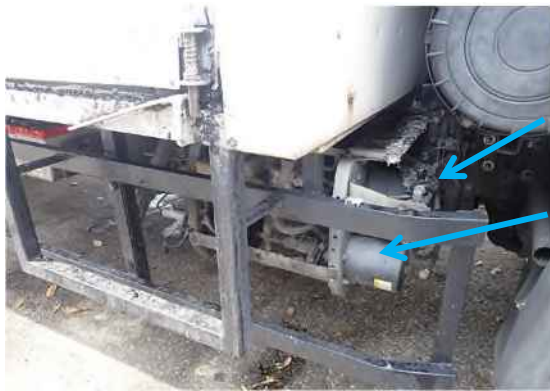
*Brake Air
Hose*

So, now focused around the LH rear wheel area, I pointed my assessment on the potential cause of the fire and, after a quick look, I found that the LH rear wheel rim, tyres and brake system as a whole were damaged by very intense heat. But this heat wasn't a consequence of the fire itself, it was the origin of the loss, specifically the brakes system of the rear left wheels.

1. Handbrake system not/partially released during the towing.
2. Brake hose leaking air.
 - a. "Air brake systems", like this lorry, have a safety feature that engage the brakes if the truck has no compressed air in its system.
 - b. So, if the truck was leaking air during the towing, the brakes of all the wheels should have started to be activated but the rear left wheel was the more affected starting the fire.
3. Finally, it could be just a mechanical failure in the brake components of the rear left wheel causing its unintended engaging. If so, that could explain why the lorry engine was overheating before the towing (driving the lorry with one wheel partially braked requires more power from the engine and that could be the reason of the breakdown)

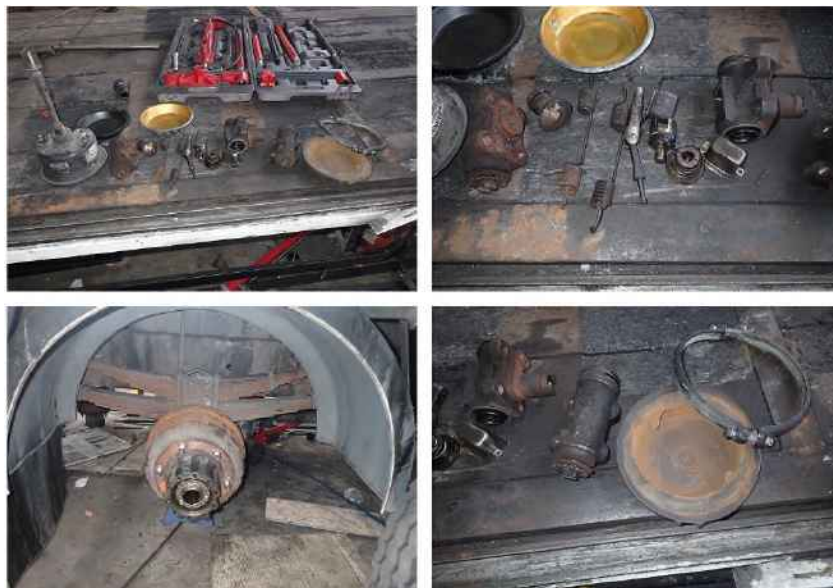
During reinspection on 13/07/2021, most of the damaged parts had already been dismantled and replaced by the workshop. We regret to inform that the critical components (Air Brake Hose and Air Brake Shoe) were already disposed.

However, there is no other indication of the cause of fire rather than the brake engaging while the vehicle was towed – eg. Short circuit (electrical, wiring) or intentional act (cigarette butt).
