Your Ref: MTS2022D0006273 21st November 2022

Our Ref: CI/III22011700/P

TECHNICAL INVESTIGATION REPORT OF WARRANTY CLAIM INVOLVING THE INSURED VEHICLE SKM 2904E ON 31st October 2022

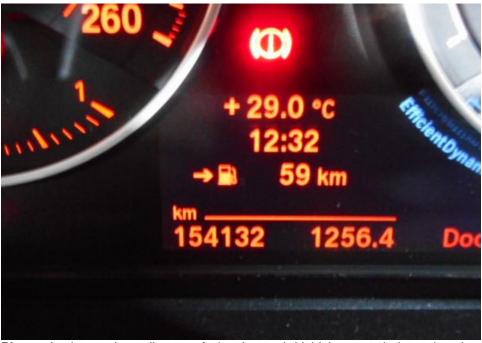
Photo 1 shows the mileage of the Insured Vehicle recorded at the time inspection at 154,132KM

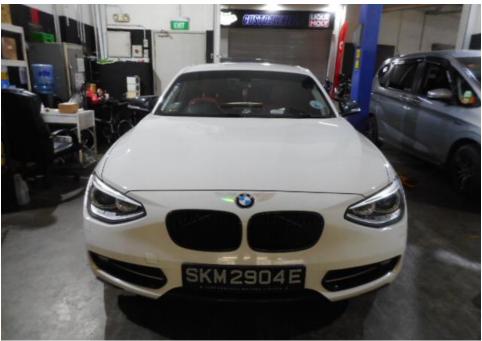
Photo 2 shows the general view of the front portion of the Insured Vehicle at the time of our inspection. The Insured Vehicle is observed to be unaffected by any signs of accident.

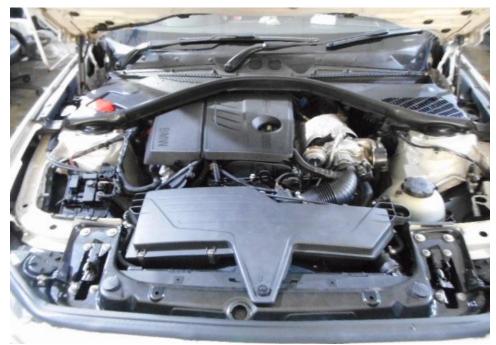
Photo 3 shows the general view of the engine portion of the Insured Vehicle at the time of our inspection. The engine compartment is observed to be unaffected by any signs of accident.

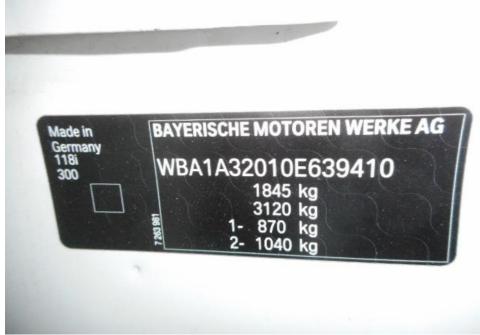
Photo 4 shows the chassis number of the Insured Vehicle at the time of our inspection.

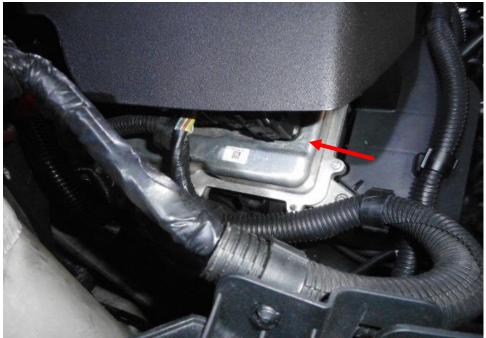
Photo 5 shows the general view of the vehicle electrical control unit (ECU) (arrowed) in the engine compartment portion which was mounted onto the engine of the Insured Vehicle at the time of our inspection. The vehicle electrical control unit is observed to be unaffected and by any signs of accident.

- 8. We did not find any evidence which had suggested that the cause of abnormalities to the Insured Vehicle was due to poor maintenance and/or recurring problem.
- 9. The recommendation to replace the Engine Control Unit at \$4,772.20 is justifiable as all the relevant checks has been conducted.

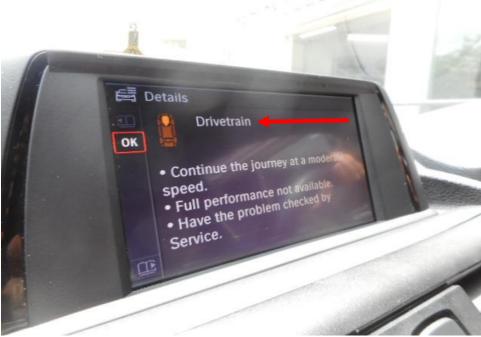
5. The complaint on the Insured Vehicle was noted be that will engine will vibrate and engine drive train error will be lighted up. There is a recommendation by the workshop to replace vehicle Engine Control Unit (ECU). The vehicle was observed to be unaffected by any signs of accident. During our inspection, a test drive was conducted on the vehicle and the engine of the vehicle was unable to produced engine power and the engine drive train error was lighted up.

Photo 6 shows the conducted ECU diagnosis of the Insured Vehicle at the time of our inspection. There was an engine drivetrain error (arrowed) on the Insured Vehicle and the engine was not producing sufficient engine power during our test drive.

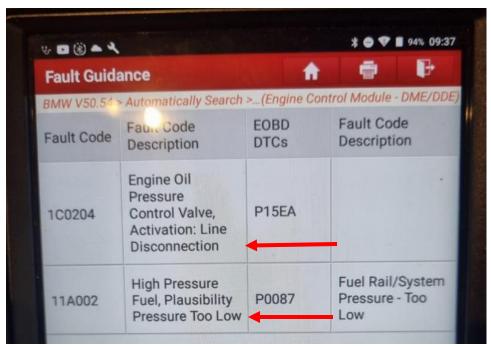
Photo 7 shows the conducted ECU diagnosis of the Insured Vehicle at the time of our inspection. There was a few electronic error which all pointed to the engine oil pressure control valve and low pressure for the high pressure fuel line (arrowed) on the Insured Vehicle.
