AUTOMOBILE INSPECTION REPORT OF INSURED VEHICLE SJS 1750T

Vehicle Registration No.	: SJS 1750T
Make / Model	: TOYOTA RUSH 1.5X A
Chassis No	: J200E0026465
Year of Registration	: July 2009
Mileage	: 138,381km

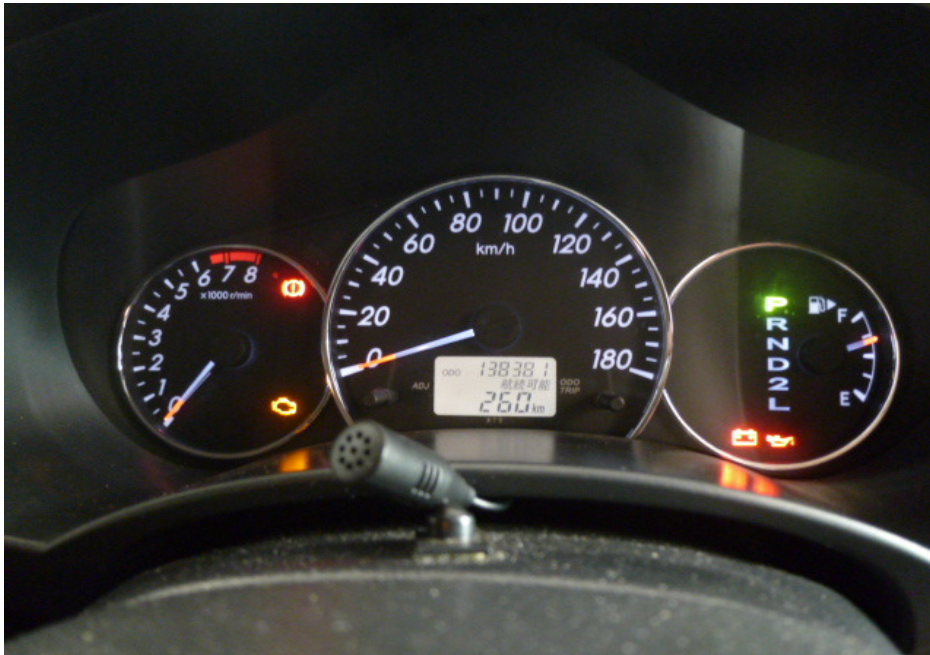
Photo 1 shows the mileage of the Insured Vehicle at the time of our inspection. The mileage observed was 138,381km.

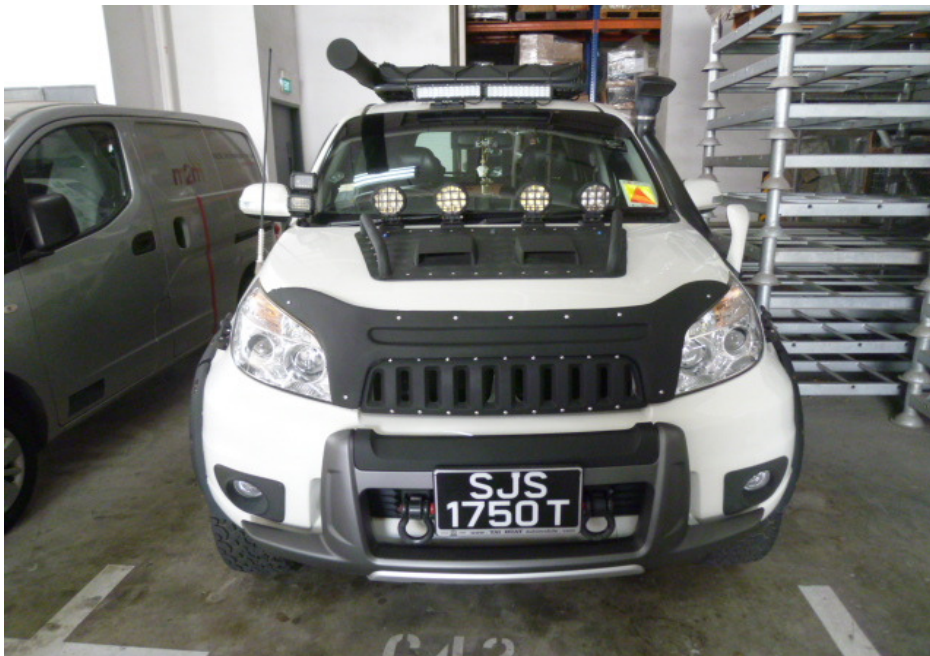
Photo 2 shows a general view of the Insured Vehicle's front body at the time of our inspection.

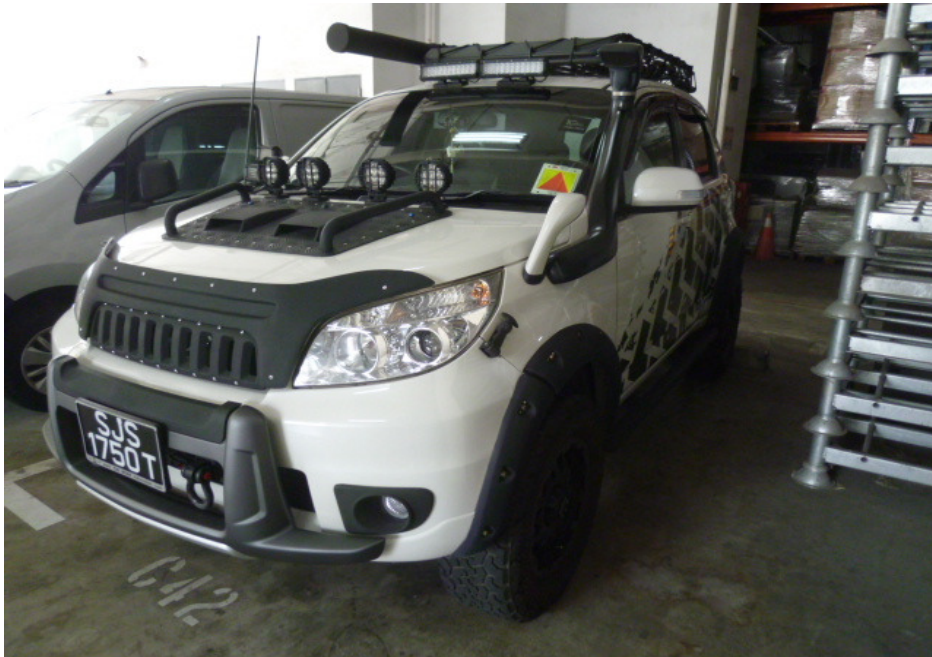
Photo 3 shows a general view of the Insured Vehicle's left frontal portion at the time of our inspection.

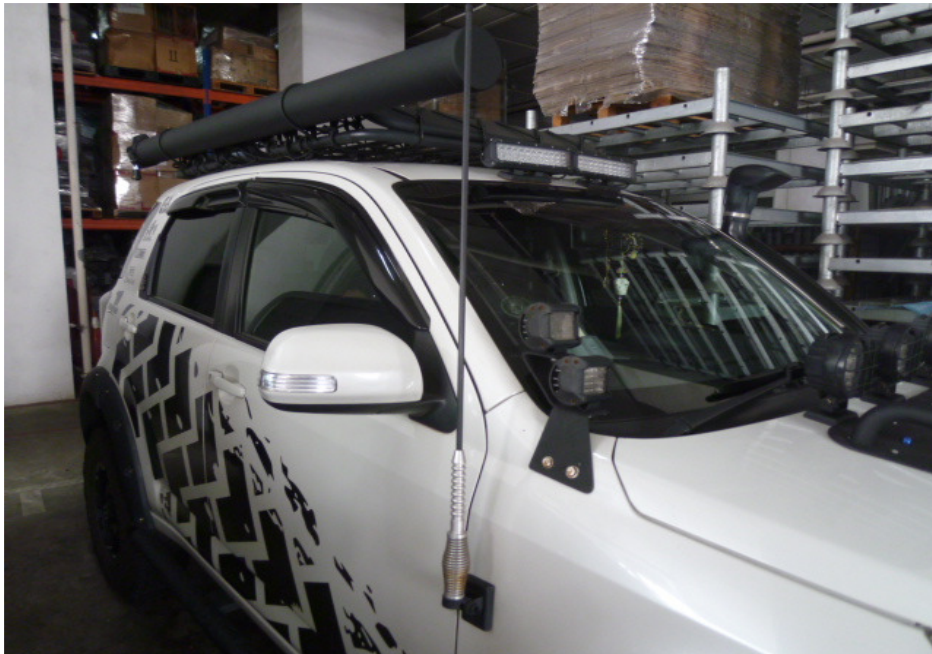
Photo 4 shows a general view of the Insured Vehicle's right body at the time of our inspection.

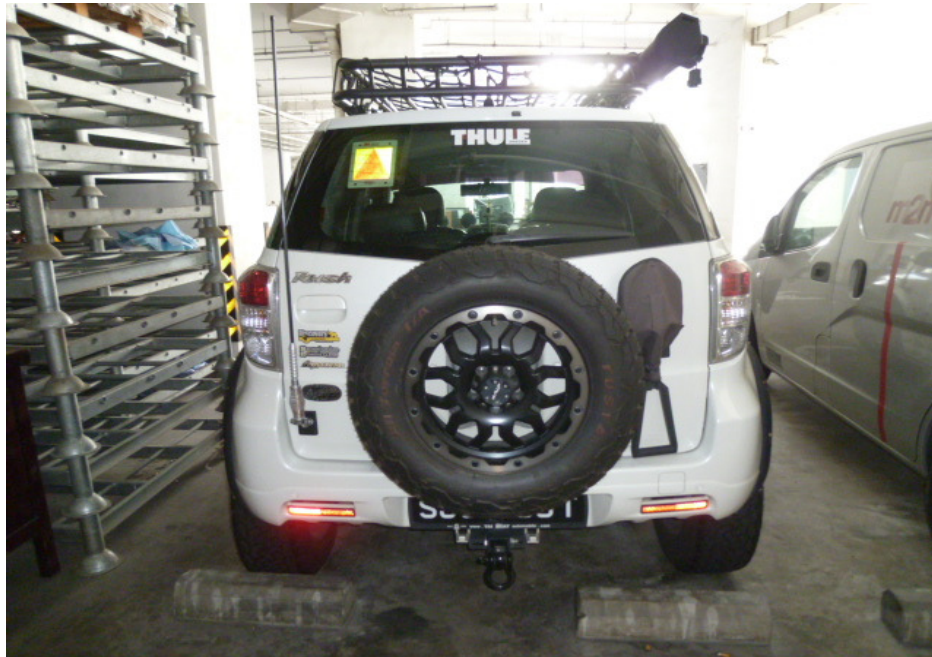
Photo 5 shows a general view of the Insured Vehicle's rear portion at the time of our inspection.

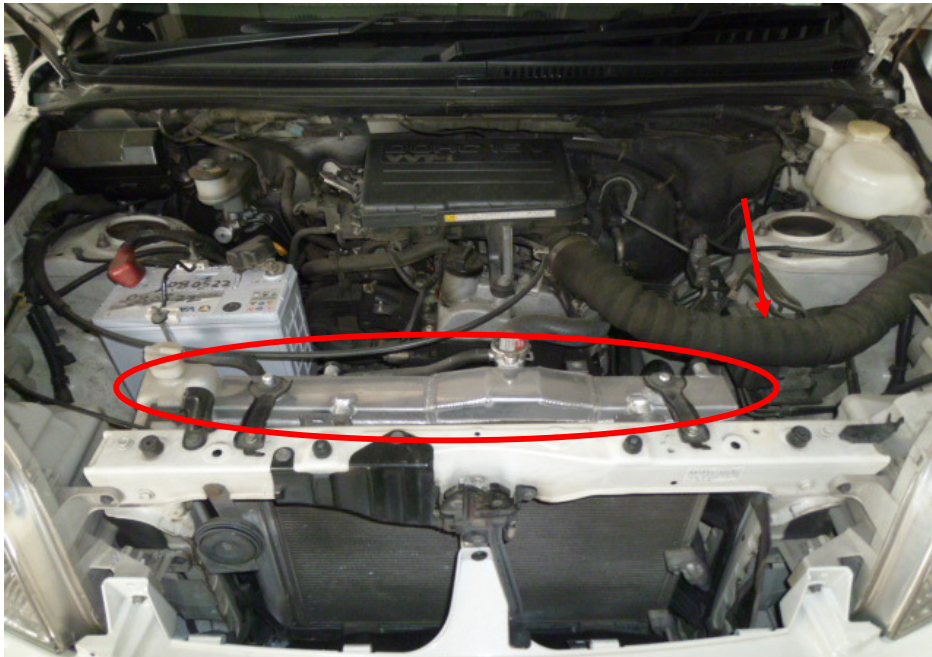
Photo 6 shows a general view of the engine compartment of the Insured Vehicle. Additional non-standard parts were found fitted. This includes a non- standard radiator (circled) and snorkel (arrowed).

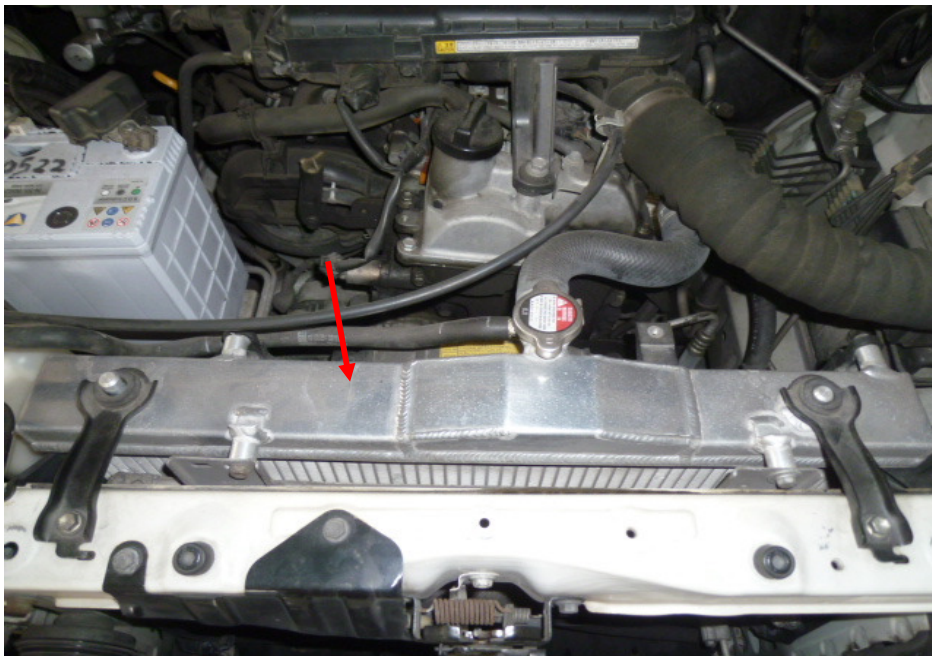
Photo 7 shows a close up view of the non- standard radiator fitted onto the Insured Vehicle upon our inspection (arrowed).

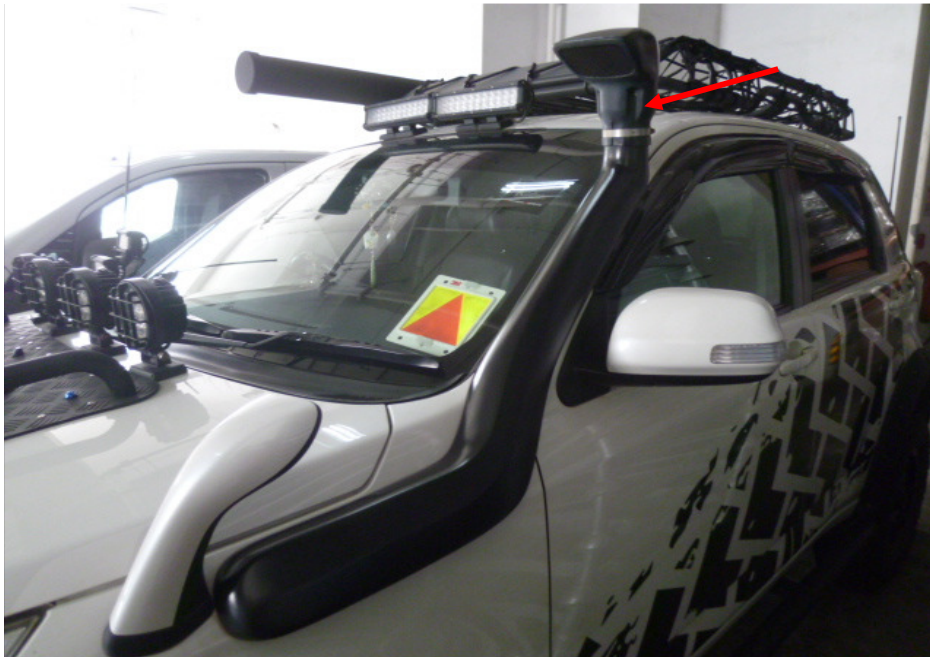
Photo 8 shows a close up view of the non- standard snorkel fitted onto the Insured Vehicle upon our inspection (arrowed).

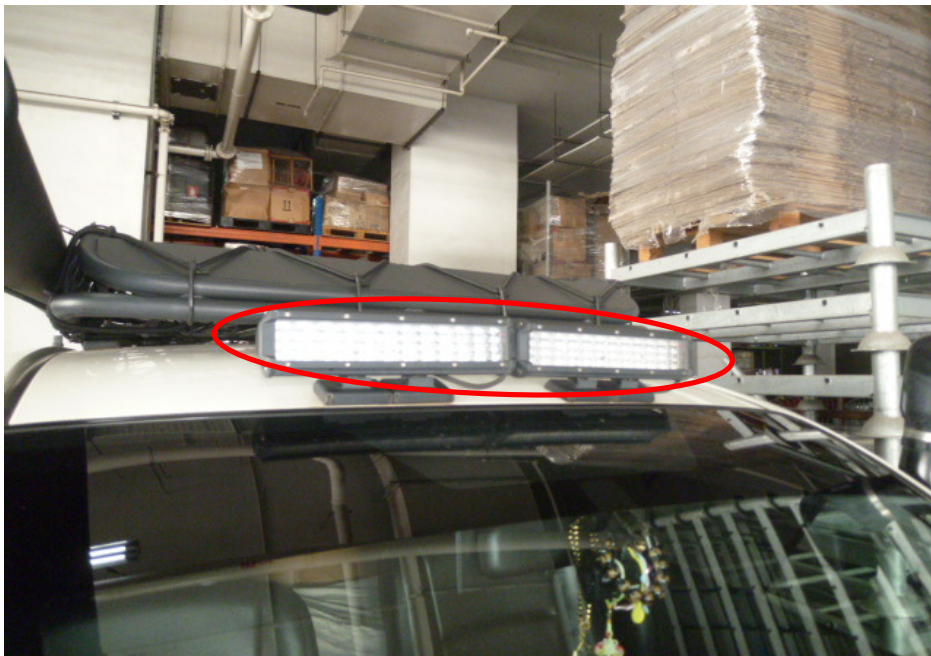
Photo 9 shows the spot lamps additionally fitted onto the roof of the Insured Vehicle upon our inspection (circled). However upon closer inspection, we observed that the spot lamps were not connected.

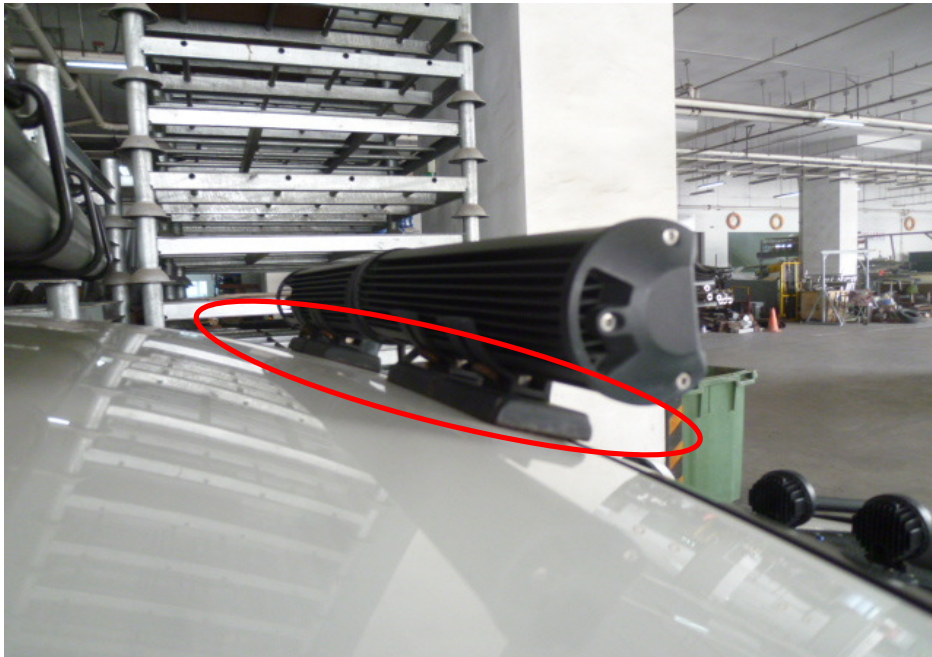
Photo 10 shows the spot lamps additionally fitted onto the roof of the Insured Vehicle upon our inspection. However upon closer inspection, we observed that the spot lamps were not connected (circled).

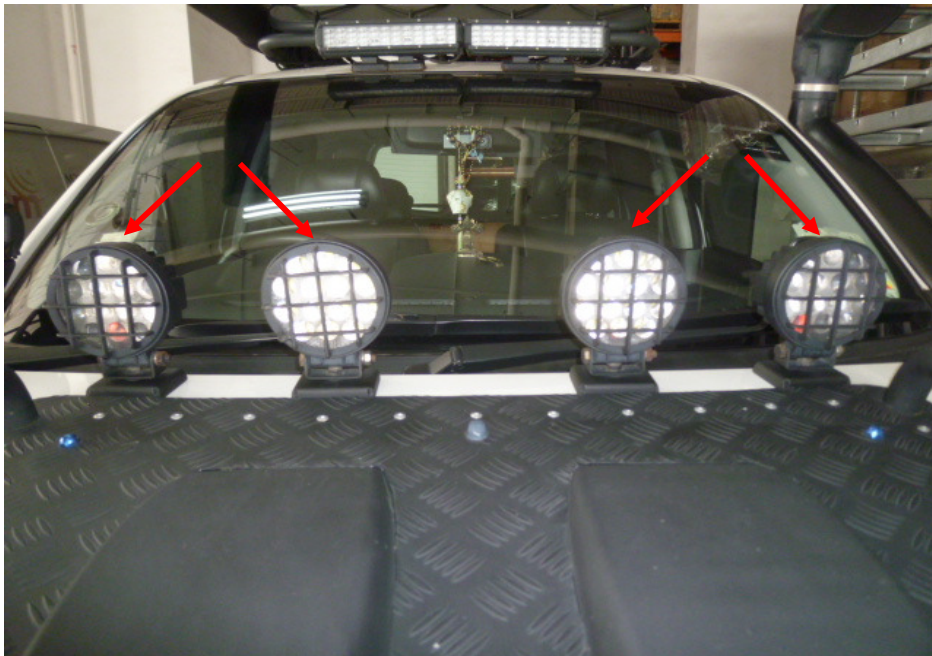
Photo 11 shows the spot lamps additionally fitted onto the front bonnet of the Insured Vehicle upon our inspection (circled). However upon closer inspection, we observed that the spot lamps were not connected.

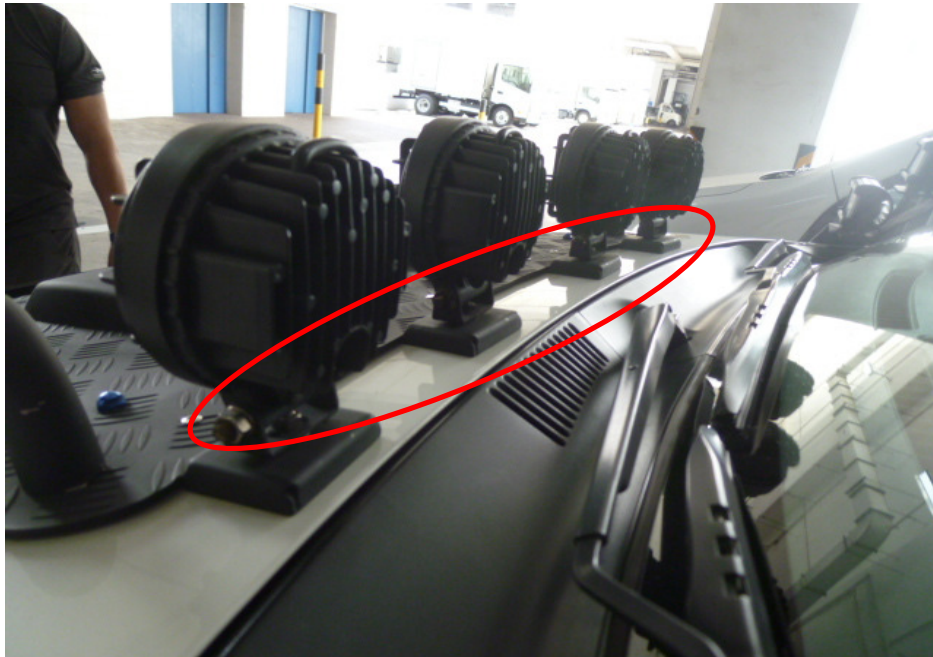
Photo 12 shows the spot lamps additionally fitted onto the front bonnet of the Insured Vehicle upon our inspection. However upon closer inspection, we observed that the spot lamps were not connected (circled).

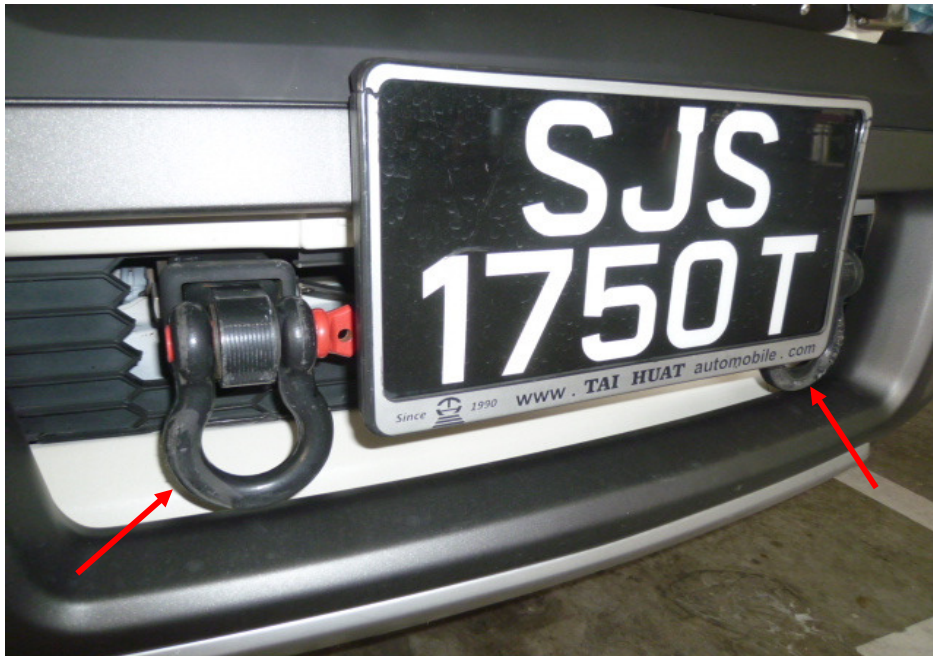
Photo 13 shows the tow hooks found to be fitted onto the frontal portion of the Insured Vehicle at the time of our inspection (arrowed). The tow hooks fitted on the Insured Vehicle were not the standard type for the Insured Vehicle.

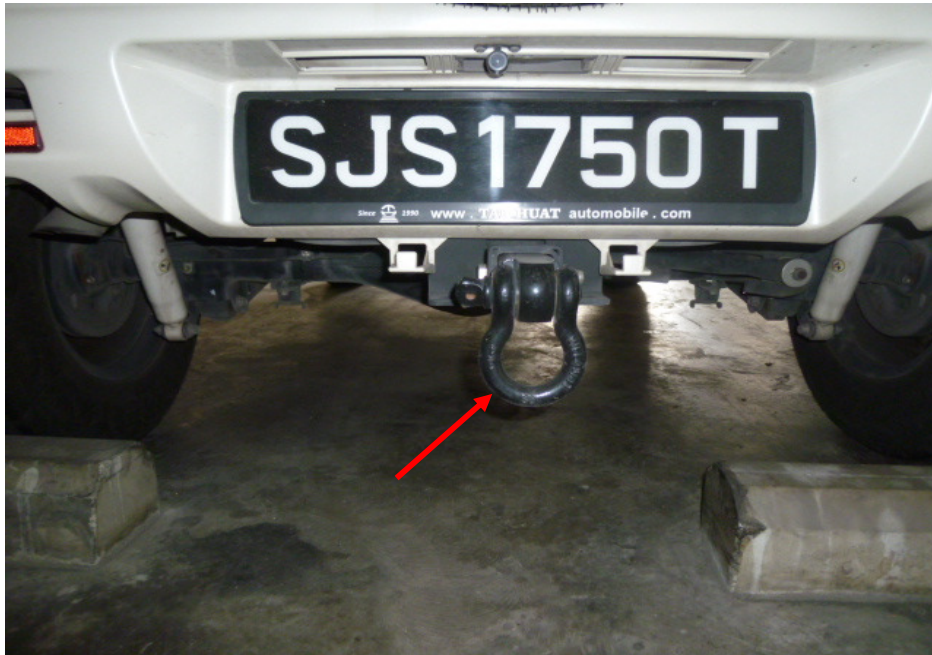
Photo 14 shows the tow hook found to be fitted on the rear portion of the Insured Vehicle at the time of our inspection (arrowed). The tow hook fitted on the Insured Vehicle was not the standard type for the Insured Vehicle.

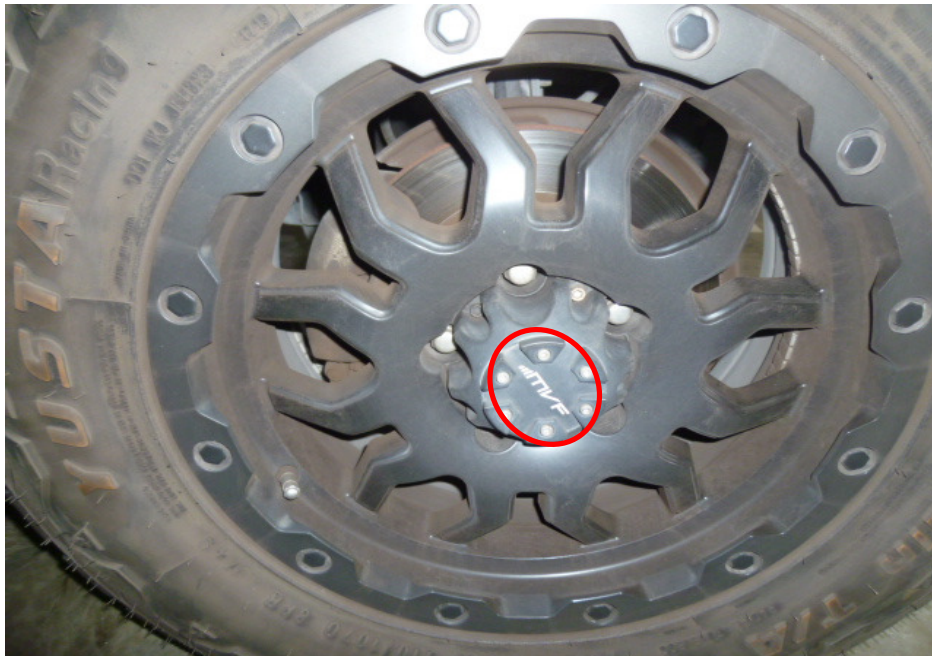
Photo 15 shows the non-standard rim found to be fitted on the Insured Vehicle at the time of our inspection. The 16-inch alloy rims fitted on the Insured Vehicle were not the standard type for the Insured Vehicle. The brand of the rim was 'MVF' (circled).

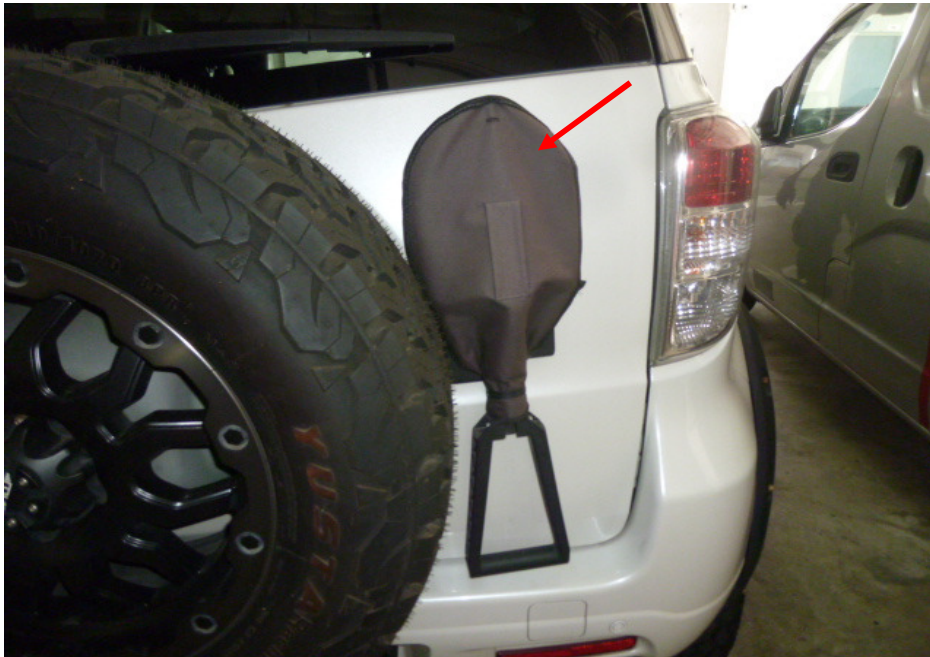
Photo 16 shows an aftermarket shovel (arrowed) fitted on the rear portion of the Insured Vehicle at the time of our inspection.

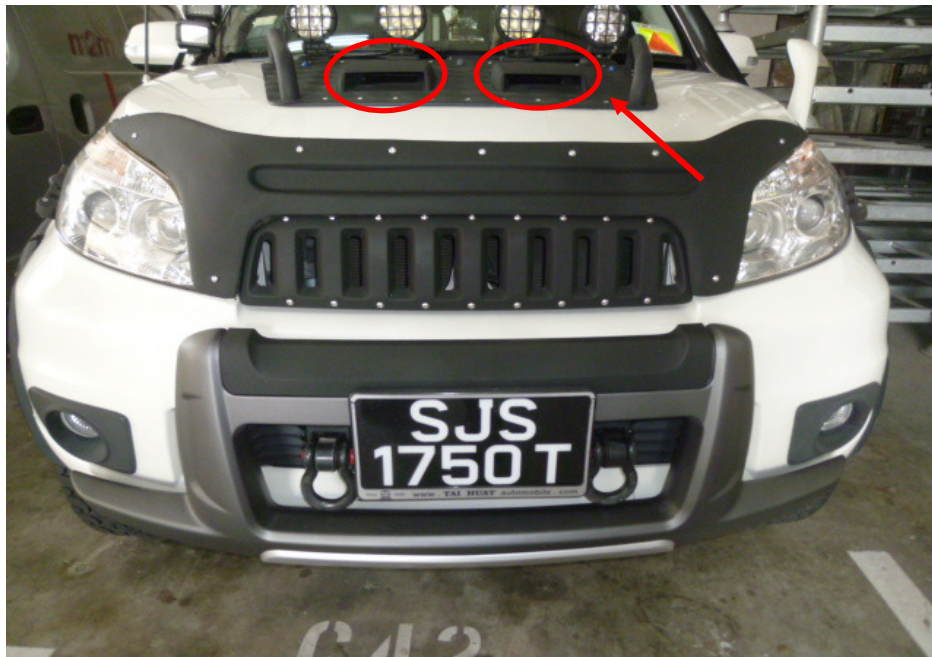
Photo 17 shows a general view of the front bonnet of the Insured Vehicle at the time of our inspection. An aftermarket checkered plate (arrowed) with air scoops (circled) were found fitted.

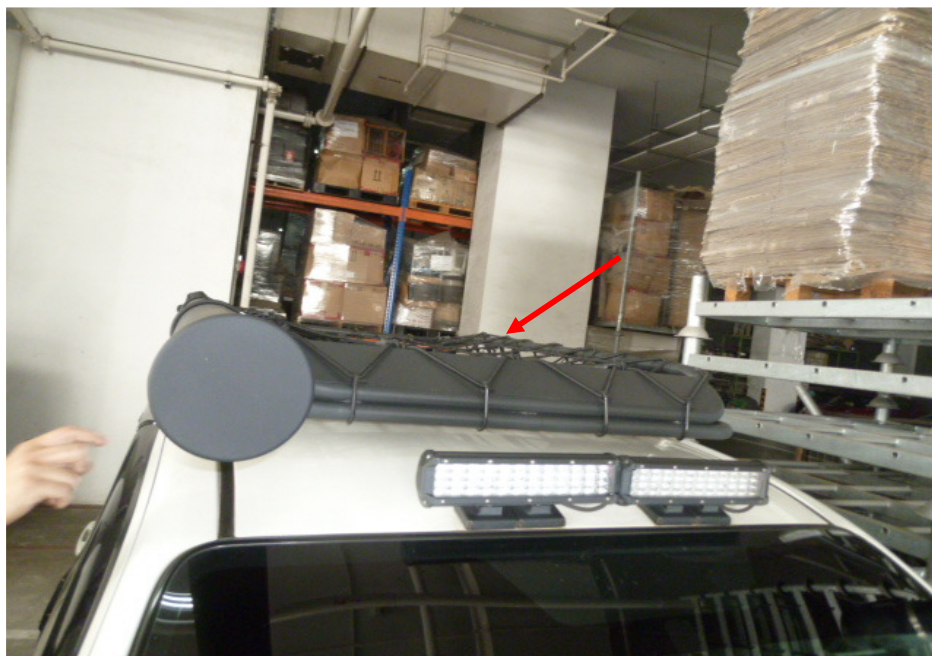
Photo 18 shows the roof rack found to be fitted on the Insured Vehicle at the time of our inspection (arrowed). The roof rack fitted onto the Insured Vehicle was not the standard type for the Insured Vehicle.

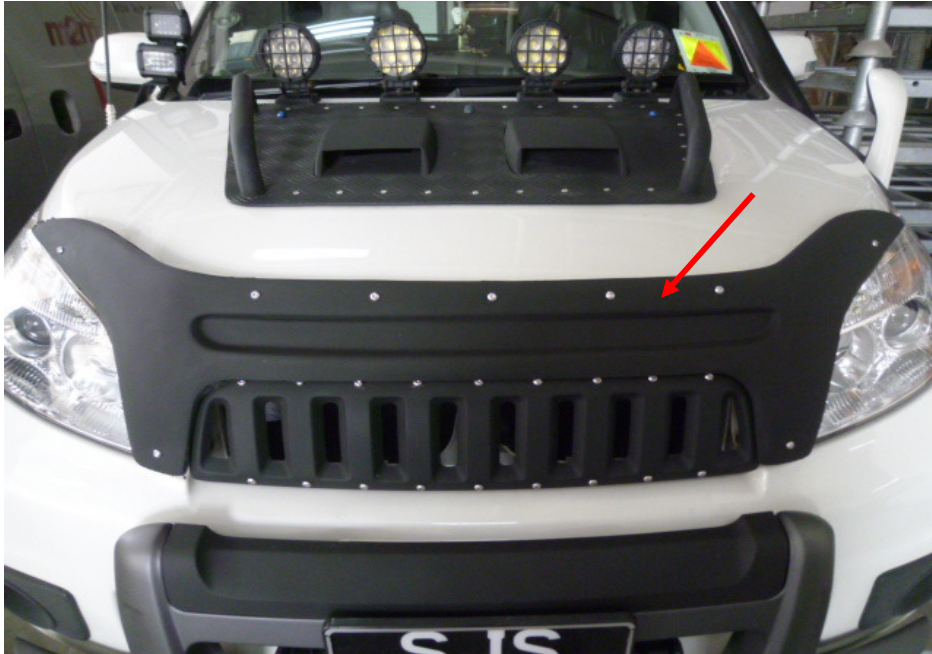
Photo 19 shows the front bonnet guard found to be fitted on the Insured Vehicle at the time of our inspection (arrowed). The front bonnet guard fitted onto the Insured Vehicle was not the standard type for the Insured Vehicle. We noted that the front grille rack was fitted on the Insured Vehicle post- accident.

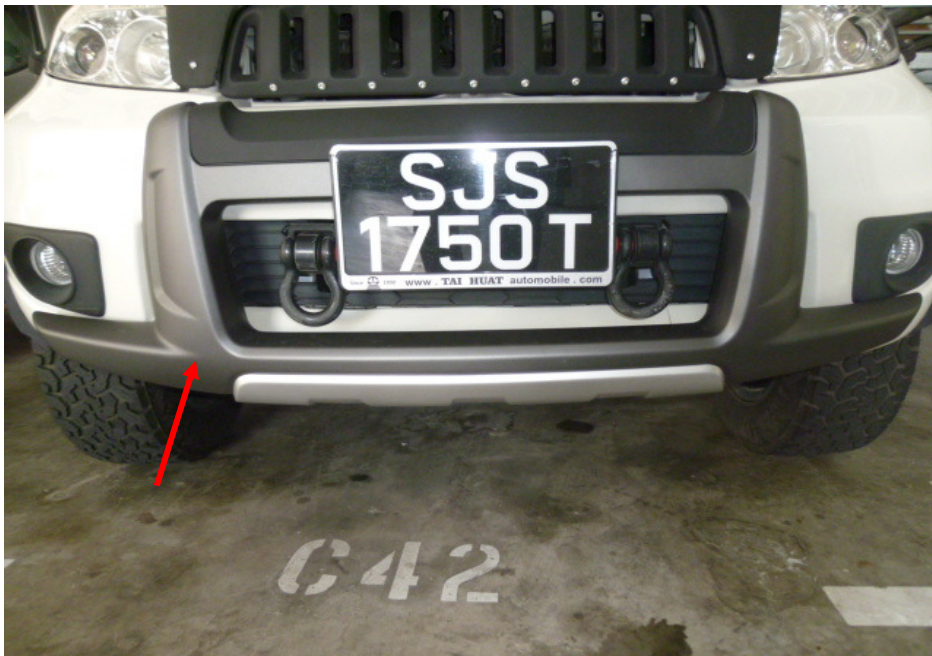
Photo 20 shows the front bumper guard additionally fitted onto the Insured Vehicle upon our inspection (arrowed).

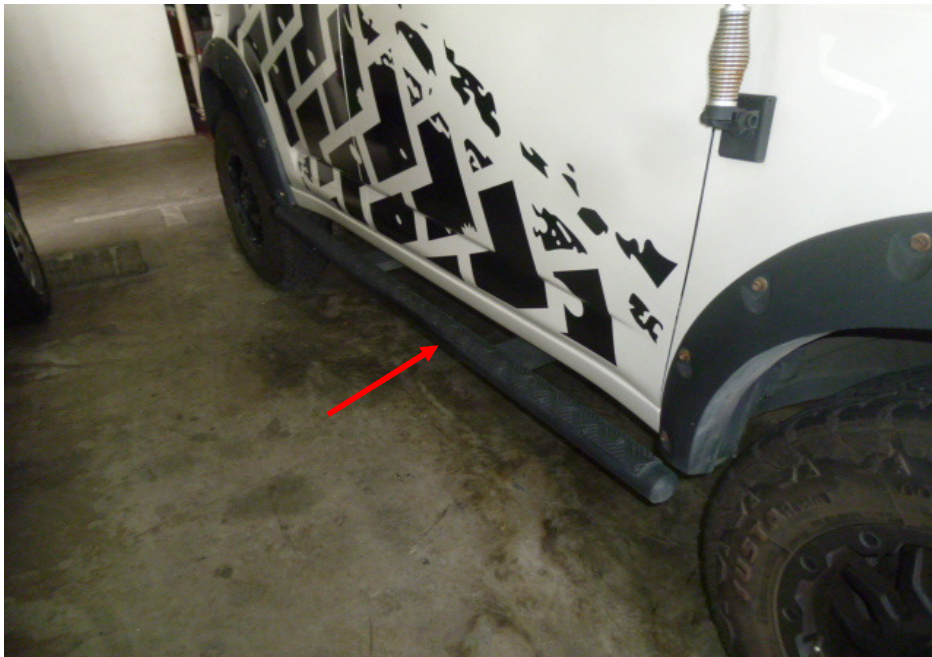
Photo 21 shows the side step panels additionally fitted onto the Insured Vehicle upon our inspection (arrowed).

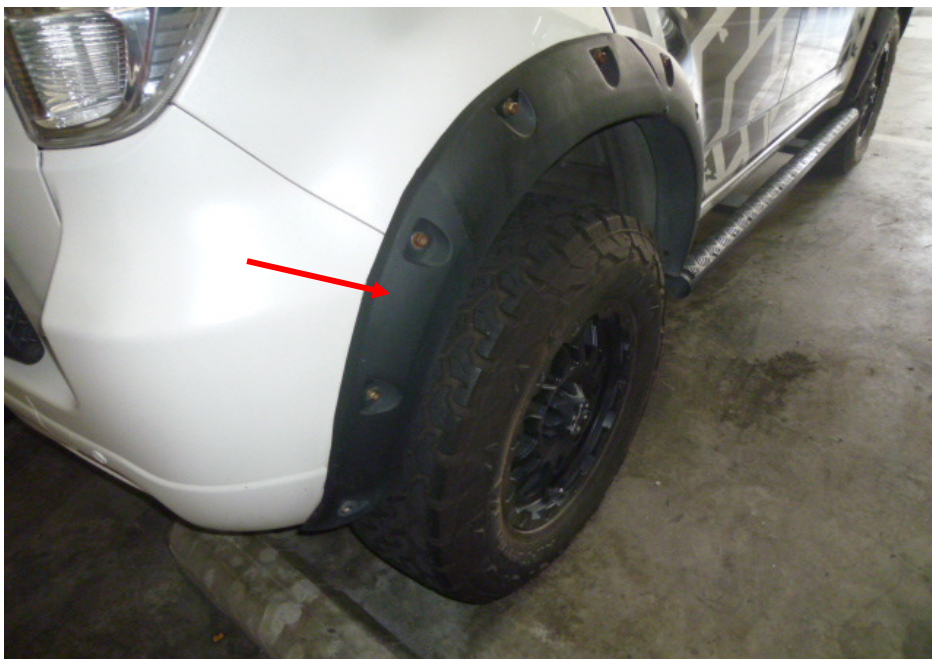
Photo 22 shows the fender covers additionally fitted onto the Insured Vehicle upon our inspection (arrowed).
