Your Ref: McLaren GT
(chassis number SBM22GCCXMW001068)
Our Ref : CI/TP22011788/D

23 November 2022

**INSPECTION REPORT OF AN UNREGISTERED MCLAREN GT MOTOR CAR
WITH CHASSIS NUMBER SBM22GCCXMW001068**

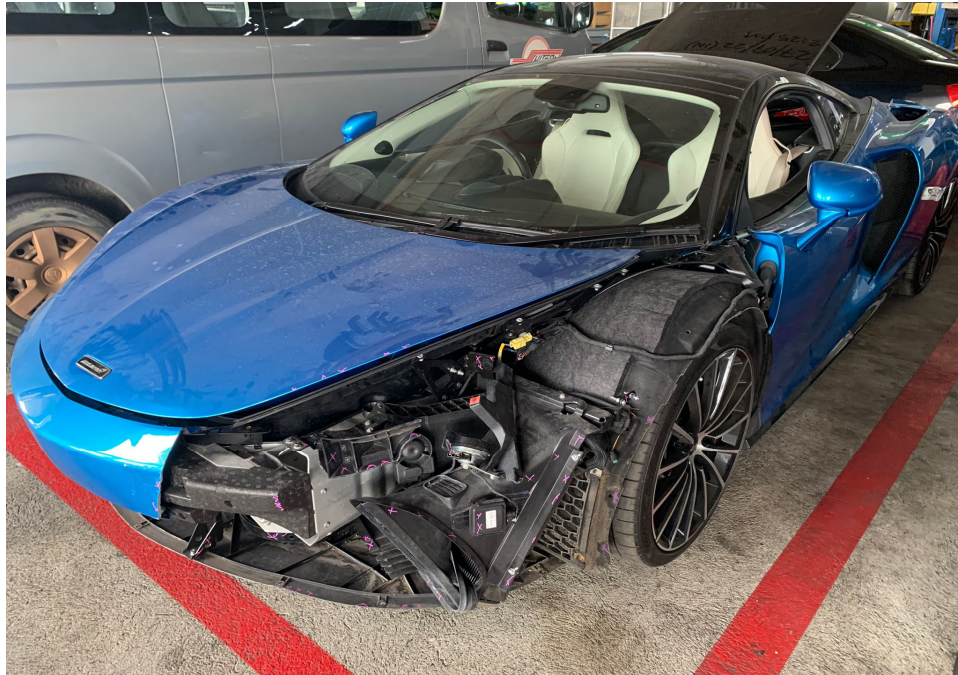
3. The photographs provided to me had showed damage to the front left portion of the Motor Car. Body parts damaged include the front bumper, front bumper lower cover, front bumper sensors, front bumper left bracket, front bumper left reflector, front bumper left air duct, front left headlamp and front left fender amongst others.
4. Apart for the front left portion, there was no physical damage observed to other areas of the Motor Car. The airbag(s) was not deployed as seen from the photographs that were provided to me. See photo 1 – 5 below.

Photo 1 shows the front left body of the Motor Car (photograph provided to me). The photographs provided to me had showed damage to the front left portion of the Motor Car. The front bumper, front bumper lower cover, front bumper sensors, front bumper left bracket, front bumper left reflector, front bumper left air duct, front left headlamp and front left fender were amongst the body parts that were observed to have been damaged.

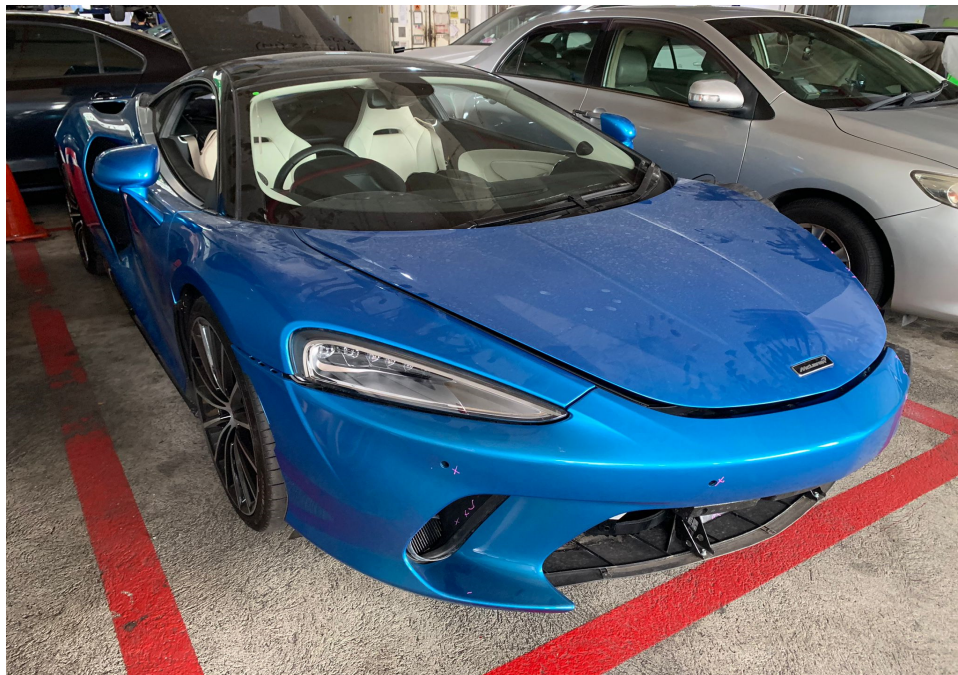
Photo 2 shows the front right body of the Motor Car (photograph provided to me). Apart for the front left portion, there was no physical damage observed to other areas of the Motor Car. The airbag(s) of the Motor Car was not deployed as seen from the photographs that were provided to me.

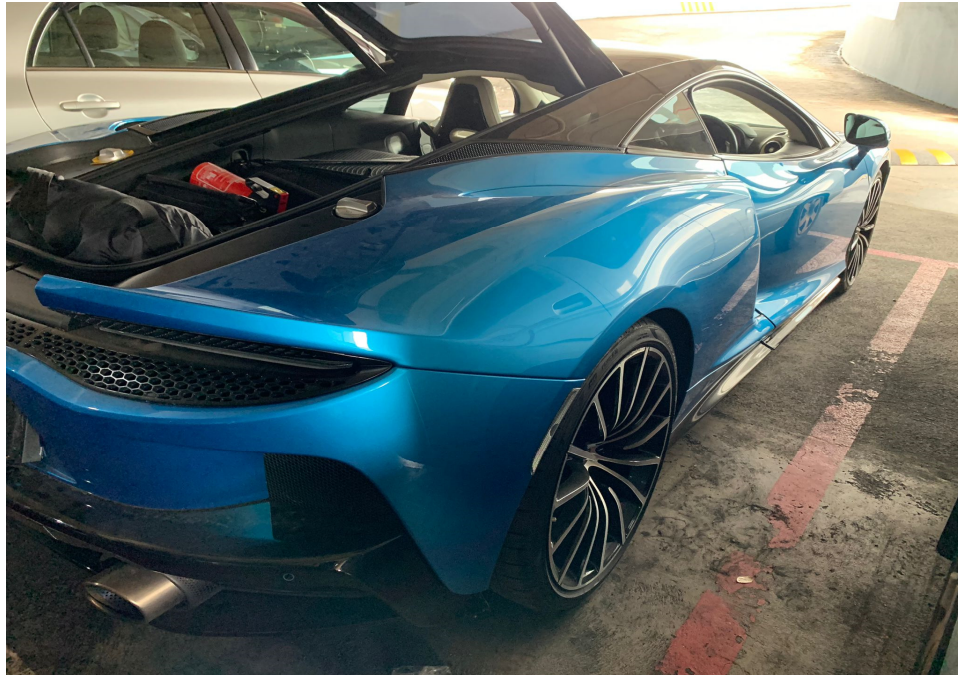
Photo 3 shows the rear right body of the Motor Car (photograph provided to me). Apart for the front left portion, there was no physical damage observed to other areas of the Motor Car.

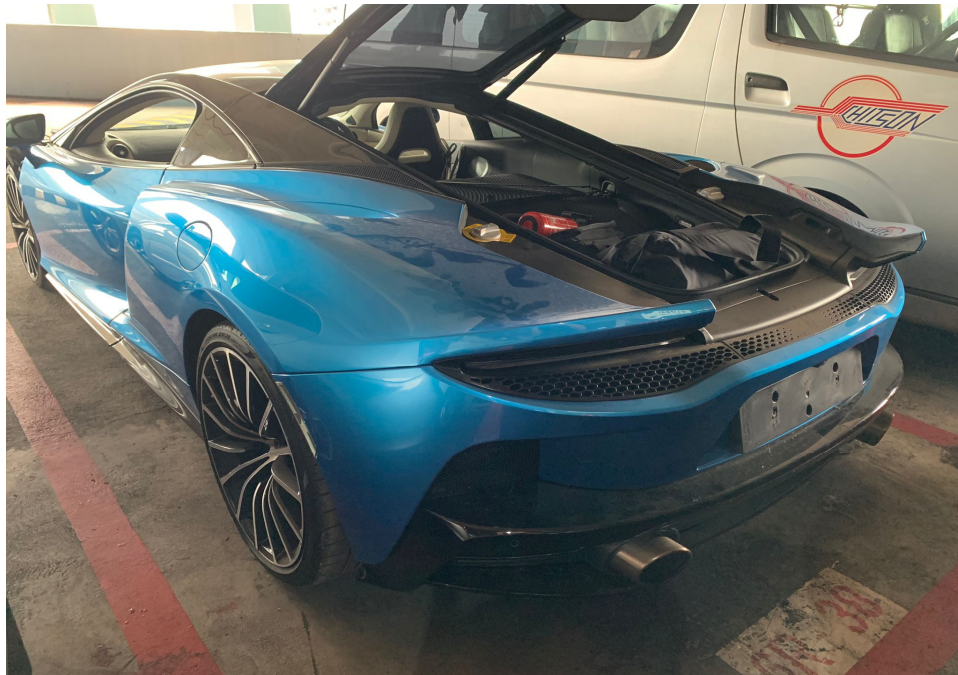
Photo 4 shows the rear left body of the Motor Car (photograph provided to me). Apart for the front left portion, there was no physical damage observed to other areas of the Motor Car. The airbag(s) of the Motor Car was not deployed as seen from the photographs that were provided to me.

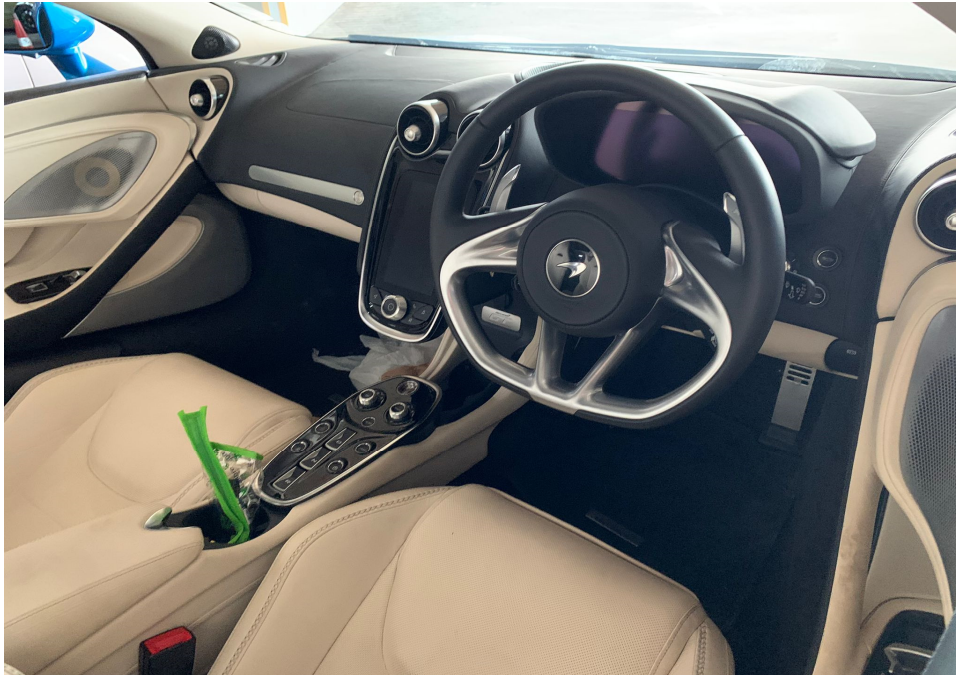
Photo 5 shows the interior compartment of the Motor Car (photograph provided to me). The various parts and components within the interior compartment were all intact and unaffected. The Motor Car's airbag(s) was not deployed as seen from the photographs that were provided to me.

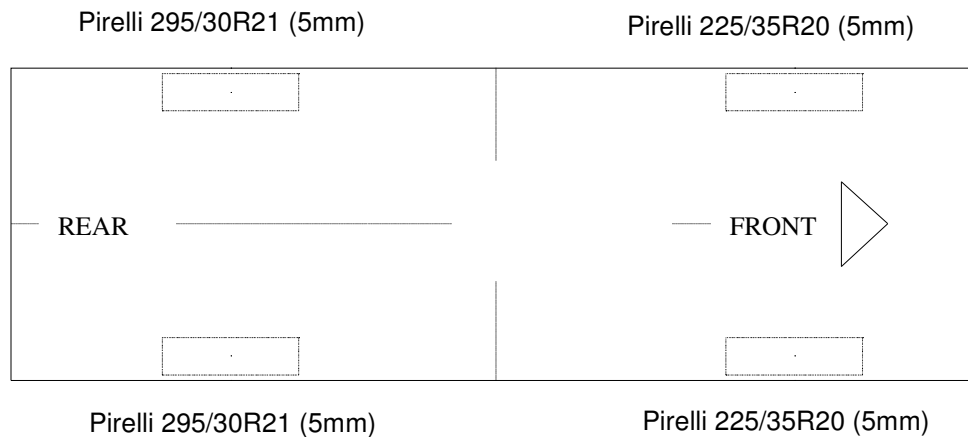
8. It was fitted with 20inch (front) and 21inch (rear) sport wheel rims that were wrapped with tyres that were observed to be of serviceable condition. The tyres were also sufficiently inflated for vehicular operation. The tyre brand, tyre size and approximate remaining tread depth of the 4 tyres of the Motor Car were recorded as follows: -

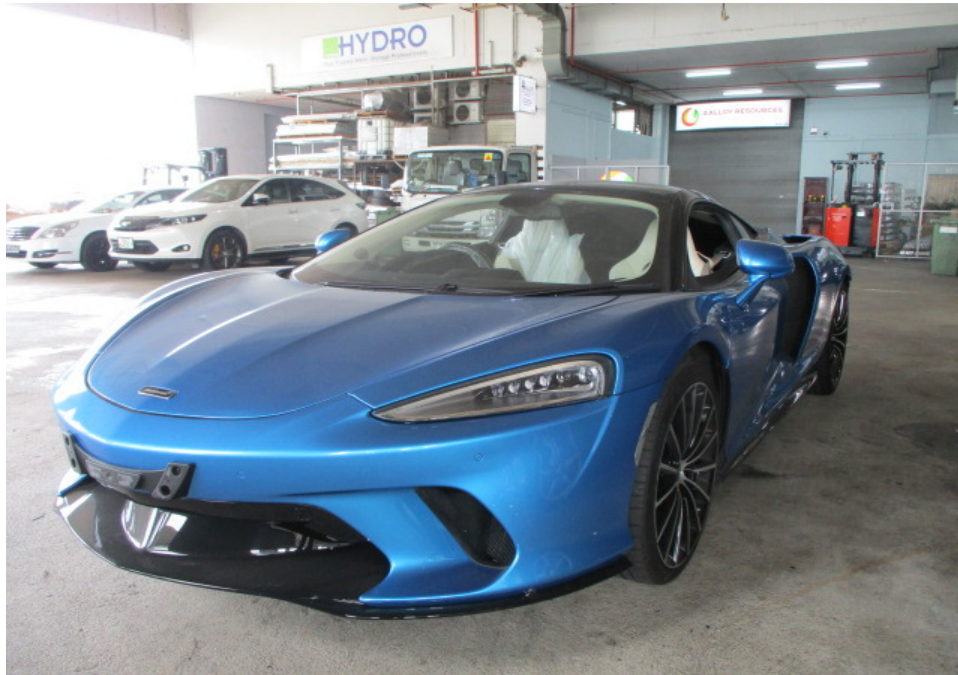
Photo 6 shows a general view of the front left body of the Motor Car at the time of my inspection. The Motor Car was observed to be in a relatively good general condition with no loose exterior fittings observed. The body parts at the front left portion of the Motor Car were visually examined and it was observed that the repair/restoration works carried out to the damaged area of the Motor Car (refer to photograph 1 above) were reasonably adequate and in order.

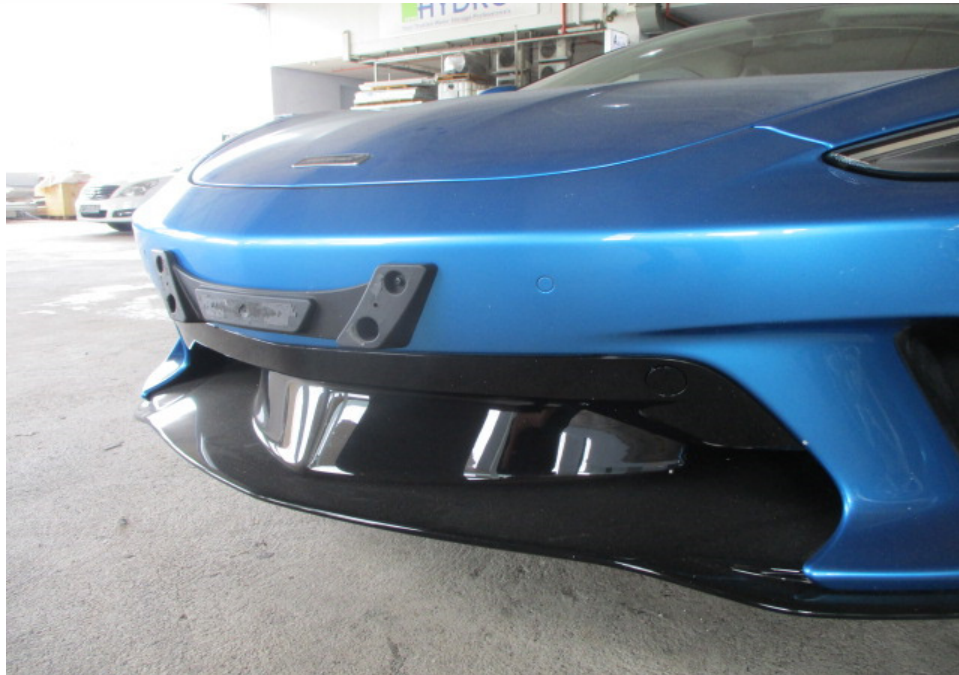
Photo 7 shows a closer view of the Motor Car's front bumper, front bumper lower cover and front bumper sensors. The body parts at the front left portion of the Motor Car were visually examined and it was observed that the repair/restoration works carried out to the damaged area of the Motor Car (refer to photograph 1 above) were reasonably adequate and in order.

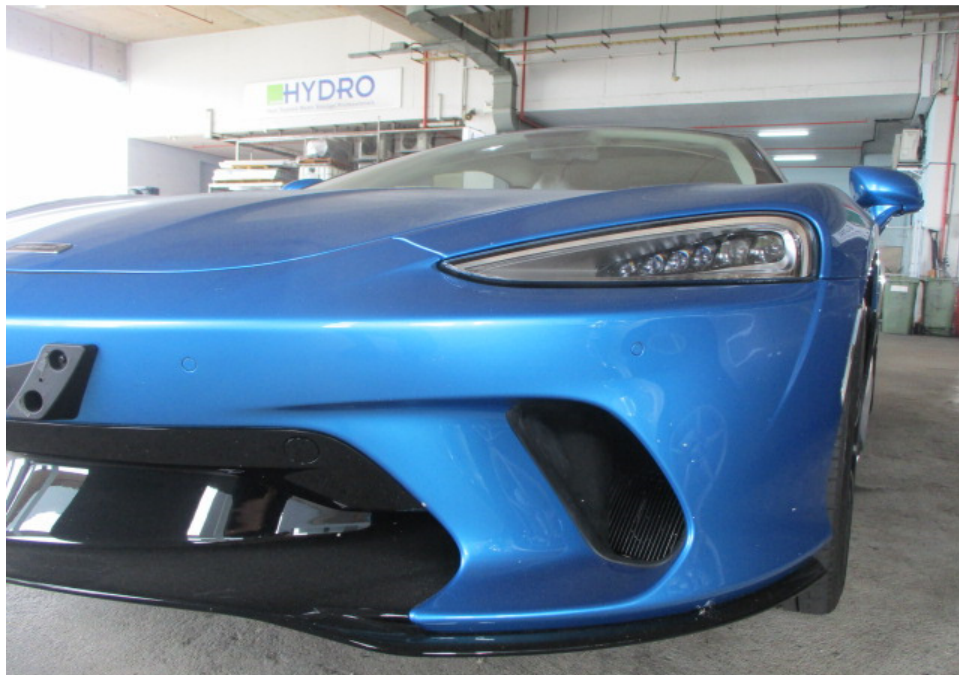
Photo 8 shows a closer view of the Motor Car's front bumper, front bumper lower cover, front bumper sensors, front bumper left air duct and front left headlamp at the time of my inspection. The body parts at the front left portion of the Motor Car were visually examined and it was observed that the repair/restoration works carried out to the damaged area of the Motor Car (refer to photograph 1 above) were reasonably adequate and in order.

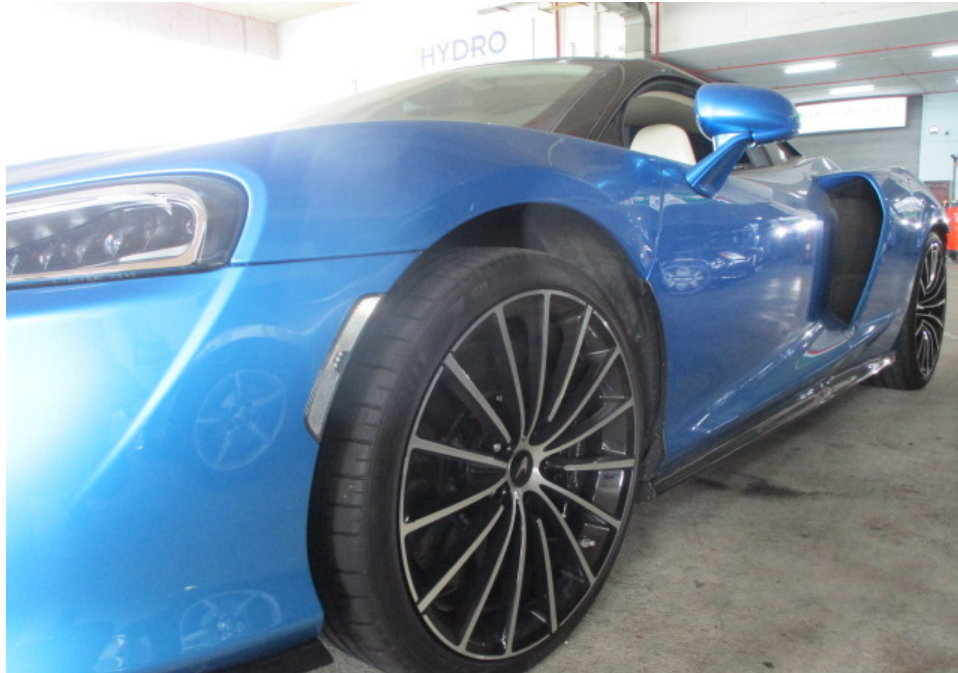
Photo 9 shows a closer view of the Motor Car's front bumper left reflector, front left fender and front left wheel rim at the time of my inspection. The body parts at the front left portion of the Motor Car were visually examined and it was observed that the repair/restoration works carried out to the damaged area of the Motor Car (refer to photograph 1 above) were reasonably adequate and in order.

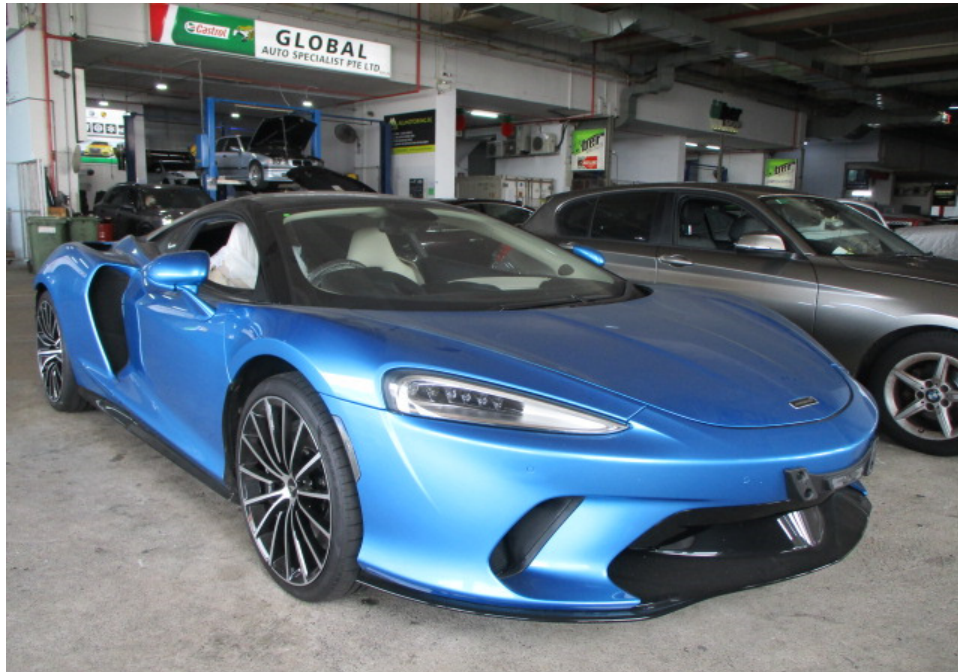
Photo 10 shows a general view of the front right body of the Motor Car at the time of my inspection. The Motor Car was observed to be in a relatively good general condition with no loose exterior fittings observed. The mileage of the Motor Car recorded at the time of my inspection was 6,097km.

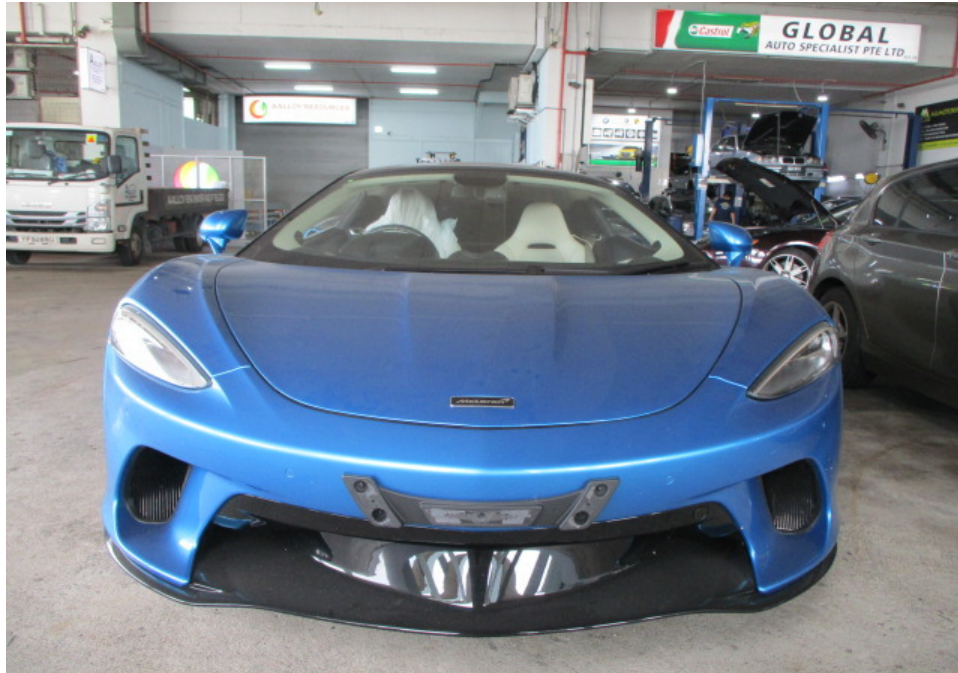
Photo 11 shows a general view of the frontal body of the Motor Car at the time of my inspection. The Motor Car was observed to be in a relatively good general condition with no loose exterior fittings observed. The body parts at the front left portion of the Motor Car were visually examined and it was observed that the repair/restoration works carried out to the damaged area of the Motor Car (refer to photograph 1 above) were reasonably adequate and in order.

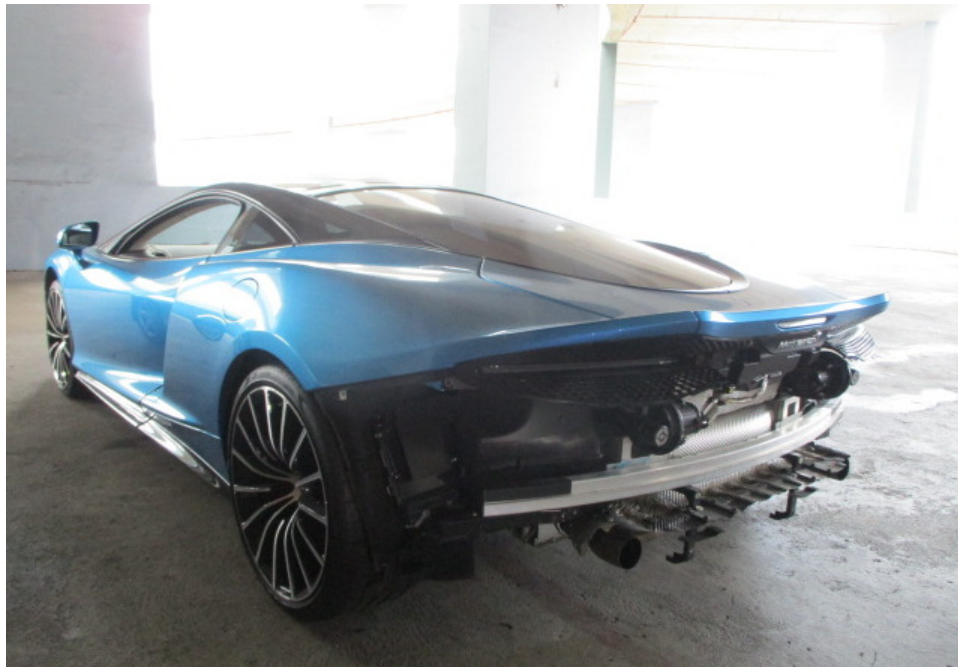
Photo 12 shows a general view of the rear left body of the Motor Car at the time of my inspection, with its rear bumper and rear under cover removed to facilitate checks of its engine compartment and exhaust system. Overall, the Motor Car was observed to be in a relatively good general condition with no loose exterior fittings observed.

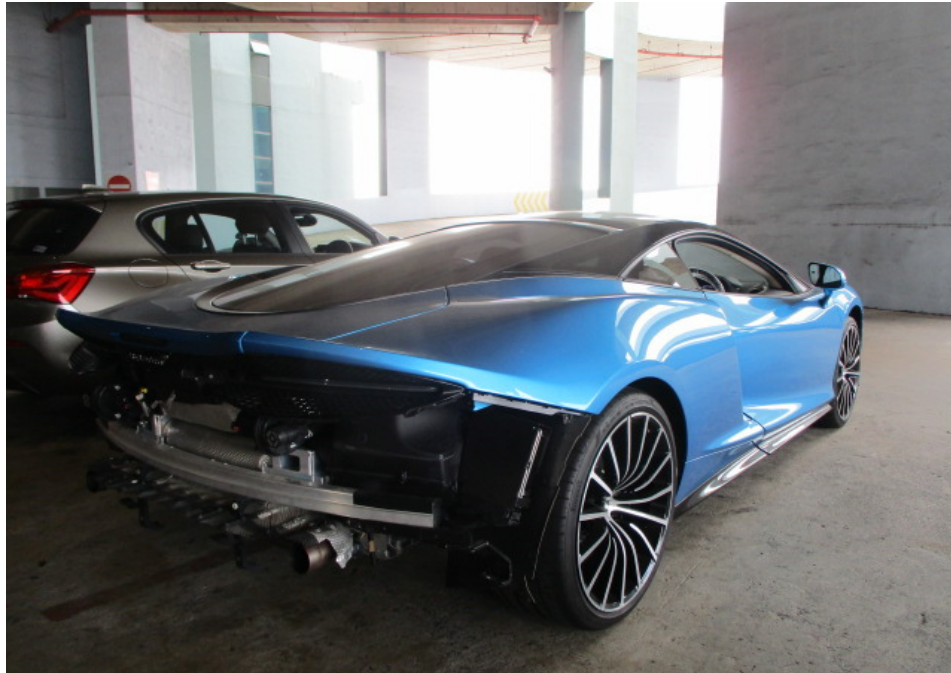
Photo 13 shows a general view of the rear right body of the Motor Car at the time of my inspection, with its rear bumper and rear under cover removed to facilitate checks of its engine compartment and exhaust system. Overall, the Motor Car was observed to be in a relatively good general condition with no loose exterior fittings observed.

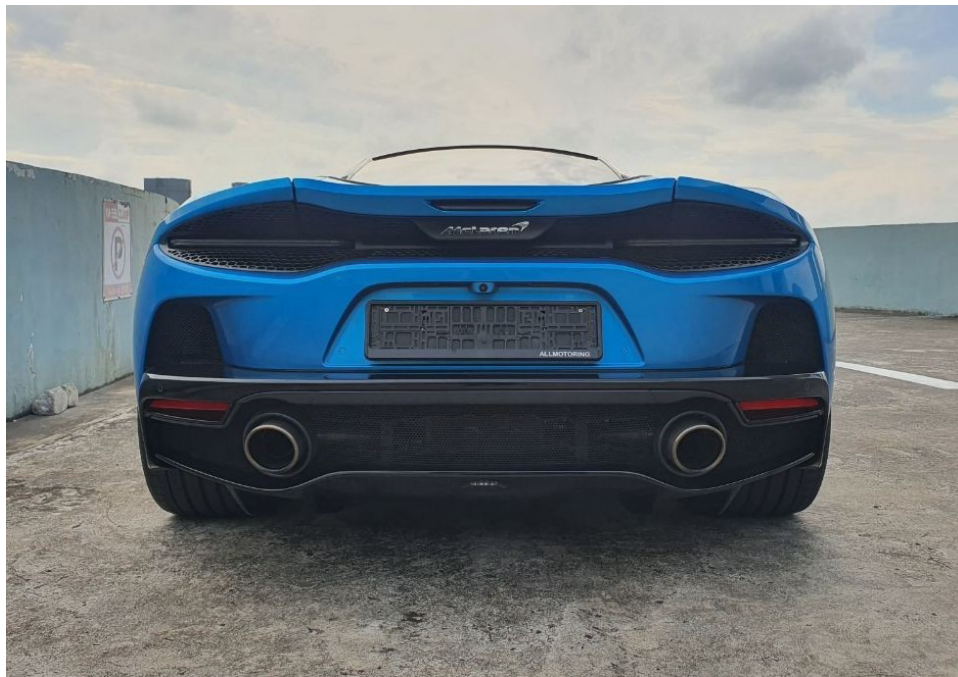
Photo 14 shows a general view of the rear body of the Motor Car at the time of my inspection, with its rear bumper and rear under cover re-fitted. The Motor Car was observed to be in a relatively good general condition with no loose exterior fittings observed. The mileage of the Motor Car recorded at the time of my inspection was 6,097km.

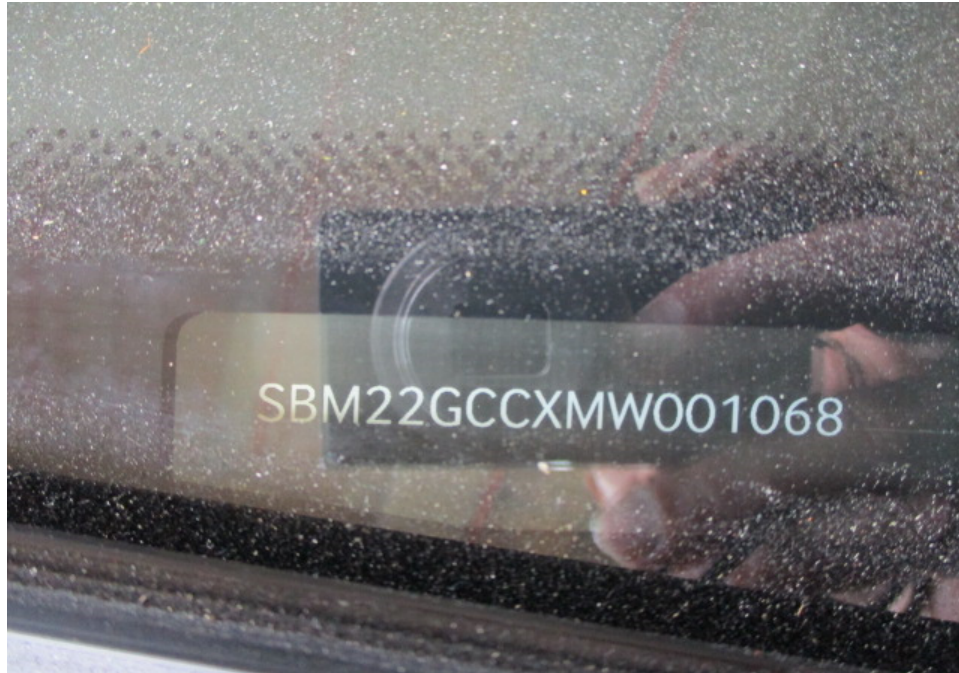
Photo 15 shows the chassis number of the Motor Car. The chassis number recorded was SBM22GCCXMW001068.

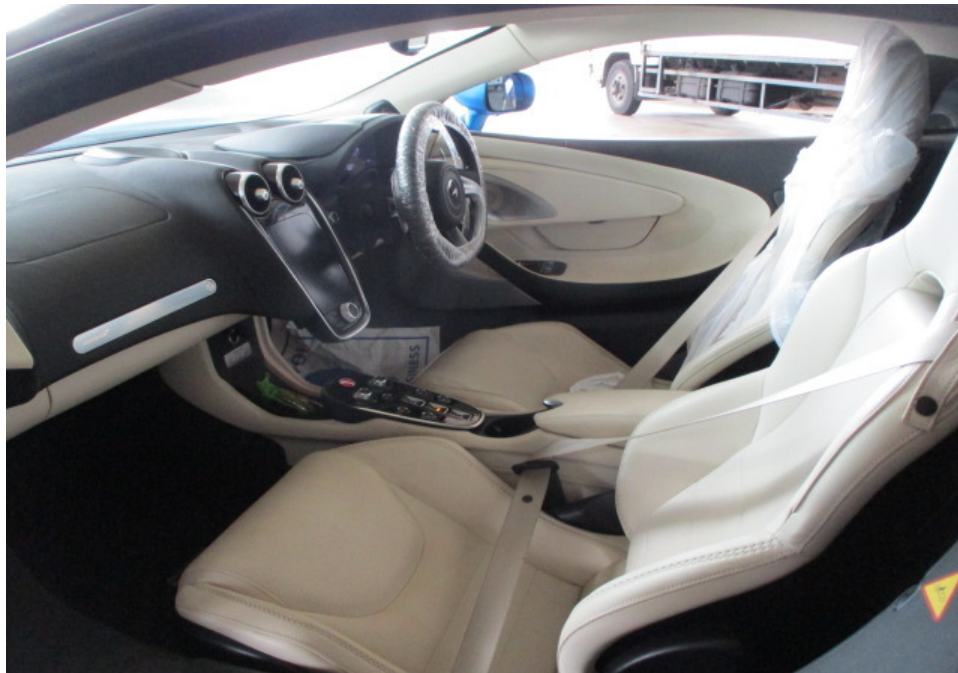
Photo 16 shows the interior compartment of the Motor Car at the time of my inspection. The various parts and components, trims, carpet, and upholstery inside the interior compartment were all observed to be intact and properly fitted.

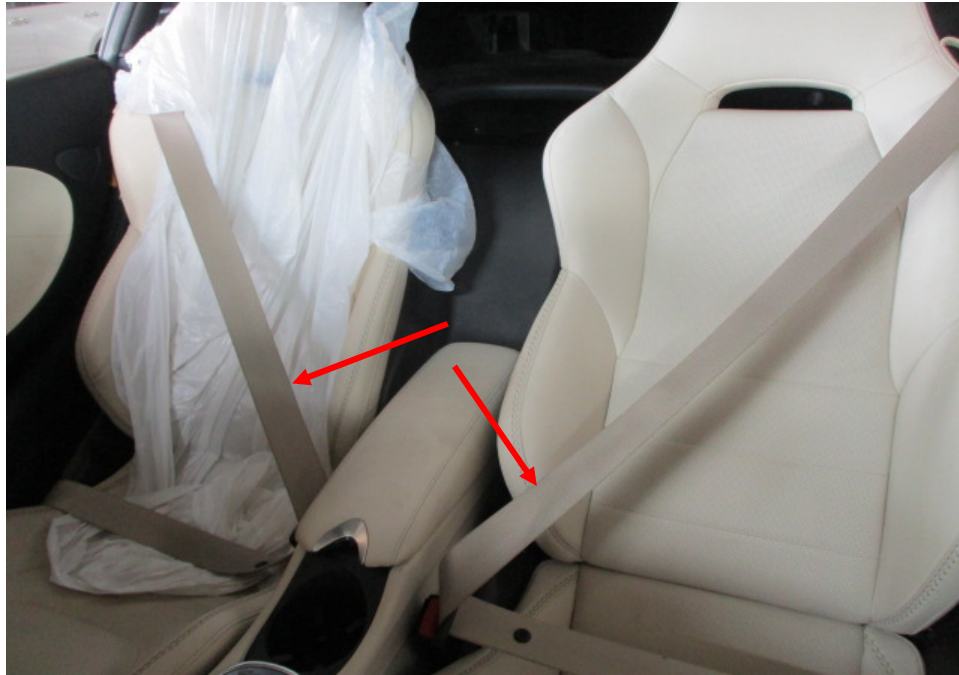
Photo 17 shows the seats of the Motor Car. All the seats of the Motor Car were secured via seat rails to the floorboard. They were also fitted with a retractable seat belt reel and a pre-tensioner. The seat belts (arrowed) were tested and were able to be fastened into the respective pre-tensions that were fitted on the side of each individual seat.

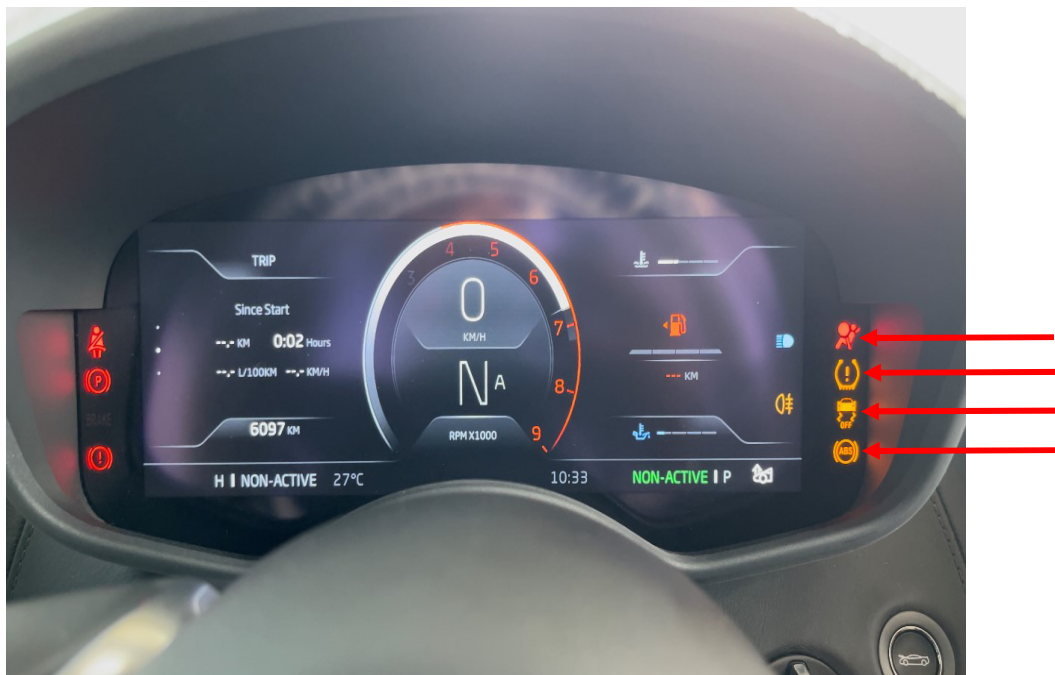
Photo 18 shows the warning lights for the various electronic safety features appearing on the instrument panel of the Motor Car during its self-test when the engine is cranked, in particular the ABS, SRS, TPM and TCS lights (arrowed).

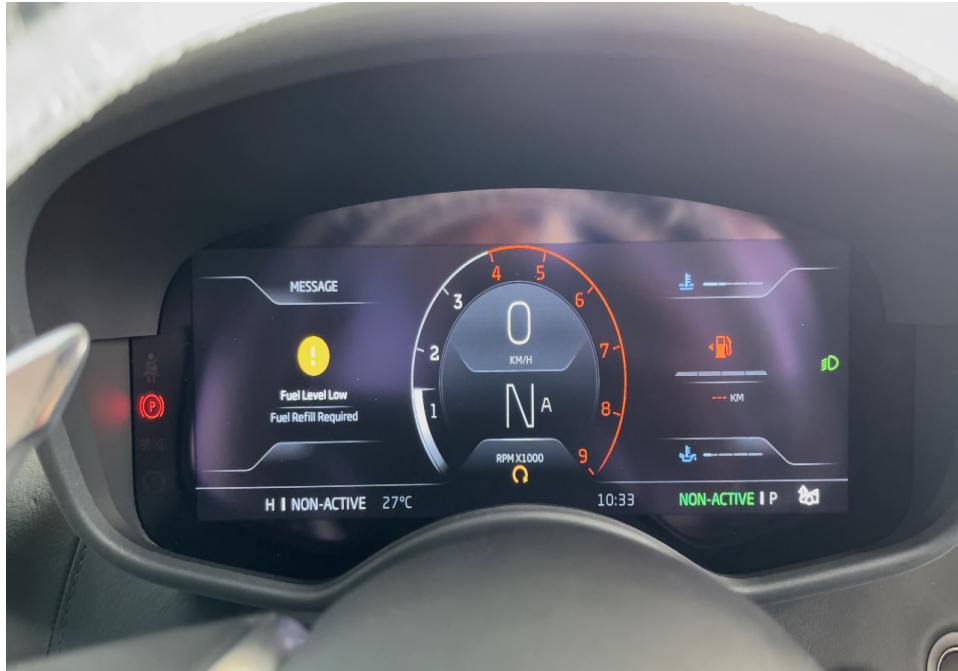
Photo 19 shows the respective warning lights no longer illuminated, indicating that there is no fault detected to the ABS, SRS, TPM and TCS systems of the Motor Car during the self-test. These electronic systems were hence in working condition at the time of my inspection.

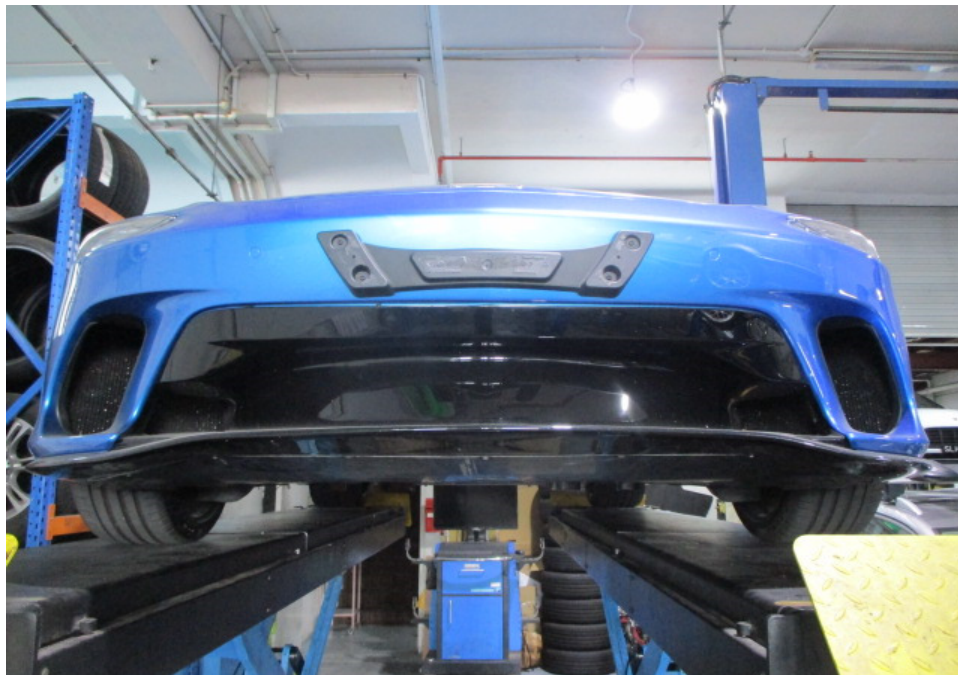
Photo 20 shows the Motor Car hoisted up for checks on its undercarriage. There was no sign(s) or indication(s) of fluid leakage and/or fluid stain(s) on the underside of the Motor Car. The undercarriage components of the Motor Car were also all observed to be intact and secured in an appropriate manner.

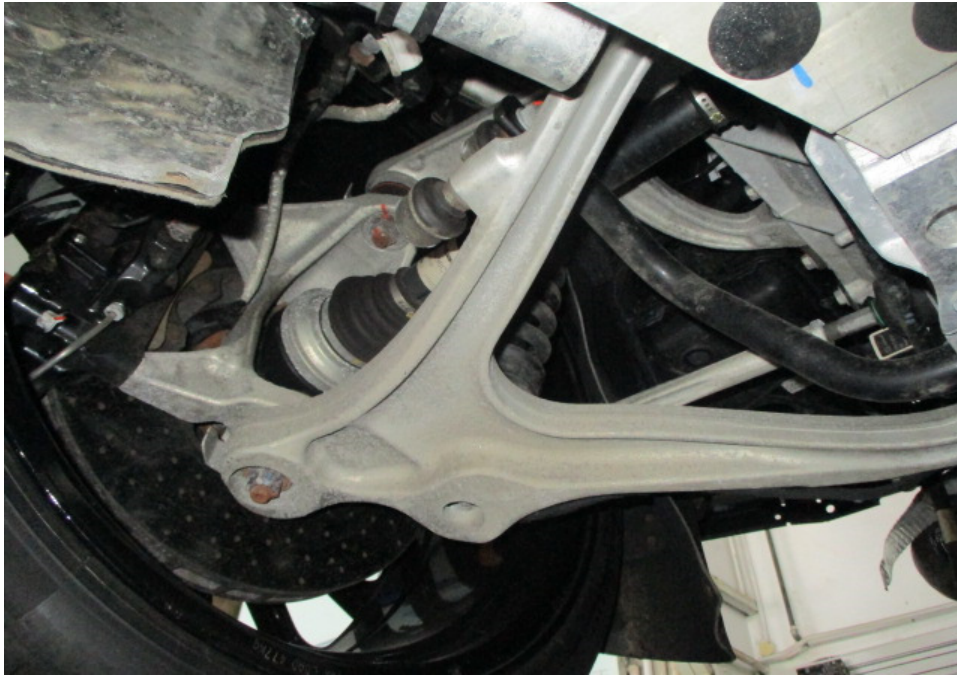
Photo 21 shows a general view of the control arms and linkages at the rear right wheel of the Motor Car. I did not observe any fluid leak and/or fluid stain on the underside of the Motor Car. All of the Motor Car's undercarriage components were observed to be intact and secured in an appropriate manner.

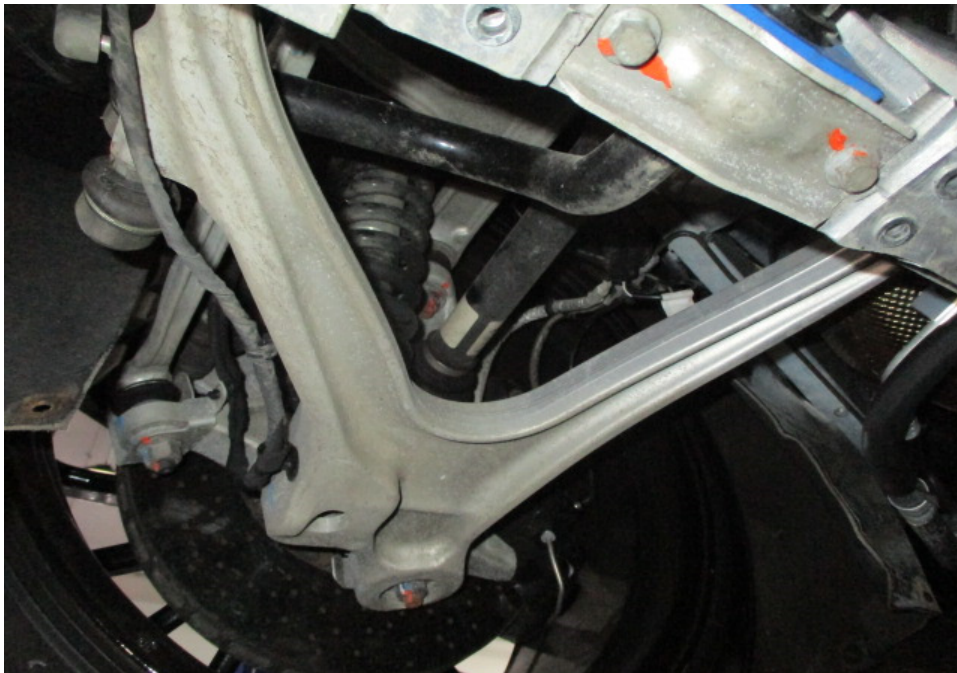
Photo 22 shows a general view of the control arms and linkages at the rear left wheel of the Motor Car. I did not observe any fluid leak and/or fluid stain on the underside of the Motor Car. All of the Motor Car's undercarriage components were observed to be intact and secured in an appropriate manner.

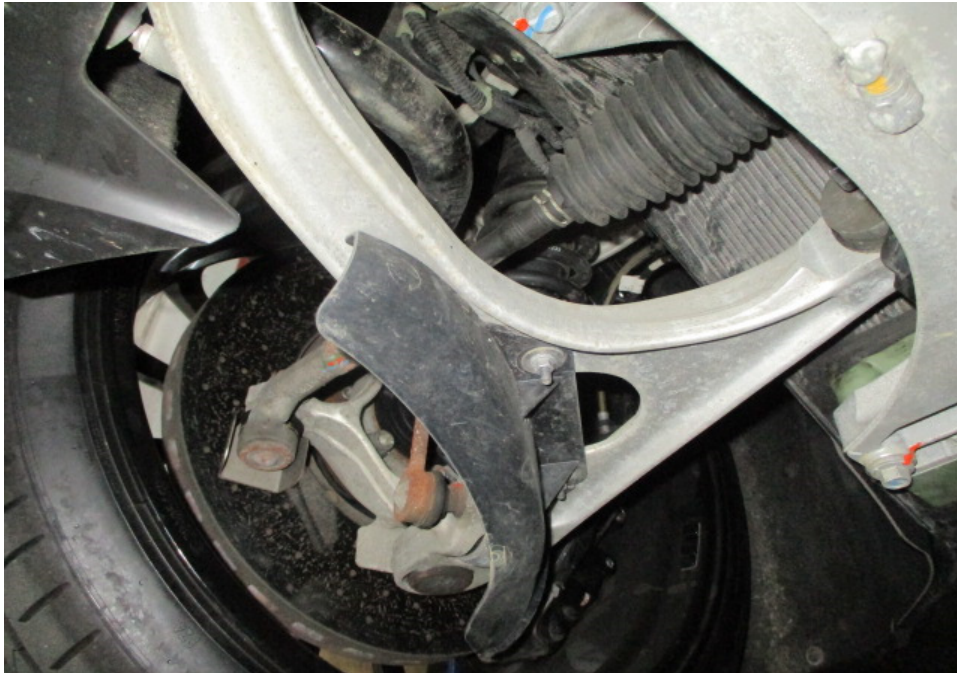
Photo 23 shows the various undercarriage components at the front left wheel of the Motor Car. The mechanical components, control arms and linkages were all found to be intact and secured in an appropriate manner.

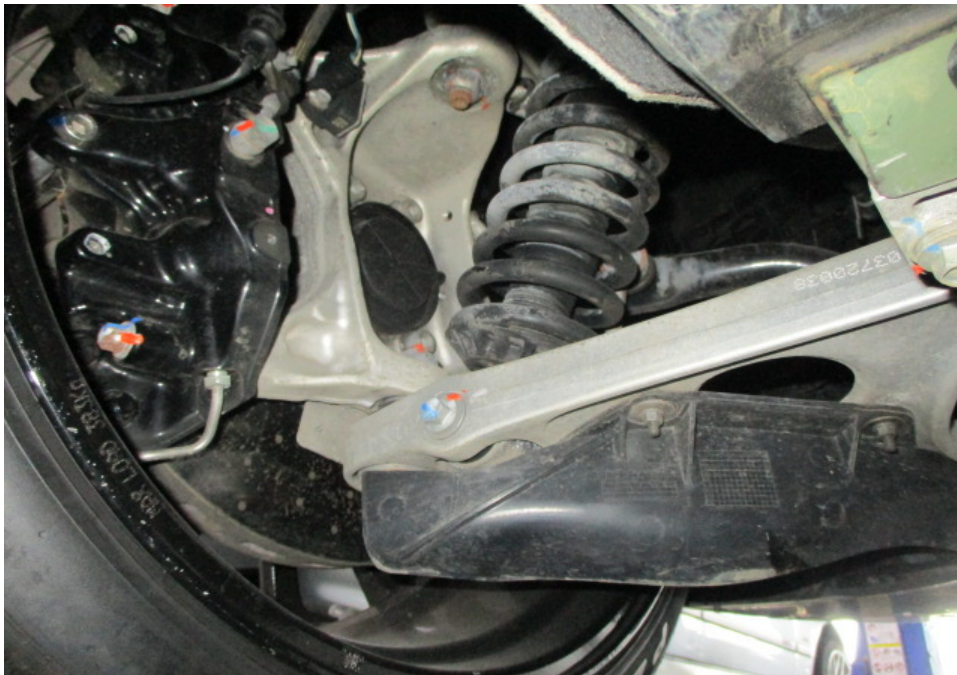
Photo 24 shows the various undercarriage components at the front right wheel of the Motor Car. The mechanical components, control arms and linkages were all found to be intact and secured in an appropriate manner. I also did not observe any fluid leak and/or fluid stain on the underside of the Motor Car.

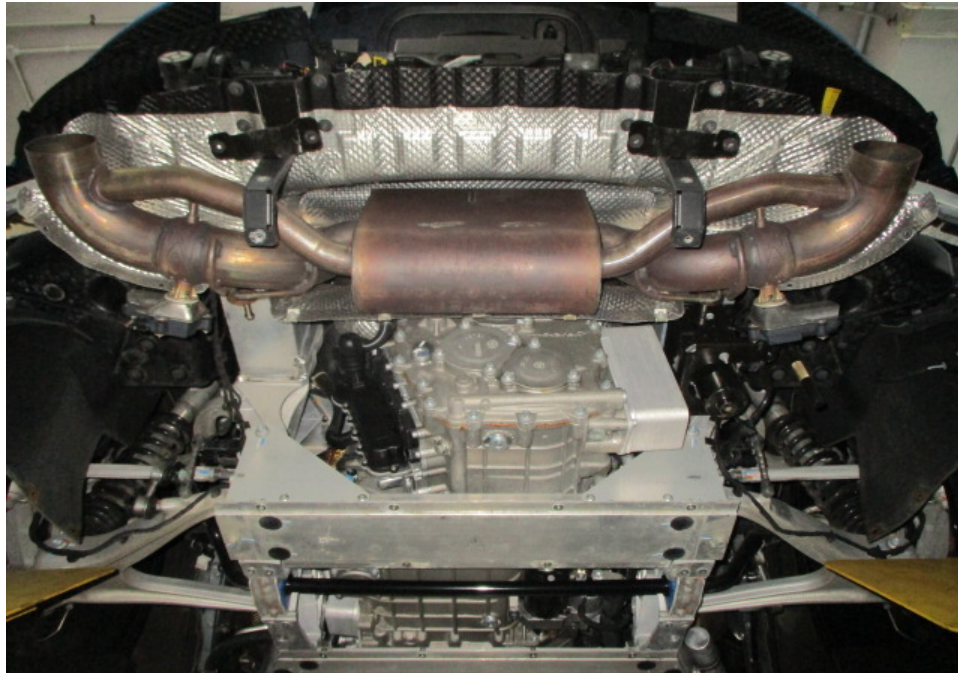
Photo 25 shows the Motor Car's exhaust system after dismantling of the rear bumper and rear under cover. In general, my examination of the Motor Car's exhaust system revealed no sign(s) or indication(s) of any cut or weld marks along its exhaust pipes, on its catalytic converters and on its rear muffler.

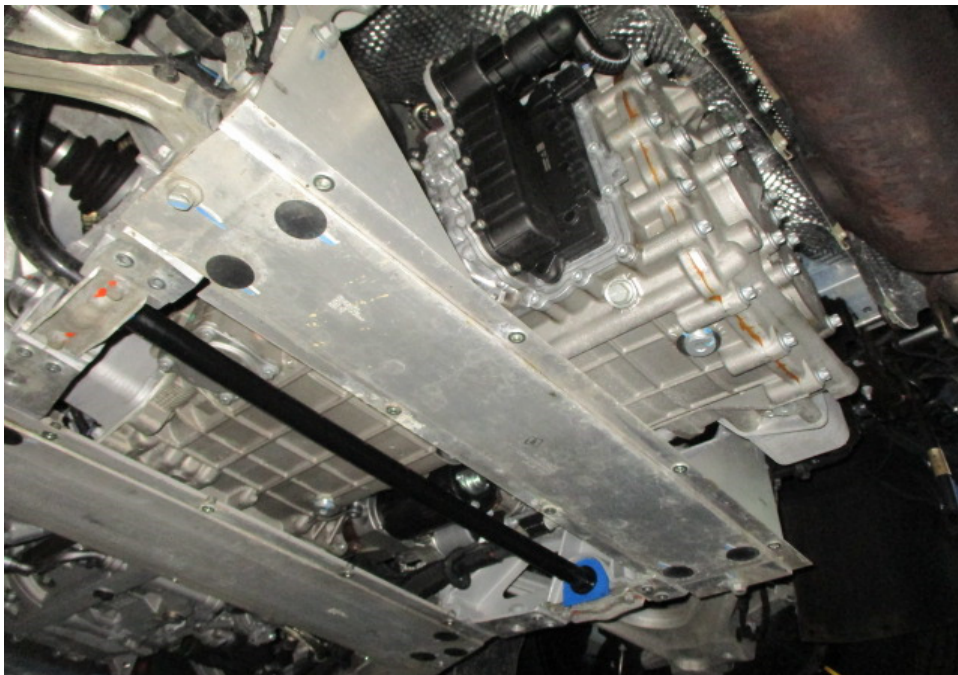
Photo 26 shows the Motor Car's engine compartment as viewed from the rear underside of the Motor Car. The various parts and components inside the engine compartment were all observed to be intact and properly fitted. There was also no sign(s) or indication(s) of fluid leak and/or fluid stain found inside the engine compartment.

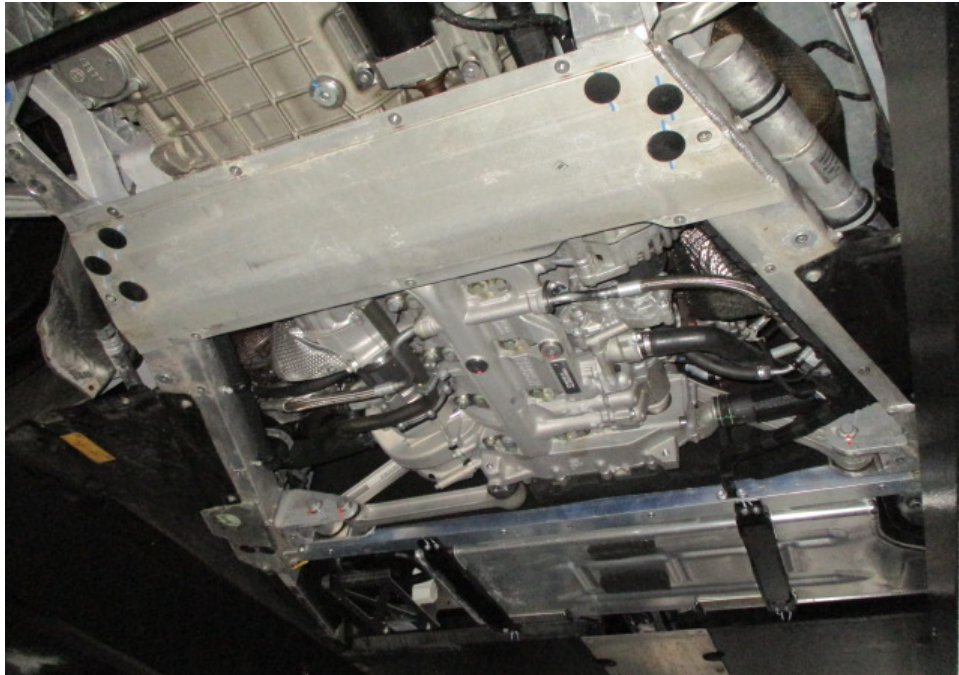
Photo 27 shows another view of the Motor Car's engine compartment as viewed from the rear underside of the Motor Car. The various parts and components inside the engine compartment were all observed to be intact and properly fitted. There was also no sign(s) or indication(s) of fluid leak and/or fluid stain found inside the engine compartment.

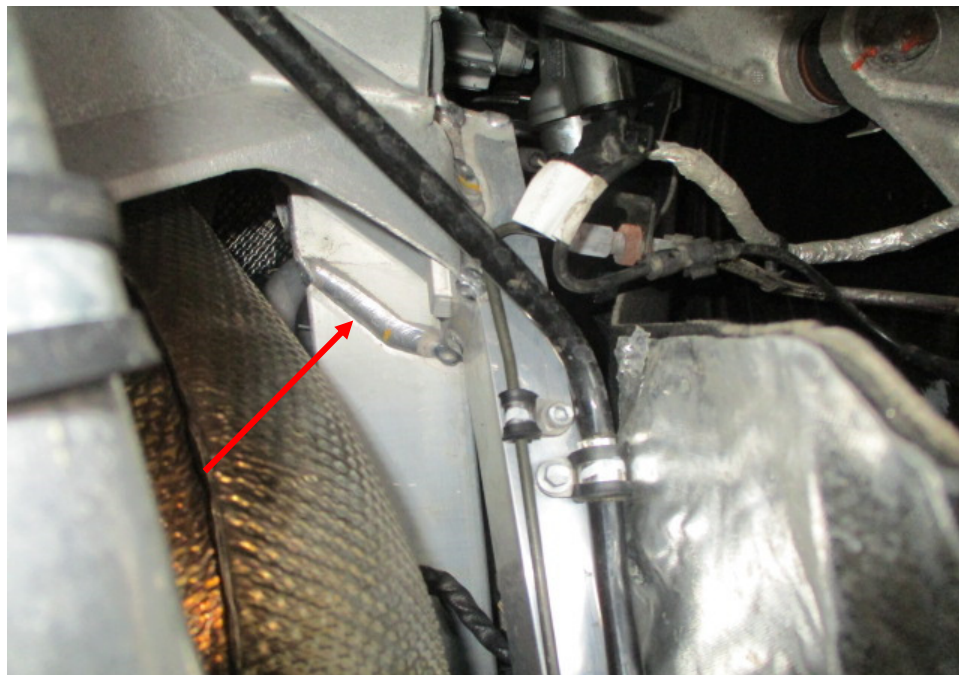
Photo 28 shows the aluminium chassis/structural body at the underside rear right of the Motor Car. I did not find any weld marks other than original spot weld marks on the chassis/structural body of the Motor Car. The original factory sealant (arrowed) at the joints along the chassis/structural body was untouched, indicating no work was done on the chassis/structural body of the Motor Car and that the chassis/structural body was originally fitted.

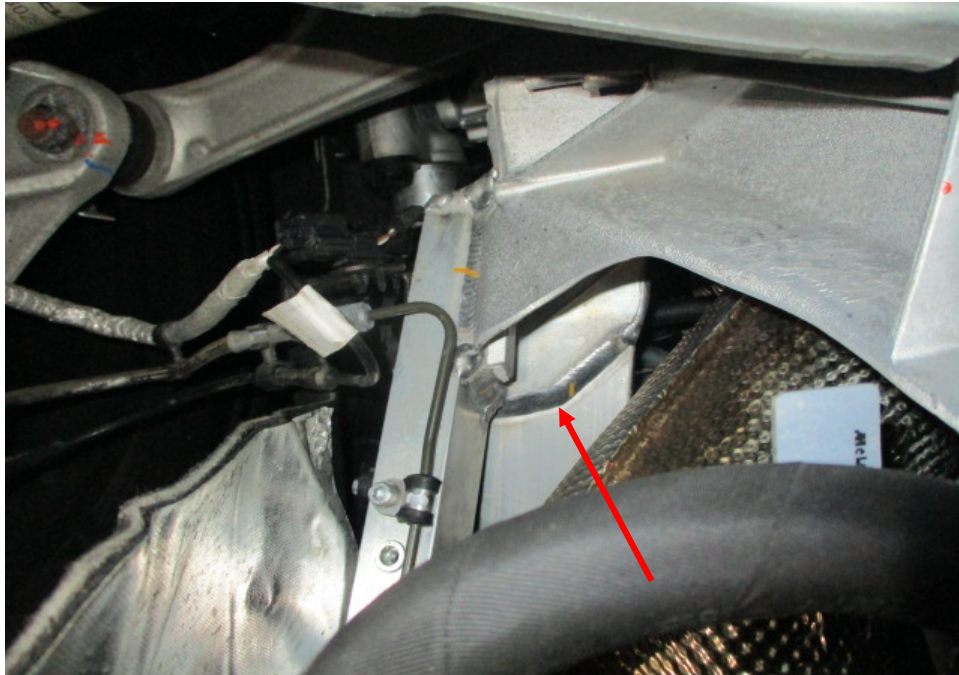
Photo 29 shows the aluminium chassis/structural body at the underside rear left of the Motor Car. I did not find any weld marks other than original spot weld marks on the chassis/structural body of the Motor Car. The original factory sealant (arrowed) at the joints along the chassis/structural body was untouched, indicating no work was done on the chassis/structural body of the Motor Car and that the chassis/structural body was originally fitted.

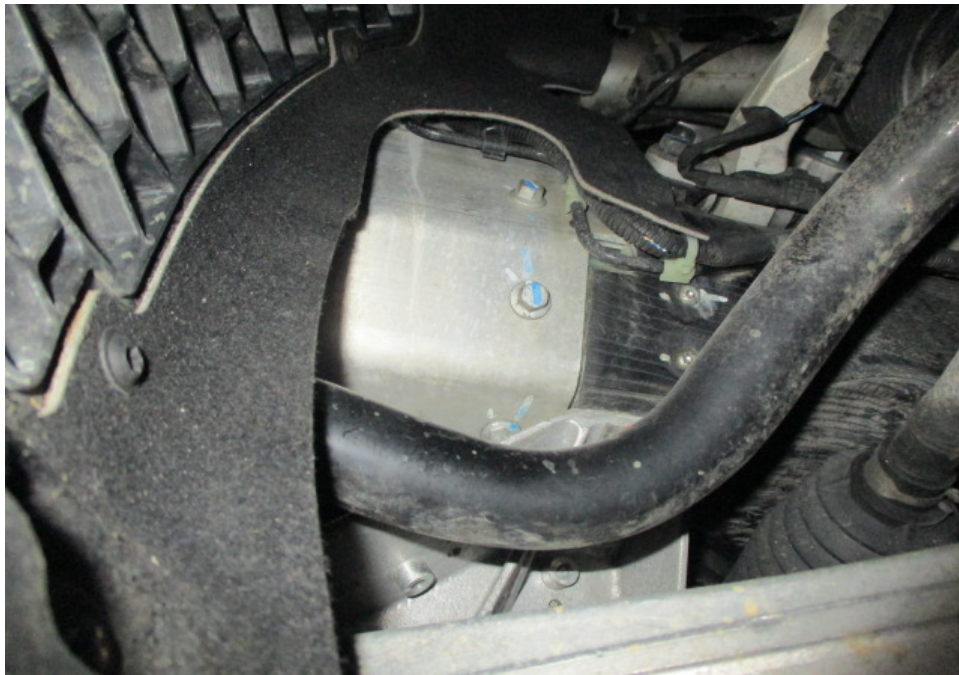
Photo 30 shows the aluminium chassis/structural body at the underside front left of the Motor Car. The original factory sealant at the joints along the chassis/structural body was observed to be untouched. In general, I had found no work was carried out on the chassis/structural body of the Motor Car. The aluminium chassis/structural body of the Motor Car was originally fitted.
