Your Ref: McLaren GT
(chassis number SBM22GCCXMW001068)
Our Ref : CI/TP22011788/D

23 November 2022

**INSPECTION REPORT OF AN UNREGISTERED MCLAREN GT MOTOR CAR
WITH CHASSIS NUMBER SBM22GCCXMW001068**

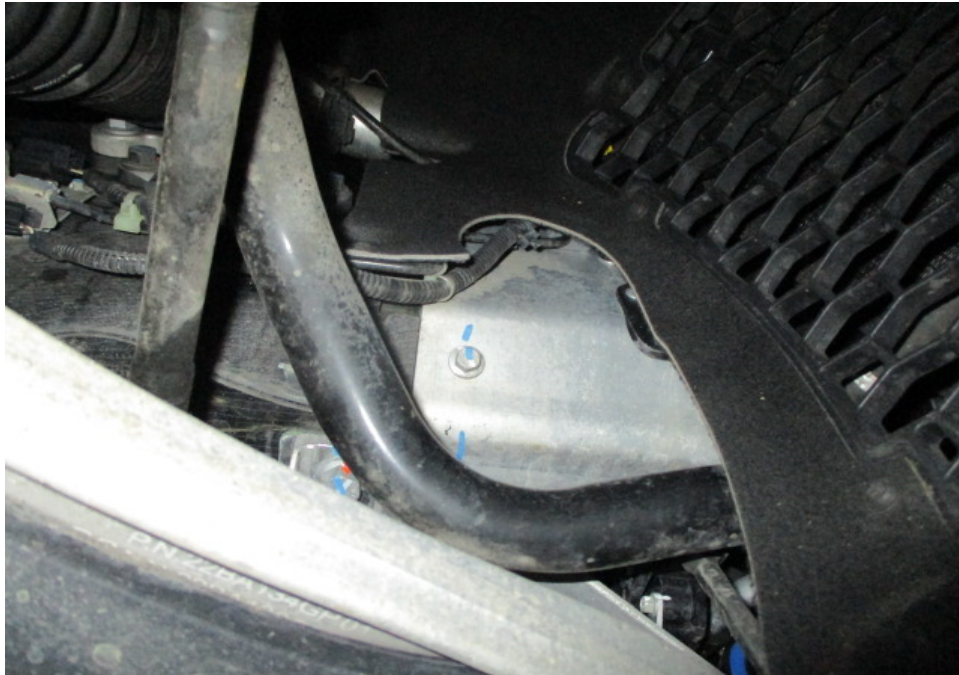
Photo 31 shows the aluminium chassis/structural body at the underside front right of the Motor Car. I did not find any weld marks other than original spot weld marks on the chassis/structural body of the Motor Car. The original factory sealant at the joints along the chassis/structural body was untouched, indicating no work was done on the chassis/structural body of the Motor Car and that the chassis/structural body was originally fitted.

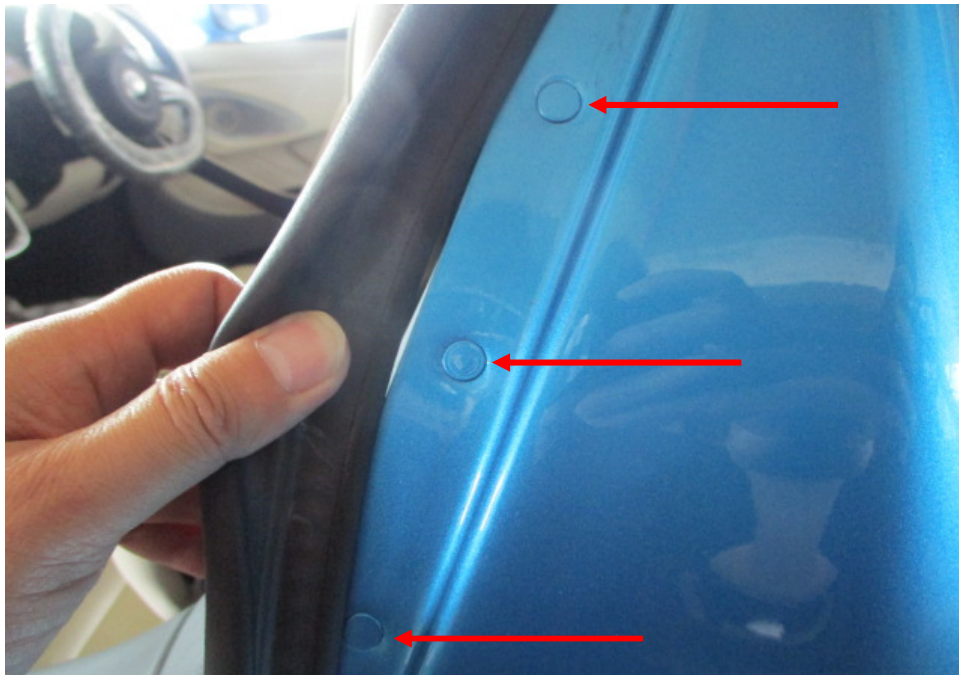
Photo 32 shows the left side rear body panel of the Motor Car. I did not find any weld marks other than original spot weld marks (arrowed) on the left side rear body panel of the Motor Car, which indicates that there was no re-welding works carried out. In general, I had found all the non-detachable body panels of the Motor Car to be originally fitted at the time of my inspection.

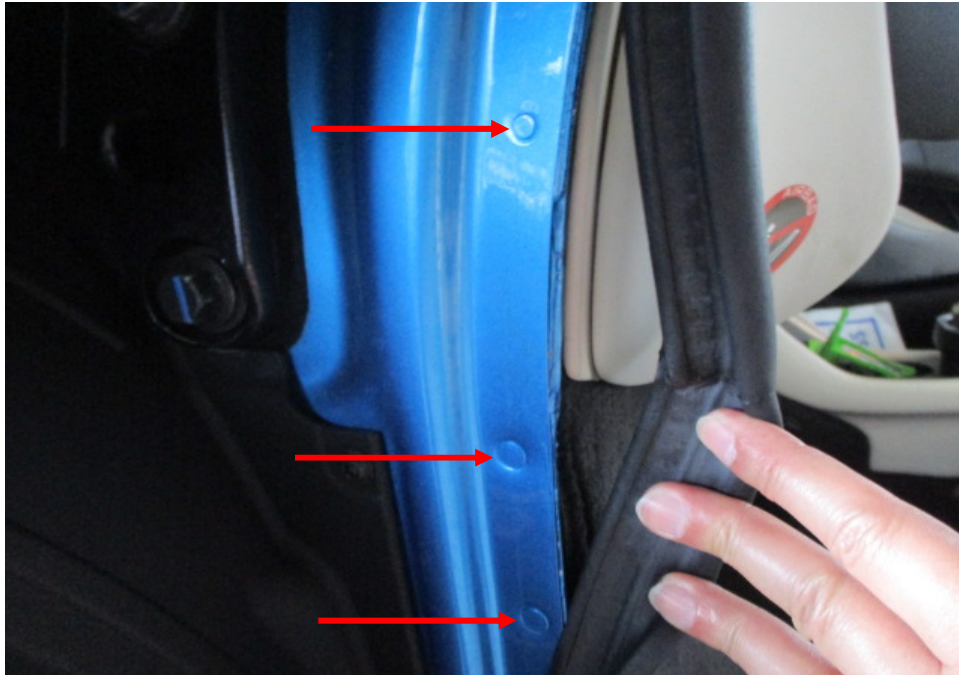
Photo 33 shows the left side "A" pillar of the Motor Car. I did not find any weld marks other than original spot weld marks (arrowed) on the left side "A" pillar of the Motor Car, which indicates that there was no re-welding works carried out. In general, I had found all the non-detachable body panels of the Motor Car to be originally fitted at the time of my inspection.

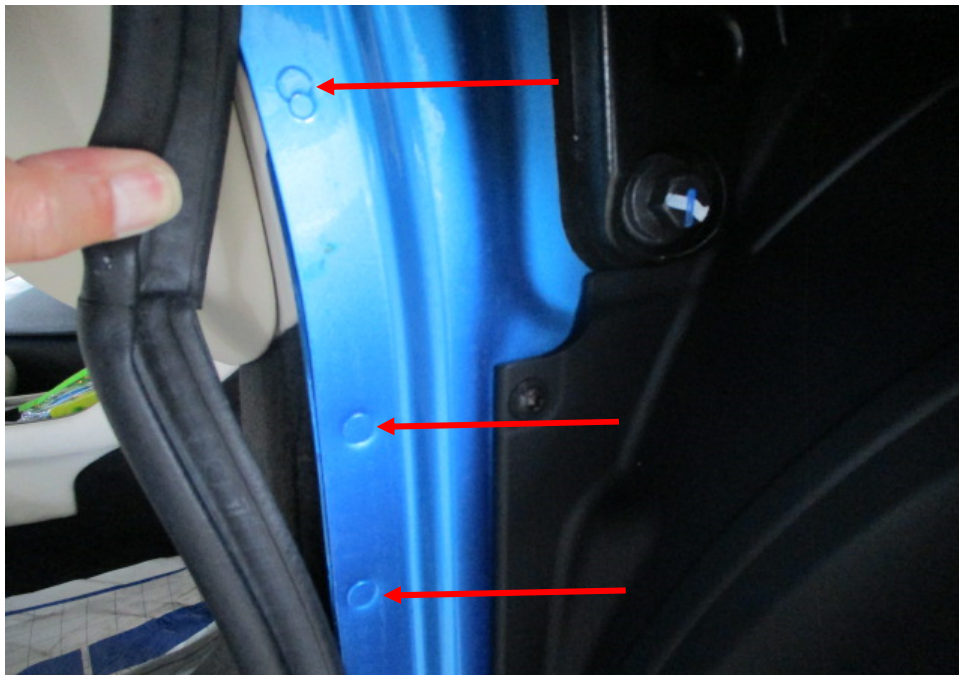
Photo 34 shows the right side "A" pillar of the Motor Car. I did not find any weld marks other than original spot weld marks (arrowed) on the right side "A" pillar of the Motor Car, which indicates that there was no re-welding works carried out. In general, I had found all the non-detachable body panels of the Motor Car to be originally fitted at the time of my inspection.

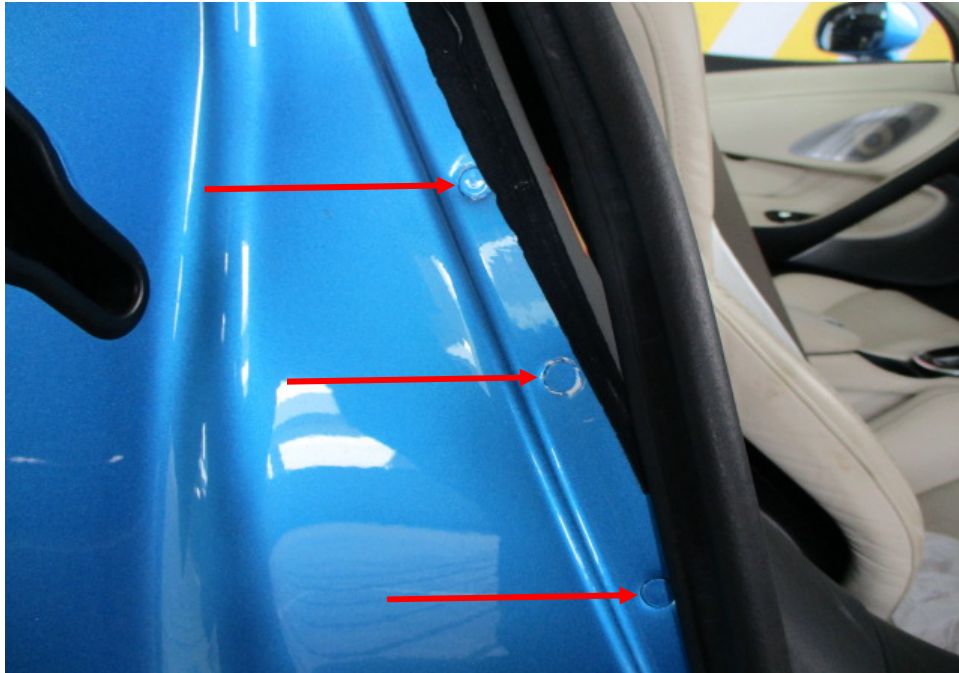
Photo 35 shows the right side rear body panel of the Motor Car. I did not find any weld marks other than original spot weld marks (arrowed) on the right side rear body panel of the Motor Car, which indicates that there was no re-welding works carried out. In general, I had found all the non-detachable body panels of the Motor Car to be originally fitted at the time of my inspection.
