Your Ref: Porsche Cayenne  
(chassis number WP1ZZZ9YZLDA36933)  
Our Ref : CI/TP22011816/D

24 November 2022

**INSPECTION REPORT OF AN UNREGISTERED PORSCHE CAYENNE  
MOTOR CAR WITH CHASSIS NUMBER WP1ZZZ9YZLDA36933**

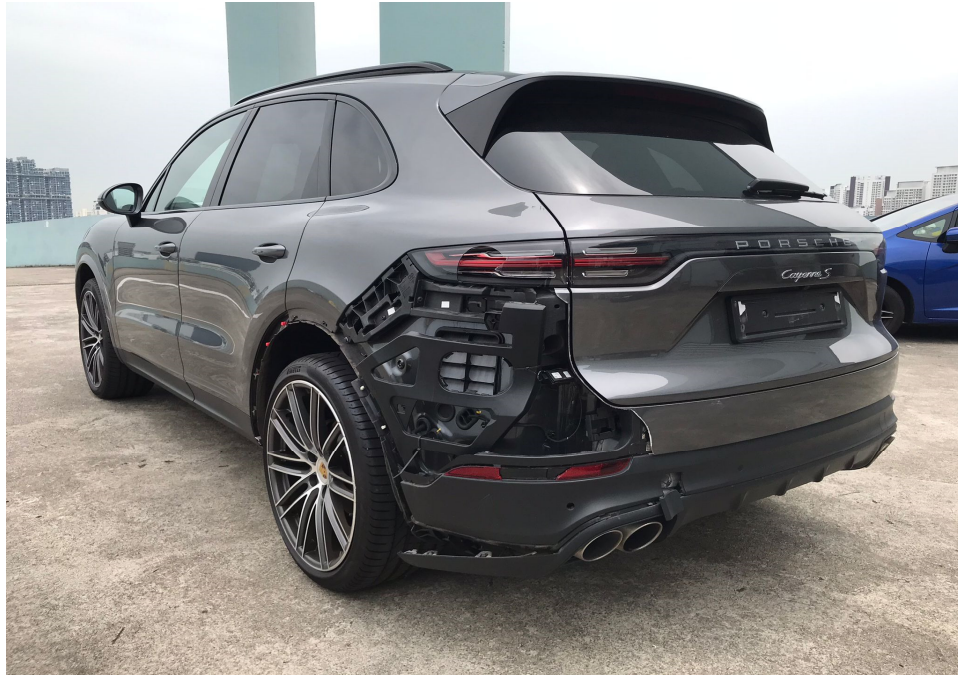
**Photo 1** shows the rear left body of the Motor Car (photograph provided to me). The photographs provided to me had showed damage to the rear left portion of the Motor Car. The rear bumper, rear bumper lower cover, rear bumper lower garnish, rear bumper left sensors, rear bumper left reflector, rear bumper left bracket and rear left taillamp were amongst the body parts that were observed to have been damaged.

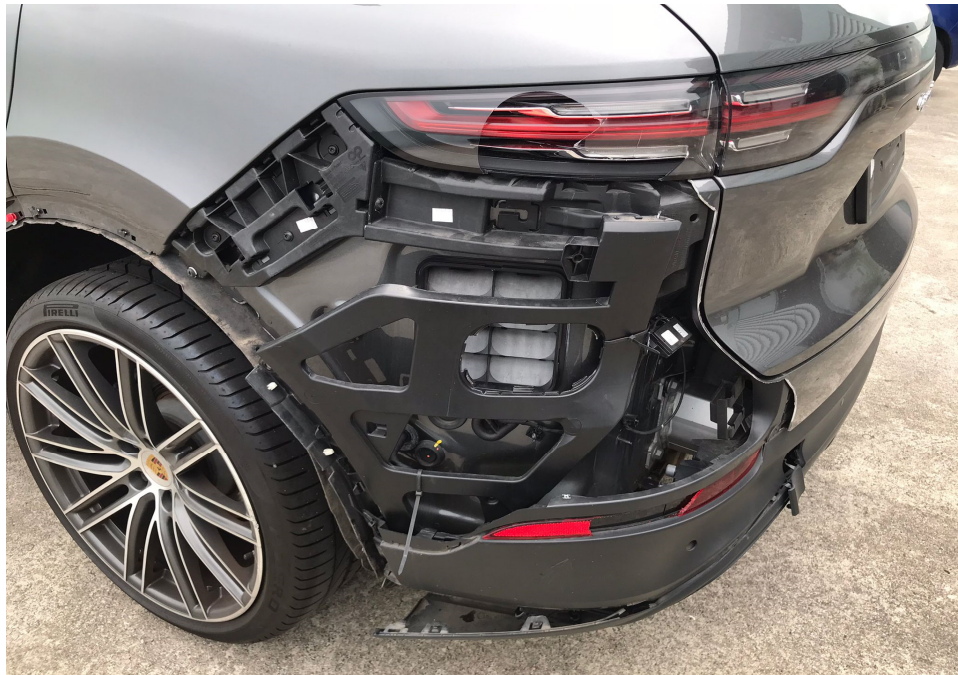
**Photo 2** shows a closer view of the damage at the rear left portion of the Motor Car (photograph provided to me). The rear bumper, rear bumper lower cover, rear bumper lower garnish, rear bumper left bracket, rear left taillamp and rear left bracket, rear left fender wheel arc garnish were amongst the body parts that were observed to have been damaged.

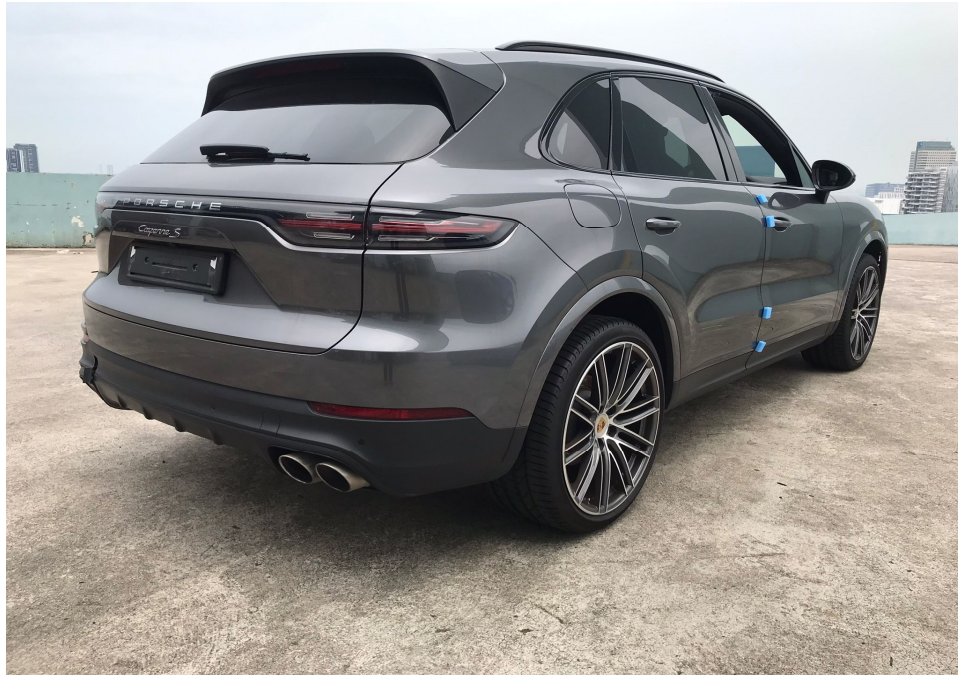
**Photo 3** shows the rear right body of the Motor Car (photograph provided to me). Apart for the rear left portion, there was no physical damage observed to other areas of the Motor Car.

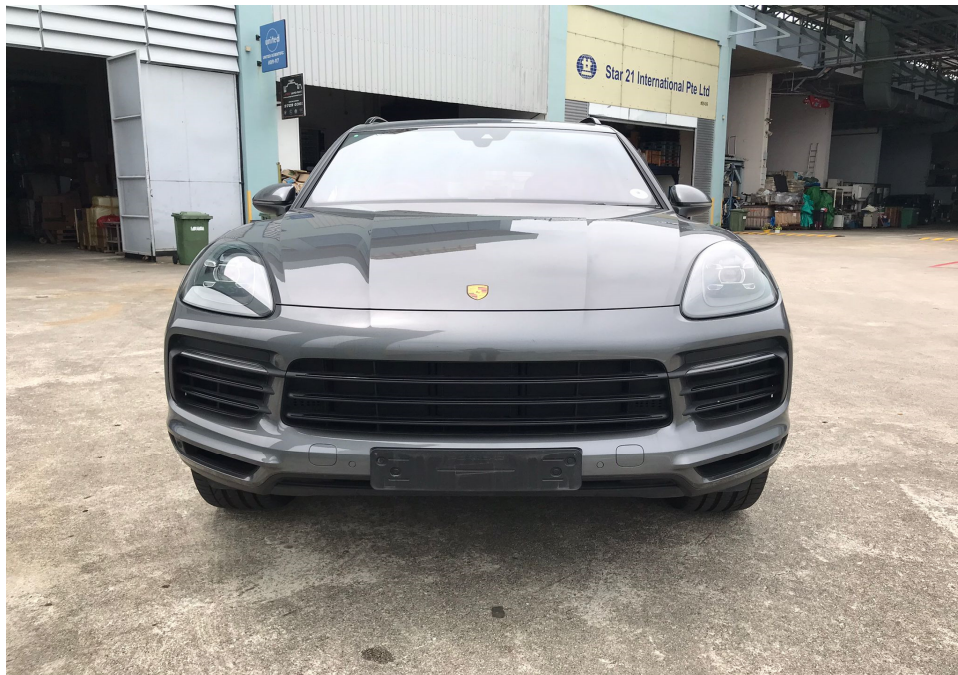
**Photo 4** shows the frontal body of the Motor Car (photograph provided to me). Apart for the rear left portion, there was no physical damage observed to other areas of the Motor Car.

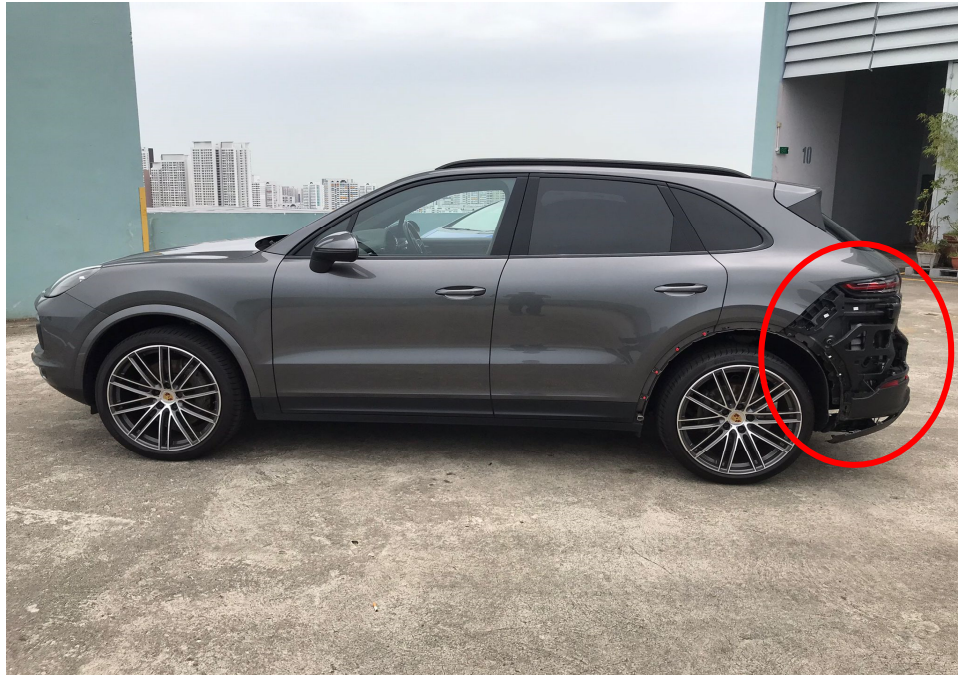
**Photo 5** shows the left side body of the Motor Car (photograph provided to me). Apart for the rear left portion (circled), there was no physical damage observed to other areas of the Motor Car.

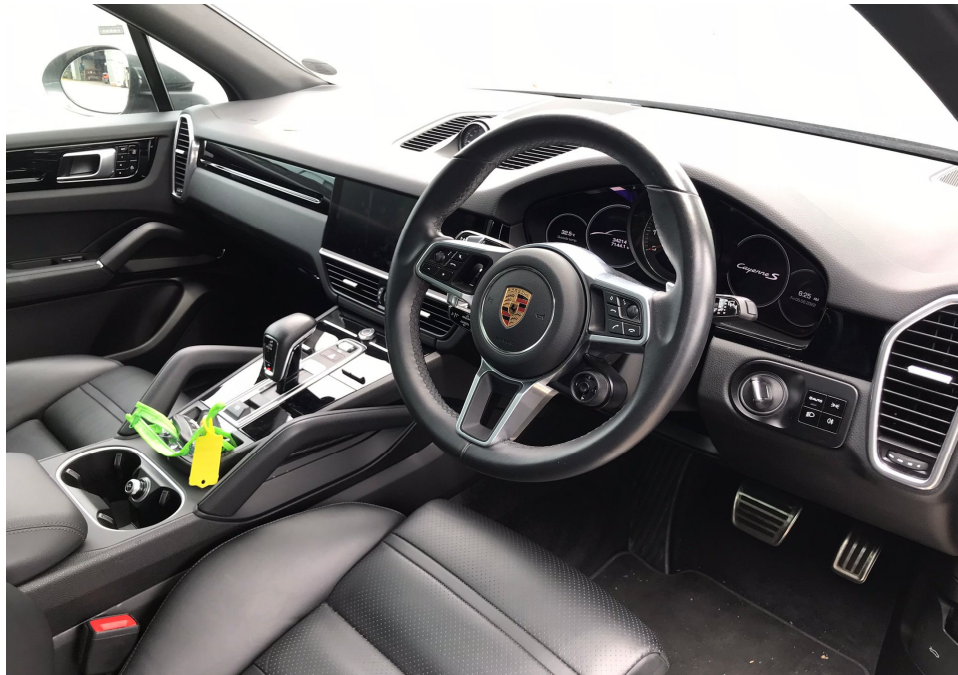
**Photo 6** shows the interior compartment of the Motor Car (photograph provided to me). The various parts and components within the interior compartment were all intact and unaffected. The airbag(s) was not deployed as seen from the photographs that were provided to me.

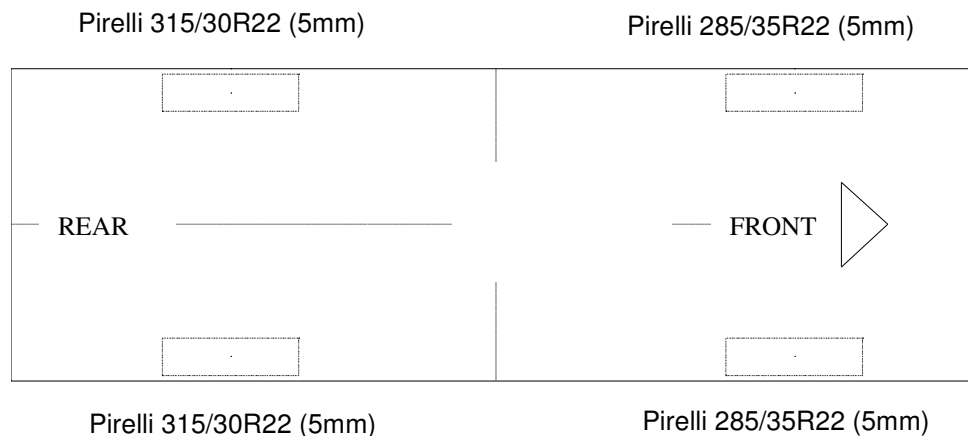
8. It was fitted with 22inch sport wheel rims that were wrapped with tyres that were observed to be of serviceable condition. The tyres were also sufficiently inflated for vehicular operation. The tyre brand, tyre size and approximate remaining tread depth of the 4 tyres of the Motor Car were recorded as follows: -

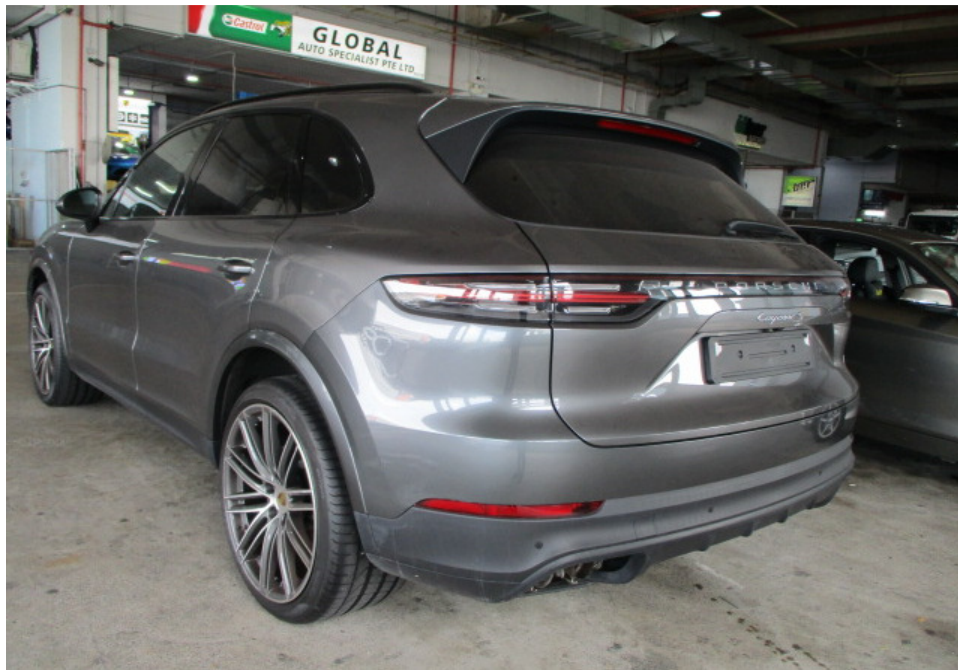
**Photo 7** shows a general view of the rear left body of the Motor Car at the time of my inspection. The Motor Car was observed to be in a relatively good general condition with no loose exterior fittings observed. The body parts at the rear left portion of the Motor Car were visually examined and it was observed that the repair/restoration works carried out to the damaged area of the Motor Car (refer to photograph 1, 2 & 5 above) were reasonably adequate and in order.

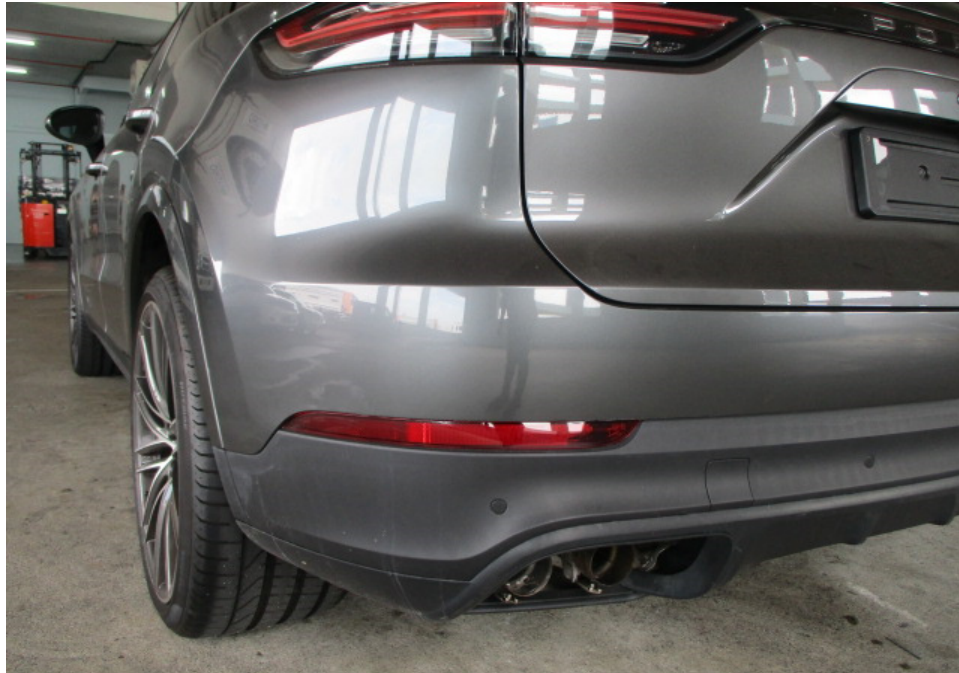
**Photo 8** shows a closer view of the Motor Car's rear bumper, rear bumper lower cover, rear bumper lower garnish, rear bumper left sensors and rear bumper left reflector at the time of my inspection. The body parts at the rear left portion of the Motor Car were visually examined and it was observed that the repair/restoration works carried out to the damaged area of the Motor Car (refer to photograph 1, 2 & 5 above) were reasonably adequate and in order.

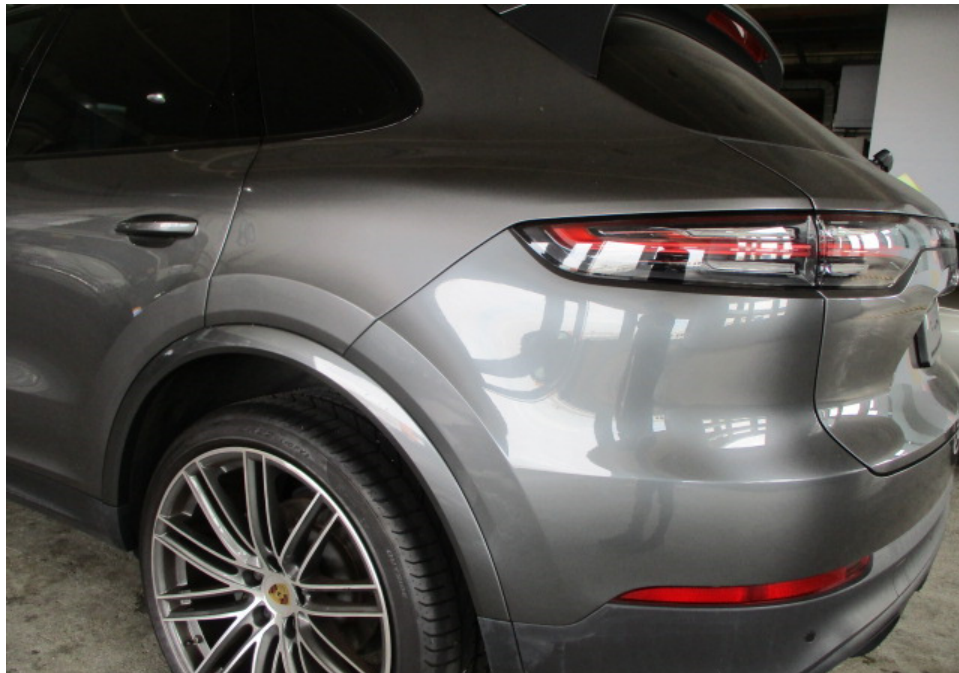
**Photo 9** shows a closer view of the Motor Car's rear bumper, rear left taillamp, rear left fender and rear left fender wheel arc garnish. The body parts at the rear left portion of the Motor Car were visually examined and it was observed that the repair/restoration works carried out to the damaged area of the Motor Car (refer to photograph 1, 2 & 5 above) were reasonably adequate and in order.

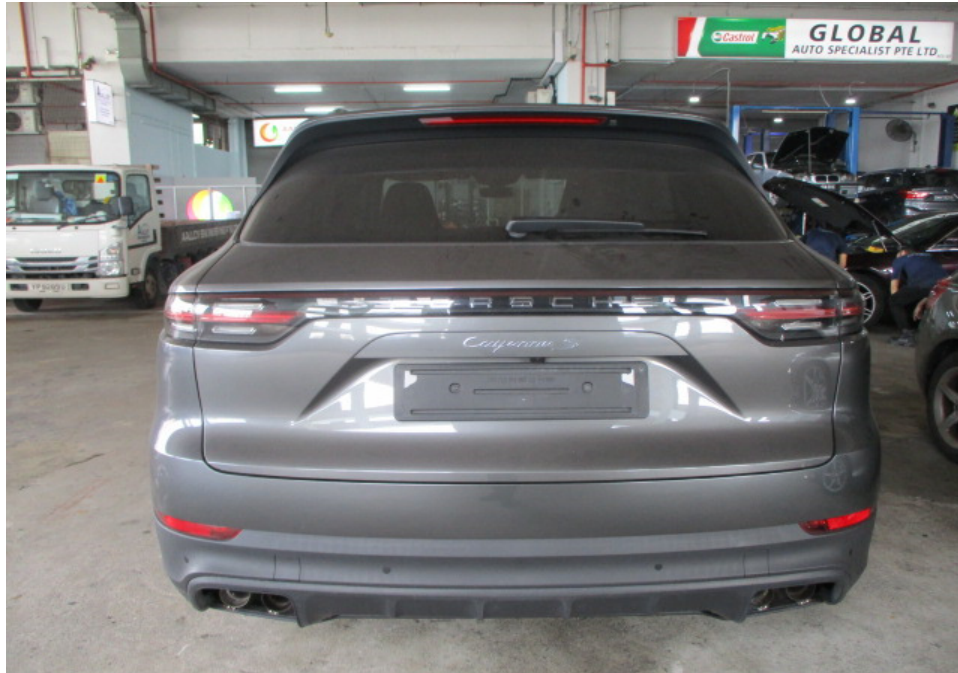
**Photo 10** shows a general view of the rear body of the Motor Car at the time of my inspection. The Motor Car was observed to be in a relatively good general condition with no loose exterior fittings observed. The body parts at the rear left portion of the Motor Car were visually examined and it was observed that the repair/restoration works carried out to the damaged area of the Motor Car (refer to photograph 1, 2 & 5 above) were reasonably adequate and in order.

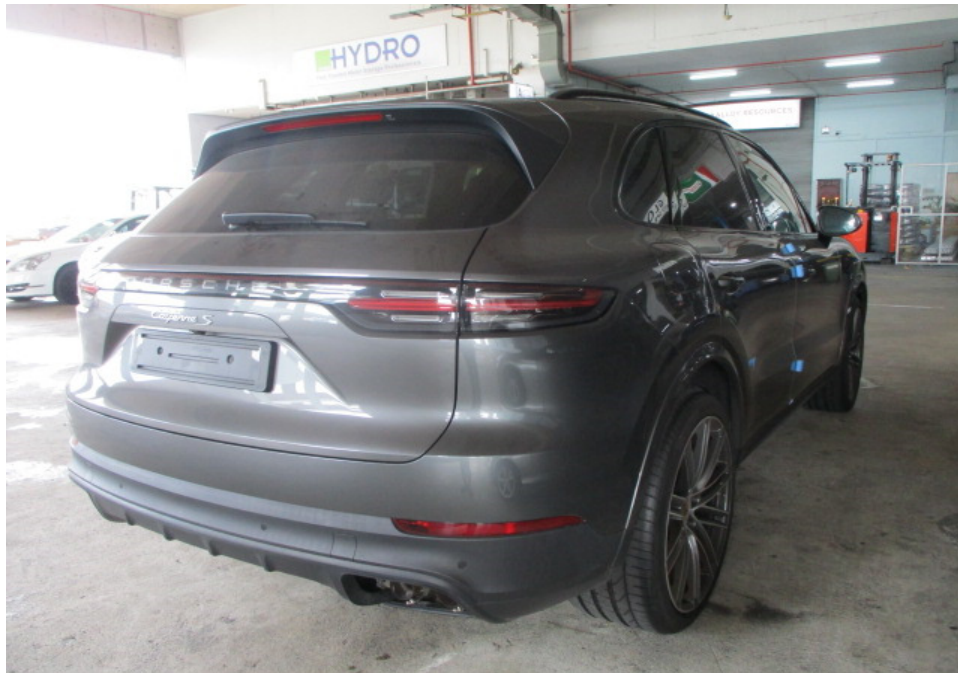
**Photo 11** shows a general view of the rear right body of the Motor Car at the time of my inspection. The Motor Car was observed to be in a relatively good general condition with no loose exterior fittings observed. The mileage of the Motor Car recorded at the time of my inspection was 34,498km.

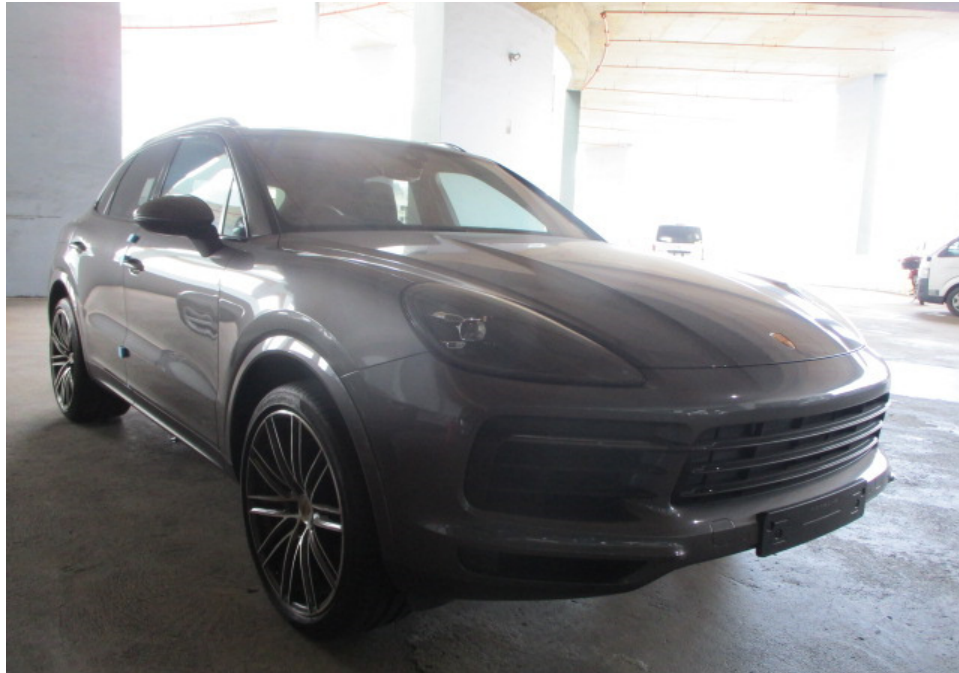
**Photo 12** shows a general view of the front right body of the Motor Car at the time of my inspection. The Motor Car was observed to be in a relatively good general condition with no loose exterior fittings observed. The mileage of the Motor Car recorded at the time of my inspection was 34,498km.

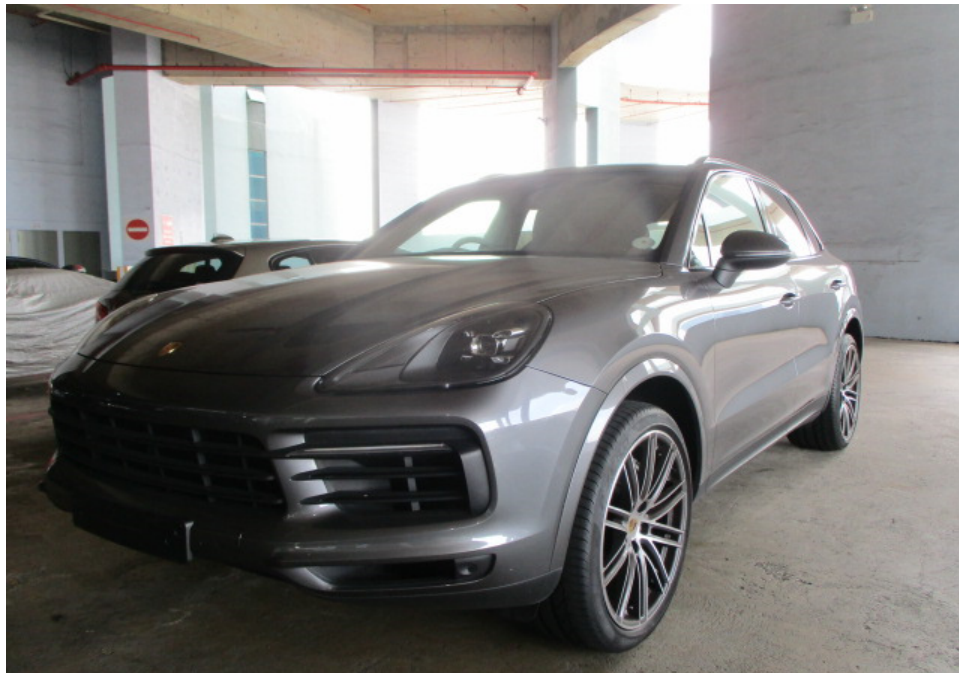
**Photo 13** shows a general view of the front left body of the Motor Car at the time of my inspection. The Motor Car was observed to be in a relatively good general condition with no loose exterior fittings observed. The mileage of the Motor Car recorded at the time of my inspection was 34,498km.

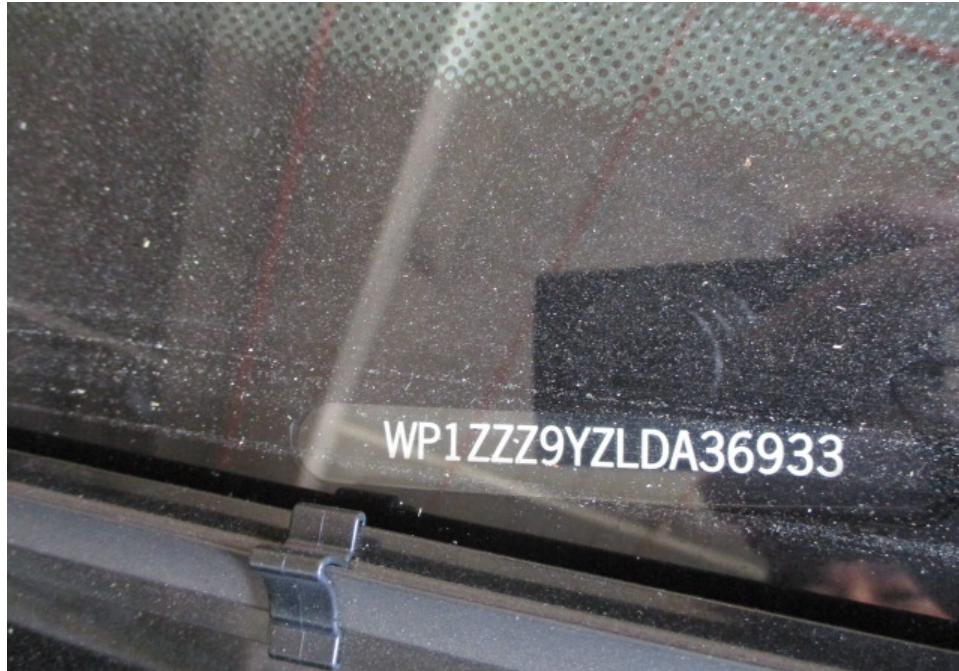
**Photo 14** shows the chassis number of the Motor Car. The chassis number recorded was WP1ZZZ9YZLDA36933.

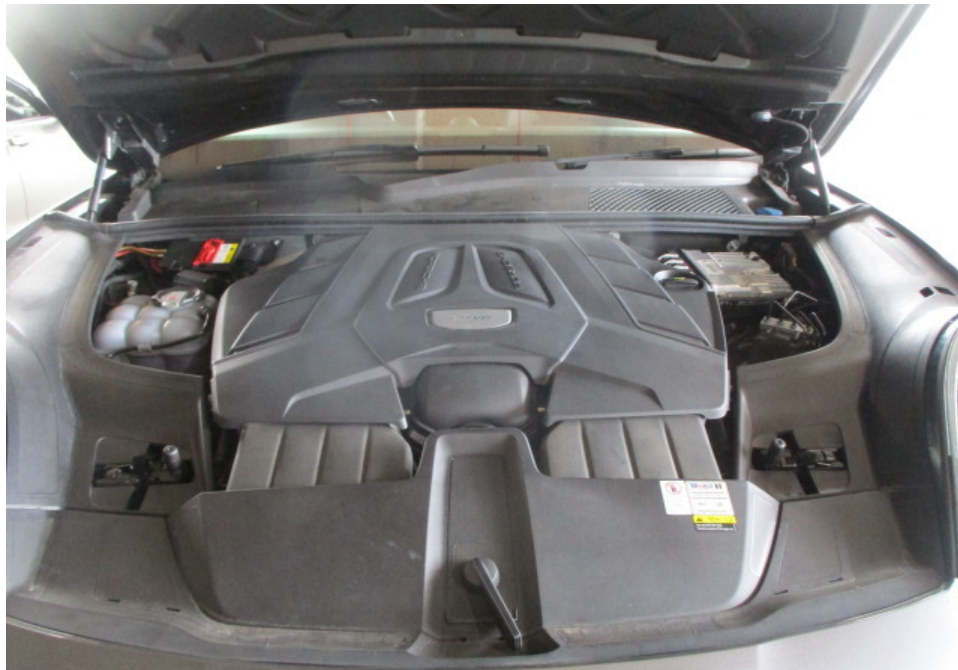
**Photo 15** shows a general view of the engine compartment of the Motor Car at the time of my inspection. The various parts and components inside the engine compartment were all observed to be intact and properly fitted. There was also no sign(s) or indication(s) of fluid leak and/or fluid stain found inside the engine compartment.

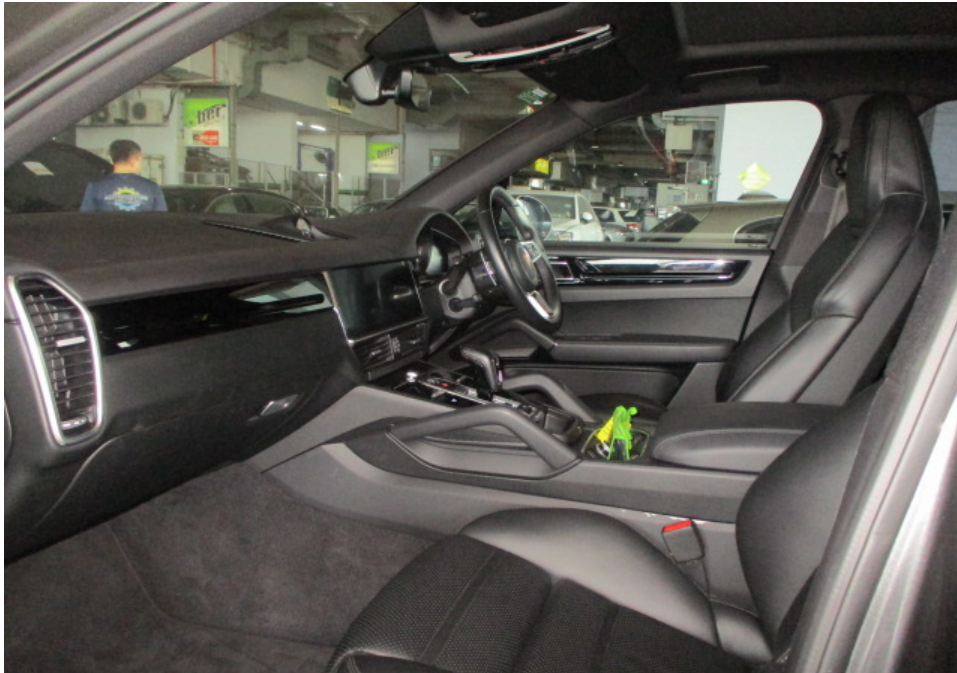
**Photo 16** shows the interior compartment of the Motor Car at the time of my inspection. The various parts and components, trims, carpet, and upholstery inside the interior compartment were all observed to be intact and properly fitted.

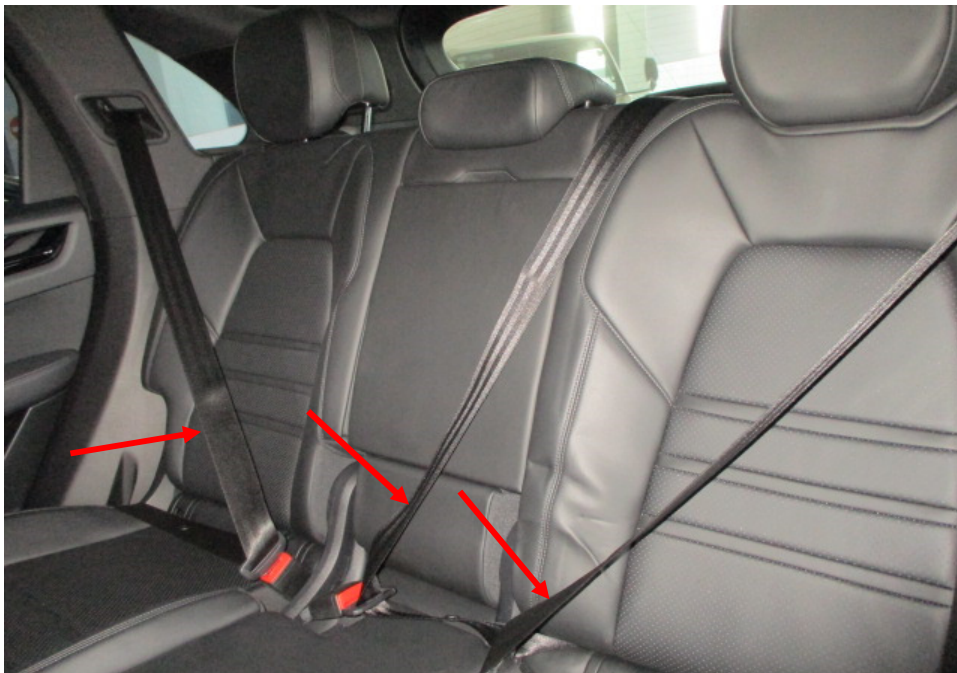
**Photo 17** shows the rear seats of the Motor Car. All the seats of the Motor Car were secured via seat rails to the floorboard. They were also fitted with a retractable seat belt reel and a pre-tensioner. The seat belts (arrowed) were tested and were able to be fastened into the respective pre-tensions that were fitted on the side of each individual seat.

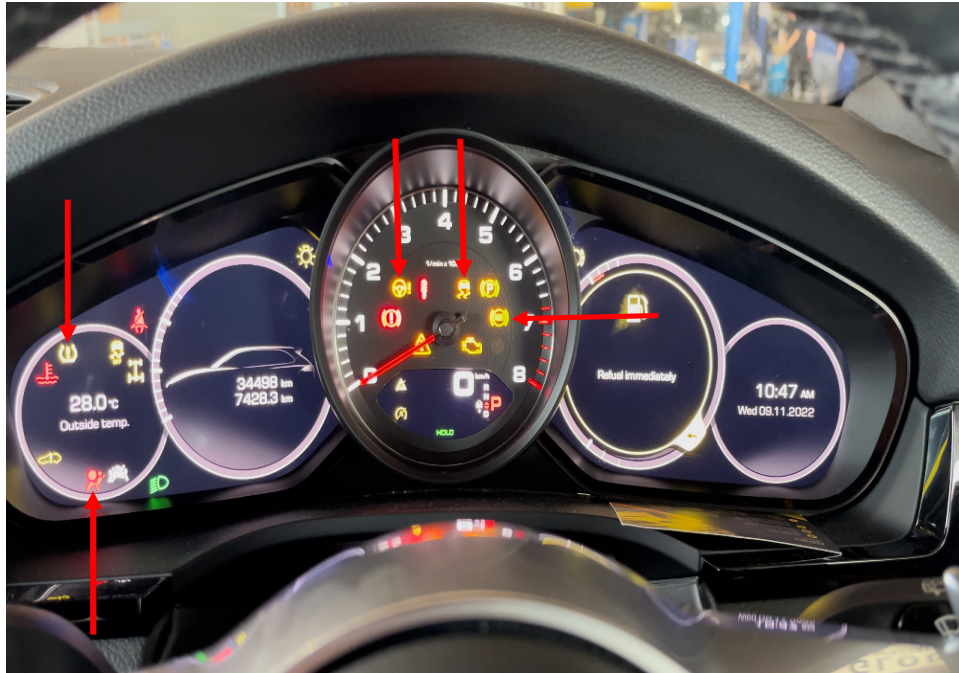
**Photo 18** shows the warning lights for the various electronic safety features appearing on the instrument panel of the Motor Car during its self-test when the engine is cranked, in particular the ABS, SRS, EPS, TPM and TCS lights (arrowed).

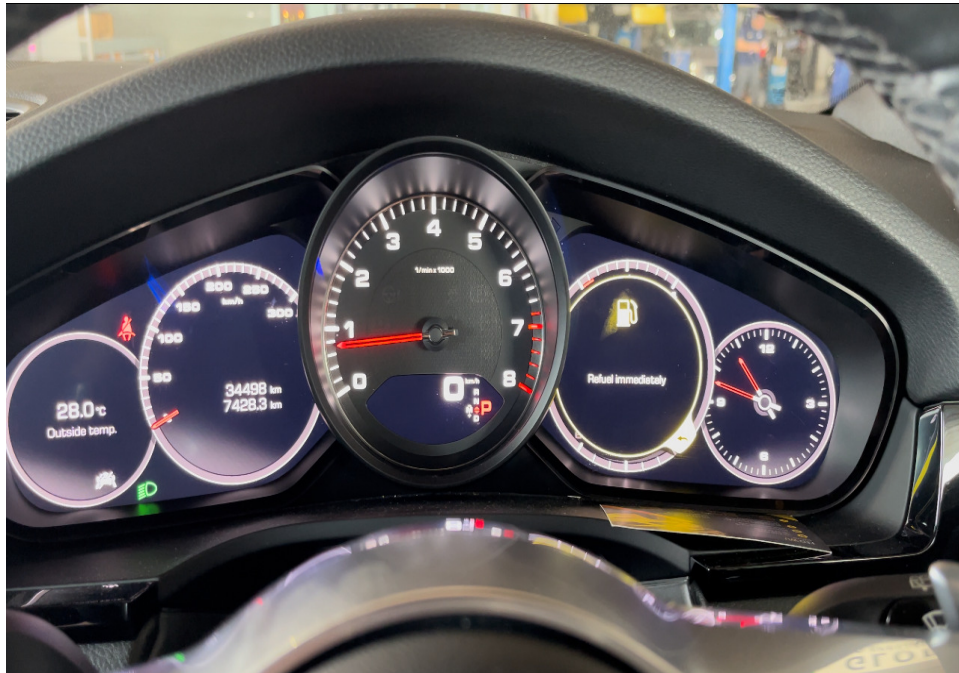
**Photo 19** shows the respective warning lights no longer illuminated, indicating that there is no fault detected to the ABS, SRS, EPS, TPM and TCS systems of the Motor Car during the self-test. These electronic systems were hence in working condition at the time of my inspection.

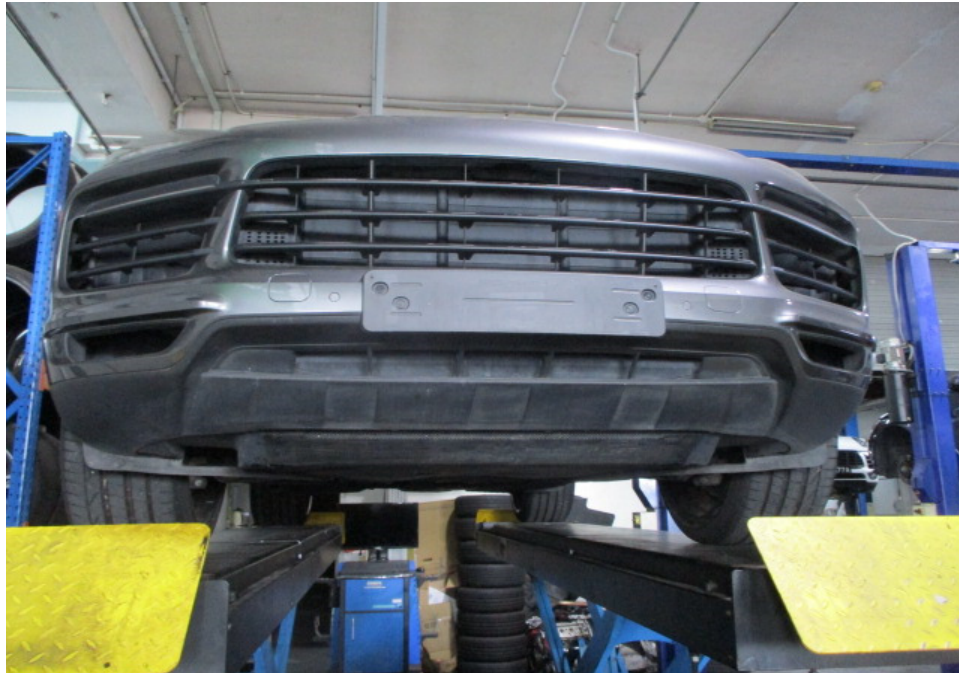
**Photo 20** shows the Motor Car hoisted up for checks on its undercarriage. There was no sign(s) or indication(s) of fluid leakage and/or fluid stain(s) on the underside of the Motor Car. The undercarriage components of the Motor Car were also all observed to be intact and secured in an appropriate manner.

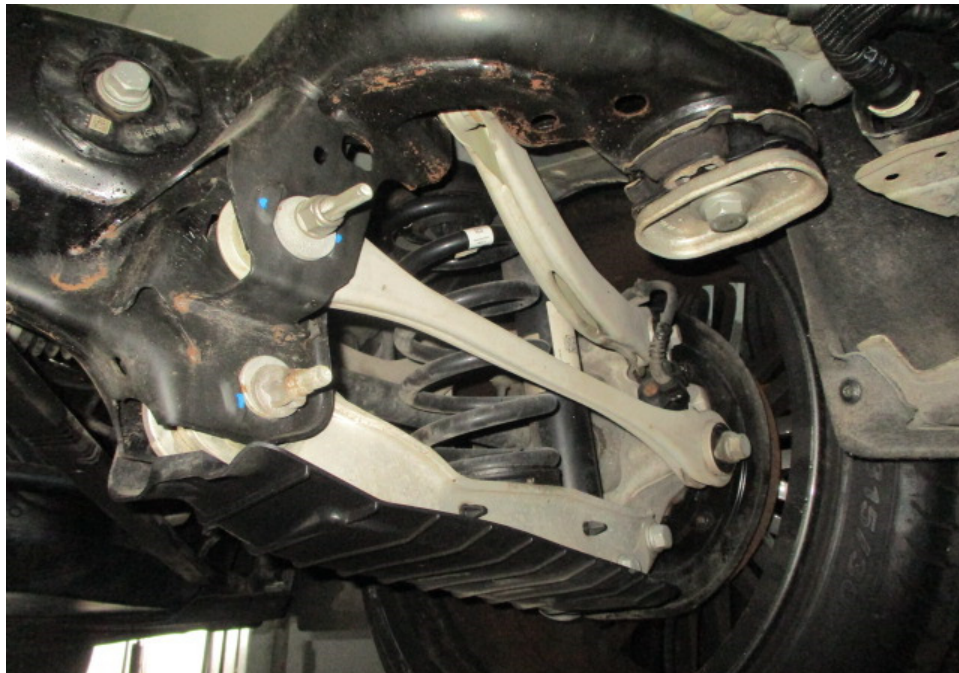
**Photo 21** shows a general view of the control arms and linkages at the rear right wheel of the Motor Car. I did not observe any fluid leak and/or fluid stain on the underside of the Motor Car. All of the Motor Car's undercarriage components were observed to be intact and secured in an appropriate manner.

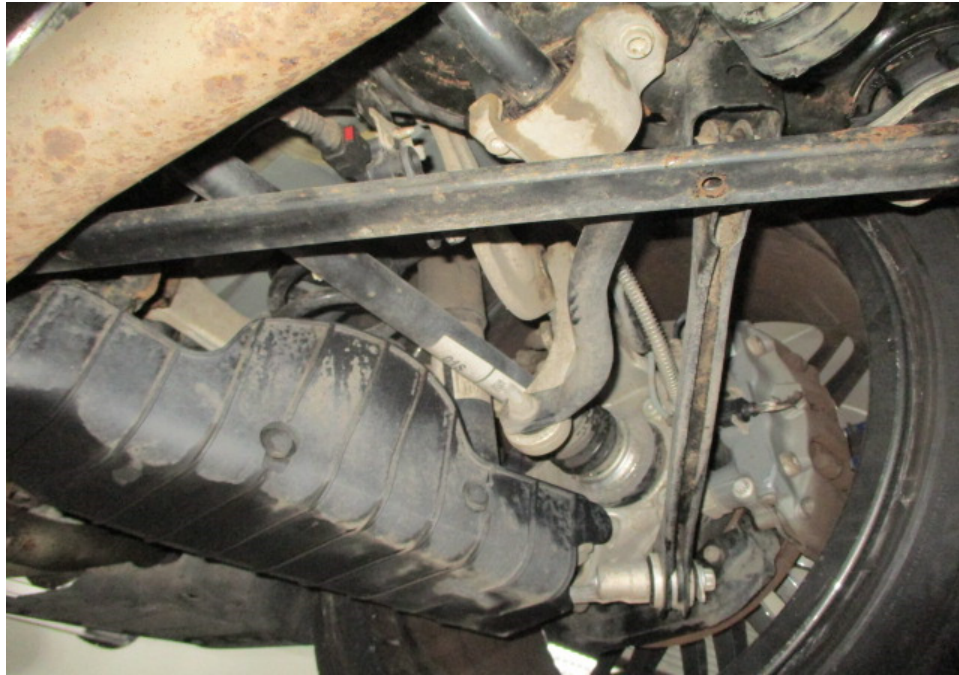
**Photo 22** shows a general view of the control arms and linkages at the rear left wheel of the Motor Car. I did not observe any fluid leak and/or fluid stain on the underside of the Motor Car. All of the Motor Car's undercarriage components were observed to be intact and secured in an appropriate manner.

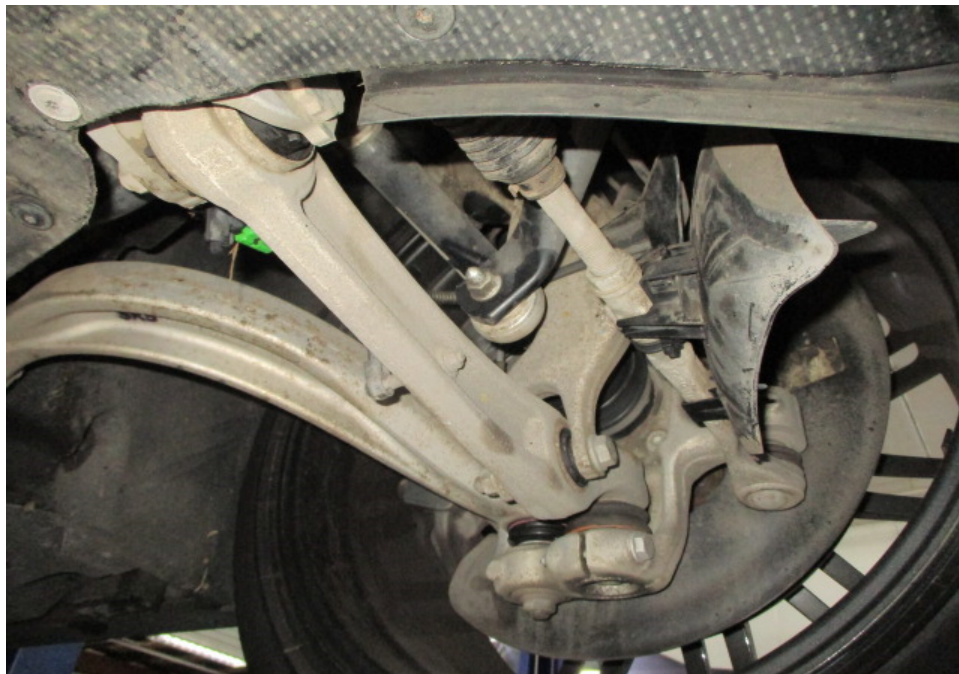
**Photo 23** shows the various undercarriage components at the front left wheel of the Motor Car. The mechanical components, control arms and linkages were all found to be intact and secured in an appropriate manner.

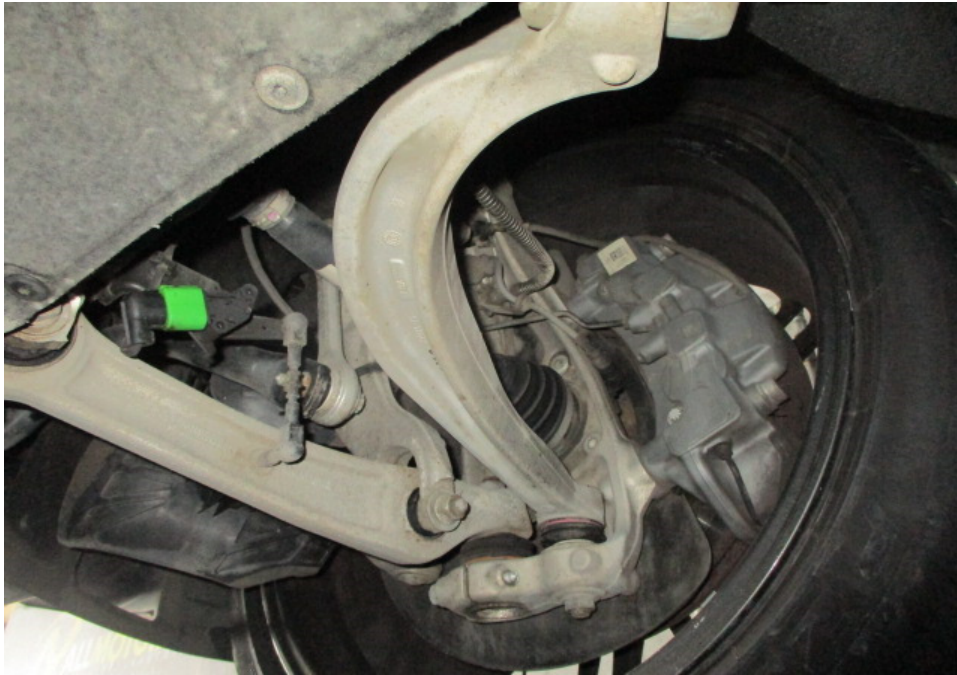
**Photo 24** shows the various undercarriage components at the front right wheel of the Motor Car. The mechanical components, control arms and linkages were all found to be intact and secured in an appropriate manner. I also did not observe any fluid leak and/or fluid stain on the underside of the Motor Car.

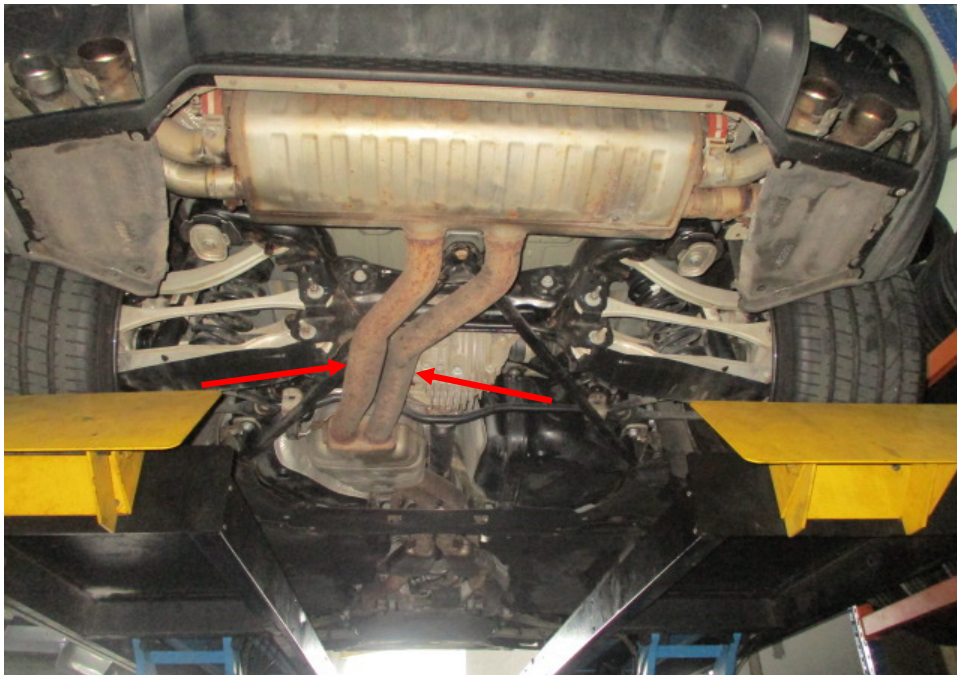
**Photo 25** shows the rear section of the Motor Car's exhaust system. My examination of the Motor Car's exhaust system revealed no sign(s) or indication(s) of any cut or weld marks along its exhaust pipes (arrowed), on its rear muffler, on its centre resonator boxes and on its catalytic converters.

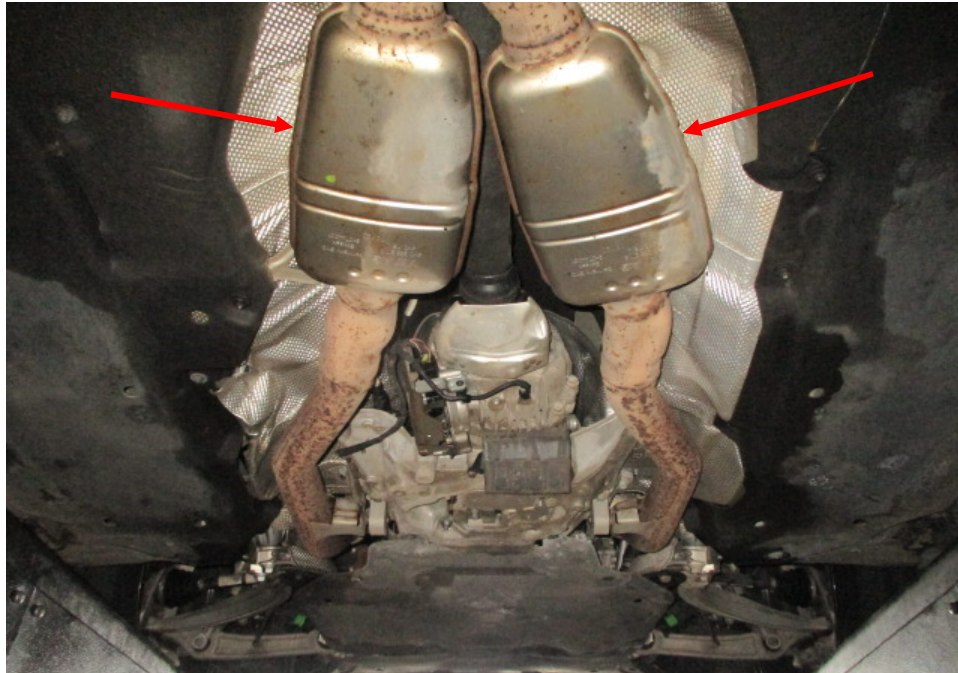
**Photo 26** shows the front section of the Motor Car's exhaust system. My examination of the Motor Car's exhaust system revealed no sign(s) or indication(s) of any cut or weld marks along its exhaust pipes, on its rear muffler, on its centre resonator boxes (arrowed) and on its catalytic converters.

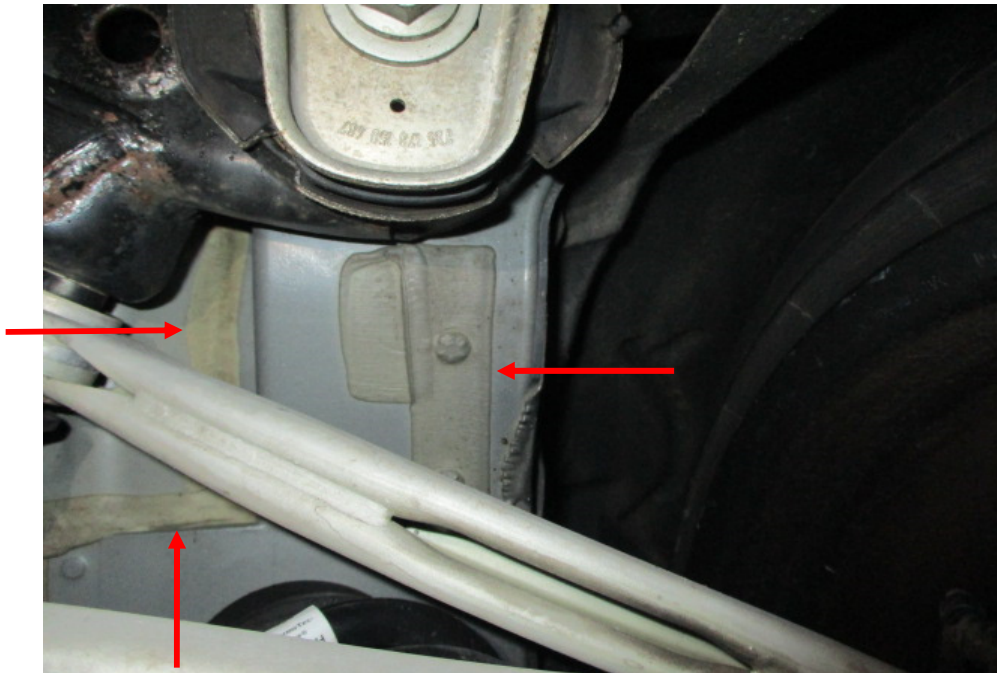
**Photo 27** shows the chassis/structural body at the underside rear right of the Motor Car. I did not find any weld marks other than original spot weld marks on the chassis/structural body of the Motor Car. The original factory sealant (arrowed) at the joints along the chassis/structural body was untouched, indicating no work was done on the chassis/structural body of the Motor Car and that the chassis/structural body was originally fitted.

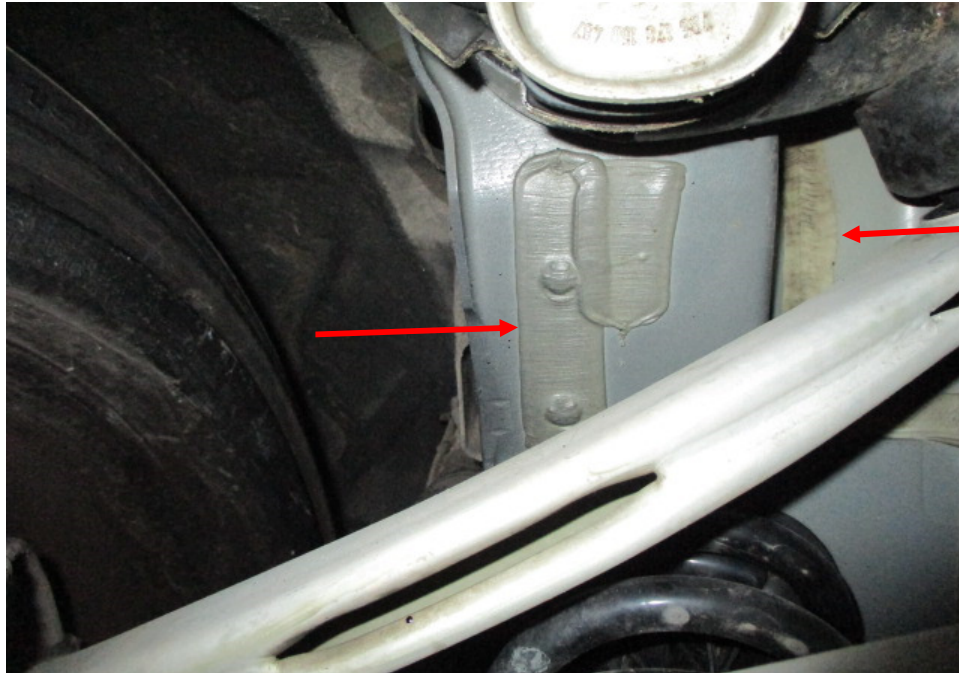
**Photo 28** shows the chassis/structural body at the underside rear left of the Motor Car. The original factory sealant (arrowed) at the joints along the chassis/structural body was observed to be untouched. In general, I had found no work was carried out on the chassis/structural body of the Motor Car. The chassis/structural body of the Motor Car was originally fitted.

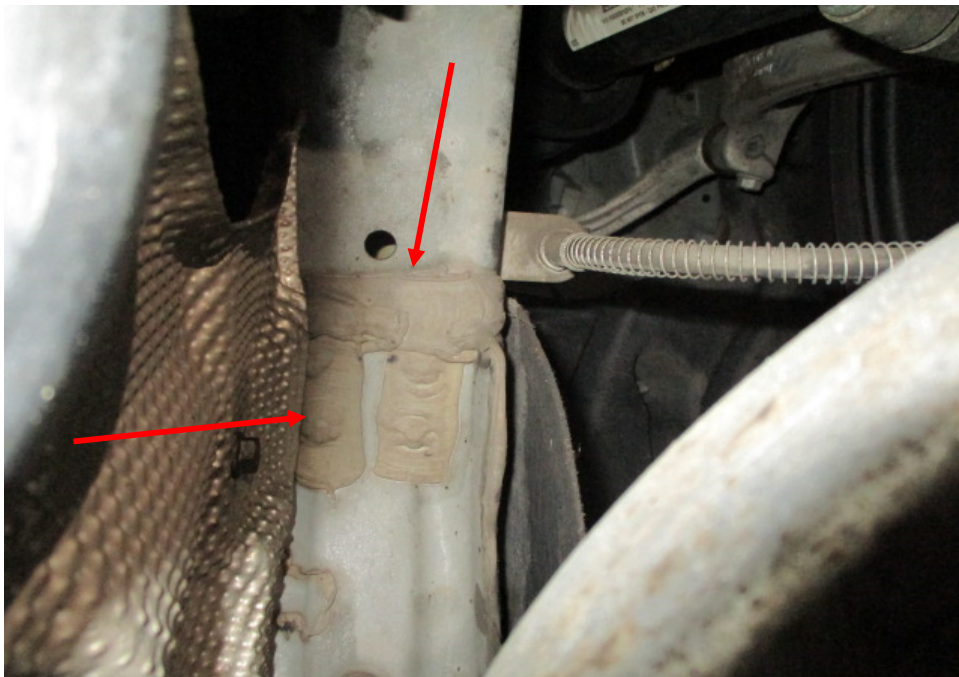
**Photo 29** shows the chassis/structural body at the underside front left of the Motor Car. I did not find any weld marks other than original spot weld marks on the chassis/structural body of the Motor Car. The original factory sealant (arrowed) at the joints along the chassis/structural body was untouched, indicating no work was done on the chassis/structural body of the Motor Car and that the chassis/structural body was originally fitted.

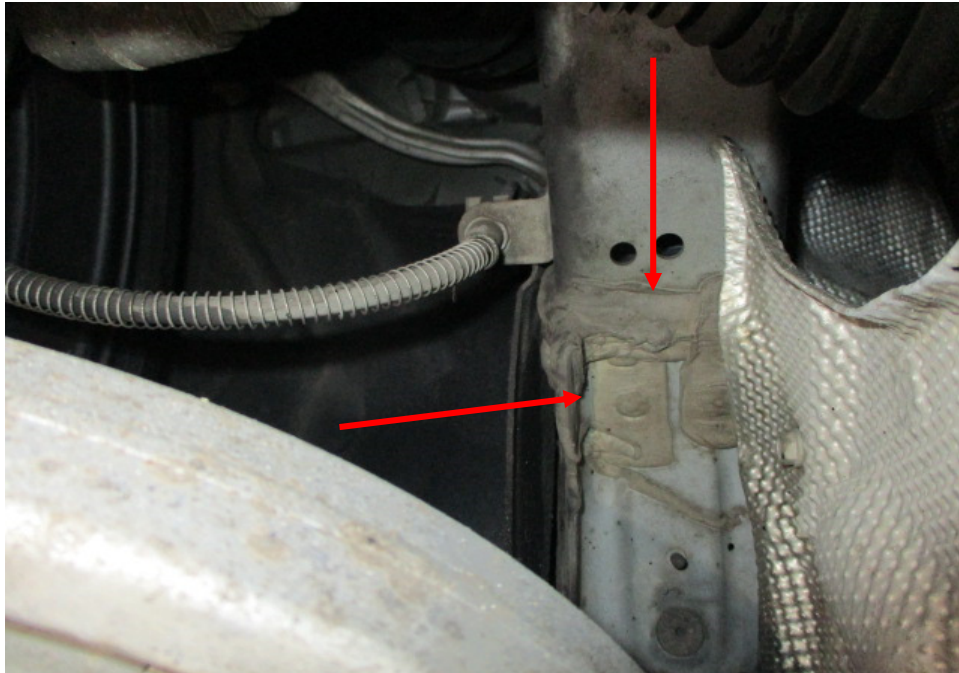
**Photo 30** shows the chassis/structural body at the underside front right of the Motor Car. The original factory sealant (arrowed) at the joints along the chassis/structural body was observed to be untouched. In general, I had found no work was carried out on the chassis/structural body of the Motor Car. The chassis/structural body of the Motor Car was originally fitted.
