Vehicle No. GBG 9986K  
Insured Veh. SLL 2511Z  
Claim No. SNM22D208404/C02  
Policy No. DMPCSNW00166992100  
Accident Date 20/11/2022  
Inspection Date 21/11/2022

## LKK Auto Consultants Pte Ltd

### ADJUSTMENT ON REPAIR COST FOR VEHICLE NO. GBG 9986K

### PHOTOGRAPHS FOR VEHICLE NO. GBG 9986K

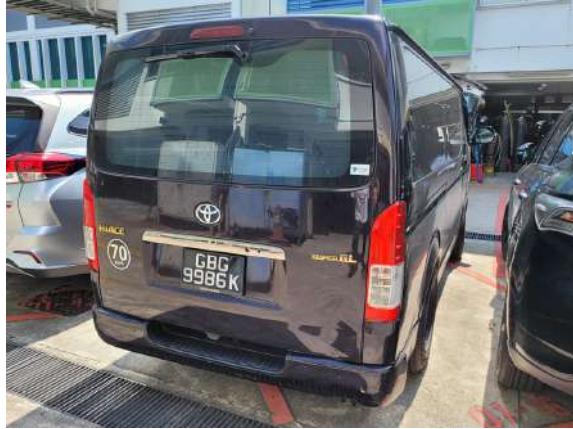
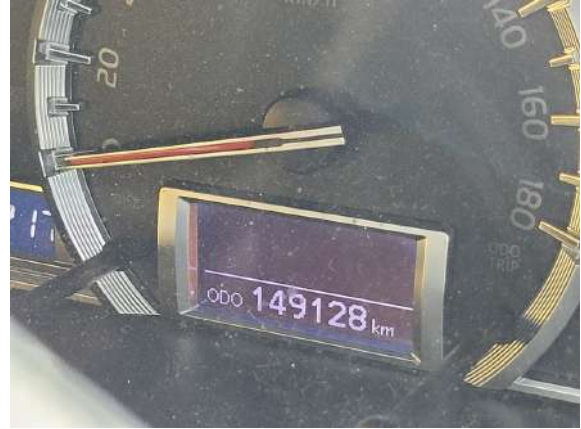
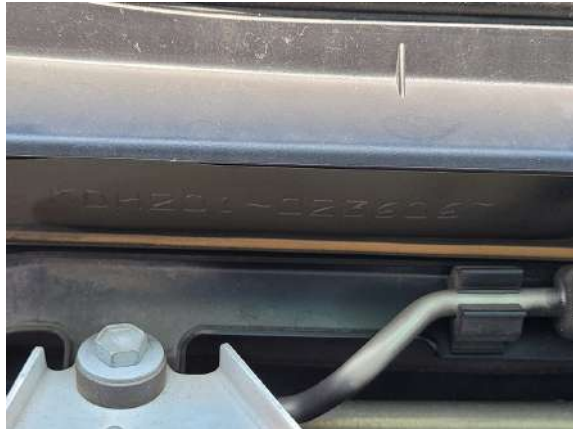
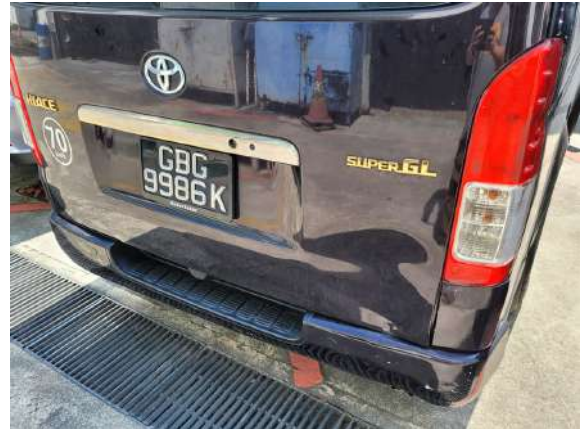
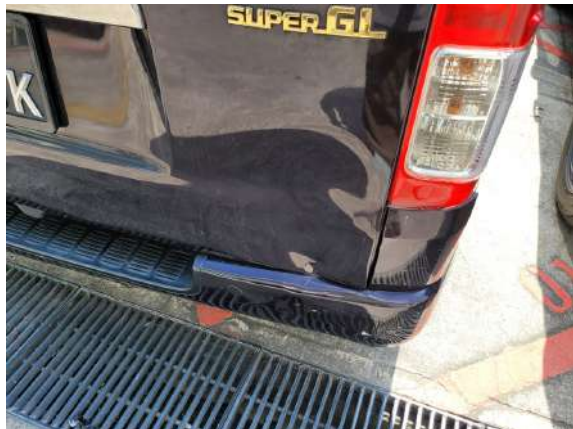
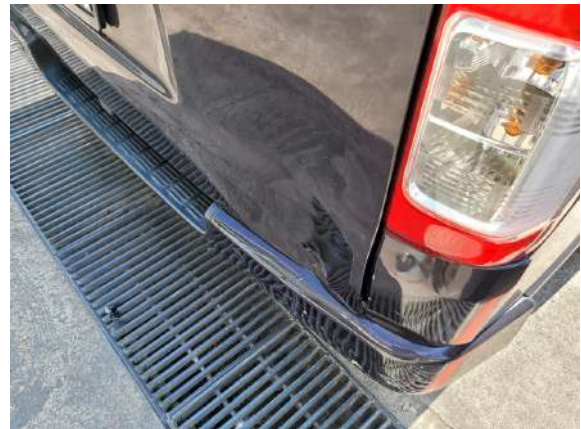
### INSPECTION

| Affiliated to Federation Internationale Des Experts En Automobile | | | | |
|---|---|---|---|---|
| | THE VEHICLE SUSTAINED DAMAGES AT THE REAR PORTION.<br>DAMAGES SEE DETAILS. | | | |
