# PRO-OPTION SERVICES

## ACCIDENT VEHICLE INSPECTION REPORT

Report no : 930M22.MCS  
Vehicle no : SMH4861J

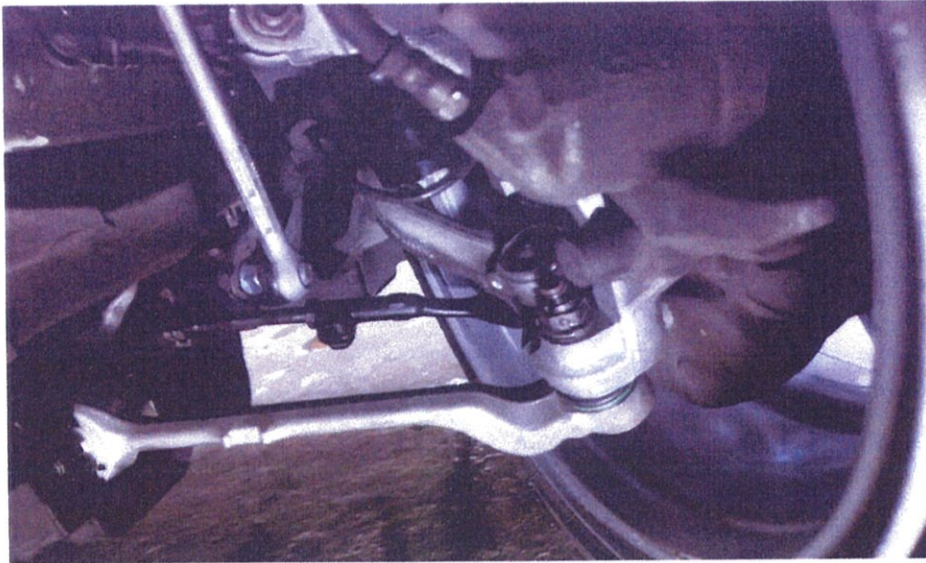
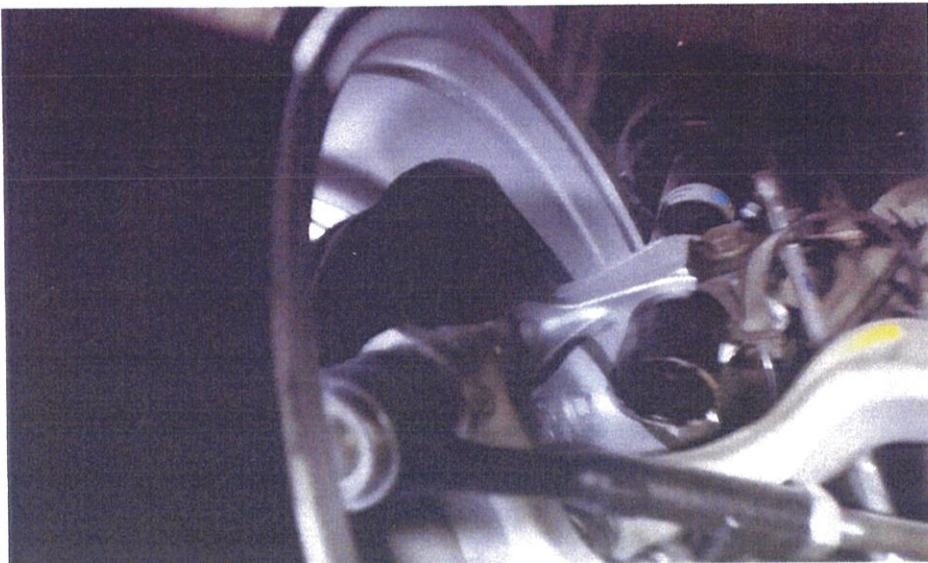
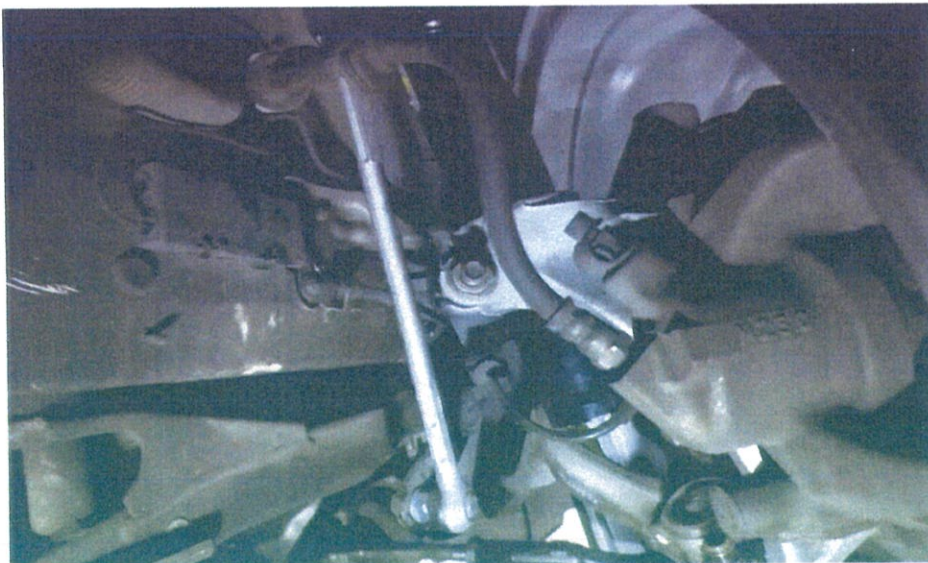
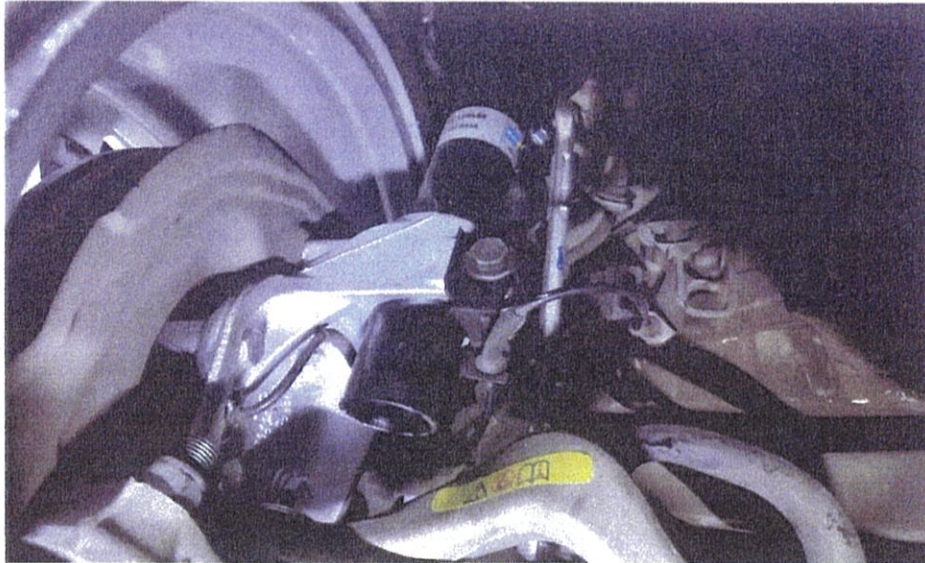
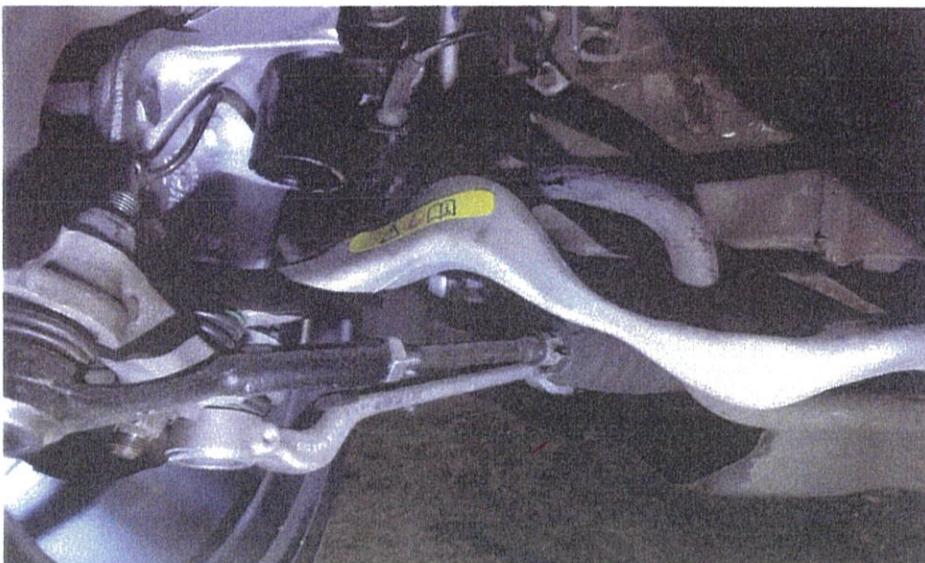
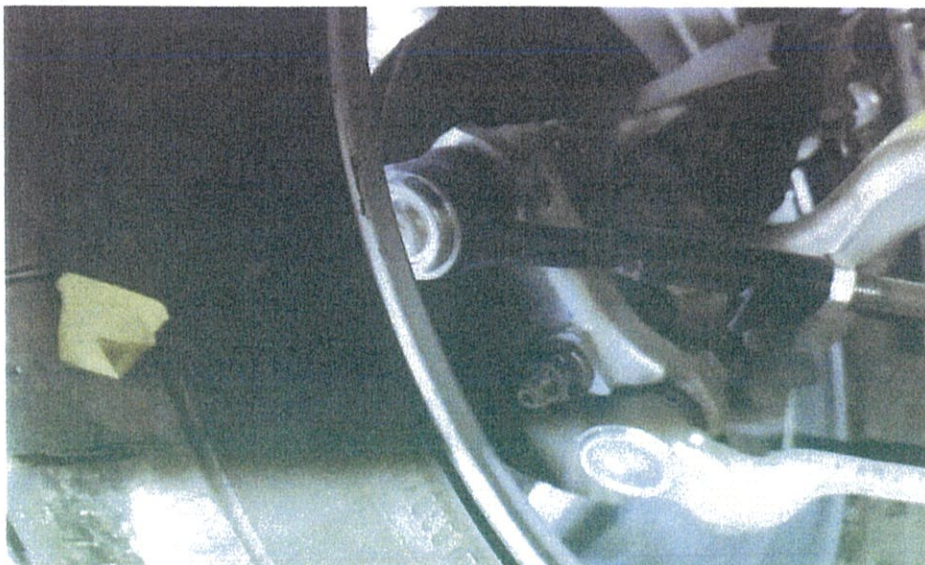
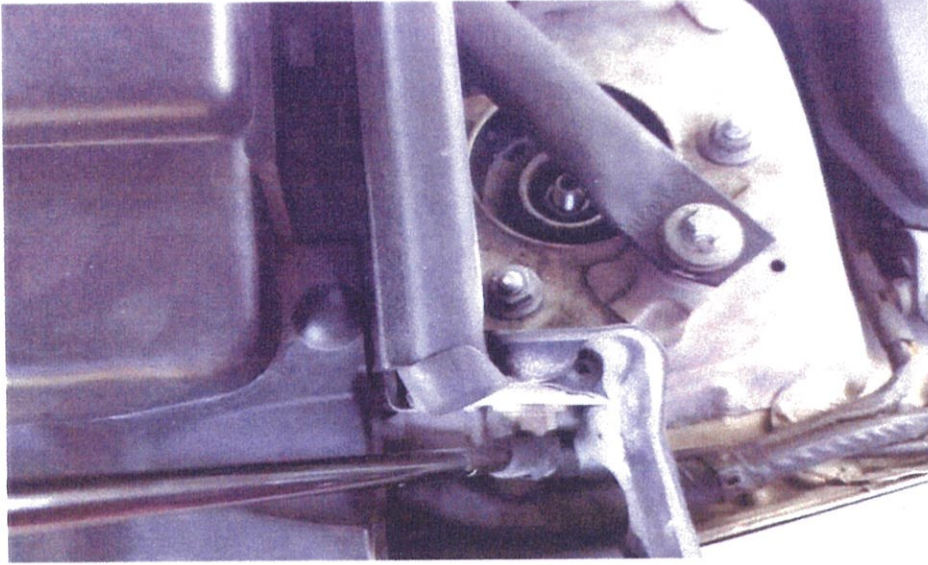
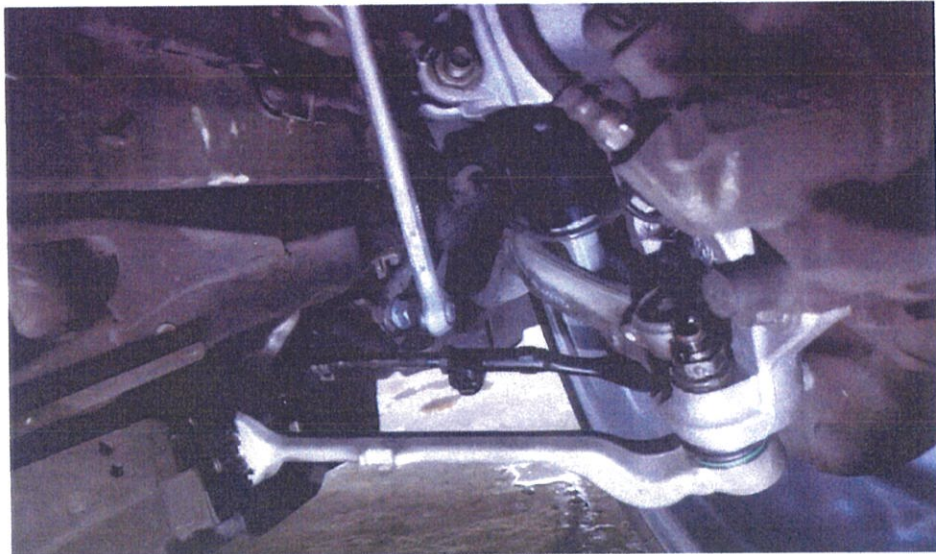
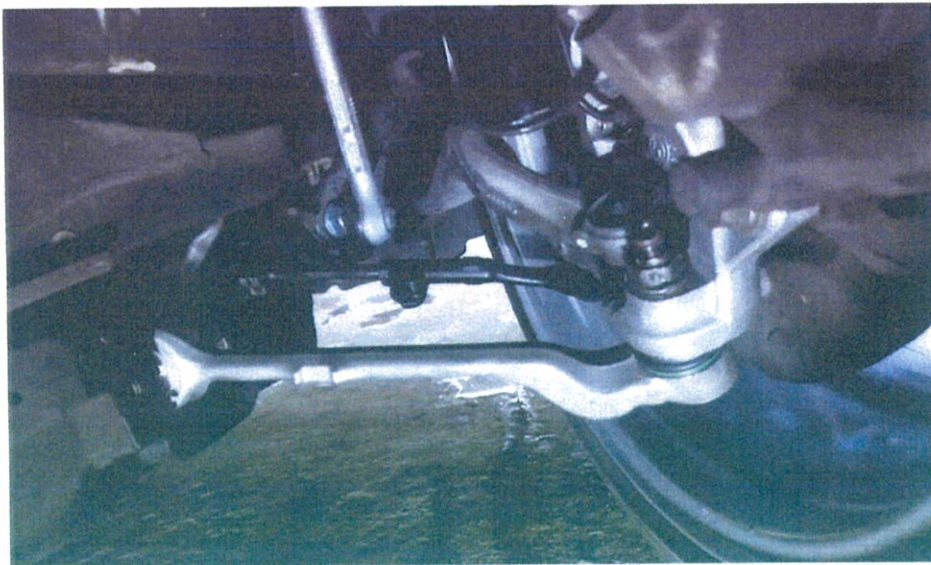
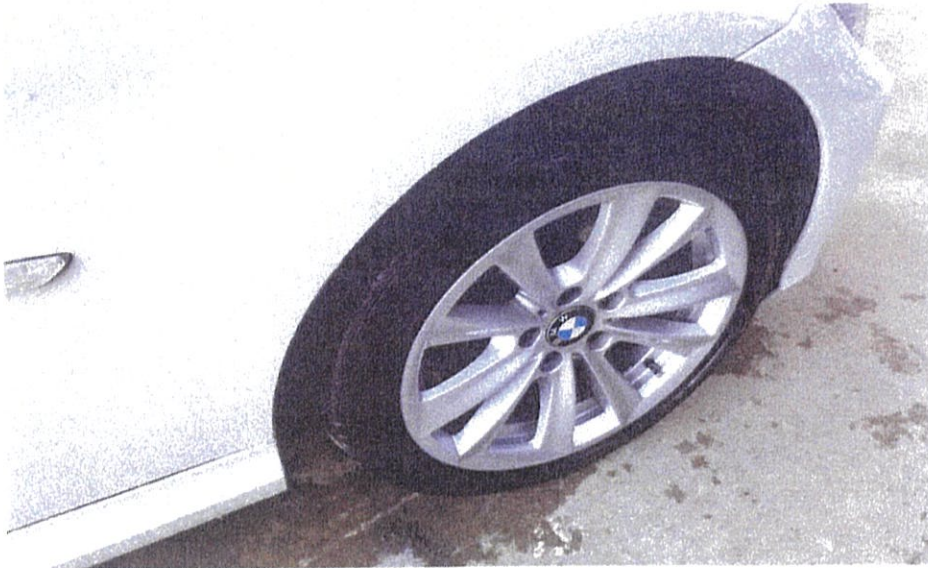
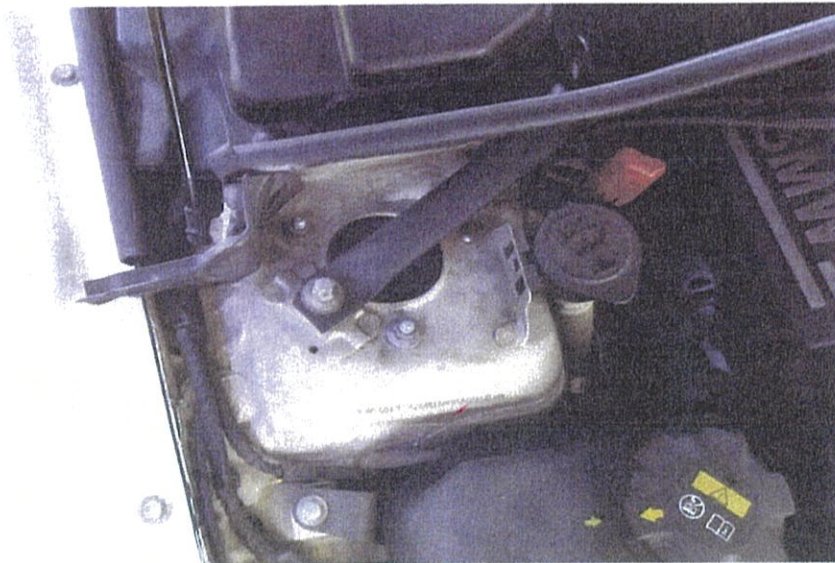
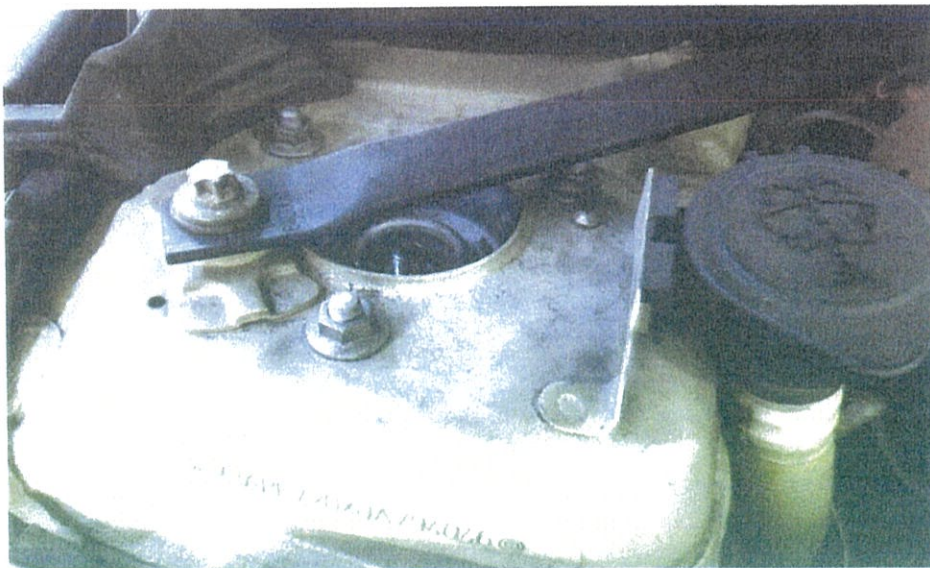
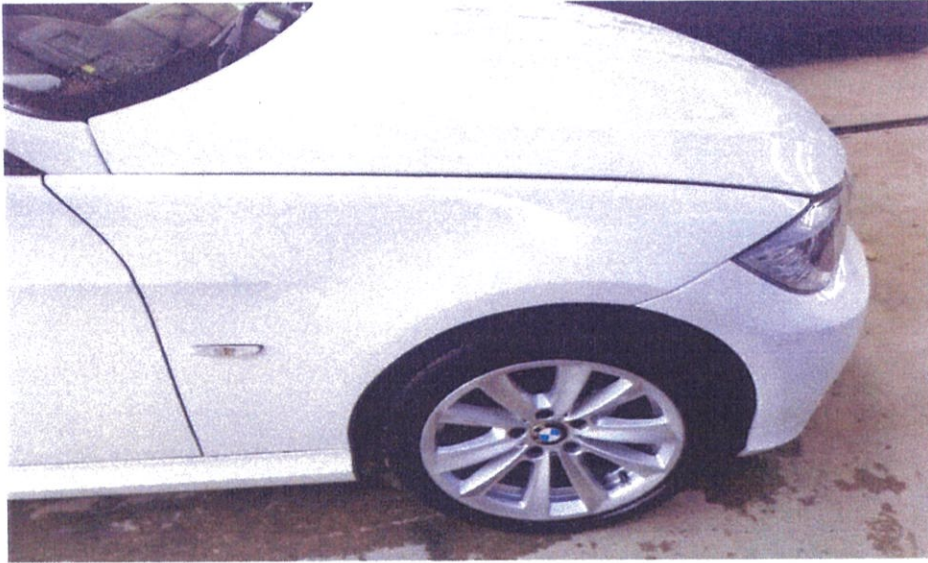
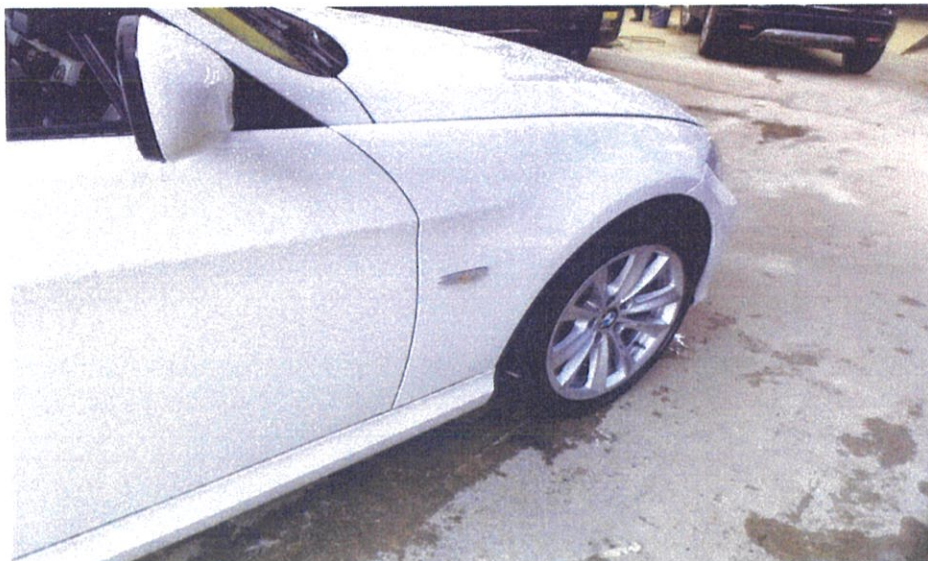
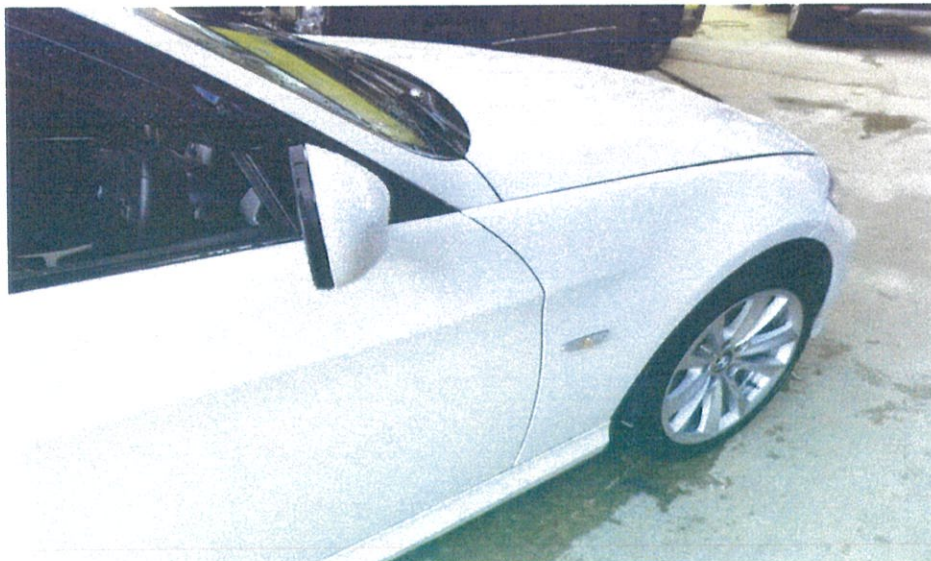
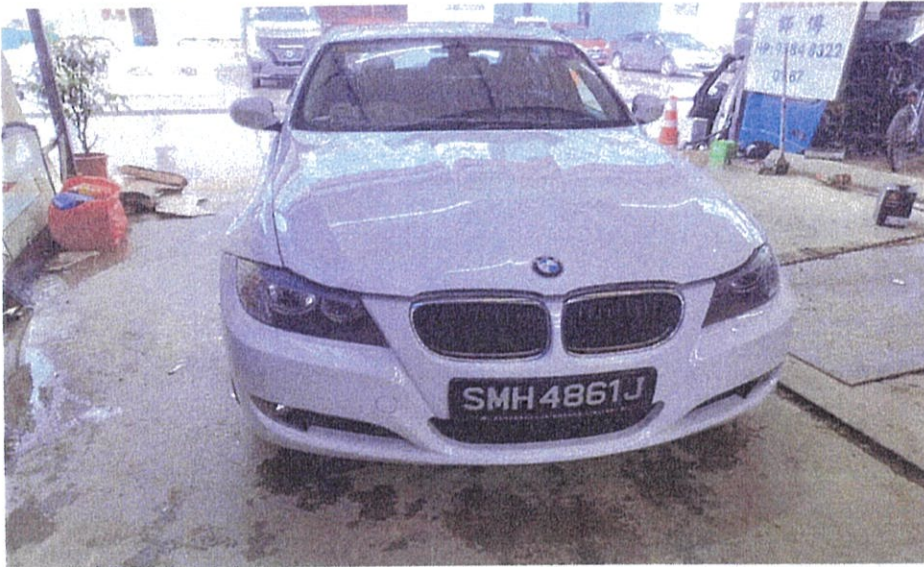
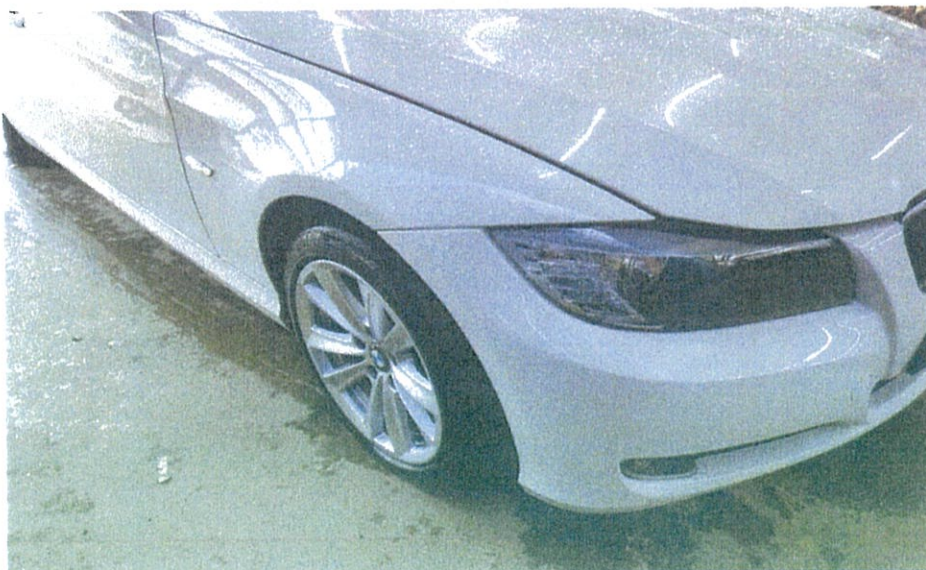
POST REPAIR

(Post Repair Inspection conducted on 30 September 2022)
