Your Ref: ynYv6aQ7mh
Our Ref : CI/III22011913/P

**TECHNICAL INVESTIGATION REPORT OF WARRANTY CLAIM INVOLVING
THE INSURED VEHICLE SMY 7674Z ON 16th November 2022**

Vehicle Registration No.	: SMY 7674Z
Make / Model	: MERCEDES BENZ GLC 300 SPORT 4MATIC (A) M-HYBRID
Chassis No	: W1N2539842V250746
Year of Registration	: MARCH 2021
Mileage	: 19,846KM

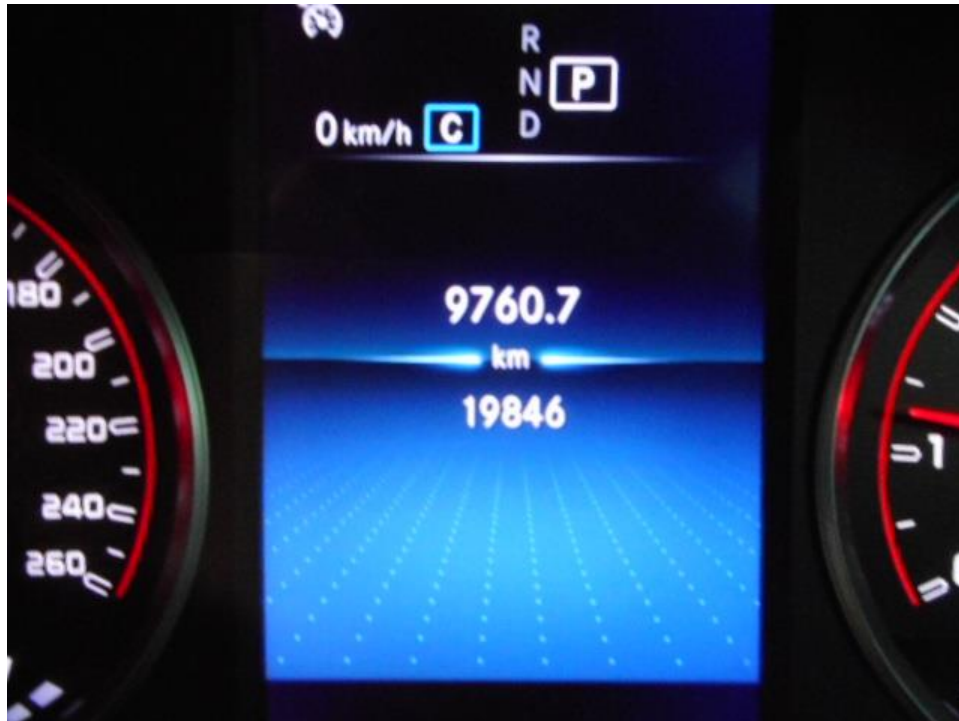
Photo 1 shows the mileage of the Insured Vehicle recorded at the time inspection at 19,846KM

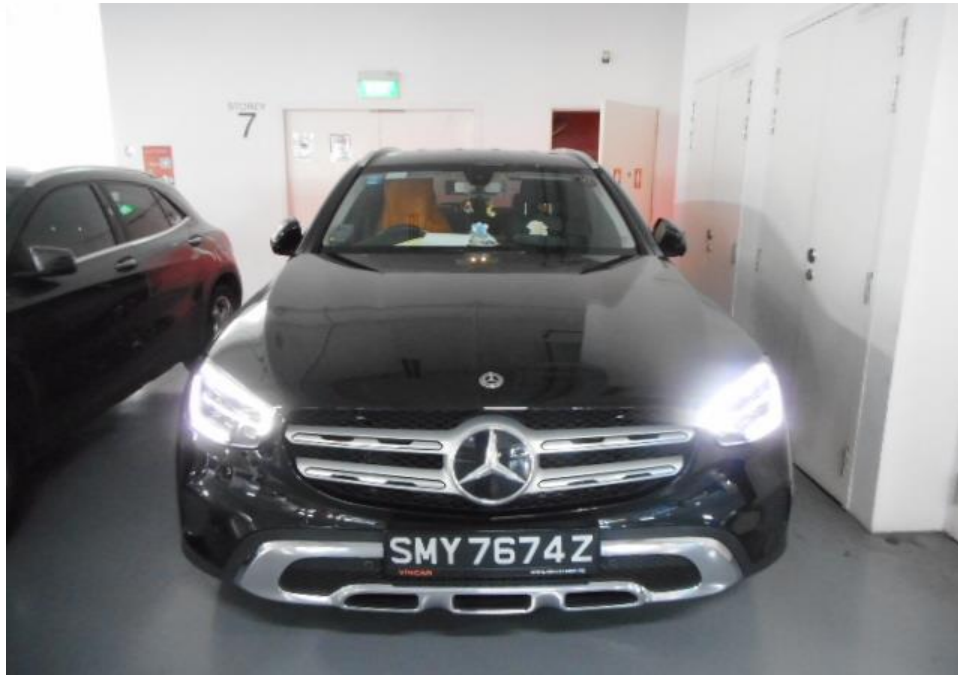
Photo 2 shows the general view of the front portion of the Insured Vehicle at the time of our inspection. The Insured Vehicle is observed to be unaffected by any signs of accident.

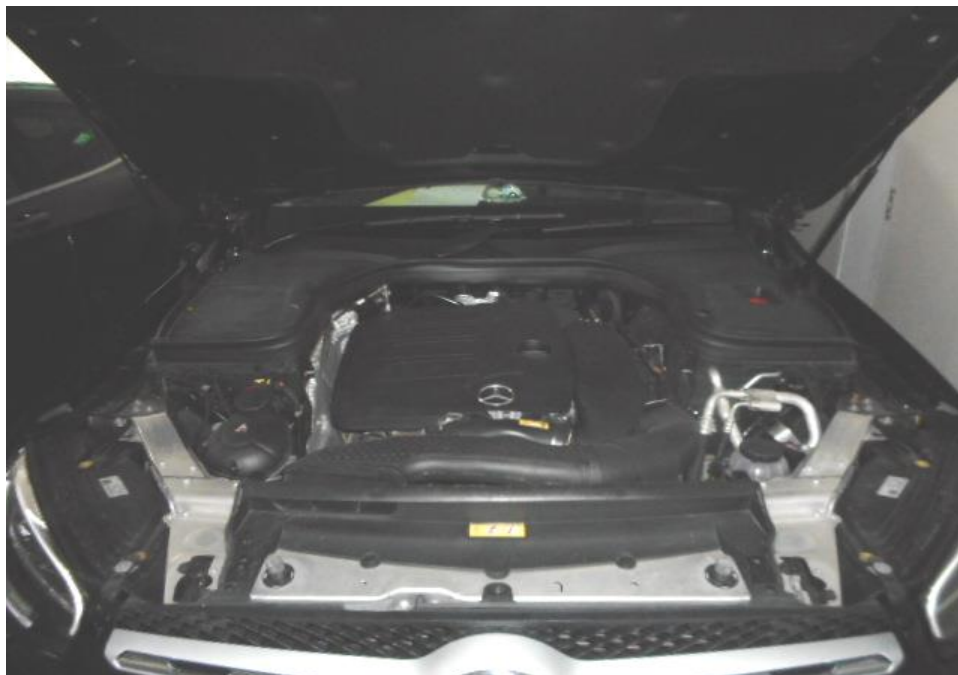
Photo 3 shows the general view of the engine portion of the Insured Vehicle at the time of our inspection. The engine compartment is observed to be unaffected by any signs of accident.

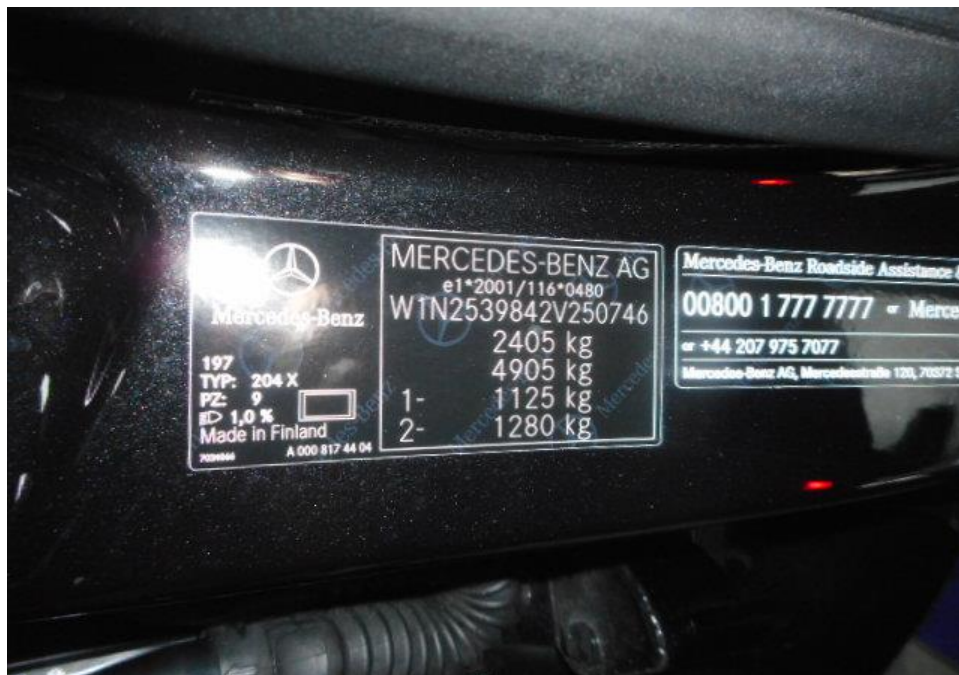
Photo 4 shows the chassis number of the Insured Vehicle at the time of our inspection.

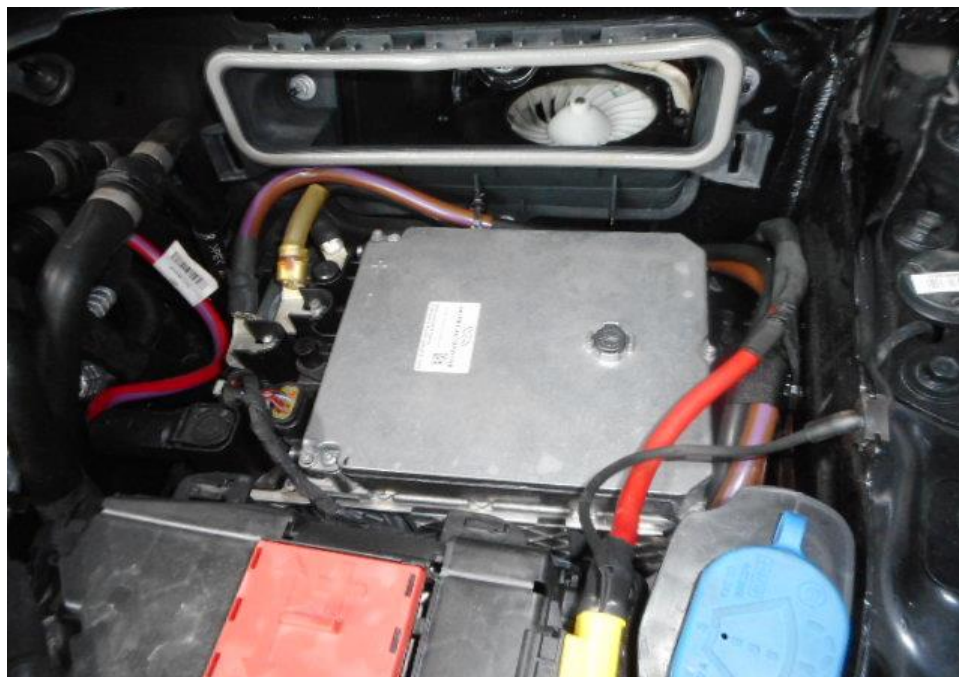
Photo 5 shows the general view of the 48v battery and its components in the engine compartment portion of the Insured Vehicle at the time of our inspection. The 48v battery and its components is observed to be unaffected and by any signs of accident.

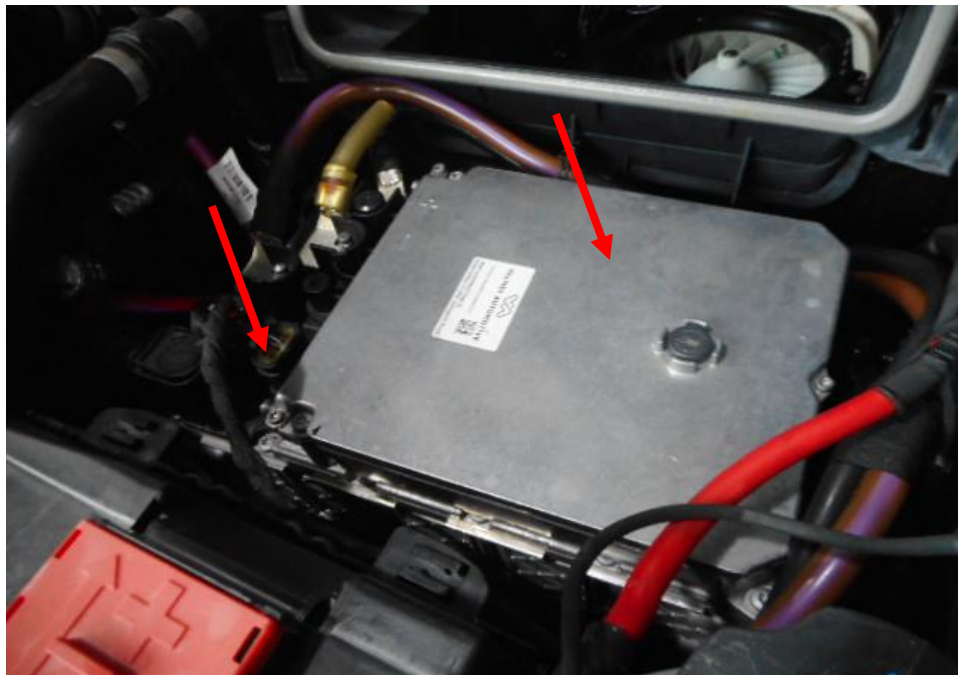
Photo 6 shows the close up view of the 48v battery and its components (arrowed) in the engine compartment portion of the Insured Vehicle at the time of our inspection. The 48v battery and its components is observed to be unaffected and by any signs of accident.

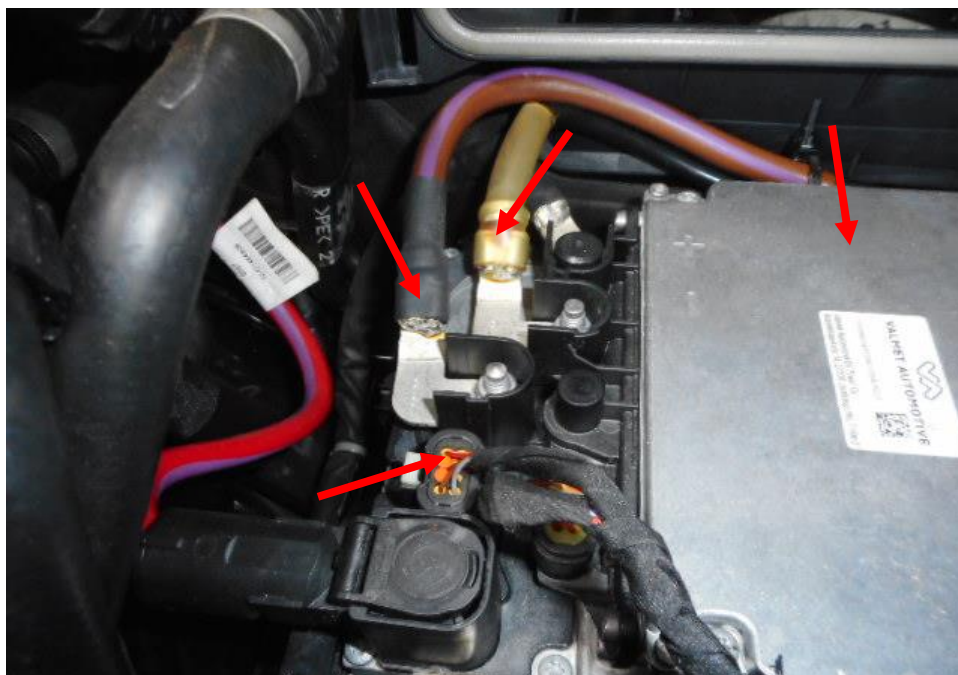
Photo 7 shows the close up view of the 48v battery and its components (arrowed) in the engine compartment portion of the Insured Vehicle at the time of our inspection. The 48v battery and its components is observed to be unaffected and by any signs of accident.

8. We did not find any evidence which had suggested that the cause of abnormalities to the Insured Vehicle was due to poor maintenance and/or recurring problem.
9. The recommendation to replace the 48V battery at \$4,183.70 is justifiable as all the relevant checks has been conducted.

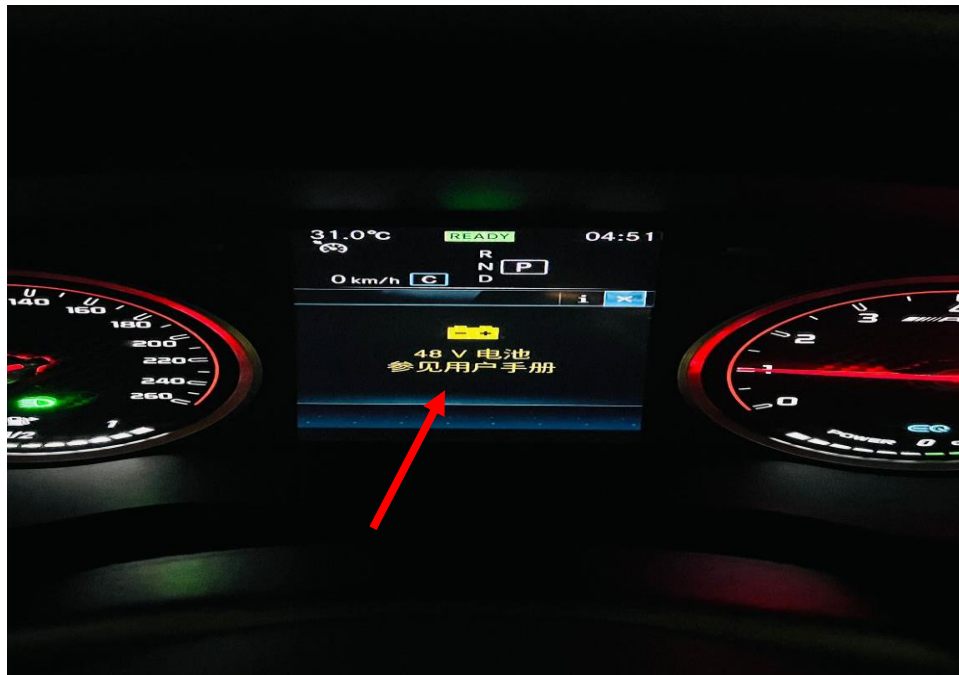
Photo 8 shows the conducted ECU diagnosis of the Insured Vehicle at the time of our inspection. There was an electronic error (arrowed) on the 48v battery integrated starter system (ISG) of the Insured Vehicle.
