Your Ref: Porsche 718 Boxster
(chassis number WP0ZZZ98ZNS222413)
Our Ref : CI/TP22011942/D

INSPECTION REPORT OF AN UNREGISTERED PORSCHE 718 BOXSTER MOTOR CAR WITH CHASSIS NUMBER WP0ZZZ98ZNS222413

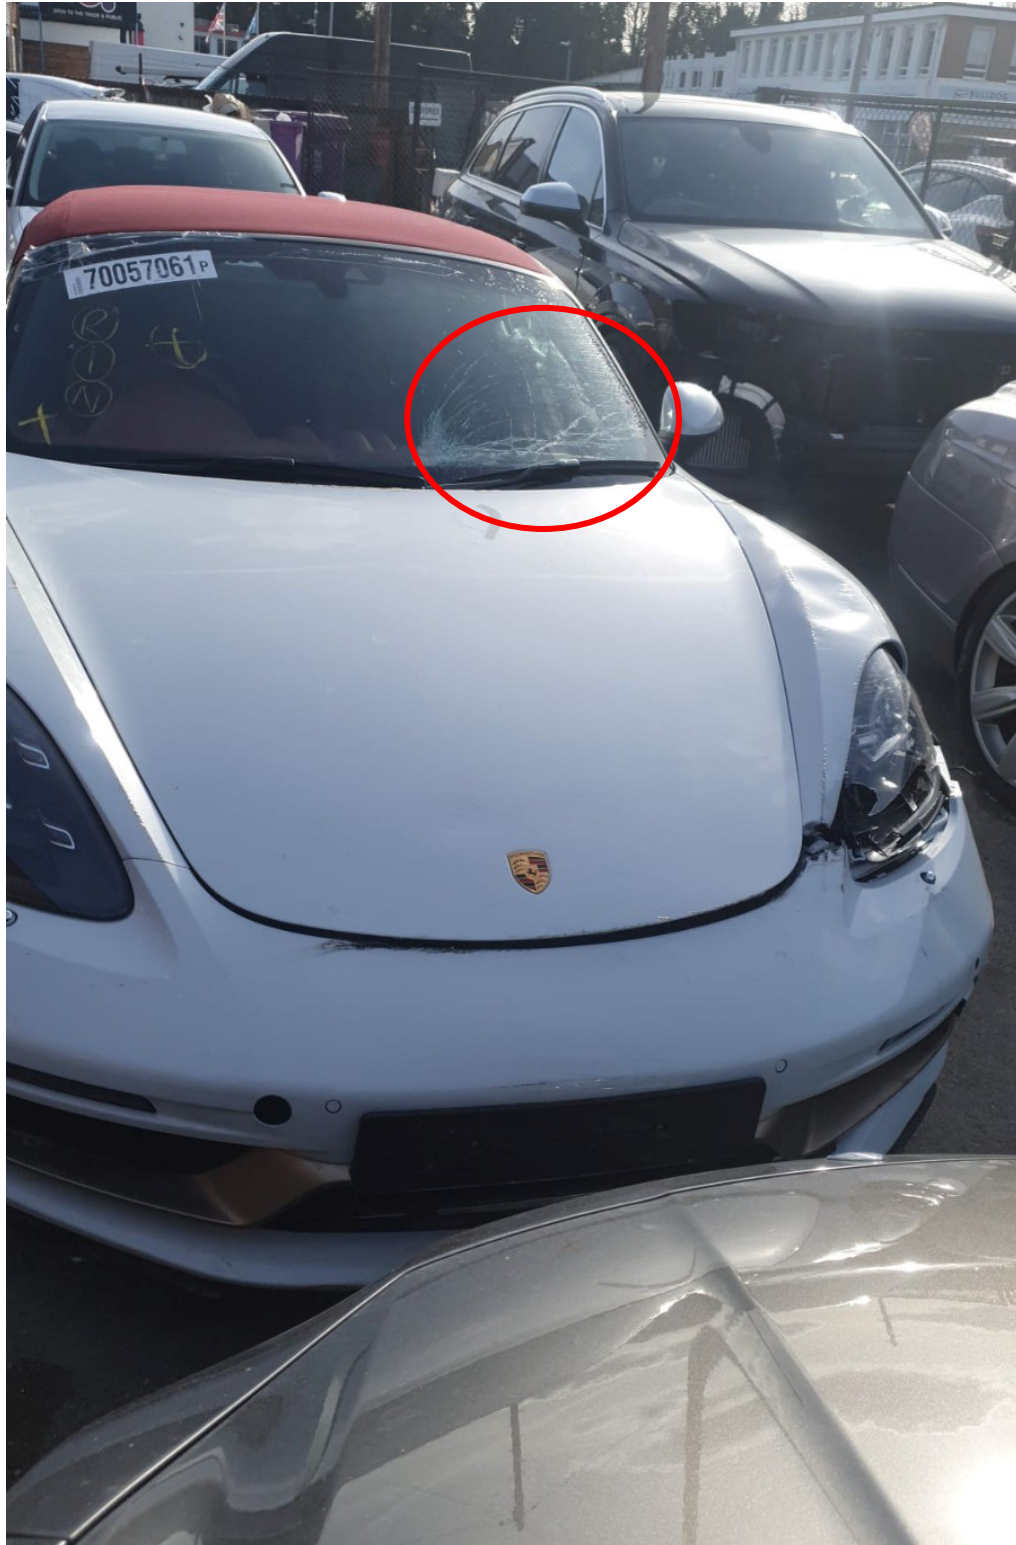
3. The photographs provided to me had showed damage along the entire left side portion and rear portion of the Motor Car. Body parts damage along the left side portion include the front bumper, front bonnet, front windscreen, front left headlamp, front left fender, front left wheel rim, front left door, rear left body panel, rear left side air duct, left side rocker panel garnish and soft top roof amongst others. As for the rear portion, I had observed damage to the rear bumper and rear bumper lower cover amongst others.

Photo 1 shows the frontal body of the Motor Car (photograph provided to me). The photographs provided to me had showed damage along the entire left side portion and rear portion of the Motor Car. The front bumper, front left headlamp, front left fender and front windscreen (circled) were amongst the body parts that were observed to have been damaged.

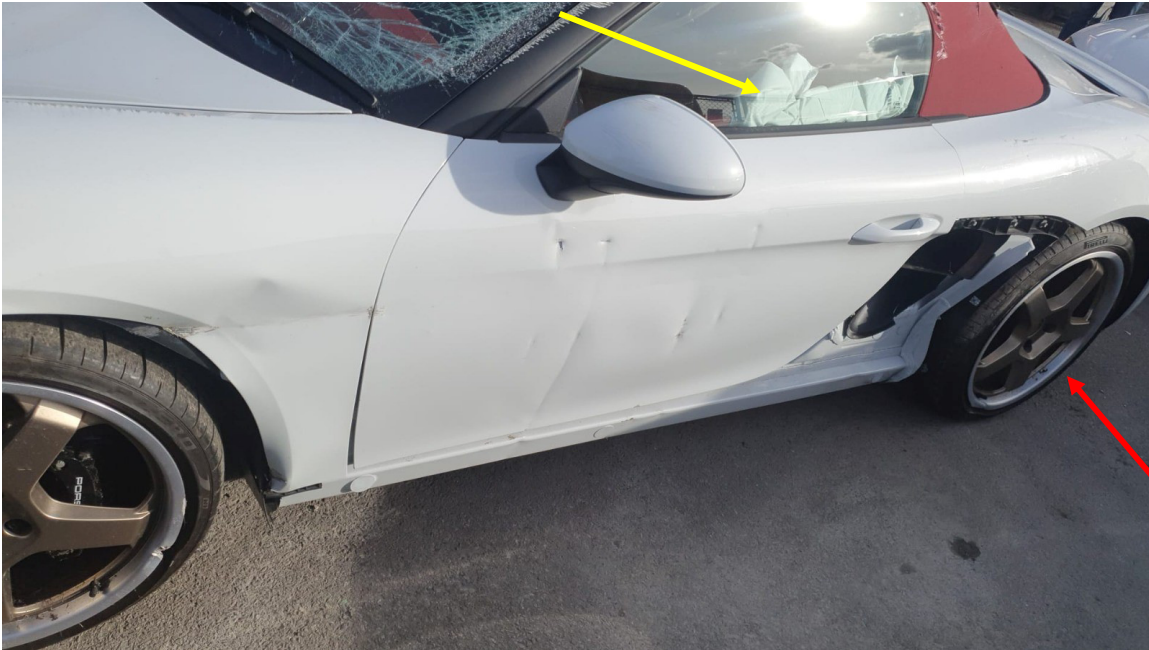
4. The Motor Car's rear left wheel appears to be orientated slightly towards the left. This indicates damage to the rear left undercarriage parts of the Motor Car. Parts that may possibly be damage include the rear left lower arm, rear left knuckle arm and rear left shock absorber amongst others.

Photo 2 shows a general view of the left side body of the Motor Car (photograph provided to me). The front left wheel rim, front left door, rear left body panel, rear left side air duct, left side rocker panel garnish and soft top roof were amongst the body parts that were observed to have been damaged. The front left door airbag was deployed (yellow arrow). The Motor Car's rear left wheel (red arrow) appears to be orientated slightly towards the left. This indicates damage to the rear left undercarriage parts of the Motor Car. Parts that may possibly be damage include the rear left lower arm, rear left knuckle arm and rear left shock absorber amongst others.

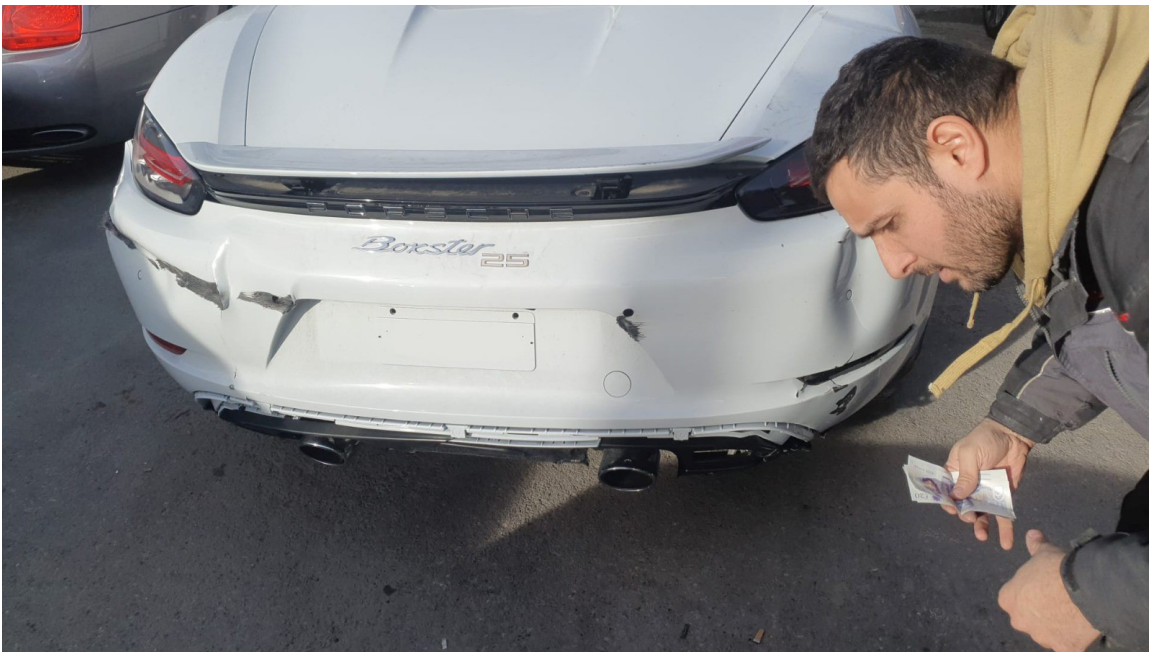
Photo 3 shows a general view of the rear body of the Motor Car (photograph provided to me). Apart for the left side portion, the photographs provided had also showed damage at the rear portion of the Motor Car. The rear bumper and rear bumper lower cover were amongst the body parts that were observed to have been damaged.

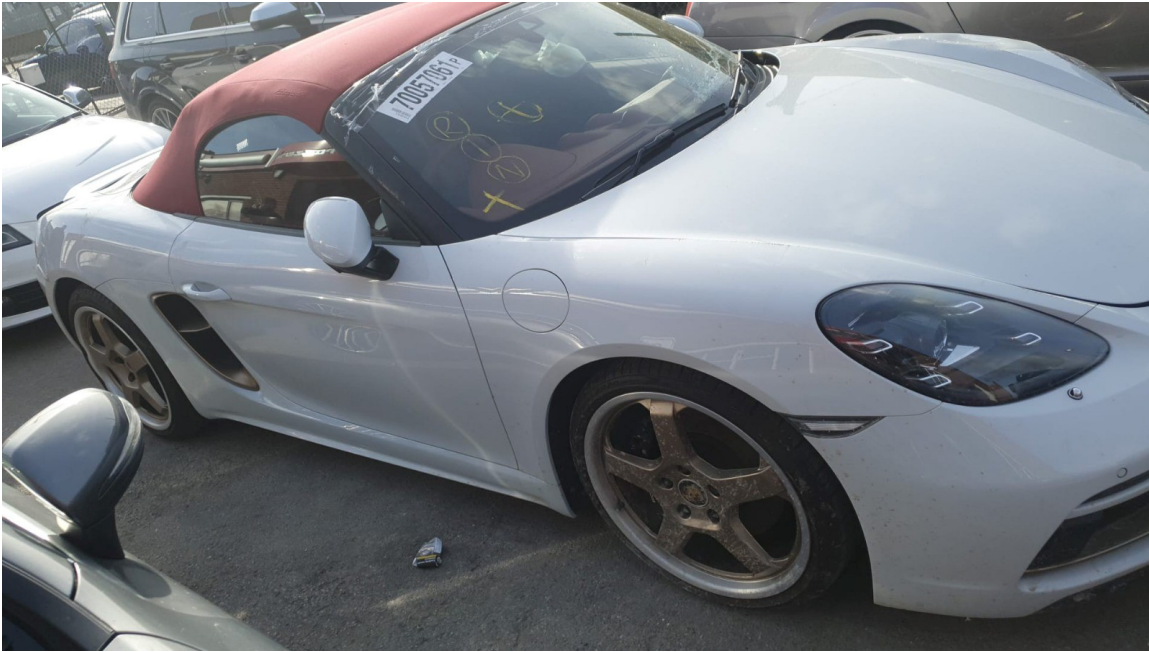
Photo 4 shows the right side body of the Motor Car (photograph provided to me). No physical damage was seen to the right side portion of the Motor Car.

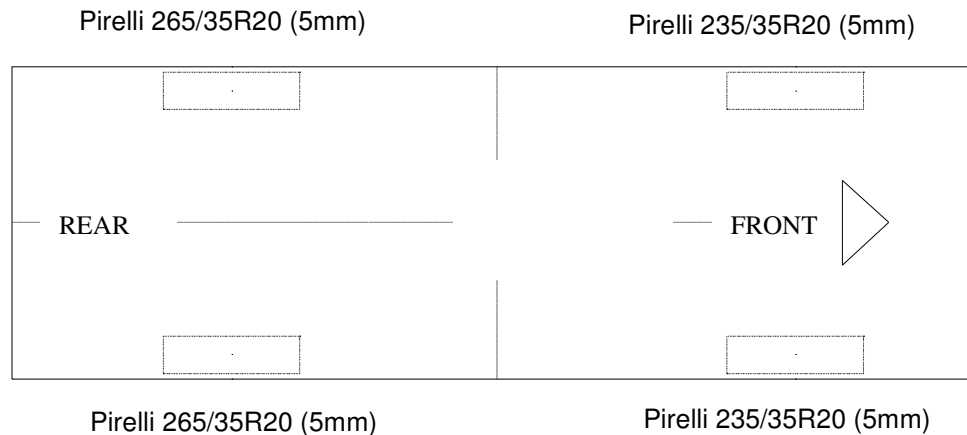
10. It was fitted with 20inch sport wheel rims that were wrapped with tyres that were observed to be of serviceable condition. The tyres were also sufficiently inflated for vehicular operation. The tyre brand, tyre size and approximate remaining tread depth of the 4 tyres of the Motor Car were recorded as follows: -

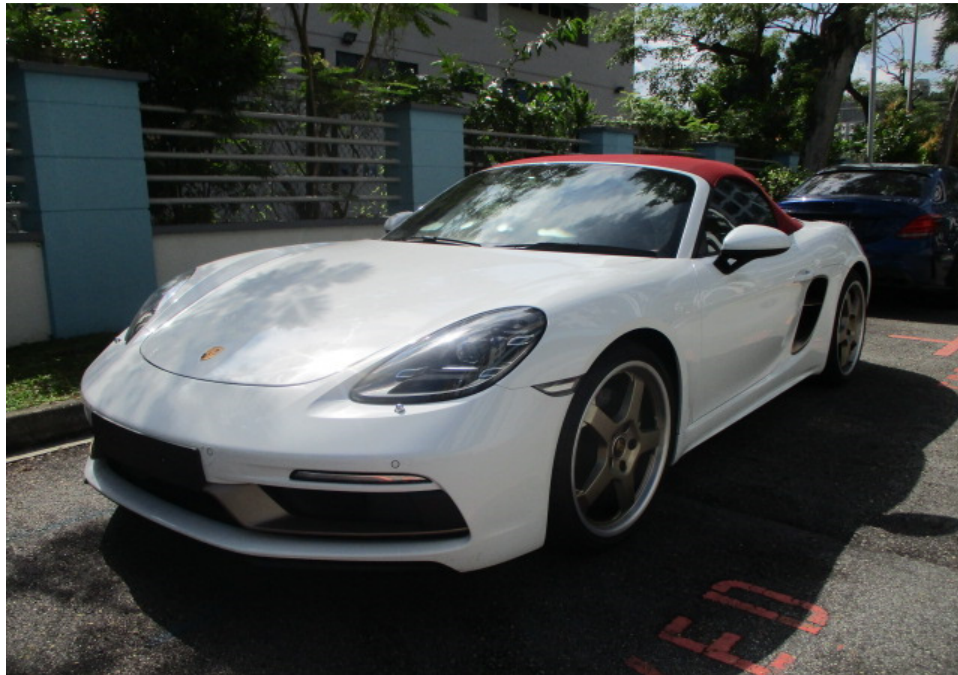
Photo 5 shows a general view of the front left body of the Motor Car at the time of my inspection. The Motor Car was observed to be in a relatively good general condition with no loose exterior fittings observed. The body parts along the entire left side portion of the Motor Car were visually examined and it was observed that the repair/restoration works carried out to the damaged area of the Motor Car (refer to photograph 1 & 2 above) were reasonably adequate and in order.

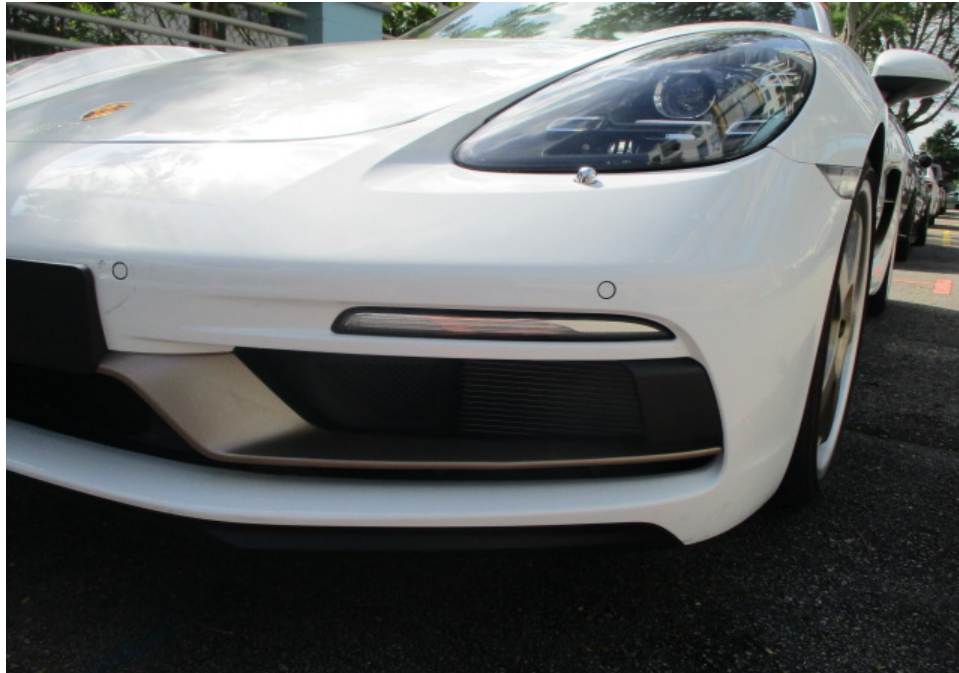
Photo 6 shows a closer view of the Motor Car's front bumper, front bumper left air duct, front bonnet, front left day light and front left headlamp. The body parts along the entire left side portion of the Motor Car were visually examined and it was observed that the repair/restoration works carried out to the damaged area of the Motor Car (refer to photograph 1 & 2 above) were reasonably adequate and in order.

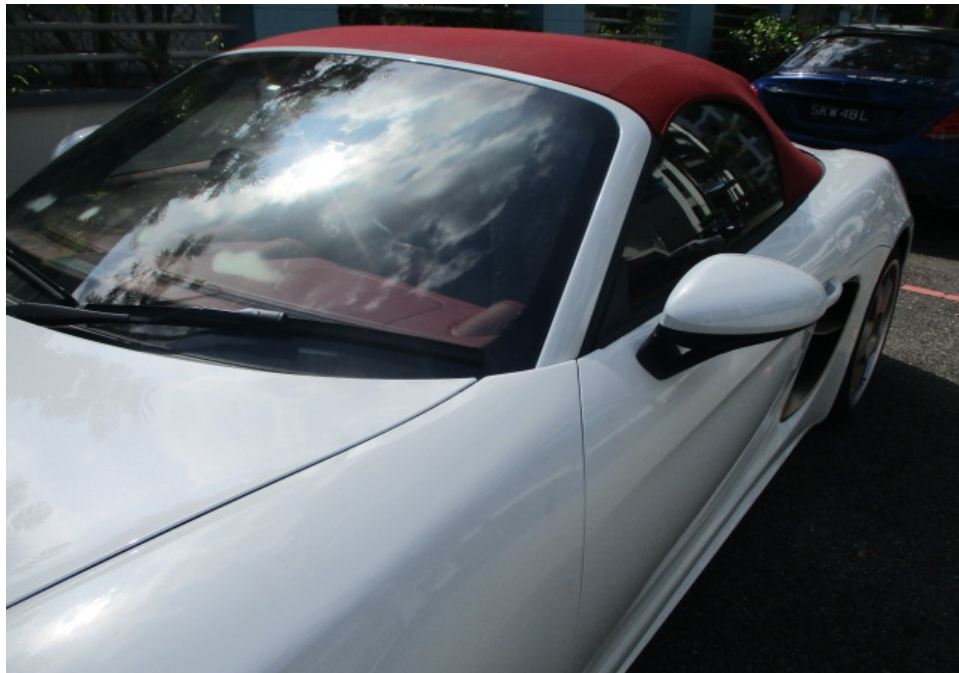
Photo 7 shows a closer view of the Motor Car's front windscreen and left wing mirror. The body parts along the entire left side portion of the Motor Car were visually examined and it was observed that the repair/restoration works carried out to the damaged area of the Motor Car (refer to photograph 1 & 2 above) were reasonably adequate and in order.

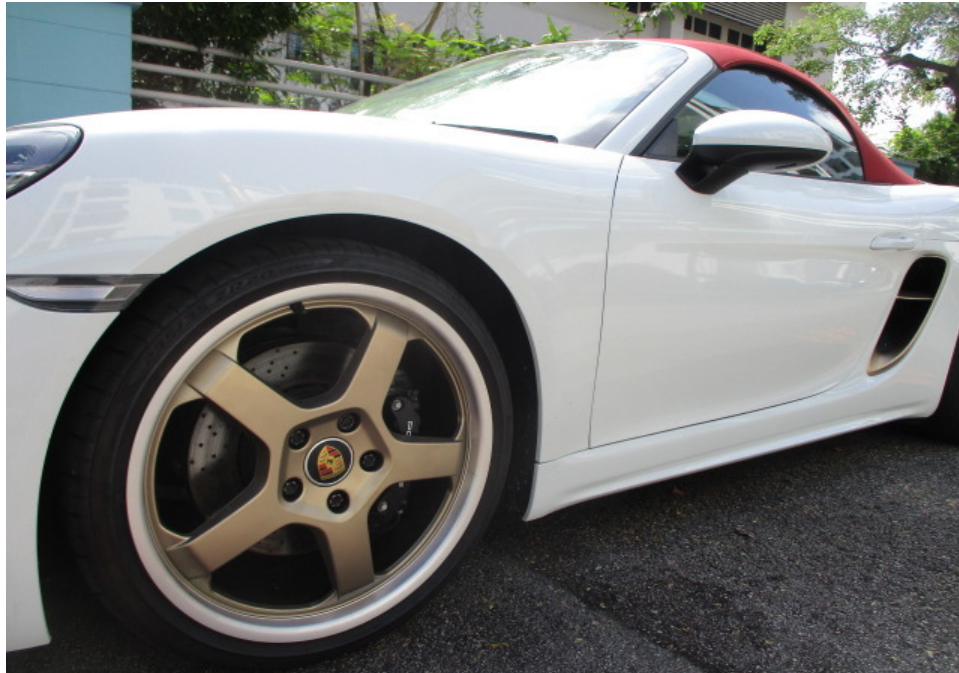
Photo 8 shows a closer view of the Motor Car's front left wheel rim, front left fender, front left door and left side rocker panel garnish. The body parts along the entire left side portion of the Motor Car were visually examined and it was observed that the repair/restoration works carried out to the damaged area of the Motor Car (refer to photograph 2 above) were reasonably adequate and in order.

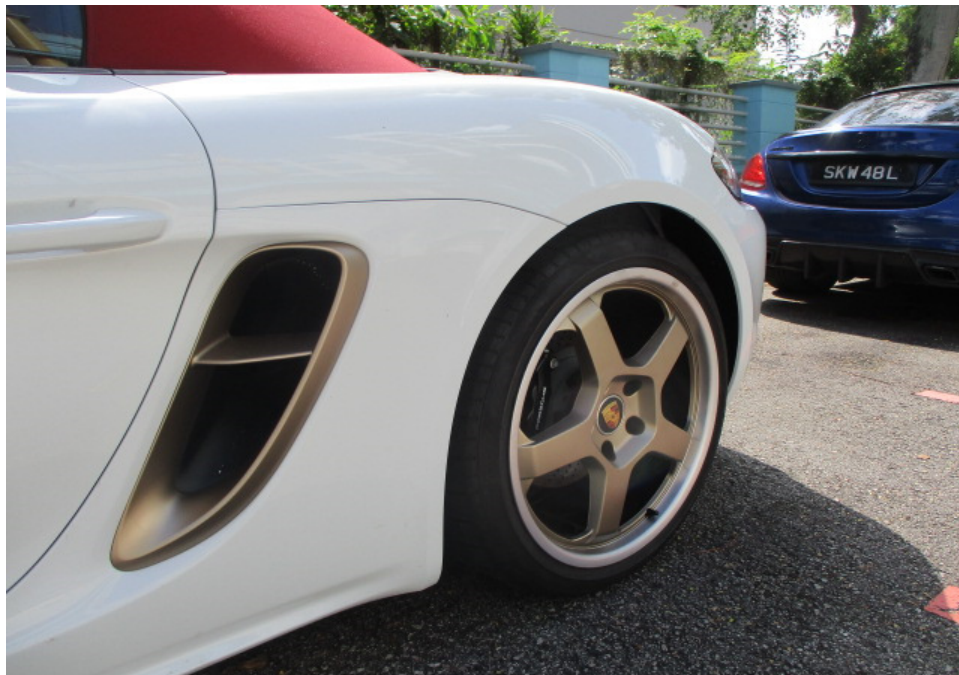
Photo 9 shows a closer view of the Motor Car's rear body panel, rear left side air duct, rear left wheel rim and left side rocker panel garnish. The body parts along the entire left side portion of the Motor Car were visually examined and it was observed that the repair/restoration works carried out to the damaged area of the Motor Car (refer to photograph 2 above) were reasonably adequate and in order.

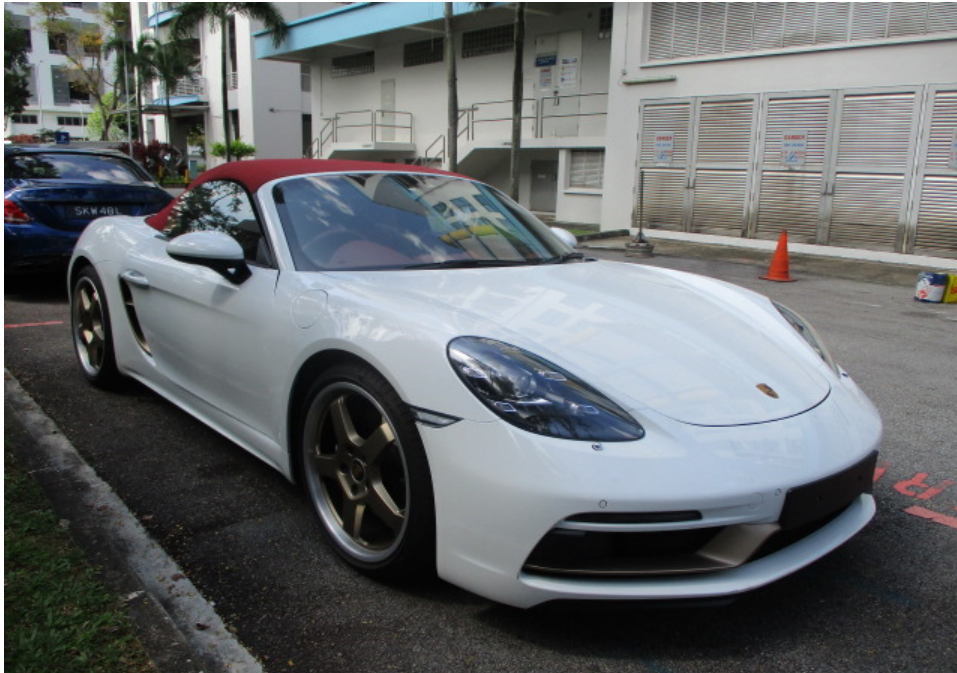
Photo 10 shows a general view of the front right body of the Motor Car at the time of my inspection. The Motor Car was observed to be in a relatively good general condition with no loose exterior fittings observed. The mileage of the Motor Car recorded at the time of my inspection was 1,755km.

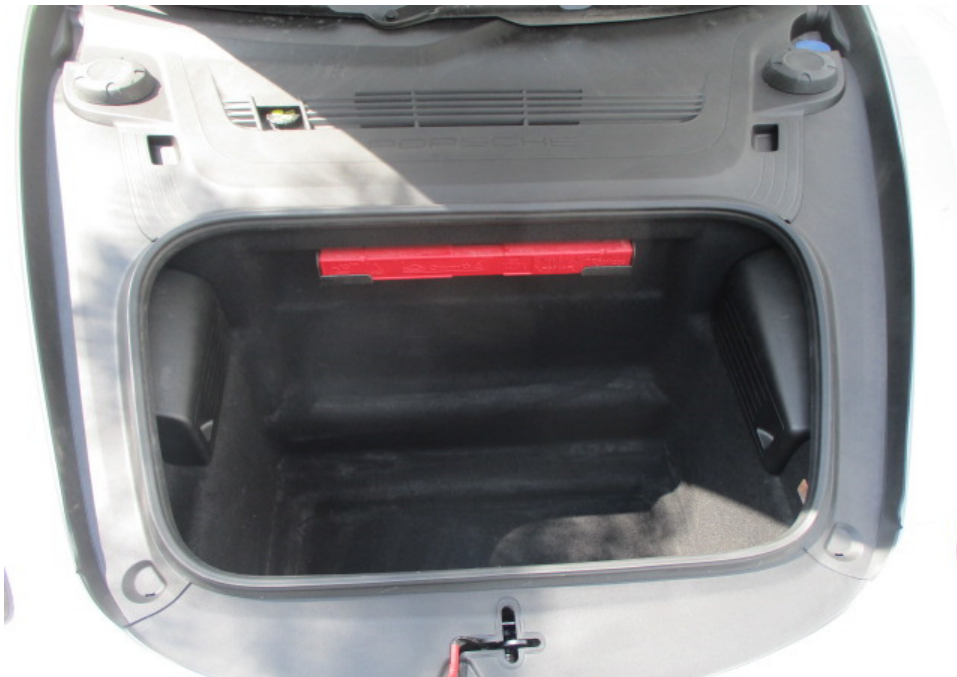
Photo 11 shows a general view of the Motor Car's front bonnet compartment at the time of my inspection. All inner trims, garnishes and upholstery etc were observed to be properly fitted.

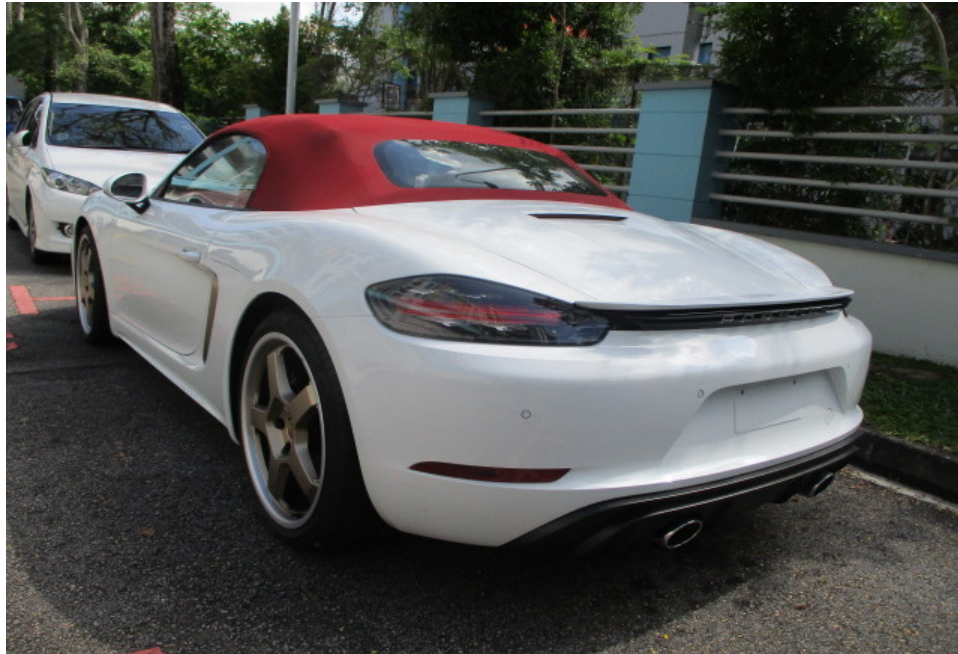
Photo 12 shows a general view of the rear left body of the Motor Car at the time of my inspection. The Motor Car was observed to be in a relatively good general condition with no loose exterior fittings observed. The body parts along the entire left side portion and the rear portion of the Motor Car were visually examined and it was observed that the repair/restoration works carried out to the damaged area of the Motor Car (refer to photograph 2 & 3 above) were reasonably adequate and in order.

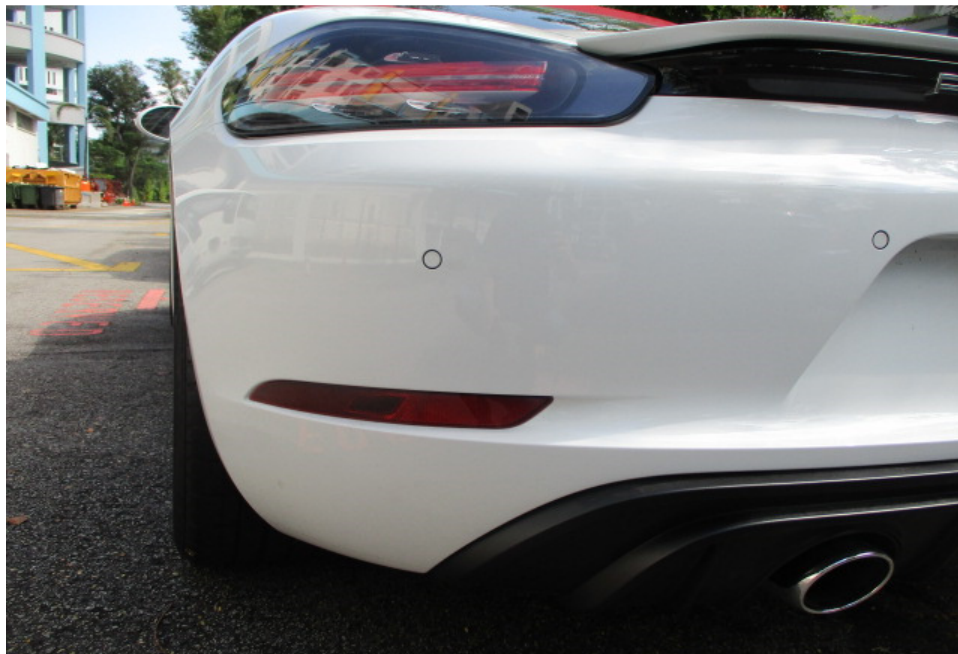
Photo 13 shows a closer view of the Motor Car's rear bumper, rear bumper lower cover, rear bumper left reflector and rear left taillamp. The body parts at the rear portion of the Motor Car were visually examined and it was observed that the repair/restoration works carried out to the damaged area of the Motor Car (refer to photograph 3 above) were reasonably adequate and in order.

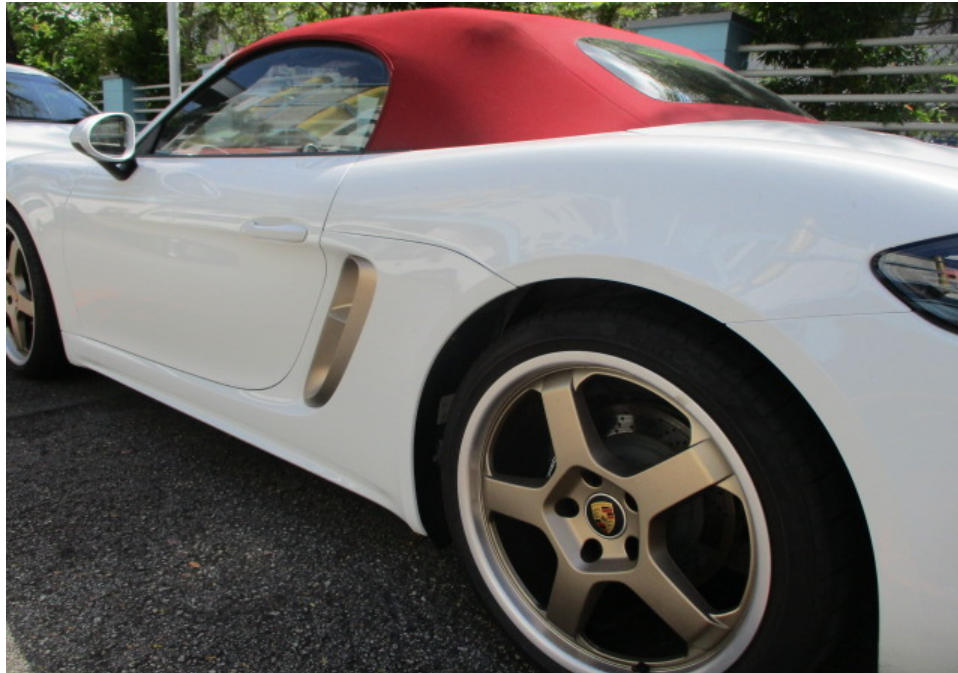
Photo 14 shows a closer view of the Motor Car's rear left wheel rim, rear left body panel, left side rocker panel garnish and soft top roof. The body parts along the entire left side portion of the Motor Car were visually examined and it was observed that the repair/restoration works carried out to the damaged area of the Motor Car (refer to photograph 2 above) were reasonably adequate and in order.

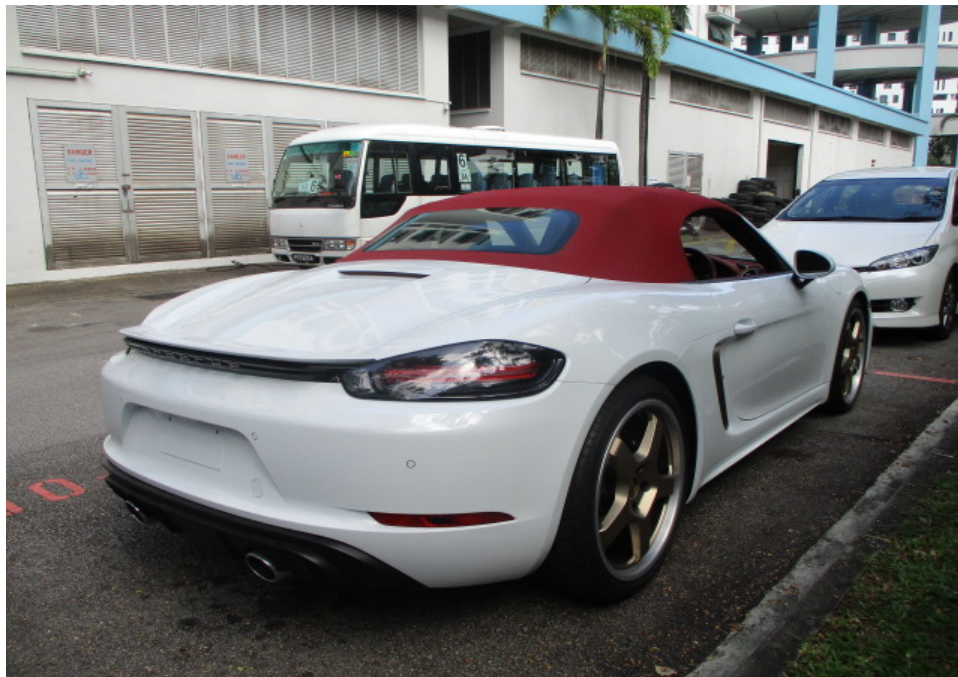
Photo 15 shows a general view of the rear right body of the Motor Car at the time of my inspection. The Motor Car was observed to be in a relatively good general condition with no loose exterior fittings observed. The body parts at the rear portion of the Motor Car were visually examined and it was observed that the repair/restoration works carried out to the damaged area of the Motor Car (refer to photograph 3 above) were reasonably adequate and in order.

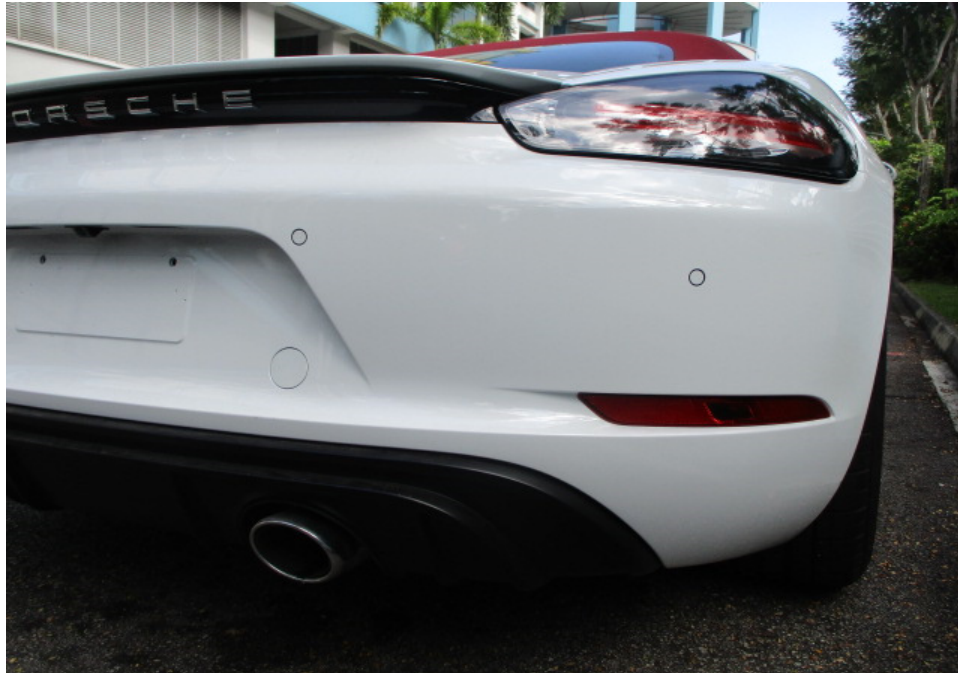
Photo 16 shows a closer view of the Motor Car's rear bumper, rear bumper lower cover, rear bumper right reflector, rear bumper sensors and rear right taillamp. The body parts at the rear portion of the Motor Car were visually examined and it was observed that the repair/restoration works carried out to the damaged area of the Motor Car (refer to photograph 3 above) were reasonably adequate and in order.

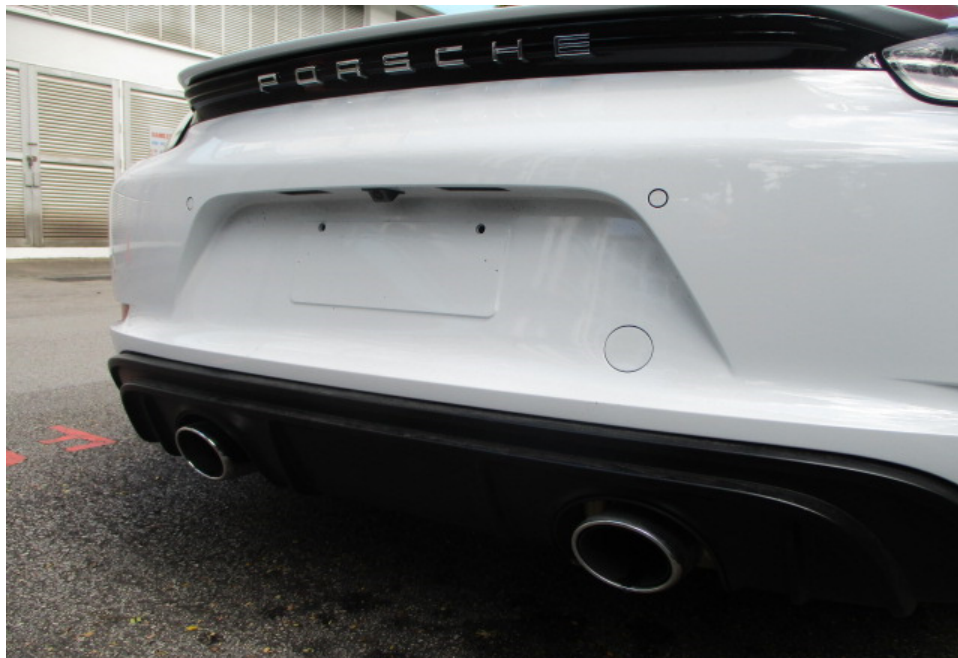
Photo 17 shows a closer view of the Motor Car's rear bumper, rear bumper lower cover and rear bumper sensors. The body parts at the rear portion of the Motor Car were visually examined and it was observed that the repair/restoration works carried out to the damaged area of the Motor Car (refer to photograph 3 above) were reasonably adequate and in order.

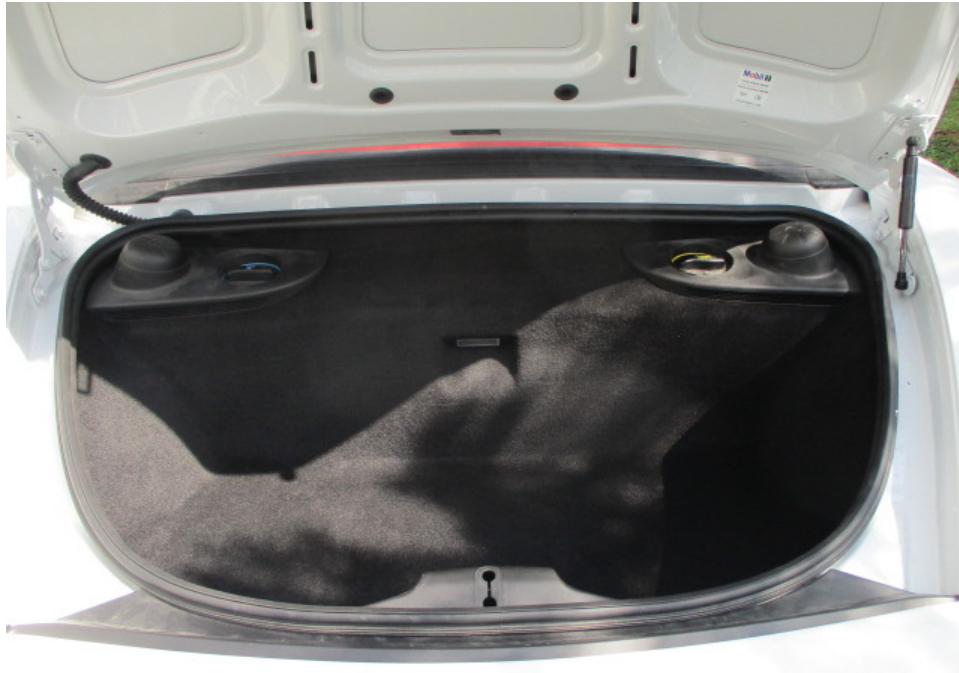
Photo 18 shows a general of the Motor Car's rear compartment at the time of my inspection. All inner trims, garnishes and upholstery etc were observed to be properly fitted.

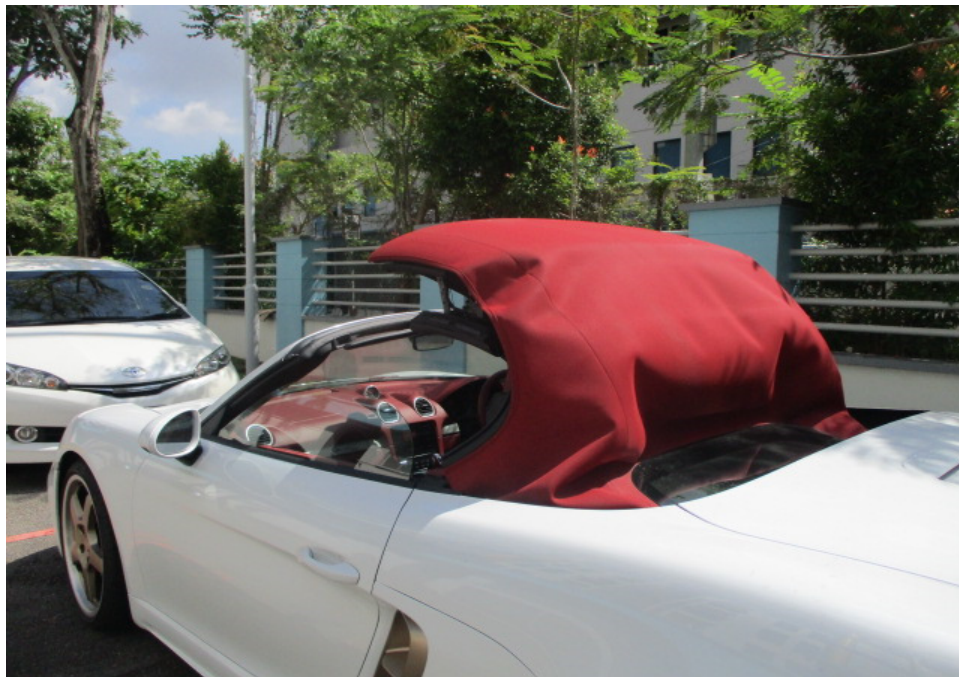
Photo 19 shows the Motor Car's soft top roof being tested. It was observed that as a safety feature, the soft top roof could only open and close when the Motor Car was in a stationary position or at low travelling speed. When opened, the soft top roof is completely folded into the rear compartment with no parts protruding out of the Motor Car's body. The soft top roof was also found adequately secured to the "A" pillar after closing.

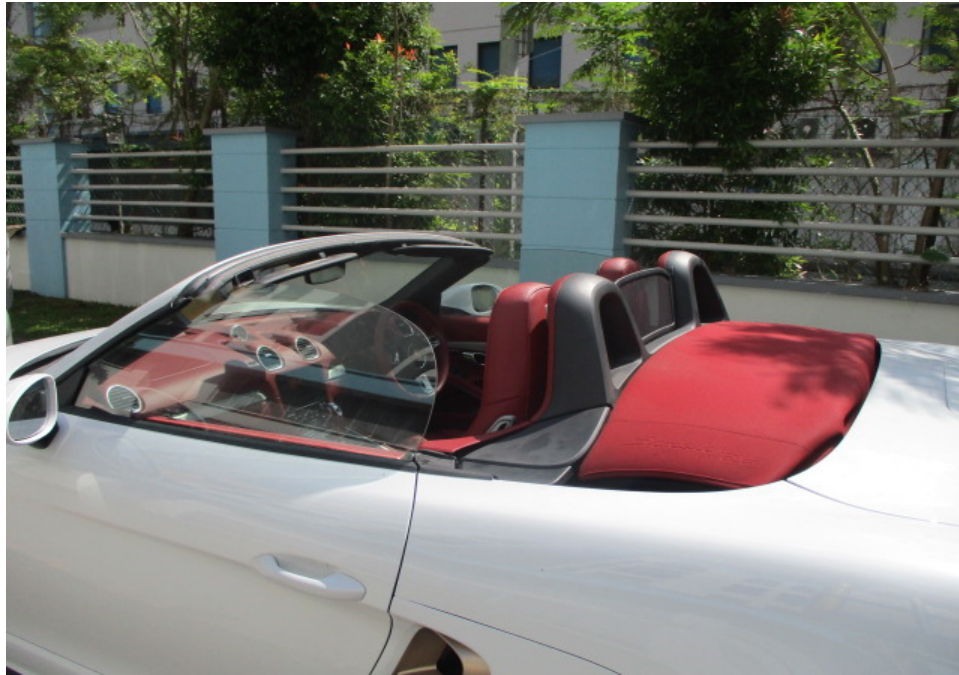
Photo 20 shows the Motor Car with its soft top roof completely folded. It was observed that as a safety feature, the soft top roof could only open and close when the Motor Car was in a stationary position or at low travelling speed. When opened, the soft top roof is completely folded into the rear compartment with no parts protruding out of the Motor Car's body. The soft top roof was also found adequately secured to the "A" pillar after closing.

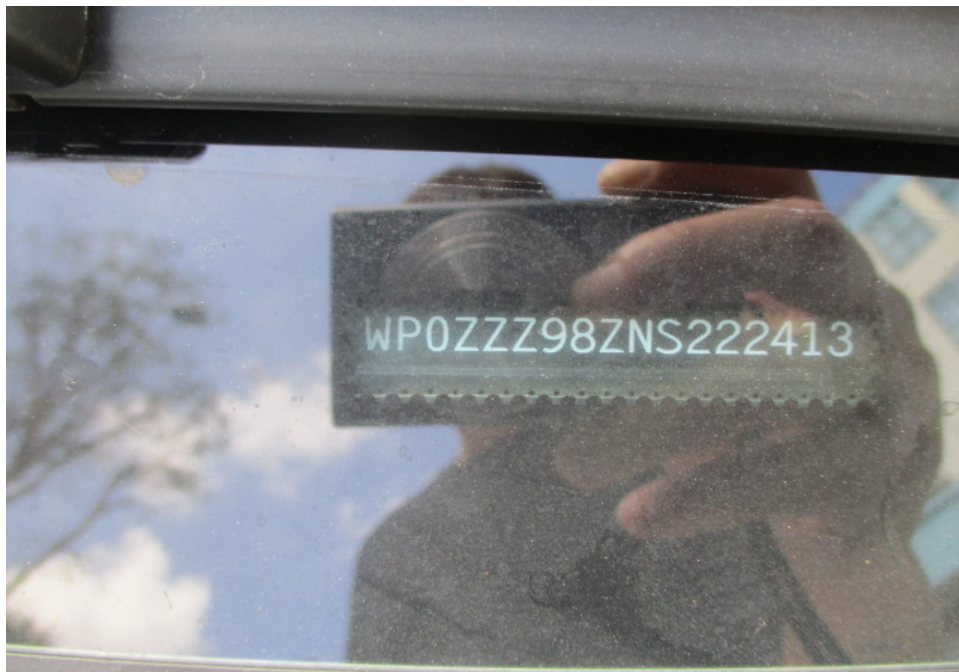
Photo 21 shows the chassis number of the Motor Car. The chassis number recorded was WP0ZZZ98ZNS222413.

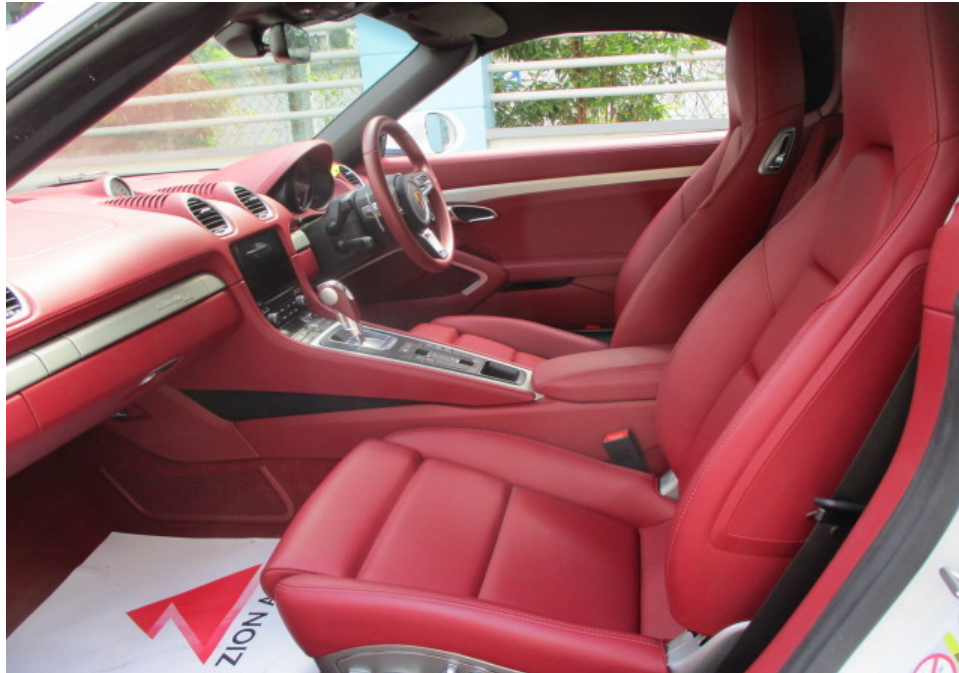
Photo 22 shows the interior compartment of the Motor Car at the time of my inspection. The various parts and components, trims, carpet, and upholstery inside the interior compartment were all observed to be intact and properly fitted.

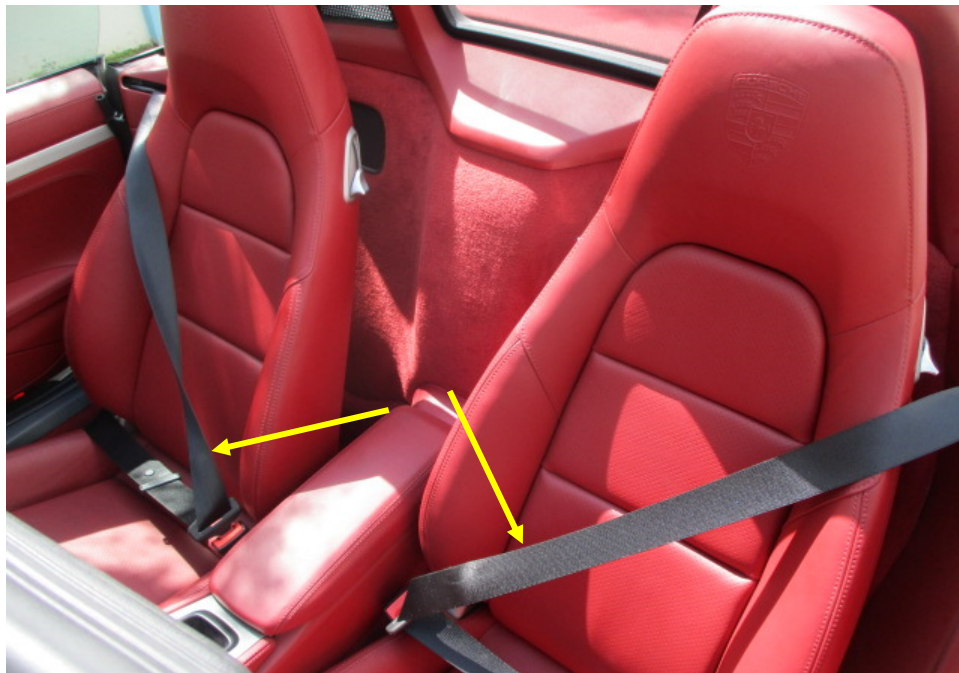
Photo 23 shows the seats of the Motor Car. All the seats of the Motor Car were secured via seat rails to the floorboard. They were also fitted with a retractable seat belt reel and a pre-tensioner. The seat belts (arrowed) were tested and were able to be fastened into the respective pre-tensions that were fitted on the side of each individual seat.

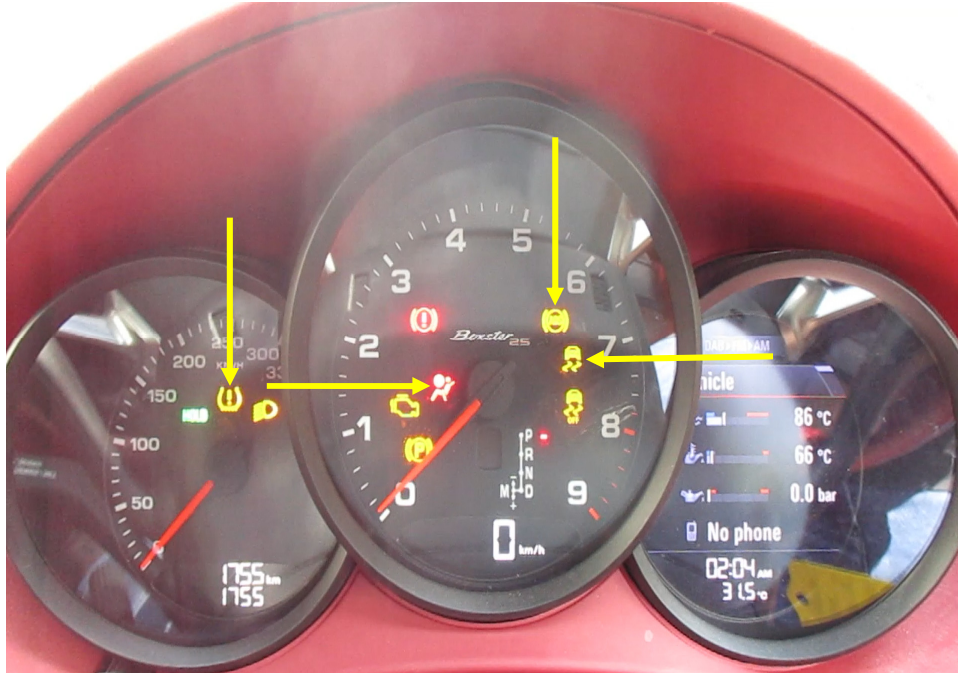
Photo 24 shows the warning lights for the various electronic safety features appearing on the instrument panel of the Motor Car during its self-test when the engine is cranked, in particular the ABS, SRS, TPM and TCS lights (arrowed).

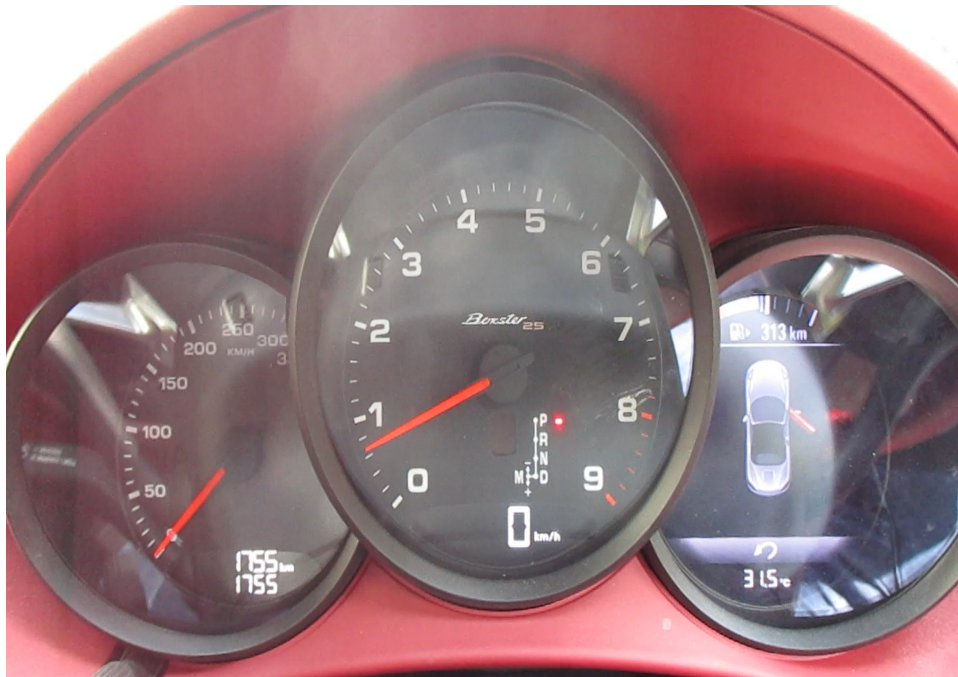
Photo 25 shows the respective warning lights no longer illuminated, indicating that there is no fault detected to the ABS, SRS, TPM and TCS systems of the Motor Car during the self-test. These electronic systems were hence in working condition at the time of my inspection.

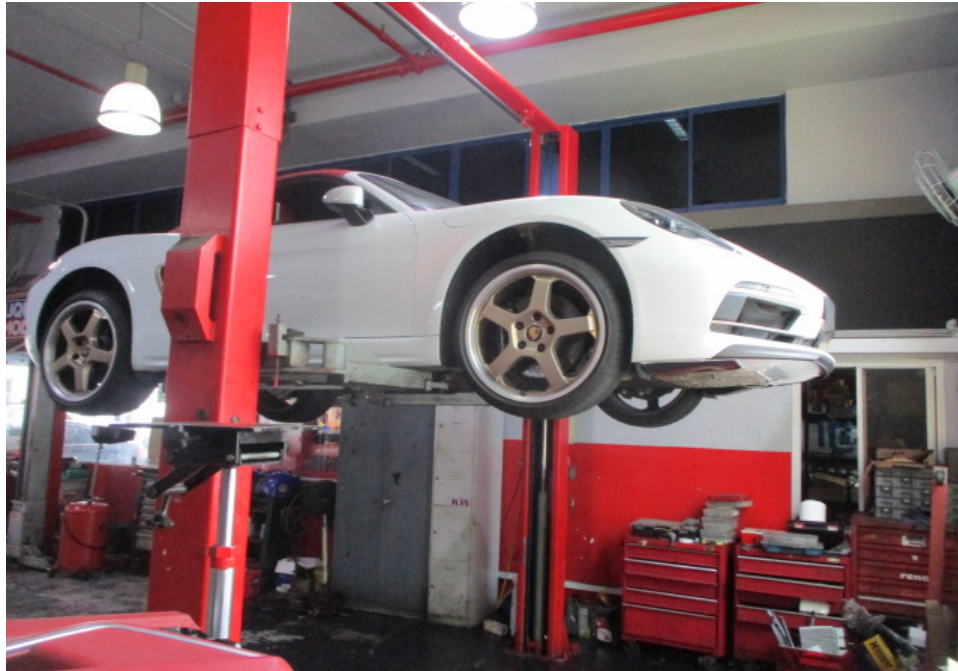
Photo 26 shows the Motor Car hoisted up for checks on its undercarriage. There was no sign(s) or indication(s) of fluid leakage and/or fluid stain(s) on the underside of the Motor Car. The undercarriage components of the Motor Car were also all observed to be intact and secured in an appropriate manner.

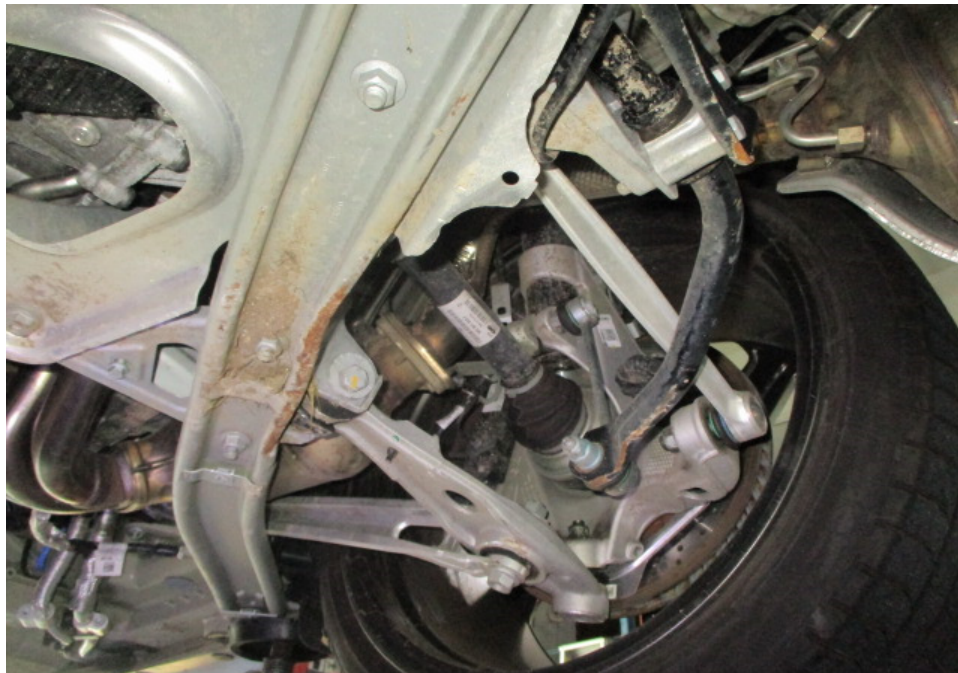
Photo 27 shows a general view of the control arms and linkages at the rear right wheel of the Motor Car. I did not observe any fluid leak and/or fluid stain on the underside of the Motor Car. All of the Motor Car's undercarriage components were observed to be intact and secured in an appropriate manner.

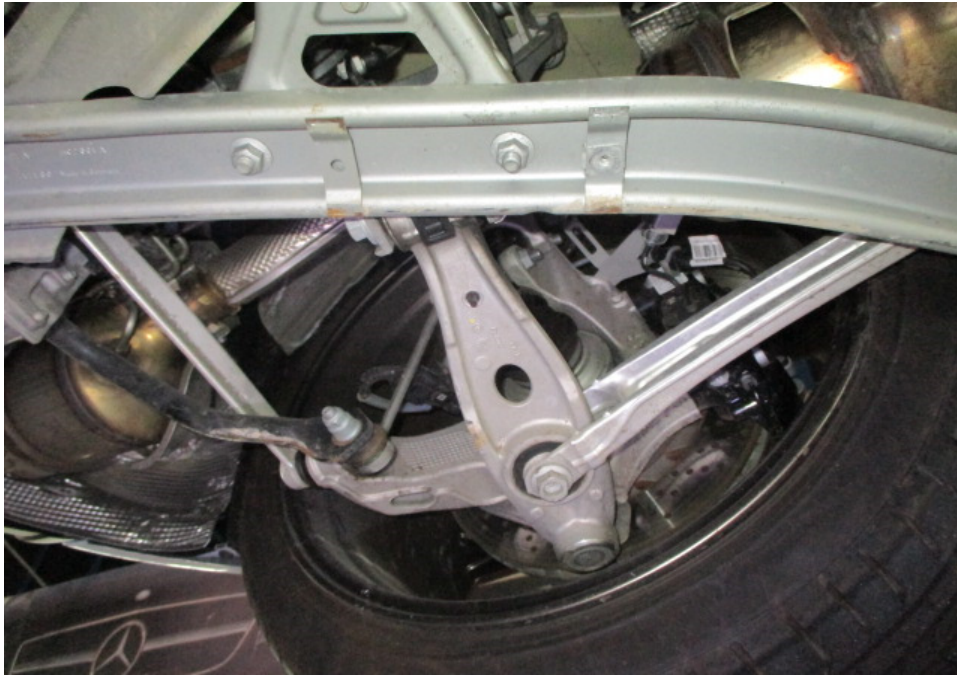
Photo 28 shows a general view of the control arms and linkages at the rear left wheel of the Motor Car. I did not observe any fluid leak and/or fluid stain on the underside of the Motor Car. All of the Motor Car's undercarriage components were observed to be intact and secured in an appropriate manner.
