Your Ref: Porsche 718 Boxster
(chassis number WP0ZZZ98ZNS222413)
Our Ref : CI/TP22011942/D

INSPECTION REPORT OF AN UNREGISTERED PORSCHE 718 BOXSTER MOTOR CAR WITH CHASSIS NUMBER WP0ZZZ98ZNS222413

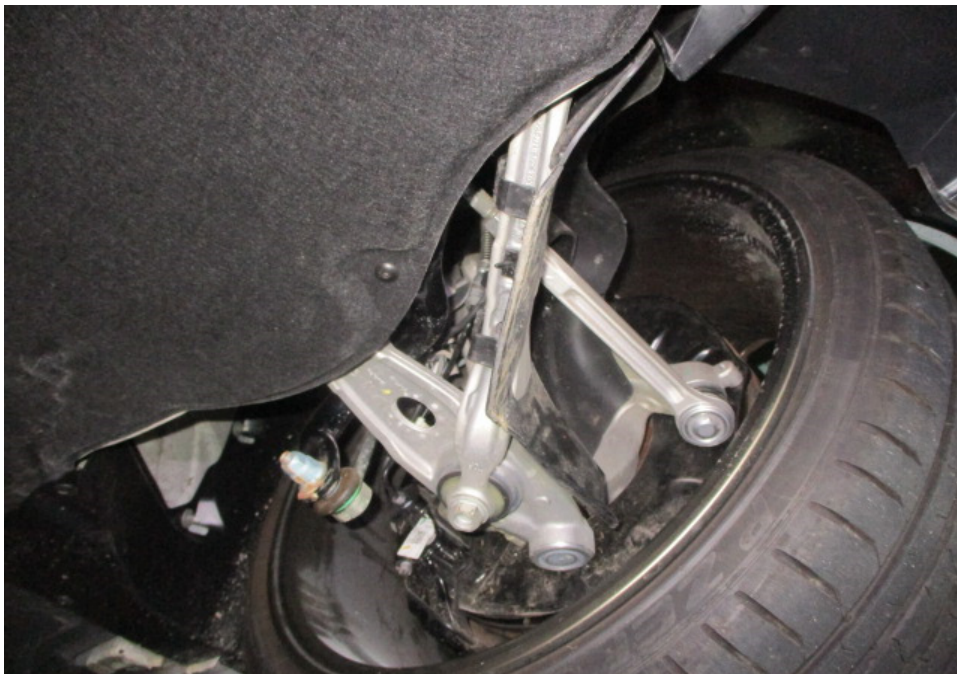
Photo 29 shows the various undercarriage components at the front left wheel of the Motor Car. The mechanical components, control arms and linkages were all found to be intact and secured in an appropriate manner.

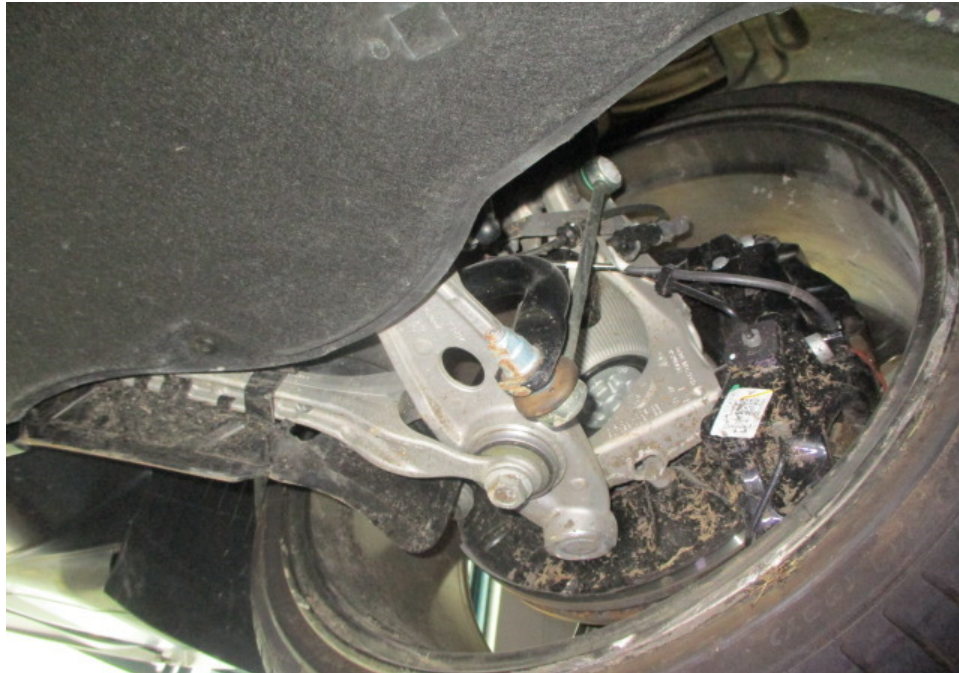
Photo 30 shows the various undercarriage components at the front right wheel of the Motor Car. The mechanical components, control arms and linkages were all found to be intact and secured in an appropriate manner. I also did not observe any fluid leak and/or fluid stain on the underside of the Motor Car.

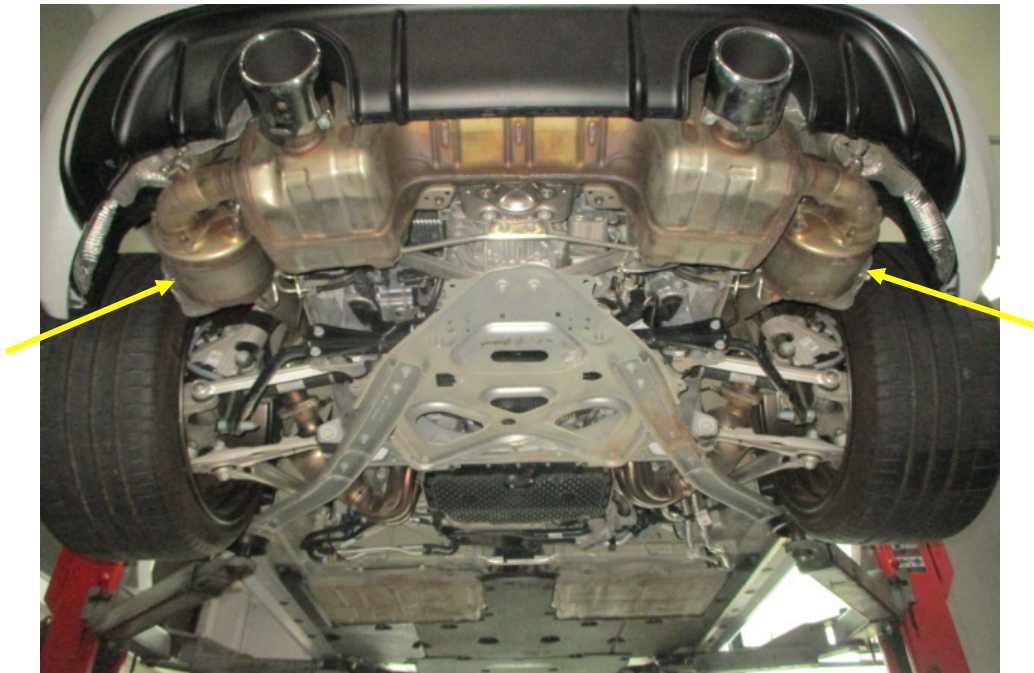
Photo 31 shows the Motor Car's exhaust system. My examination of the Motor Car's exhaust system revealed no sign(s) or indication(s) of any cut or weld marks along its exhaust pipes, on its resonator boxes (arrowed), on its catalytic converters and on its rear mufflers.

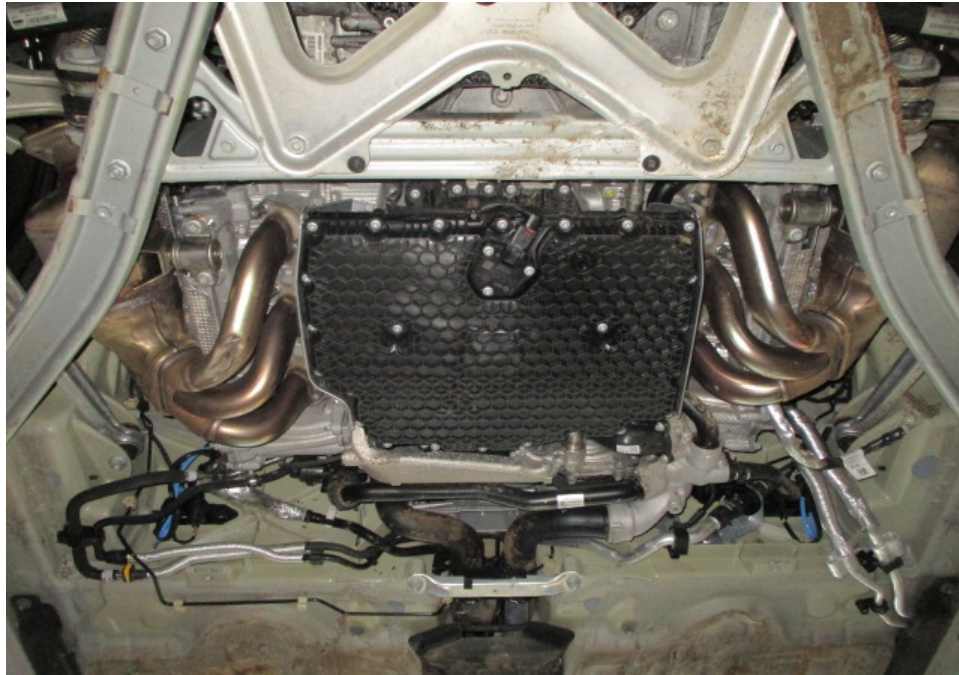
Photo 32 shows the Motor Car's exhaust manifolds. My examination of the Motor Car's exhaust system revealed no sign(s) or indication(s) of any cut or weld marks along its exhaust pipes, on its resonator boxes, on its catalytic converters and on its rear mufflers.

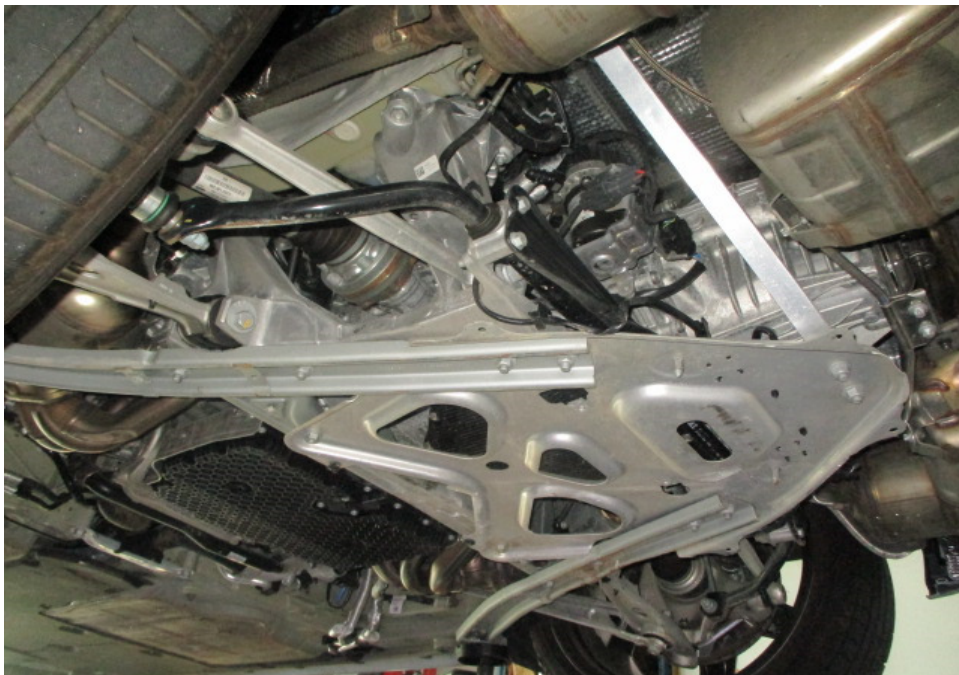
Photo 33 shows a general view of the Motor Car's engine compartment. The engine compartment was at the rear underside of the Motor Car. The various parts and components inside the engine compartment were all observed to be intact and properly fitted. There was also no sign(s) or indication(s) of fluid leak and/or fluid stain found inside the engine compartment.

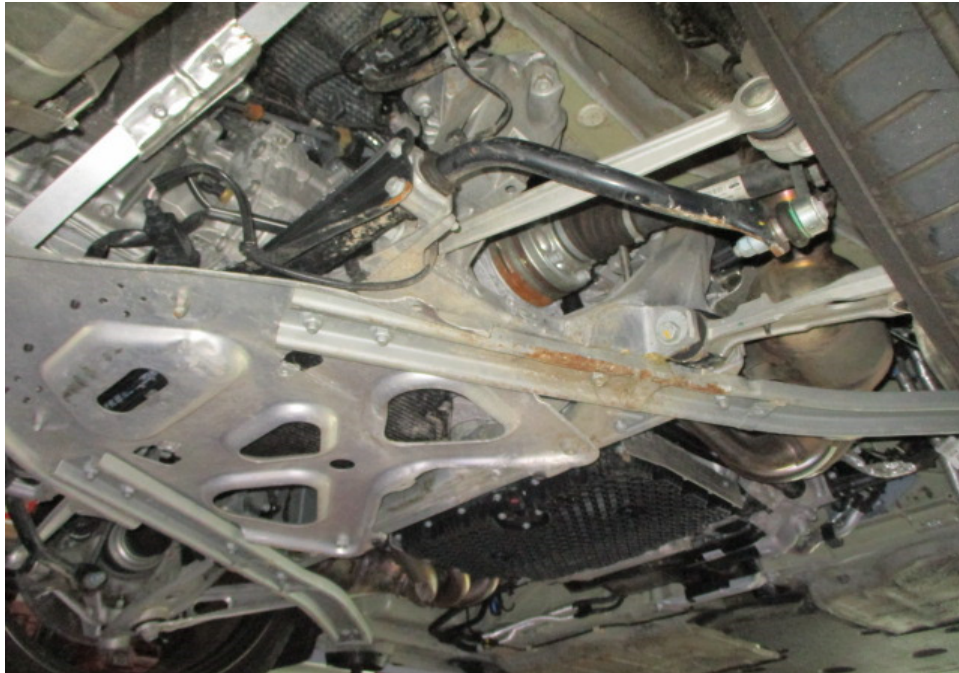
Photo 34 shows another view of the Motor Car's engine compartment. The engine compartment was at the rear underside of the Motor Car. The various parts and components inside the engine compartment were all observed to be intact and properly fitted. There was also no sign(s) or indication(s) of fluid leak and/or fluid stain found inside the engine compartment.

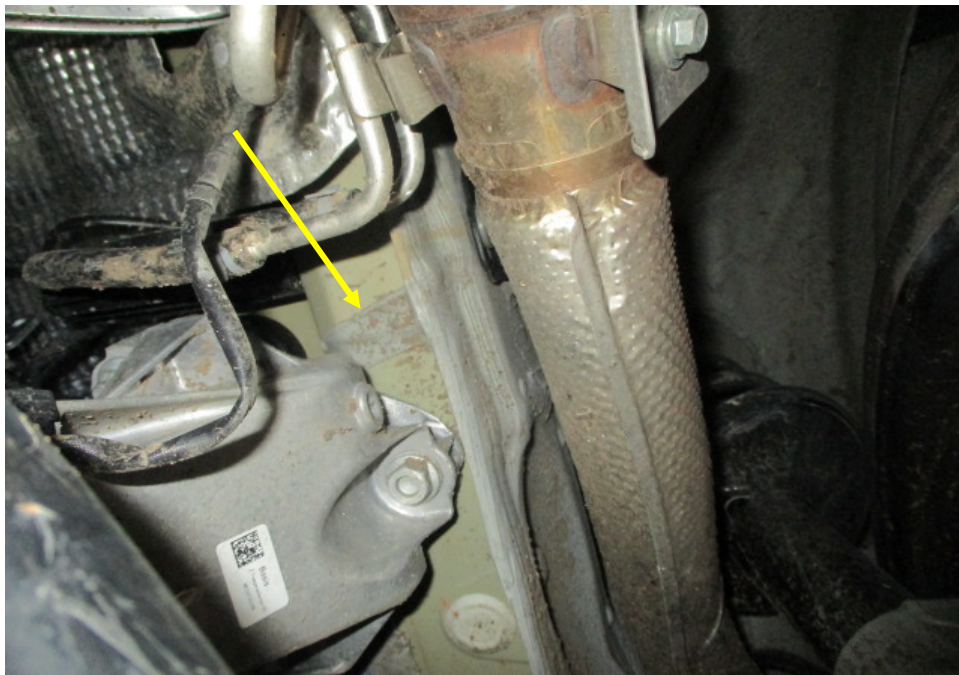
Photo 35 shows the chassis/structural body at the underside rear right of the Motor Car. I did not find any weld marks other than original spot weld marks on the chassis/structural body of the Motor Car. The original factory sealant (arrowed) at the joints along the chassis/structural body was untouched, indicating no work was done on the chassis/structural body of the Motor Car and that the chassis/structural body was originally fitted.

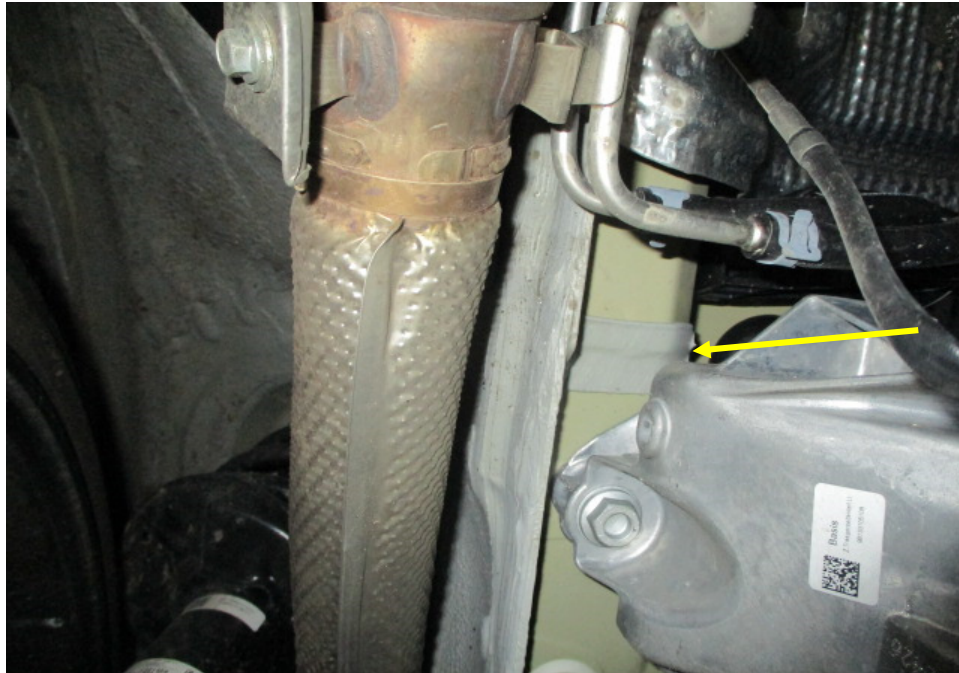
Photo 36 shows the chassis/structural body at the underside rear left of the Motor Car. The original factory sealant (arrowed) at the joints along the chassis/structural body was observed to be untouched. In general, I had found no work was carried out on the chassis/structural body of the Motor Car. The chassis/structural body of the Motor Car was originally fitted.

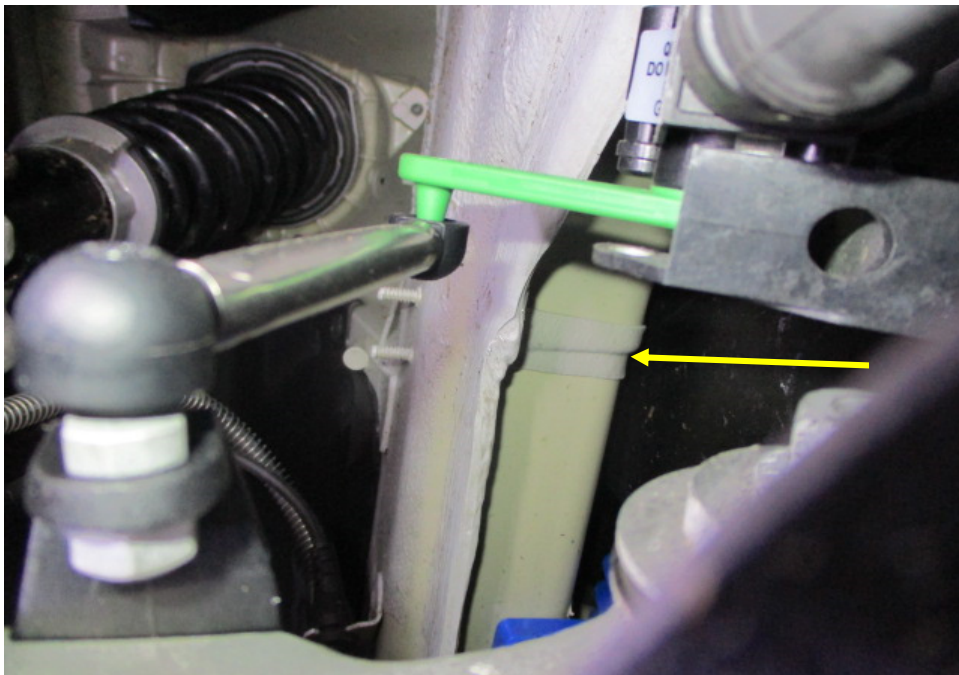
Photo 37 shows the chassis/structural body at the underside front left of the Motor Car. I did not find any weld marks other than original spot weld marks on the chassis/structural body of the Motor Car. The original factory sealant (arrowed) at the joints along the chassis/structural body was untouched, indicating no work was done on the chassis/structural body of the Motor Car and that the chassis/structural body was originally fitted.

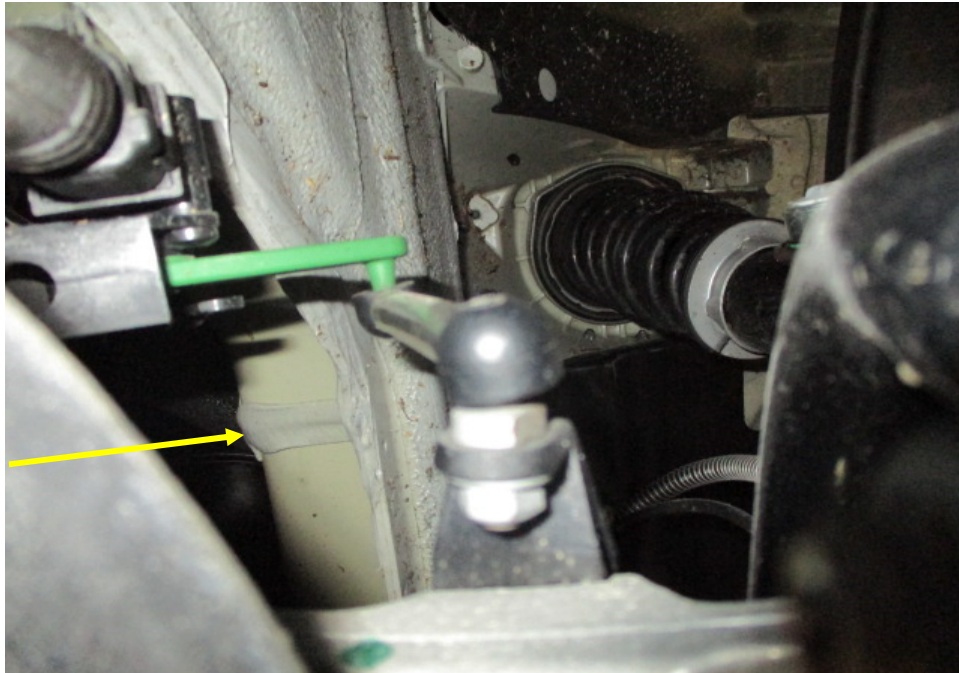
Photo 38 shows the chassis/structural body at the underside front right of the Motor Car. The original factory sealant (arrowed) at the joints along the chassis/structural body was observed to be untouched. In general, I had found no work was carried out on the chassis/structural body of the Motor Car. The chassis/structural body of the Motor Car was originally fitted.

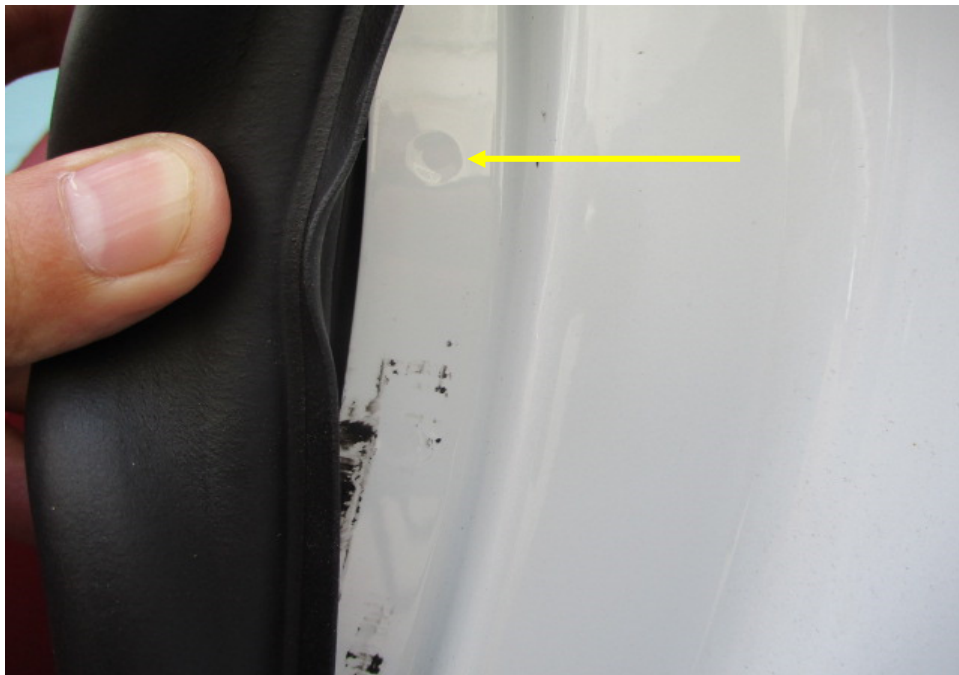
Photo 39 shows the rear left body panel of the Motor Car. I did not find any weld marks other than original spot weld marks (arrowed) on the rear left body panel of the Motor Car, which indicates that there was no re-welding works carried out. In general, I had found all the non-detachable body panels of the Motor Car to be originally fitted at the time of my inspection.

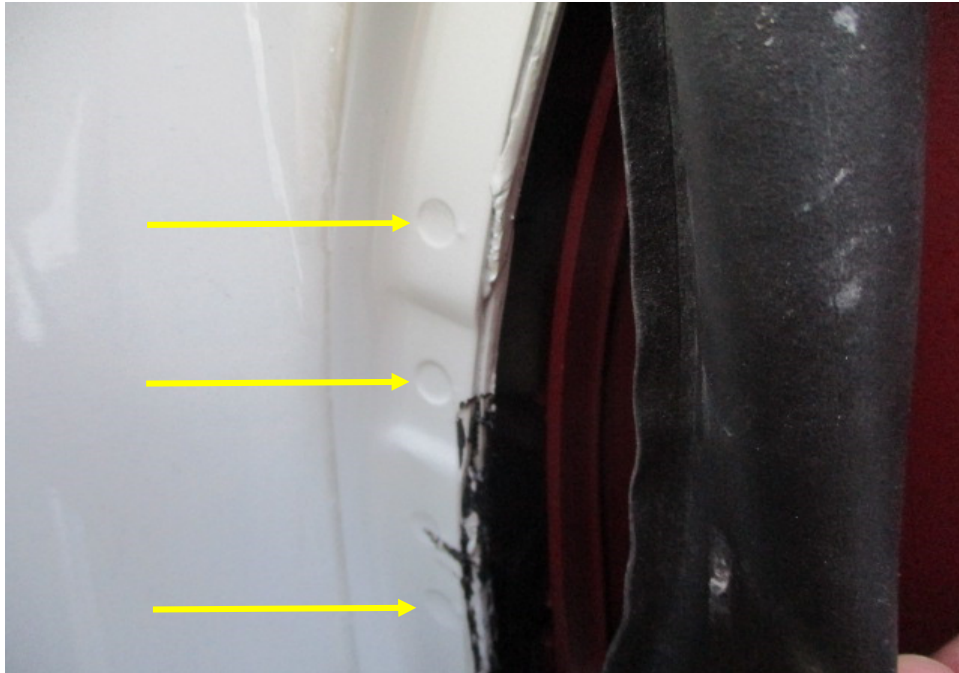
Photo 40 shows the left side "A" pillar of the Motor Car. I did not find any weld marks other than original spot weld marks (arrowed) on the left side "A" pillar of the Motor Car which, indicates that there was no re-welding works carried out. In general, I had found all the non-detachable body panels of the Motor Car to be originally fitted at the time of my inspection.

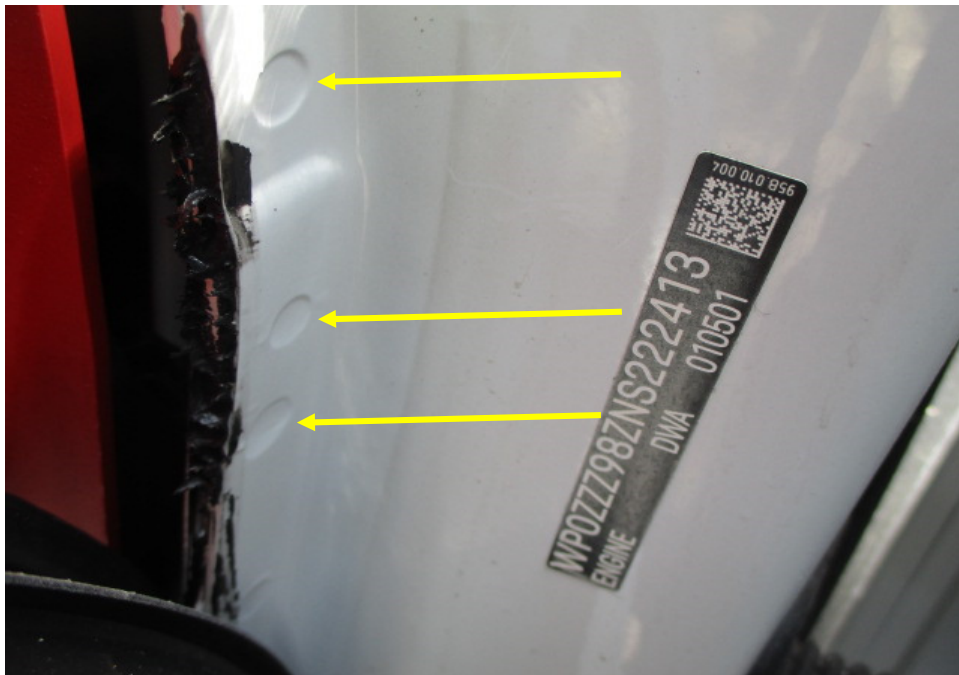
Photo 41 shows the right side "A" pillar of the Motor Car. I did not find any weld marks other than original spot weld marks (arrowed) on the right side "A" pillar of the Motor Car which, indicates that there was no re-welding works carried out. In general, I had found all the non-detachable body panels of the Motor Car to be originally fitted at the time of my inspection.

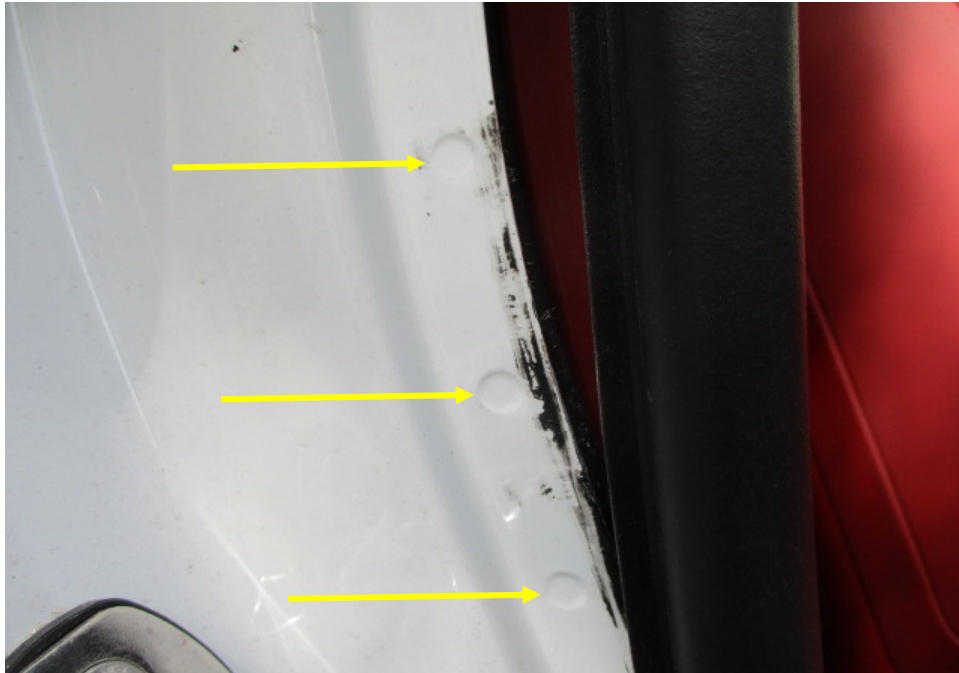
Photo 42 shows the rear right body panel of the Motor Car. I did not find any weld marks other than original spot weld marks (arrowed) on the rear right body panel of the Motor Car, which indicates that there was no re-welding works carried out. In general, I had found all the non-detachable body panels of the Motor Car to be originally fitted at the time of my inspection.
