Your Ref: 4631152650SG
Our Ref : CI/AIG22011964/N

28 November 2022

TECHNICAL INVESTIGATION REPORT OF FIRE INCIDENT INVOLVING THE INSURED VEHICLE SJF 838A ON 17 NOVEMBER 2022

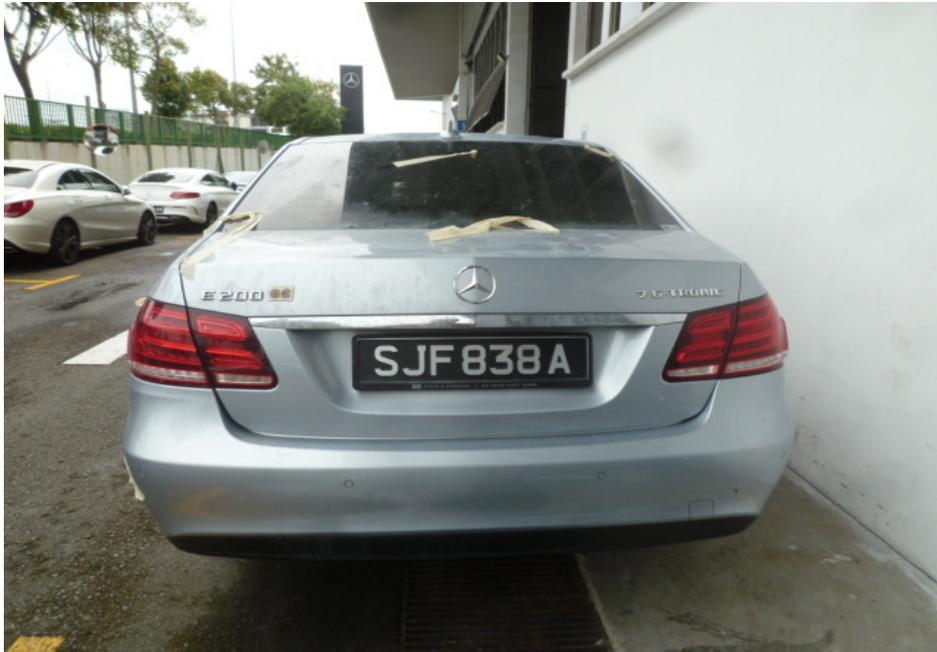
Photo 1 shows the rear view of the Insured Vehicle. The rear portion of the Insured Vehicle was observed to be relatively unaffected by the fire.

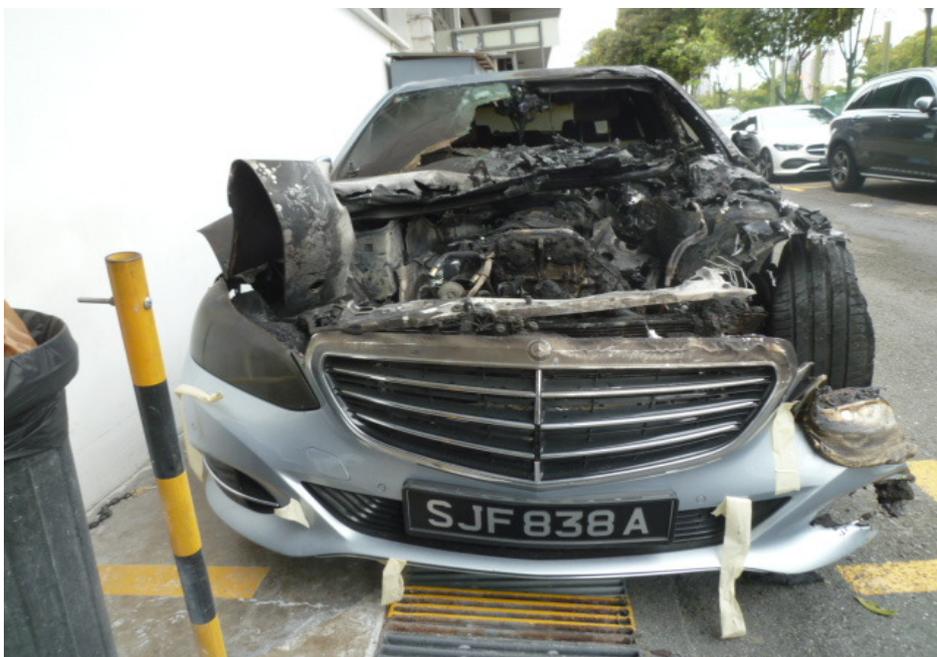
Photo 2 shows the general view of the frontal portion of the Insured Vehicle at the time of our inspection. The exterior body of the Insured Vehicle had sustained visible fire damage. This included its front windscreen, front bonnet, front bumper, front bumper reinforcement panel, headlights, side panels, front wheel rims and front tyres.

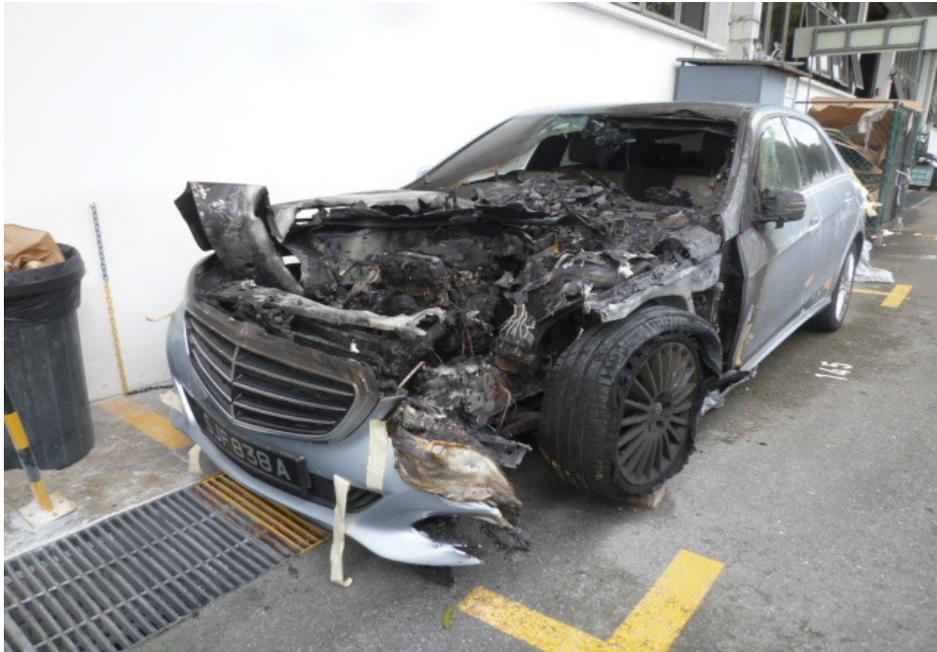
Photo 3 shows the general view of the left portion of the Insured Vehicle at the time of our inspection. The exterior body of the Insured Vehicle had sustained visible fire damage. This included its front windscreen, front bonnet, left headlight, front bumper, left front panel, left front wheel rim and left front tyre.

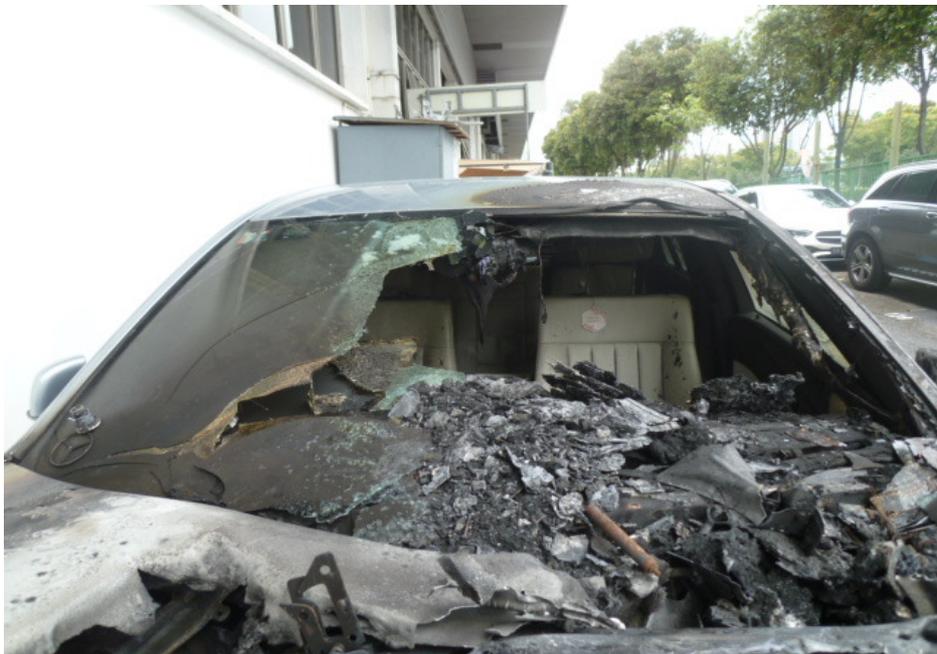
Photo 4 shows a closer view of the front windscreen of the Insured Vehicle at the time of our inspection. The front windscreen had sustained extensive fire damage.

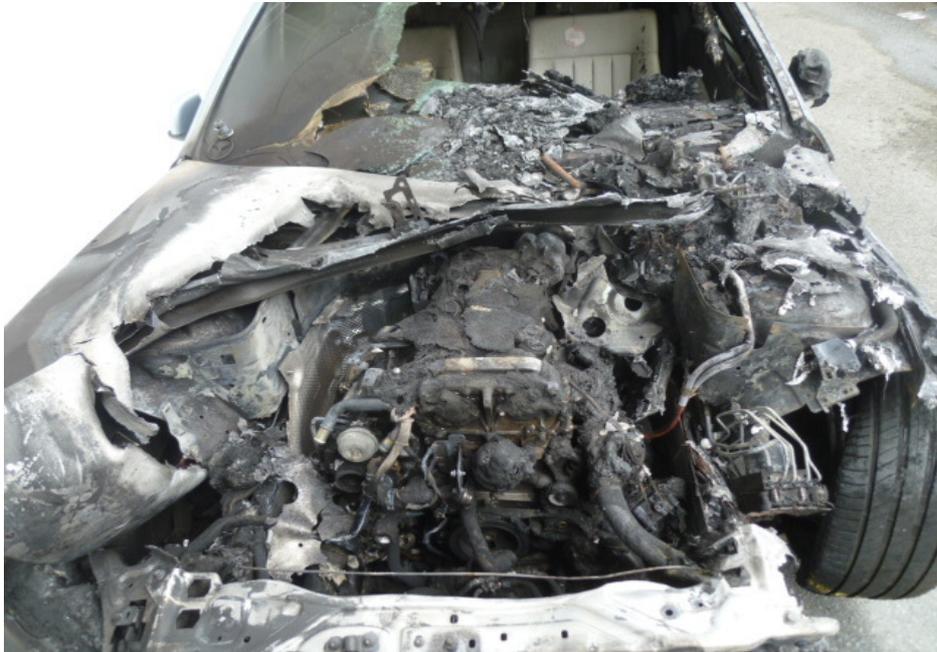
Photo 5 shows a general view of the engine compartment of the Insured Vehicle at the time of our inspection. Most of the components inside the engine compartment were found to be severely burnt and/or melted as a result of the fire.

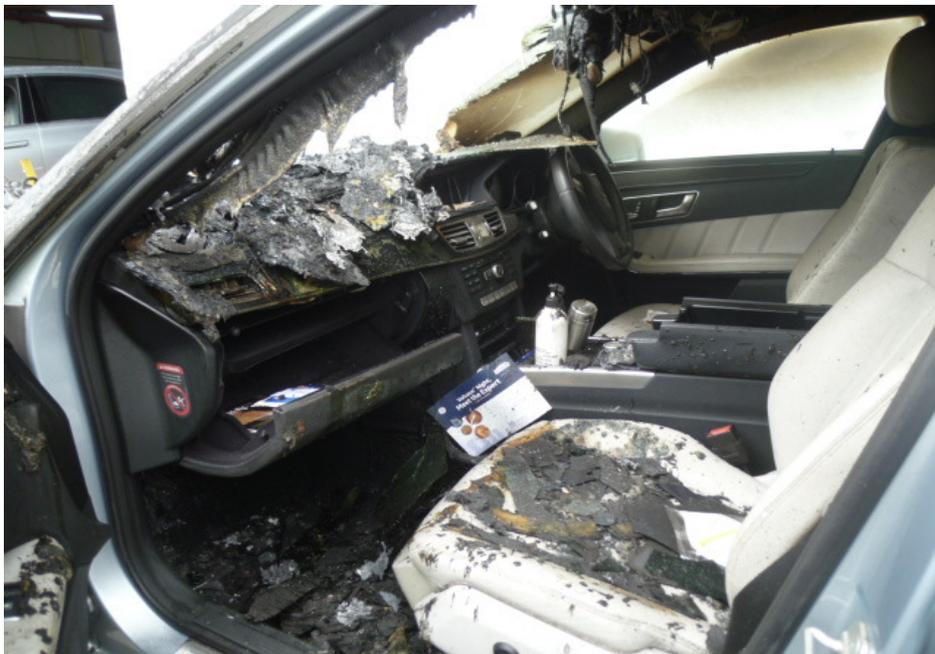
Photo 6 shows the interior compartment of the Insured Vehicle, which was observed to be severely affected by the fire.

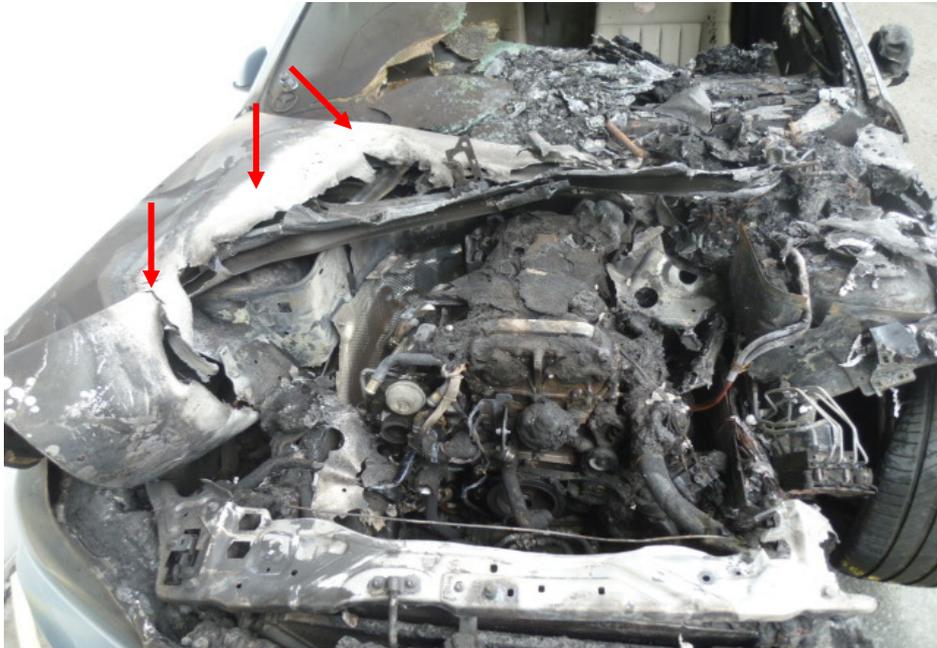
8. For this particular case, the fire appears to have originated within the engine compartment of the Insured Vehicle, somewhere around the left rear portion of the engine compartment due to the nature of the fire damage which was more extensive at the left portion. Furthermore, the hole found in the front bonnet of the Insured Vehicle indicate that the front left portion of the Insured Vehicle was exposed to prolonged high heat intensity. Following the characteristic of heat (hot air rises), the origin of fire can then be determined to be from the engine compartment of the Insured Vehicle as the engine compartment is covered by the front bonnet and front fenders. Flames from the confined spaces of the engine compartment would travel outwards and upwards, exposing the front bonnet and front fenders of the Insured Vehicle to high heat intensity hence leaving a hole in the front bonnet as seen.

Photo 7 shows the hole found in the front bonnet of the Insured Vehicle which indicates that the front portion of the Insured Vehicle was exposed to prolonged high heat intensity. The whitish burn marks (arrowed) are a result of exposure to prolonged heat intensity.

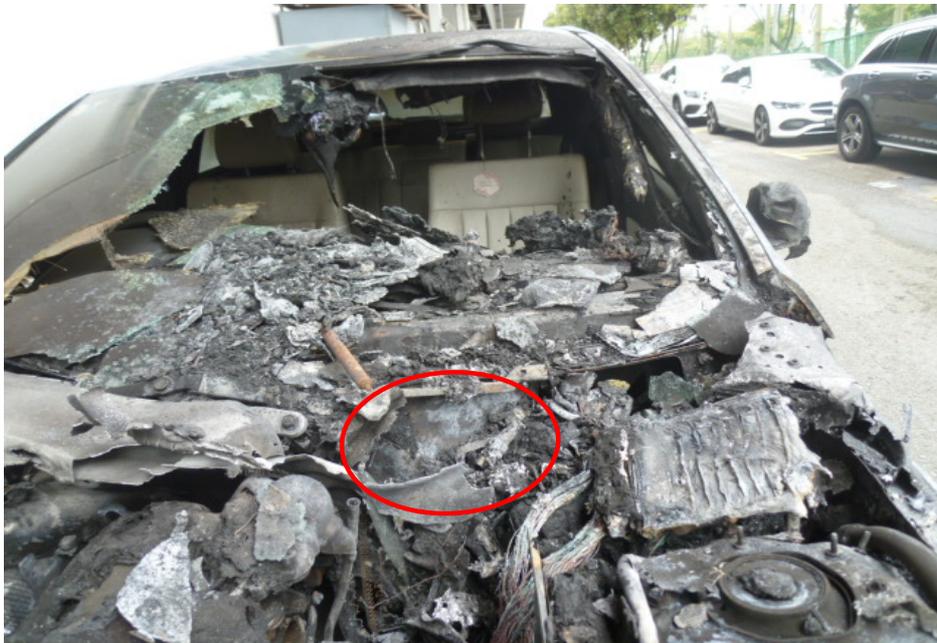
9. The whitish burn marks are a result of exposure to prolonged heat intensity. Rust would normally start to develop around these areas soon after a fire as prolonged exposure to high heat intensity usually causes steel/metal material body parts to be exposed to natural environmental condition. The rust that had developed on the left rear portion of the engine compartment is an indication that the left rear portion of the engine compartment had sustained exposure to prolonged high heat intensity. See photos 7 & 8 below.

Photo 8 shows a closer view of the rust that had developed on the left rear portion of the engine compartment (circled). The development of rust is an indication that this area was subjected to prolonged exposure to high heat intensity, which had caused the steel/metal material of the front bonnet to be exposed to natural environmental condition. Hence the fire to the Insured Vehicle can be determined to have originated towards the left rear portion of the engine compartment.

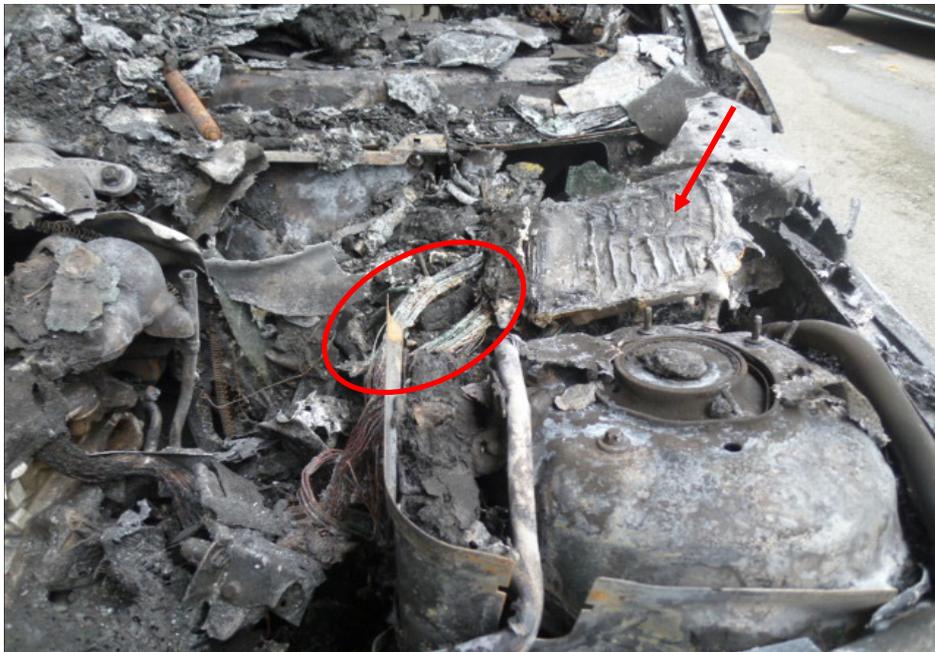
10. Upon closer examination of the left rear portion of the engine compartment, which was where the fire to the Insured Vehicle had likely started, we had found traces of greenish residue on several stretches of burnt wirings leading from the Engine Control Module (ECM). The presence of greenish residue indicates internal heating of copper wires, a sign of an electrical short circuit occurring. The greenish residue is normally left behind from oxidation as a result of chemical reaction involving the copper wires. This physical evidence would then appear to suggest that the cause of fire to the Insured Vehicle could have possibly been due to electrical in nature. See photos 9 - 12 below.

Photo 9 shows the burnt wirings around the left rear portion of the engine compartment which is in the immediate vicinity where the fire to the Insured Vehicle had likely started. We noticed greenish residue on several stretches of burnt wirings leading from the Engine Control Module (ECM) (circled). The presence of greenish residue indicates internal heating of copper wires, a sign of an electrical short circuit occurring. The greenish residue is normally left behind from oxidation as a result of chemical reaction involving the copper wires.

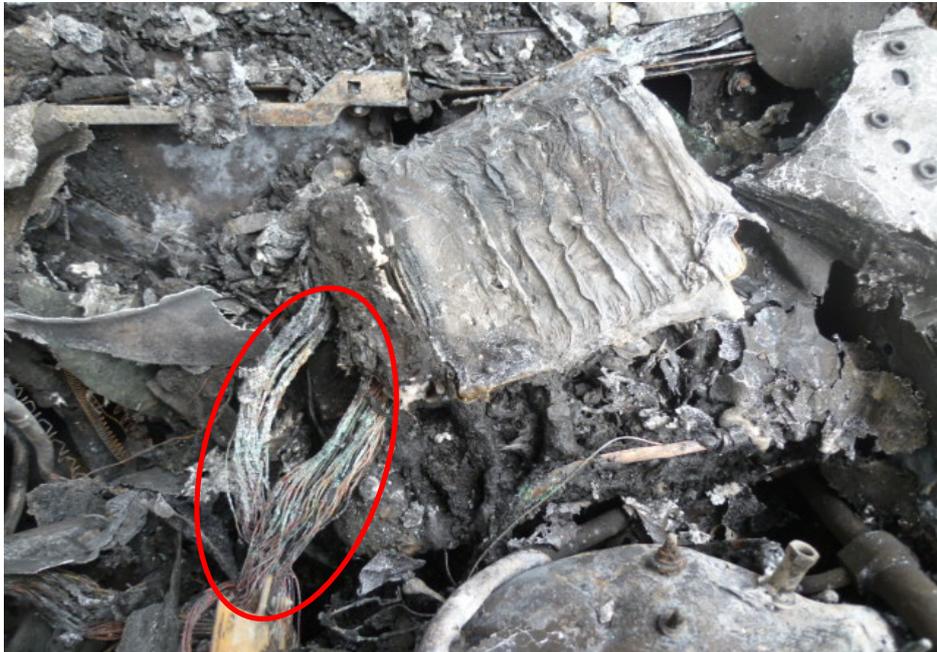
Photo 10 shows a closer view of the burnt wirings around the left rear portion of the engine compartment, which is in the immediate vicinity where the fire to the Insured Vehicle had likely started. We noticed greenish residue on several stretches of burnt wirings leading from the Engine Control Module (ECM) (circled).

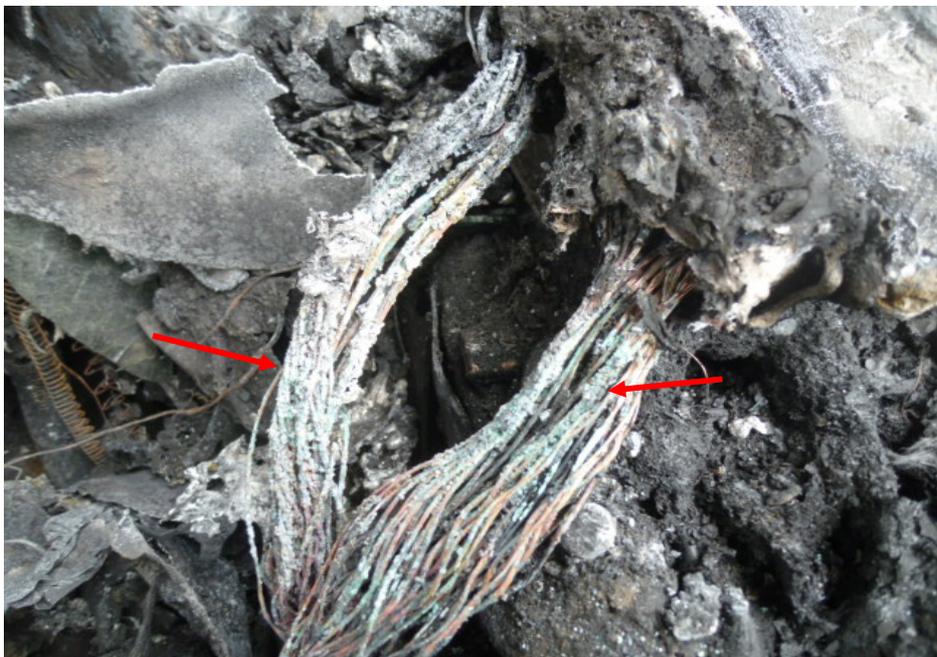
Photo 11 shows a close up view of the greenish residue found on several stretches of burnt wirings (red arrows). The presence of such greenish residue suggests occurrence of an electrical short circuit.

27. Having investigated and technically analysed the damages to the Insured Vehicle, we are of the view that the cause of fire to the Insured Vehicle was of electrical in nature. For this particular case, the fire had originated along the wirings inside the engine compartment, somewhere around the left rear portion. The wirings were original factory wirings leading from the Engine Control Module (ECM) of the Insured Vehicle.

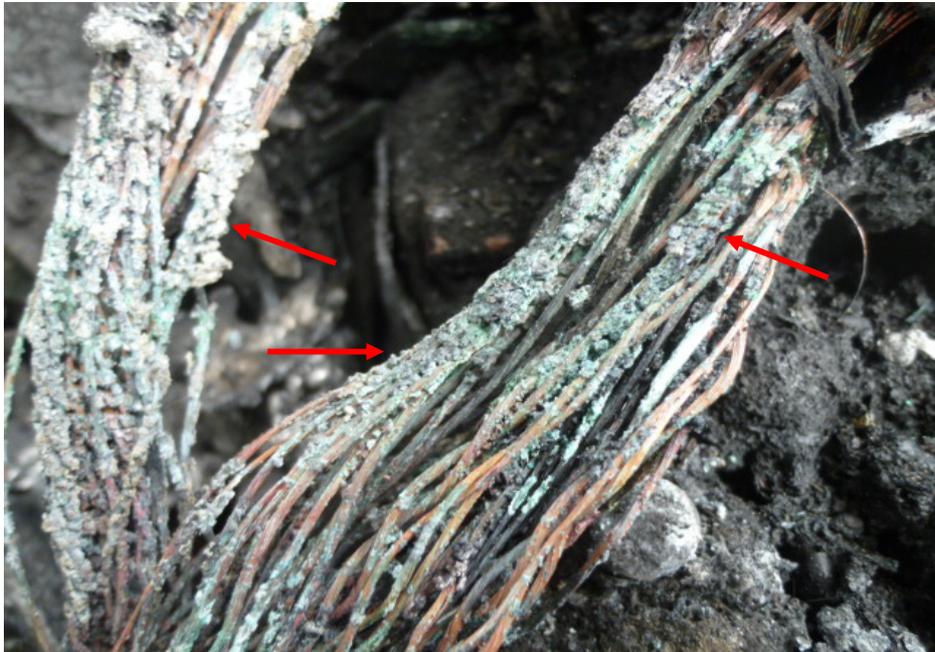
Photo 12 shows a close up view of the greenish residue found on several stretches of burnt wirings (red arrows). The presence of such greenish residue suggests occurrence of an electrical short circuit.

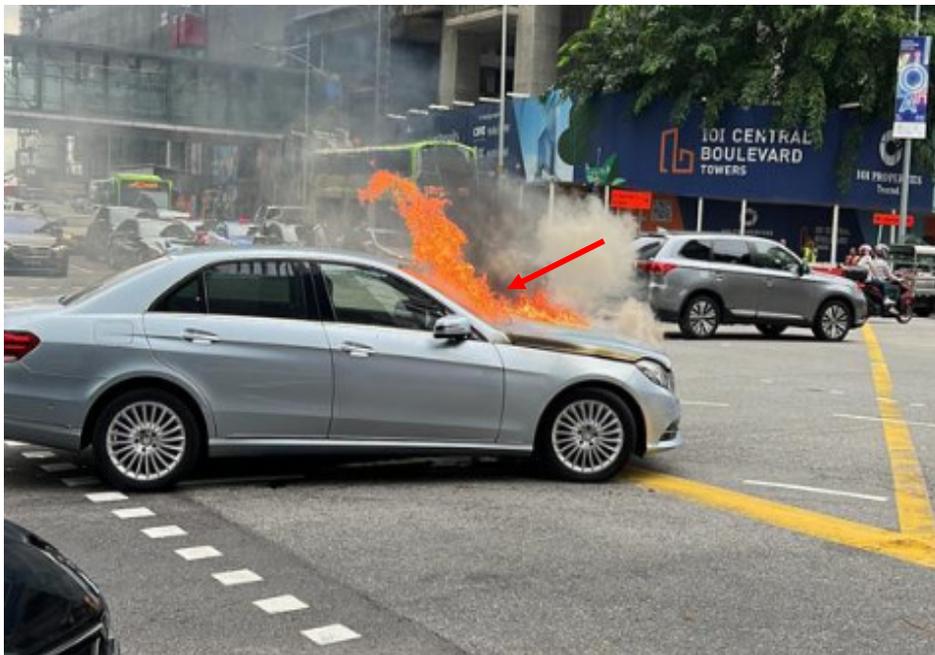
Photo 13 shows the Insured Vehicle on fire before the arrival of the SCDF. In general, the information that could be gathered from this photograph had corresponded to the events that were related to us by Mr Yeong, which is the fire had started from the left rear portion of the engine compartment (arrowed).

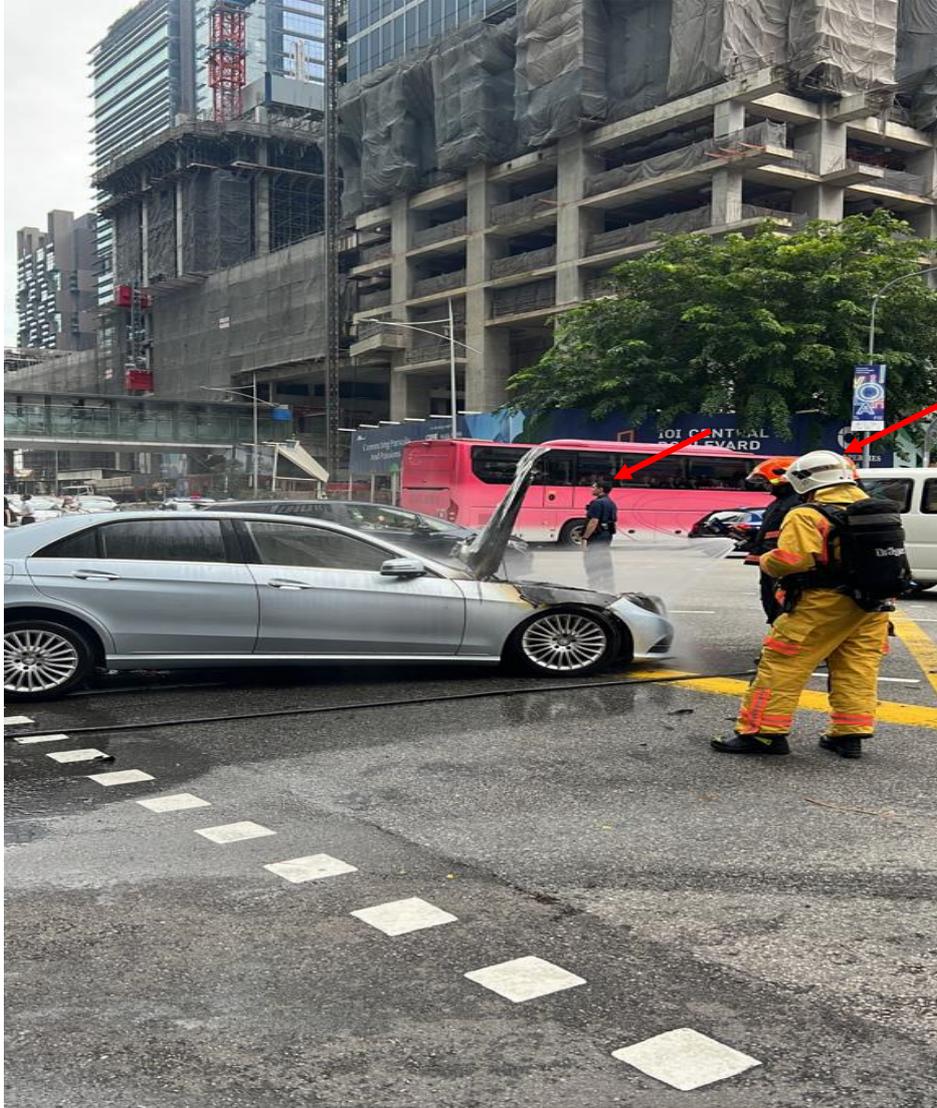
Photo 14 shows the Insured Vehicle at the incident scene after the fire was extinguished. In general, the information that could be gathered from this photograph had corresponded to the events that were related to us by Mr Yeong, which is the police and SCDF were present at the incident location (arrowed).

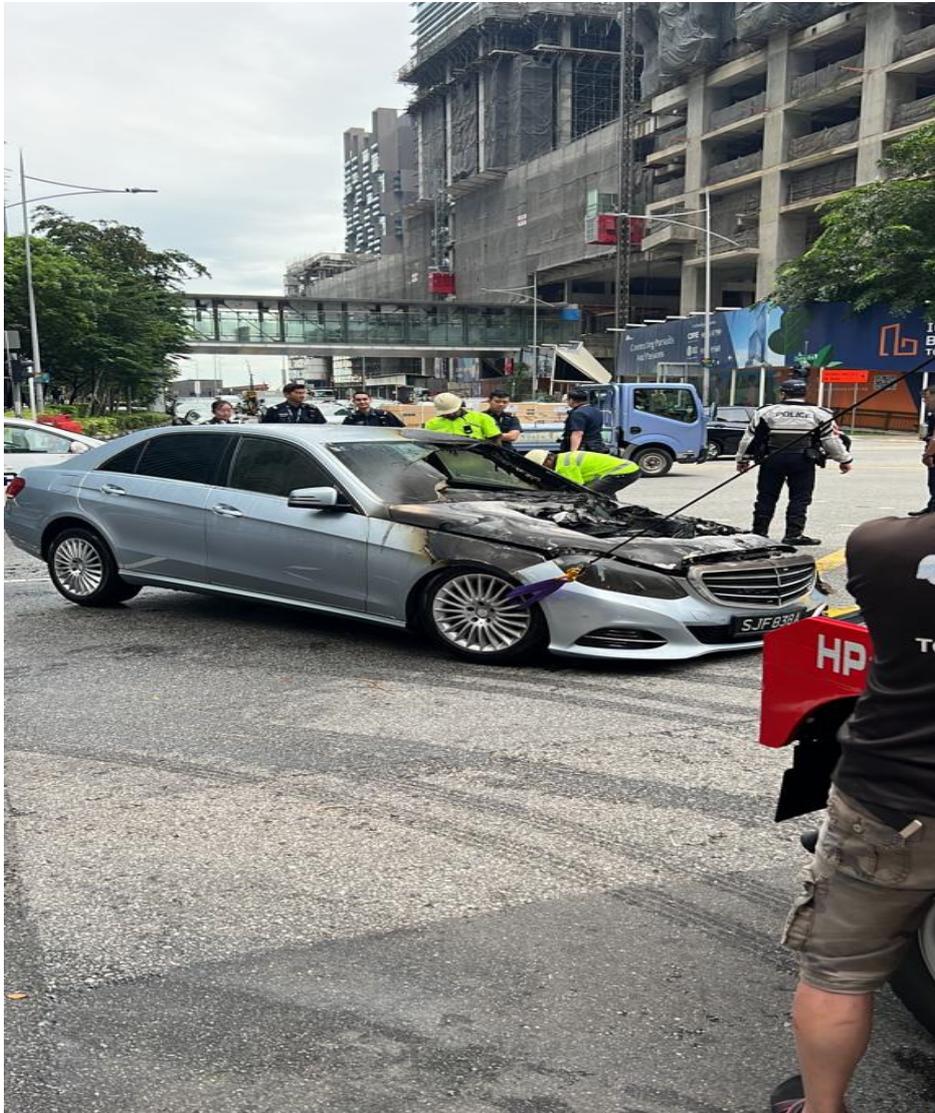
Photo 15 shows the Insured Vehicle at the incident scene being prepped to be towed to KFS.
