LKK Auto Consultants Pte Ltd

Affiliated to Federation Internationale Des Experts En Automobile				
CHINA TAIPING INSURANCE (S) PTE LTD 3 ANSON ROAD #16-00 SPRINGLEAF TOWERSINGAPORE 079909			Ref: CC6/CTI22012066/Kya3q2 Date: 18/02/2023 Code: CTI

ADJUSTMENT ON REPAIR COST FOR VEHICLE NO. SME 5644D

PHOTOGRAPHS FOR VEHICLE NO. SME 5644D

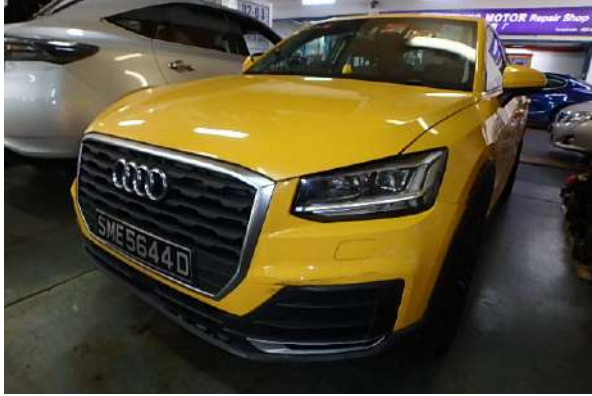
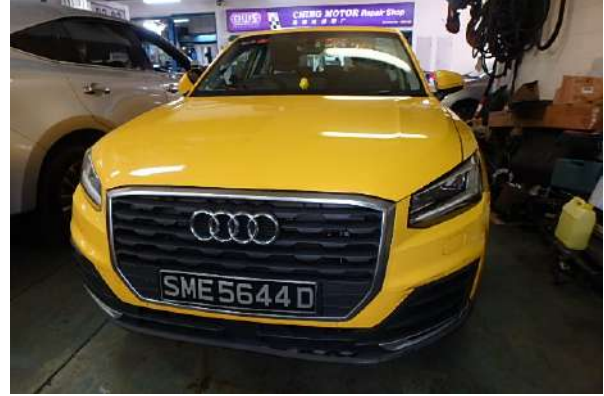
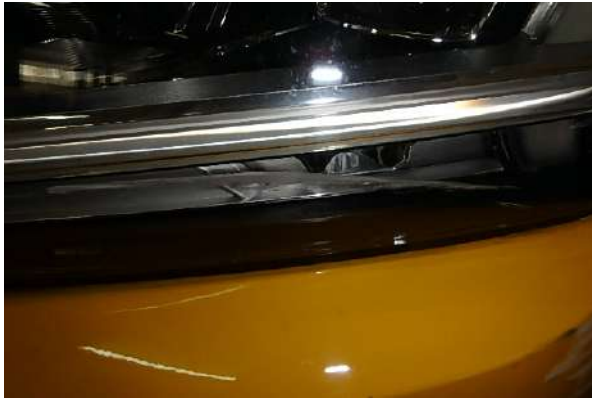
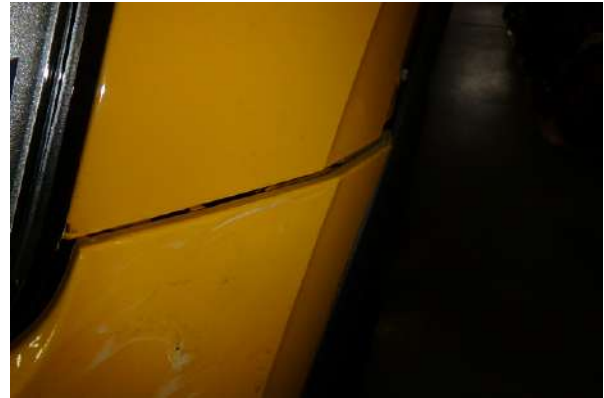
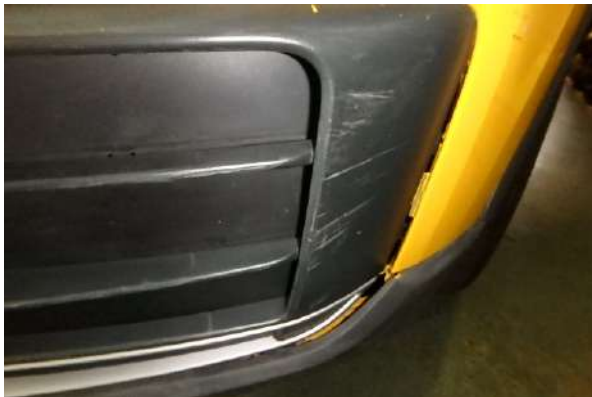
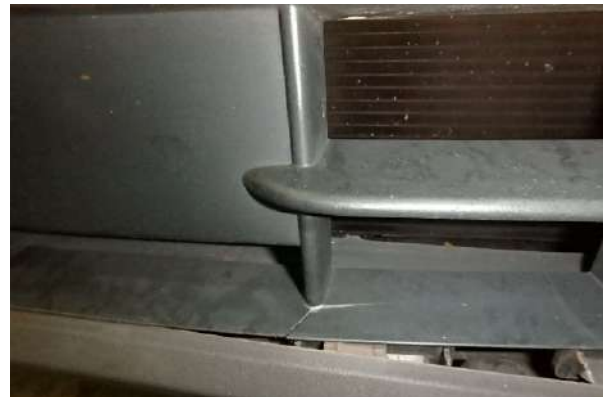
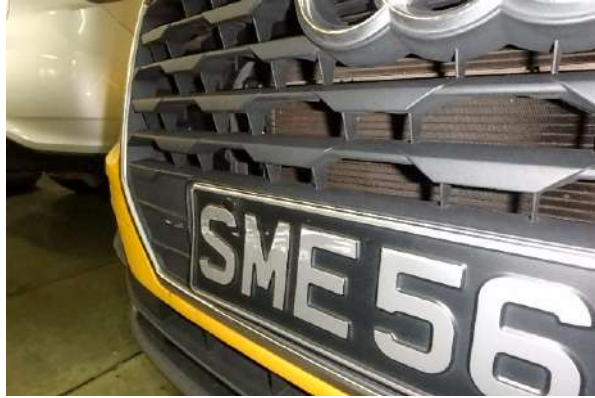
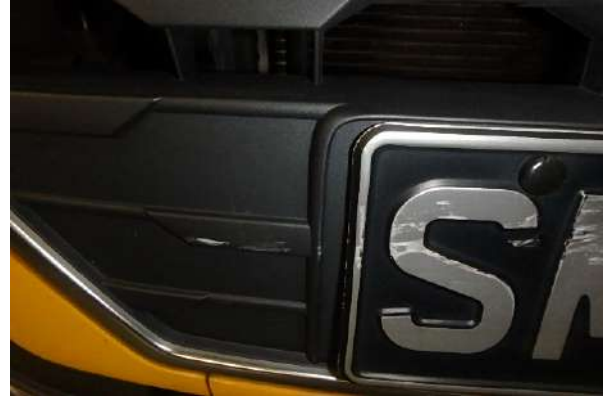
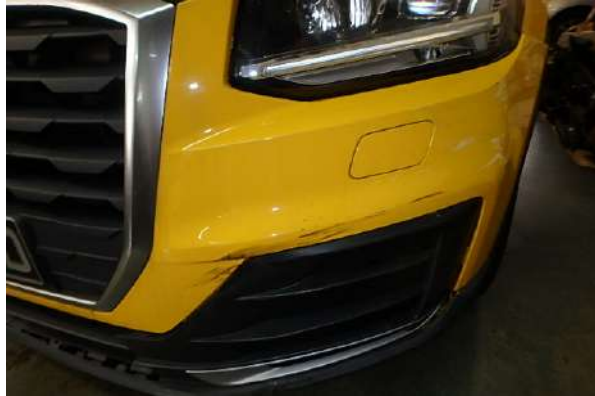
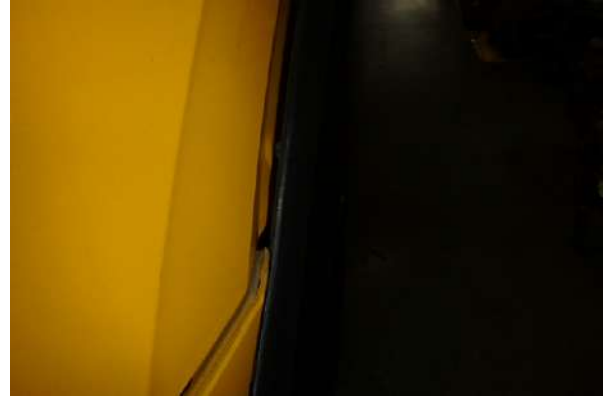
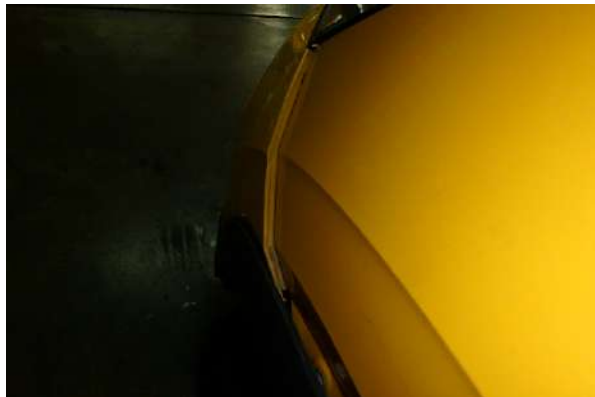
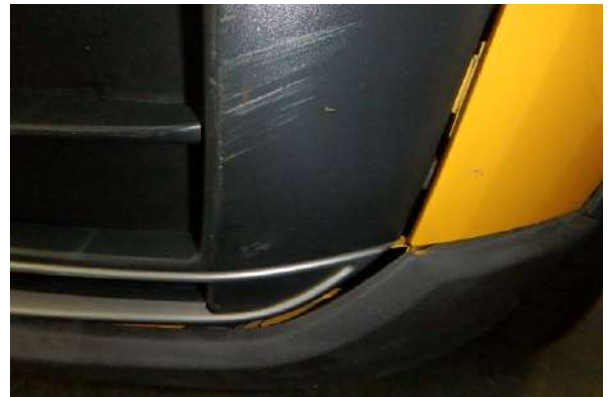
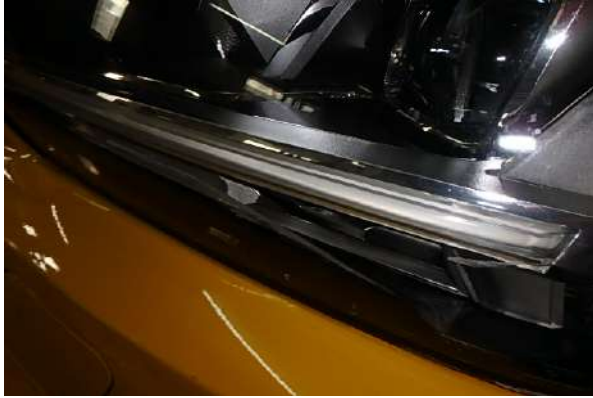
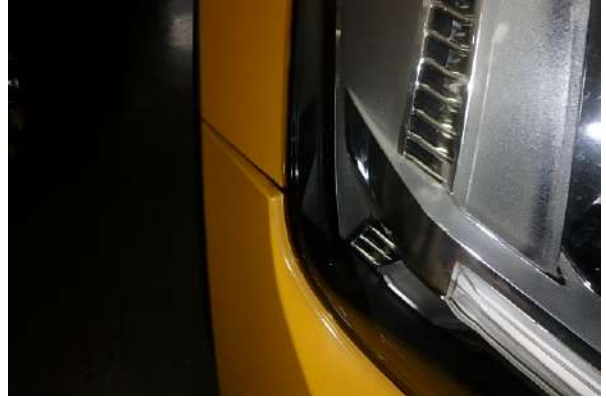
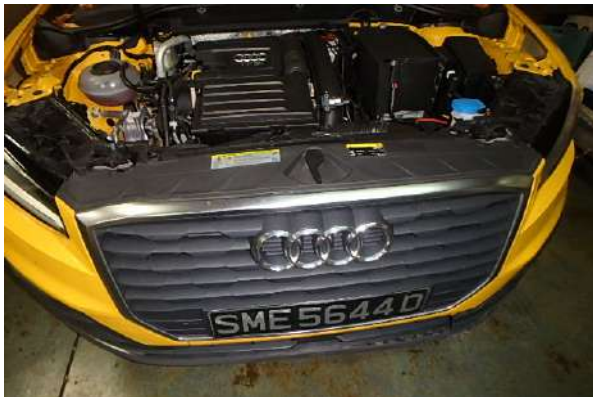
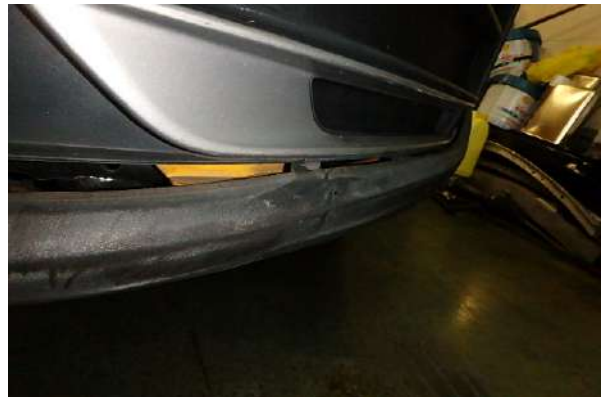
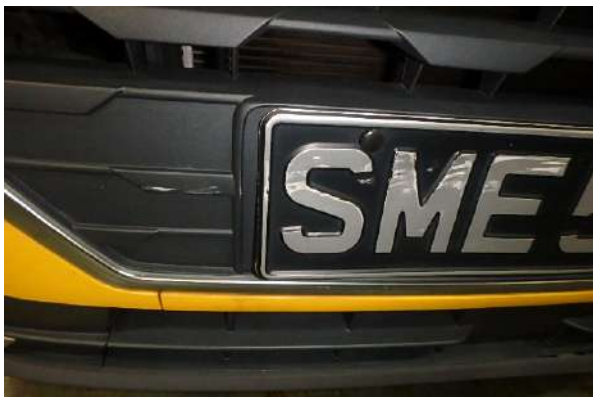
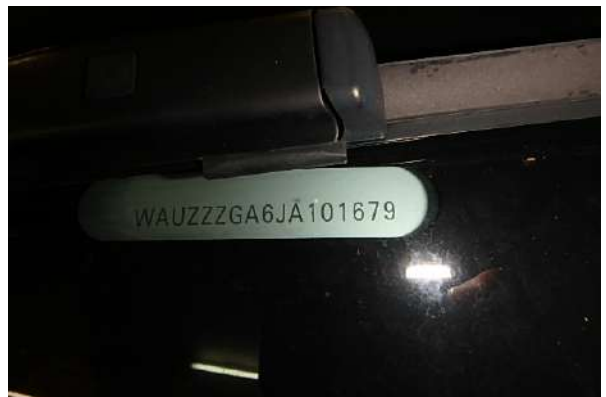
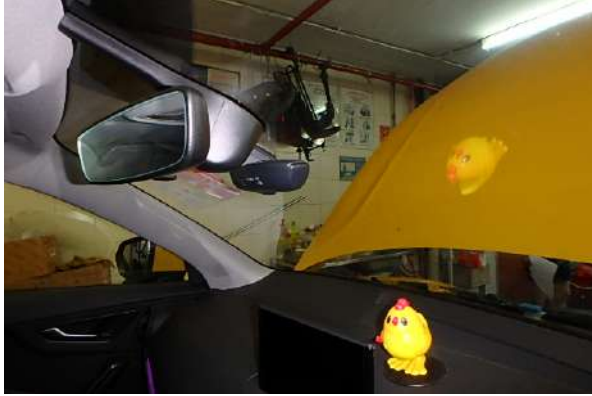
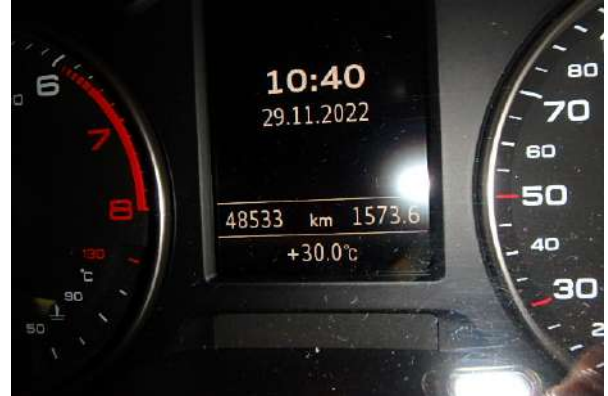
4. Description of Damages				
THE VEHICLE SUSTAINED DAMAGES AT THE FRONT PORTION. DAMAGES SEE DETAILS.				
5. General Information				
Accident Date	27/11/2022	Inspection Date	29/11/2022	
Survey held at	GUAN MOTOR WORKS 176 SIN MING DRIVE #02-03 SIN MING AUTOCARE SINGAPORE 575721			
5a. Remarks				
A)THE INSPECTION WAS CONDUCTED ON A"WITHOUT PREJUDICE" BASIS. B)IN ACCORDANCE TO YOUR INSTRUCTIONS, WE HAVE NOT AUTHORISED REPAIRS.				
5b. Estimate Days of Repair				
ESTIMATED NORMAL PERIOD FOR REPAIR:			4 Working Days

Qty	Description of Parts	Condition	Estimate By Workshop (\$)	Our Adjusted (\$)
	<u>REPLACEMENT OF PARTS</u>			
1	FRONT BUMPER	BUCKLED	812.95	812.95
1	FRONT BUMPER LOWER SPOILER	DENTED	315.75	315.75
1	FRONT BUMPER LH FOG LAMP COVER	CUT	179.10	179.10
1	FRONT BUMPER LOWER GRILLE	CRACKED	205.70	205.70
1	FRONT BUMPER LH SIDE RETAINER	DISTORTED	41.35	41.35
1	FRONT BUMPER INNER FOAM	SERVICEABLE	72.15	-
1	FRONT BUMPER INNER REINFORCEMENT	BENT	681.25	681.25
1	FRONT GRILLE ASSY	CUT	1,253.75	1,253.75
1	LH HEADLAMP (LED)	CUT	4,437.40	4,124.60
1	LH HEADLAMP WASHER NOZZLE	SERVICEABLE	115.65	-
1	LH HEADLAMP WASHER NOZZLE COVER	SERVICEABLE	41.10	-
1	FRONT LH FENDER	TO REPAIR SEE LABOUR	901.95	-
1	FRONT LH FENDER LOWER WHEEL ARCH BLACK GARNISH	BUCKLED	312.75	312.75
	LESS 5% DISCOUNT		-468.54	-396.36
			8,902.31	7,530.84
	<u>SPECIAL NETT ITEMS</u>			
1	FRONT NUMBER PLATE (SN)	DENTED	50.00	45.00

50.00	45.00
	<u>LABOUR</u>			
	LABOUR CHARGES FOR REMOVE /REFIT ,REPAIR AND REPLACEMENT OF DAMAGES.INCLUSIVE OF THE REPAIR OF FRONT LH FENDER .		600.00	400.00
	TO PUTTY AND SPRAY SPRAY PAINTING CHARGES.		600.00	550.00
	TO CHECK WIRING AND LIGHTINGS.		40.00	20.00
	TO SUPPLY AND APPLY ANTI RUST TREATMENT .	NOT NECESSARY	60.00	-
			1,300.00	970.00
	GRAND TOTAL		10,252.31	8,545.84
