Your Ref: BMW M5  
(chassis number WBSJF02090CD23506)  
Our Ref : CI/TP22012170/D

06 December 2022

**INSPECTION REPORT OF AN UNREGISTERED BMW M5 MOTOR CAR WITH CHASSIS NUMBER WBSJF02090CD23506**

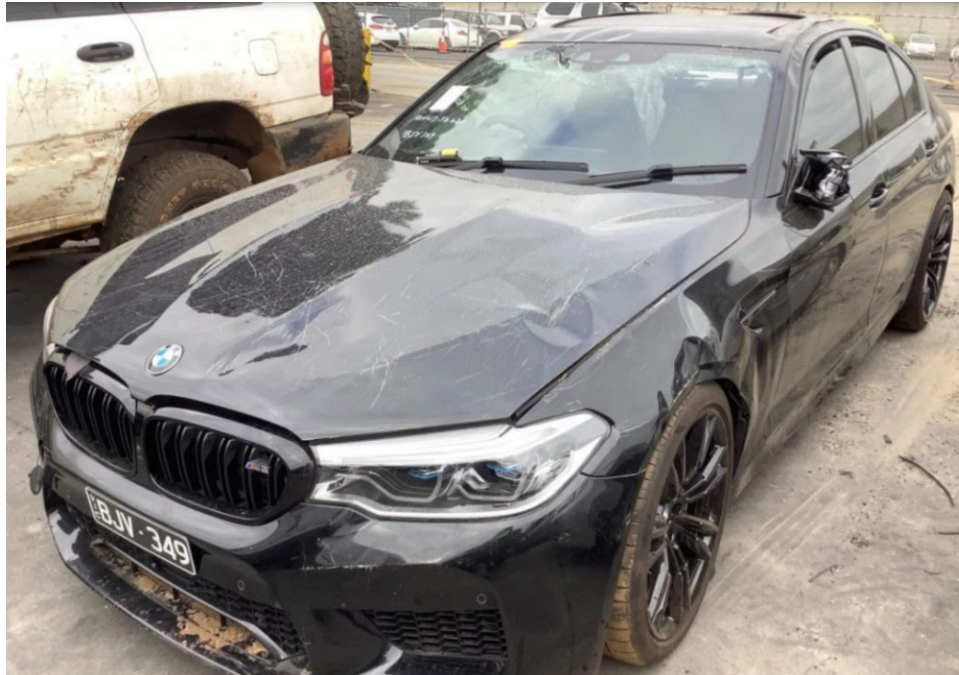
3. The photographs provided to me had showed damage to the left side portion and right side portion of the Motor Car. Body parts damaged at the left side portion include the front bumper, front bonnet, front left fender, front left outer "A" pillar, left wing mirror, rear left door, rear left outer "C" pillar and rear left fender amongst others.
4. As for the Motor Car's right side portion, I had observed damage to right side wing mirror, right side outer "A" pillar, front right door, rear right door, rear right outer "C" pillar, rear right fender, rear right taillamp, rear bumper and fuel filler cover amongst others.
5. The Motor Car's roof panel, front windscreen and rear windscreen were also damaged. The left curtain airbag and right curtain airbag were deployed as seen from the photographs that were provided to me. See photo 1 – 5 below.

**Photo 1** shows the front left body of the Motor Car (photograph provided to me). The photographs provided to me had showed damage to the left side portion of the Motor Car. The front bumper, front bonnet, front left fender, front left outer "A" pillar and left wing mirror were amongst the body parts that were observed to have been damaged.

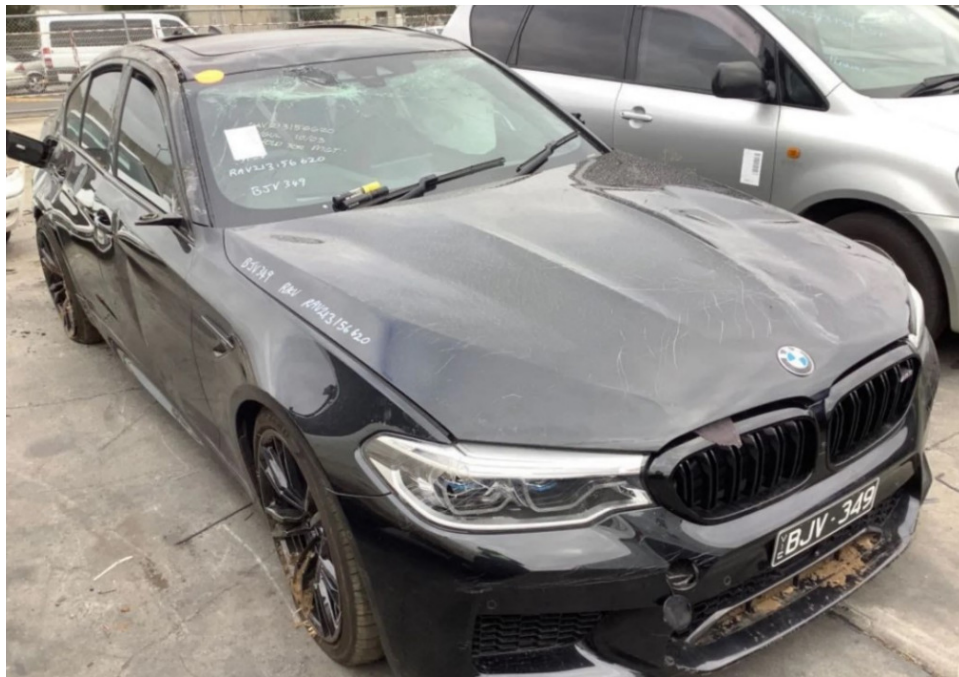
**Photo 2** shows the front right body of the Motor Car (photograph provided to me). The photographs provided to me had showed damage to the right side portion of the Motor Car. The front right outer "A" pillar and right wing mirror were amongst the body parts that were observed to have been damaged. The Motor Car's roof panel and front windscreen were also observed to be damaged.

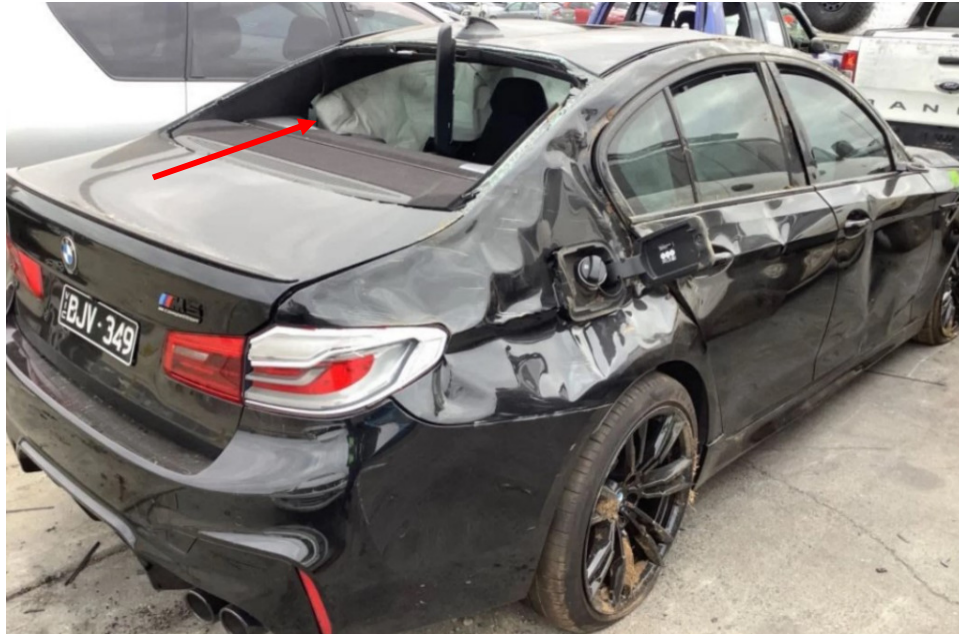
**Photo 3** shows the rear right body of the Motor Car (photograph provided to me). Apart for the left side portion, damage was also seen to the right side portion of the Motor Car. Body parts damaged include the right side wing mirror, front right door, rear right door, rear right outer "C" pillar, rear right fender, rear right taillamp, rear bumper and fuel filler cover amongst others. The Motor Car's roof panel and rear windscreen were also observed to be damaged. The left curtain airbag was deployed (arrowed).

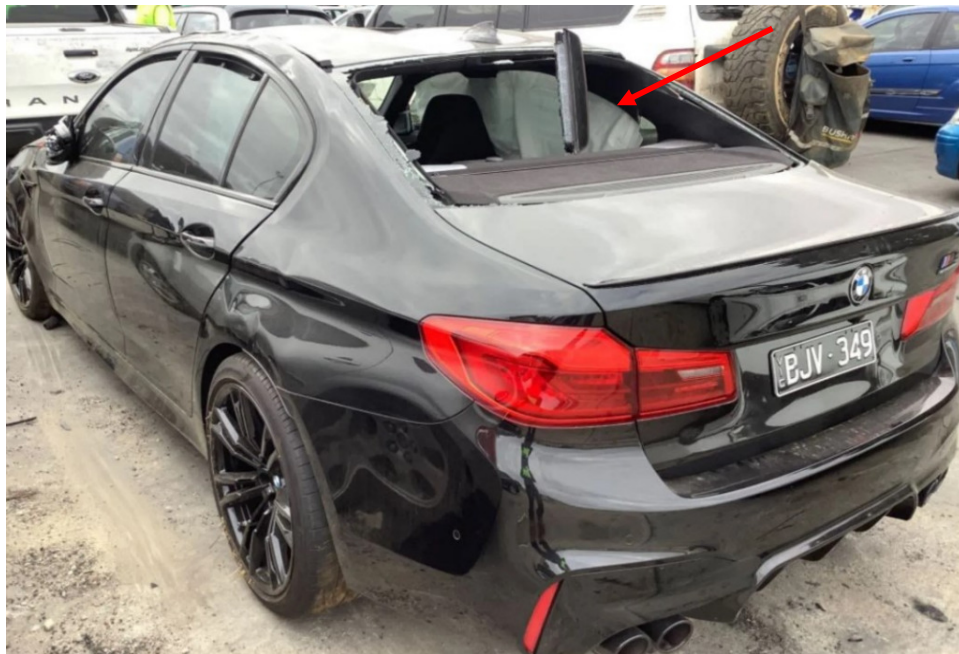
**Photo 4** shows the rear left body of the Motor Car (photograph provided to me). The photographs provided to me had showed damage to the left side portion of the Motor Car. The rear left fender, rear left door and rear left outer "C" pillar were amongst the body parts that were observed to have been damaged. The Motor Car's roof panel and rear windscreen were also observed to be damaged. The right curtain airbag was deployed (arrowed).

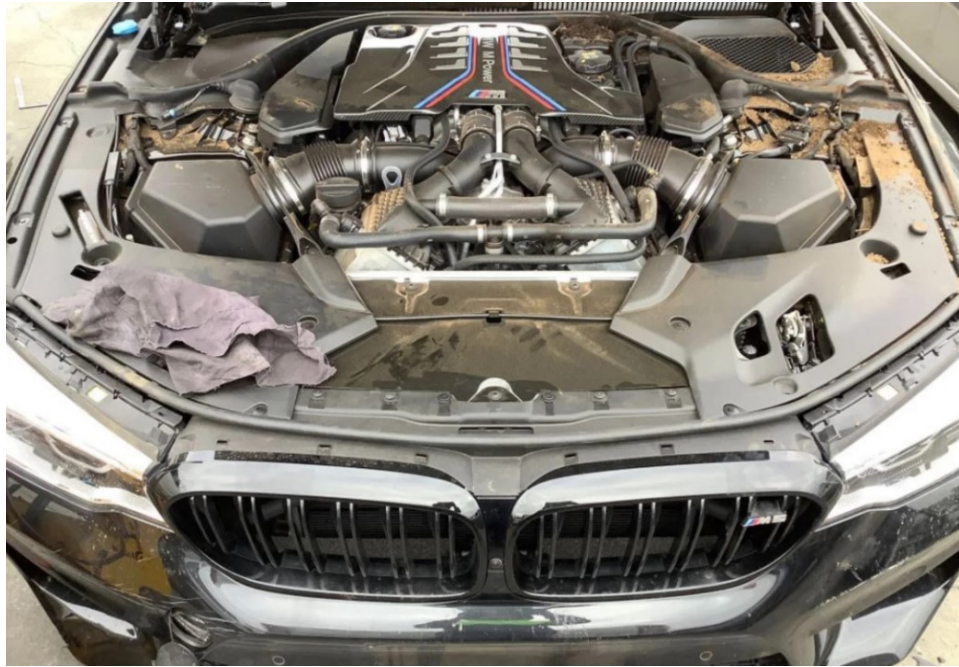
**Photo 5** shows the engine compartment of the Motor Car (photograph provided to me). The various parts and components within the engine compartment were all intact and unaffected.

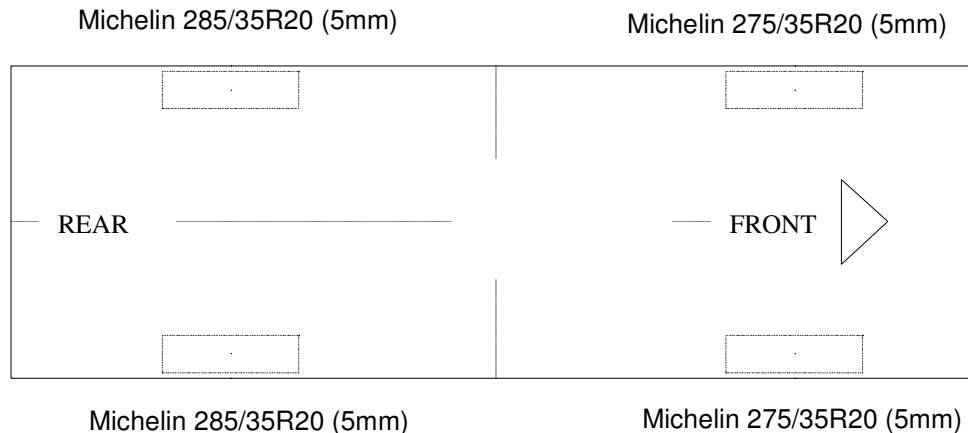
9. The Motor Car was fitted with 20inch sport wheel rims that were wrapped with tyres that were observed to be of serviceable condition. The tyres were also sufficiently inflated for vehicular operation. The tyre brand, tyre size and approximate remaining tread depth of the 4 tyres of the Motor Car were recorded as follows: -

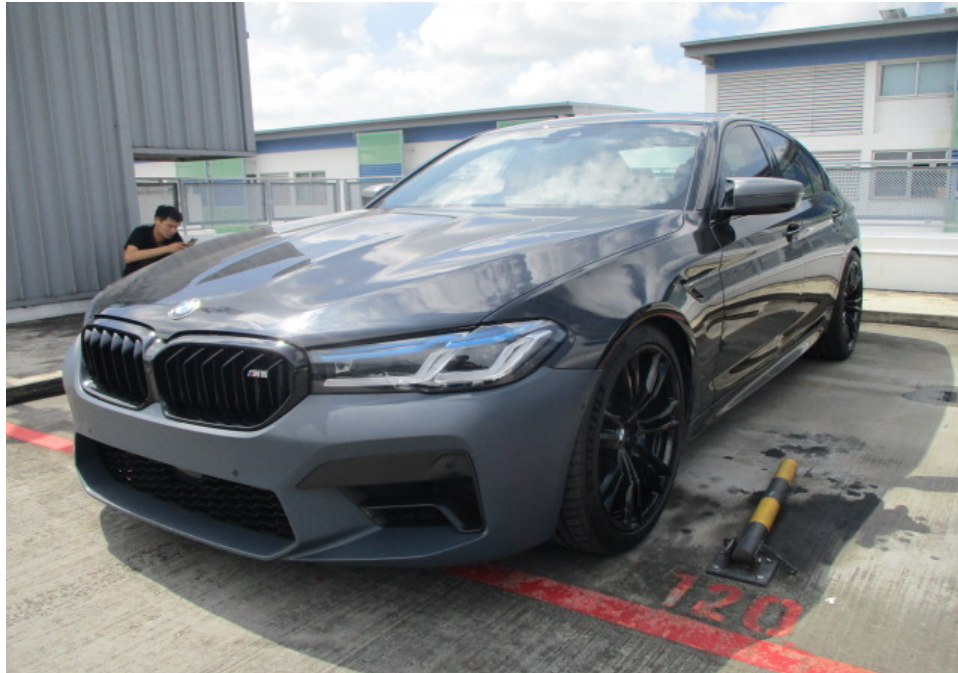
**Photo 6** shows a general view of the front left body of the Motor Car at the time of my inspection. The Motor Car was observed to be in a relatively good general condition with no loose exterior fittings observed. The body parts at the left side portion of the Motor Car were visually examined and it was observed that the repair/restoration works carried out to the damaged area of the Motor Car (refer to photograph 1 above) were reasonably adequate and in order.

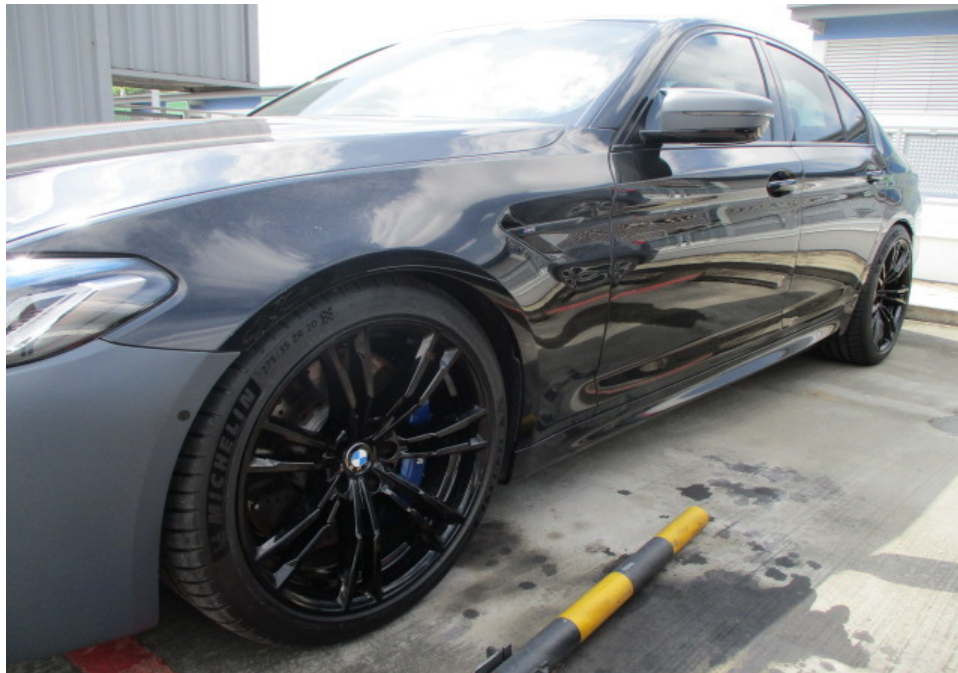
**Photo 7** shows a closer view of the Motor Car's front bumper, front left fender, front left wheel rim and front left door. The body parts at the left side portion of the Motor Car were visually examined and it was observed that the repair/restoration works carried out to the damaged area of the Motor Car (refer to photograph 1 above) were reasonably adequate and in order.

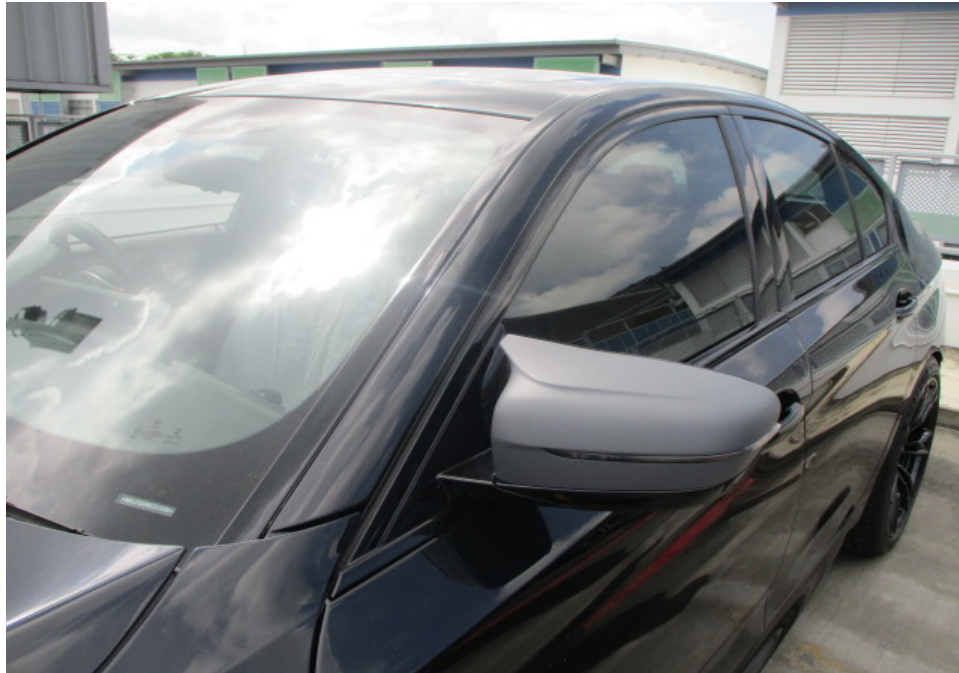
**Photo 8** shows a closer view of the Motor Car's left side wing mirror, front left outer "A" pillar and front windscreen. The body parts at the left side portion of the Motor Car were visually examined and it was observed that the repair/restoration works carried out to the damaged area of the Motor Car (refer to photograph 1 above) were reasonably adequate and in order.

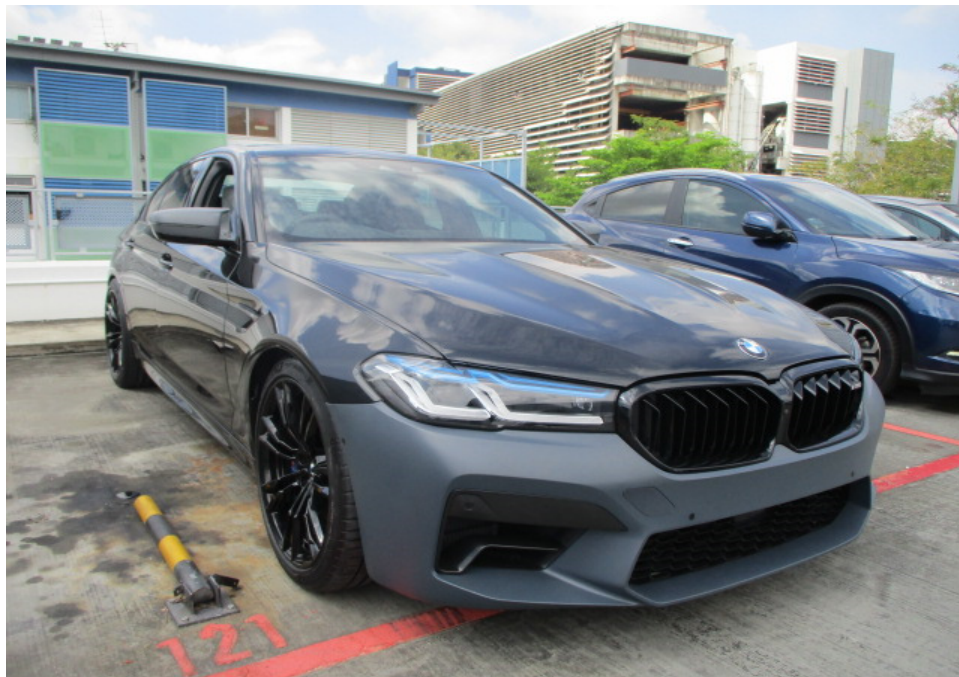
**Photo 9** shows a general view of the front right body of the Motor Car at the time of my inspection. The Motor Car was observed to be in a relatively good general condition with no loose exterior fittings observed. The body parts at the right side portion of the Motor Car were visually examined and it was observed that the repair/restoration works carried out to the damaged area of the Motor Car (refer to photograph 2 above) were reasonably adequate and in order.

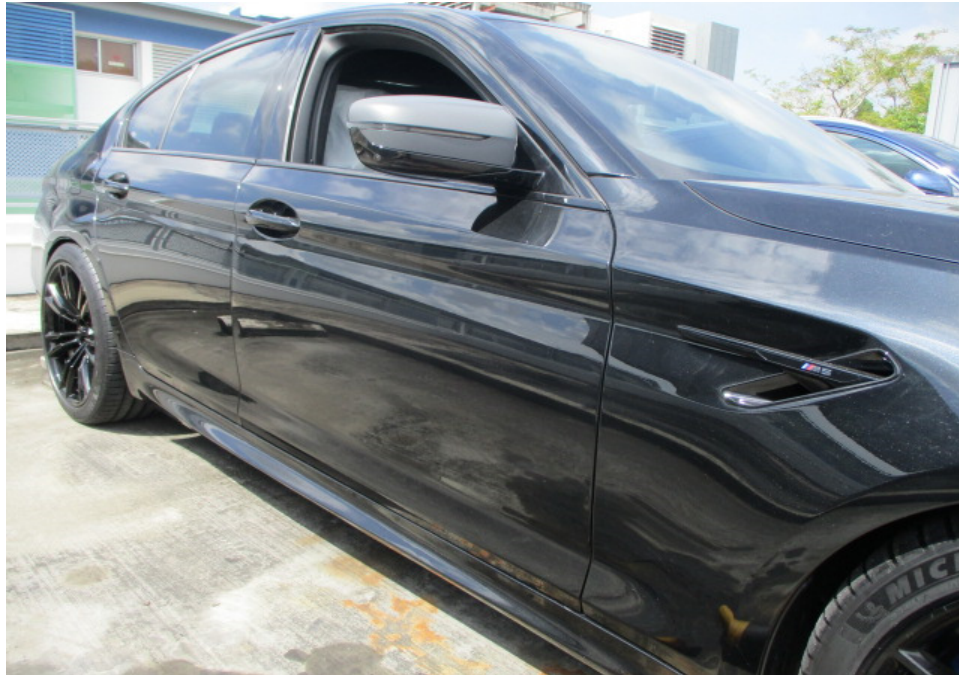
**Photo 10** shows a closer view of the Motor Car's front right fender, front right door, front right outer "A" pillar and right side wing mirror. The body parts at the right side portion of the Motor Car were visually examined and it was observed that the repair/restoration works carried out to the damaged area of the Motor Car (refer to photograph 2 above) were reasonably adequate and in order.

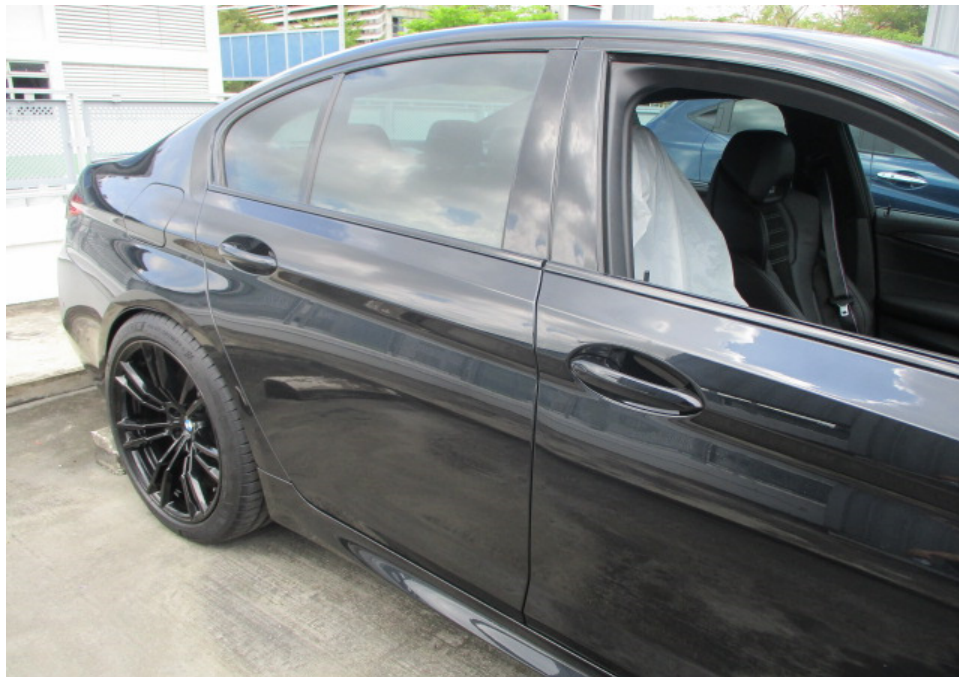
**Photo 11** shows a closer view of the Motor Car's front right door and rear right door. The body parts at the right side portion of the Motor Car were visually examined and it was observed that the repair/restoration works carried out to the damaged area of the Motor Car (refer to photograph 2 & 3 above) were reasonably adequate and in order.

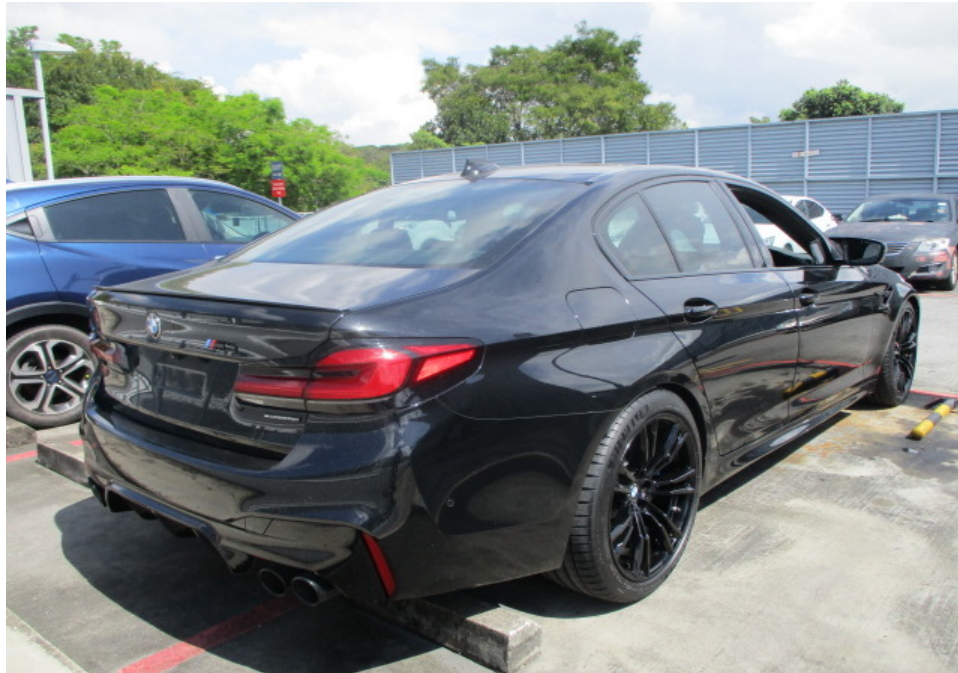
**Photo 12** shows a general view of the rear right body of the Motor Car at the time of my inspection. The Motor Car was observed to be in a relatively good general condition with no loose exterior fittings observed. The body parts at the right side portion of the Motor Car were visually examined and it was observed that the repair/restoration works carried out to the damaged area of the Motor Car (refer to photograph 3 above) were reasonably adequate and in order.

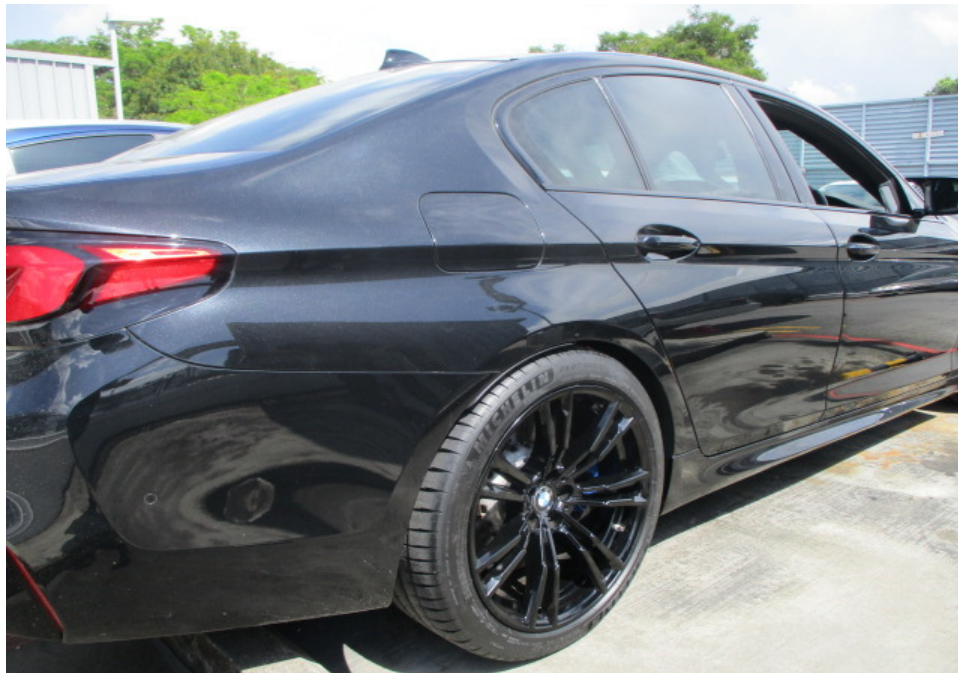
**Photo 13** shows a closer view of the Motor Car's rear bumper, rear right taillamp, rear right fender, rear right wheel rim and fuel filler cover. The body parts at the right side portion of the Motor Car were visually examined and it was observed that the repair/restoration works carried out to the damaged area of the Motor Car (refer to photograph 3 above) were reasonably adequate and in order.

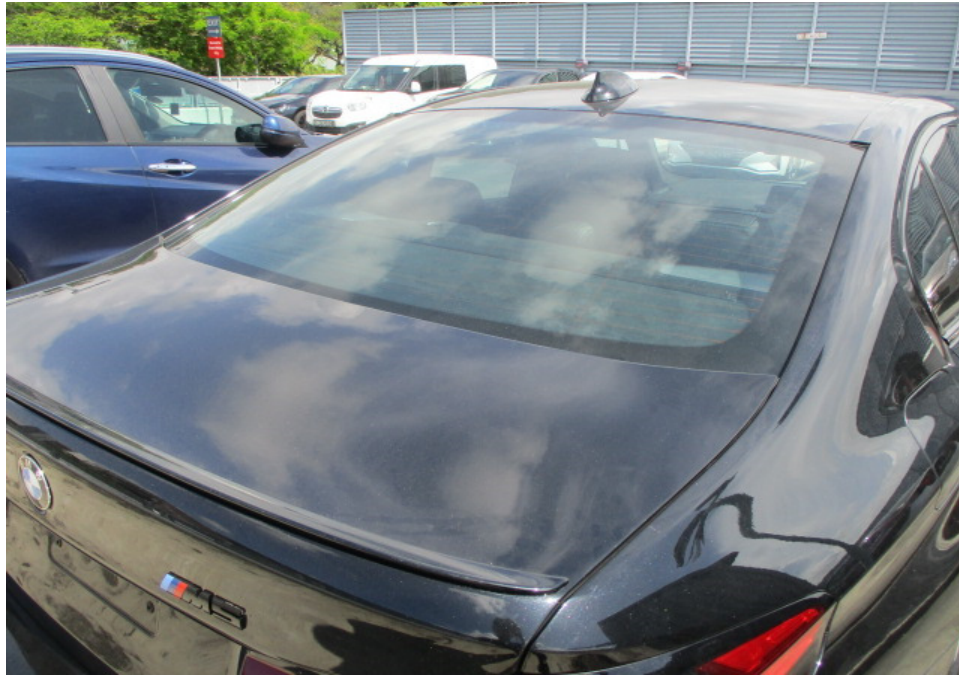
**Photo 14** shows a closer view of the Motor Car's rear bootlid, rear right outer "C" pillar and rear windscreen. The body parts at the right side portion of the Motor Car were visually examined and it was observed that the repair/restoration works carried out to the damaged area of the Motor Car (refer to photograph 3 above) were reasonably adequate and in order.

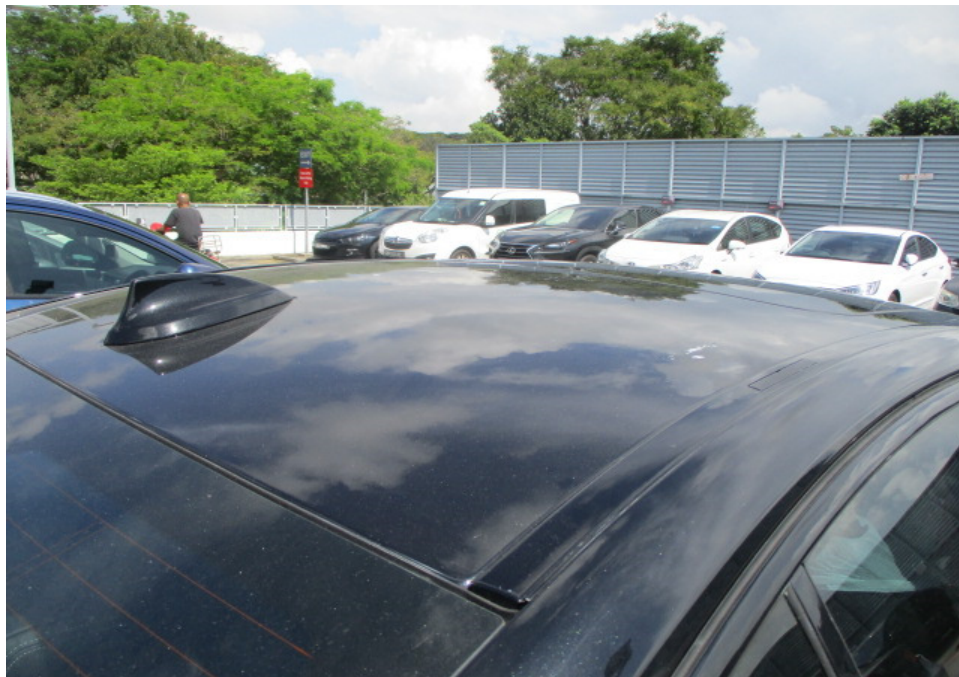
**Photo 15** shows a closer view of the Motor Car's rear right outer "C" pillar and roof panel. The body parts at the right side portion of the Motor Car were visually examined and it was observed that the repair/restoration works carried out to the damaged area of the Motor Car (refer to photograph 3 above) were reasonably adequate and in order.

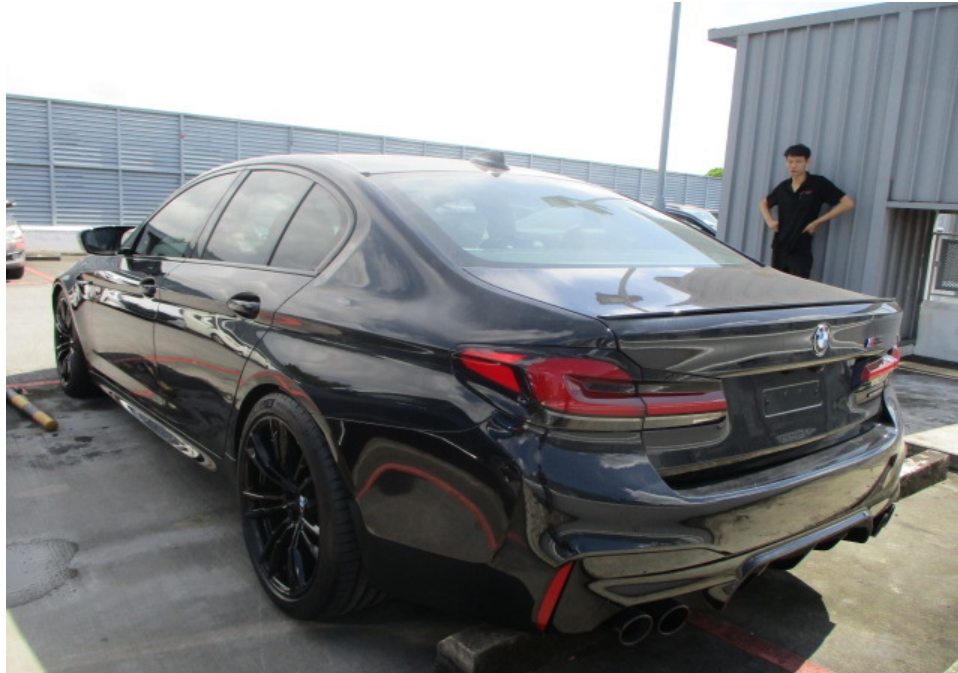
**Photo 16** shows a general view of the rear left body of the Motor Car at the time of my inspection. The Motor Car was observed to be in a relatively good general condition with no loose exterior fittings observed. The body parts at the left side portion of the Motor Car were visually examined and it was observed that the repair/restoration works carried out to the damaged area of the Motor Car (refer to photograph 4 above) were reasonably adequate and in order.

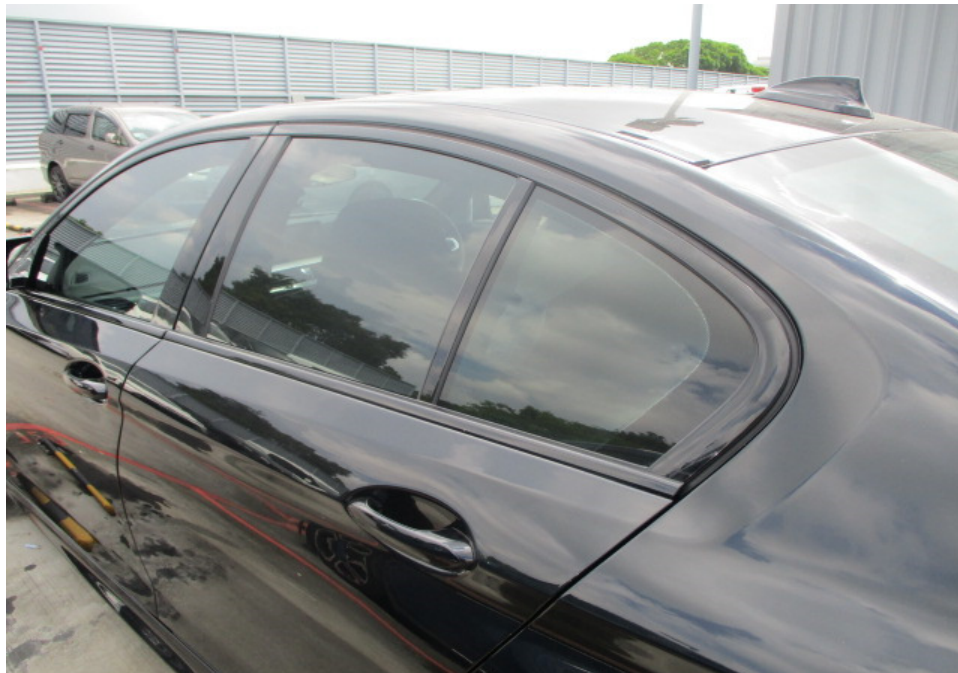
**Photo 17** shows a closer view of the Motor Car's rear left outer "C" pillar, rear left fender and rear left door. The body parts at the left side portion of the Motor Car were visually examined and it was observed that the repair/restoration works carried out to the damaged area of the Motor Car (refer to photograph 4 above) were reasonably adequate and in order.

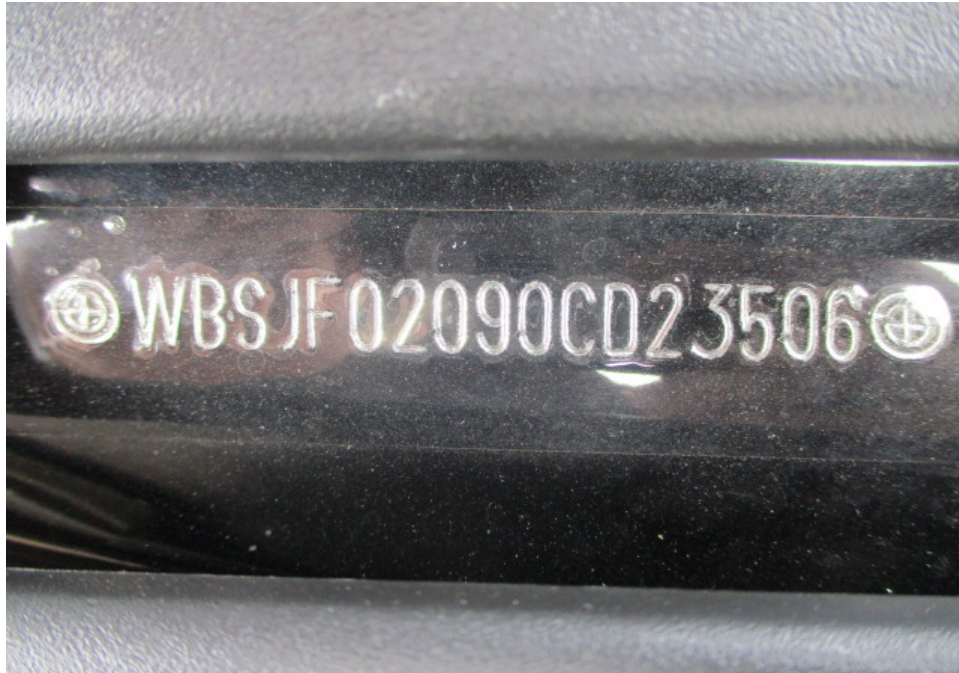
**Photo 18** shows the chassis number of the Motor Car. The chassis number recorded was WBSJF02090CD23506.

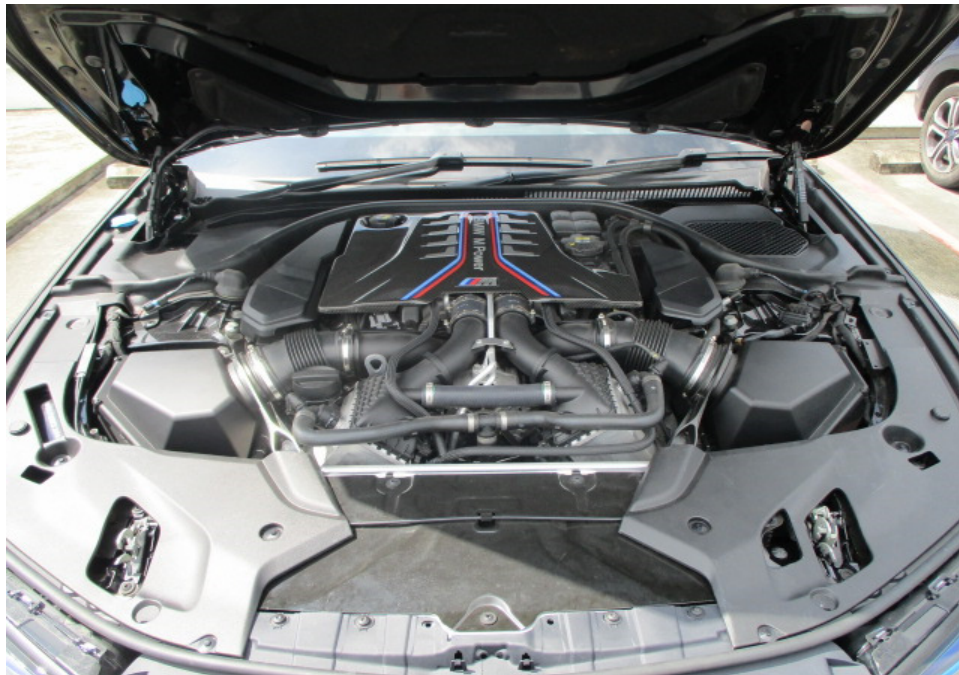
**Photo 19** shows a general view of the Motor Car's engine compartment at the time of my inspection. The various parts and components inside the engine compartment were all observed to be intact and properly fitted. There was also no sign(s) or indication(s) of fluid leak and/or fluid stain found inside the engine compartment.

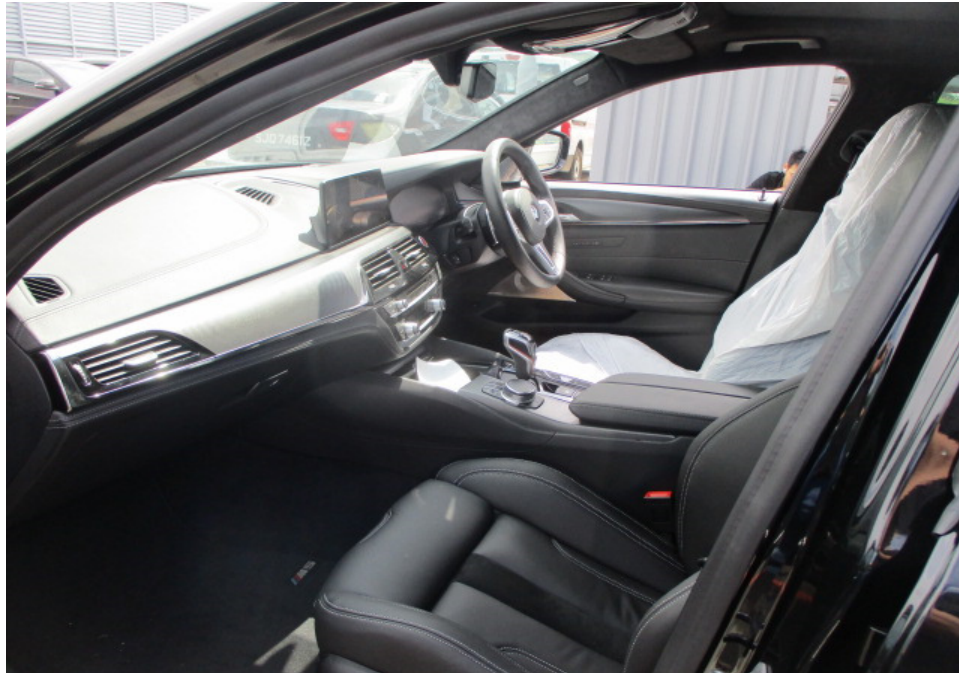
**Photo 20** shows the interior compartment of the Motor Car at the time of my inspection. The various parts and components, trims, carpet, and upholstery inside the interior compartment were all observed to be intact and properly fitted.

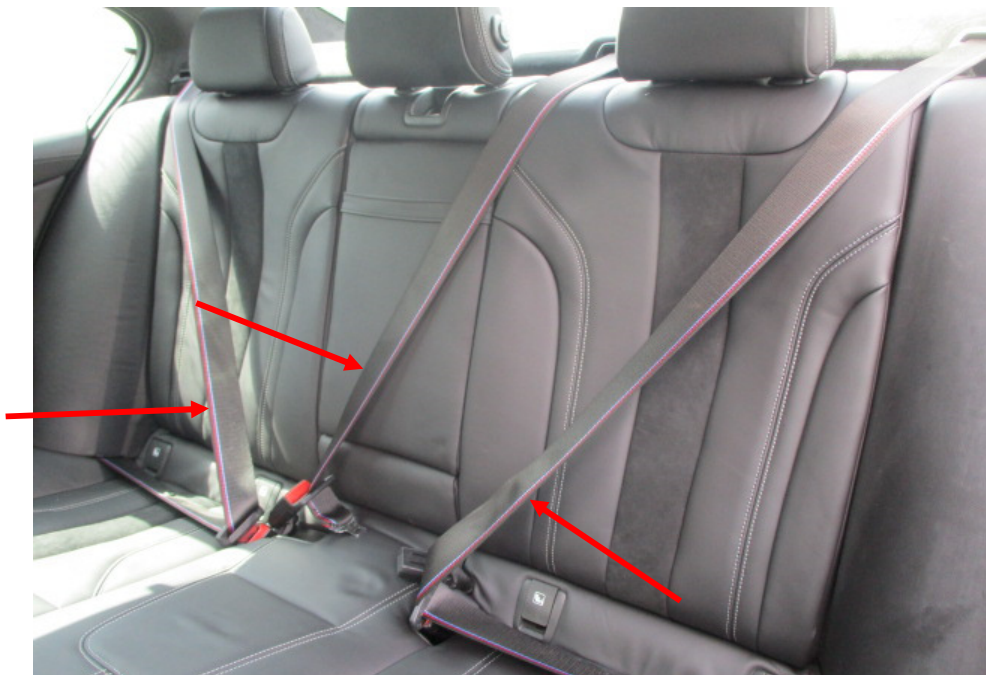
**Photo 21** shows the rear seats of the Motor Car. All the seats of the Motor Car were secured via seat rails to the floorboard. They were also fitted with a retractable seat belt reel and a pre-tensioner. The seat belts (arrowed) were tested and were able to be fastened into the respective pre-tensions that were fitted on the side of each individual seat.

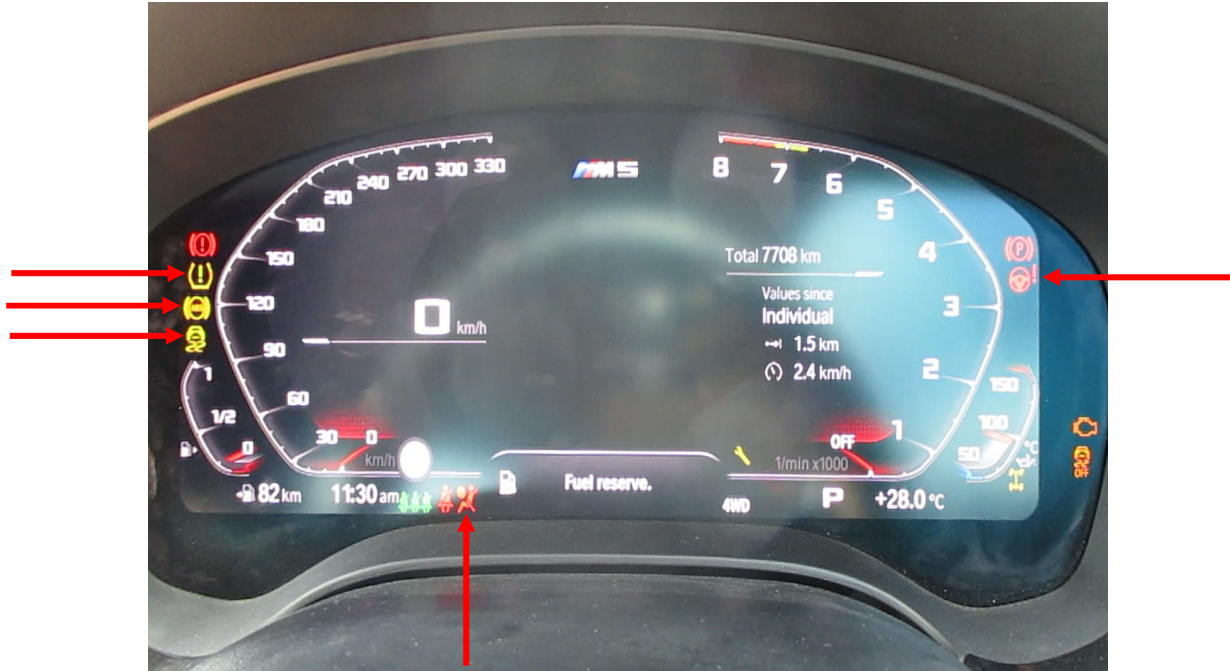
**Photo 22** shows the warning lights for the various electronic safety features appearing on the instrument panel of the Motor Car during its self-test when the engine is cranked, in particular the ABS, SRS, IAS, TPM and DSC lights (arrowed).

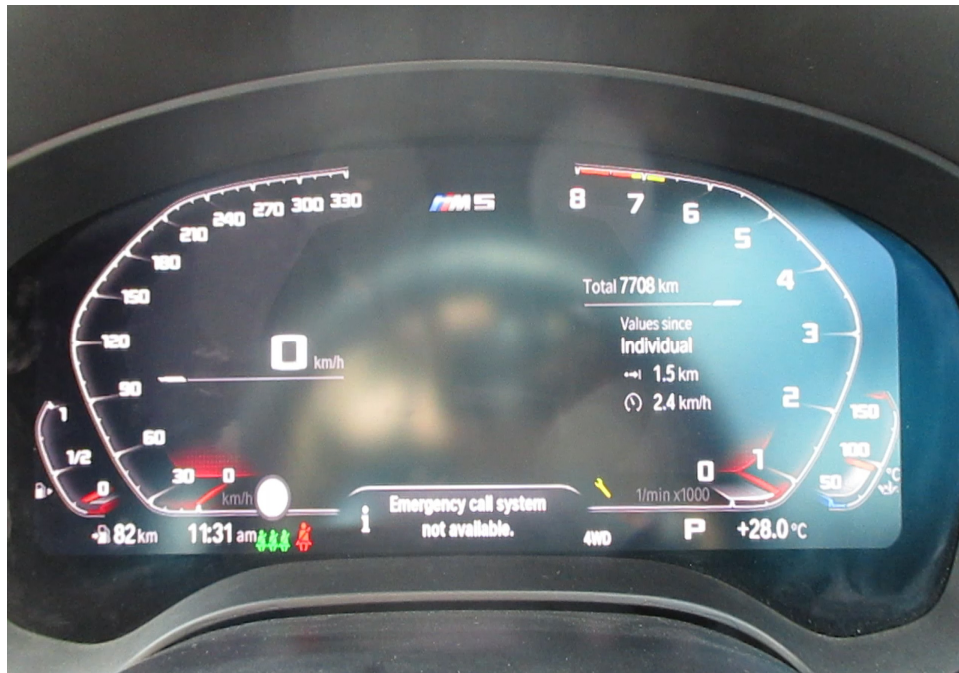
**Photo 23** shows the respective warning lights no longer illuminated, indicating that there is no fault detected to the ABS, SRS, IAS, TPM and DSC systems of the Motor Car during the self-test. These electronic systems were hence in working condition at the time of my inspection.

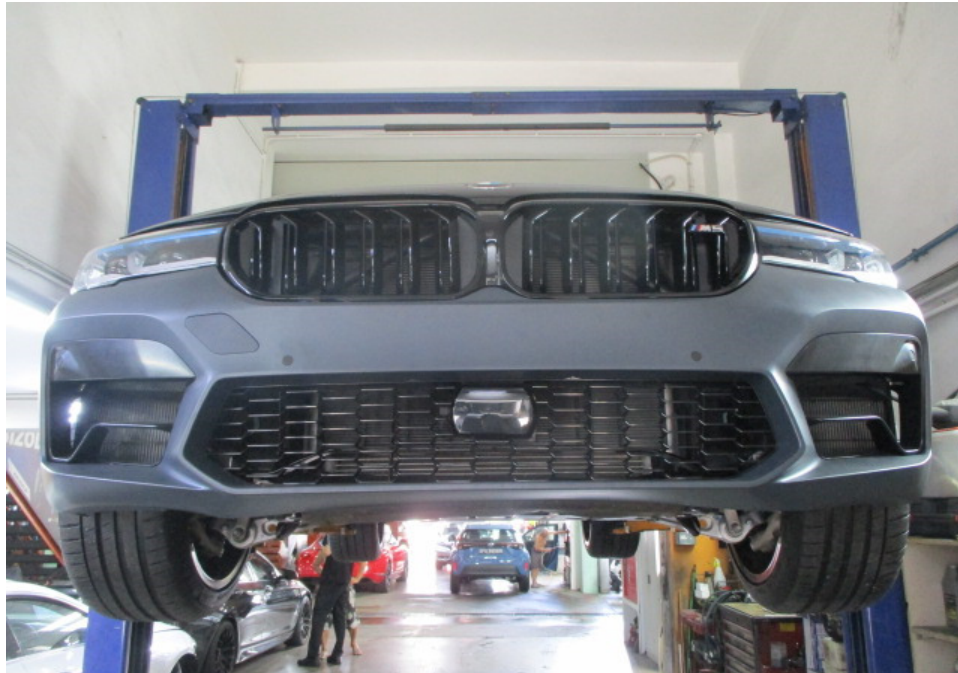
**Photo 24** shows the Motor Car hoisted up for checks on its undercarriage. There was no sign(s) or indication(s) of fluid leakage and/or fluid stain(s) on the underside of the Motor Car. The undercarriage components of the Motor Car were also all observed to be intact and secured in an appropriate manner.

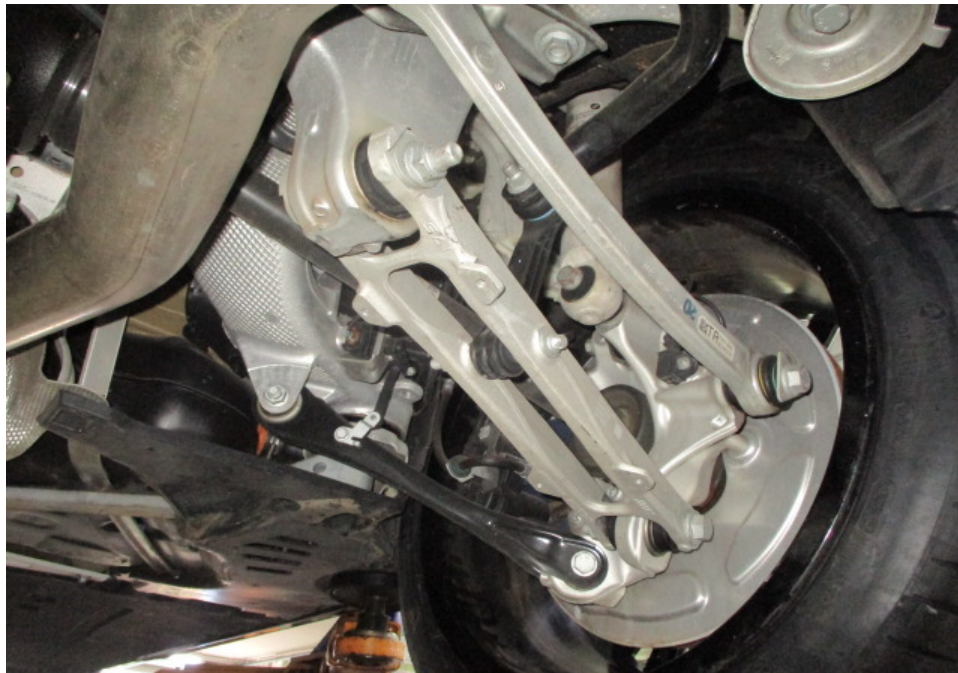
**Photo 25** shows a general view of the control arms and linkages at the rear right wheel of the Motor Car. I did not observe any fluid leak and/or fluid stain on the underside of the Motor Car. All of the Motor Car's undercarriage components were observed to be intact and secured in an appropriate manner.

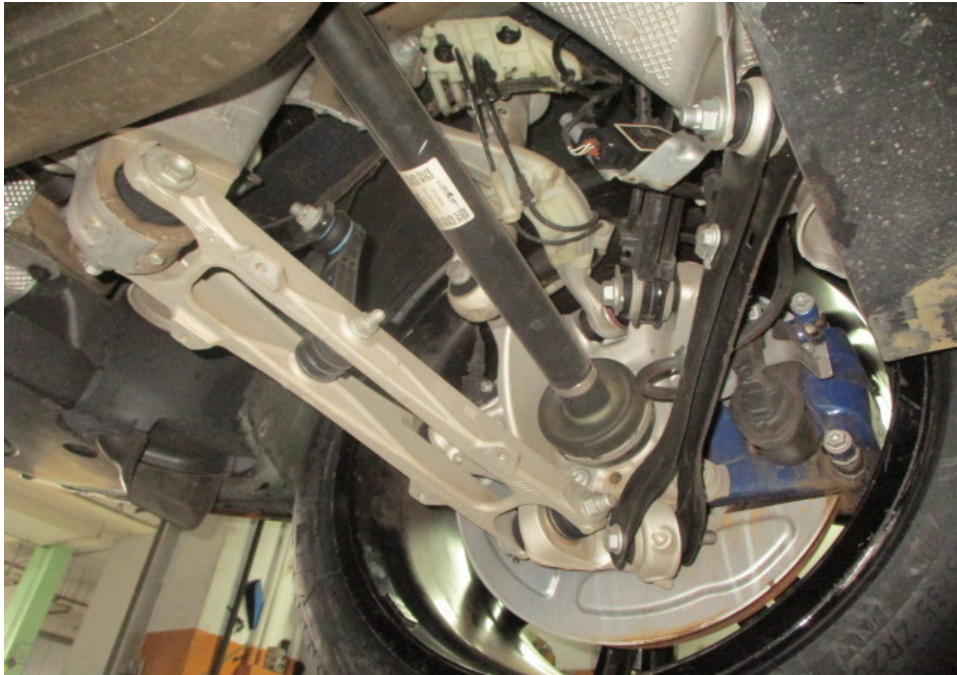
**Photo 26** shows a general view of the control arms and linkages at the rear left wheel of the Motor Car. I did not observe any fluid leak and/or fluid stain on the underside of the Motor Car. All of the Motor Car's undercarriage components were observed to be intact and secured in an appropriate manner.

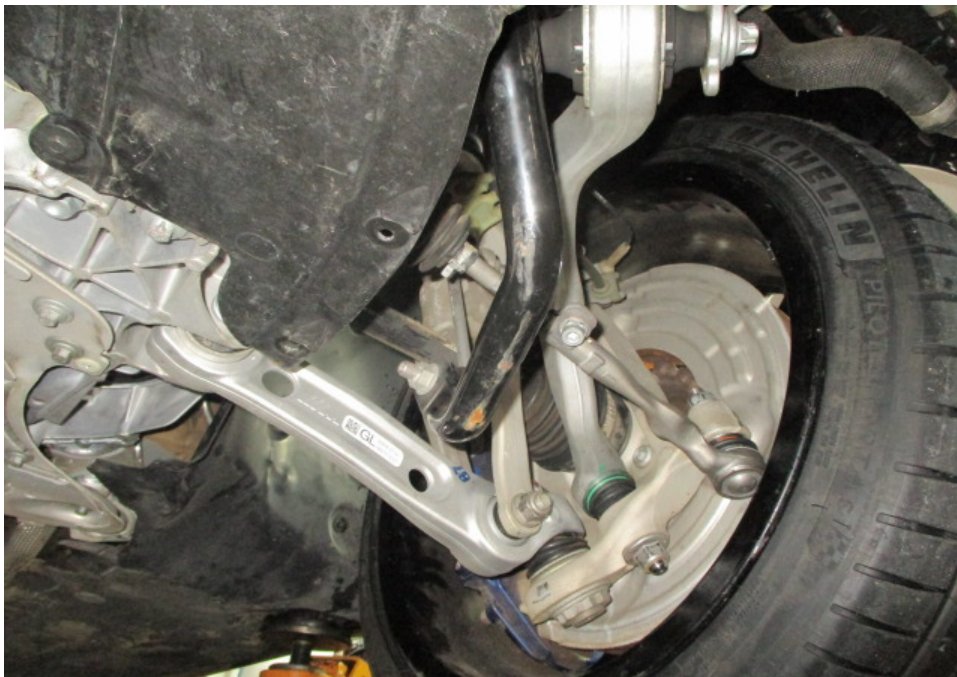
**Photo 27** shows the various undercarriage components at the front left wheel of the Motor Car. The mechanical components, control arms and linkages were all found to be intact and secured in an appropriate manner.

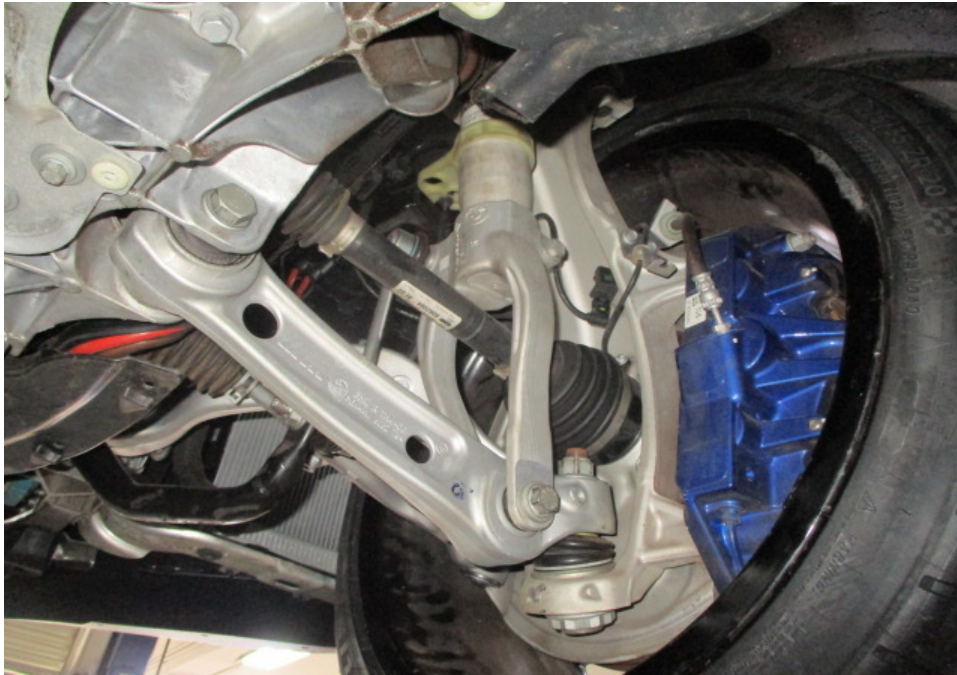
**Photo 28** shows the various undercarriage components at the front right wheel of the Motor Car. The mechanical components, control arms and linkages were all found to be intact and secured in an appropriate manner. I also did not observe any fluid leak and/or fluid stain on the underside of the Motor Car.

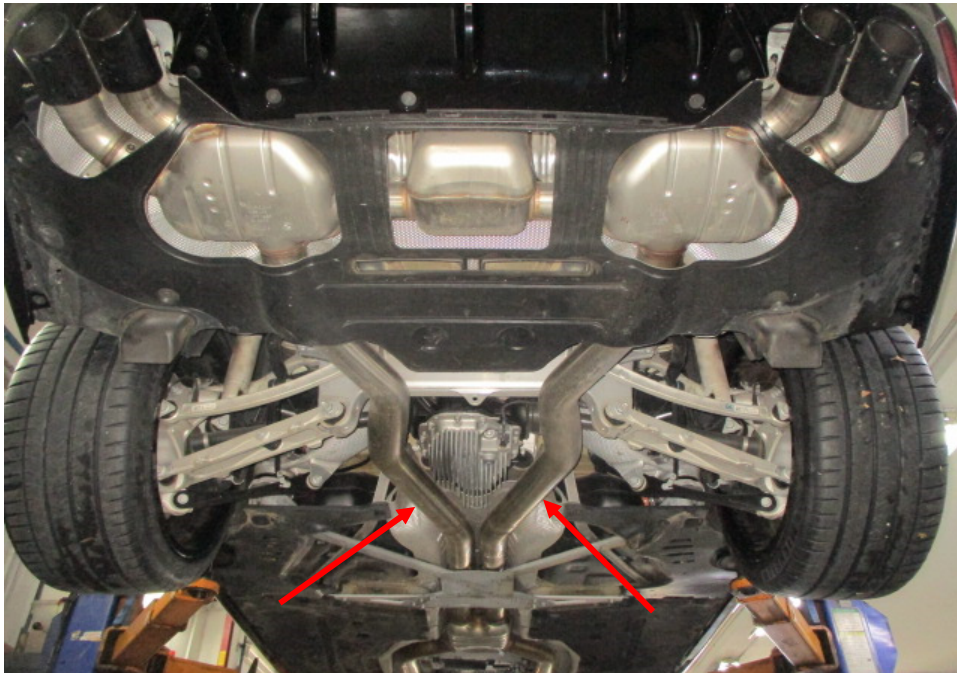
**Photo 29** shows the rear section of the Motor Car's exhaust system. My examination of the Motor Car's exhaust system revealed no sign(s) or indication(s) of any cut or weld marks along its exhaust pipes (arrowed), on its rear mufflers, on its centre resonator box and on its catalytic converters.
