Your Ref: BMW M5  
(chassis number WBSJF02090CD23506)  
Our Ref : CI/TP22012170/D

06 December 2022

**INSPECTION REPORT OF AN UNREGISTERED BMW M5 MOTOR CAR WITH CHASSIS NUMBER WBSJF02090CD23506**

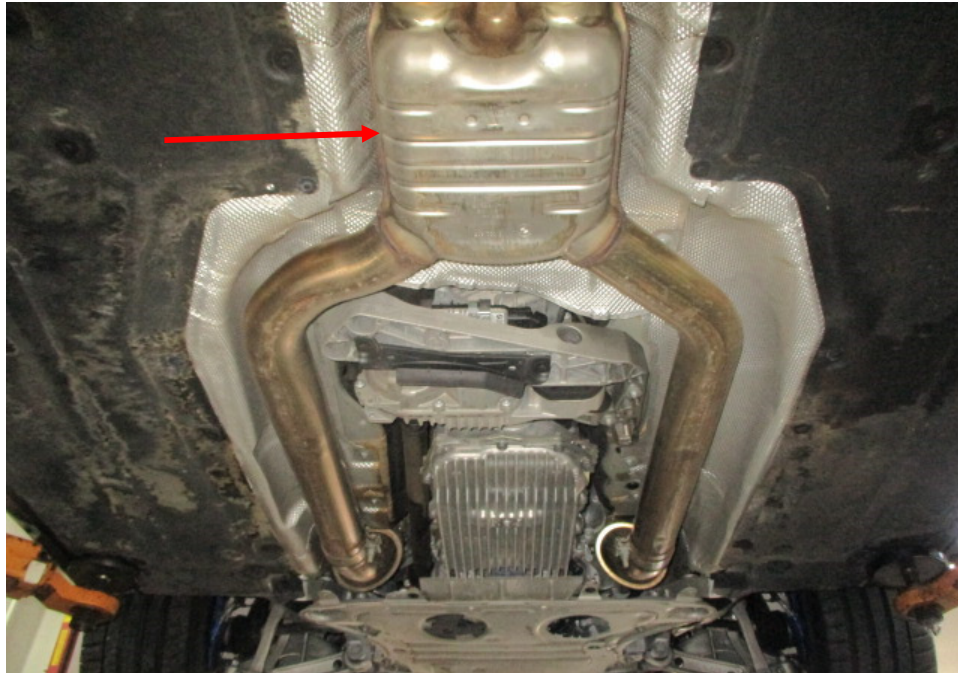
**Photo 30** shows the front section of the Motor Car's exhaust system. My examination of the Motor Car's exhaust system revealed no sign(s) or indication(s) of any cut or weld marks along its exhaust pipes, on its rear mufflers, on its centre resonator box (arrowed) and on its catalytic converters.

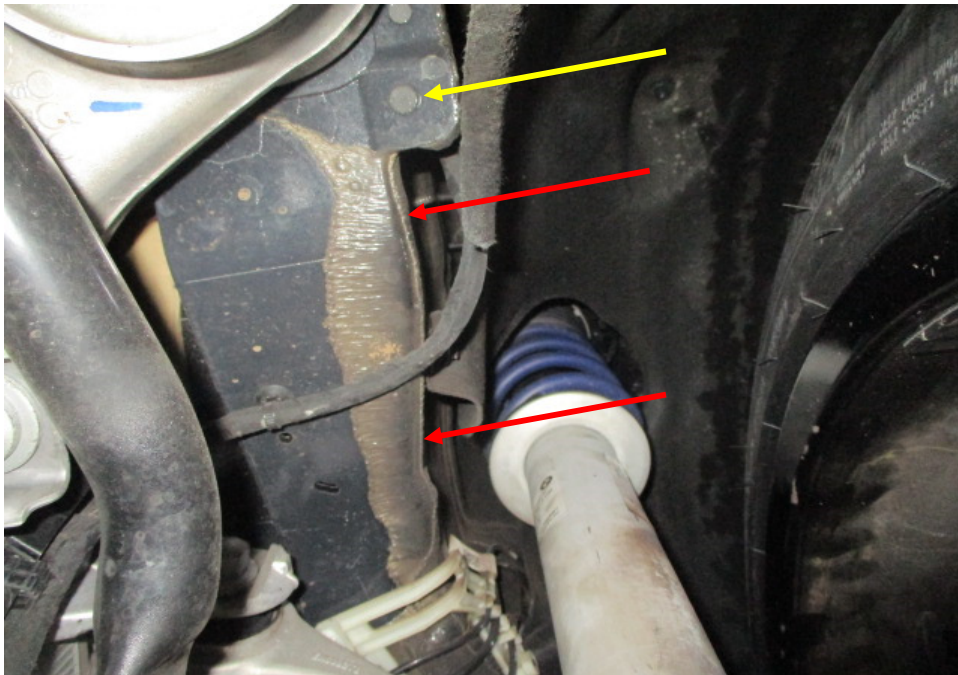
**Photo 31** shows the chassis/structural body at the underside rear right of the Motor Car. I did not find any weld marks other than original spot weld marks (yellow arrow) on the chassis/structural body of the Motor Car. The original factory sealant (red arrow) at the joints along the chassis/structural body was untouched, indicating no work was done on the chassis/structural body of the Motor Car and that the chassis/structural body was originally fitted.

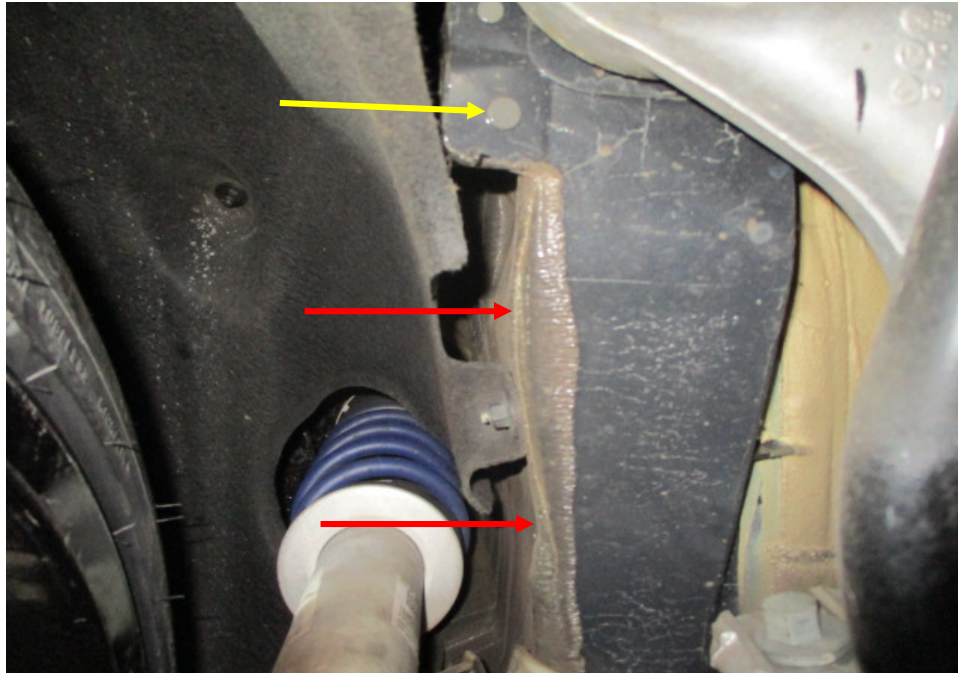
**Photo 32** shows the chassis/structural body at the underside rear left of the Motor Car. I did not find any weld marks other than original spot weld marks (yellow arrow) on the chassis/structural body of the Motor Car. The original factory sealant (red arrow) at the joints along the chassis/structural body was untouched, indicating no work was done on the chassis/structural body of the Motor Car and that the chassis/structural body was originally fitted.

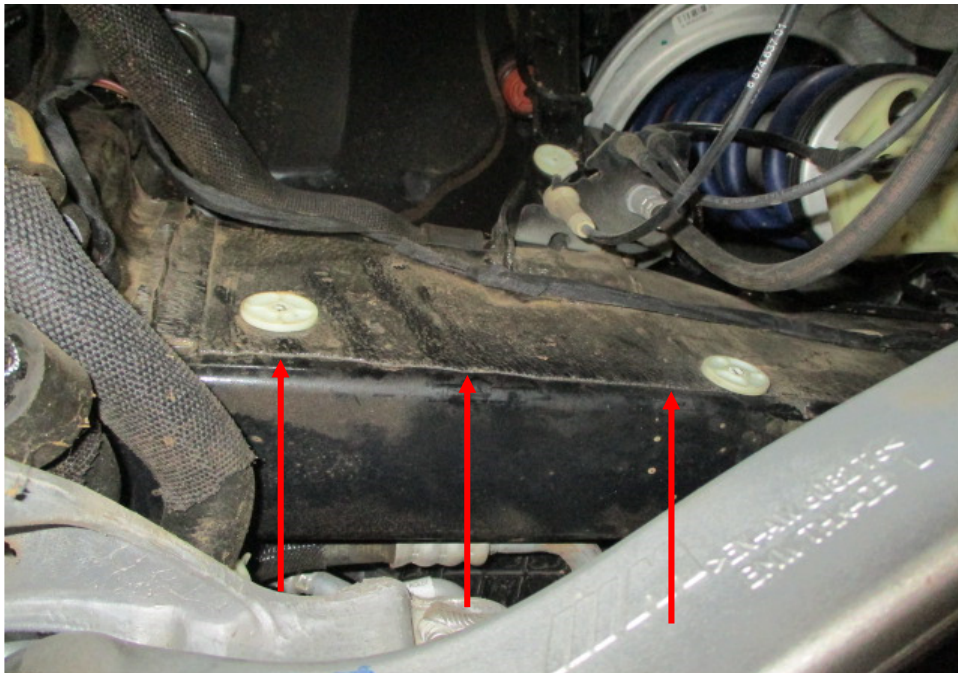
**Photo 33** shows the chassis/structural body at the underside front left of the Motor Car. The original factory sealant (arrowed) at the joints along the chassis/structural body was observed to be untouched. In general, I had found no work was carried out on the chassis/structural body of the Motor Car. The chassis/structural body of the Motor Car was originally fitted.

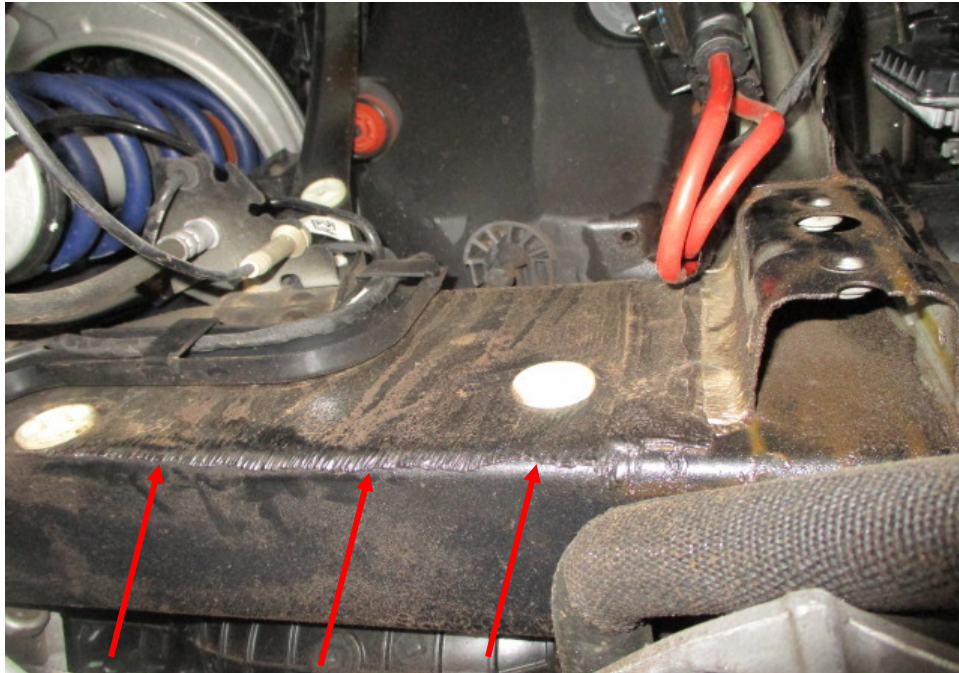
**Photo 34** shows the chassis/structural body at the underside front right of the Motor Car. I did not find any weld marks other than original spot weld marks on the chassis/structural body of the Motor Car. The original factory sealant (arrowed) at the joints along the chassis/structural body was untouched, indicating no work was done on the chassis/structural body of the Motor Car and that the chassis/structural body was originally fitted.

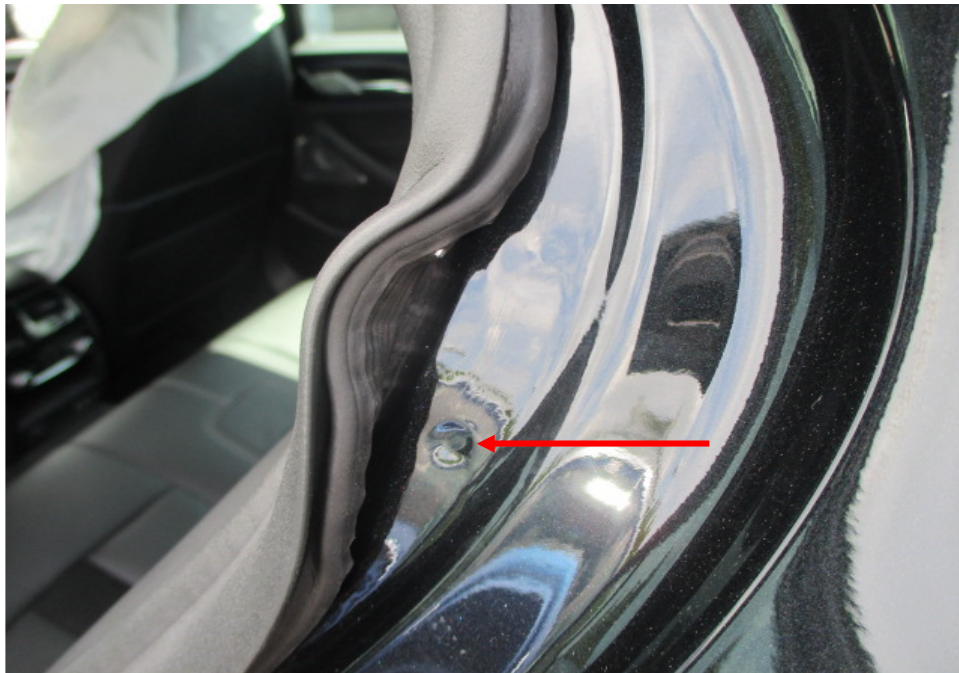
**Photo 35** shows the left side "C" pillar of the Motor Car. I did not find any weld marks other than original spot weld marks (arrowed) on the left side "C" pillar of the Motor Car, which indicates that there was no re-welding works carried out. In general, I had found all the non-detachable body panels of the Motor Car to be originally fitted at the time of my inspection.

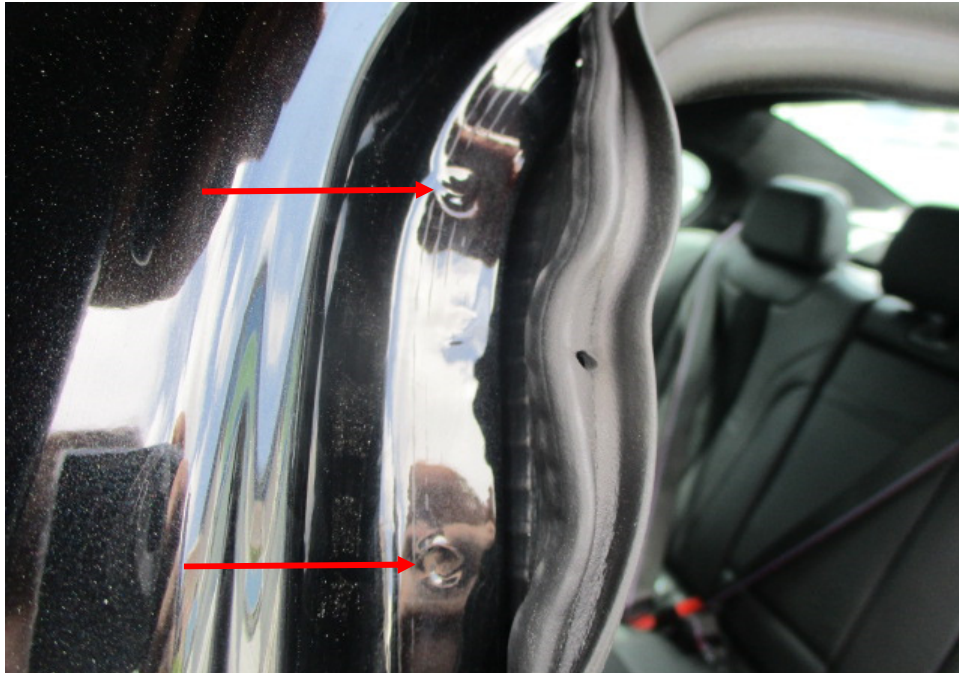
**Photo 36** shows the left side "B" pillar of the Motor Car. I did not find any weld marks other than original spot weld marks (arrowed) on the left side "B" pillar of the Motor Car, which indicates that there was no re-welding works carried out. In general, I had found all the non-detachable body panels of the Motor Car to be originally fitted at the time of my inspection.

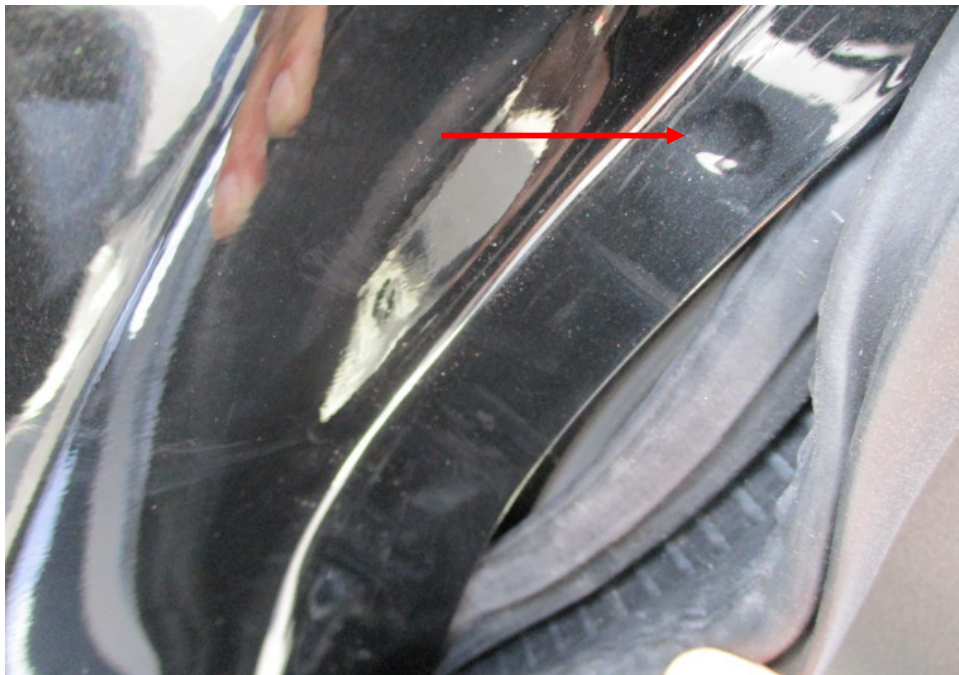
**Photo 37** shows the left side "A" pillar of the Motor Car. I did not find any weld marks other than original spot weld marks (arrowed) on the left side "A" pillar of the Motor Car, which indicates that there was no re-welding works carried out. In general, I had found all the non-detachable body panels of the Motor Car to be originally fitted at the time of my inspection.

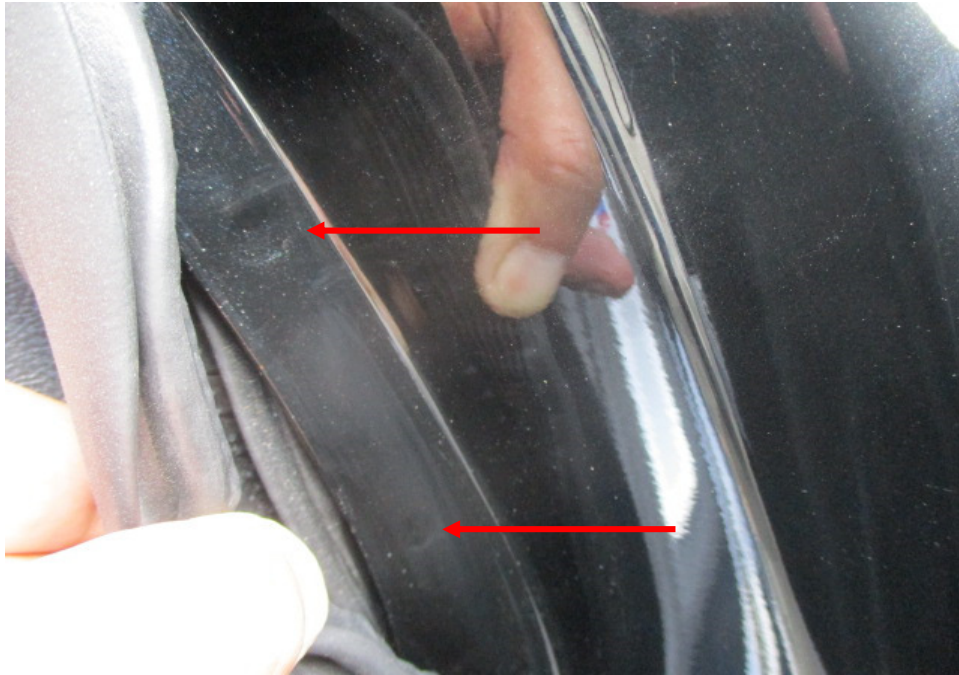
**Photo 38** shows the right side "A" pillar of the Motor Car. I did not find any weld marks other than original spot weld marks (arrowed) on the right side "A" pillar of the Motor Car, which indicates that there was no re-welding works carried out. In general, I had found all the non-detachable body panels of the Motor Car to be originally fitted at the time of my inspection.

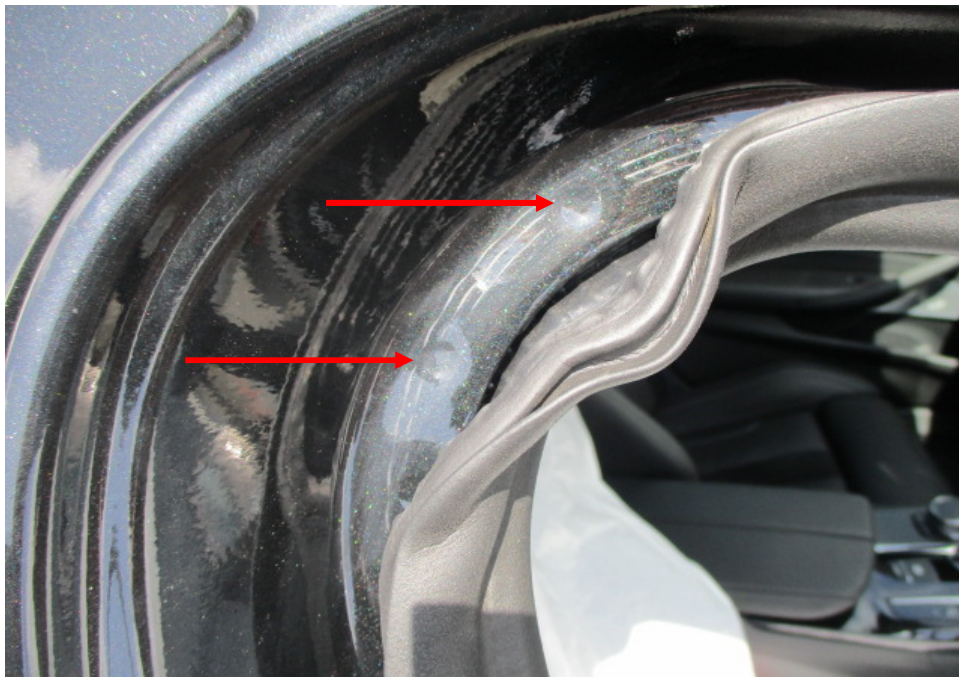
**Photo 39** shows the right side "B" pillar of the Motor Car. I did not find any weld marks other than original spot weld marks (arrowed) on the right side "B" pillar of the Motor Car, which indicates that there was no re-welding works carried out. In general, I had found all the non-detachable body panels of the Motor Car to be originally fitted at the time of my inspection.

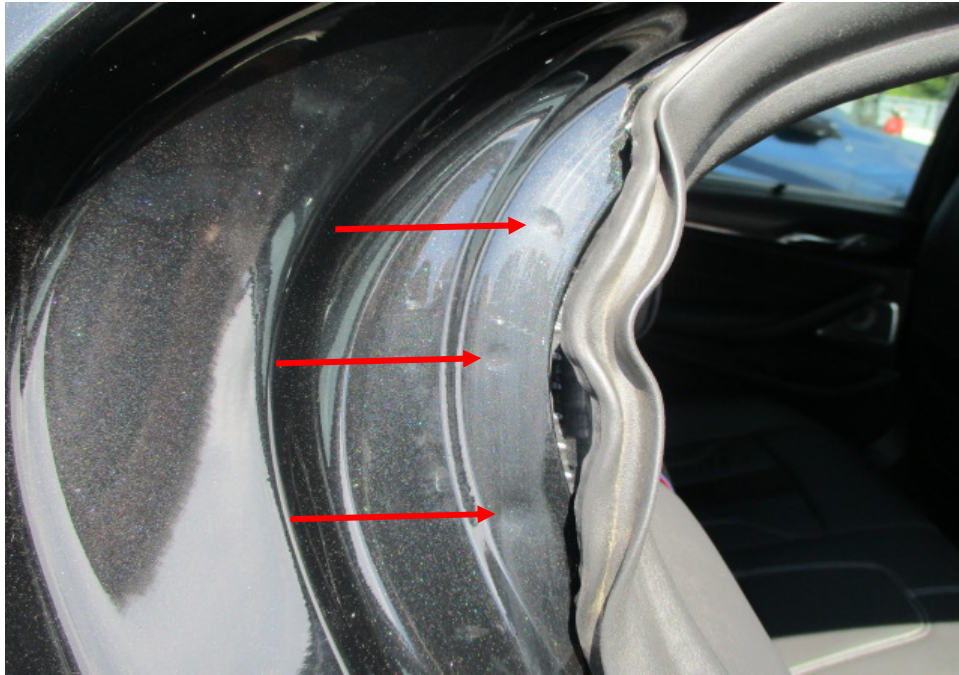
**Photo 40** shows the right side "C" pillar of the Motor Car. I did not find any weld marks other than original spot weld marks (arrowed) on the right side "C" pillar of the Motor Car, which indicates that there was no re-welding works carried out. In general, I had found all the non-detachable body panels of the Motor Car to be originally fitted at the time of my inspection.
