Your Ref: EG 4994J  
Our Ref : CI/TP22012275/D

## **AUTOMOBILE INSPECTION REPORT OF MOTOR CAR EG 4994J**

Vehicle Registration No.	: EG 4994J
Make / Model	: Honda Integra 2.0A
Chassis No	: JHMDC54506S201183
Year of Registration	: 2006 (August)
Mileage	: 119,319km

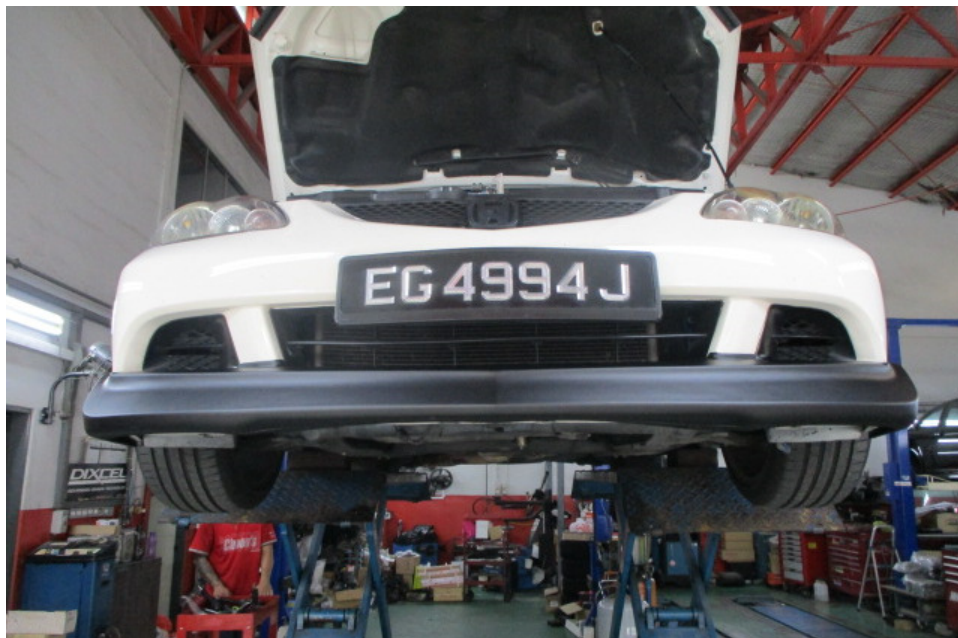
**Photo 1** shows the Motor Car being hoisted up at the time of my inspection. The mileage of the Motor Car recorded was 119,319km.

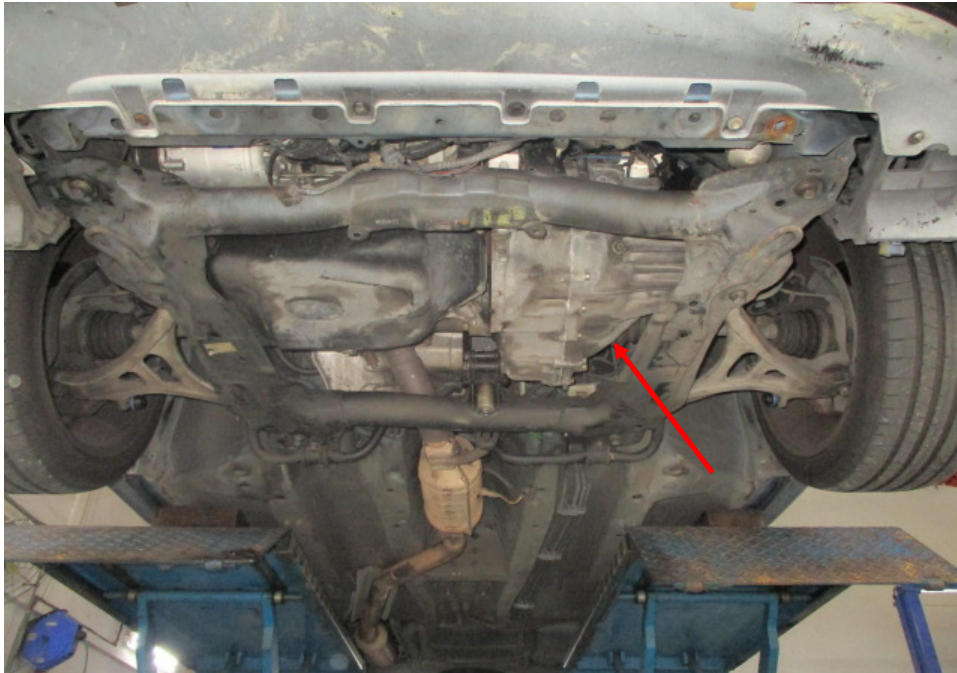
6. The Motor Car was fitted with a 5-speed manual transmission assembly. The input side of the transmission assembly is bolted to the crankshaft side of the engine block. The left and right drive shafts were observed to be securely fitted from the main shaft, located inside the transmission assembly, to the front left wheel and front right wheel respectively. There was also no crack and/or hole observed on the housing of the transmission assembly.

**Photo 2** shows a general view of the transmission assembly (arrowed) that was fitted on the Motor Car. The input side of the transmission assembly is bolted to the crankshaft side of the engine block. The left and right drive shafts were securely fitted from the main shaft, located inside the transmission assembly, to the front left wheel and front right wheel respectively. There was no crack and/or hole observed on the housing of the transmission assembly.

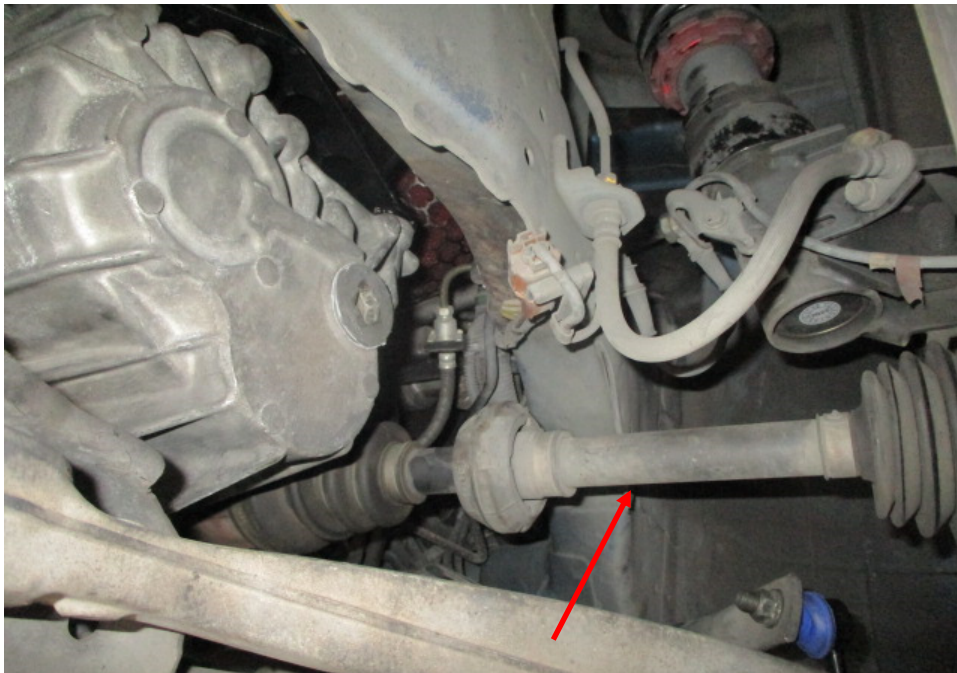
**Photo 3** shows the left drive shaft (arrowed) of the Motor Car. The left and right drive shafts were observed to be securely fitted from the main shaft, located inside the transmission assembly, to the Motor Car's front left wheel and front right wheel respectively.

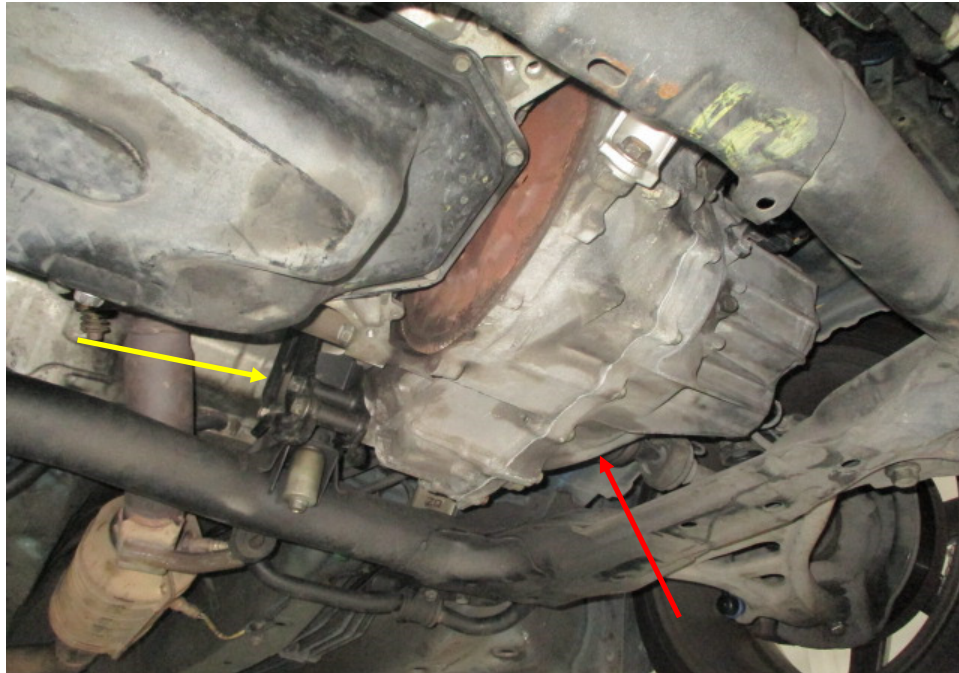
7. The transmission assembly of the Motor Car was supported by 3 brackets. One at the front of the transmission assembly, one at the rear of the transmission assembly while the other was at the left side of the transmission assembly. The bracket at the front and rear of the transmission assembly was mounted onto the engine cross member while the bracket at the left side was mounted onto the left side front chassis, adjacent to the Motor Car's left side front wheel house. The 3 brackets are with rubber bushings, which absorbs any vibrations arising from the rotation of the transmission gears, minimising any stress to the bracket and correspondingly also minimise any stress to the engine crossmember and left side front chassis that these brackets are mounted onto.

**Photo 4** shows another view of the transmission assembly (red arrow) that was fitted on the Motor Car. This was at the input side where the transmission assembly is bolted onto the crankshaft side of the engine block. The transmission assembly of the Motor Car was supported by 3 brackets. One at the front of the transmission assembly, one at the rear of the transmission assembly (yellow arrow) while the other was at the left side of the transmission assembly.

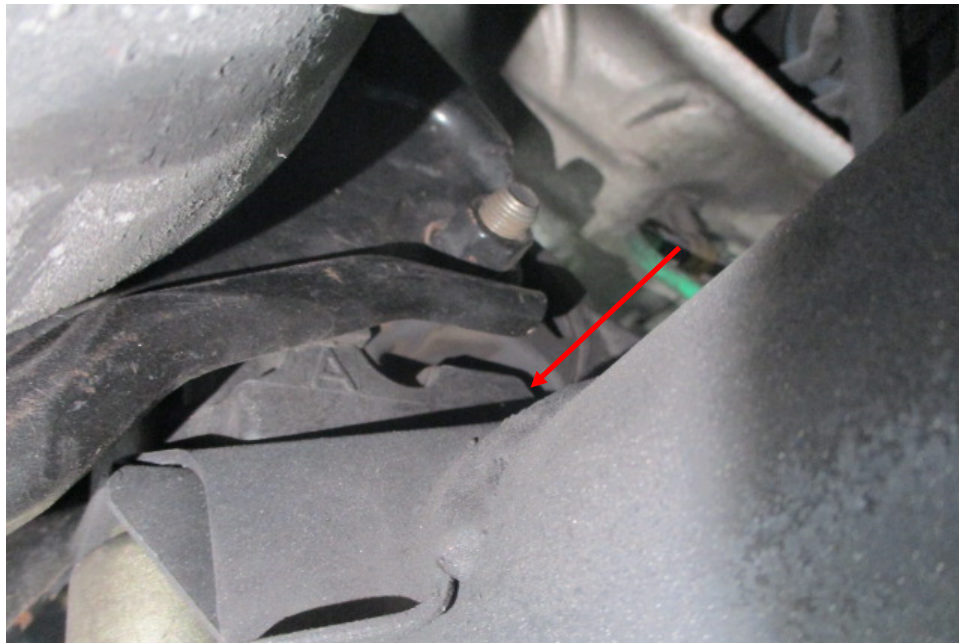
**Photo 5** shows the bracket supporting the rear of the Motor Car's transmission assembly. This bracket was mounted onto the engine cross member. The bracket was with rubber bushings (arrowed) that absorbs any vibrations arising from the rotation of the transmission gears, minimising any stress to the bracket and correspondingly also minimise any stress to the engine crossmember.

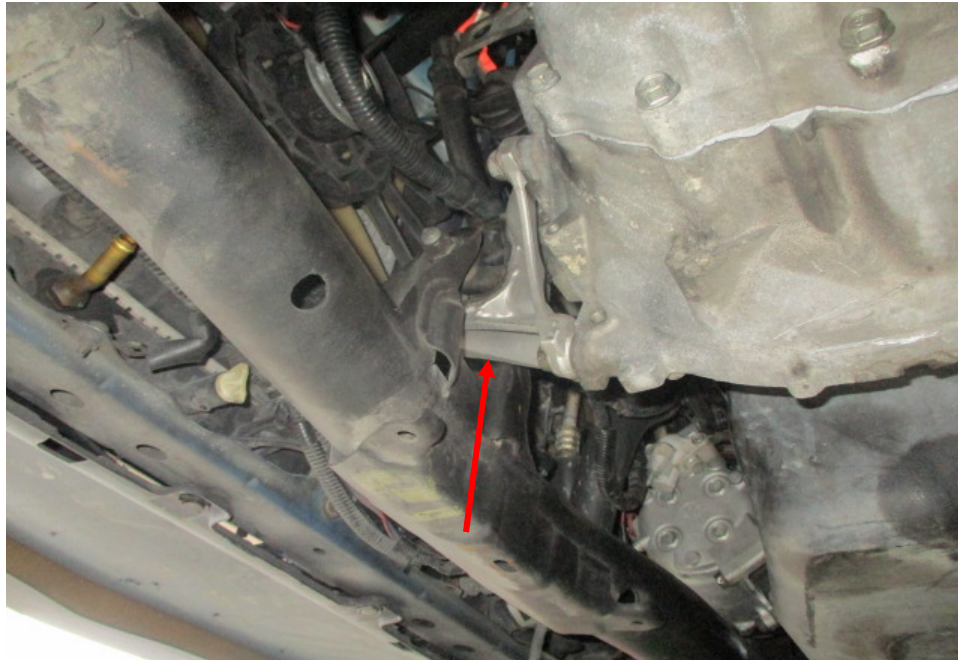
**Photo 6** shows the bracket (arrowed) supporting the front side of the Motor Car's transmission assembly. This bracket was mounted onto the engine cross member. The bracket was with rubber bushings that absorbs any vibrations arising from the rotation of the transmission gears, minimising any stress to the bracket and correspondingly also minimise any stress to the engine crossmember.

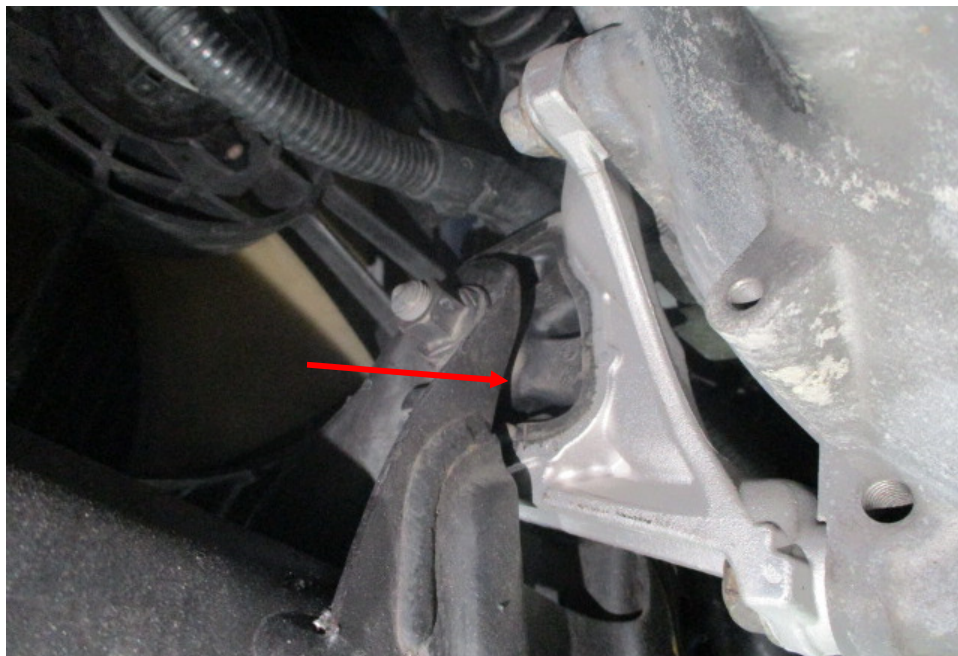
**Photo 7** shows a closer view of the bracket supporting the front of the Motor Car's transmission assembly. This bracket was mounted onto the engine cross member. The bracket was with rubber bushings (arrowed) that absorbs any vibrations arising from the rotation of the transmission gears, minimising any stress to the bracket and correspondingly also minimise any stress to the engine crossmember.

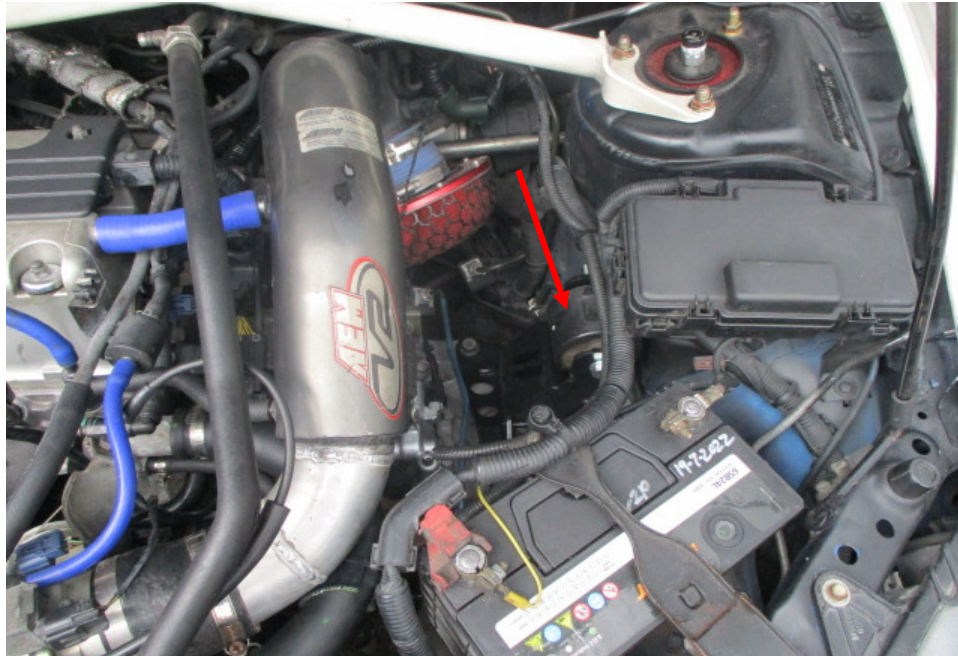
**Photo 8** shows the bracket (arrowed) supporting the left side of the Motor Car's transmission assembly. This bracket was mounted onto the left side front chassis, adjacent to the left side front wheel house of the Motor Car. The bracket was with rubber bushings that absorbs any vibrations arising from the rotation of the transmission gears, minimising any stress to the bracket and correspondingly also minimise any stress to the engine crossmember.

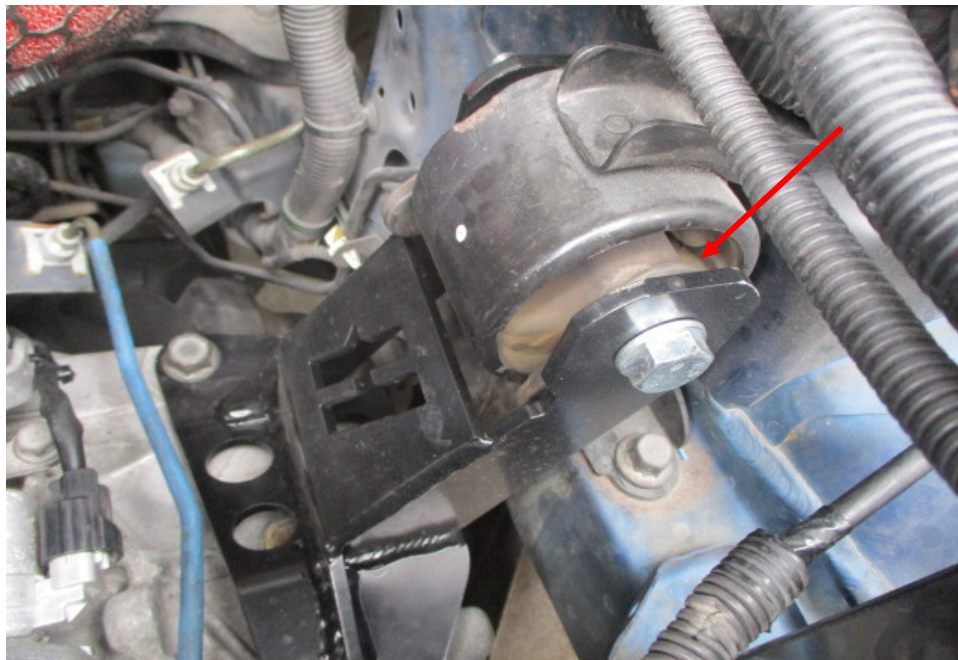
**Photo 9** shows a closer view of the bracket supporting the left side of the Motor Car's transmission assembly. This bracket was mounted onto the left side front chassis, adjacent to the left side front wheel house of the Motor Car. The bracket was with rubber bushings (arrowed) that absorbs any vibrations arising from the rotation of the transmission gears, minimising any stress to the bracket and correspondingly also minimise any stress to the engine crossmember.

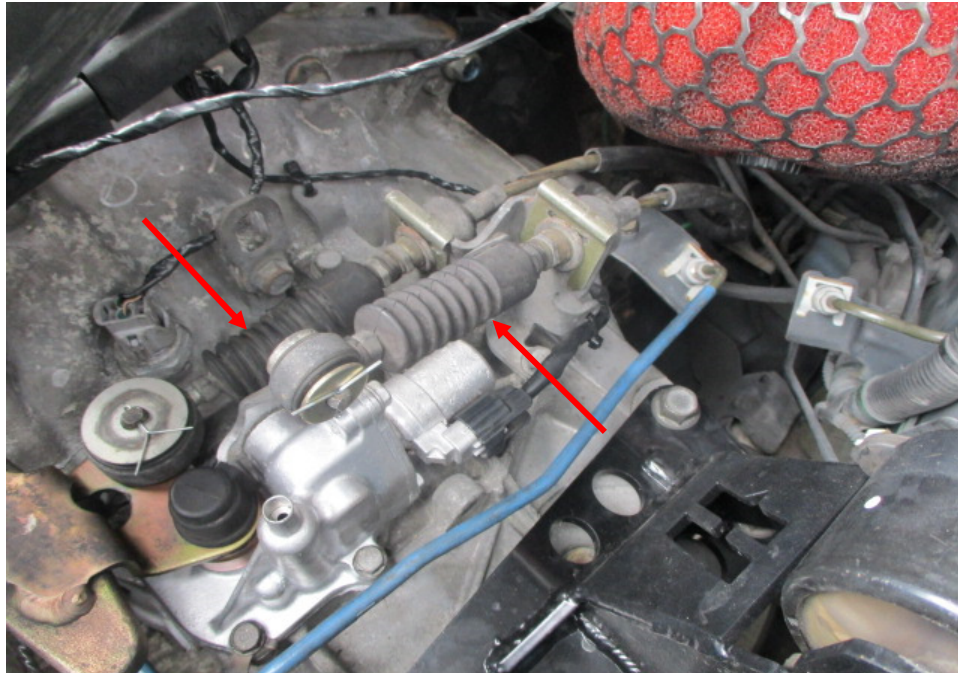
8. The gear selector cables from the transmission assembly to the gear shifter of the Motor Car was observed to be securely fitted. The gear selector cables connect to the gear shifter in the interior compartment of the Motor Car through the floorboard. See photo 1 – 11 below.

**Photo 10** shows the gear selector cables (arrowed) from the transmission assembly to the gear shifter of the Motor Car. The gear selector cables were observed to be securely fitted on the underside of the Motor Car. These gear selector cables connect to the gear shifter in the interior compartment of the Motor Car through the floorboard.

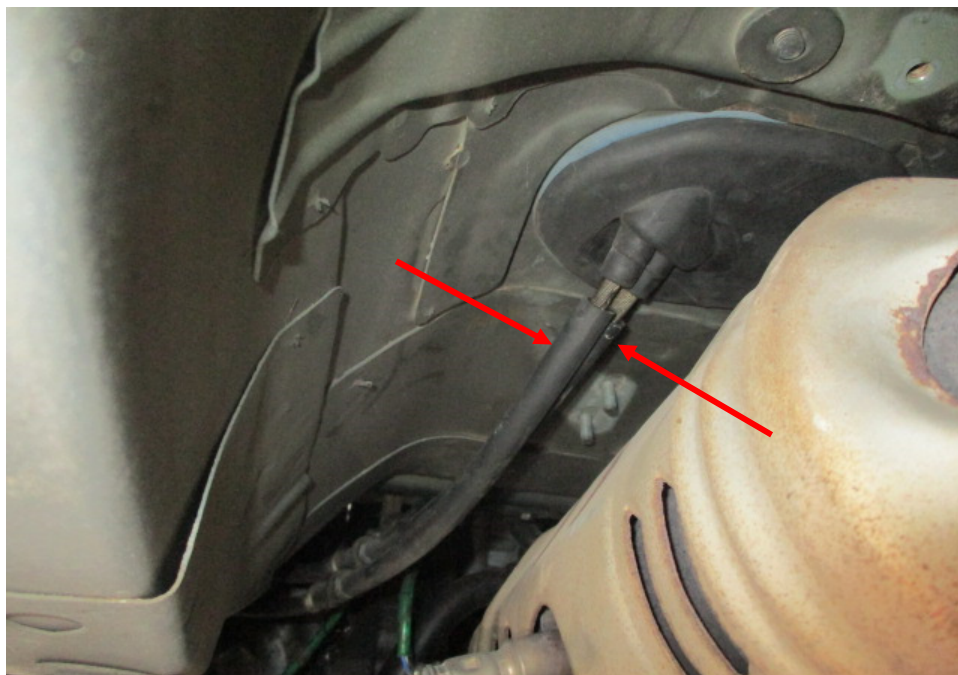
**Photo 11** shows the gear selector cables (arrowed), at the side where it connects to the gear shifter in the interior compartment of the Motor Car through the floorboard.

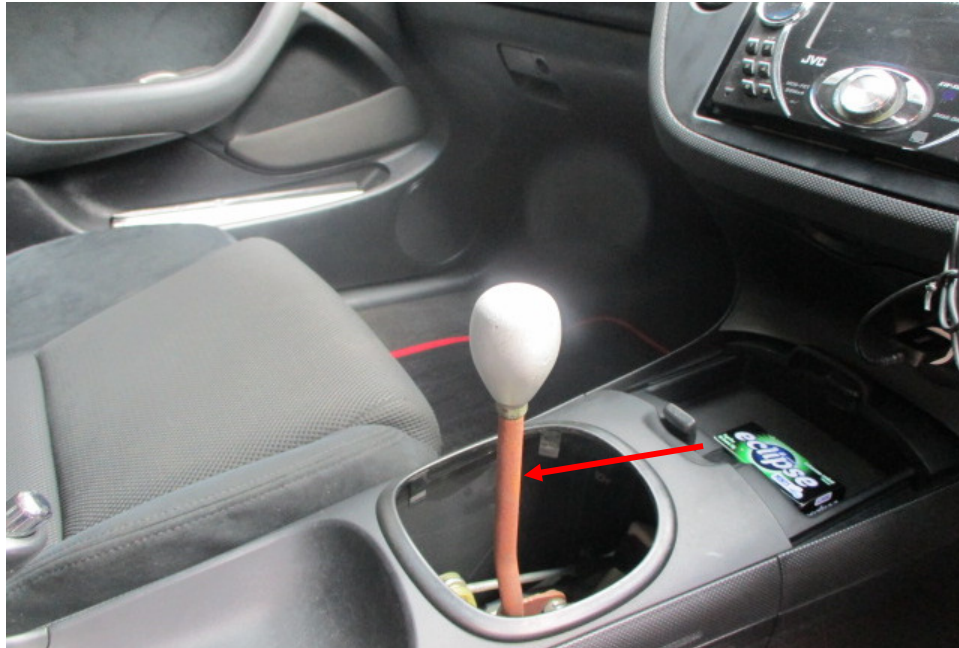
**Photo 12** shows the gear shifter (arrowed) that was fitted on the Motor Car, for manually selecting the transmission gear to be engaged. The gear selector cables from the underside of the Motor Car (refer to photograph 10 & 11 above) connects to this gear shifter through the floorboard.

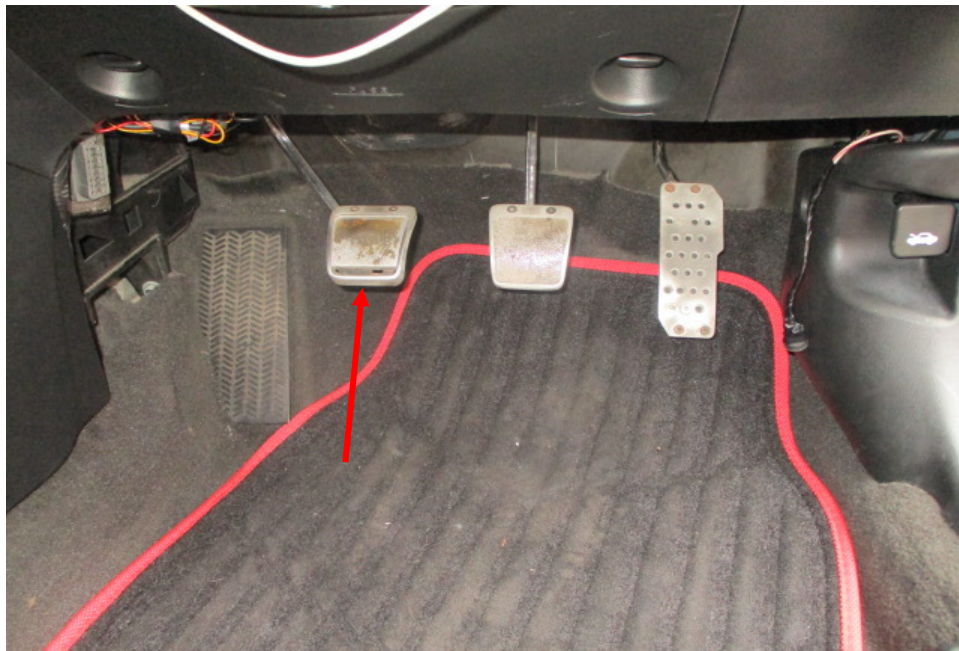
**Photo 13** shows the clutch pedal (arrowed) of the Motor Car, for engaging and disengaging the transmission gears.
