Your Ref: S2M03URD / S2M03V27  
Our Ref: CI/ASM22012360/D

05 December 2022

**TECHNICAL EVALUATION REPORT OF ACCIDENTS INVOLVING THE  
INSURED VEHICLE SMF 2318K ON 02 MARCH 2022**

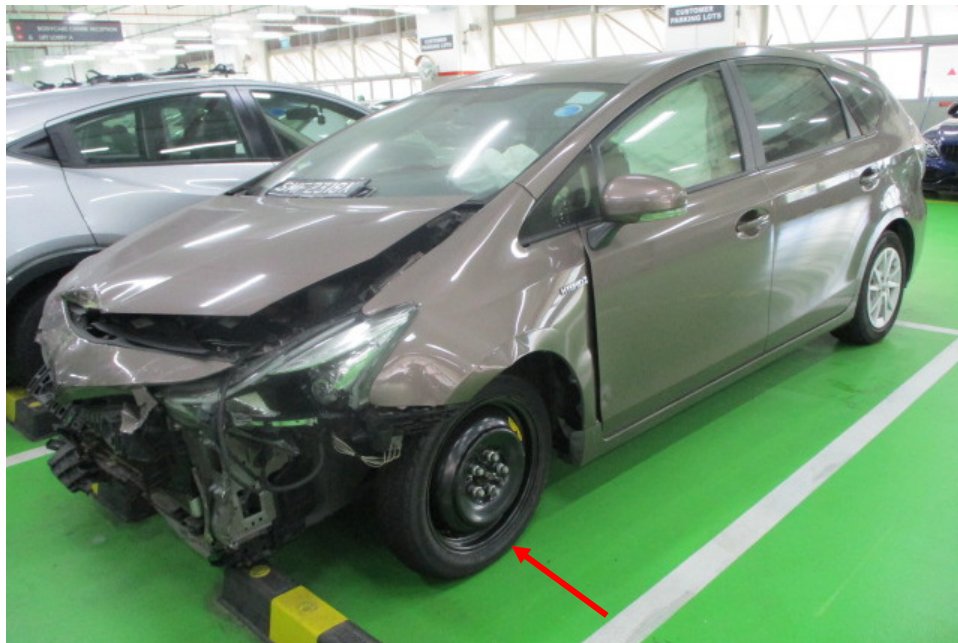
**Photo 1** shows a general view of the front left body of the Insured Vehicle at the time of my inspection on 27 June 2022. The Insured Vehicle was observed to have sustained impact damages at its frontal portion. The driver's airbag, driver's seat airbag, driver's knee airbag and front left passenger airbag were deployed. The front left tyre fitted on the Insured Vehicle was a spare tyre (arrowed).

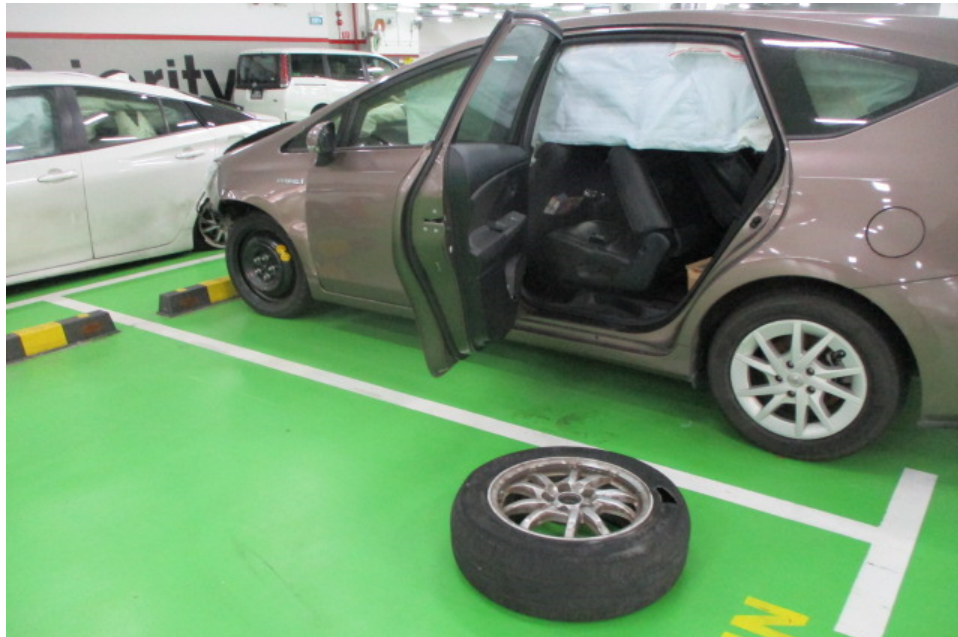
7. For this case, I had carried out an inspection of the Insured Vehicle on 27 June 2022. During my inspection, I had found the original front left tyre, still wrapped around the front left wheel rim, lying in the rear boot compartment of the Insured Vehicle. Upon my closer examination of the tyre, I had found a hole and cut on the outer sidewall of the tyre. There were also marks of grazing nature to the edges of the outer circumference of the front left wheel rim.
8. The condition of the original front left tyre and wheel rim would suggest to me that the Insured Vehicle had grazed against a road kerb, causing the original front left tyre to be damaged. This immobilized the Insured Vehicle and therefore requiring the replacement to a spare tyre. See photo 1 – 4 below.

**Photo 2** shows the Insured Vehicle at the time of my inspection on 27 June 2022. The original front left tyre, still wrapped around the front left wheel rim, was found lying in the rear boot compartment of the Insured Vehicle. Upon my closer examination of the tyre, I had found a hole and cut on the outer sidewall of the tyre. There were also marks of grazing nature to the edges of the outer circumference of the front left wheel rim. The condition of the original front left tyre and wheel rim would suggest to me that the Insured Vehicle had grazed against a road kerb, causing the original front left tyre to be damaged, immobilizing the Insured Vehicle and requiring the replacement to a spare tyre.

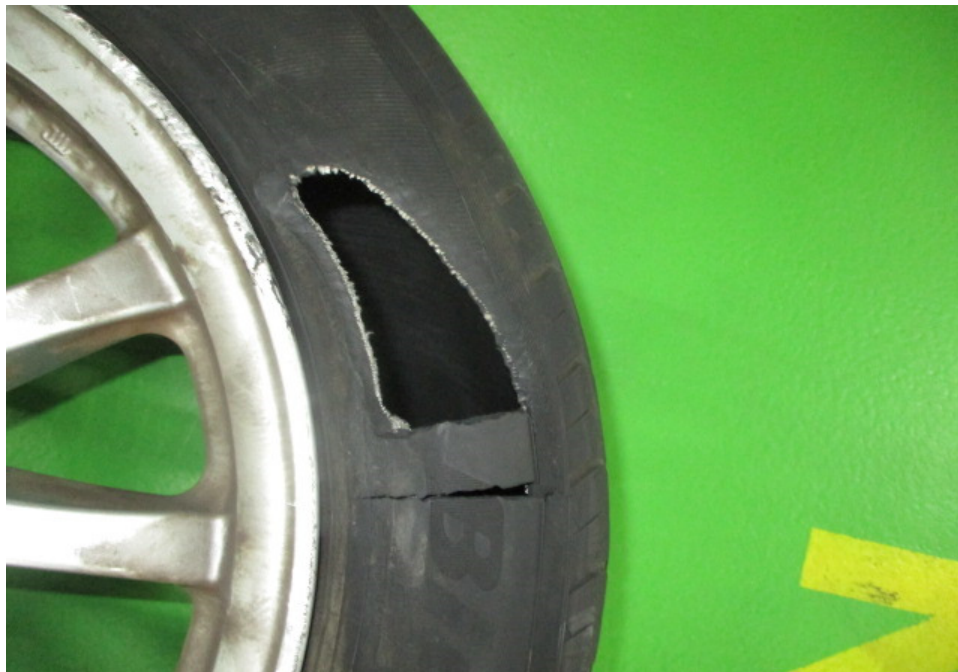
**Photo 3** shows a closer view of the hole and cut on the outer sidewall of the Insured Vehicle's original front left tyre.

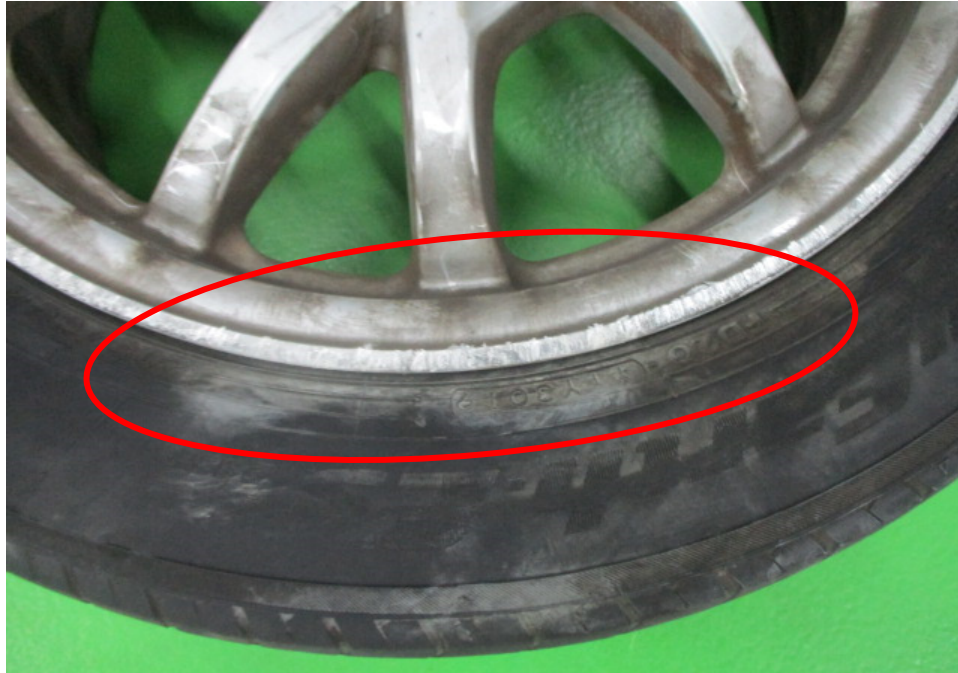
**Photo 4** shows a closer view of the marks of grazing nature (circled) to the edges of the outer circumference of the Insured Vehicle's front left wheel rim. The condition of the original front left tyre and wheel rim would suggest to me that the Insured Vehicle had grazed against a road kerb, causing the original front left tyre to be damaged, immobilizing the Insured Vehicle and therefore requiring the replacement to a spare tyre.

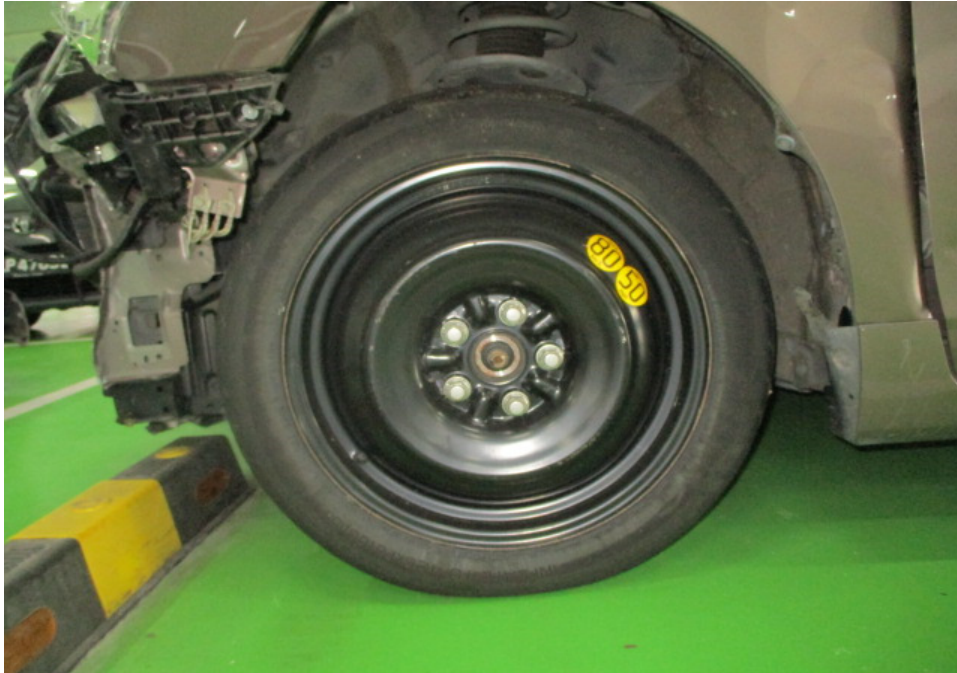
10. The spare tyre that was fitted at the front left wheel of the Insured Vehicle was seen to be pasted with 2 bright coloured yellow stickers on the wheel rim indicating the maximum speed of 80km per hour and 50miles per hour. In other words, the maximum safe travelling speed of a vehicle that is fitted with this spare tyre is 80km per hour or 50 miles per hour. If indeed Mr Loo had replaced the damaged original spare tyre himself, it would be reasonable to expect him to know this maximum safe travelling speed. See photo 5 & 6 below.

**Photo 5** shows the spare tyre that was fitted at the front left wheel of the Insured Vehicle. The spare tyre was observed to be sufficiently inflated with relatively good remaining tread depth and tread pattern for vehicular operation. 2 bright coloured yellow stickers were pasted on the wheel rim of the spare tyre, which had indicated the maximum speed of 80km per hour and 50miles per hour.

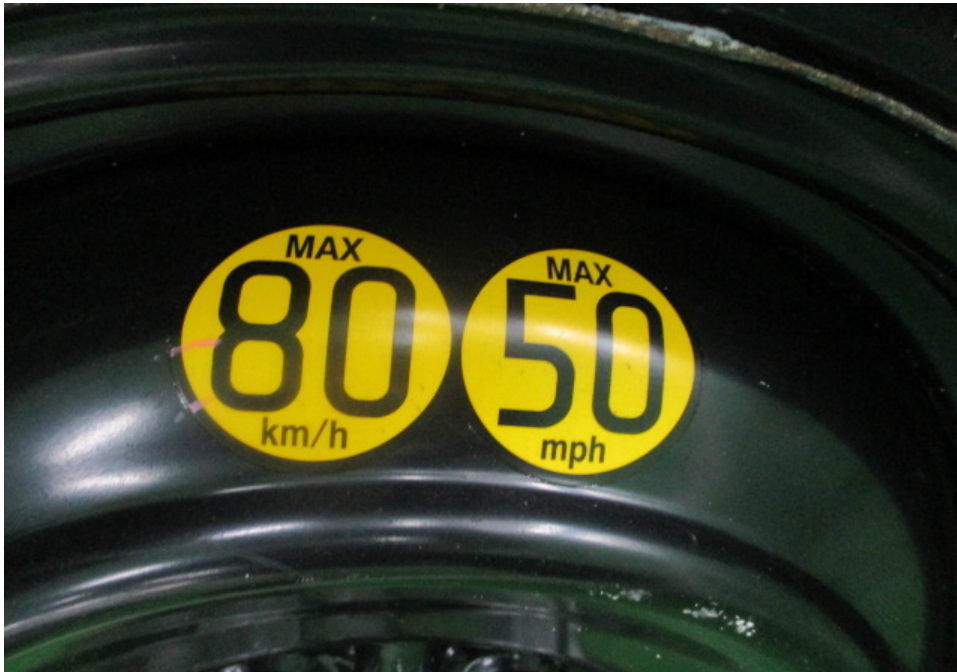
**Photo 6** shows a closer view of the 2 bright coloured yellow stickers that were pasted on the wheel rim of the spare tyre. The stickers indicate that the maximum safe travelling speed of a vehicle that is fitted with this spare tyre is 80km per hour or 50 miles per hour.

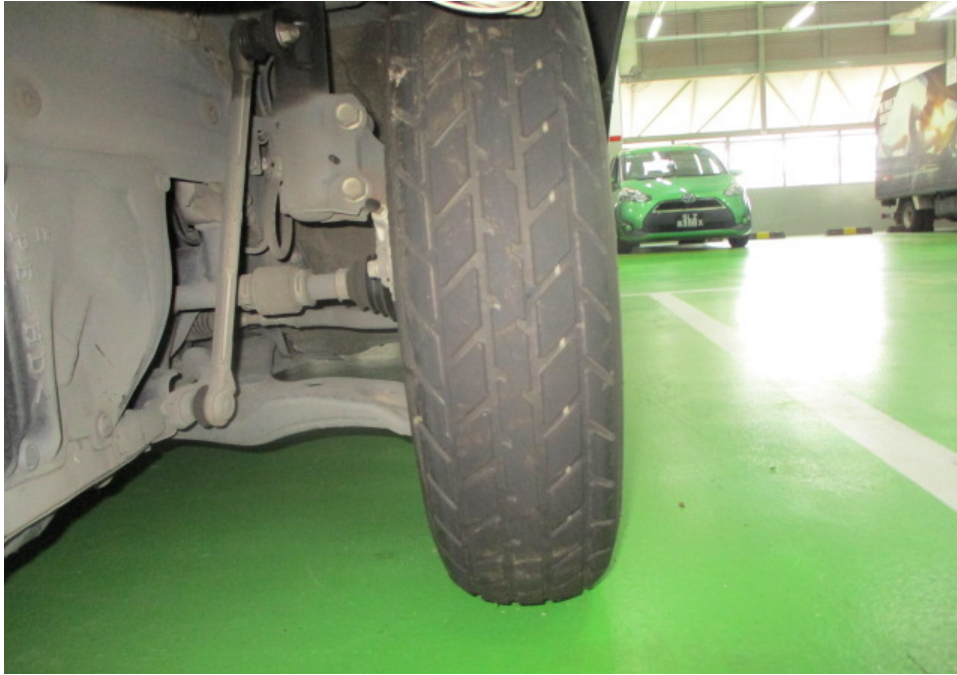
13. Basing on the tyre markings, the spare tyre that was fitted at the front left wheel of the Insured Vehicle has a narrower width as compared to the 3 other tyres that were fitted on the Insured Vehicle at the material time of accident, approximately 30% narrower. A narrower width equates to lesser contact area between tyre and ground. As tyres are the only part of a vehicle that contacts onto the ground, the front left wheel of the Insured Vehicle would therefore have 30% less contact area between Insured Vehicle and ground at the material time of both accidents. See photo 7 & 8 below.

**Photo 7** shows the narrower width of the spare tyre that was fitted on the Insured Vehicle as compared to the wider width of the other 3 tyres (refer to photograph 8 below) that were fitted on the Insured Vehicle at the material time of accident. A narrower width equates to lesser contact area between tyre and ground.

14. Because of this lesser contact area, there is an imbalance of contact area, in totality, between the Insured Vehicle and the ground, which could lead to the road handling, stability and braking of the Insured Vehicle being affected. Notwithstanding this, given the nature of these 2 accidents, the spare tyre that was fitted at the front left wheel of the Insured Vehicle is unlikely to have caused and/or contributed to the 2 accidents. Reasons for which are set out in the below paragraphs.

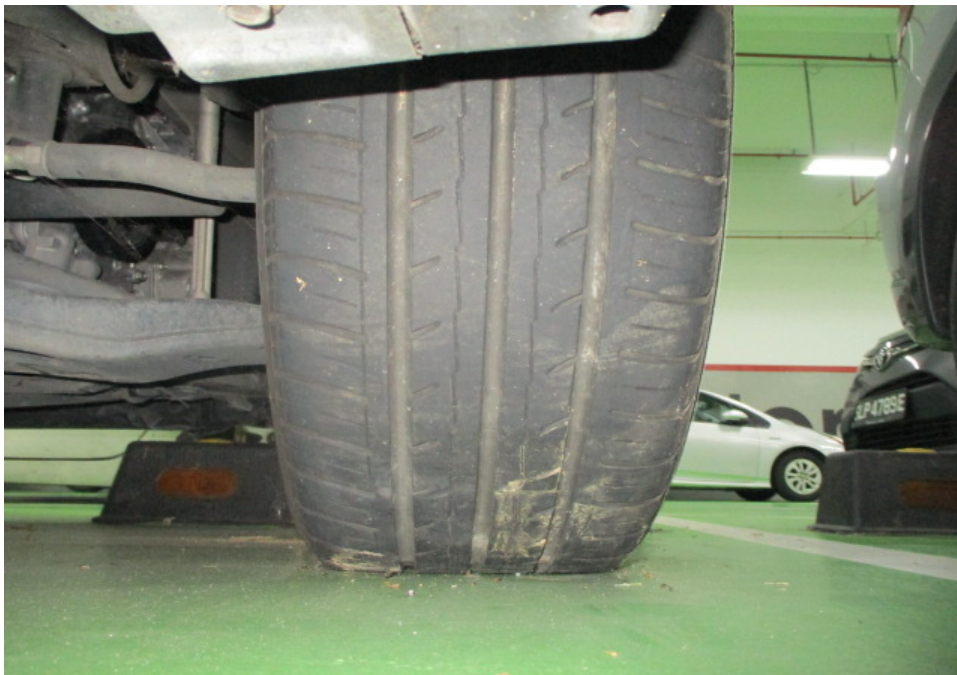
**Photo 8** shows the width of the front right tyre that was fitted on the Insured Vehicle at the material time of accident. The width of the other 3 tyres that were fitted on the Insured Vehicle was wider as compared to the narrower width of the spare tyre that was fitted on the front left wheel of the Insured Vehicle (refer to photograph 7 above).
