Dur ref. : UAM21.01.01-AK-STP-HLA-SDY8187M
Date : 30 Aug 2022

Re : Third Party Claim For Vehicle Registration No. SDY8187M

VEHICLE INSPECTION REPORT

Registration no.	: SDY8187M	Odometer	: 119513 km
Make / Model	: Mercedes Benz E200 Sedan Edition E R18 LED	Chassis no.	: WDD2120342B228939
Regn. date	: 03 Dec 2015	Engine no.	: 27492030455808
Body colour	: Grey	Engine cap.	: 1991 cc

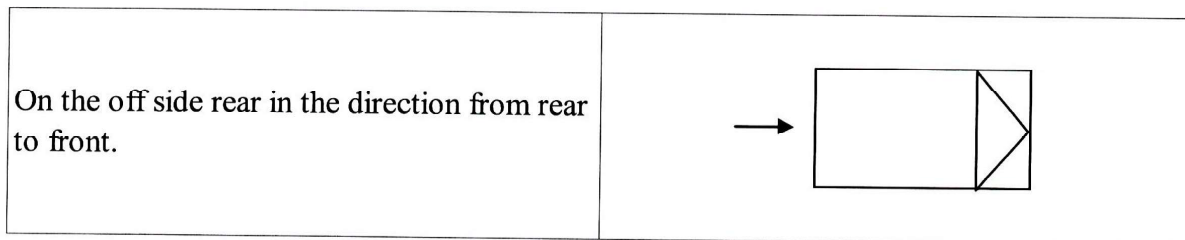
POINT OF IMPACT

The impact of the collision has damaged / affected the rear bumper, rear end panel, taillamp, o/s rear ender, rear undercarriage and etc...
