Your Ref: SMJ 1071G
Our Ref : CI/III22012542/P

**TECHNICAL INVESTIGATION REPORT OF WARRANTY CLAIM INVOLVING
THE INSURED VEHICLE SMJ 1071G ON 16th November 2022**

Vehicle Registration No.	: SMJ 1071G
Make / Model	: CITROEN C4 PICASSO 1.6 BLUEHDI EAT6 S/R
Chassis No	: VF73ABHZTFJ870929
Year of Registration	: APR 2016
Mileage	: 84,885KM

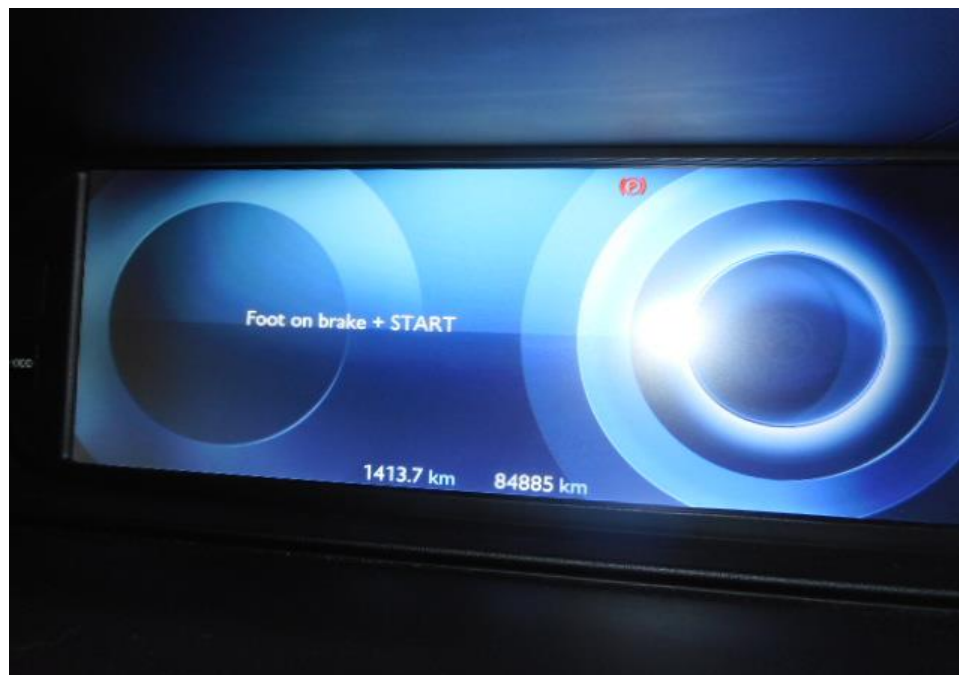
Photo 1 shows the mileage of the Insured Vehicle recorded at the time inspection at 84,885KM

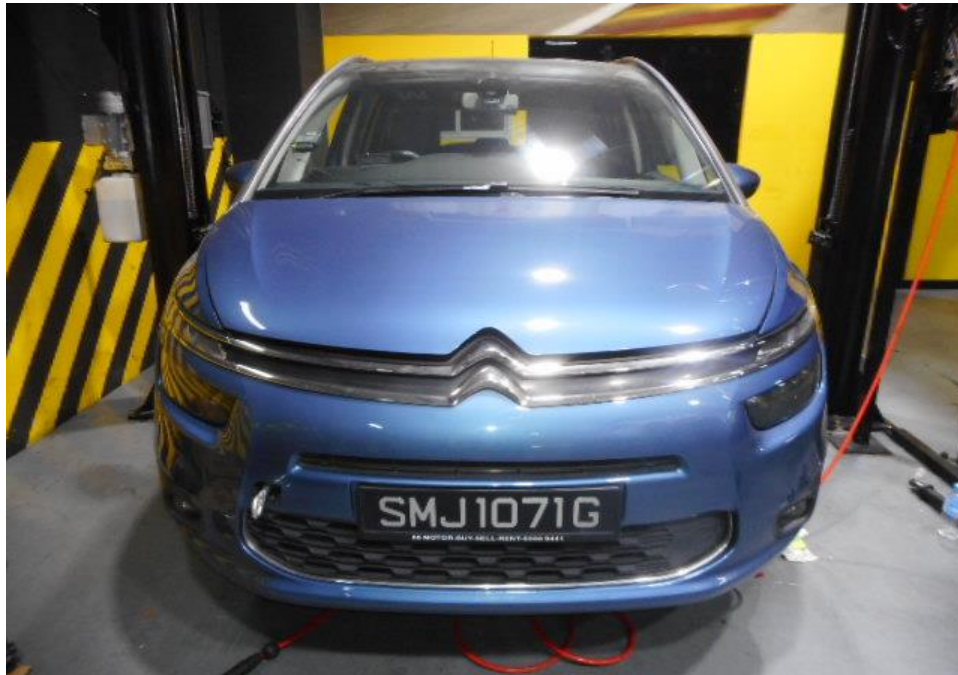
Photo 2 shows the general view of the front portion of the Insured Vehicle at the time of our inspection. The Insured Vehicle is observed to be unaffected by any signs of accident.

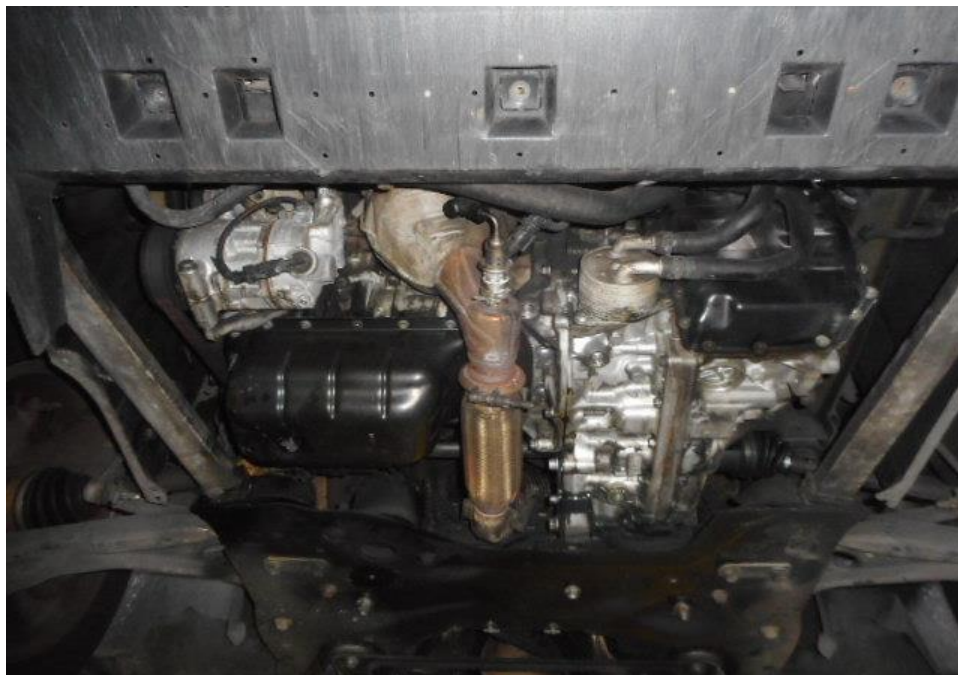
Photo 3 shows the general view of the undercarriage portion of the Insured Vehicle at the time of our inspection. The undercarriage compartment is observed to be unaffected by any signs of accident.

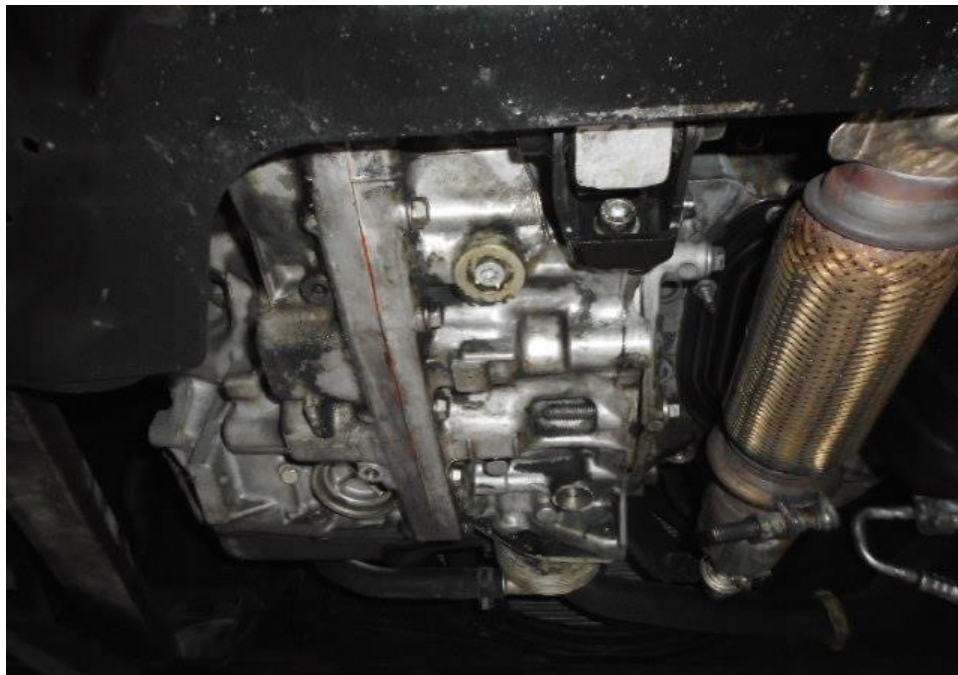
Photo 4 shows the general view of the gearbox underside portion of the Insured Vehicle at the time of our inspection. The gearbox underside compartment is observed to be unaffected and by any signs of accident.

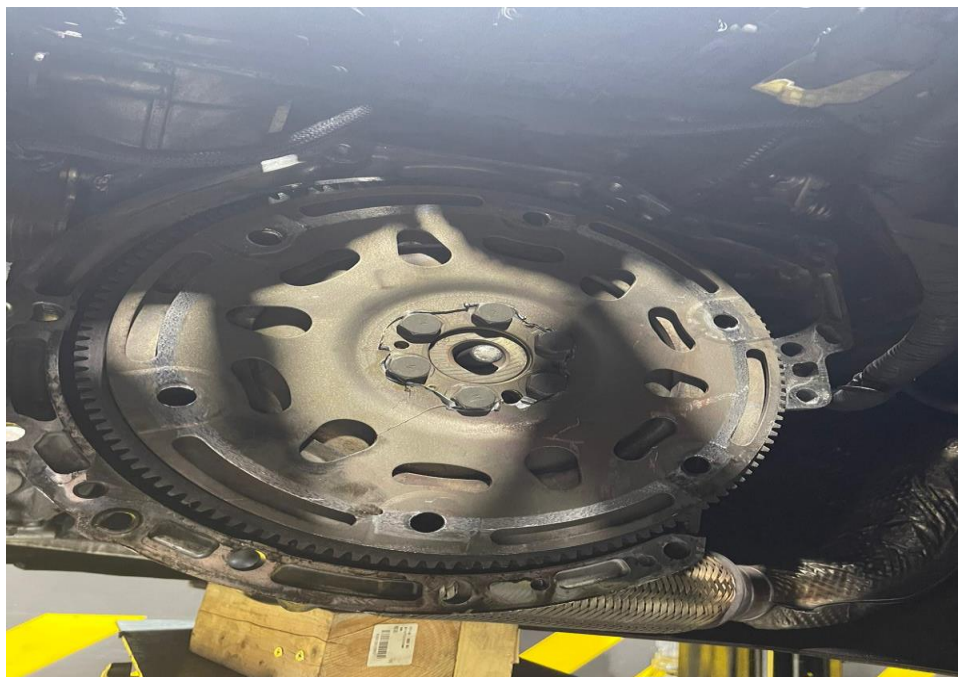
6. Prior to our inspection, the workshop had informed us that they had already conducted checks and upon dismantling the gearbox from the engine they have found free play to the flywheel resulting to the flywheel itself and the gearbox converter to sustained damages on the Insured Vehicle and agreed that the complained problem is from these components of the engine flywheel. See photos 1 – 7 below.

Photo 5 shows the general view of the engine flywheel of the Insured Vehicle at the time of our inspection. The engine flywheel was observed to have free play and also sustained damages on it.

8. We did not find any evidence which had suggested that the cause of abnormalities to the Insured Vehicle was due to poor maintenance and/or recurring problem.
9. The recommendation to replace the flywheel and the gearbox convertor unit at \$3,795.70 as stated in the quotation is justifiable as all the relevant checks has been conducted to the Insured Vehicle.

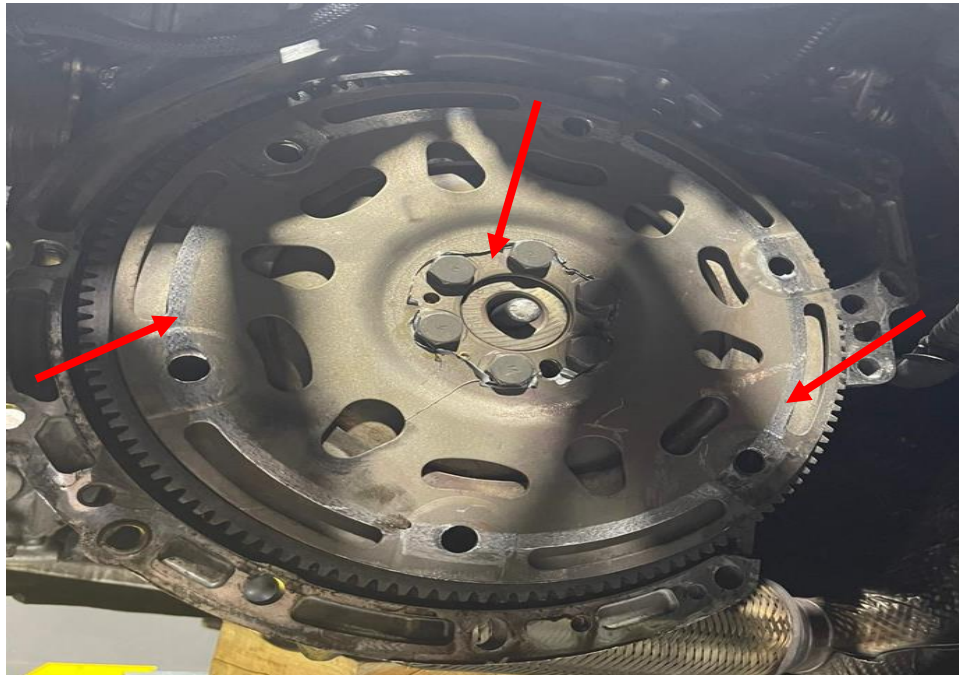
Photo 6 shows the close up view of the engine flywheel of the Insured Vehicle at the time of our inspection. The engine flywheel (arrowed) was observed to have free play and also sustained damages on it.

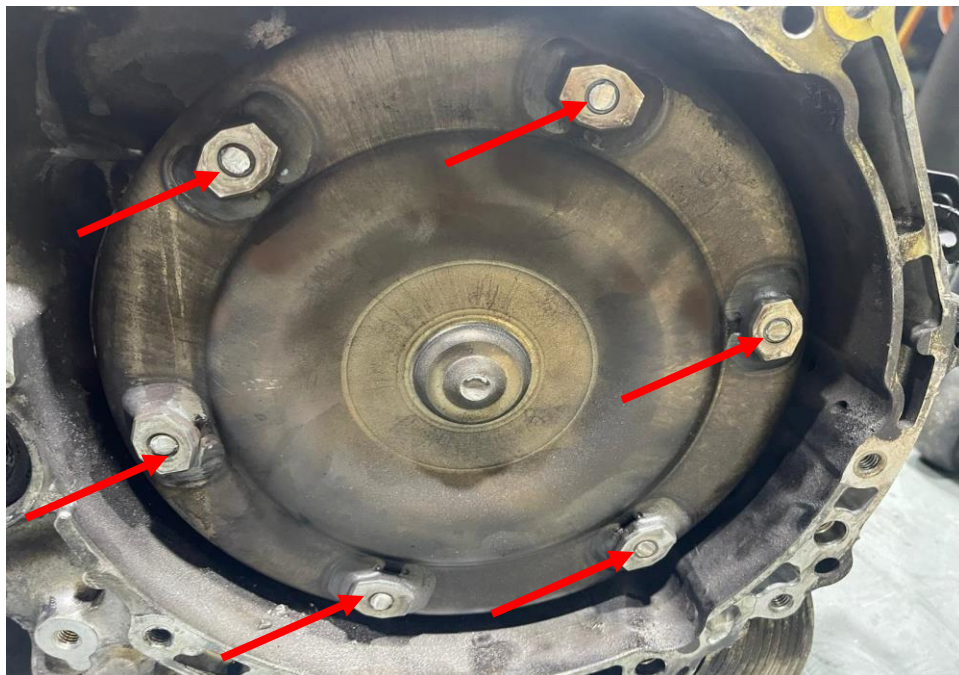
Photo 7 shows the close up view of the gearbox converter unit of the Insured Vehicle at the time of our inspection. The gearbox converter unit (arrowed) was observed to have sustained damages on it due to the free play of the engine flywheel.
