Your Ref: L/20221022/0016
Our Ref: CI/SPF22012698/P

28th December 2022

MECHANICAL INSPECTION REPORT OF MOTOR LORRY YN 7315B

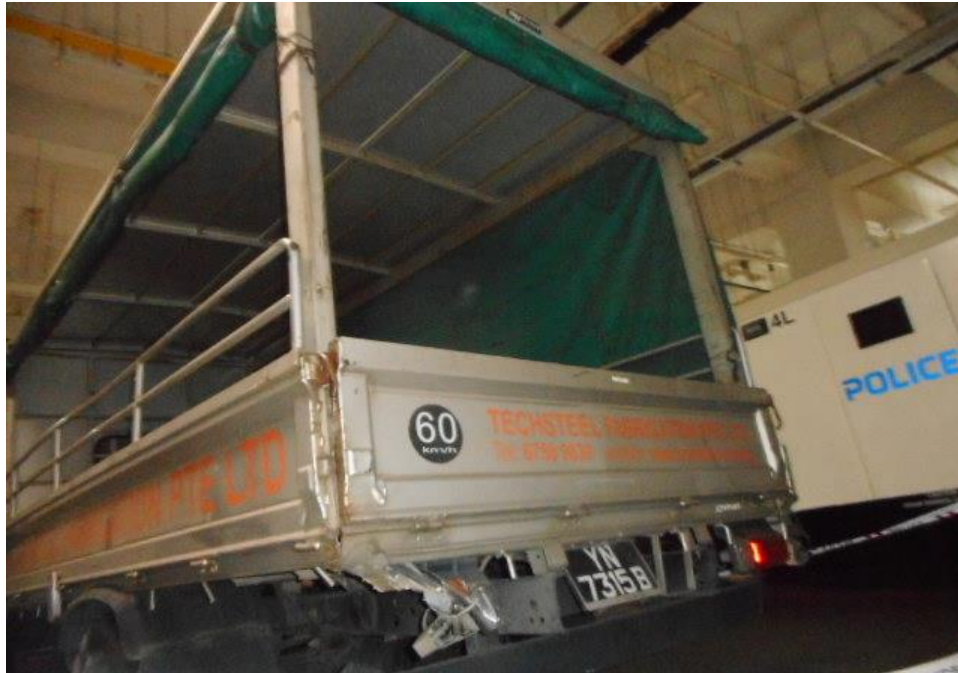
Photo 1 shows the general view of the rear portion of the Motor Lorry at the time of our inspection. The Motor Lorry was observed sustained major damages to its front and rear portion. Its front cabin, front windscreen, front bumper and front body panel, its both doors as well as its rear left body panel and its rear left brake lamp as a result of the accident. The Supplemental Restraint System (SRS) was activated as a result of the accident.

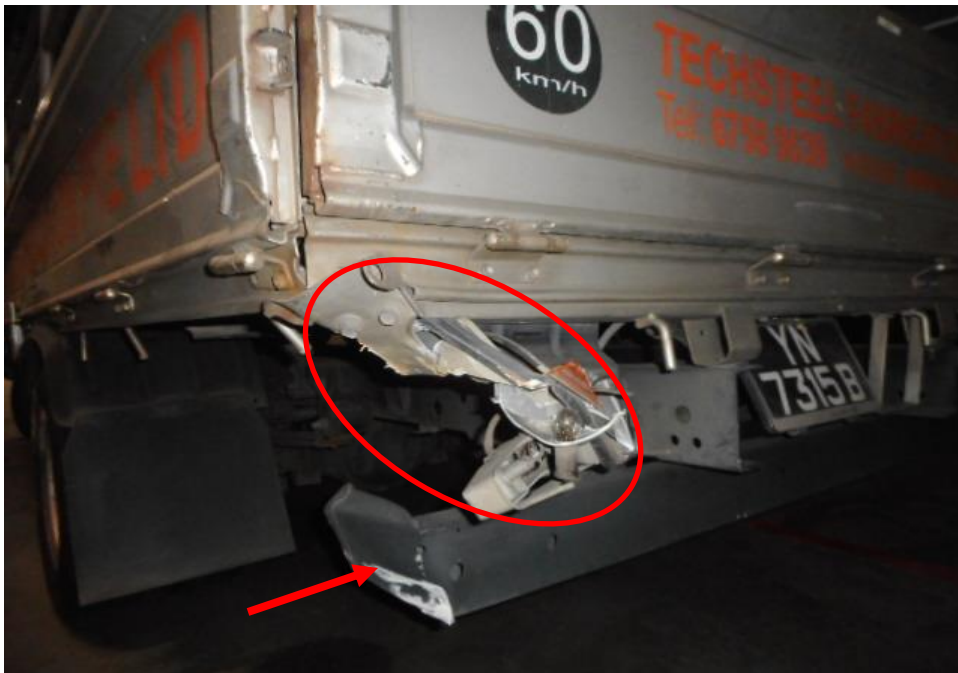
Photo 2 shows the close up view of the rear portion of the Motor Lorry at the time of our inspection. The Motor Lorry was observed to have sustained damages to its rear left bumper (arrowed) and rear left brake lamp (circled) that was damaged as a result of the accident's impact.

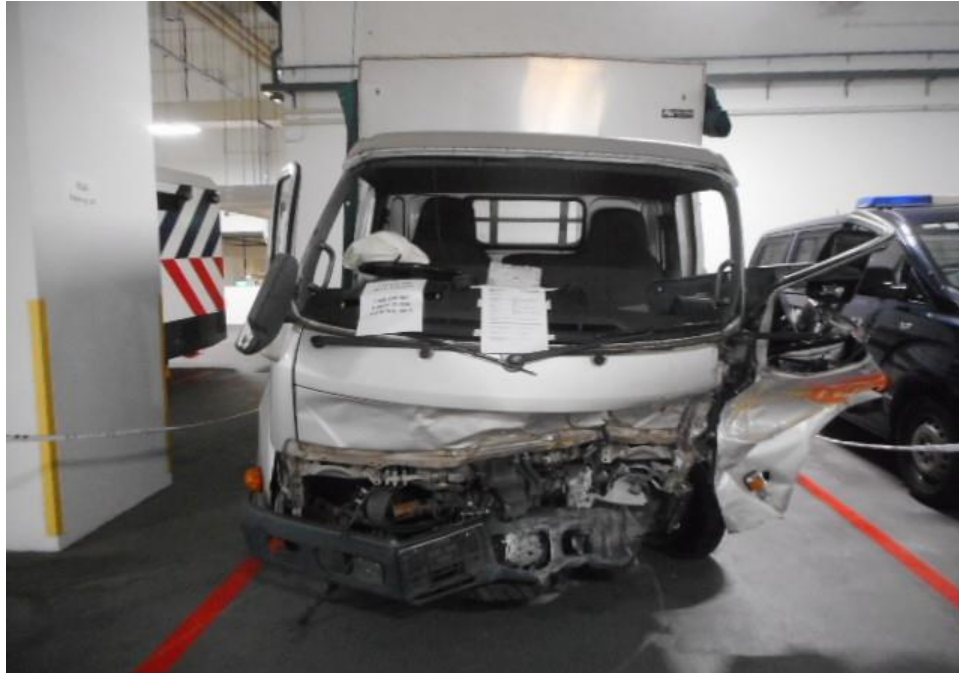
Photo 3 shows a general view of the front portion of the Motor Lorry at the time of our inspection. The Motor Lorry was observed sustained major damages to its front and rear portion. Its front cabin, front windscreen, front bumper and front body panel and its both doors as a result of the accident. The Supplemental Restraint System (SRS) was activated as a result of the accident.

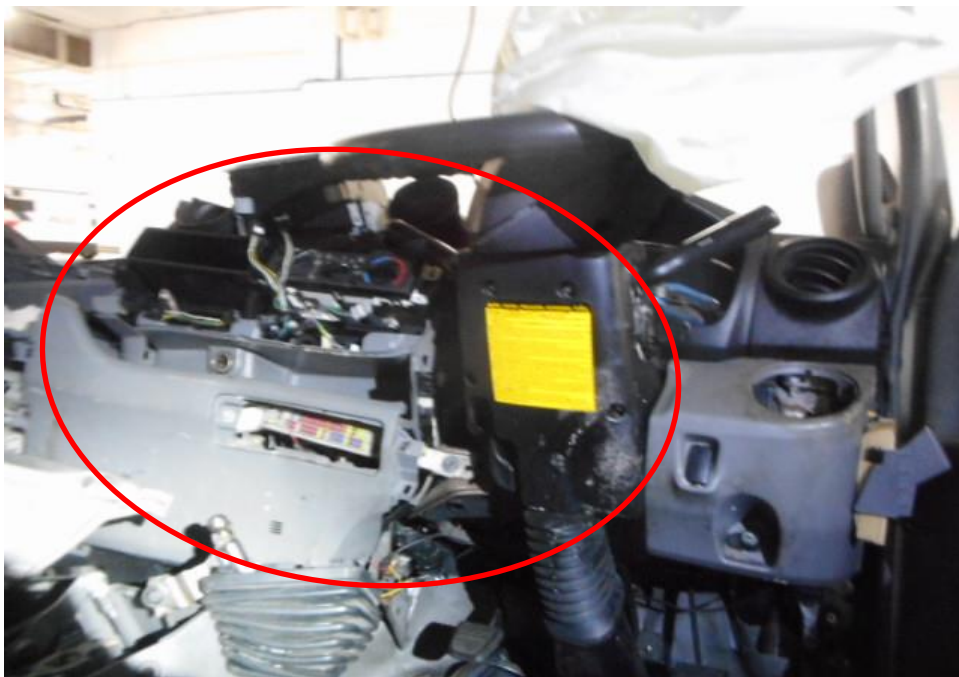
Photo 4 shows the close up view of the front portion of the Motor Lorry at the time of our inspection. The Motor Lorry was observed to have sustained major damages to its dashboard (circled) that was crushed due to the accident's impact.

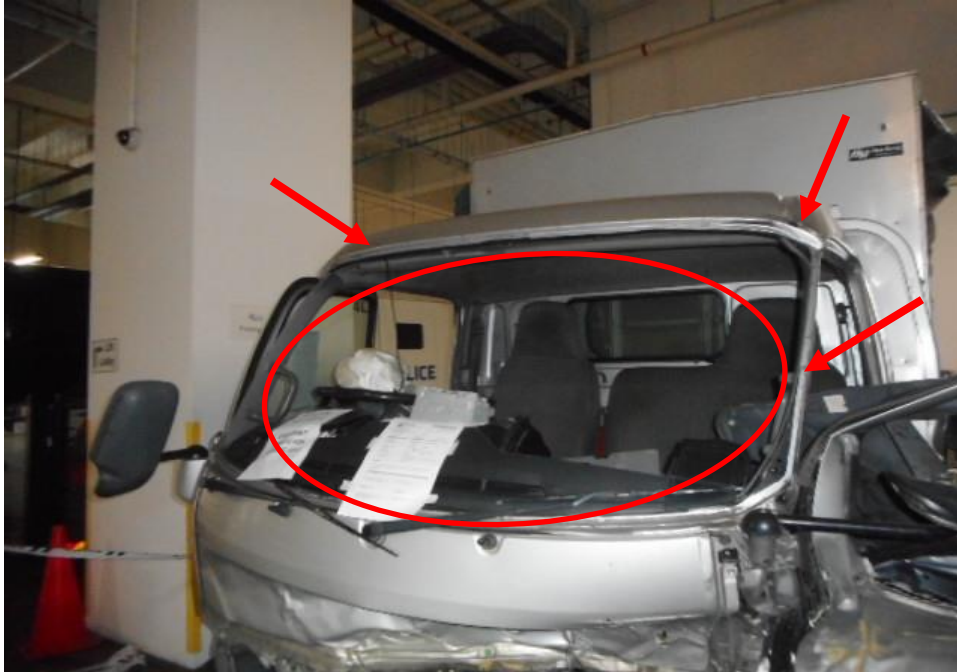
Photo 5 shows the close up view of the front portion of the Motor Lorry at the time of our inspection. The Motor Lorry was observed to have sustained major damages to its front windscreen (red circle) and its front cabin (arrowed) that was crushed due to the accident's impact.

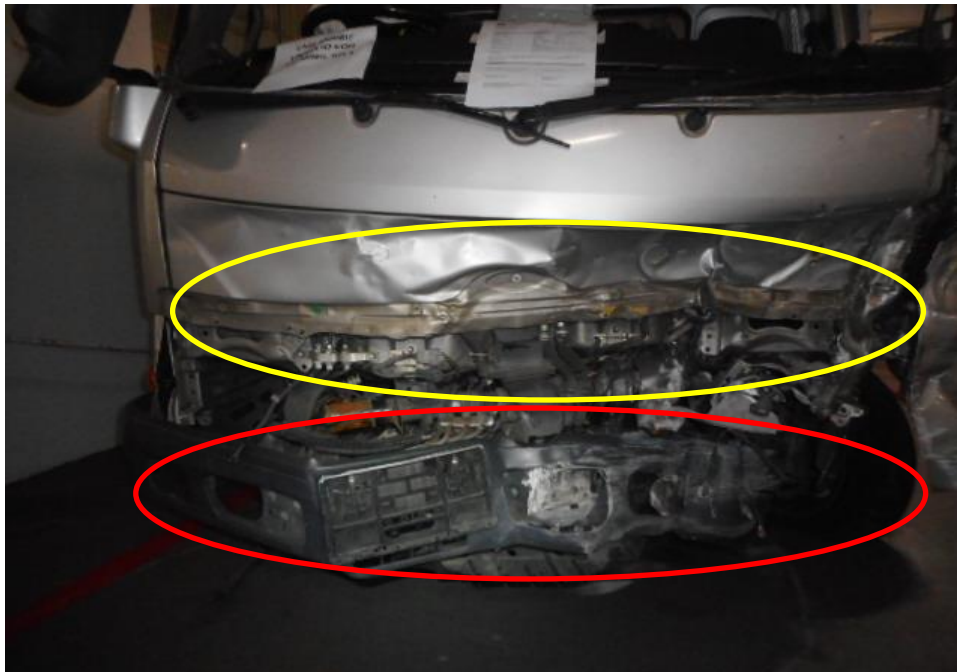
Photo 6 shows the close up view of the front portion of the Motor Lorry at the time of our inspection. The Motor Lorry was observed to have sustained major damages to its front bumper (red circle) and its front body panel (yellow circle) that was damaged as a result of the accident's impact.

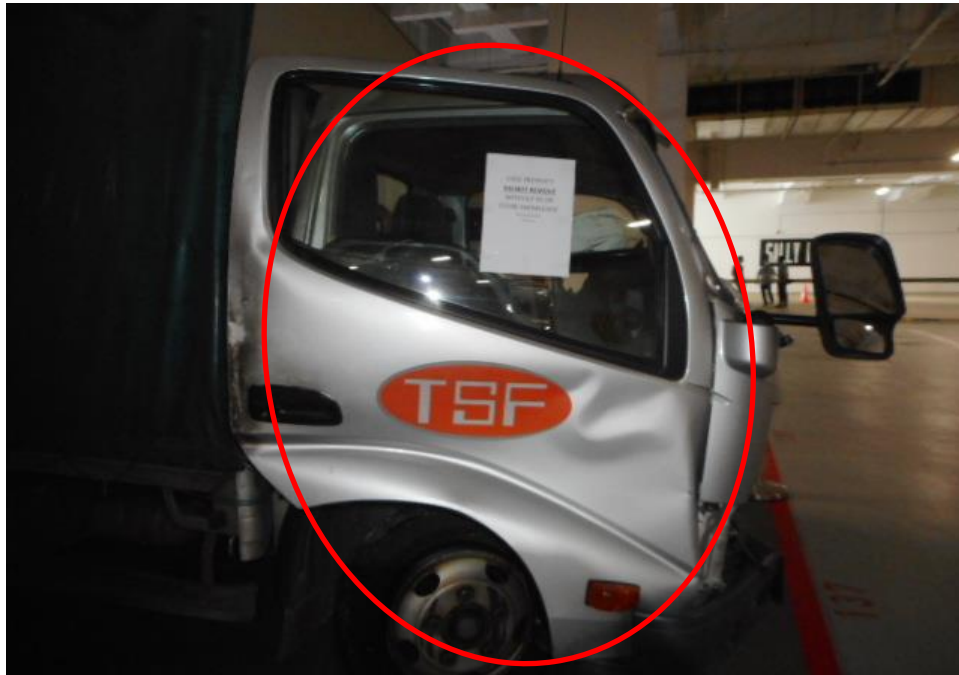
Photo 7 shows the close up view of the right door of the Motor Lorry at the time of our inspection. The Motor Lorry was observed to have sustained damages to its right door (circled) as a result of the accident.

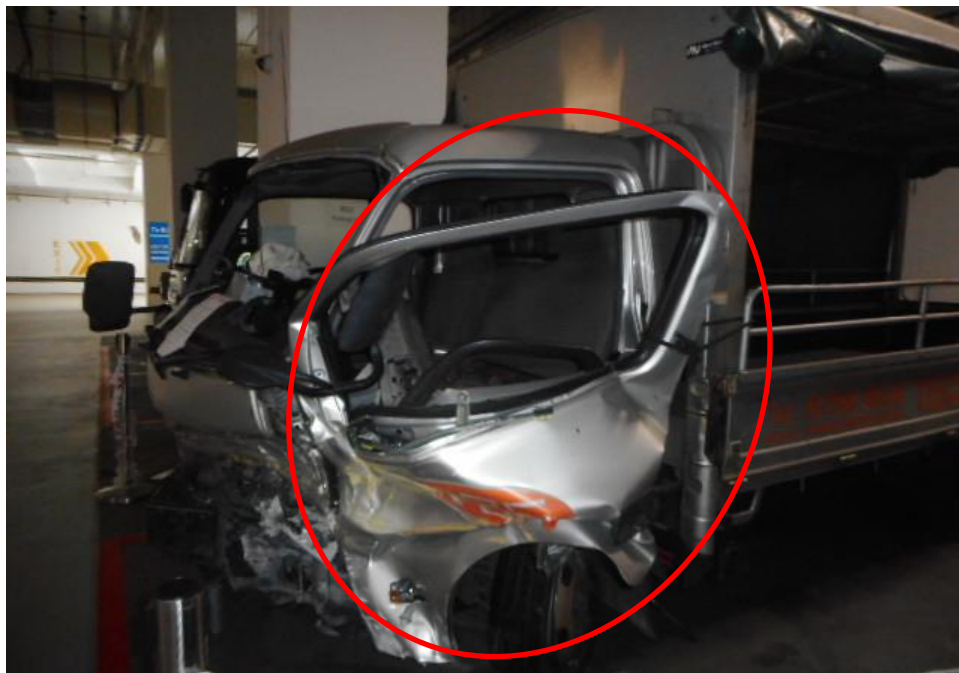
Photo 8 shows the close up view of the left door of the Motor Lorry at the time of our inspection. The Motor Lorry was observed to have sustained damages to its left door (circled) as a result of the accident.

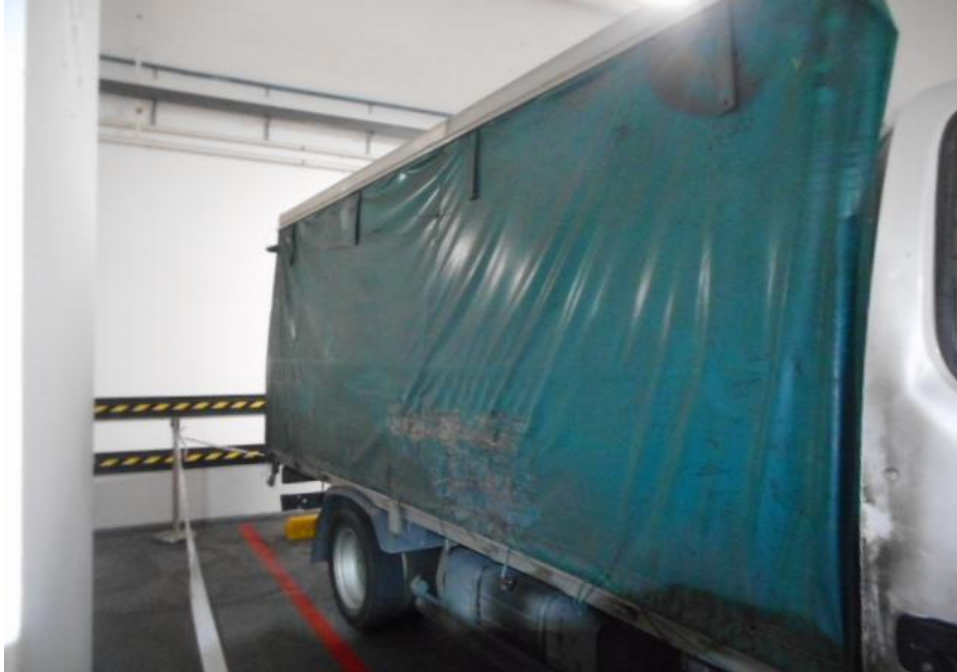
Photo 9 shows a general view of the Motor Lorry's right body at the time of my inspection. The right portion of the Motor Lorry was observed to have been unaffected by the accident.

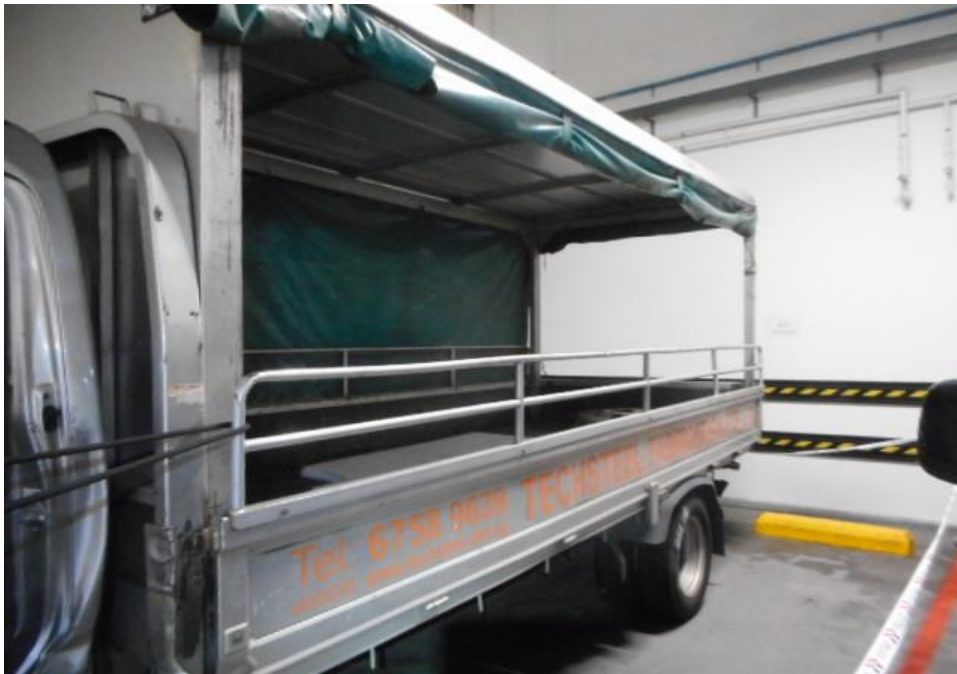
Photo 10 shows a general view of the Motor Lorry's left body at the time of my inspection. The left portion of the Motor Lorry was observed to have been unaffected by the accident.

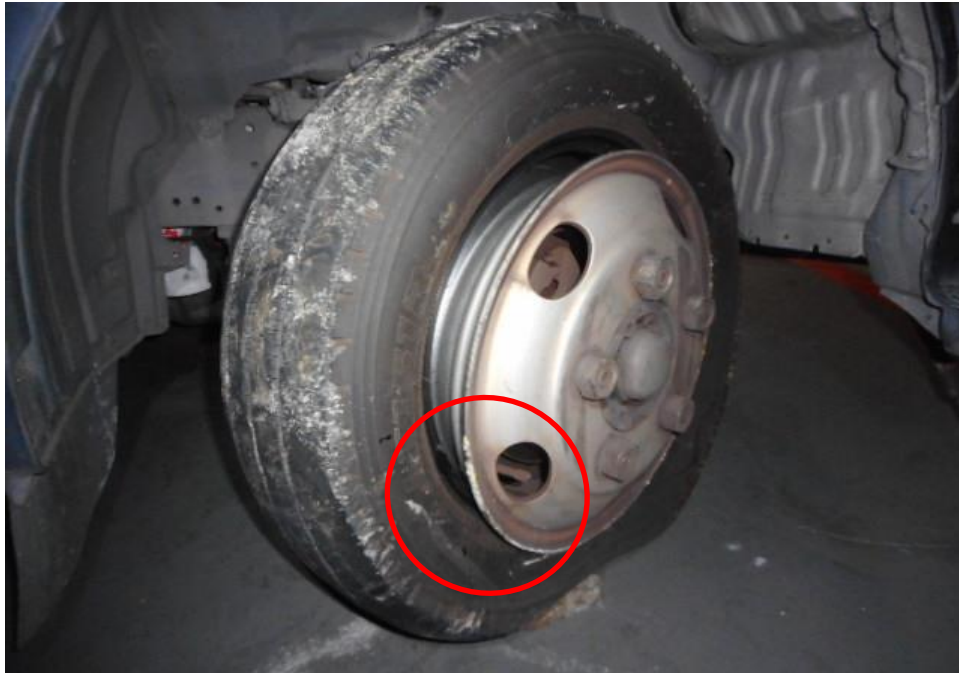
Photo 11 shows the condition of the outer side of the front right tyre of the Motor Lorry, which was observed to be in unserviceable condition with remaining tread depth of approximately 6.5mm. The steel wheel rim, was observed damage (circled) and the tyre was observed to be cut and deflated as a result of the accident.

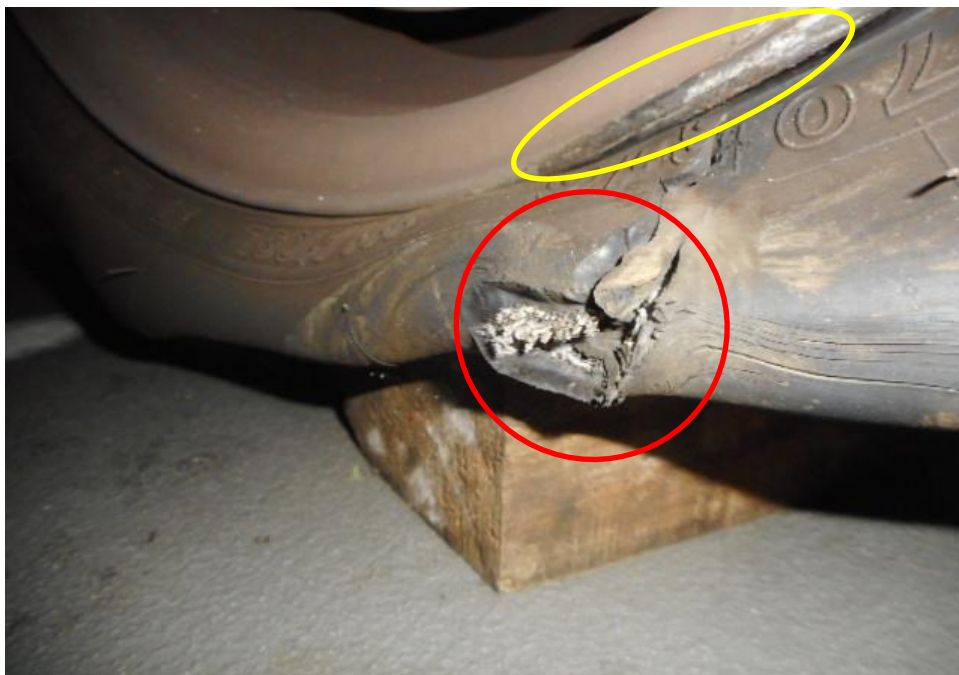
Photo 12 shows the condition of the inner side of the front right tyre of the Motor Lorry, which was observed to be in unserviceable condition with remaining tread depth of approximately 6.5mm. The steel wheel rim, was observed damage (yellow circle) and the tyre was observed to be cut and deflated (red circle) as a result of the accident.

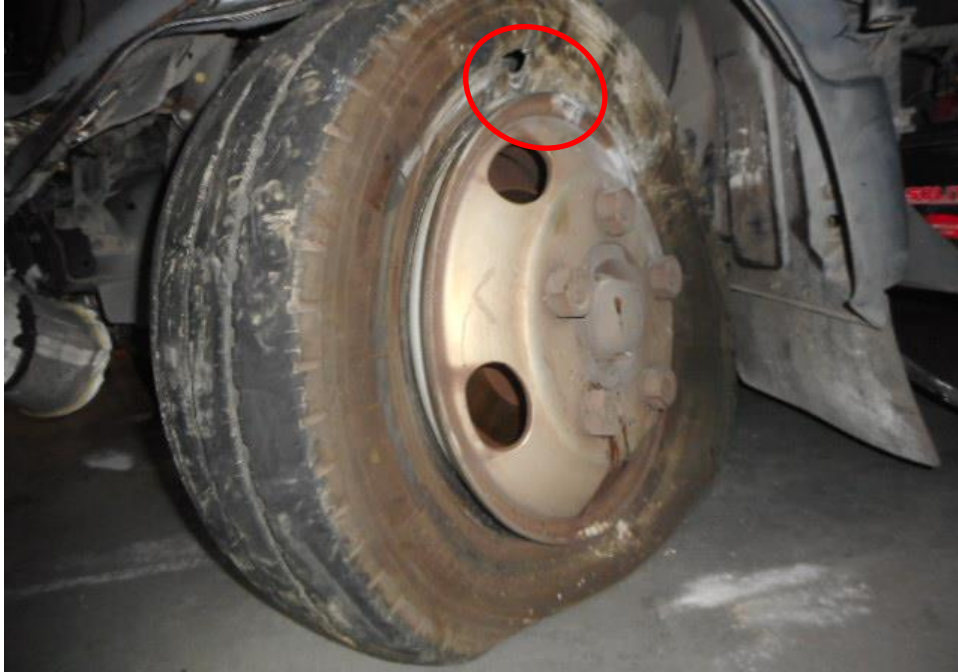
Photo 13 shows the condition of the outer side of the front left tyre of the Motor Lorry, which was observed to be in unserviceable condition with remaining tread depth of approximately 6.5mm. The steel wheel rim, was observed damage (circled) and the tyre was observed to be cut and deflated as a result of the accident.

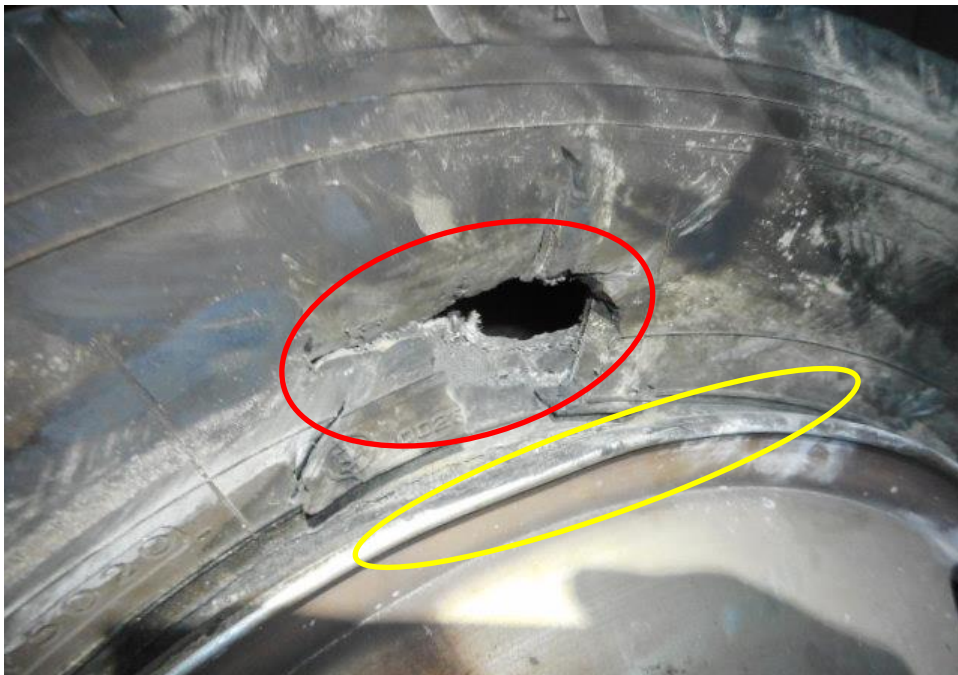
Photo 14 shows the condition of the outer side of the front left tyre of the Motor Lorry, which was observed to be in unserviceable condition with remaining tread depth of approximately 6.5mm. The steel wheel rim, was observed damage (yellow circle) and the tyre was observed to be cut and deflated (red circle) as a result of the accident.

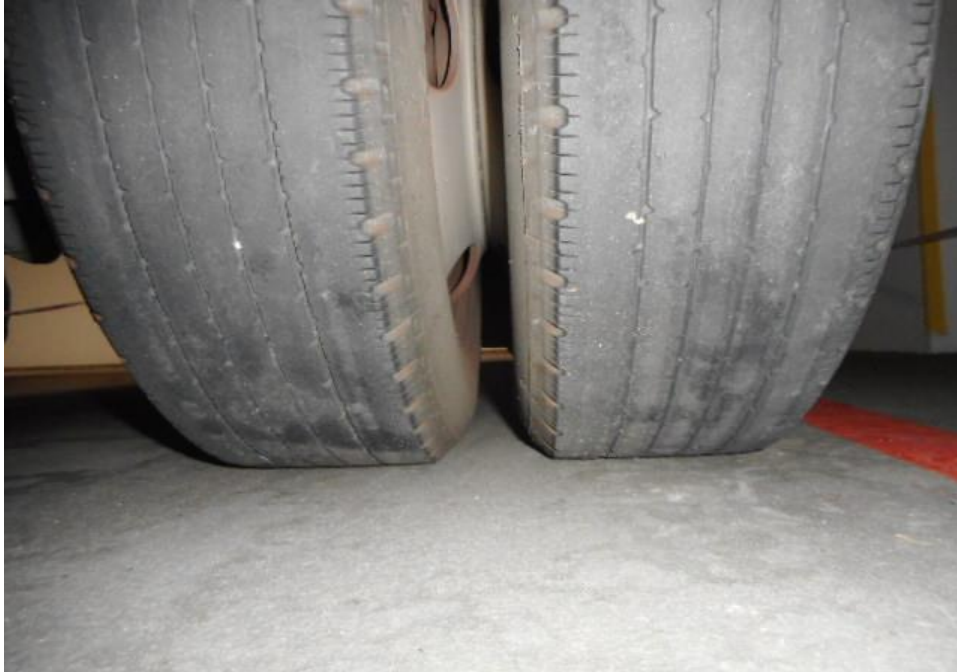
Photo 15 shows the condition of the rear right tyres of the Motor Lorry, which were observed to be in serviceable condition with remaining, tread depth of approximately 2.1mm. The tyres, which was wrapped around standard steel wheel rim, it was observed to be sufficiently inflated for vehicular operation.

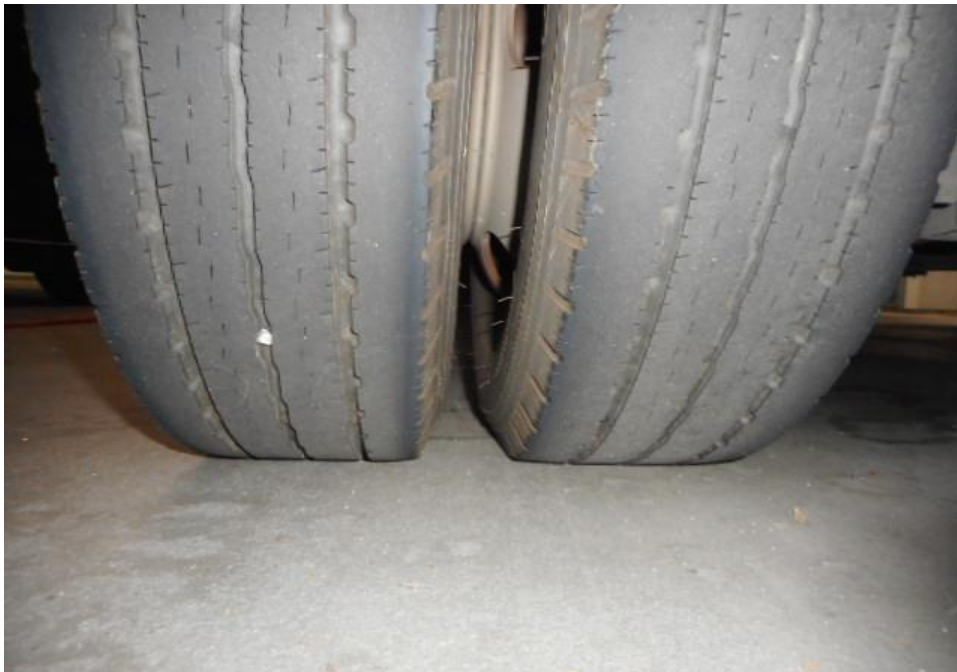
Photo 16 shows the condition of the rear left tyres of the Motor Lorry, which were observed to be in serviceable condition with remaining, tread depth of approximately 5.7mm. The tyres, which was wrapped around standard steel wheel rim, it was observed to be sufficiently inflated for vehicular operation.

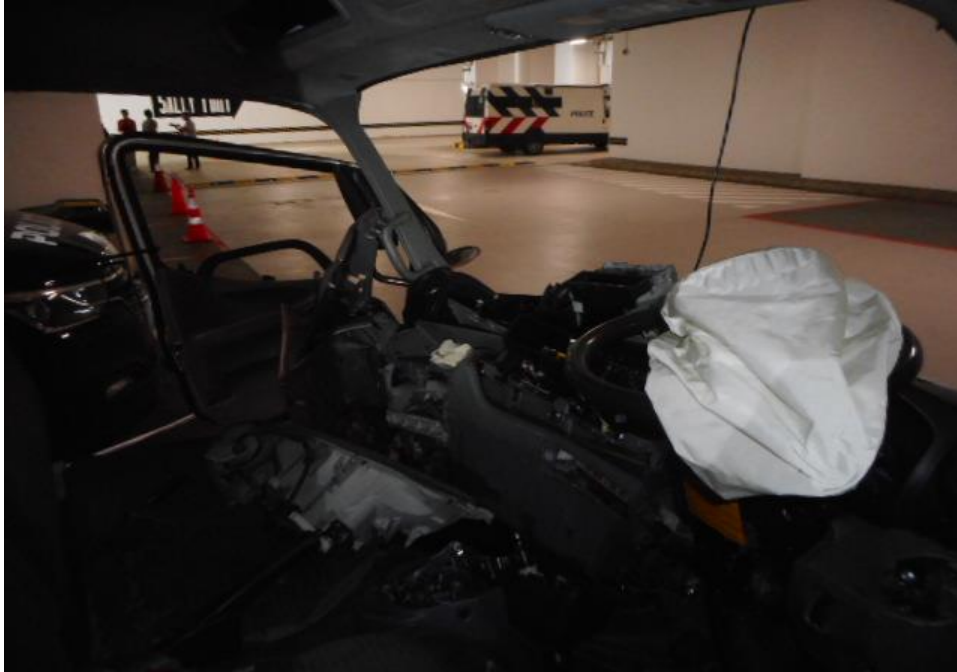
Photo 17 shows the deployment of the Supplemental Restraint System (SRS) airbag in the Motor Lorry as a result of the accident.

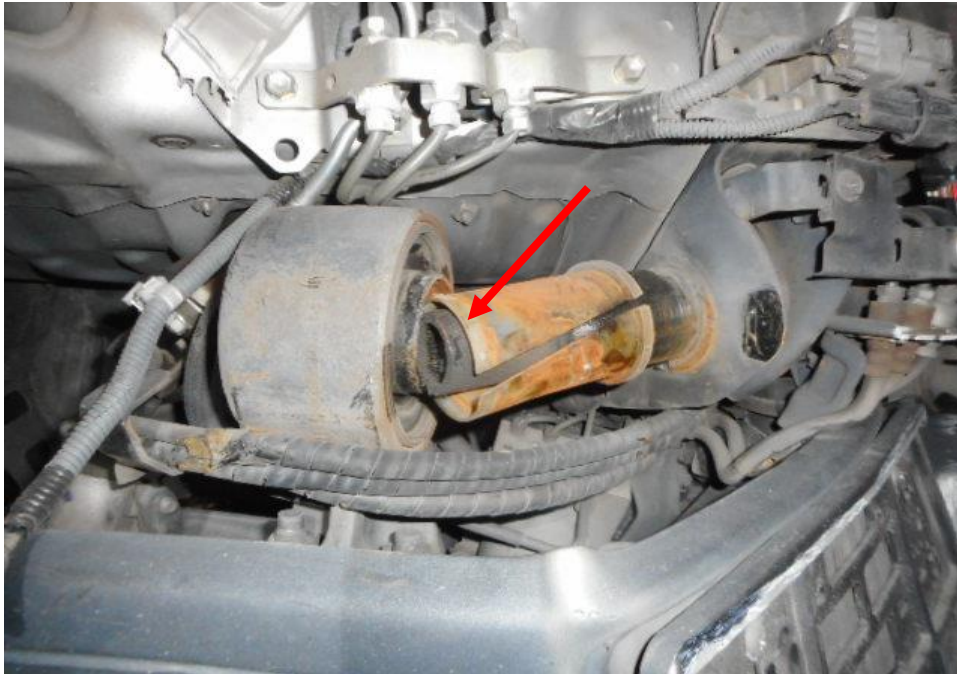
Photo 18 shows the induced damage to the front cabin opening mechanism (arrowed) of the Motor Lorry's which had immobilised the opening and viewing of the various parts and components inside the engine compartment a result of the accident.

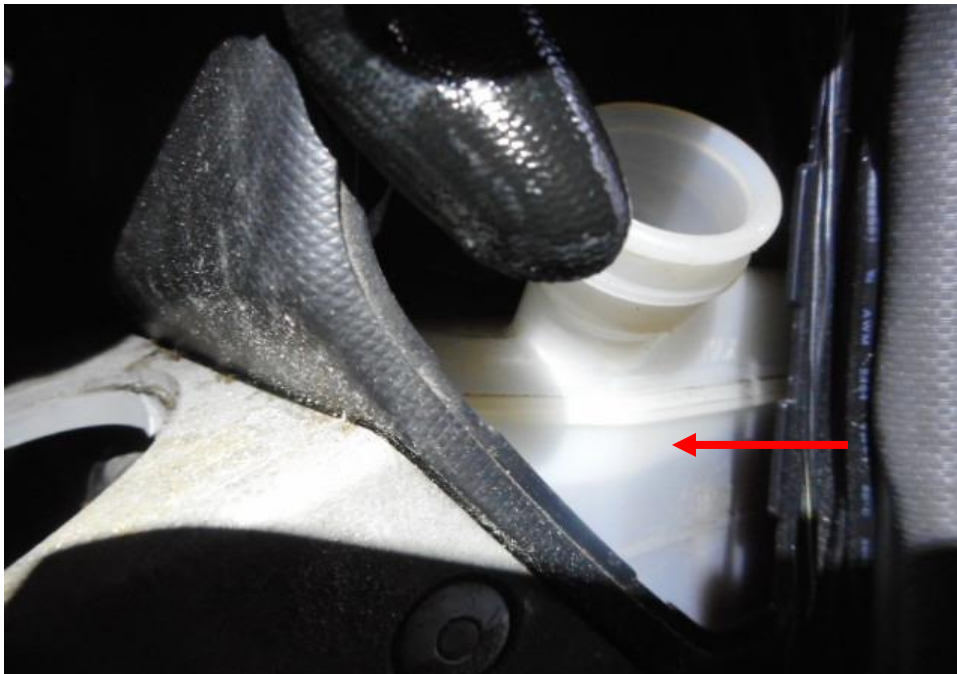
Photo 19 shows the brake fluid reservoir of the Motor Lorry at the time of my inspection. The brake fluid was observed to be of sufficient level (arrowed) and without any visible contamination.

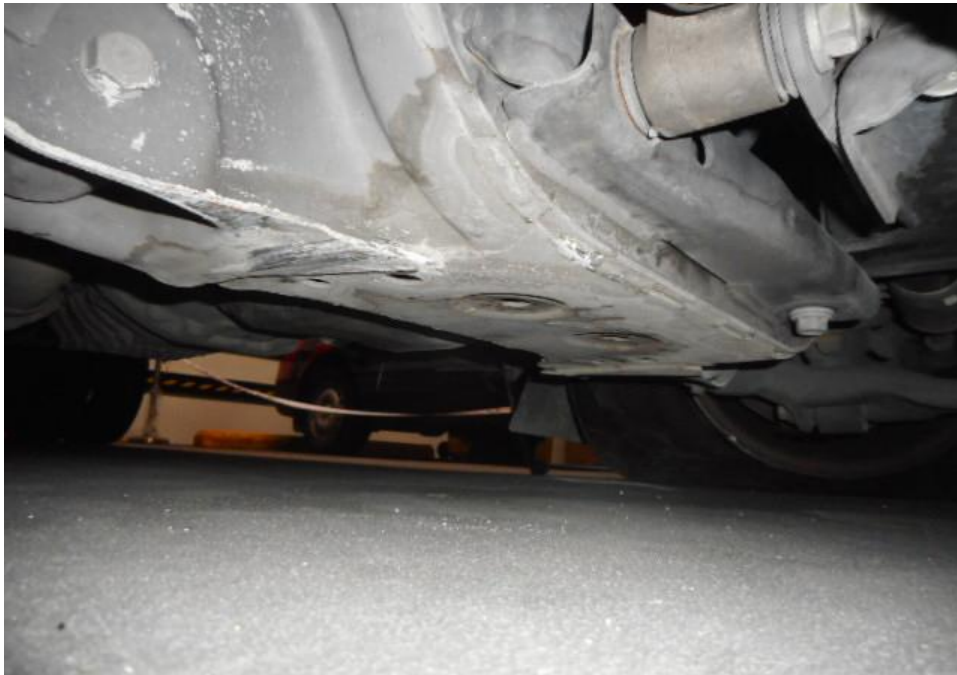
Photo 20 shows the undercarriage of the Motor Lorry, at the area where the engine housing and transmission housing are located. I did not find any sign(s) or indication(s) of fluid leak and/or fluid stain(s) on the underside of the Motor Lorry.

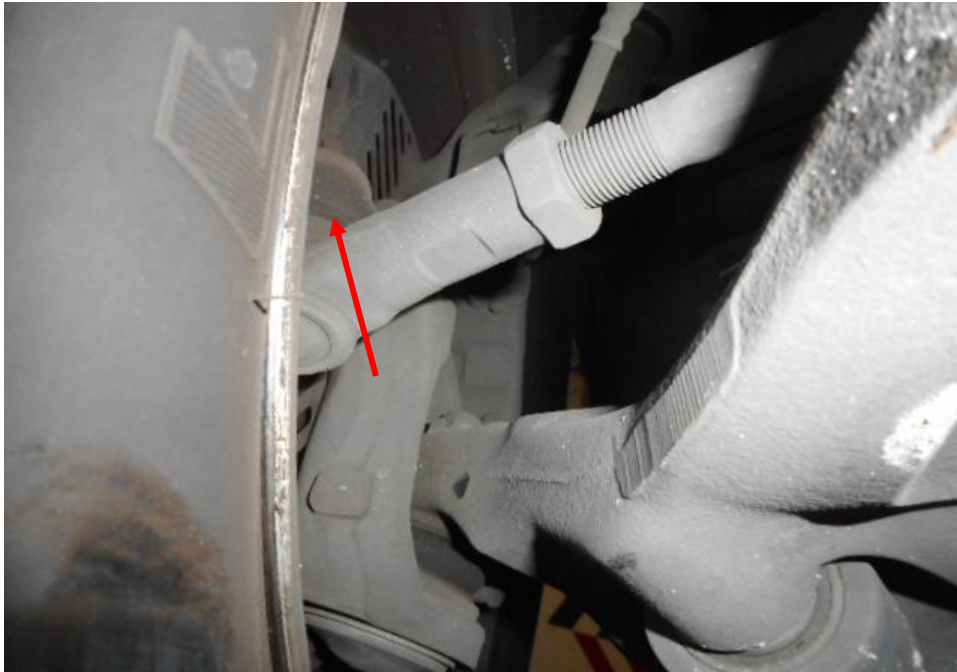
Photo 21 shows the various undercarriage components at the front right wheel of the Motor Lorry, in particular the steering tie rod end (arrowed). The various steering components were all found to be intact.

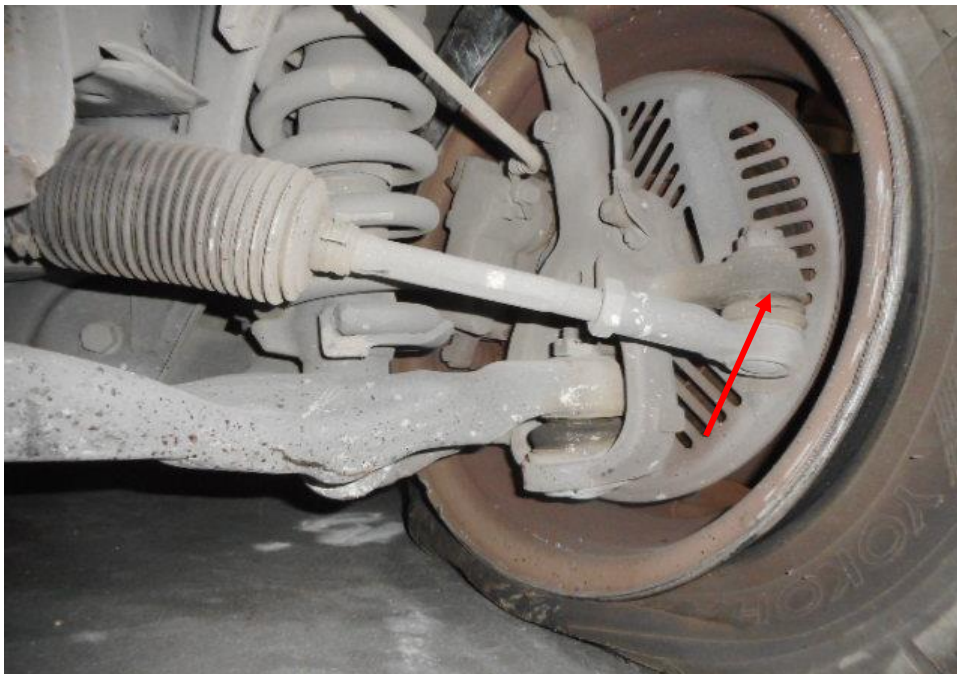
Photo 22 shows the various undercarriage components at the front left wheel of the Motor Lorry, in particular the steering tie rod end (arrowed). The various undercarriage components of the Motor Lorry were all found to be intact without any visible damage. There was also no sign of fluid stain(s) observed on the various undercarriage components.

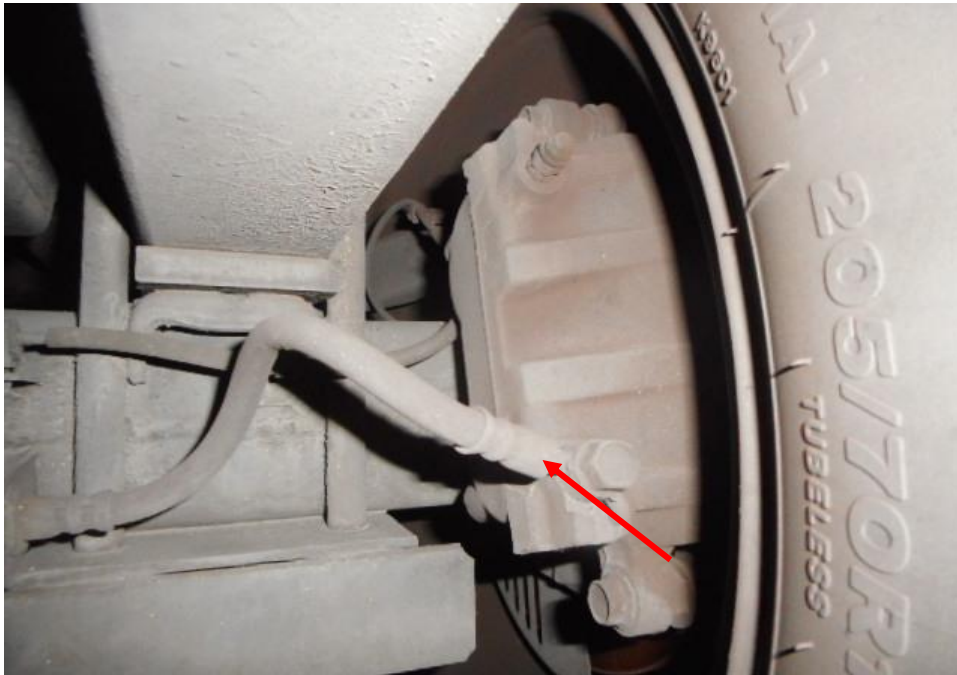
Photo 23 shows the brake pipe (arrowed) at the rear right wheel of the Motor Lorry. I did not observe any leakage of brake fluid at the time of my inspection of the Motor Lorry. My visual examination of the various mechanical components in the braking system were all found to be intact without any visible damage.

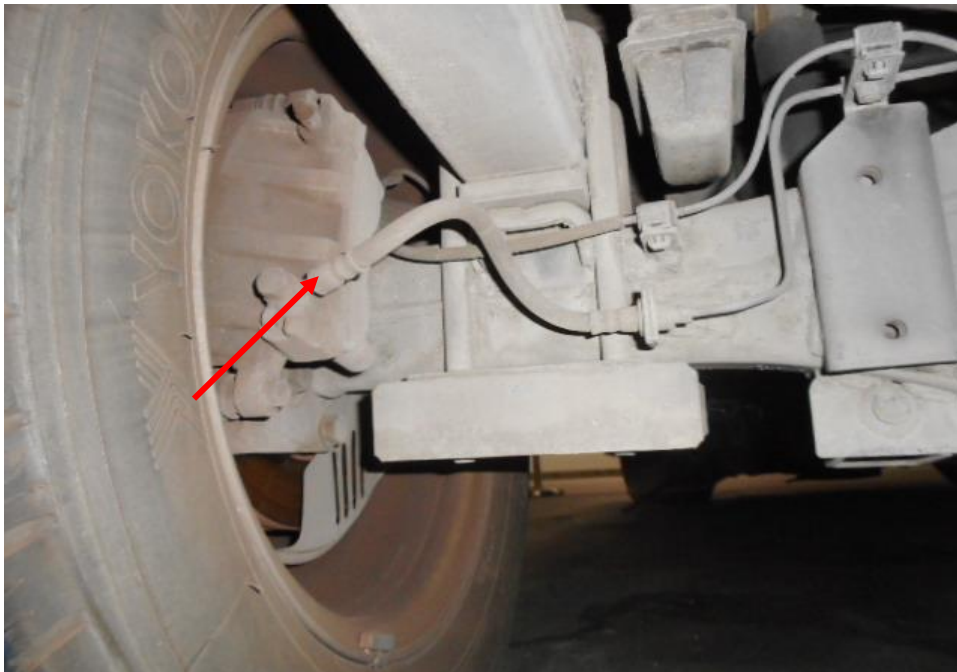
Photo 24 shows the brake pipe (arrowed) at the rear left wheel of the Motor Lorry. I did not observe any leakage of brake fluid at the time of my inspection of the Motor Lorry. My visual examination of the various mechanical components in the braking system were all found to be intact without any visible damage.

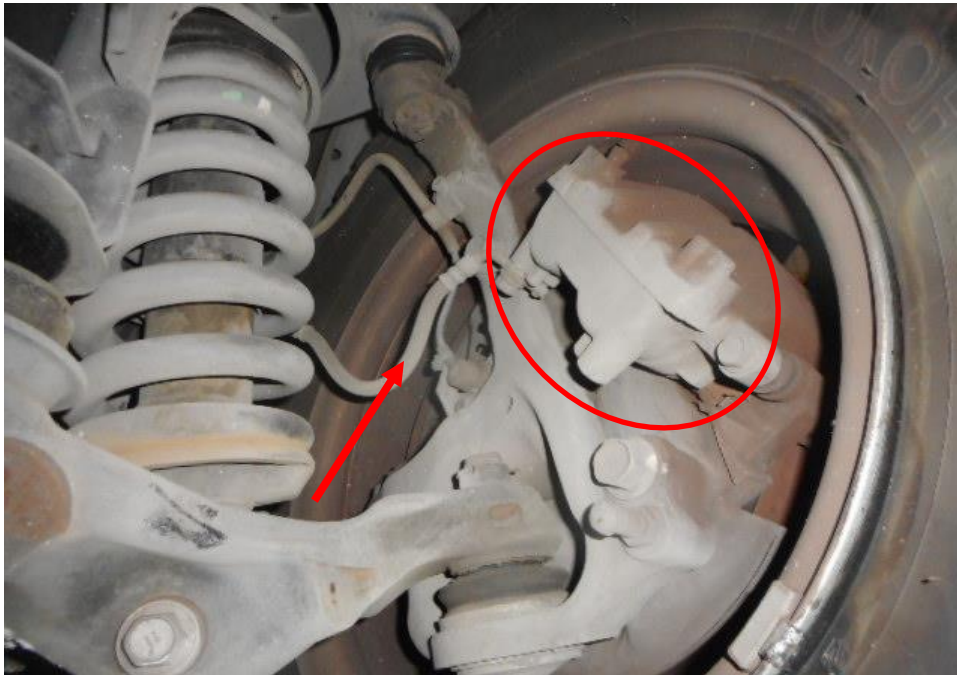
Photo 25 shows the brake hose/pipe (arrowed) at the front right wheel of the Motor Lorry. No leakage of brake fluid was observed. Visual examination of the various components of the braking system like the brake caliper (circled) had revealed all to be intact and without visible damage. There was also no sign of fluid stain(s) observed on the various undercarriage components.

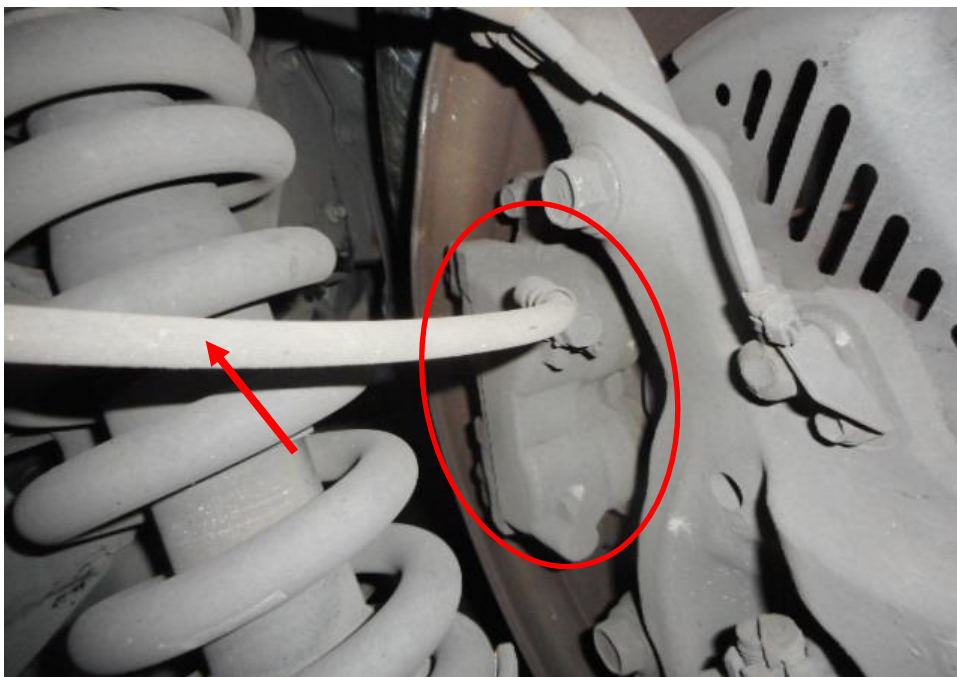
Photo 26 shows the brake hose/pipe (arrowed) at the front left wheel of the Motor Lorry. No leakage of brake fluid was observed. Visual examination of the various components of the braking system like the brake caliper (circled) had revealed all to be intact and without visible damage. There was also no sign of fluid stain(s) observed on the various undercarriage components.

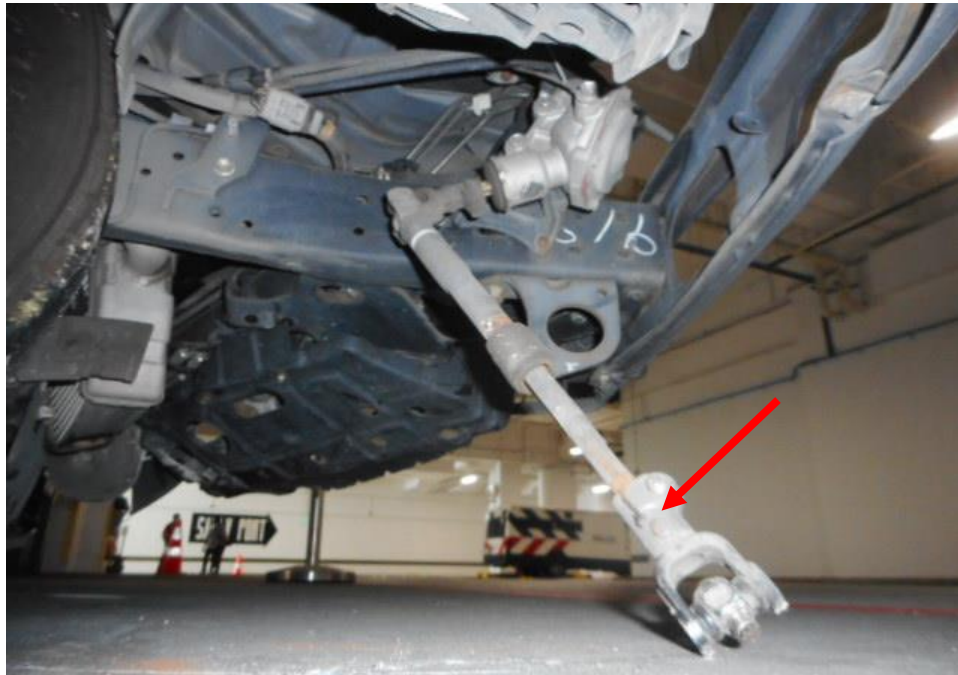
Photo 27 shows the various undercarriage components of the Motor Lorry, in particular the steering shaft (arrowed) was observed to be broken off as a result of the accident.

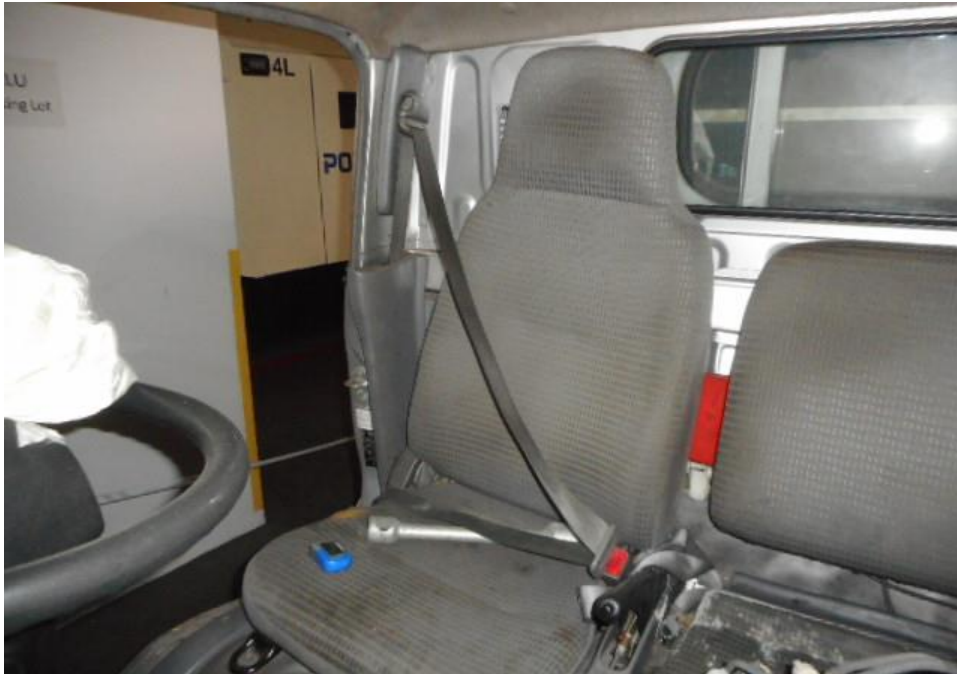
Photo 28 shows that the seat belt on the right seat was able to be fastened securely into the respective pre-tensioners that were fitted at the sides of each seat

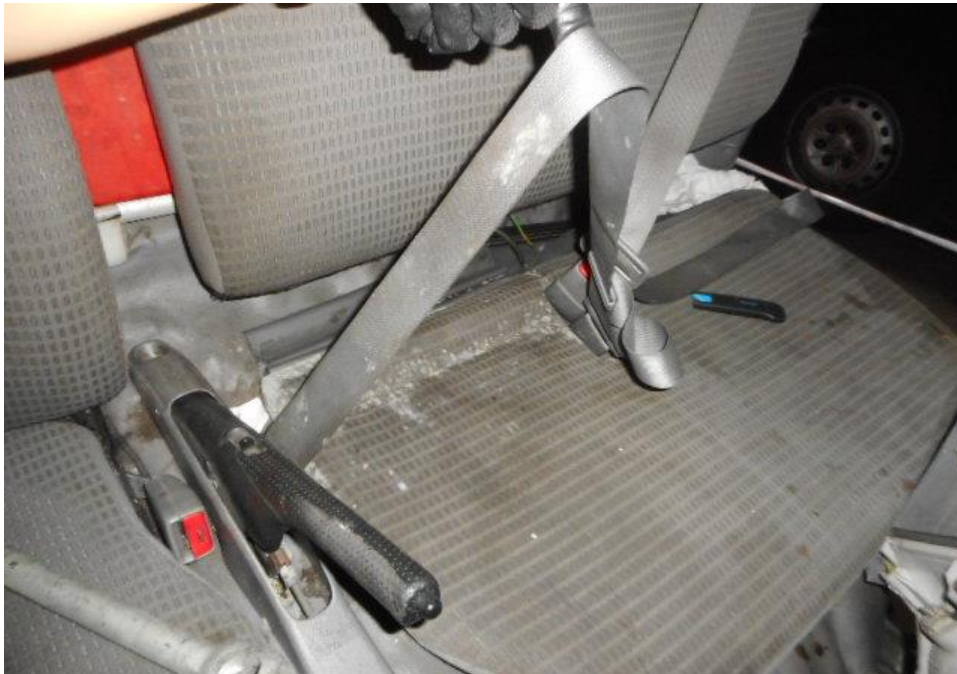
Photo 29 shows that the seat belt on the centre seat was able to be fastened securely into the respective pre-tensioners that were fitted at the sides of each seat

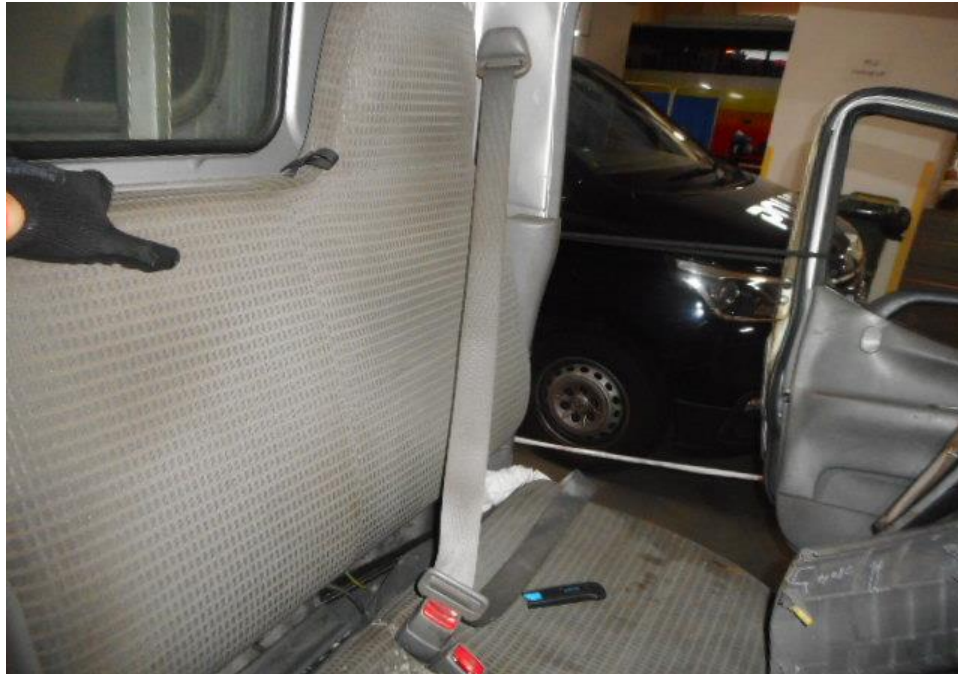
Photo 30 shows that the seat belt on the left seat was able to be fastened securely into the respective pre-tensioners that were fitted at the sides of each seat.
