Your Ref: Porsche 911 Targa
(chassis number WP0ZZZ99ZNS227448)
Our Ref : CI/TP22012716/D

20 December 2022

INSPECTION REPORT OF AN UNREGISTERED PORSCHE 911 TARGA MOTOR CAR WITH CHASSIS NUMBER WP0ZZZ99ZNS227448

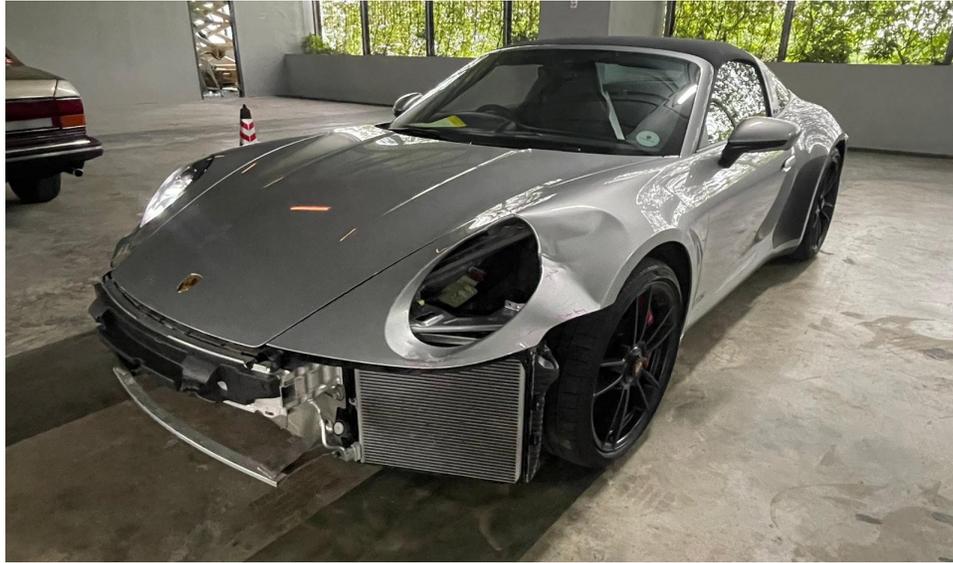
3. The photographs provided to me had showed damage to the Motor Car's front left portion and rear portion. Body parts damaged at the front left portion include the front left fender amongst others. The front left headlamp, front left day light, front right day light, front left signal lamp, front right signal lamp, front bumper and all its related parts and attachments like the front bumper lower lip, front bumper sensors, front bumper centre lower air guide, front bumper left lower grille and front bumper right lower grille amongst others were also observed to be missing/dislodged/damaged.

Photo 1 shows the front left body of the Motor Car (photograph provided to me). The Motor Car was observed to have sustained damage at its front left portion. The front left fender was amongst the body parts that were observed to have been damaged. The front left headlamp, front left day light, front left signal lamp, front bumper and all its related parts and attachments like the front bumper left lower grille, front bumper centre air guide and front bumper sensors amongst others were also observed to be missing/dislodged/damaged.

24. The body parts at the front left portion and rear portion of the Motor Car were visually examined and it was noted that the repair/restoration works carried out to the damaged area of the Motor Car (refer to photograph 1 - 5 above) were reasonably adequate and in order.

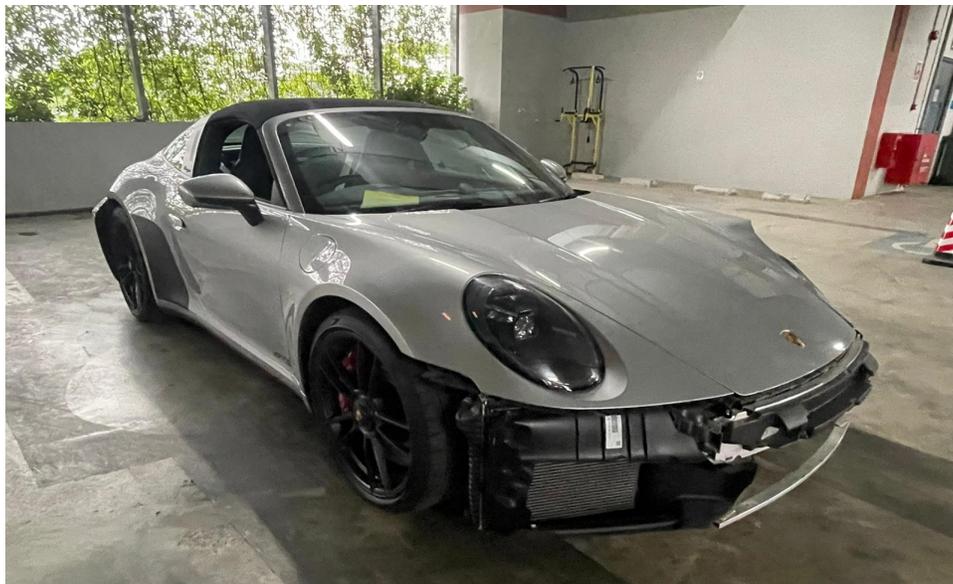
Photo 2 shows the front right body of the Motor Car (photograph provided to me). The front right headlamp, front right day light, front right signal lamp, front bumper and all its related parts and attachments like the front bumper lower lip, front bumper right lower grille and front bumper sensors amongst others were also observed to be missing/dislodged/damaged. The airbag(s) was not deployed.

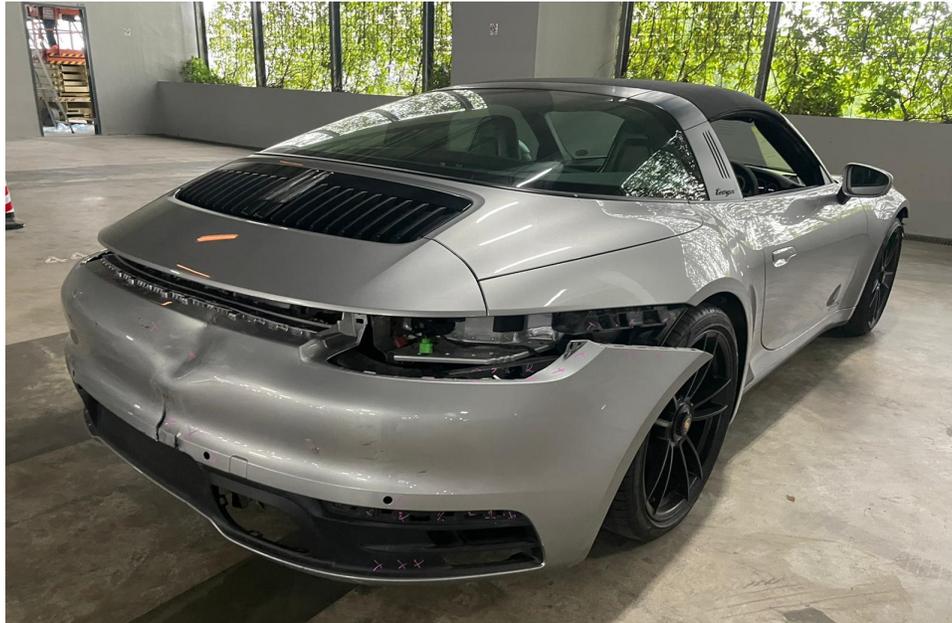
4. As for the rear portion, I had observed damage to the rear bumper, rear bumper lower cover and rear top centre reflector amongst others. The rear left taillamp, rear right taillamp, rear left exhaust garnish, rear right exhaust garnish, rear bumper and all its related parts and attachments like the rear bumper sensors, rear bumper left reflector and rear bumper right reflector amongst others were also observed to be missing/dislodged/damaged.

Photo 3 shows the rear right body of the Motor Car (photograph provided to me). Apart for the front left portion, I had also observed damage to the rear portion of the Motor Car. The rear bumper and rear bumper lower cover were amongst the body parts that were observed to be damaged. The rear right taillamp, rear right exhaust garnish, rear bumper and all its related parts and attachments like the rear bumper sensors and rear bumper right reflector amongst others were also observed to be missing/dislodged/damaged.

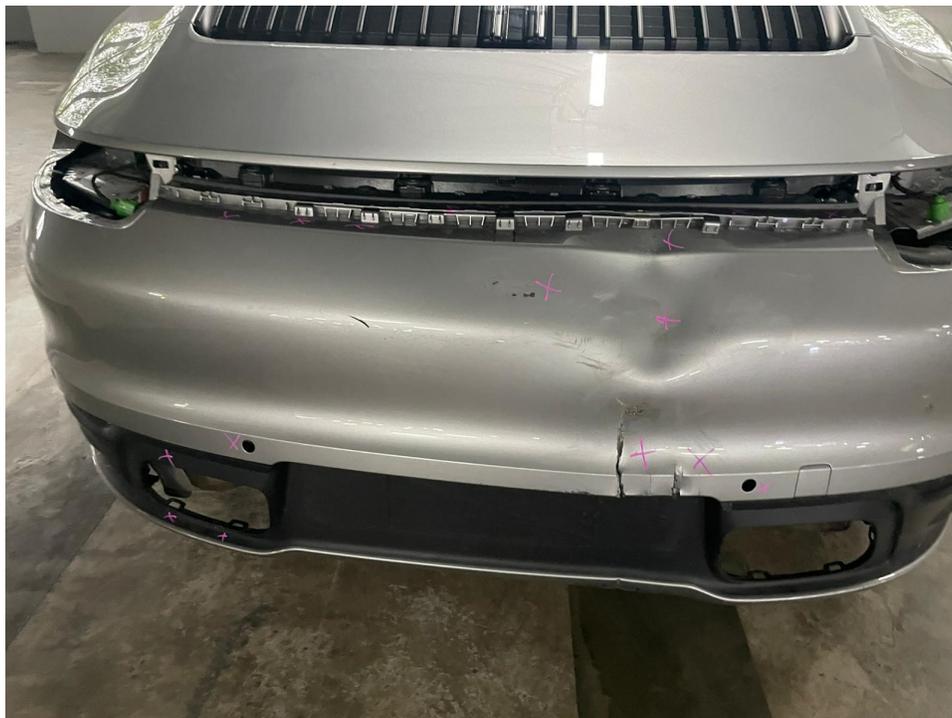
Photo 4 shows the rear body of the Motor Car (photograph provided to me). Apart for the front left portion, I had also observed damage to the rear portion of the Motor Car. The rear bumper, rear bumper lower cover and rear top centre reflector were amongst the body parts that were observed to be damaged.

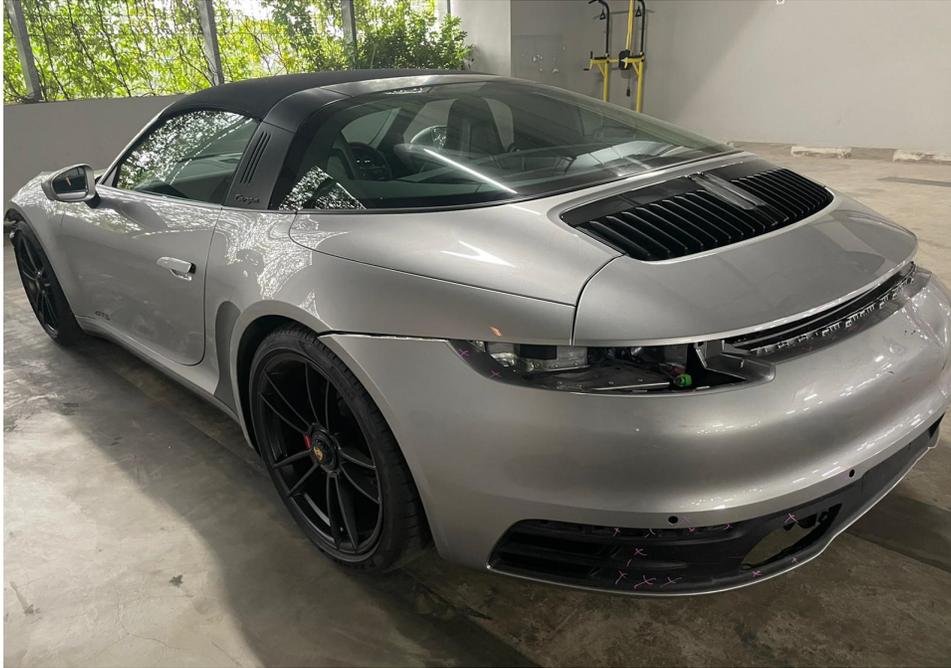
Photo 5 shows the rear left body of the Motor Car (photograph provided to me). Apart for the front left portion, I had also observed damage to the rear portion of the Motor Car. The rear bumper and rear bumper lower cover were amongst the body parts that were observed to be damaged. The rear left taillamp, rear left exhaust garnish, rear bumper and all its related parts and attachments like the rear bumper sensors and rear bumper left reflector amongst others were also observed to be missing/dislodged/damaged. The airbag(s) was not deployed.

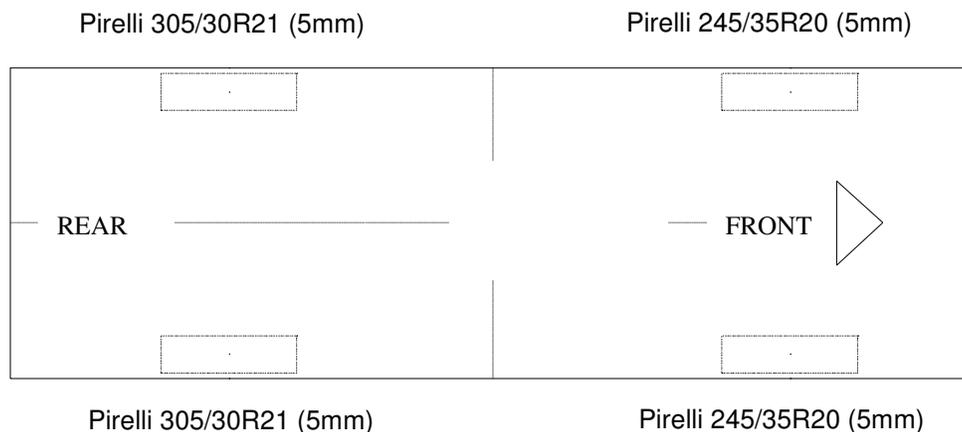
10. The Motor Car was fitted with 20inch (front) and 21inch (rear) sport wheel rims that were wrapped with tyres that were observed to be of serviceable condition. The tyres were also sufficiently inflated for vehicular operation. The tyre brand, tyre size and approximate remaining tread depth of the 4 tyres of the Motor Car were recorded as follows: -

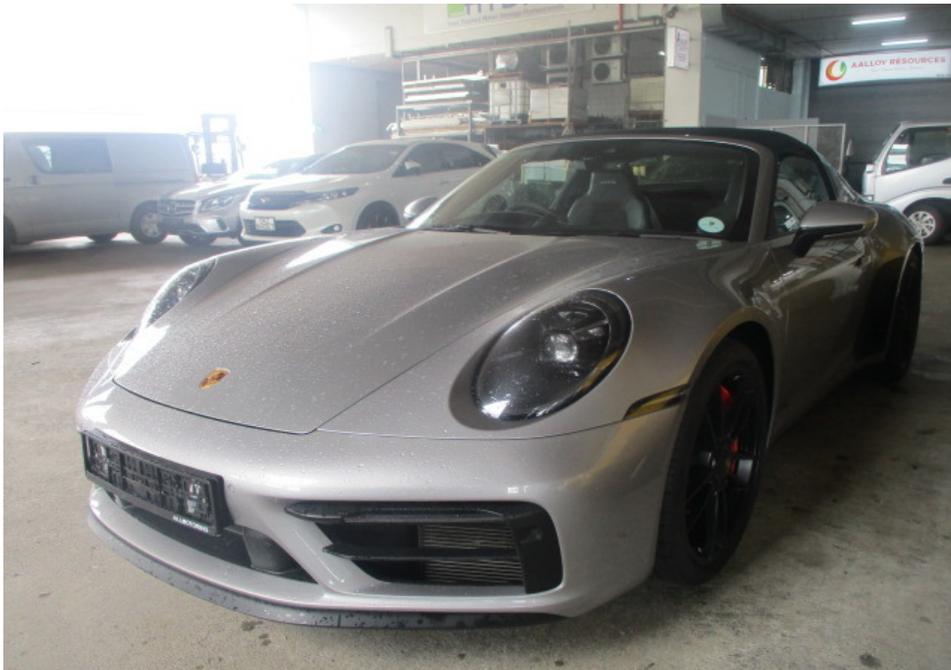
Photo 6 shows a general view of the front left body of the Motor Car at the time of my inspection. The Motor Car was observed to be in a relatively good general condition with no loose exterior fittings observed. The body parts at the front left portion of the Motor Car were visually examined and it was observed that the repair/restoration works carried out to the damaged area of the Motor Car (refer to photograph 1 above) were reasonably adequate and in order.

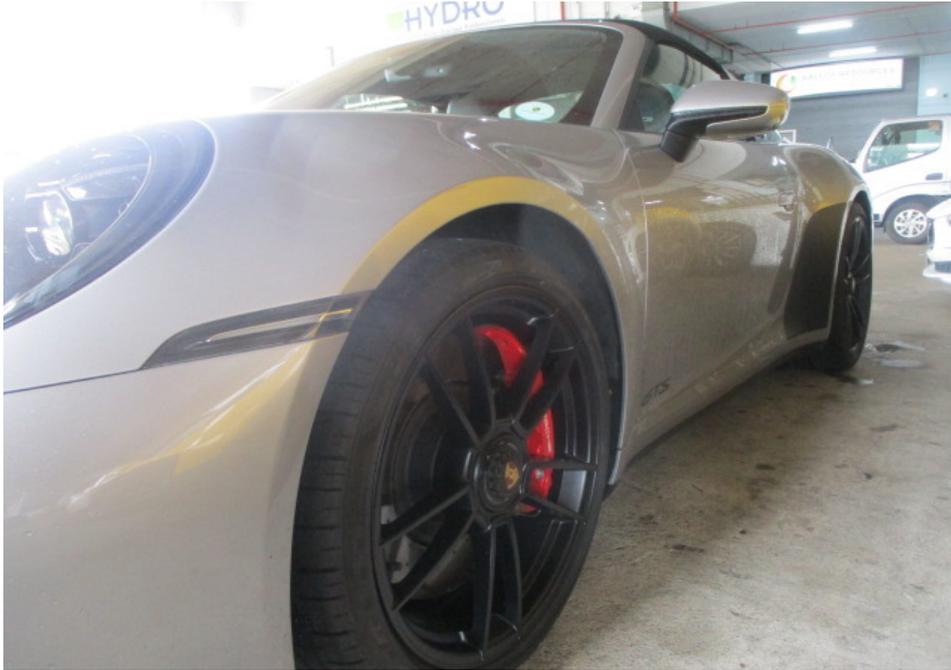
Photo 7 shows a closer view of the Motor Car's front bumper, front left fender, front left signal lamp and front left wheel rim. The body parts at the front left portion of the Motor Car were visually examined and it was observed that the repair/restoration works carried out to the damaged area of the Motor Car (refer to photograph 1 above) were reasonably adequate and in order.

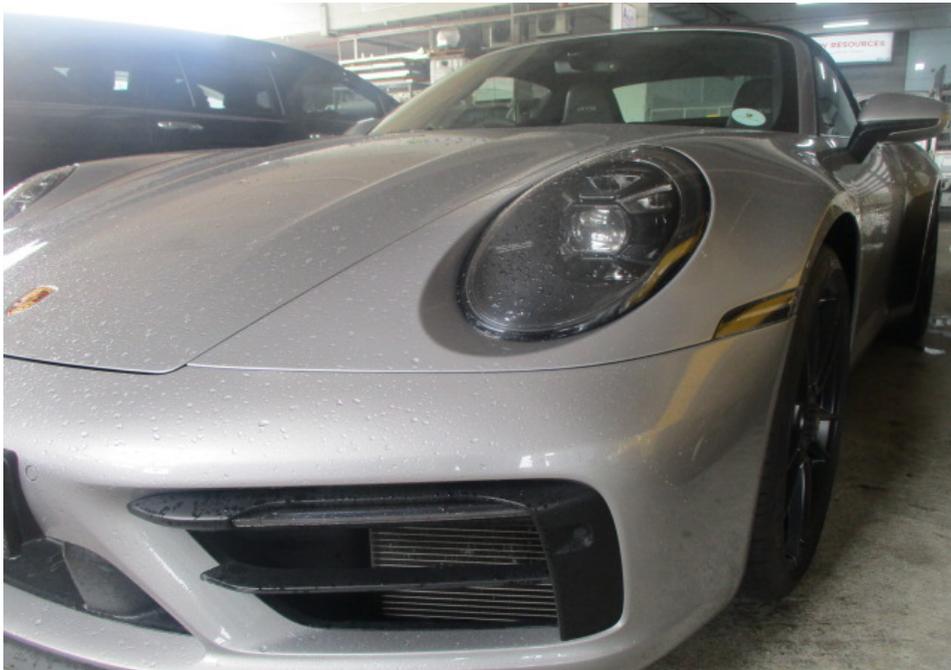
Photo 8 shows a closer view of the Motor Car's front bumper, front bumper left lower grille, front left day light and front left headlamp. The body parts at the front left portion of the Motor Car were visually examined and it was observed that the repair/restoration works carried out to the damaged area of the Motor Car (refer to photograph 1 above) were reasonably adequate and in order.

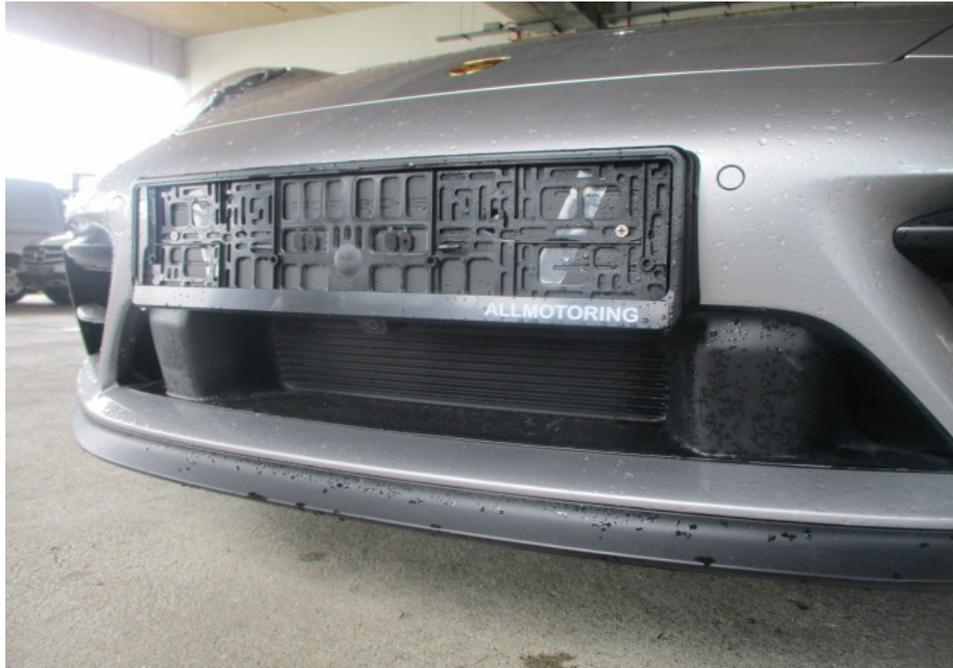
Photo 9 shows a closer view of the Motor Car's front bumper, front bumper lower lip, front bumper sensor and front bumper centre lower air guide. The body parts at the frontal portion of the Motor Car were visually examined and it was observed that the repair/restoration works carried out to the damaged area of the Motor Car (refer to photograph 1 & 2 above) were reasonably adequate and in order.

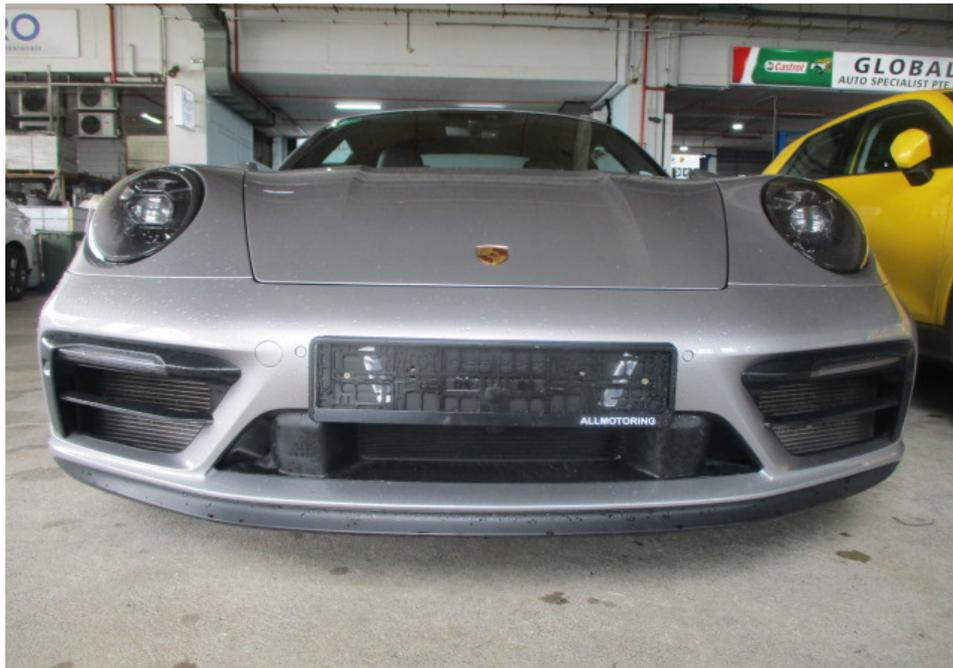
Photo 10 shows a closer view of the Motor Car's frontal portion. The body parts at the frontal portion of the Motor Car were visually examined and it was observed that the repair/restoration works carried out to the damaged area of the Motor Car (refer to photograph 1 & 2 above) were reasonably adequate and in order.

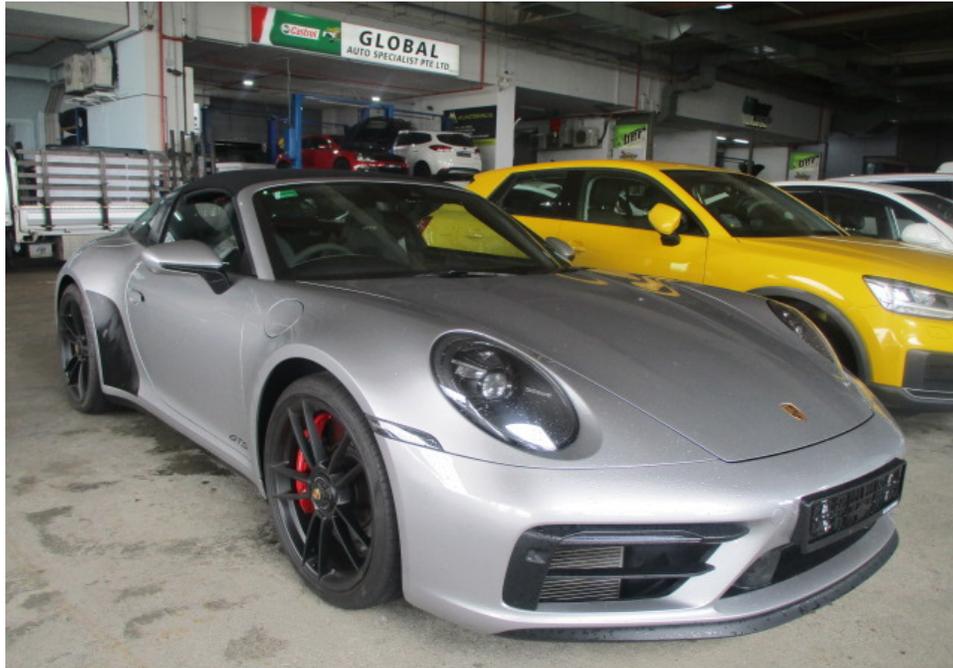
Photo 11 shows a general view of the front right body of the Motor Car at the time of my inspection. The Motor Car was observed to be in a relatively good general condition with no loose exterior fittings observed. The body parts at the frontal portion of the Motor Car were visually examined and it was observed that the repair/restoration works carried out to the damaged area of the Motor Car (refer to photograph 2 above) were reasonably adequate and in order.

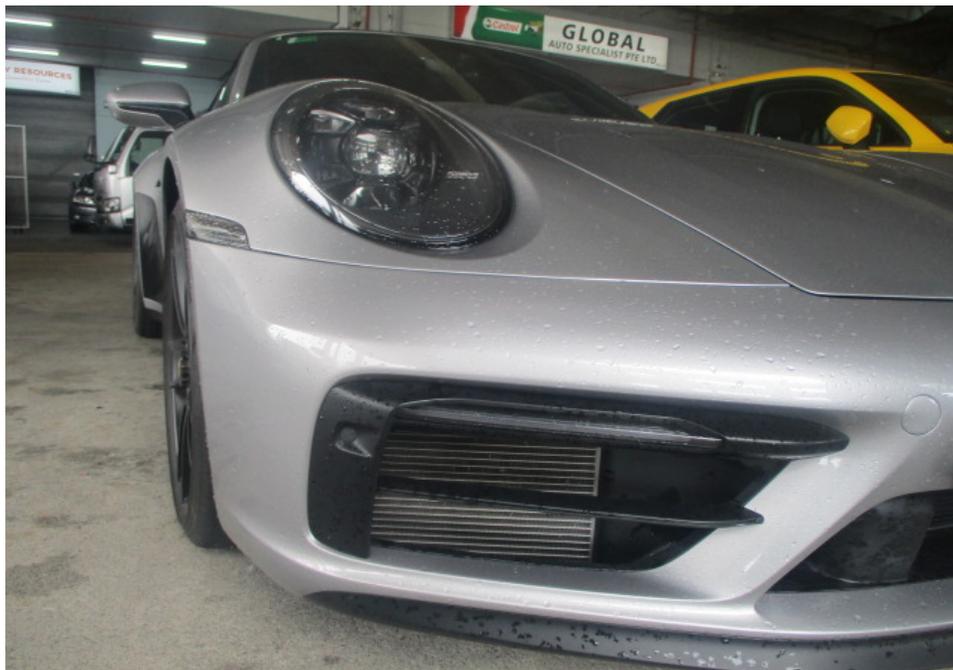
Photo 12 shows a closer view of the Motor Car's front bumper, front bumper right lower grille, front right day light and front right headlamp. The body parts at the frontal portion of the Motor Car were visually examined and it was observed that the repair/restoration works carried out to the damaged area of the Motor Car (refer to photograph 2 above) were reasonably adequate and in order.

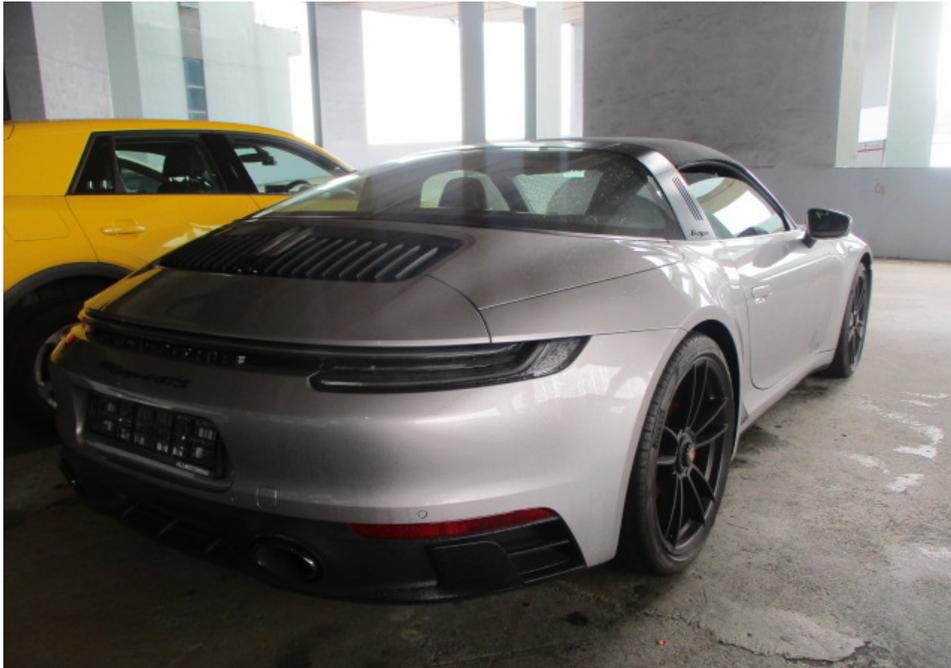
Photo 13 shows a general view of the rear right body of the Motor Car at the time of my inspection. The Motor Car was observed to be in a relatively good general condition with no loose exterior fittings observed. The body parts at the rear portion of the Motor Car were visually examined and it was observed that the repair/restoration works carried out to the damaged area of the Motor Car (refer to photograph 3 - 5 above) were reasonably adequate and in order.

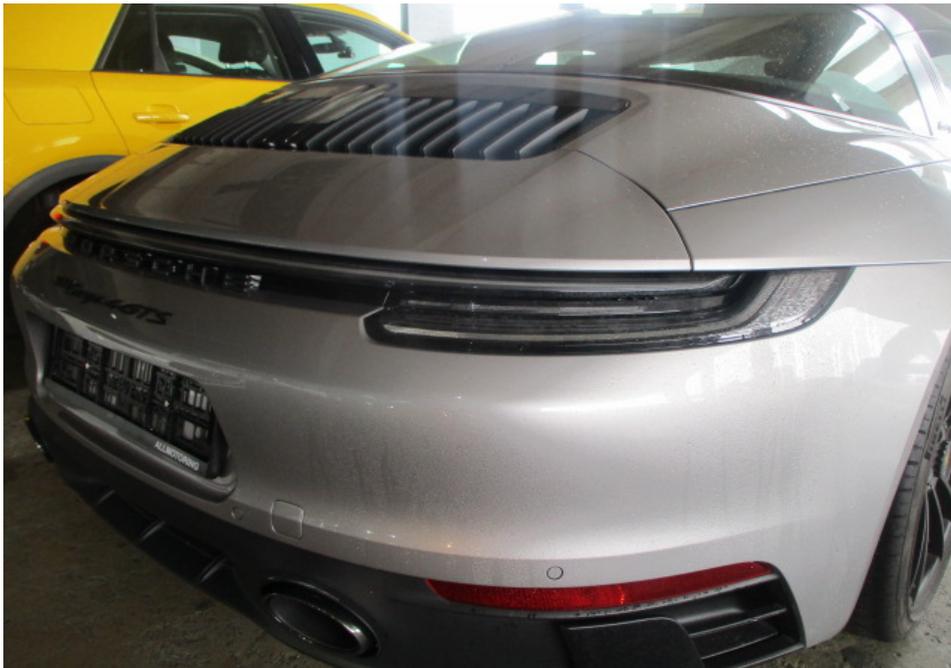
Photo 14 shows a closer view of the Motor Car's rear bumper, rear bumper lower cover, rear bumper right reflector and rear right taillamp. The body parts at the rear portion of the Motor Car were visually examined and it was observed that the repair/restoration works carried out to the damaged area of the Motor Car (refer to photograph 3 - 5 above) were reasonably adequate and in order.

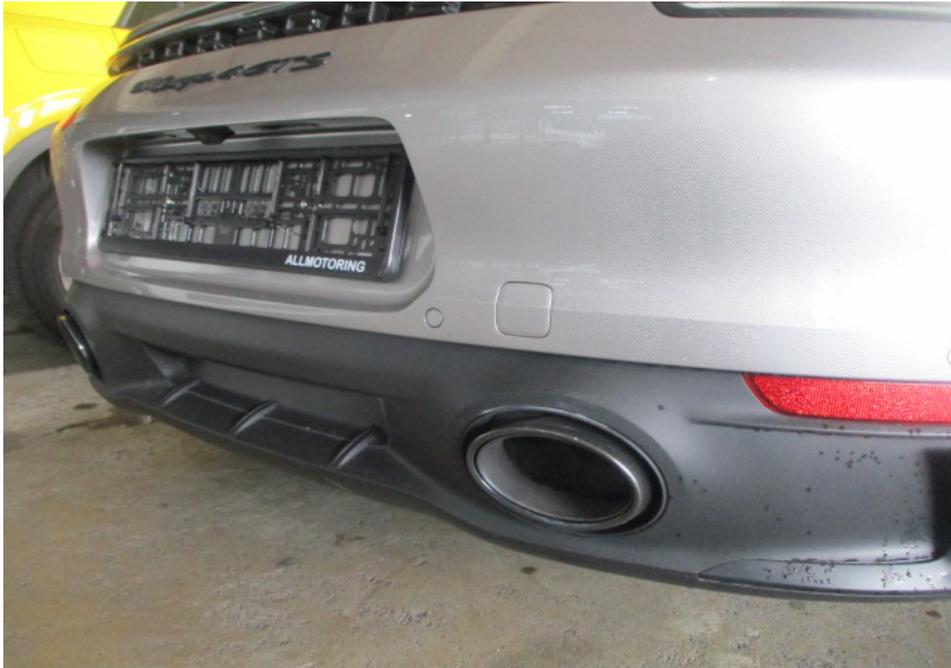
Photo 15 shows a closer view of the Motor Car's rear bumper, rear bumper lower cover, rear bumper right reflector and rear right exhaust garnish. The body parts at the rear portion of the Motor Car were visually examined and it was observed that the repair/restoration works carried out to the damaged area of the Motor Car (refer to photograph 3 - 5 above) were reasonably adequate and in order.

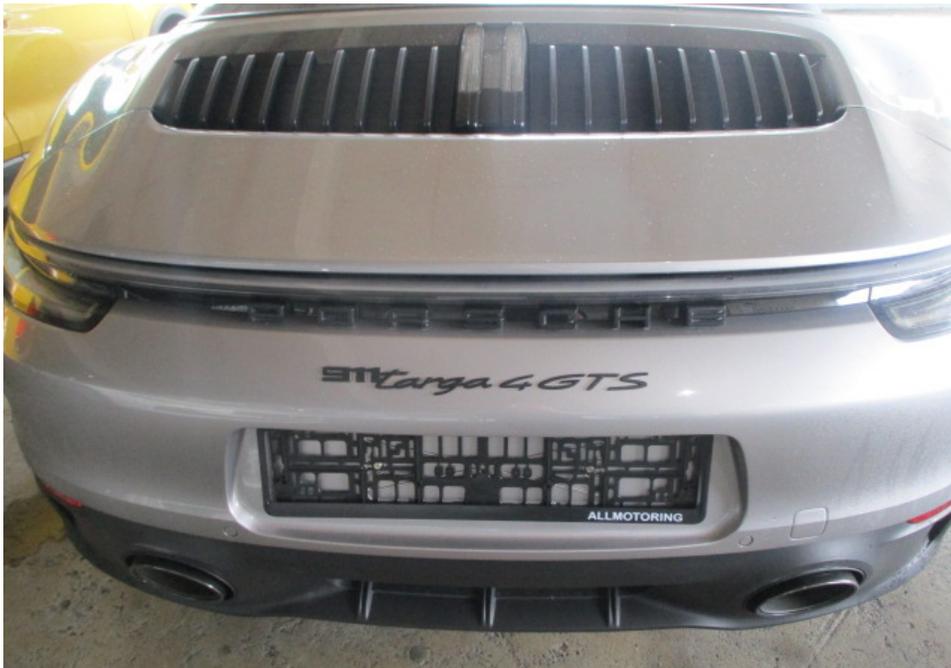
Photo 16 shows a closer view of the Motor Car's rear bumper, rear bumper lower cover, rear bumper sensors and rear top centre reflector. The body parts at the rear portion of the Motor Car were visually examined and it was observed that the repair/restoration works carried out to the damaged area of the Motor Car (refer to photograph 4 above) were reasonably adequate and in order.

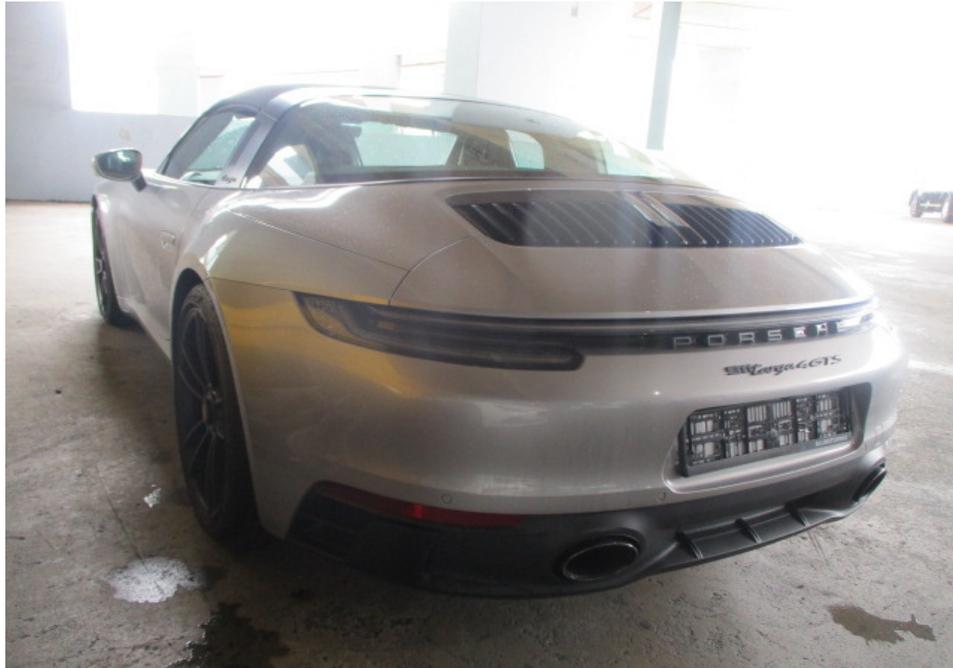
Photo 17 shows a general view of the rear left body of the Motor Car at the time of my inspection. The Motor Car was observed to be in a relatively good general condition with no loose exterior fittings observed. The body parts at the rear portion of the Motor Car were visually examined and it was observed that the repair/restoration works carried out to the damaged area of the Motor Car (refer to photograph 3 - 5 above) were reasonably adequate and in order.

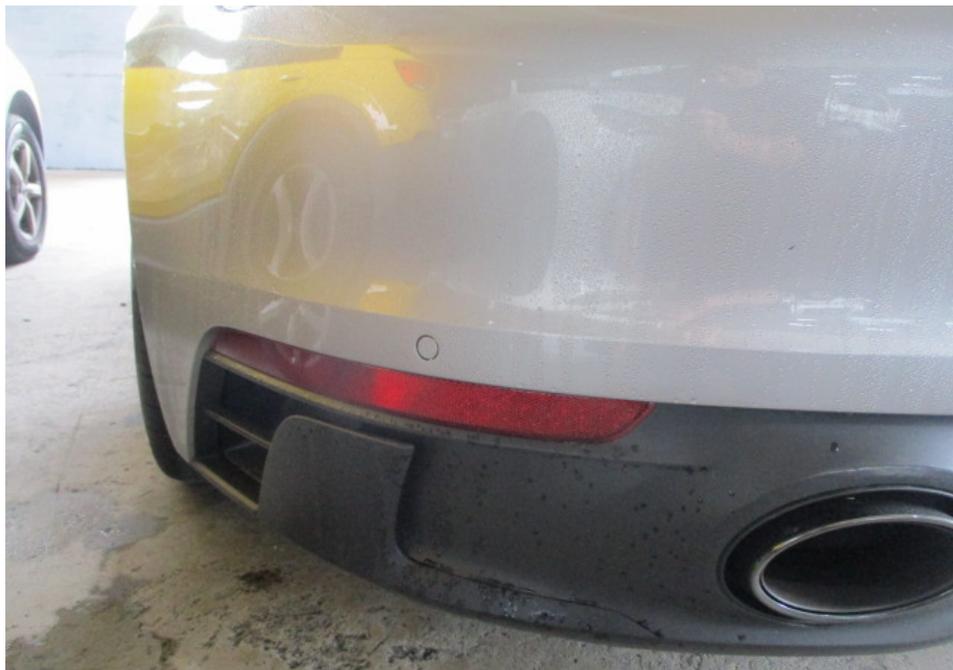
Photo 18 shows a closer view of the Motor Car's rear bumper, rear bumper left reflector, rear bumper sensor and rear right exhaust garnish. The body parts at the rear portion of the Motor Car were visually examined and it was observed that the repair/restoration works carried out to the damaged area of the Motor Car (refer to photograph 4 & 5 above) were reasonably adequate and in order.

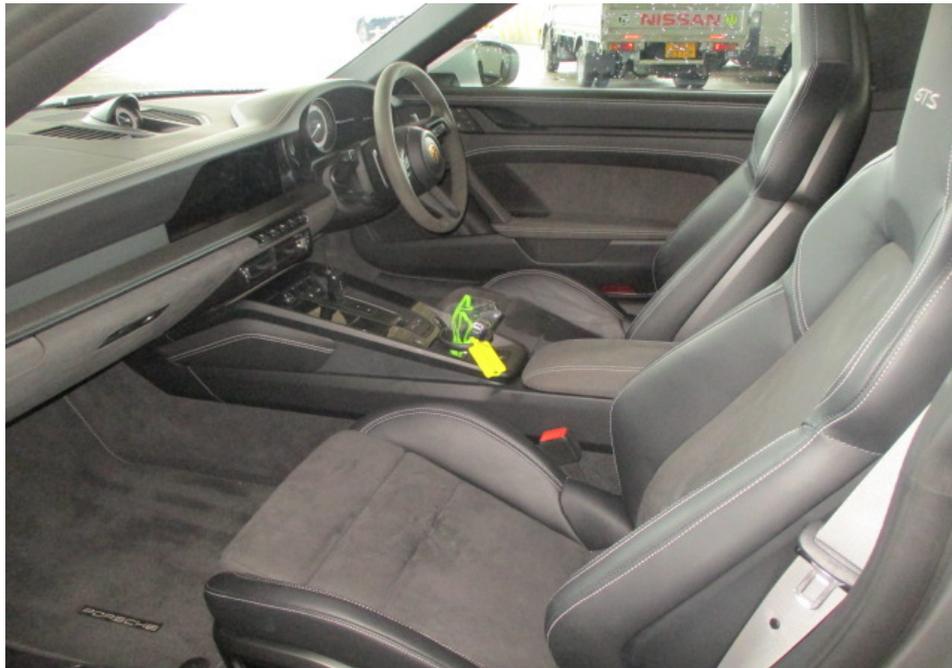
Photo 20 shows the interior compartment of the Motor Car. The front dashboard, steering wheel, seats, upholstery and trims etc were all observed to be intact and properly fitted.

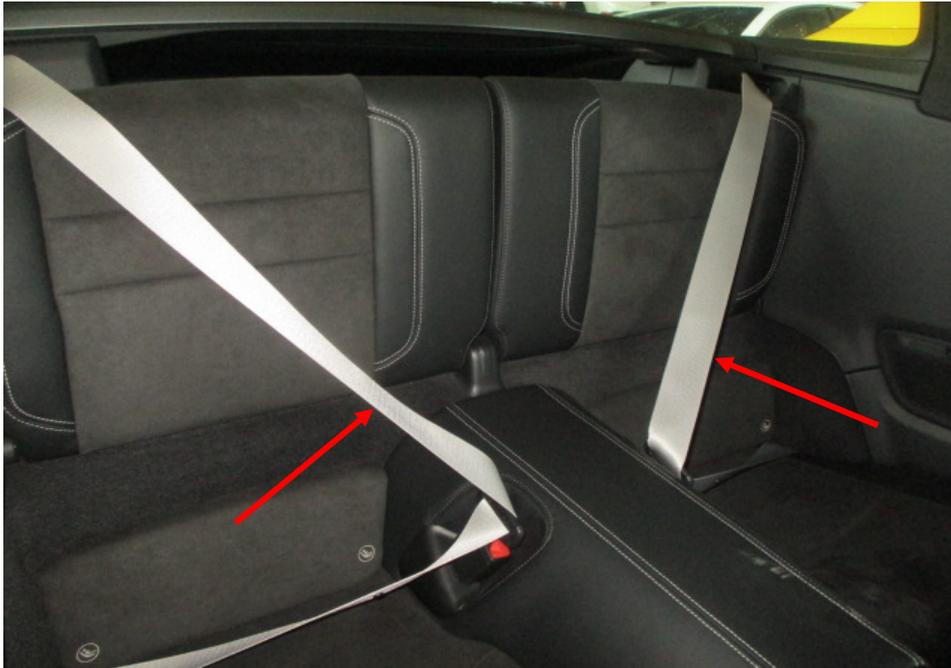
Photo 21 shows the rear seats of the Motor Car. All the seats of the Motor Car were secured via seat rails to the floorboard. They were also fitted with a retractable seat belt reel and a pre-tensioner. The seat belts (arrowed) were tested and were able to be fastened into the respective pre-tensions that were fitted on the side of each individual seat.

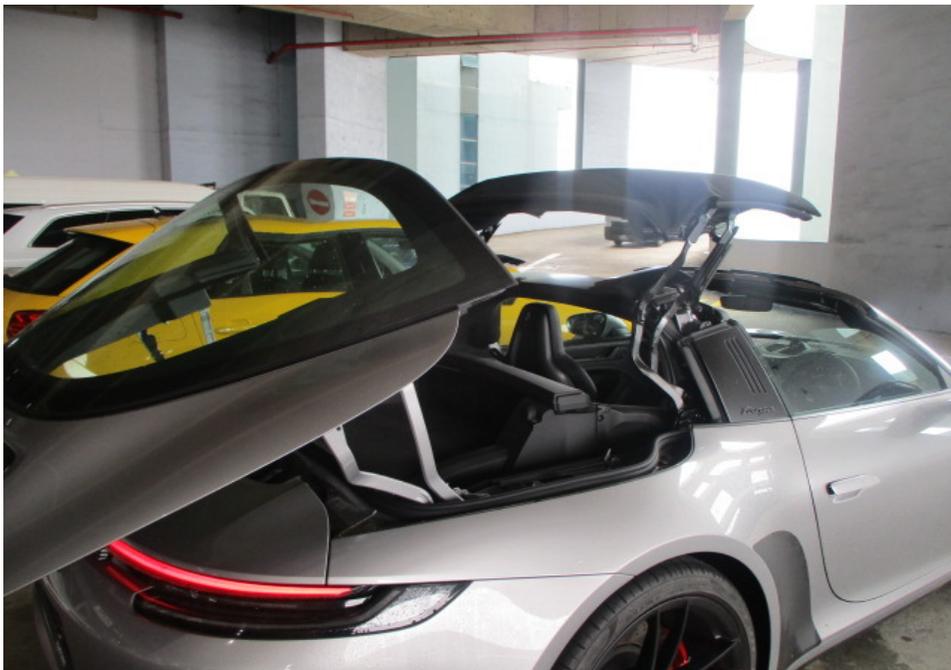
Photo 22 shows the Motor Car's soft top roof being tested. It was observed that as a safety feature, the soft top roof could only open and close when the Motor Car was in a stationary position or at low travelling speed. When opened, the soft top roof is completely folded into the rear compartment with no parts protruding out of the Motor Car's body. The soft top roof was also found adequately secured to the "A" pillar after closing.

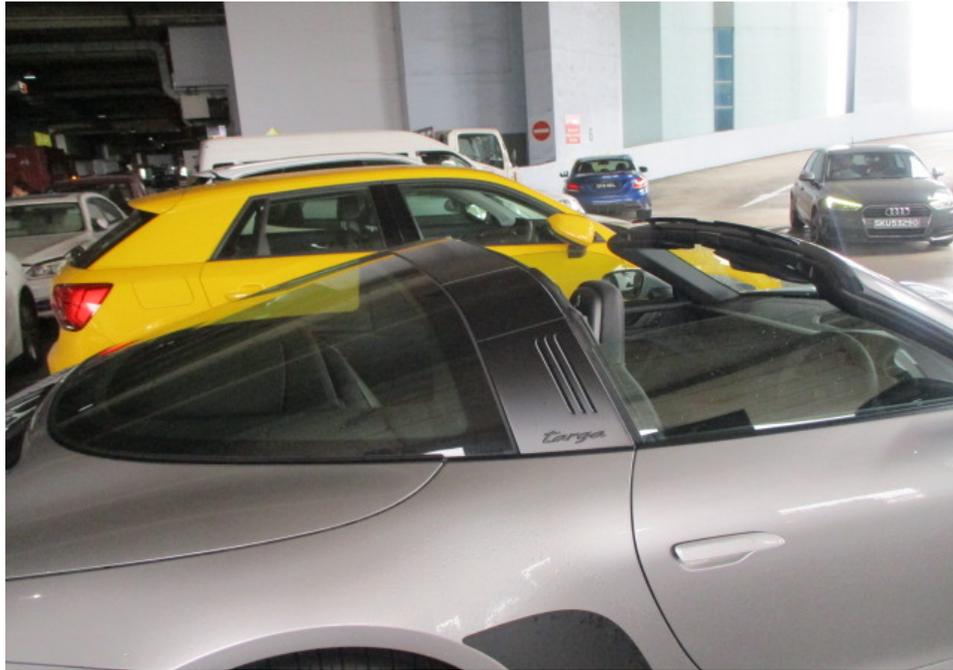
Photo 23 shows the Motor Car with its soft top roof completely folded. It was observed that as a safety feature, the soft top roof could only open and close when the Motor Car was in a stationary position or at low travelling speed. When opened, the soft top roof is completely folded into the rear compartment with no parts protruding out of the Motor Car's body. The soft top roof was also found adequately secured to the "A" pillar after closing.

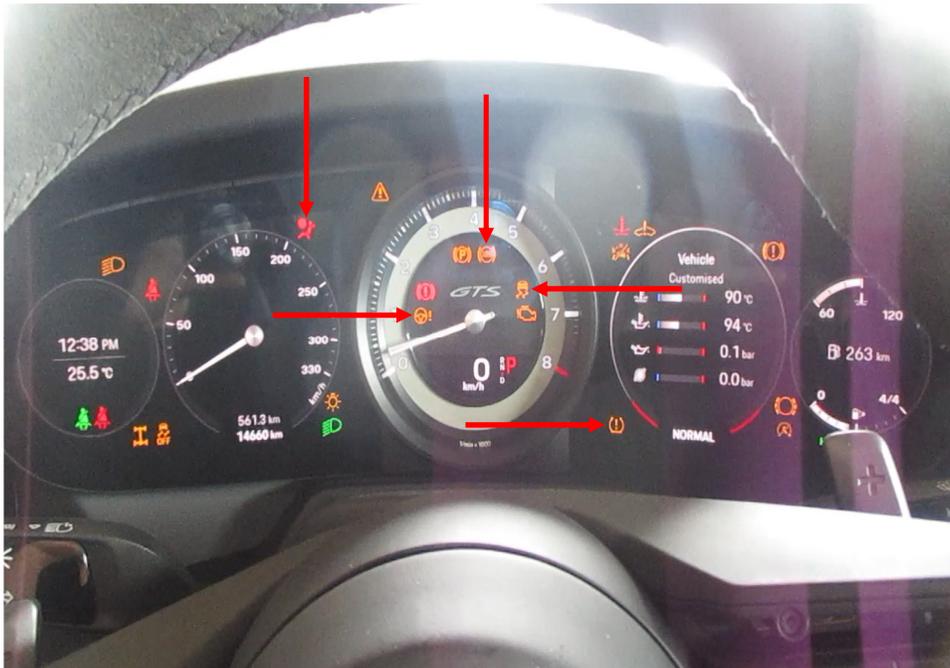
Photo 24 shows the warning lights for the various electronic safety features appearing on the instrument panel of the Motor Car during its self-test when the engine is cranked, in particular the ABS, SRS, EPS, TPM and TCS lights (arrowed).

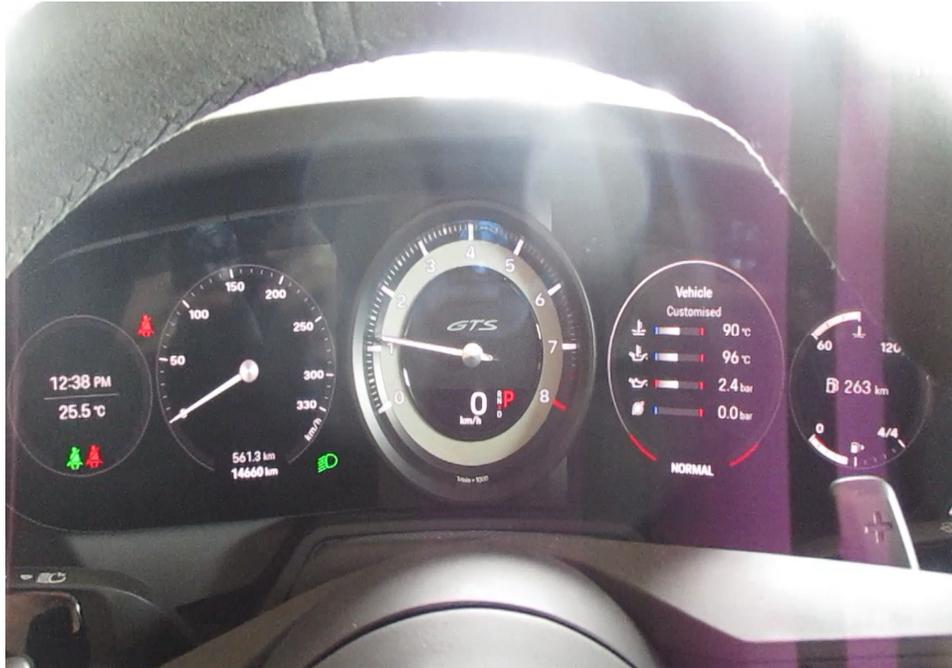
Photo 25 shows the respective warning lights no longer illuminated, indicating that there is no fault detected to the ABS, SRS, EPS, TPM and TCS systems of the Motor Car during the self-test. These electronic systems were hence in working condition at the time of my inspection.

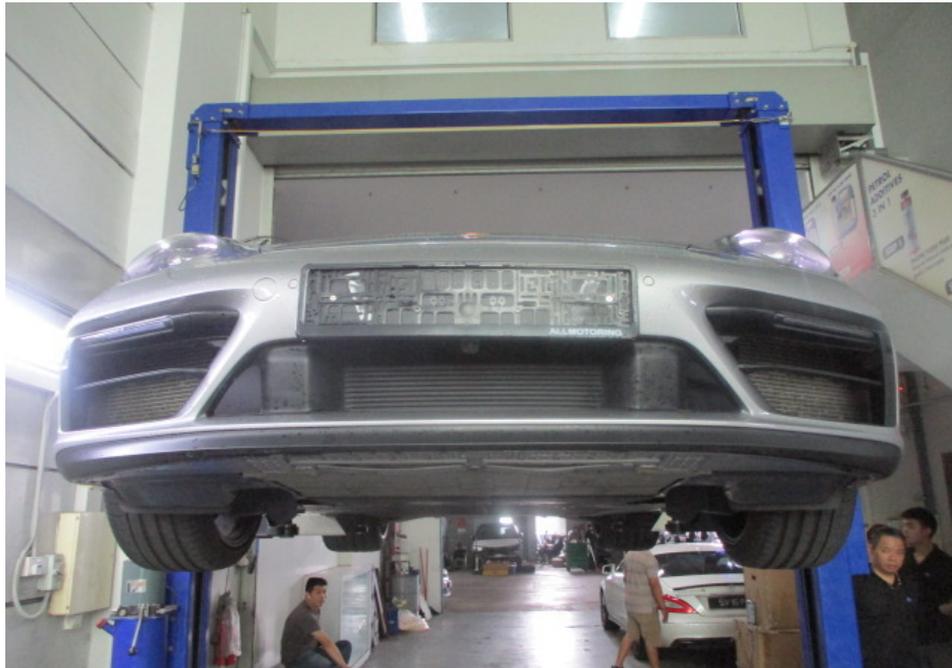
Photo 26 shows the Motor Car hoisted up for checks on its undercarriage. There was no sign(s) or indication(s) of fluid leakage and/or fluid stain(s) on the underside of the Motor Car. The undercarriage components of the Motor Car were also all observed to be intact and secured in an appropriate manner.

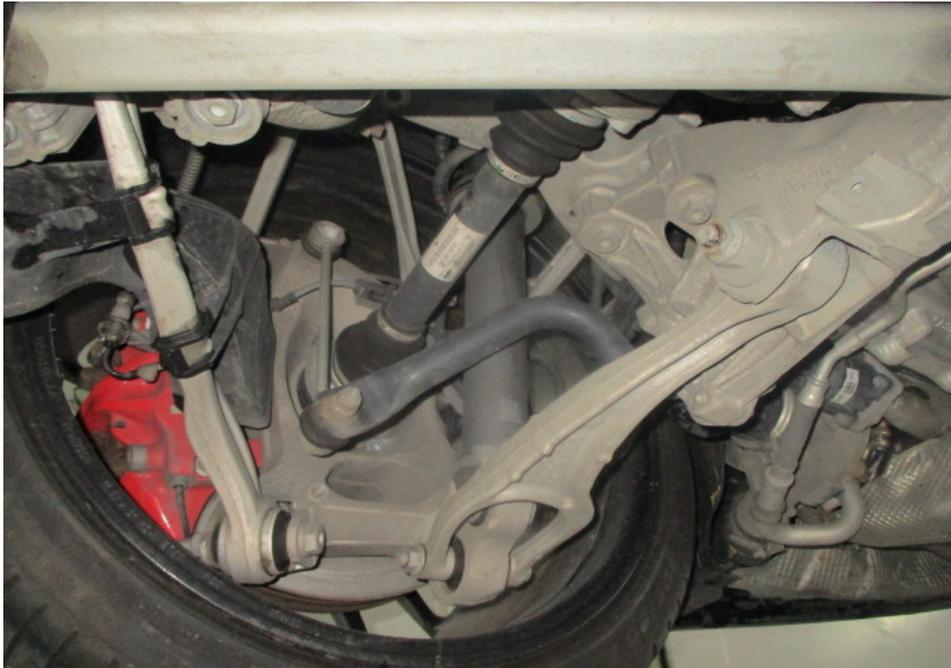
Photo 27 shows a general view of the control arms and linkages at the rear right wheel of the Motor Car. I did not observe any fluid leak and/or fluid stain on the underside of the Motor Car. All of the Motor Car's undercarriage components were observed to be intact and secured in an appropriate manner.

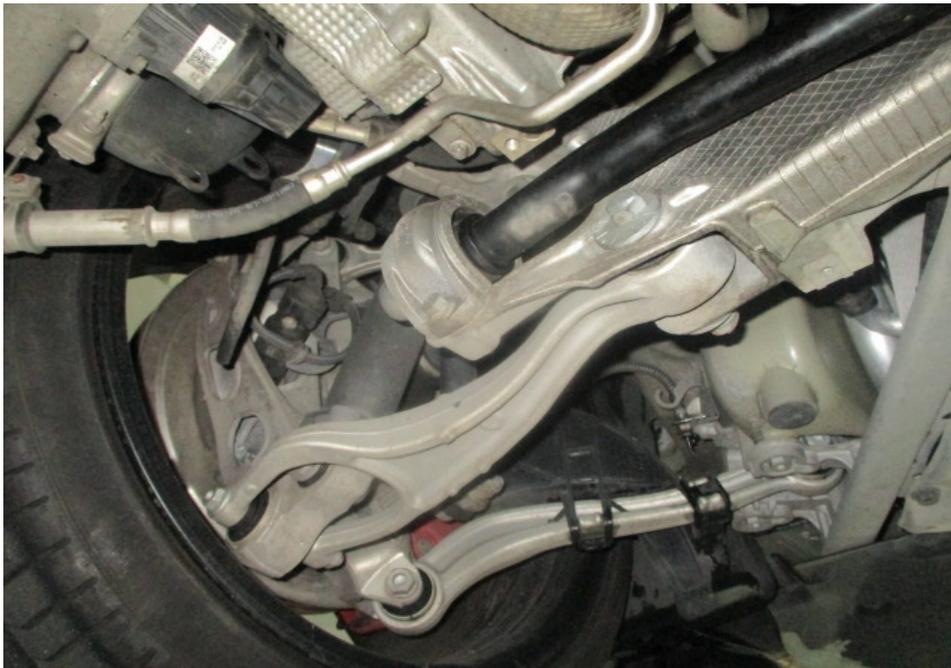
Photo 28 shows a general view of the control arms and linkages at the rear left wheel of the Motor Car. I did not observe any fluid leak and/or fluid stain on the underside of the Motor Car. All of the Motor Car's undercarriage components were observed to be intact and secured in an appropriate manner.

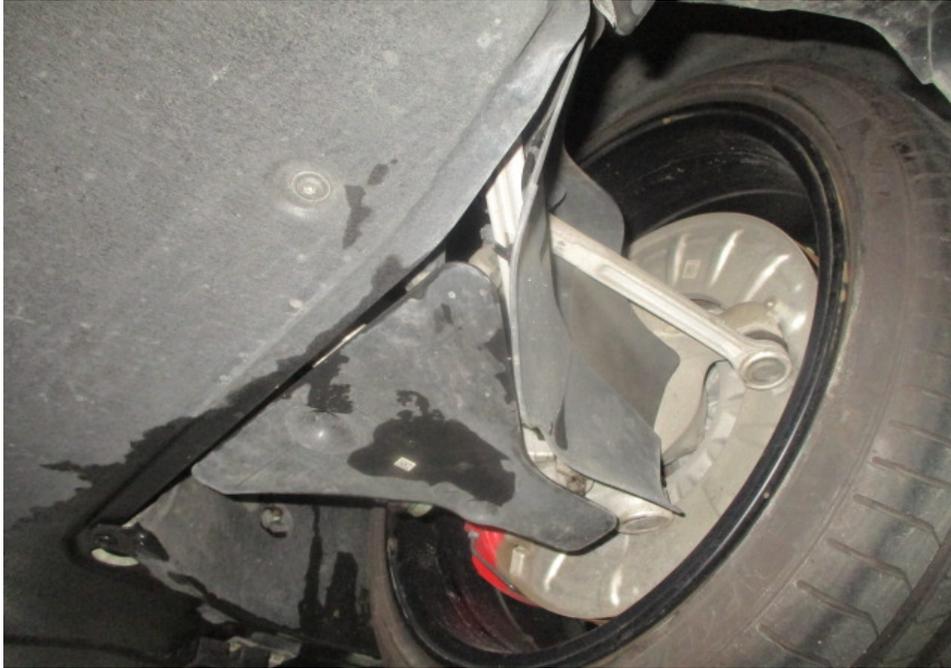
Photo 29 shows a general view of the control arms and linkages at the front left wheel of the Motor Car. I did not observe any fluid leak and/or fluid stain on the underside of the Motor Car. All of the Motor Car's undercarriage components were observed to be intact and secured in an appropriate manner.

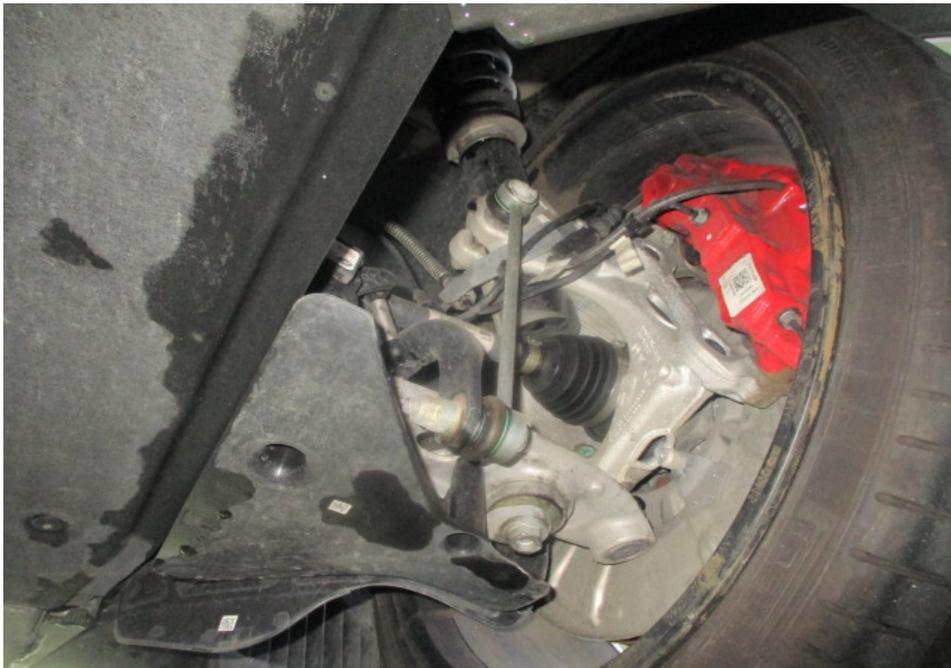
Photo 30 shows the various undercarriage components at the front right wheel of the Motor Car. The mechanical components, control arms and linkages were all found to be intact and secured in an appropriate manner. I also did not observe any fluid leak and/or fluid stain on the underside of the Motor Car.
