Your Ref: Porsche 911 Targa
(chassis number WP0ZZZ99ZNS227448)
Our Ref : CI/TP22012716/D

20 December 2022

INSPECTION REPORT OF AN UNREGISTERED PORSCHE 911 TARGA MOTOR CAR WITH CHASSIS NUMBER WP0ZZZ99ZNS227448

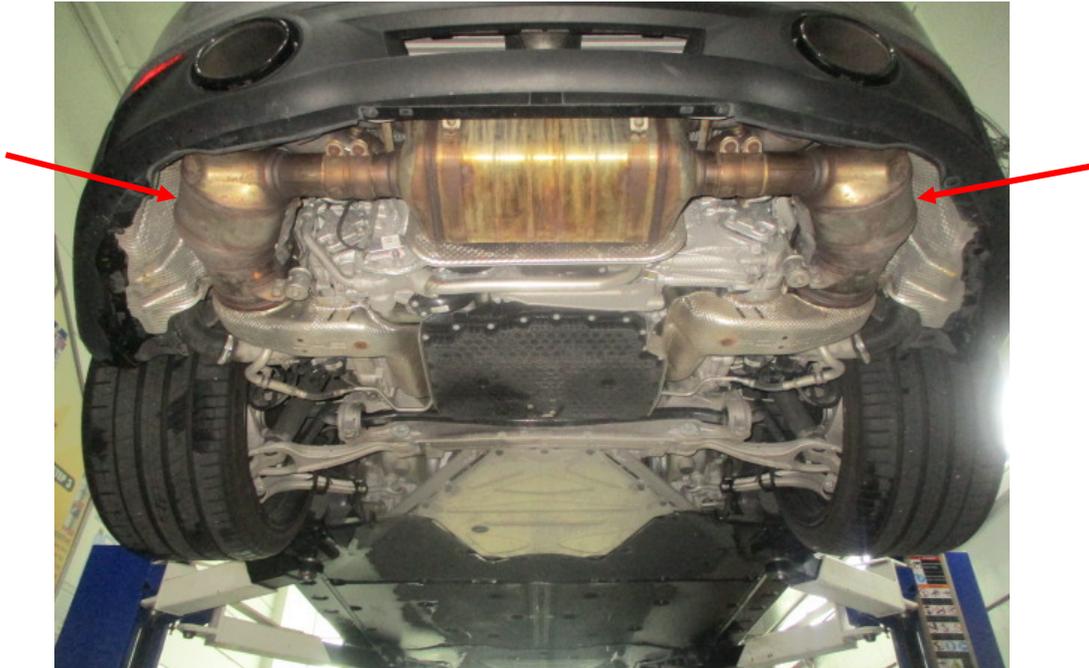
Photo 31 shows the Motor Car's exhaust system. My examination of the Motor Car's exhaust system revealed no sign(s) or indication(s) of any cut or weld marks along its exhaust pipes, on its catalytic converters (arrowed) and on its rear muffler.

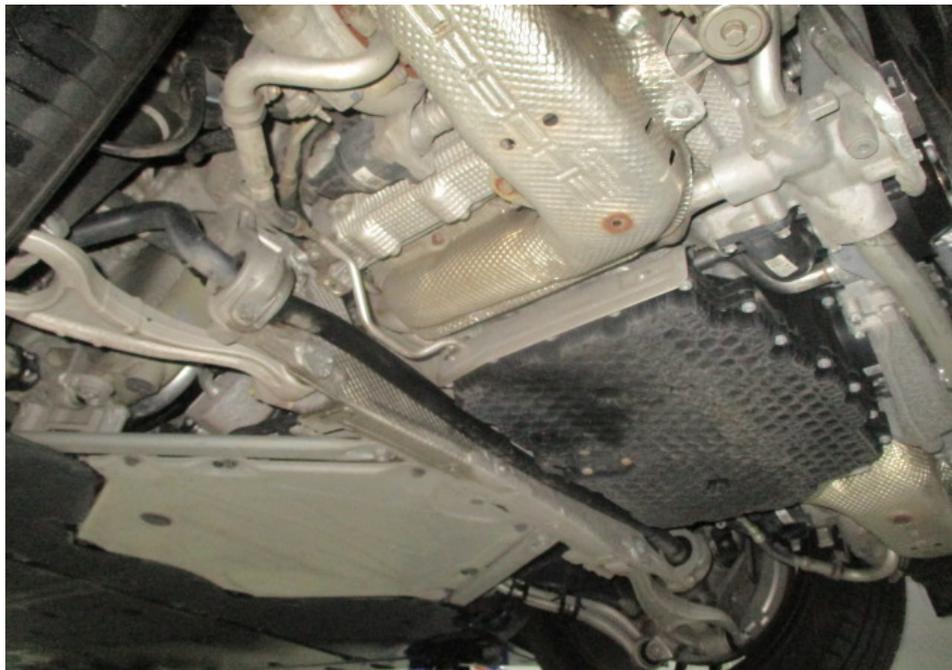
Photo 32 shows a general view of the Motor Car's engine compartment. The engine compartment was at the rear underside of the Motor Car. The various parts and components inside the engine compartment were all observed to be intact and properly fitted. There was also no sign(s) or indication(s) of fluid leak and/or fluid stain found inside the engine compartment.

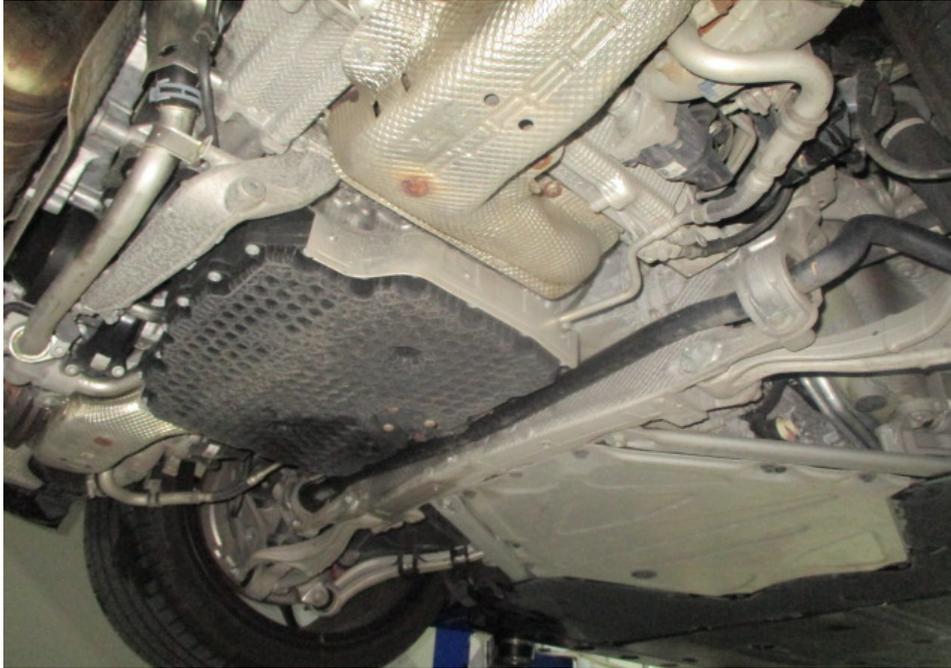
Photo 33 shows another view of the Motor Car's engine compartment. The engine compartment was at the rear underside of the Motor Car. The various parts and components inside the engine compartment were all observed to be intact and properly fitted. There was also no sign(s) or indication(s) of fluid leak and/or fluid stain found inside the engine compartment.

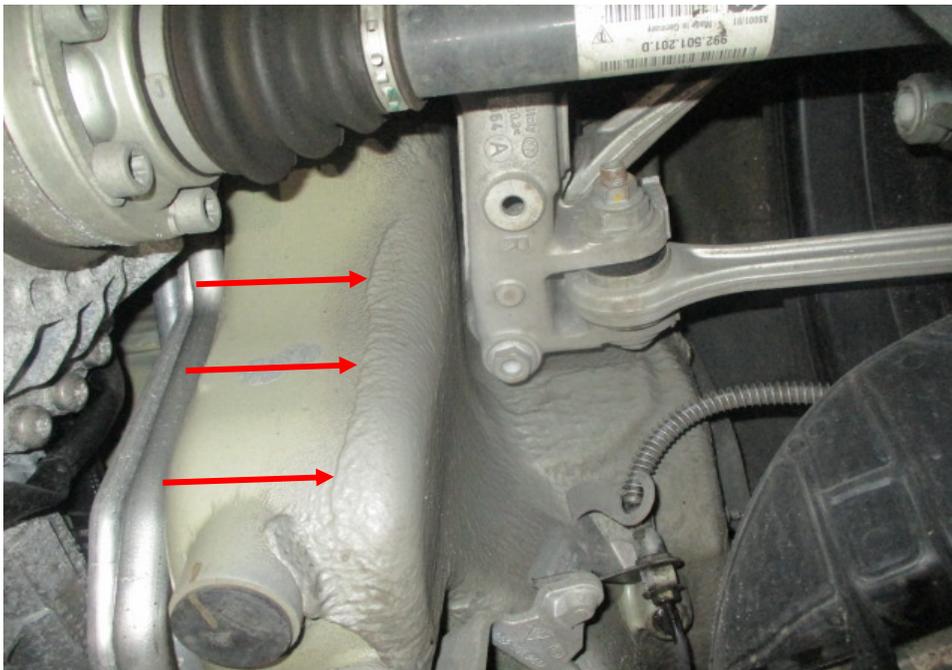
Photo 34 shows the chassis/structural body at the underside rear right of the Motor Car. I did not find any weld marks other than original spot weld marks on the chassis/structural body of the Motor Car. The original factory sealant (arrowed) at the joints along the chassis/structural body was untouched, indicating no work was done on the chassis/structural body of the Motor Car and that the chassis/structural body was originally fitted.

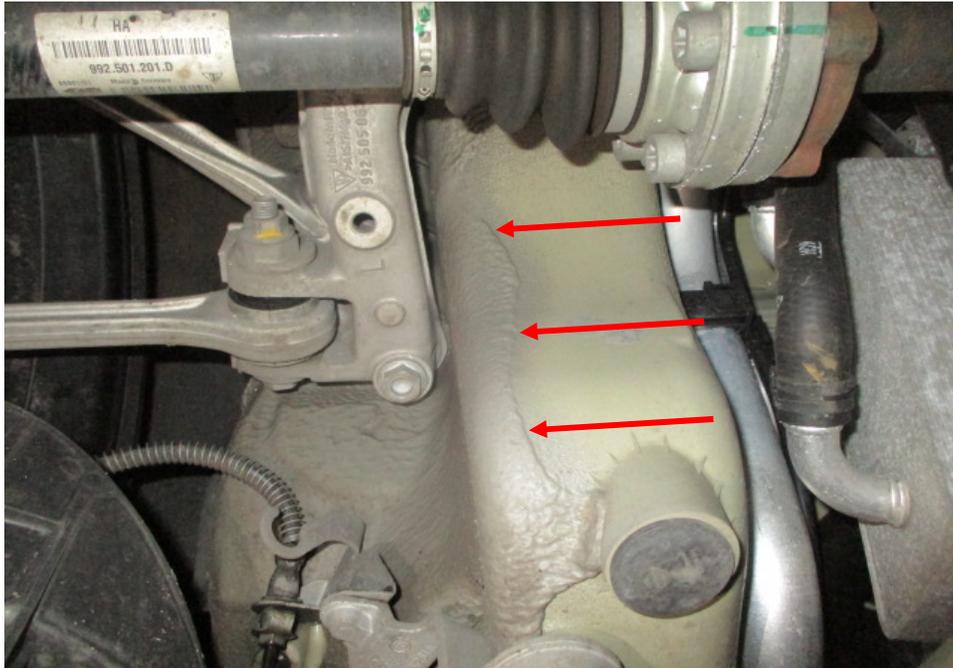
Photo 35 shows the chassis/structural body at the underside rear left of the Motor Car. I did not find any weld marks other than original spot weld marks on the chassis/structural body of the Motor Car. The original factory sealant (arrowed) at the joints along the chassis/structural body was untouched, indicating no work was done on the chassis/structural body of the Motor Car and that the chassis/structural body was originally fitted.

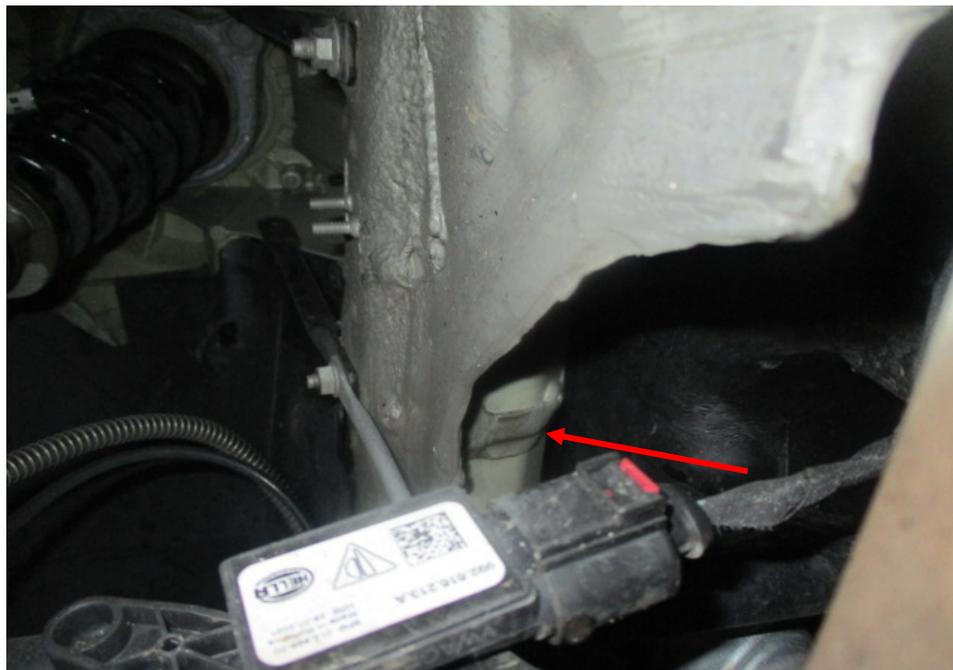
Photo 36 shows the chassis/structural body at the underside front left of the Motor Car. The original factory sealant (arrowed) at the joints along the chassis/structural body was observed to be untouched. In general, I had found no work was carried out on the chassis/structural body of the Motor Car. The chassis/structural body of the Motor Car was originally fitted.

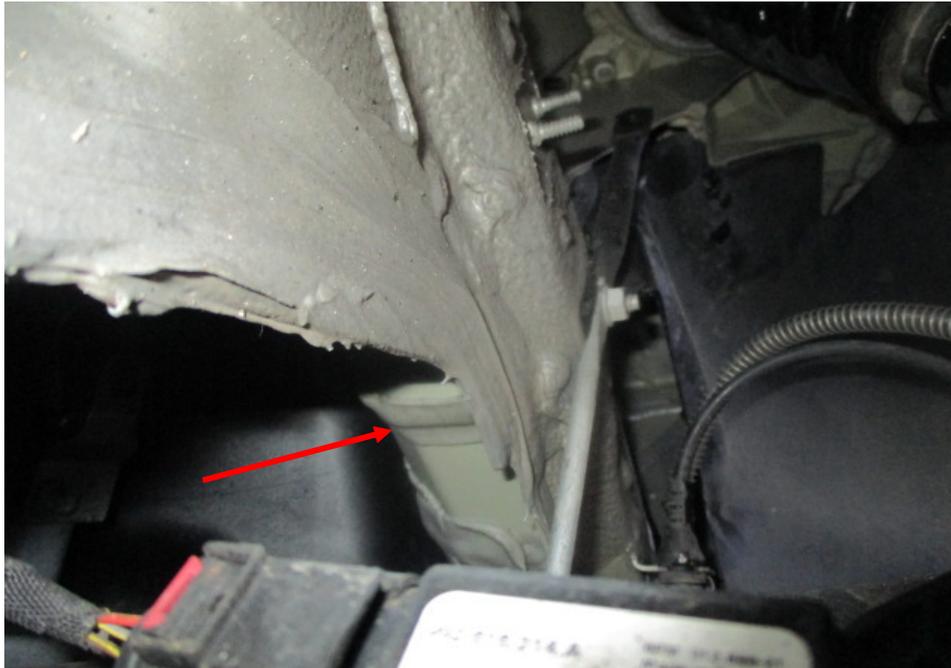
Photo 37 shows the chassis/structural body at the underside front right of the Motor Car. I did not find any weld marks other than original spot weld marks on the chassis/structural body of the Motor Car. The original factory sealant (arrowed) at the joints along the chassis/structural body was also untouched, indicating no work was done on the chassis/structural body of the Motor Car and that the chassis/structural body was originally fitted.
