Your Ref: MTS2022D0011571
Our Ref : CI/III22012763/P

**TECHNICAL INVESTIGATION REPORT OF WARRARTY CLAIM INVOLVING
THE INSURED VEHICLE SLP 6650H ON 21st December 2022**

Vehicle Registration No.	: SLP 6650H
Make / Model	: MERCEDES BENZ E220D (A)
Chassis No	: WDD2130042A216891
Year of Registration	: JUNE 2017
Mileage	: 180,491KM

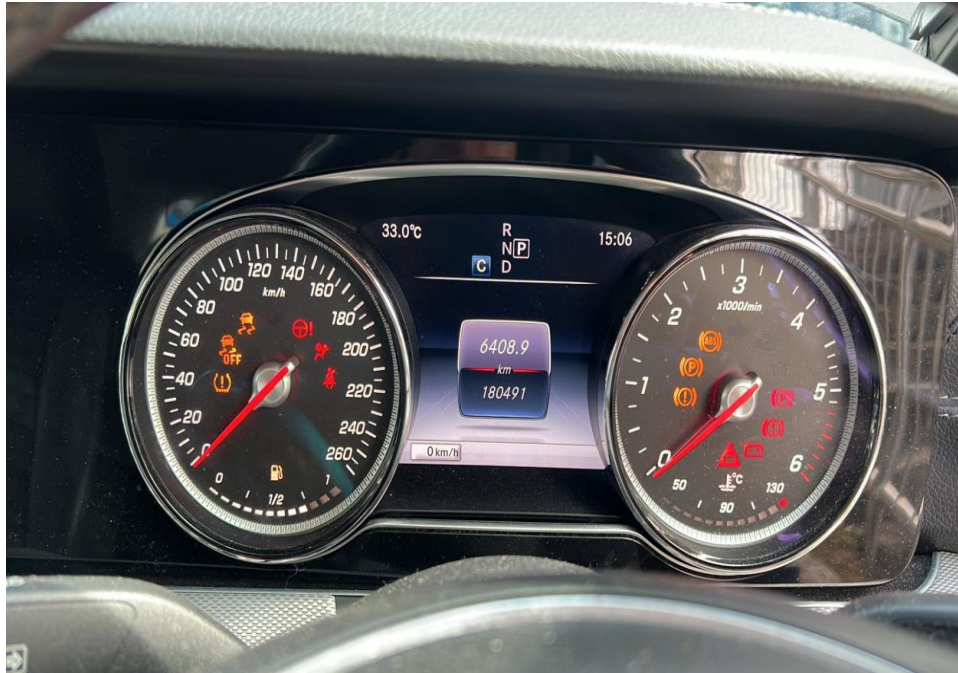
Photo 1 shows the mileage of the Insured Vehicle recorded at the time inspection at 180,491KM.

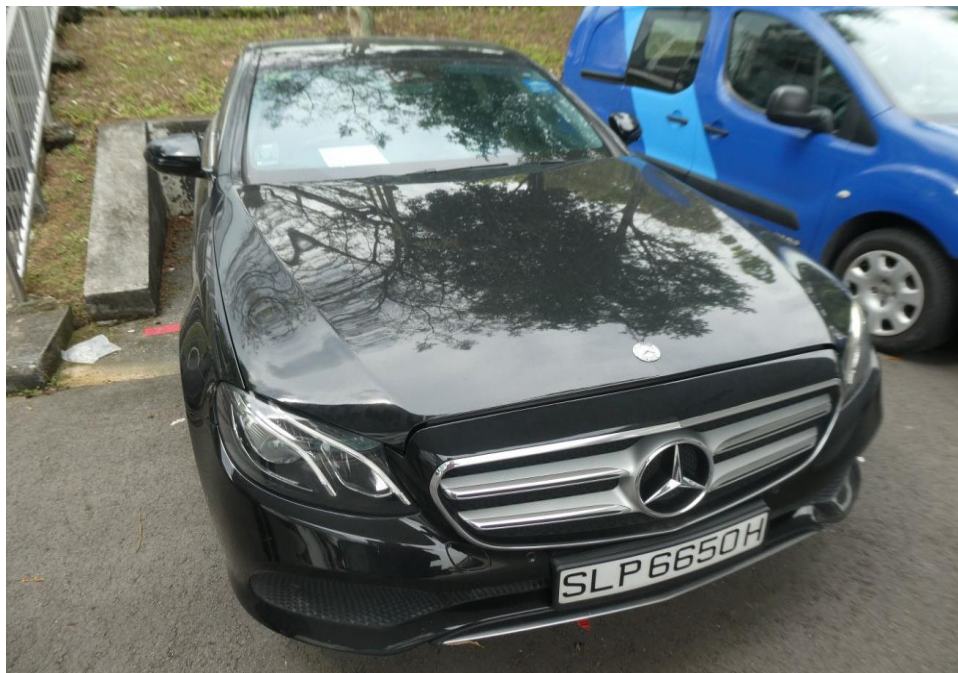
Photo 2 shows the general view of the front portion of the Insured Vehicle at the time of our inspection. The Insured Vehicle is observed to be unaffected by any signs of accident.

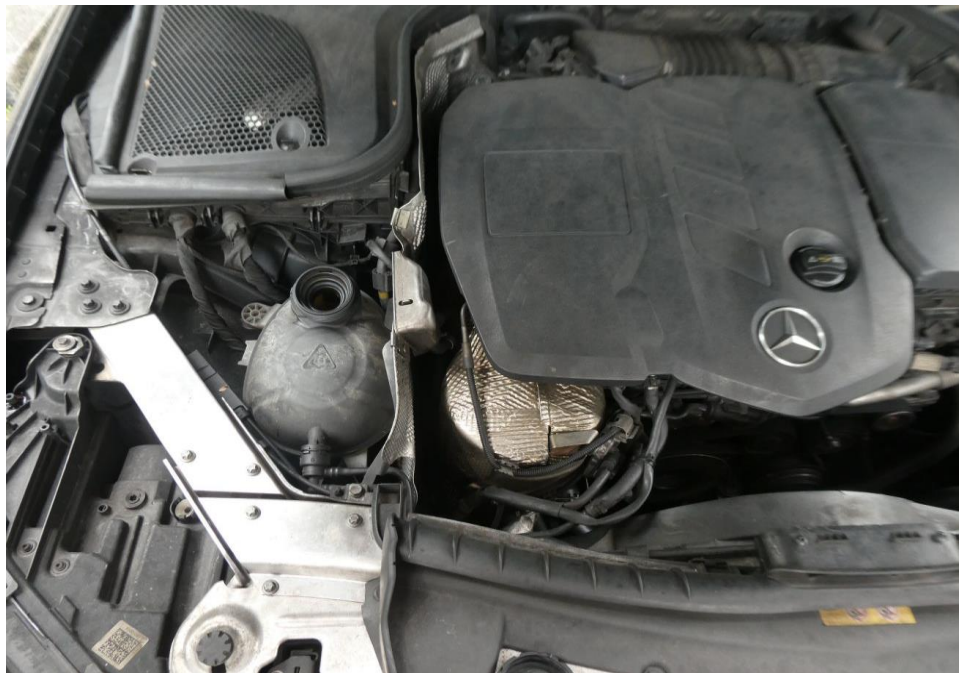
Photo 3 shows the general view of the engine portion of the Insured Vehicle at the time of our inspection. The engine compartment is observed to be unaffected by any signs of accident.

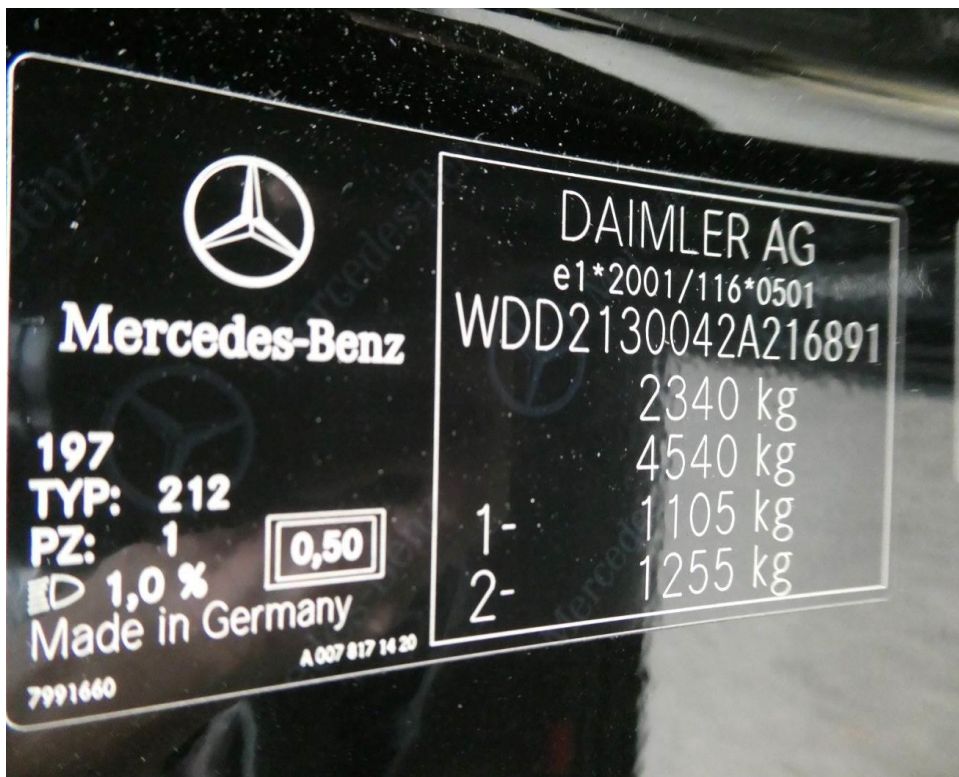
Photo 4 shows the chassis number of the Insured Vehicle at the time of our inspection.

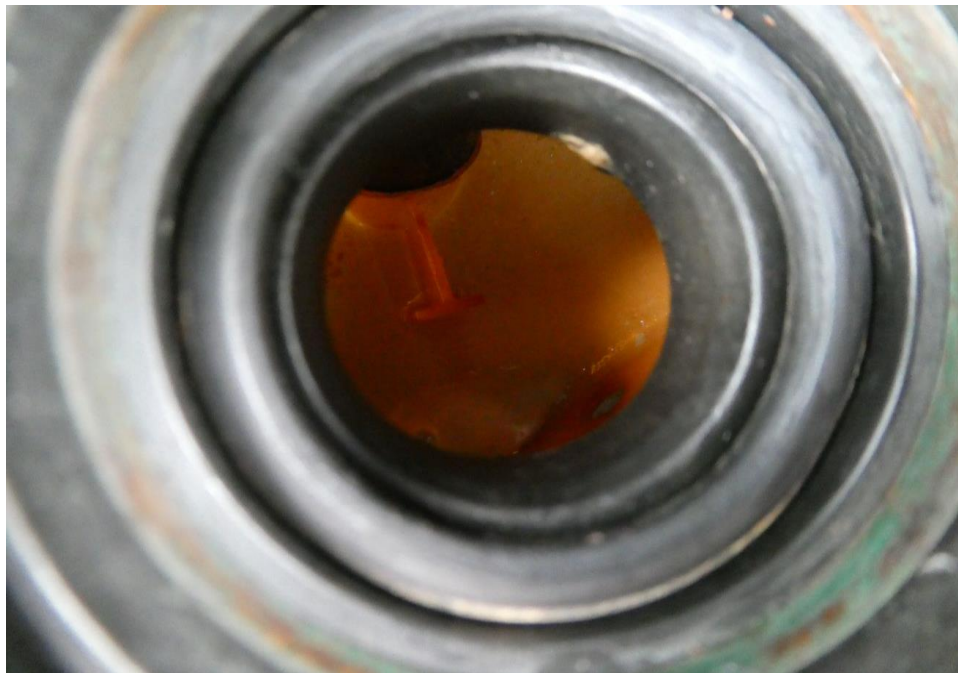
Photo 5 shows the close up view of inside the coolant reservoir of the Insured Vehicle at the time of our inspection. The coolant reservoir is observed to be unaffected and by any signs of accident, however the coolant was observed to be insufficient.

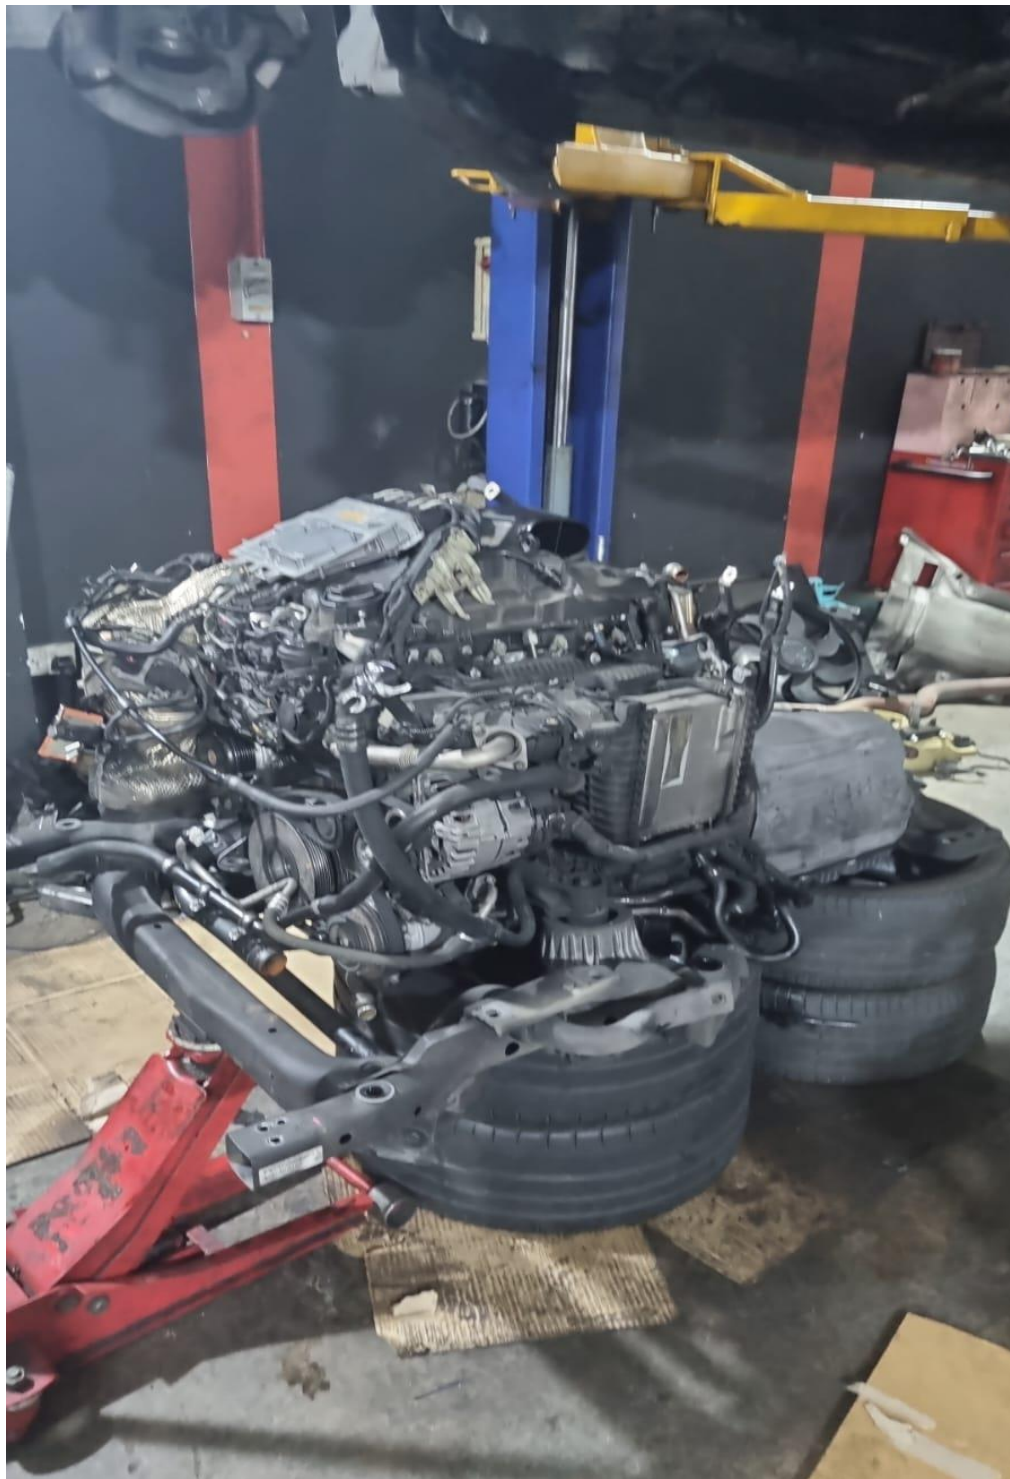
Photo 6 shows the general view of the engine unit of the Insured Vehicle at the start of the dismantling. The exterior of the engine unit is observed to be unaffected and by any signs of accident.

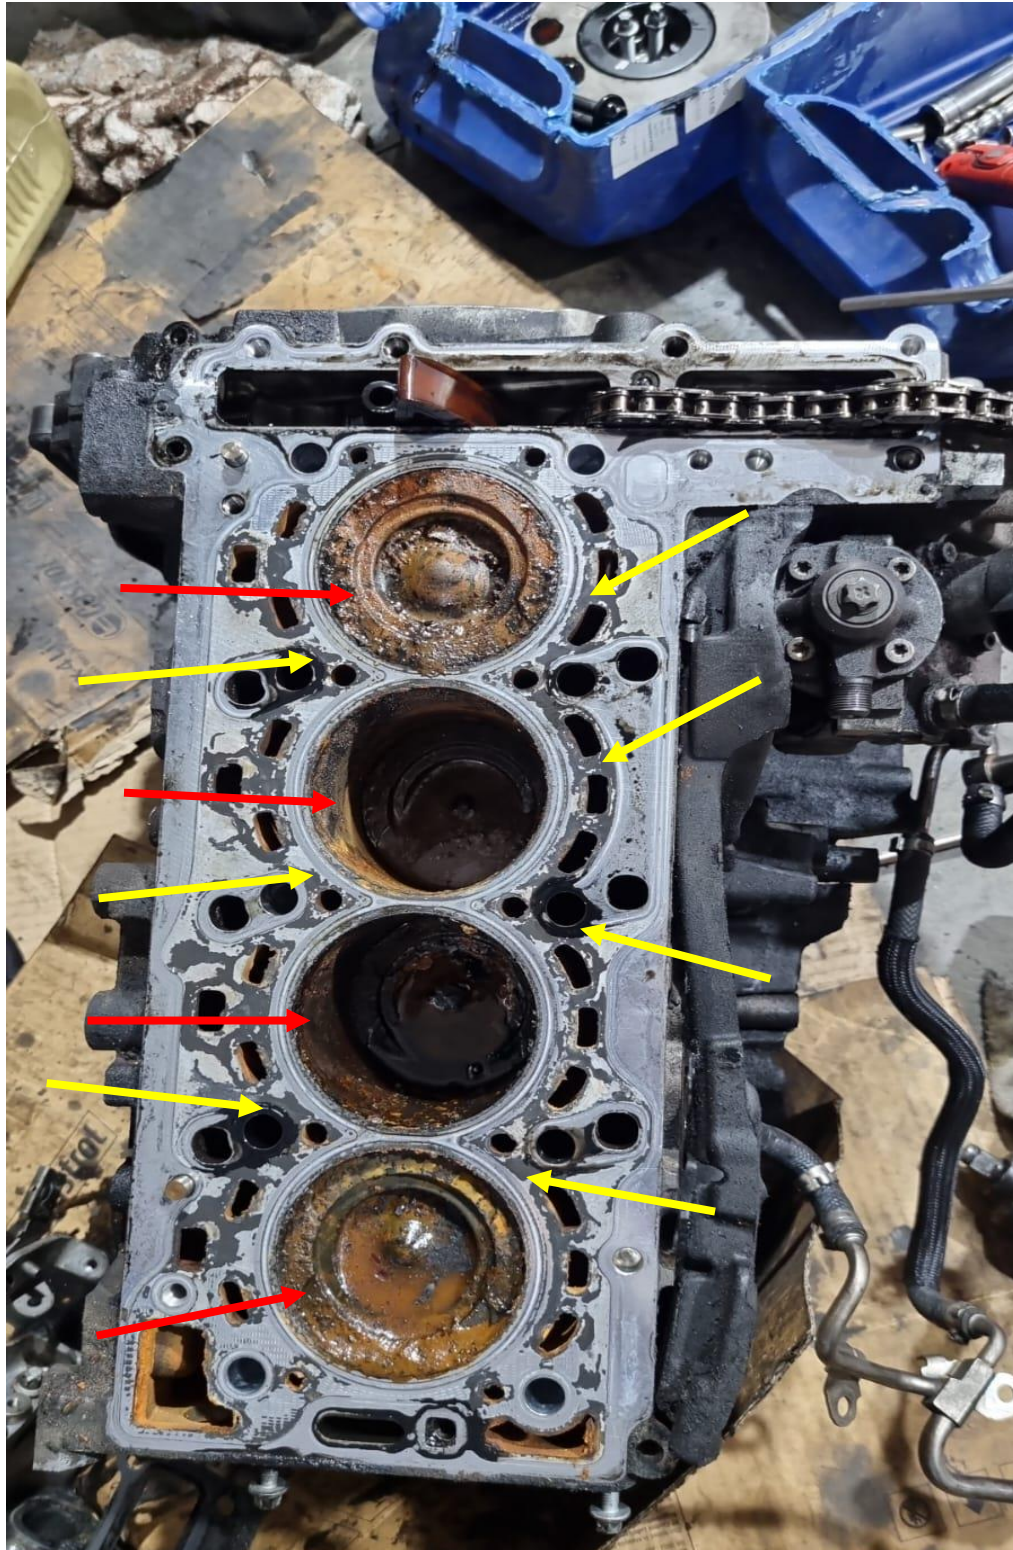
6. Upon dismantling the engine, they have found damages to the engine head gasket, engine piston and connecting rod of the Insured Vehicle. We have observed rust that piston and inside the engine cylinder was observed to be covered in rust and rust was caused by the engine coolant. The head engine gasket was melted and stuck onto the surface of the engine block. We agreed that the complained problem of the engine being unable to be started up was caused by the overheating of the engine head gasket which had cause the engine head gasket to melt and give way to the engine coolant to flow into the engine piston and cylinder resulting in the engine piston and connecting rods to be damaged and build-up of rust on the surfaces. See photos 6 – 8 below.

Photo 7 shows the close up view of the inside of the engine unit after the dismantling, we observed that piston and inside the cylinder (red arrow) was observed to be covered in rust as a result of engine coolant entering the engine piston and cylinder. The head engine gasket (yellow arrow) was melted and stuck onto the surface of the engine block.

7. From our understanding, the engine coolant runs in coolant galleries in a close loop system which was sealed by the engine gasket in the engine, however due to the wear and tear of the engine gasket overtime it causes the engine coolant to leak through the gasket and into the engine causing the engine to seize up and the result was rust build up on the piston and the damages to the connecting rods.
8. Our checks with both local and international bodies and associations had also revealed that at the time of writing this report, there is no manufacturer recall of similar make and model vehicle as the Insured Vehicle that may possibly be related to abnormalities being originated from the engine system of the Insured Vehicle. See search result from LTA below.

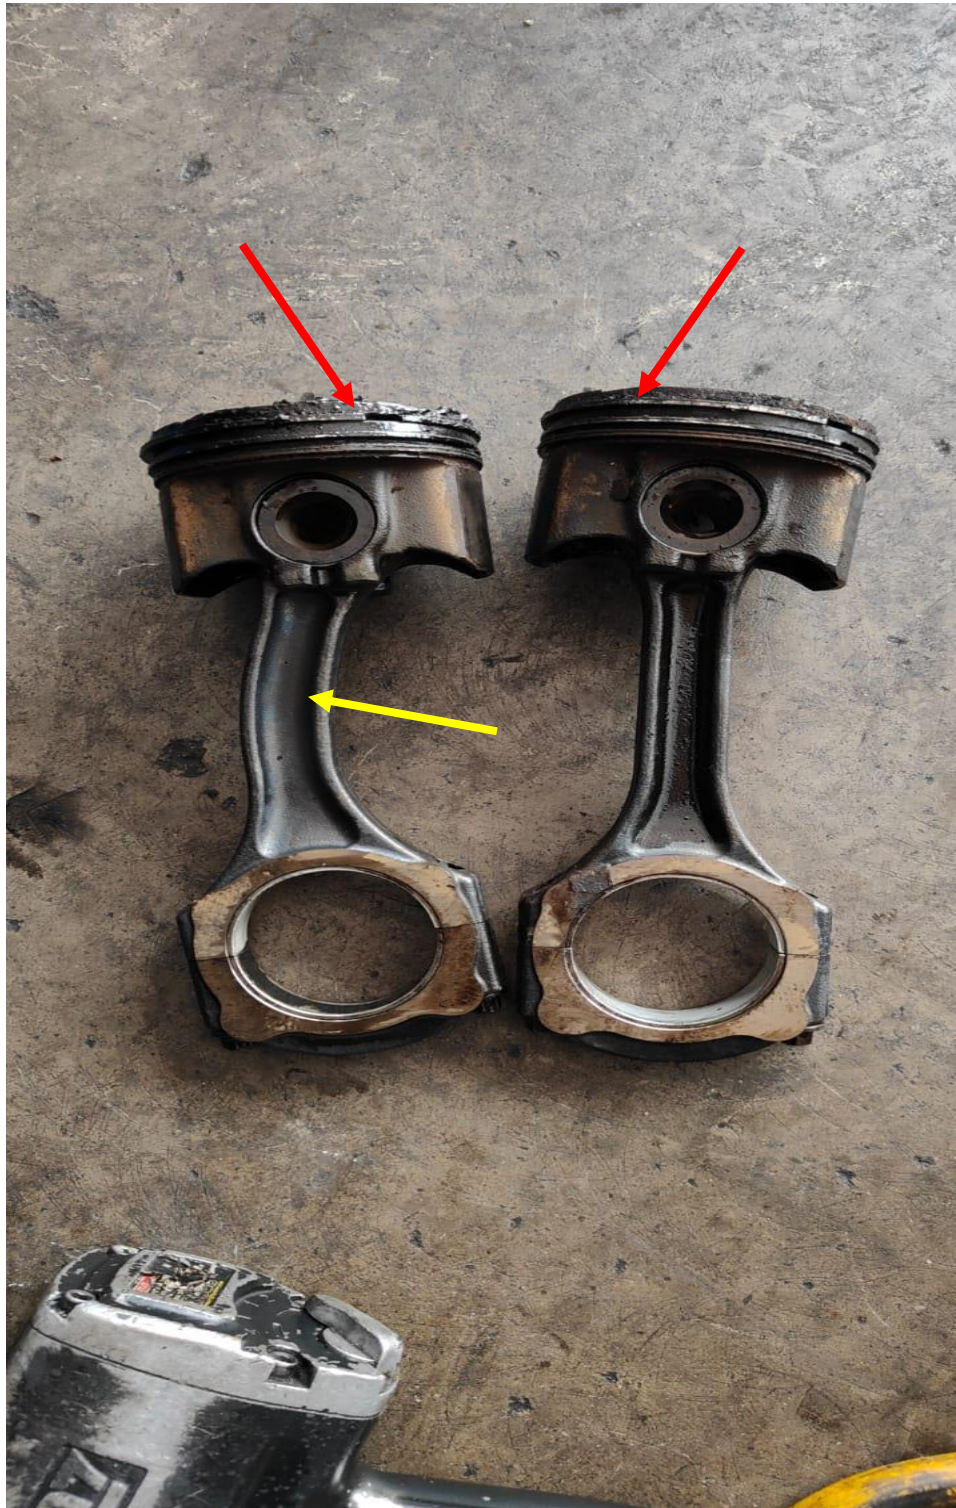
Photo 8 shows the general view of the piston and connecting rod of the Insured Vehicle at the time of our inspection. We observed that the piston (red arrow) and connecting rod (yellow arrow) was damaged as a result of the engine coolant which had resulted in the damage to the engine.
