# Tommie Lim Appraisal

## VEHICLE INSPECTION REPORT

| Ref. no. | : TLA/2022/11/003 | 3rd party Veh. | : SHB5616K |

| Registration no. | : SMA451Y | Odometer | : 036785 KM |

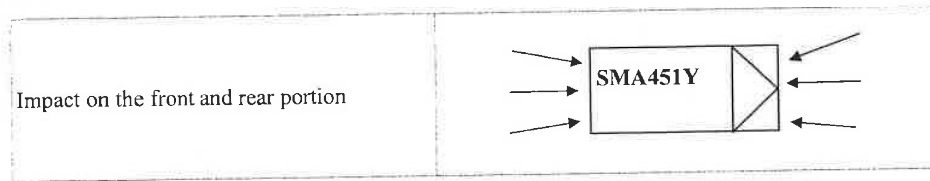
## POINT OF IMPACT

The impact of the collision has damaged/affected the bonnet assy, front bumper assy, both headlamps, front support panel, front grille assy, air con condenser assy, tail gate assy, both taillamps, rear bumper assy, rear end panel assy, rear spare tyre compartment and etc...  
Please refer to Annex A (Appraisement Schedule) for a detailed account of the damages and photographs taken.

Our adjusted cost of repair is SGD 14,300.00 to carry out the repairs. Please refer to Annex A (Appraisement Schedule) for a detailed account of the cost estimates.
