LKK Auto Consultants Pte Ltd

Vehicle No.	SMQ 3356K
Insured Veh.	SMS 8804R
Claim No.	SNM22D209391/C02
Policy No.	DMCVSNW00280592200
Accident Date	20/12/2022
Inspection Date	30/12/2022

ADJUSTMENT ON REPAIR COST FOR VEHICLE NO. SMQ 3356K

PHOTOGRAPHS FOR VEHICLE NO. SMQ 3356K

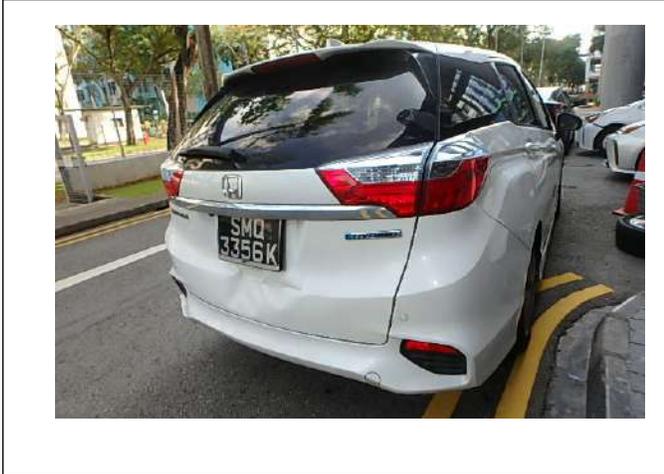
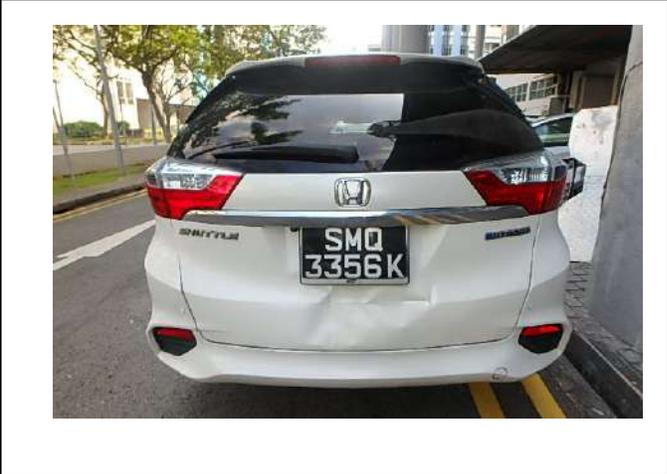
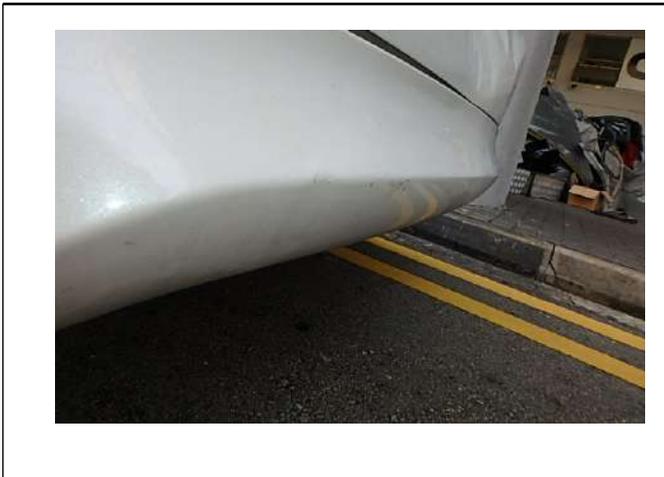
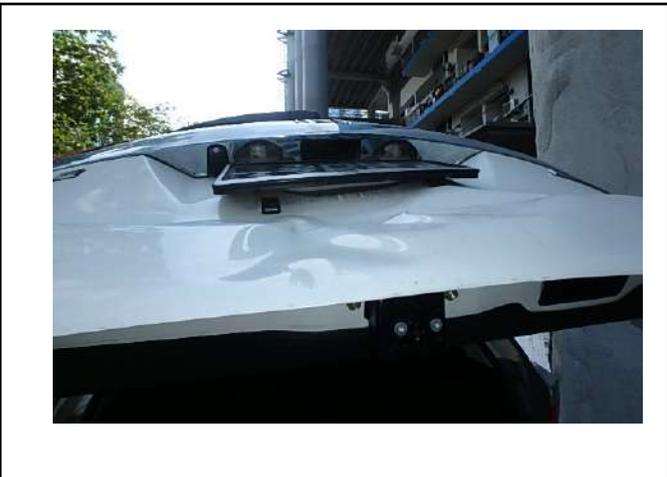
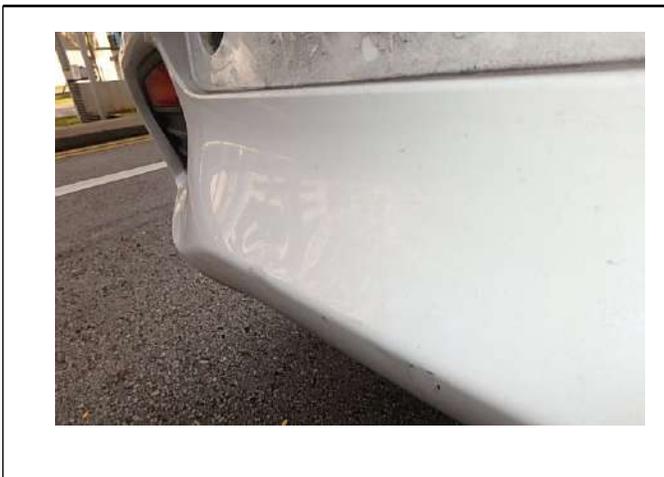
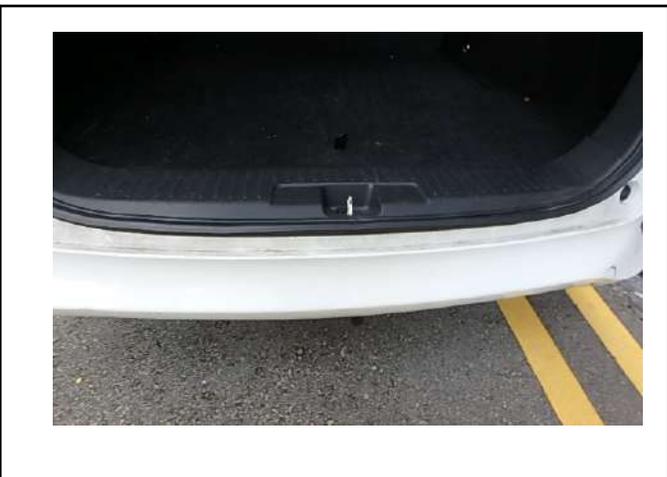
4. Description of Damages			
THE VEHICLE SUSTAINED DAMAGES AT THE REAR PORTION. DAMAGES SEE DETAILS.			
5. General Information			
Accident Date	20/12/2022	Inspection Date	30/12/2022
Survey held at	OPTIMA WERKZ PTE LTD 10 ANG MO KIO INDUSTRIAL PARK 2A #01-05 AMK AUTOPOINT SINGAPORE 568047		
5a. Remarks			
A)THE INSPECTION WAS CONDUCTED ON A"WITHOUT PREJUDICE" BASIS. B)IN ACCORDANCE TO YOUR INSTRUCTIONS, WE HAVE NOT AUTHORISED REPAIRS.			
5b. Estimate Days of Repair			
ESTIMATED NORMAL PERIOD FOR REPAIR:		4 Working Days
