Your Ref: Porsche Taycan  
(chassis number WP0ZZZY1ZMSA26856)  
Our Ref : CI/TP22012954/D

29 December 2022

**INSPECTION REPORT OF AN UNREGISTERED PORSCHE TAYCAN MOTOR CAR WITH CHASSIS NUMBER WP0ZZZY1ZMSA26856**

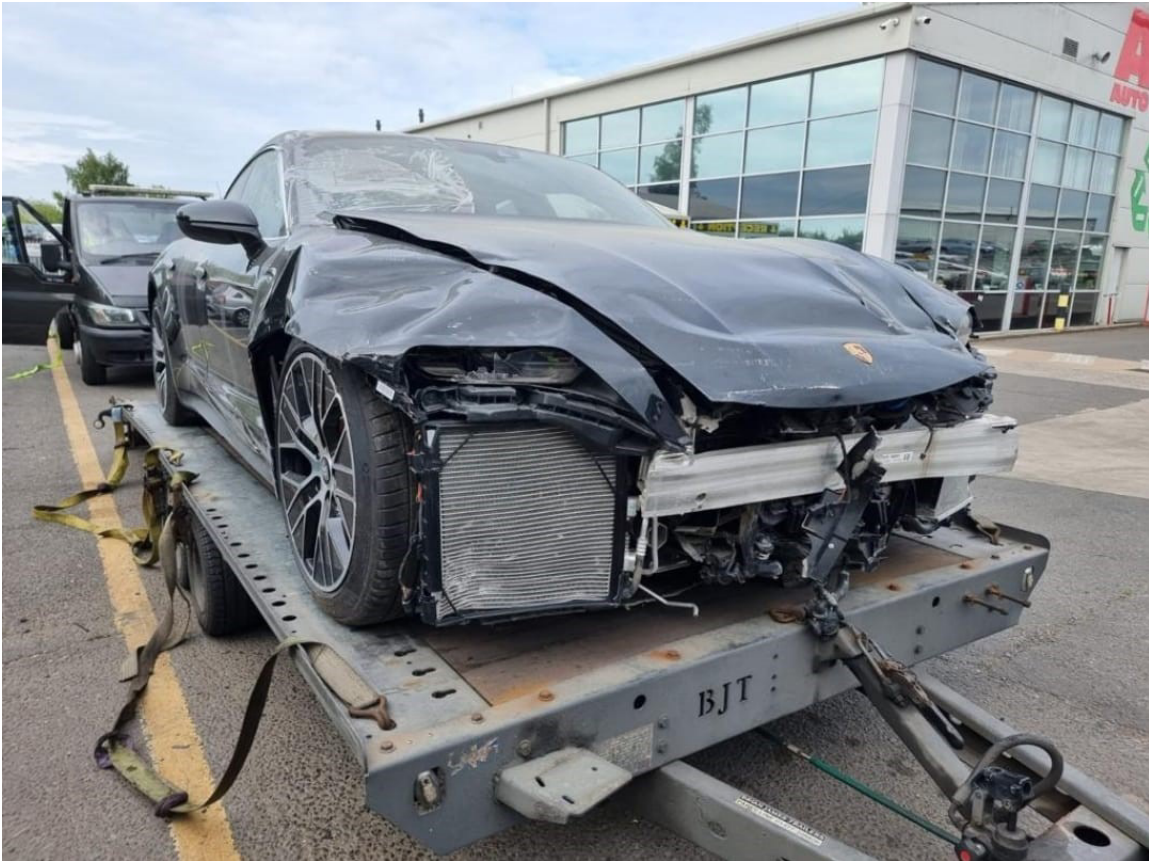
3. The photographs provided to me had showed damage to the frontal portion of the Motor Car. Body parts damaged include the front bumper, front bumper lower lip, front bumper reinforcement, front bumper centre frame, front bumper right air guide, front bumper right lower grille, front bumper left air guide, front bumper left lower grille, front bumper sensors, front bonnet, front bonnet hinges, front right headlamp, front right aircon condenser, front right signal lamp, front right fender, front right fender inner shield, front left headlamp, front left signal lamp, front left fender, front left fender inner shield, front left radiator, front left door and front windscreen amongst others.

**Photo 1** shows the front right body of the Motor Car (photograph provided to me). The Motor Car was observed to have sustained damage at its frontal portion. The front bumper, front bumper reinforcement, front bumper centre frame, front bumper lower lip, front bumper right air guide, front bumper right lower grille, front bumper sensors, front bonnet, front bonnet right hinge, front right headlamp, front right signal lamp, front right fender, front right fender inner shield, front right aircon condenser and front windscreen were amongst the body parts that were observed to have been damaged.

22. The body parts at the frontal portion of the Motor Car were visually examined, and it was noted that the repair/restoration works carried out to the damaged area of the Motor Car (refer to photograph 1 - 3 above) were reasonably adequate and in order.

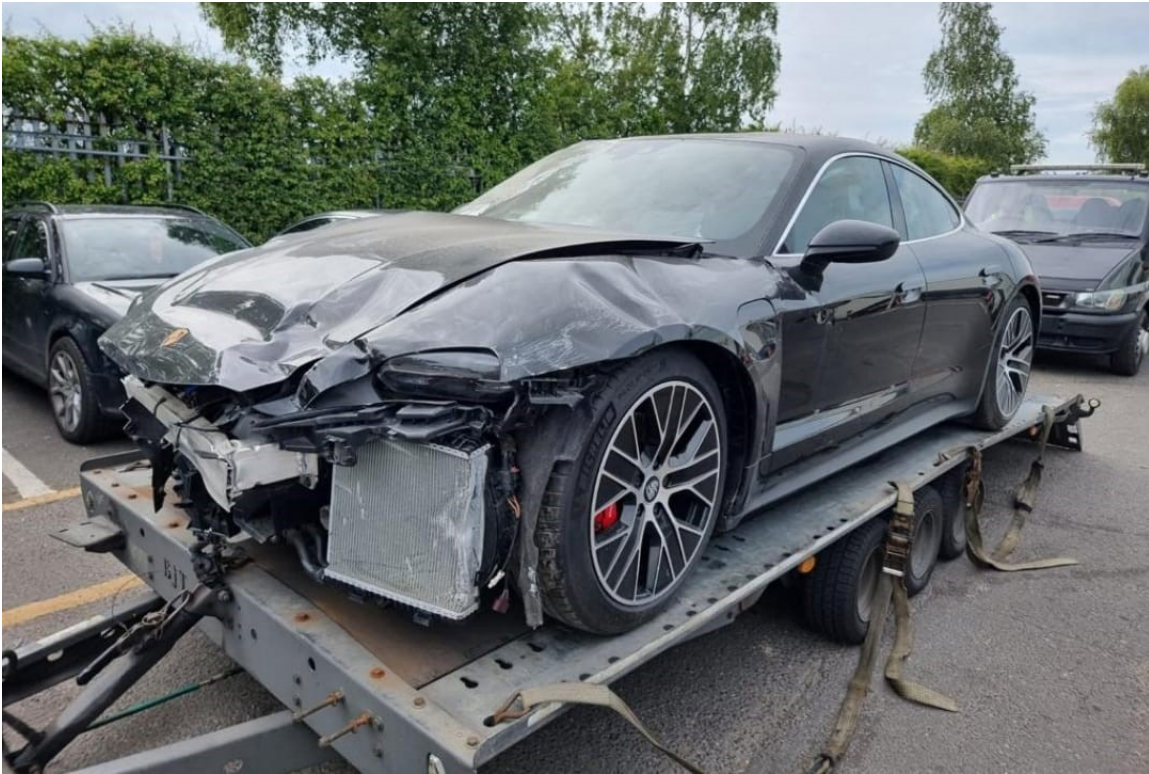
**Photo 2** shows the front left body of the Motor Car (photograph provided to me). The Motor Car was observed to have sustained damage at its frontal portion. The front bumper, front bumper lower lip, front bumper left air guide, front bumper left lower grille, front bumper sensors, front bonnet, front bonnet left hinge, front left headlamp, front left signal lamp, front left fender, front left fender inner shield, front left radiator and front left door were amongst the body parts that were observed to have been damaged.

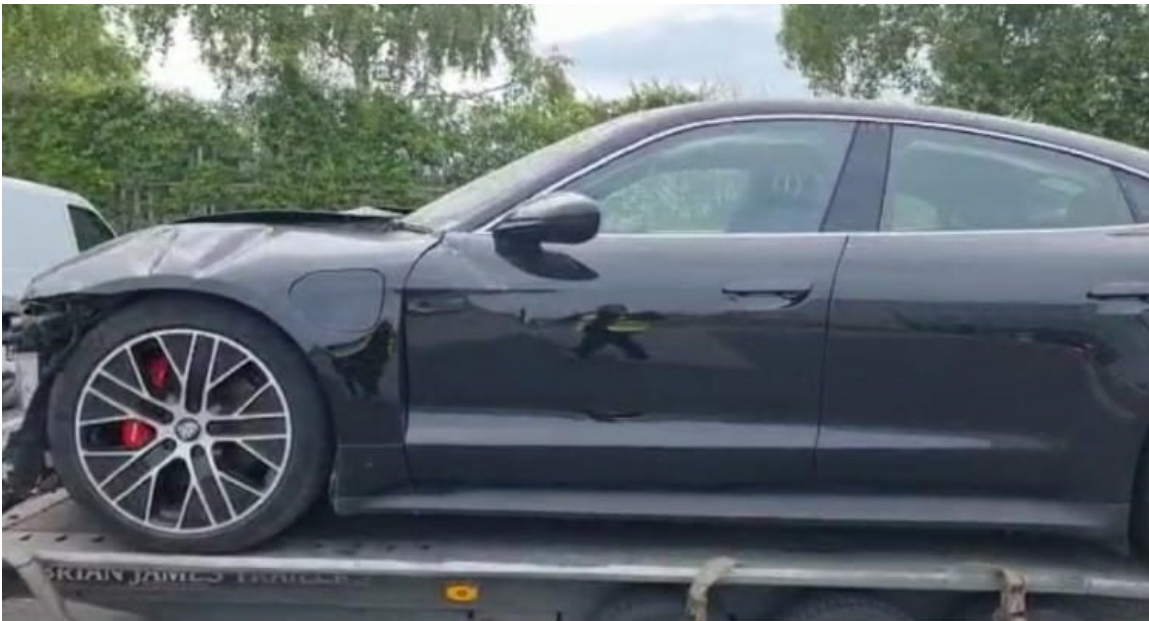
**Photo 3** shows the left side body of the Motor Car (photograph provided to me). The Motor Car was observed to have sustained damage at its frontal portion. The front left fender and front left door were amongst the body parts that were observed to have been damaged.

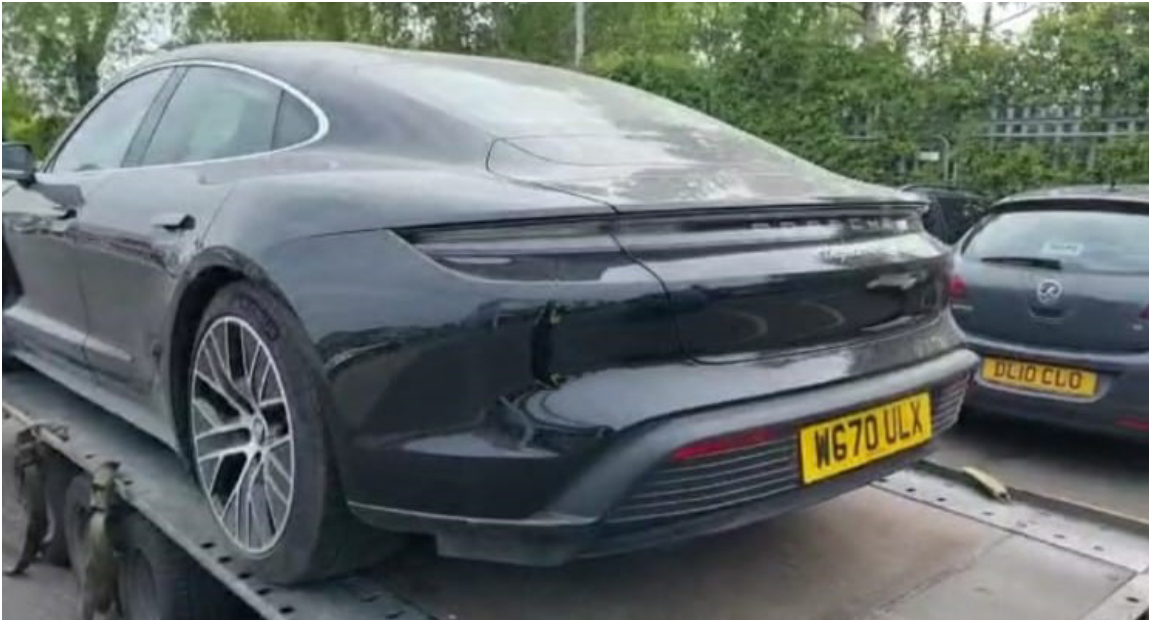
**Photo 4** shows the rear left body of the Motor Car (photograph provided to me). Apart for the frontal portion, there was no physical damage observed to other areas of the Motor Car.

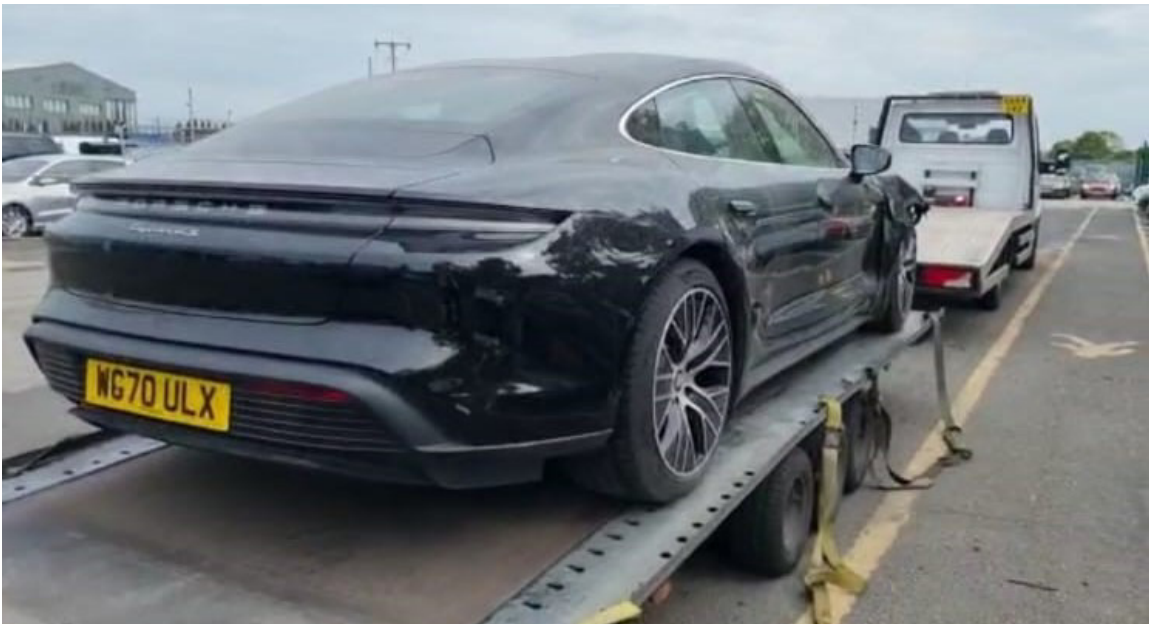
**Photo 5** shows the rear right body of the Motor Car (photograph provided to me). Apart for the frontal portion, there was no physical damage observed to other areas of the Motor Car.

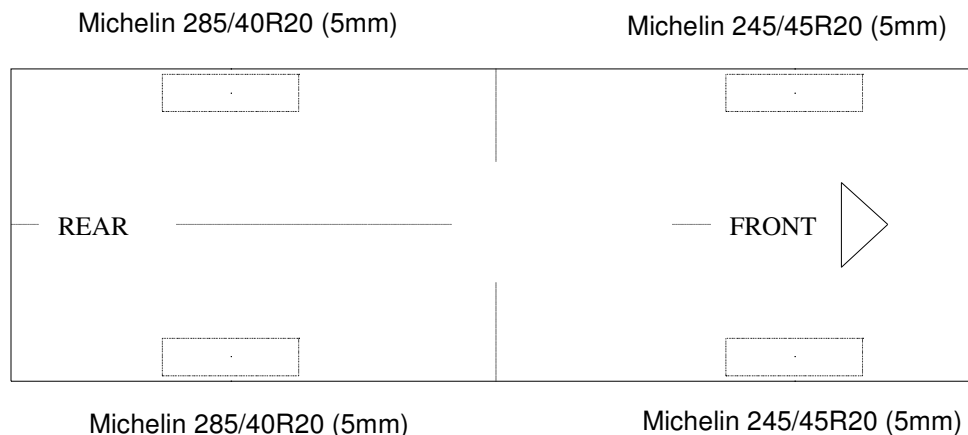
8. It was fitted with 20inch sport wheel rims that were wrapped with tyres that were observed to be of serviceable condition. The tyres were also sufficiently inflated for vehicular operation. The tyre brand, tyre size and approximate remaining tread depth of the 4 tyres of the Motor Car were recorded as follows: -

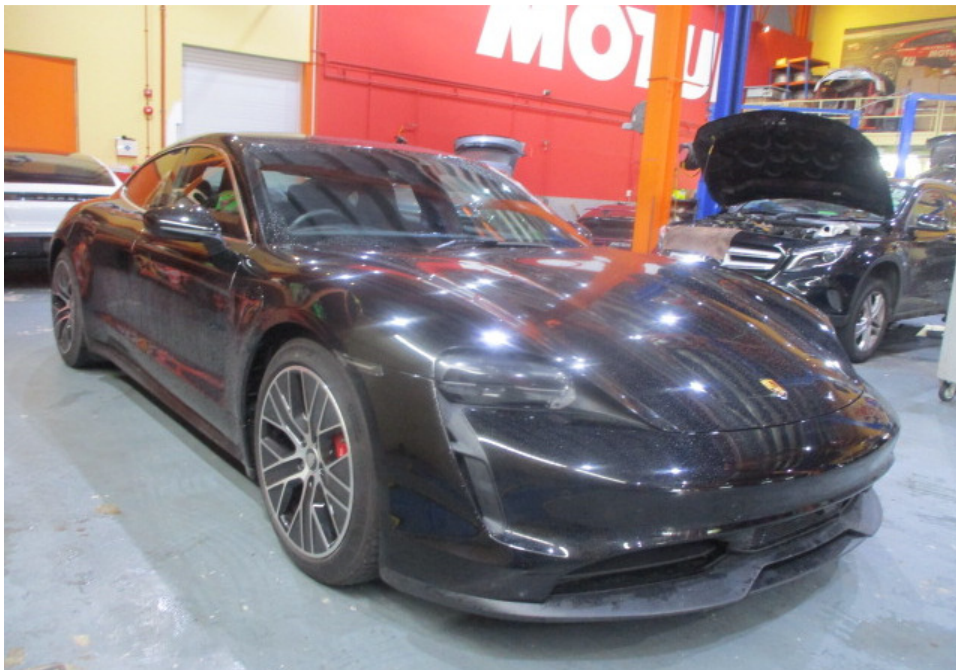
**Photo 6** shows a general view of the front right body of the Motor Car at the time of my inspection. The Motor Car was observed to be in a relatively good general condition with no loose exterior fittings observed. The body parts at the frontal portion of the Motor Car were visually examined and it was observed that the repair/restoration works carried out to the damaged area of the Motor Car (refer to photograph 1 - 3 above) were reasonably adequate and in order.

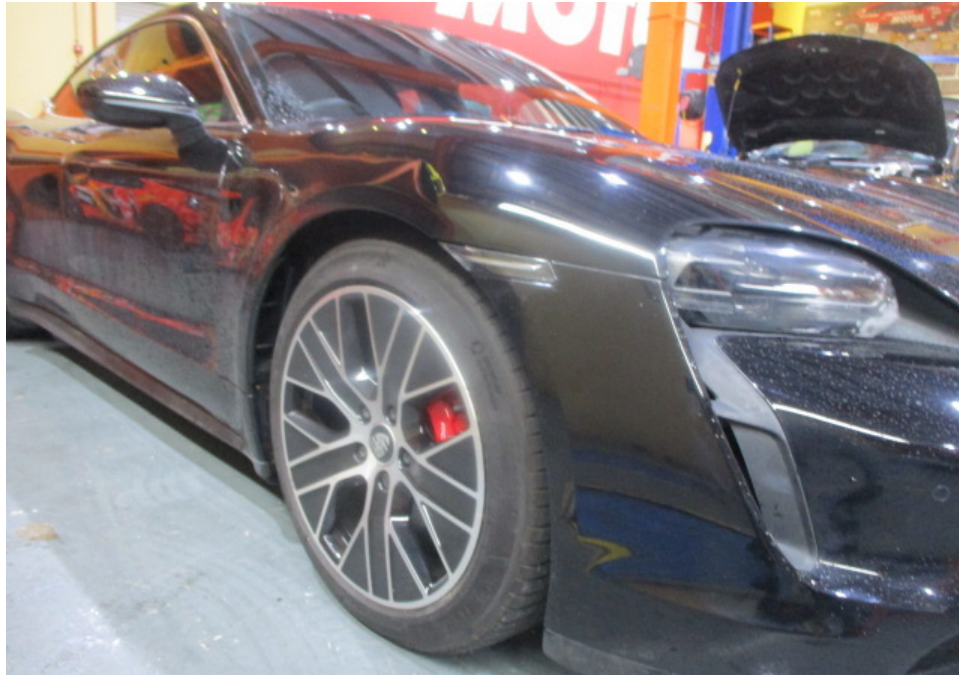
**Photo 7** shows a closer view of the Motor Car's front right headlamp, front right signal lamp, front right fender and front right wheel rim. The body parts at the frontal portion of the Motor Car were visually examined and it was observed that the repair/restoration works carried out to the damaged area of the Motor Car (refer to photograph 1 - 3 above) were reasonably adequate and in order.

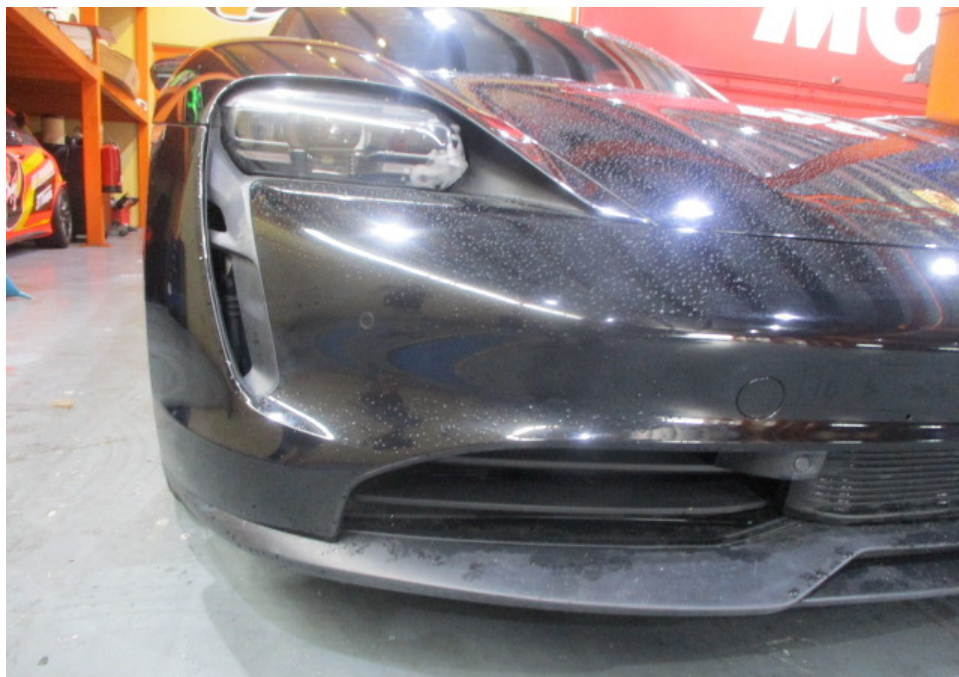
**Photo 8** shows a closer view of the Motor Car's front bumper, front bumper lower lip, front bumper right air guide, front bumper right lower grille and front right headlamp. The body parts at the frontal portion of the Motor Car were visually examined and it was observed that the repair/restoration works carried out to the damaged area of the Motor Car (refer to photograph 1 - 3 above) were reasonably adequate and in order.

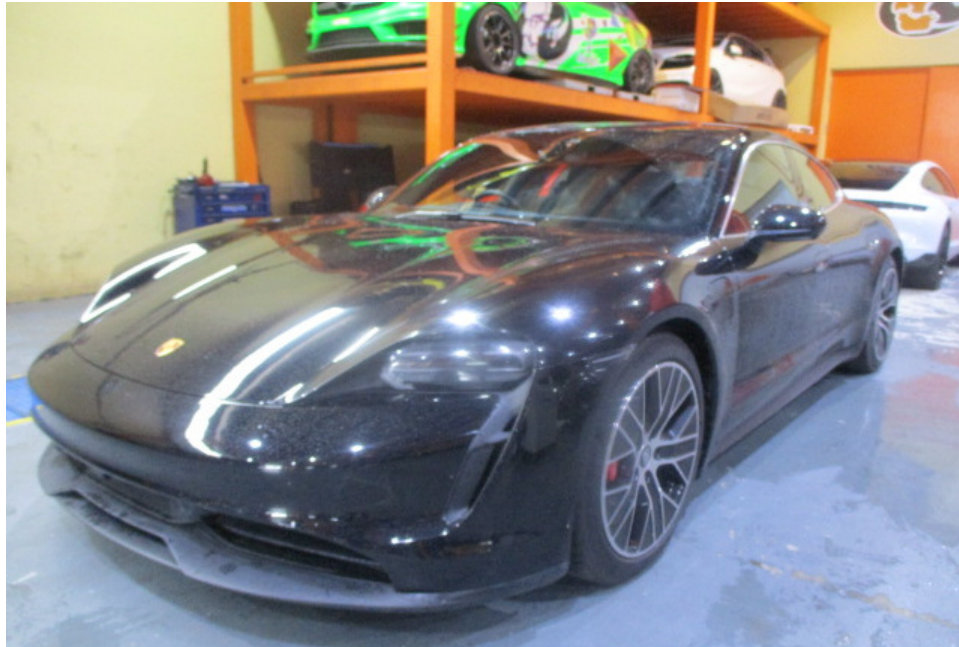
**Photo 9** shows a general view of the front left body of the Motor Car at the time of my inspection. The Motor Car was observed to be in a relatively good general condition with no loose exterior fittings observed. The body parts at the frontal portion of the Motor Car were visually examined and it was observed that the repair/restoration works carried out to the damaged area of the Motor Car (refer to photograph 1 - 3 above) were reasonably adequate and in order.

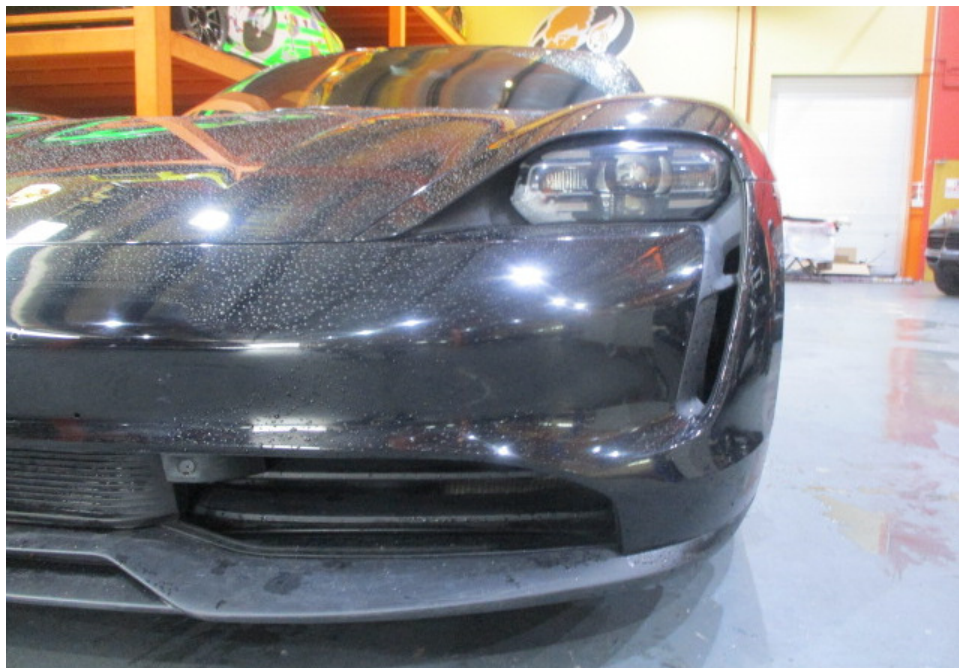
**Photo 10** shows a closer view of the Motor Car's front bumper, front bumper lower lip, front bumper left air guide, front bumper left lower grille and front left headlamp. The body parts at the frontal portion of the Motor Car were visually examined and it was observed that the repair/restoration works carried out to the damaged area of the Motor Car (refer to photograph 1 - 3 above) were reasonably adequate and in order.

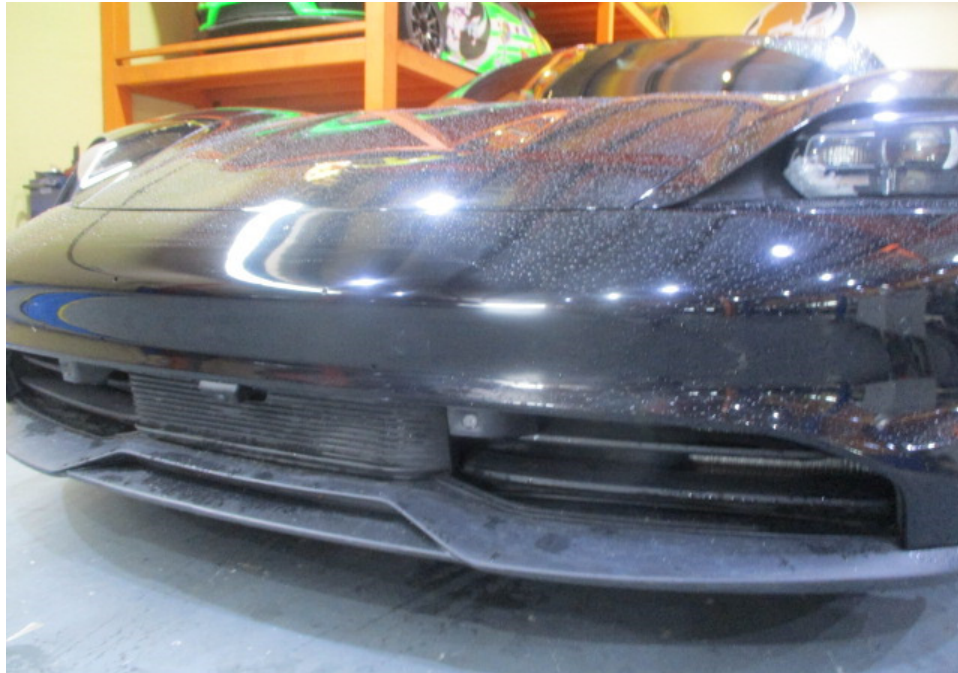
**Photo 11** shows a closer view of the Motor Car's front bumper, front bumper lower lip, front bumper sensors, front bumper centre frame and front bonnet. The body parts at the frontal portion of the Motor Car were visually examined and it was observed that the repair/restoration works carried out to the damaged area of the Motor Car (refer to photograph 1 - 3 above) were reasonably adequate and in order.

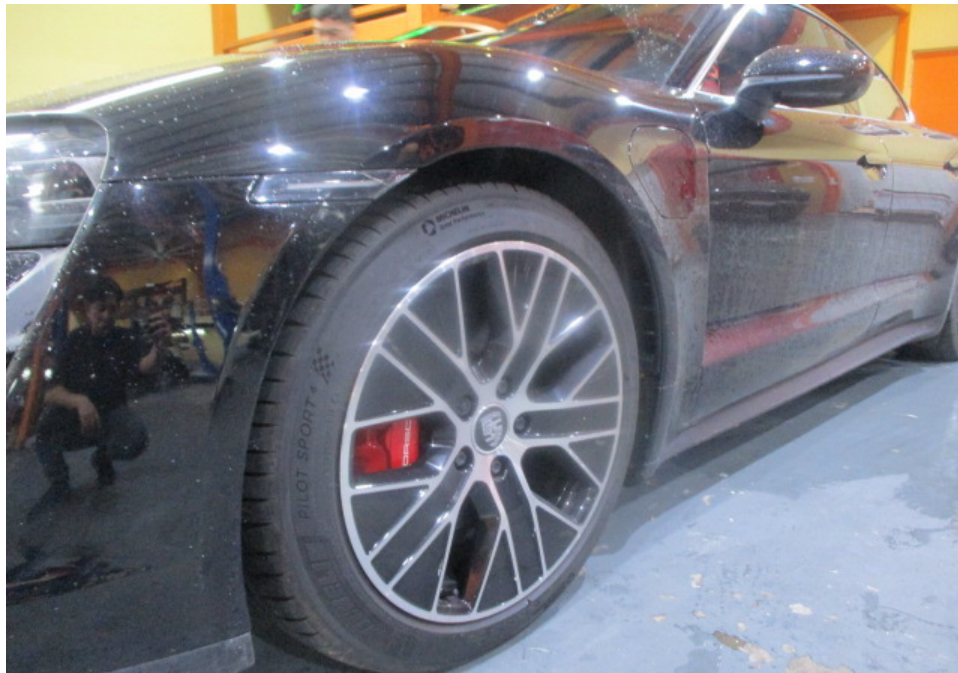
**Photo 12** shows a closer view of the Motor Car's front left signal lamp, front left fender and front left wheel rim. The body parts at the frontal portion of the Motor Car were visually examined and it was observed that the repair/restoration works carried out to the damaged area of the Motor Car (refer to photograph 1 - 3 above) were reasonably adequate and in order.

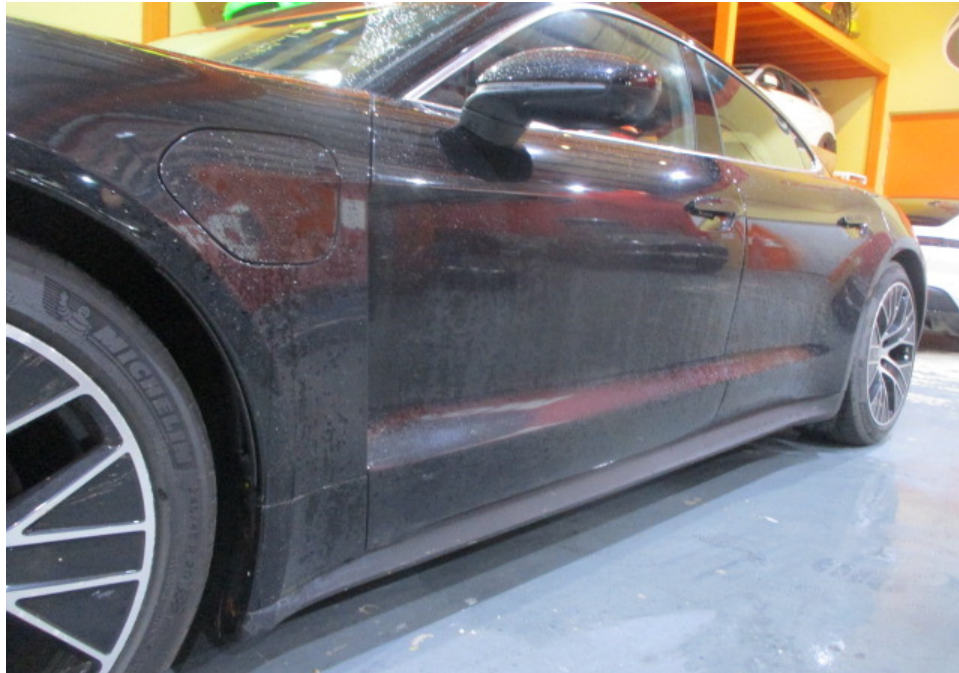
**Photo 13** shows a closer view of the Motor Car's left side high voltage charging port cover, front left door, left side wing mirror and left side rocker panel garnish. The body parts at the frontal portion of the Motor Car were visually examined and it was observed that the repair/restoration works carried out to the damaged area of the Motor Car (refer to photograph 1 - 3 above) were reasonably adequate and in order.

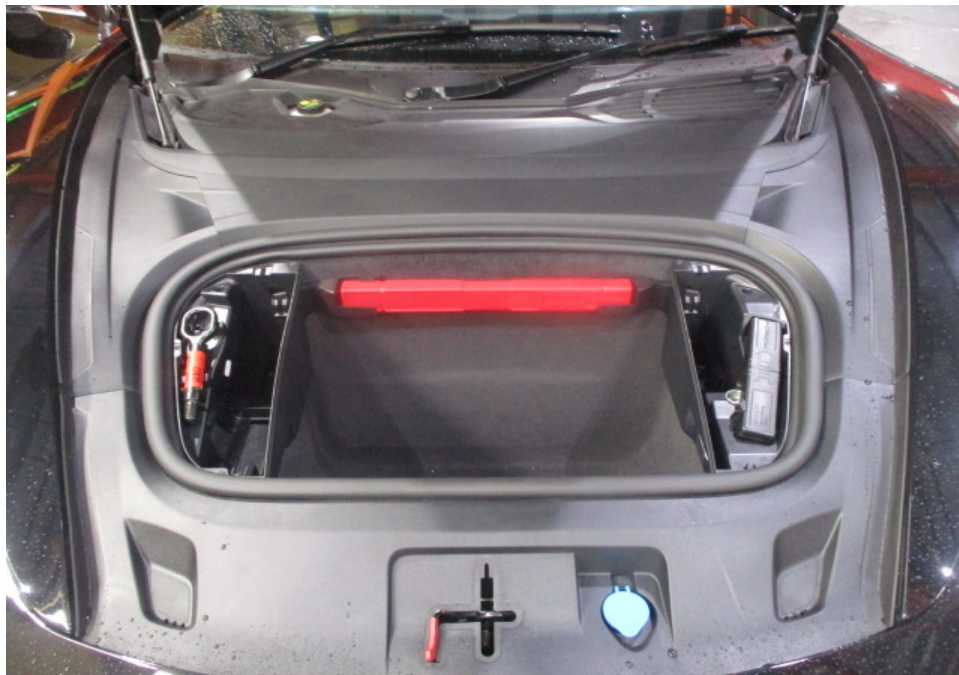
**Photo 14** shows a general view of the Motor Car's front bonnet compartment at the time of my inspection. All inner trims, garnishes and upholstery etc were observed to be properly fitted.

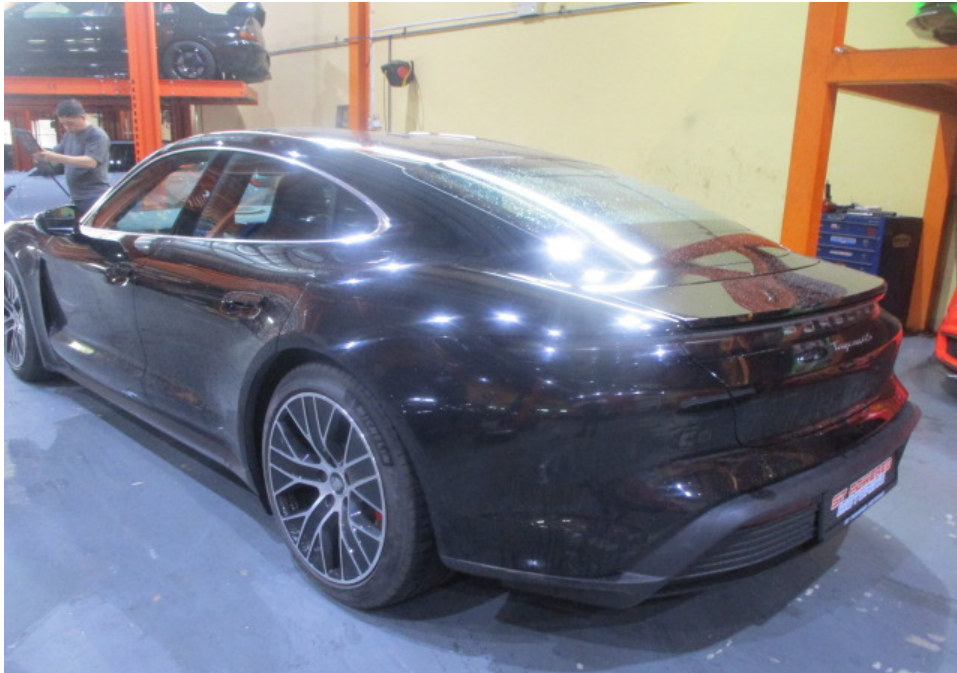
**Photo 15** shows a general view of the rear left body of the Motor Car at the time of my inspection. The Motor Car was observed to be in a relatively good general condition with no loose exterior fittings observed. The mileage of the Motor Car recorded at the time of my inspection was 5,364km.

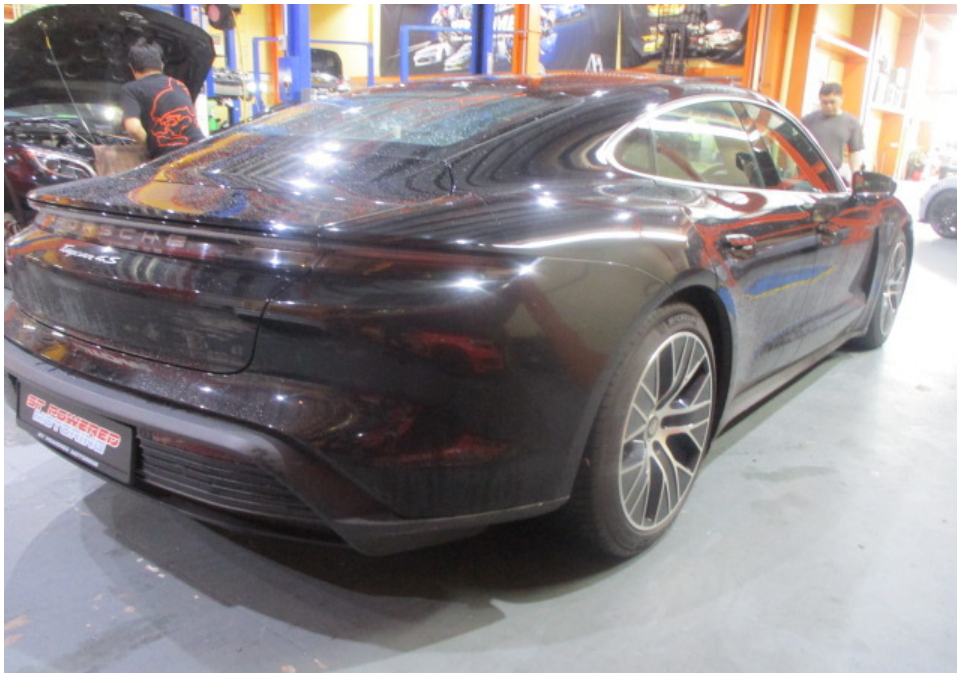
**Photo 16** shows a general view of the rear right body of the Motor Car at the time of my inspection. The Motor Car was observed to be in a relatively good general condition with no loose exterior fittings observed. The mileage of the Motor Car recorded at the time of my inspection was 5,364km.

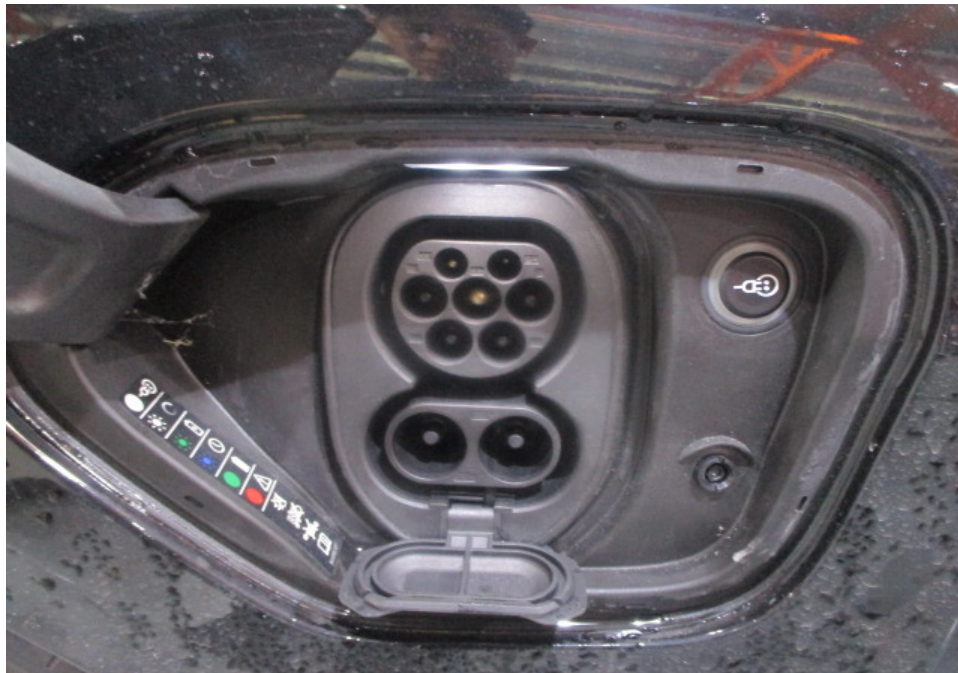
**Photo 18** shows the high voltage charging port located at the front left fender of the Motor Car at the time of my inspection. A Combined Charging Standard 2 (CCS 2) for direct current (DC) charging was fitted on the front left fender of the Motor Car. No physical damage was observed to the charging head.

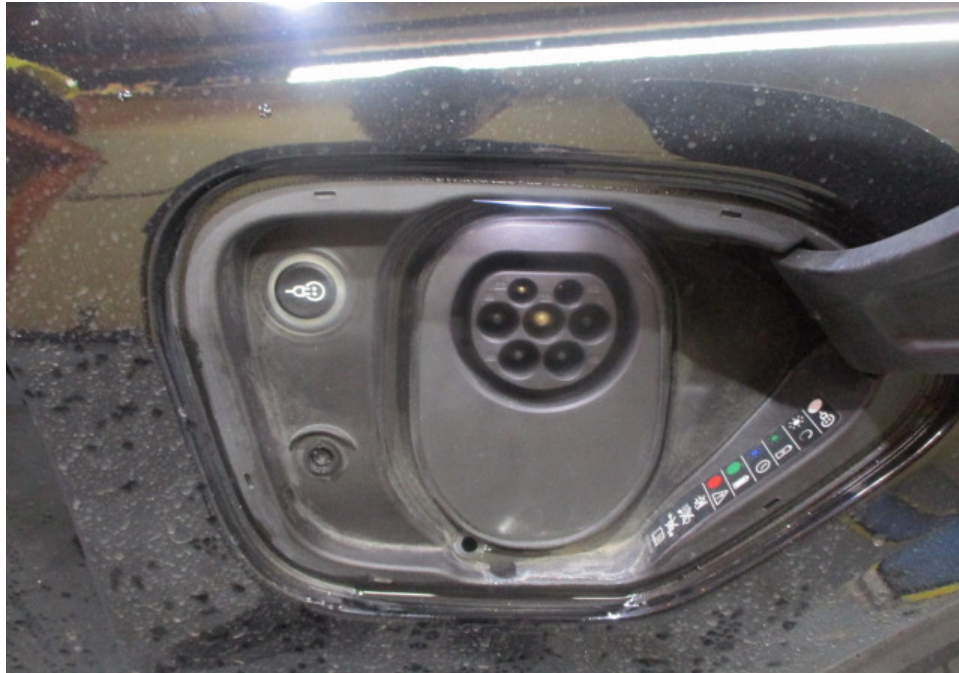
**Photo 19** shows the high voltage charging port located at the front right fender of the Motor Car at the time of my inspection. A JS 1772 (Type 2) for alternating current (AC) charging was fitted on the front right fender of the Motor Car. No physical damage was observed to the charging head.

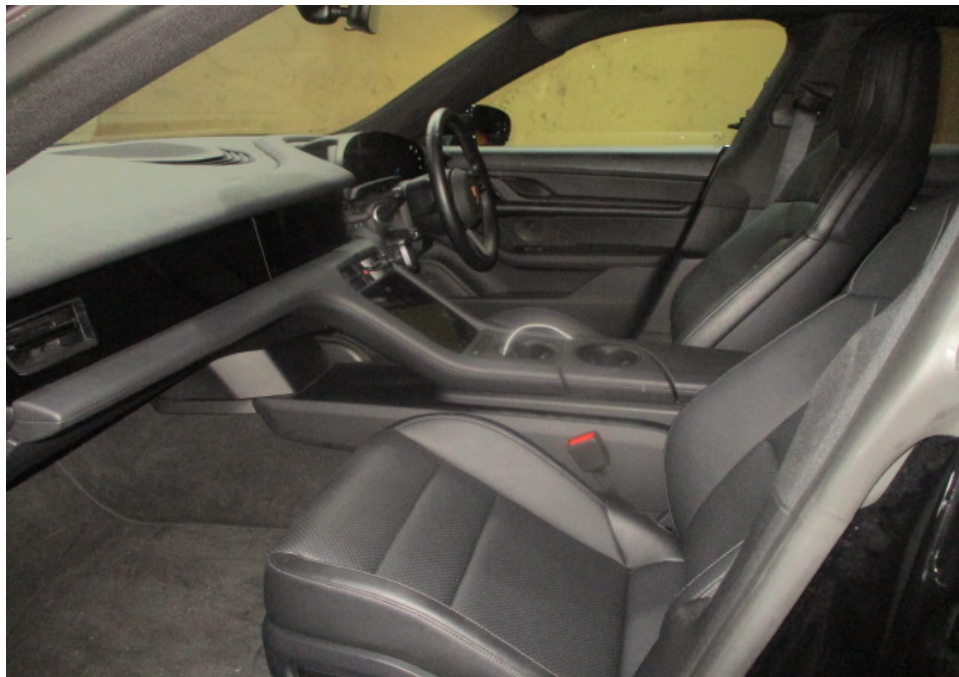
**Photo 20** shows the interior compartment of the Motor Car at the time of my inspection. The various parts and components, trims, carpet, and upholstery inside the interior compartment were all observed to be intact and properly fitted.

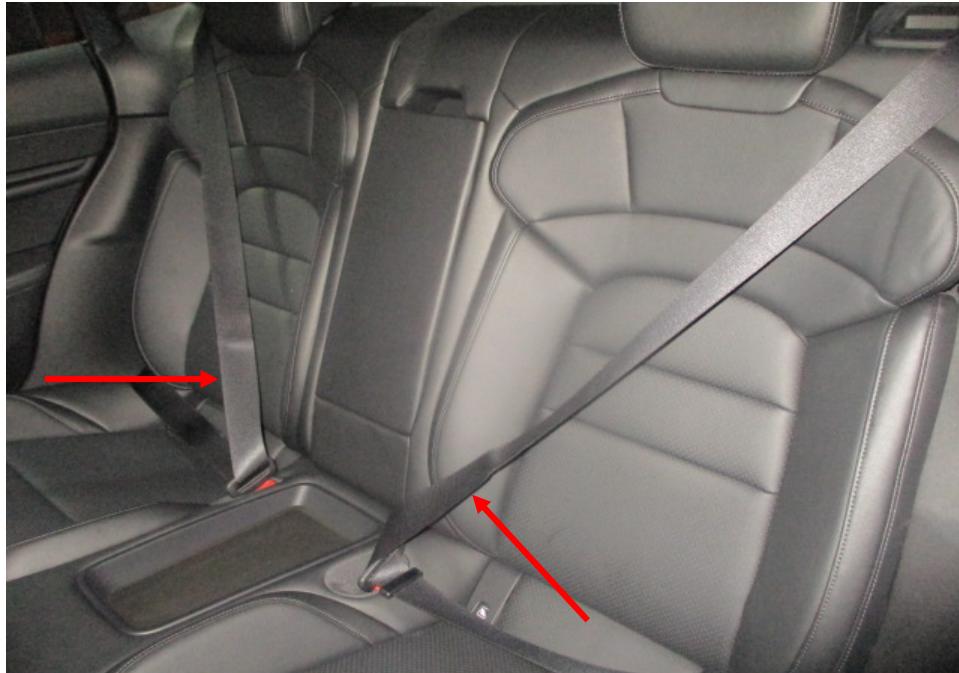
**Photo 21** shows the rear seats of the Motor Car. All the seats of the Motor Car were secured via seat rails to the floorboard. They were also fitted with a retractable seat belt reel and a pre-tensioner. The seat belts (arrowed) were tested and were able to be fastened into the respective pre-tensions that were fitted on the side of each individual seat.

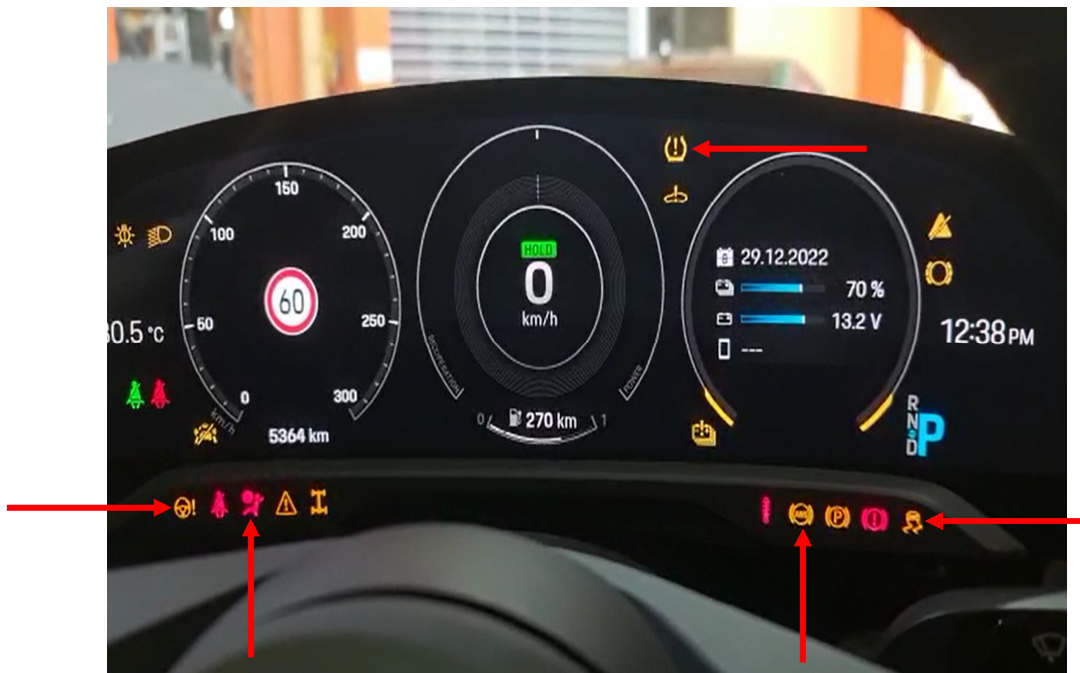
**Photo 22** shows the warning lights for the various electronic safety features appearing on the instrument panel of the Motor Car during its self-test when the engine is cranked, in particular the ABS, SRS, EPS, TPM and SCS lights (arrowed).

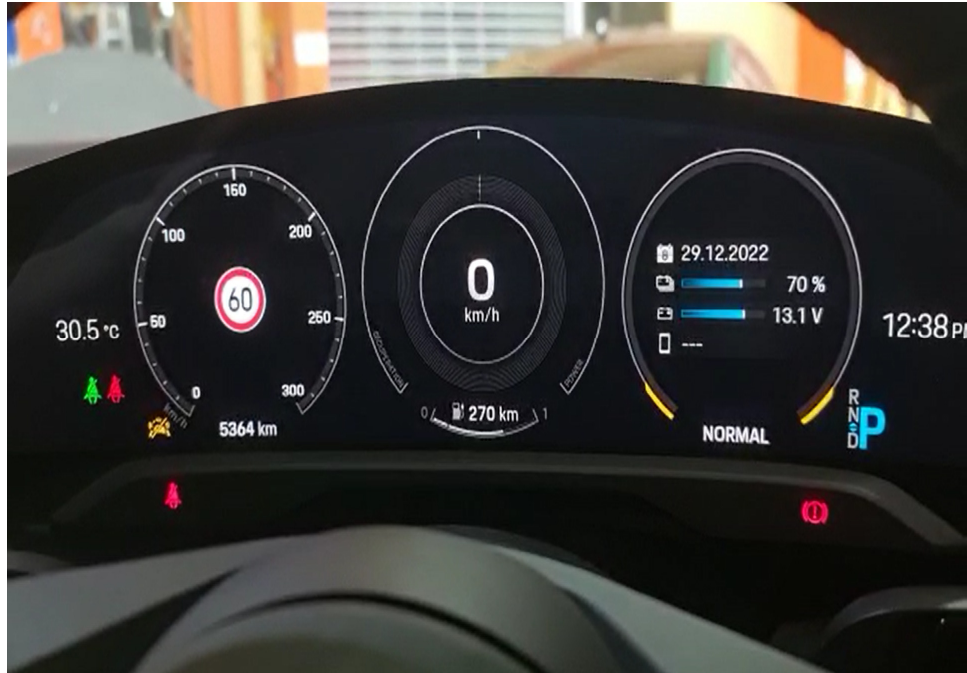
**Photo 23** shows the respective warning lights no longer illuminated, indicating that there is no fault detected to the ABS, SRS, EPS, TPM and SCS systems of the Motor Car during the self-test. These electronic systems were hence in working condition at the time of my inspection.

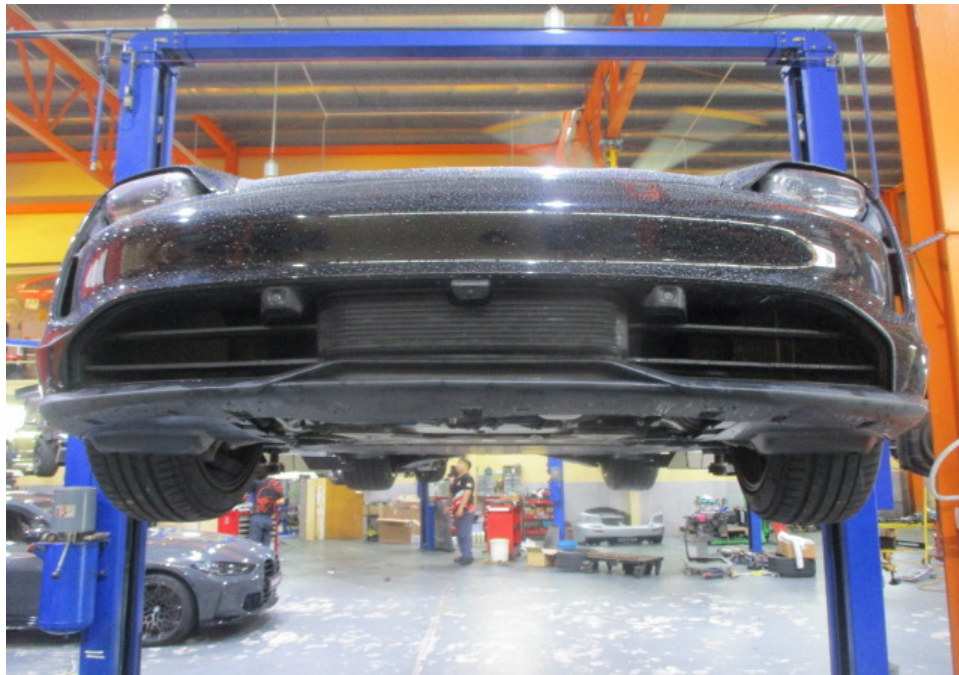
**Photo 24** shows the Motor Car hoisted up for checks on its undercarriage. There was no sign(s) or indication(s) of fluid leakage and/or fluid stain(s) on the underside of the Motor Car. The undercarriage components of the Motor Car were also all observed to be intact and secured in an appropriate manner.

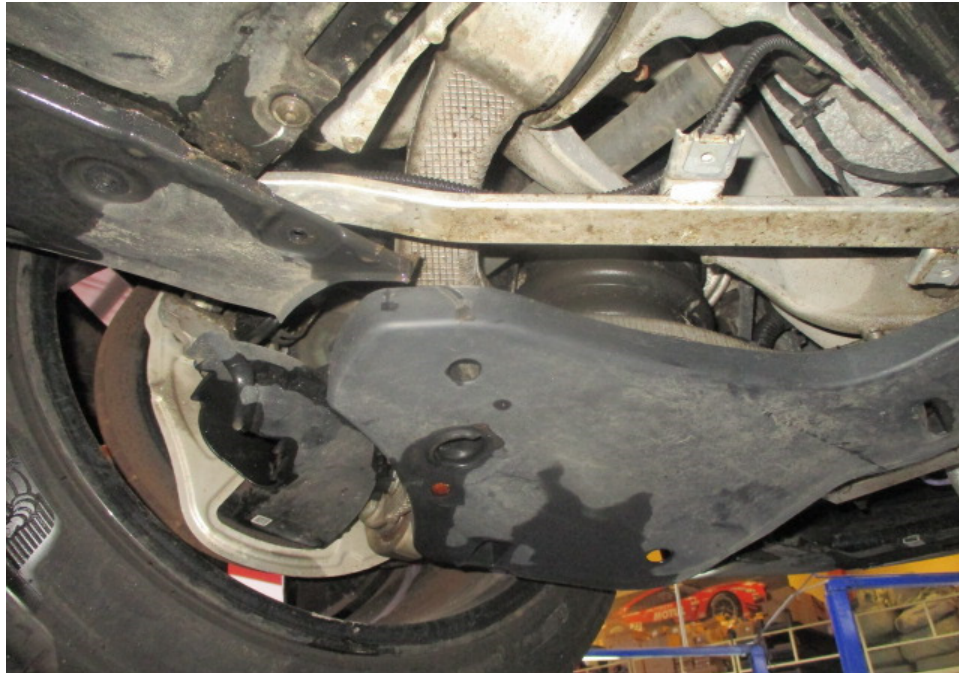
**Photo 25** shows a general view of the control arms and linkages at the rear right wheel of the Motor Car. I did not observe any fluid leak and/or fluid stain on the underside of the Motor Car. All of the Motor Car's undercarriage components were observed to be intact and secured in an appropriate manner.

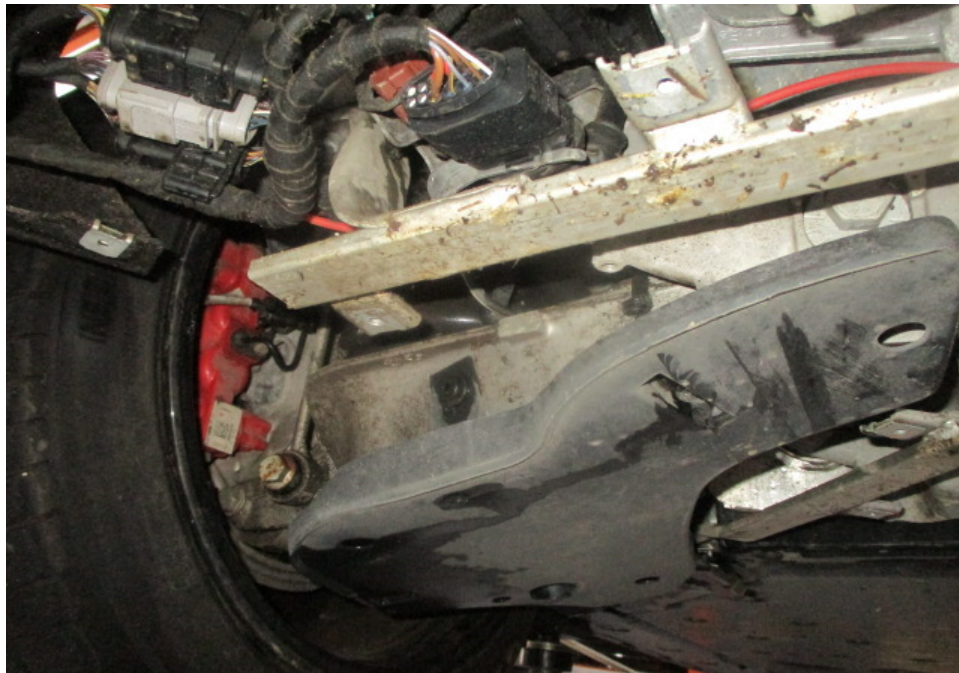
**Photo 26** shows a general view of the control arms and linkages at the rear left wheel of the Motor Car. I did not observe any fluid leak and/or fluid stain on the underside of the Motor Car. All of the Motor Car's undercarriage components were observed to be intact and secured in an appropriate manner.

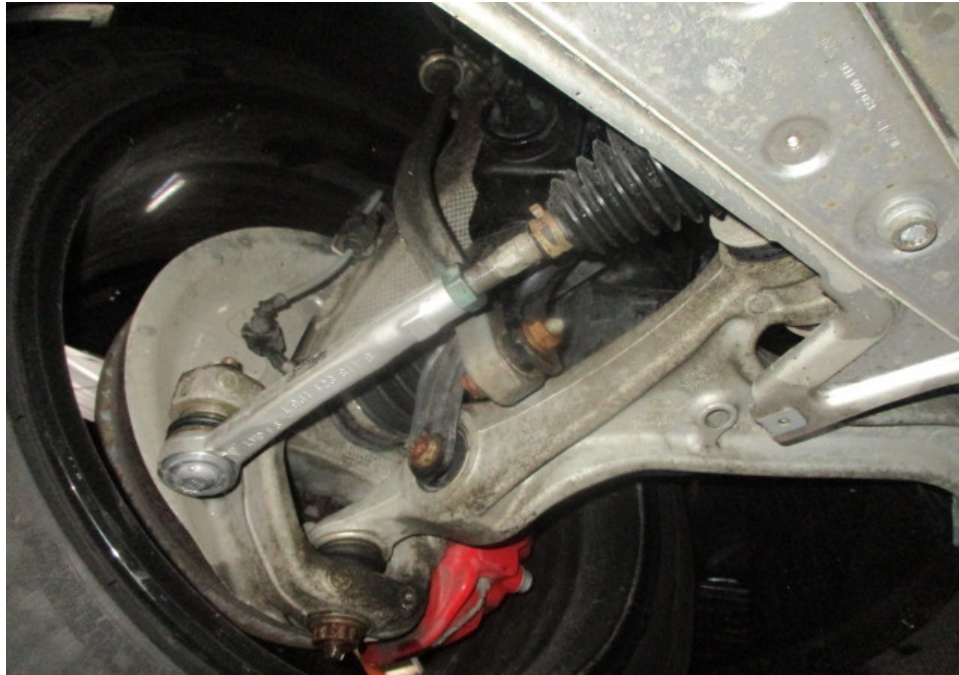
**Photo 27** shows the various undercarriage components at the front left wheel of the Motor Car. The mechanical components, control arms and linkages were all found to be intact and secured in an appropriate manner.

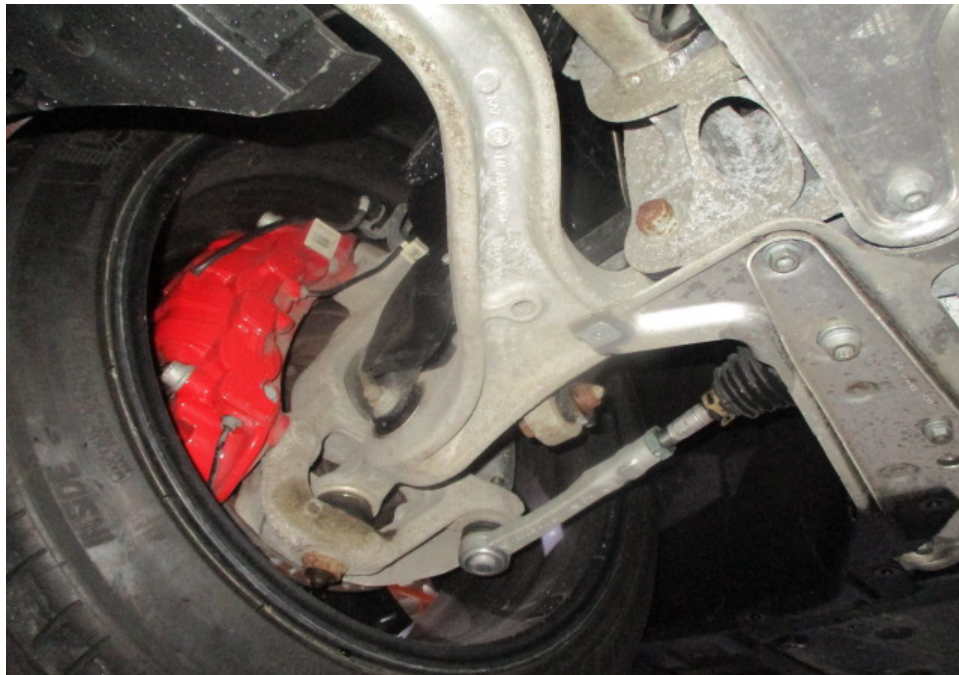
**Photo 28** shows the various undercarriage components at the front right wheel of the Motor Car. The mechanical components, control arms and linkages were all found to be intact and secured in an appropriate manner. I also did not observe any fluid leak and/or fluid stain on the underside of the Motor Car.

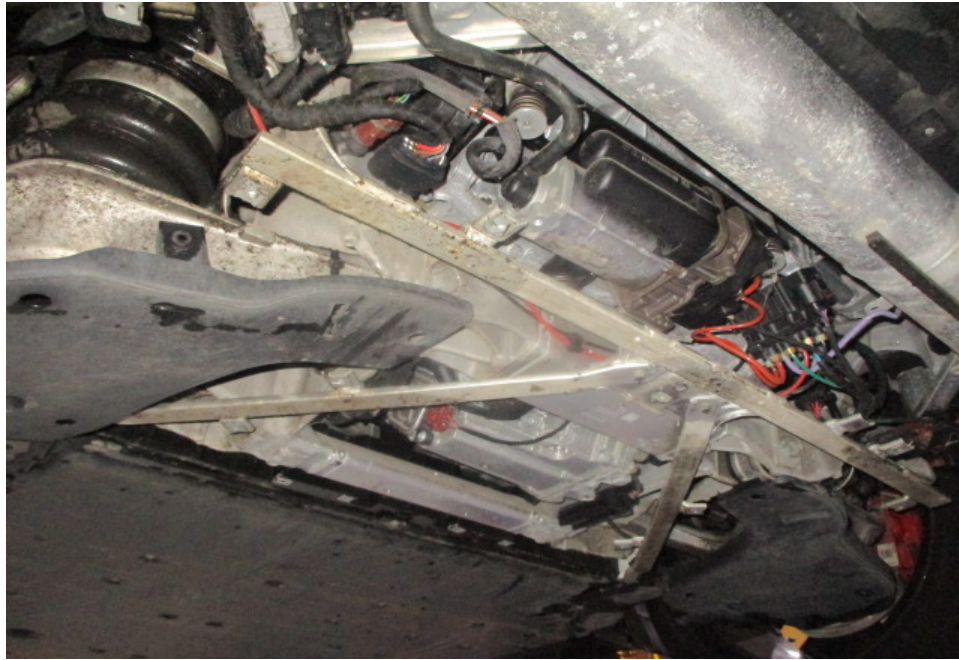
**Photo 29** shows the underside rear of the Motor Car, at the location where the rear electric motor is fitted. The high voltage system of the Motor Car was visually checked, and it was observed that the various high voltage parts and components like the high voltage battery, inverter unit, converter unit, high voltage cables, electric motors and electric aircon compressor amongst others, were properly secured and without any physical damage.
