Your Ref: Porsche Taycan  
(chassis number WP0ZZZY1ZMSA26856)  
Our Ref : CI/TP22012954/D

29 December 2022

**INSPECTION REPORT OF AN UNREGISTERED PORSCHE TAYCAN MOTOR CAR WITH CHASSIS NUMBER WP0ZZZY1ZMSA26856**

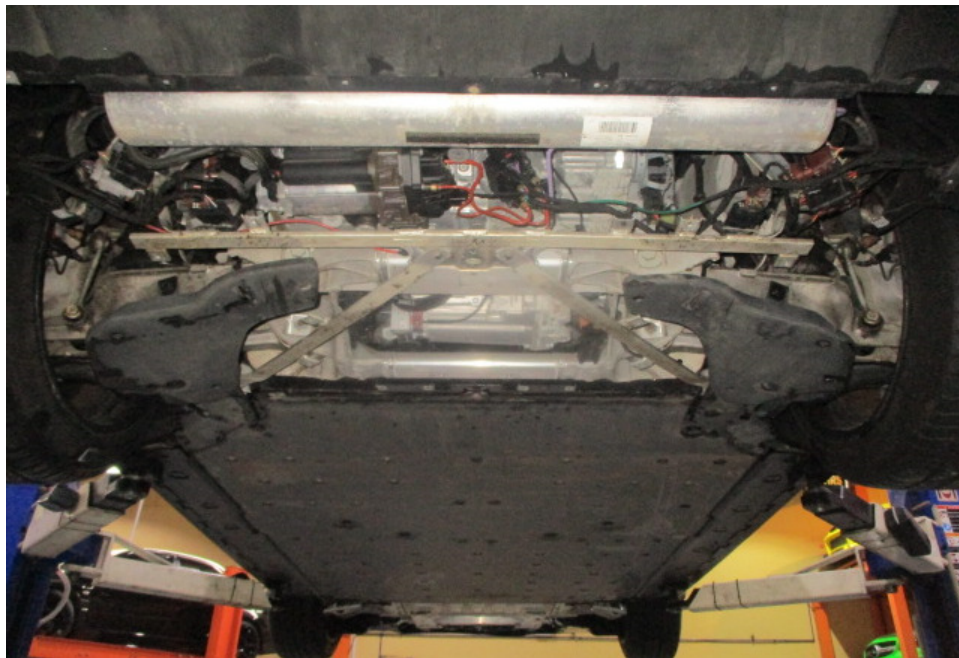
**Photo 30** shows the underside centre of the Motor Car, at the location where the high voltage battery is fitted. The high voltage system of the Motor Car was visually checked, and it was observed that the various high voltage parts and components like the high voltage battery, inverter unit, converter unit, high voltage cables, electric motors and electric aircon compressor amongst others, were properly secured and without any physical damage.

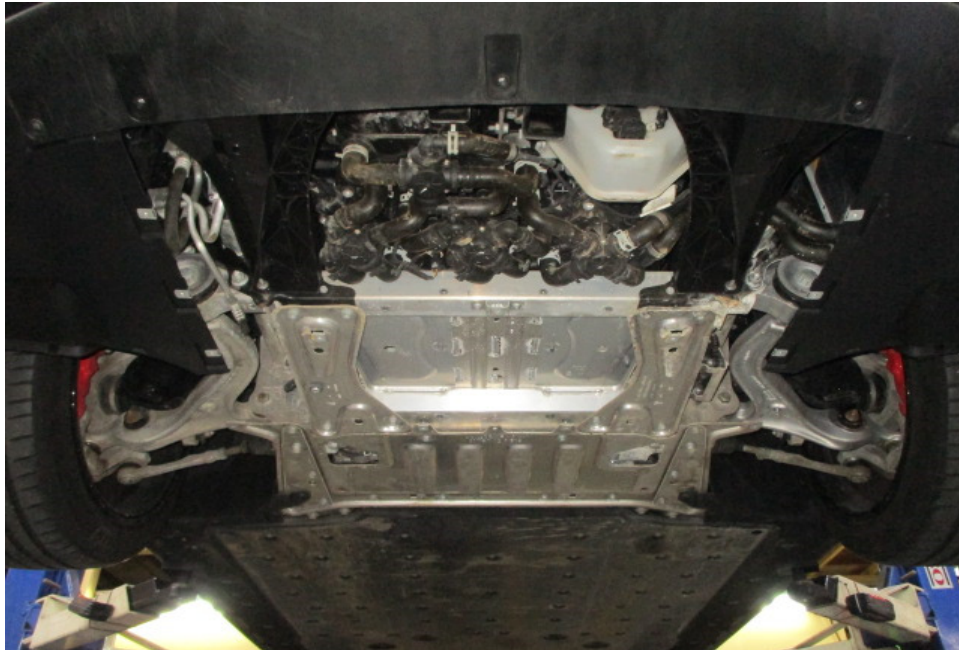
**Photo 31** shows the underside front of the Motor Car, at the location where the front electric motor, is fitted. The high voltage system of the Motor Car was visually checked, and it was observed that the various high voltage parts and components like the high voltage battery, inverter unit, converter unit, high voltage cables, electric motors and electric aircon compressor amongst others, were properly secured and without any physical damage.

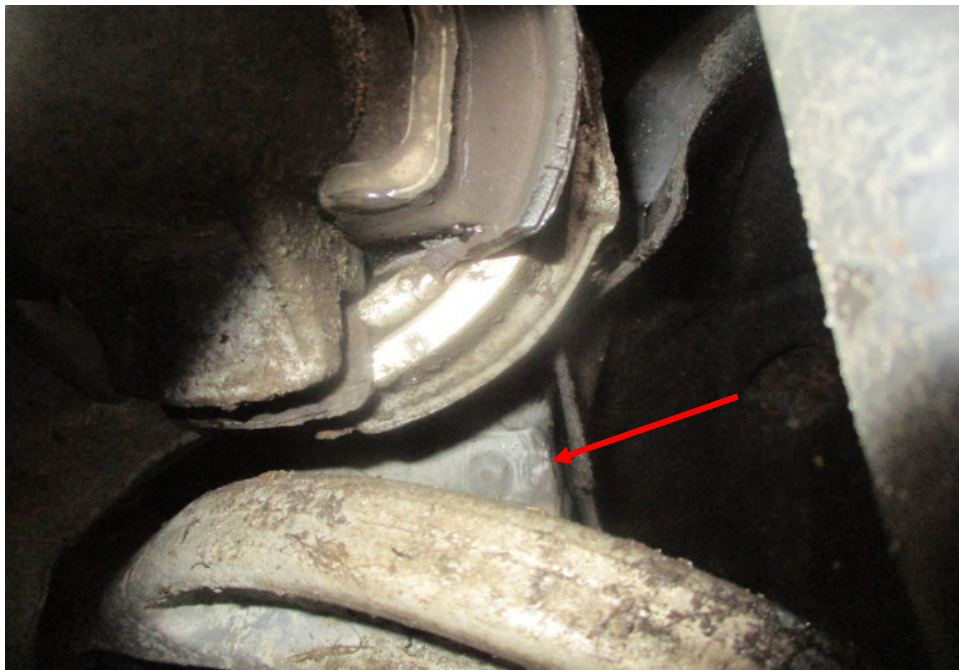
**Photo 32** shows the chassis/structural body at the underside rear right of the Motor Car. I did not find any weld marks other than original spot weld marks on the chassis/structural body of the Motor Car. The original factory sealant (arrowed) at the joints along the chassis/structural body was untouched, indicating no work was done on the chassis/structural body of the Motor Car and that the chassis/structural body was originally fitted.

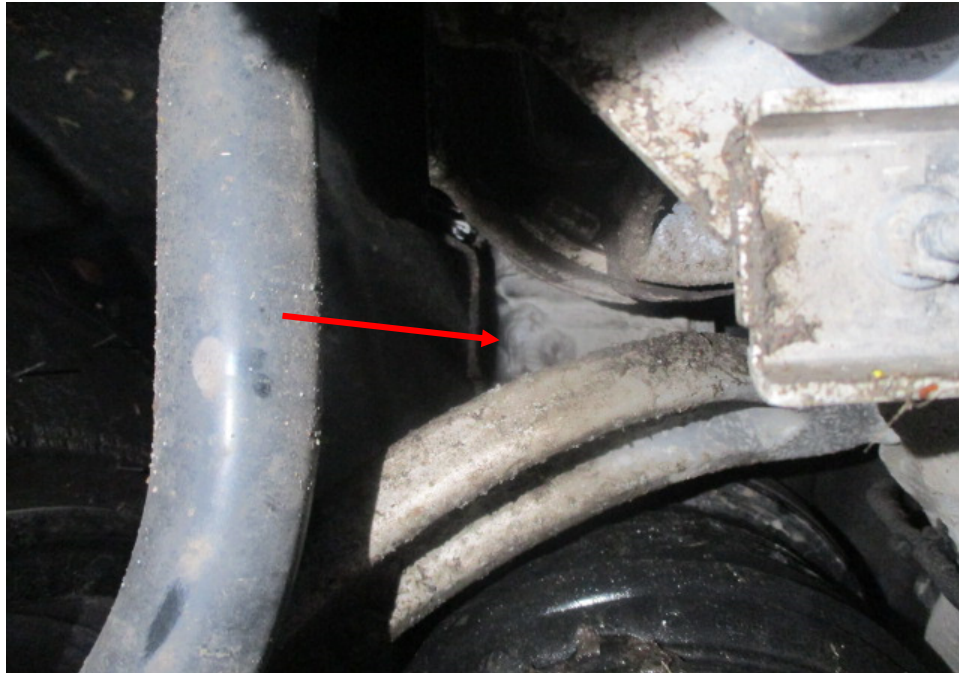
**Photo 33** shows the chassis/structural body at the underside rear left of the Motor Car. The original factory sealant (arrowed) at the joints along the chassis/structural body was observed to be untouched. In general, I had found no work was carried out on the chassis/structural body of the Motor Car. The chassis/structural body of the Motor Car was originally fitted.

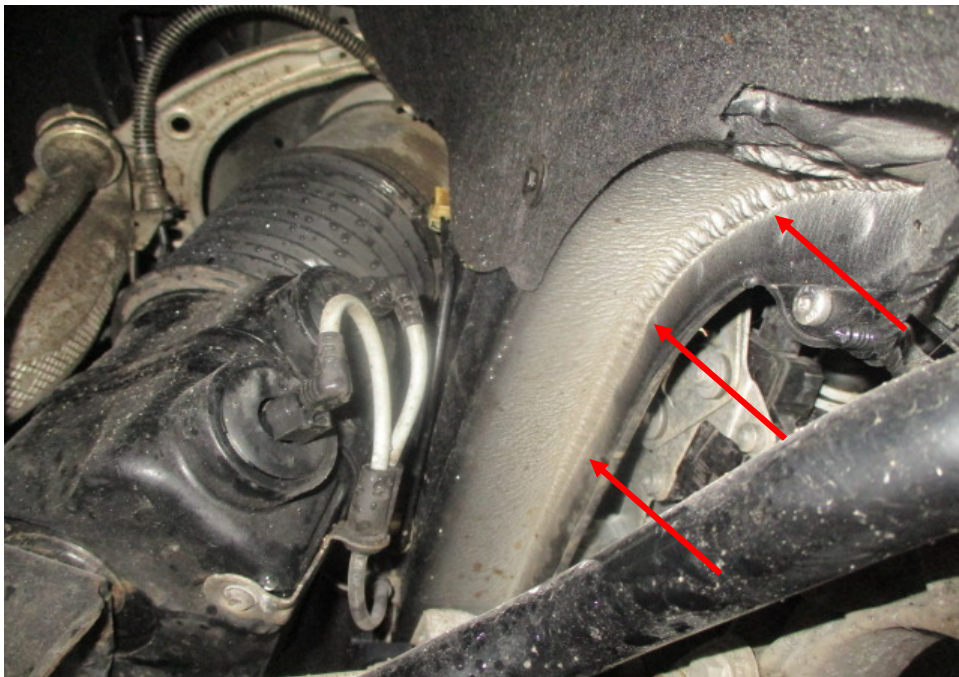
**Photo 34** shows the chassis/structural body at the underside front left of the Motor Car. I did not find any weld marks other than original spot weld marks on the chassis/structural body of the Motor Car. The original factory sealant (arrowed) at the joints along the chassis/structural body was untouched, indicating no work was done on the chassis/structural body of the Motor Car and that the chassis/structural body was originally fitted.

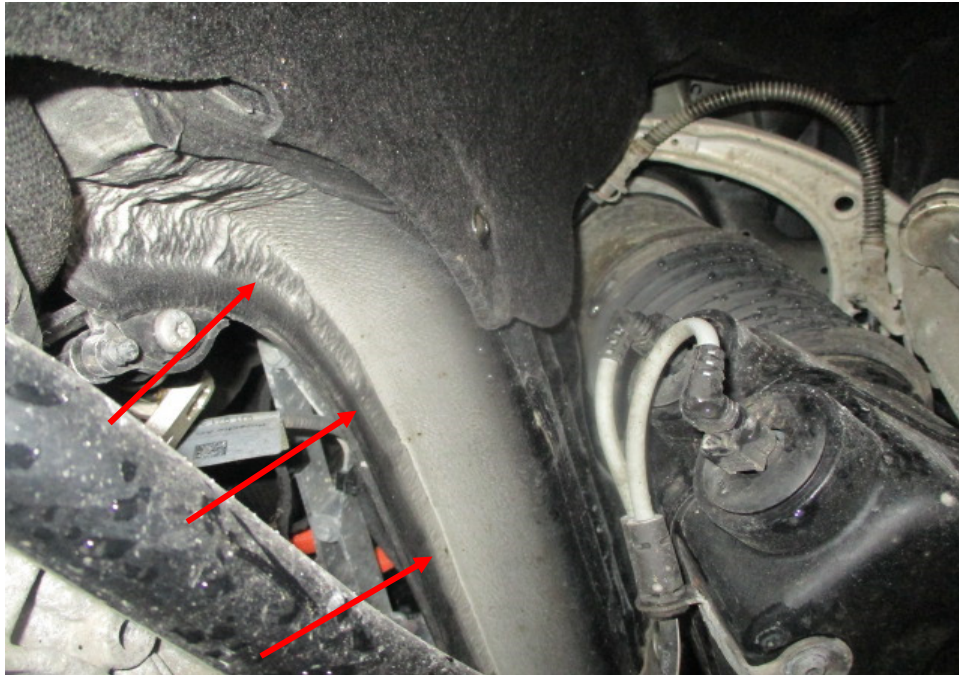
**Photo 35** shows the chassis/structural body at the underside front right of the Motor Car. The original factory sealant (arrowed) at the joints along the chassis/structural body was observed to be untouched. In general, I had found no work was carried out on the chassis/structural body of the Motor Car. The chassis/structural body of the Motor Car was originally fitted.
